**2013 ANNUAL MONITORING REPORT
(REPORT 1)
for
SOUTH ROAD MITIGATION SITE #15**

New Hampshire Department of Transportation
Salem-Manchester IM-0931(205), 10418F
[Related to Federal Project No. IM-IR-93-1(174)0]
Interstate 93 Improvements
Londonderry, New Hampshire

Pathways Consulting, LLC

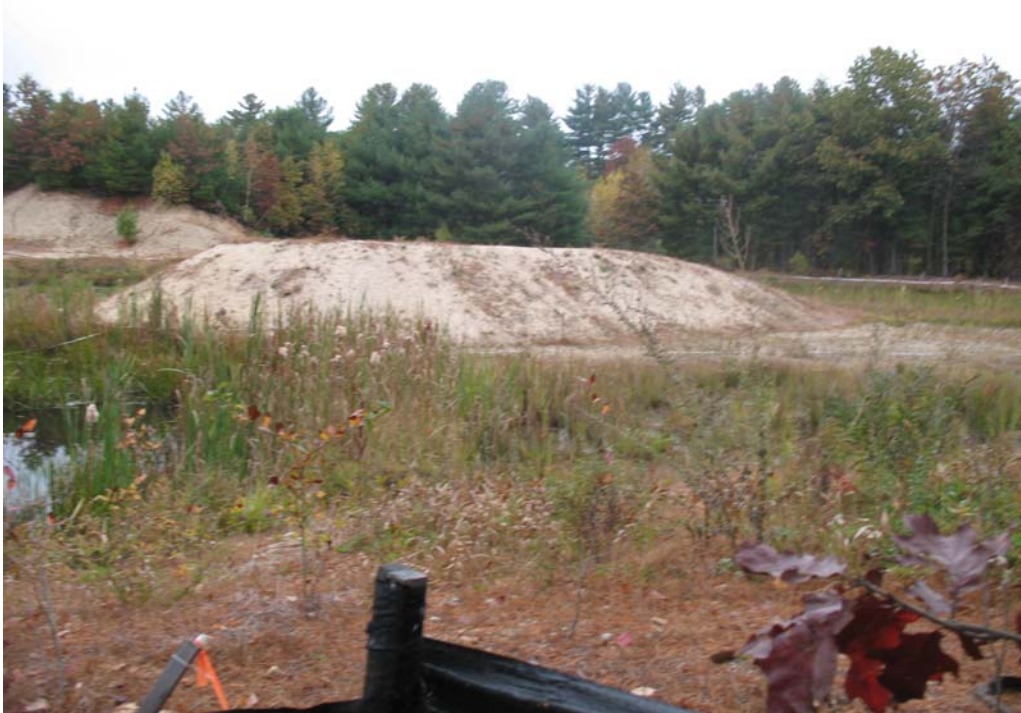
Photograph No. 1 (taken 10/16/13): View from near Sta. 202+00 50' RT on east side of the berm looking west toward turtle nesting area.

- **Turtle Nesting Area (Island)** - As observed during the spring visit, the ground surface in this area still consisted of mostly bare sand with very little vegetation on and around the turtle nesting mound (see Site Photograph Nos. 1, 4, 5, 6, 11, and 12 in Appendix A). Vegetation from adjacent seeded areas has not yet spread substantially onto these areas. The soil in the flat sand areas appeared to be hydric, and the vegetation included mostly hydrophytic vegetation, with some non-indicator species. The vegetation that was present on the turtle nesting area primarily consisted of small clumps of Switch Grass (*Panicum virgatum*), Slender Flat-sedge (*Cyperus filiculnris*), Clover (*Trifolium spp.*), and occasional

and Cattails were also observed in other areas of the site, including along the slopes of the muck moat (see Site Photograph Nos. 1 through 3). It is possible that invasive plants may have been introduced to the site through organic soils imported during construction. We also observed some Oriental Bittersweet (*Celastrus orbiculatus*), a invasive species, along the perimeter of the mitigation area near the northeast end of the chain link fence. Similar to our spring 2013 observations, we also noted at least three Autumn Olive (*Elaeagnus umbellate*) on the berm at the south side of the site, even though several plants had been removed by hand from the same area in the spring.

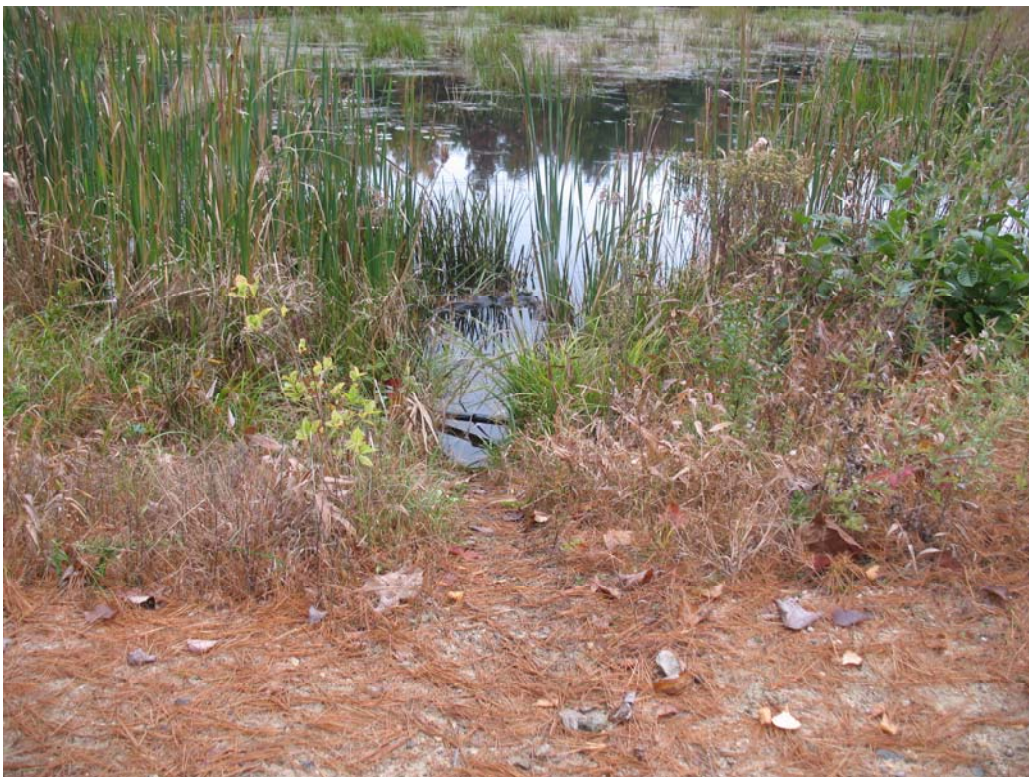
Photograph No. 2 (taken 10/16/13): View from Sta. 201+50 100' RT looking to the west across the animal trail that connects the existing pond to the mitigation site.

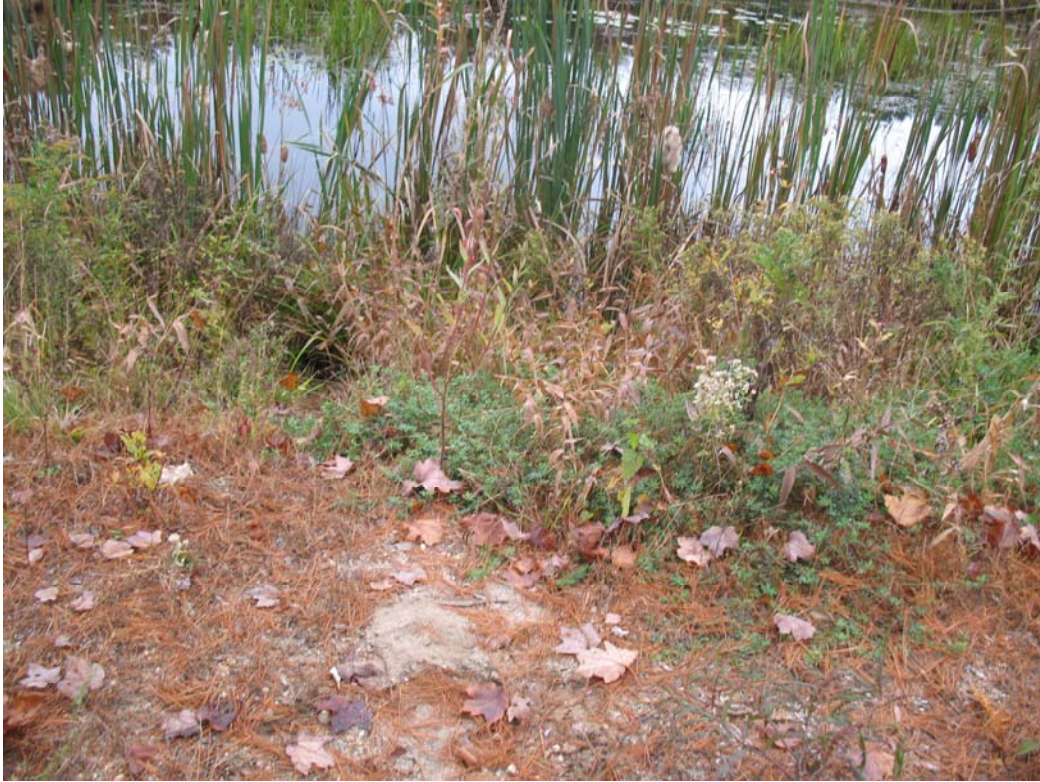
Photograph No. 3 (taken 10/16/13): View from Sta. 202+00 100' RT looking to the west across another animal trail that connects the existing pond to the mitigation site.

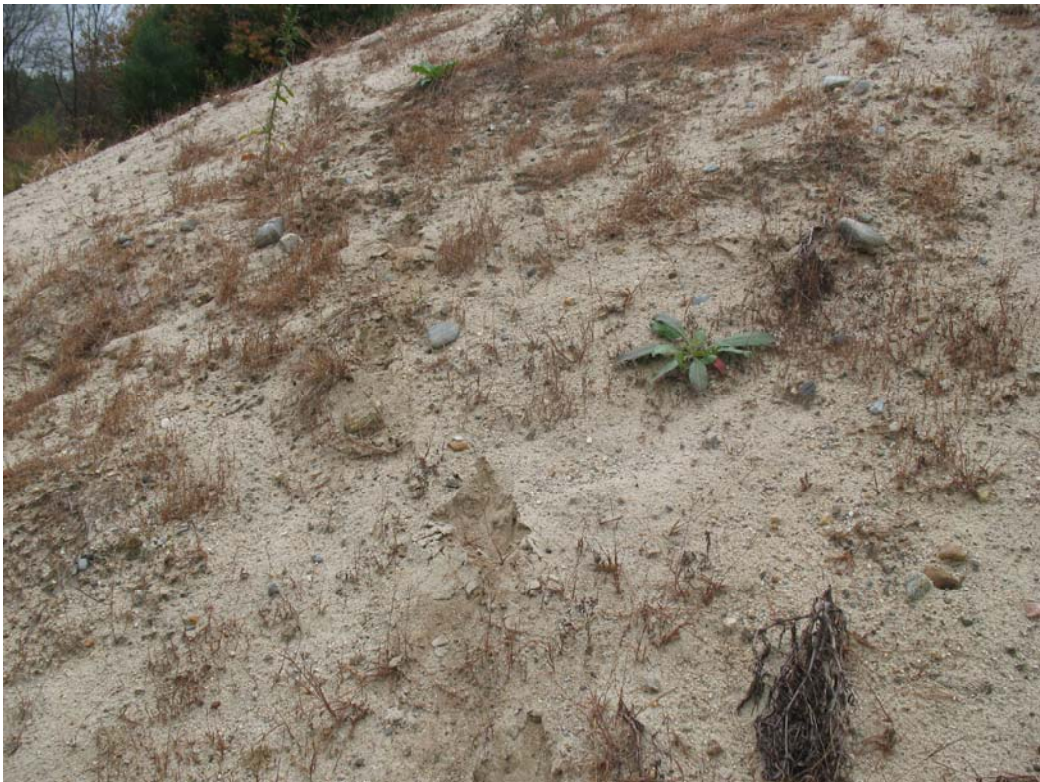
Photograph No. 4 (taken 10/16/13): Deer tracks on southeast side of the turtle mound.

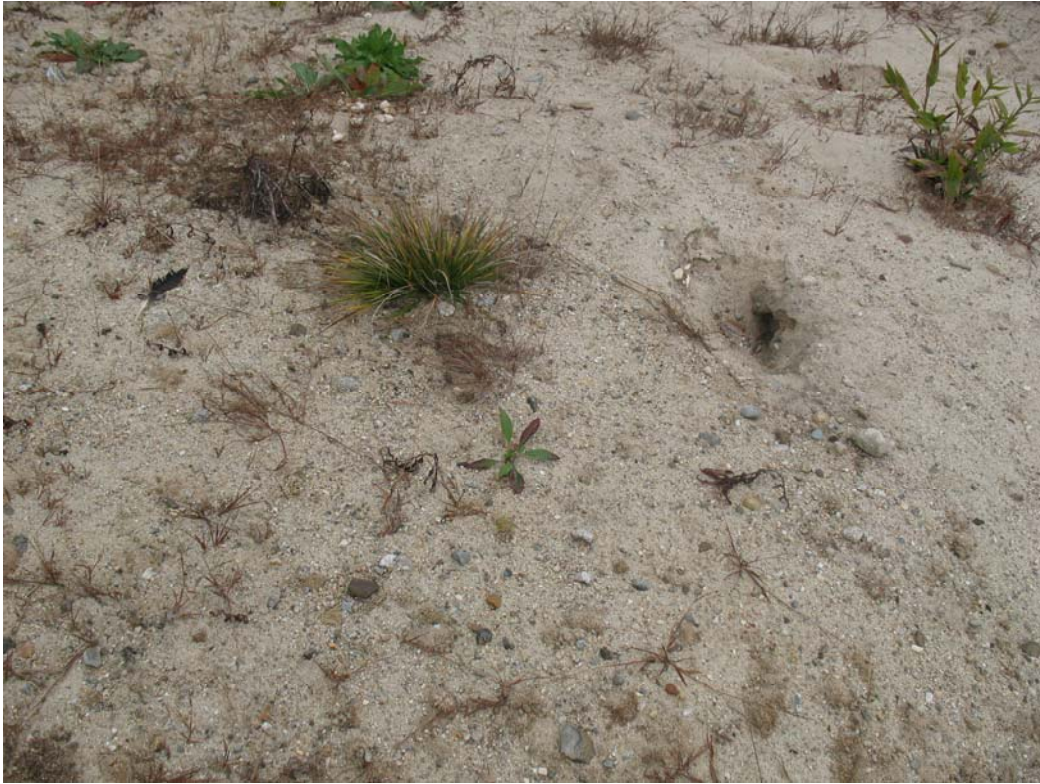
Photograph No. 5 (taken 10/16/13): View of turtle mound showing evidence of animal predation on turtle eggs.

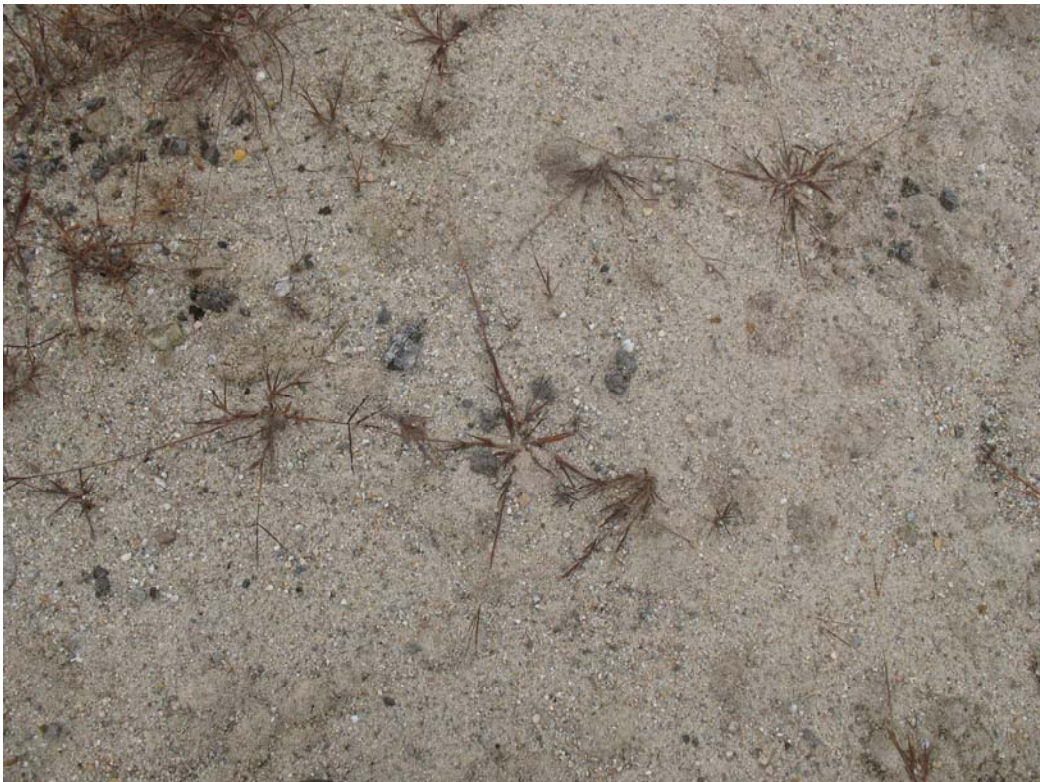
Photograph No. 6 (taken 10/16/13): Animal scat on turtle mound.

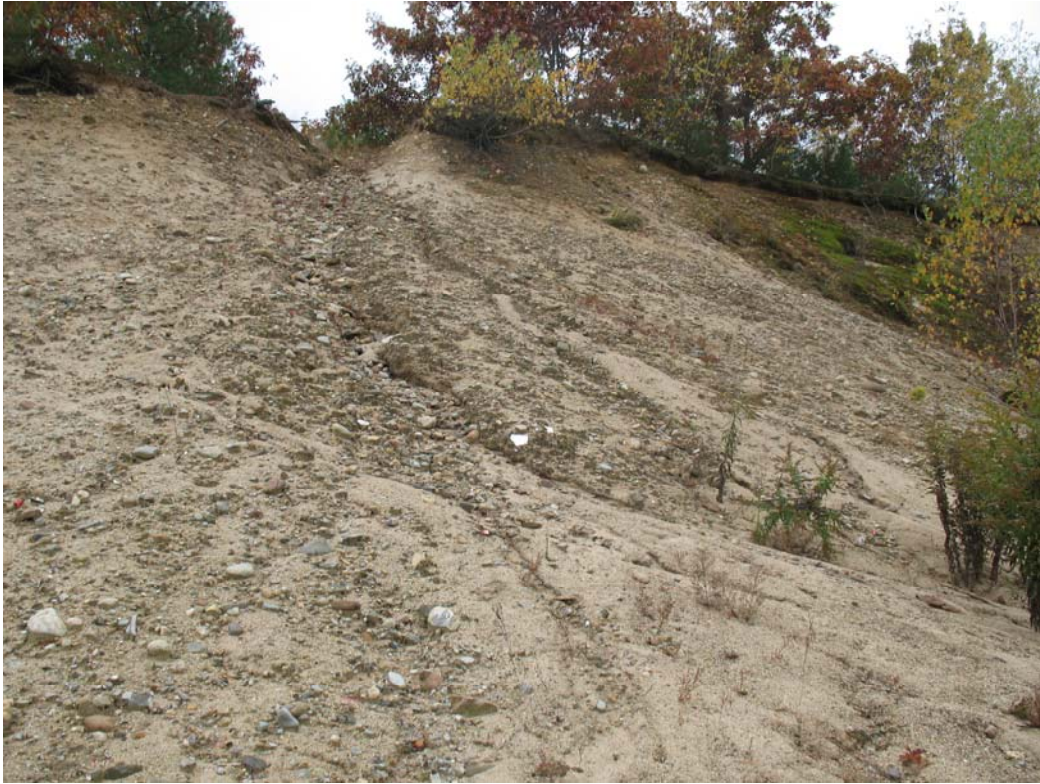
Photograph No. 7 (taken 10/16/13): View of erosion continuing on existing sand esker slopes southwest of the muck moat.

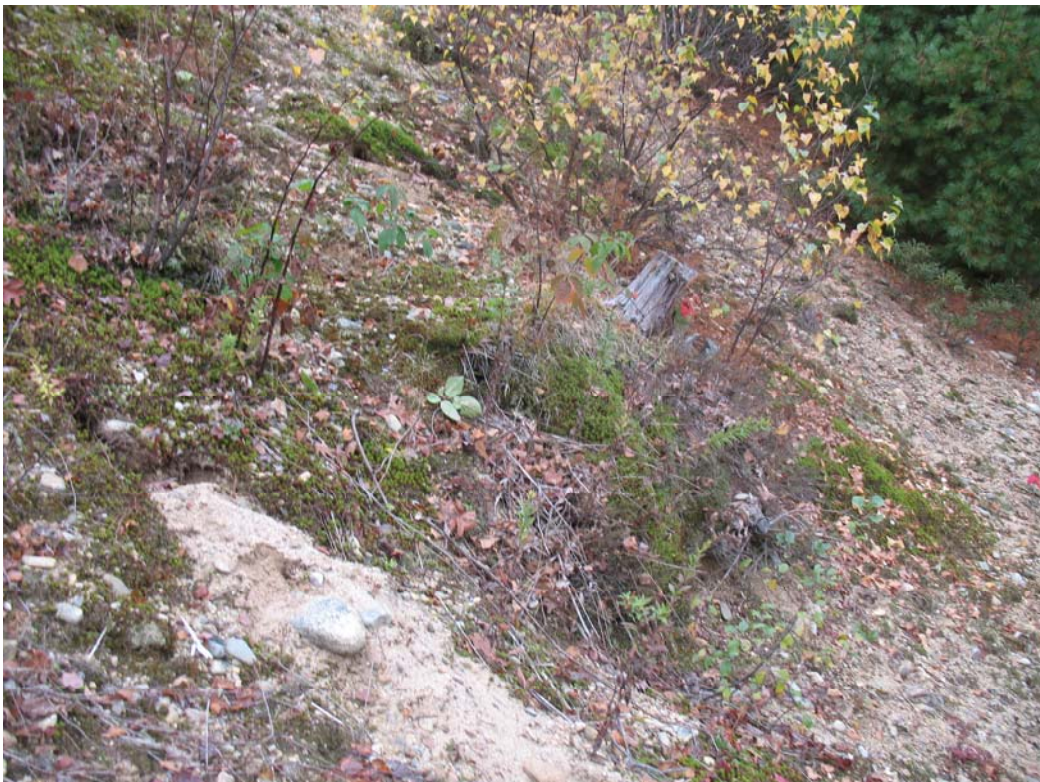
Photograph No. 8 (taken 10/16/13): View of an animal burrow on the upper slope of the existing sand esker southwest of the muck moat.

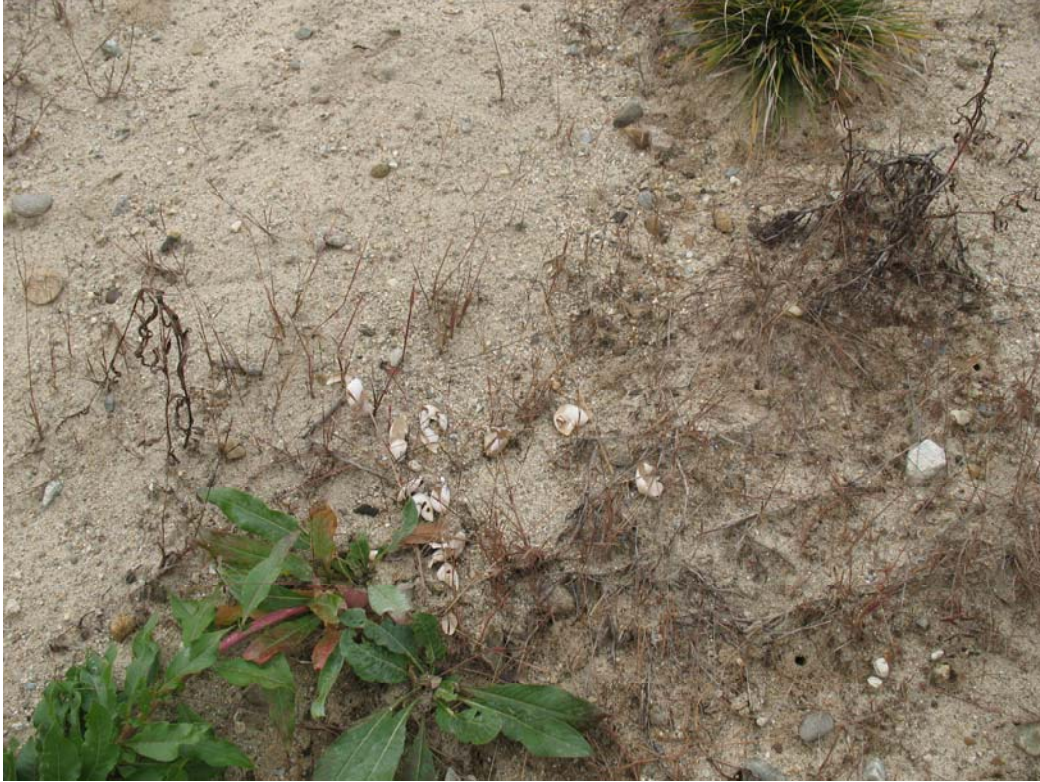
Photograph No. 9 (taken 10/16/13): View of additional evidence of turtle egg predation on the south side of turtle nesting area.

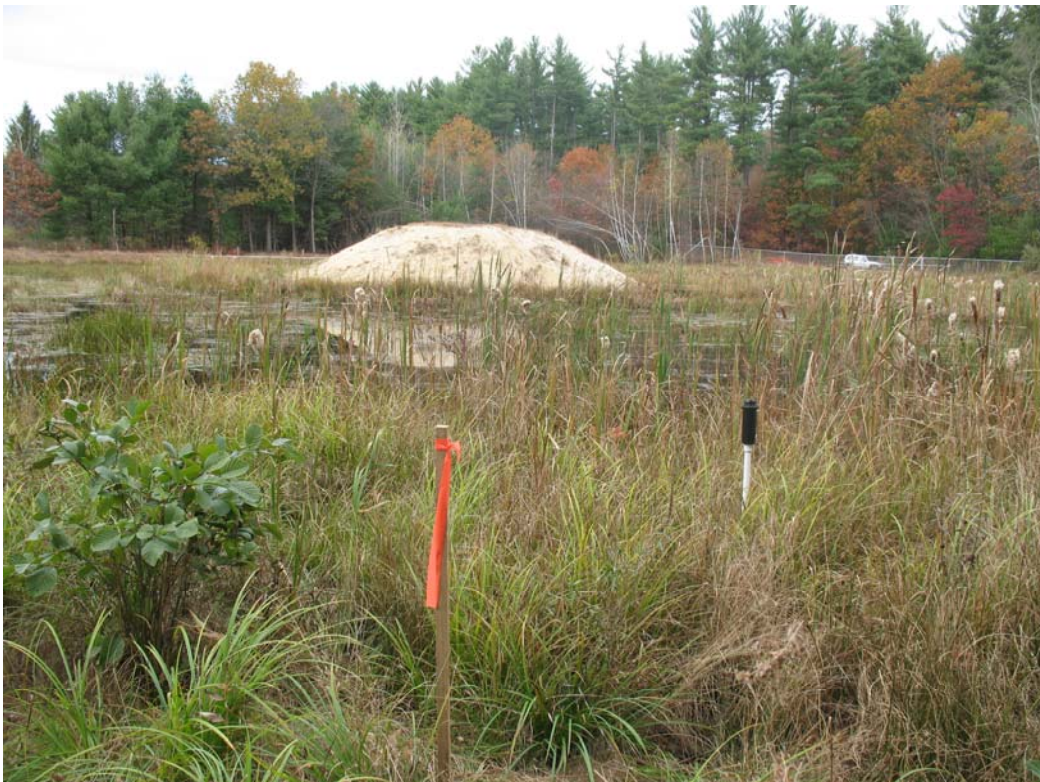
Photograph No. 10 (taken 10/26/13): View of Vegetation Plot #1 at Sta. 200+76 RT 30' looking to the northwest toward the turtle nesting area.

- As mentioned above, some populations of invasive/undesirable species were noted vegetation plots VEG-1 and VEG-5, including Purple Loosestrife (*Lythrum salicaria*) and Cattails (*Typha angustifolia*) (see Site Photograph Nos. 10 and 13 in Appendix A). The average areal coverage of invasive/undesirable species within the herbaceous layer was calculated for each vegetation plot and summarized in Table B below. Outside the vegetation plots, higher concentrations of Purple Loosestrife

Vegetation Plot No.	Invasive/Undesirable Species Type	Areal Coverage of Herbaceous Layer (%)
VEG-1	Purple Loosestrife	1
VEG-2	-	-
VEG-3	-	-
VEG-4	-	-
VEG-5	Cattails/Purple Loosestrife	15/2
VEG-6	-	-

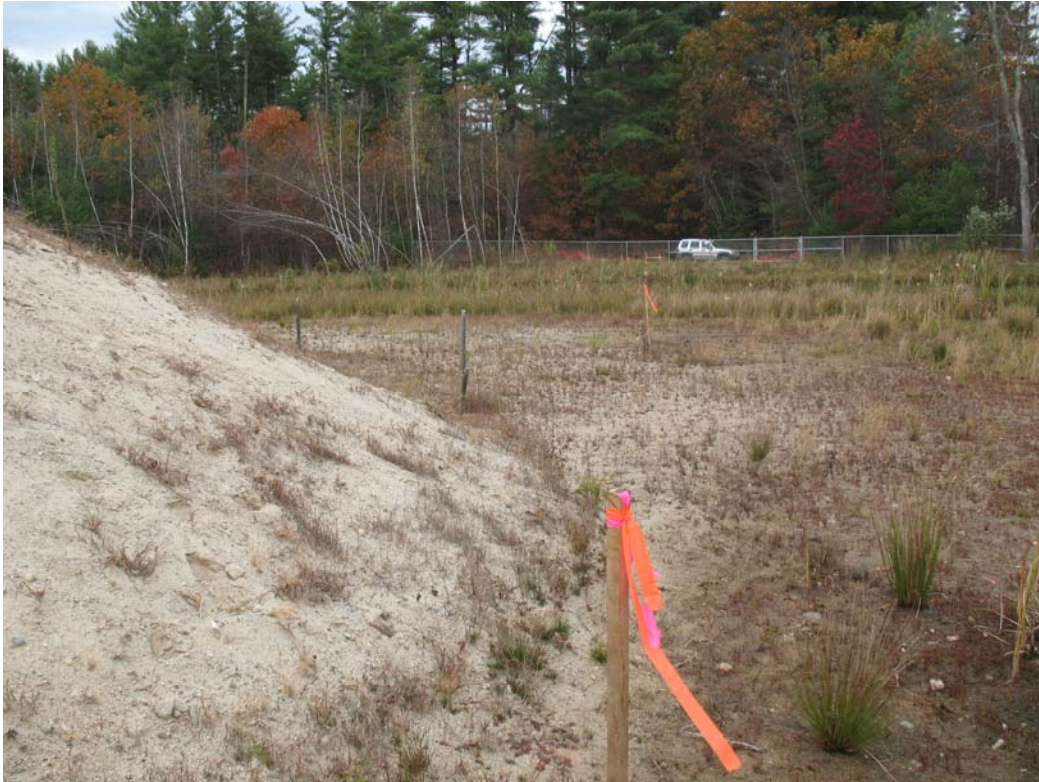
Photograph No. 11 (taken 10/26/13): View of Vegetation Plot #2 at Sta. 202+03 RT 60' looking toward Vegetation Plot #3.

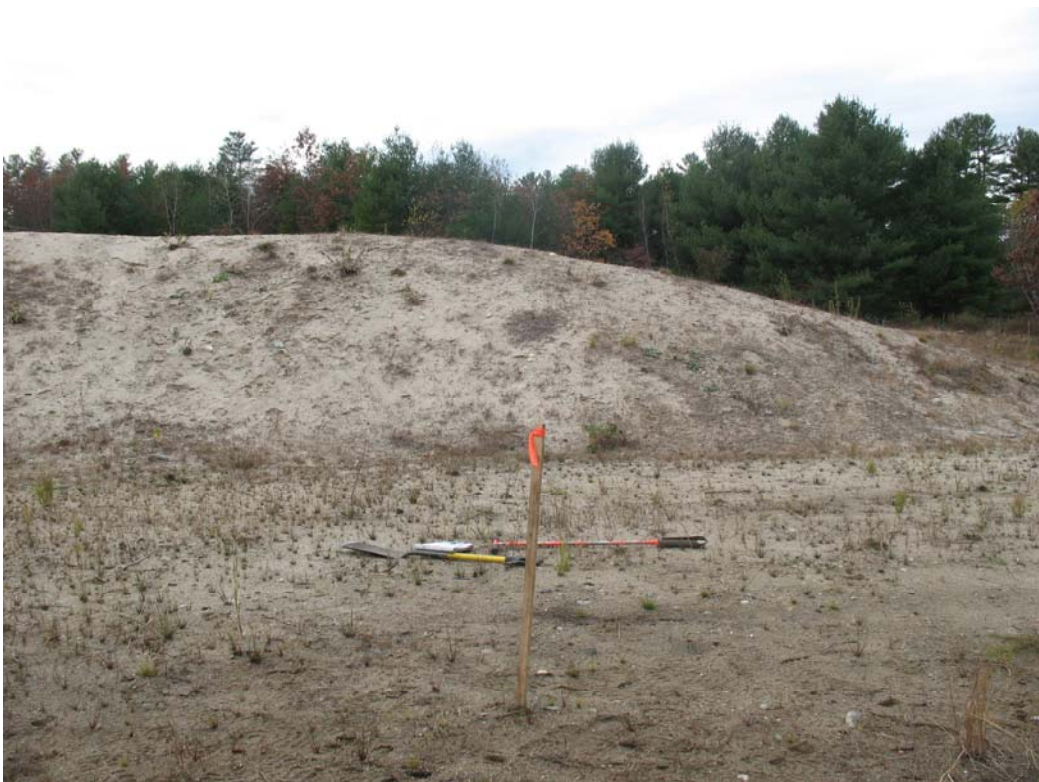
Photograph No. 12 (taken 10/26/13): View of Vegetation Plot #3 at Sta. 202+50 RT 50'.

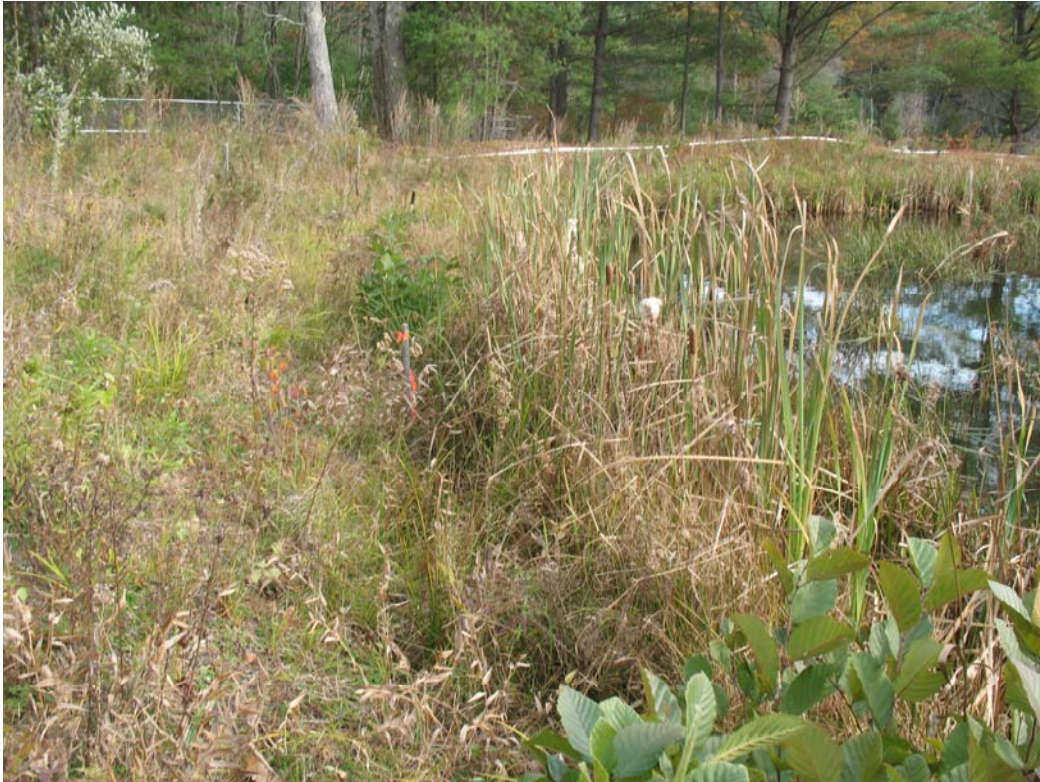
Photograph No. 13 (taken 10/26/13): View of Vegetation Plot #5 at Sta. 203+80 from 25' left looking to the east.

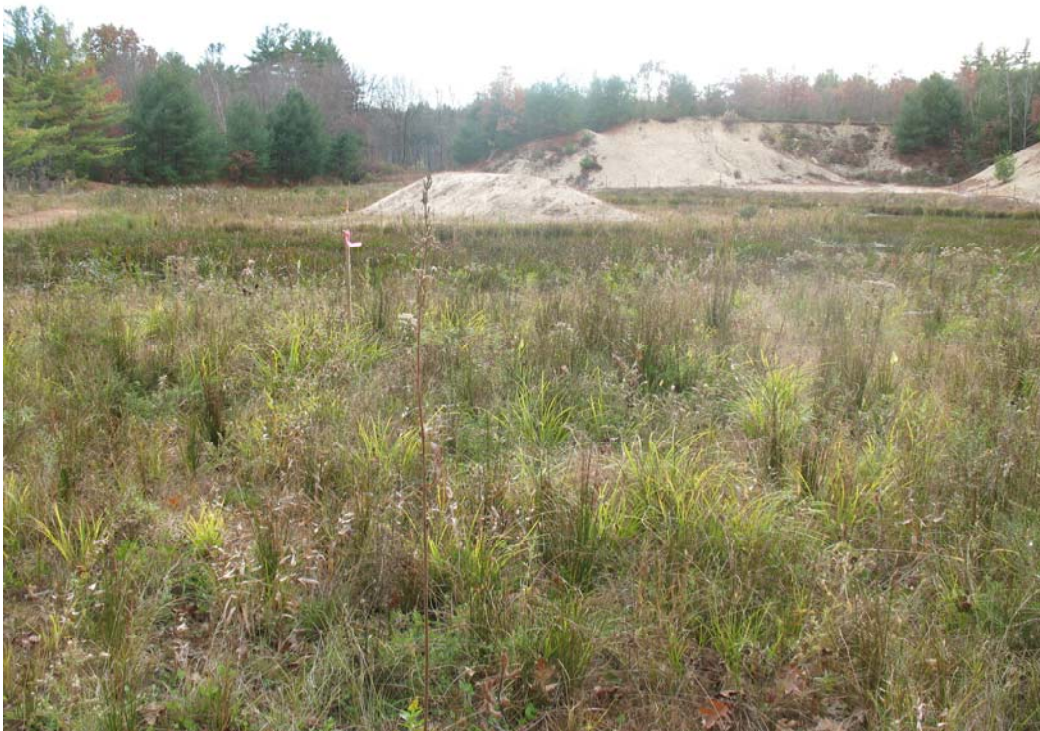
Photograph No. 14 (taken 10/26/13): View of Vegetation Plot #6 at Sta. 204+00 looking south along baseline transect from near chain link fence.

Vegetation Plot No. 6 (VEG-6): VEG-6 is located at transect Sta. 204+00 within the planned shrub/forested upland area identified on the NHDOT Project Plans for slope stabilization (see Site Photograph No. 14 in Appendix A). This plot was located in an area that was disturbed during construction, so no shrubs and trees were noted at this plot, although we noted a few pioneer species, such as Gray Birch (*Betula populifolia*)(FAC) beginning to populate the surrounding area. The vegetation at this upland plot included a substantial herbaceous layer, dominated by 40% Shallow Sedge (*Carex lurida*)(OBL), 20% Soft Rush (*Juncus effuses*) (FACW+), and 20% Lance-leaved Goldenrod (*Euthamia graminifolia*)(FAC), along with 5% Deer Tongue Grass (*Panicum clandestinum*)(NI), 5% Red Clover (*Trifolium repens*)(FACU-), and 5% Birdsfoot Trefoil (*Lotus corniculatus*) (FACU-). Some of the herbaceous vegetation observed at this plot was part of the proposed planting list and/or specified seed mix.

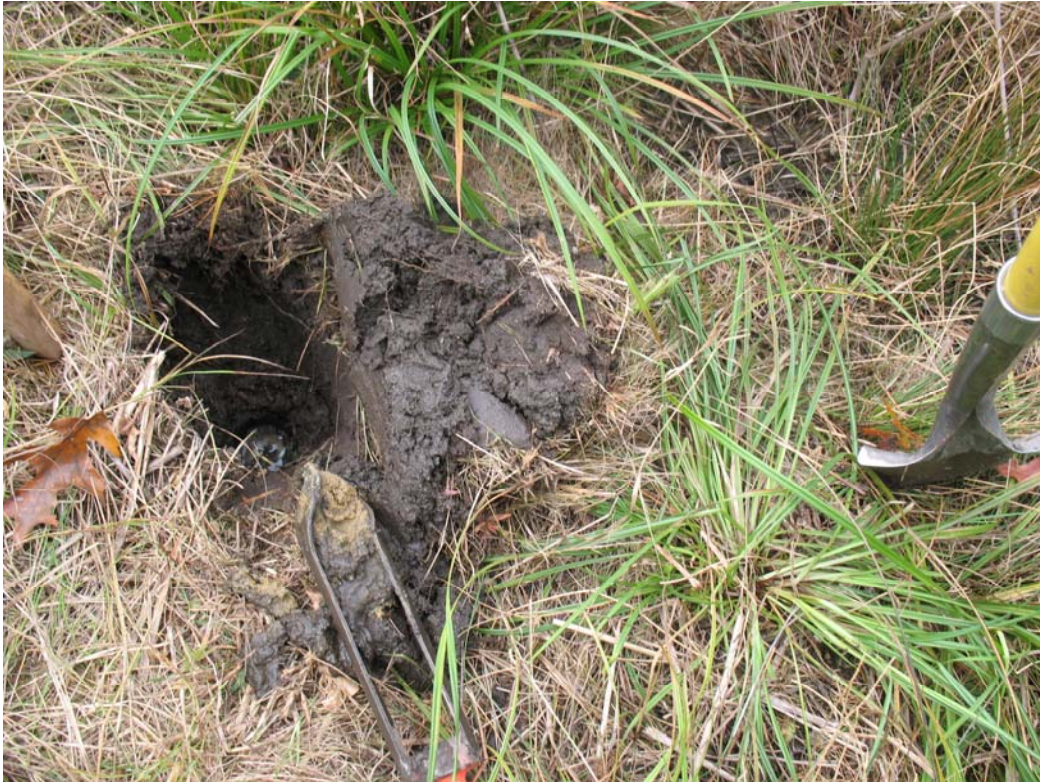
Depth	Horizon/Description
0" - 17"	Ap ; Very Dark Grayish Brown; 10YR 3/2 Fine sandy loam (saturated)
17" - 20"	Bg ; Olive Brown 2.5Y 4/3 medium sand; loose single grain; loose; many large prominent redox concentrations; saturated to the surface
	Note: Water entering hole at 16" at the time of the investigation

Photograph No. 15 (taken 10/26/13): View of soil test hole at Vegetation Plot #1.

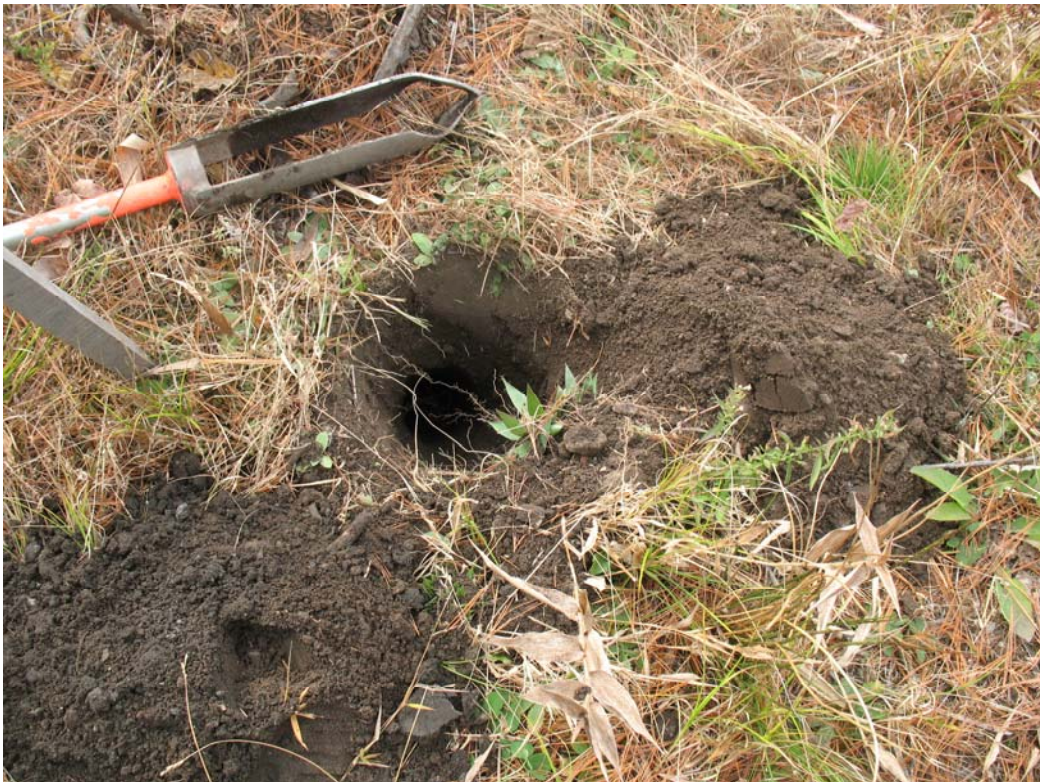
Photograph No. 16 (taken 10/26/13): View of soil test hole at Vegetation Plot #2.

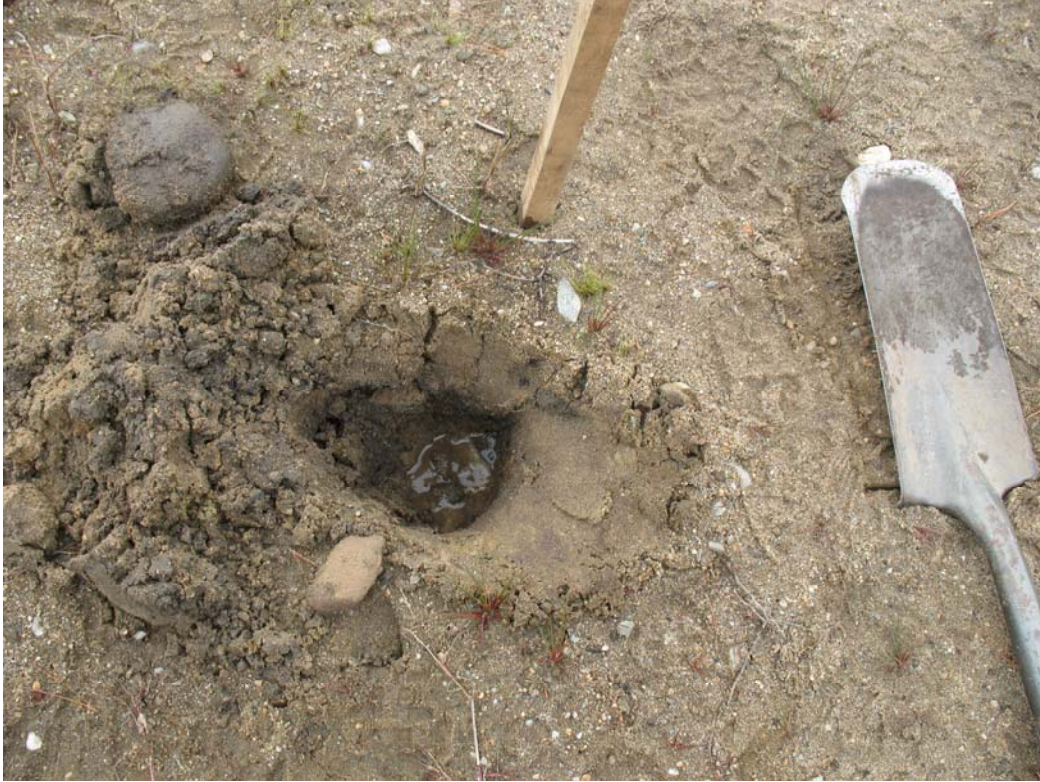
Photograph No. 17 (taken 10/26/13): View of soil test hole at Vegetation Plot #3.

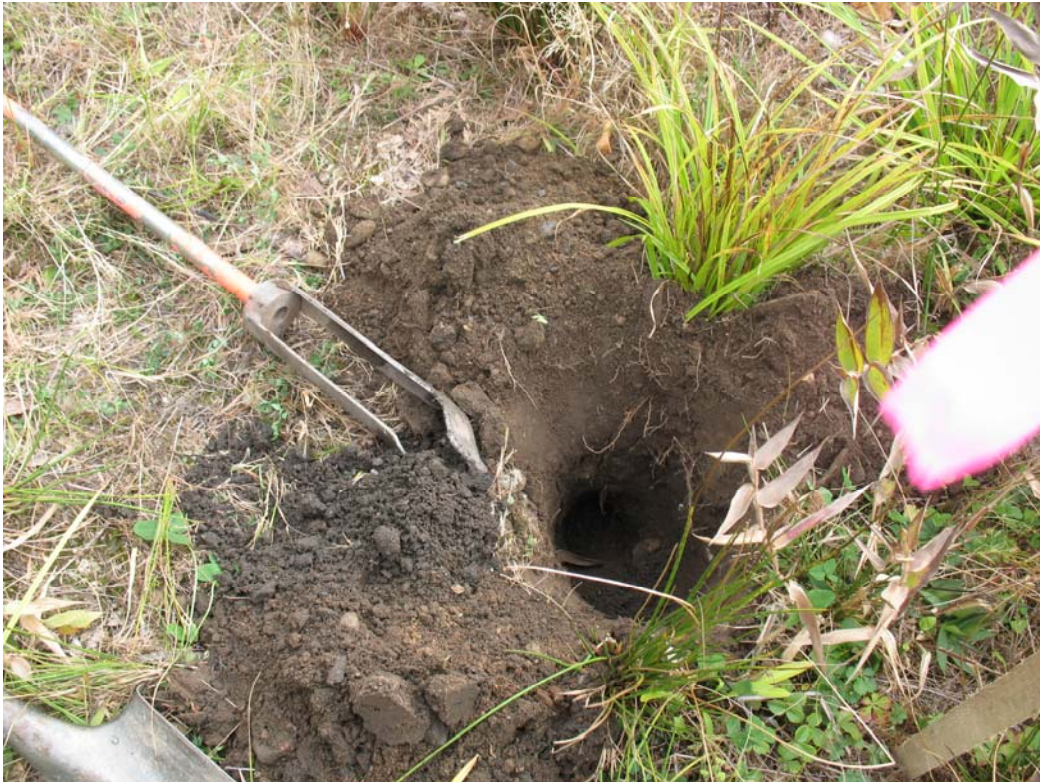
Photograph No. 18 (taken 10/26/13): View of soil test hole at Vegetation Plot #6.

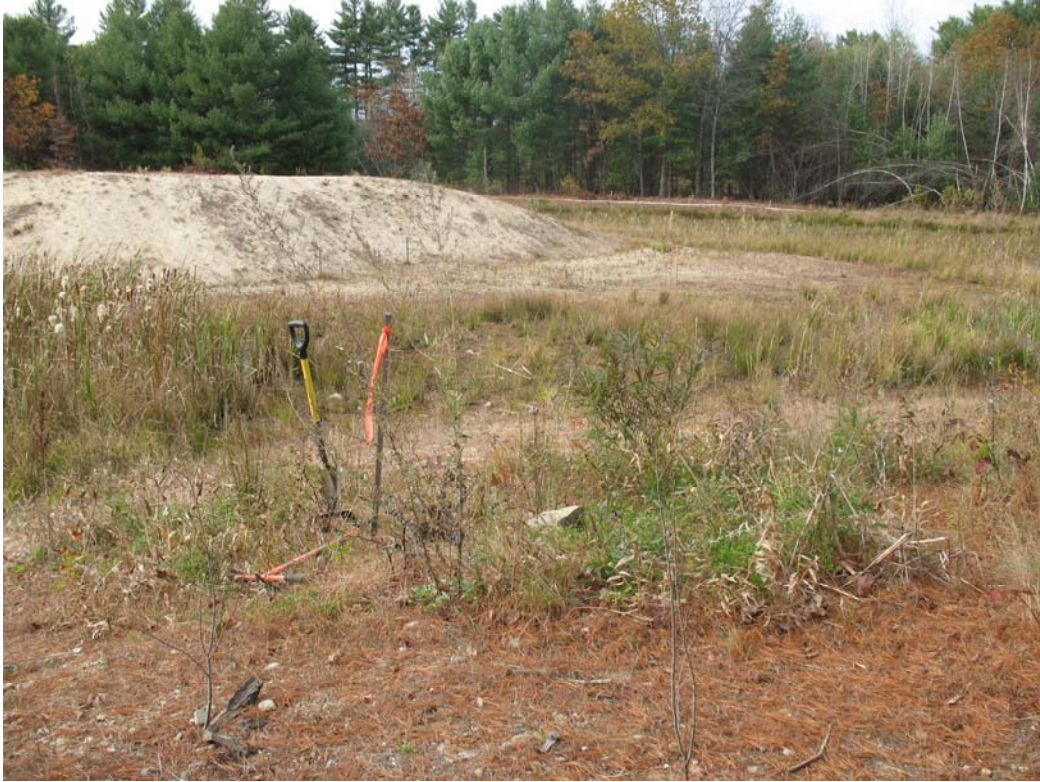
Photograph No. 19 (taken 10/26/13): View of Vegetation Plot #2 at Sta. 202+03 RT 60' from existing berm looking to west toward turtle nesting area.
