# Railway Brook Restoration

Wetland Mitigation for the Spaulding  
Turnpike Improvements  
Newington, New Hampshire

November 2015

## 2015 1<sup>st</sup> Year Monitoring Report Railway Brook Restoration Project, Newington, NH

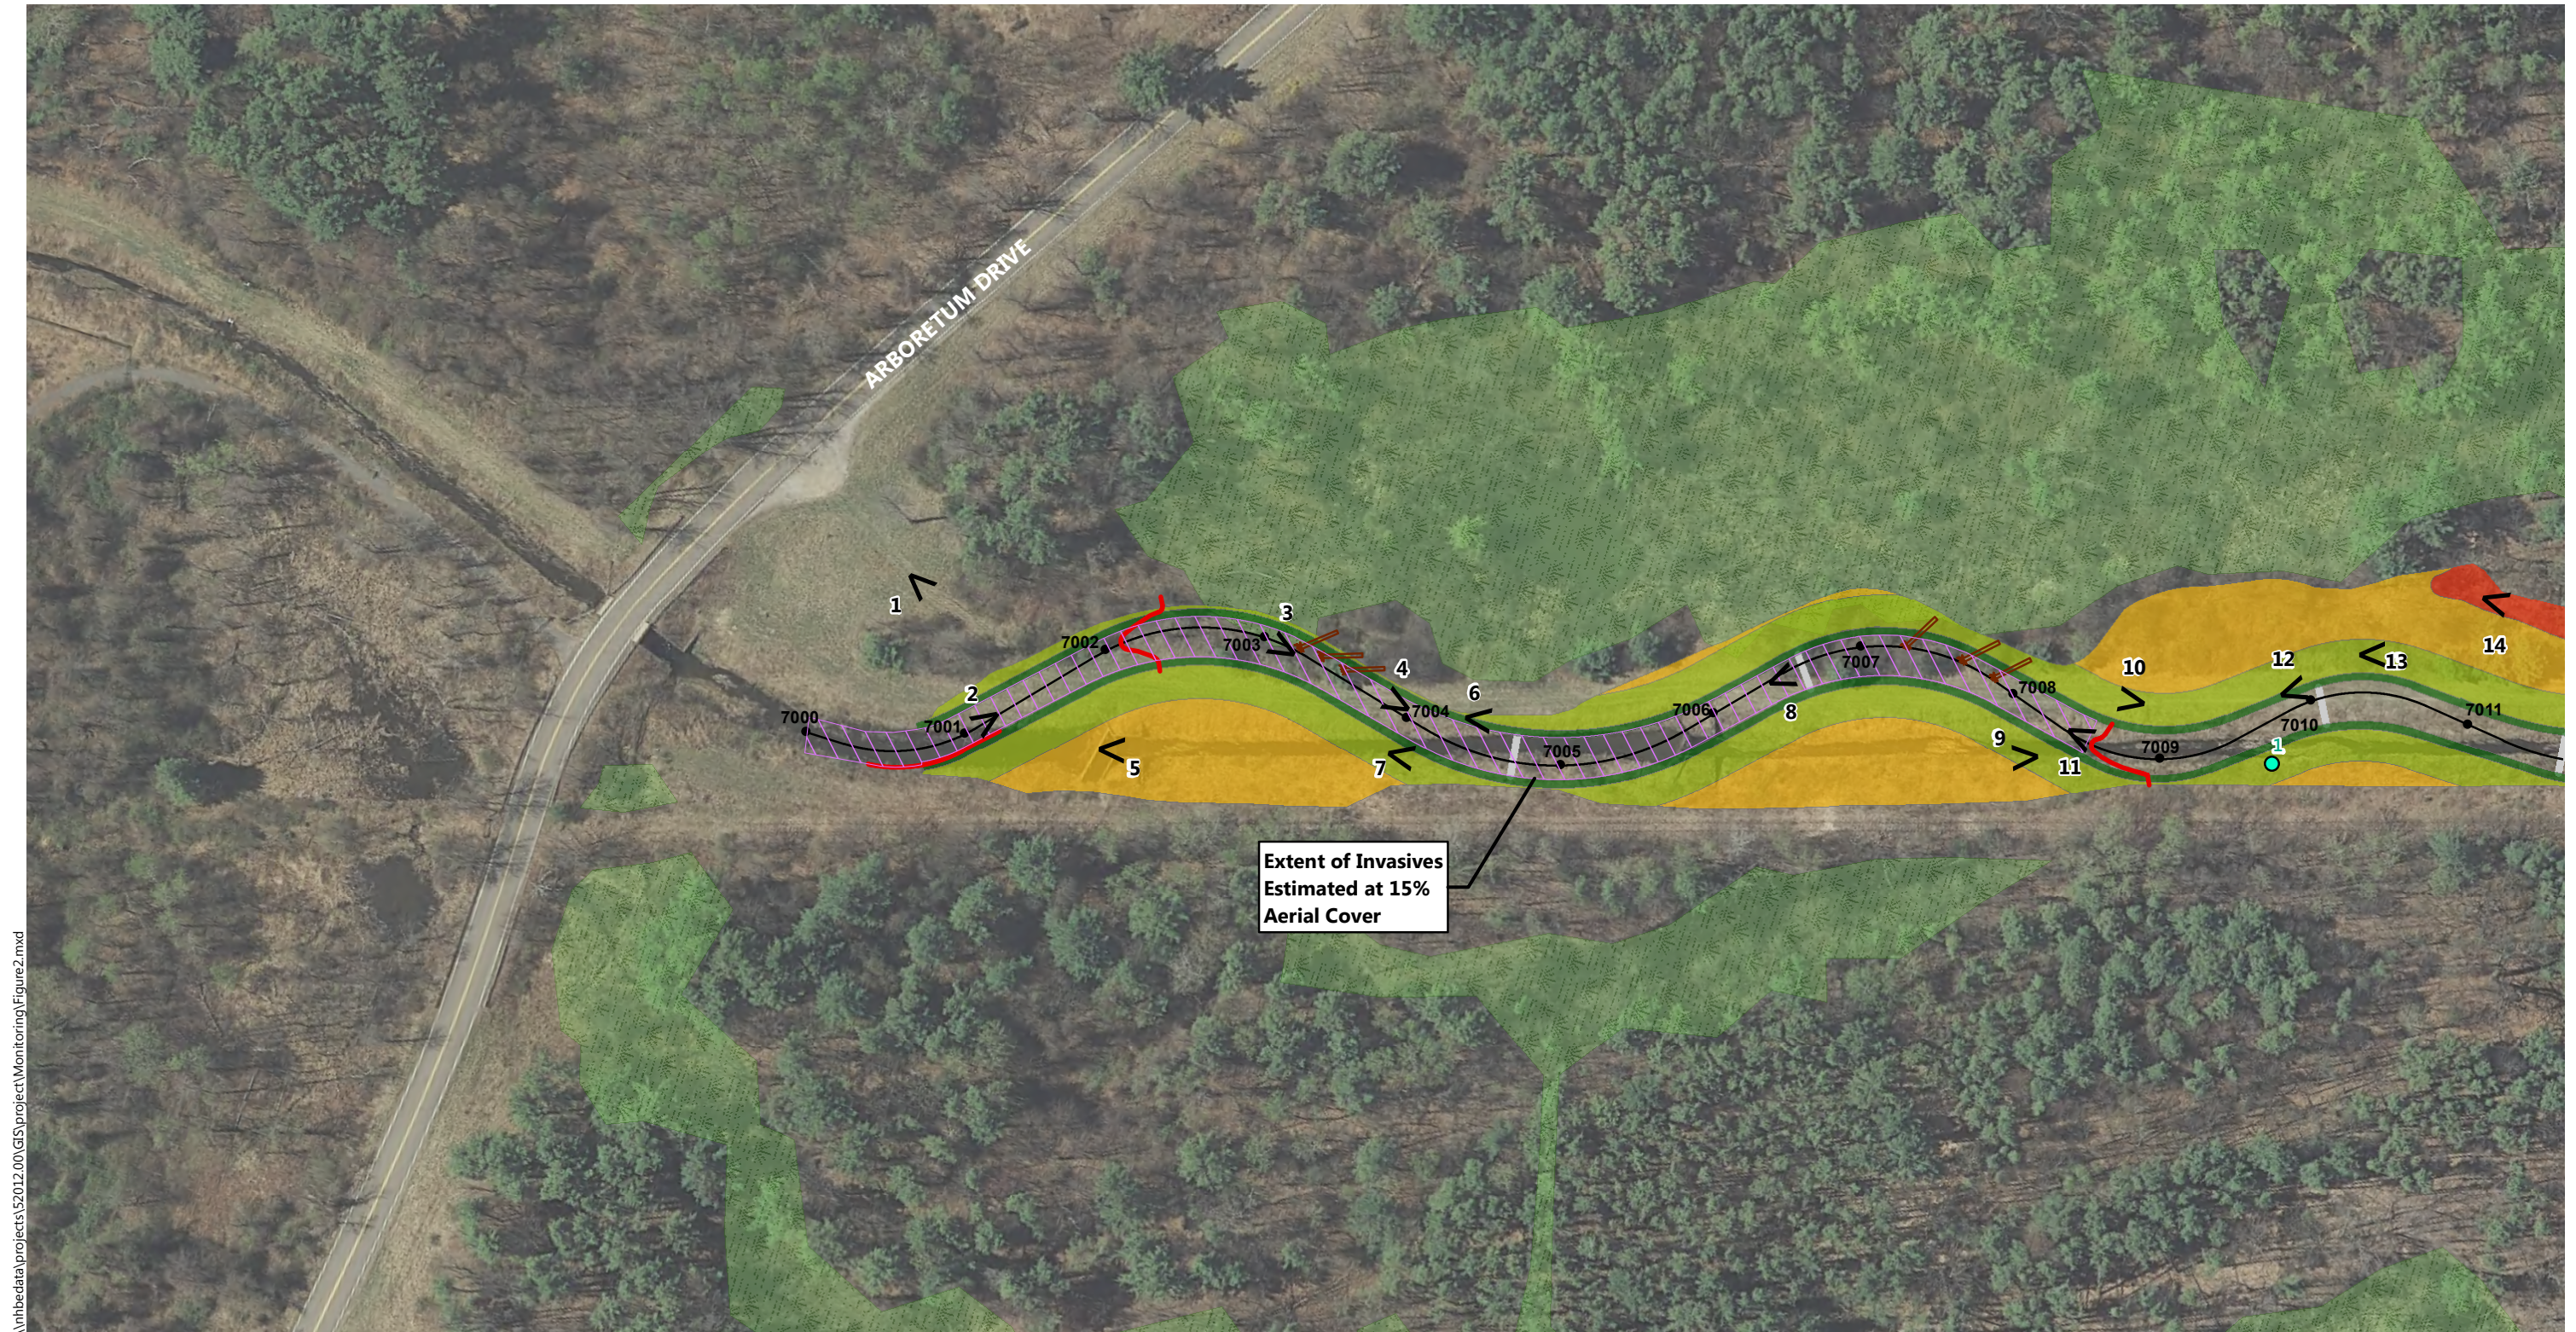
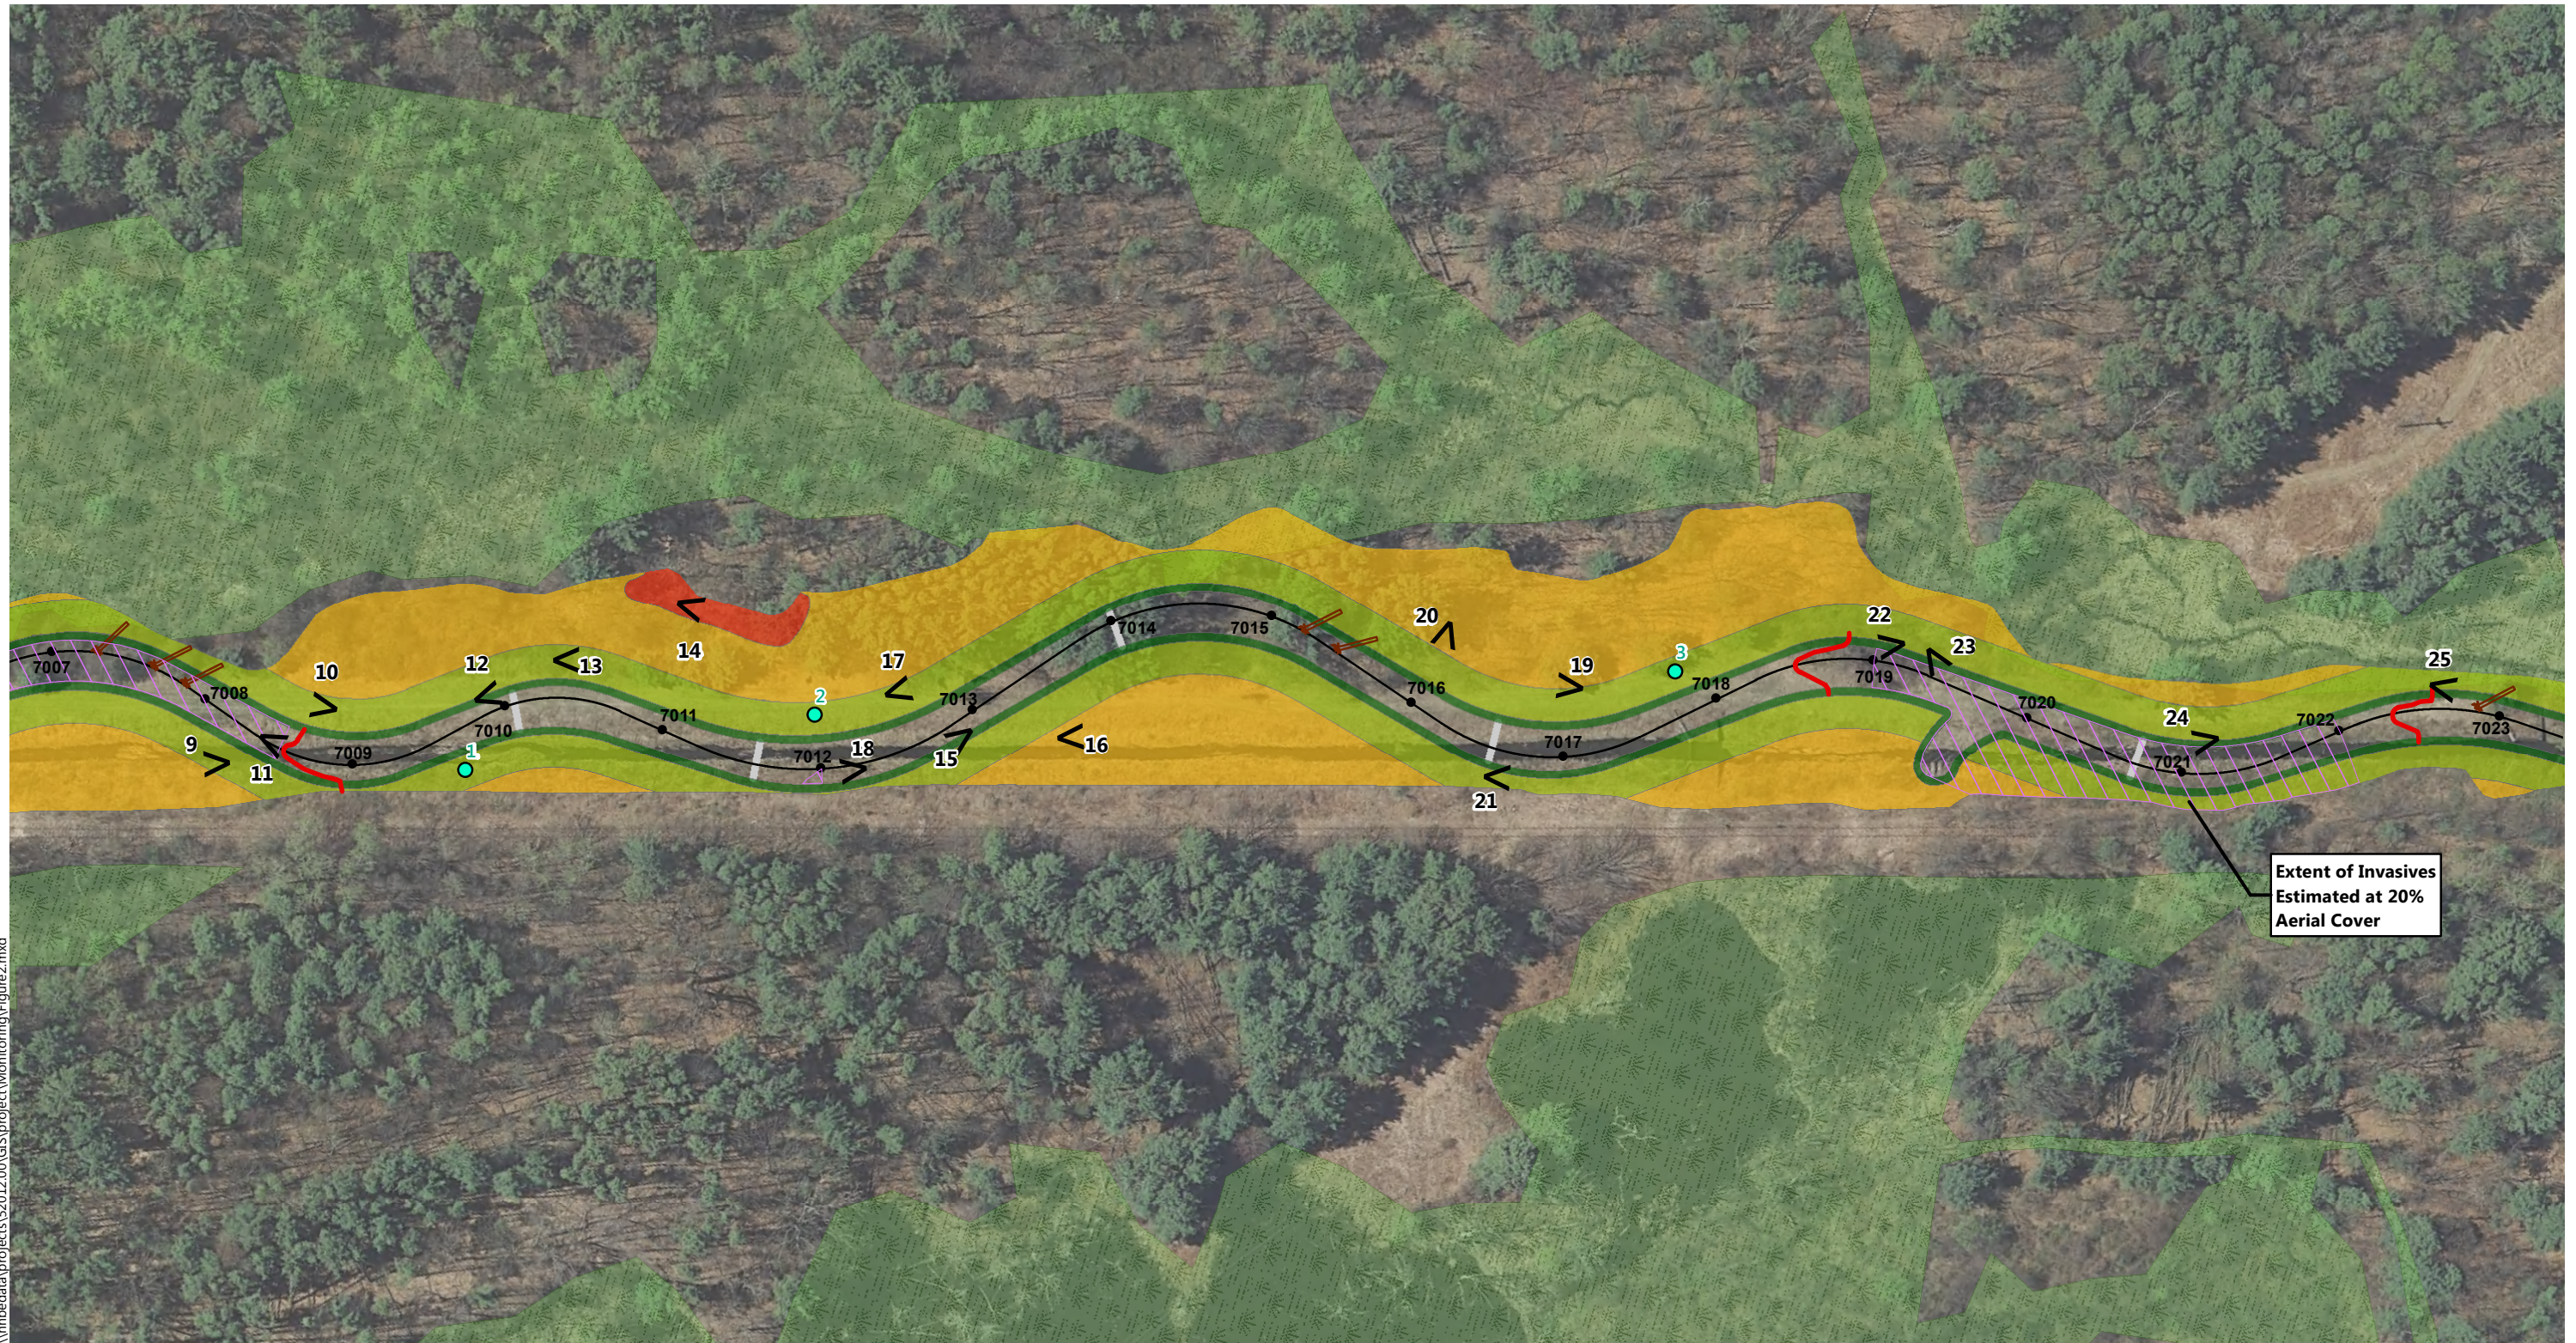
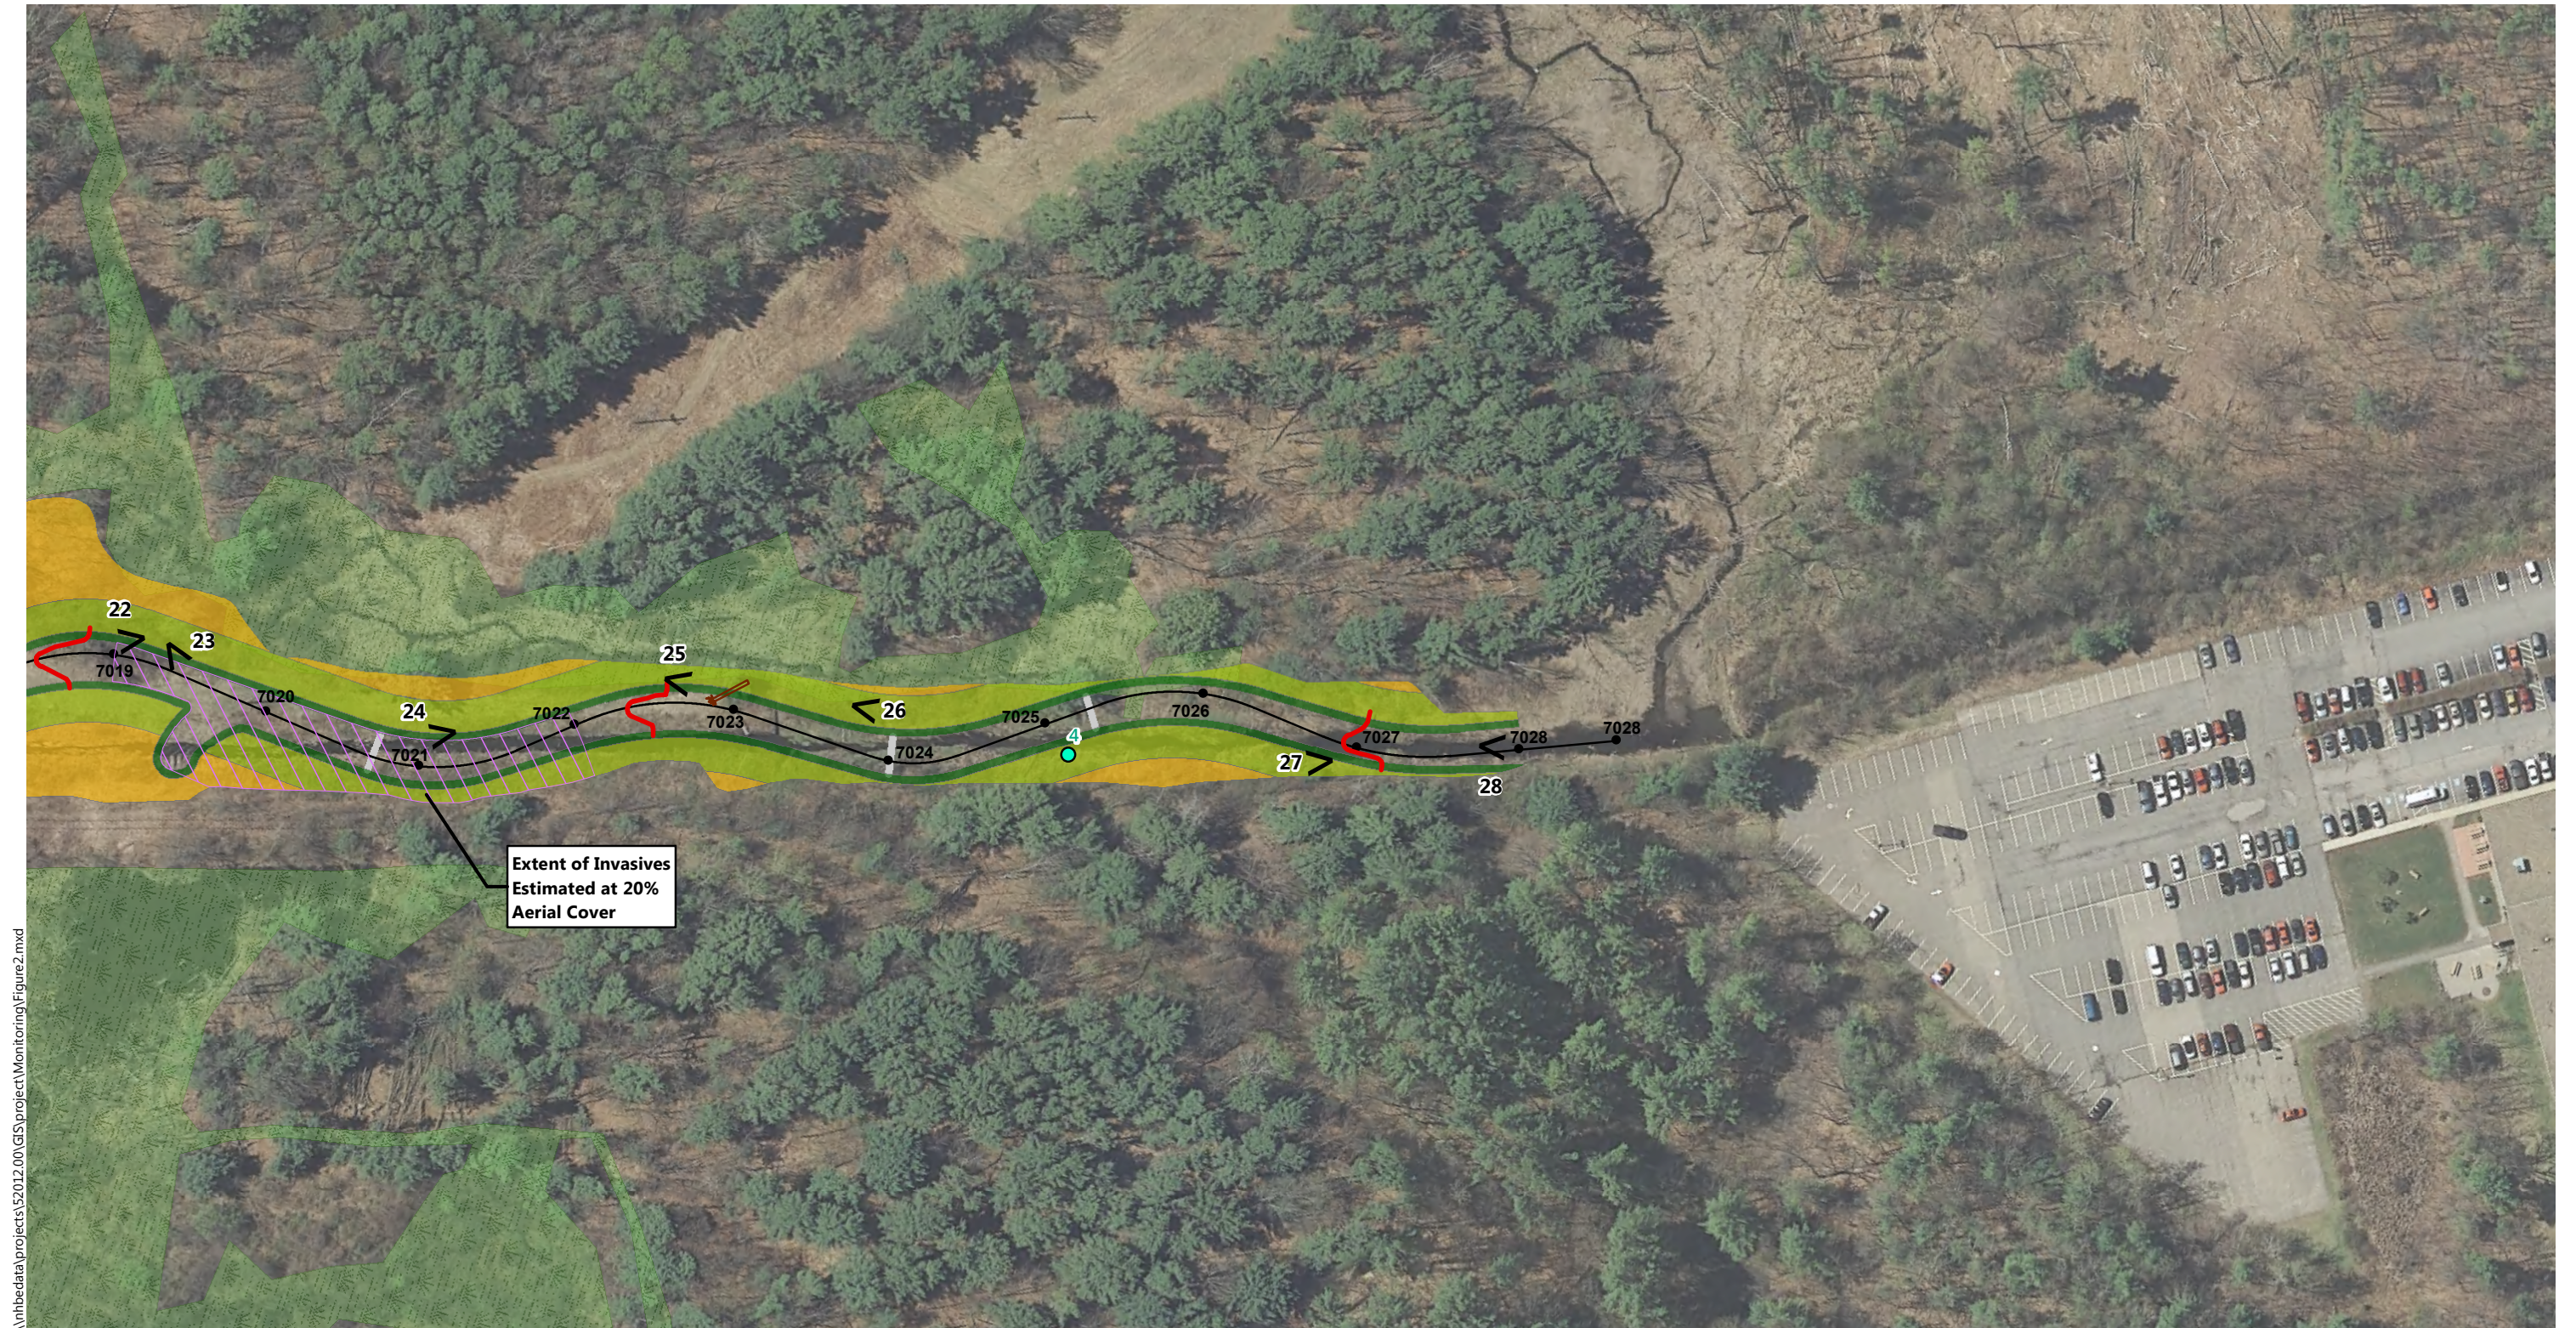
**Railway Brook  
1st Year Monitoring Map**

No other areas of invasive species were identified within the restoration site. Refer to **Figure 2** for mapped locations of purple loosestrife and narrow-leaf cattail within the restoration site.

Extent of Invasives  
Estimated at 20%  
Aerial Cover

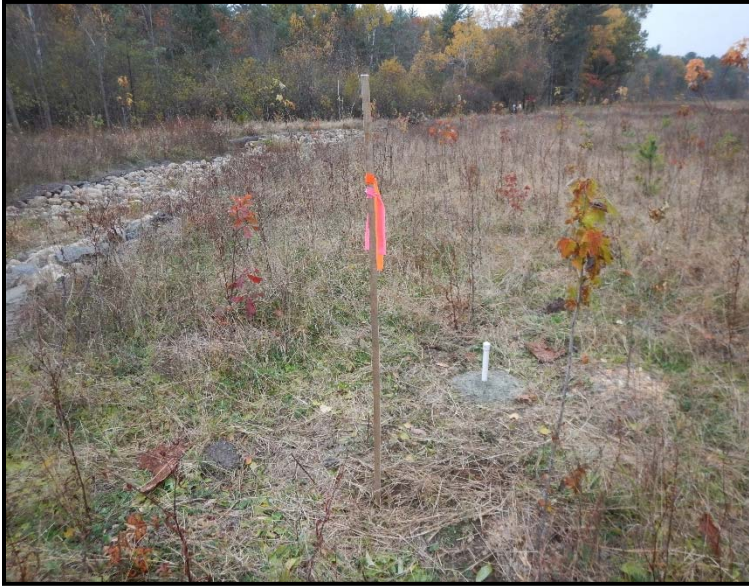
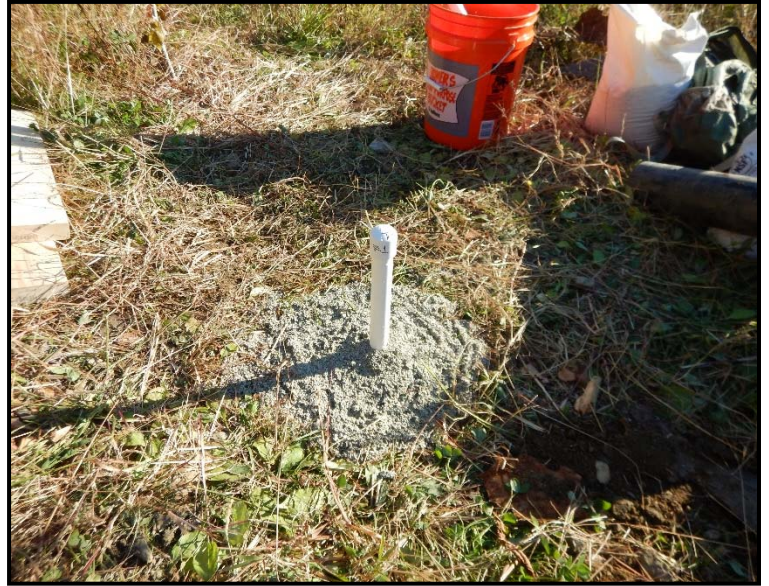
Shallow Groundwater Well #1 installed within Zone 2 along the eastern side of Railway Brook adjacent to Stations 7005-7006. Date: 10-23-2015.

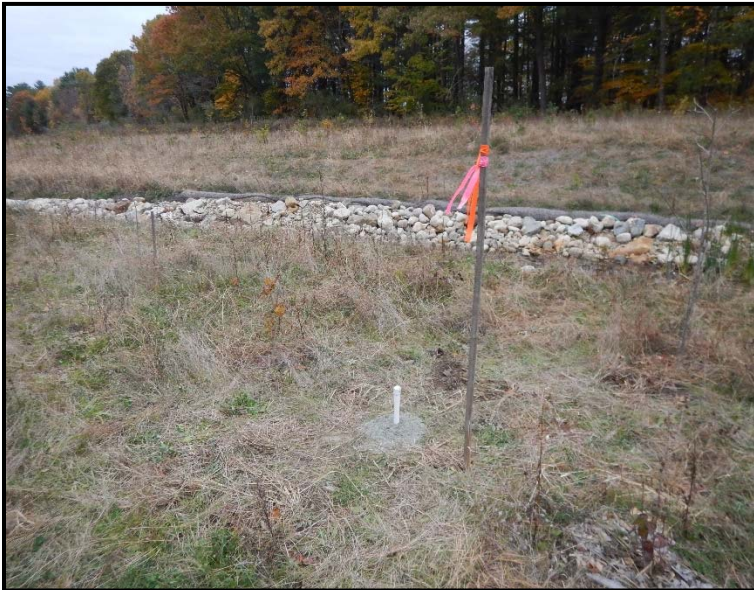
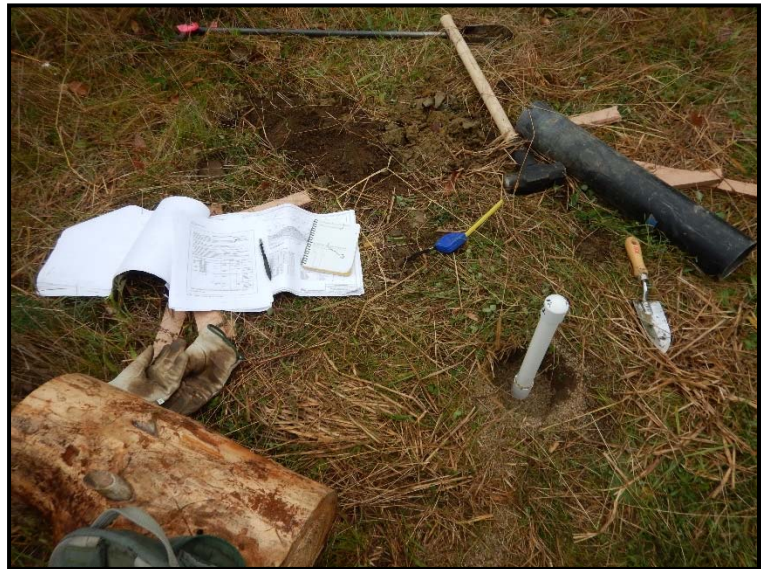
Shallow Groundwater Well #2 installed within Zone 2 along the western side of Railway Brook adjacent to Station 7012. Date: 10-28-2015.

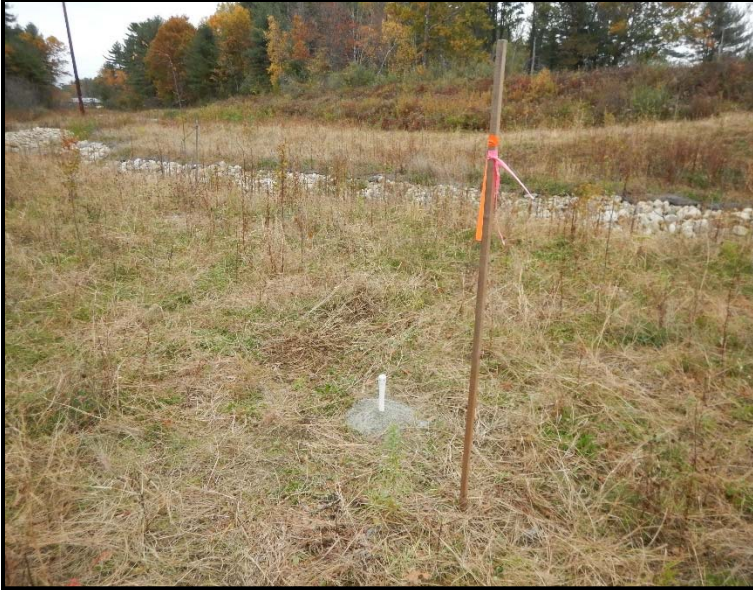
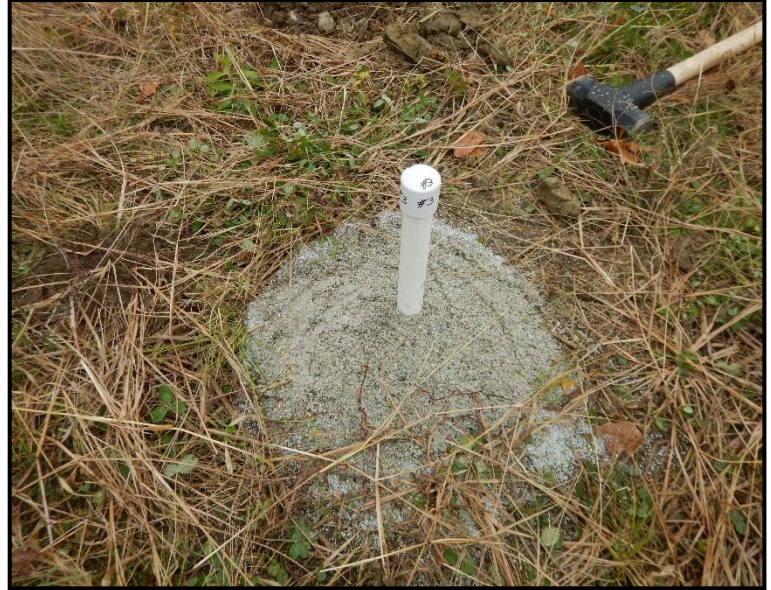
**Shallow Groundwater Well #3 installed within Zone 2 along the western side of Railway Brook adjacent to Station 7018. Date: 10-28-2015.**

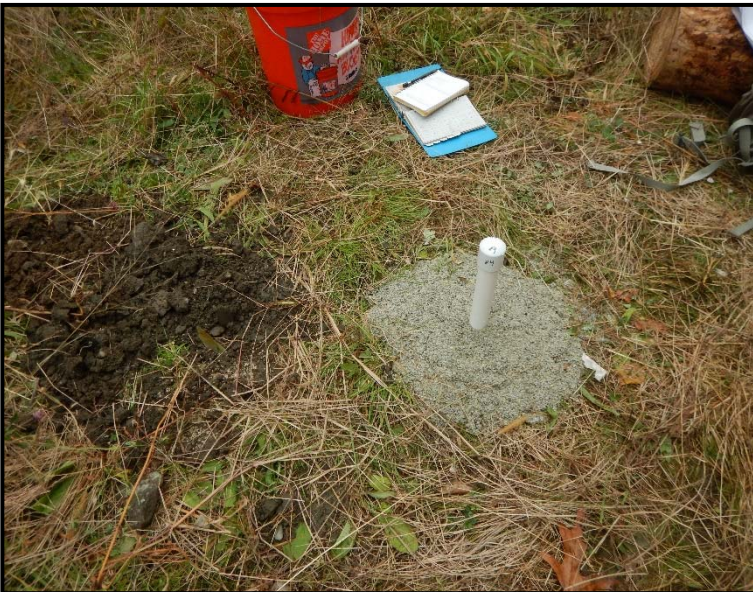
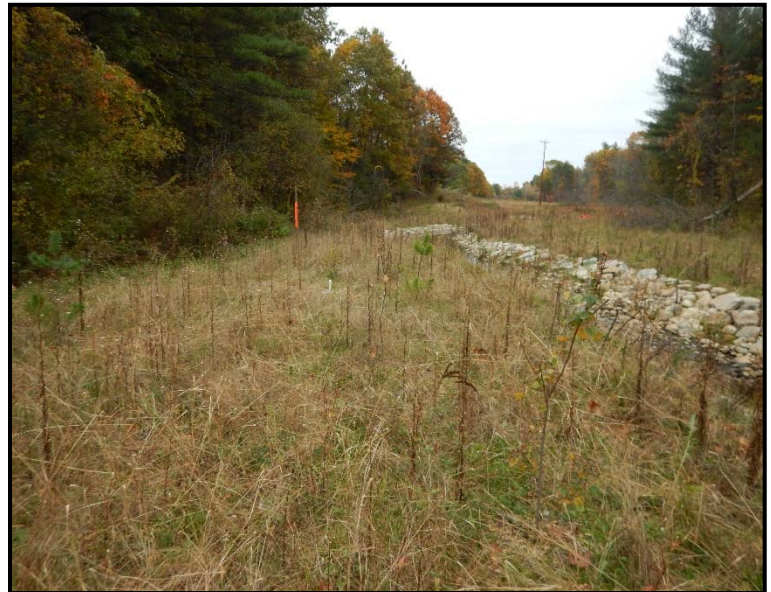
**Shallow Groundwater Well #4 installed within Zone 2 along the eastern side of Railway Brook adjacent to Station 7025. Date: 10-28-2015.**

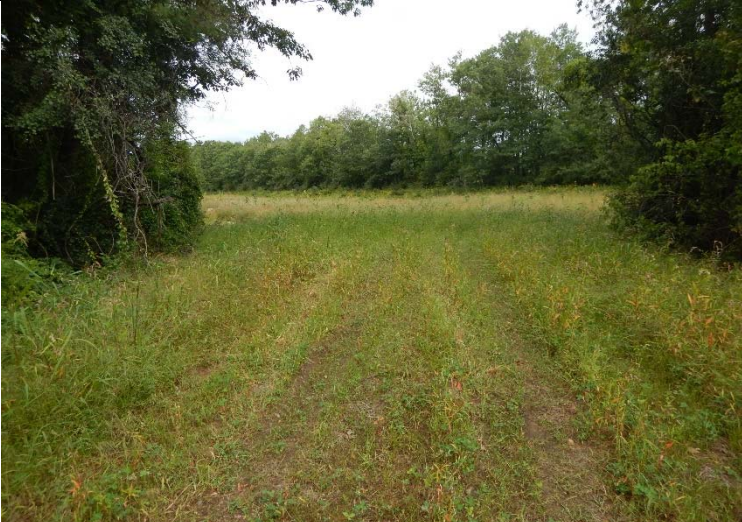
Photo #1: View east toward Railway Brook from staging area.	Location: Railway Brook Restoration Site, Newington, NH

Lastly, stone has been removed from the construction access and staging area located at the southern (upstream) end of the restoration site and this area has been restored to pre-existing conditions and permanently stabilized with seed and mulch. Dense vegetation consisting of grasses and weedy species was observed within this area during the October 28<sup>th</sup> inspection by VHB.

Description: Stone has been removed from the construction access and staging area located at the southern end of the restoration site and this area has been restored with seed and mulch. Dense vegetation consisting of grasses and weeds have become established in this area.
Photo #2: View south at Railway Brook from Station 7001.	Location: Railway Brook Restoration Site, Newington, NH

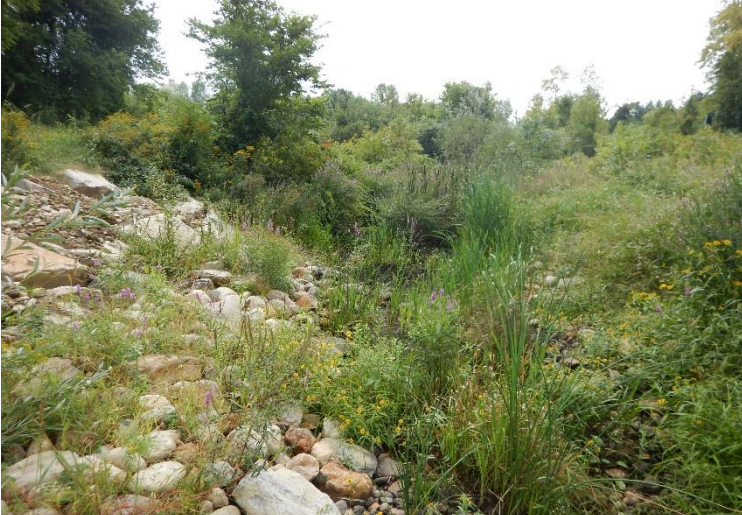
Based on the observed locations of purple loosestrife and cattail within the restored channel itself, establishment of this species appears to be the direct result of plant material being transported to the brook via drainage from other wetland systems present nearby. The establishment of purple loosestrife within Zones 1 and 2 between Stations 7019 and 7022 may also be influenced by the existing transmission line right-of-way which contains additional populations of purple loosestrife both outside of the eastern and western limits of the restoration site. It is also theorized that the establishment of these species within the stream bed is a direct result of the upstream diversion remaining in place. Without full flow restored to the channel, pockets of the stream are naturalizing as wetland habitat favoring the growth of vegetation of which would otherwise be absent if the brook contained flowing water.

Description: Vegetation dominated by narrow-leaf cattail ( <i>Typha angustifolia</i> ), but also including nodding smartweed ( <i>Polygonum lapathifolium</i> ), beggar-ticks ( <i>Bidens frondosa</i> ), jewelweed ( <i>Impatiens capensis</i> ), species of vetch ( <i>Vicia sp.</i> ), fox sedge ( <i>Carex vulpinoides</i> ), three-way sedge ( <i>Dulichium arundinaceum</i> ), lance-leaved coreopsis ( <i>Coreopsis lanceolata</i> ), and barnyard grass ( <i>Echinochloa crusgalli</i> ) was observed to be growing within the stream bed from Station 7000 to Station 7008. Purple loosestrife was also present at this location. Narrow-leaf cattail and purple loosestrife were estimated to account for 15% of the total cover.

Treatment including manual, chemical or biological control will be assessed as part of Years 2 through 5 of the monitoring period to ensure that purple loosestrife does not become further established within the restoration site.

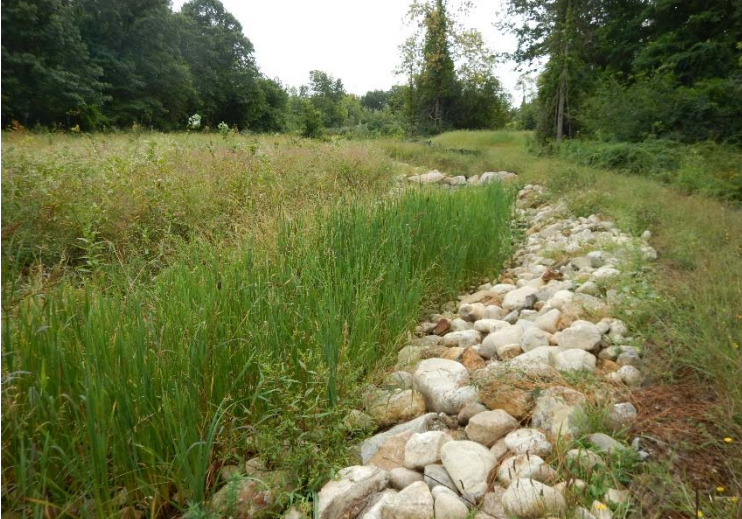
Photo #3: View south at Railway Brook from Station 7003.	Location: Railway Brook Restoration Site, Newington, NH

Description: Another view of narrow-leaf cattail which was observed to be growing in small dense stands within the stream bed between Stations 7000 and 7009.

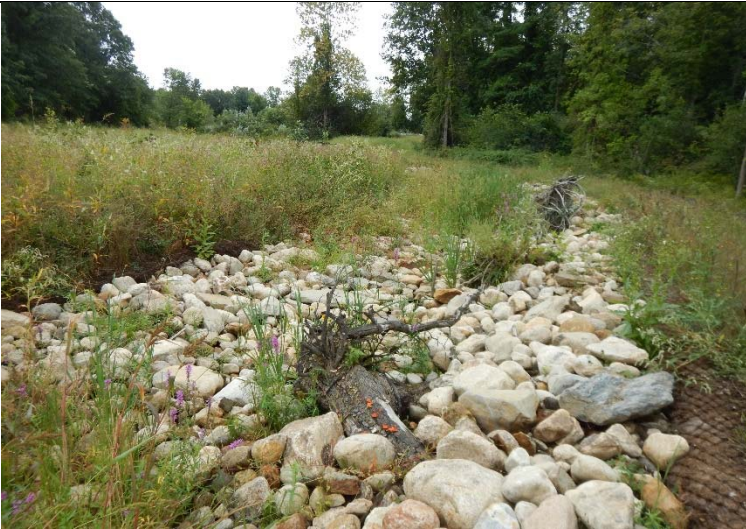
Photo #4: View south at Railway Brook from Station 7004.	Location: Railway Brook Restoration Site, Newington, NH

Generally, coir fiber matting and rolls installed along the banks of the brook remain securely in place as installed. Some sloughing was observed during a previous site visit conducted by VHB over the course of the planting and seeding work (May 2015), but has since been repaired and mitigated with the establishment of dense vegetation. Additionally, installed cross-vane structures, root wads, and boulder cluster grade controls remain in place with very little migration of bedding materials (cobble-gravel-sand) observed. Additional trimming of geotextile fabric below channel bed elevations at cross-vane locations is recommended by VHB and has been communicated to NHDOT and the on-site contractor. Deposition of some smaller cobble material was previously observed in the far northern (downstream) portion of the restored channel during the May 2015 site inspection. However, movement of the streambed material appeared to have been limited to the smaller particles which were on top of the channel bed, while the larger stones beneath did not move. Discharge from the twin 36-inch culverts located at Station 7020 and tributaries from the wetland located to the west contributed to stream flow which likely mobilized some of these smaller particles. Movement of smaller particles is expected as the streambed settles and streamflow moves stones until they embed or settle out. Some grade stakes were still observed within the channel at the time of the most previous inspection (October 28, 2015) and have been brought to the attention of NHDOT and the on-site contractor.

Description: Coir fiber roll and rootwads installed along the eastern bank of Railway Brook between Stations 7002 and 7004 were observed to be stable and securely in place.
Photo #5: View north to Zone 3 plantings, east side of brook.	Location: Railway Brook Restoration Site, Newington, NH

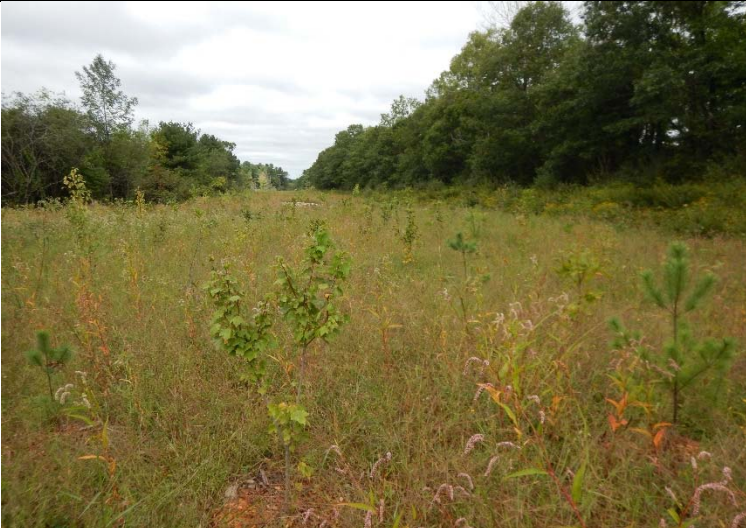
Description: Tree and shrub plantings were observed to be healthy and growing between 2 and 4 feet tall within Zone 3 along the eastern side of Railway Brook between Stations 7001 and 7004. In addition to the plantings, herbaceous plants and grasses included in applied seed mixes, have become densely established alongside the stream. A number of weedy volunteer species, such as nodding smartweed, were also observed to have densely colonized the streamside.
Photo #6: View north to Zones 1 and 2, west side of brook.	Location: Railway Brook Restoration Site, Newington, NH

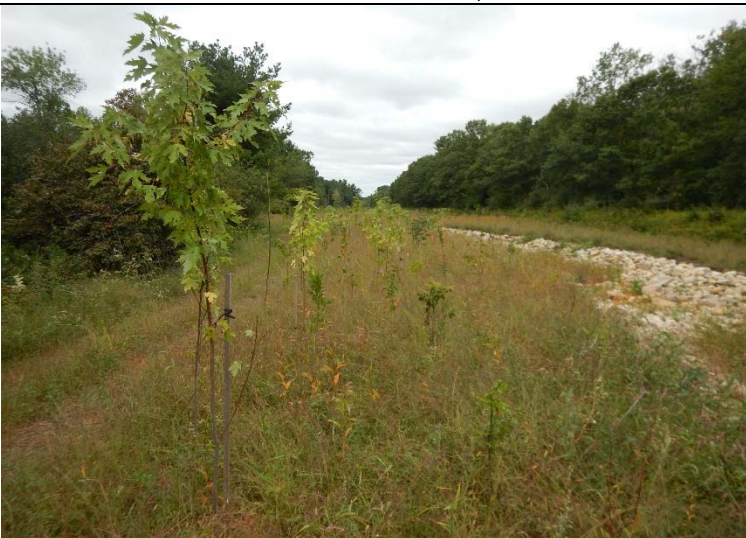
Description: Plantings were observed to be healthy and growing above 18" in height within Zones 1 and 2 along the western side of Railway Brook adjacent to Stations 7004 and 7005.

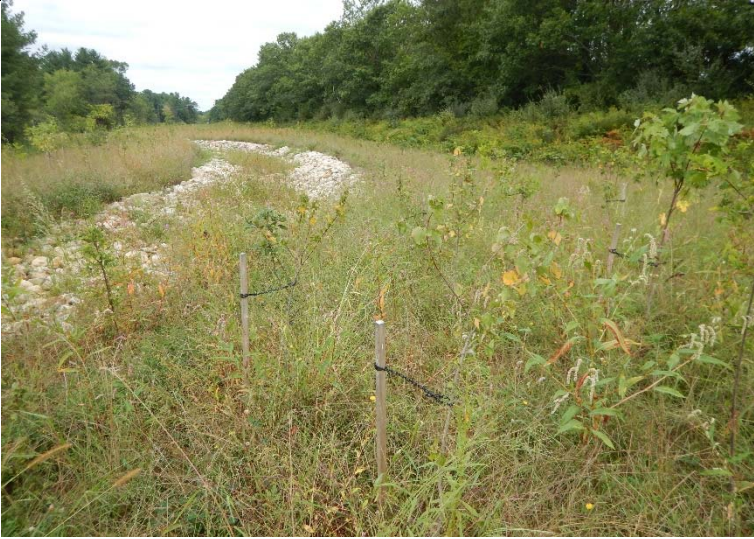
Photo #7: View north to Zones 1 and 2, east side of brook.	Location: Railway Brook Restoration Site, Newington, NH

Description: Plantings were observed to be healthy and growing above 18" in height within Zones 1 and 2 along the eastern side of Railway Brook adjacent to Stations 7004 and 7005.
Photo #8: View north at Railway Brook from Station 7006+50	Location: Railway Brook Restoration Site, Newington, NH

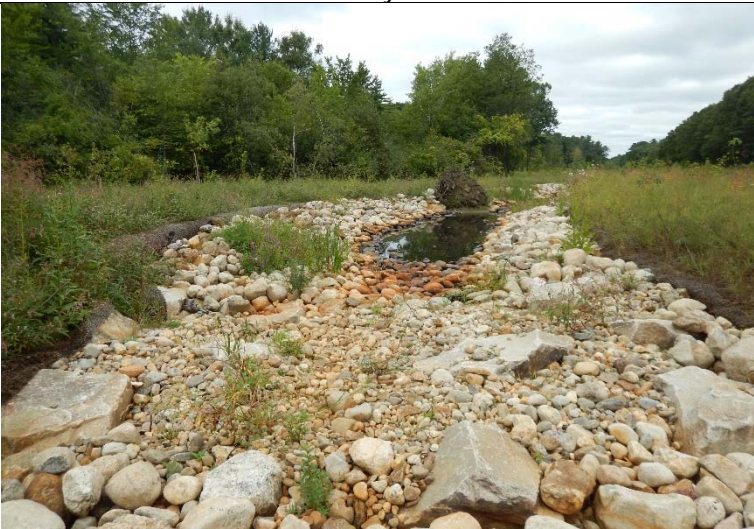
Description: Installed boulder cluster and rootwad at Station 7006+50 was observed to be stable at the time of the site inspections. Some vegetation is beginning to grow in along this section of the channel.
Photo #9: View south at Zones 2 and 3, east side of brook.	Location: Railway Brook Restoration Site, Newington, NH

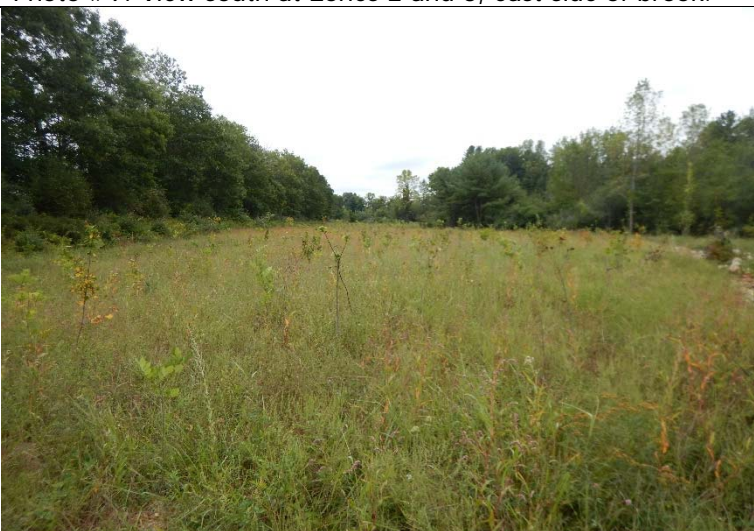
Description: Tree and shrub plantings were observed to be healthy and growing between 3 and 5 feet tall within Zones 2 and 3 along the eastern side of Railway Brook between Stations 7006 and 7009.

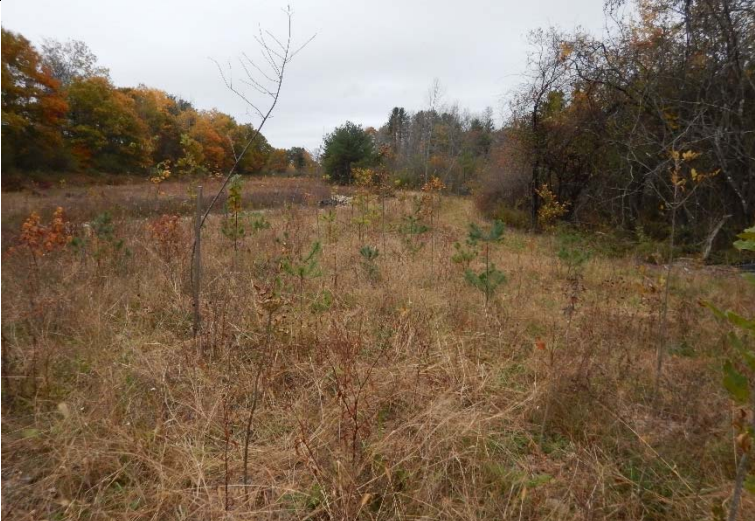
<p>Photo #10: View south at Zones 1 and 2, west side of brook.</p>

<p>Location: Railway Brook Restoration Site, Newington, NH</p> <p>Description: Plantings were observed to be healthy and growing above 18" in height within Zones 1 and 2 along the western side of Railway Brook adjacent to Stations 7008 and 7009.</p>
<p>Photo #11: View N at Railway Brook from Station 7008+50.</p>

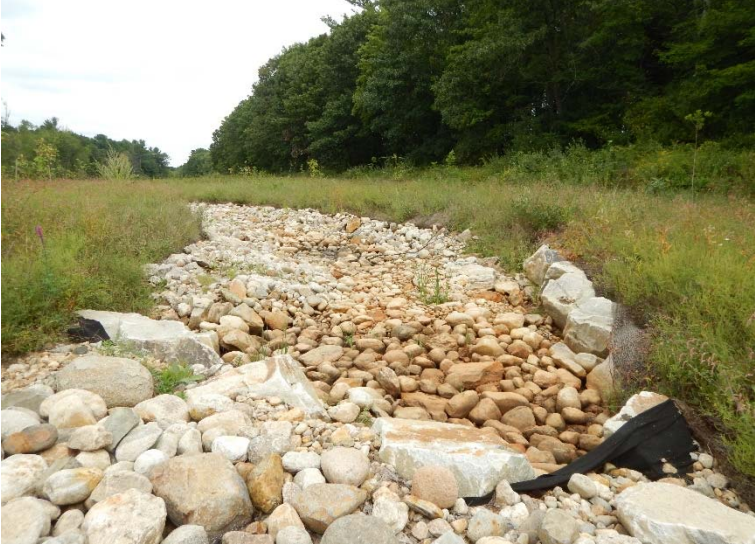
<p>Location: Railway Brook Restoration Site, Newington, NH</p> <p>Description: Additional trimming of geotextile fabric below channel bed elevations at cross vane locations has been recommended by VHB and communicated to NHDOT and the on-site contractor.</p>
<p>Photo #12: View north along west bank at Station 7010.</p>

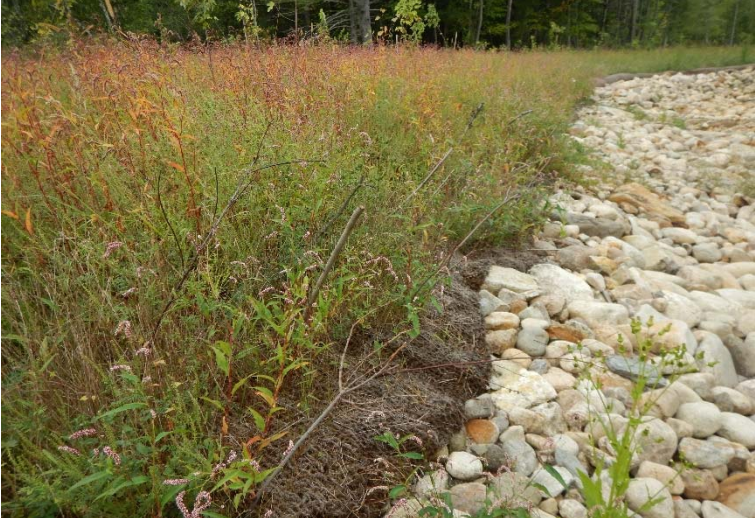
1 - At this time it is difficult to determine the success of the live stake plantings in Zone 1. The success of live stakes will continue to be monitored as part of the requirements of the restoration plan. Observations and recommendations will be documented in the annual monitoring reports.

<p>Location: Railway Brook Restoration Site, Newington, NH</p> <p>Description: View north at live stakes planted within Zone 1 along the western bank of Railway Brook near Station 7010. At this time it is difficult to determine the success of the live stake plantings. They were installed in April 2015 and live stakes typically take at least a year to become established. The success of the live stakes will continue to be monitored as part of the requirements of the restoration plan.</p>

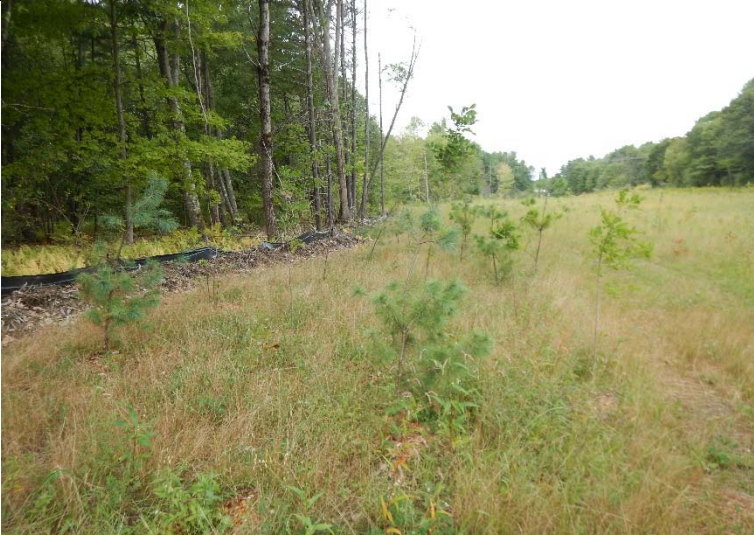
<p>Location: Railway Brook Restoration Site, Newington, NH Description: Tree species, including white pine and black cherry, planted within Zone 4 along the western side of the brook (adjacent to Station 7011) were observed to be healthy and growing over 3 feet tall, with some exceeding 6 feet in height.</p>
<p>Photo #15: View south along Zone 1, east side of brook.</p>  	<p>Location: Railway Brook Restoration Site, Newington, NH Description: View south at live stakes planted within Zone 1 along the eastern side of Railway Brook near Station 7013. Adjacent slopes are stable and well vegetated.</p>

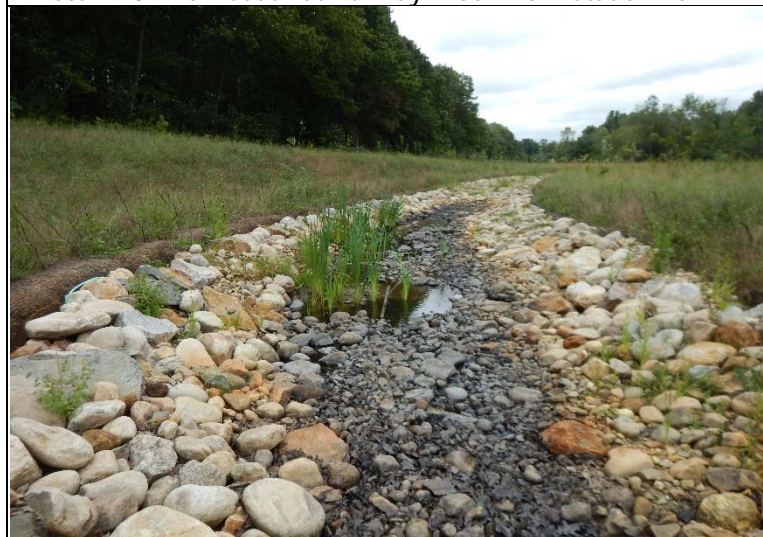
<p>Location: Railway Brook Restoration Site, Newington, NH</p> <p>Description: An isolated pocket of narrow-leaf cattail was observed within the stream bed at Station 7012. Coir fiber rolls installed along the eastern bank at this location are stable and remain securely in place.</p>

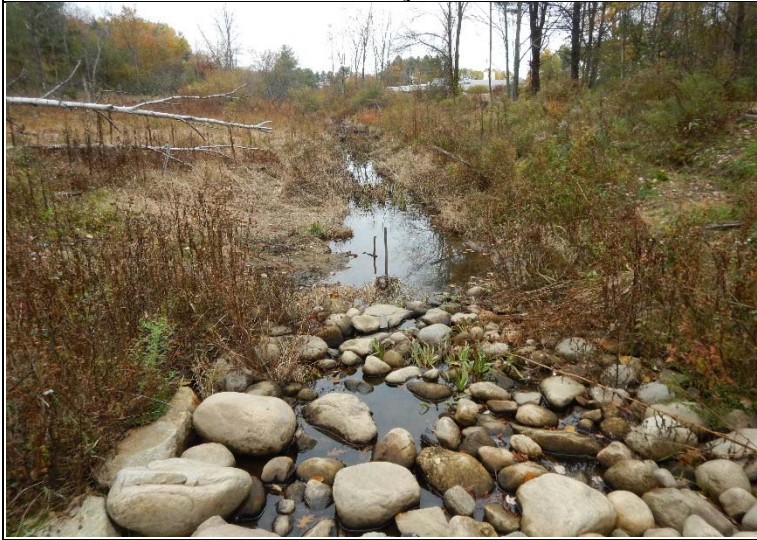
Photo #28: View north at Railway Brook from Station 7028.

Description: View to the northern limits of the restoration site. The sand-bag restriction previously installed within the brook has been removed and the stream bed and adjacent areas remain stable.
