# Railway Brook Restoration

Wetland Mitigation for the Spaulding  
Turnpike Improvements  
Newington, New Hampshire

November 2015

## 2015 1<sup>st</sup> Year Monitoring Report Railway Brook Restoration Project, Newington, NH

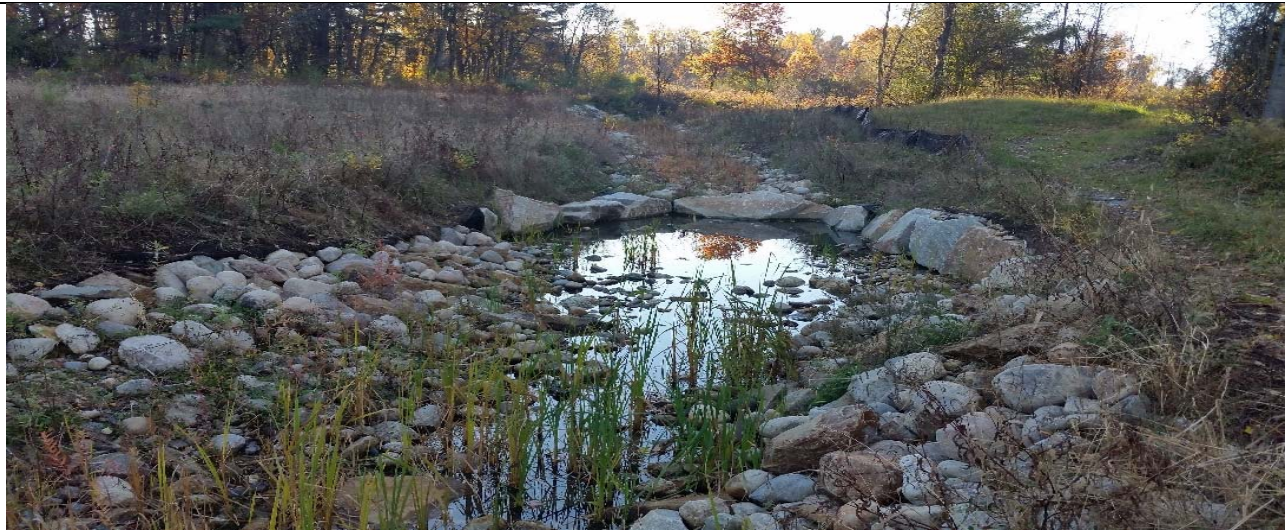
Photo #1: Sta. 7002+75 – Looking upstream

The BEHI for Railway Brook restoration site ranged from 5.5 to 8.6 with an average ranking of 7.3 which has an erosion potential score of very low. To be conservative, the highest value for each bank condition range, as presented by Rosgen, was used to calculate the BEHI. The bankfull depth matched the bank height for the entire length of the restoration site. The vegetated root density covered approximately 90% to 100% of the bank areas. The areas without significant root density included portions of the coir mat and the coir log; however, the bank surface is protected by these erosion control measures. Side slopes ranged between 1(h):1(v) to 3(h):1(v) as designed. Overall, the Railway Brook stream banks are stable without any observed signs of erosion and a very low BEHI erosion potential.
