# **2015 Wetland Monitoring Report**

**Filed with the U. S. Army Corps of Engineers – New England District**

## **Fitchburg Expansion Project**

Permit Number NAE-2007-3029

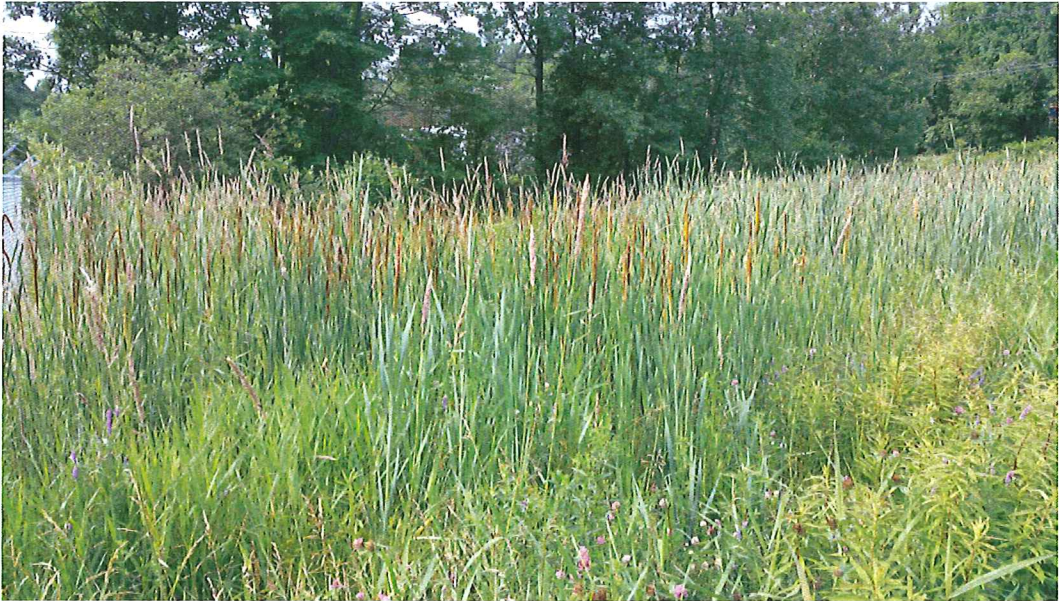
| <b>Photo No.</b><br><b>1</b> | <b>Date:</b><br>6-23-15 | | |

| <b>Description:</b><br><br>View of dense herbaceous cover within WL-WR-01 | | | |

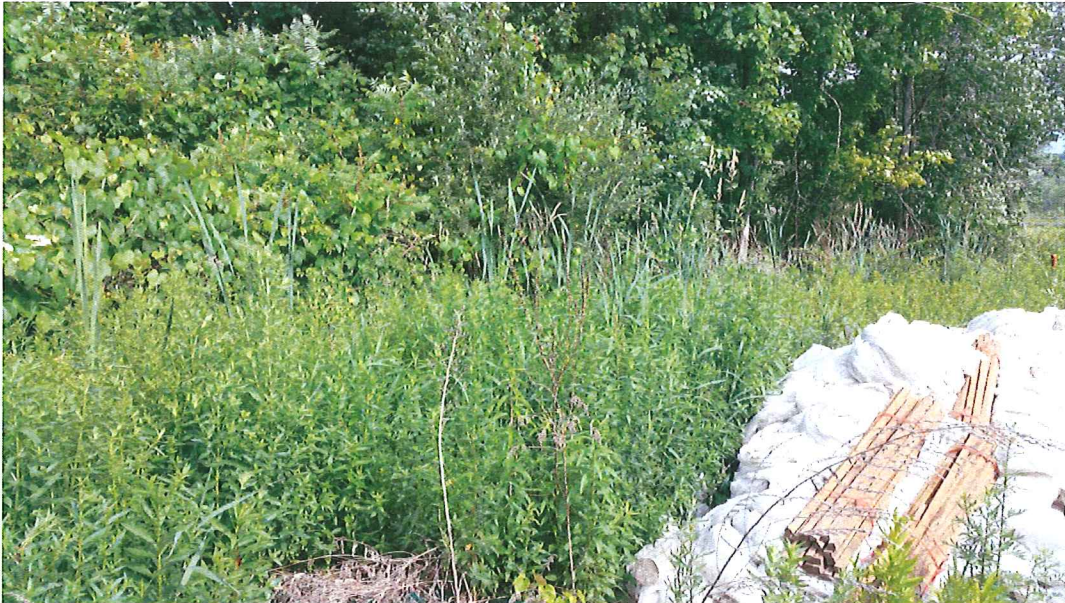
| <b>Photo No.</b><br><b>2</b> | <b>Date:</b><br>6-23-15 | |

| <b>Description:</b><br><br>View emergent vegetation within WL-WR-03. | | |

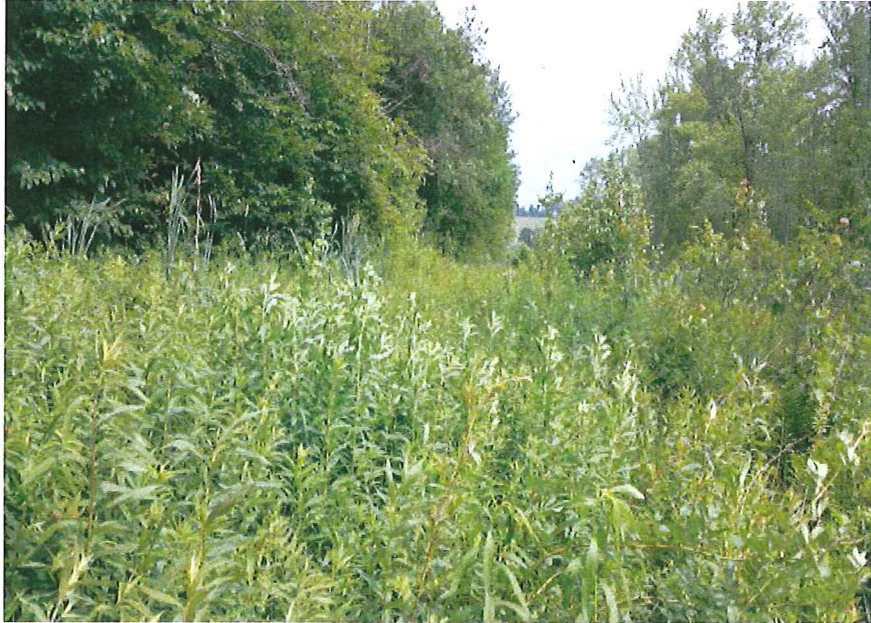
| <b>Photo No.</b><br><b>3</b> | <b>Date:</b><br>6-23-15 | | |

| <b>Description:</b><br><br>View of dense herbaceous cover within WL-WR-06. | | | |

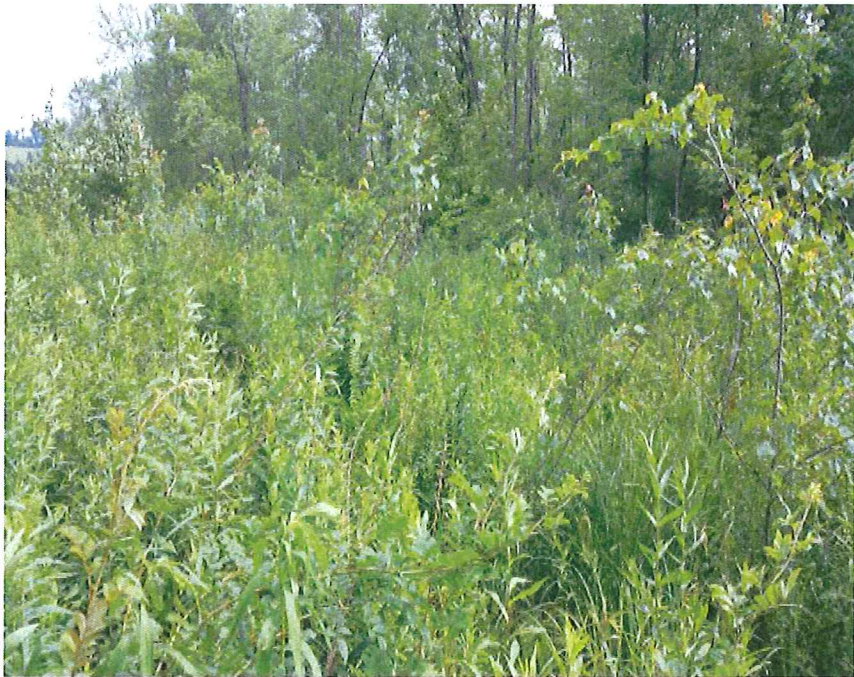
| <b>Photo No.</b><br><b>4</b> | <b>Date:</b><br>6-23-15 | |

| <b>Description:</b><br><br>Additional view of vegetation within WL-WR-06. | | |

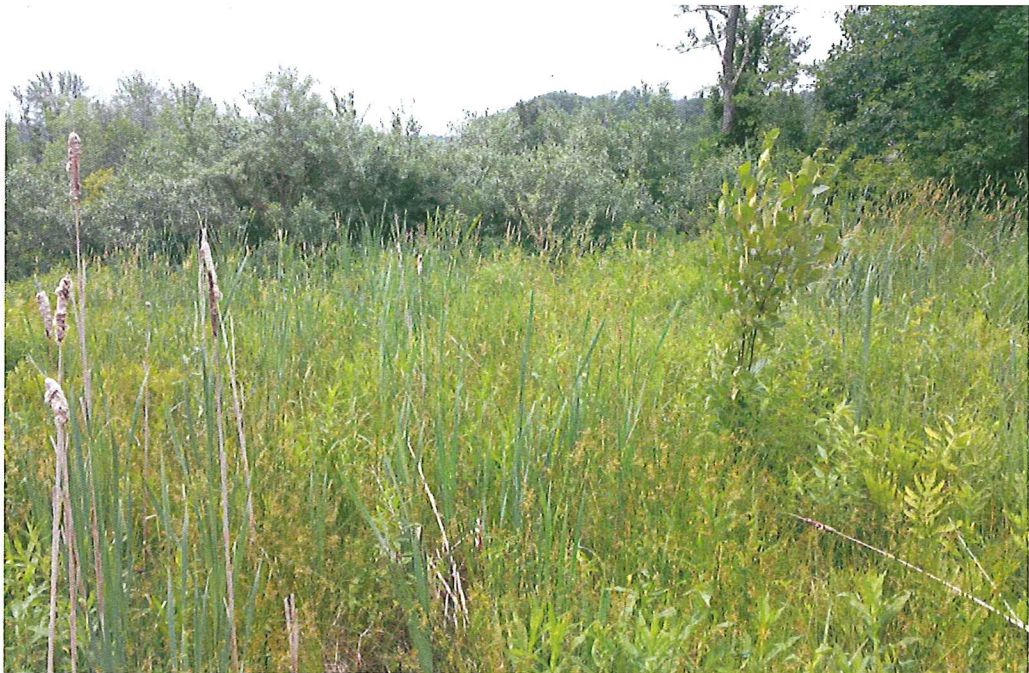
| <b>Photo No.</b><br><b>5</b> | <b>Date:</b><br>6-23-15 | | |

| <b>Description:</b><br><br>View of dense herbaceous cover within WL-WR-07. | | | |

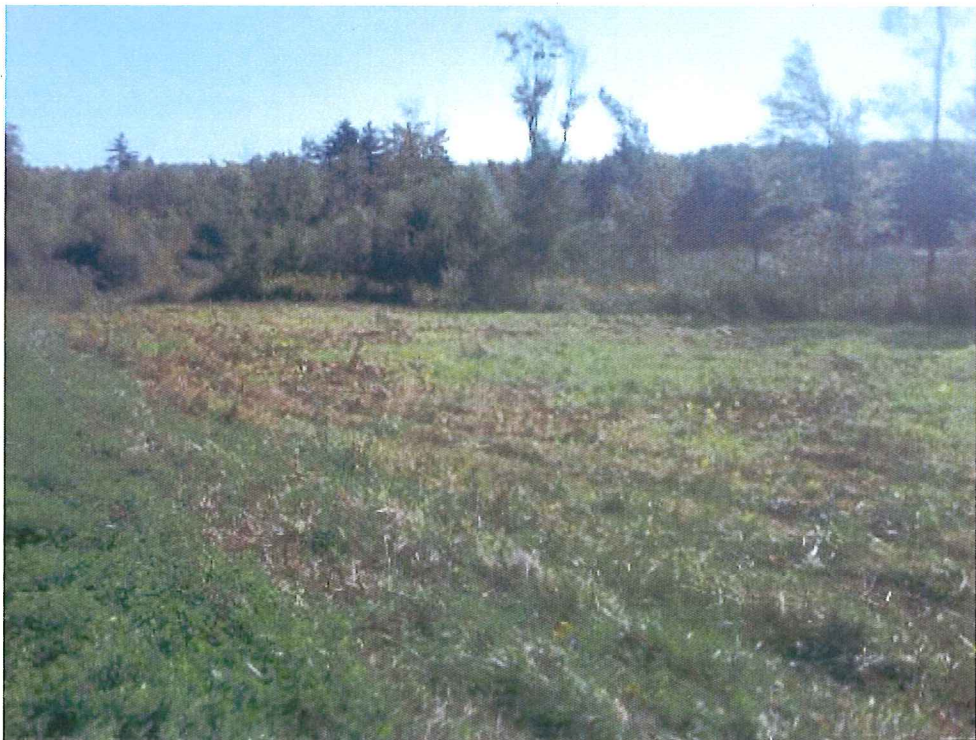
| <b>Photo No.</b><br><b>6</b> | <b>Date:</b><br>9-13-15 | |

| <b>Description:</b><br><br>View of PEM vegetation recently mowed by landowner within WL-WR-04. | | |

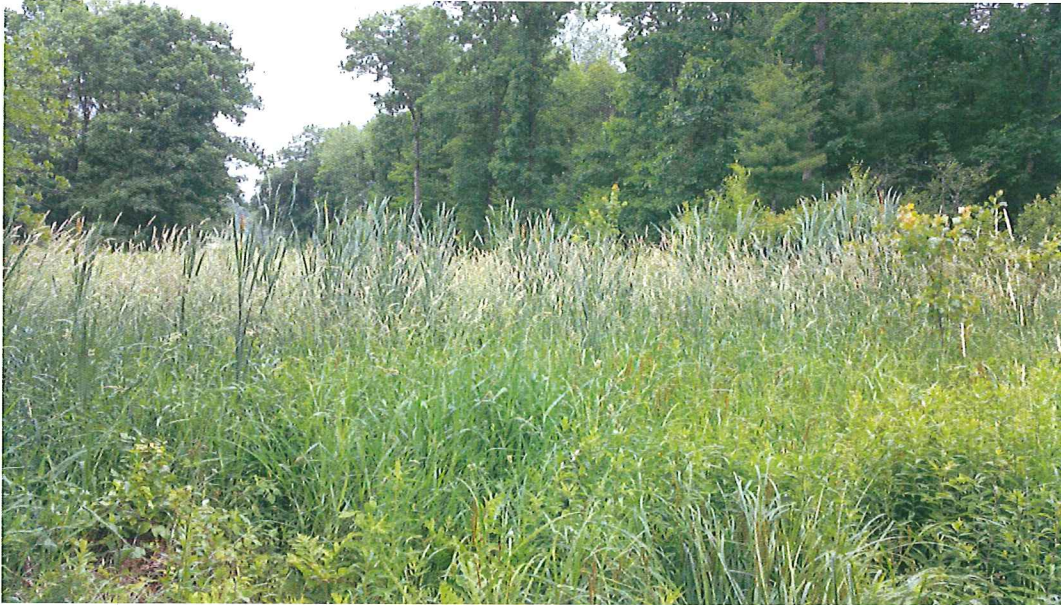
| <b>Photo No.</b><br><b>7</b> | <b>Date:</b><br>6-23-15 | | |

| <b>Description:</b><br><br>View of dense emergent wetland cover within WL-WR-09. | | | |

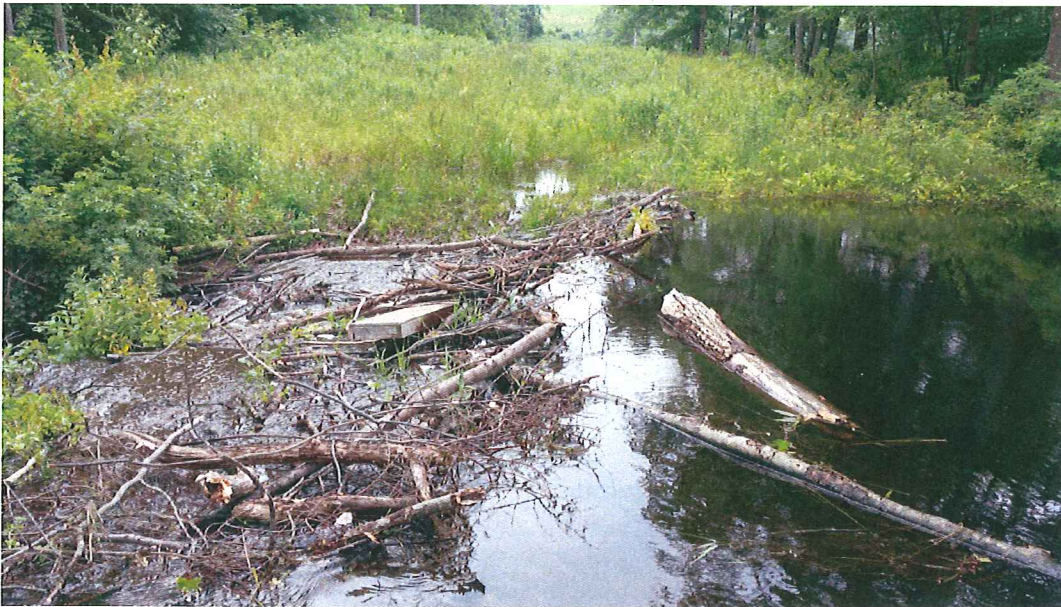
| <b>Photo No.</b><br><b>8</b> | <b>Date:</b><br>6-23-15 | |

| <b>Description:</b><br><br>View of beaver activity within waterbody S-4 prior to site restoration in September of 2015. | | |

- Distribution of 6,000 *Galerucella* sp. beetles in 2015 to aid in the control of purple loosestrife at seven (7) specific wetland locations;
  - The removal of a beaver impoundment to return natural post-construction flow conditions through an existing culvert at Waterbody S-4;

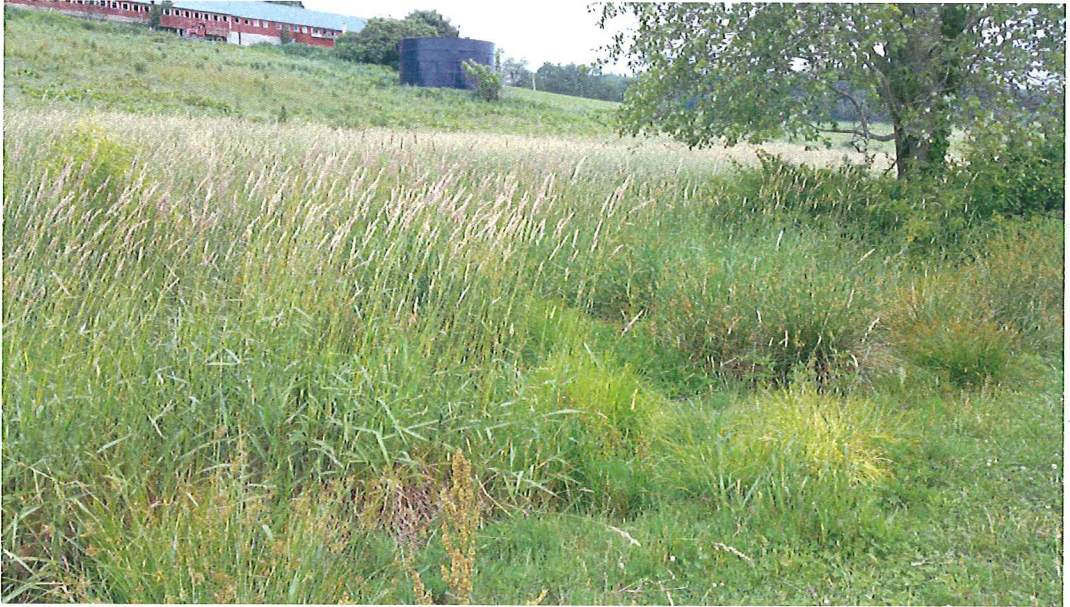
| <b>Photo No.</b><br><b>9</b> | <b>Date:</b><br>6-23-15 | | |

| <b>Description:</b><br><br>View of emergent wetland communities within WL-WR-10. | | | |

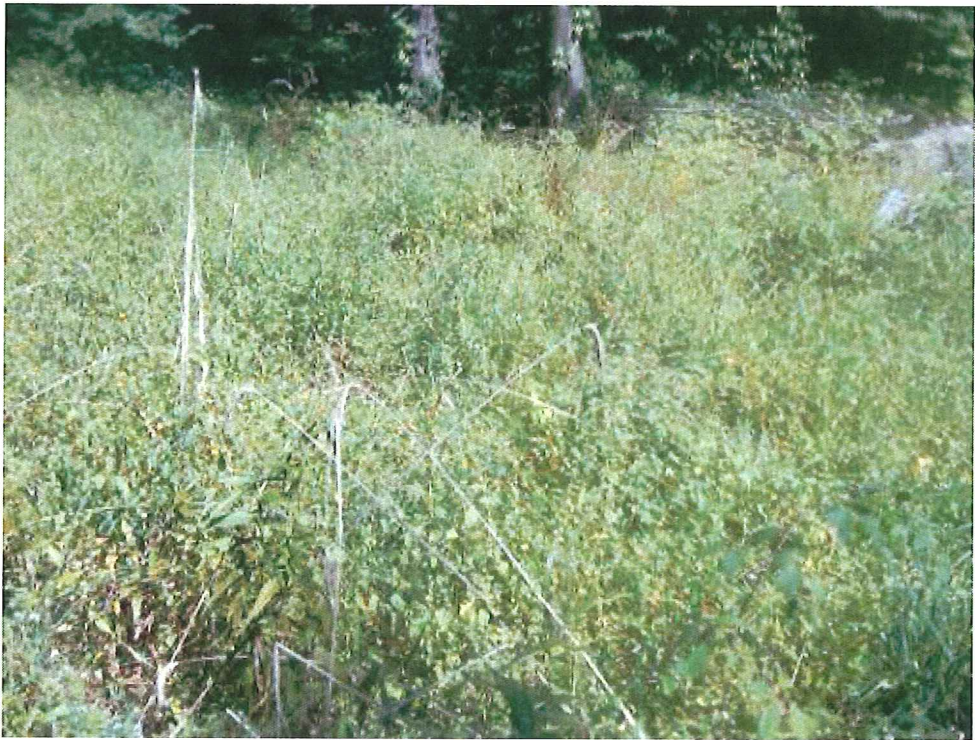
| <b>Photo No.</b><br><b>10</b> | <b>Date:</b><br>9-13-15 | |

| <b>Description:</b><br><br>View of well vegetated floodplain/bank locations associated with waterbody S-5. | | |

- Additional revegetation efforts were performed within upland locations adjacent to the waterbody S-5 crossing, as locations were noted in 2010 as lacking the required vegetated groundcover.

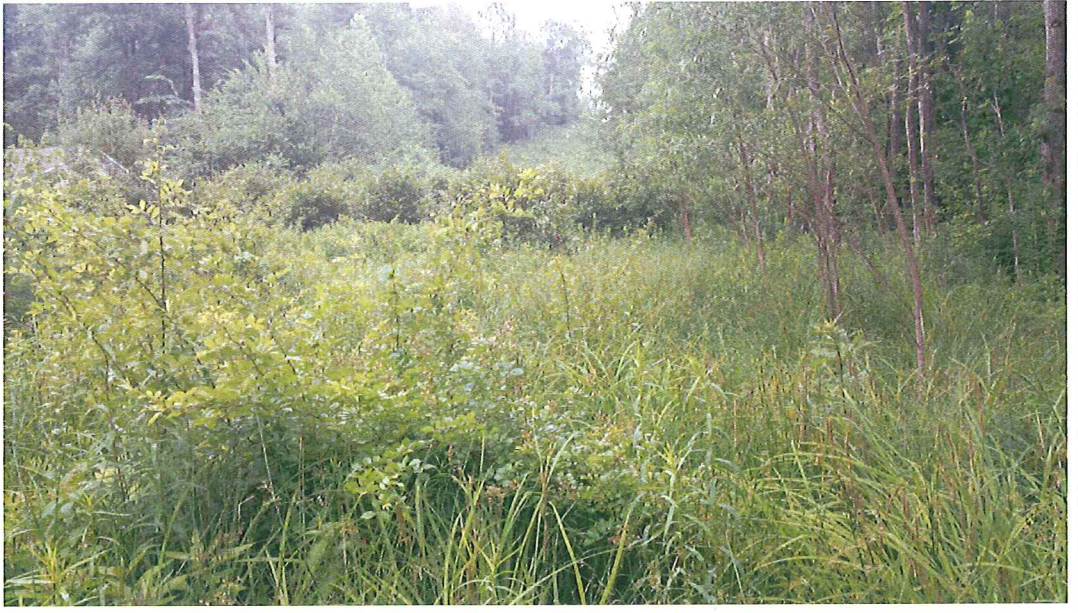
| <b>Photo No.</b><br><b>11</b> | <b>Date:</b><br>6-23-15 | | |

| <b>Description:</b><br><br>View of re-vegetated locations within WL-WR-11 which were previously disturbed by off-road vehicle activities in 2011/2014. | | | |

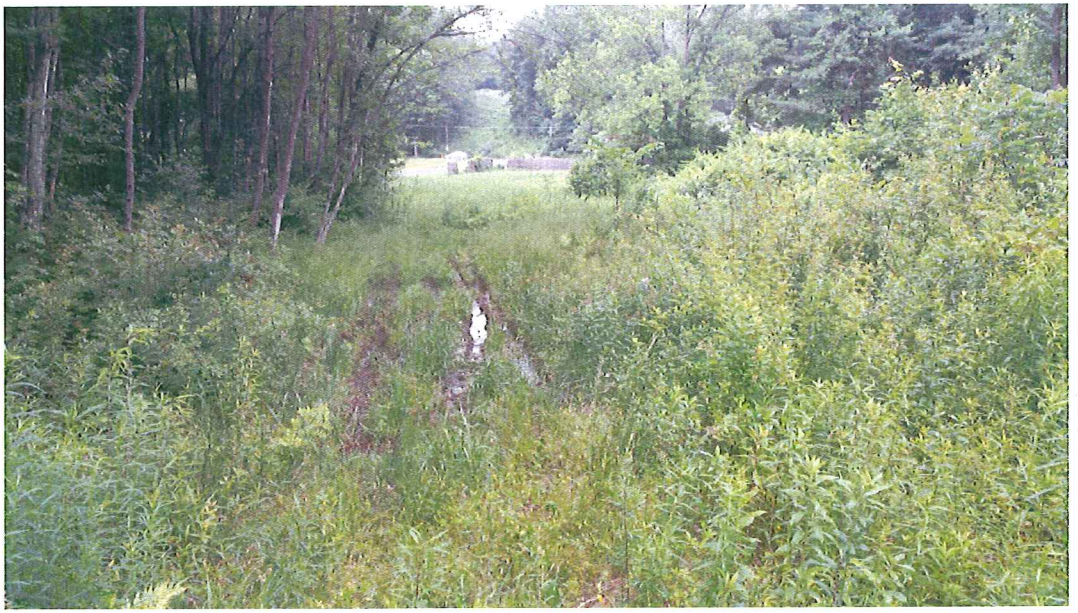
| <b>Photo No.</b><br><b>12</b> | <b>Date:</b><br>6-23-15 | |

| <b>Description:</b><br><br>View of off-road vehicle activity within WL-WR-12. | | |

- 2011 Restoration Activities
  - Grading and seeding of locations within wetland WL-WR-12 were performed in 2011 as a result of unauthorized off-road vehicle traffic noted in 2010;

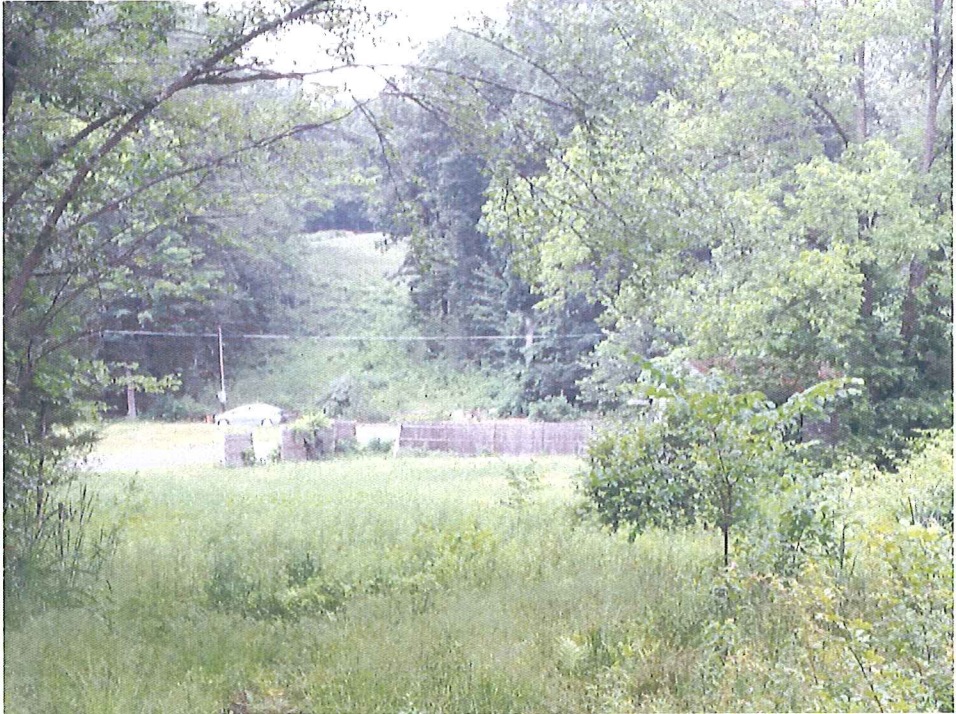
| <b>Photo No.</b><br><b>13</b> | <b>Date:</b><br>6-23-15 | | |

| <b>Description:</b><br><br>View of restored buffer zone locations which were re-vegetated in response to the 2011/2014 monitoring observations- NW of WL-WR-12. | | | |

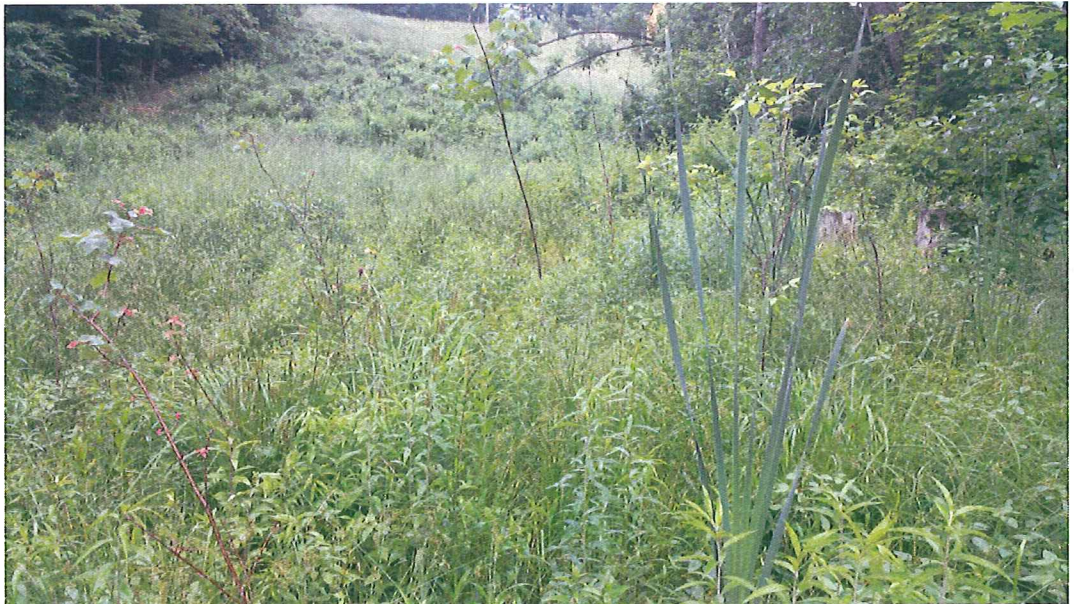
| <b>Photo No.</b><br><b>14</b> | <b>Date:</b><br>6-23-15 | |

| <b>Description:</b><br><br>View of robust herbaceous wetland cover within WL-WR-13. | | |

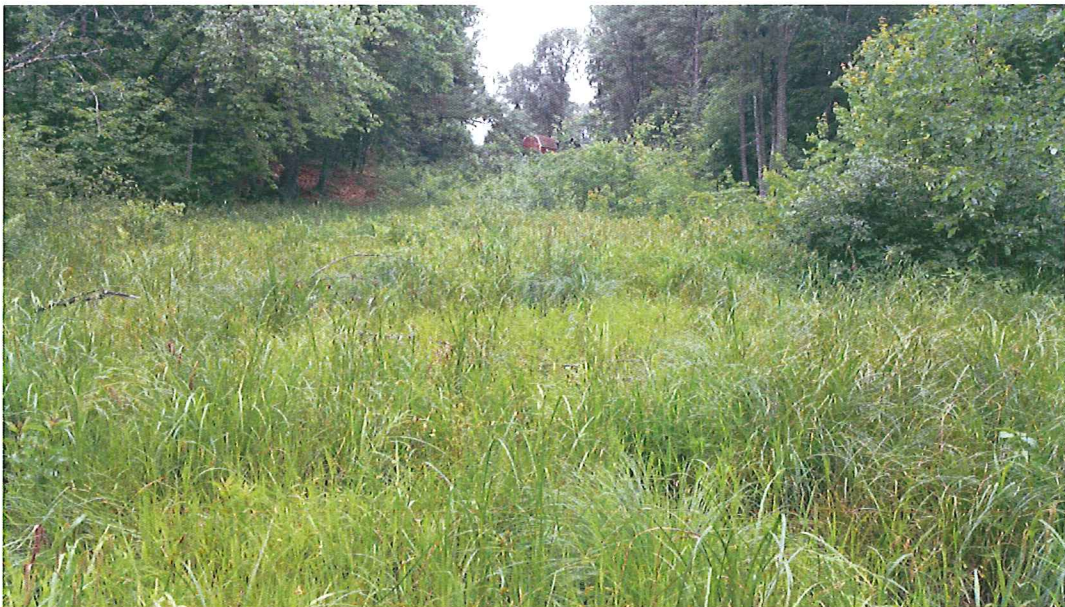
| <b>Photo No.</b><br><b>15</b> | <b>Date:</b><br>6-23-15 | | |

| <b>Description:</b><br><br>View of robust herbaceous cover within WL-WR-14. | | | |

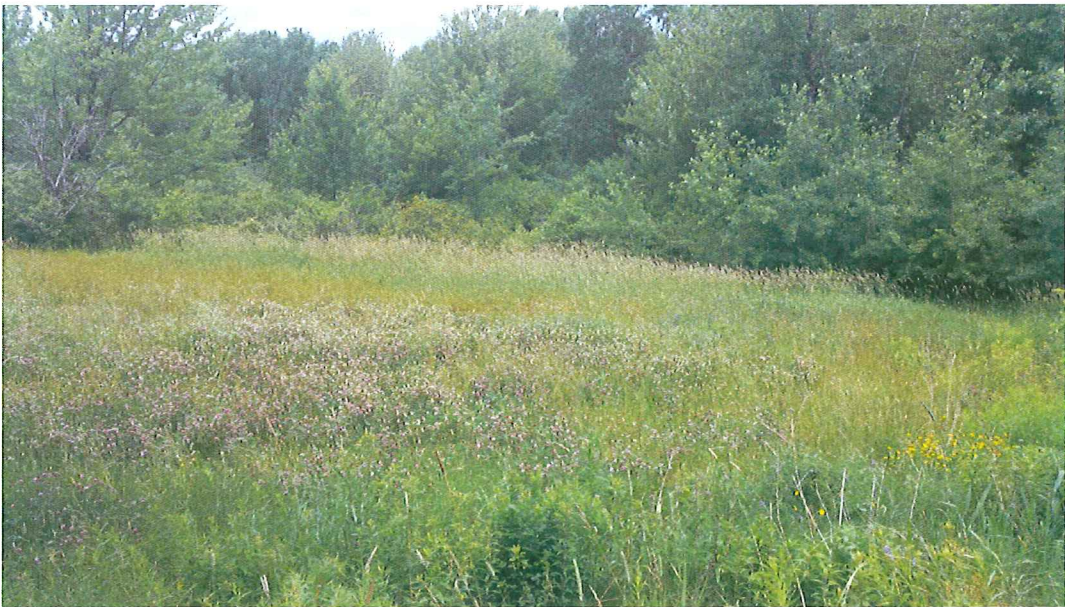
| <b>Photo No.</b><br><b>16</b> | <b>Date:</b><br>6-23-15 | |

| <b>Description:</b><br><br>View of re-vegetated wetland/buffer zone locations associated with WL-WR-15, which were restored in response to 2011 monitoring observations. | | |

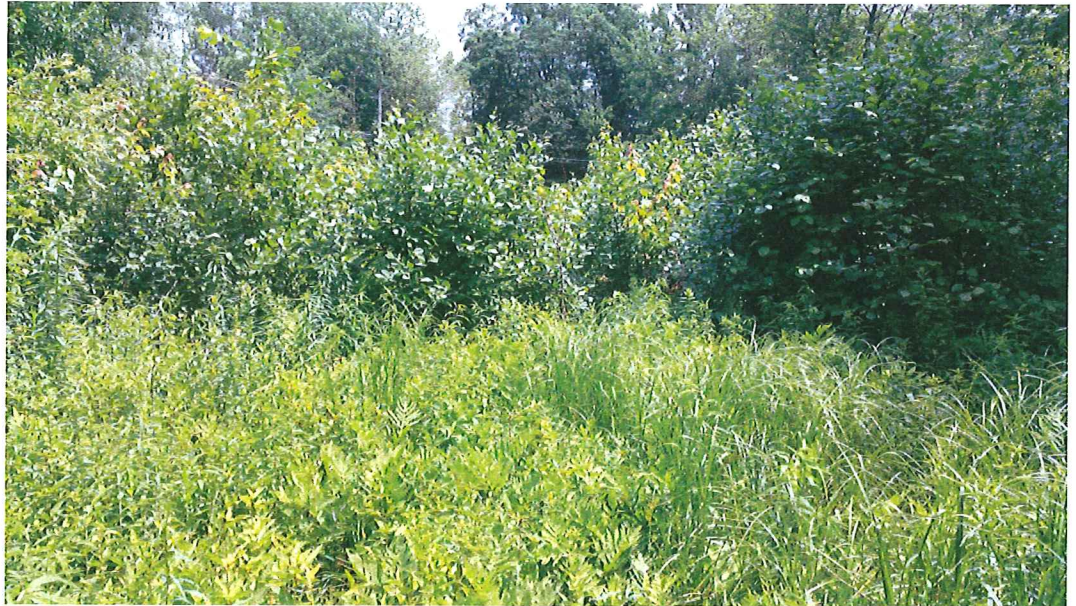
**Description:**  
View of dense herbaceous wetland cover within WL-WR-17 and along banks/flood plain areas of waterbody S-9.

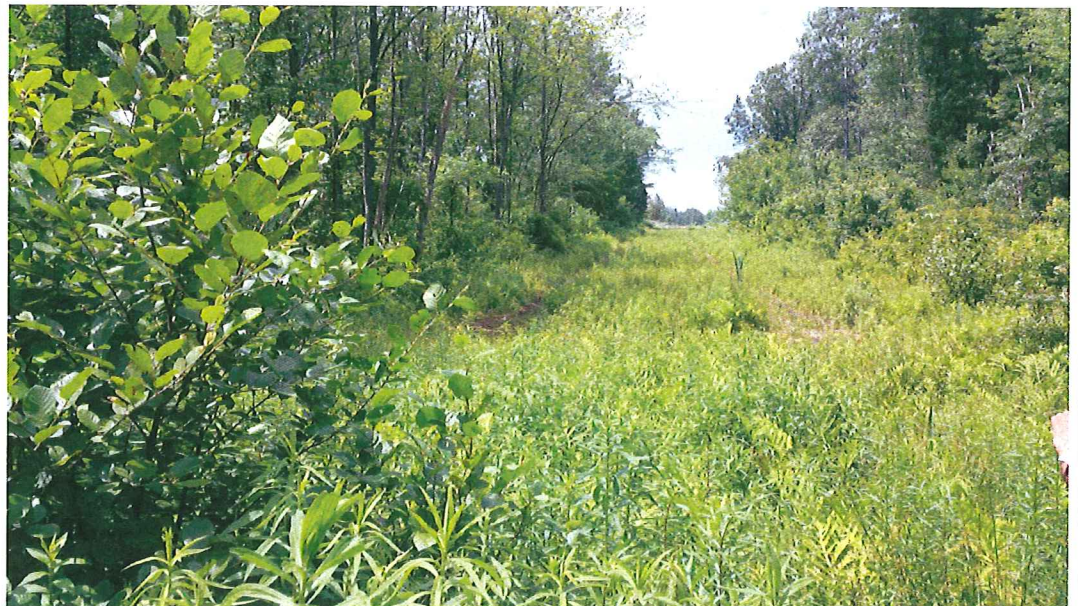
**Photo No.**  
**18**

**Description:**  
View of dense cover within WL-WR-18.

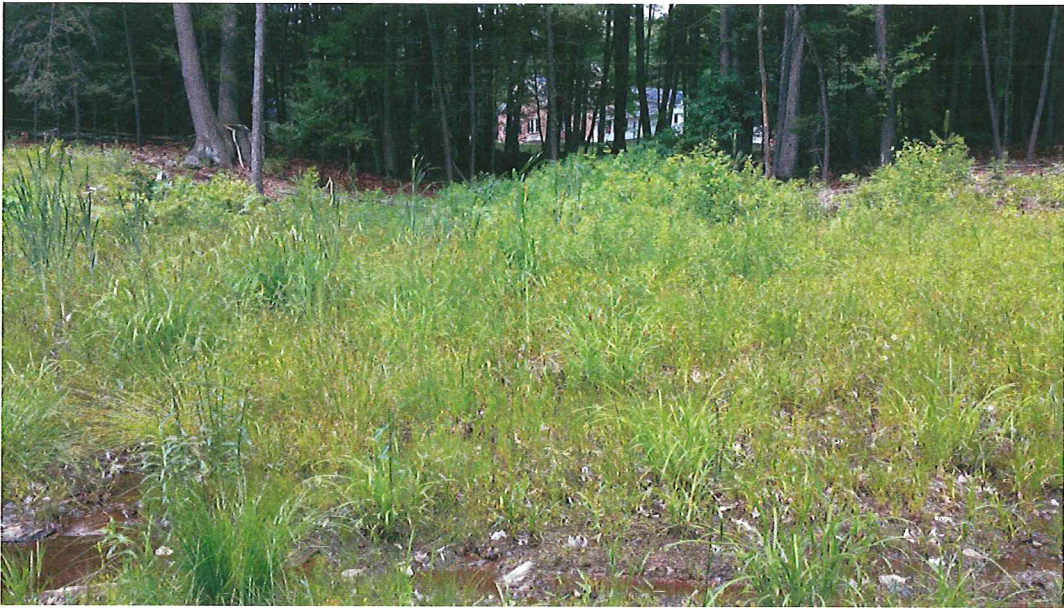
| <b>Photo No.</b><br><b>20</b> | <b>Date:</b><br>6-23-15 | |

| <b>Description:</b><br><br>View of re-vegetated herbaceous cover within WL-WR-20 which was hand-seeded in 2014. | | |

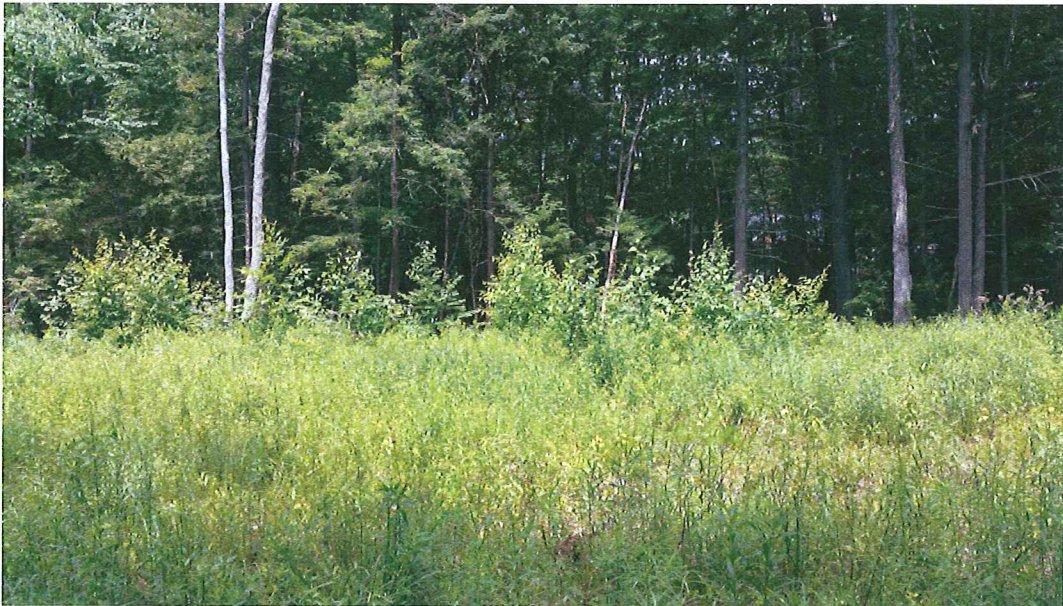
| <b>Photo No.</b><br><b>21</b> | <b>Date:</b><br>6-23-15 | | |

| <b>Description:</b><br><br>View of emergent wetland vegetation within WL-WR-21. | | | |

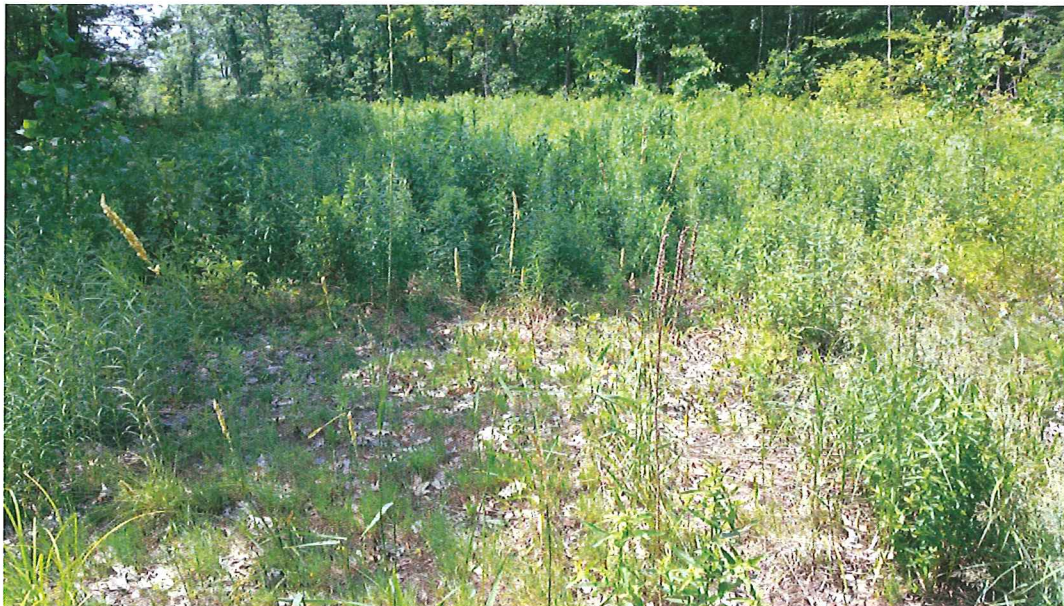
| <b>Photo No.</b><br><b>22</b> | <b>Date:</b><br>6-23-15 | |

| <b>Description:</b><br><br>View emergent vegetation at WL-WR-23. | | |

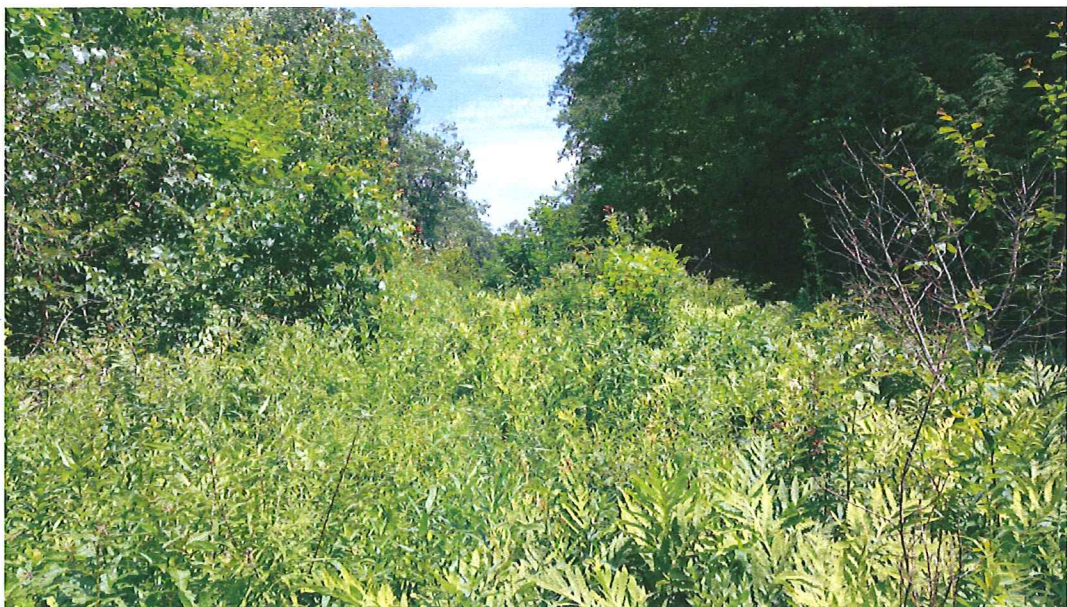
| <b>Photo No.</b><br><b>23</b> | <b>Date:</b><br>6-23-15 | | |

| <b>Description:</b><br><br>View of shrubs/saplings and herbaceous development within WL-WR-24. | | | |

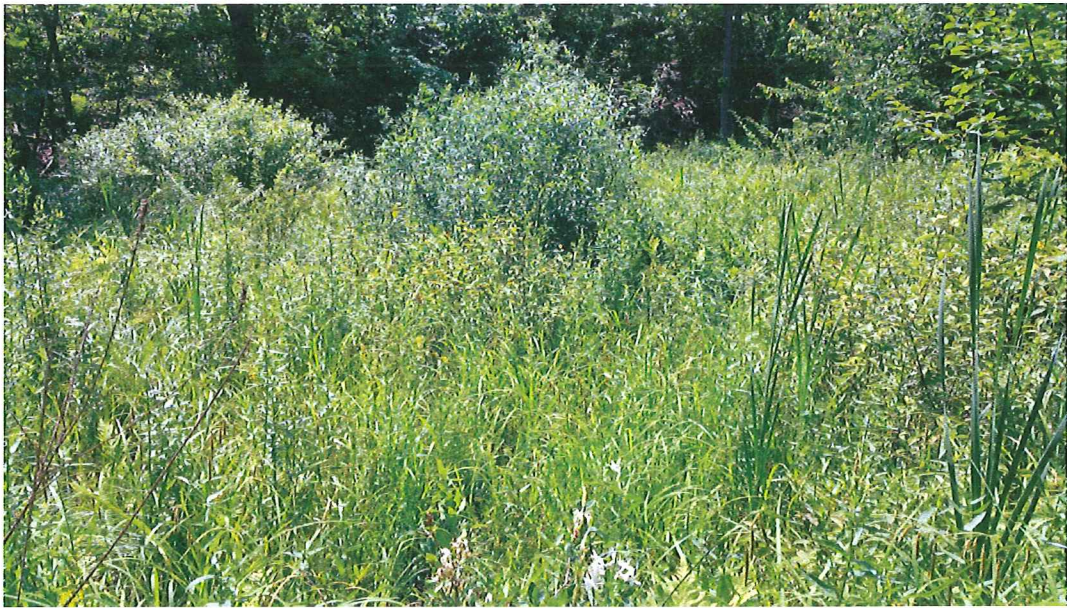
| <b>Photo No.</b><br><b>24</b> | <b>Date:</b><br>6-23-15 | |

| <b>Description:</b><br><br>View of shrubs/saplings and herbaceous development within WL-WR-25. | | |

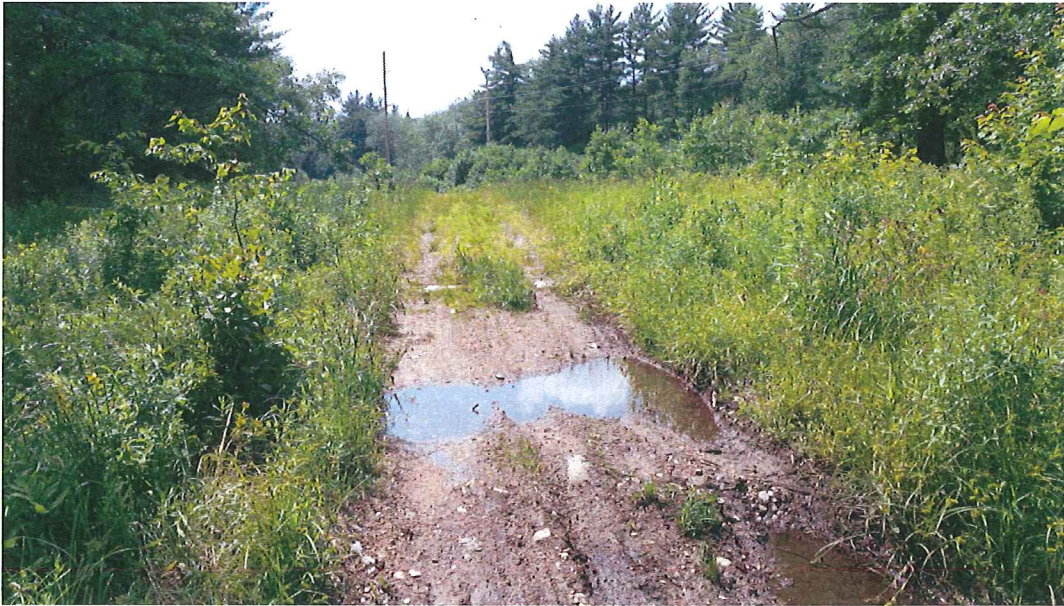
| <b>Photo No.</b><br><b>25</b> | <b>Date:</b><br>6-23-15 | | |

| <b>Description:</b><br><br>View of site disturbances within wetland WL-WR-28 and waterbody S-14 prior to fall 2015 restoration activities. | | | |

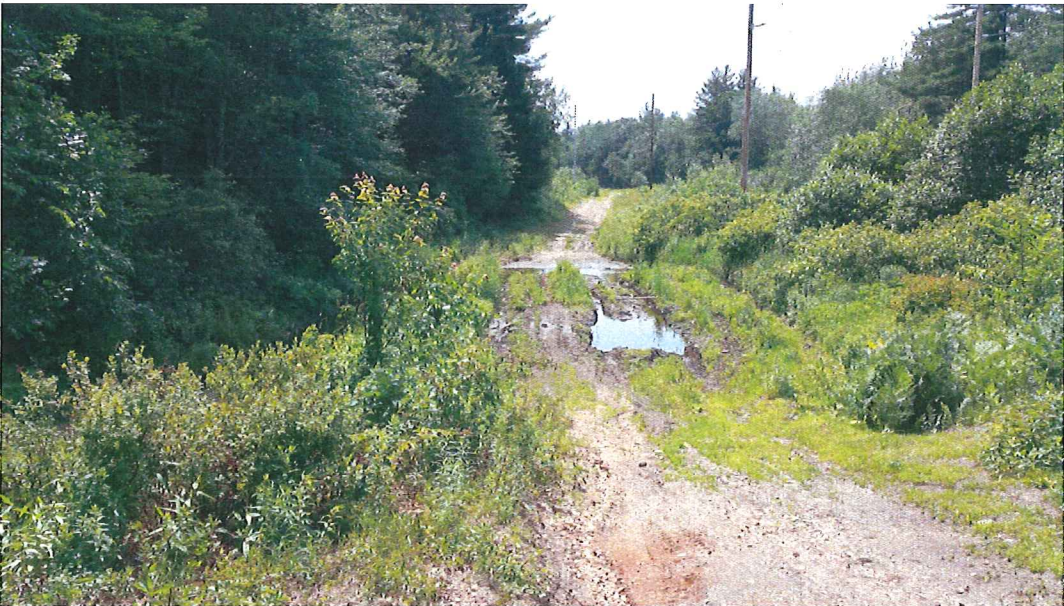
| <b>Photo No.</b><br><b>26</b> | <b>Date:</b><br>6-23-15 | |

| <b>Description:</b><br><br>Additional view of site disturbances within wetland WL-WR-28 and waterbodies S-15 and S-16 prior to fall 2015 restoration activities. | | |

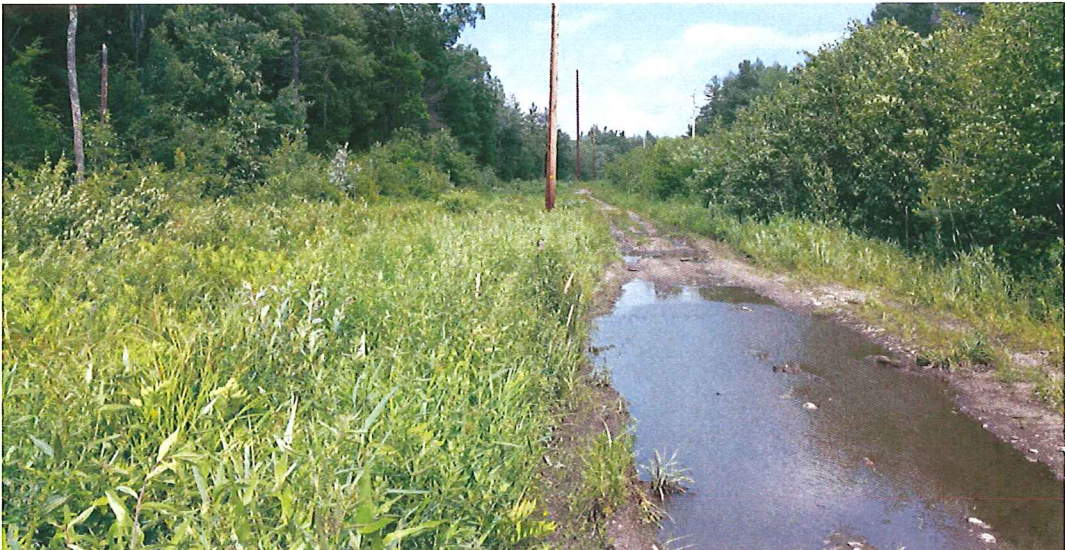
| <b>Photo No.</b><br><b>27</b> | <b>Date:</b><br>6-23-15 | | |

| <b>Description:</b><br><br>View of degraded wetland locations due to unauthorized off-road vehicle traffic within WL-WR-29 prior to fall 2015 restoration activities | | | |

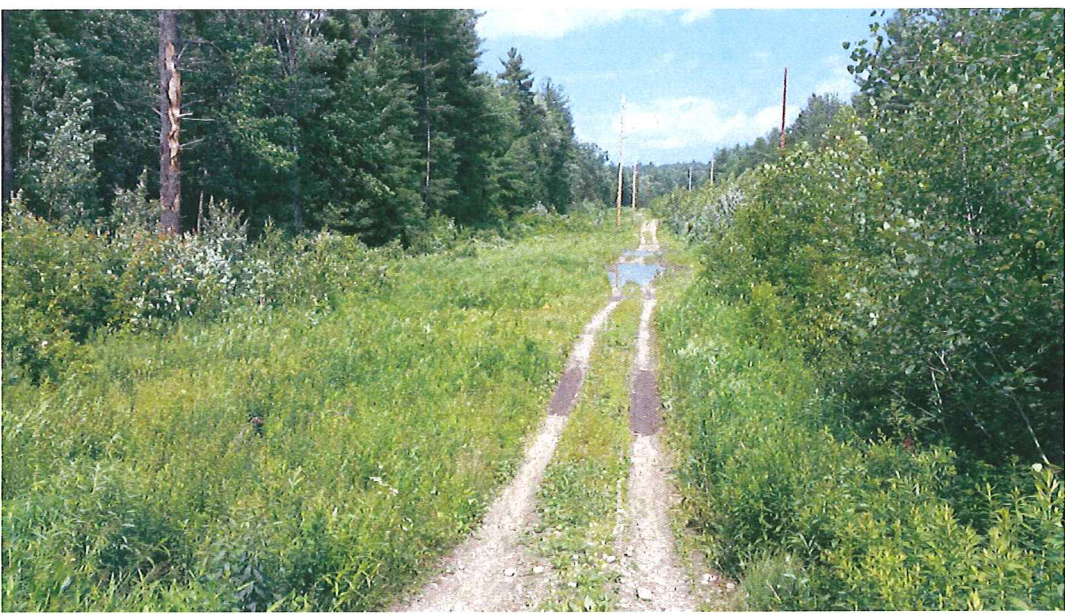
| <b>Photo No.</b><br><b>28</b> | <b>Date:</b><br>6-23-15 | |

| <b>Description:</b><br><br>View of travel ways within wetland WL-WR-31 prior to fall 2015 restoration activities. | | |

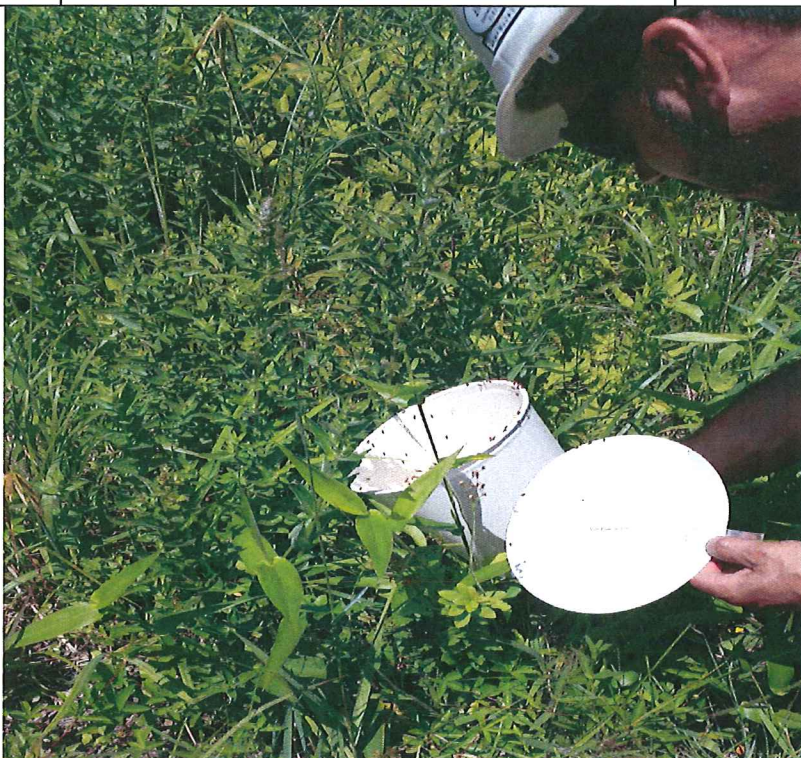
| <b>Photo No.</b><br><b>1</b> | <b>Date:</b><br>6-24-15 | | |

| <b>Description:</b><br><br>View of the release of <i>Galerucella</i> sp. beetles onto purple loosestrife plants within the restored ROW. | | | |

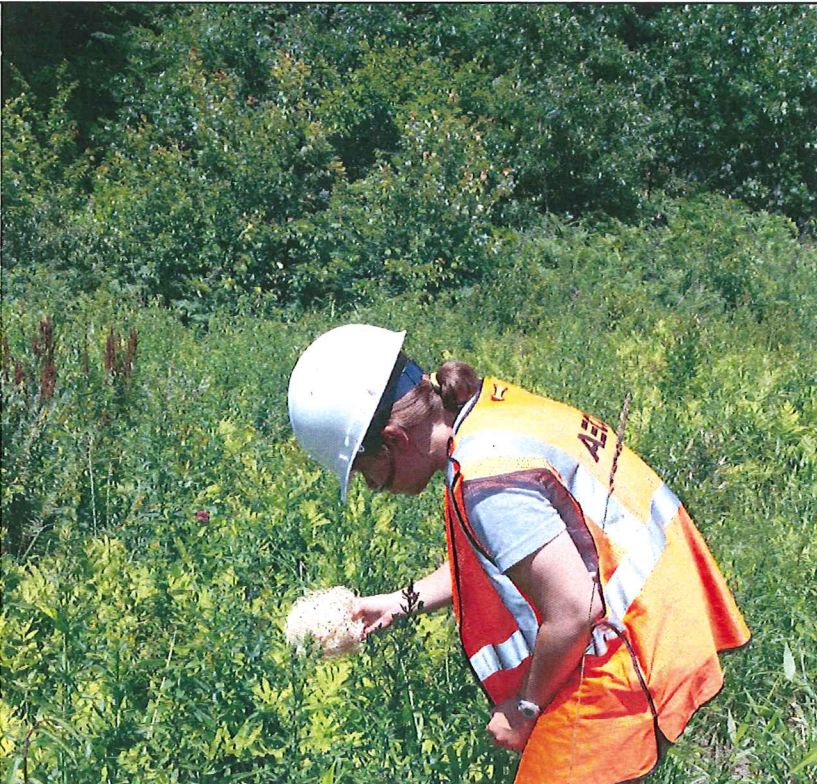
| <b>Photo No.</b><br><b>2</b> | <b>Date:</b><br>6-24-15 | |

| <b>Description:</b><br><br>Additional view of the release of <i>Galerucella</i> sp. beetles onto purple loosestrife plants within the restored ROW. | | |

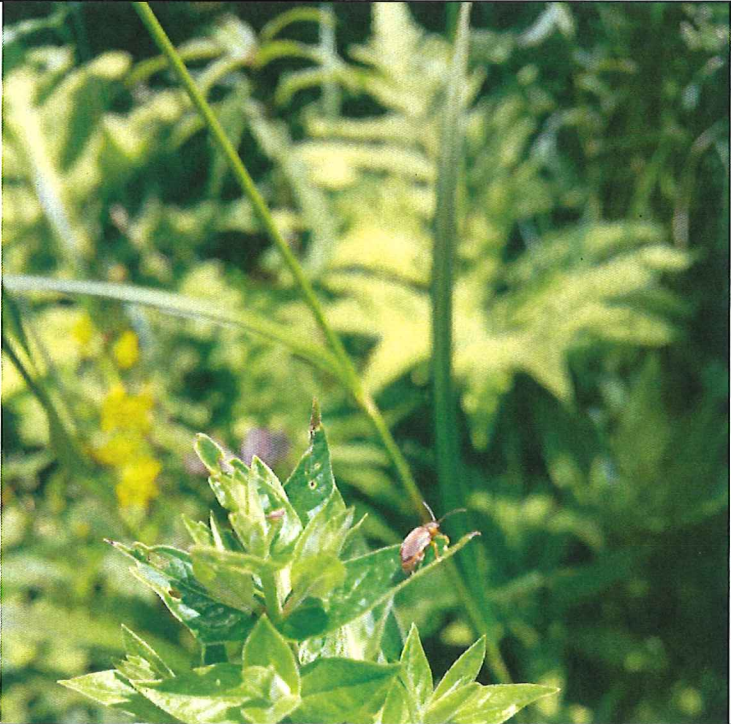
| <b>Photo No.</b><br><b>4</b> | <b>Date:</b><br>6-24-15 | |

| <b>Description:</b><br><br>Additional image of <i>Galerucella</i> sp. beetles feeding on purple loosestrife plants following release within the restored ROW. | | |

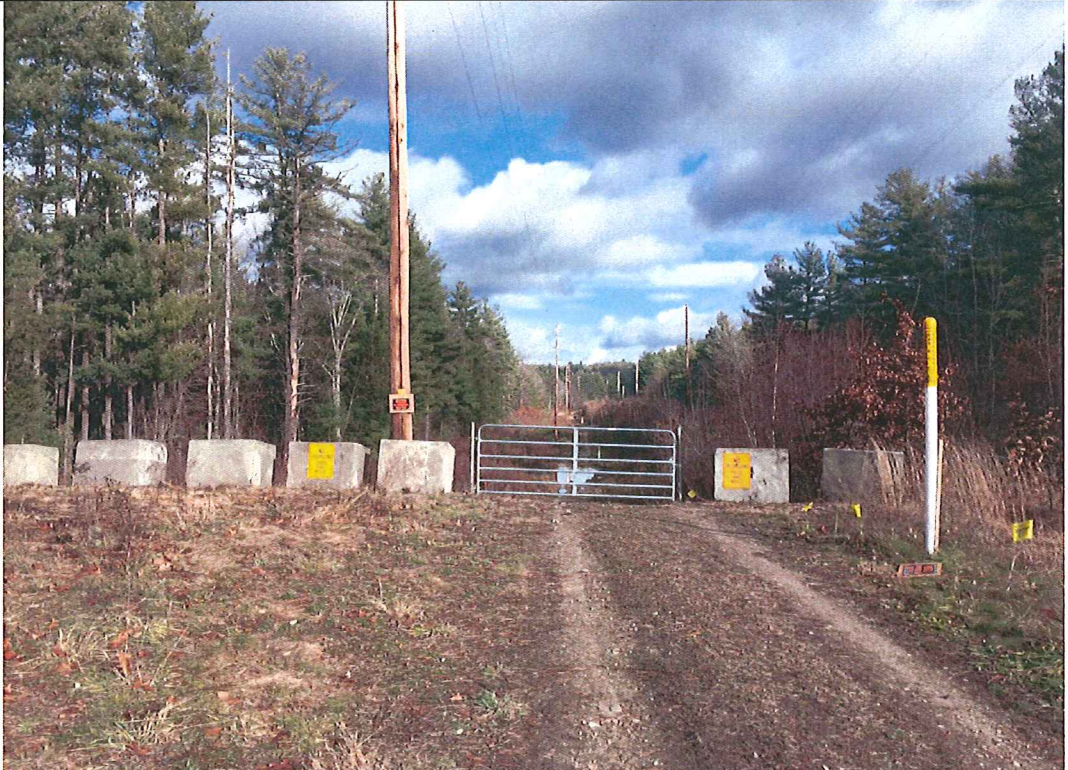
| <b>Photo No.</b><br><b>5</b> | <b>Date:</b><br>12-04-15 | | |

| <b>Description:</b><br><br>View of installed concrete blocks, "no trespassing" signage and cattle gate to discourage unauthorized vehicle access through restored resource areas between Pleasant Street and Electric Avenue. | | | |

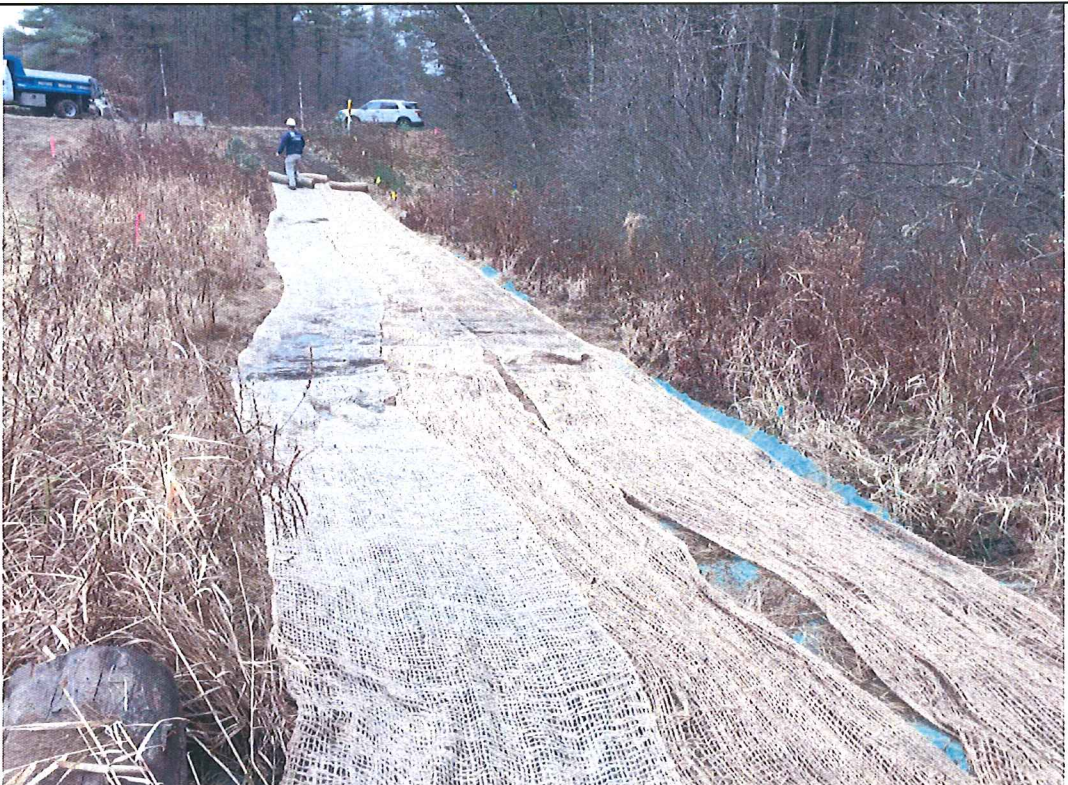
| <b>Photo No.</b><br><b>6</b> | <b>Date:</b><br>11-15 | |

| <b>Description:</b><br><br>View of the installation of jute matting following the grading, seeding and mulching of restored locations within WL-WR-28. | | |
