# **2015 Wetland Monitoring Report**

**Filed with the U. S. Army Corps of Engineers – New England District**

## **Fitchburg Expansion Project**

Permit Number NAE-2007-3029

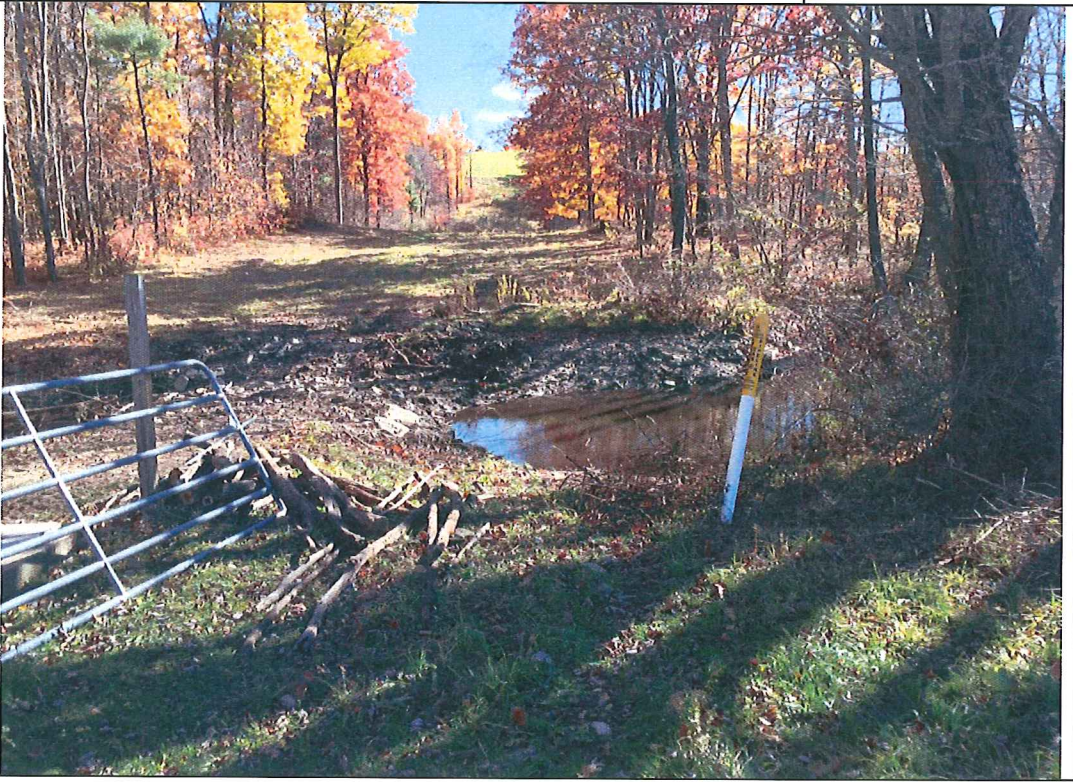
| PHOTOGRAPH LOG | | | |
|---|---|---|---|
| <b>Photo No.</b><br>9 | <b>Date:</b> | | |

| PHOTOGRAPH LOG | | | |
|---|---|---|---|
| <b>Description:</b><br><br>View following the removal of the beaver impoundment and debris within the obstructed culvert system at waterbody S-4. | | | |

- Distribution of 6,000 *Galerucella* sp. beetles in 2015 to aid in the control of purple loosestrife at seven (7) specific wetland locations;
  - The removal of a beaver impoundment to return natural post-construction flow conditions through an existing culvert at Waterbody S-4;
