Title: Evaluation of fish use and passage at the Owens Pond Fishway,
Wentworth Farm Conservation Area, Amherst, MA

Boyd Kynard, Brian Kynard, and Campbell Morgan
BK-Riverfish, LLC, 28 Echo Hill Rd., Amherst, MA 01002

4 February 2016

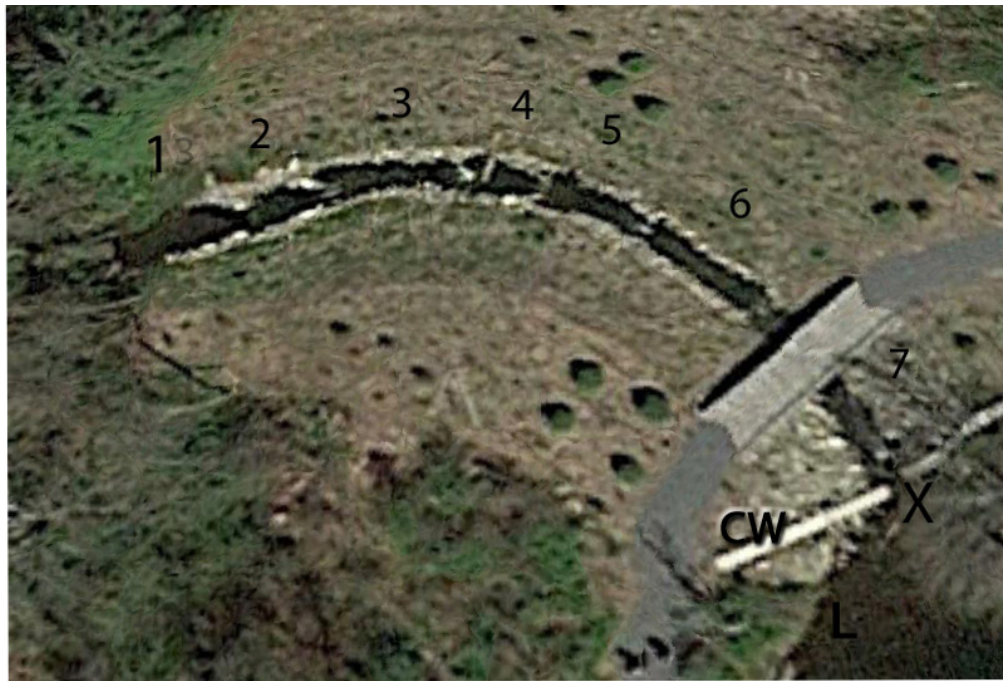
Fig. 1. Plan view of fishway showing reaches 1-7; CW= cutoff wall, L = temperature/depth logger location, and X is location of video camera.

Fig. 1. Google picture of the Owens Pond Fishway. Each of the seven reaches in the fishway are numbered, 1 (lowermost) to 7 (top). The cutoff wall top of the fishway is labeled CW. Location of the underwater camera used to observe fish passage at the top of the fishway is indicated by X. Location of the temperature-water depth logger in the pond (edge shown in lower right corner of picture) is indicated by L.

The fishway is a semi-natural channel (Jungwirth et al. 1998; Rosgen 2007) with seven step pools or cross rock vanes (VHB design drawings, April 2013). Fig. 1 shows an overhead view of the constructed fishway (174 ft 4 inches long (53.2 m) from the top of the fishway at the overflow cut-off wall at Owens Pond to the downstream end of Reach 1, the downstream limit of our fish sampling.

The large boulder steps forming the upstream edge of each pool naturally divide the fishway into 7 reaches (labeled 1-7 on Fig. 1). Each step has a head of 6-9 inches. Also on Fig. 1 are the following important locations: underwater camera location (X) used to monitor fish passage up- and downstream at the v-notch in the cut-off wall (CW), and the location of the temperature-water depth logger (L).

Prior to sampling the fishway, we installed an Onset data logger (Hobo U2OL; 0.1% accuracy) in Owens Pond (location – L indicated on Fig. 1). This site was the closest location to the top of the fishway that provided security from vandals. The location was close enough to the cut-off v-notch that passes water from the pond into the top of the fishway to monitor general changes in water depth and water temperature during the entire study. Installation date was 18 May 2015 (2 days before the first video sample); removal date was 18 November 2015 (day of last electroshocking sample). The data logger recorded temperature and depth each 2 h, providing a daily mean for each factor. We used a measured water depth over the logger and a measured water depth in the center of the v-notch to convert logger water depths to water depths in the v-notch of the cutoff wall, where fish passed moving up- or downstream in the fishway (thus, the location where we monitored fish passage). Additionally, we monitored water depth in the center of the v-notch of the cutoff wall on each day we monitored fish passage at the cutoff wall.

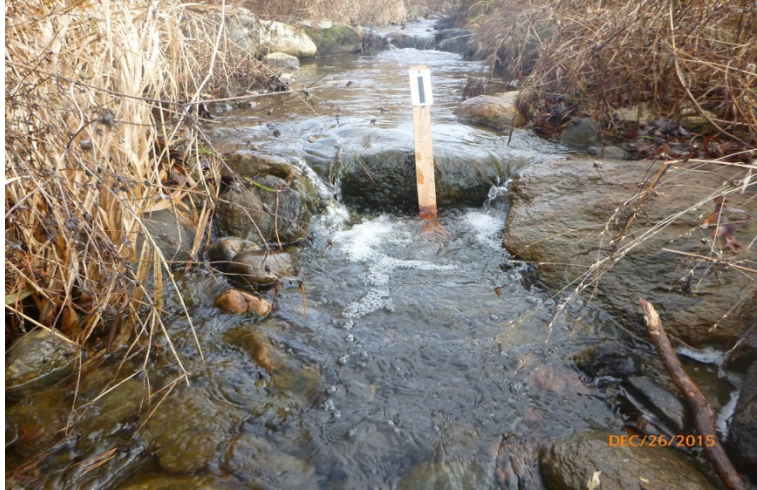
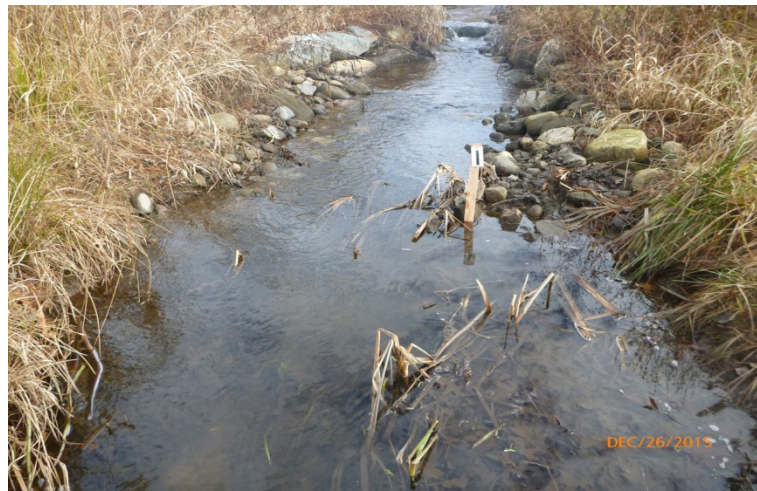
Fig. 2a. Reach 1 (deep slow run bottom picture) and rocky riffle-run (top picture).

Fig. 2. Pictures of Reach 1 (lowermost reach), Reach 5 (showing fast raceway in bottom picture and pool below boulder weir in top picture), and Reach 7 (showing riffle in bottom picture and top of reach at the cutoff wall in top picture).

Fig. 2 (a, b, c on three separate pages) shows two pictures of Reaches 1, 5, and 7. These pictures show the habitat and reach variability in the fishway, from Reach 1 (with a downstream, not an upstream pool at the boulder step, Reach 5 (typical of Reaches 2, 3, 4, and 6 with a riffle-run downstream reach ending at an upstream pool and boulder step), and Reach 7 (atypical reach with no pool, but instead is a riffle-run reach to the boulder at the cutoff wall). (A pool was designed and constructed just downstream of the boulder (one of several boulders making a reverse horseshoe), but the pool was filled by rubble by 2015 (2 years). The picture in the lower one-half of each page shows the fast water riffle-run reach and the picture in the upper one-half of the page shows a pool and boulder step that forms the upstream limit of the reach. Pictures were taken when the water depth in the middle of the v-notch of the cutoff wall was 2 inches deep. Water depths were similar during video and fish captures.

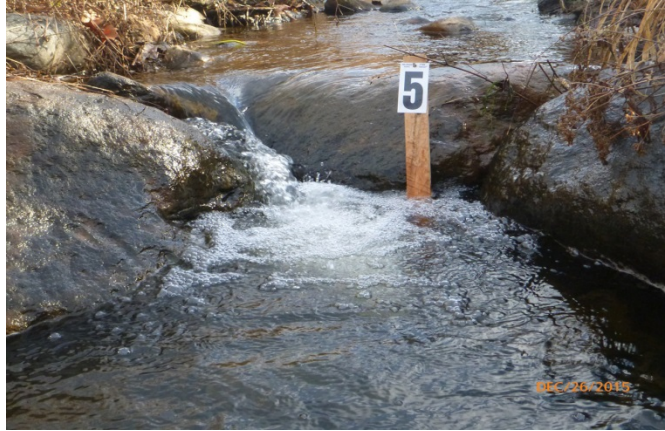
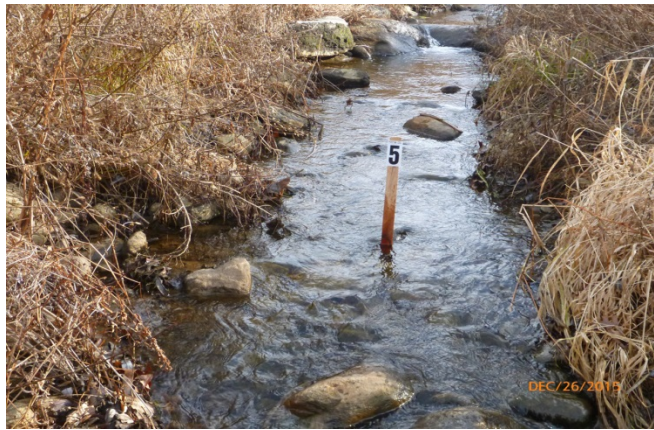
Fig. 2b. Reach 5 showing Riffle-run (bottom picture) and pool (top picture).

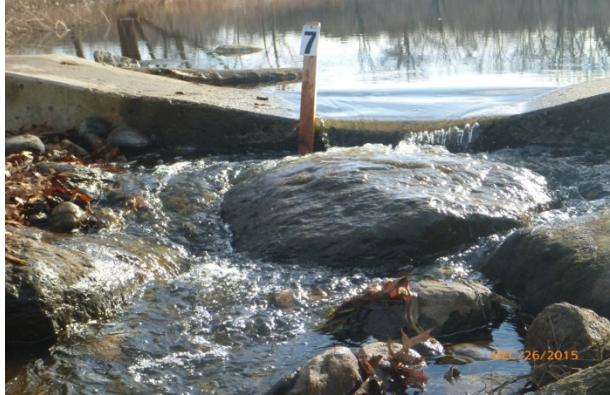
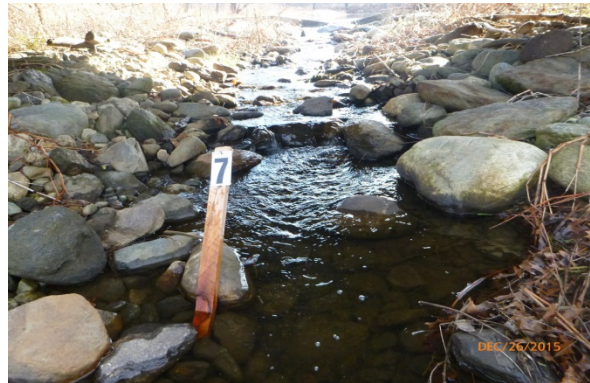
Fig. 2c. Reach 7 showing rocky riffle-run (bottom picture) and top of fishway at cutoff wall with the apex boulder of the horseshoe shaped boulder loop placed close to the cutoff wall (top picture).

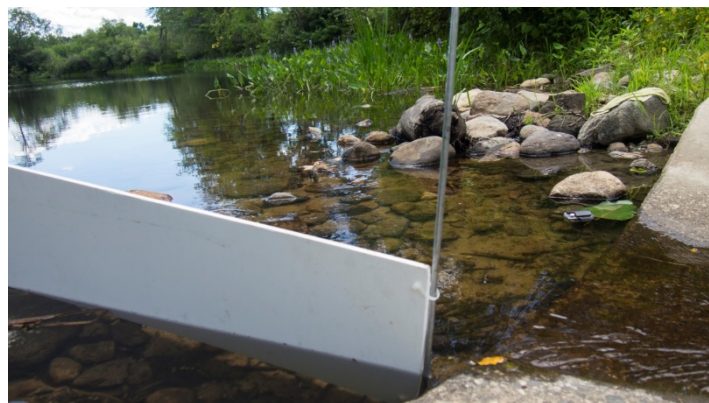
Fig. 3. White wall and camera setup for video monitoring fish moving past the v-notch in the cutoff wall (bottom right corner of picture).

Fig. 3. Picture of setup for underwater video camera monitoring of fish moving upstream past the cutoff wall notch and downstream from the pond. Black camera is underwater directly opposite the white background wall.

We monitored fish up- and downstream movements at the top of the fishway into Owens Pond from May to November by placing a GOPRO 3 camera to view at an angle underwater across the approach to the cut-off wall v-notch, the only passage route (Fig. 3). The white plastic wall directly across from the camera provided a uniform background to see fish in low light. The wall was a 1 x 4 ft piece of ¼ inch white foam-board pvc held upright by a metal pole at each end. Some fish moved downstream into the v-notch and then returned upstream into the pond (a down-up movement), so we oriented the camera to view slightly downstream across the v-notch to see if fish moved past the v-notch and into the fishway. Distance of camera to viewing wall was adjusted to be able to produce an image of the fish large enough to allow a reviewer to identify the fish to species or Family. After each video monitoring session, we removed the white wall, leaving no trace of our activities.
