Re: NH DES File #2012-001052 & 2012-1060
First Year Monitoring Report

Monitoring Photo log

Re: Pease Golf Course
Remedial Measures for Bank Stabilization

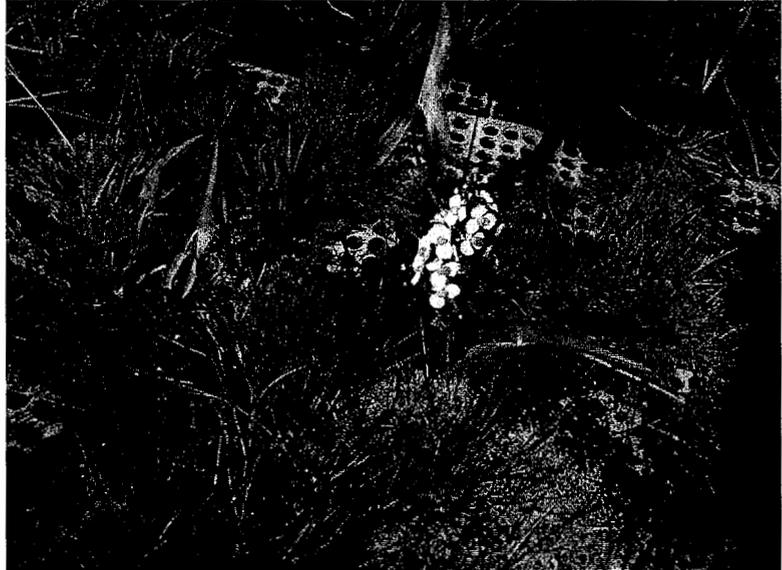
<p>Date: 8-30-14</p>
	<p>Photographer:</p>
	<p>Comments: Arrowhead (<i>Sagittaria latifolia</i>) and other wetland plant species within the stream buffer area.</p>

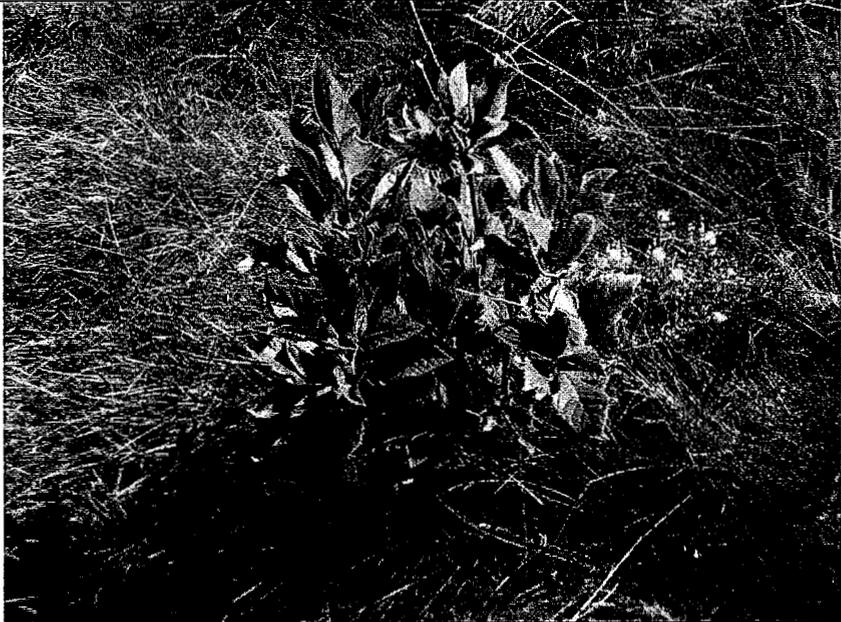
<p>Date: 8-30-14</p> <p>Photographer: Tracy Coolidge</p> <p>Comments: Healthy Meadowsweet (<i>Spirea latifolia</i>) along stream bank.</p>

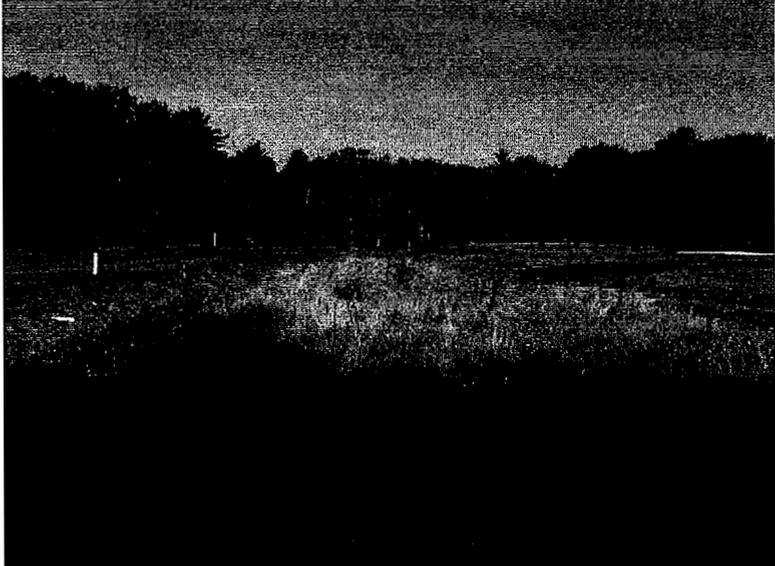
<p>Date: 8-30-14</p> <p>Photographer: Tracy Coolidge</p> <p>Comments: Wetland creation area well vegetated with herbs and planted shrubs.</p>

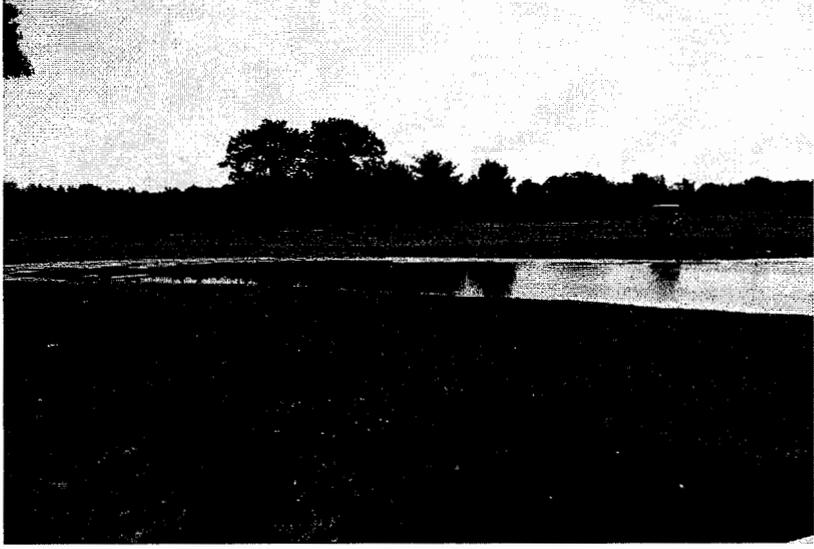
Photographer: Tracy Coolidge
	Comments: Pond 1.
	Date: 8-30-14

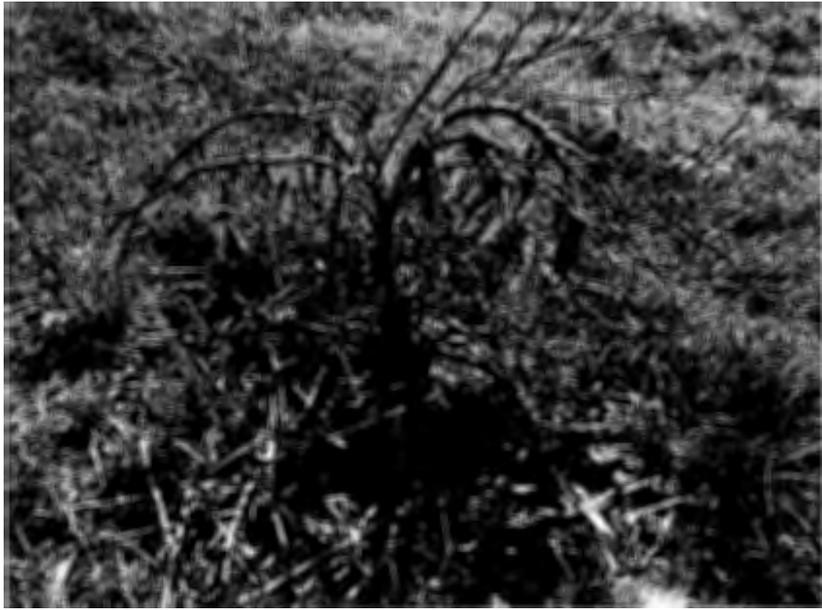
The stream restoration and wetland creation areas are well established with native wetland vegetation. Common arrowhead (*Sagittaria latifolia*) and Canada rush (*Juncus canadensis*) were both observed in the created wetland. Planted shrubs along the stream corridor and within the wetland creation area were located and checked for health and survivability. Of the 993 planted shrubs, 39 were either dead or could not be located. Upon inspection of the shrubs, over 100 plants (10%) exhibited 50-70% dieback. Additionally, many root bulbs were exposed 2-3 inches above the ground. Mowing and

exposed roots are the likely contributions to observed poor health and mortality. Despite these observations survivorship was relatively high. Percent survivability by species is outlined in Table 1 and averaged 96%. The greatest mortality was observed in plantings of silky dogwood (*Cornus amomum*).

<p>Photographer: Tracy Coolidge</p>
	<p>Comments: Heaved root bulb of Sand Cherry (<i>Prunus depressa</i>).</p>

- 3.) Check all shrubs for root bulb exposure and re-plant all shrubs with root bulbs exposed. Ensure that roots are ½" below the ground and heeled in to reduce the likelihood of heaving of roots this winter. Add loam if needed.

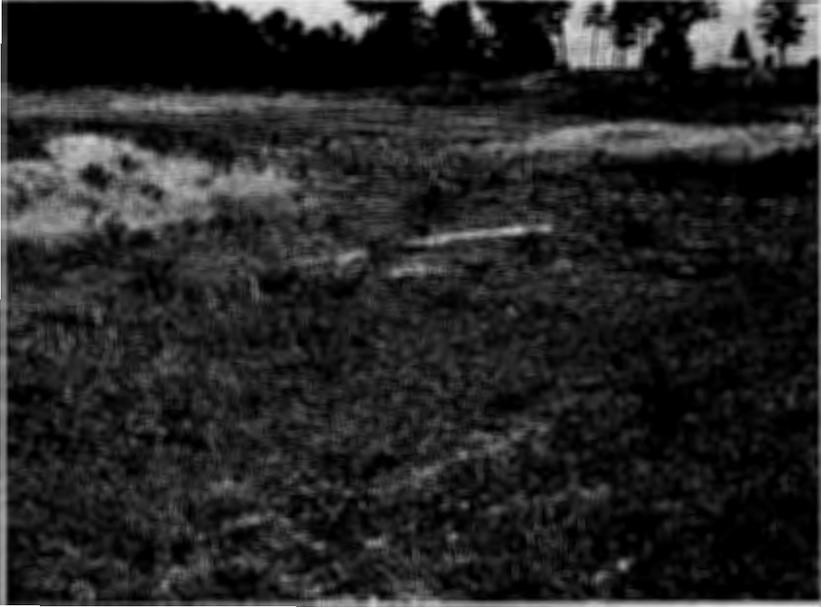
Photographer: Tracy Coolidge
	Comments: Wetland Creation area well vegetated with herbs and shrubs.

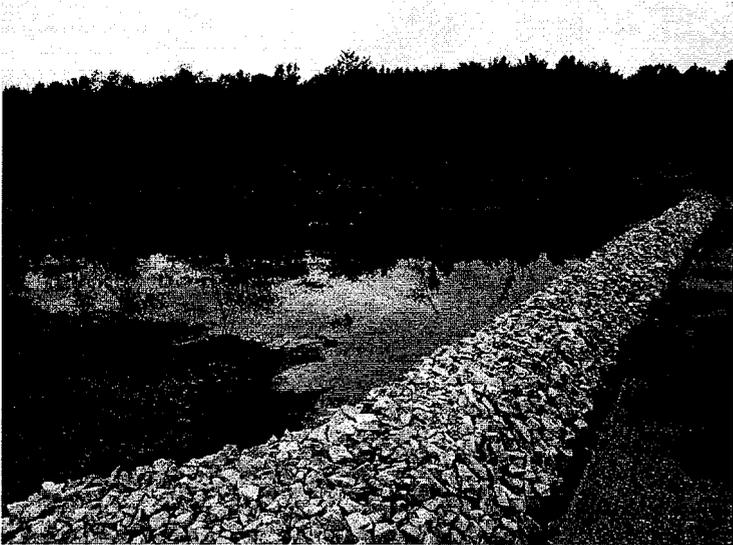
<p>Date: 9-16-2014</p> <p>Photographer: Adele Fiorillo</p> <p>Comments: level spreader adjacent to stream (post remediation).</p>

- 1.) Hand pull the few Purple Loosetrife plants within the mitigation areas while the population is small and manageable.
- 2.) The newly installed level spreader has created an increase in hydrology causing ponding behind the rip rap. Steeplebush (*Spirea tomentosa*) will likely not survive in ponded conditions. Relocate these shrubs out of the ponded area to low flat areas adjacent to side slopes in the same area.

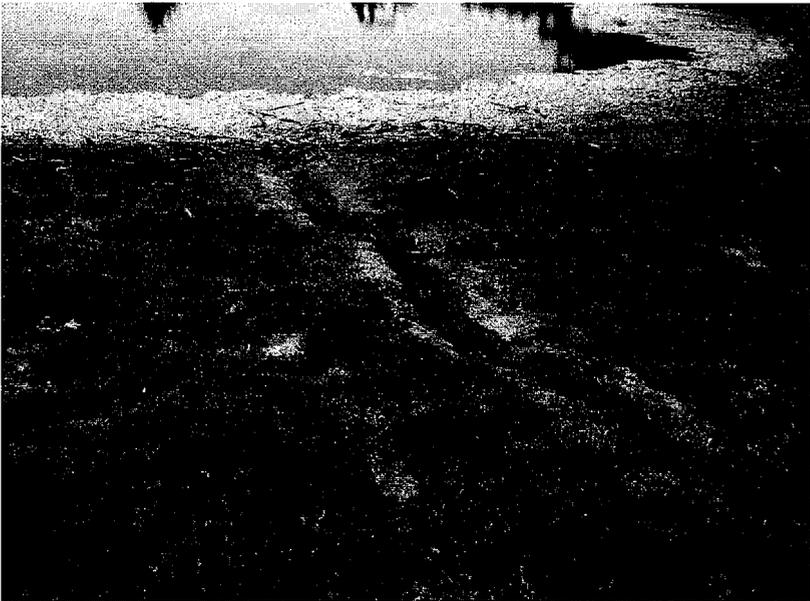
Several sites of erosion were also noted during the monitoring inspection. One area of erosion within the stream channel was previously observed during a site review on July 11, 2014. In a letter dated on August 12, 2014, Normandeau recommended that the eroded area be remediated using an erosion control blanket and installation of a level spreader within the drainage area. These recommendations were completed by the PDA during the week of September 8th, 2014. Erosion was also noted in two locations along the perimeter of pond 1. These areas were smoothed and reseeded by the PDA during the week of September 8, 2014.

<p>Date: 8-30-14</p> <p>Photographer: Tracy Coolidge</p> <p>Comments: Erosion on Pond 1.</p>

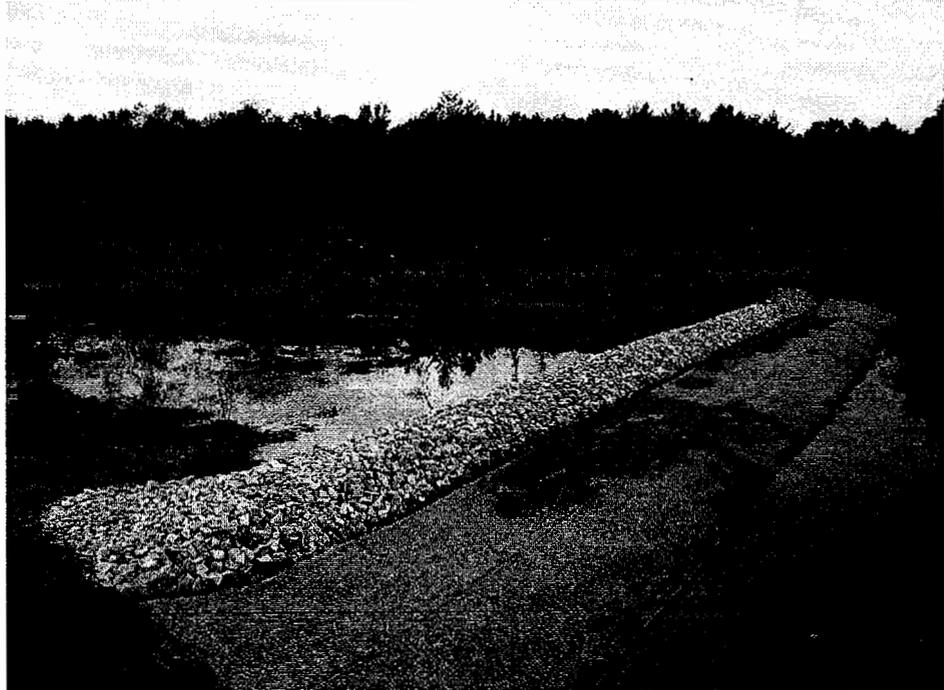
Date: 9-16-2014
	Photographer: Adele Fiorillo
Comments: Level spreader and bank restoration (post remediation).

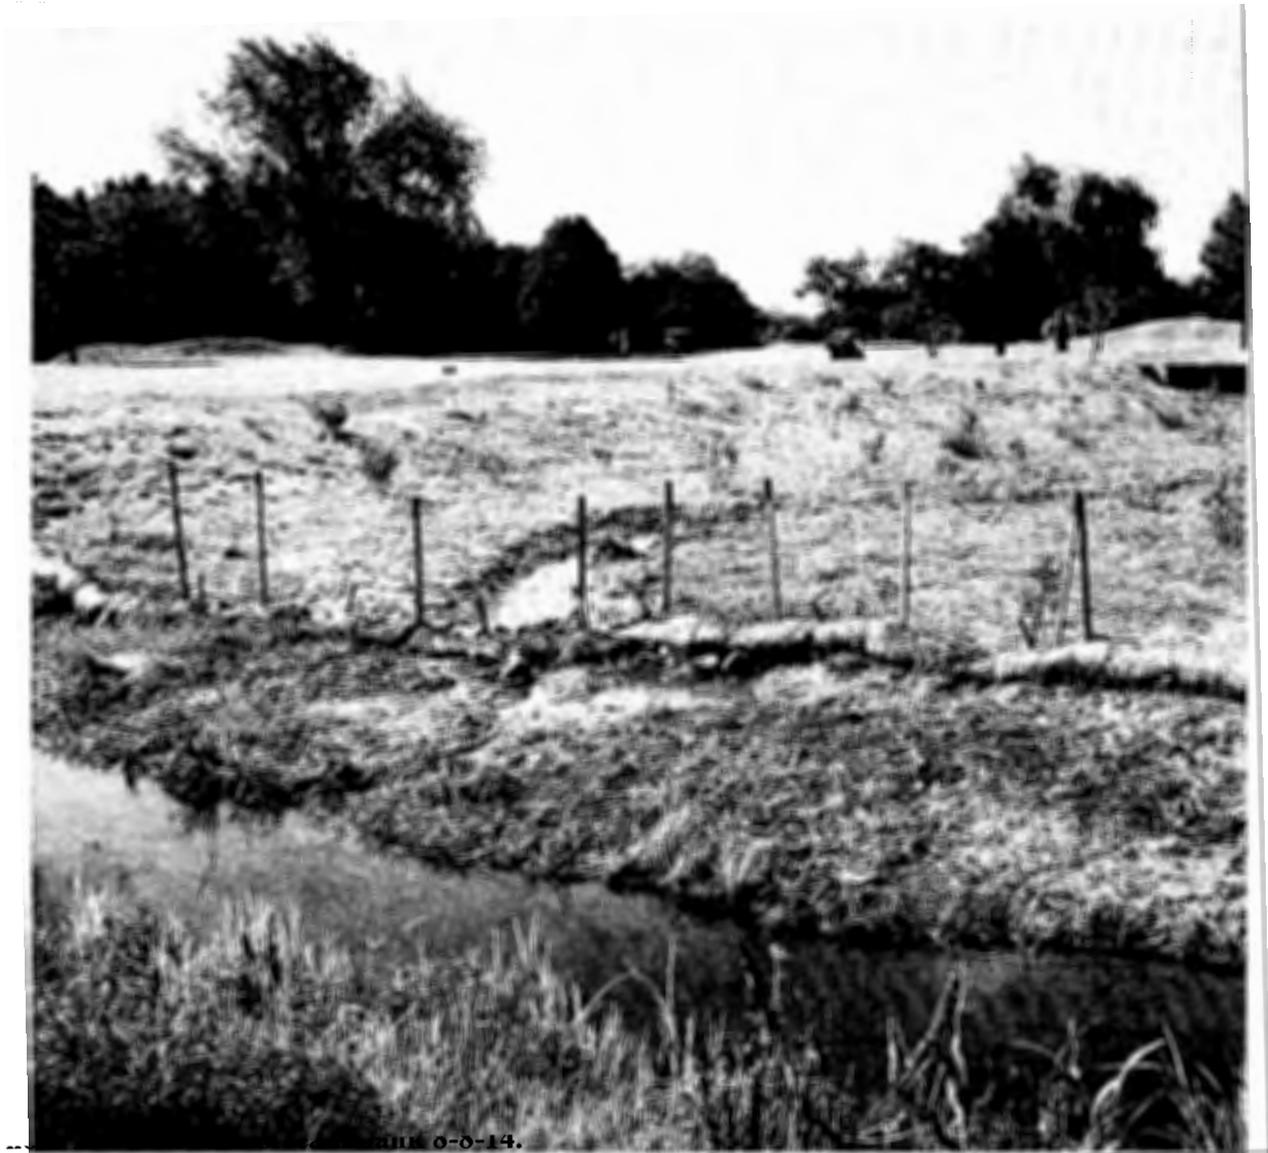
This letter is being written as a follow up to our site review on 8/11/14. After winter snow melt and spring rain events there is a section of stream bank that has slumped and eroded along a portion of the restored stream that flows across the golf course between holes 13, 15, 8 and 4 (see attached photos). The area of focus is part of the planted shrub buffer to the stream and is associated with the main drainage pipe outlet.

The slumping and erosion into the stream caused upstream flows to be blocked. This has been remedied through the removal of material from the stream. However, erosion of this area will continue if not properly stabilized. Additionally, vegetation has been compromised from erosion and also through cutting and mowing by course maintenance crews. The purpose of this letter is to establish remedial measures for the erosion that is occurring in this area. The mowing of vegetation, including the planted shrubs within the stream buffer will be addressed in a separate report following a complete assessment of the mitigation status.

Photo 1. Eroded stream bank 0-0-14.

As discussed during the site review the course of action recommended to address erosion and to stabilize the stream bank it is to re-establish the stream bank, cover it with an erosion control blanket and install a level spreader along its length within the drainage area floodway. The specifications for the level spreader will be developed by the Pease Development Authority Engineering Department. The erosion control blanket shall be Curlex Net Free or AEC Premier Straw or equivalent 100% biodegradable erosion control matting installed in accordance with manufacturers specifications. This is the same matting used in other portions of the stream bank restoration area and it has worked very well. Above the level spreader loam should be hand spread on exposed soils and then reseeded and mulched with weed free straw. Attached is a plan showing the locations for treatments as described, including a recommended seed mix.

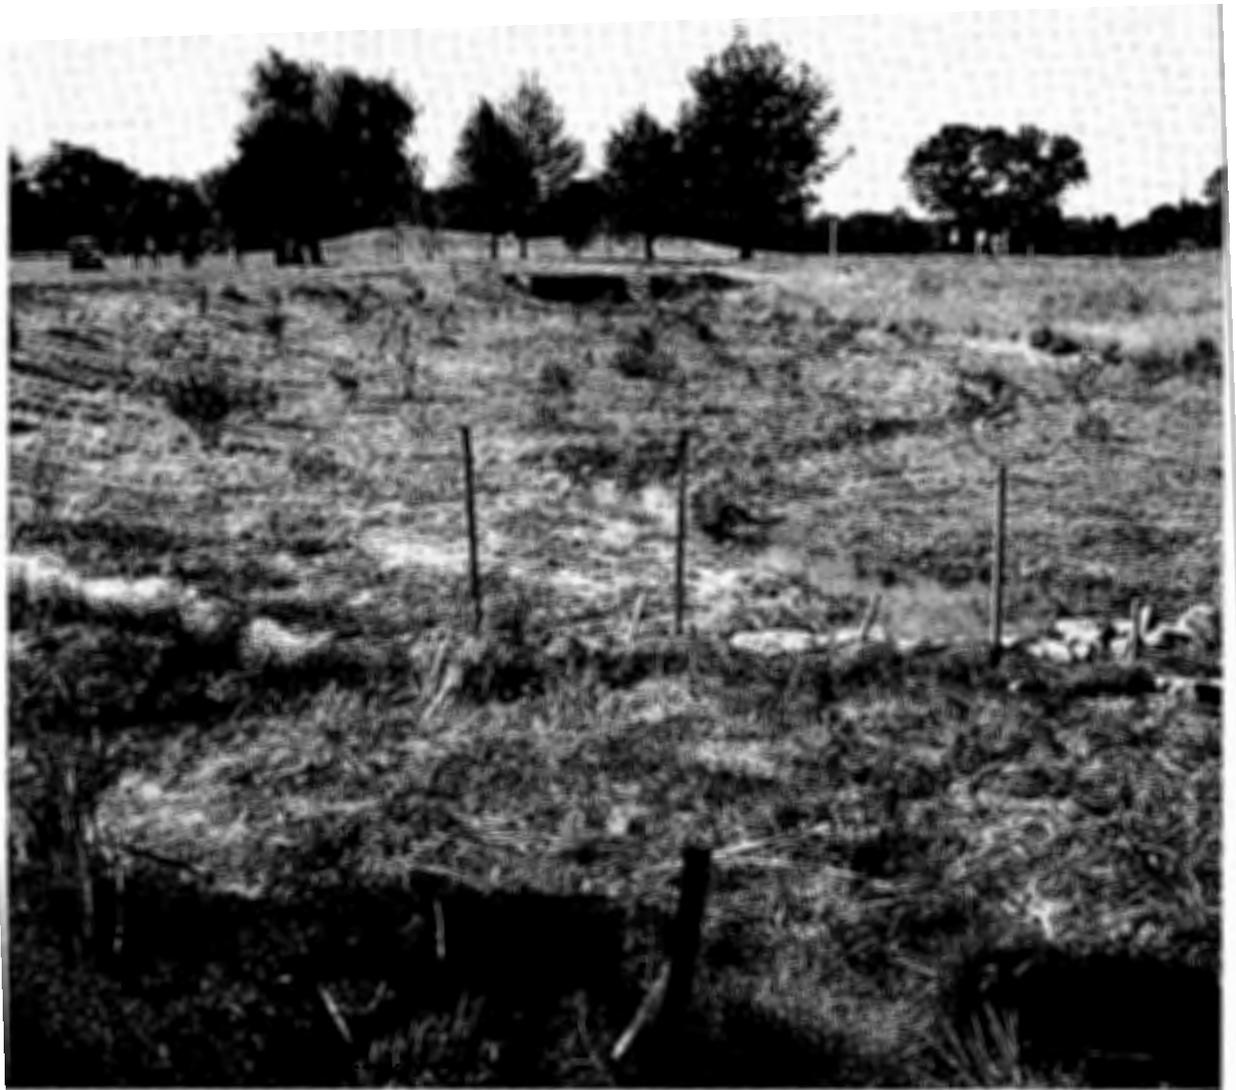
Photo 2. Eroded stream bank S.S.14
