RE: Jay Peak Resort - Jay, Vermont
Permit Number: NAE-2008-1314
Golf Course Wetland and Stream Mitigation
Third Annual (2013) Monitoring Report

Please find enclosed one hardcopy of the complete *Jay Peak Resort, Golf Course Wetland and Stream Mitigation, Third Annual (2013) Mitigation Report* and Appendix with supporting documentation, as well as a complete electronic copy on compact disc.

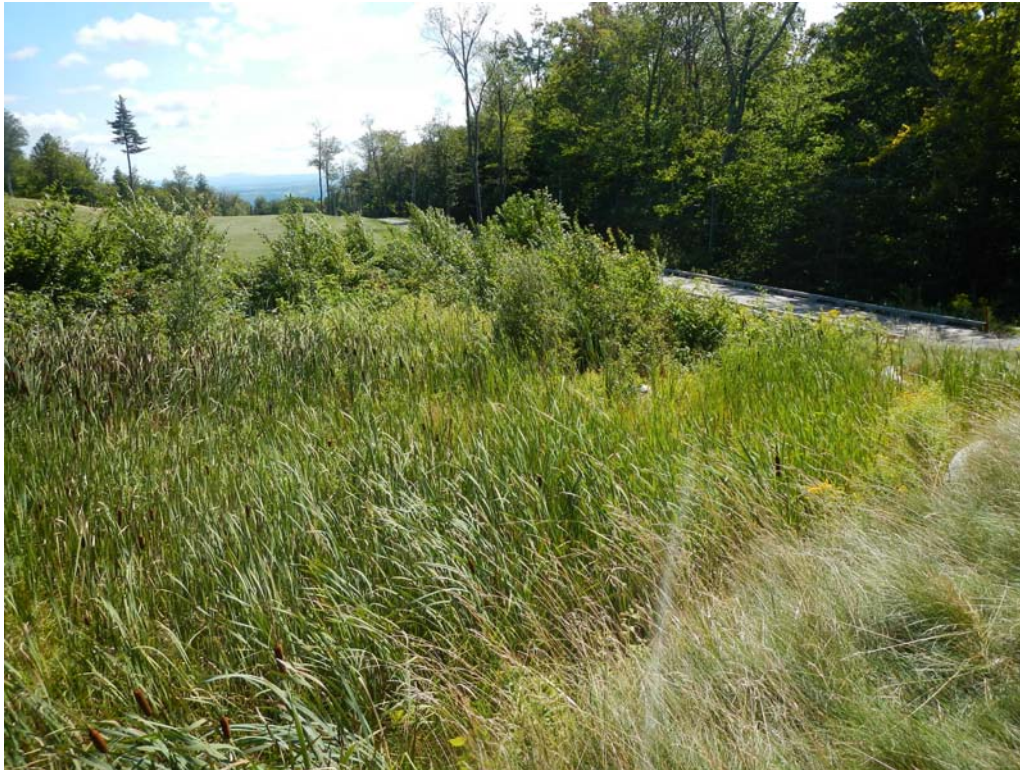
Photograph 11: H4-WT1/2 from Station H4-WT1-P1, facing southeast (P. Werts, 8/15/13)

In 2013, VHB observed the same small population (approximately 10 feet by 10 feet) of common reed (*Phragmites australis*) within Wetland H4-WT1/2. This population has previously been hand cut and treated with herbicide at various times during the growing seasons of 2009 through 2013, prior to which time it is was approximately the same dimensions. During the Year Three monitoring, it was noted that this population of common reed shows signs of stress, (i.e., looking less dense and vigorous than in previous years), and indicates that the continued cutting and targeted treatment with herbicide is having an effect. It has not spread within the wetland, or to other features, it should continue to be monitored and treated as necessary to ensure that it does not spread to other restored or created features.

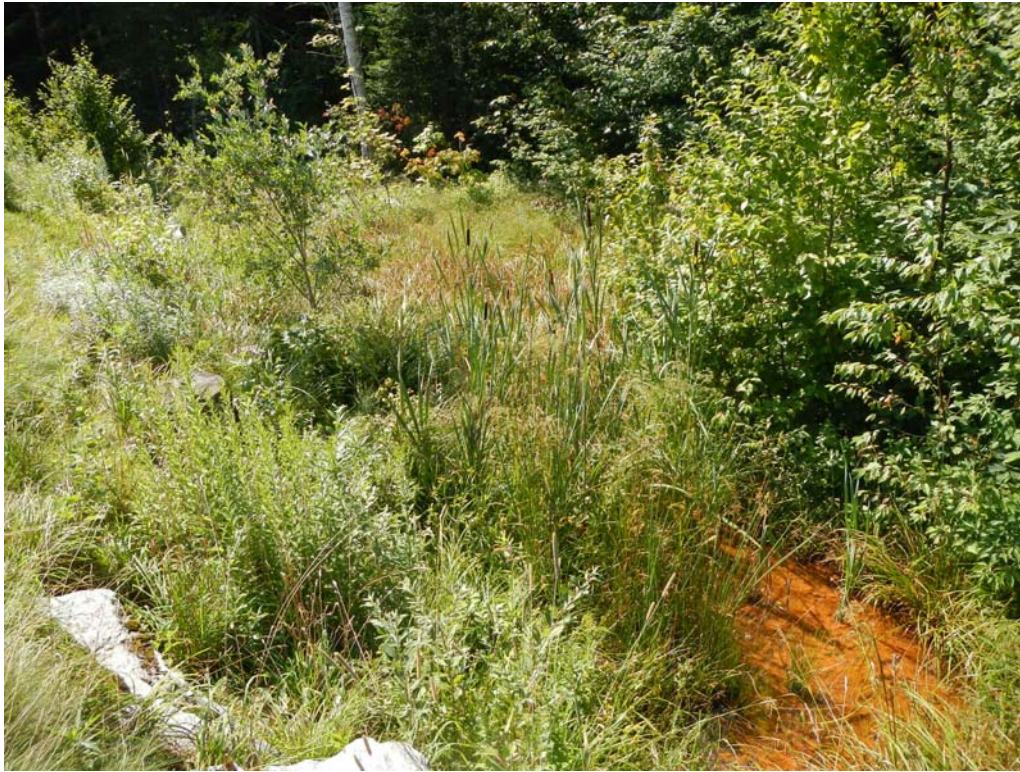
Photograph 33: H13-WT3 from Station H13-WT3-P1, facing southwest (P. Werts, 8/16/13)

During the 2013 monitoring, VHB observed a small population of reed canary grass (*Phalaris arundinacea*) in Wetland H13-WT3. This population, which was not present in 2012, was approximately two-feet by two-feet in size. Because the seed had already dispersed by the time of the 2013 monitoring, the small population was hand removed

for disposal off-site, but no further treatment was conducted or recommended for 2013. This area should be monitored in the future to ensure the reed canary grass does not spread to other wetland features; if it re-emerges in 2014, the plants should be hand-pulled and treatment with herbicide considered if the population is significantly larger than in 2013.
