RE: VTrans Maidstone STP 0271(20)
2014 Wetland Monitoring Report

Maidstone Slide – STP 0271 (20)

Year 2 Report

**Wetland and Invasive Species Monitoring
and Control Recommendations**

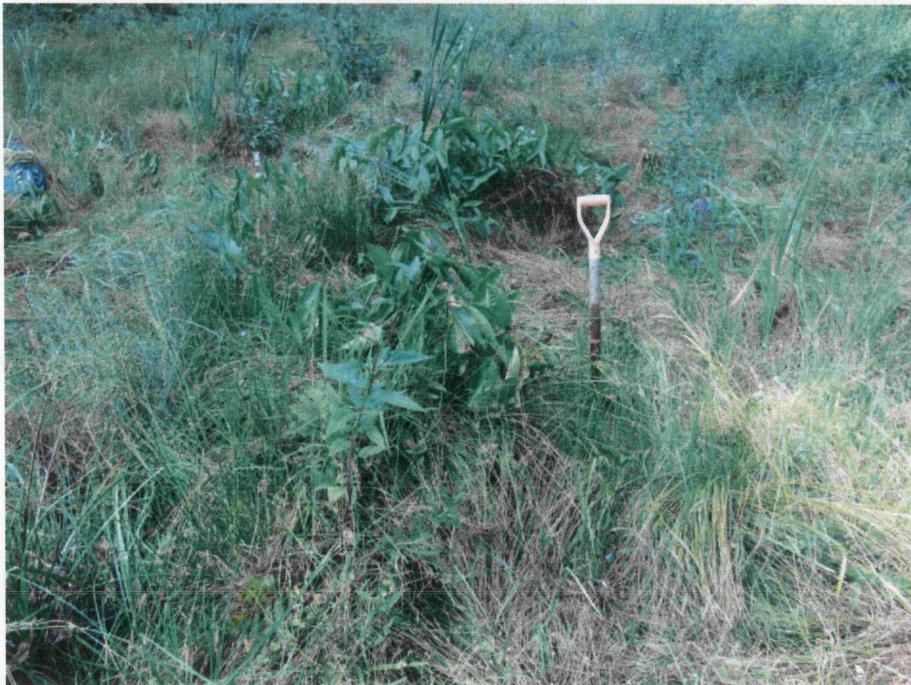
Figure 4. Vegetation of Plot 1 in second year of restoration. The prominent plants are common arrowhead, Pylae's soft rush and common fox sedge. Also apparent are broad-leaved cat-tail and a single plant of spotted joe-pye weed.

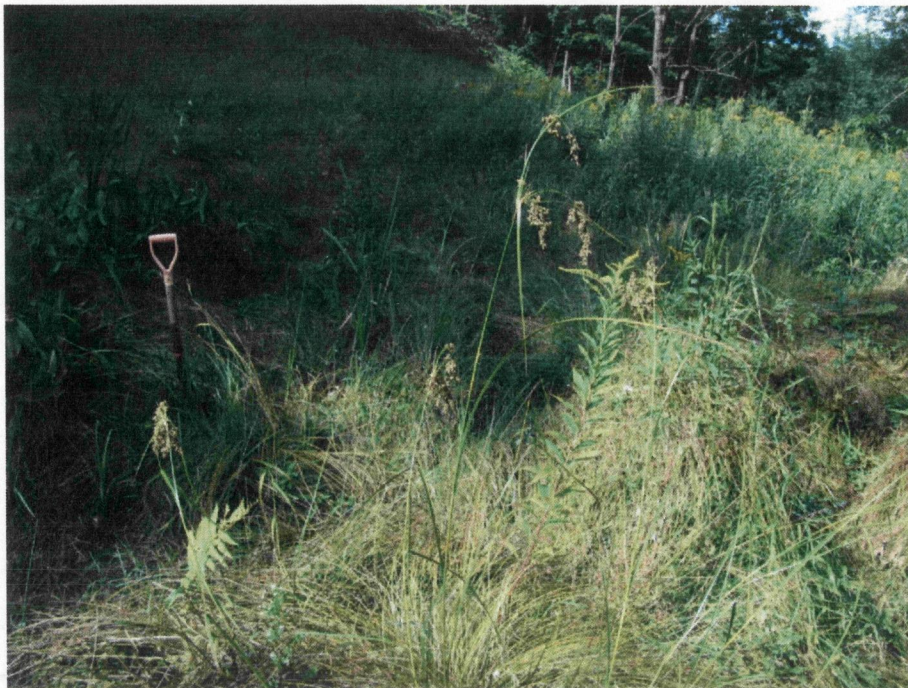
Figure 5. Vegetation of Plot 1 in second year of restoration. Pylae's soft rush, common woolsedge, common wrinkle-leaved goldenrod and one leaf of cinnamon fern are seen. Slope rise to Route 102 is in background.

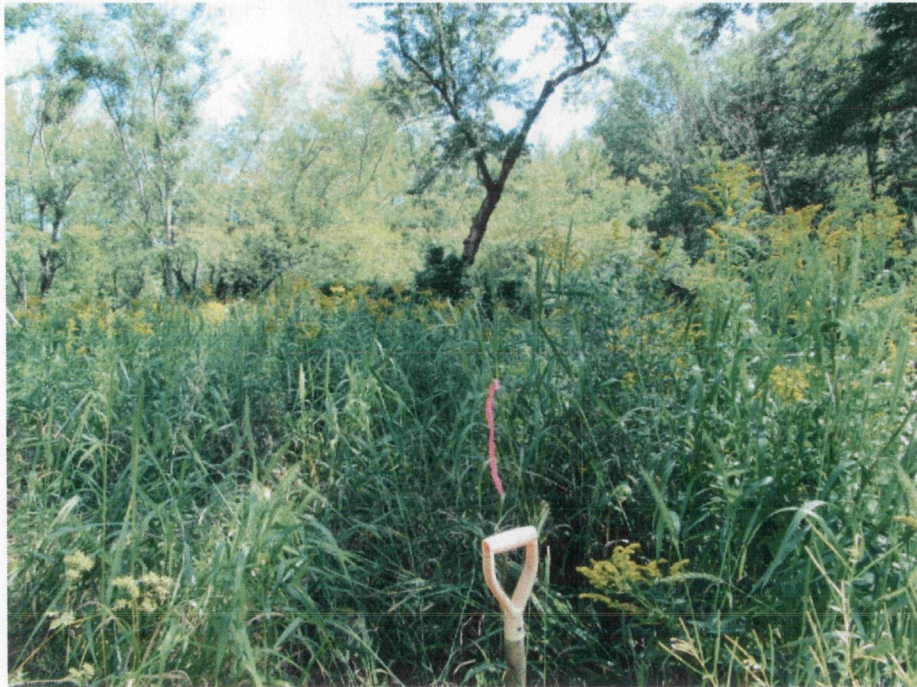
Figure 6. Vegetation of Plot 2 second year of restoration. Eastern riverbank wild-rye and smooth goldenrod are dominants along with the shorter red fescue (not showing in the photo). Tall meadow-rue seen in lower left. Intact floodplain forest to the east is in background.

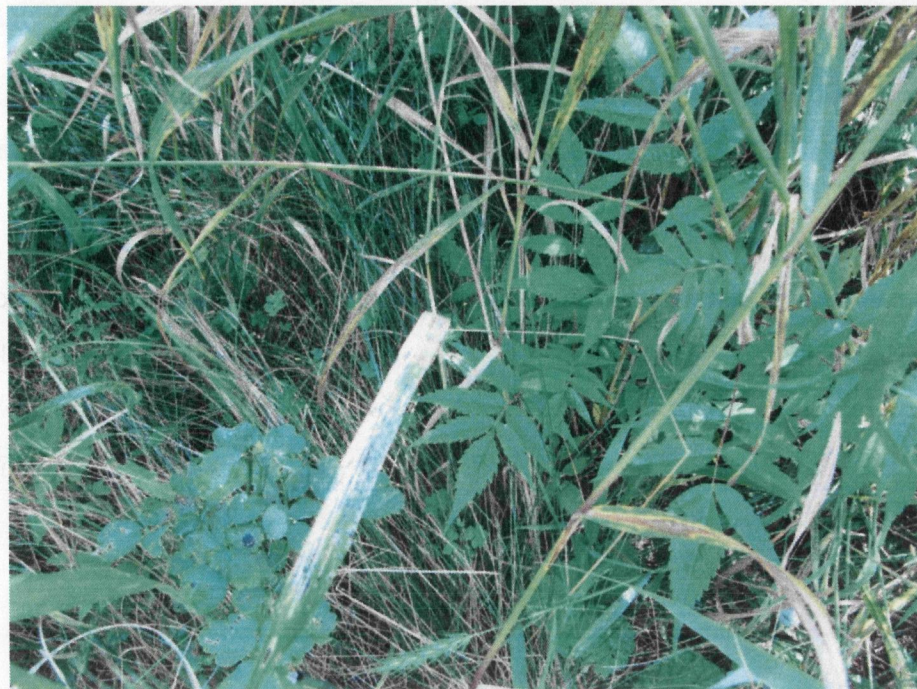
Figure 7. Vegetation of Plot 2 second year of restoration. Black elderberry, red fescue tall meadow-rue, eastern riverbank wild-rye and common yellow wood sorrel are apparent.

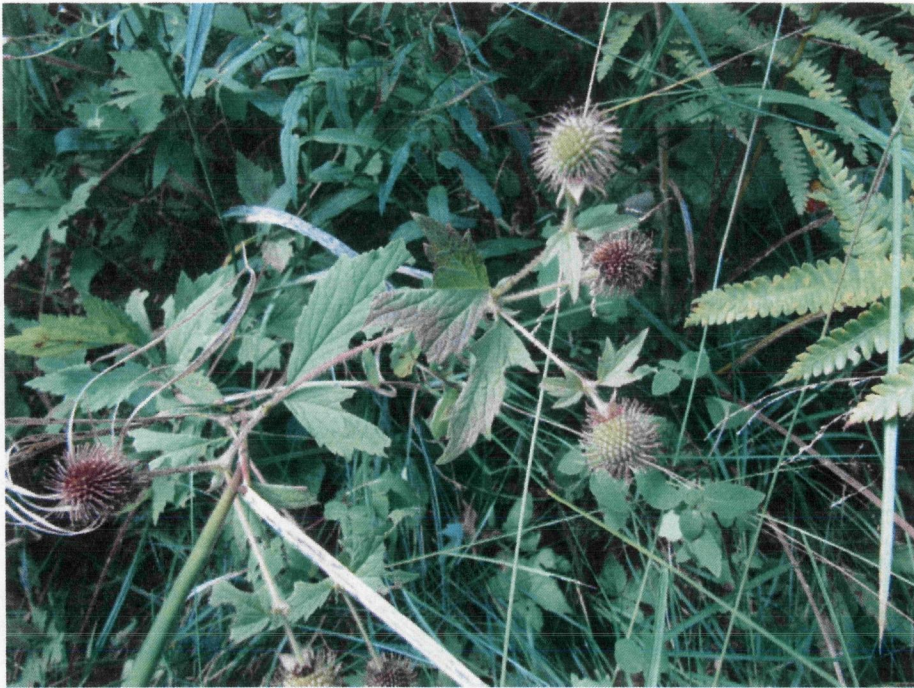
Figure 8. Rough avens north of plot 2. Year 2 monitoring verified establishment and fruiting of rough avens in the restoration area.

Year 2 monitoring verified establishment and fruiting of rough avens in the restoration area (Figure 3). The first-year rosettes observed in 2013 had attained reproductive status in their second year of growth and positive identification was possible. One individual was growing within the drier plot and another individual was in the area closely adjacent to the wetter plot. Throughout the restoration area we observed approximately eight fruiting rough avens; the majority of the population was in the area between our two sample plots. Close to the river, where the bulk of the original population had been located, does not appear to be suitable habitat, as it has been engineered with fill as a lower-slope area to help support the reconstructed slope and cannot be considered part of the wetland restoration. Nonetheless, judging from Year 2 observations of the population size, vigor and reproductive status of rough avens in the restoration area, the collection, storage and dispersal of the seeds of this uncommon species have apparently been successful since these conservation actions seem to have aided in the re-establishment of a population that would otherwise have been nearly or fully decimated in this part of the floodplain forest.

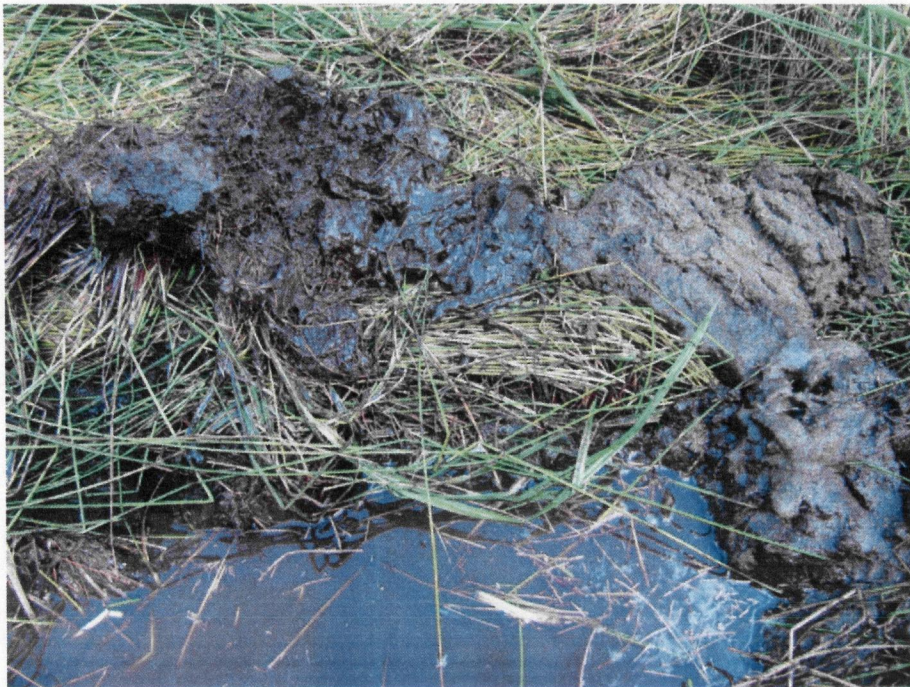
Figure 9. Soil of Plot 1 showing (from left to right) muck O horizon held together with abundant very fine roots, mucky fine sand A horizon and mottled grayish brown to gray fine sand subsoil. High water table is evident.

Plot 1 is the wetter plot, and the soil pit dug in Year 1 monitoring showed remnants of overburden from construction of the access road. The Year 2 pit did not display any overburden or roadbed stone and instead showed a very natural wetland soil profile. We did not dig around in other areas because we did not want to cause undue disturbance to vegetation in the restoration area, but our observations of the surface soil in various locations of the wetter portion of the site indicate that the Year 2

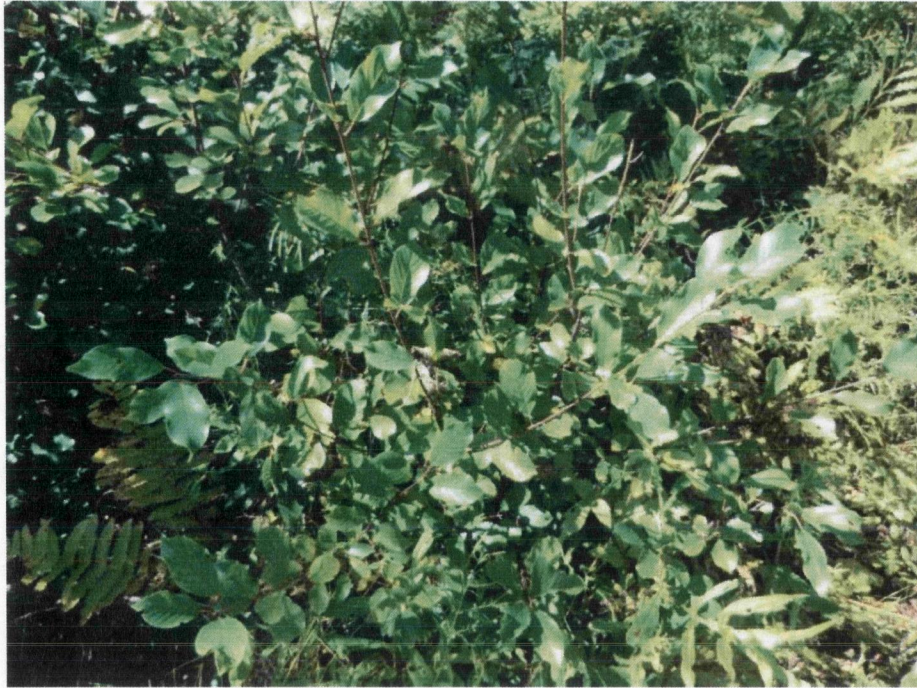
Figure 10. Invasive glossy buckthorn adjacent to former access road.

After monitoring was completed we recommended chemical control of glossy buckthorn and Eurasian honeysuckles that were in the wetland adjacent to the restoration area and Japanese knotweed that was present along the stabilized slope and the wetland buffer of the former access road (Figure 3). Chemical treatment of glossy buckthorn and Eurasian honeysuckles was completed by Vegetation Control Services on October 2, 2014. The Japanese knotweed plants we observed on the stabilized slope and in the wetland buffer of the former access road on August 19, 2014 were not conspicuous on October 2, 2014, and therefore, could not be treated with the herbicide. Chemical treatment of Japanese knotweed is recommended for spring or summer 2014. Although Japanese knotweed was not observed within the restored wetland, control of the knotweed in outlying areas is vital for preventing the spread into the wetland. Control of wild parsnip in the restored wetland was conducted by hand-pulling by Mary Nealon on August 19, 2014.

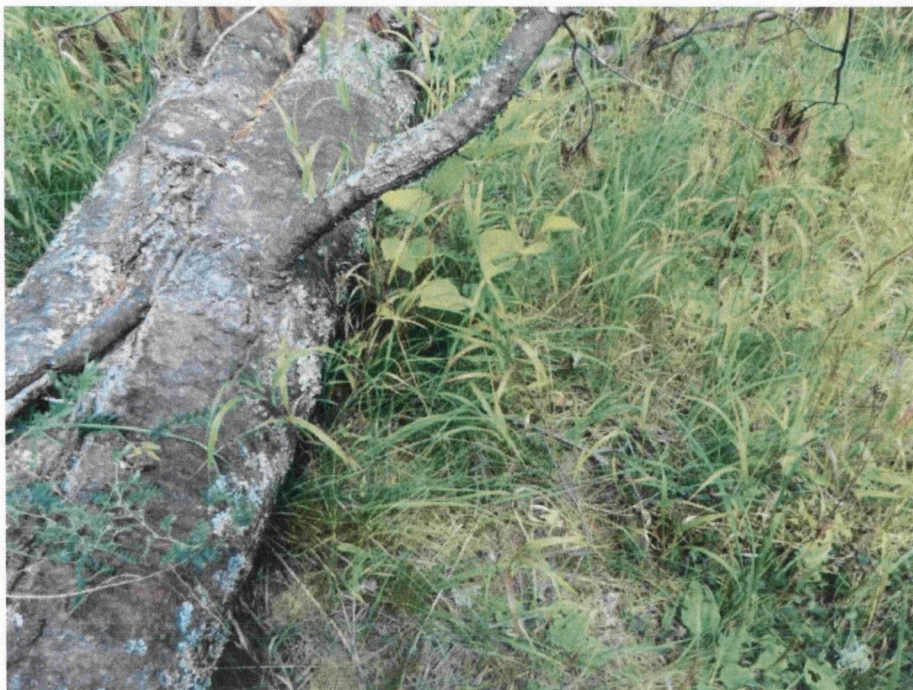
Figure 11. Japanese knotweed observed on August 19, 2014 in wetland buffer on former access road.

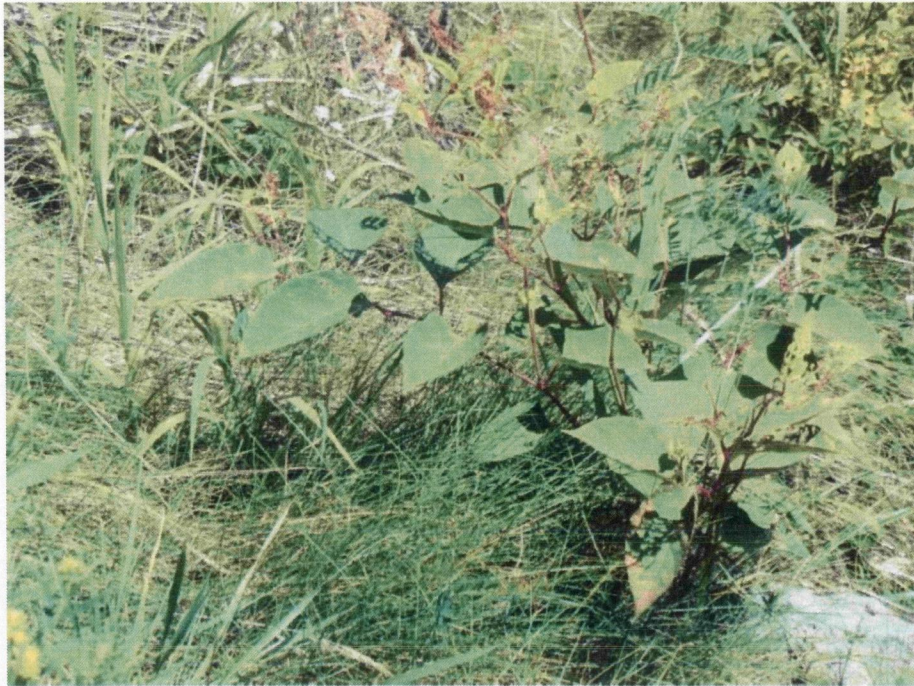
Figure 12. Japanese knotweed on stabilized slope. One of approximately 20 knotweed plants less than 1 meter high. Plants were observed on August 19, 2014, but were not conspicuous in early October 2014.

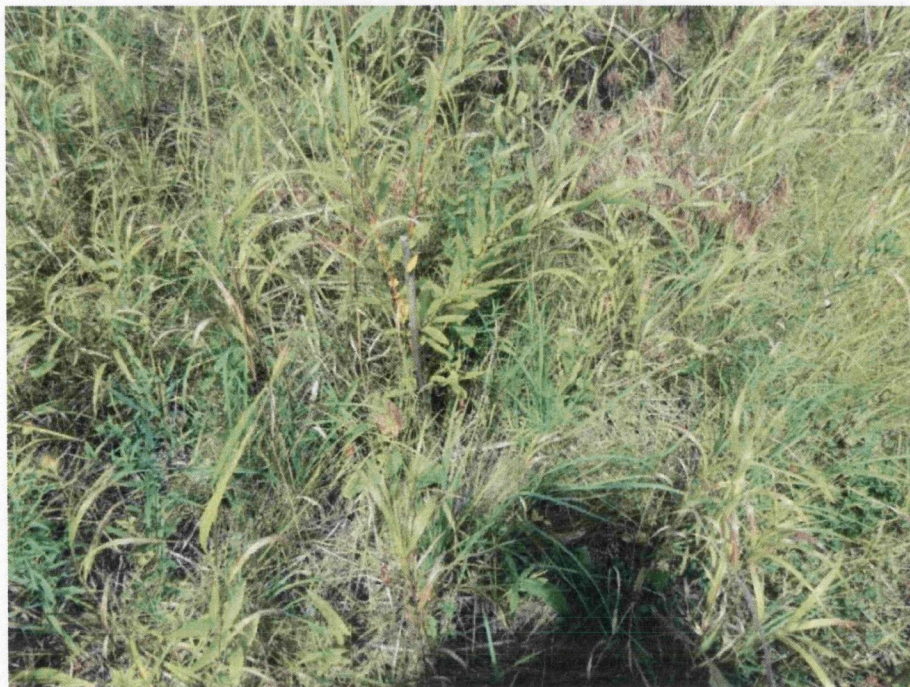
Figure 13. Willow Whip in wetland buffer. Survivorship of the planted red-osier dogwood and native shrub willow live stakes was very high.
