Maidstone Slide – STP 0271 (20)

Year 3 Report

Wetland and Invasive Species Monitoring and Control Recommendations

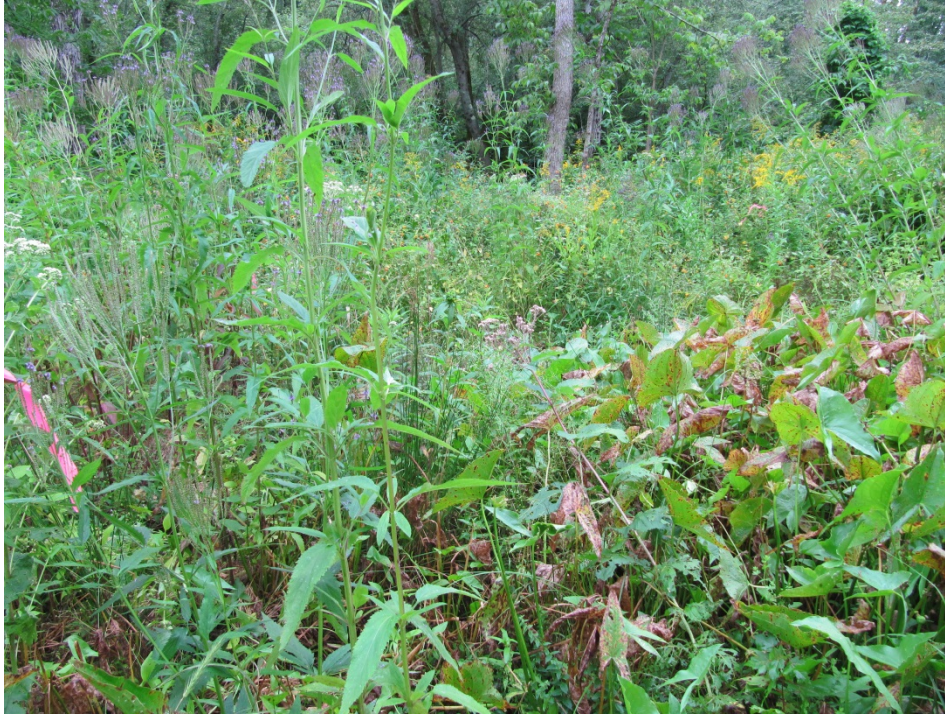
Figure 4. Vegetation of Plot 1 in third year of restoration. The prominent plants are common arrowhead (right) and blue vervain (left), with goldenrod in the background.

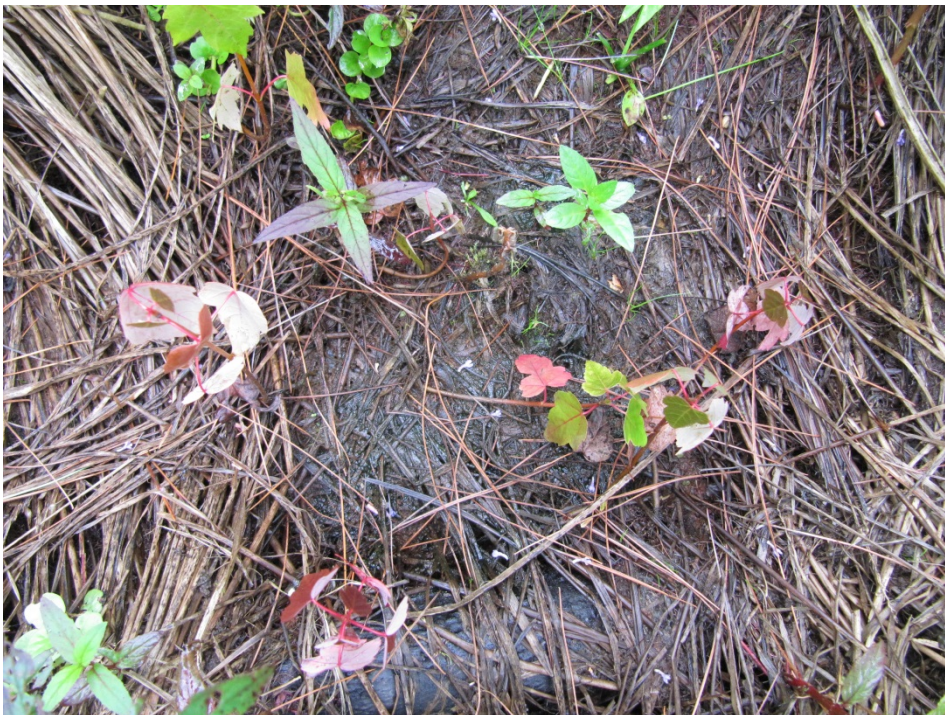
Figure 5. Vegetation of Plot 1 in third year of restoration. One of the wet, bare-soil portions showing silver maple first-year seedlings, with fringed willow-herb, moneywort, and graminoid thatch.

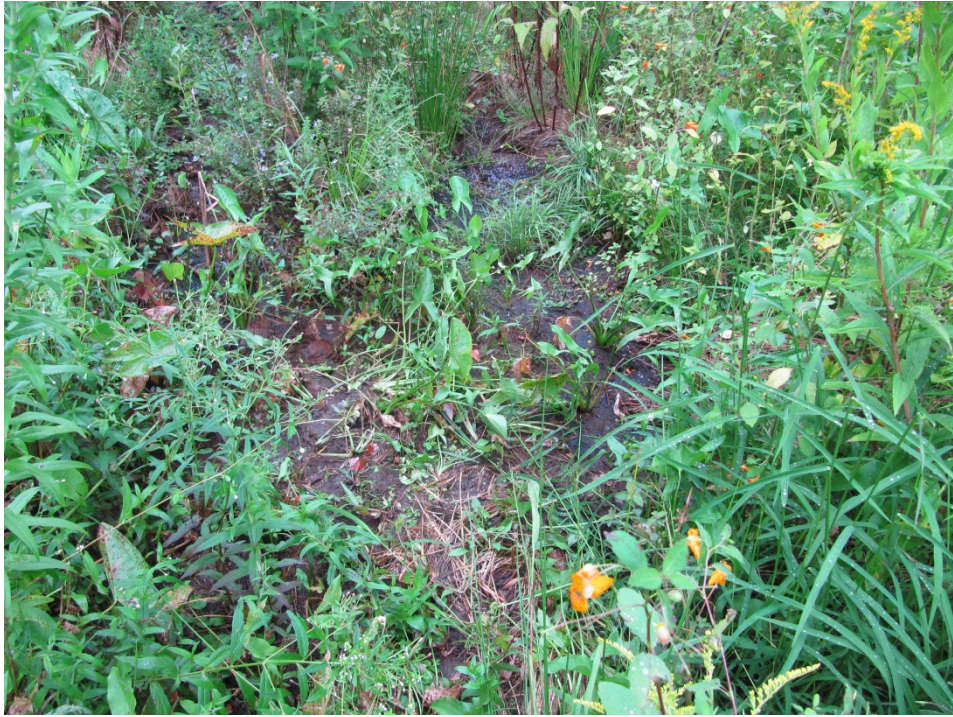
Figure 6. Vegetation of Plot 1 third year of restoration. One of the former tire ruts showing standing water and a large assortment of wetland graminoids and forbs.

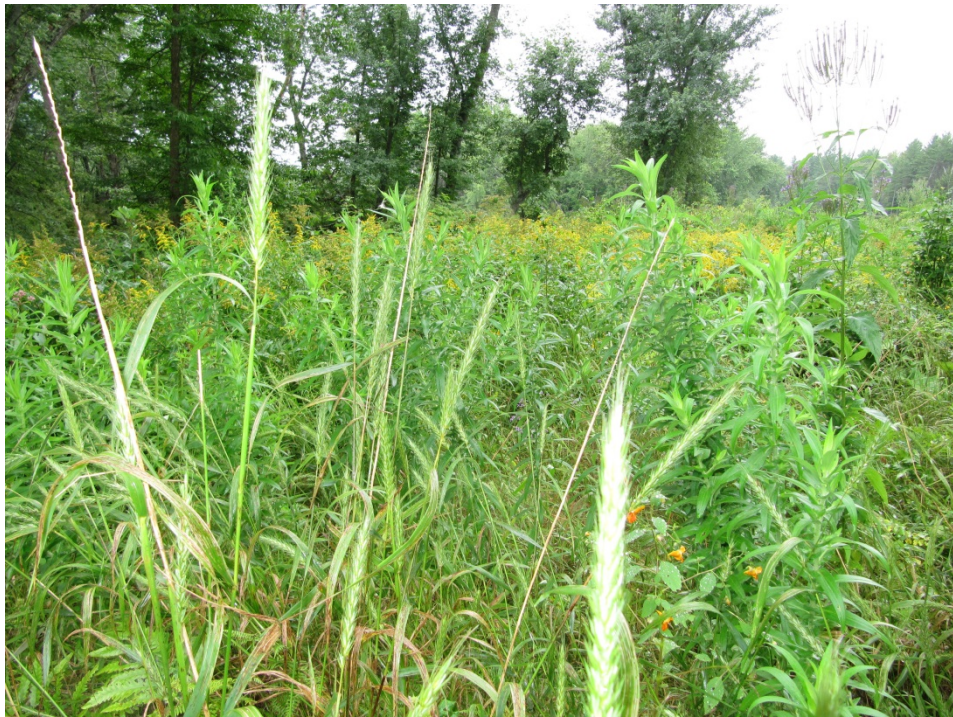
Figure 7. Vegetation of Plot 2 third year of restoration. Eastern riverbank wild-rye and smooth goldenrod dominate about one-half of the plot.

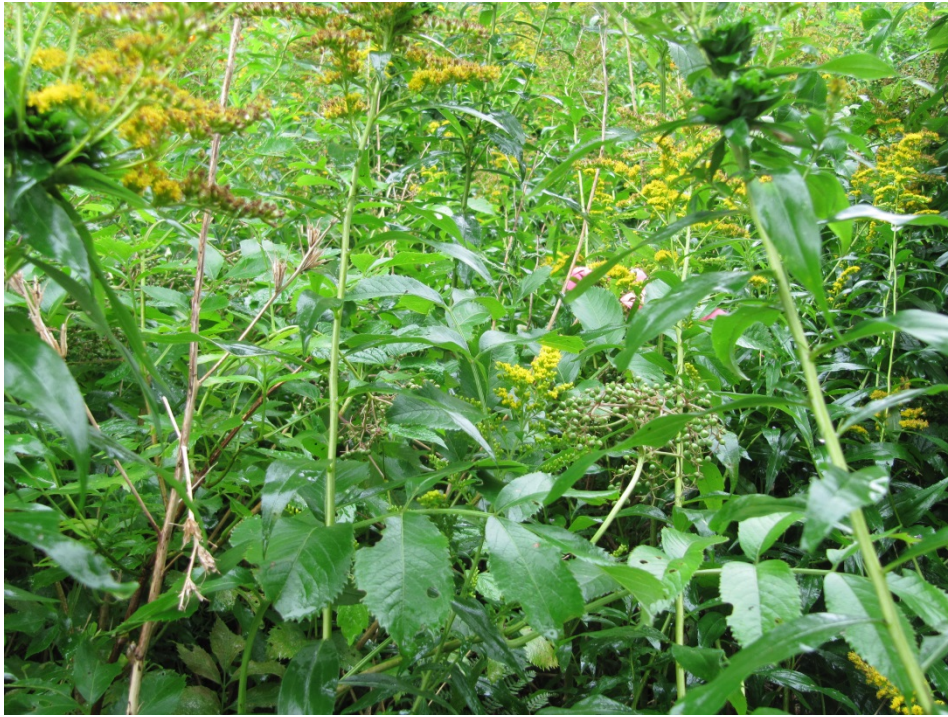
Figure 8. Vegetation of Plot 2 in third year of restoration. Center of photo shows fruiting black elderberry, a common shrub in the drier part of the restored floodplain site.

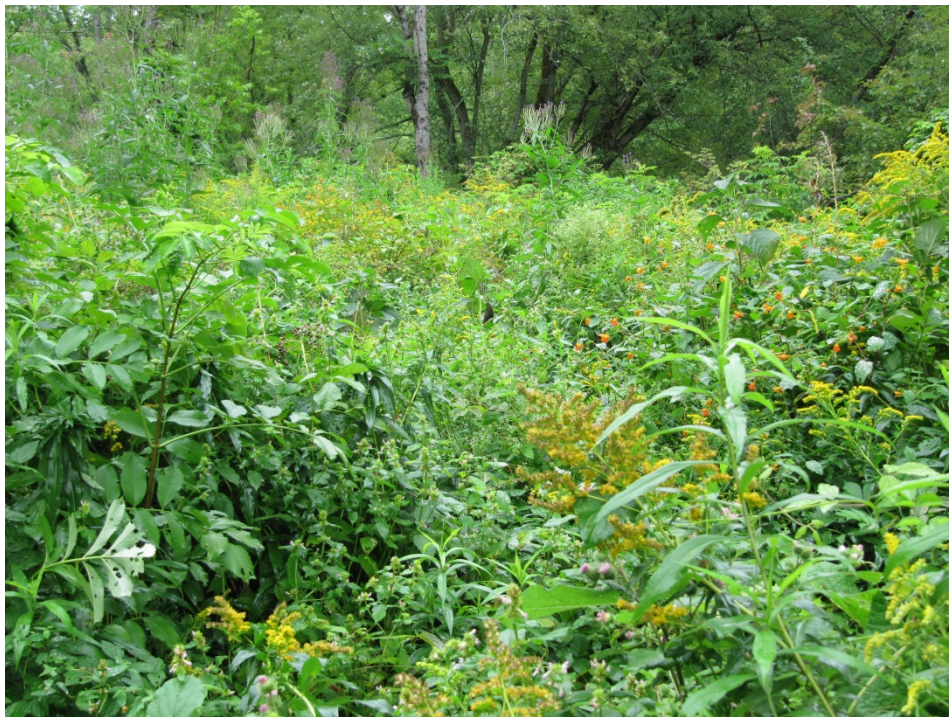
Figure 9. Vegetation of plot 2 in third year, with undisturbed floodplain forest in background. Present are black elderberry, brittle-stemmed hemp-nettle (non-native), Virginia virgin's-bower, smooth goldenrod, spotted touch-me-not, rough bedstraw, wood-nettle and blue vervain.
