Maidstone Slide – STP 0271 (20)

Year 4 Report

**Wetland and Invasive Species Monitoring
and Control Recommendations**

December 16, 2016

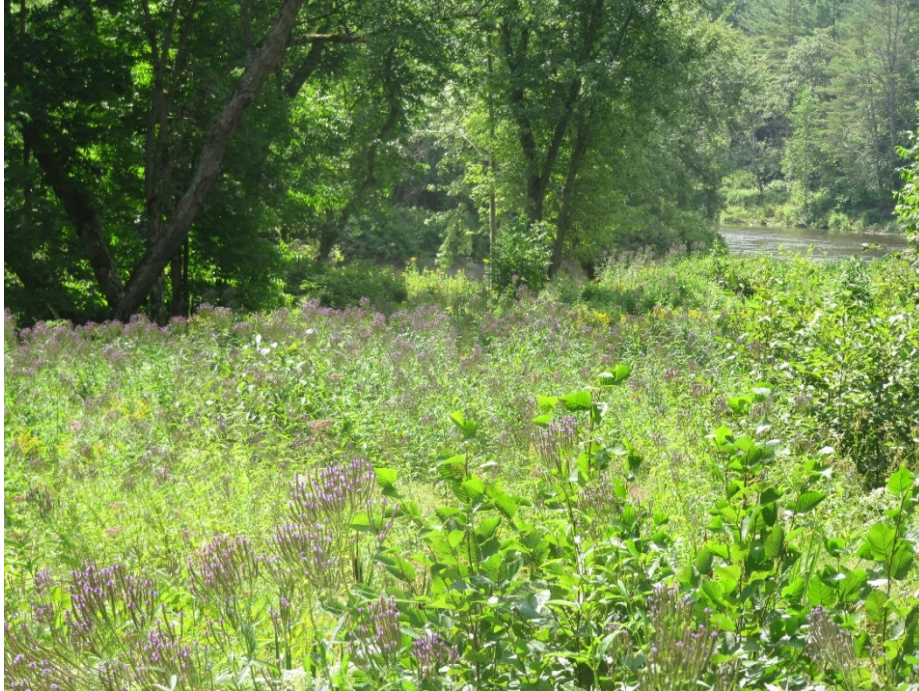
Figure 4. Overview with wetter area (Plot 1) in foreground and drier area (Plot 2) in background. Tree line shows general condition of the whole site prior to clearing of the floodplain forest. Prominent plants in flower are blue vervain and smooth goldenrod; speckled alder is shown sprouting at the edge of the restored area.

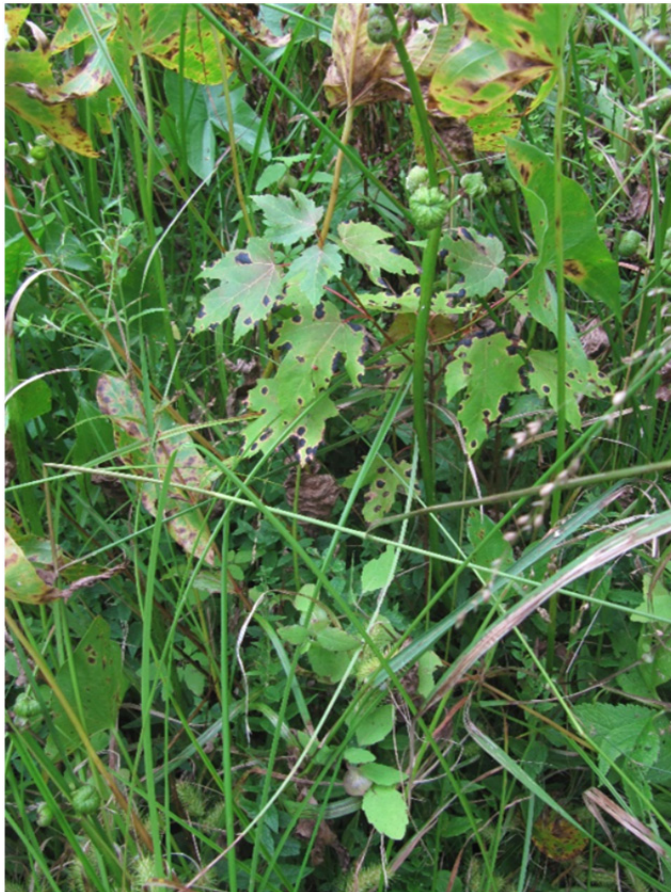
Figure 5. Vegetation of Plot 1 in fourth year of restoration. Several-year-old silver maple seedling, with common arrowhead, sedge leaves and small spotted touch-me-not.

Silver maple the dominant tree in the forest, has re-seeded into the wetter restoration area every year. Seedling numbers have varied in Plot 1 from a single individual in Year 2 to seven seedlings in Year 4, but there is no assurance or confidence that the one- or two-year-old regeneration will survive. Mortality among

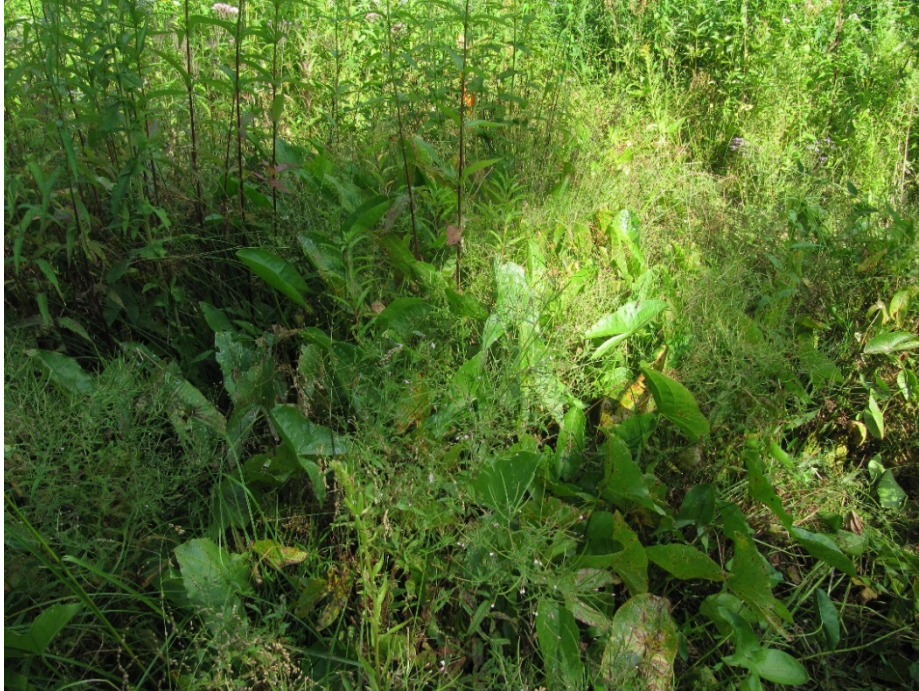
Figure 6. Vegetation of Plot 1 fourth year of restoration, showing dominant plant cover of common arrowhead and fringed willow-herb in the foreground, with tall stems of blue vervain in upper left.

Vegetation of the wetter, northern section has undergone a noticeable transition through the four years since restoration began, although common arrowhead (*Sagittaria latifolia*) has consistently been a dominant or co-dominant species since the second year (Table 1). Growth the first two years was dominated by sedge (especially *Carex vulpinoidea*), rush (*Juncus pylaei*) and, by Year 2, also arrowhead. In Year 3 blue vervain (*Verbena hastata*) and spotted touch-me-not (*Impatiens capensis*) were prominent above a lush growth of several sedges, with common arrowhead (*Sagittaria latifolia*) dominating the lowest wet spots. Year 4 vegetation saw a decrease in touch-me-not, with those present mostly much smaller and lower than the prominent blue vervain, arrowhead and fringed willow-herb (*Epilobium ciliatum*).

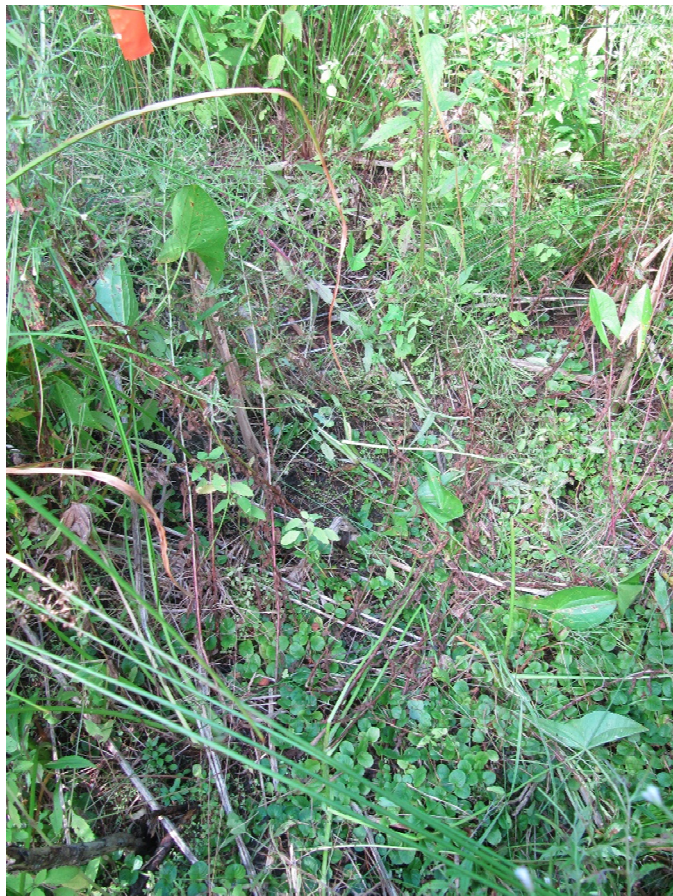
Figure 7. Vegetation of Plot 1 fourth year of restoration. Photo shows old tire rut now vegetated with creeping yellow-loosestrife, a variety of sedges, common arrowhead, and small spotted touch-me-not.

The non-native herbaceous plant creeping yellow-loosestrife (*Lysimachia nummularia*) is on the New Hampshire Invasive Species Committee's watch list.⁵ In Year 4, moneywort increased dramatically in the wettest part of the restoration, rising from 1% to 70% cover. Although it is well established, one does not notice the plant without looking purposefully at the ground among the stems of the much taller, robust wetland herbs that dominate the middle and upper sections of the herbaceous plant canopy. Moneywort has not been similarly successful in spreading through the drier part of the restoration, where the creeping herb continues to hover around 1% cover. The dense carpet in the wetter zone is not uncommon in seasonally inundated wetland types in our region. It will be of interest to see if the increase in moneywort appears to impact abundance of other plant species, but without targeted research on that question, it will not be possible to tease apart the effects of moneywort from other influences on vegetation change.

The non-invasive alien creeping yellow-loosestrife in Year 4 substantially increased cover in a limited section of the wetter part of the restoration. The Forest Service literature review of creeping yellow-loosestrife states that although the plant can occasionally become dominant in plant communities, it is generally thought to have only a moderate impact on native vegetation.⁷ The Forest Service document further states that control may be complicated by the plants ability to sprout from stems and possibly roots following treatment, and suggests control effectiveness most likely must rely upon multiple measures, such as herbicides, prescribed fire, seeding and other methods that decrease creeping yellow-loosestrife spread and favor native species. In short, control is a complex task and perhaps is often ineffective.

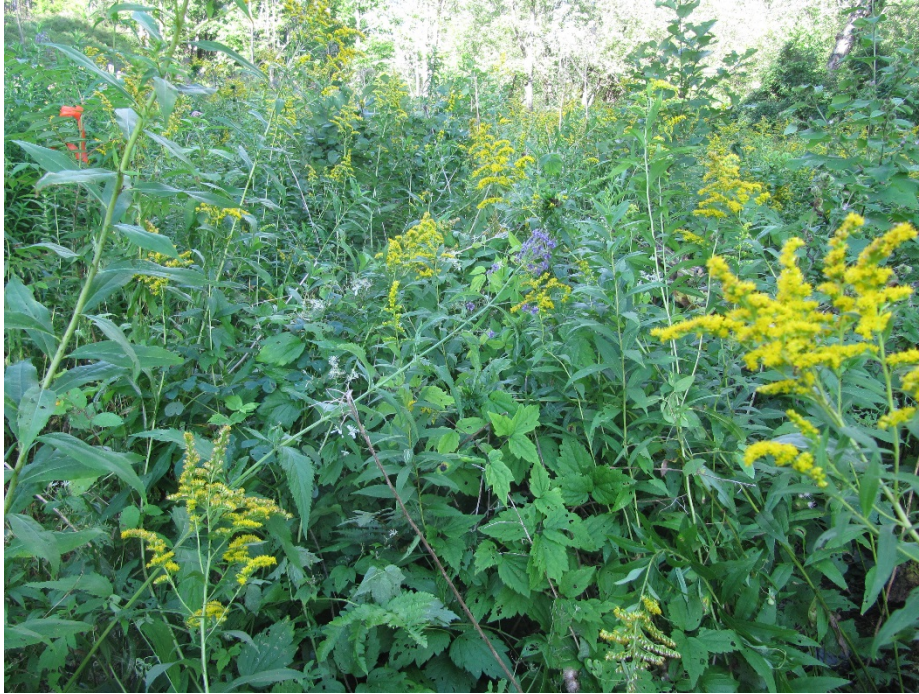
Figure 8. Vegetation of Plot 2 in fourth year of restoration. Smooth goldenrod is the dominant plant; also showing are Virginia virgin's-bower, blue vervain, crested wood fern and tall meadow-rue.

The drier restored area has consistently featured smooth goldenrod (*Solidago gigantea*) as a dominant species (Table 2). Co-dominant Year 1 was the rather weedy, non-native brittle-stemmed hemp-nettle (*Galeopsis tetrahit*), which declined substantially after that first year. Eastern riverbank wild-rye (*Elymus riparius*) joined smooth goldenrod as a prominent species in Years 2 and 3, but that species, although strongly present, now looks to be declining somewhat with spotted touch-me-not and Virginia virgin's-bower (*Clematis virginiana*) having increased. Purple-stemmed American-aster (*Symphyotrichum puniceum*) is prominent also in parts of the drier restoration zone. The shrub black elderberry (*Sambucus nigra*) has consistently been present in the drier area, although due to the Year 4 drier plot being offset a couple of

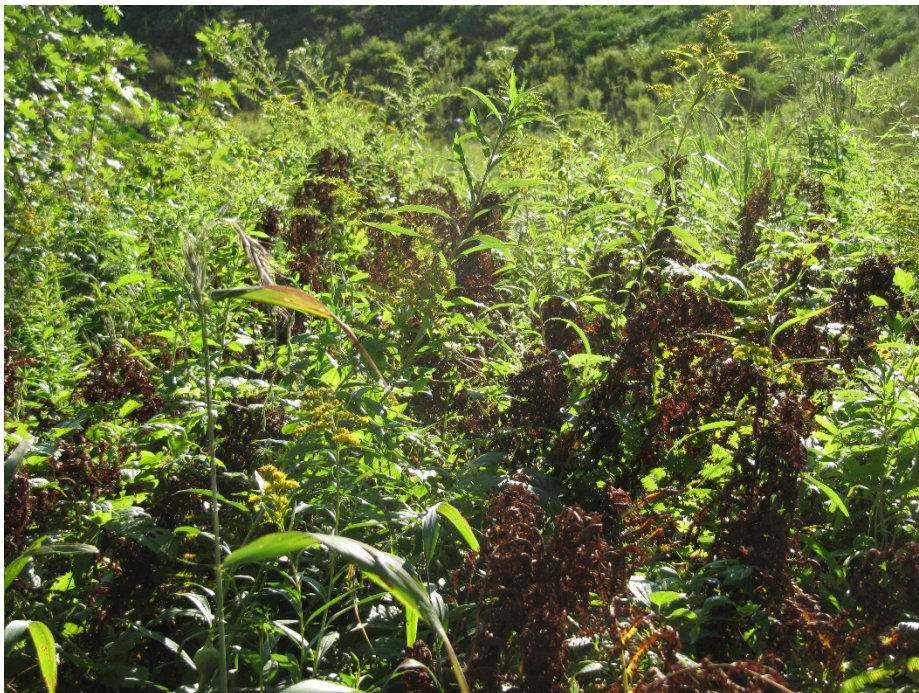
Figure 9. Wiegand's wild rye and ostrich fern at edge of disturbed area. Directly behind the grass and ferns is engineered slope with smooth goldenrod, blue vervain and reed canary grass.

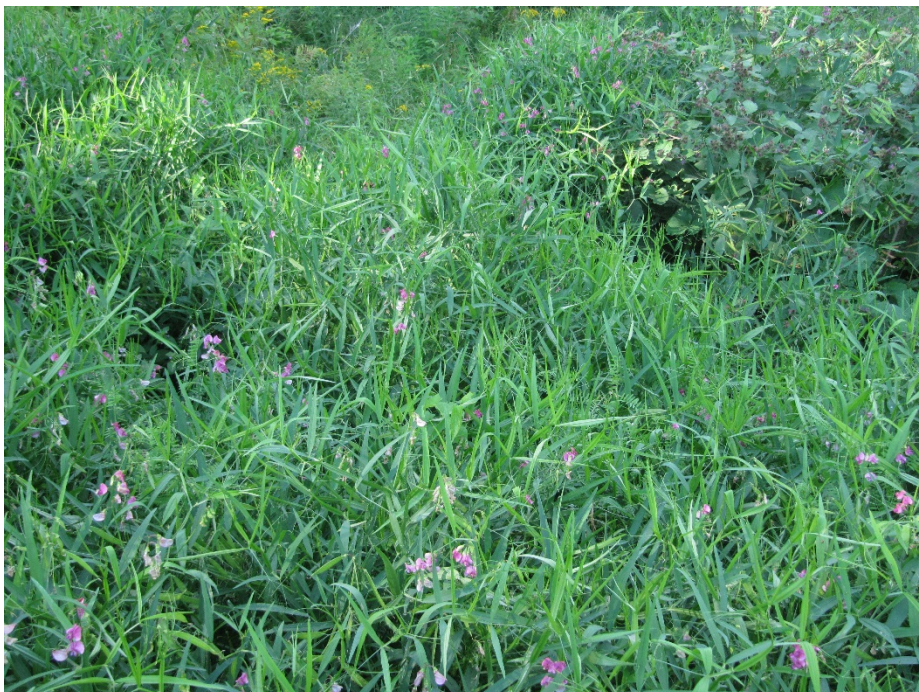
Figure 11. Engineered area between Plot 2 and the river. Everlasting vetchling and reed canary grass co-dominate a portion of this area.

New in Year 4 was a dense growth of everlasting vetchling (*Lathyrus latifolius*) on the engineered slope between the restored portion of the roadway and the river. The vetchling was not an intended component of any of the seed mixes—neither of the custom mixes (wetland and upland) developed for this project nor the VTRANS Rural Areas Conservation Mix which was used on the slope stabilization areas adjacent to the restoration. The species was present at low levels on the stabilized slope between the drier part of the restoration and the river since the initial year post-construction, but it underwent a large coverage expansion in Year 4. Everlasting vetchling was co-dominant with reed canary grass on that portion of stabilized slope; these two non-native species have the potential to spread into the wetland restoration. We will document their status in Year 5 sampling.

The wetland buffer engineered slope that extends south of the restored roadway to the river’s edge continued to be well stabilized by the now-decaying coir matting and dense herbaceous vegetation. Plant dominants in the area between the river and the restoration were two non-natives—reed canary grass and everlasting vetchling (*Lathyrus latifolius*)—along with smooth goldenrod and blue vervain. The vegetation of this part of the project area has changed dramatically over the four years and is now dominated by neither plants from the upland seed mix nor the volunteer “weeds” of the earlier years, (i.e., brittle-stemmed hemp-nettle, common agrimony and curly dock). Interesting to note, the *New Flora of Vermont*⁸ does not show everlasting vetchling as having been collected in Essex County, and the New England Wild Flower Society’s on-line flora of New England⁹ does not show it from Coos County in New Hampshire. This does not indicate that the non-native vine of disturbed areas has not been present in those counties, only that it has not been collected. It does suggest that it is not widespread in these two northernmost counties.
