General Investigation Feasibility Report and Environmental  
Assessment

# SOMERSET & SEARSBURG DAMS

## (Deerfield River Watershed Study)

**GREEN RIVER FISH PASSAGE  
GREENFIELD, MASSACHUSETTS  
CORPS OF ENGINEERS, NEW ENGLAND DISTRICT**

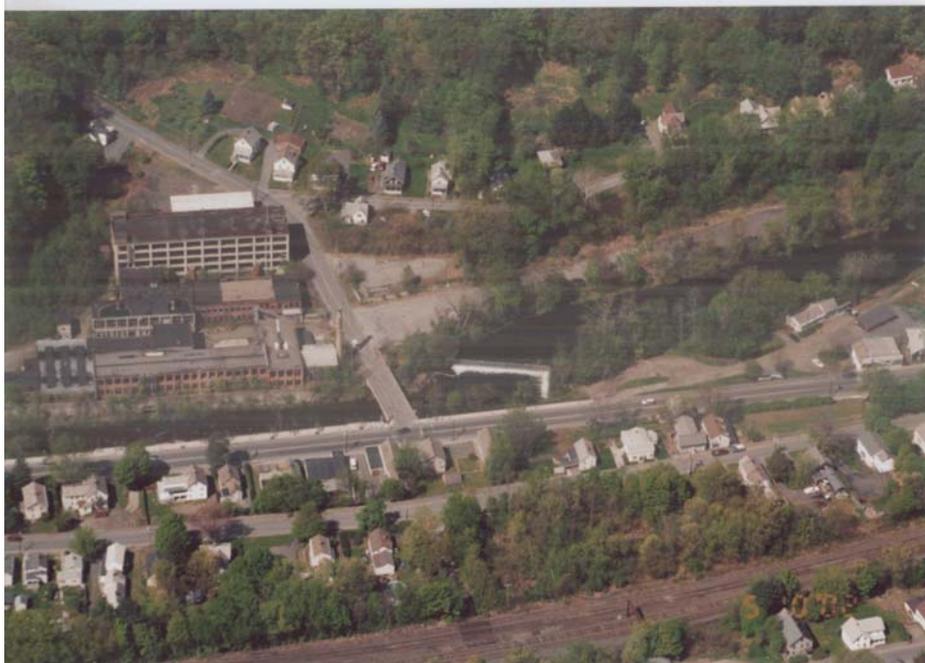
**Photo 1: The Wiley & Russell Dam is located just upstream of the Meridian Street Bridge.**

This is the first dam in the series of four dams along the Green River, located 1.2 miles above the confluence with the Deerfield River. It is a run of the river timber crib dam and concrete spillway 10 to 14 feet in height and about 185 feet in length. The dam is founded on bedrock and consists of an open timber crib with a vertical downstream face. The crib is covered on the top with a thin concrete cap and has a thin inclined concrete upstream face extending into the sediments impounded behind the dam. The structure has concrete and stone masonry abutments with abandoned outlet structures on both abutments. The two low-level outlet structures have deteriorated significantly and are inoperable, and the entire dam has fallen into considerable disrepair. The dam was constructed in 1936 for water supply for the Greenfield Tap & Die Company adjacent to the site. The Town of Greenfield currently owns the dam and was issued orders by the Massachusetts Department of Environmental Management (DEM, now known as the Department of Conservation and Recreation, DCR) that required the dam to be repaired by October 1999. The required repairs have not been performed to date. The Town has plans to revitalize the neighboring community and may have reservations about removal of the dam as it provides an aesthetically pleasing reflecting pool and has historical significance to some people. Removal or passage would provide access to 0.3 miles of habitat within the Green River.

The DEM Office of Dam Safety Inspection and Evaluation Report, dated June 18, 1998, lists the dam (ID no. 2-6-114-3) as “Small Size”, having a “Significant Hazard” classification, and being in generally poor condition. The report documents significant deficiencies in the condition of the dam and recommends detailed engineering investigations into the stability and adequacy of the dam as well as extensive remedial work. Specific deficiencies included: no corrective actions taken on previously identified deficiencies from a 1993 inspection; major cracking in the abutments; extensive tree and brush growth; spalling and severely decayed concrete; stones missing from masonry abutment walls; sinkholes along right abutment wall; trash racks and sluice gates no longer intact; and controls inoperable. Recommended investigations included: detailed hydraulic/hydrologic assessment to determine adequacy of the spillway; structural stability analysis of the masonry abutments and the timber crib and concrete spillway structures; investigation into the outlet structures integrity and seepage potential; and development of a written operations and maintenance plan.

The Corps performed an initial visual inspection on September 5, 2001 with regard to the possible installation of a fish passage. This confirmed the reported deficiencies and recommendations of the 1998 DEM report. The dam’s spillway, abutment walls, and outlet structures have not undergone any visible maintenance activities and have continued to deteriorate. The dam is considered to be in a very poor to unsafe condition. Extensive remedial, replacement, or removal actions are required to bring the dam and associated structures into a safe operating condition. Considerable deterioration and decay has occurred to the concrete

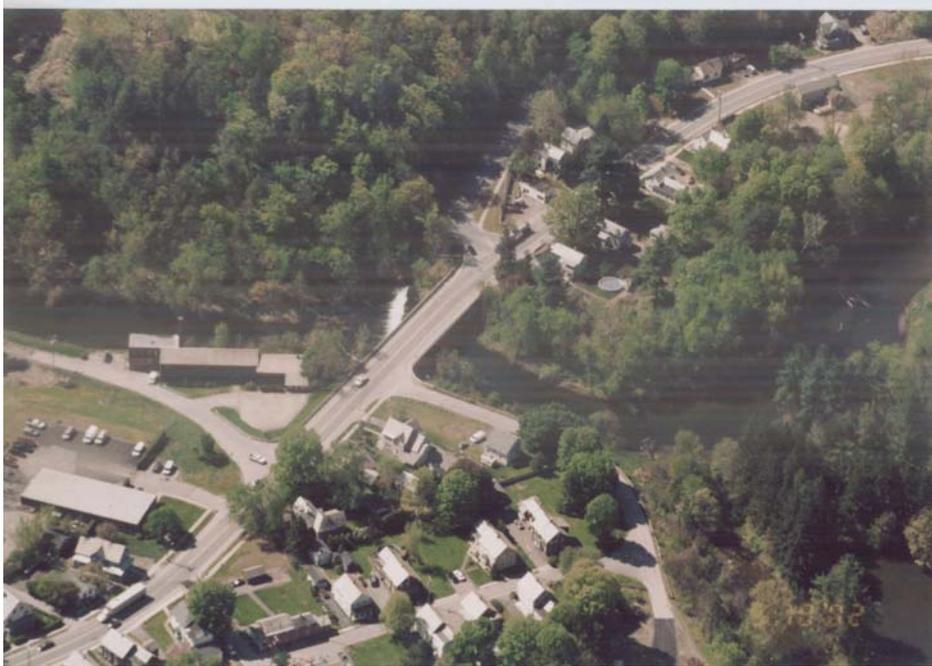
**Photo 2: The Mill Street Dam is partly beneath the Mill Street Bridge.**

This is the second dam on the Green River, located about 1.5 miles above the confluence with the Deerfield River. It is a run of the river concrete gravity dam about 12 feet in height and about 170 feet in length. The dam was originally owned and used by Greenfield Electric Light and Power, but is currently owned by the town of Greenfield. The adjacent Mill Street Bridge was reconstructed in 1981 and spans directly over the dam. The bridge's new left abutment was

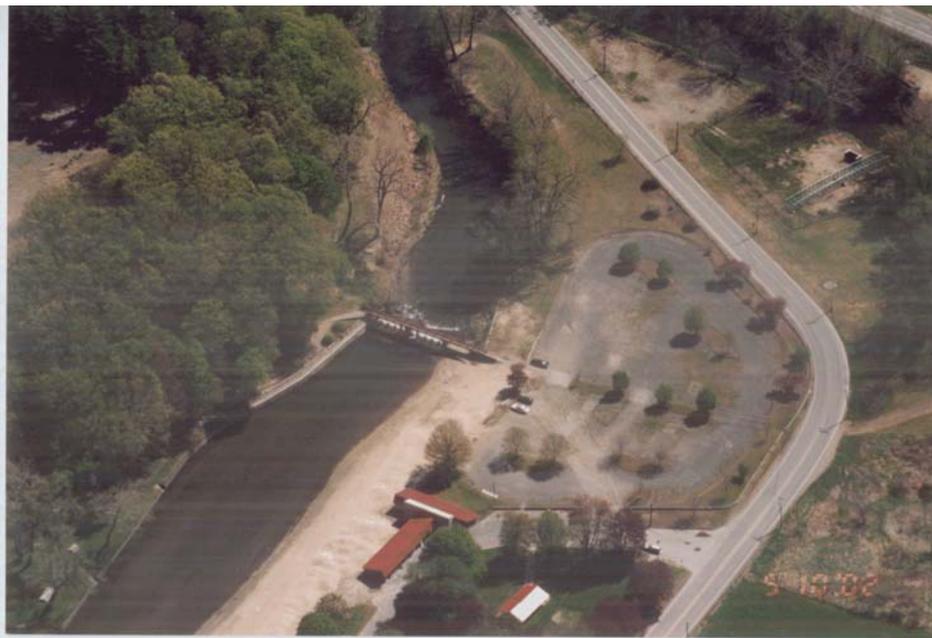
**Photo 3: The Swimming Pool Dam is located at the town park off Nash's Mill Road.**

This is the third dam on the Green River, located about 3.7 miles above the confluence with the Deerfield River. It is a run of the river concrete dam about 2 feet in height and about 75 feet in length, located adjacent to a public beach. The dam is currently owned and used currently by Greenfield for recreation purposes. An initial site inspection was performed on September 5, 2001 with regard to the possible installation of a fish passage. The dam is founded directly on bedrock and appears to be in very good condition. The dam consists of a low concrete sill extending across the river with concrete piers extending above the river bottom. During summer months, slide gates are placed between the piers to impound a small pool for recreation and swimming. Modifications for fish passage would provide access to 4.6 miles of additional habitat along the Green River.

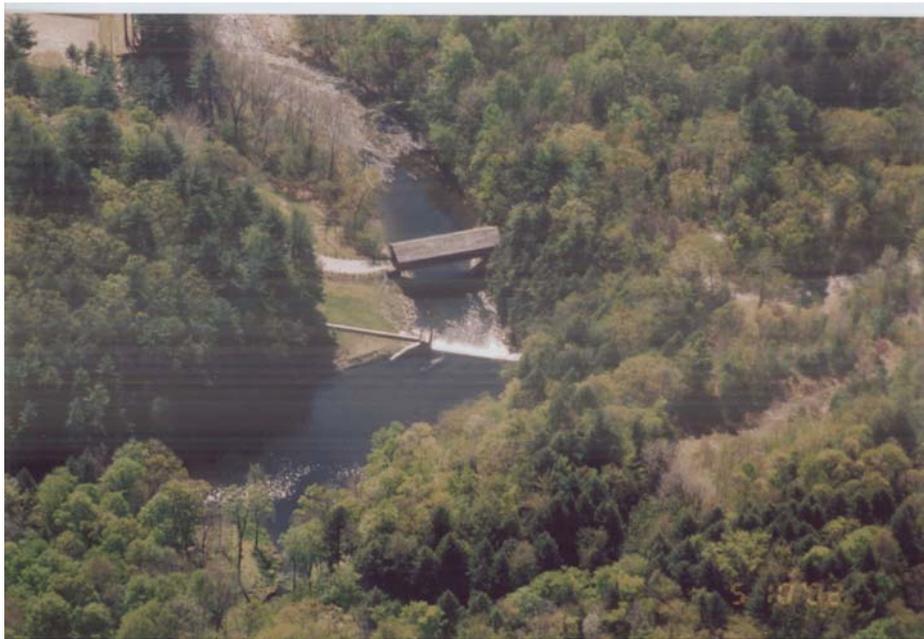
Photo 4: The Pumping Station Dam is located just upstream of the covered bridge on Eunice Williams Drive.

This is the fourth dam on the Green River, located about 8.3 miles above the confluence with the Deerfield River. It is a run of the river concrete gravity dam about 17 feet in height and about 95 feet in length. The dam is owned and currently used by Greenfield for water supply. The Corps performed an initial site inspection on September 5, 2001 with regard to the possible installation of a fish passage. The dam is founded directly on bedrock and appears to be in very good condition. It consists of a concrete overflow spillway across the main river channel, a concrete outlet works structure at the left edge of the river, and a low embankment and concrete wall extending to the left abutment. A modification to provide fish passage would open 12 miles of additional habitat along the Green River.

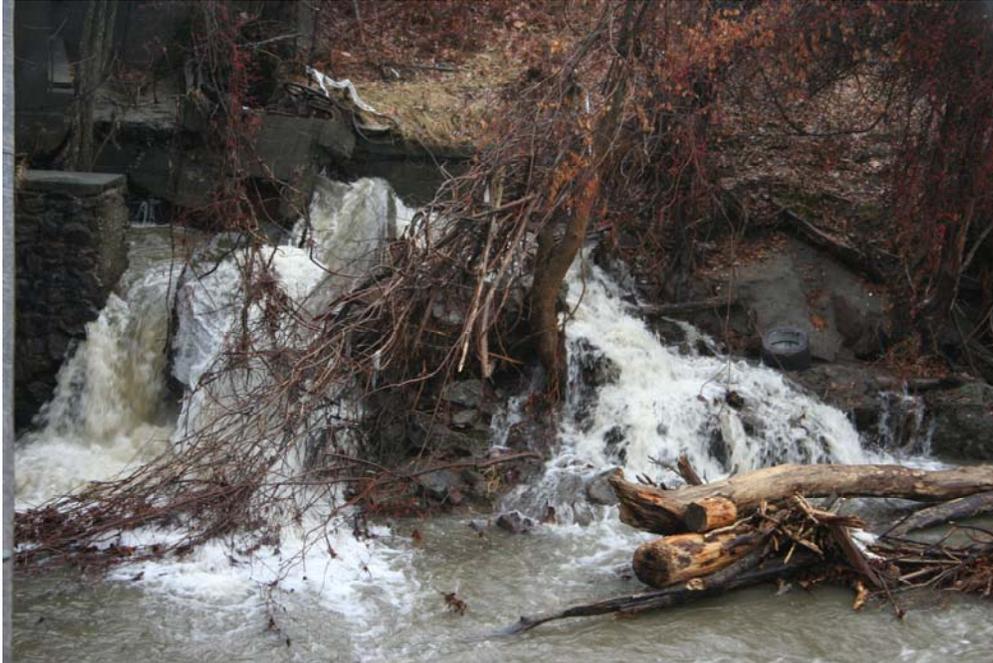
**Photo 5: Water pours through a failed sluiceway fed by the Wiley & Russell Dam impoundment. This location is immediately upstream of the Meridian Street Bridge.**

If no project is implemented, the Wiley & Russell Dam will remain as an impediment to upstream fish passage. The dam is in poor condition, especially its right abutment. It is anticipated that the State Office of Dam Safety will require the town of Greenfield to perform repairs. Major structural repairs as well as repairs to its gate structure and controls should be performed. It is also possible that the dam could fail as a consequence of the cumulative effects of high water events and deferred maintenance. In 2005, the sluiceway on the right bank of the river blew out downstream of the dam, creating a condition of greater uncertainty (see Photo 6).

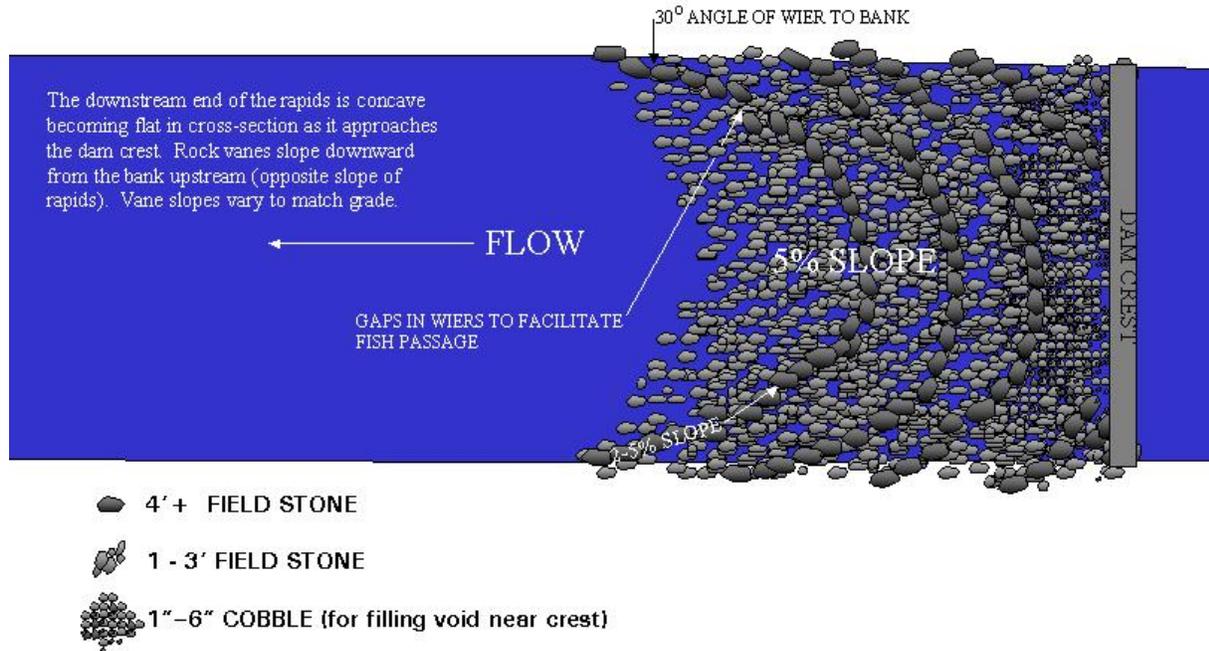
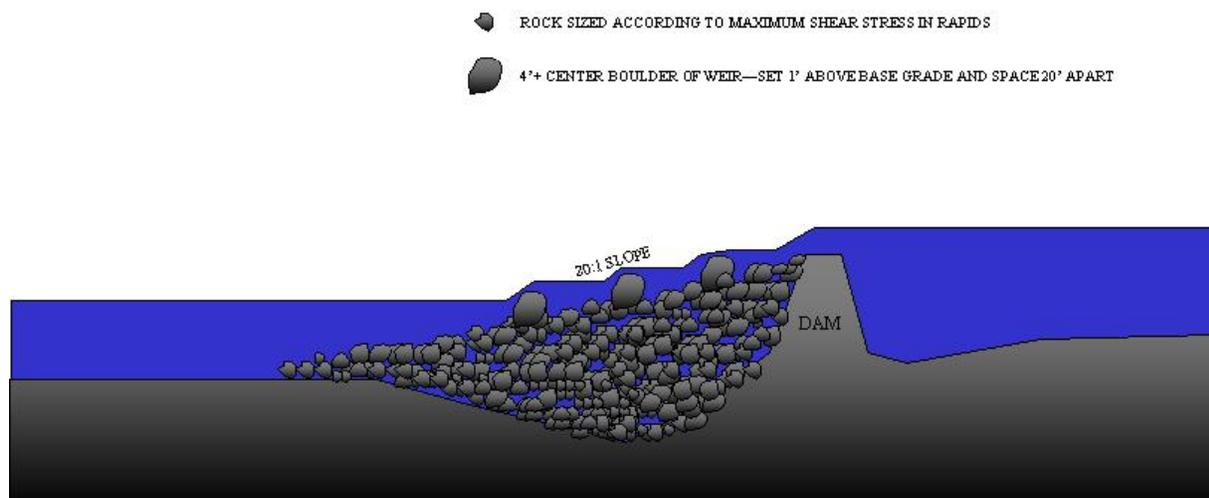
ROCK ARCH RAPIDS LONGITUDINAL PROFILE

Figure 1 : Plan & Profile of typical Rock Ramp Fishway design;  
Substructure cell walls not shown

A rock ramp fishway is a specially engineered arrangement of boulders and cobbles that creates step pools with flow patterns sized to allow fish to climb gradually upwards from its toe to its crest and over a dam or other obstacle fronted by the rock ramp (see Figure 1 and Plates 20 and 22). In general, a concrete substructure of stepped cells with gravel fill are constructed in front of the dam at a 20 to 1 slope decreasing from the dam crest to the river invert. The substructure serves to buttress the dam and support the rocks that comprise the face of the ramp. Rows of boulders are arranged in a chevron pattern, angled downstream, where the largest boulders are placed near the river's banks and the remaining boulders in each row become progressively smaller until the river channel centerline is reached. This focuses the low flows to the center of the channel as they go down the rock ramp and gradually spreads higher flows so that there is always a location on the rock ramp where fish can climb successfully.

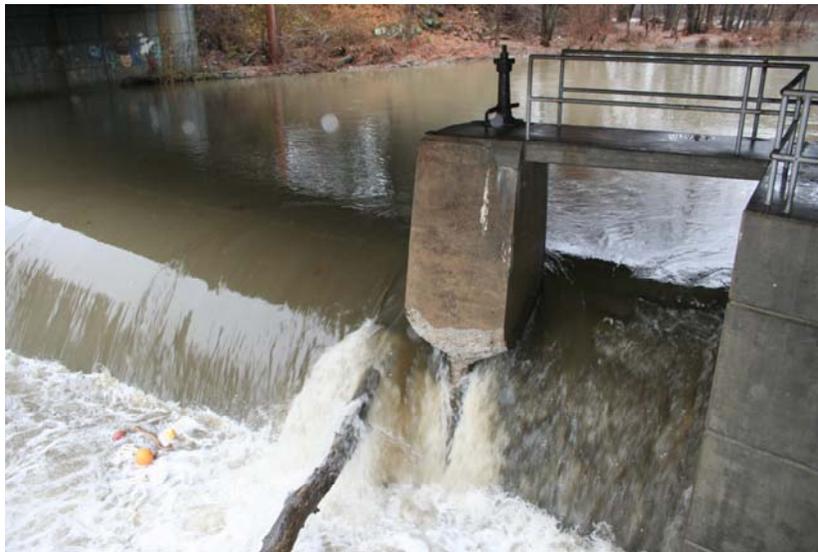
**Photo 6: Deteriorated Gate Control at Mill Street Dam**

If no project is implemented then the dam will remain as an impediment to upstream fish passage. Repairs to its gate structure and controls should be performed (See photo 6.)

A fish ladder would allow fish to pass upstream of the dam. The USFWS prepared a conceptual fish ladder and fish passage facility design for the Mill Street Dam (see Plates 14, 15, and 16). The fish ladder design would optimize the passage of some, but not all species. In conjunction with similar fish passage structures at the Swimming Pool and Pumping Station Dams, a fish ladder at Mill Street Dam would provide access to excellent spawning habitat upstream. Overall, the dam's concrete spillway appears to be in fair condition and the outlet works are in poor condition. The Town will need to repair the outlet gate structure prior to installation of a fish ladder.
