## **Site Inspection Report for Gould Island**

DERP FUDS Project Number: **D01RI033803**

**August 2009**

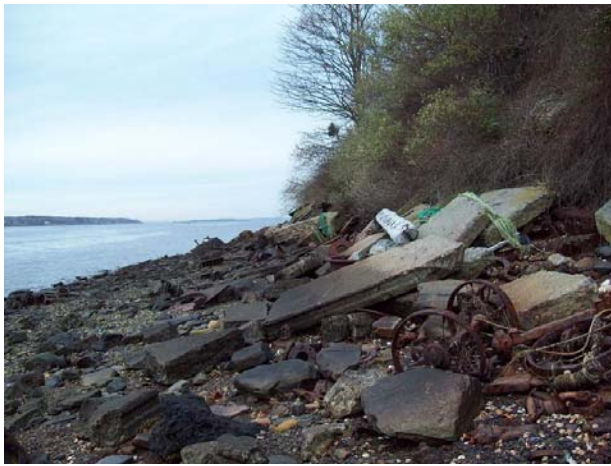
Photo E.3 –View looking north in MRS 1 (Disposal Area). Note: The beach area was cluttered with various metal debris, concrete, building materials and tar deposits.

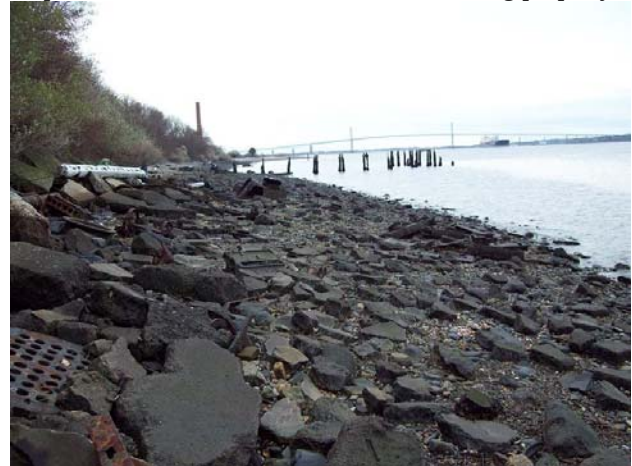
Photo E.4 – View looking south towards the small pier from MRS 1 (Disposal Area). Note: The beach area was cluttered with various metal debris, concrete, building materials and tar deposits.

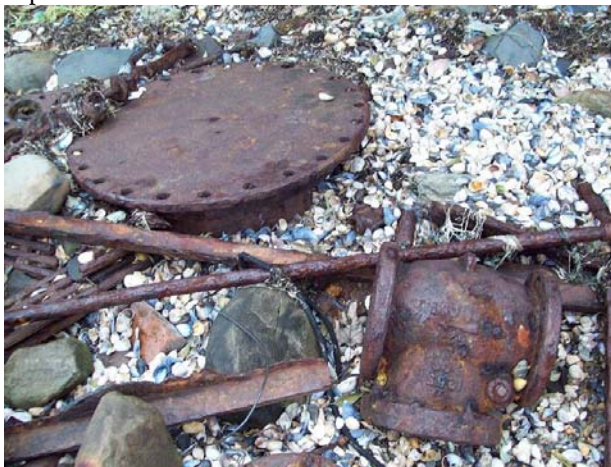
Photo E.5 – View of suspected area (based on review of photographs) where the aft torpedo propeller/shaft assembly was found during the ASR site visit. Note: the Field Team searched the entire MRS and no evidence of the torpedo was found.

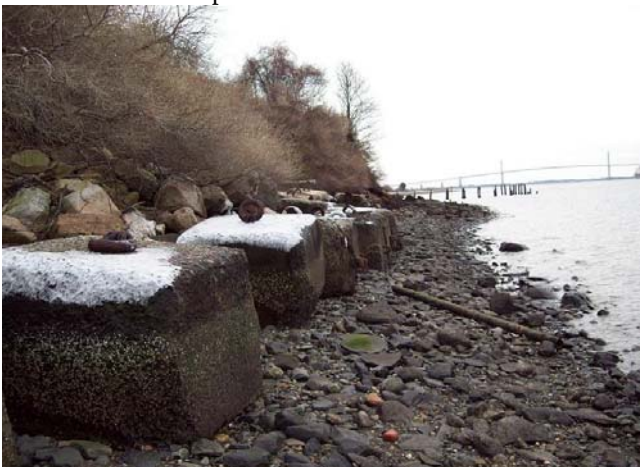
Photo E.6 –View of concrete blocks used for anchoring ships. Note: About 15 of these blocks were noted and spanned roughly 80 feet. The blocks measured approximately 6x6x4 feet in size.

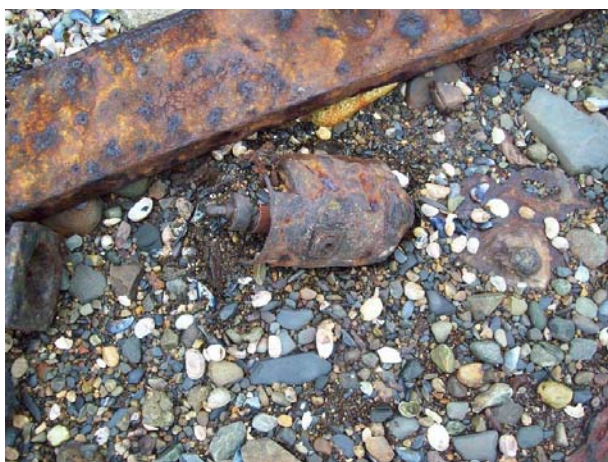
Photo E.7 – Unidentified motor part found in the beach area of the Disposal Area.

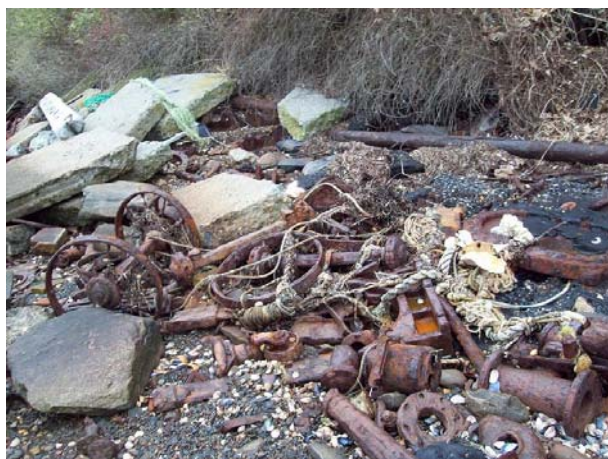
Photo E.8 – View of large debris pile in the tidal area of MRS1 (Disposal Area). Note: Black tar was covering a small portion of the pile which is visible on the right side of the photo.

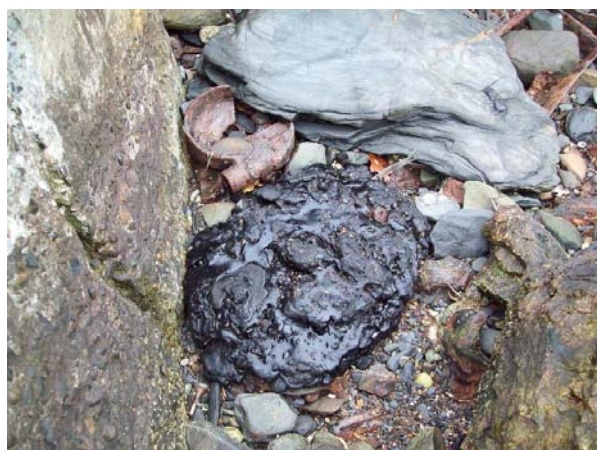
Photo E.9 – View of small pile of hardened tar found on the beach area of MRS 1(Disposal Area). Note: there were many of these small piles scattered throughout the MRS.

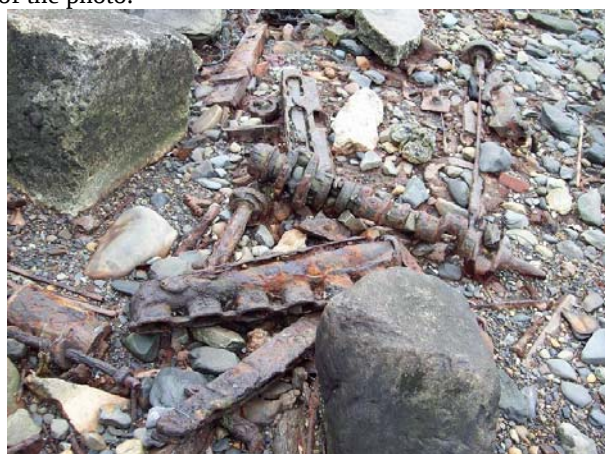
Photo E.10 – View of engine debris found within MRS 1 (Disposal Area) along the beach.

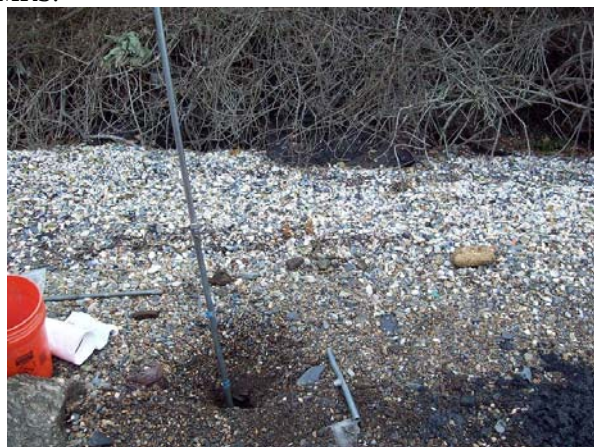
Photo E.11 – View of the proposed groundwater sample location. Note: After four attempts at auguring different locations, the groundwater sample was abandoned due to refusal from metal debris and cobble. The subsurface soil sample (GI-DA-SB-04-01) was collected in this location.

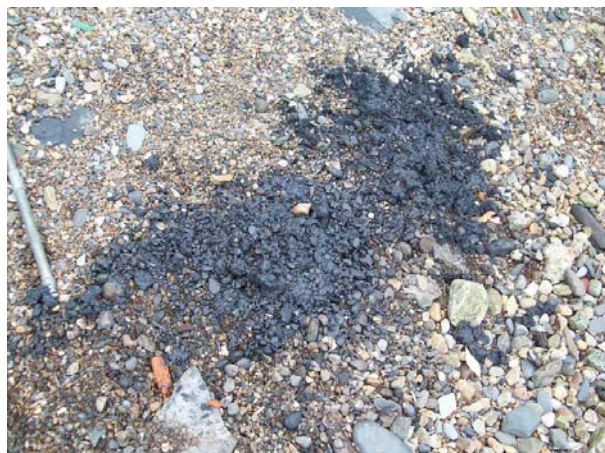
Photo E.12 – View of ground material from auguring for groundwater. Note: This material was rock and wet, greasy black material which had an odor of old fuel/oil. This material after being exposed to the air would gradually harden.

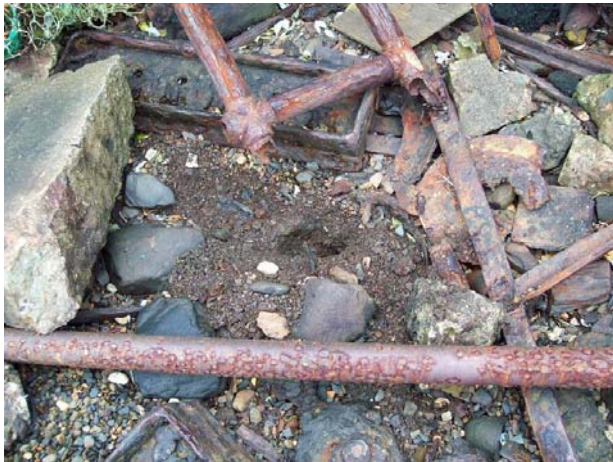
Photo E.13 – View of sediment sample location GI-DA-SD-02-01. Note: A field duplicate was also taken from this location.

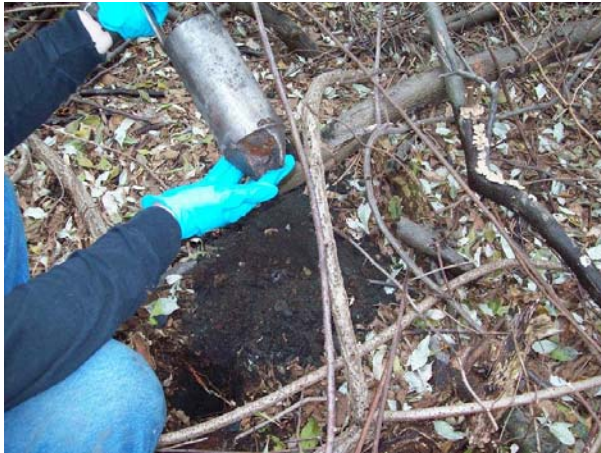
Photo E.15 – View of sample collection for surface soil sample GI-DA-SS-02-02. Note: groundcover typical of all samples in MRS 1(Disposal Area). Soil was dark in color and had traces of asphalt, rock, metal and rust.

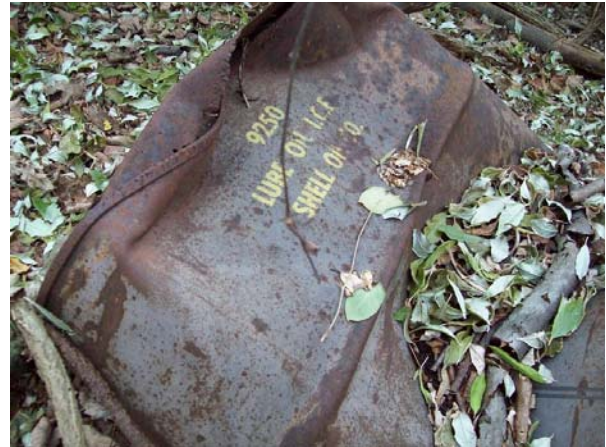
Photo E.16 – View of a crushed drum marked “lube oil” found on top of the hill above the beach within MRS 1 (Disposal Area).

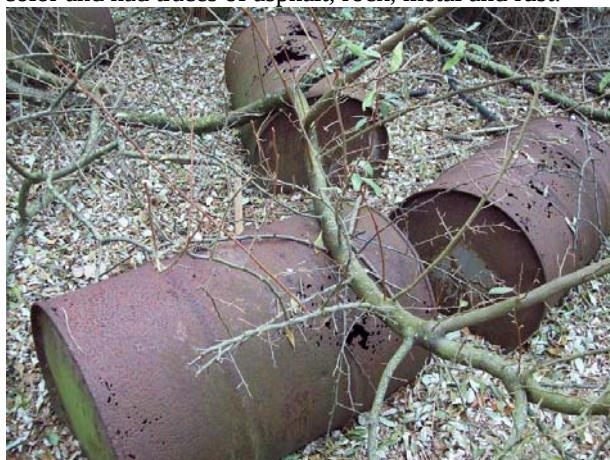
Photo E.17 – View of pile of drums located within MRS 1 (Disposal Area) in the same vicinity as those marked with “lube oil”. All drums were empty.

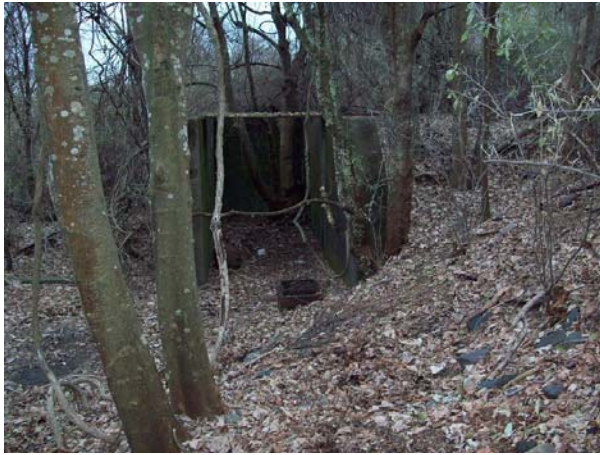
Photo E.19 – View of bunker located in the gun Mount Area (PAOI 3). The suspect southern gun mount is located right of the bunker.

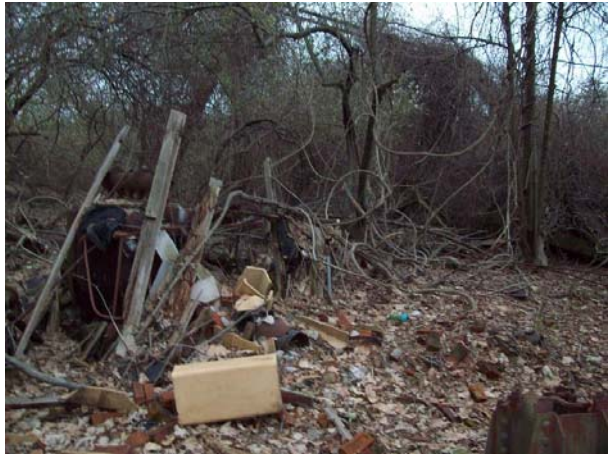
Photo E.20 – View of water tower area. The leg of the former water tower is in the lower right corner. The debris pile is suspected to be the former pump house building.

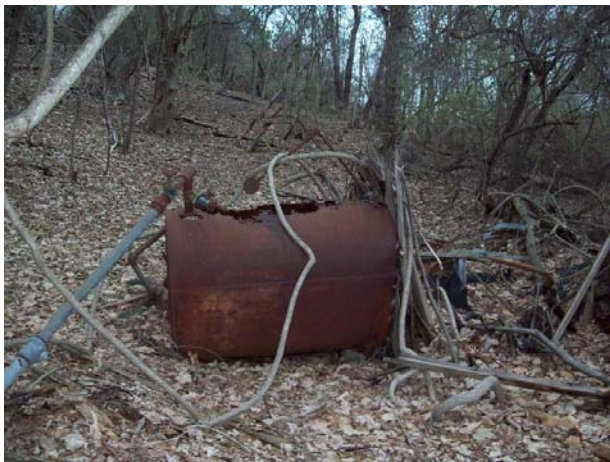
Photo E.21 – View of rusted out oil tank (empty) located within the area of the former water tower.

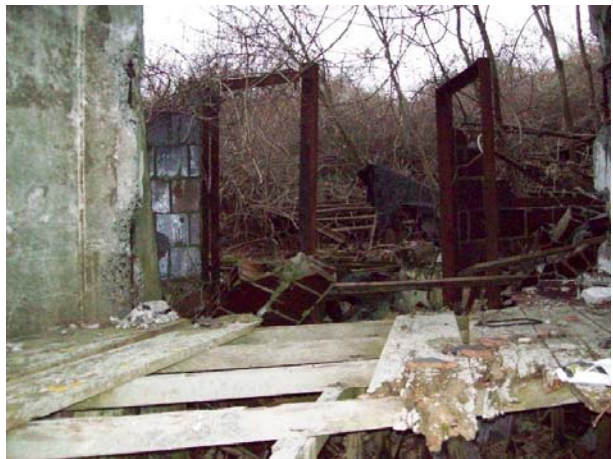
Photo E.22 – View looking into the former Bunker #12 in PAOI 1. Note: The bunker had completely collapsed and conditions were unsafe to enter.

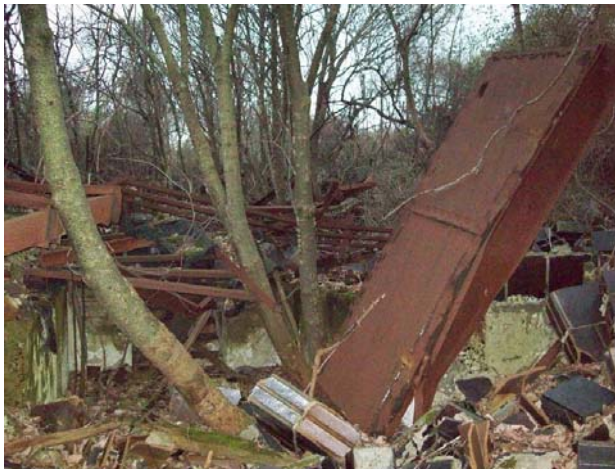
Photo E.23 – View of former Bunker 11 (now collapsed) in PAOI 1. Note: The bunker had completely collapsed and conditions were unsafe to enter.

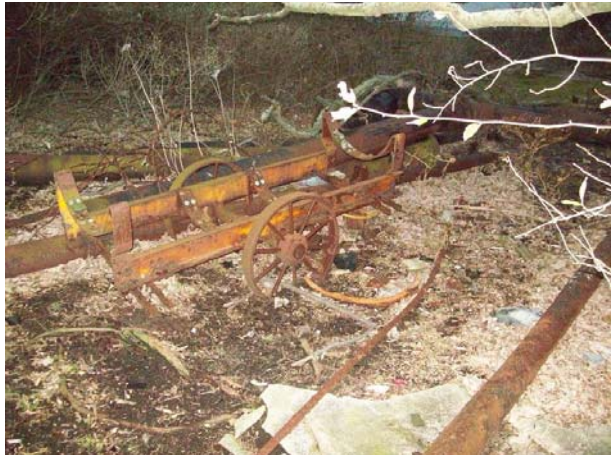
Photo E.26 – Torpedo cart observed by the Field Team near the former seaplane ramp on the southern end of Gould Island.

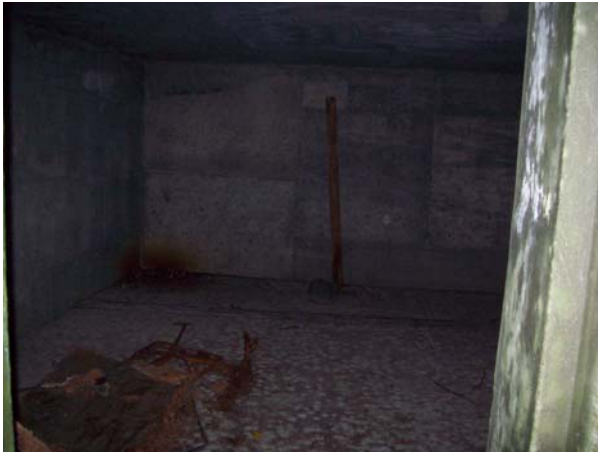
Photo E.27 – View of the aforementioned bunker in Photograph E-19 (PAOI 3). The floor at the entrance of the bunker was covered in leaves however the inside of the bunker had a bare concrete floor and there were no evidence of drains however cultural debris was noted on the floor.
