CHARLESTOWN NAVAL AUXILIARY LANDING FIELD, RHODE ISLAND

HISTORICAL ENVIRONMENTAL PHOTOGRAPHIC ANALYSIS

AUGUST 2018 FINAL REPORT

Prepared for the U.S. Army Corps of Engineers, New England District.

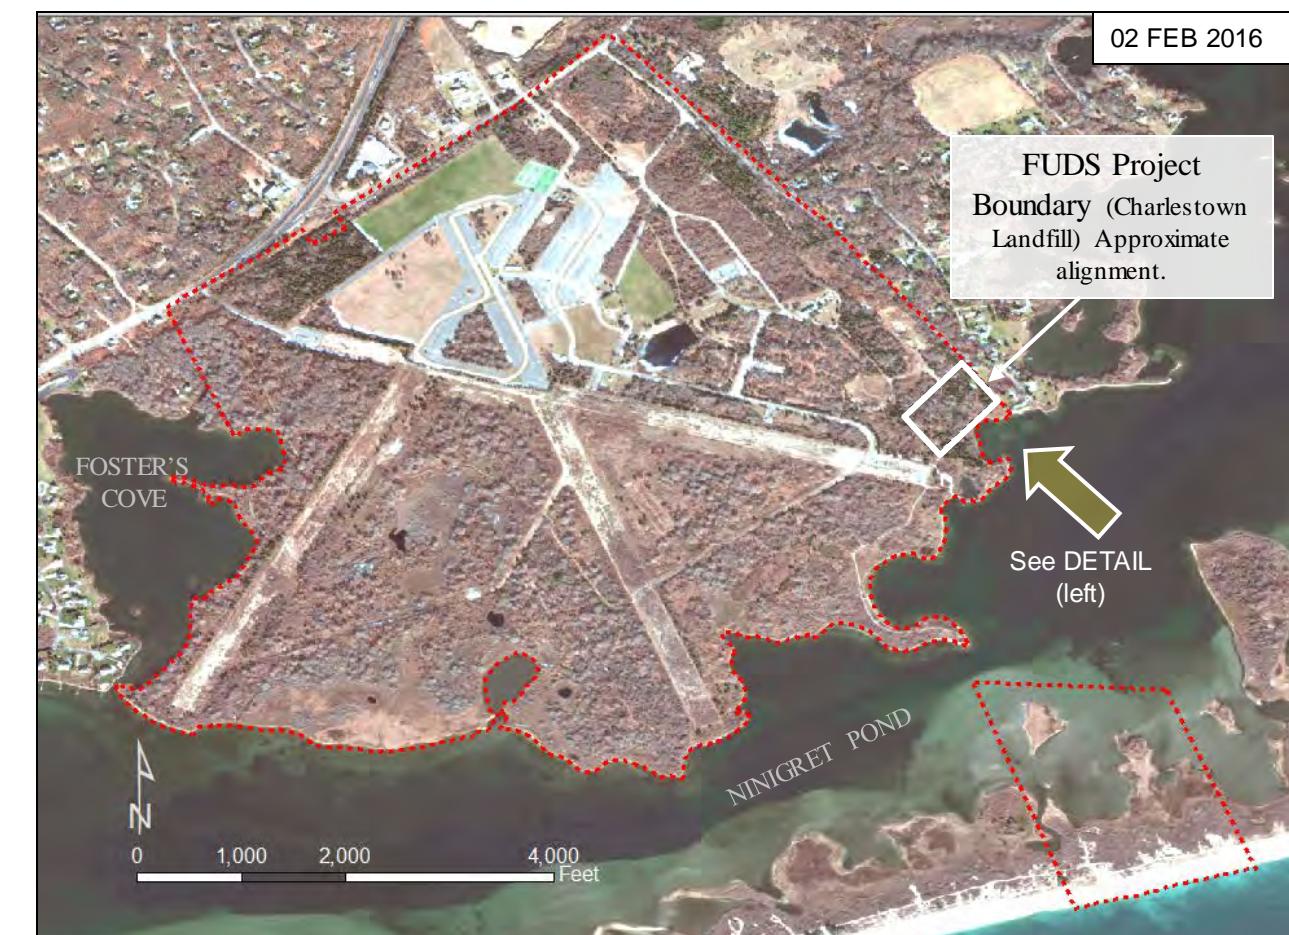
The former CNALF Dump Site also known as Charlestown Landfill is approximately four acres and located at the eastern end of the installation, currently used as local park and recreation area.

The Charlestown Landfill was utilized as a Navy trash dump from the 1940's until site closure in 1974. Historical photos of 1940s-1960s show visually prominent excavations in the area which was used for disposal and burial waste, military debris included airplane, vehicle parts, and inert practice bombs. In 1973 and 1977, the landfill was excavated in search of airplane parts by trustee of the Bradley Air Museum. There are unconfirmed reports of various airplane parts and oily water having been found during the excavation. No visual evidence of OE was found after an extensive search of this area.¹

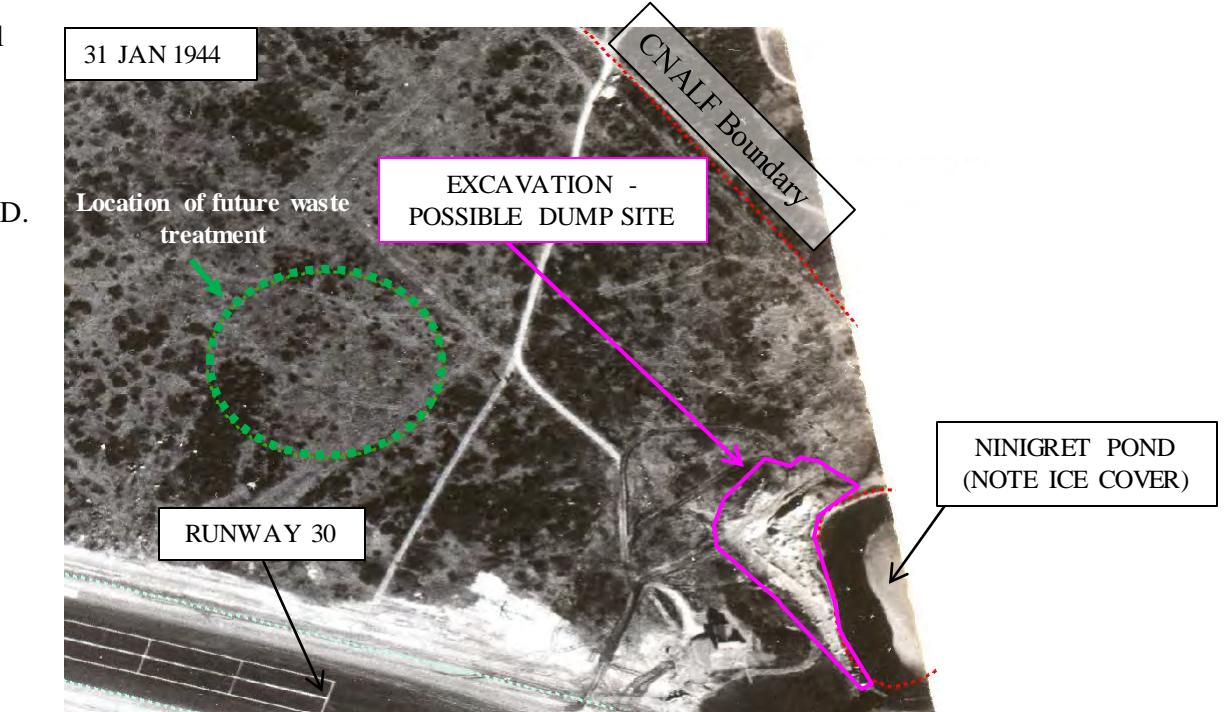
A new excavated area along with mounded soil (possibly a dump site) is observed along Ninigret Pond (Image source = NARA).

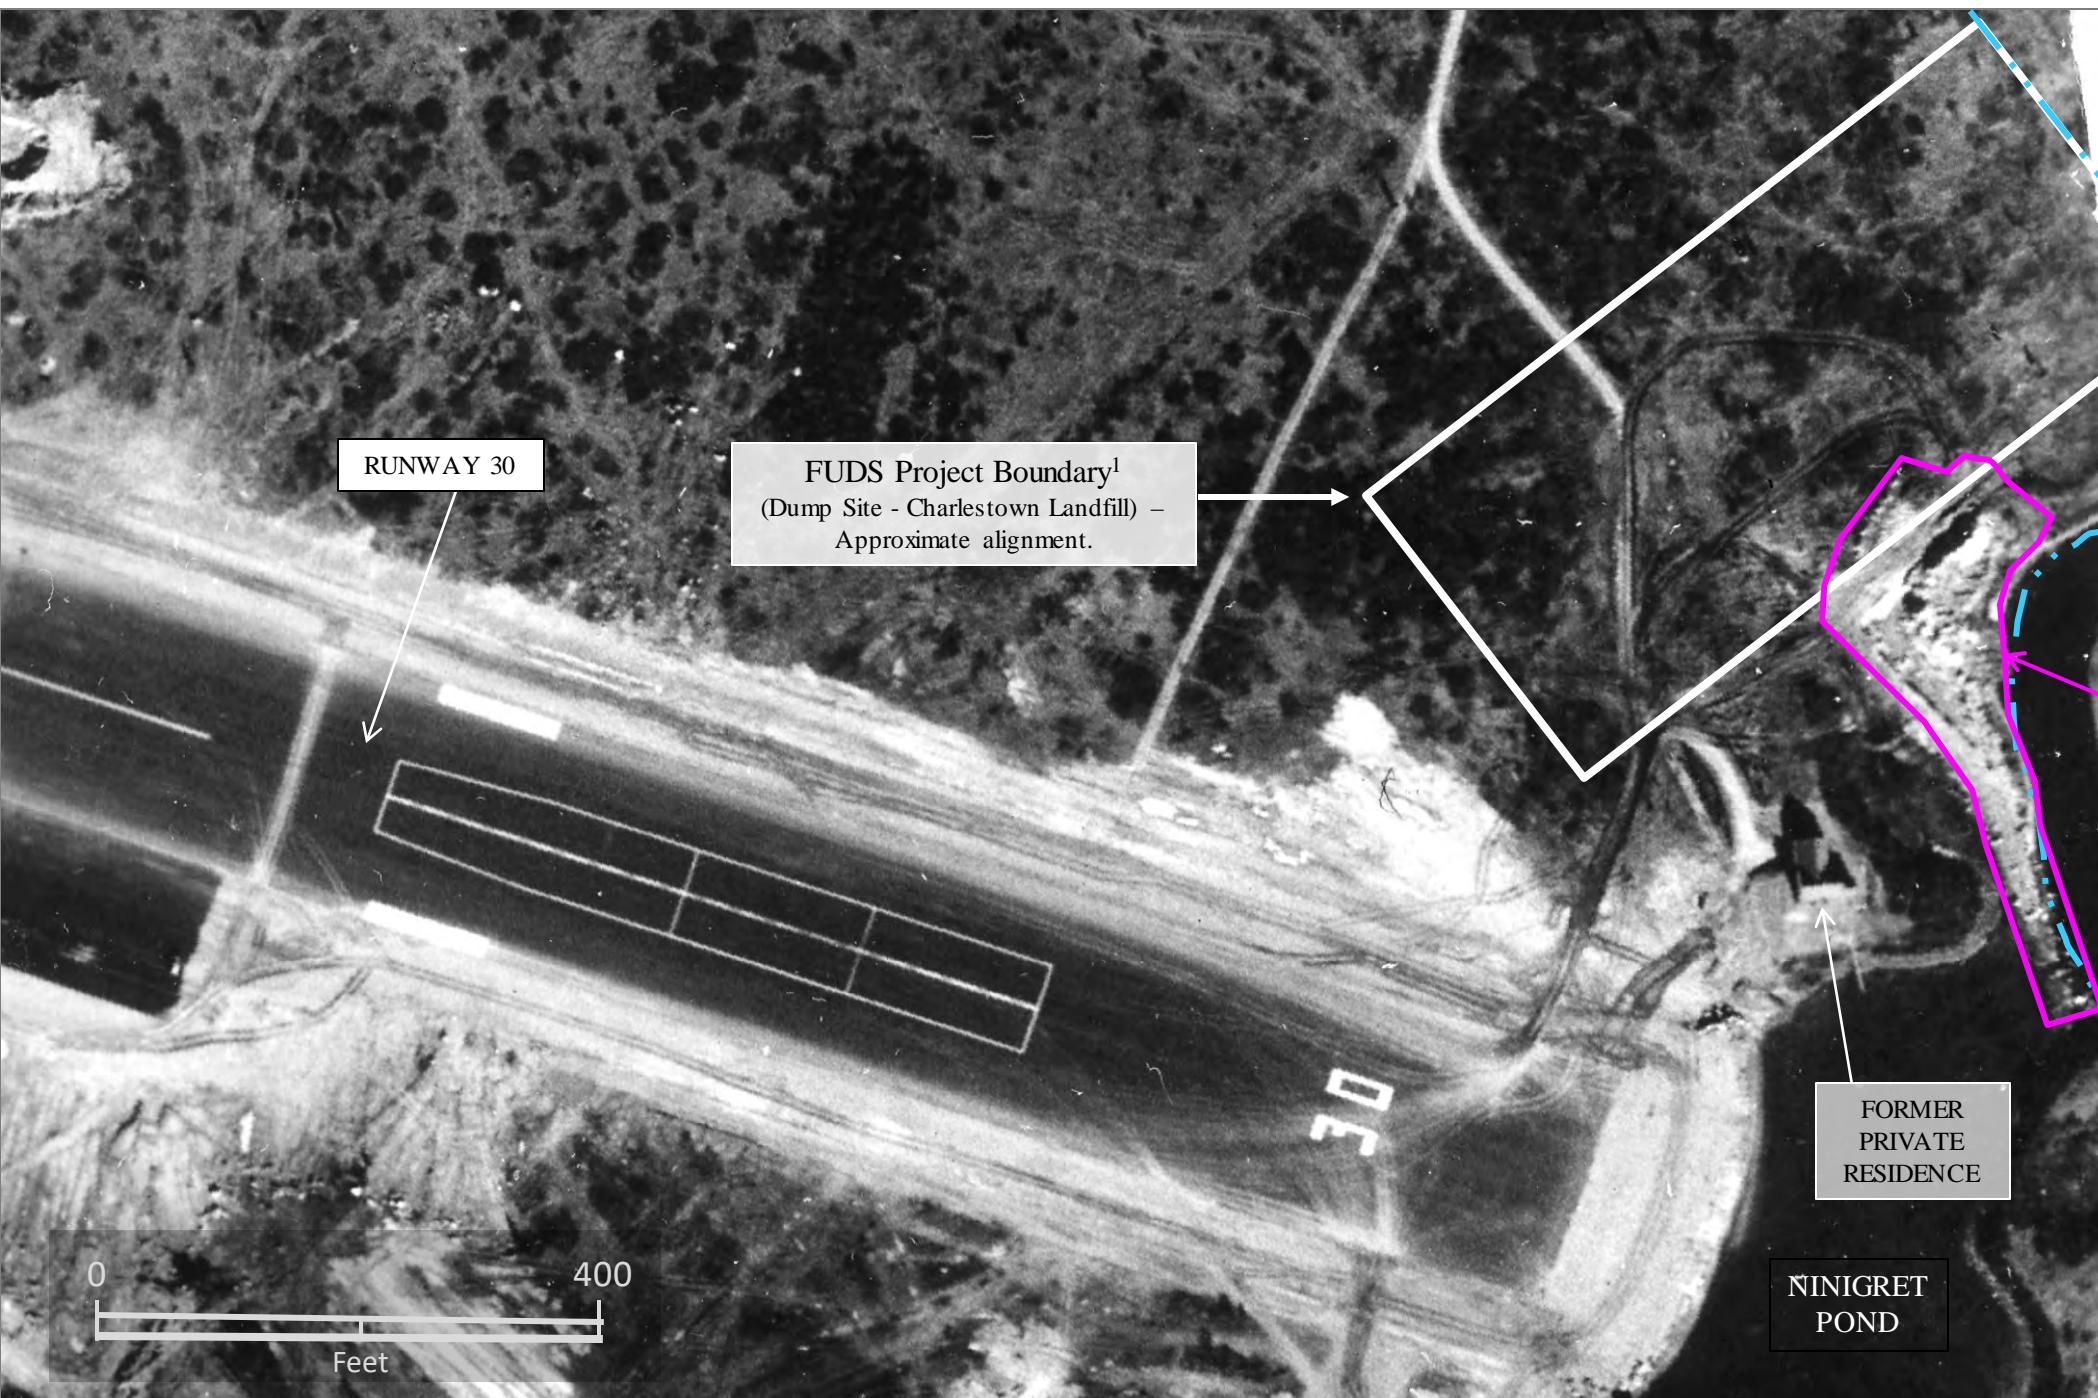
31 January 1944

Excavation

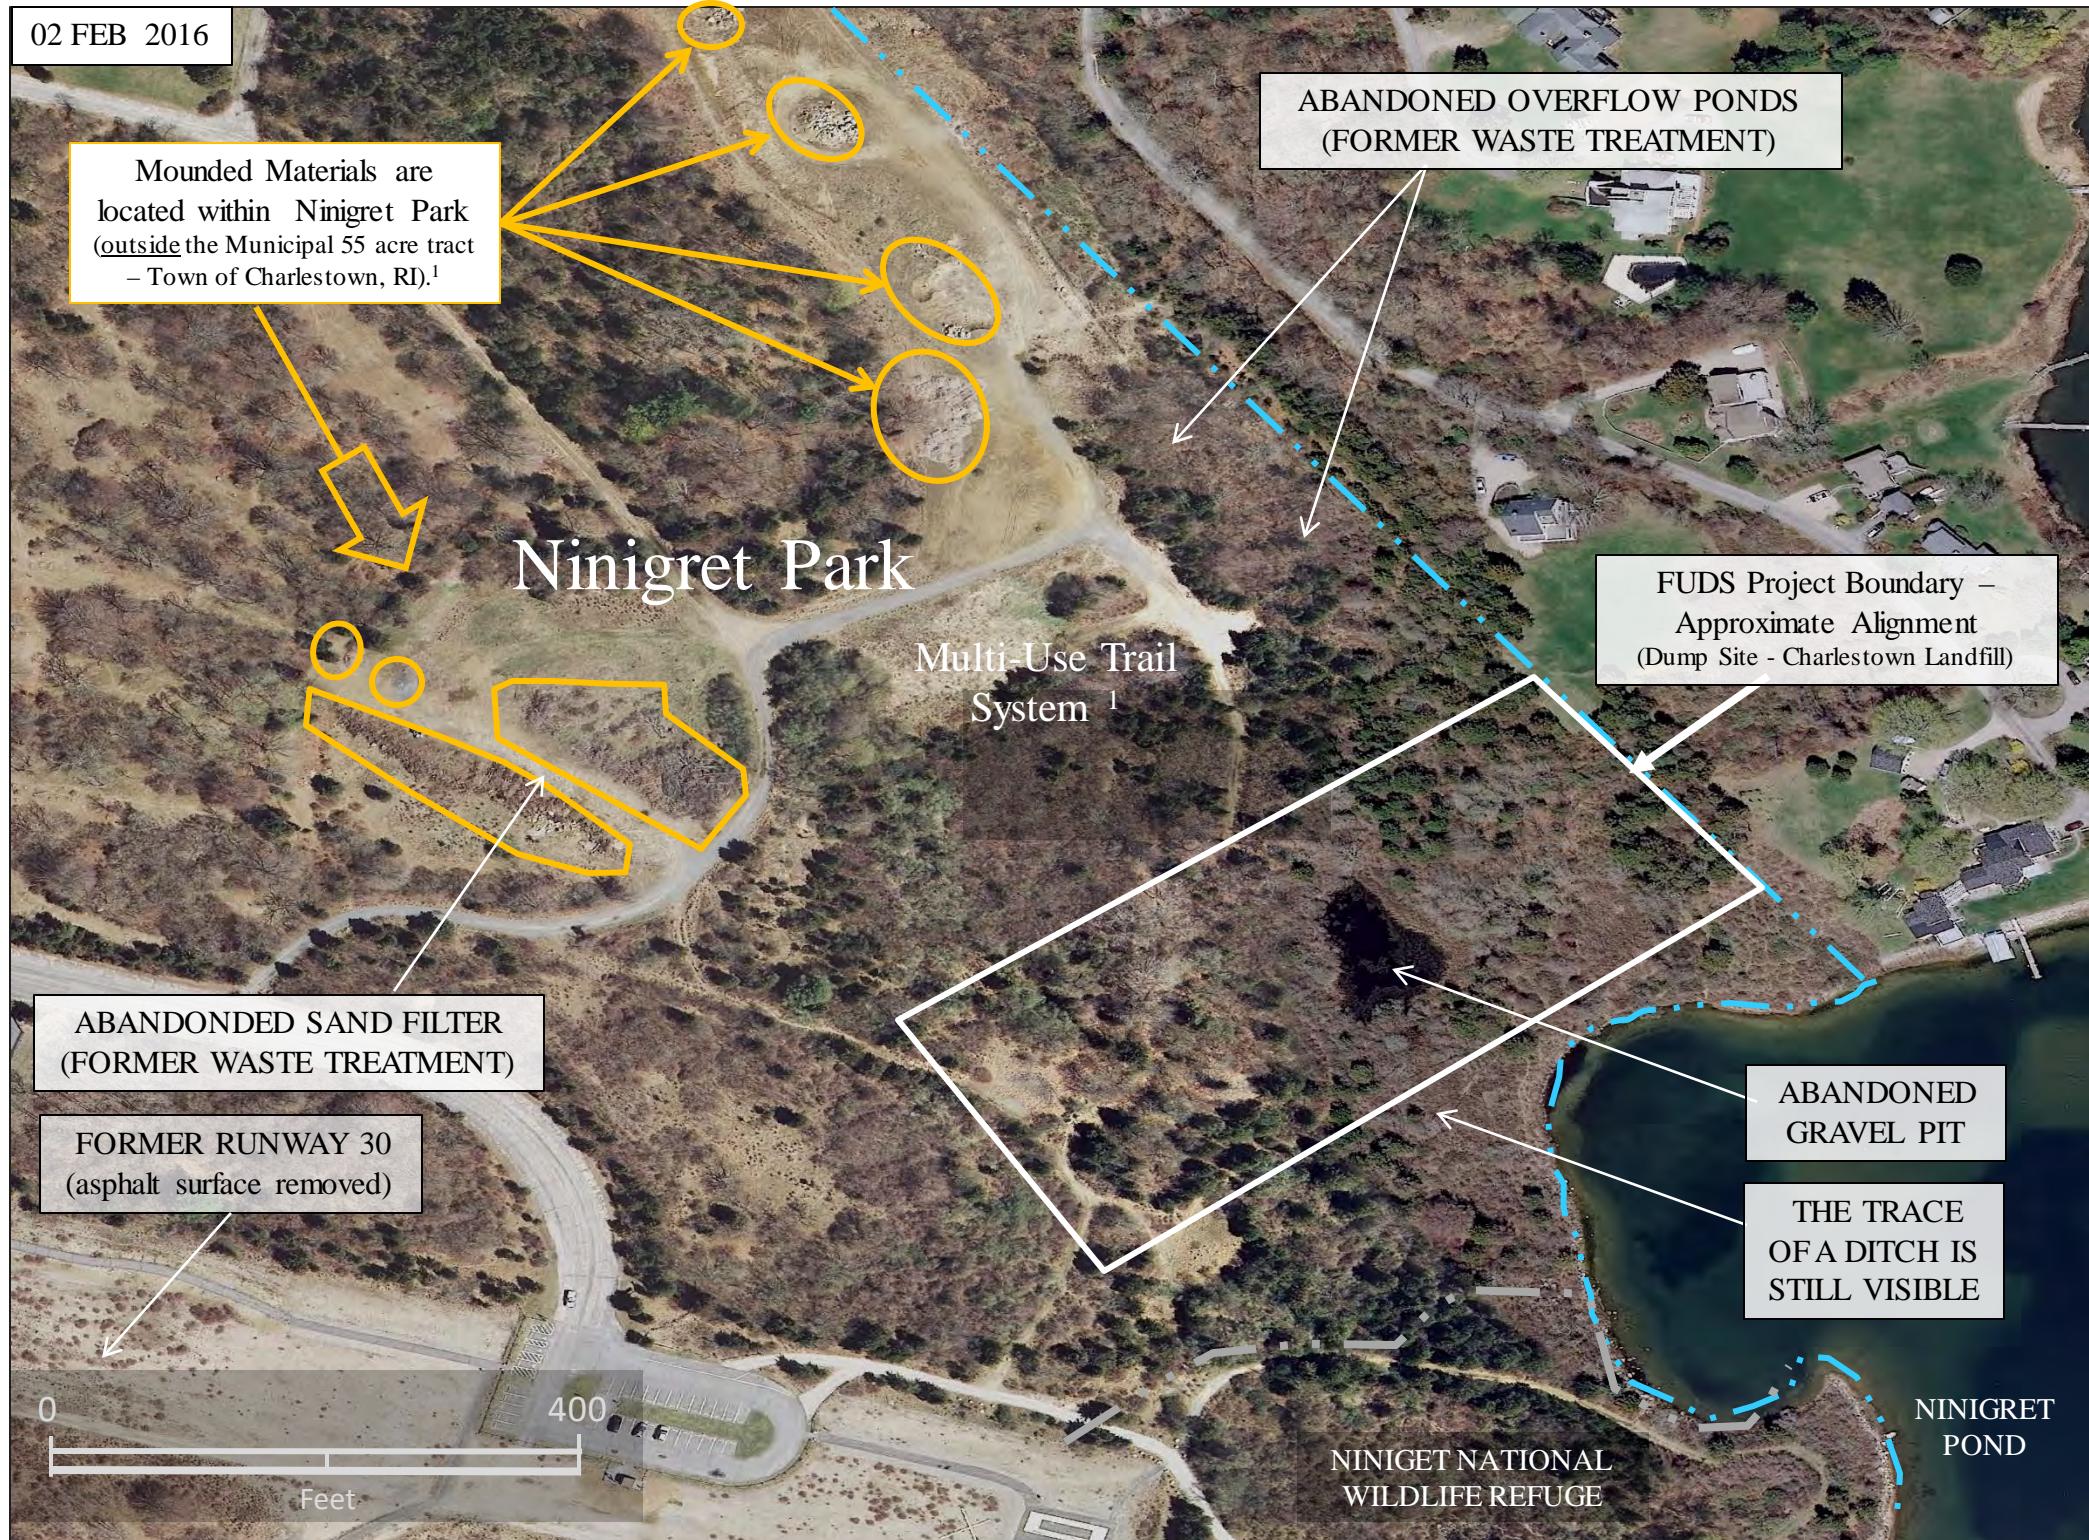
2011 VERTICAL VIEW

Disturbances to the soil caused by former CNALF (U.S. Navy) waste dump and/or landfill operations in the Charlestown Landfill and surrounding area, however, are no longer clearly visible in 2011 (as a result of the regrowth of scattered vegetative cover over the area).

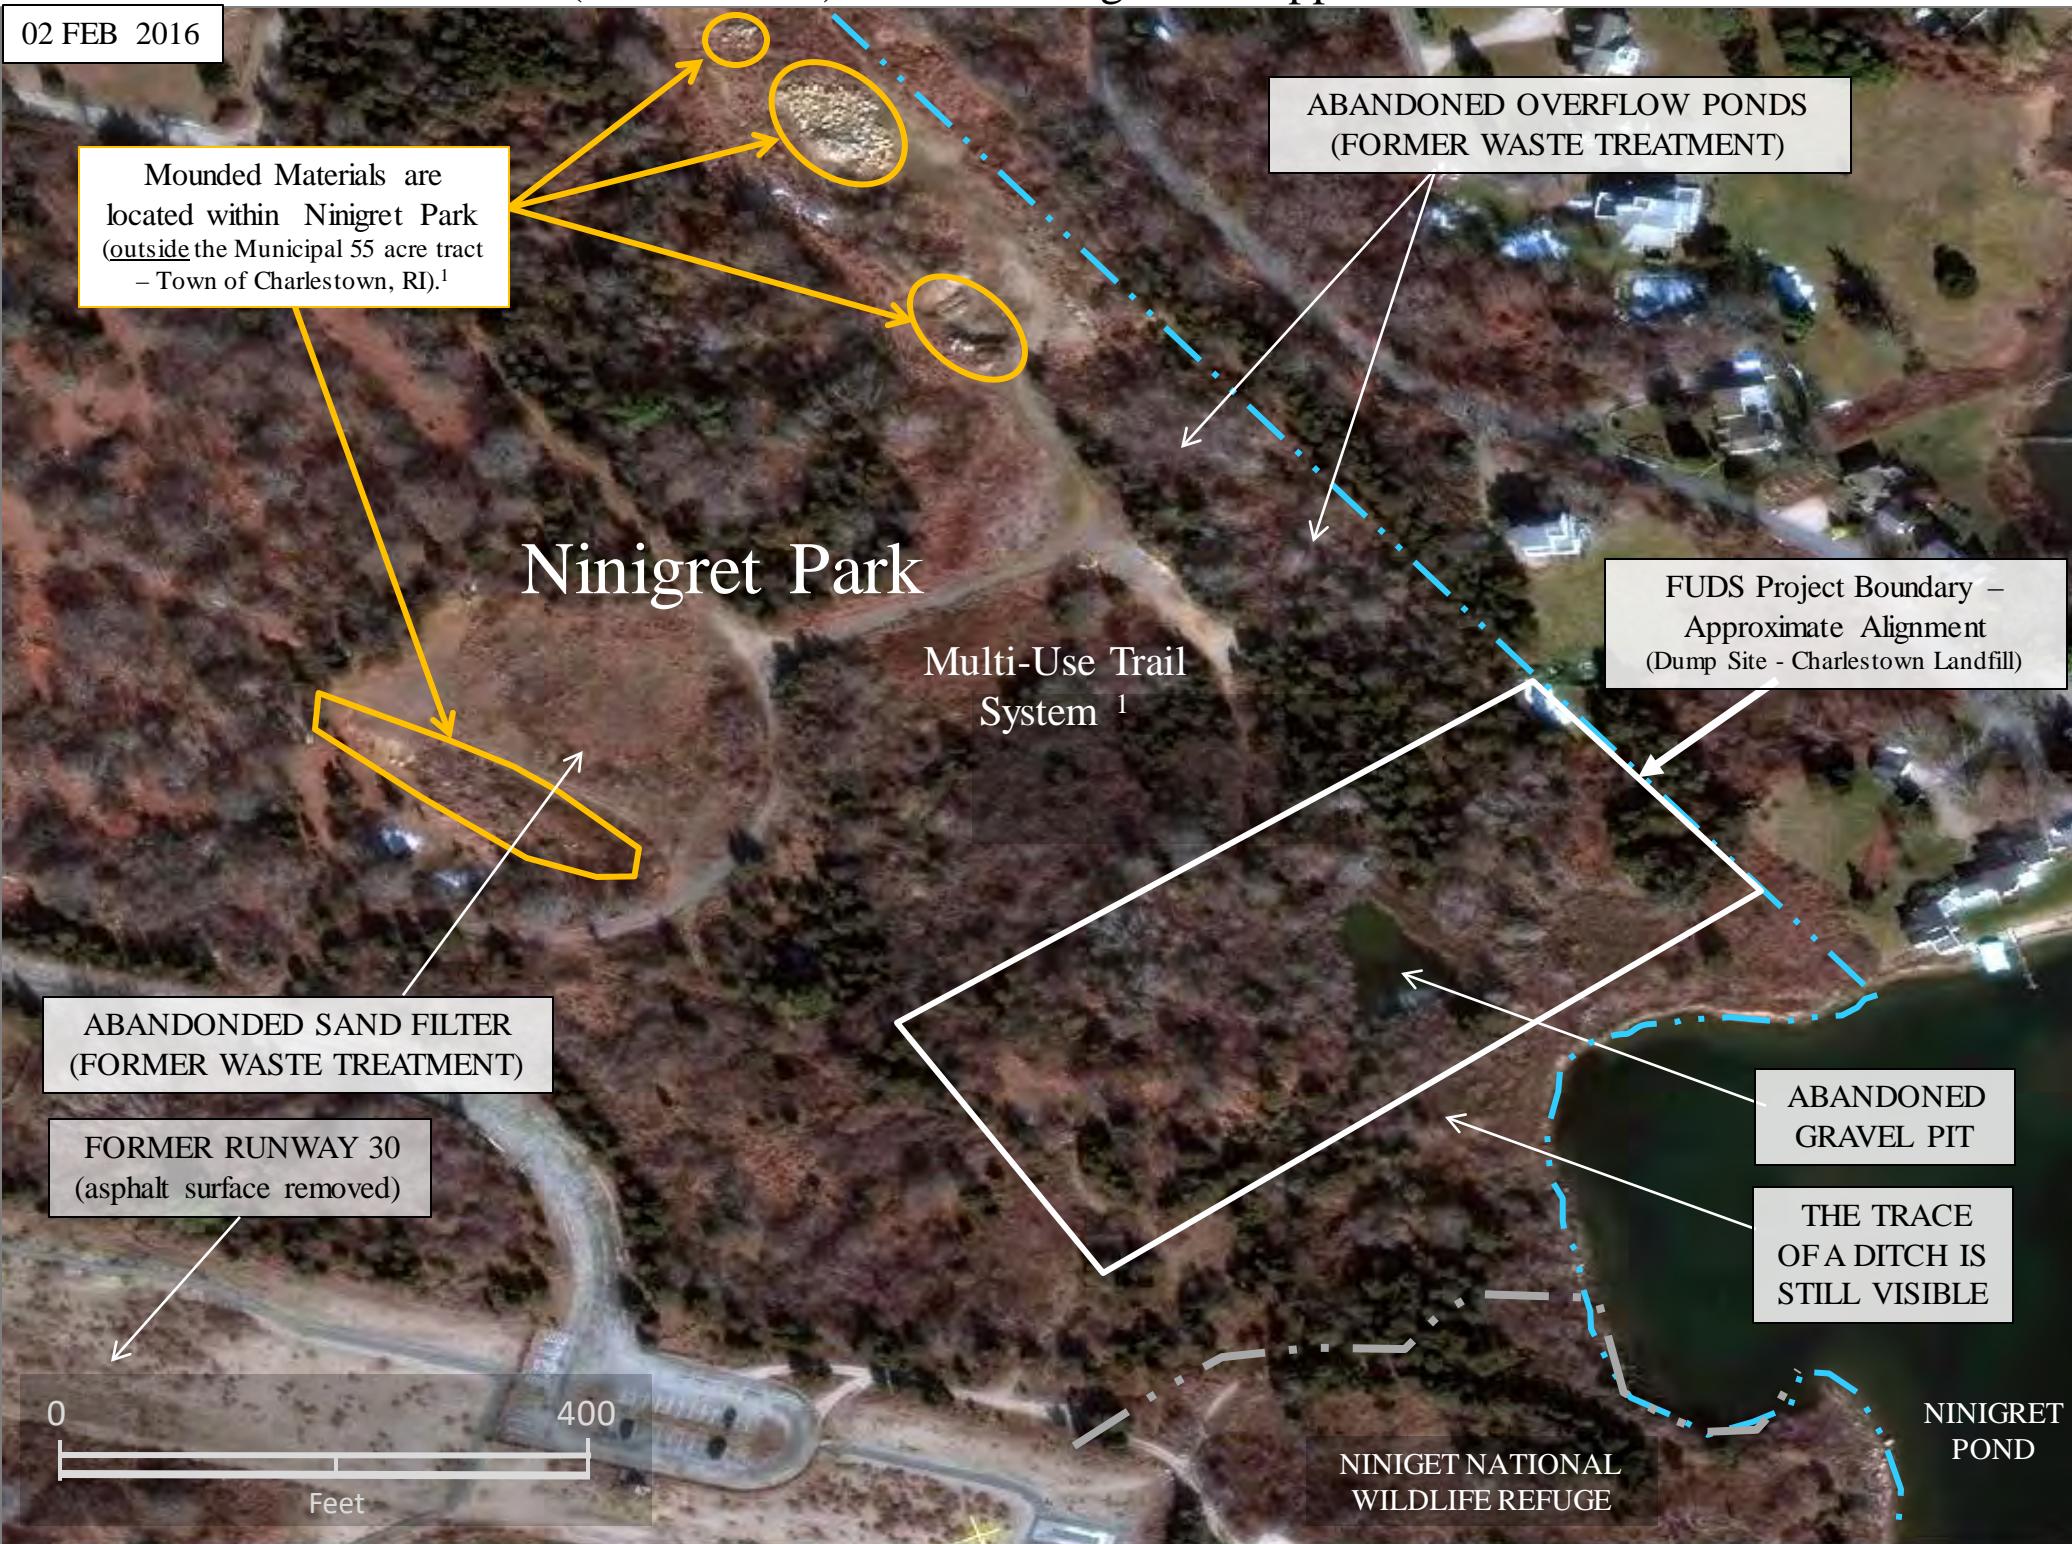
Vertical view of 2016 (current view). Scattered vegetation appears over the former CNALF area.

— Mounded Material

Disturbances to the soil caused by former CNALF (U.S. Navy) waste dump and/or landfill operations in the Charlestown Landfill and surrounding area, however, are no longer clearly visible in 2016 (as a result of the regrowth of vegetative cover over the area).

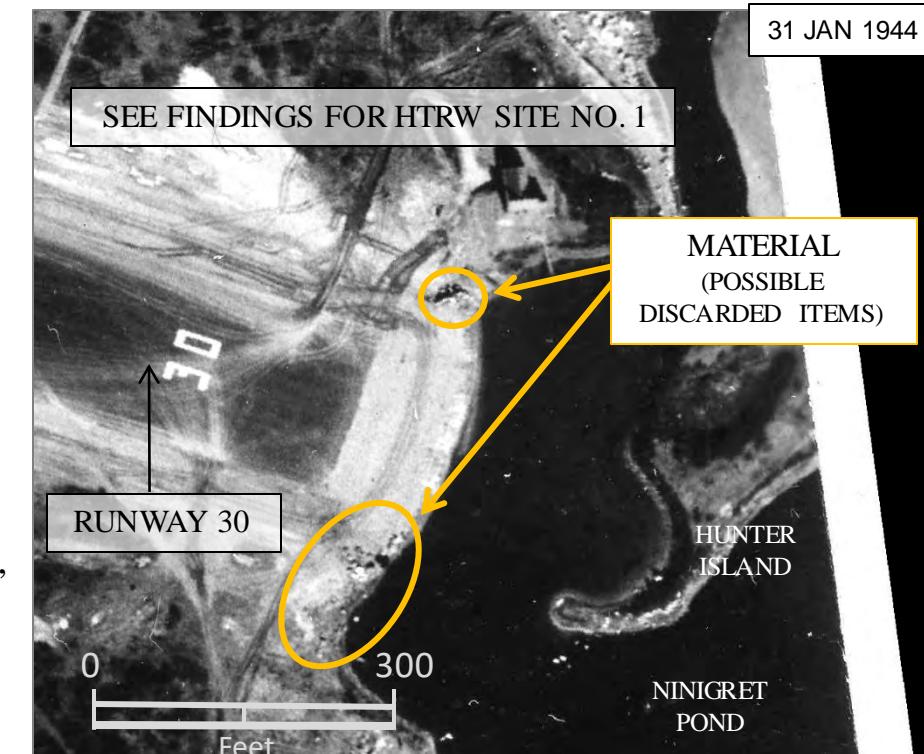
By January 1944, CNALF is well-developed.

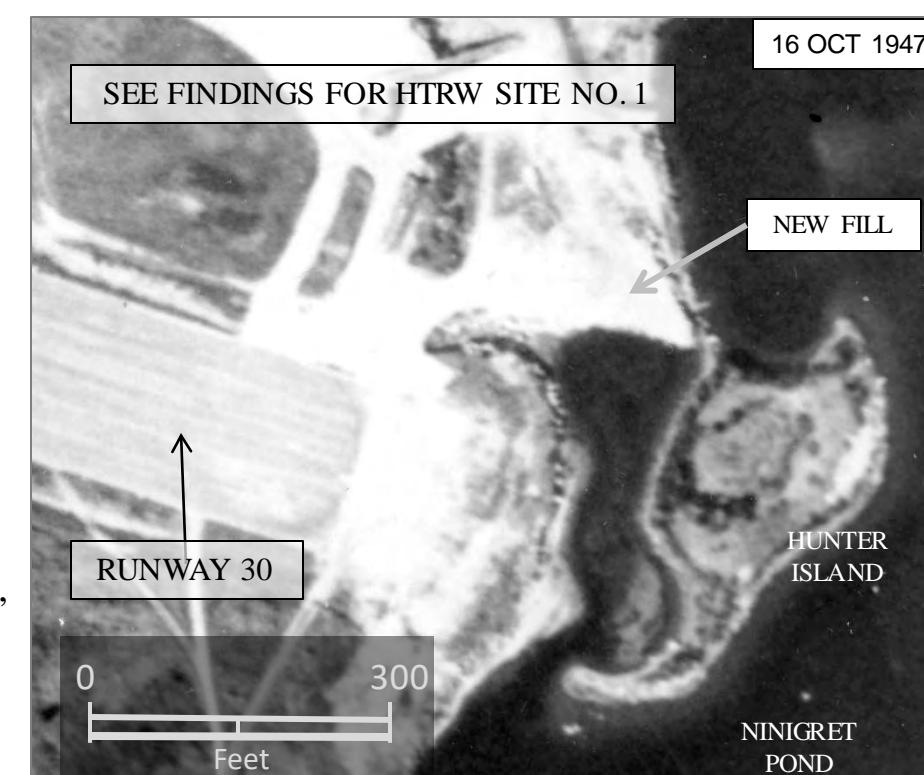
By October 1947, a new Fill Area has been created.

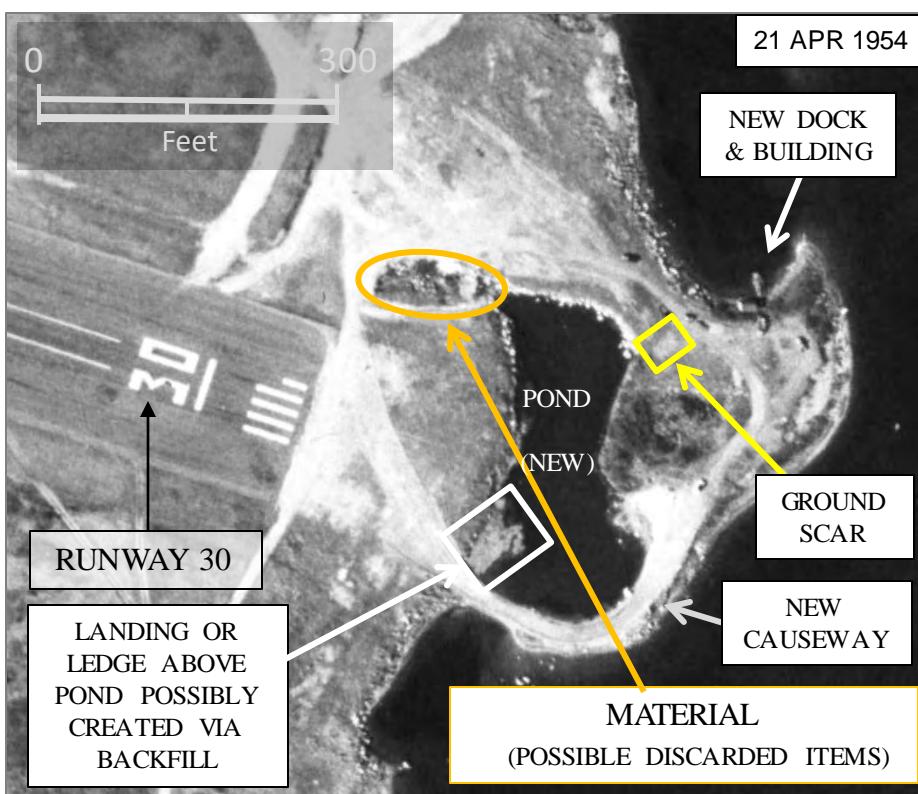
A new peninsula was constructed with fill to connect Hunter Island to the east side of CNALF.

A newly-constructed causeway linking the southern section of Hunter Island to the CNALF mainland property is clearly identified. In addition, unidentified material is observed in a location near the end of Runway 30.

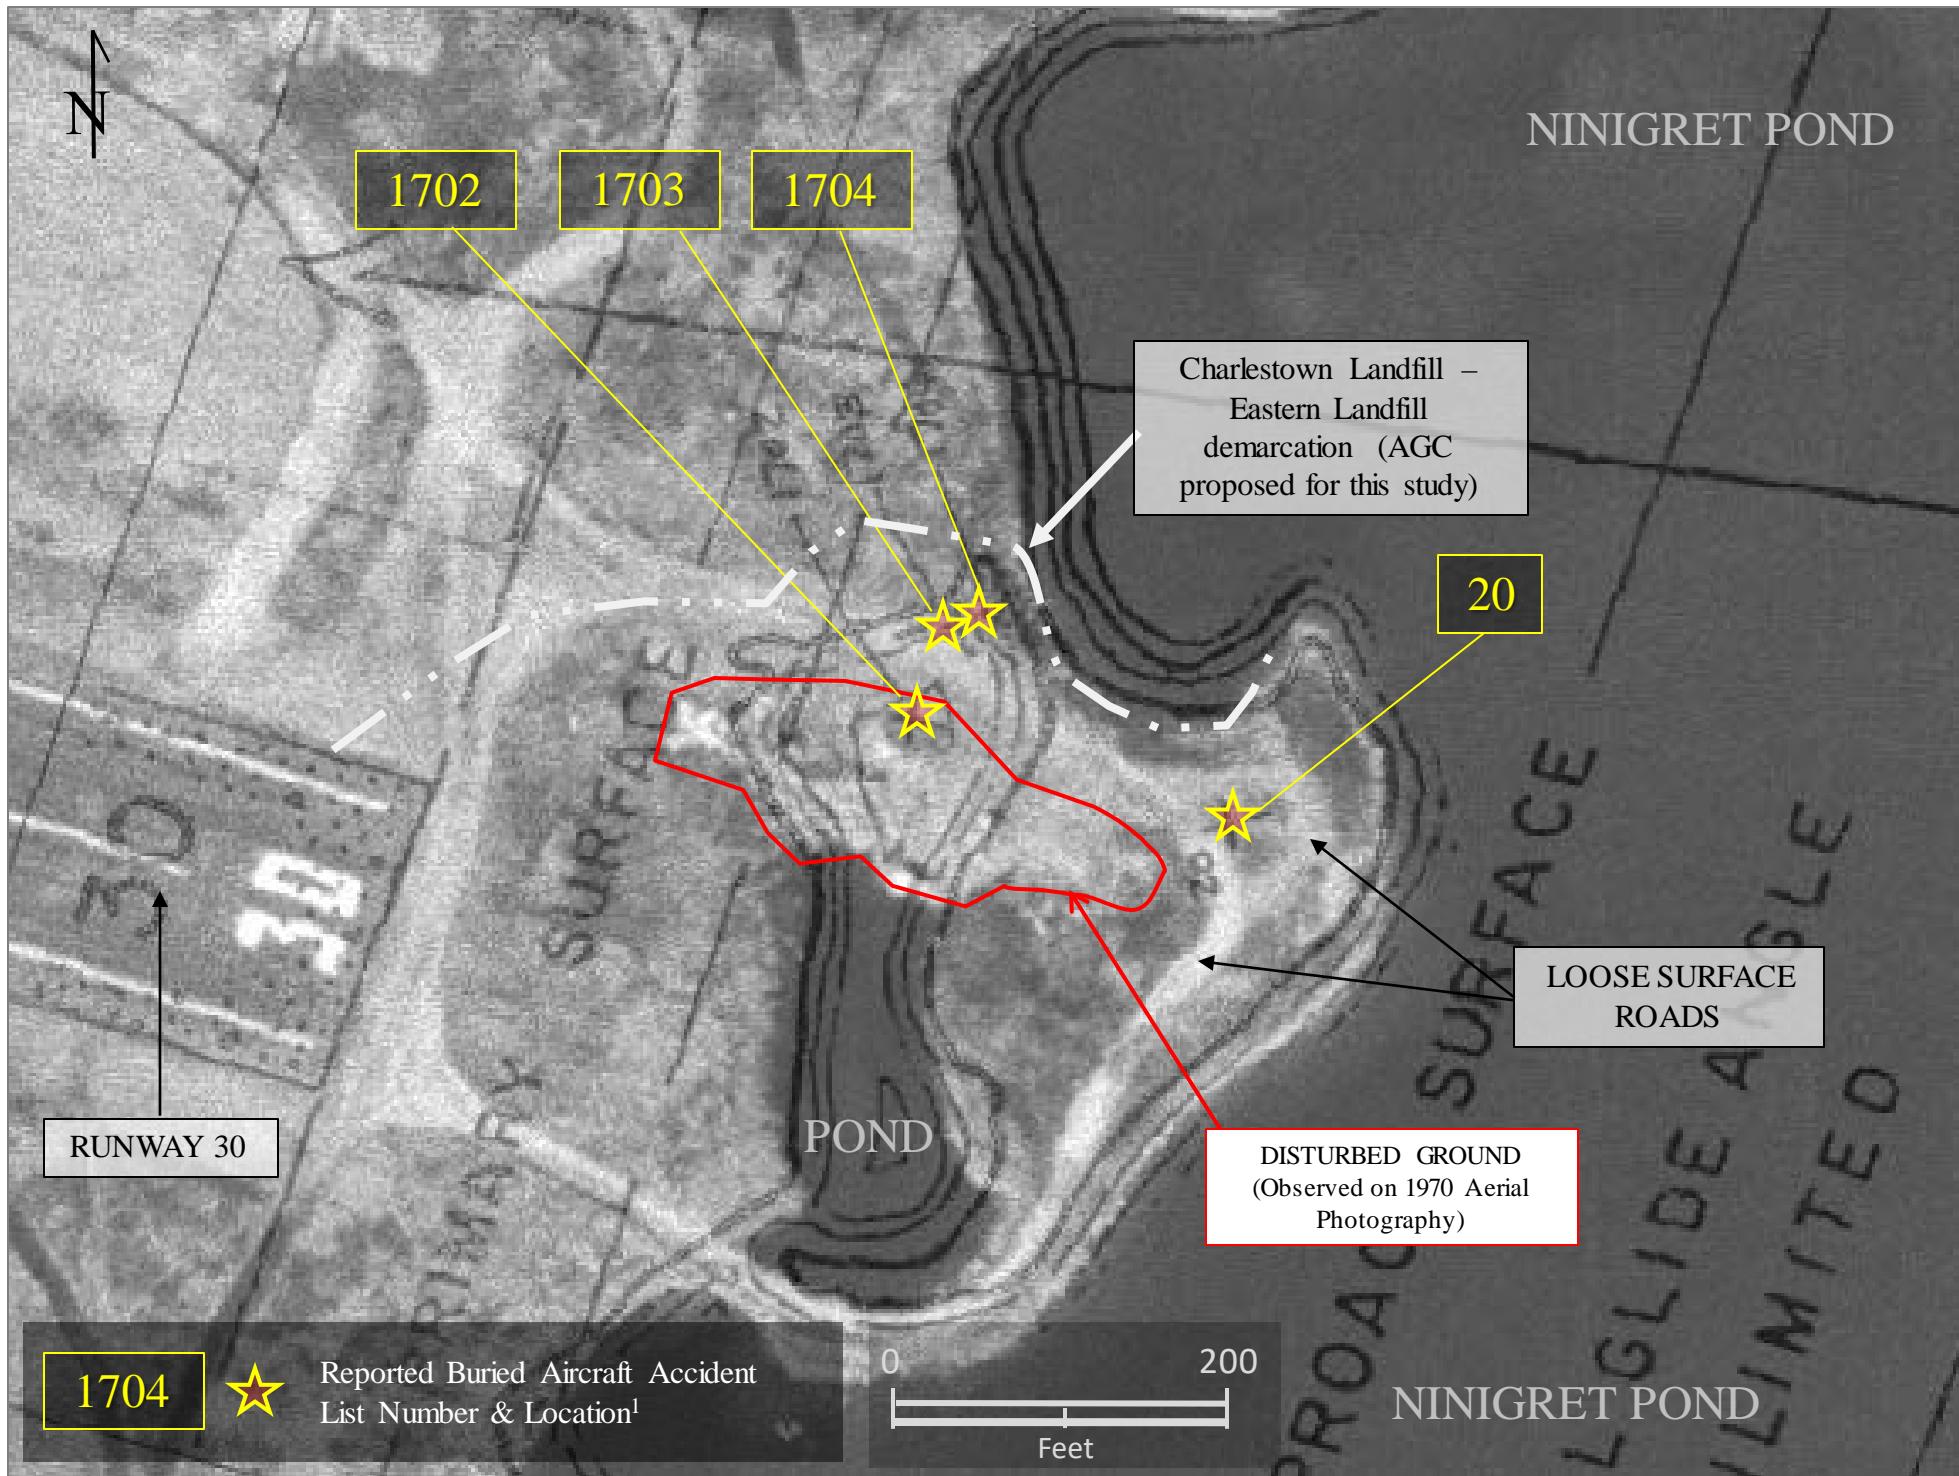
1969 Map Enclosure Draped on March 1970 Aerial Photography

In March of 1970, an area of disturbed ground is identified immediately north of the small pond - likely related to the recovery of aircraft parts of four buried aircraft and the 1969 dumping of building debris.^{1,2}

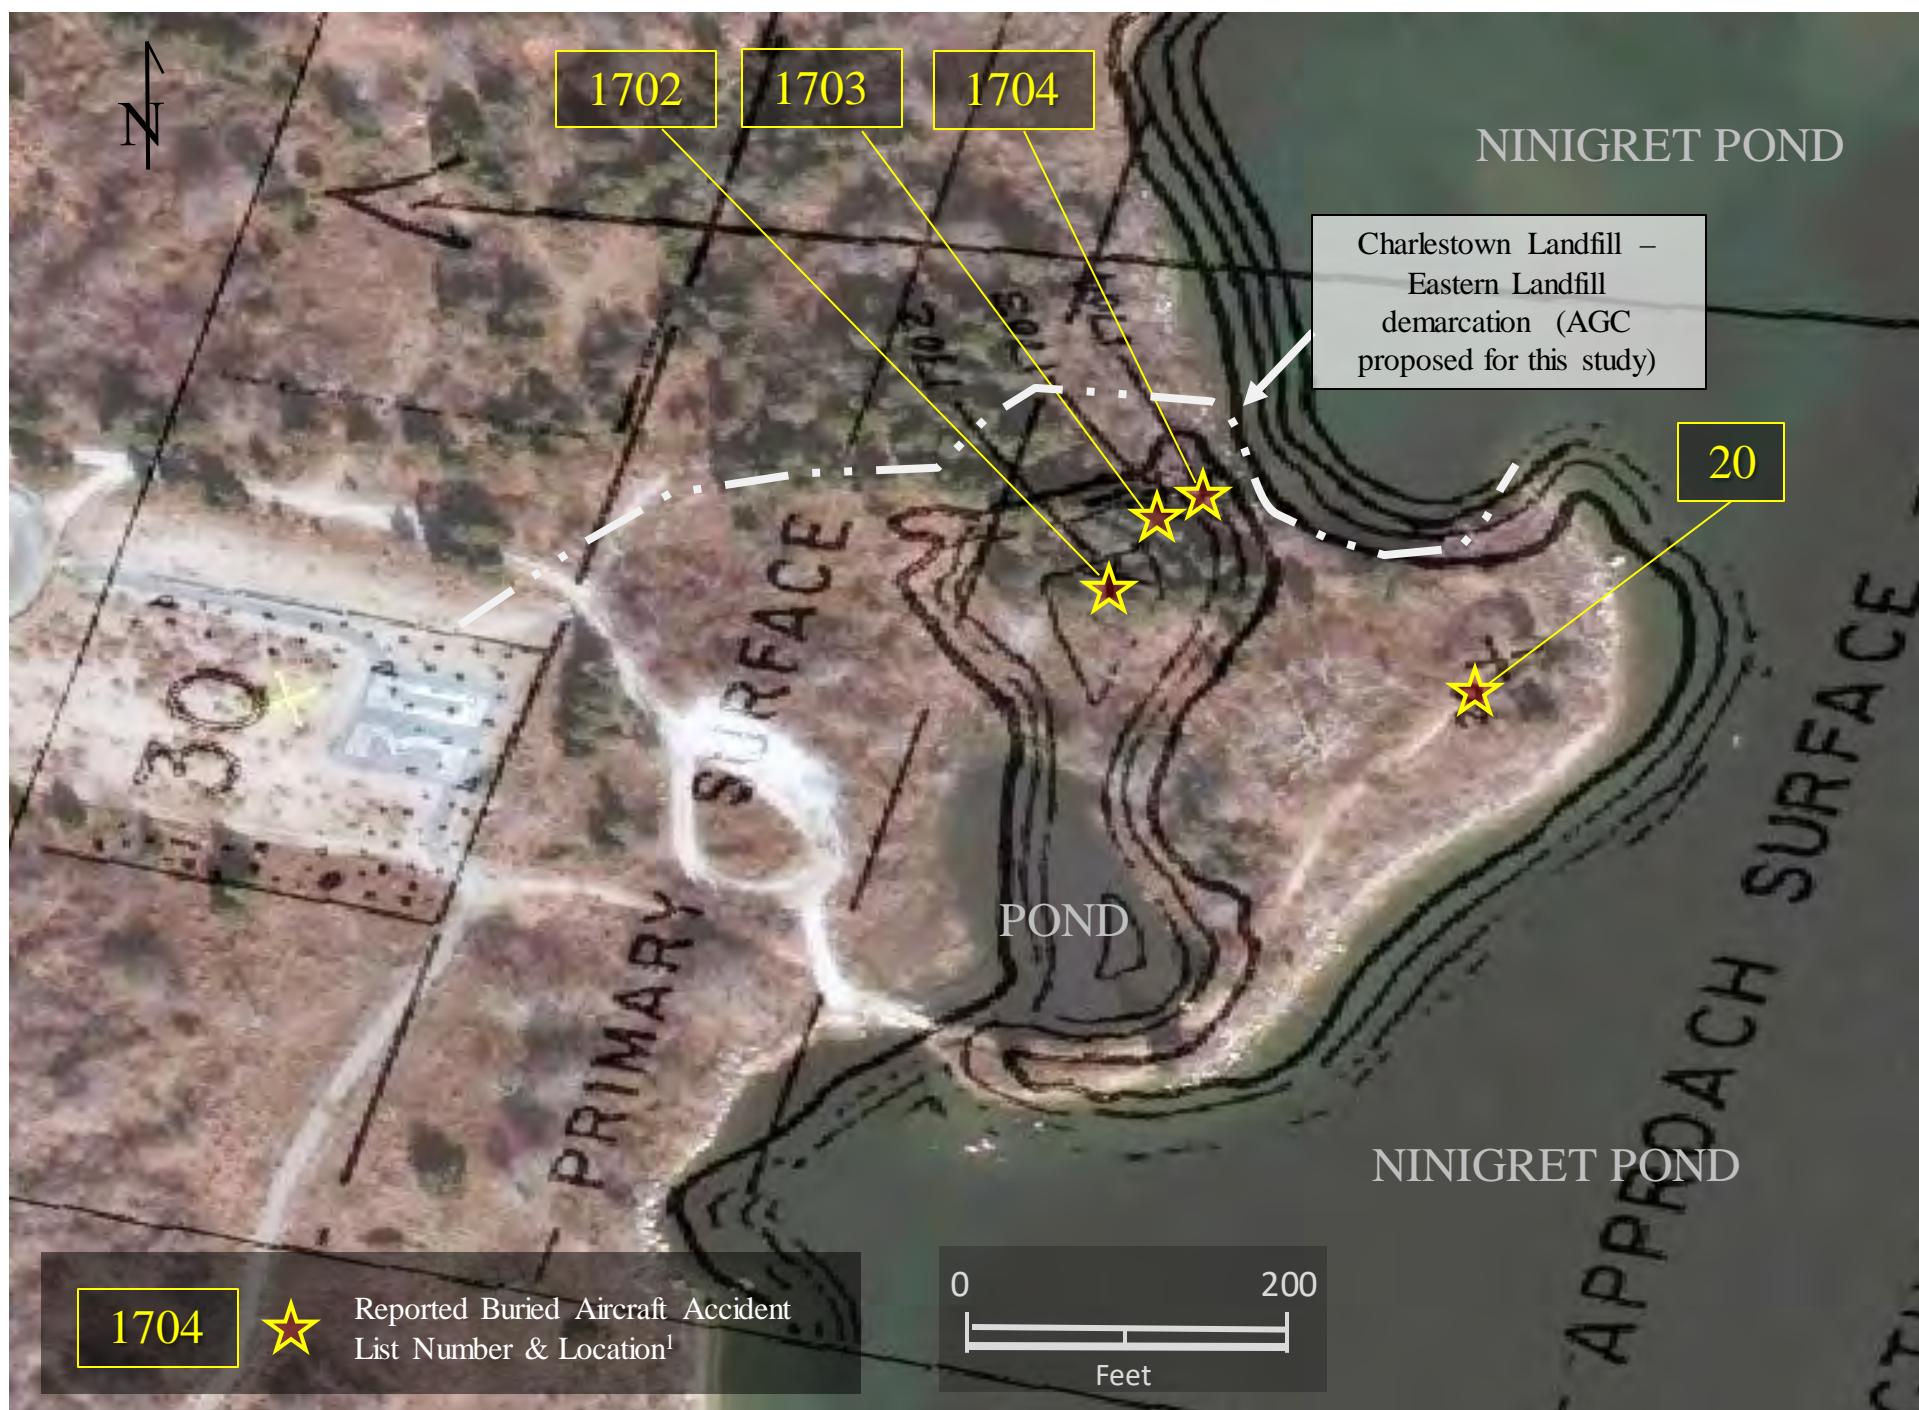
1969 Map Enclosure Draped on 2016 Imagery

Four airplane fuselages that were once used as 'burn pits' for fire training (at HTRW Site No. 3 along Runway 30) were transported to the Hunter Island area for disposal. Although the disposal action date is not known, the time period should match somewhat to the disestablishment of the fire-training burn pit area.¹

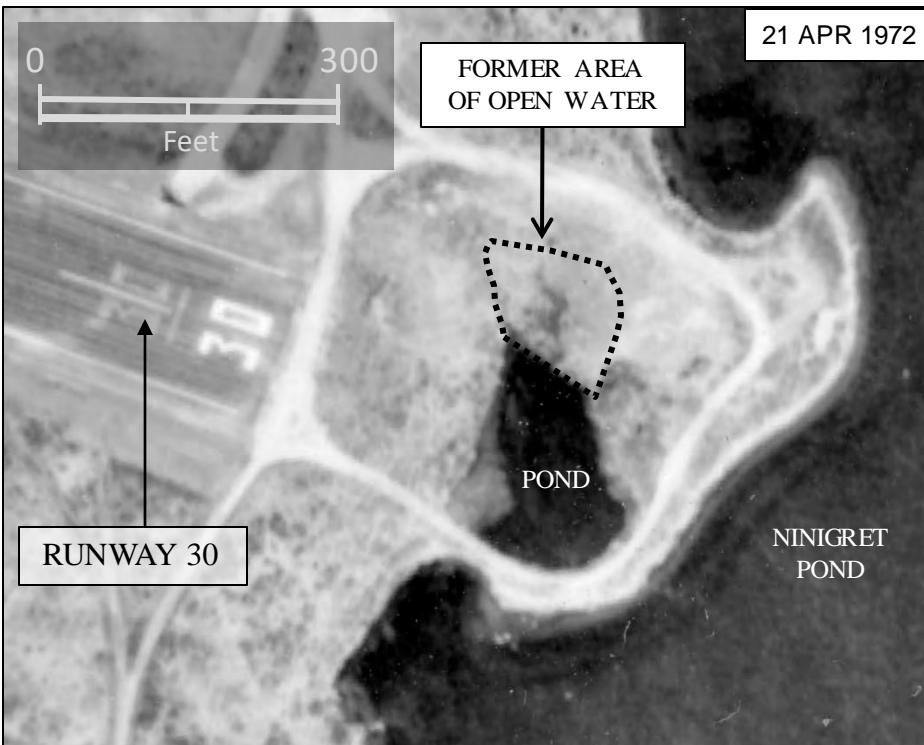
The northern section of the small pond has been filled in to a greater extent since last observed on March 1970 aerial photography.

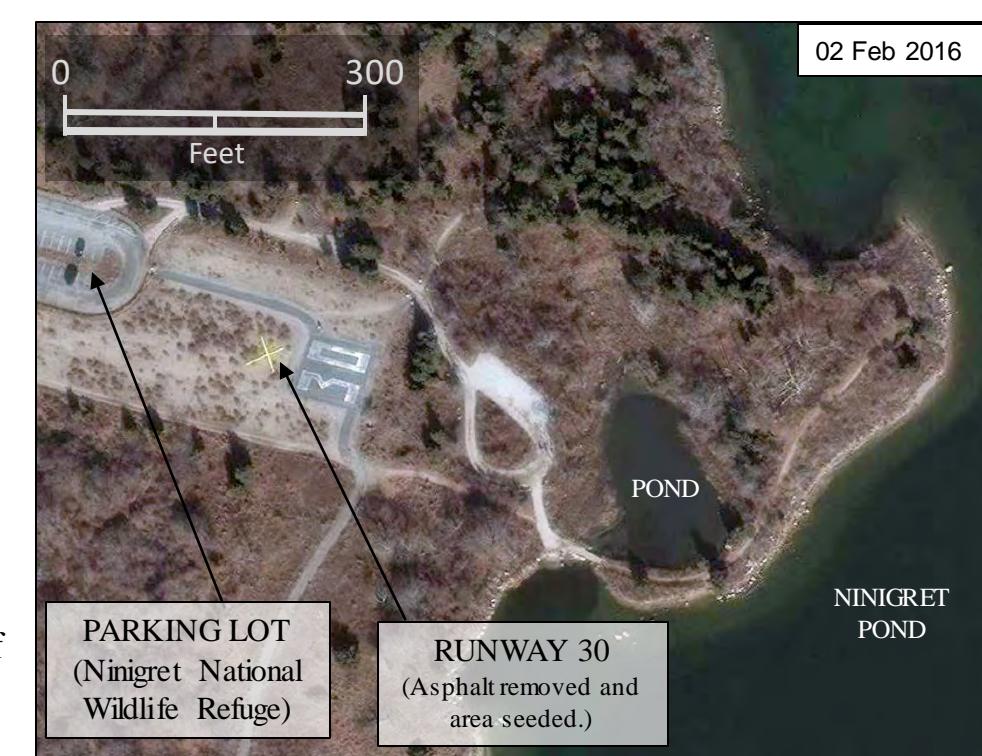
Low-lying vegetation now covers much of the Hunter Island Dump Site Area.

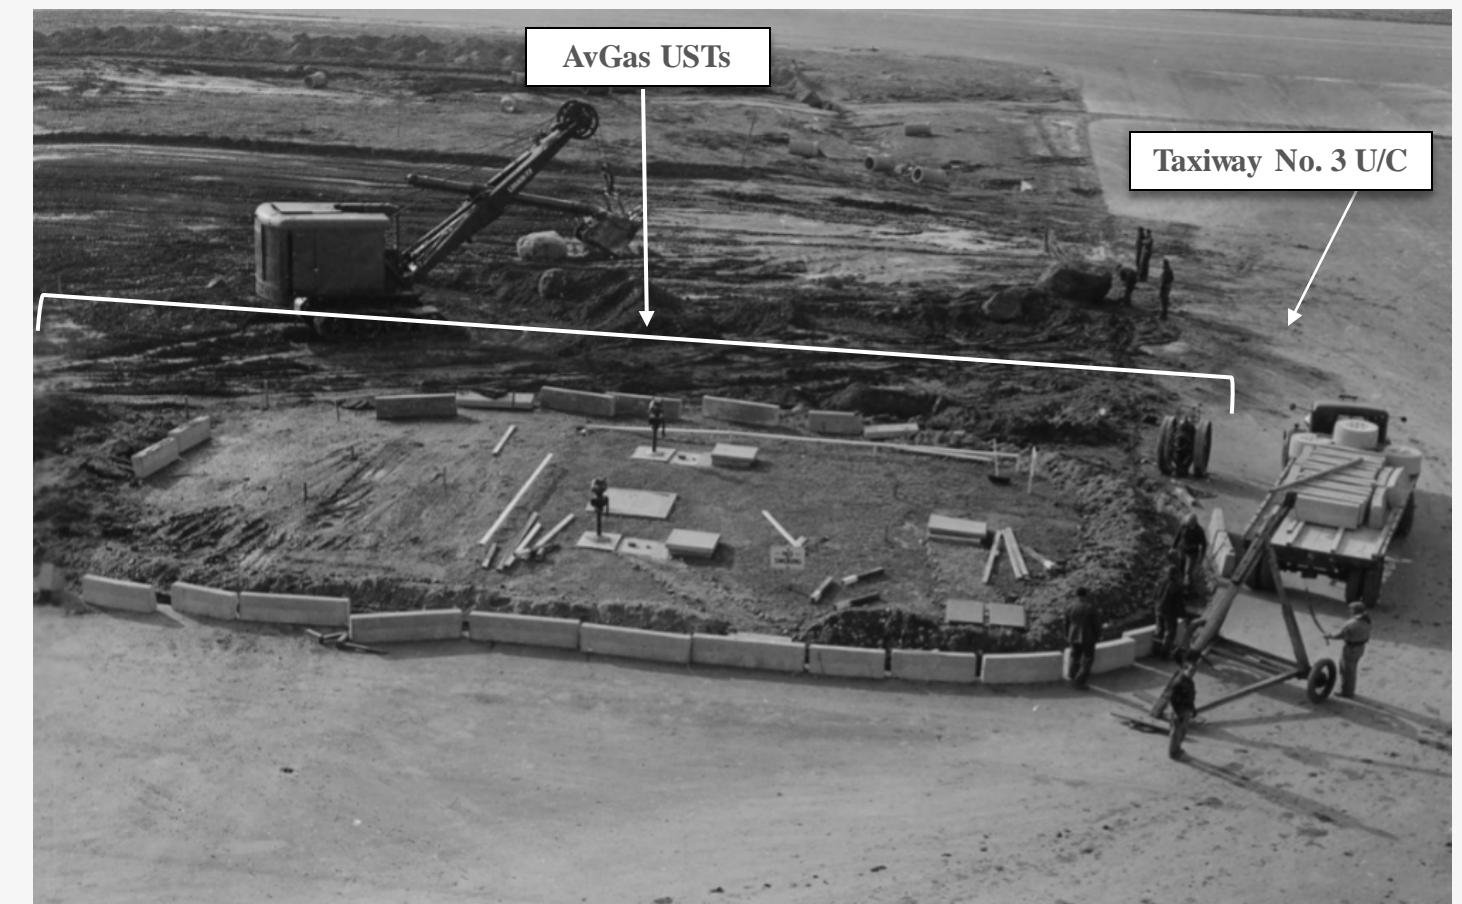
UST aviation gasoline storage south of taxiway.

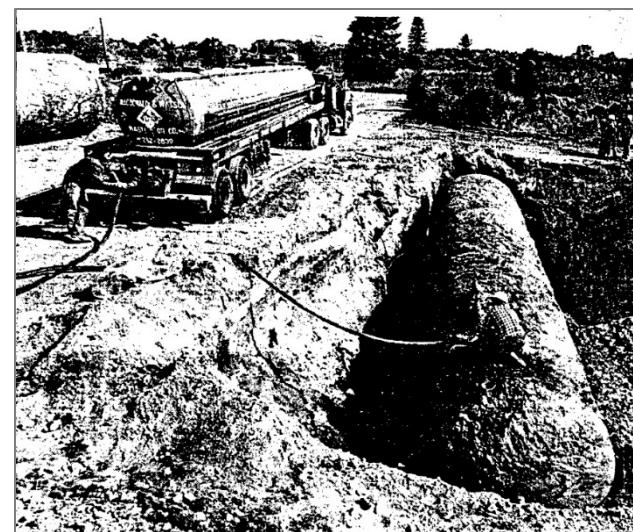
In 1970 the Charlestown Naval Auxiliary Landing Field was officially closed. The AvGas UST Tank Farm laid dormant until October 1986, when the underground tanks and contaminated soil were removed from this site.

Below are views from 1970 (the year of installation closure), 1985 (showing conditions just prior to UST & soil removal), and 1988 (conditions following environmental remediation at the site by the U.S. Army Corps of Engineers).
