CHARLESTOWN NAVAL AUXILIARY LANDING FIELD, RHODE ISLAND

HISTORICAL ENVIRONMENTAL PHOTOGRAPHIC ANALYSIS

AUGUST 2018 FINAL REPORT

Prepared for the U.S. Army Corps of Engineers, New England District.

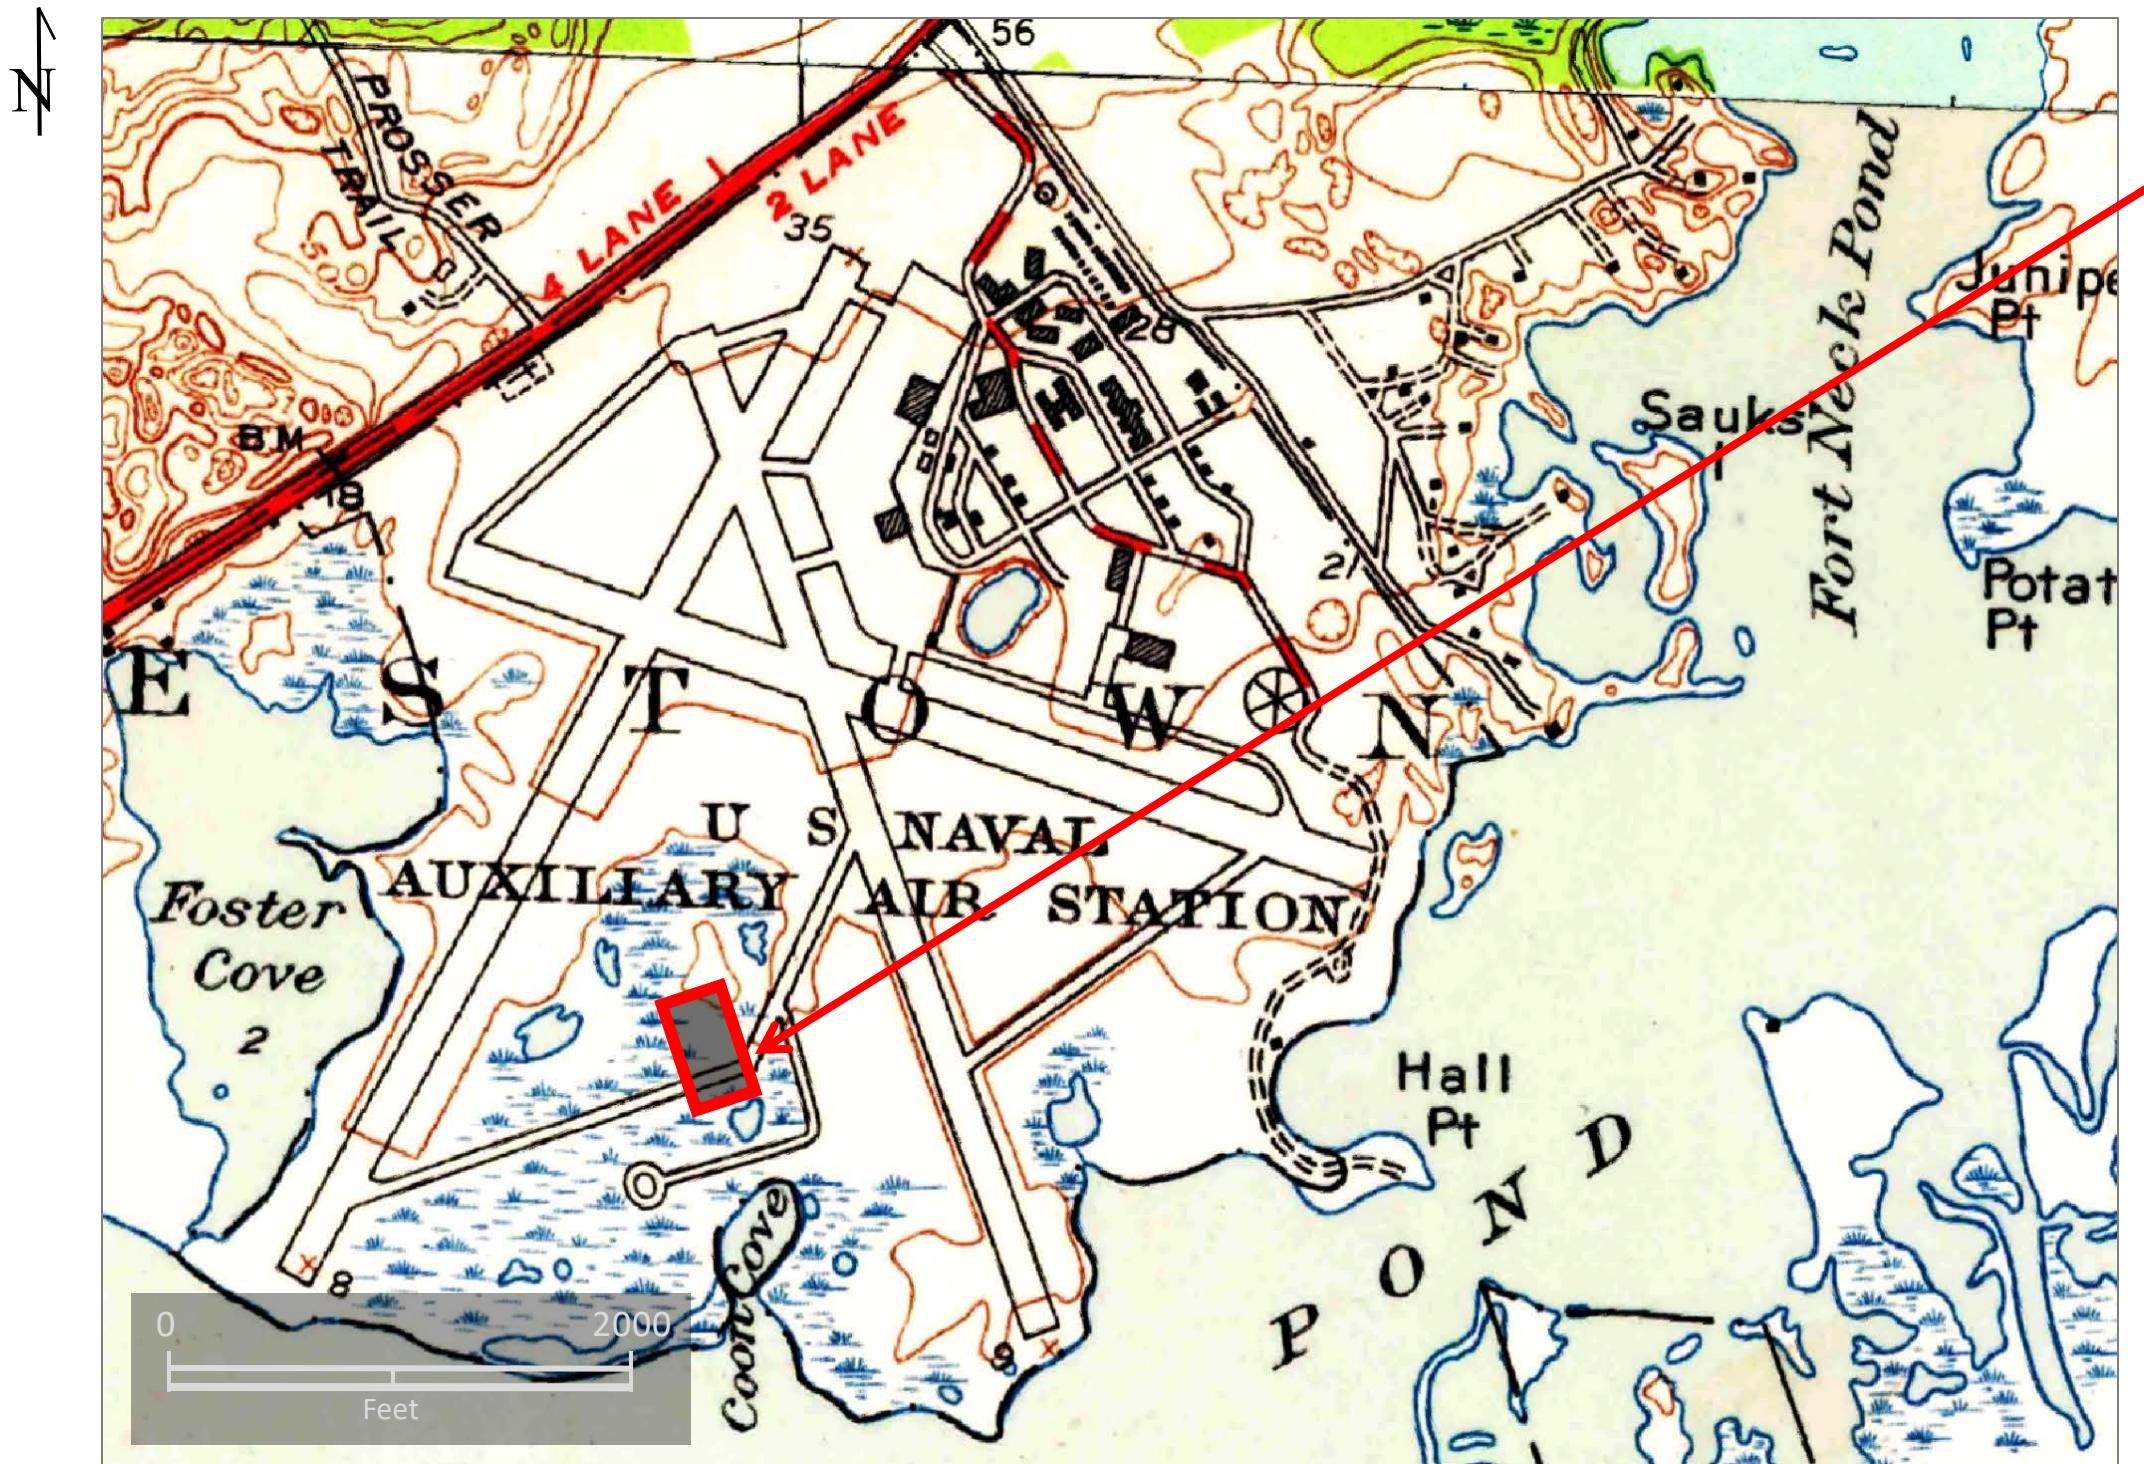
LOCATIONAL DATA – MAP INFORMATION

Location of Shoot-In-Butt
(range backstop) - MRS 5 &
aircraft hardstand: Aviation
Machine Gun Range^{1,2,3}

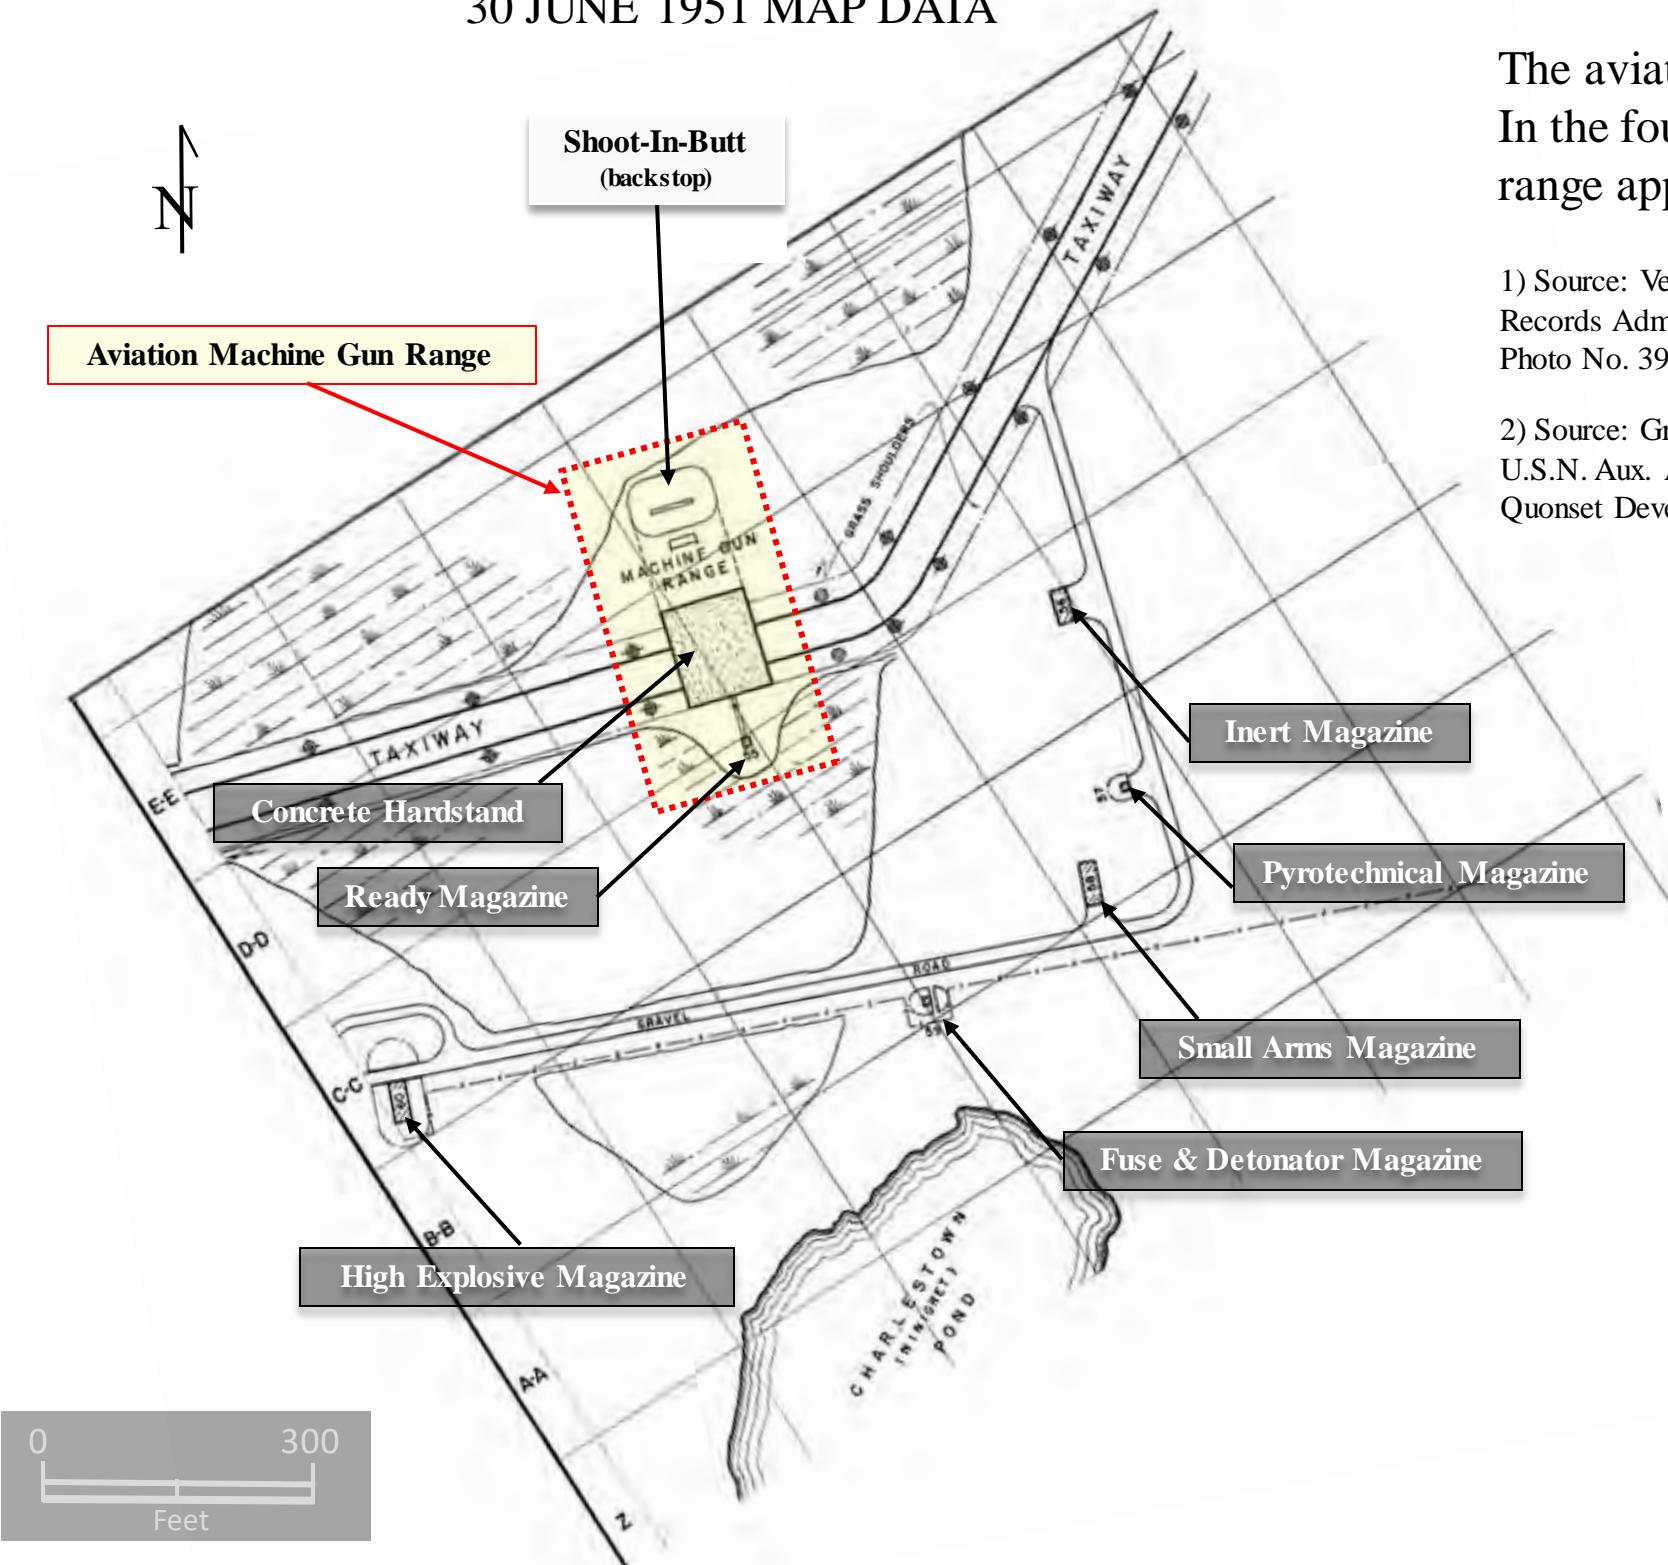
30 JUNE 1951 MAP DATA

The aviation machine gun range dates back to 1943. In the fourth quarter of 1943, construction of the range appears to be nearly complete.^{1,2}

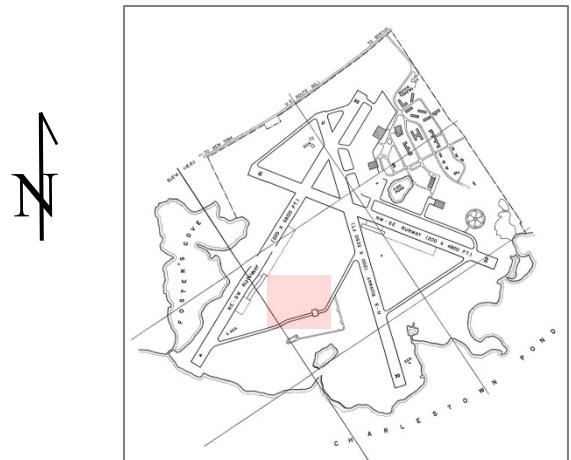
Construction of an aviation machine gun test range along with taxiway access has not yet begun.

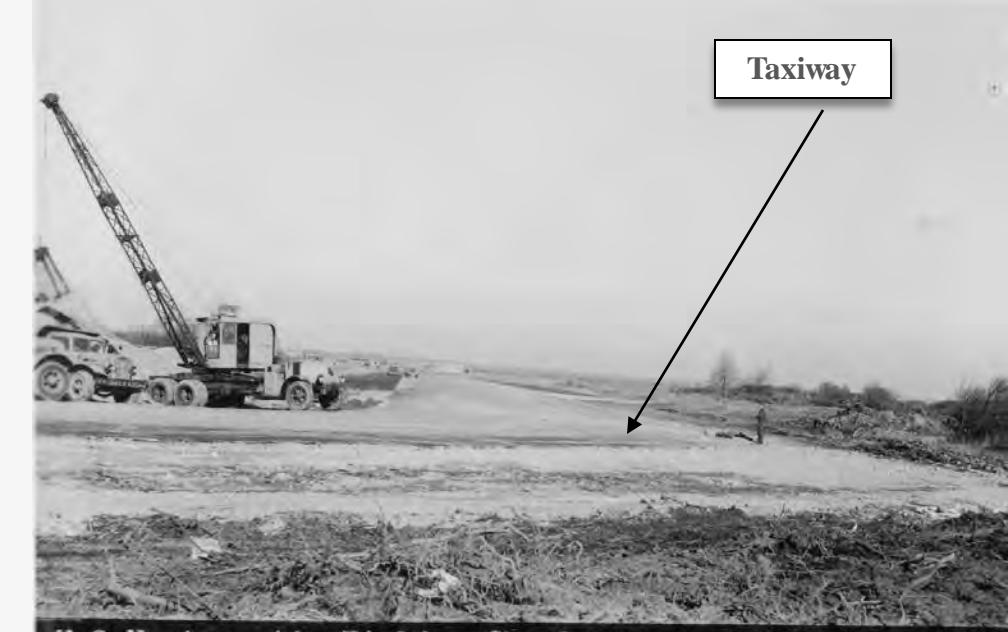
Taxiway to machine gun range.

U.S.N. Aux. Air Field Charlestown, R.I. NOy-6469
Taxiway to Machine gun test range, looking east.
E. Turgeon Co. 26 Nov. 1943 6469-3

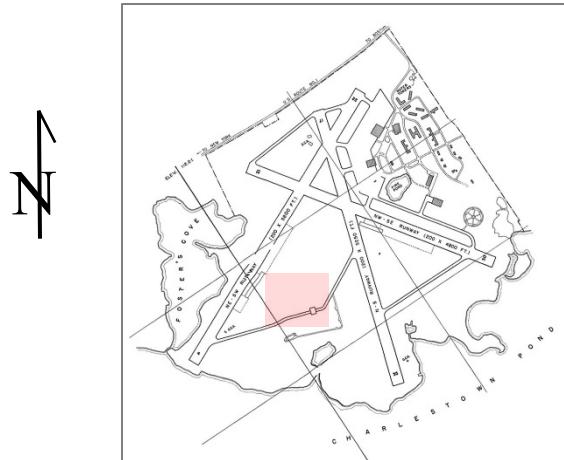
No major changes to the Shoot-in-Butt area of the Aviation Machine Gun Test Range are identified on March 1970 aerial photography.

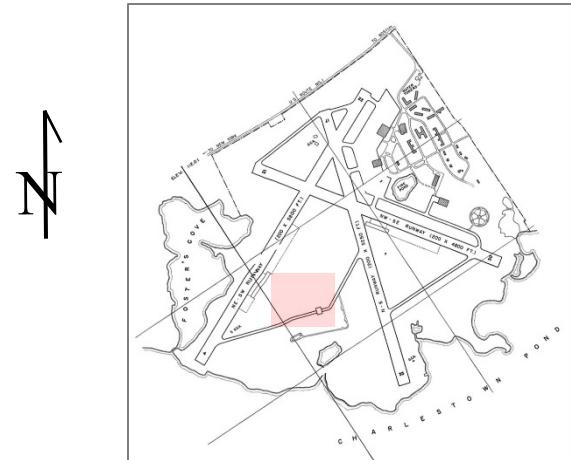
A current aerial view of the abandoned Aviation Machine Gun Test Range area.

Note: Much of the sand from the machine gun range backstop was reportedly removed and used as a fill for a road alignment (comprising 2 acres of the western entrance road which services Ninigret Park, The Town of Charlestown).¹ For additional details, refer to the next section of this report entitled “MRS 1 - Fill from Shoot-in-Butt”.

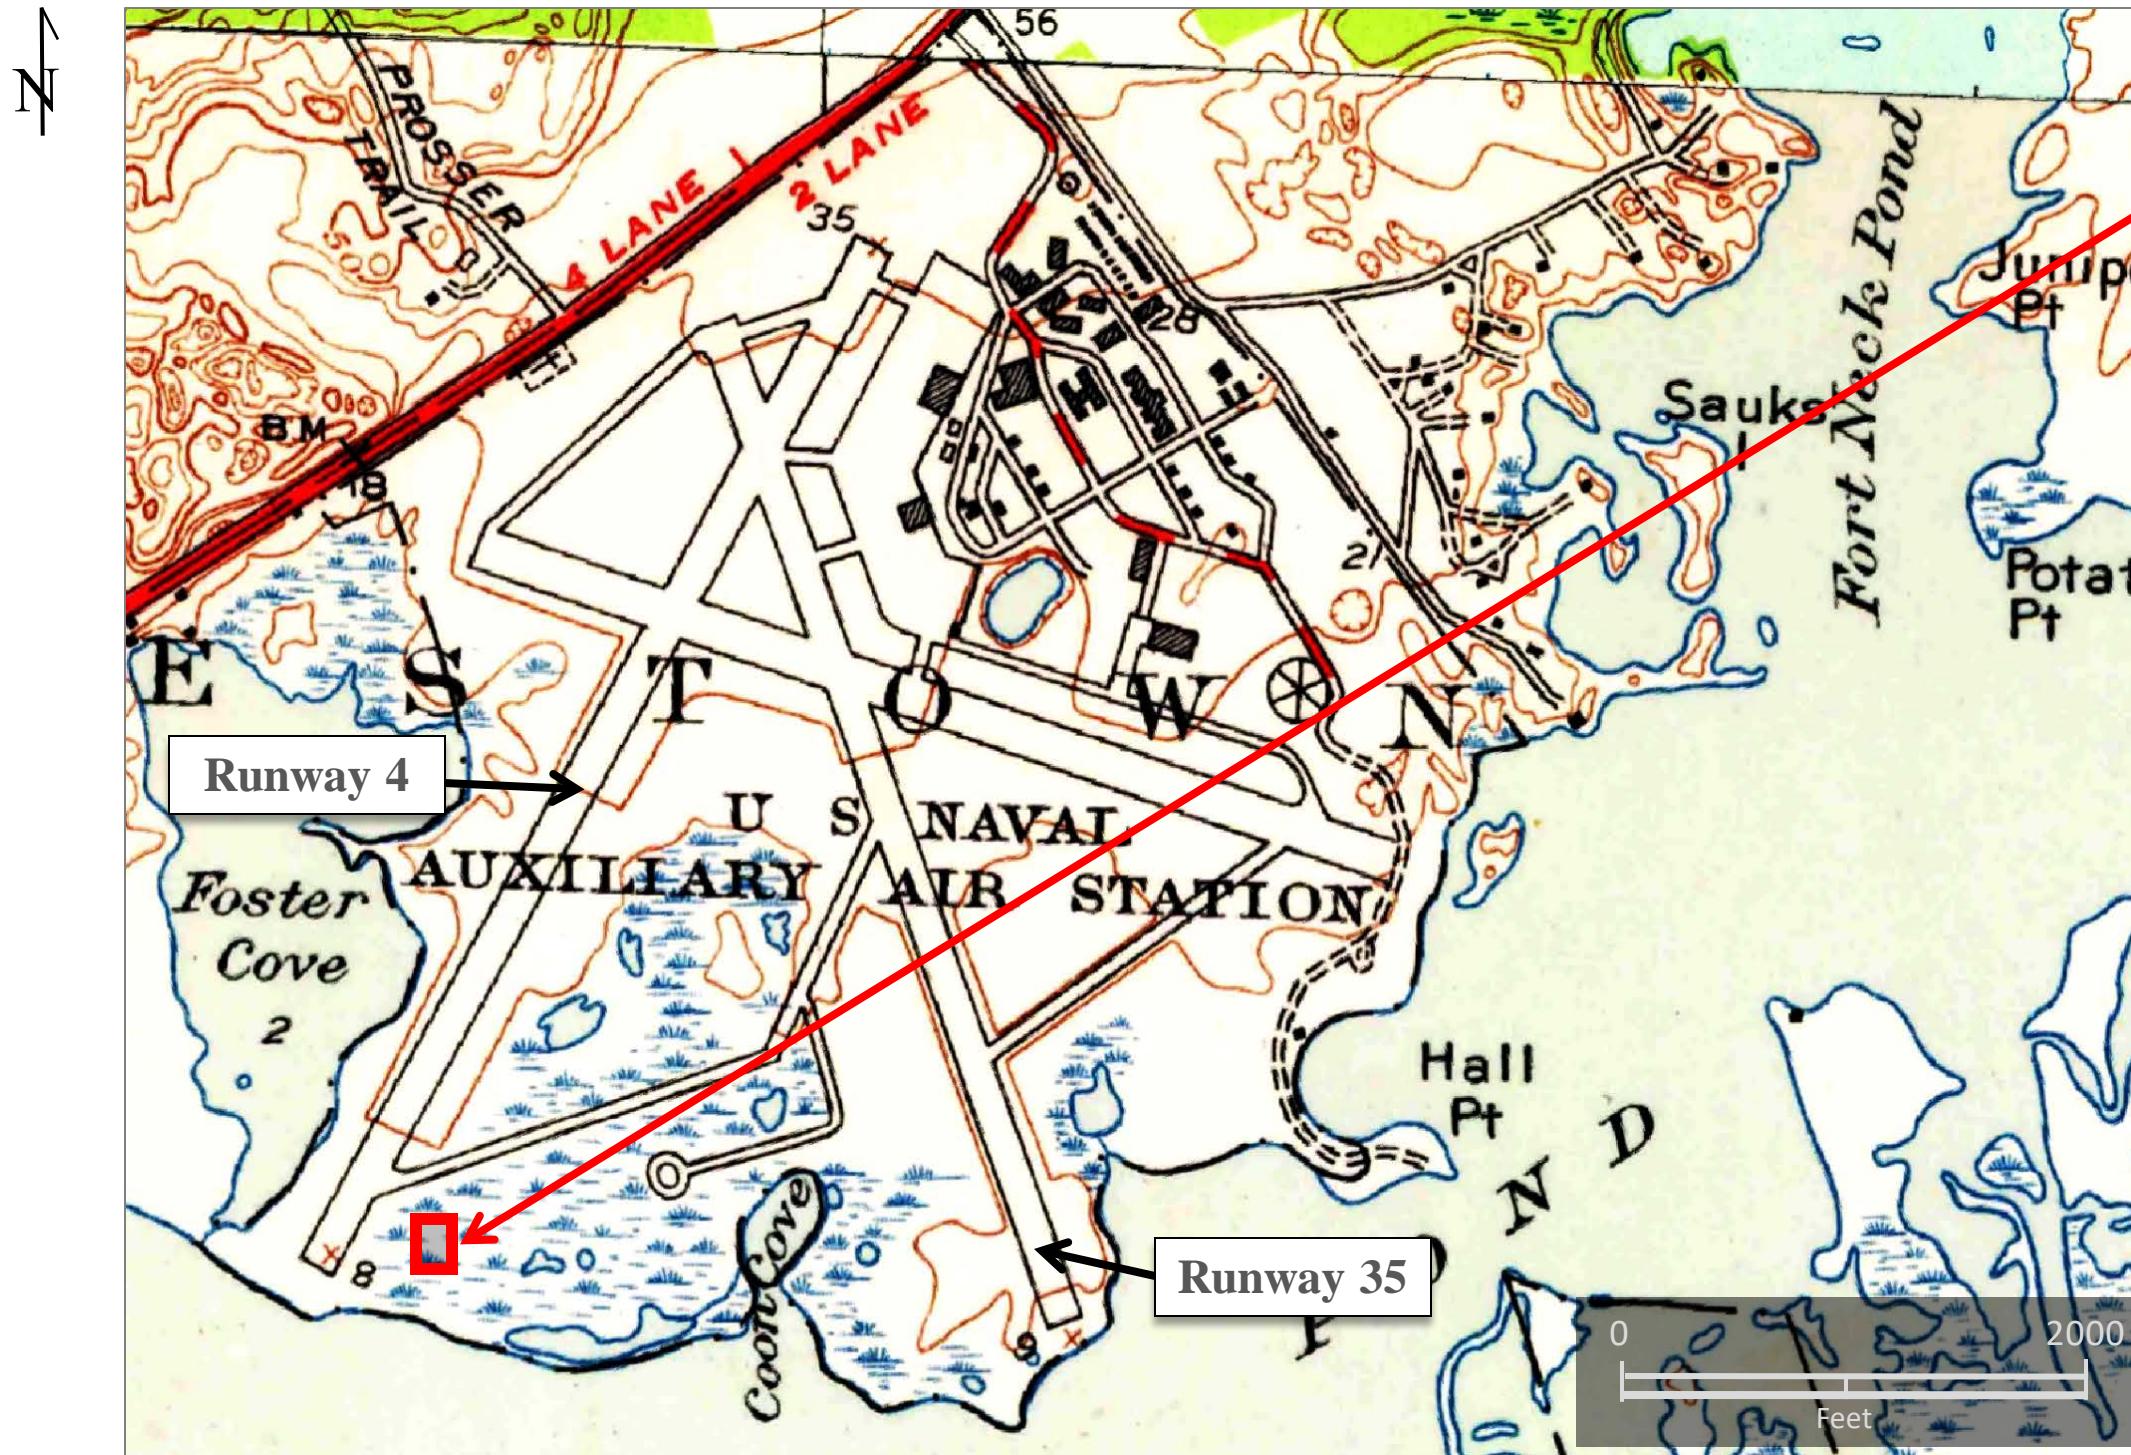
LOCATIONAL DATA – MAP INFORMATION

General area of a 25 & 50 Yard Firing Range identified graphically on a U.S. Navy layout plan, "Showing Conditions on June 30, 1943."¹

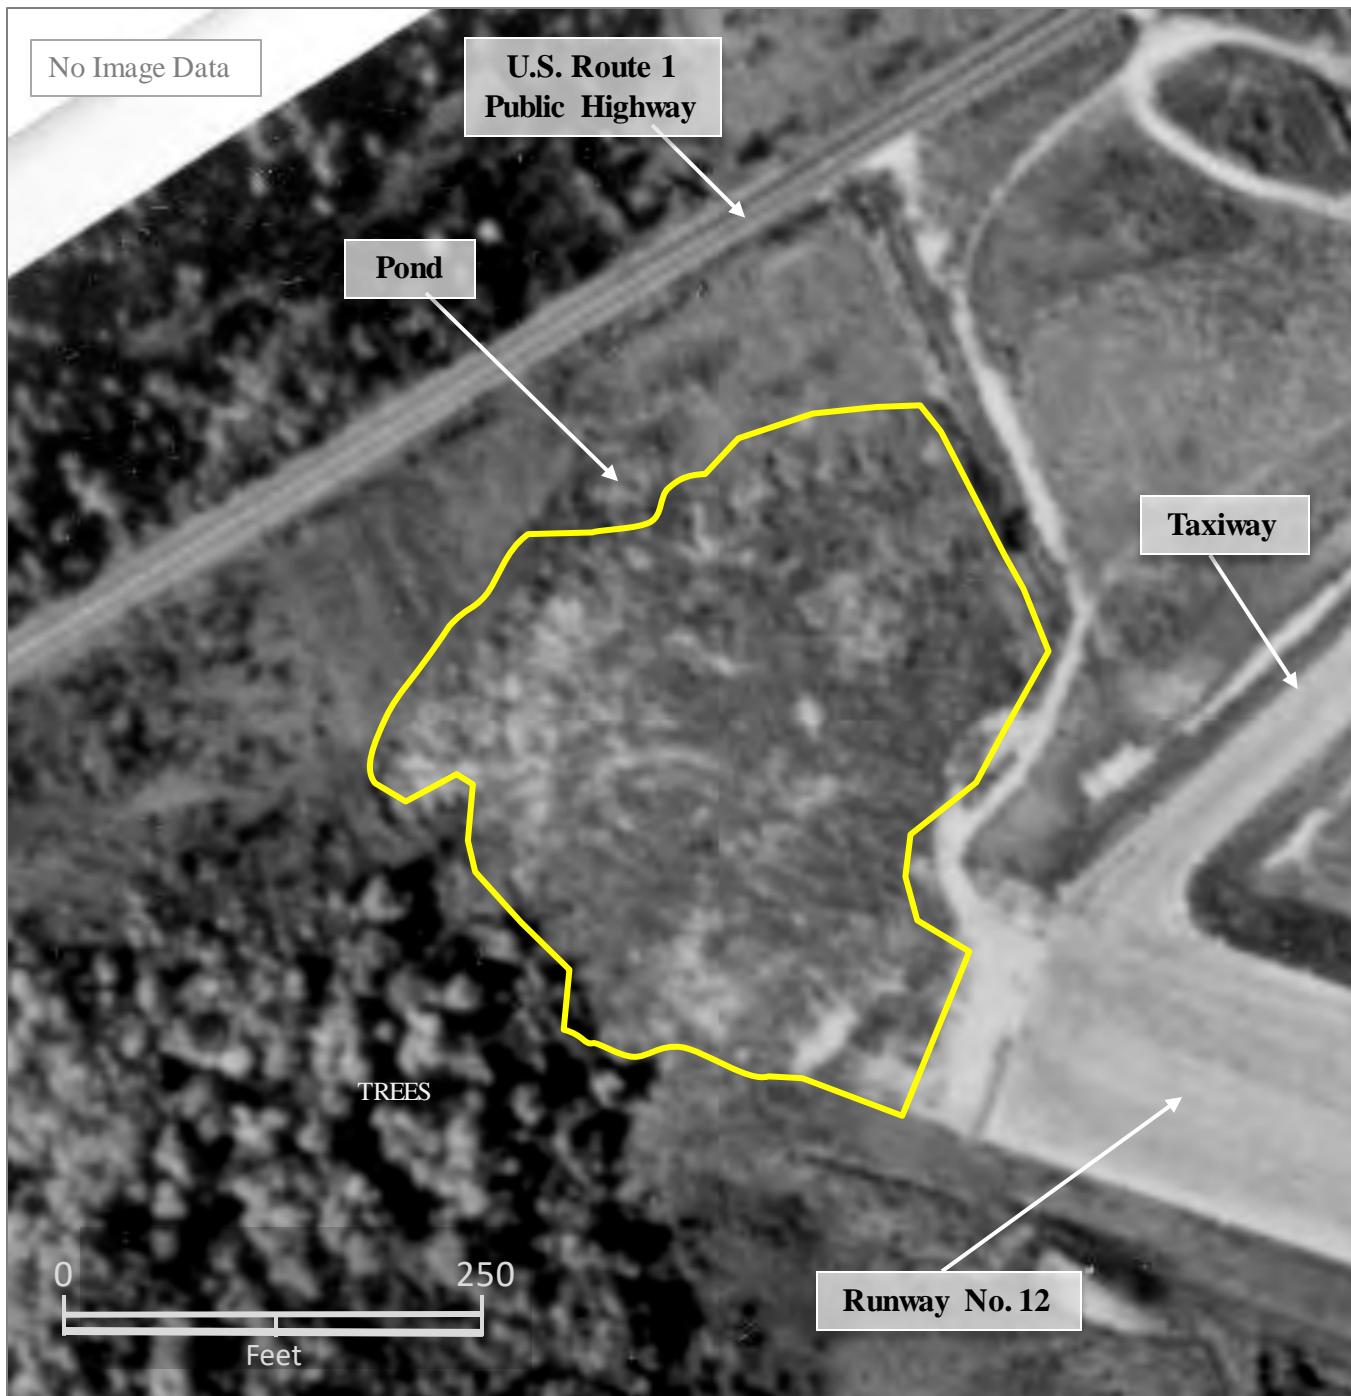
16 October 1947

Ground Scars

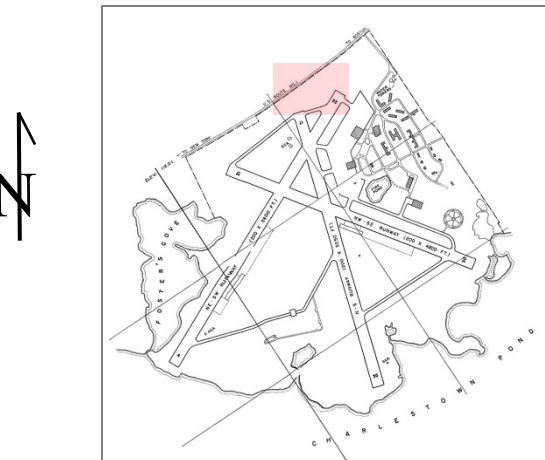
A single area of disturbed ground is first identified on October 1942 historical aerial photography.

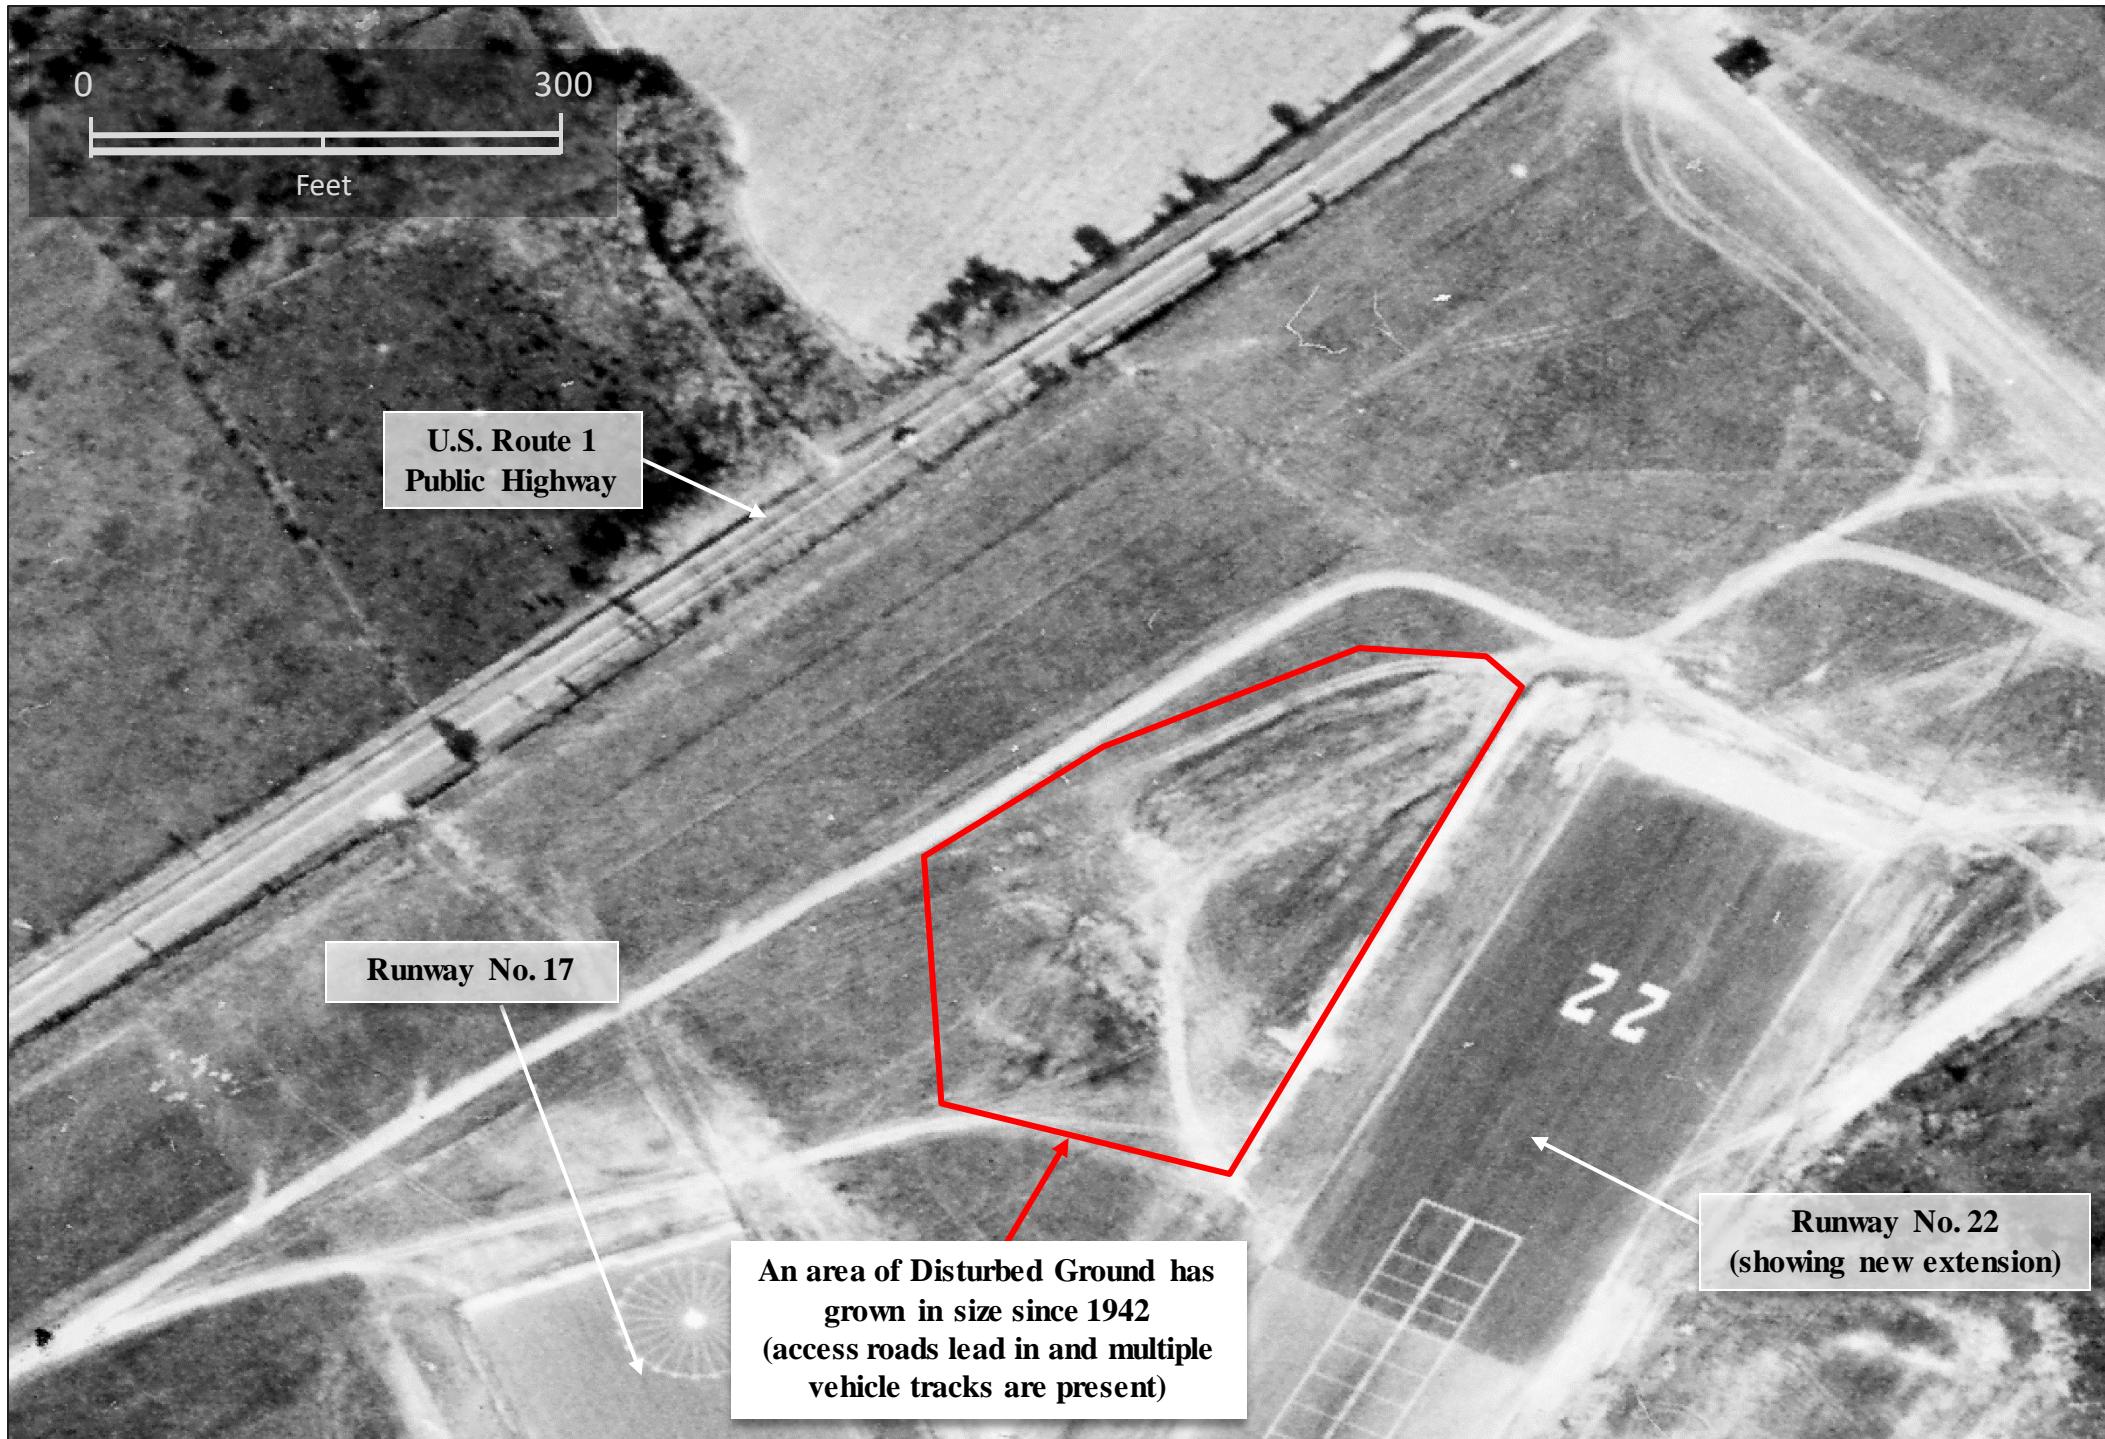
12 October 1943

An area of disturbed ground, first identified in October 1942, continues to appear active in October 1943. It is also noted that the areal extent of the disturbed ground has grown since last observed in 1942 (see previous page).

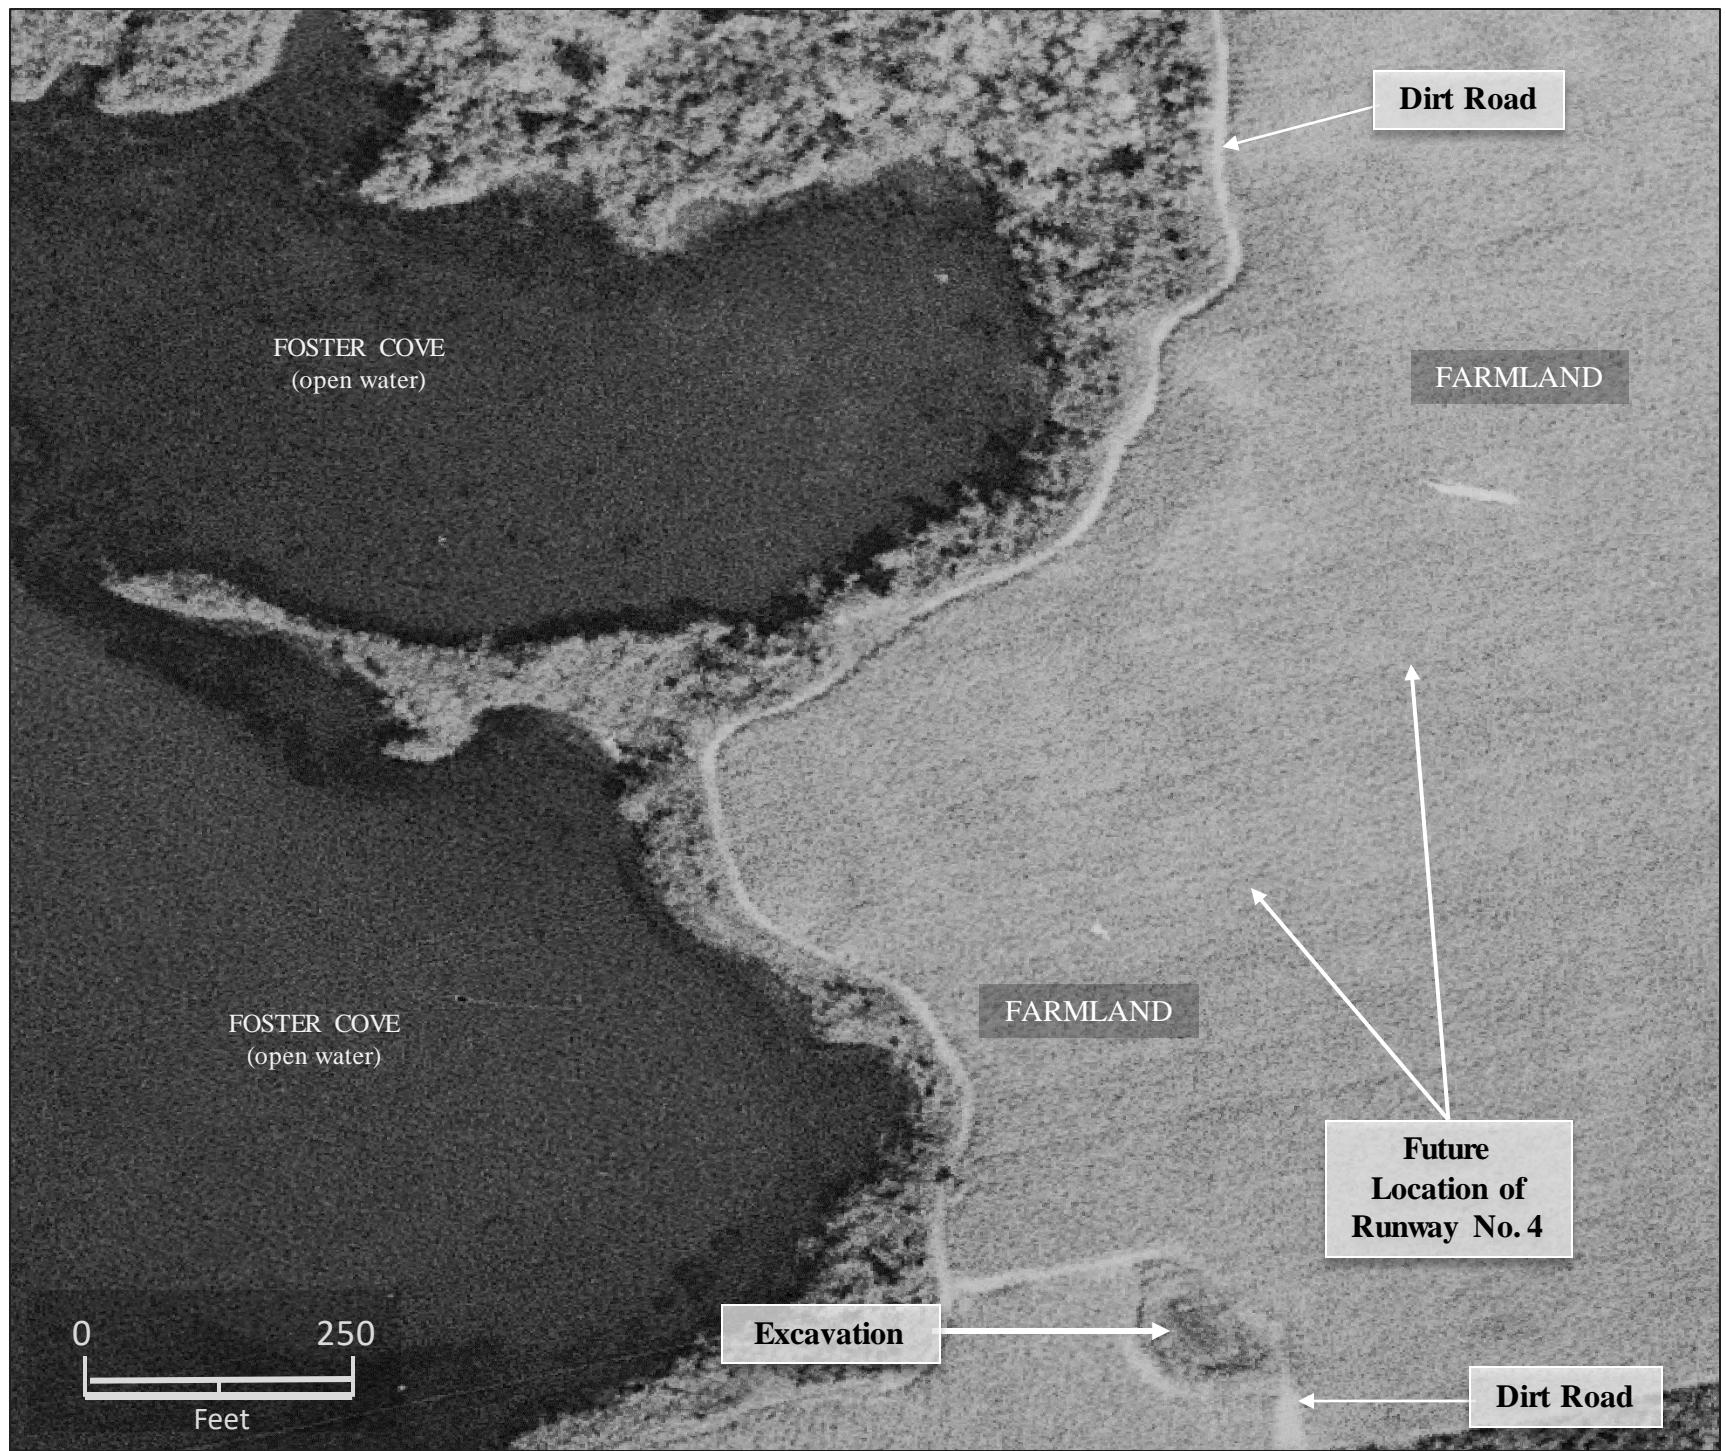
09 October 1941

An undisturbed agricultural farm field under private ownership is observed at this location near Foster Cove on October 1941 aerial photography.

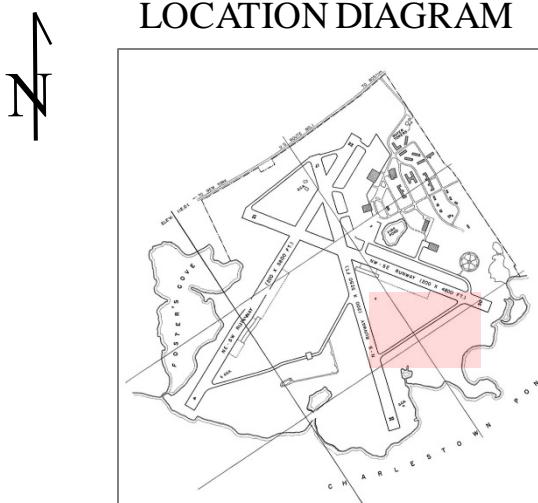
A former area of disturbed ground remains to be identified as ground scars in 1980 (see left). Unlike the aerial view of 1970, it is noted that native grasses appear to be growing on the surface of this ground scarred area (in 1980).

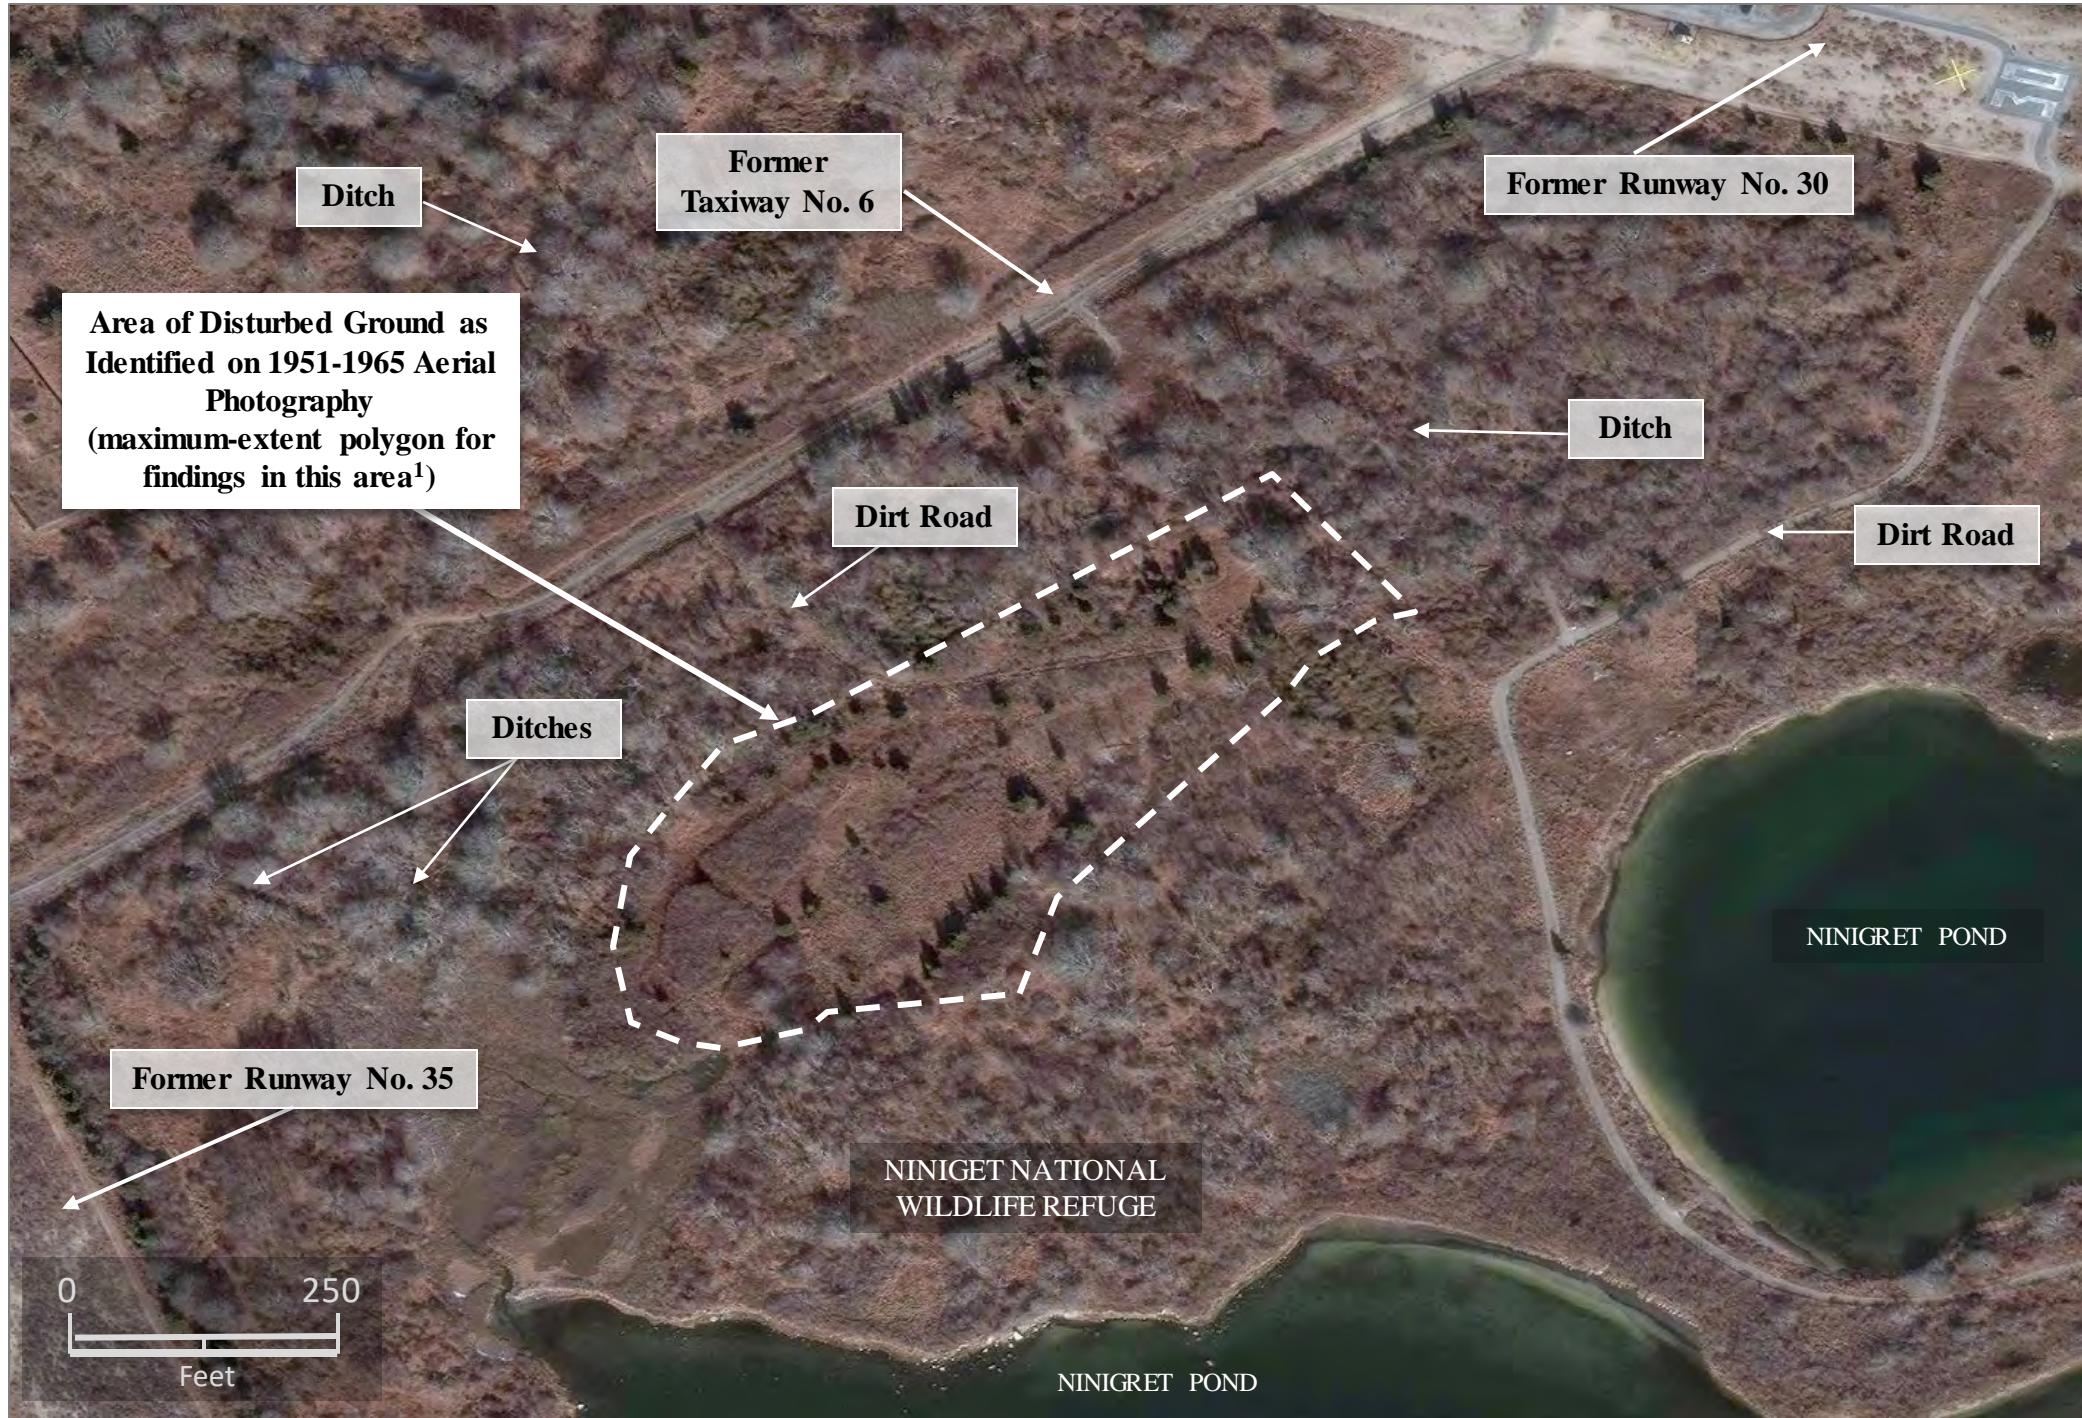
02 February 2016

1. Note: this maximum-extent polygon was generated in ArcGIS Version 10.4 operating software utilizing geo-referenced historical aerial data.
