25 June 2024

**Subject: Final 2023 Long Term Management Letter Report  
Former South Beach Moving Target Machine Gun and  
Katama Rocket Range Munitions Response Site  
Martha's Vineyard, Massachusetts  
Contract No. W912DR22C0044**

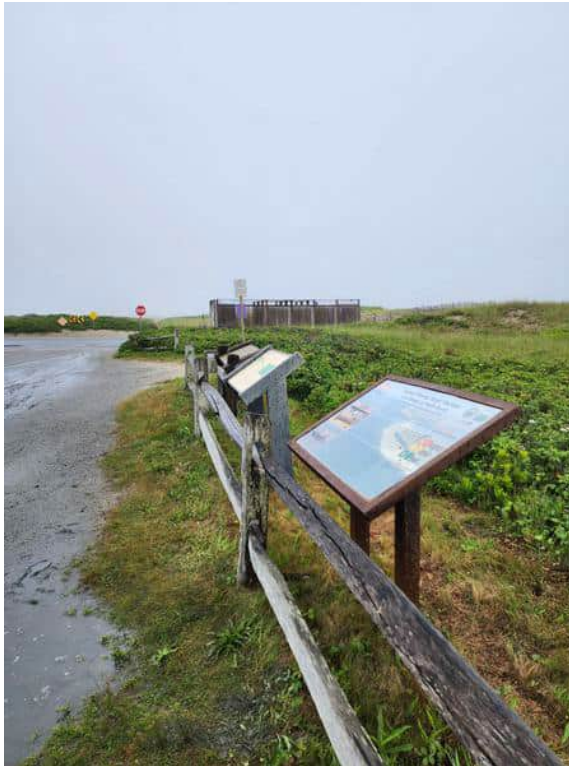
View of location of pedestrian 3Rs sign near Left Fork bus stop, in proximity to other informational signage.

For the Wasque Fishing Trail sign location, GSINA recommends that the sign be moved 30 meters south to the trail entrance for increased visibility. The sign at the Left Fork location was recorded as critical condition due to poor location. GSINA recommends that an additional sign be installed, or that the current sign be moved nearer to the beach entrance. It was noted that the dunes near the Right Fork location had been reconstructed and the sign is now no longer near the entrance to the beach path.

<b>8. South Beach Left Fork (Bus Stop)</b>  GPS: N 41 20.9620 W 070 30.7346	<b>CRITICAL</b>  Due to poor location	Cleaned – 24 June 2023	The sign has 7 chips in the surface. The sign and post are in good condition. The location of the sign is poor. The bus stop is between the sign and the beach entrance. The passengers do not pass the sign. Also, there is a parking spot across the road and individuals do not walk by the sign. South Beach Left Fork (Bus Stop) Beach Path was named Beach Path #1 when dunes were reconstructed. That is where we need to place a new sign. Recommend putting an additional sign nearer the beach entrance or move the sign.

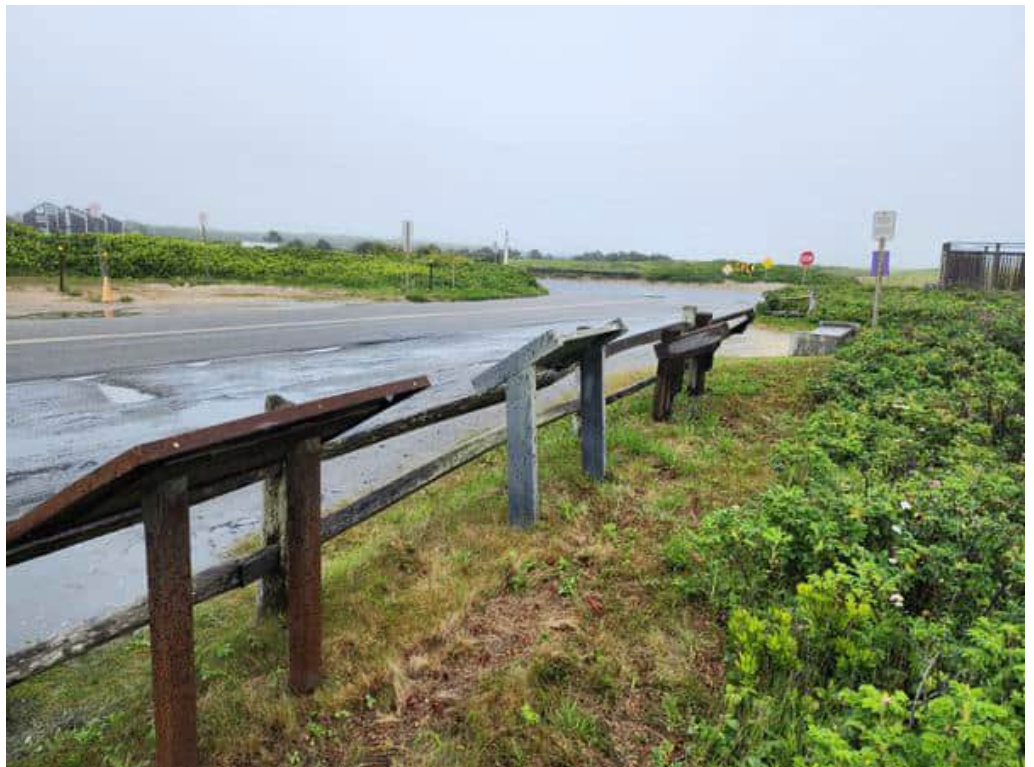
View of the back side of sign and location relative to other informational signage.

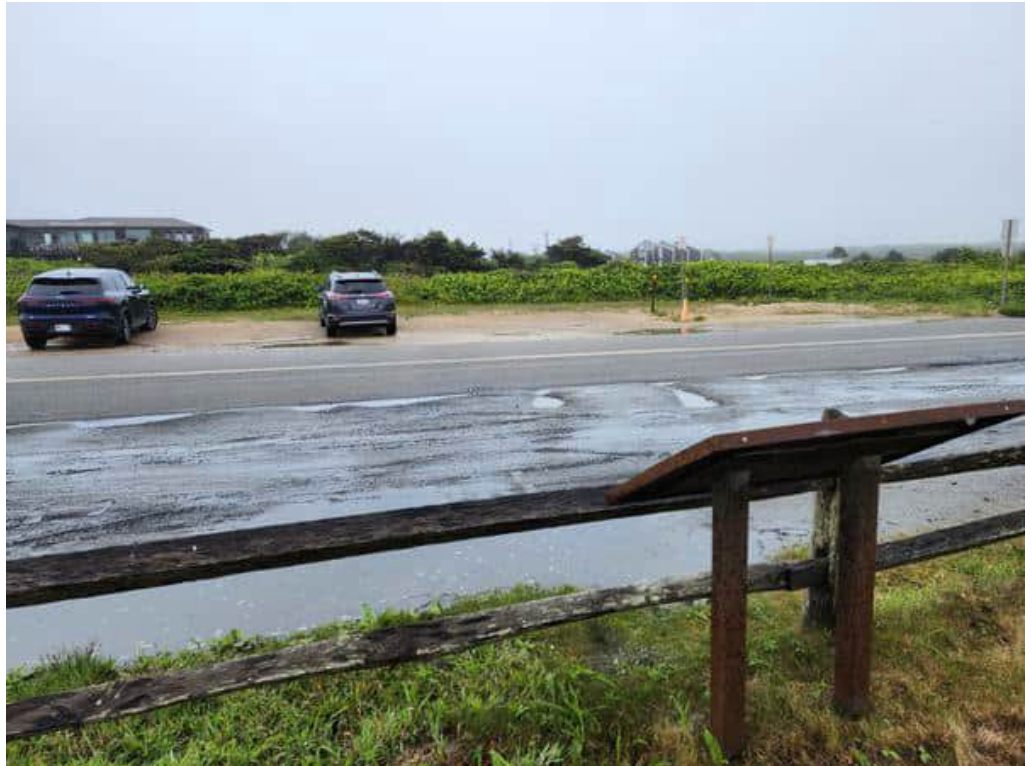
View of location of pedestrian 3Rs sign, across the street from parking area.

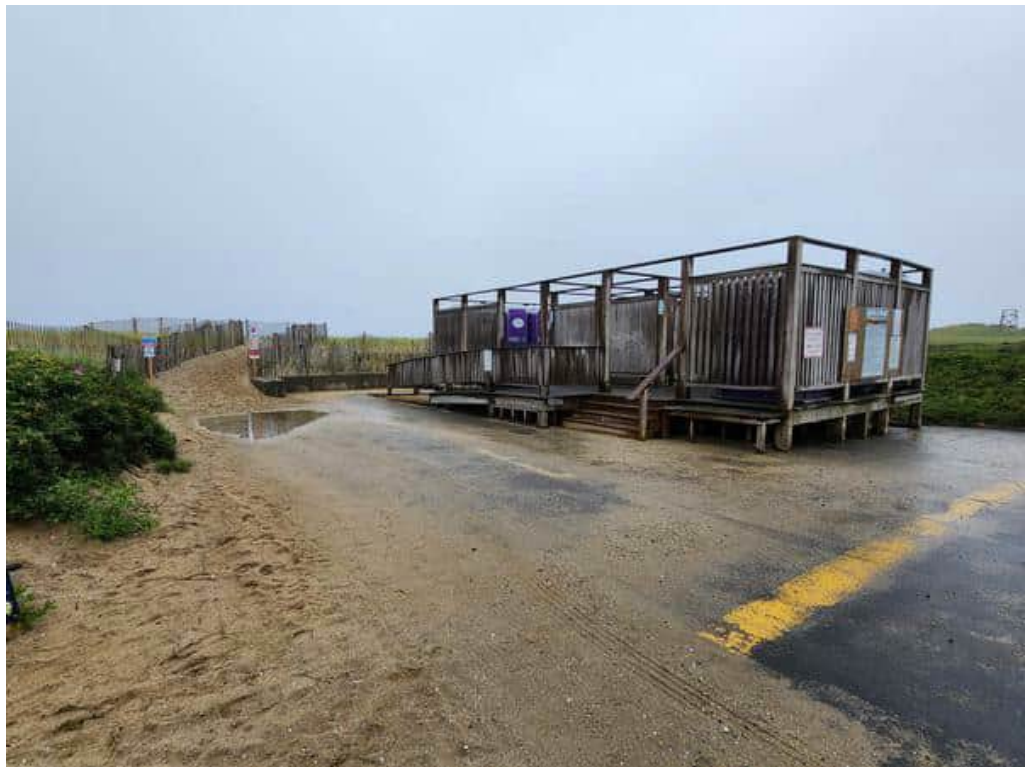
View of Left Fork bus stop entrance. 3Rs sign not easily visible from bus stop or beach path entrance.

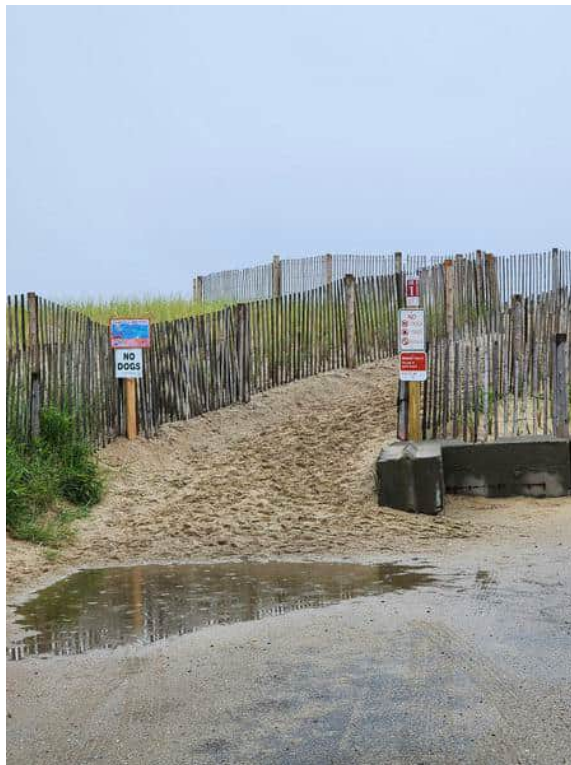
Beach path #1 near Left Fork bus stop. 3Rs sign not easily visible from path entrance.

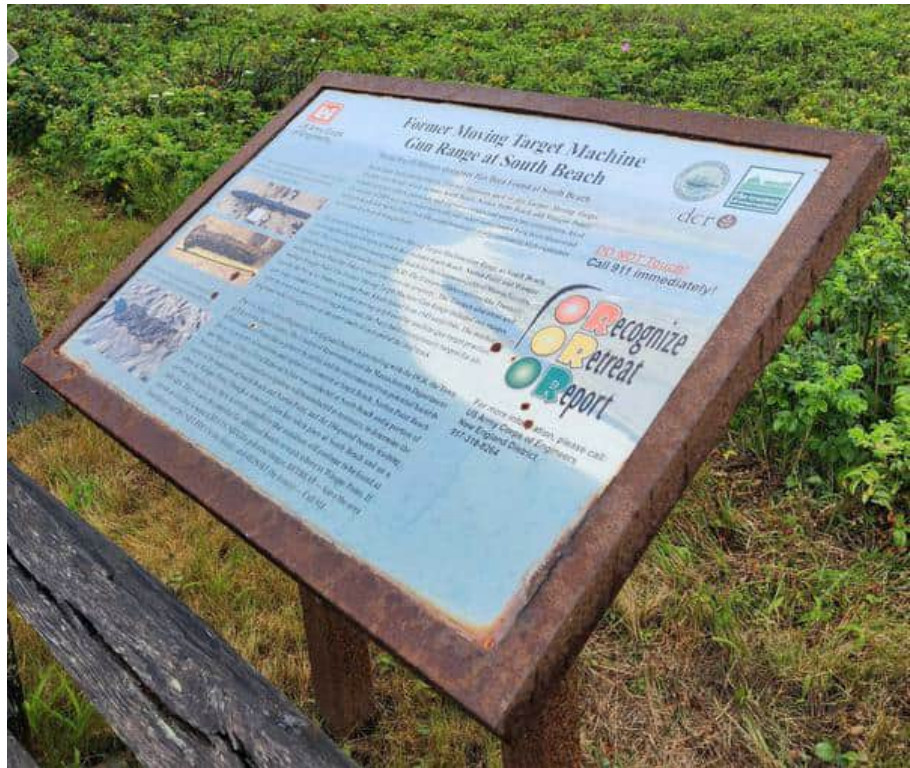
**Location:**  
South Beach Left Fork (Bus  
Stop)

**Description:**  
Front view of pedestrian 3Rs  
sign before inspection and  
cleaning.

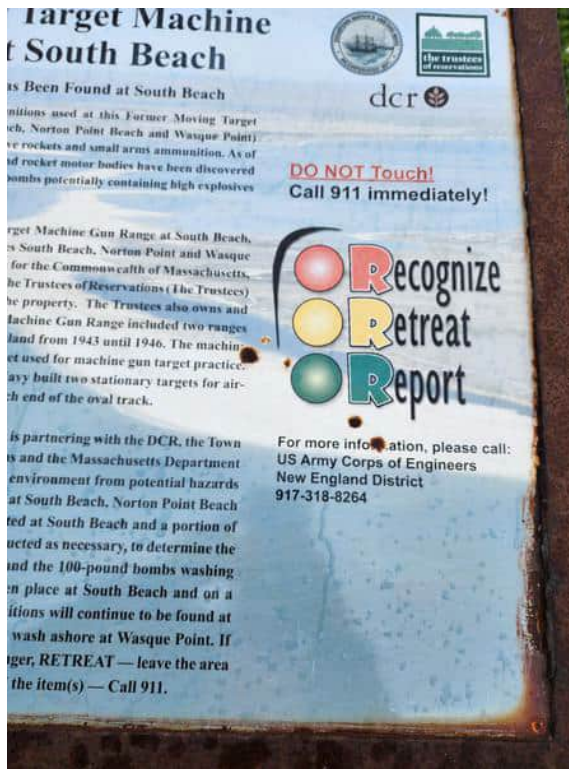
**Location:**  
South Beach Left Fork (Bus  
Stop)

**Description:**  
Close up view of pedestrian  
3Rs sign right side. Rust and  
chipping visible on display  
surface.

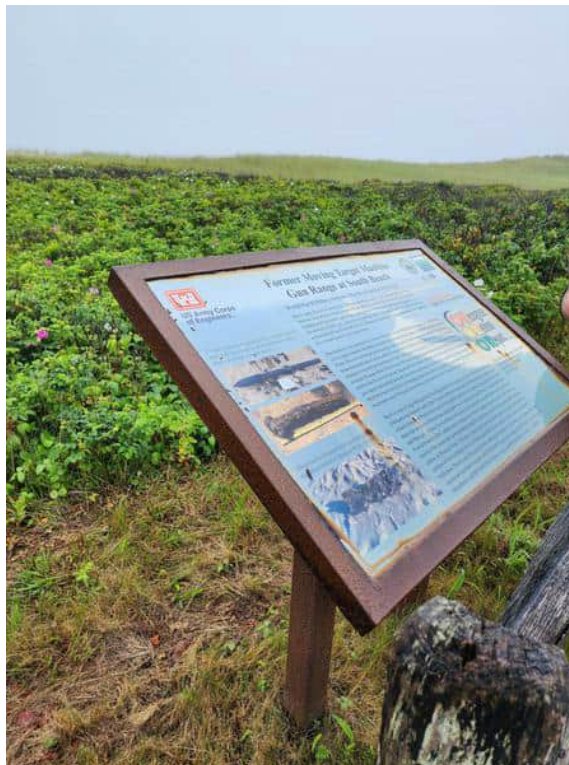
**Location:**  
South Beach Left Fork (Bus  
Stop)

**Description:**  
Left side view of sign before  
inspection and cleaning.

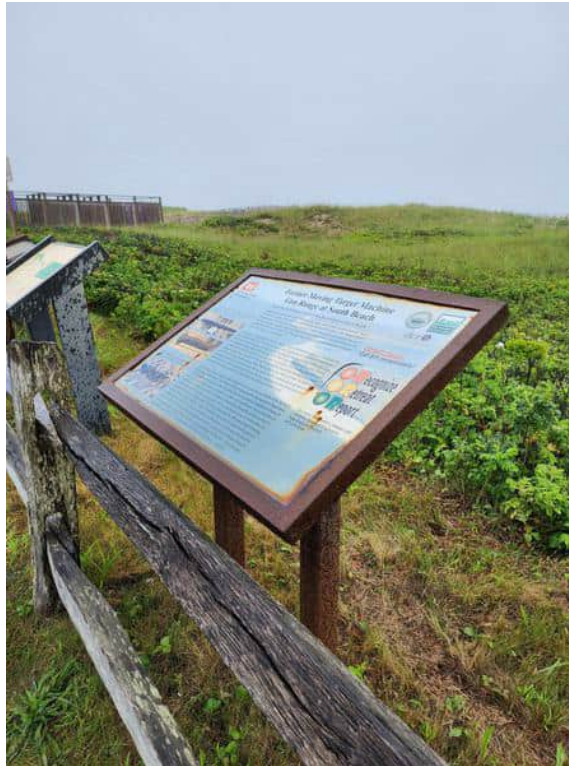
**Location:**  
South Beach Left Fork (Bus Stop)

**Description:**  
Right side view of sign before inspection and cleaning.

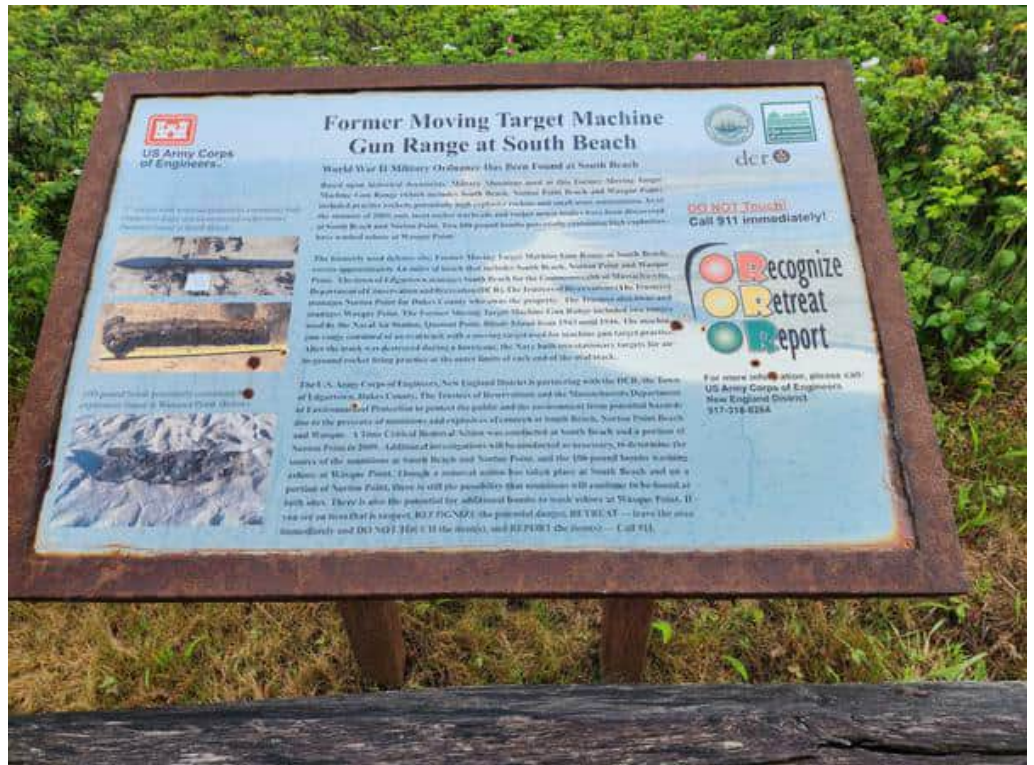
**Location:**  
South Beach Left Fork (Bus Stop)

**Description:**  
Front view of pedestrian 3Rs sign after inspection and cleaning.

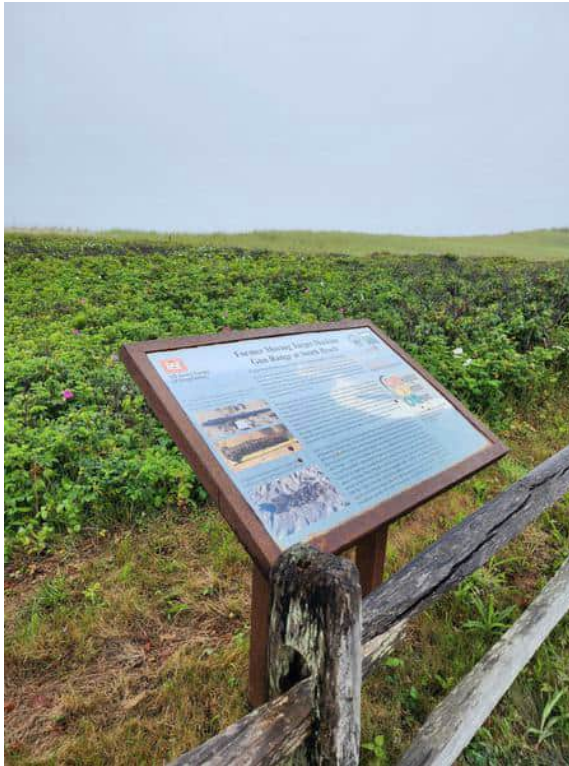
**Location:**South Beach Left Fork  
(Bus Stop)**Description:**Left side view of sign after  
inspection and cleaning.

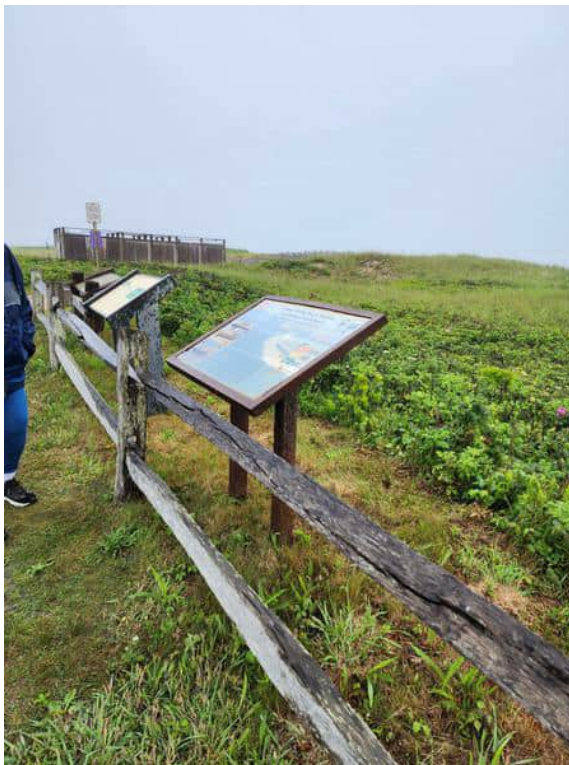
**Location:**South Beach Left Fork (Bus  
Stop)**Description:**Right side view of sign after  
inspection and cleaning.

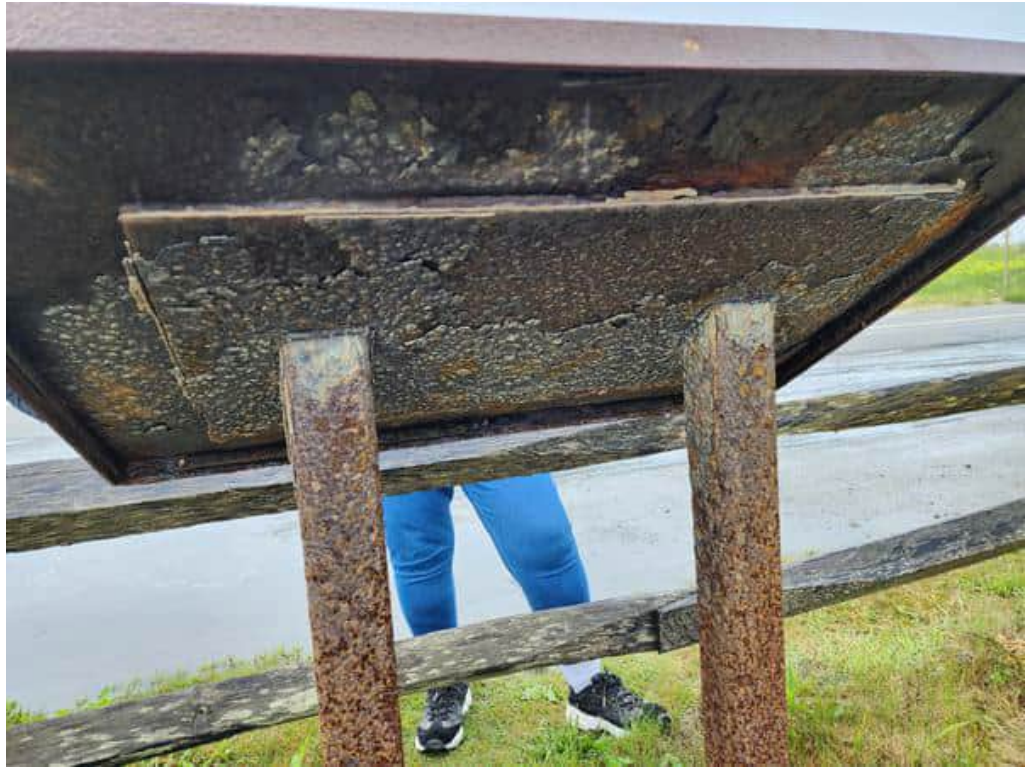
**Location:**  
South Beach Left  
Fork (Bus Stop)

**Description:**  
View of underside of  
pedestrian 3Rs sign.

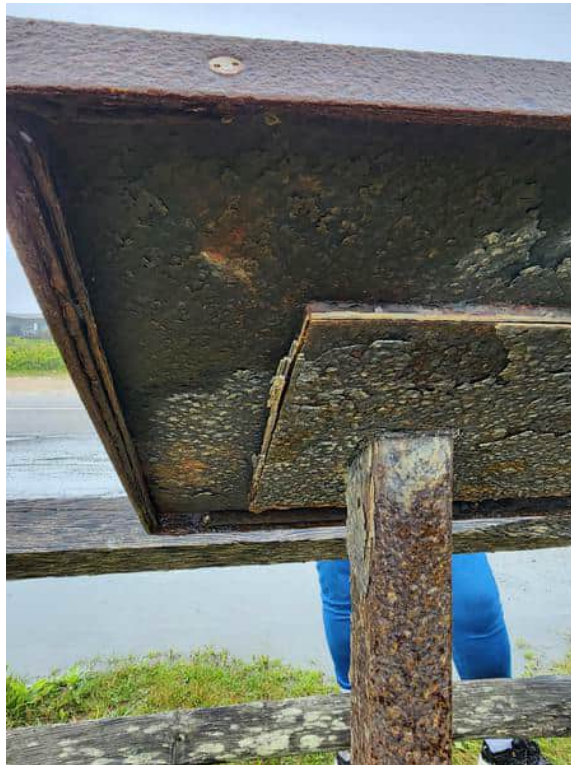
**Location:**  
South Beach Left Fork (Bus  
Stop)

**Description:**  
Close up of right underside of  
sign. Rust visible.

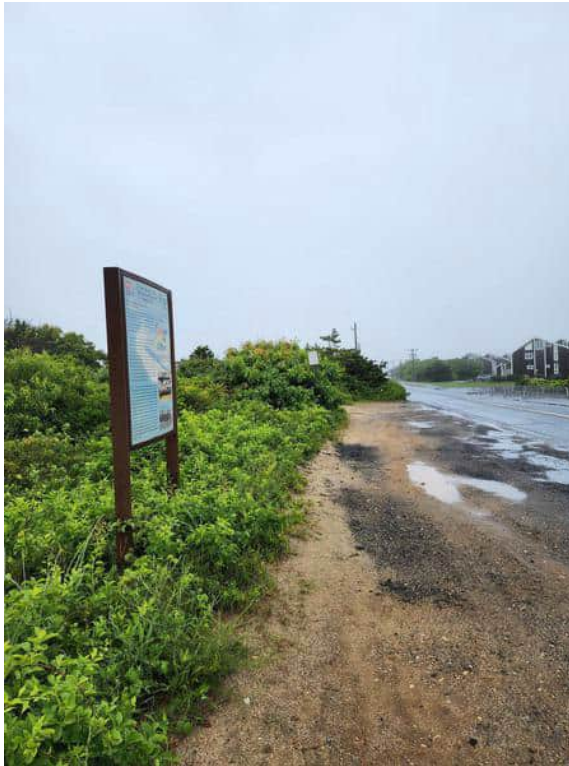
View of location of 3Rs  
vehicle sign at Left Fork tire  
deflation station, facing east.

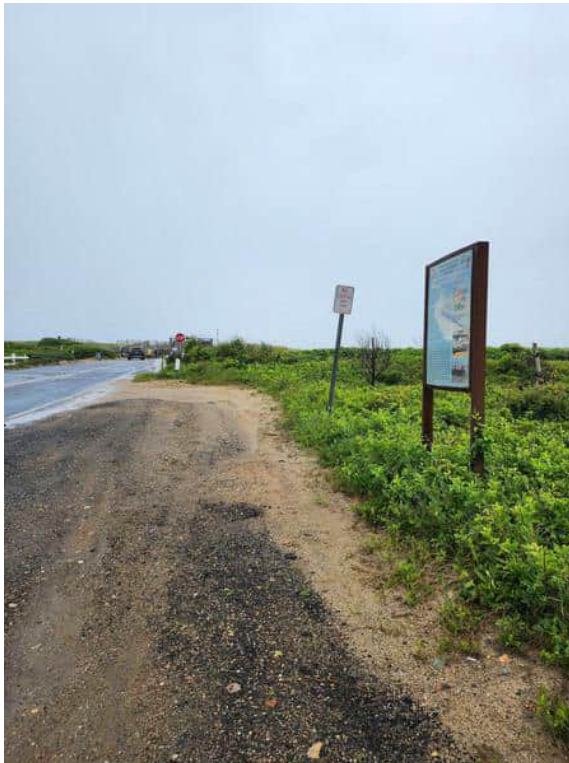
View of location of 3Rs  
vehicle sign at Left Fork tire  
deflation station, facing west.

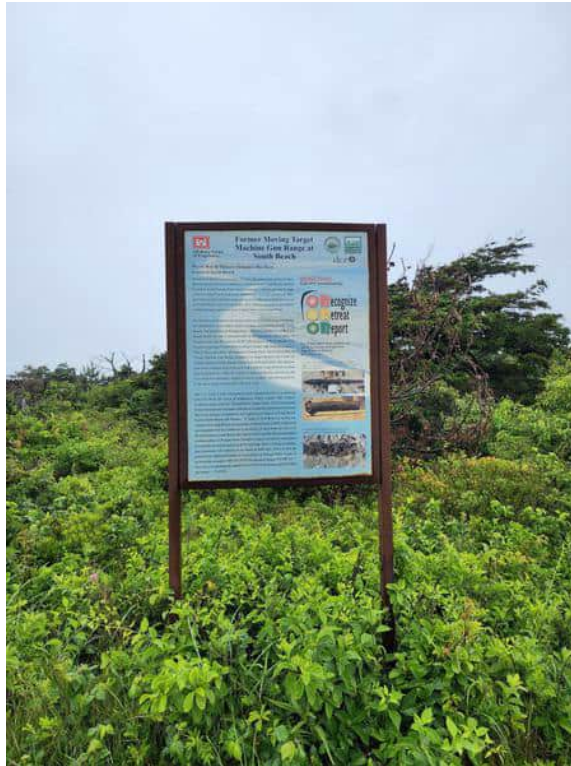
**Location:**  
Left Fork Tire Deflation Area

**Description:**  
Front view of sign before  
inspection and cleaning.

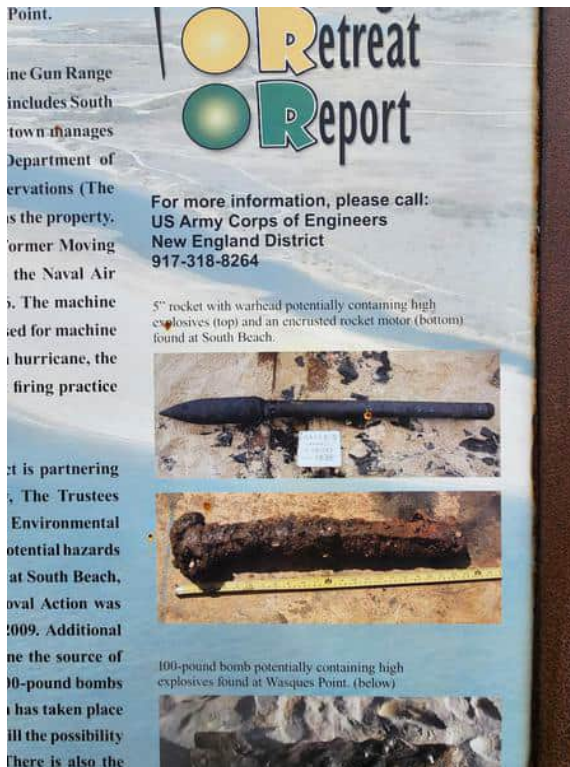
**Location:**  
Left Fork Tire Deflation Area

**Description:**  
Close up view of 3Rs vehicle  
sign. Rust and chipping  
visible on display surface.

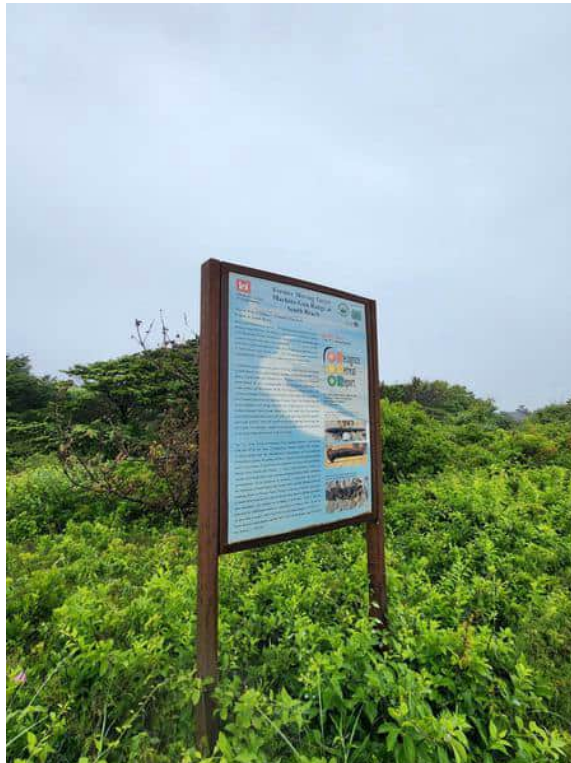
**Location:**  
Left Fork Tire Deflation Area

**Description:**  
Left side view of sign before inspection and cleaning.

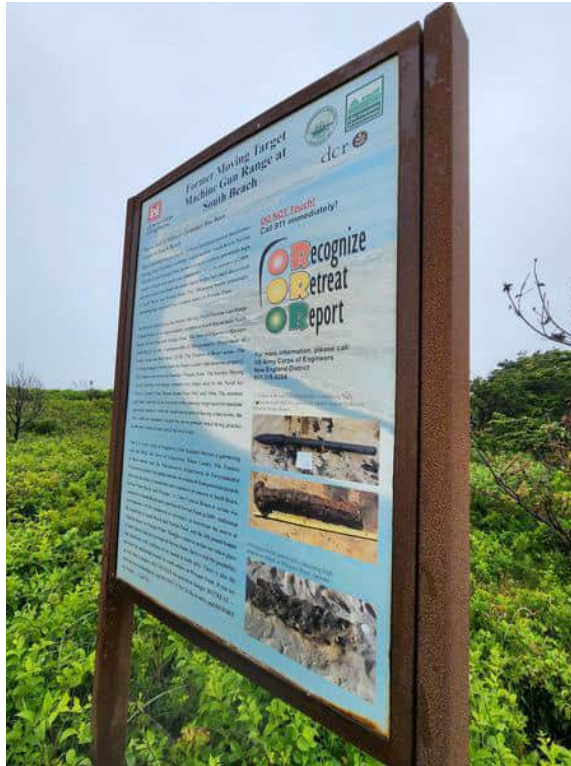
**Location:**  
Left Fork Tire Deflation Area

**Description:**  
Right side view of sign before inspection and cleaning.

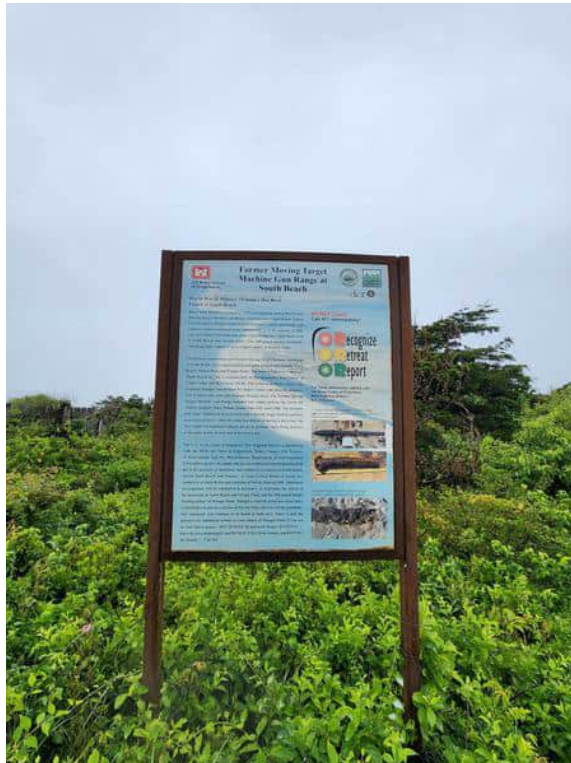
**Location:**  
Left Fork Tire Deflation Area

**Description:**  
Front view of sign after inspection and cleaning.

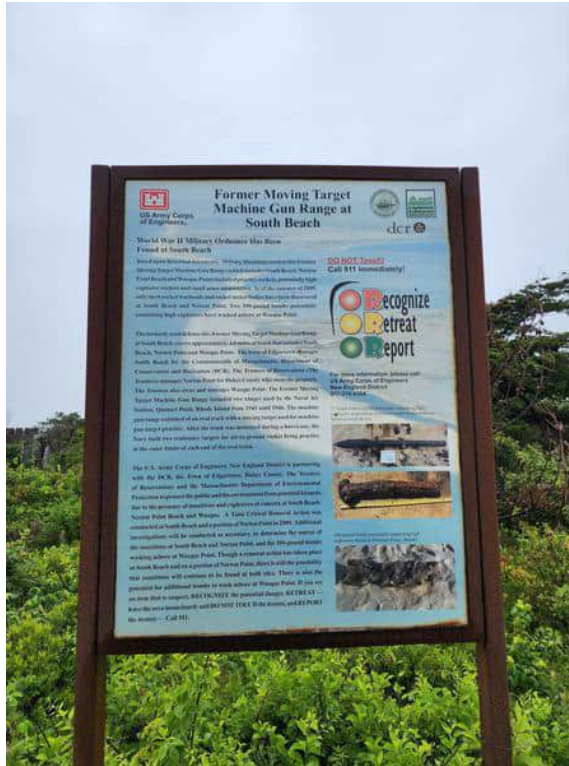
**Location:**  
Left Fork Tire Deflation Area

**Description:**  
Front view of sign after  
inspection and cleaning.

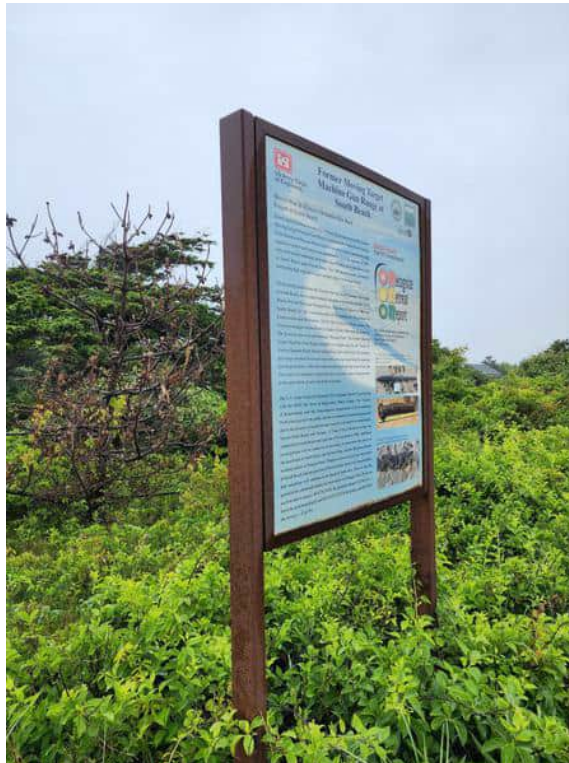
**Location:**  
Left Fork Tire Deflation Area

**Description:**  
Left side view of sign after  
inspection and cleaning.

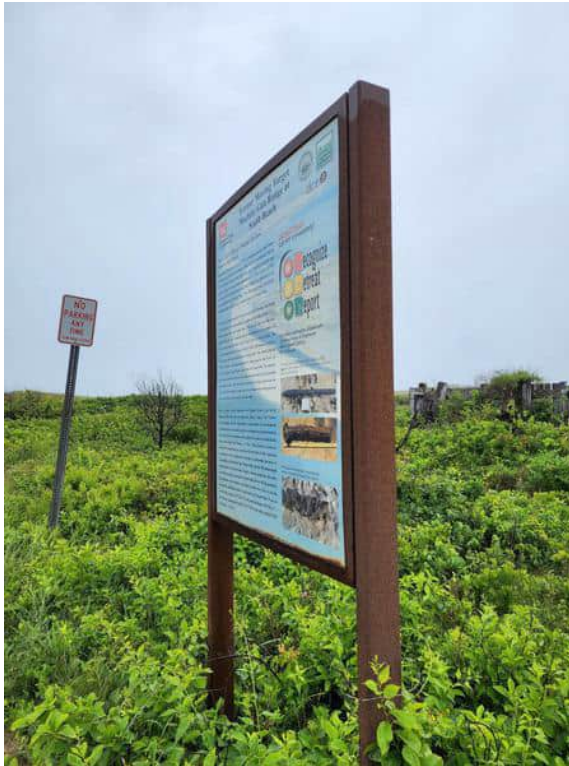
**Location:**  
Left Fork Tire Deflation Area

**Description:**  
Right side view of sign after  
inspection and cleaning.

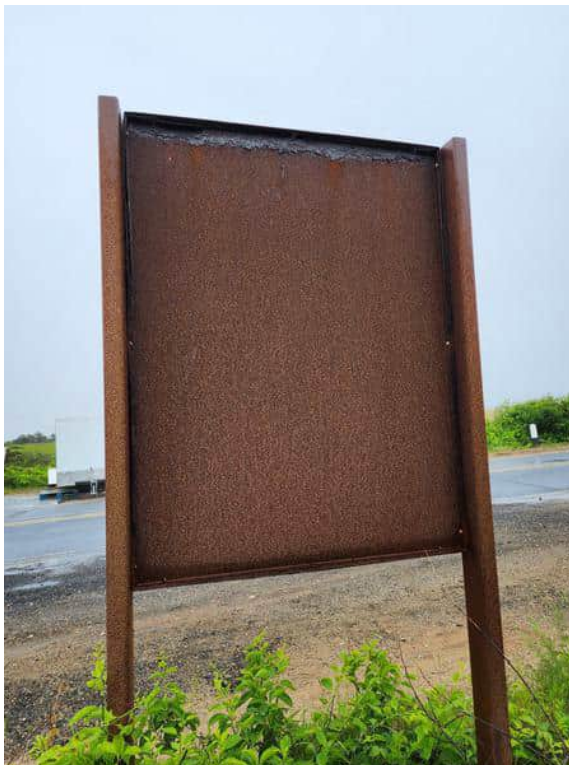
**Location:**  
Left Fork Tire Deflation Area

**Description:**  
Back side view of 3Rs vehicle  
sign at Left Fork Tire deflation  
station.

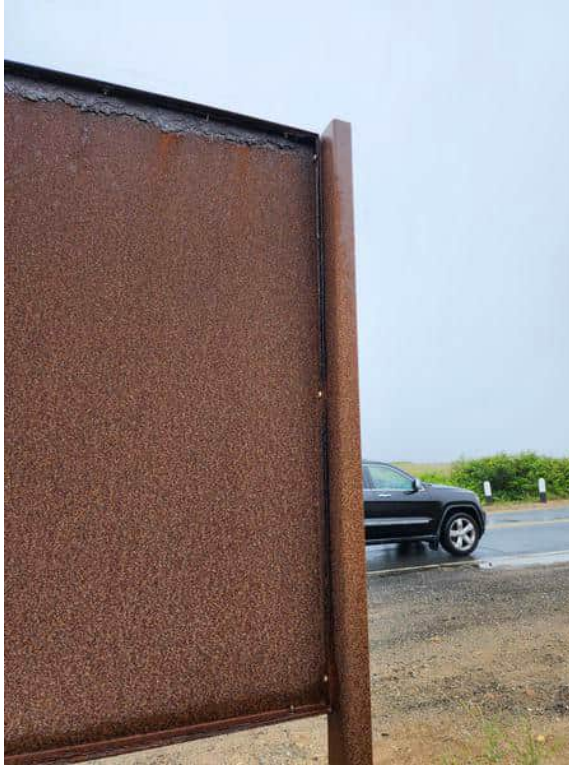
Close up view of left-back side of 3Rs vehicle sign. Rust visible.

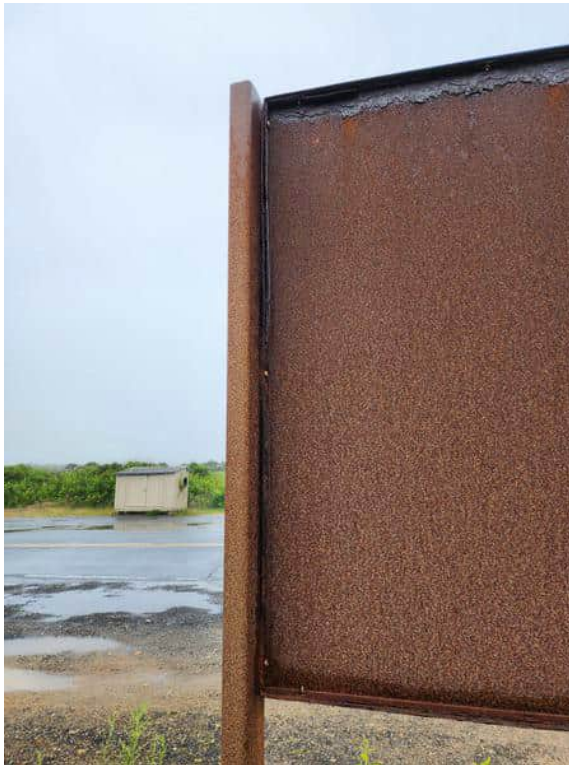
Close up view of right-back side of 3Rs vehicle sign. Rust visible.

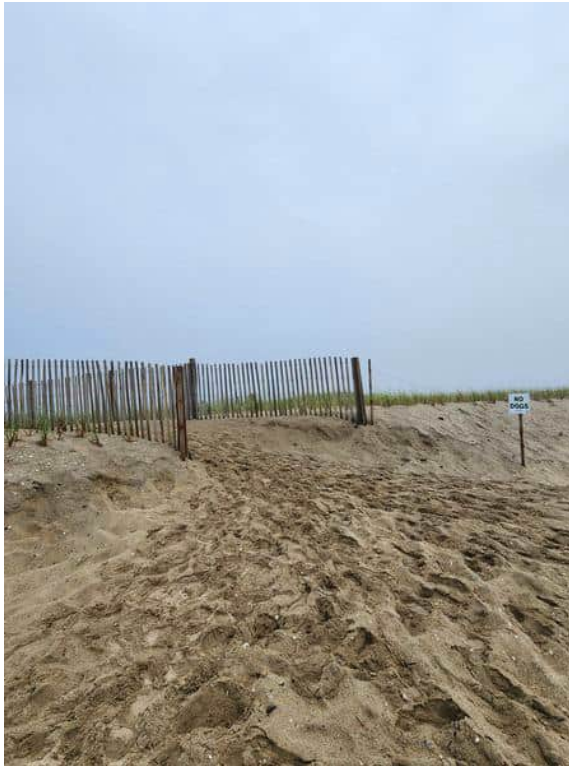
**Location:**Norton Point Trail Entrance  
Sign 2**Description:**View of Norton Point Trail  
entrance where 3Rs vehicle  
sign should be. Sign is  
missing.

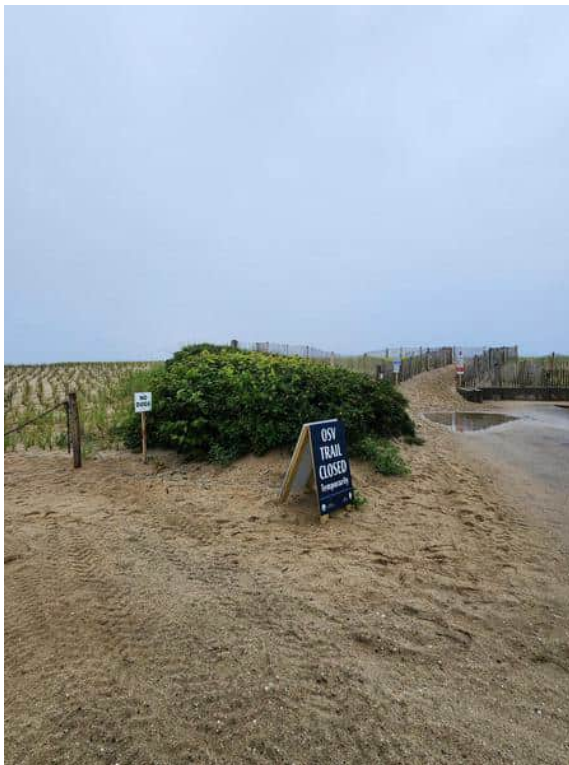
**Location:**Norton Point Trail Entrance  
Sign 2**Description:**View of sign indicating that  
the over-sand vehicle trail is  
temporarily closed.

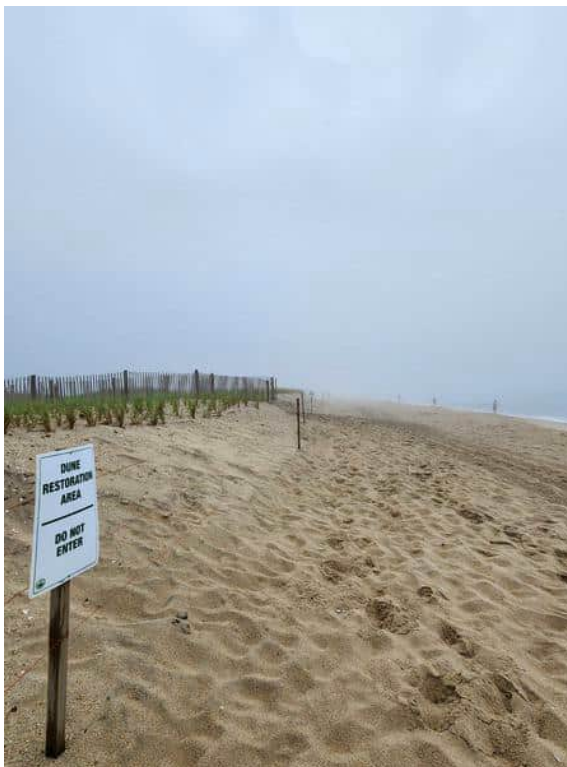
**Location:**  
Norton Point Trail Entrance  
Sign 2

**Description:**  
View of sign and fencing  
indicating that entrance to the  
dune area is restricted at this  
location.

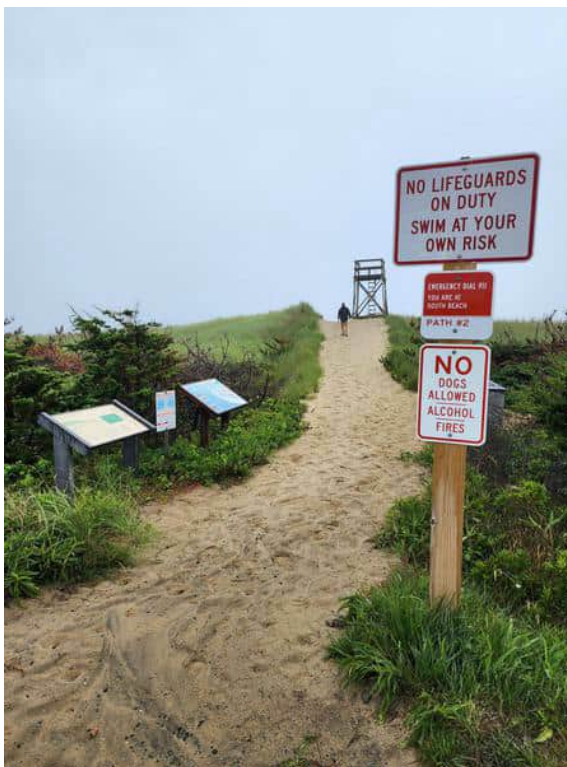
**Location:**  
Beach Path #2

**Description:**  
View of 3Rs pedestrian sign  
location relative to South  
Beach Path #2 signage and  
lifeguard tower.

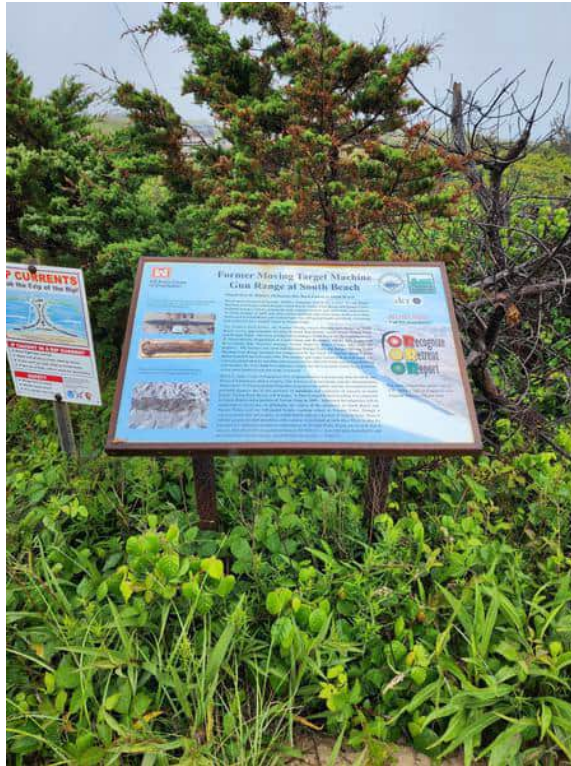
**Location:**  
Beach Path #2

**Description:**  
Front view of sign before  
inspection and cleaning.

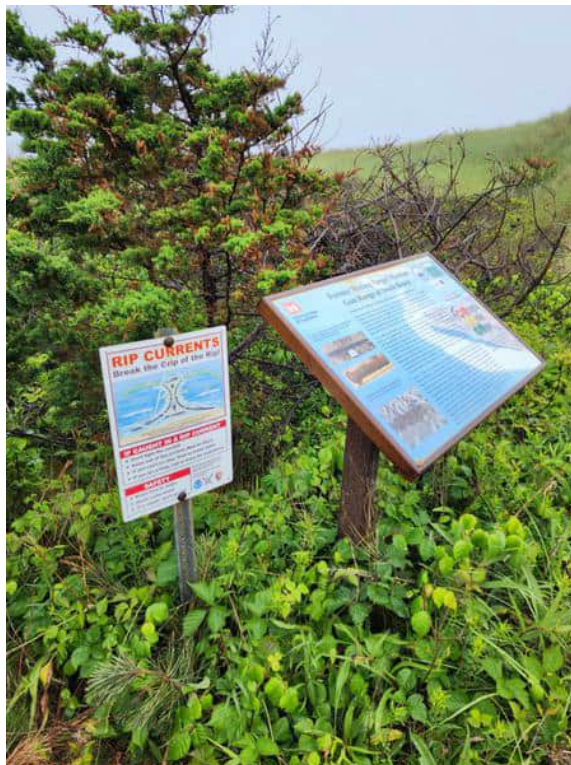
**Location:**  
Beach Path #2

**Description:**  
Left side view of 3Rs  
pedestrian sign before  
inspection and cleaning.

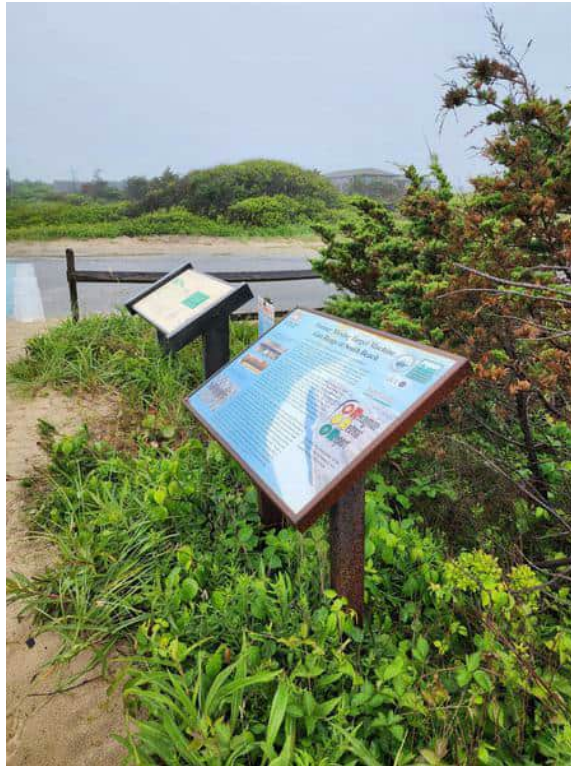
**Location:**  
Beach Path #2

**Description:**  
Right side view of 3Rs  
pedestrian sign before  
inspection and cleaning.

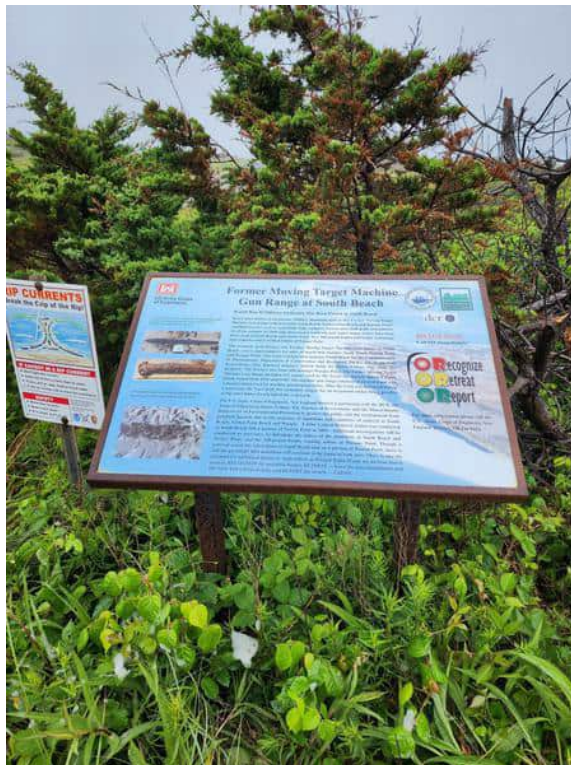
**Location:**  
Beach Path #2

**Description:**  
Front view of sign after  
inspection and cleaning.

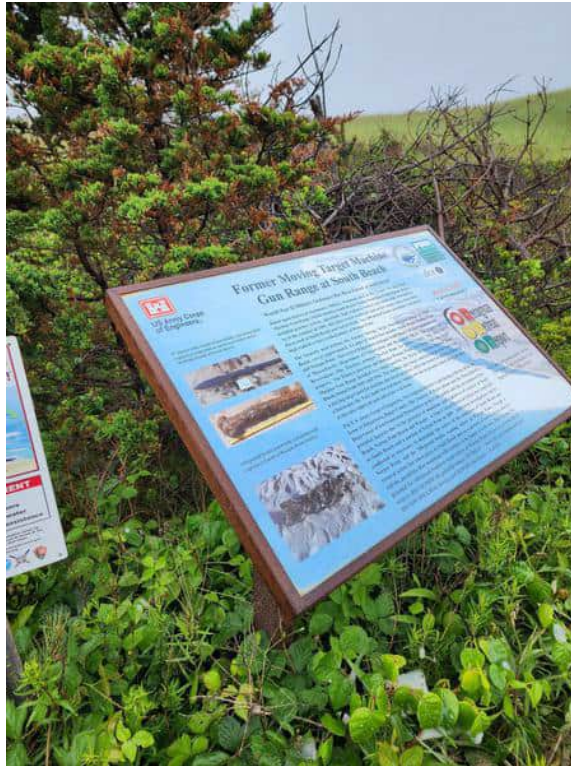
**Location:**  
Beach Path #2

**Description:**  
Left side view of 3Rs  
pedestrian sign after  
inspection and cleaning.

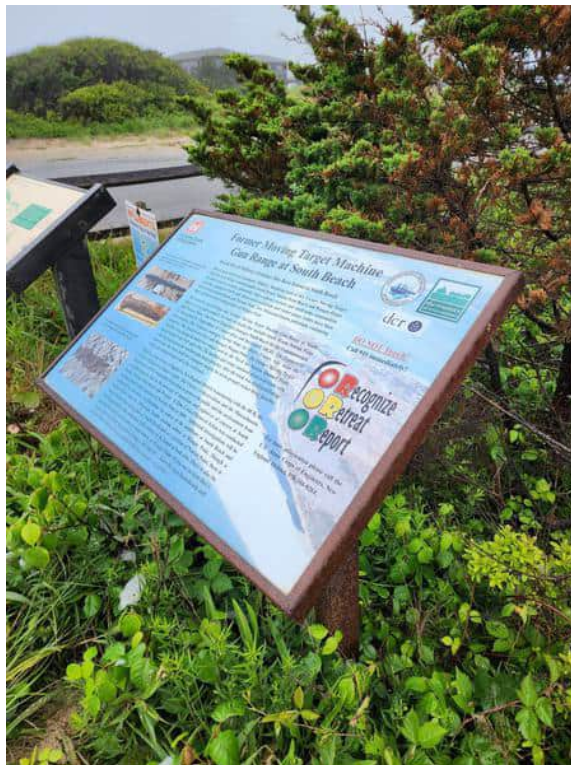
**Location:**  
Beach Path #2

**Description:**  
Right side view of 3Rs  
pedestrian sign after  
inspection and cleaning.

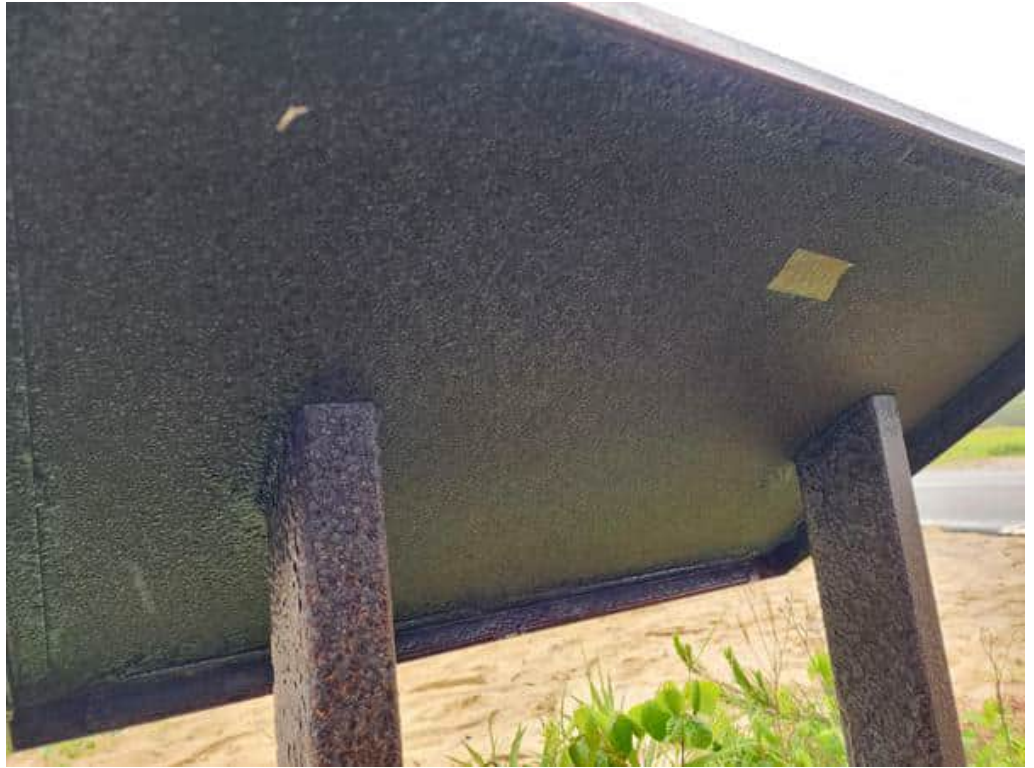
Underside view of 3Rs pedestrian sign.

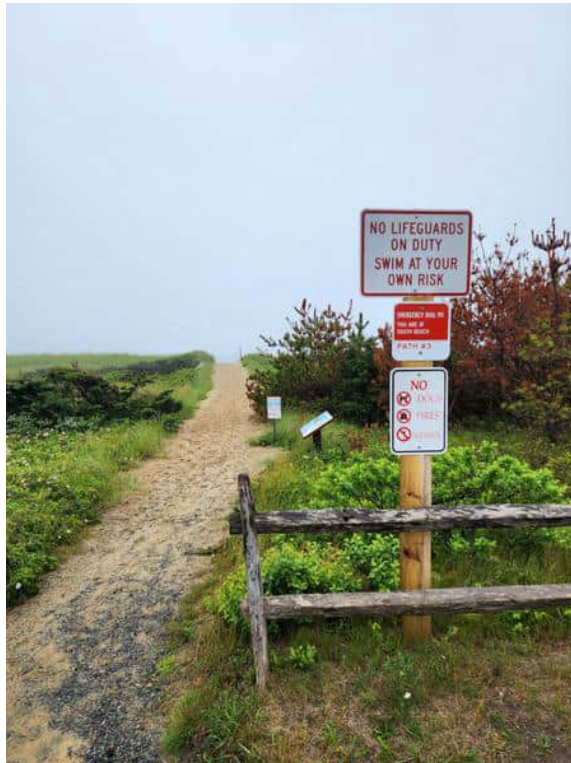
**Location:**South Beach Entrance #3  
(Path #3)**Description:**

View of the 3Rs pedestrian sign location along South Beach Path #3 relative to the beach path sign.

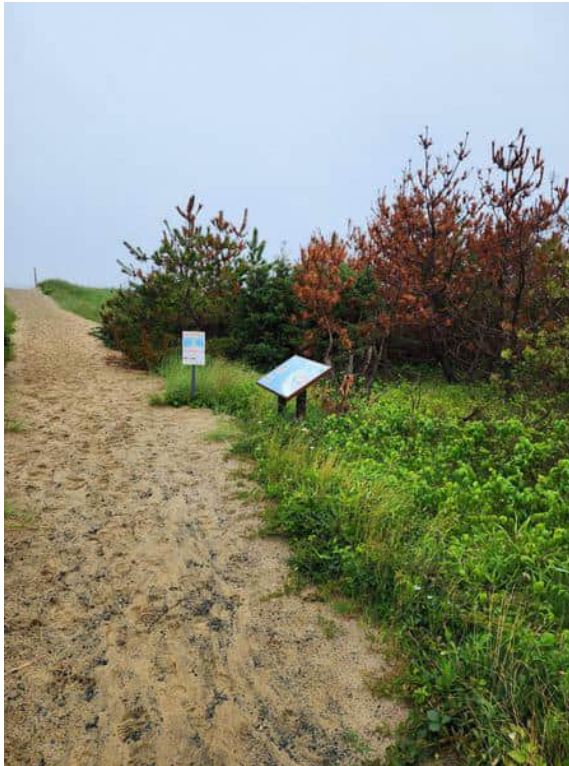
**Location:**South Beach Entrance #3  
(Path #3)**Description:**View of the 3Rs  
pedestrian sign location  
along South Beach Path  
#3

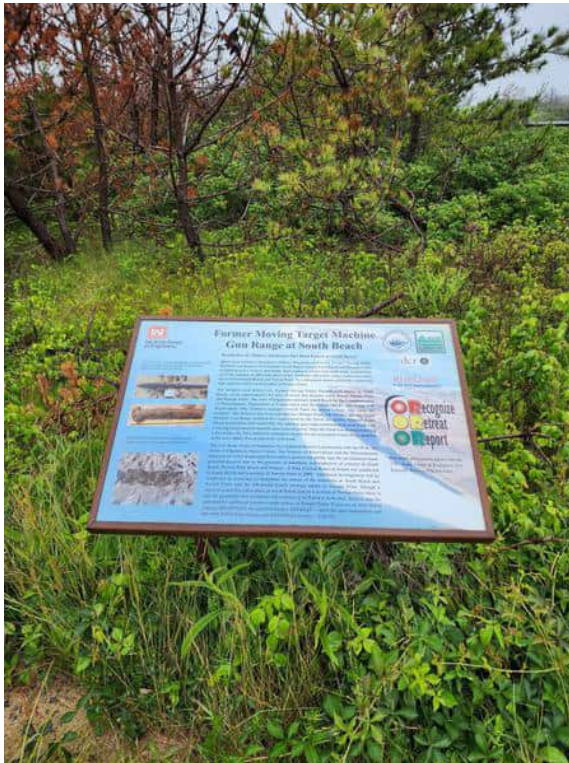
**Location:**South Beach Entrance #3  
(Path #3)**Description:**Front view of the 3Rs  
pedestrian sign before  
inspection and cleaning.

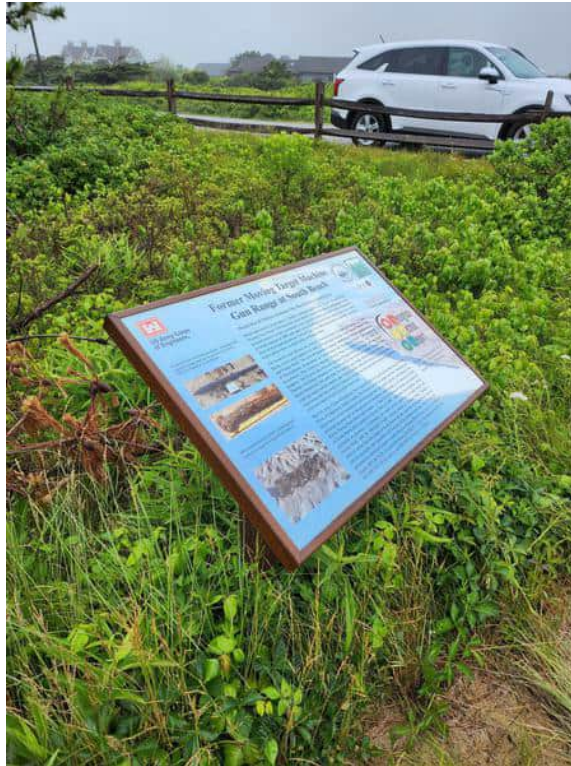
**Location:**  
South Beach Entrance #3  
(Path #3)

**Description:**  
Left side view of the sign  
before inspection and  
cleaning.

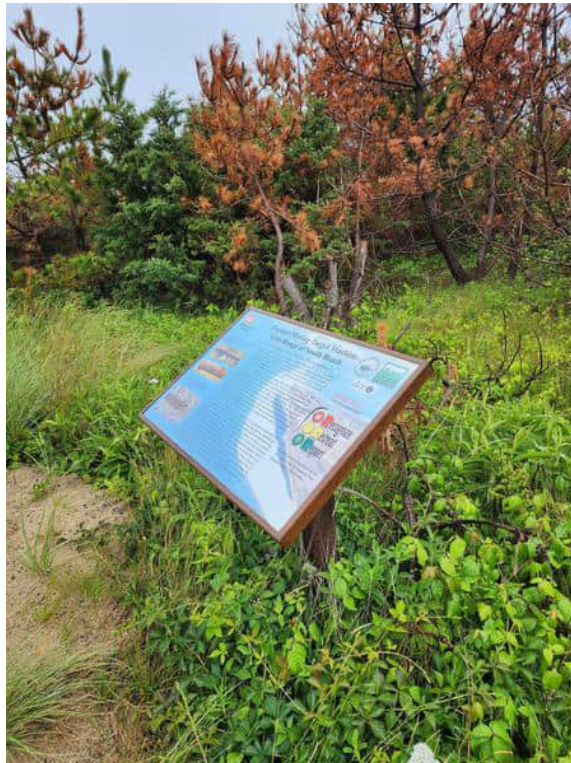
**Location:**  
South Beach Entrance #3  
(Path #3)

**Description:**  
Right side view of the sign  
before inspection and  
cleaning.
