25 June 2024

**Subject: Final 2023 Long Term Management Letter Report  
Former South Beach Moving Target Machine Gun and  
Katama Rocket Range Munitions Response Site  
Martha's Vineyard, Massachusetts  
Contract No. W912DR22C0044**

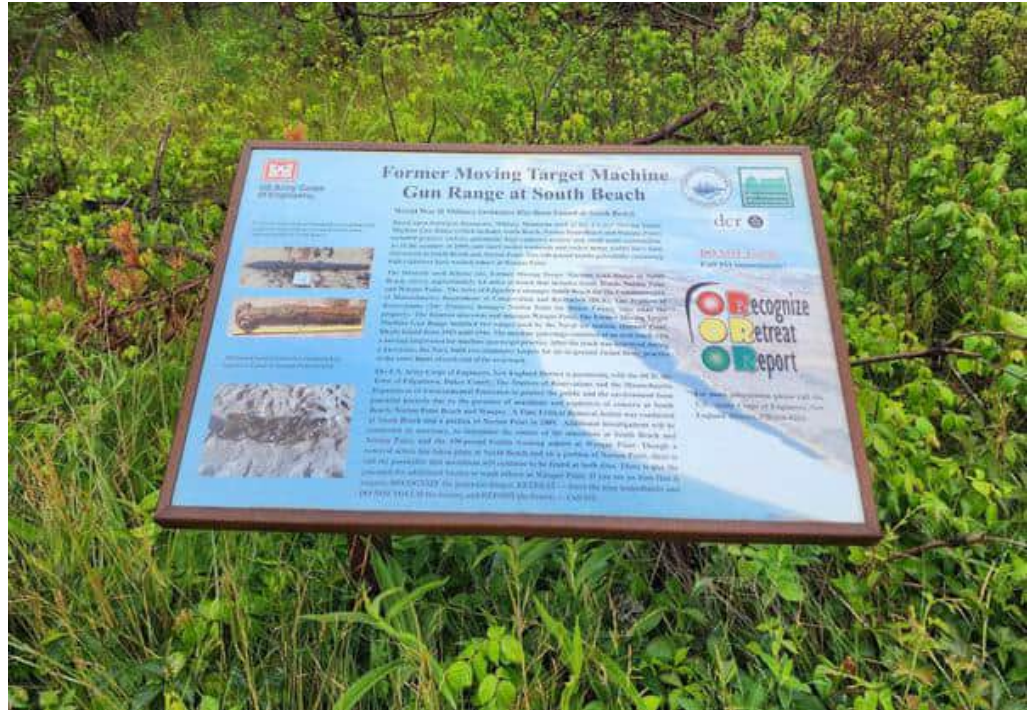
**Location:**  
South Beach Entrance #3  
(Path #3)

**Description:**  
Front view of the 3Rs  
pedestrian sign after  
inspection and cleaning.

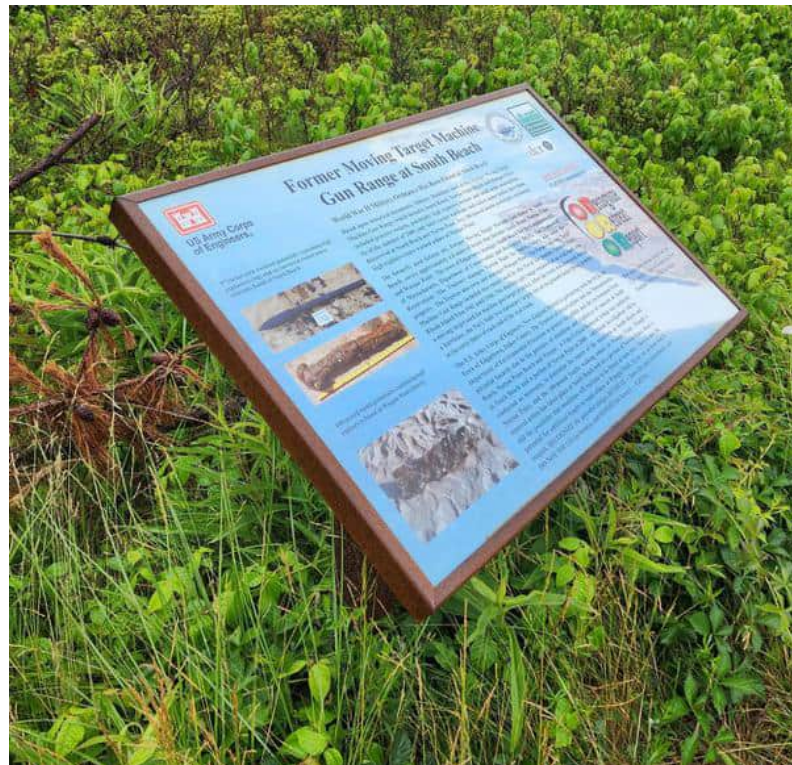
**Location:**  
South Beach Entrance #3  
(Path #3)

**Description:**  
Left side view of the sign  
after inspection and cleaning.

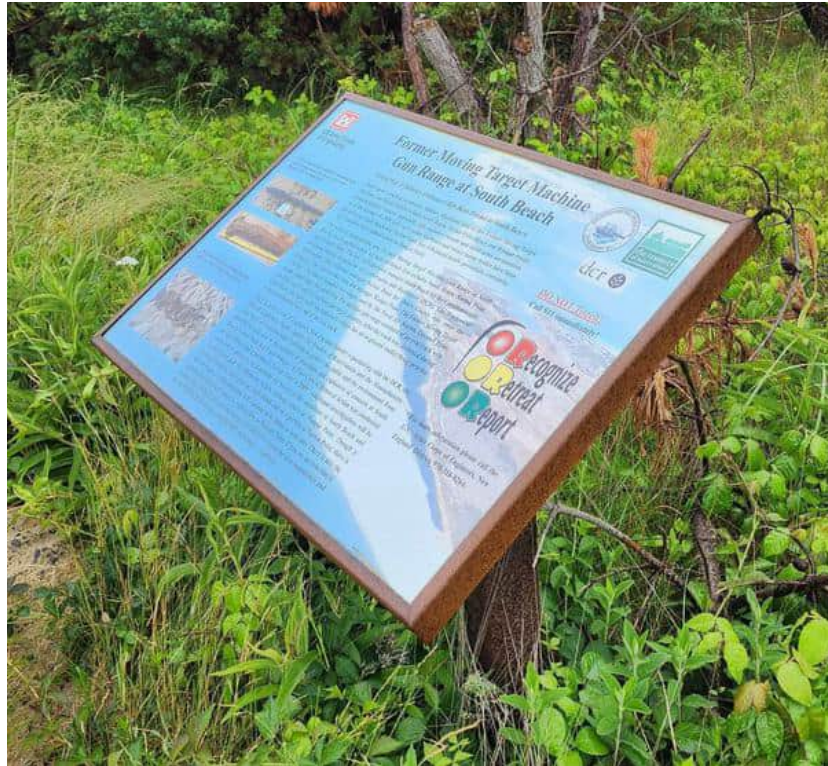
**Location:**  
South Beach Entrance #3  
(Path #3)

**Description:**  
Right side view of the sign  
after inspection and cleaning.

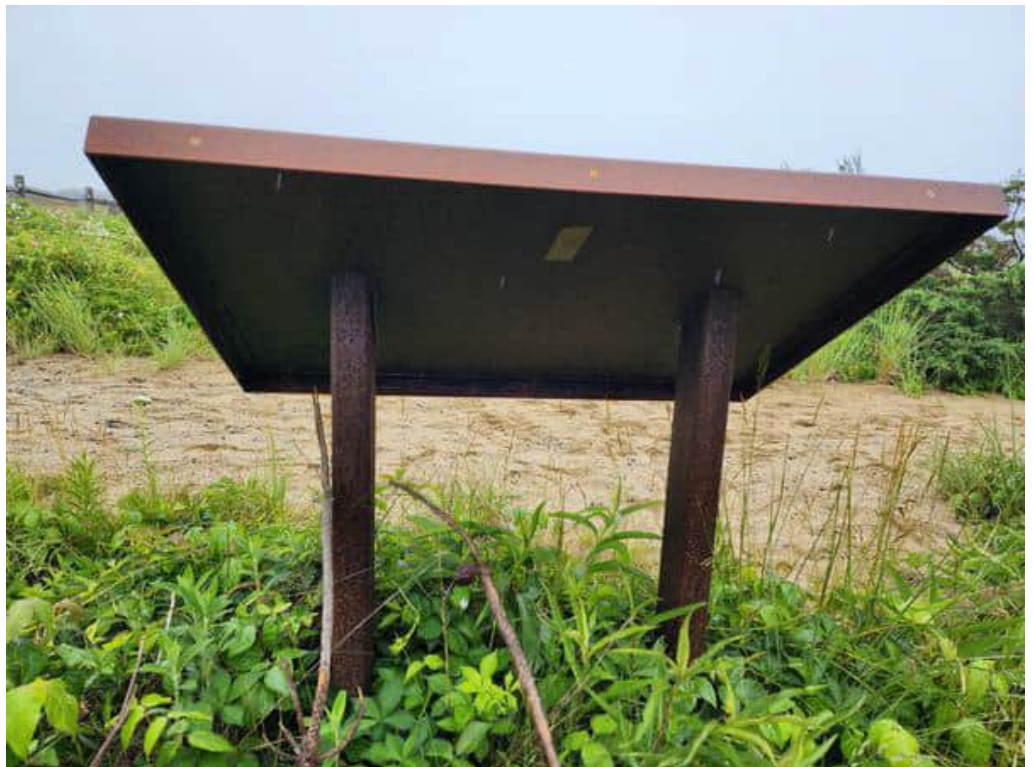
**Location:**  
South Beach Entrance #3  
(Path #3)

**Description:**  
View of the underside of the  
3Rs pedestrian sign.

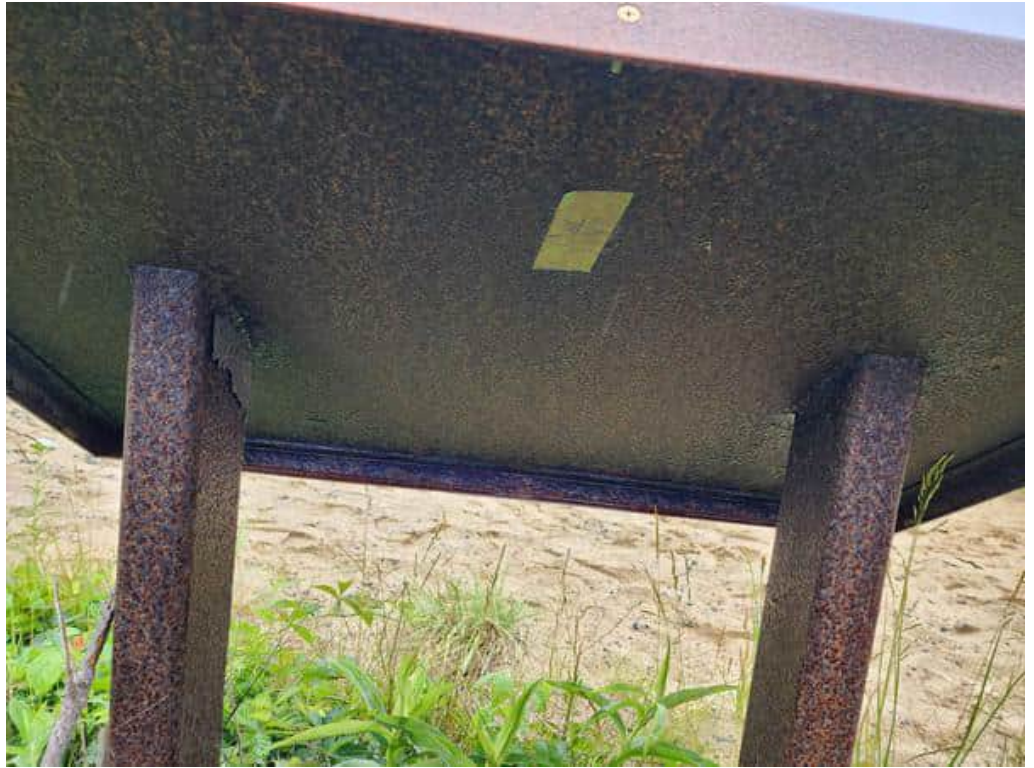
**Location:**South Beach Entrance #3  
(Path #3)**Description:**Close up view of the  
underside of the 3Rs  
pedestrian sign.

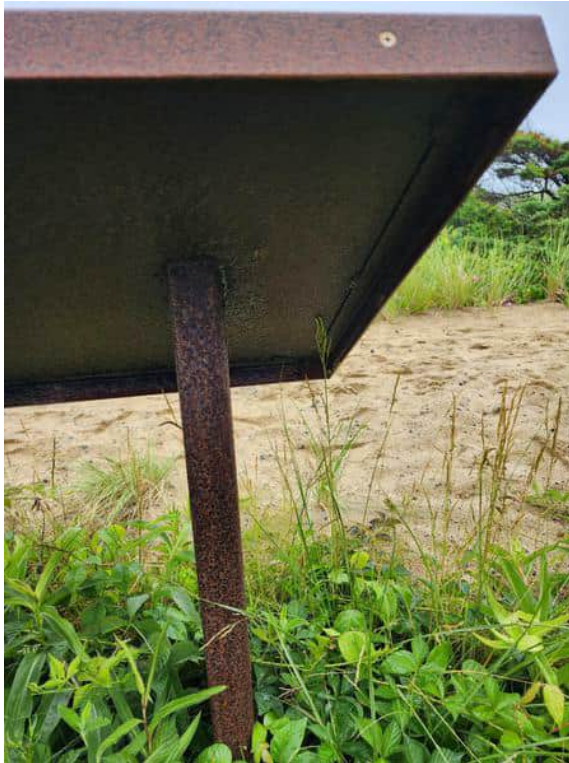
**Location:**South Beach Entrance #3  
(Path #3)**Description:**Close up view of the left side  
post of the sign where it  
attaches to the underside.

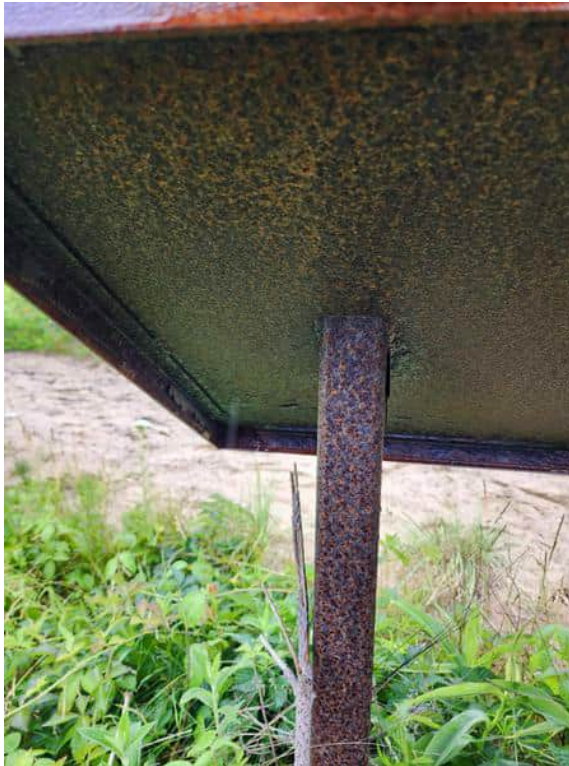
**Location:**South Beach Entrance #3  
(Path #3)**Description:**

Close up view of the right side post of the sign where it attaches to the underside.

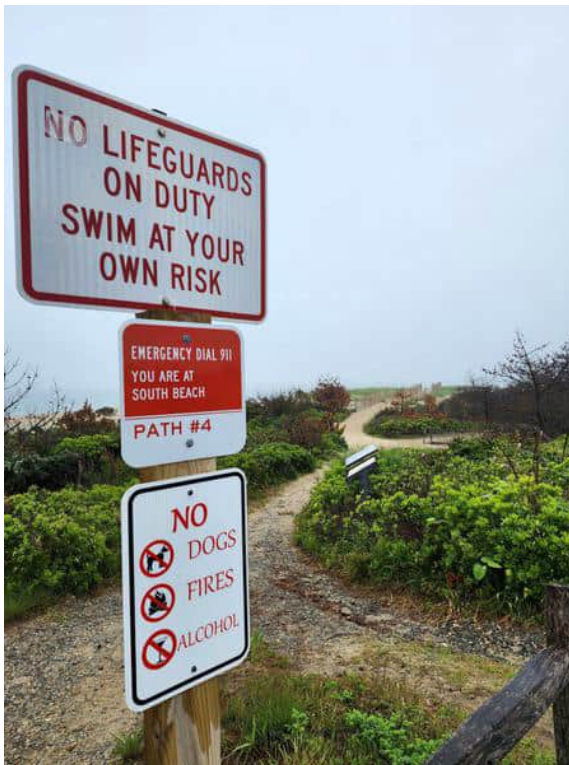
**Location:**South Beach Entrance #2  
(Path #4)**Description:**

View of the 3Rs pedestrian sign location relative to the South Beach Path #4 sign.

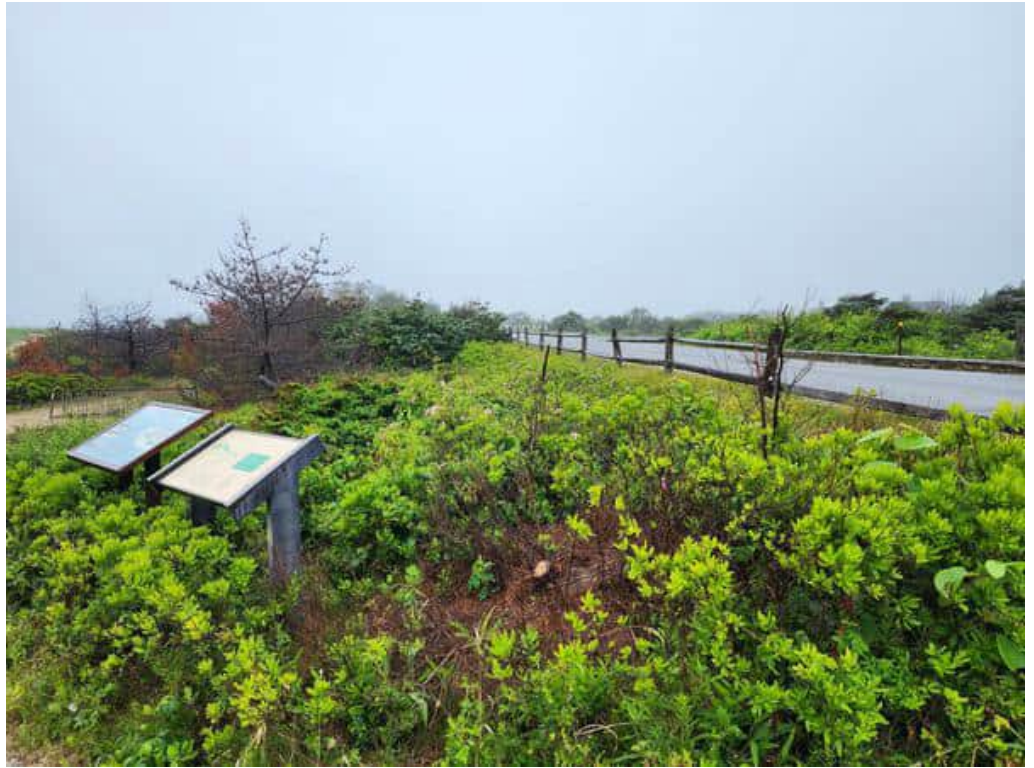
**Location:**South Beach Entrance #2  
(Path #4)**Description:**View of the 3Rs  
pedestrian sign location  
relative to Atlantic Drive.

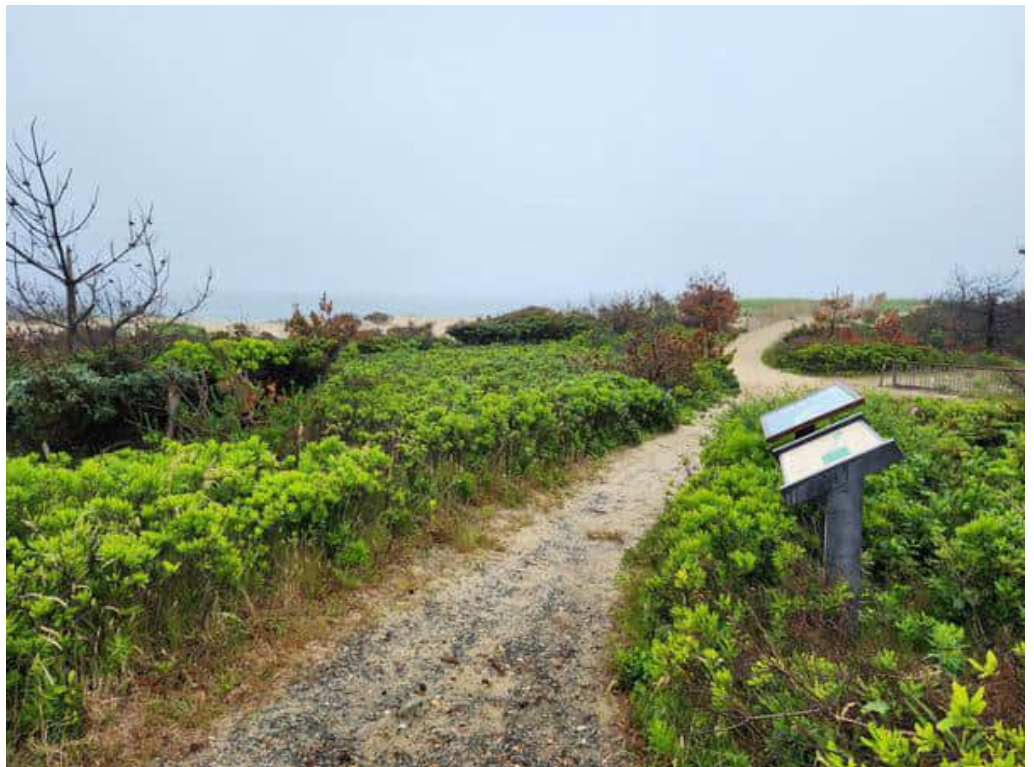
**Location:**South Beach Entrance #2  
(Path #4)**Description:**View of the 3Rs pedestrian  
sign location relative to South  
Beach Path #4, bicycle rack,  
and the beach.

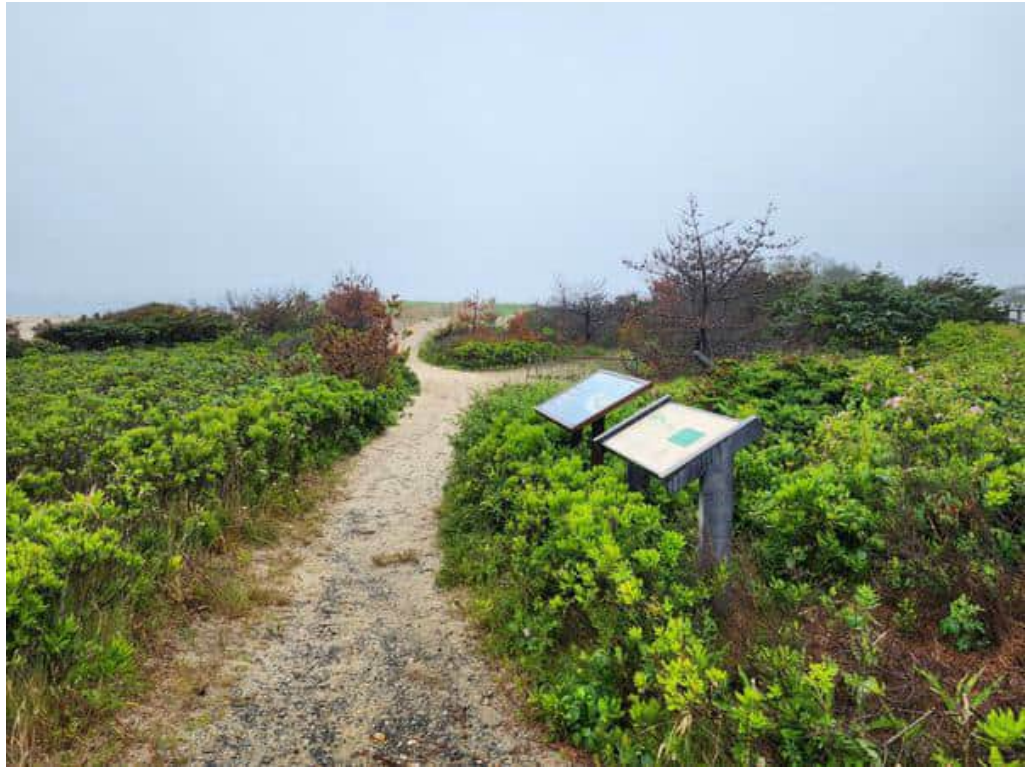
View of the 3Rs pedestrian sign location relative to South Beach Path #4 and bicycle rack.

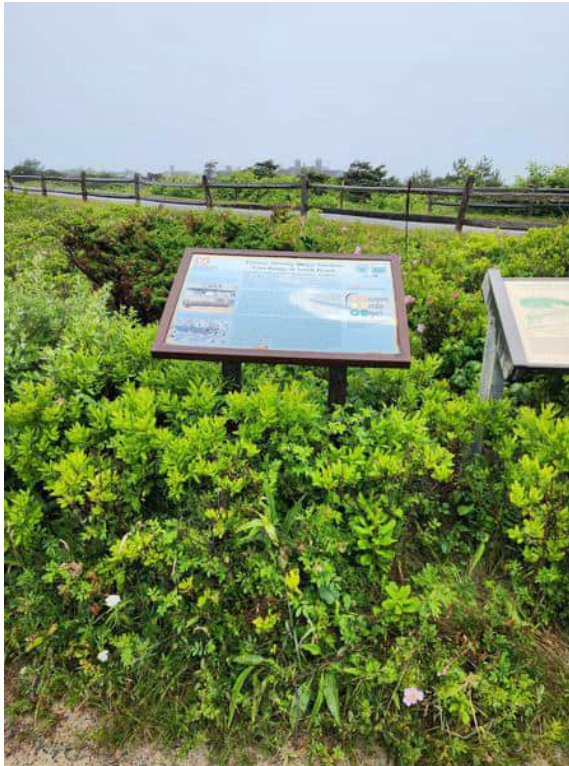
**Location:**South Beach Entrance #2  
(Path #4)**Description:**Front view of the pedestrian  
3Rs sign before inspection  
and cleaning.

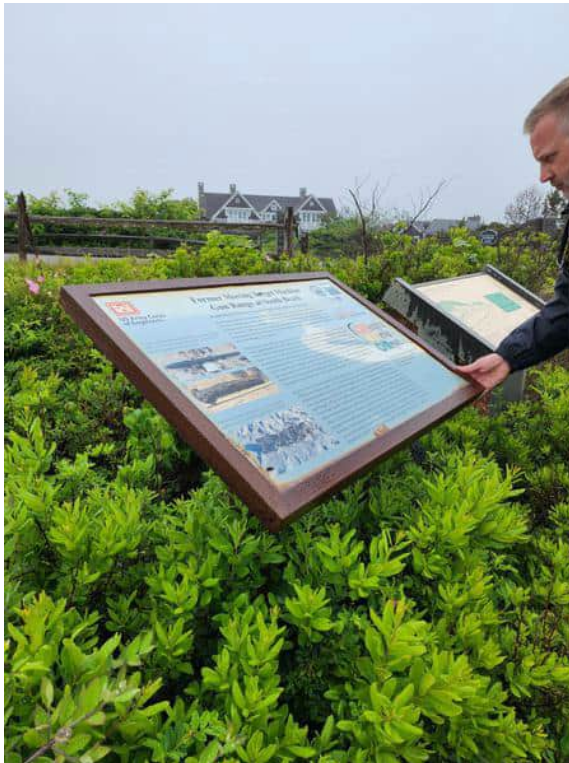
**Location:**South Beach Entrance #2  
(Path #4)**Description:**Left side view of the sign  
before inspection and  
cleaning.

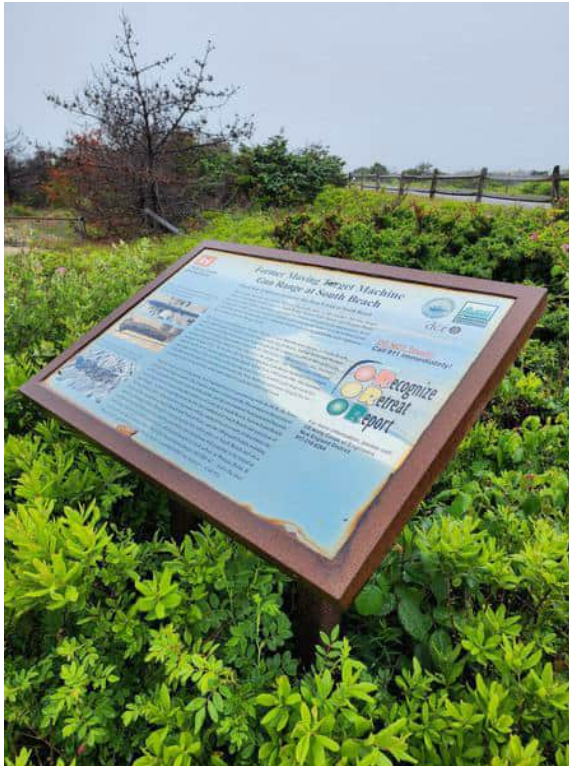
**Location:**  
South Beach Entrance #2  
(Path #4)

**Description:**  
Right side view of the sign  
before inspection and  
cleaning.

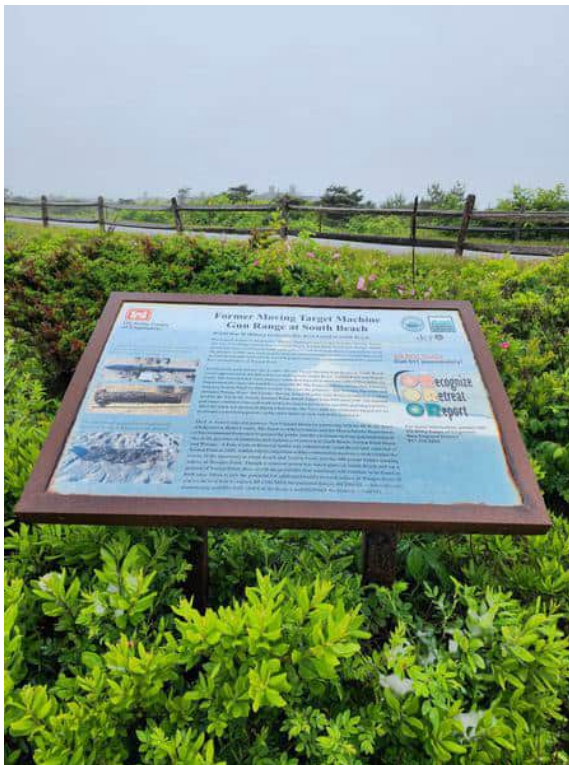
**Location:**  
South Beach Entrance #2  
(Path #4)

**Description:**  
Front view of the pedestrian  
3Rs sign after inspection and  
cleaning.

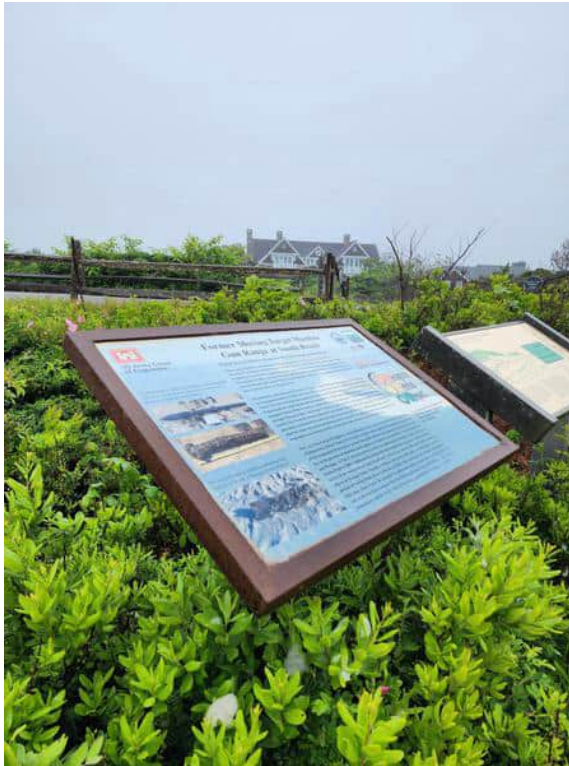
**Location:**South Beach Entrance #2  
(Path #4)**Description:**Left side view of the sign  
after inspection and cleaning.

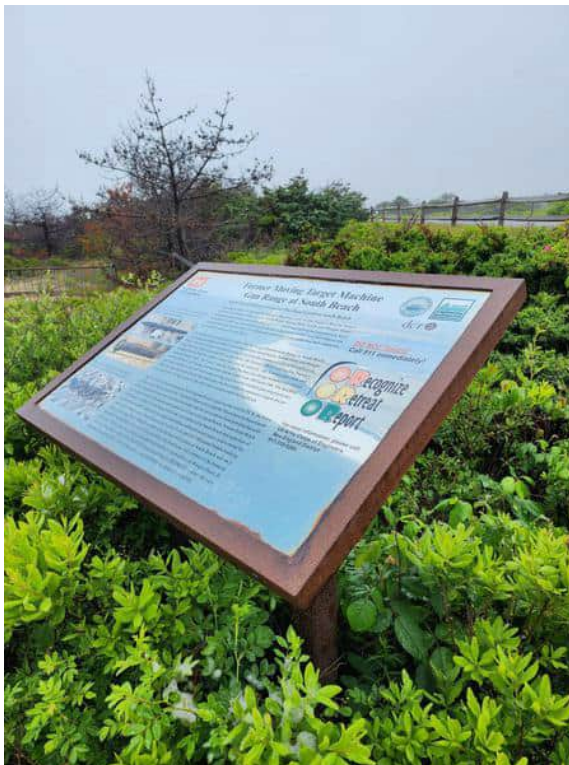
**Location:**South Beach Entrance #2  
(Path #4)**Description:**Right side view of the sign  
after inspection and cleaning.

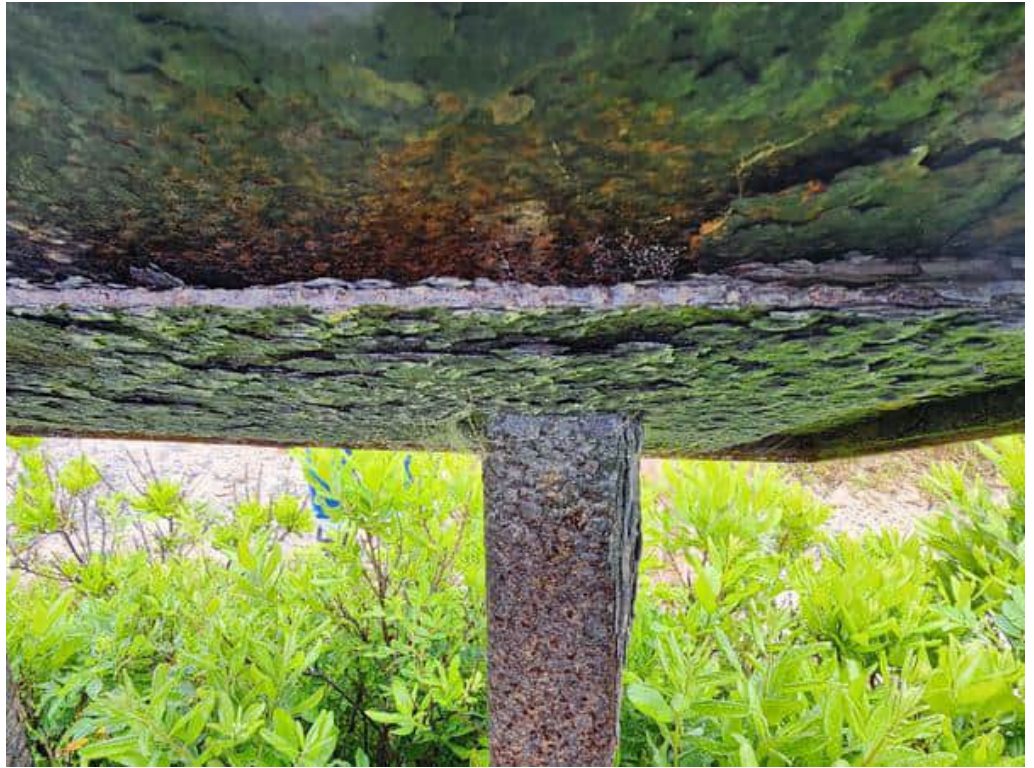
**Location:**South Beach Entrance #2  
(Path #4)**Description:**Close up view of the  
underside of the 3Rs  
pedestrian sign.

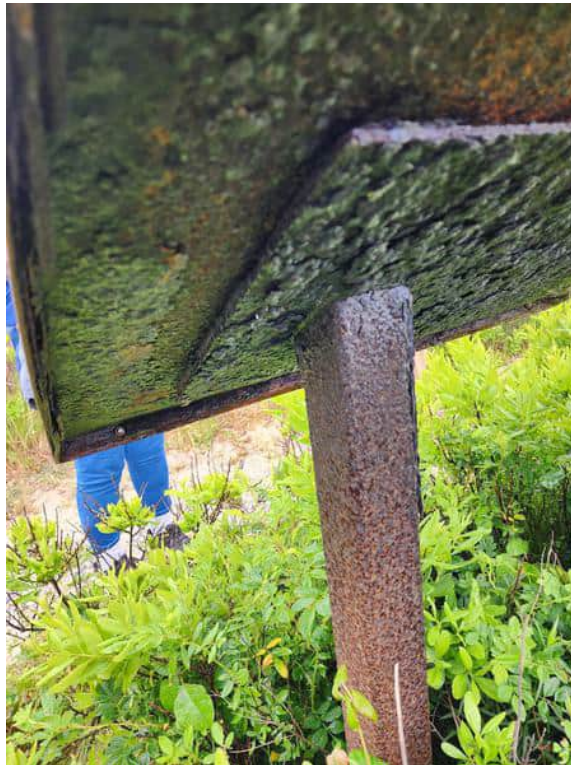
**Location:**South Beach Entrance #2  
(Path #4)**Description:**Left underside close up view  
of the pedestrian 3Rs sign.

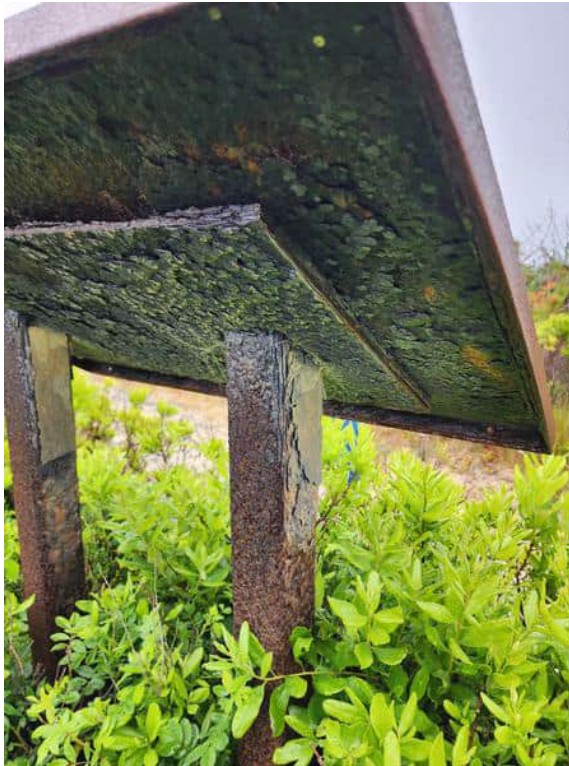
**Location:**South Beach Entrance #2  
(Path #4)**Description:**Right underside close up  
view of the pedestrian 3Rs  
sign.

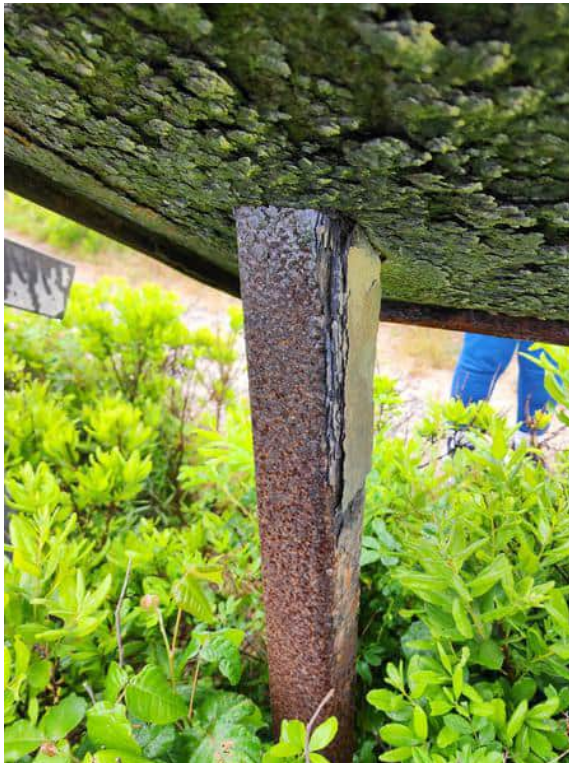
**Location:**South Beach Entrance #2  
(Path #4)**Description:**Close up view of the  
underside of the 3Rs  
pedestrian sign where the  
right side post attaches. Rust  
visible.

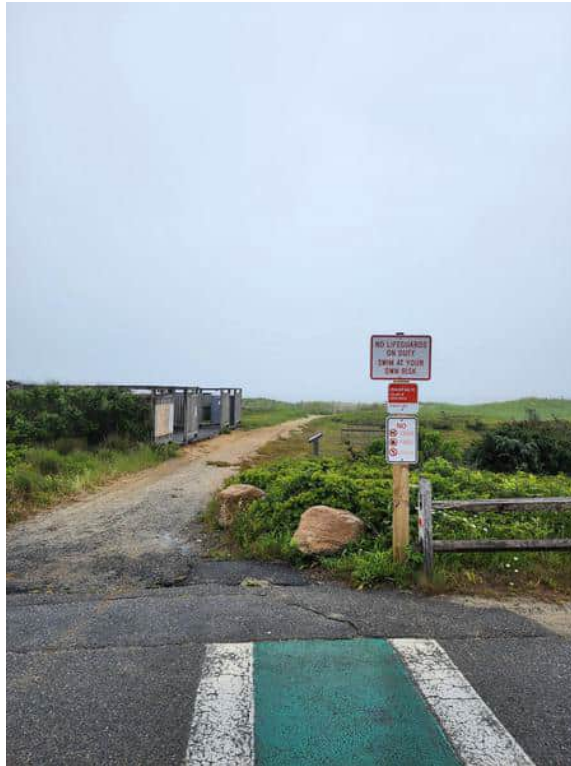
**Description:**  
View of the beginning of  
South Beach Path #5,  
proposed additional  
pedestrian sign location.

GSINA personnel identified and recorded an additional location for proposed signage (Beach Entrance 5). The proposed location is identified on the Sign Location Figure in Attachment B and photos of the proposed location are in the photo documentation log (Attachment B) with reasons provided for the recommendations on the sign inspection form (Attachment C).

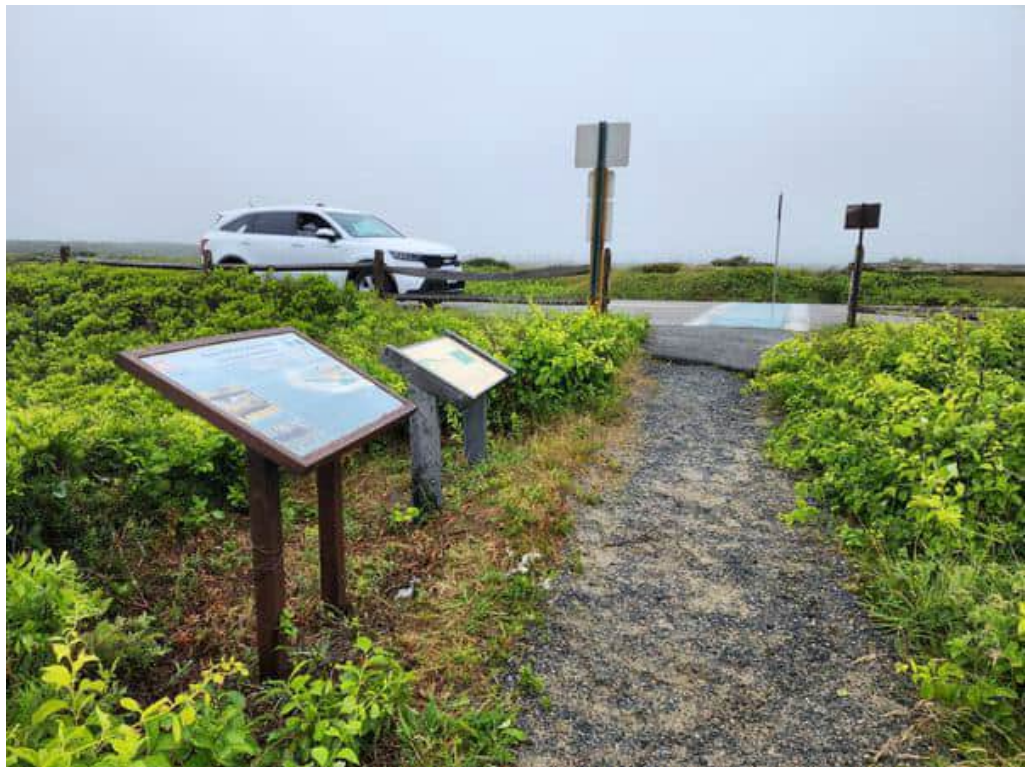
View of the 3Rs pedestrian sign location relative to the road, crosswalk, and other informational sign.

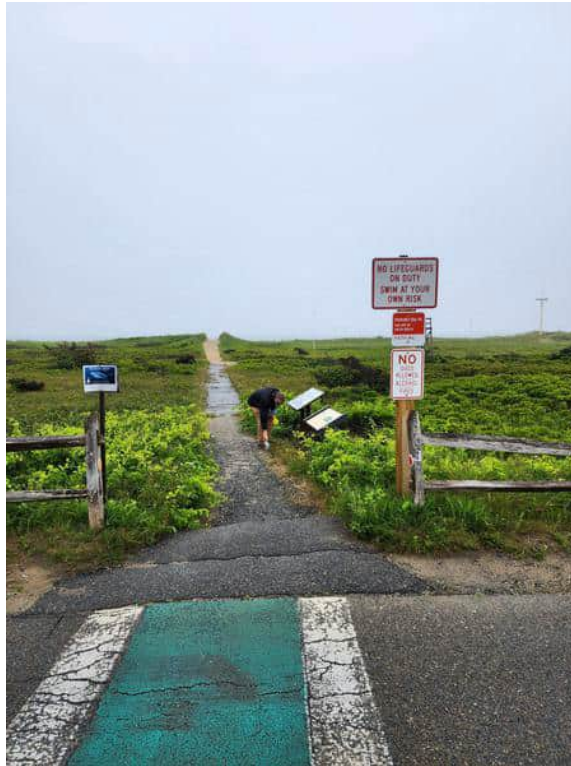
**Location:**  
South Beach Entrance 1  
(Path #6)

**Description:**  
View of the 3Rs pedestrian  
sign location relative to the  
beach path and Beach Path  
#6 sign.

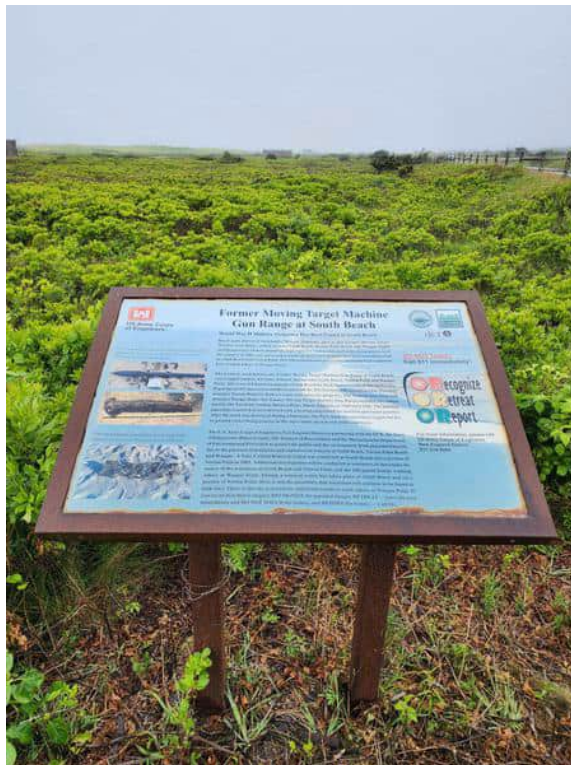
**Location:**  
South Beach Entrance 1  
(Path #6)

**Description:**  
Front view of the sign before  
inspection and cleaning.

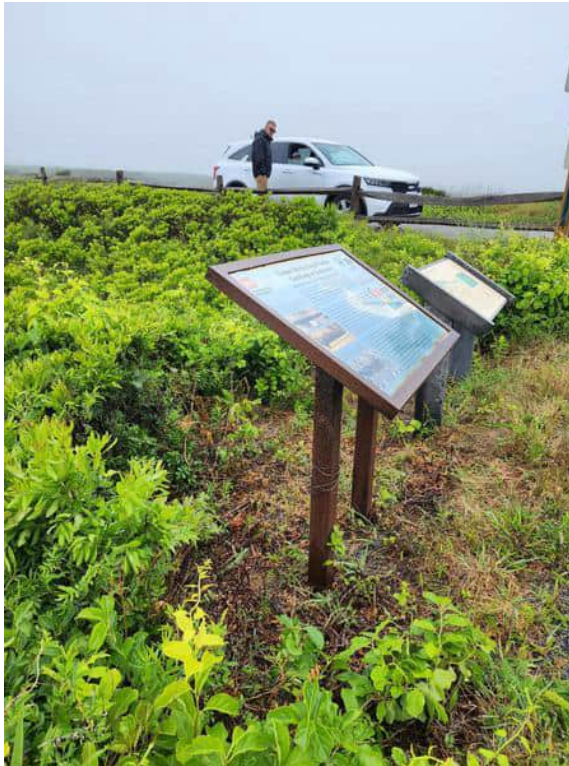
**Location:**South Beach Entrance 1  
(Path #6)**Description:**Left side view of the sign  
before inspection and  
cleaning.

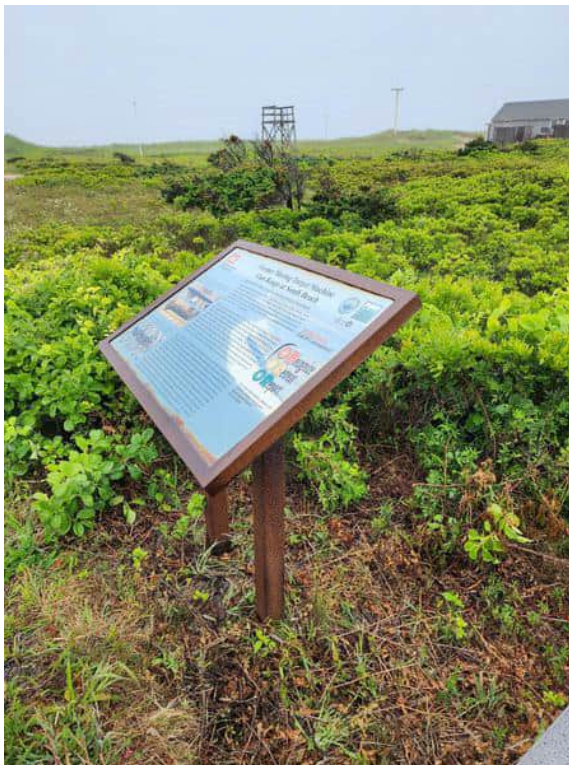
**Location:**South Beach Entrance 1  
(Path #6)**Description:**Right side view of the sign  
before inspection and  
cleaning.

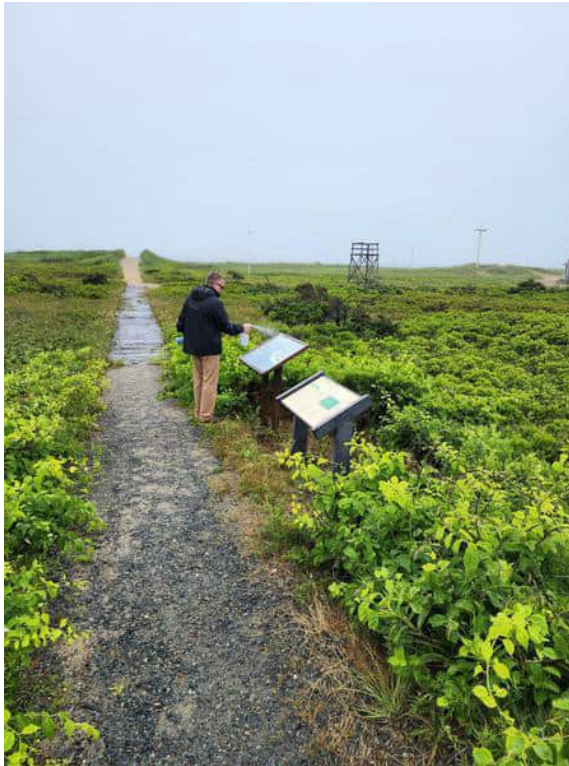
**Location:**South Beach Entrance 1  
(Path #6)**Description:**View of 3Rs pedestrian sign  
at beach path #6 being  
cleaned.

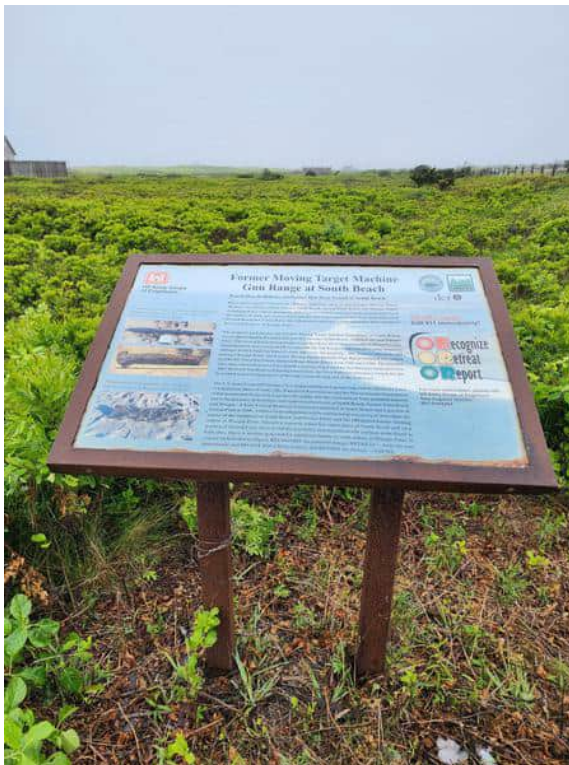
**Location:**South Beach Entrance 1  
(Path #6)**Description:**Front view of sign after  
inspection and cleaning.

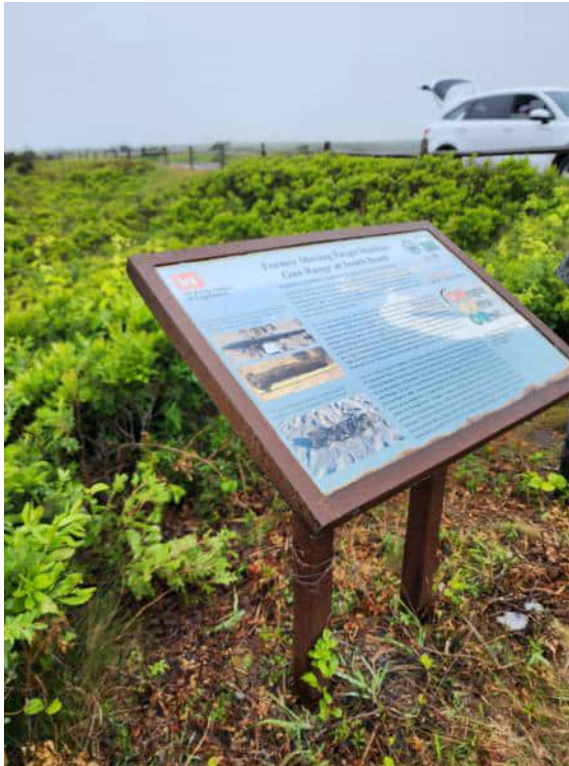
**Location:**South Beach Entrance 1  
(Path #6)**Description:**Left side view of the sign  
after inspection and cleaning.

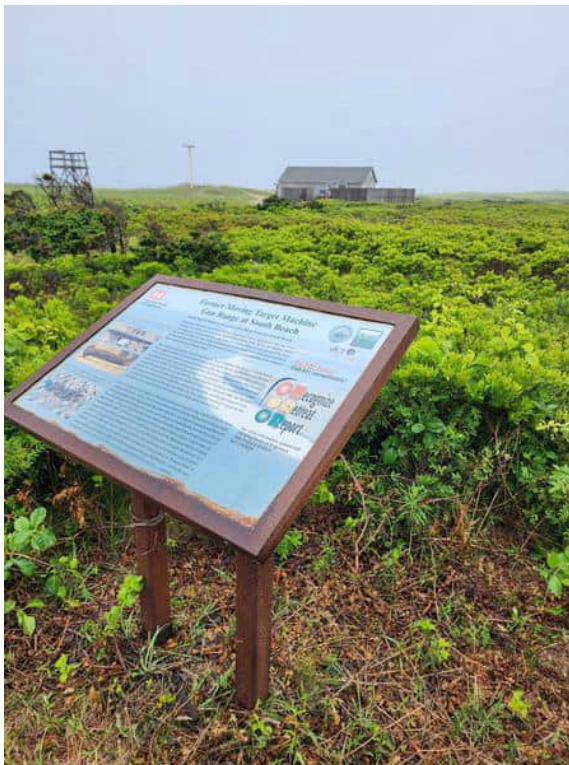
**Location:**South Beach Entrance 1  
(Path #6)**Description:**Right side view of the sign  
after inspection and cleaning.

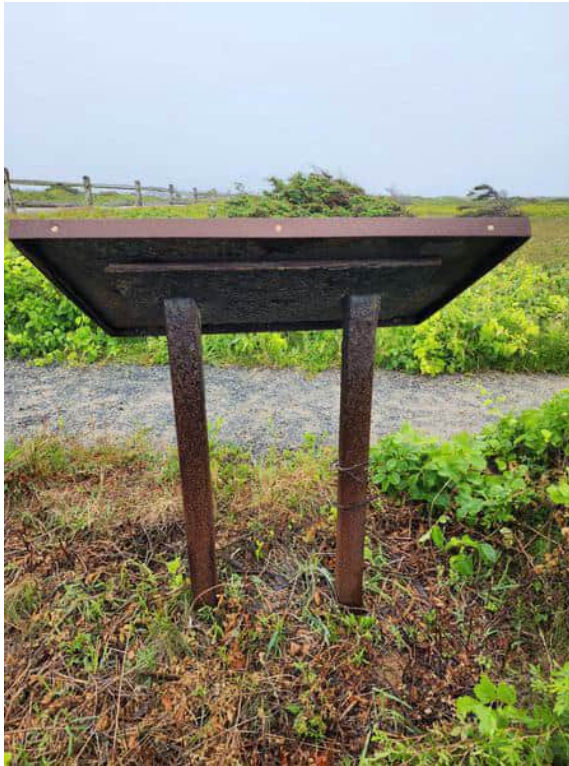
**Location:**South Beach Entrance 1  
(Path #6)**Description:**Underside view of 3Rs  
pedestrian sign.

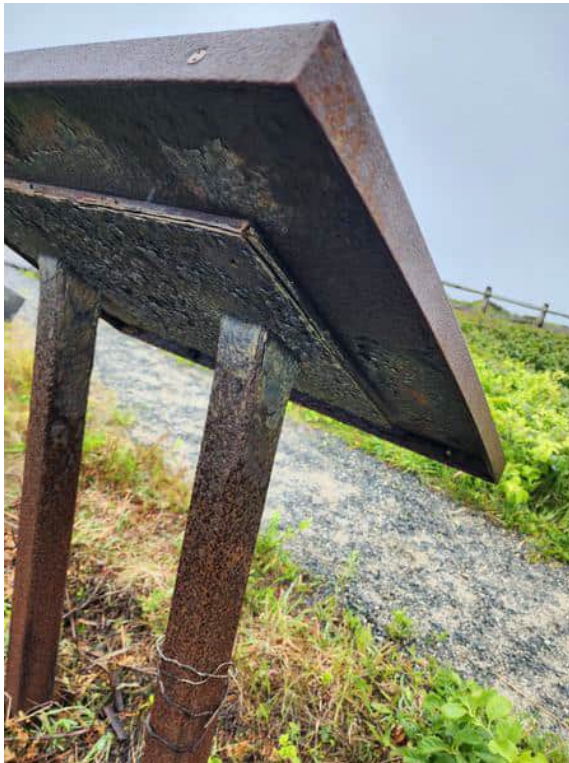
**Location:**South Beach Entrance 1  
(Path #6)**Description:**Left side view of the  
underside of the 3Rs  
pedestrian sign.

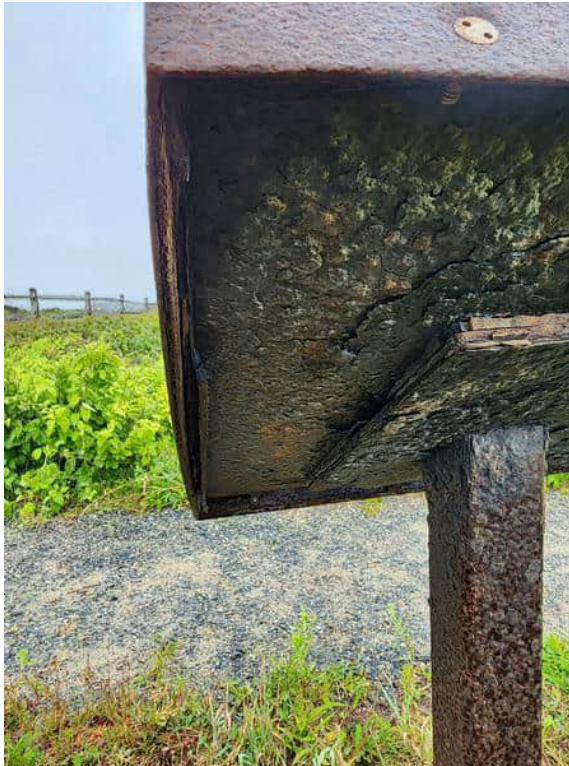
Right side view of the underside of the 3Rs pedestrian sign. Rust and jagged edges visible.

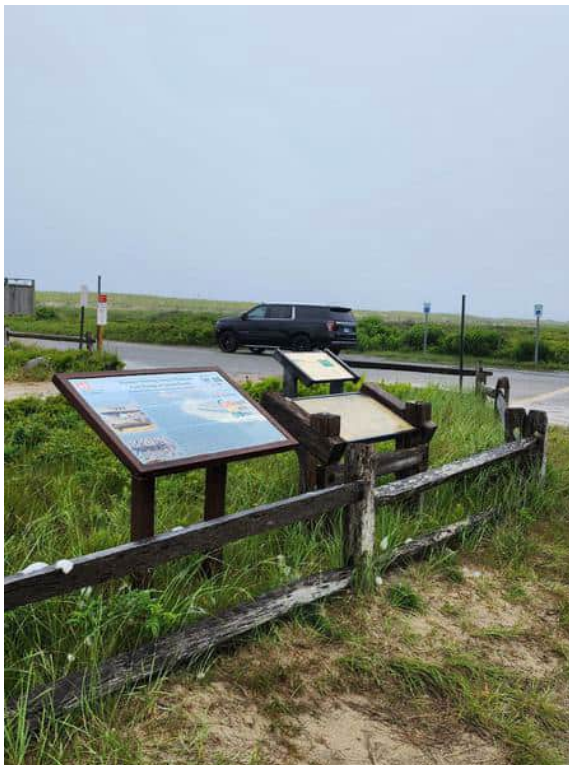
View of the location of the Right Fork 3Rs pedestrian sign relative to the road and other informational signage.

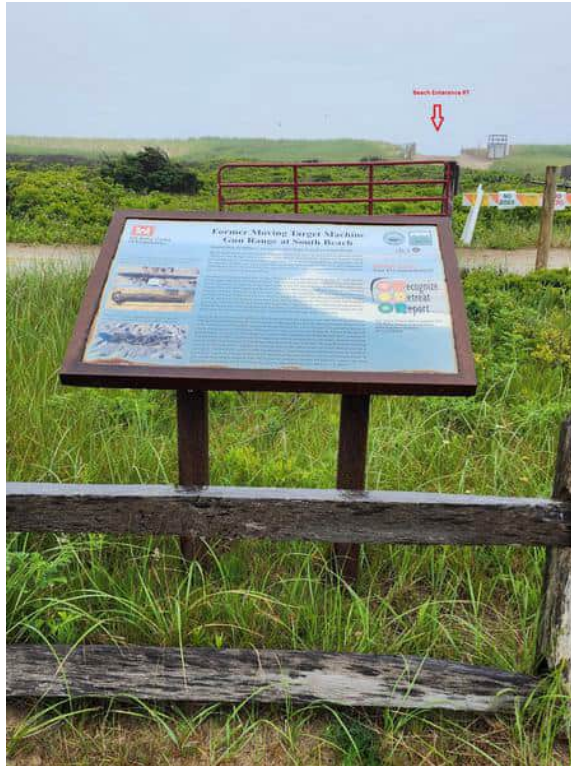
**Location:**  
South Beach Right Fork

**Description:**  
View of location of 3Rs  
pedestrian sign relative to  
Beach Path #7.

<b>9. South Beach Right Fork</b>  GPS: N 41 21.0390 W 070 21.5670	Poor - Due to frame condition  Critical Need of 2 <sup>nd</sup> sign at Beach Path #7	Cleaned – 24 June 2023	The sign is in good condition, but the frame is in poor condition. Rusted and loose from the posts. Posts are solid and in good condition. The location is in a poor location, it does serve the path along the back of the dunes but need to place a new sign nearer to the path entrance to the beach. South Beach Right Fork was labeled as Beach Path # 7 when dunes were reconstructed.
<b>10. Left Fork Tire Deflation Area</b>  GPS: N 41 20.9927 W 070 30.7060	Good	Cleaned – 24 June 2023	The sign is in good condition. The sign has 8 chips. The posts are in good condition. No erosion at sign location. The location of the sign is good, the deflation staging area and across from the re-inflation area.
<b>11. Norton Point Trail Entrance</b>  GPS: Sign Missing	CRITICAL	Inspected – 24 June 2023	The sign is missing. Appears significant erosion has occurred over the last year.

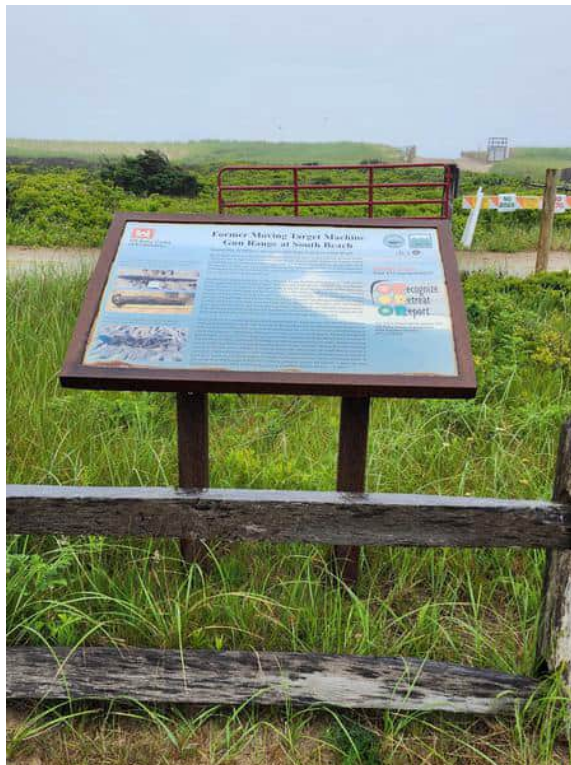
**Location:**  
South Beach Right Fork

**Description:**  
Front view of the sign before  
inspection and cleaning.

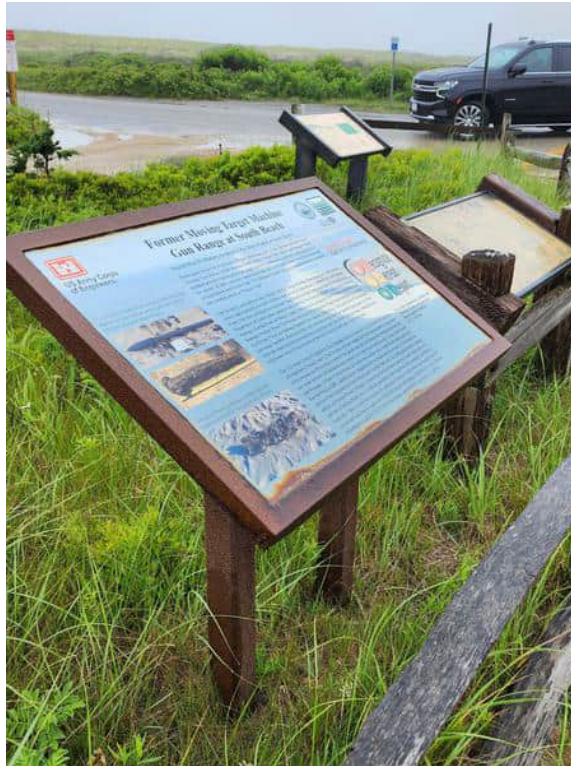
**Location:**  
South Beach Right Fork

**Description:**  
Left side view of the sign  
before inspection and  
cleaning.

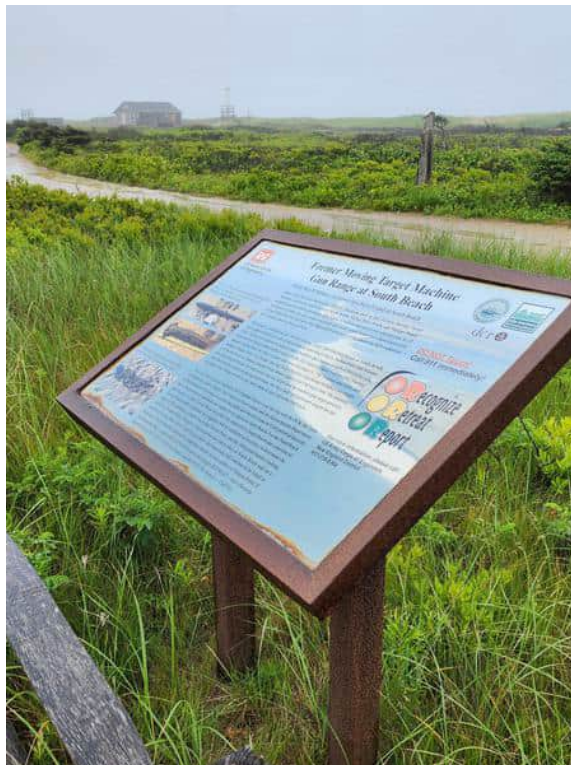
**Location:**  
South Beach Right Fork

**Description:**  
Right side view of the sign  
before inspection and  
cleaning.

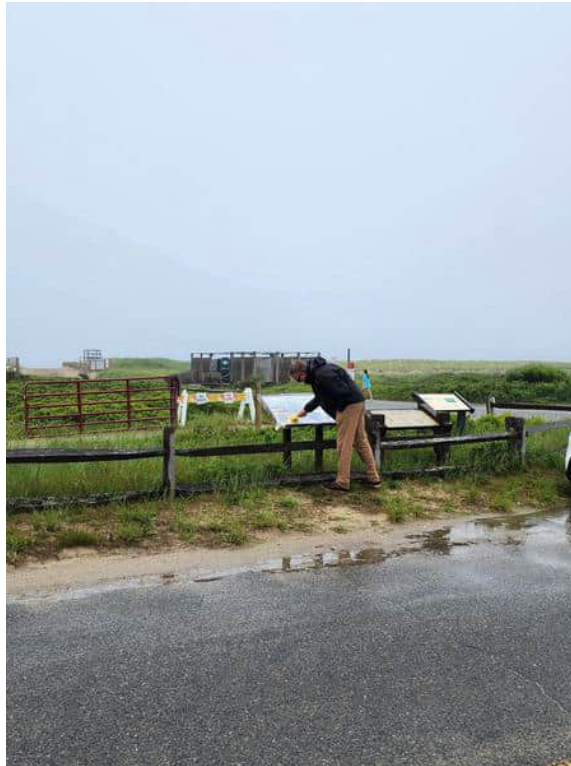
**Location:**  
South Beach Right Fork

**Description:**  
View of 3Rs pedestrian sign at South Beach Right Fork being cleaned.
