25 June 2024

**Subject: Final 2023 Long Term Management Letter Report  
Former South Beach Moving Target Machine Gun and  
Katama Rocket Range Munitions Response Site  
Martha's Vineyard, Massachusetts  
Contract No. W912DR22C0044**

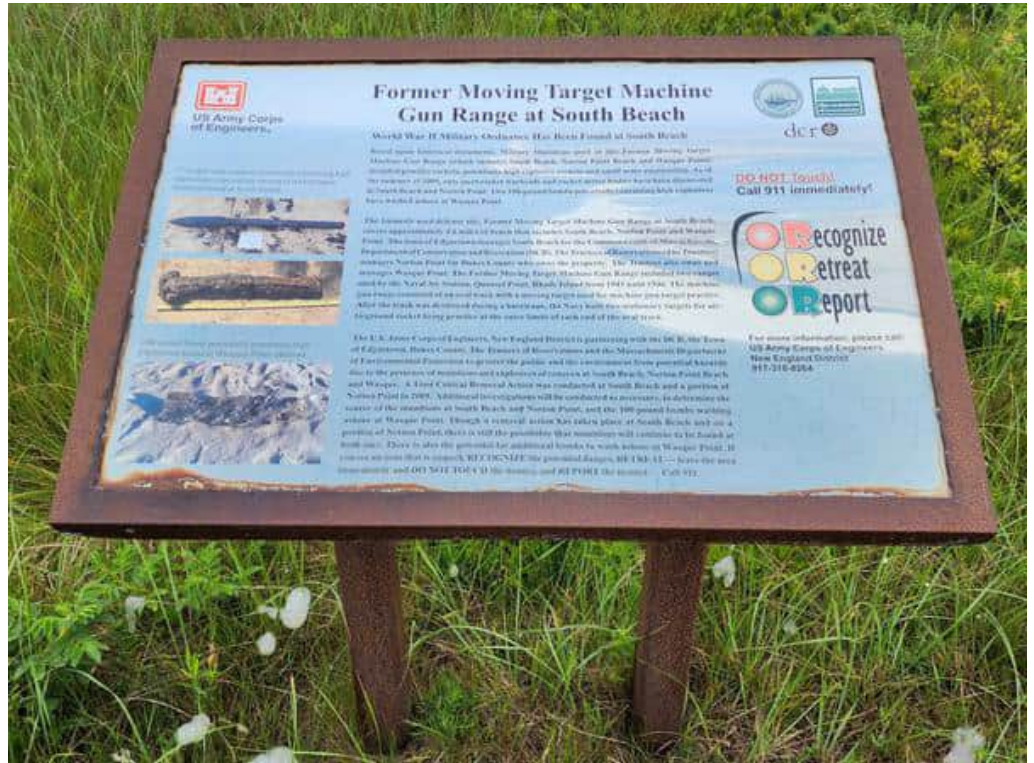
**Location:**  
South Beach Right Fork

**Description:**  
Front view of sign after inspection and cleaning.

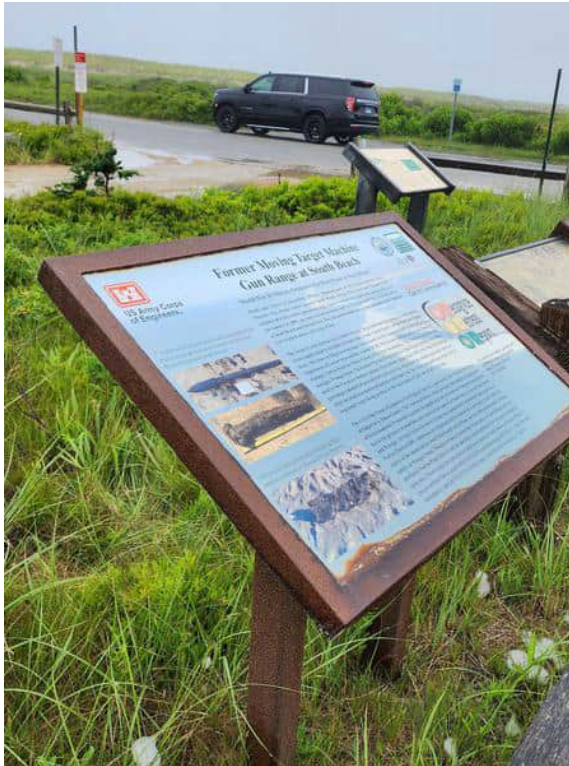
Left side view of the sign after inspection and cleaning.

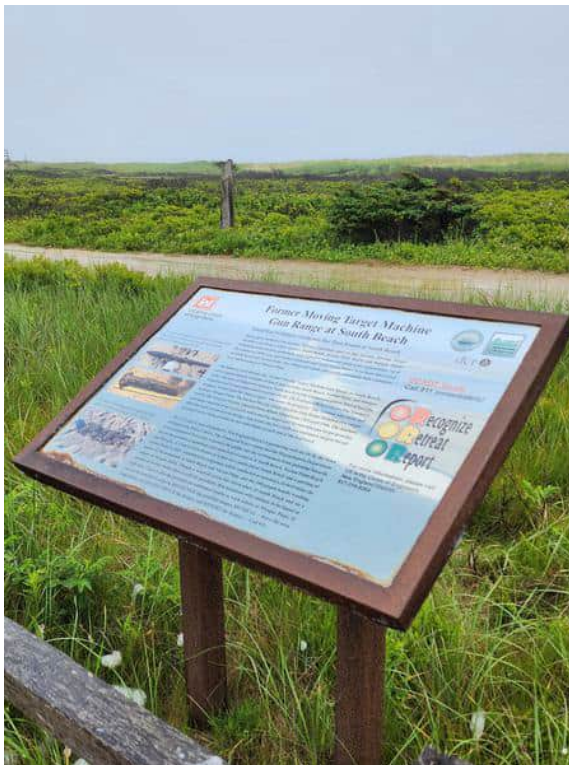
Right side view of sign after inspection and cleaning.

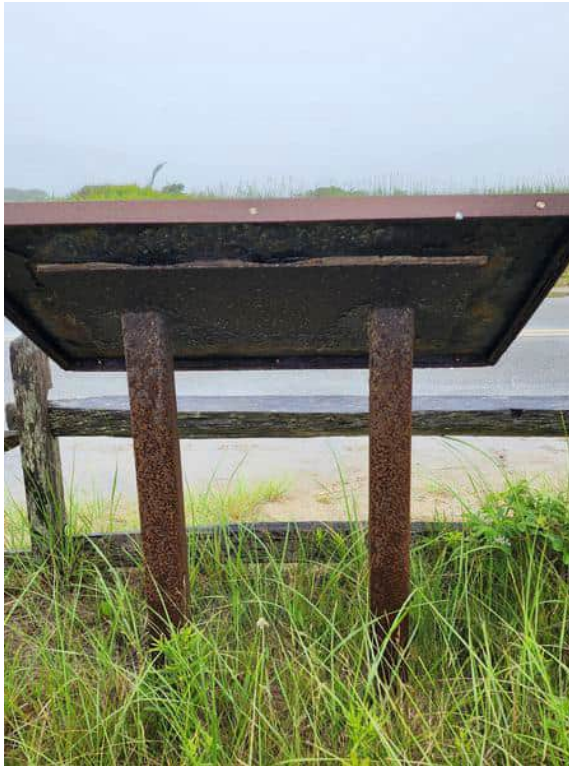
South Beach Right Fork

**Description:** Underside view of 3Rs pedestrian sign.

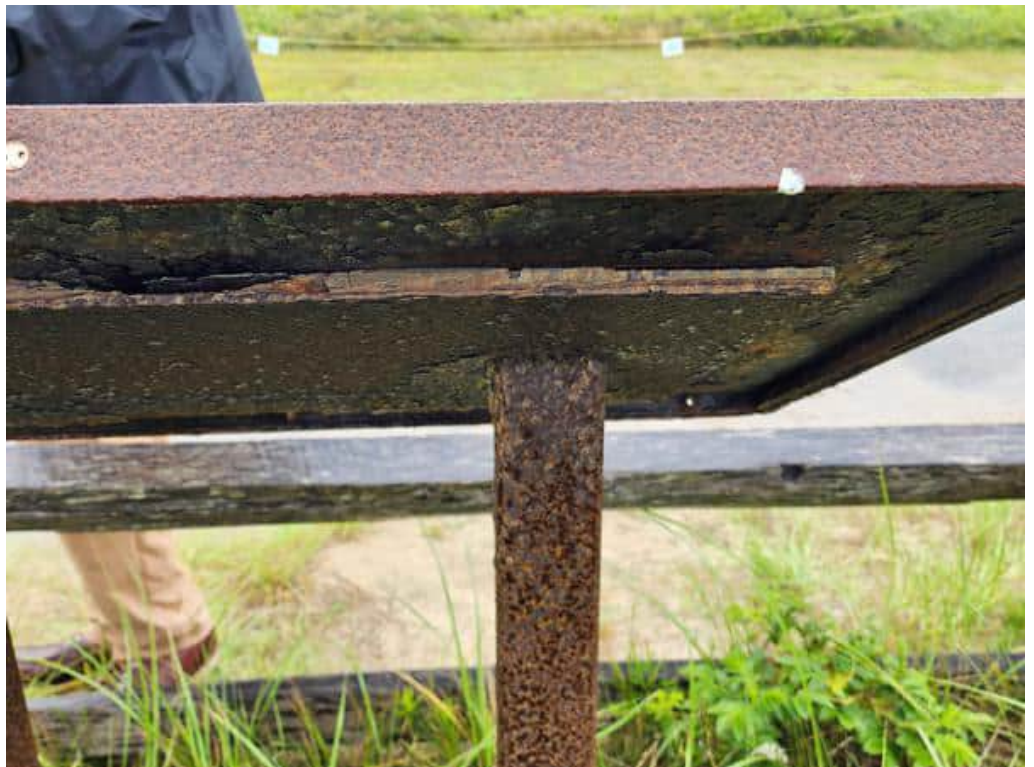
Close up view of the left underside of the sign.

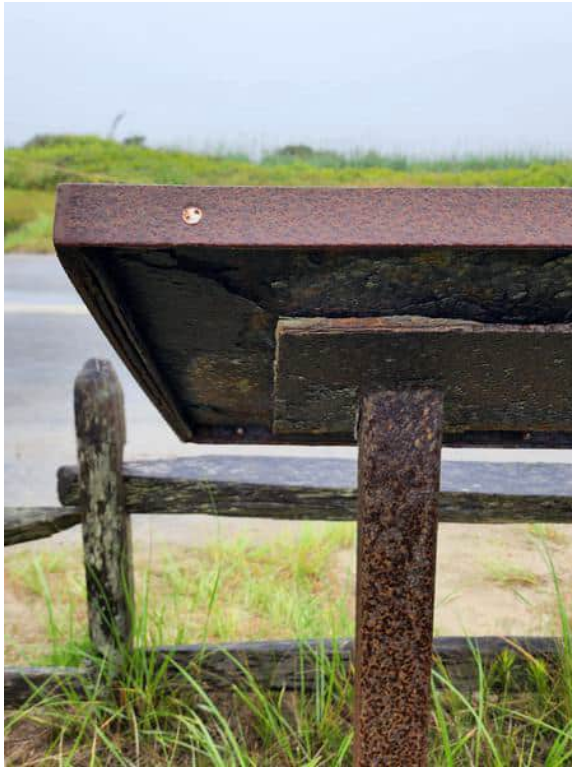
Close up view of the right underside of the sign. Rust and jagged edges visible.

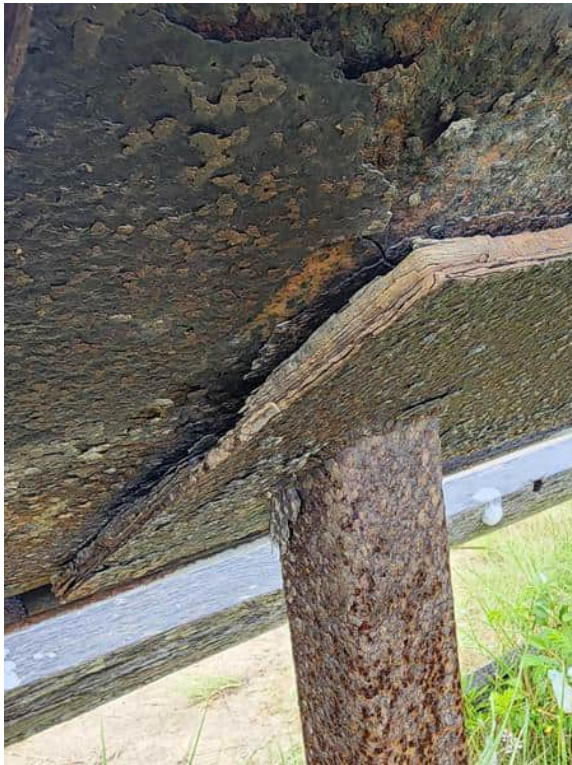
Close up view of the condition of the underside of the sign. Rust and delamination visible.

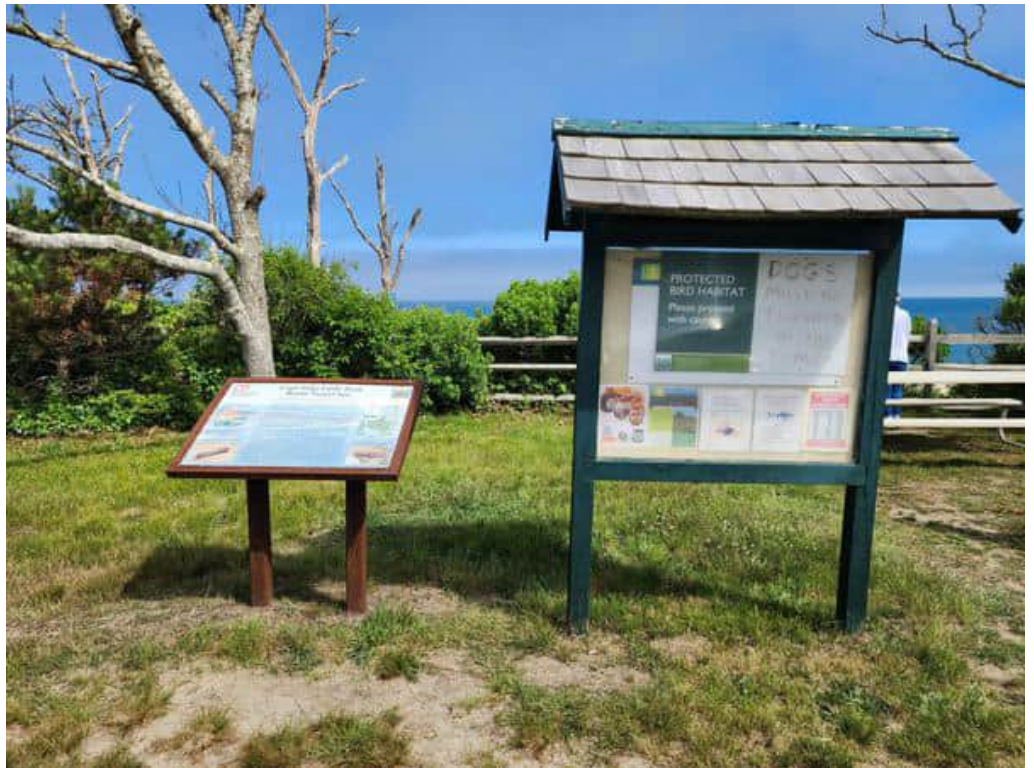
**Location:**  
Chappaquiddick Wasque  
Fishing Trail

**Description:**  
View of 3Rs pedestrian sign  
at Wasque Fishing Trail  
showing proximity to notice  
board sign.

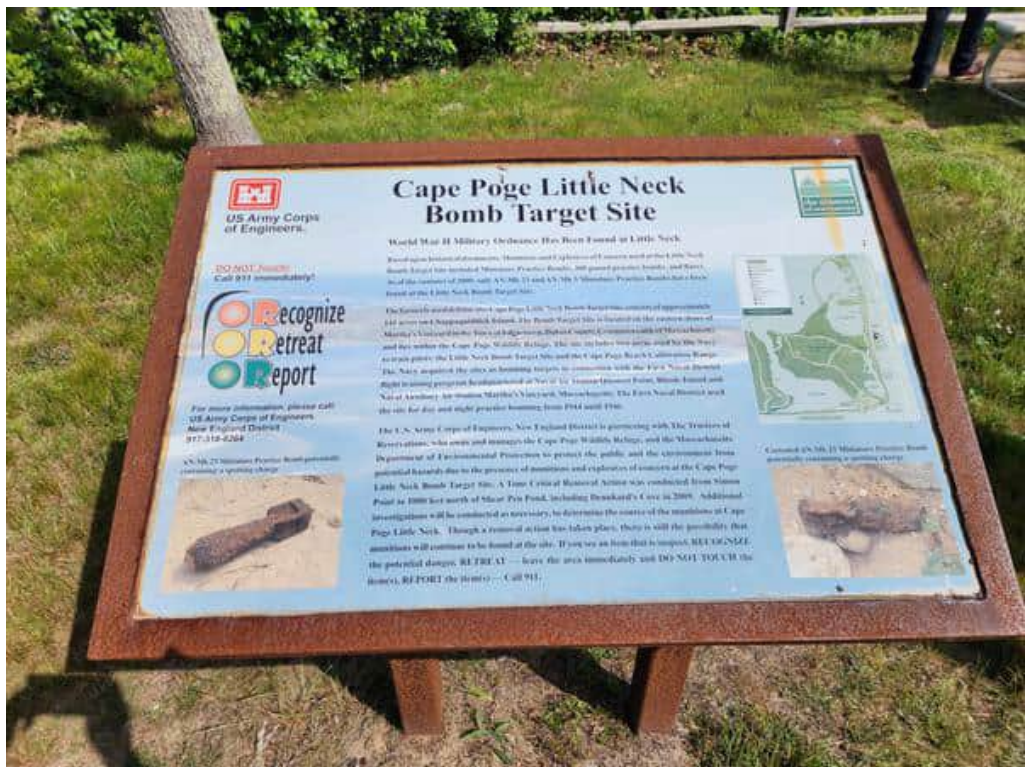
**Location:**  
Chappaquiddick Wasque  
Fishing Trail

**Description:**  
Front view of pedestrian 3Rs  
sign before inspection and  
cleaning.

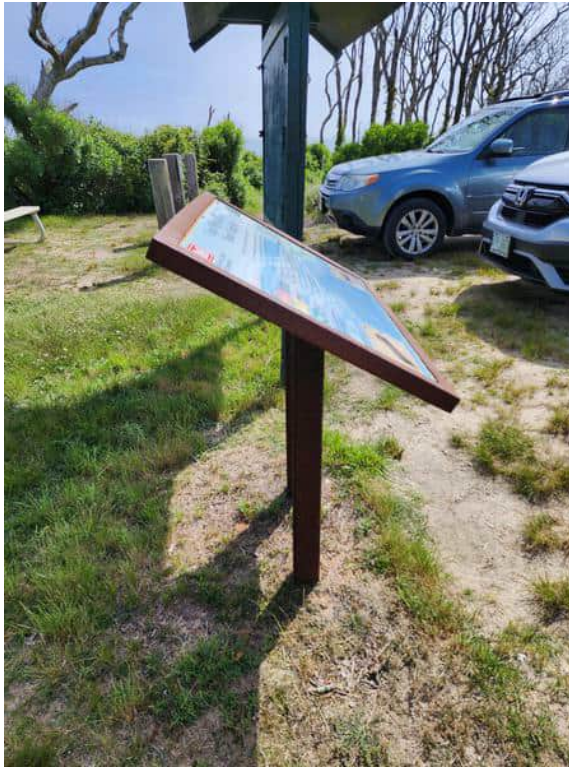
**Location:**  
Chappaquiddick Wasque  
Fishing Trail

**Description:**  
Left side view of pedestrian  
3Rs sign before inspection  
and cleaning.

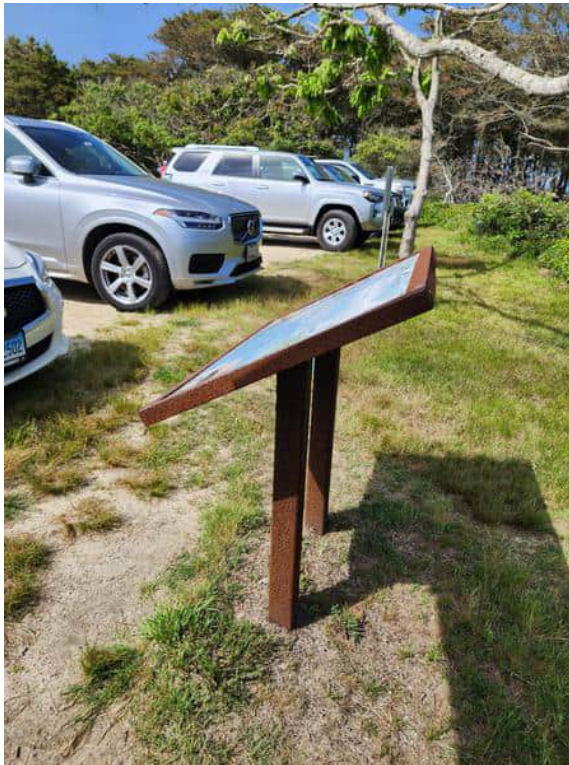
**Location:**  
Chappaquiddick Wasque  
Fishing Trail

**Description:**  
Right side view of pedestrian  
3Rs sign before inspection  
and cleaning.

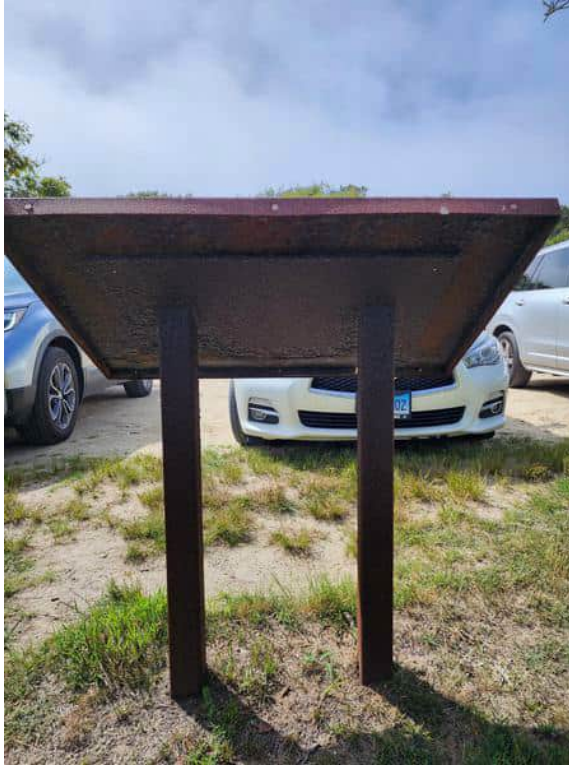
**Location:**  
Chappaquiddick Wasque  
Fishing Trail

**Description:**  
Back side of pedestrian 3Rs  
sign.

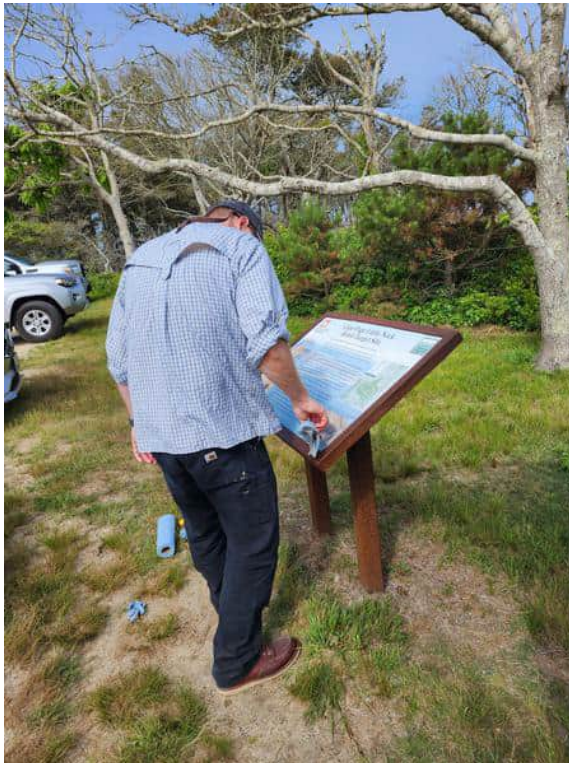
**Location:**  
Chappaquiddick Wasque  
Fishing Trail

**Description:**  
Pedestrian 3Rs sign being  
cleaned.

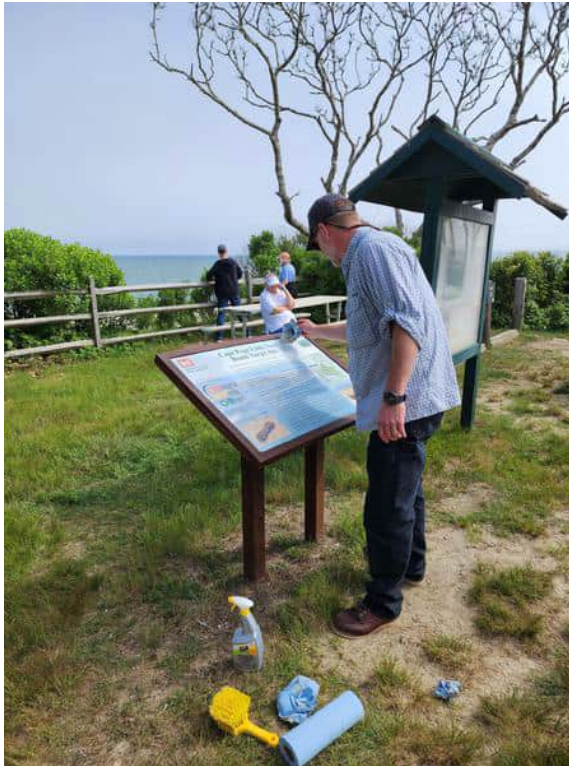
**Location:**  
Chappaquiddick Wasque  
Fishing Trail

**Description:**  
Pedestrian 3Rs sign being  
cleaned. Cleaning solution,  
shop towels, and brush in  
foreground.

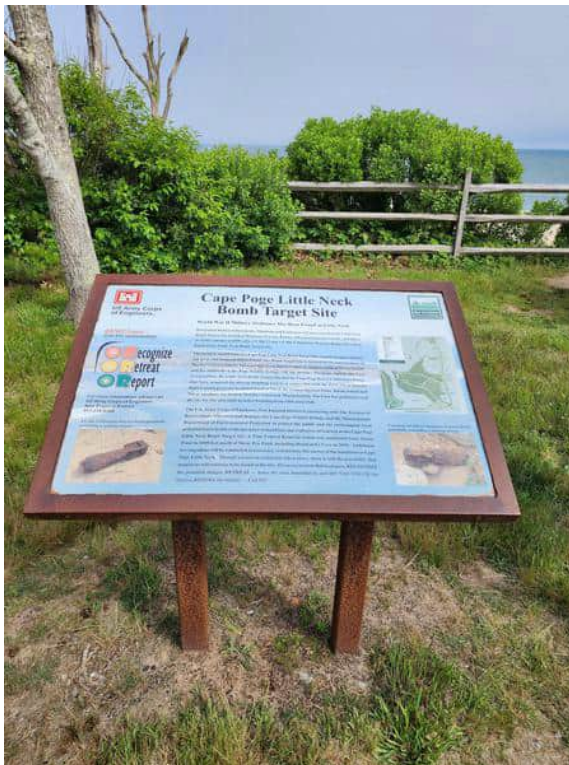
**Location:**  
Chappaquiddick Wasque  
Fishing Trail

**Description:**  
Front view of pedestrian 3Rs  
sign after inspection and  
cleaning.

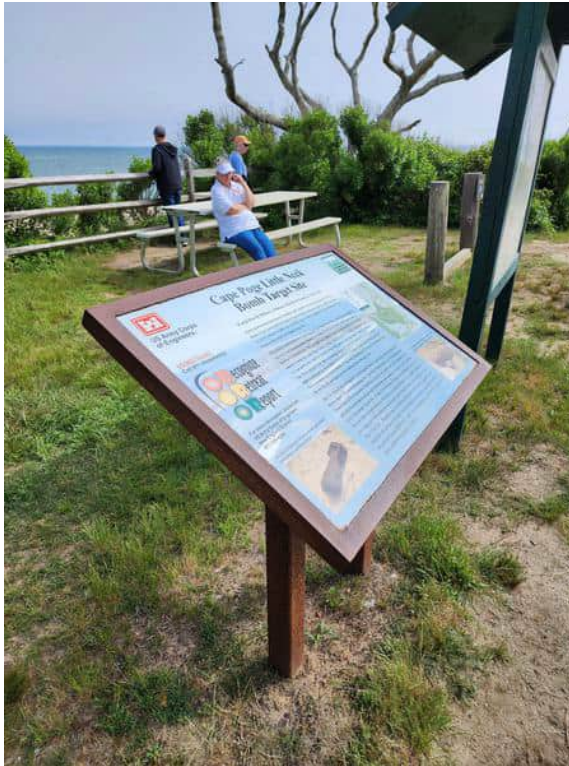
**Location:**  
Chappaquiddick Wasque  
Fishing Trail

**Description:**  
Left side view of pedestrian  
3Rs sign after inspection and  
cleaning.

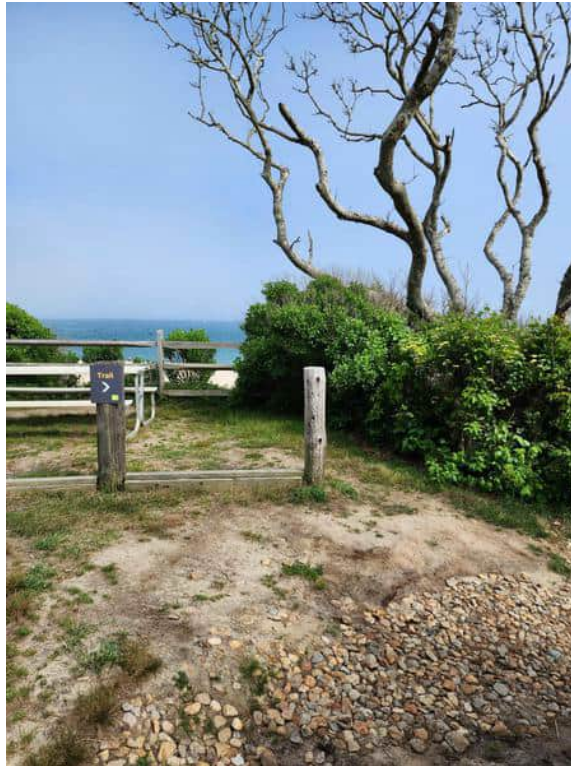
**Description:**  
First proposed location for  
additional or relocated 3Rs  
pedestrian sign.

For the Wasque Fishing Trail sign location, GSINA recommends that the sign be moved 30 meters south to the trail entrance for increased visibility. The sign at the Left Fork location was recorded as critical condition due to poor location. GSINA recommends that an additional sign be installed, or that the current sign be moved nearer to the beach entrance. It was noted that the dunes near the Right Fork location had been reconstructed and the sign is now no longer near the entrance to the beach path.

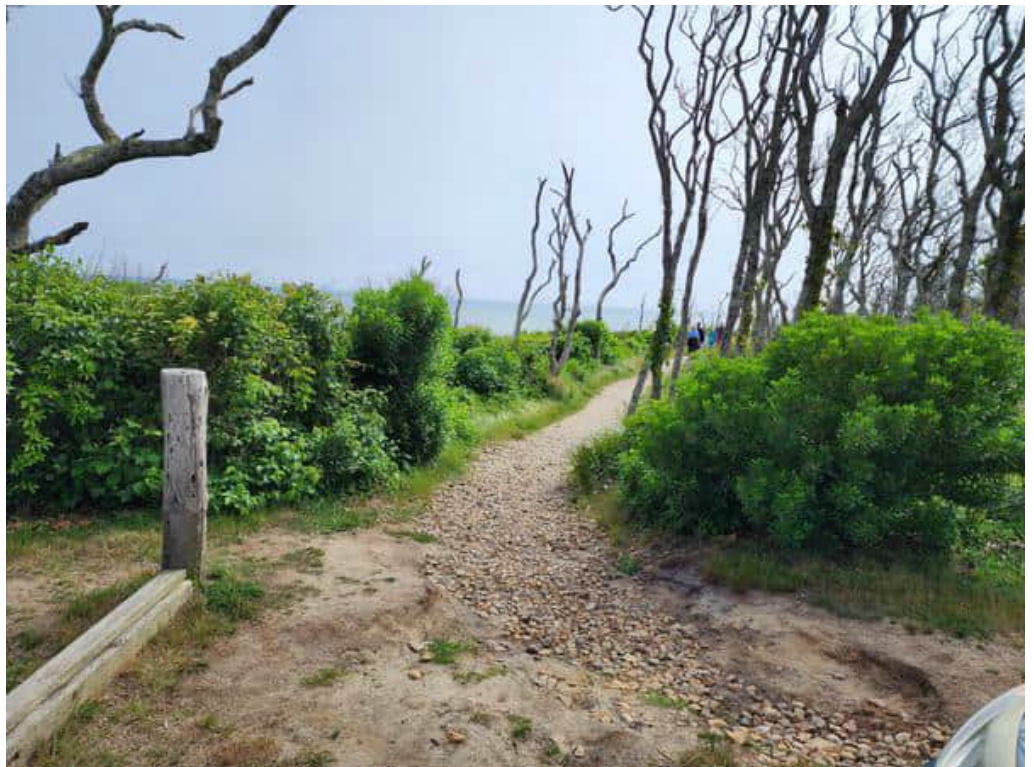
**Description:**  
Second proposed location for  
additional or relocated 3Rs  
pedestrian sign. At trail  
entrance.

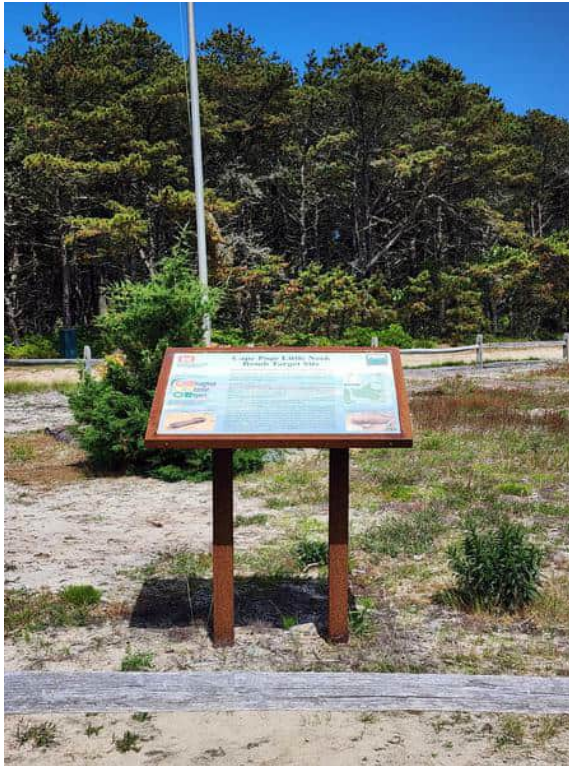
**Location:**  
Chappaquiddick Wasque  
Gate House

**Description:**  
View of pedestrian 3Rs sign  
at Wasque Gate House  
showing proximity to flag  
pole.

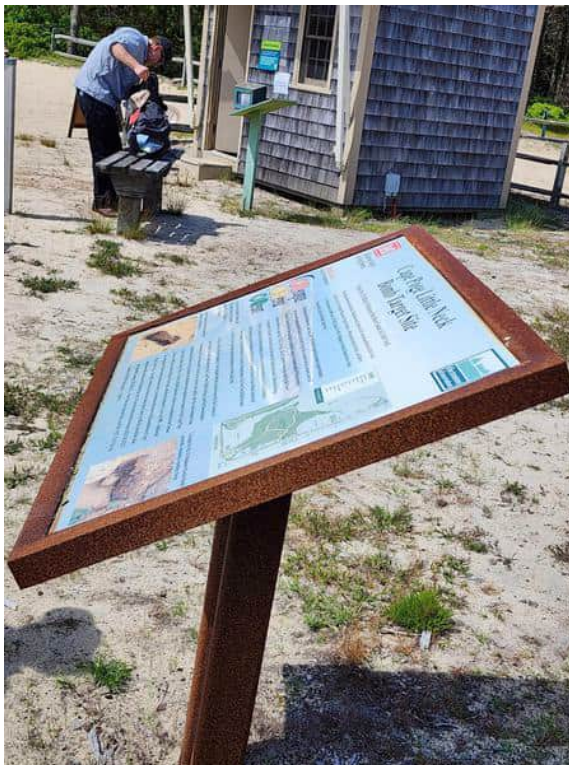
**Location:**  
Chappaquiddick  
Wasque Gate House

**Description:**  
Right side view of 3Rs  
pedestrian sign showing  
proximity to gate house.

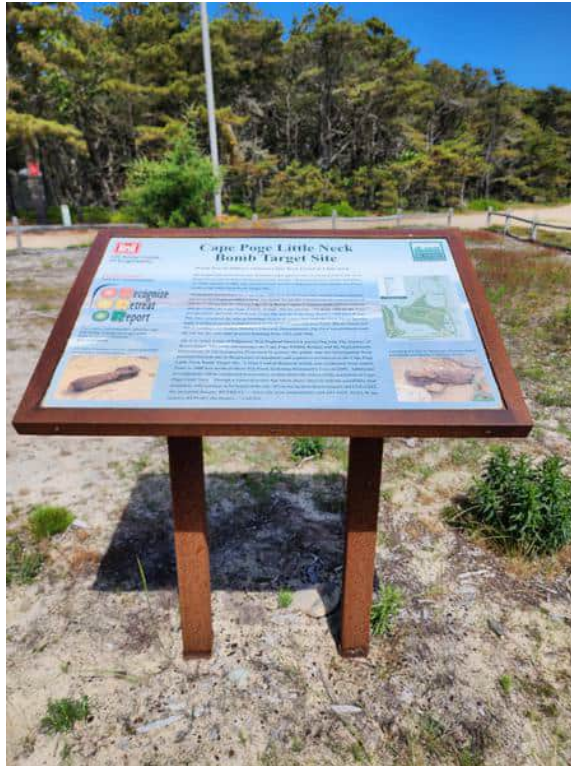
**Location:**  
Chappaquiddick Wasque  
Gate House

**Description:**  
Front view of pedestrian 3Rs  
sign before inspection and  
cleaning.

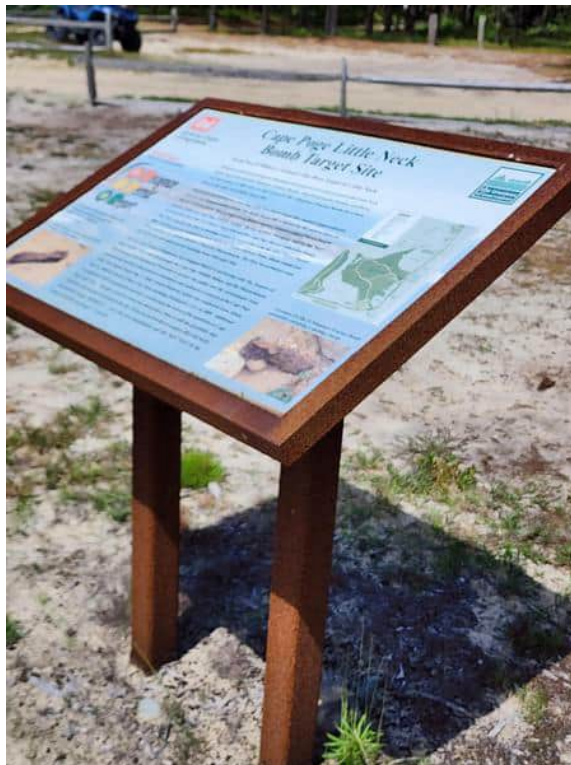
**Location:**  
Chappaquiddick Wasque  
Gate House

**Description:**  
Right side view of pedestrian  
3Rs sign before inspection  
and cleaning.

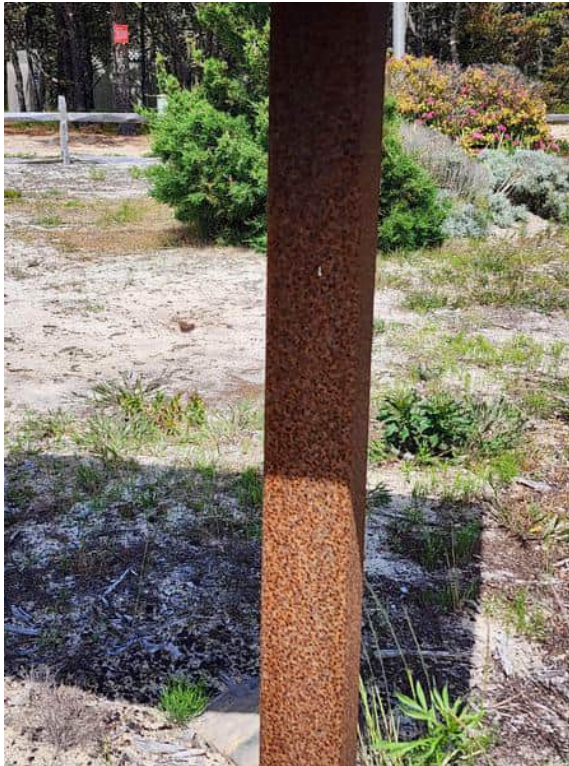
**Location:**  
Chappaquiddick Wasque  
Gate House

**Description:**  
View of right leg of pedestrian  
3Rs sign showing rust.

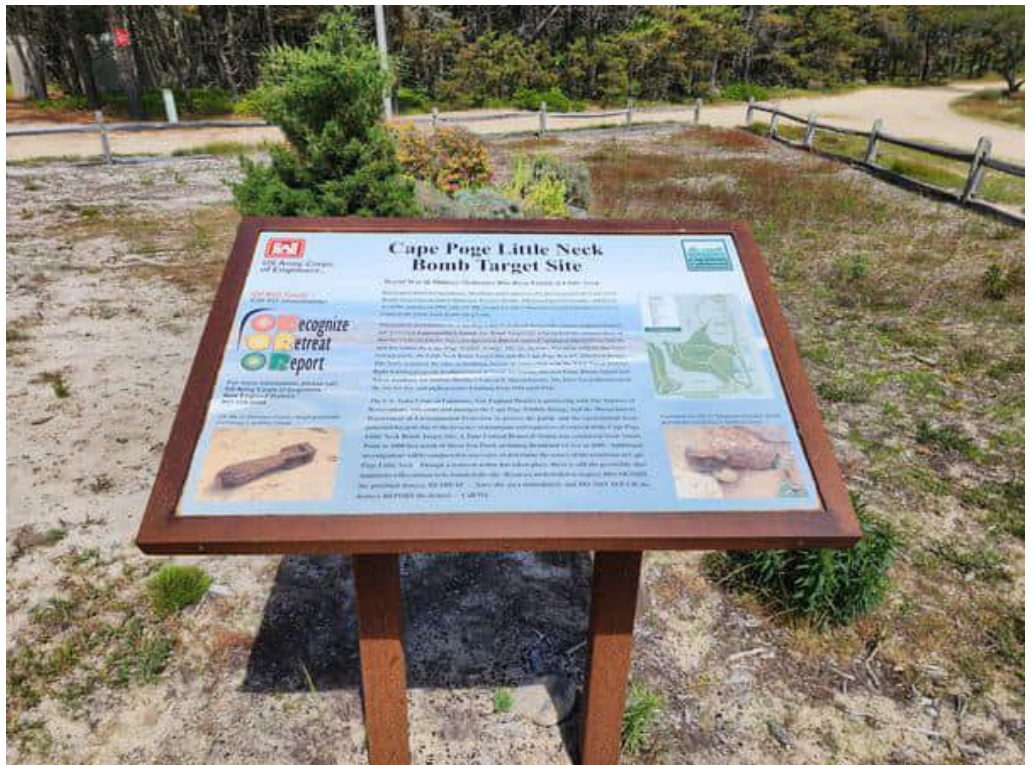
**Location:**  
Chappaquiddick Wasque  
Gate House

**Description:**  
Front view of pedestrian 3Rs  
sign after inspection and  
cleaning.

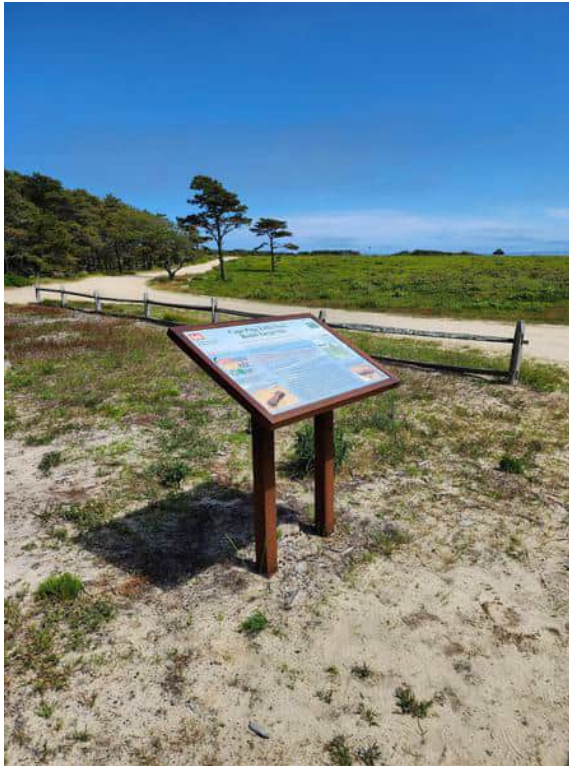
**Location:**Chappaquiddick Wasque  
Gate House**Description:**Left side view of pedestrian  
3Rs sign after inspection and  
cleaning.

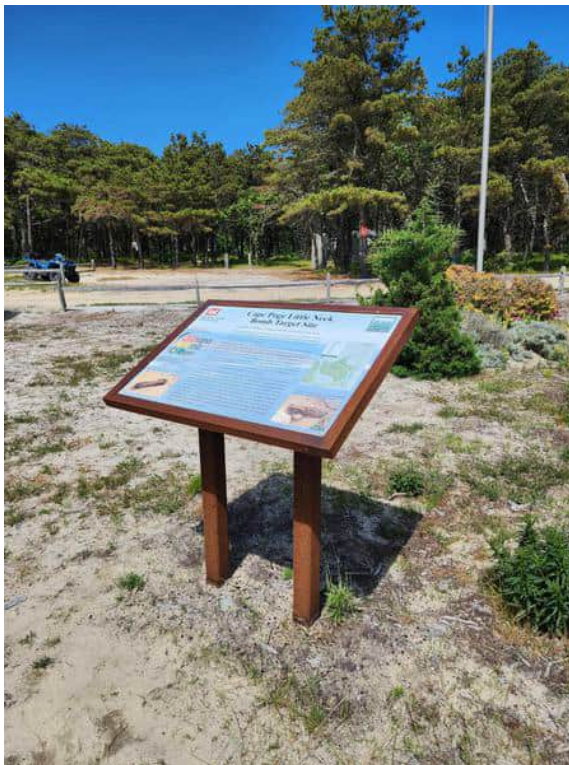
**Location:**Chappaquiddick Wasque  
Gate House**Description:**Right side view of pedestrian  
3Rs sign after inspection and  
cleaning.

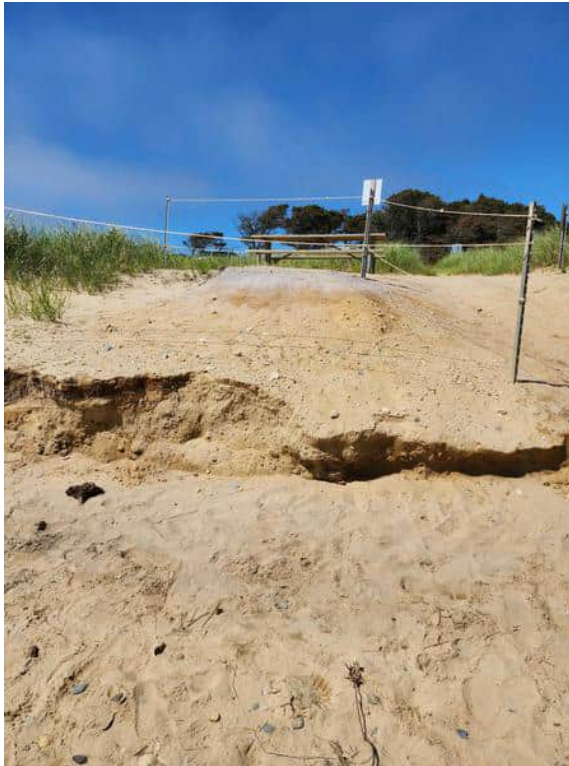
**Location:**Chappaquiddick Wasque  
Swimming Trail**Description:**

View of location where 3Rs  
pedestrian sign should be  
located at Wasque Swimming  
Trail. Beach area shows signs  
of erosion.

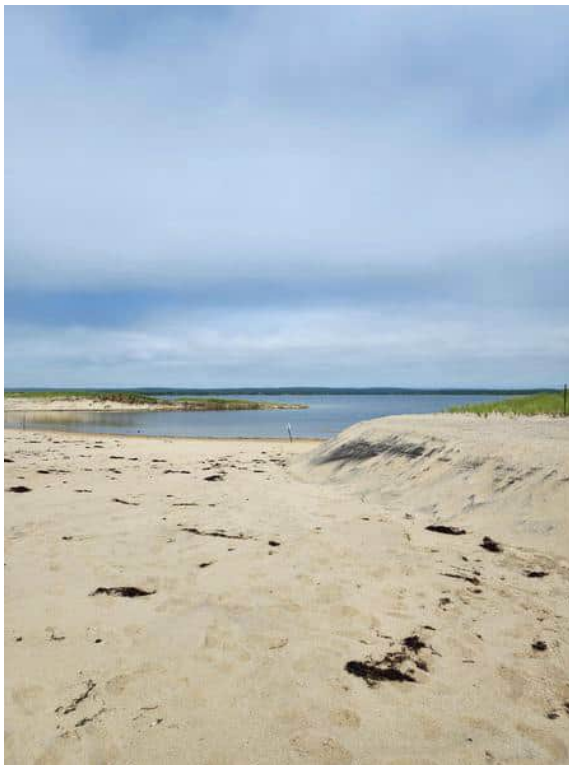
**Location:**Chappaquiddick Wasque  
Tire Inflation Station**Description:**

View of location where 3Rs  
pedestrian sign should be  
located at Wasque Tire  
Inflation Station. Beach area  
shows signs of erosion.

1. CHAPPAQUIDDICK WASQUE TIRE INFLATION AREA	EROSION SIGN GONE ON PREVIOUS YEAR NO MD/MEC	Sign missing - NOTED BY LUCID MAP <u>NOTE!</u> ① client thinks sign should be listed under Cape Poge Due to sign language 23Jun23

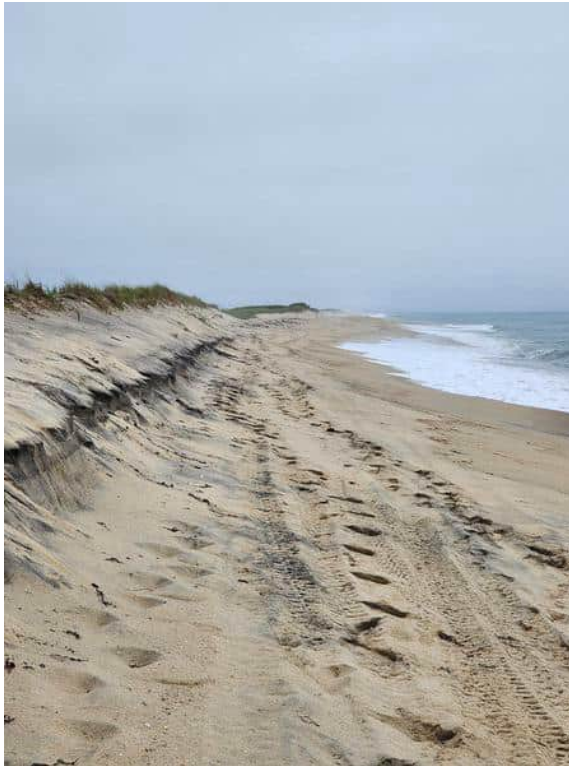
View north of beach near  
Wasque Tire Inflation Station  
sign location. Signs of  
erosion visible.

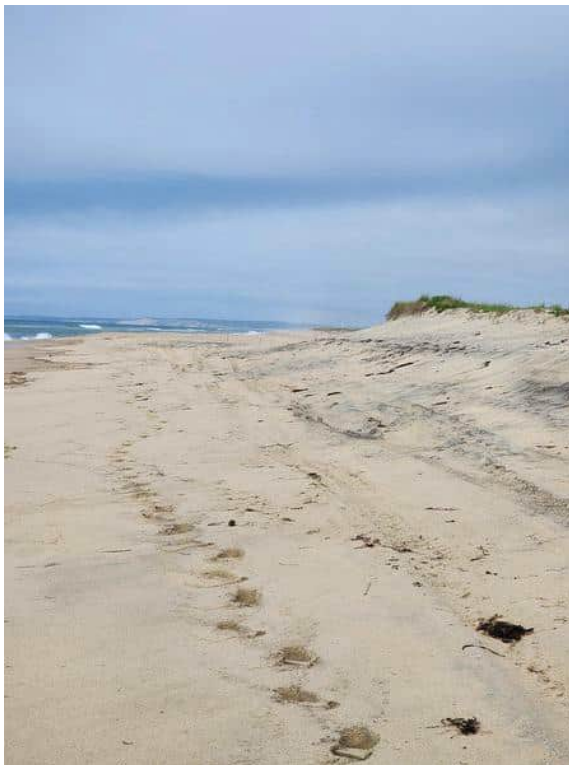
View south of beach near  
Wasque Tire Inflation Station  
sign location.
