**FLOATING DEBRIS BOOM REPLACEMENT
U.S. ARMY CORPS OF ENGINEERS
THOMASTON DAM
THOMASTON, CT
STATEMENT OF WORK**

Informational Photos

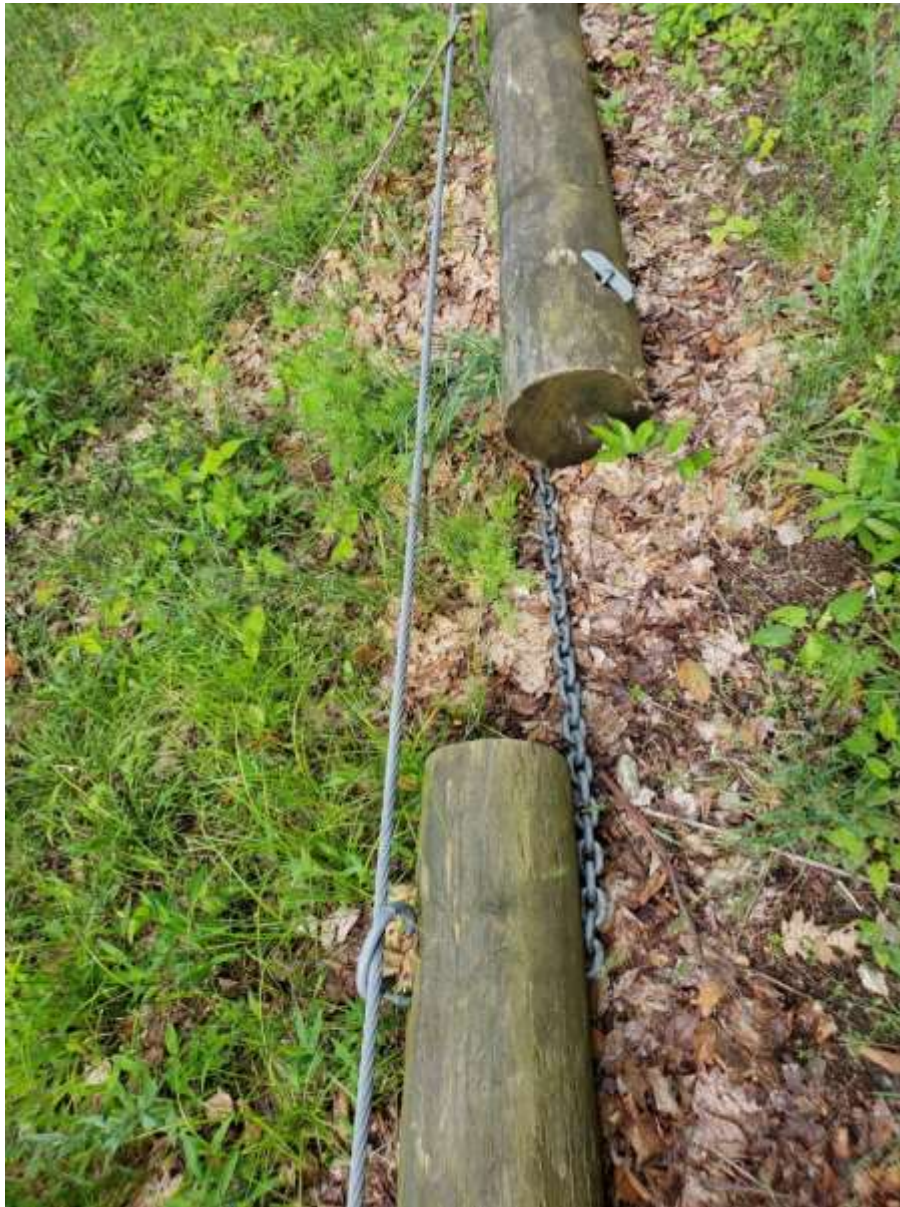
Informational Photo 1 – Log to log to chain connection (existing boom).

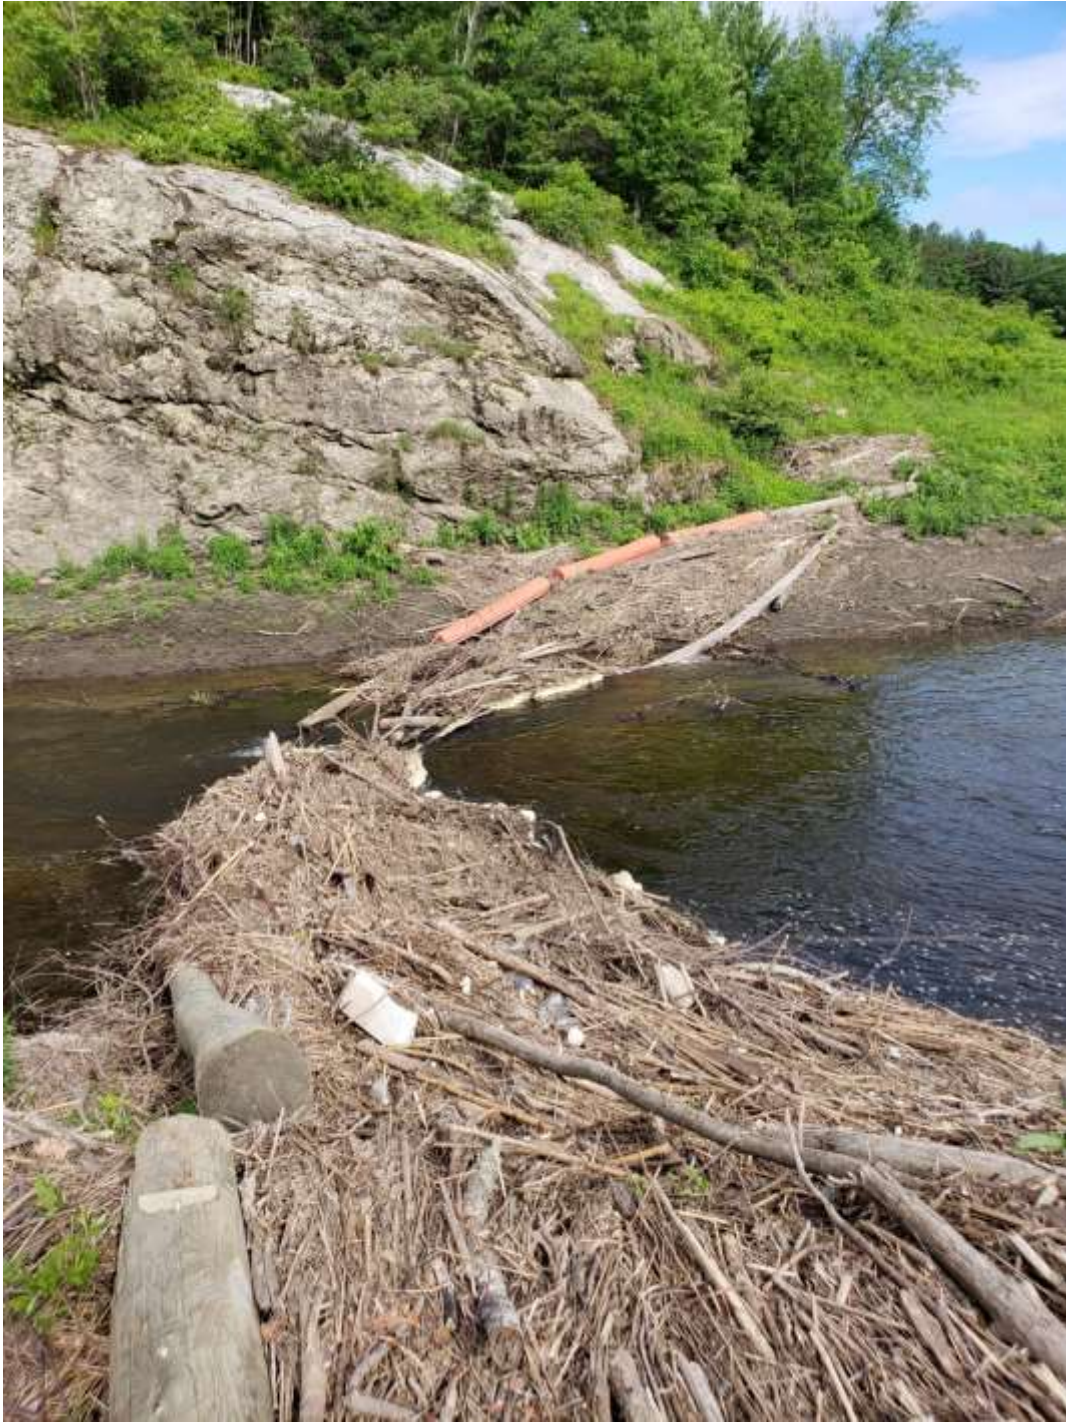
Informational Photo 2 – Boom crossing the Naugatuck River during normal pool.

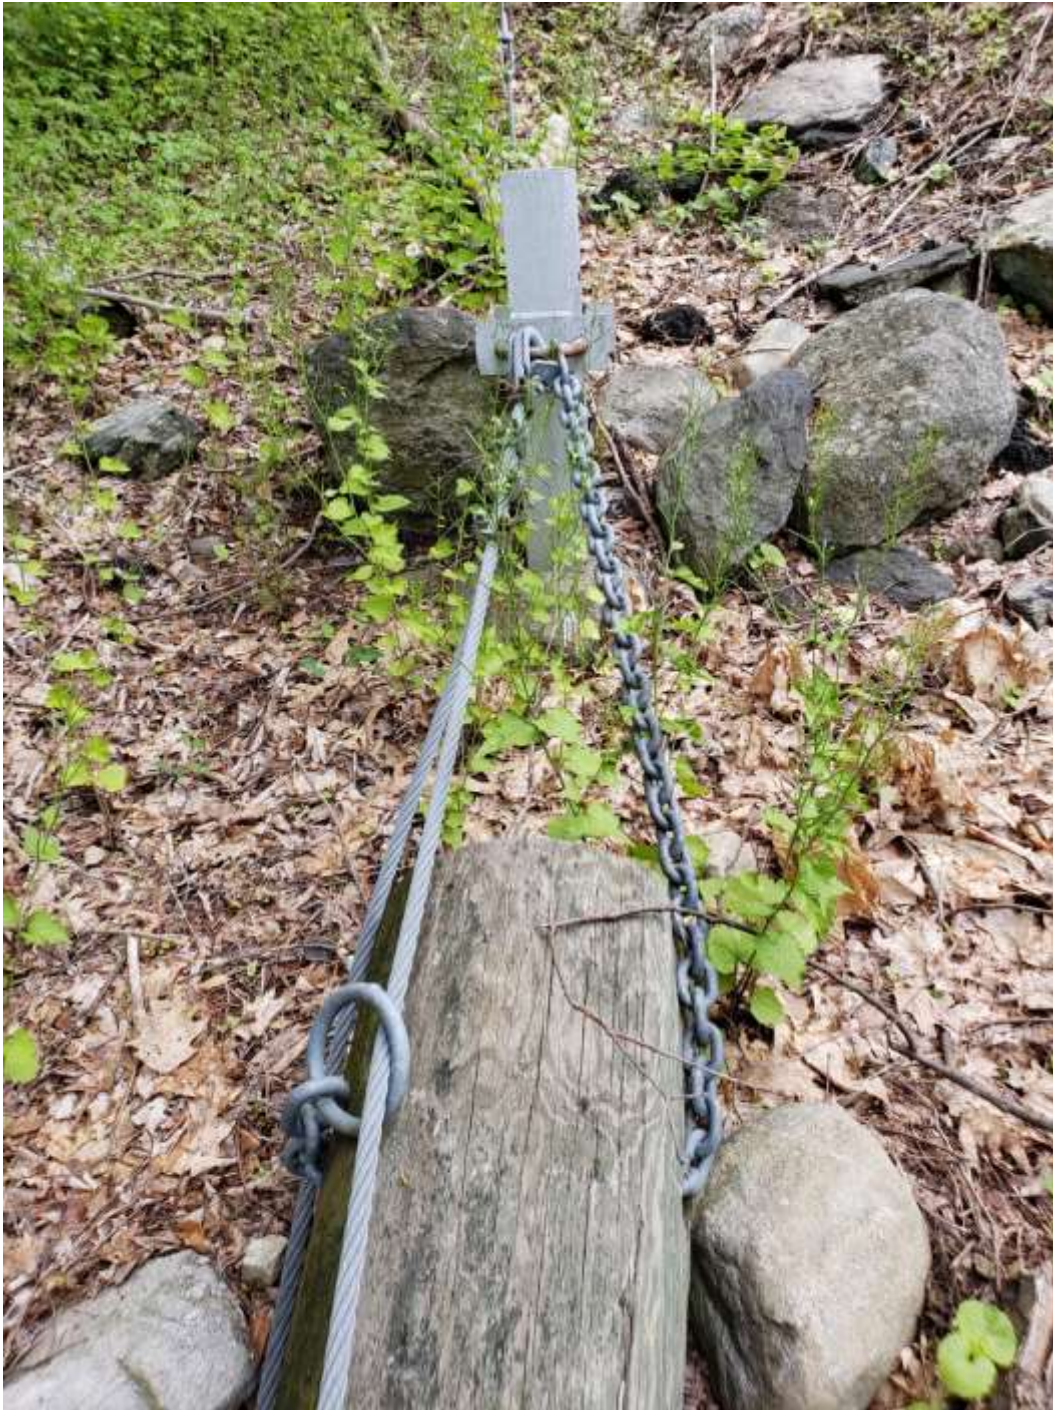
Informational Photo 3 – East anchor- cable will remain and chain to be replaced.

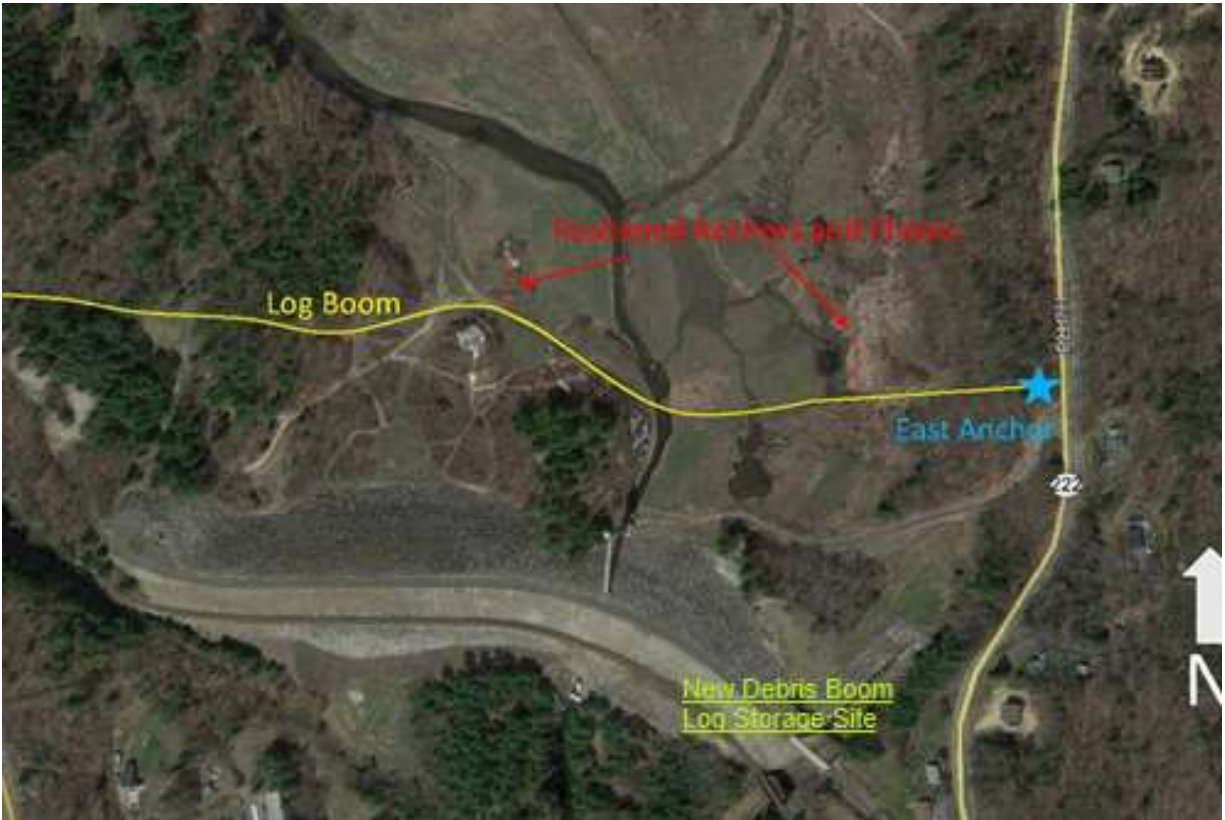
Informational Photo 4 – Layout of entire debris boom, anchors, and center anchor chains.

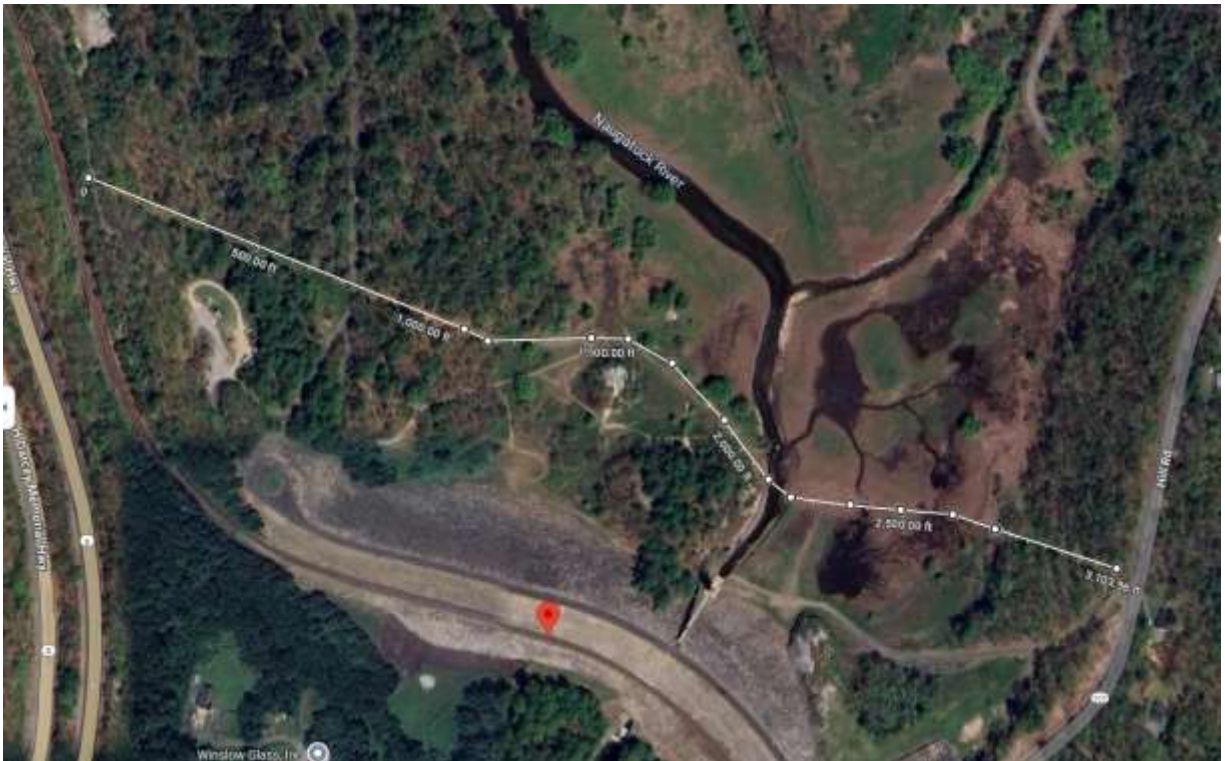
Informational Photo 5: Approximate layout of existing debris boom with measurements (in feet)

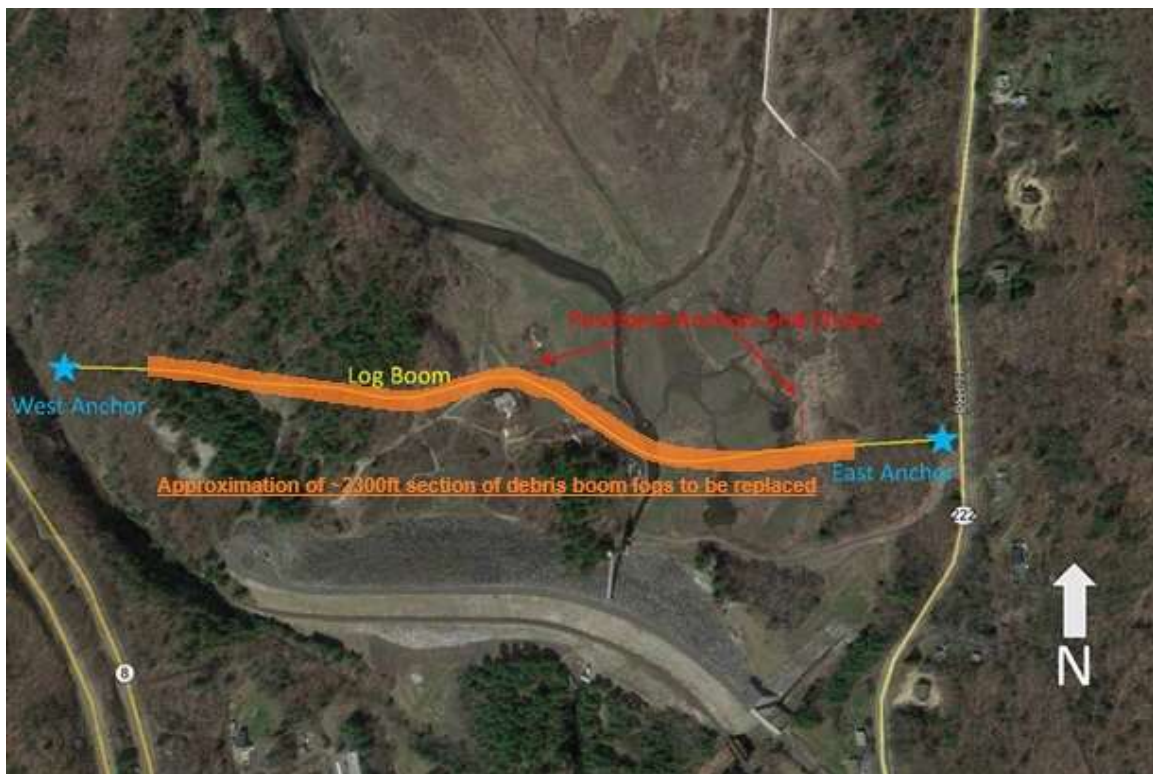
Informational Photo 6: Mockup of section to be replaced. Actual section to be replaced will be marked out by Technical Point of Contact prior to start of work.

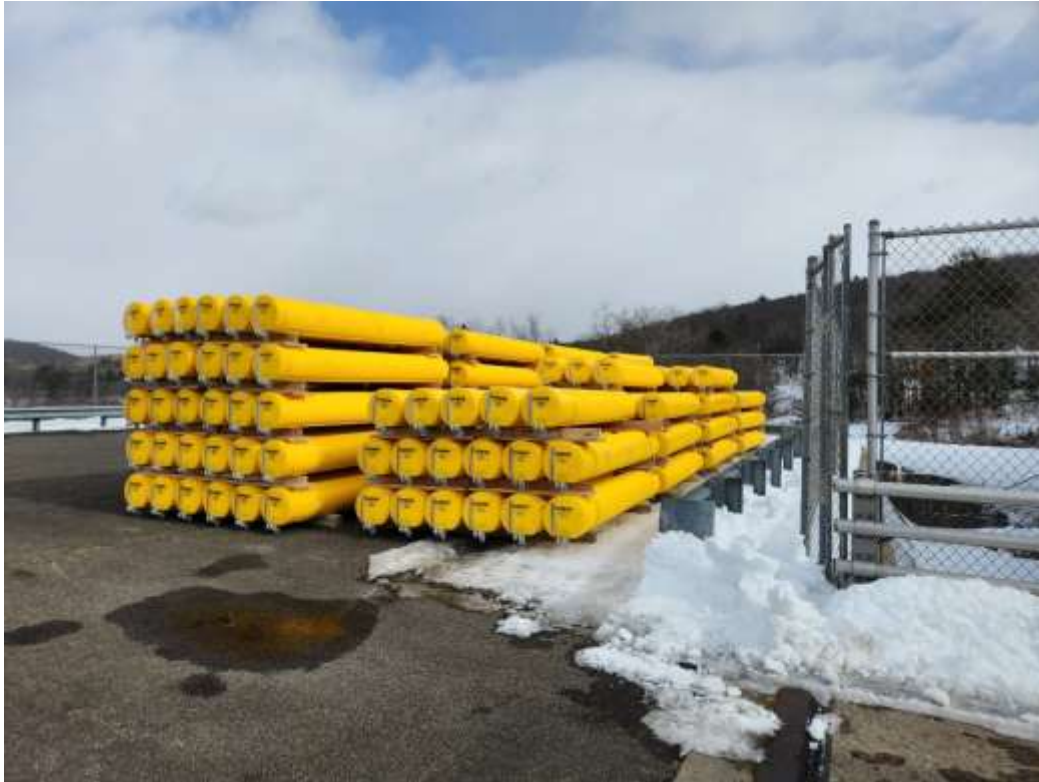
Informational Photo 7: Actual Debris Boom Logs stored at Thomaston Dam

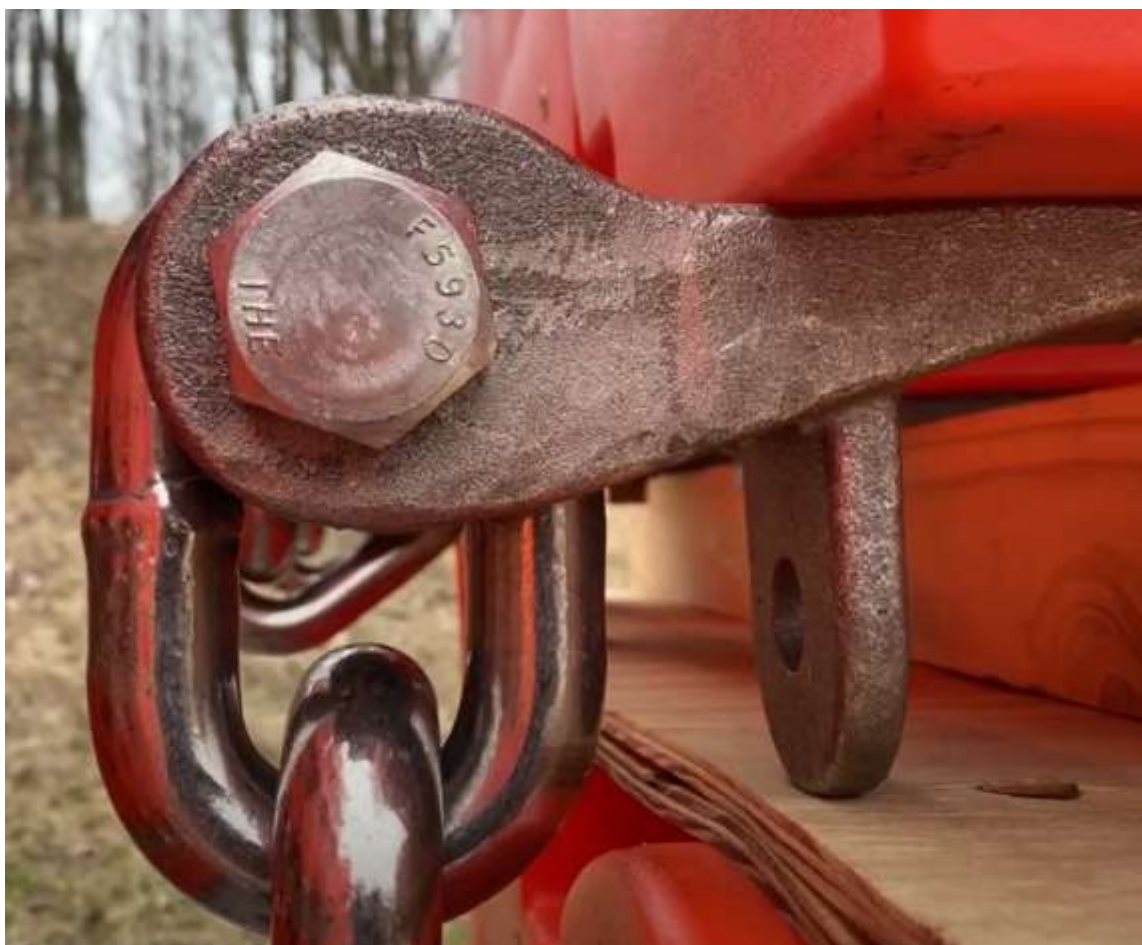
Informational photo 9: Example of new connection hardware (3-part weldless links installed by manufacturer).
