Informational Maps/ Photos

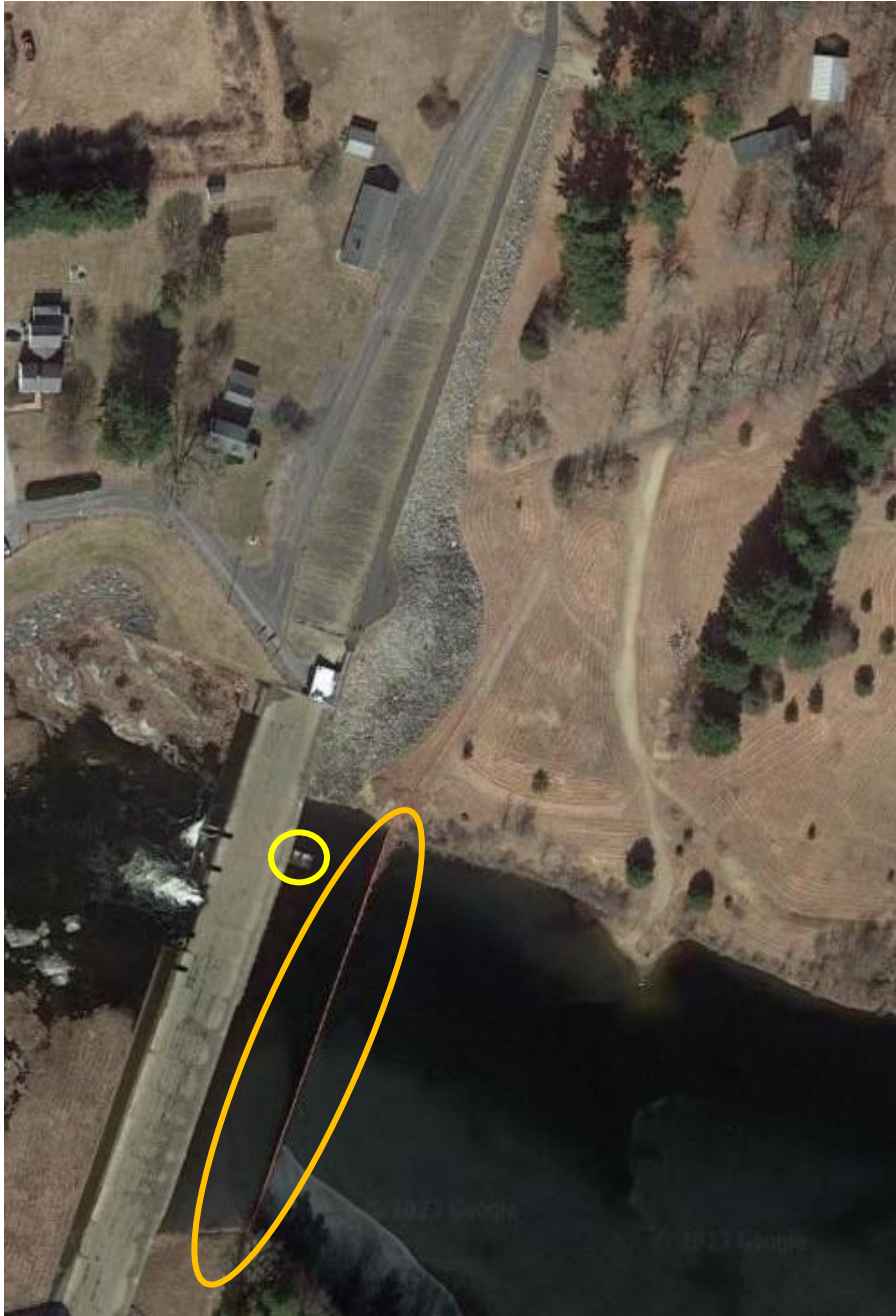
Map 1: Image showing Mansfield Hollow Dam inlet area. Orange log boom (orange circle) and weir box structure (yellow circle) is visible in bottom left of image.

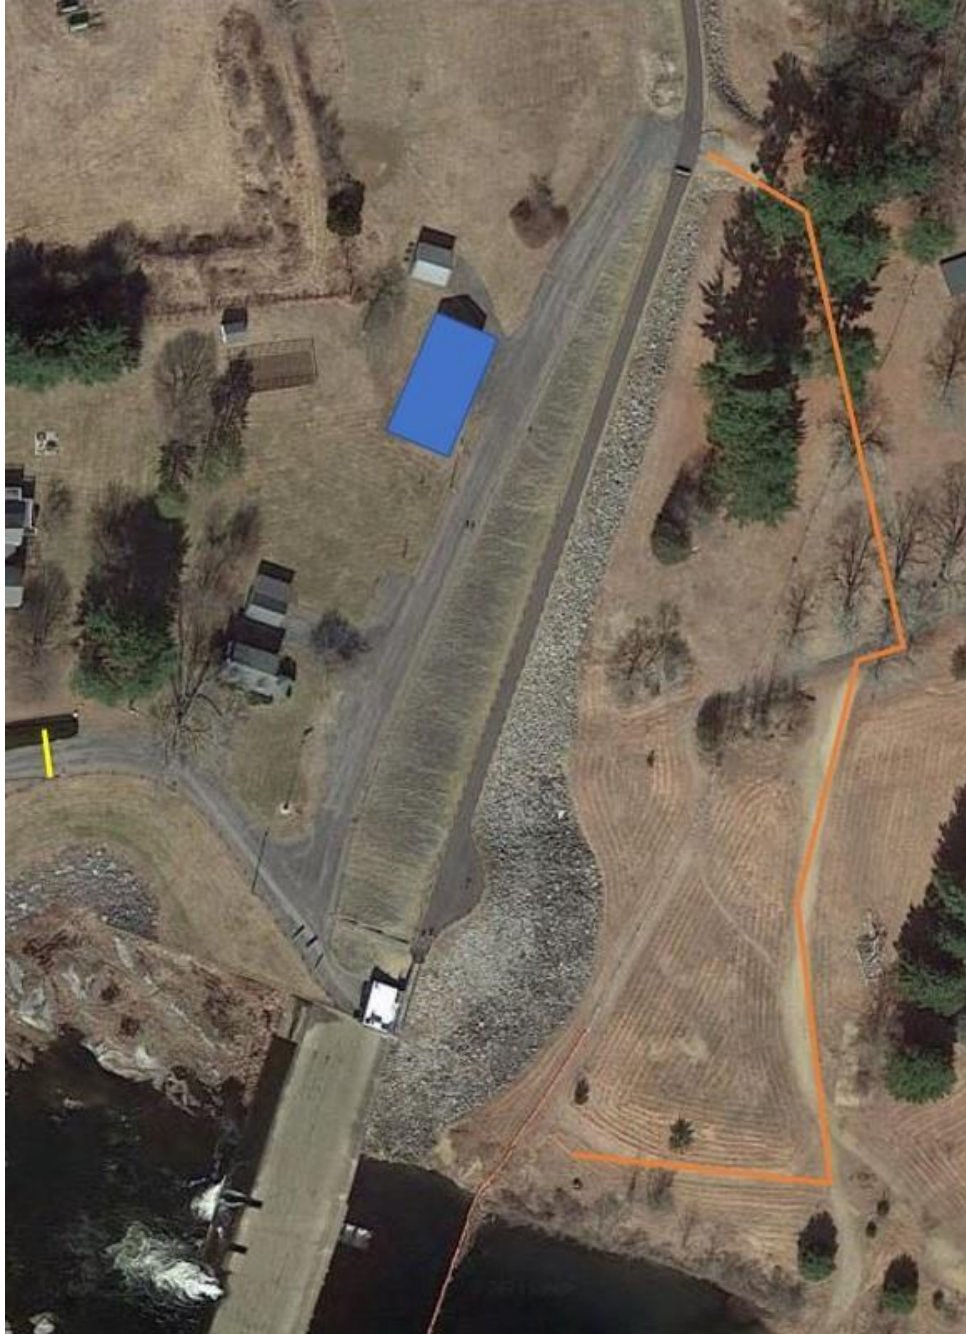
Map 2: Image showing access road leading to debris removal area. Yellow line indicates USACE access gate (combination will be provided at contract award), blue square indicates project office and orange line indicates road access to debris removal site.

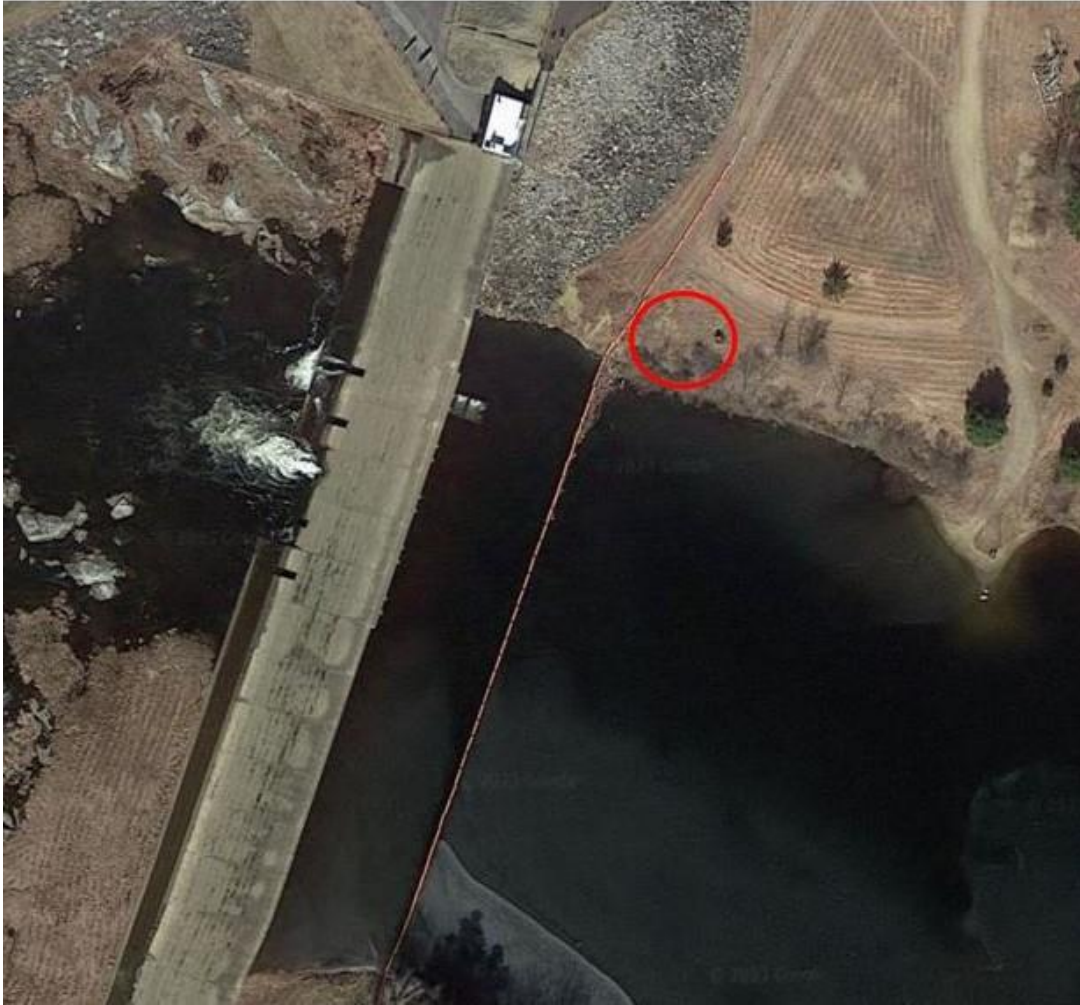
Map 3: Image showing working area where crane is proposed to be staged. 90 ft crane is recommended due to natural working pad location.

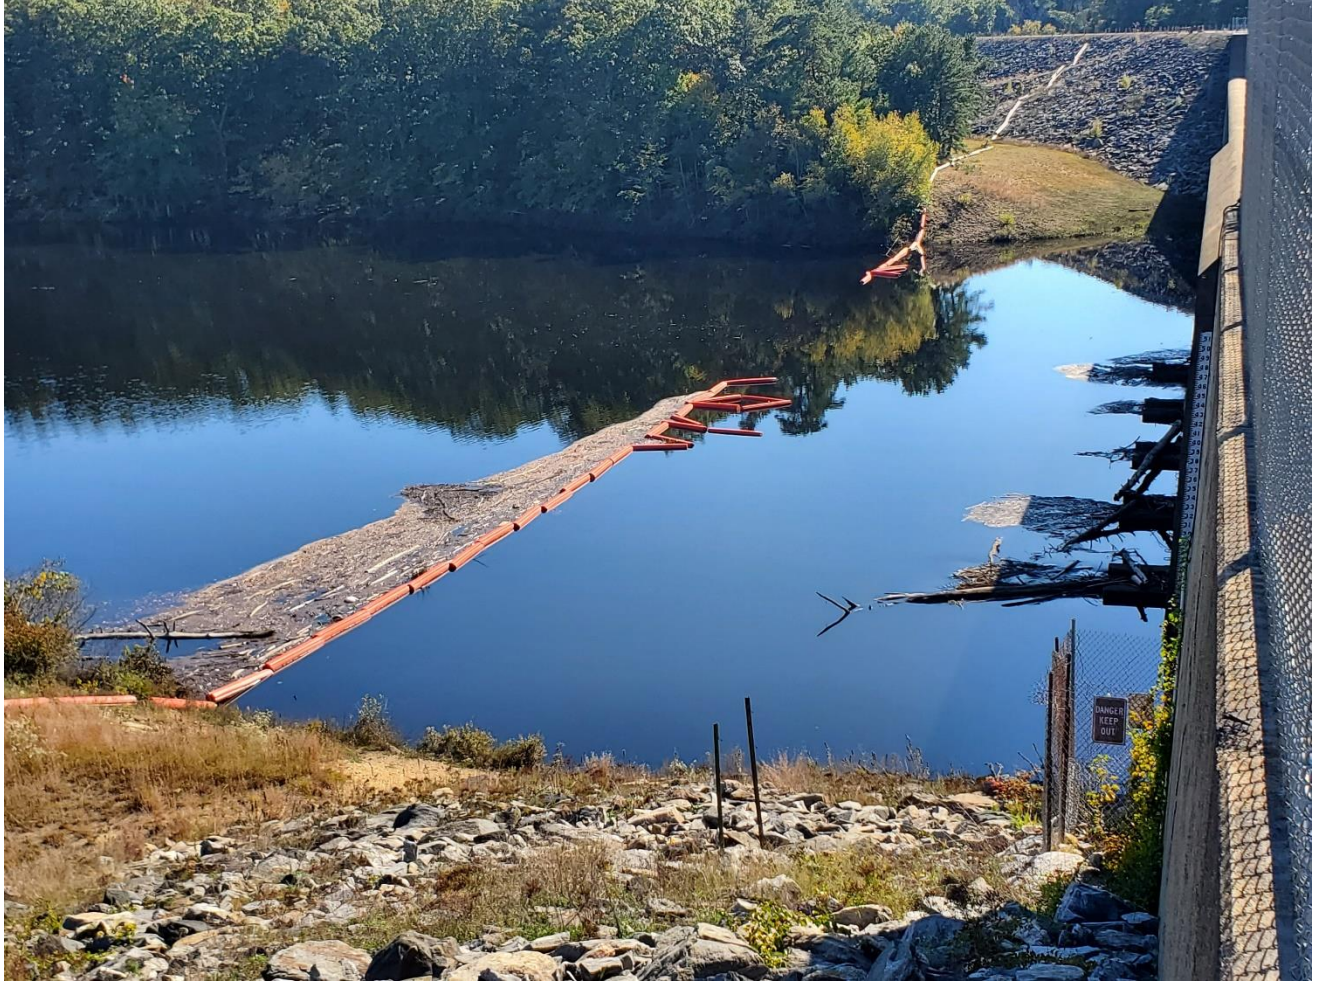
Image 1: Image showing current condition of log boom and weir box structures. Most of the debris is located at the left side of the log boom structure and debris on weir boxes is exclusively on the top of them (15ft from the bottom of the dam structure).

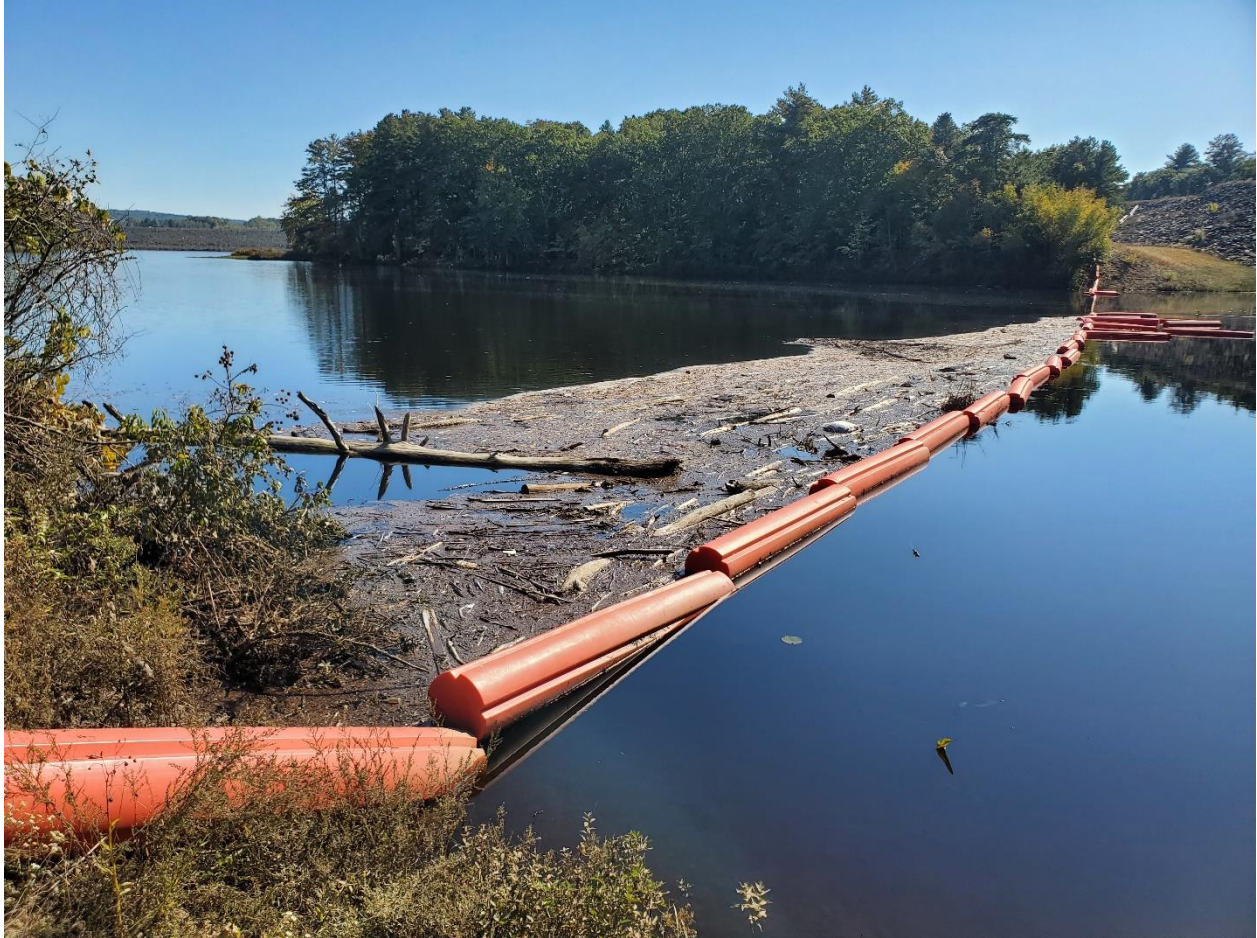
Image 2: Image showing current condition of log boom structure. Most of the debris present is small (3-5ft. in length) with one or two full sized trees stuck to the structure.

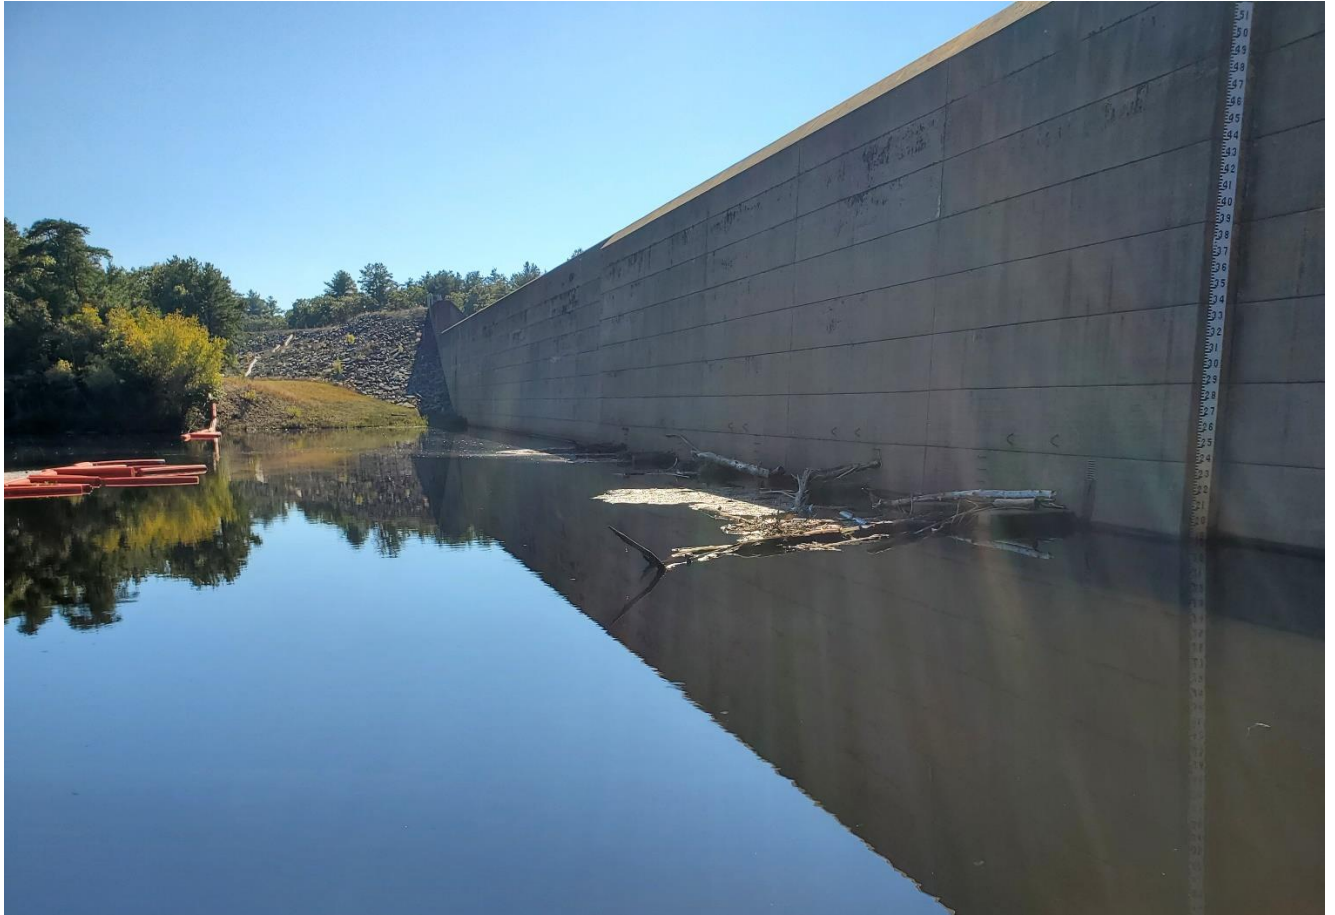
Image 3: Image showing current condition of weir box structures. Most of the debris present is larger, full-size trees (10-15+ ft.) stuck on top of the weir box structures.
