Monitoring Survey at the Isles of Shoals North Disposal Site, October 2021

Disposal Area Monitoring System - DAMOS

Contribution 214
September 2022

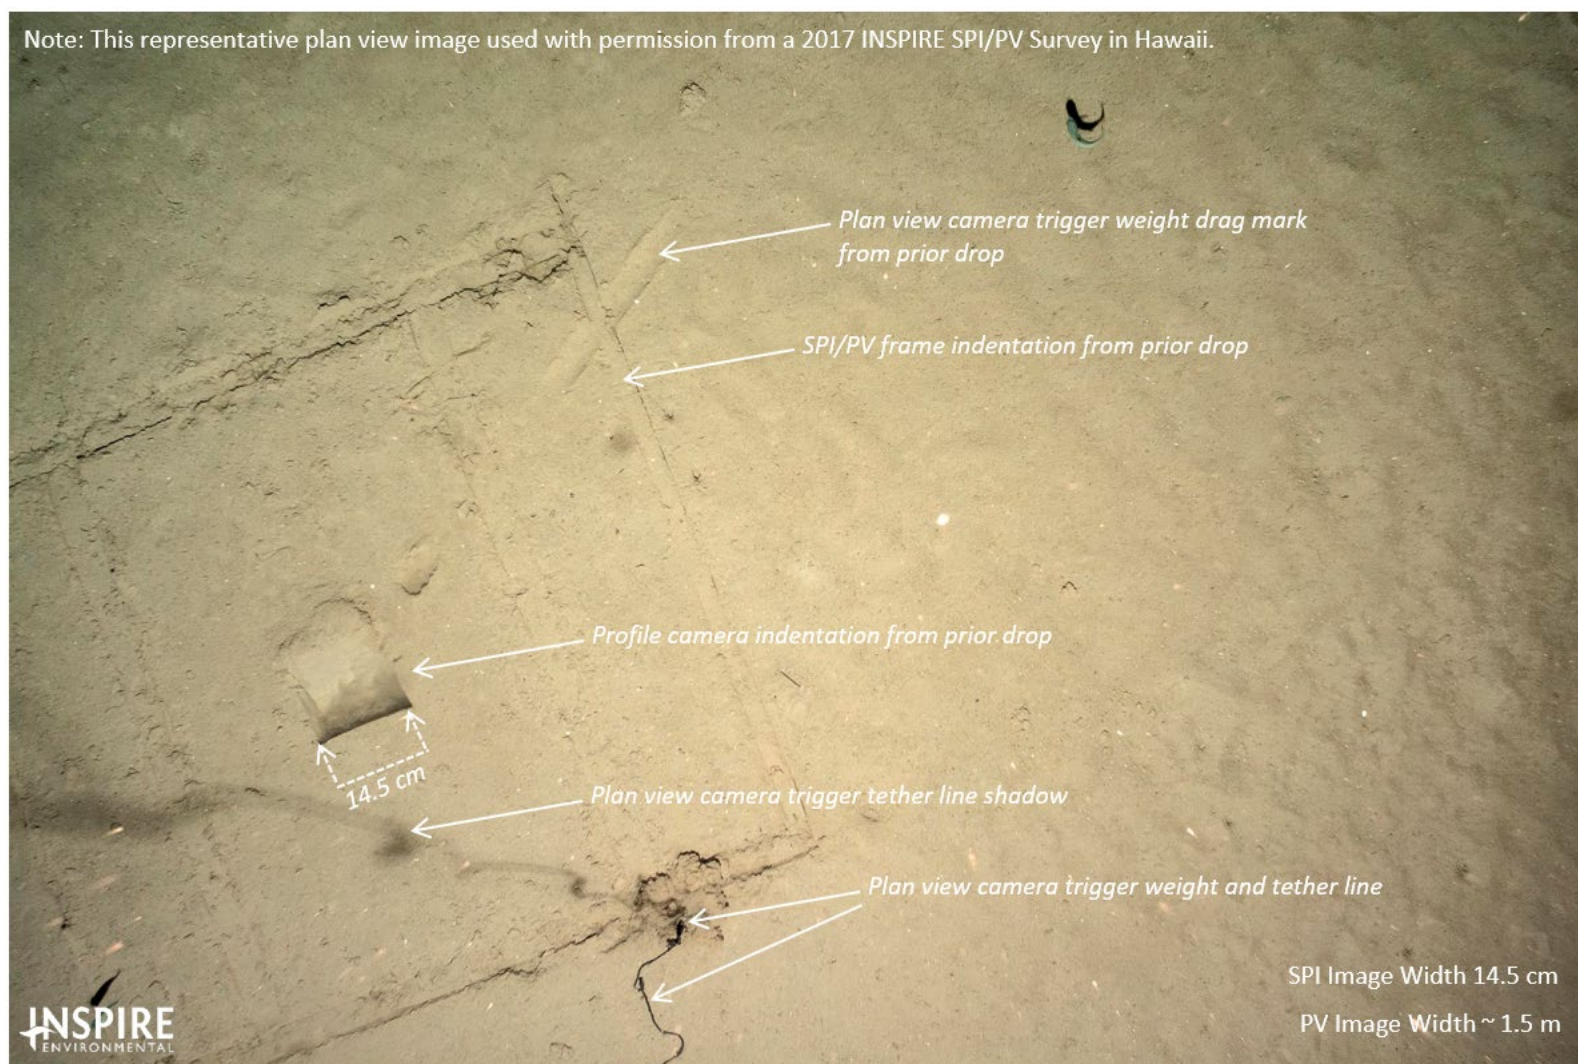
Figure 2-6. This representative plan view image shows the sampling relationship between plan view and sediment profile images. Note: plan view images differ between surveys and stations and the area covered by each plan view image may vary slightly between images and stations.

The PV images provided a much larger field-of-view than the SPI images and provided valuable information about the landscape ecology and sediment topography in the area where the pinpoint “optical core” of the sediment profile was taken (Figure 2-6). Unusual surface sediment layers, textures, or structures detected in any of the sediment profile images can be interpreted within the larger context of surface sediment features, i.e., is a surface layer or topographic feature a regularly occurring feature and typical of the bottom in this general vicinity or just an isolated anomaly. The scale information provided by the underwater lasers allows for accurate density counts of attached epifaunal colonies,

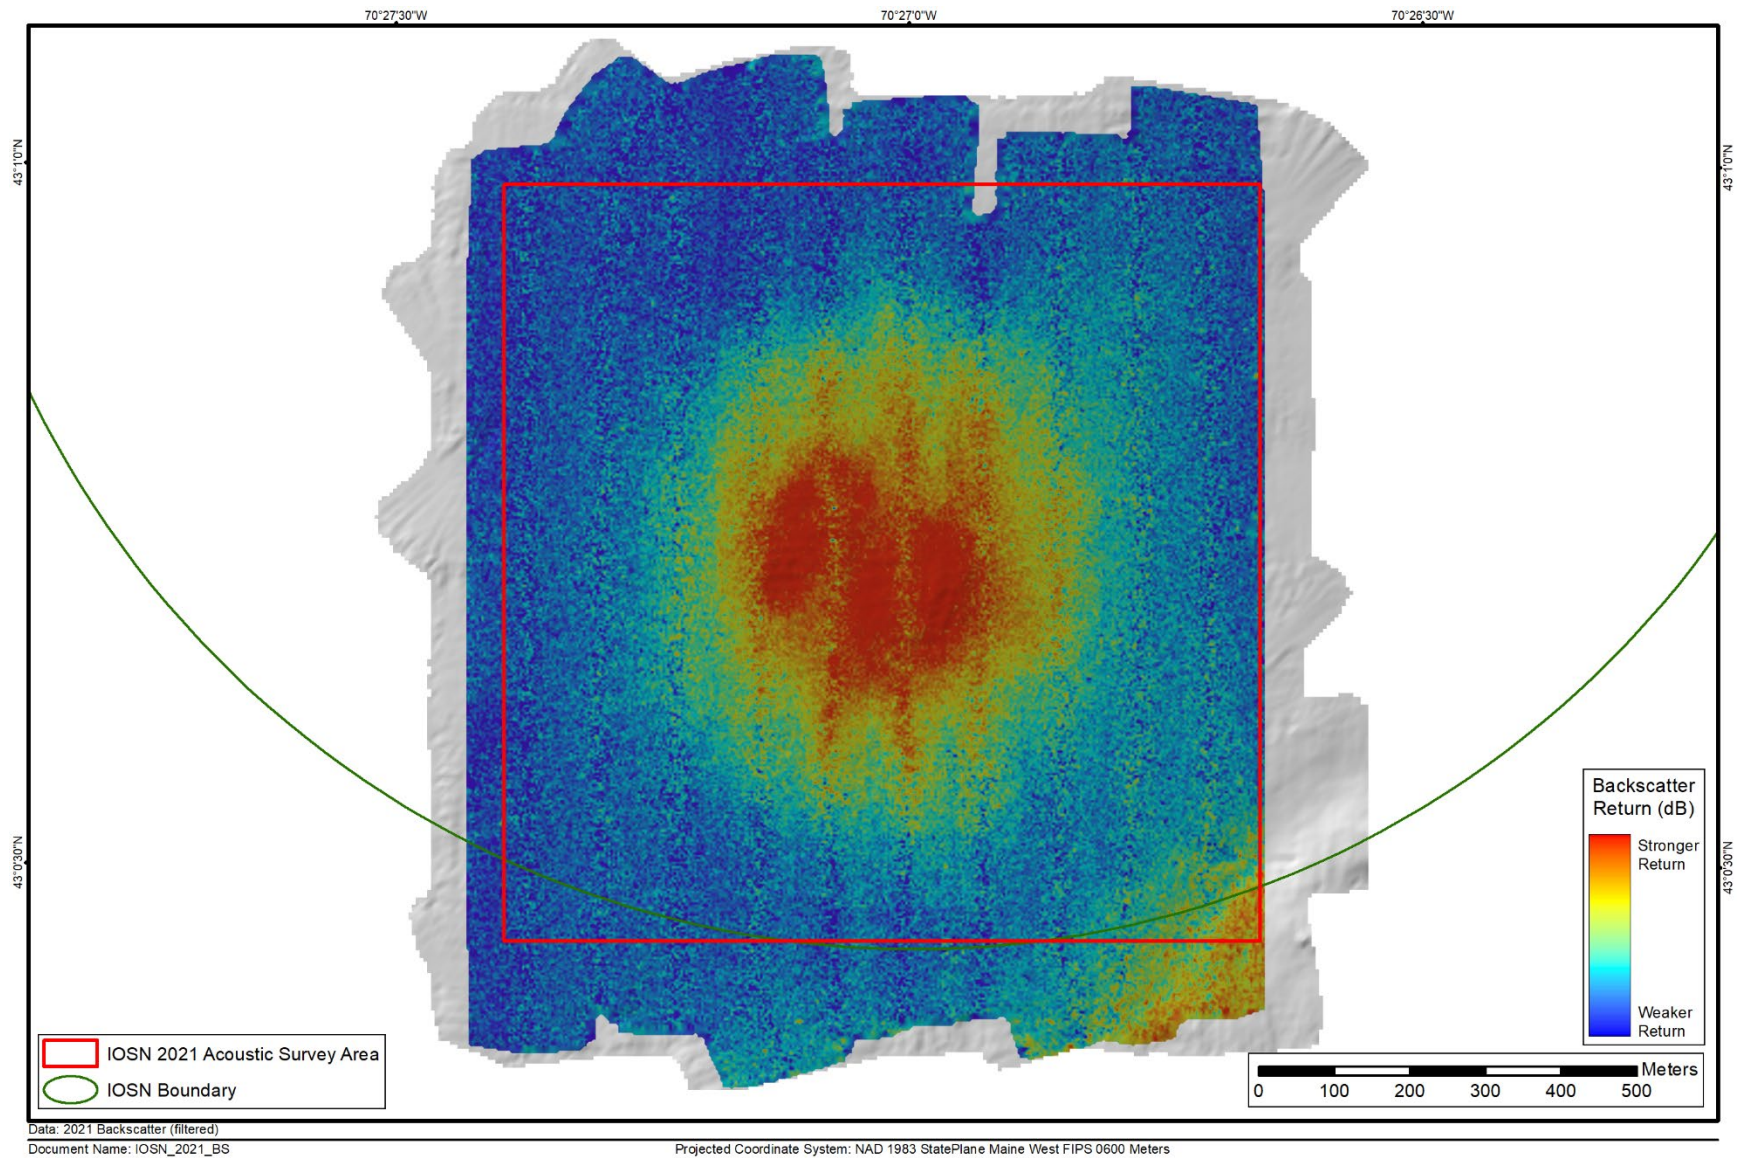
Figure 3-3. Filtered backscatter over acoustic relief model of IOSN - October 2021
