Monitoring Survey at the Central Long Island Sound Disposal Site June 2004

Disposal Area Monitoring System DAMOS

Contribution 163
September 2005

**US Army Corps
of Engineers**®
New England District

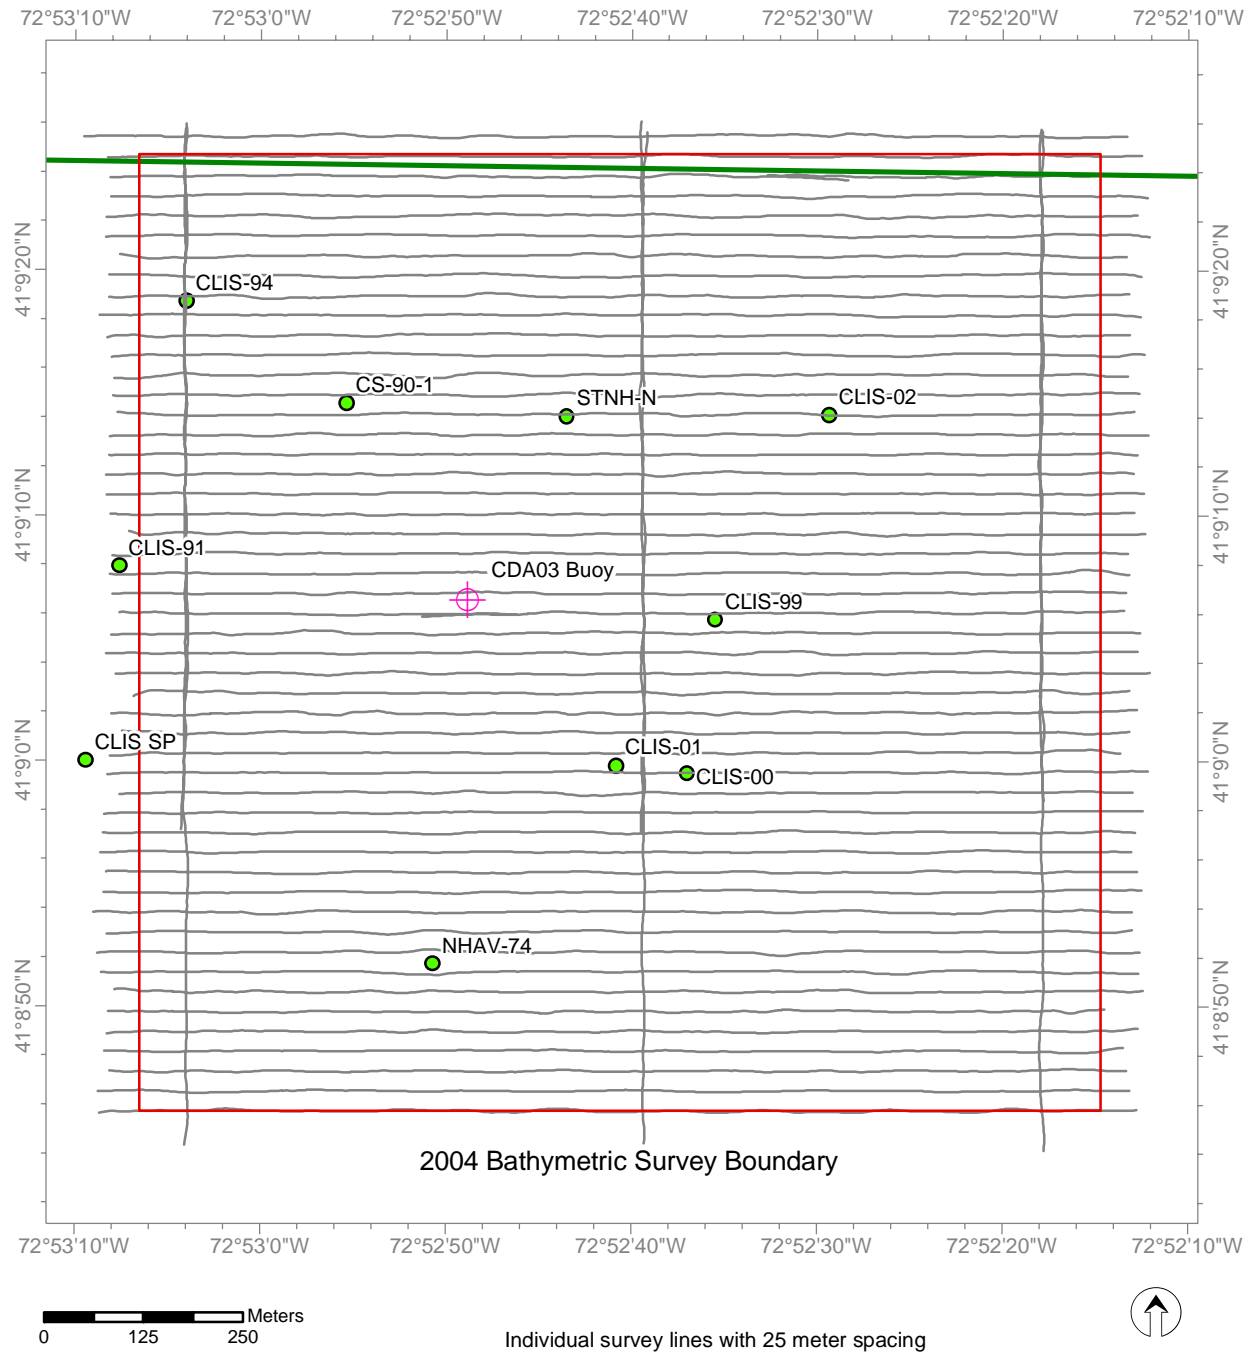
Figure 2-1. Bathymetric survey lines at CLDS, June 2004

Bathymetric data were collected using an Innerspace Model 448 Echo Sounder outfitted with an 8° transducer, which achieved an accuracy of approximately 3 cm in CLDS water depths. Data were collected at a rate of 17 to 18 soundings per second at boat speeds of 4 to 4.5 knots, resulting in soundings spaced at less than 0.2 meter intervals along each survey transect line. Calibration procedures were conducted on-site prior to data collection as well as at the conclusion of each survey day. The average speed of sound through the water column was obtained from a full depth cast of a CTD profiler. Additional calibration information was obtained from a bar check. Tidal elevations were recorded in meters and were referenced to Mean Low Water (MLW) based on water level data obtained from the National Oceanic and Atmospheric Administration (NOAA) tide station in New Haven, CT. Bathymetric data were recorded by means of a high-resolution trace on a thermal printer in addition to the digital data stored within Hypack®. Hypack® managed data acquisition and storage of data from the echosounder and the Trimble DGPS. In addition, Hypack® recorded depth, vessel heave, heading, position, and time along each survey transect line.

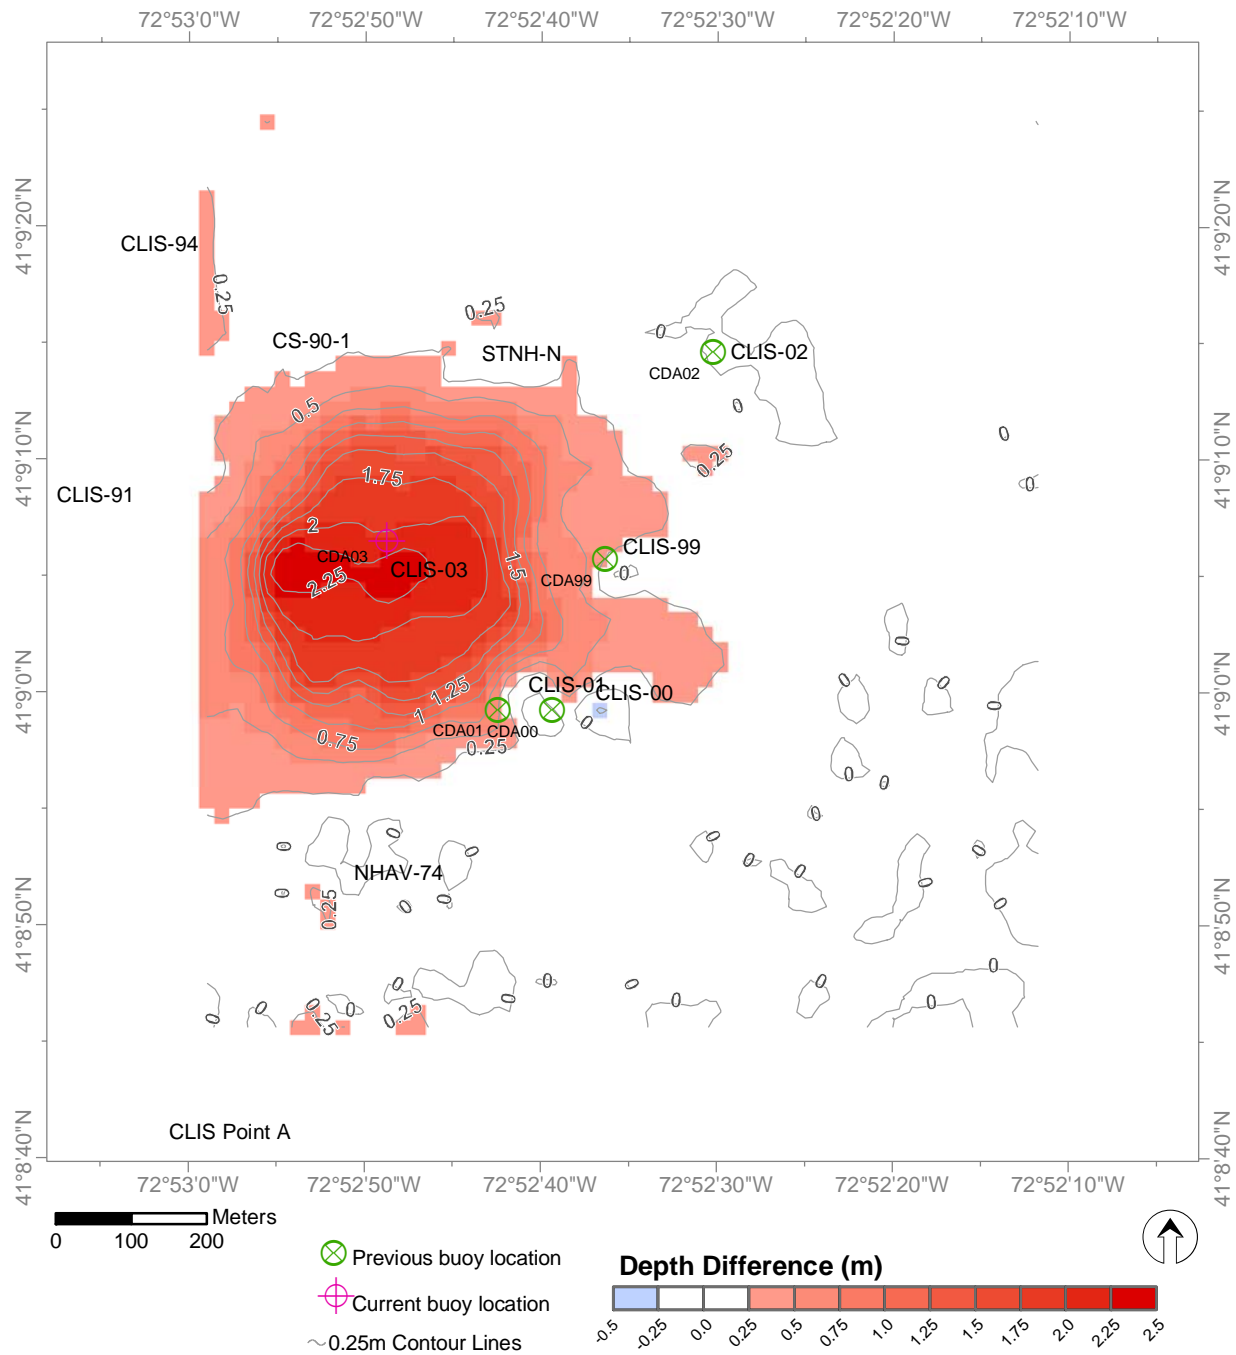
The overlapping bathymetric data from the 2004 survey (Figure 3-1) and the 2003 survey (Figure 3-2) were used to generate a depth-difference map (Figure 3-3). The depth-difference map was plotted at 0.25 m contour intervals. The most significant feature was the newly formed disposal mound, CLIS 03, which was about 1.5 m above

Figure 3-3. Depth difference contour map of CLDS survey area, September 2003 vs. June 2004 survey results (0.25-m contour interval).

The June 2004 bathymetric survey at CLDS was intended to assess the seafloor topography of a portion of the site where dredged material had been deposited since the last survey in 2003. A new mound, CLIS 03, was observed approximately 300 m west of the CLIS 99 Mound. The relatively large mound was formed primarily from the disposal of approximately 426,000 m³ of material during the 2003-2004 disposal season. The depth-difference map indicated that the detectable apron of the newly formed mound extended into previously formed mounds CLIS 99, CLIS 00, CLIS 01, STNH-N and CS-90-1. These historic mounds were partially encompassed into the CLIS 03 Mound, and were less distinct in the bathymetric data. The CS-90-1 Mound was wholly encompassed into the CLIS 03 Mound, and was no longer evident in the 2004 bathymetry data.

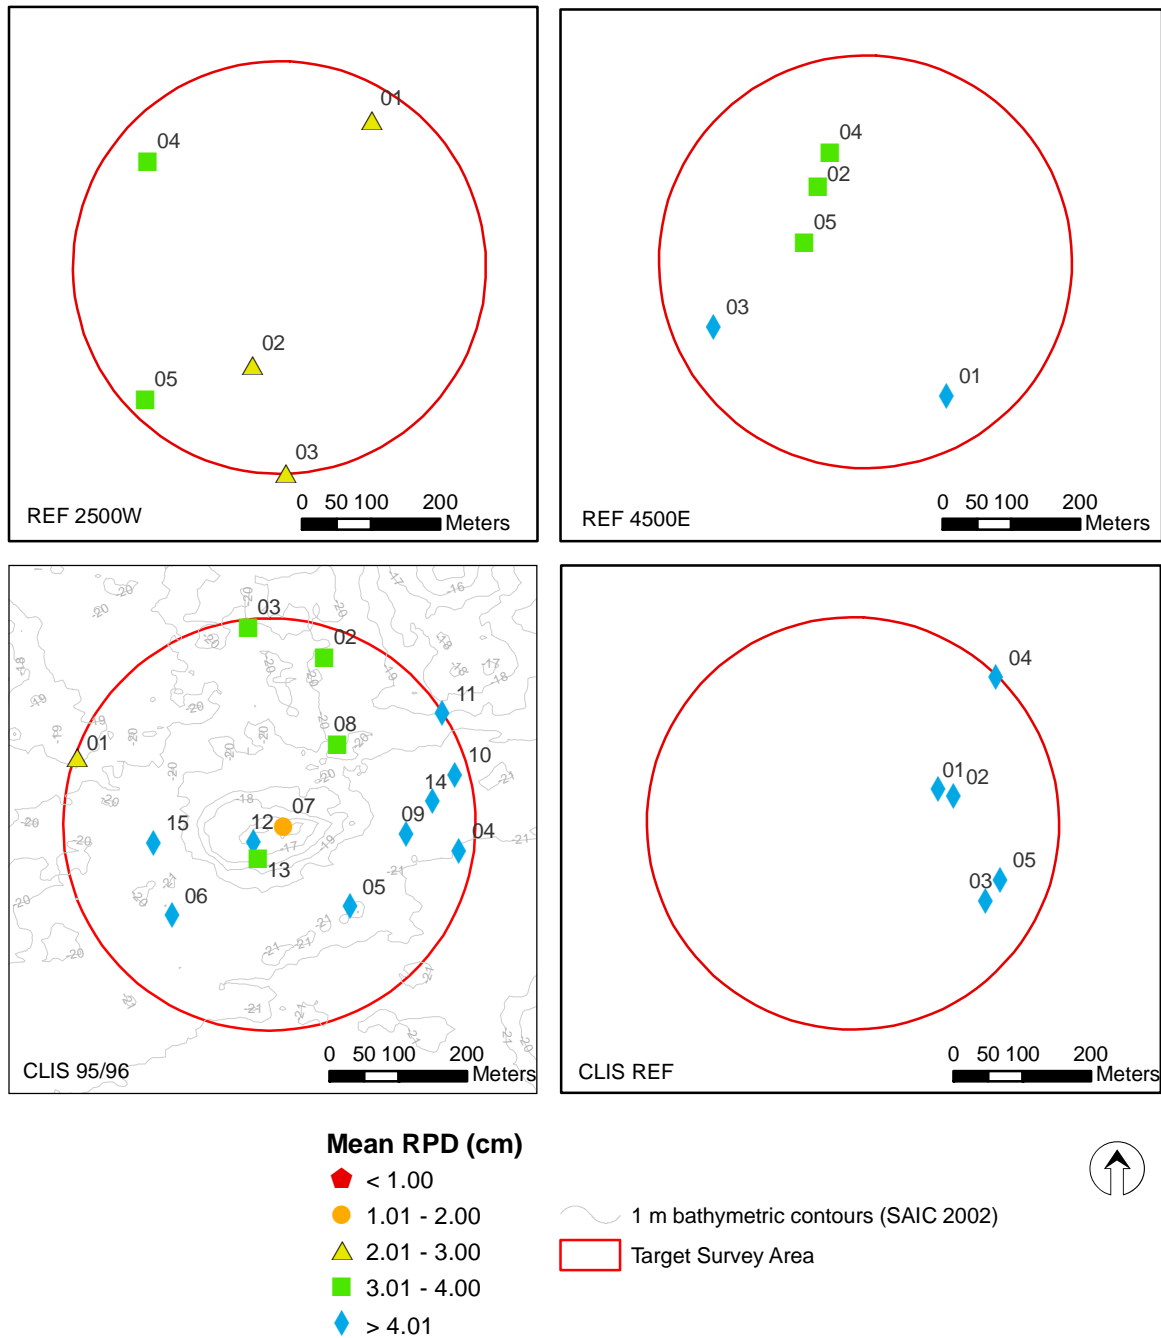
The mean apparent RPD depths at the reference areas ranged from 2.6 cm (2500W 1) to 5.7 cm (CLISREF 2), with an overall mean of 4.1 cm (Table 3-1, Figure 3-6). These values are typical of early summer ambient bottom conditions in those areas of central Long Island Sound not experiencing hypoxia. While these values are all considered indicative of a normal or healthy degree of sediment aeration, the greatest RPD depths were observed most consistently at CLISREF and the shallowest at 2500W (Figure 3-6).

Figure 3-6. Map of mean apparent RPD depths at the reference area and CLIS 95/96 Mound stations, June 2004

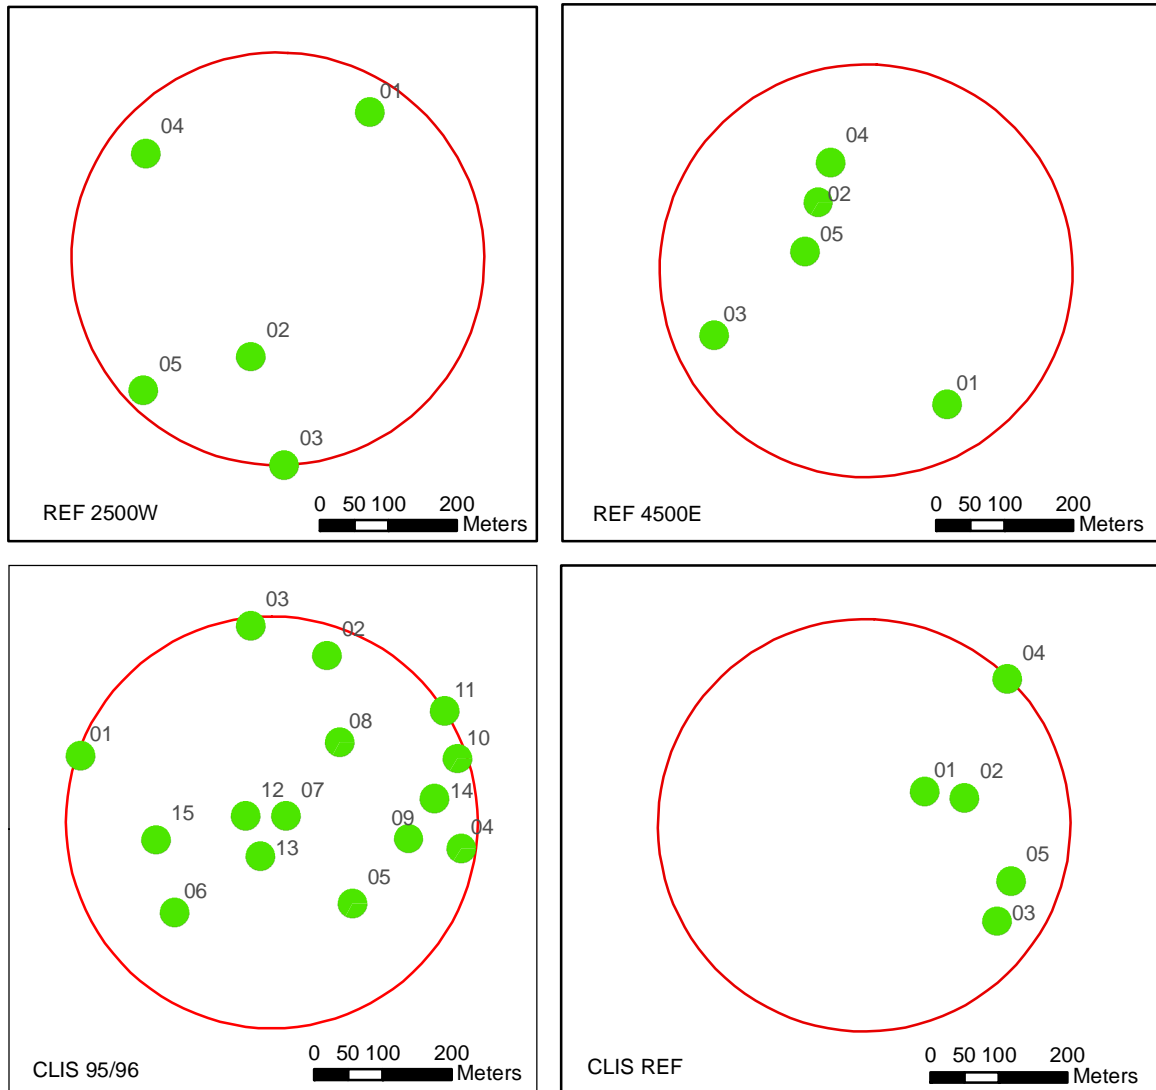
Infaunal successional stages were dominated by Stage I-III assemblages at all of the reference area stations (Table 3-1; Figure 3-7). Evidence of Stage I included both upright/intact and broken/recumbent tubes at the sediment surface, while active, subsurface feeding voids were evidence of Stage III (Figures 3-4 and 3-5). Three or more feeding voids, on average, were visible in the images at the majority of stations (Table 3-1). Median OSI values at the reference area stations ranged from +9 to +11, indicative of undisturbed benthic habitat conditions on the ambient bottom of central LIS at the time of the survey in June 2004 (Table 3-1). The spatial distribution of OSI values among the reference areas reflect the somewhat shallower RPD depths at 2500W and the greater RPD depths at CLISREF (Figure 3-8).

Figure 3-7. Map of infaunal successional stages at the reference area and CLIS 95/96 Mound stations, June 2004

well as ample evidence of an abundant subsurface community of larger-bodied, deposit-feeding, Stage III taxa. All the images collected at both the reference area and CLIS 95/96 Mound stations were assigned an advanced successional stage designation consisting of Stage III, Stage I on III, or Stage II going to III (Tables 3-1 and 3-2; Figure 3-7).

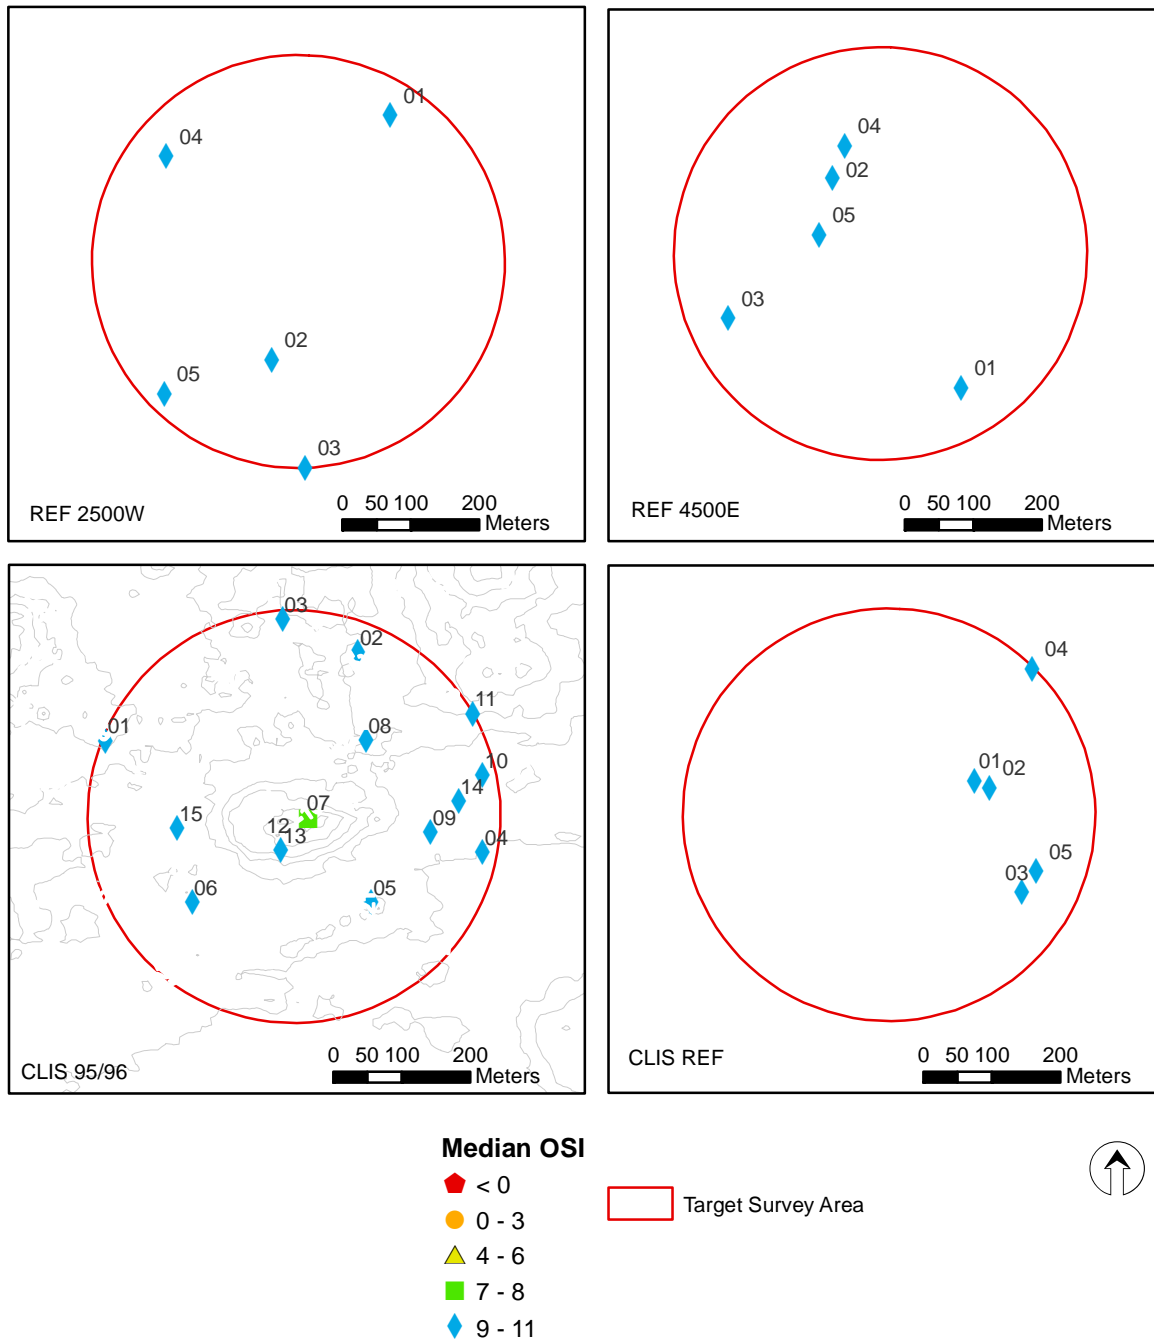
Figure 3-8. Map of median OSI values at the reference area and CLIS 95/96 Mound stations, June 2004

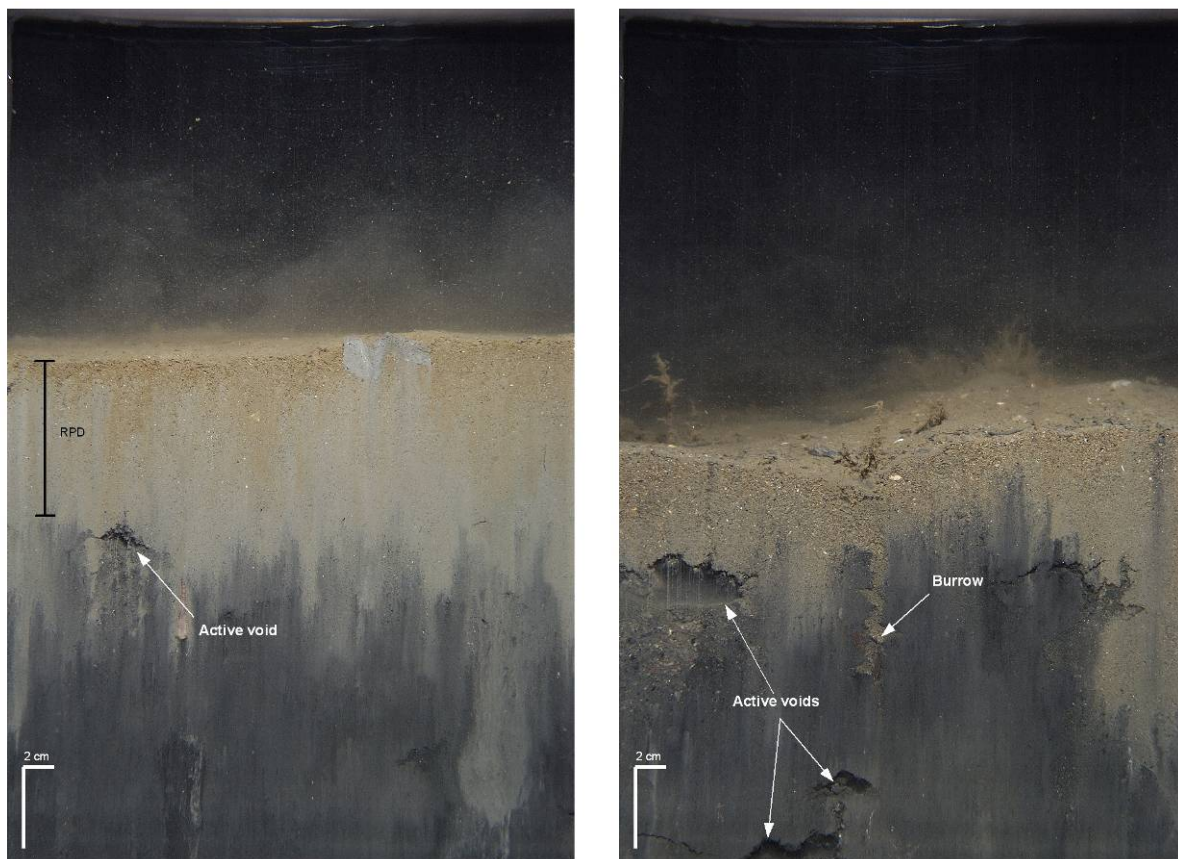
Older dredged material was observed at all of the stations over the CLIS 95/96 Mound Complex in the June 2004 survey, similar to the results of the previous SPI survey of September 2003 (Table 3-2; Figure 3-9). The average thickness of the dredged material layer was greater than the penetration depth of the sediment-profile camera at each of the 15 stations (Figures 3-9 and 3-10). The sediment comprising the dredged material was predominantly silt-clay (grain size major mode of >4 phi) at all of the stations (Table 3-2 and Figure 3-10, left). At a number of stations (particularly 02, 03, 06, 07, 08, 10, 14 and 15), there was a significant component of fine to medium sand that was either mixed with the silt-clay or occurred in distinct layers (Figure 3-10, right).

Figure 3-10. SPI images from Stations CLDS04 13 A (left) and CLDS04 07 A (right) at the CLIS 95/96 Mound showing dredged material extending from the sediment surface to below the imaging depth of the SPI camera (i.e., DM thickness > penetration). The dredged material in both images is distinguished by its darker reflectance at depth, indicating higher inventories of organic matter and the presence of reduced sulfides, compared to ambient sediments. Both images also show evidence of extensive surface and sub-surface biological activity, including well-developed RPDs, Stage I tubes, and numerous active Stage III feeding voids and burrows.

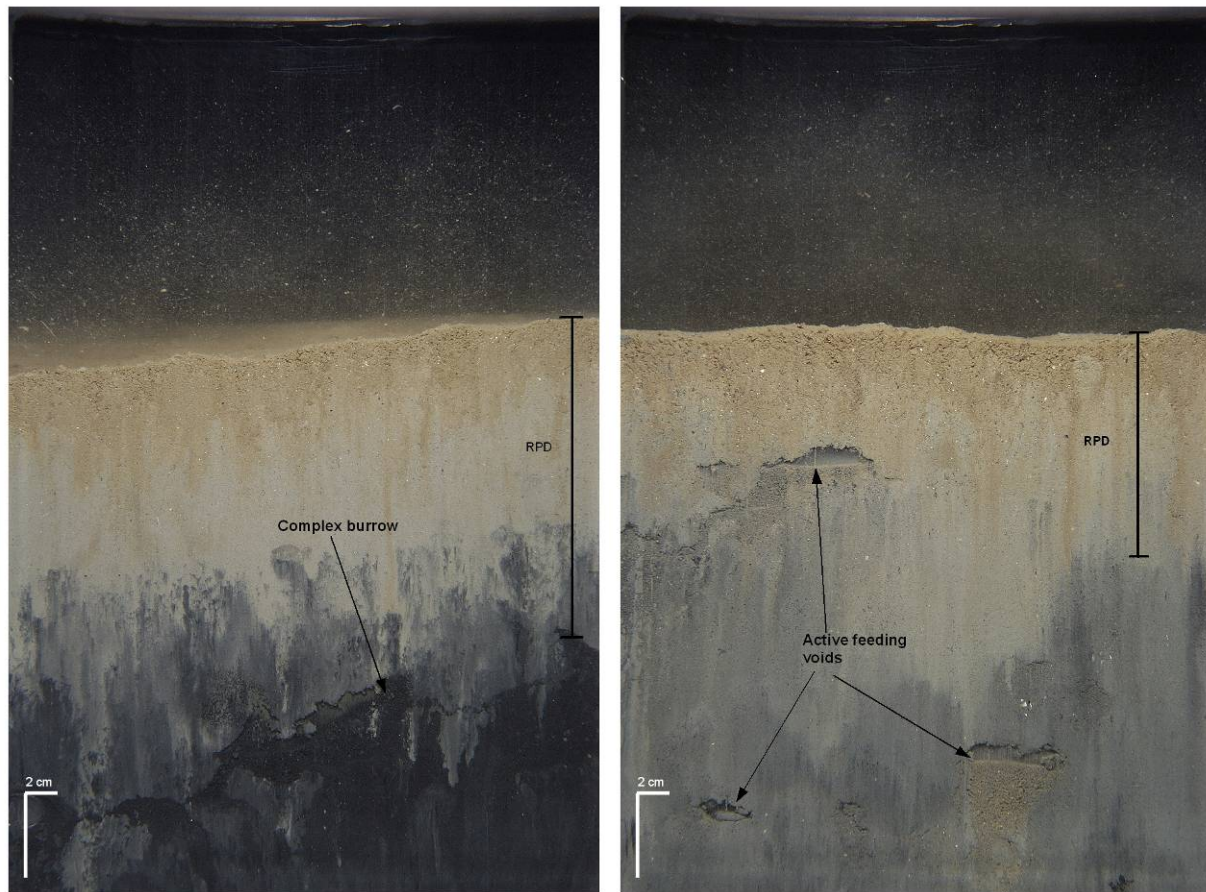
Similar to observations at the reference stations, the sediment at and just below the SWI over the CLIS 95/96 Mound Complex appeared tan or rust-colored compared to underlying light-to-dark gray or black sediments (Figure 3-12). The orange hue was at least in part due to the presence of elevated levels of phytodetritus on the sediment surface and in the upper 1 to 2 cm of the sediment column.

Figure 3-12. SPI images from Stations CLDS04 06 A (left) and CLDS04 03 C (right) illustrating the transition in sediment color from tan/rust at and just below the SWI, to light grey above the apparent RPD, to dark grey or black at depth below the apparent RPD. In both images, the RPD is well-developed (5.3 cm (left) and 3.8 cm (right)), and the sediment surface appears to have a grainier texture due to intensive biological reworking (e.g., tunneling and fecal pellet production). An extensive feeding void complex/burrow is visible in the black subsurface sediment in the left image. Several active, subsurface feeding voids are visible in the right image. Note the oxidized sediment that has been subducted and comprises the floor of the feeding void at right.

The surface layers observed in both the September 2003 and June 2004 SPI surveys appeared to have a coarser and/or more flocculent texture than the underlying sediment (e.g., Figures 3-5 and 3-12). This is attributed to stimulation of bacterial decomposition processes and meiofaunal burrowing, feeding, and fecal pellet production. Such stimulation undoubtedly occurred in September 2003, resulting in the high densities of small polychaete tubes observed within the phytodetritus layer. This represents an expected and relatively short-term response of the benthos to a natural episodic event, as opposed to an indication of an adverse impact or retrograde successional pattern. The rapidly sedimented organic matter creates a relatively thin zone (i.e., microhabitat) of enhanced food supply, intense biogenic reworking, and increased benthic consumption and production. Rhoads et al. (1977) noted that such biogenic reworking of surface sediments in LIS is highest in the fall, when both water temperatures and faunal densities remain high. In the weeks following the September 2003 survey, therefore, it is reasonable to assume that significant consumption and degradation of the original phytodetrital layer occurred, making it less likely that this layer would persist over the nine months preceding the June 2004 follow-up survey.
