Disposal Area Monitoring System DAMOS

Contribution 185
April 2012

USACE. 2012. Monitoring Surveys of New England CAD Cells, October 2009. DAMOS Contribution No. 185. U.S. Army Corps of Engineers, New England District, Concord, MA, 151 pp.

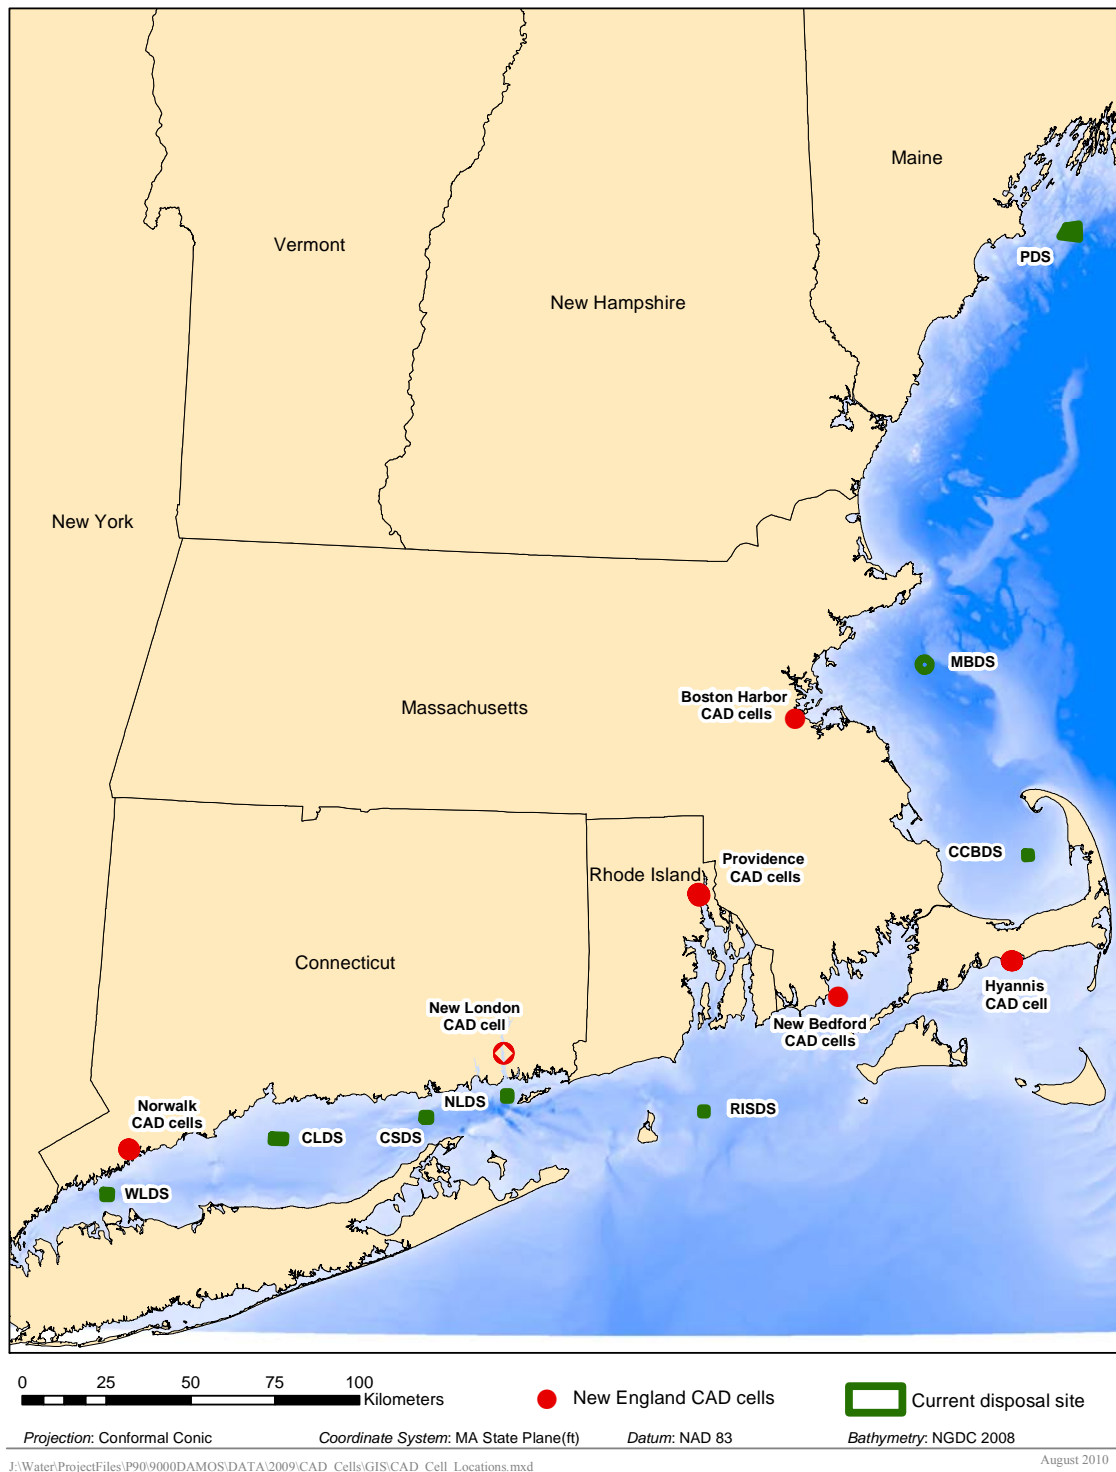
Figure 1-2. CAD cell locations in New England

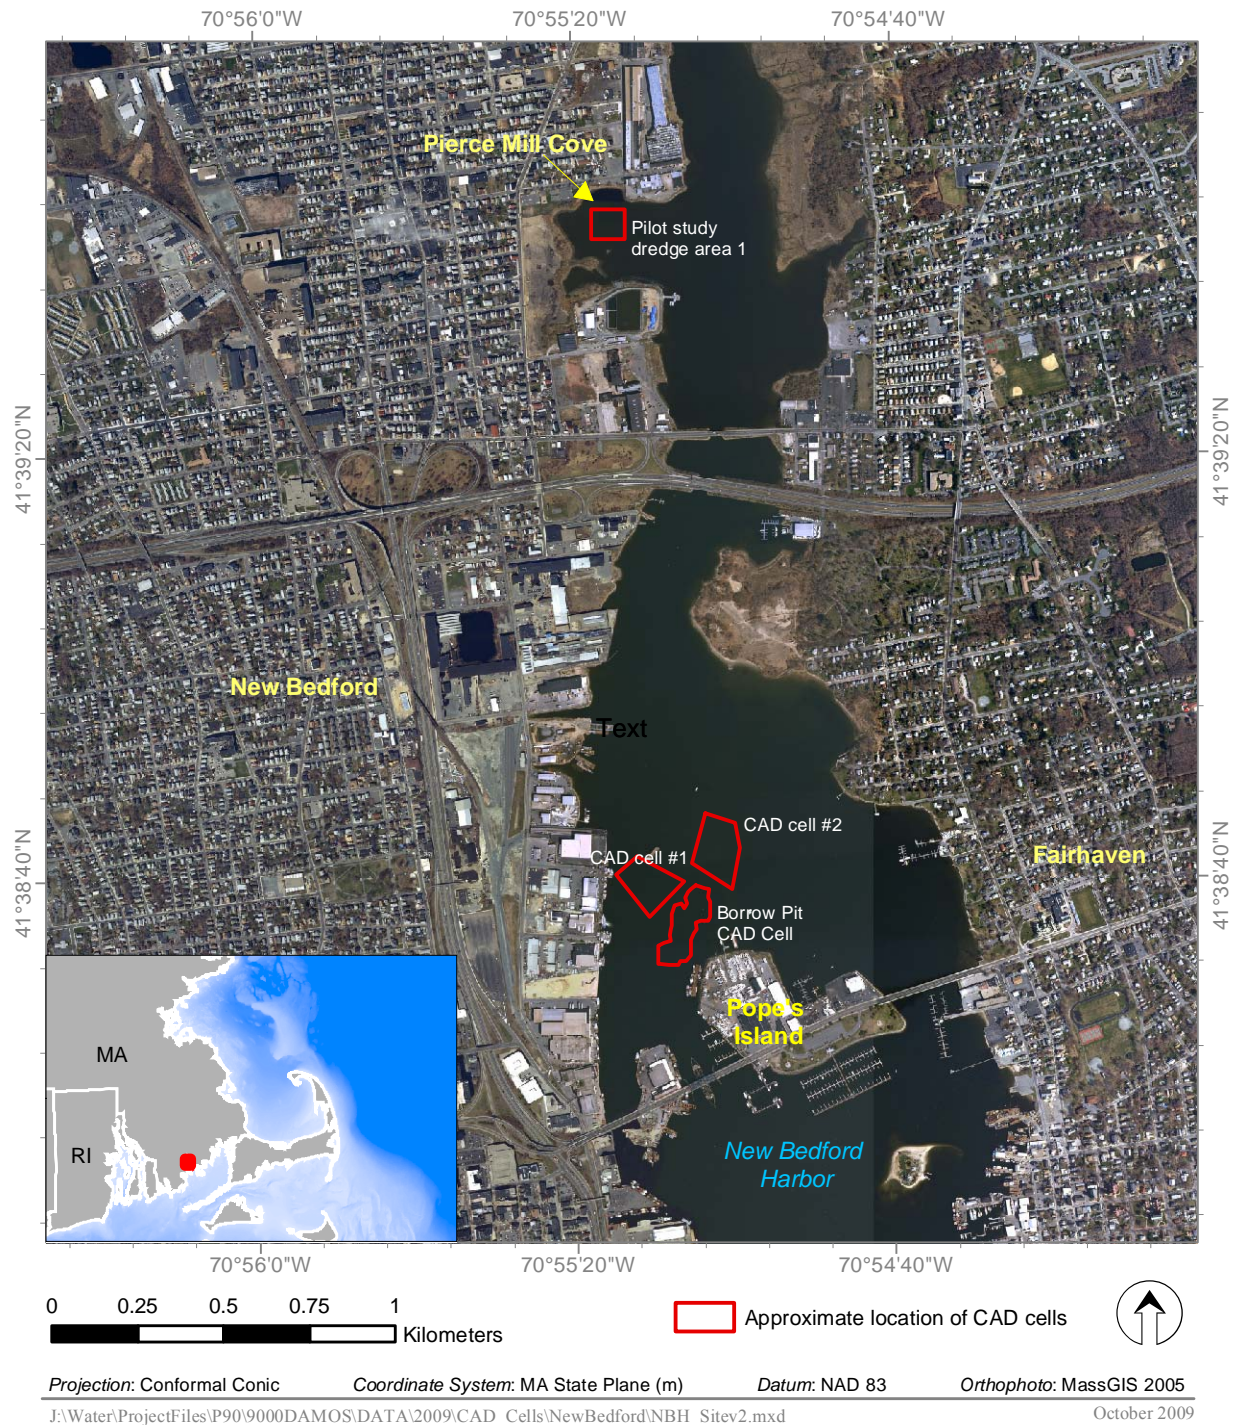
Figure 1-4. New Bedford Harbor CAD cells

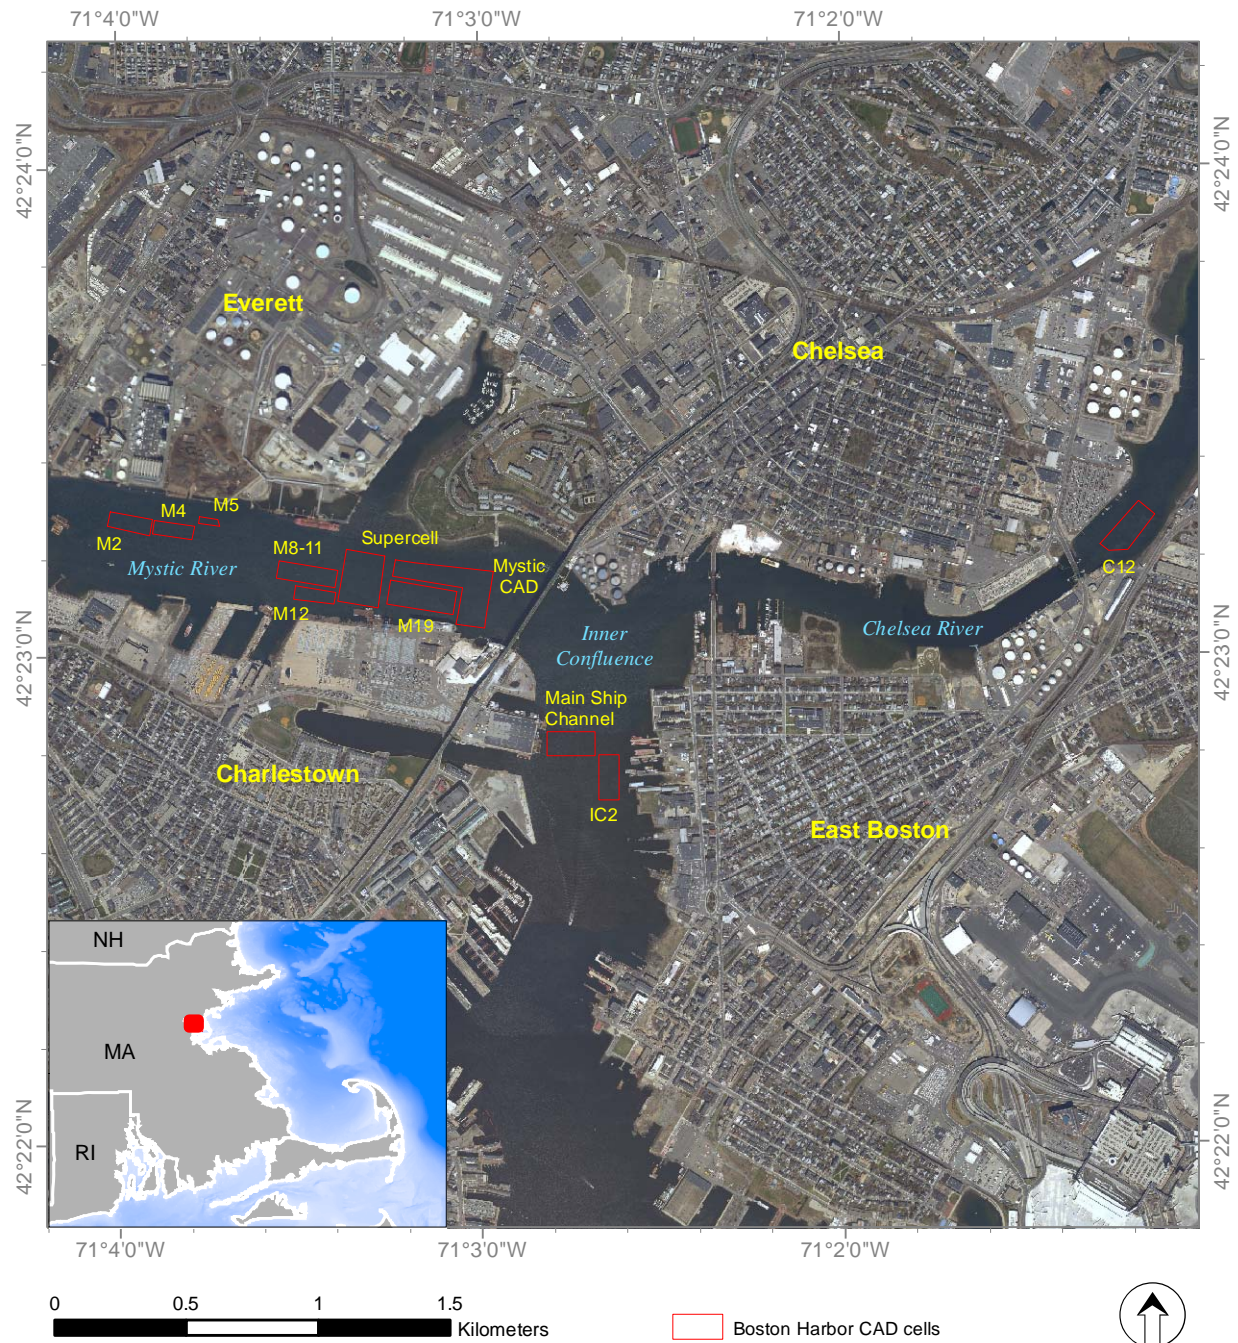
Figure 1-5. Boston Harbor CAD cell locations

Two additional CAD cells were created as part of a separate maintenance dredging project in Boston Harbor in 2008 (Mystic CAD cell and Main Ship Channel CAD cell, Figure 1-5). Approximately 537,000 m³ of material was placed into the two most recent CAD cells. Eleven of the 12 Boston Harbor CAD cells have been capped with sand; only the Chelsea cell remains uncapped. The most recent survey of the BHCAD cells was conducted in November 2009 and is presented in a separate report (USACE in prep).

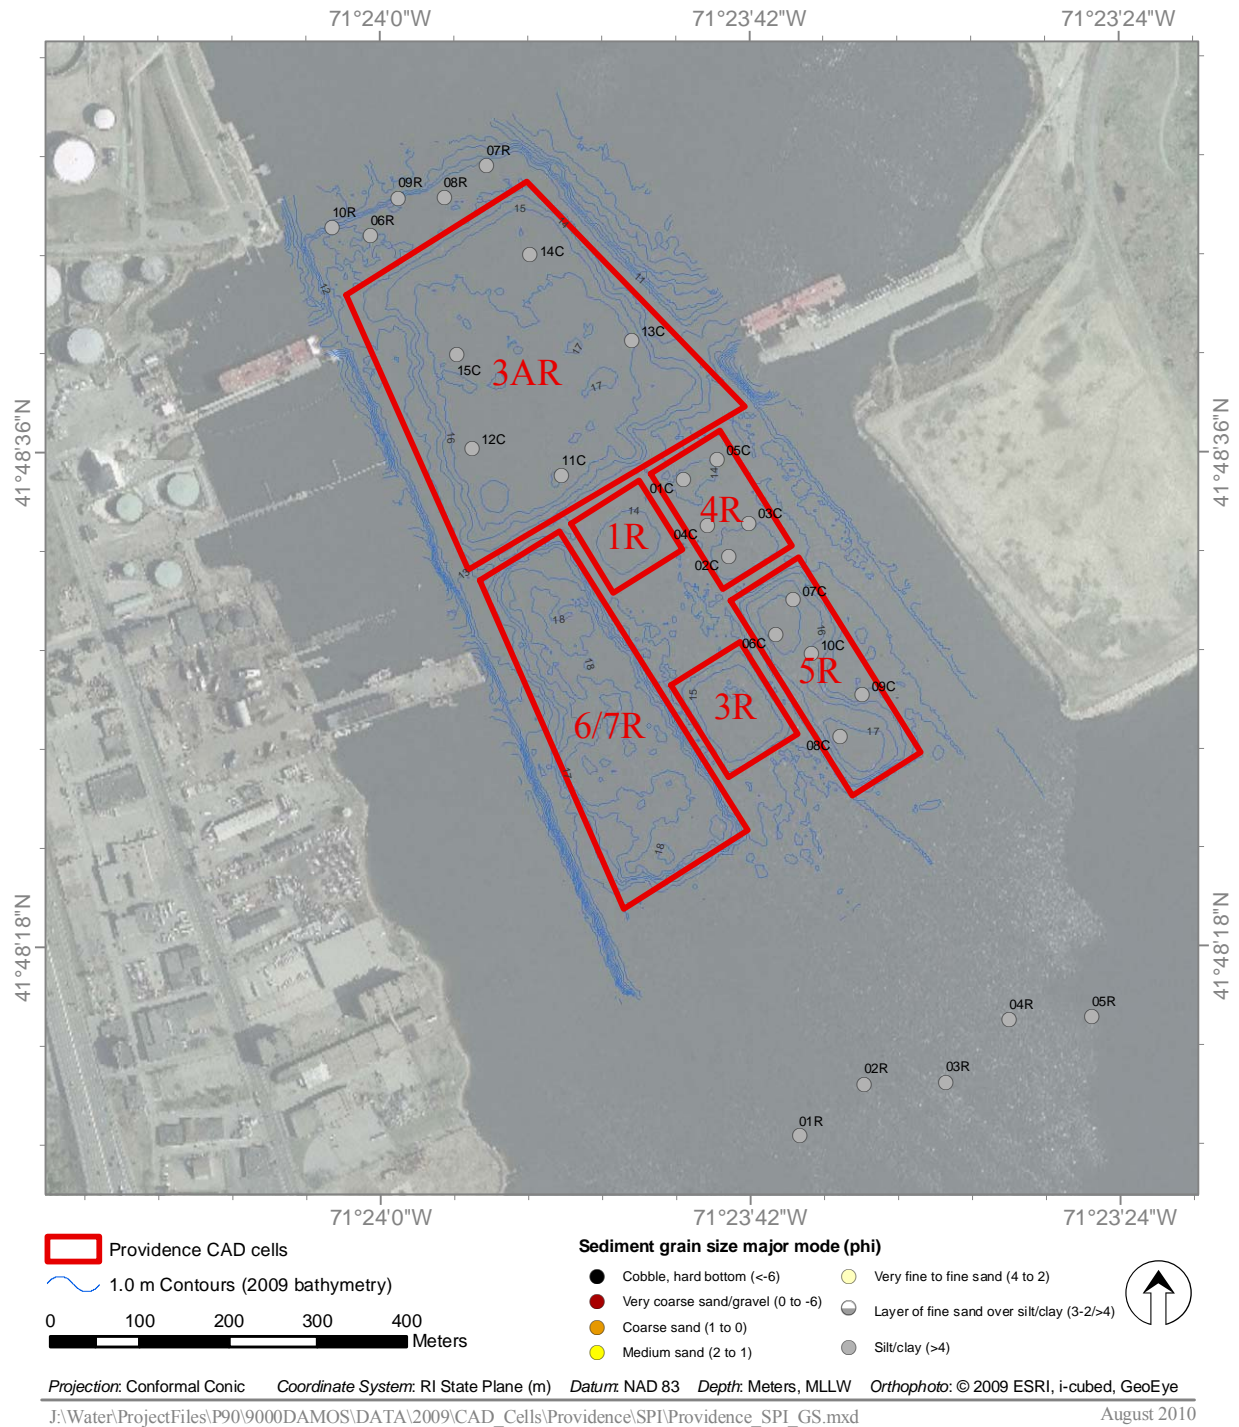
Figure 3-27. Spatial distribution of grain size major mode (phi) for Providence Harbor

Grain size composition of sediments observed within the CAD cells and from reference locations (as identified with SPI), was consistent for all stations with a major mode of >4 phi (silt-clay) (Table 3-3 and Figure 3-27). Soft silt-clay sediments were also observed in the plan-view video at all stations.

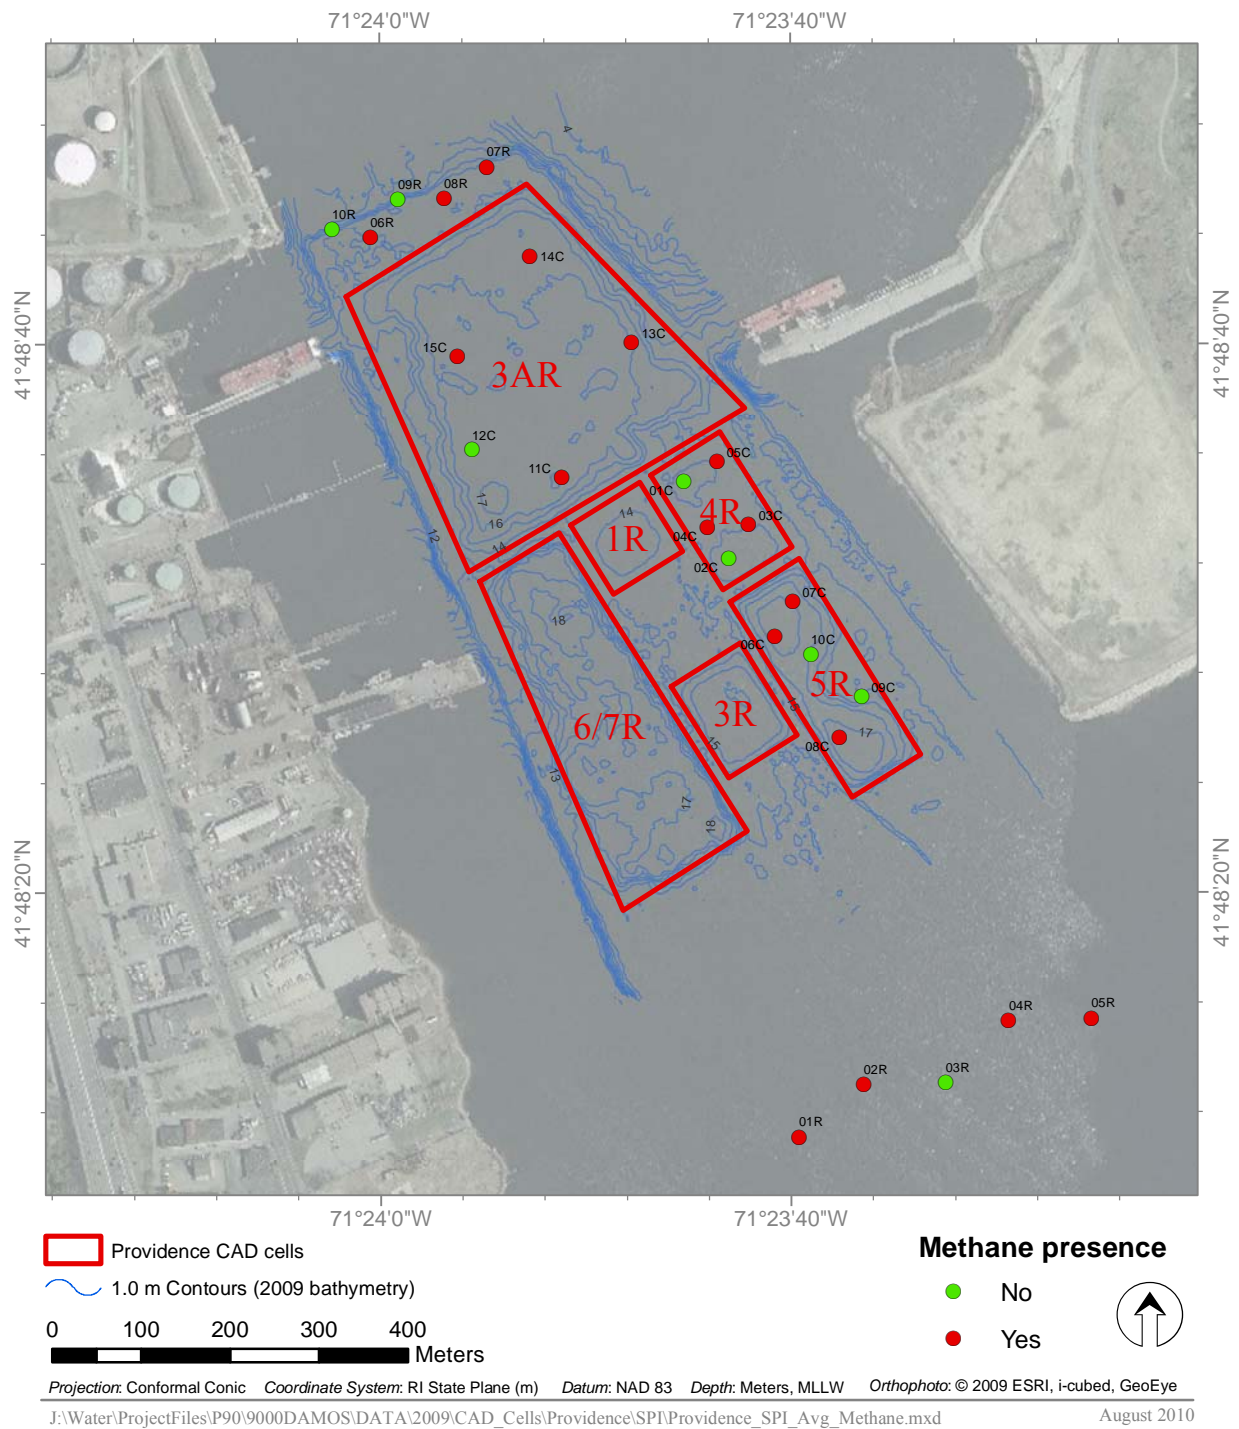
Figure 3-32. Spatial distribution of methane presence for Providence Harbor

Methane was observed within images from both reference and CAD cell locations (Table 3-3 and Figure 3-32). Methane bubbles were observed at three of the five stations in the northern reference area and four of the five stations in the southern reference area. Within the three CAD cells surveyed, 10 of the 15 stations contained methane. The presence and the depth of observed methane bubbles within the sediment are provided in Appendix A.

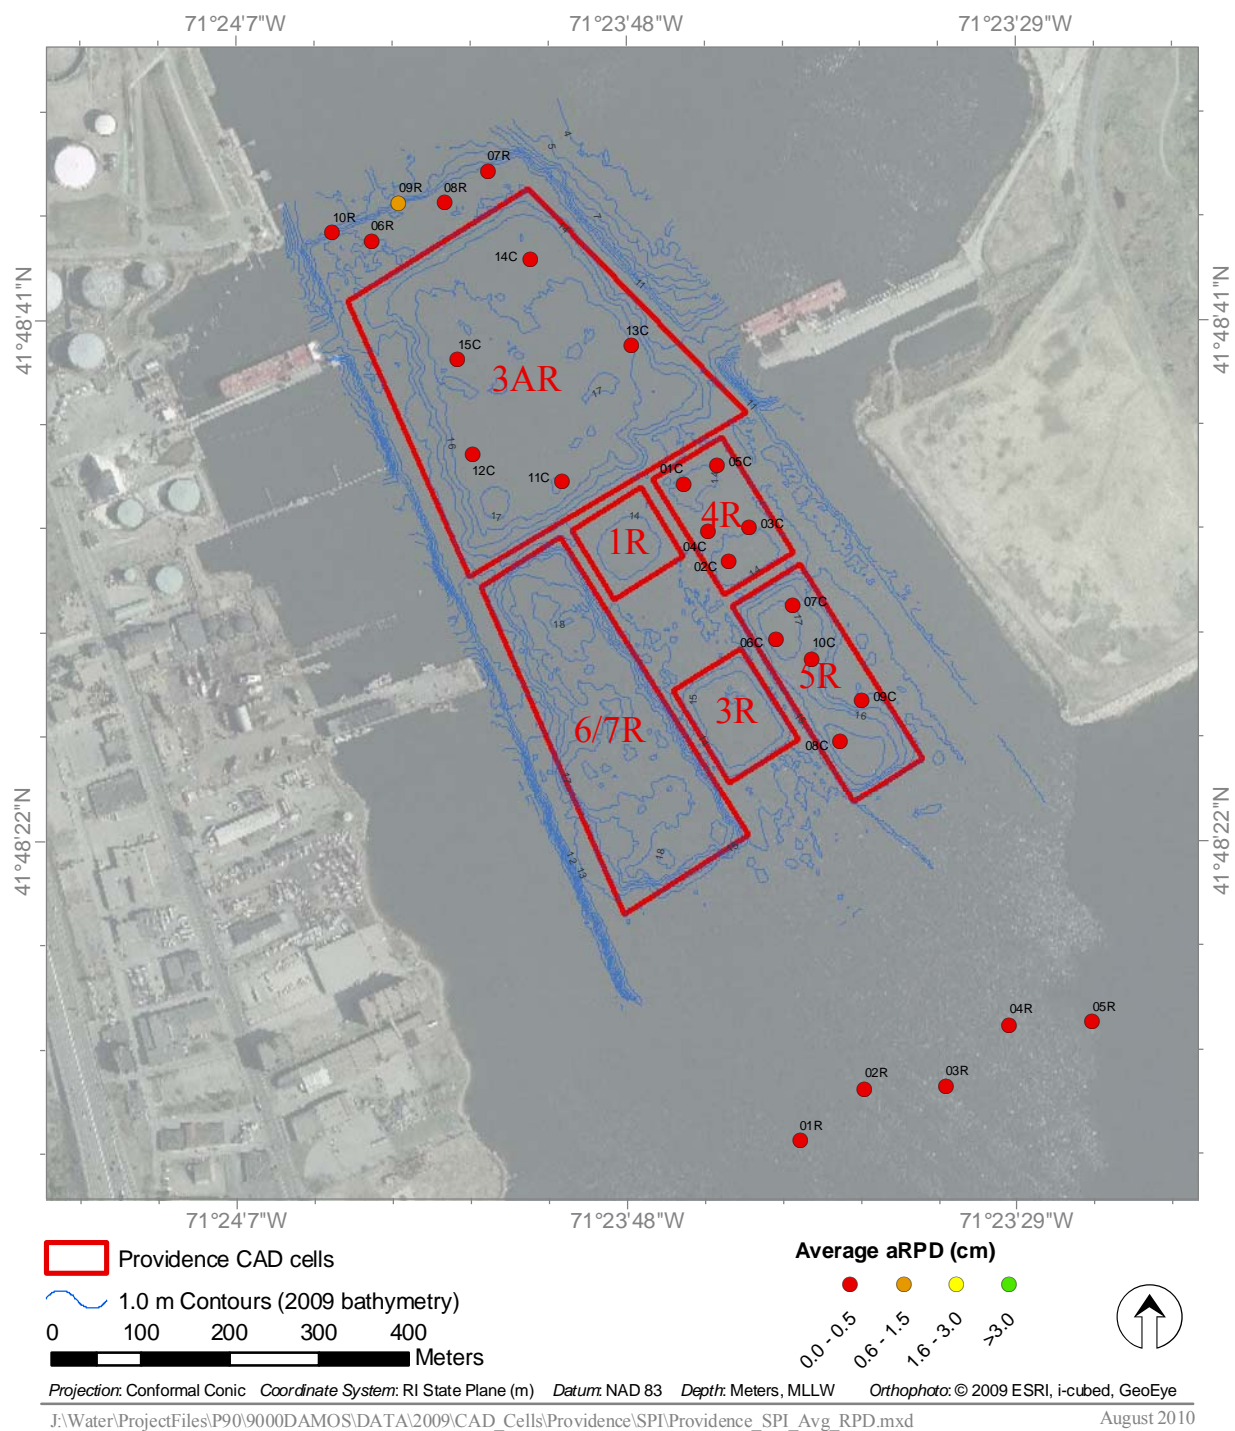
Figure 3-33. Spatial distribution of station-averaged aRPD depths (cm) for Providence Harbor
