Monitoring Survey at the Central Long Island Sound Disposal Site September and October 2011

Disposal Area Monitoring System DAMOS

Contribution 192
January 2013

**MONITORING SURVEY AT THE
CENTRAL LONG ISLAND SOUND DISPOSAL SITE
SEPTEMBER AND OCTOBER 2011**

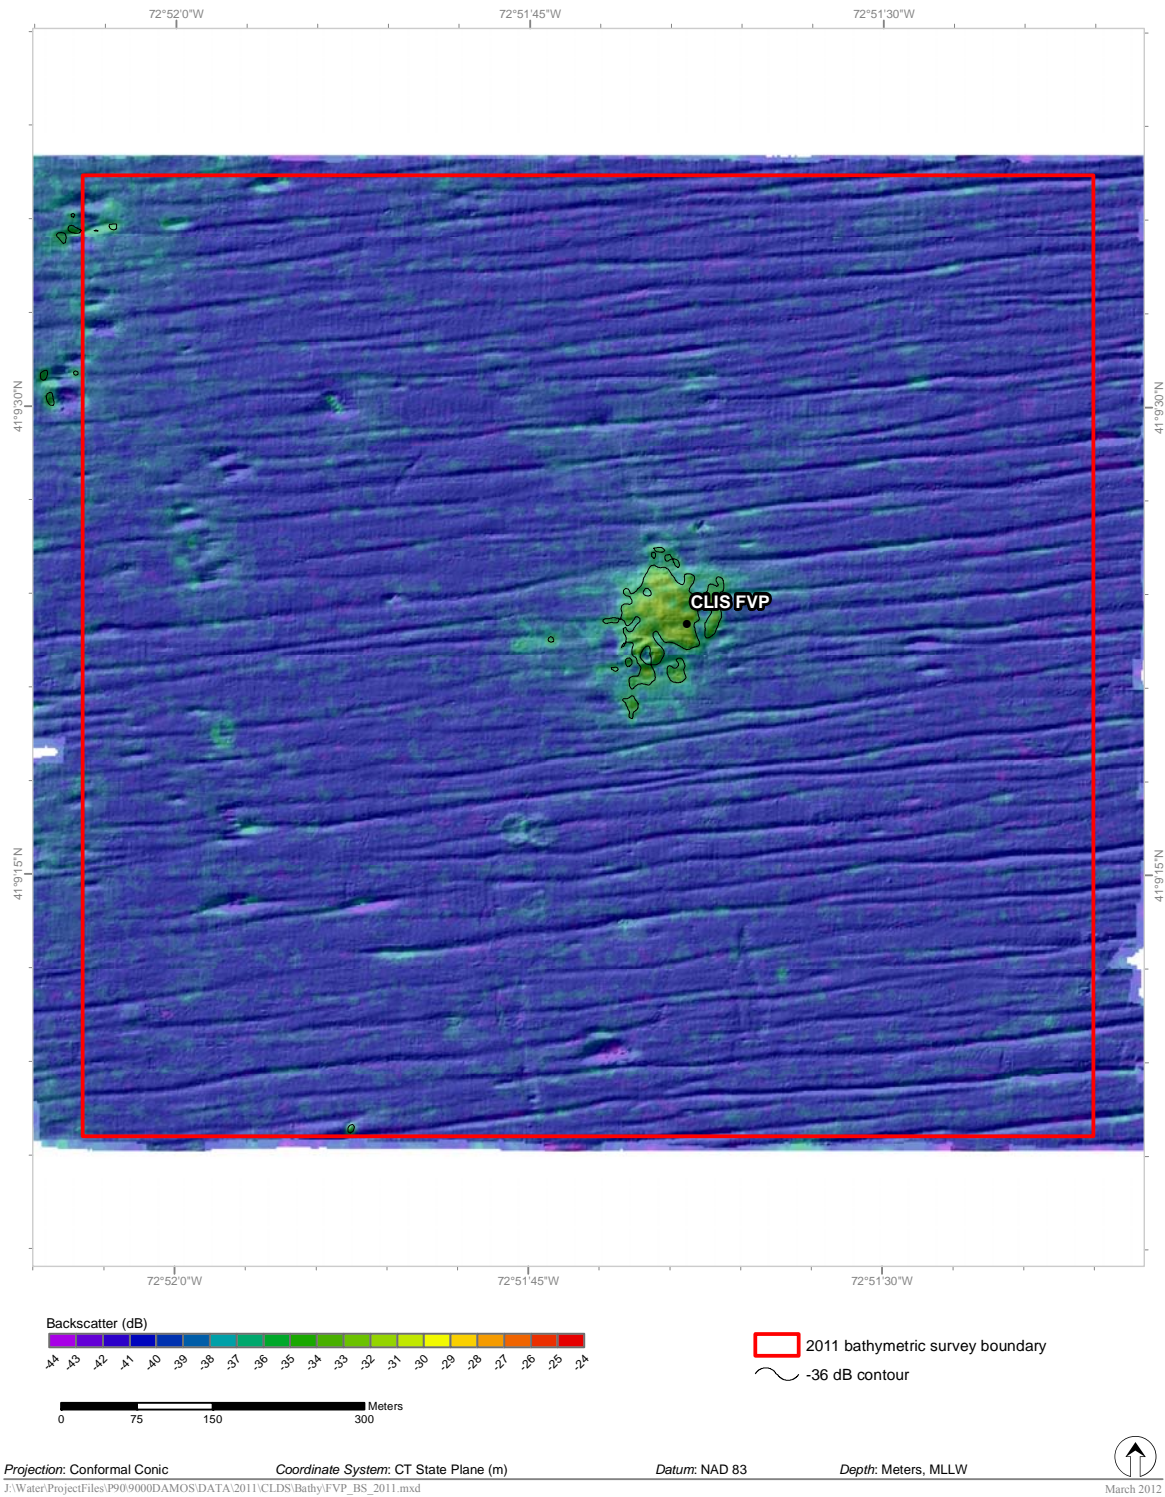
Figure 3-7. Backscatter intensity (dB) of the FVP mound, 2011

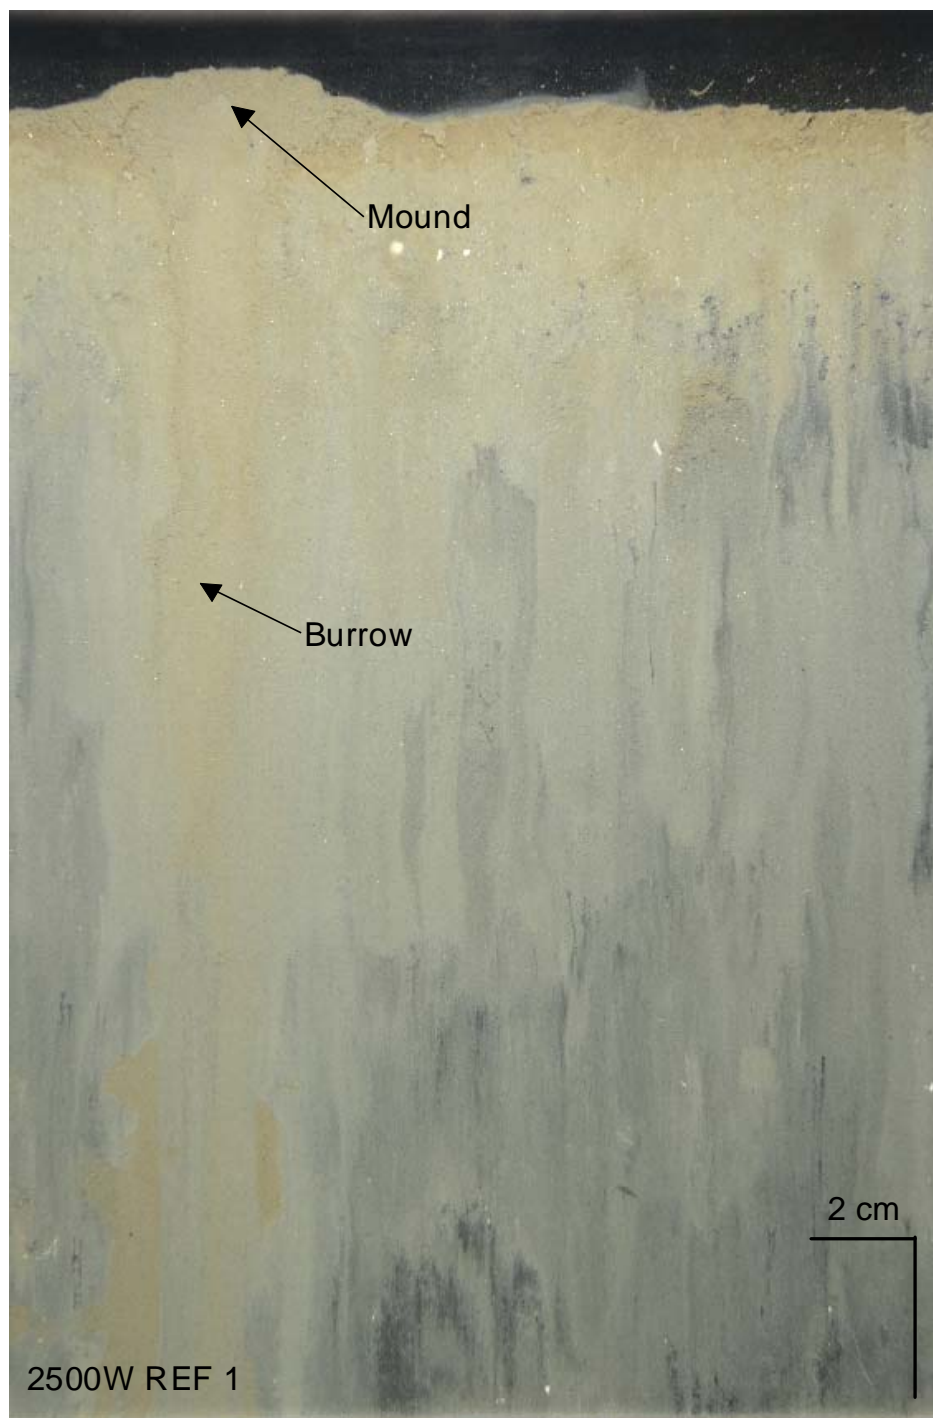
Figure 3-11. Profile image from 2500W REF station 1 showing a large subsurface burrow that culminates in a small mound at the sediment-water interface. This is an example of biological surface roughness.

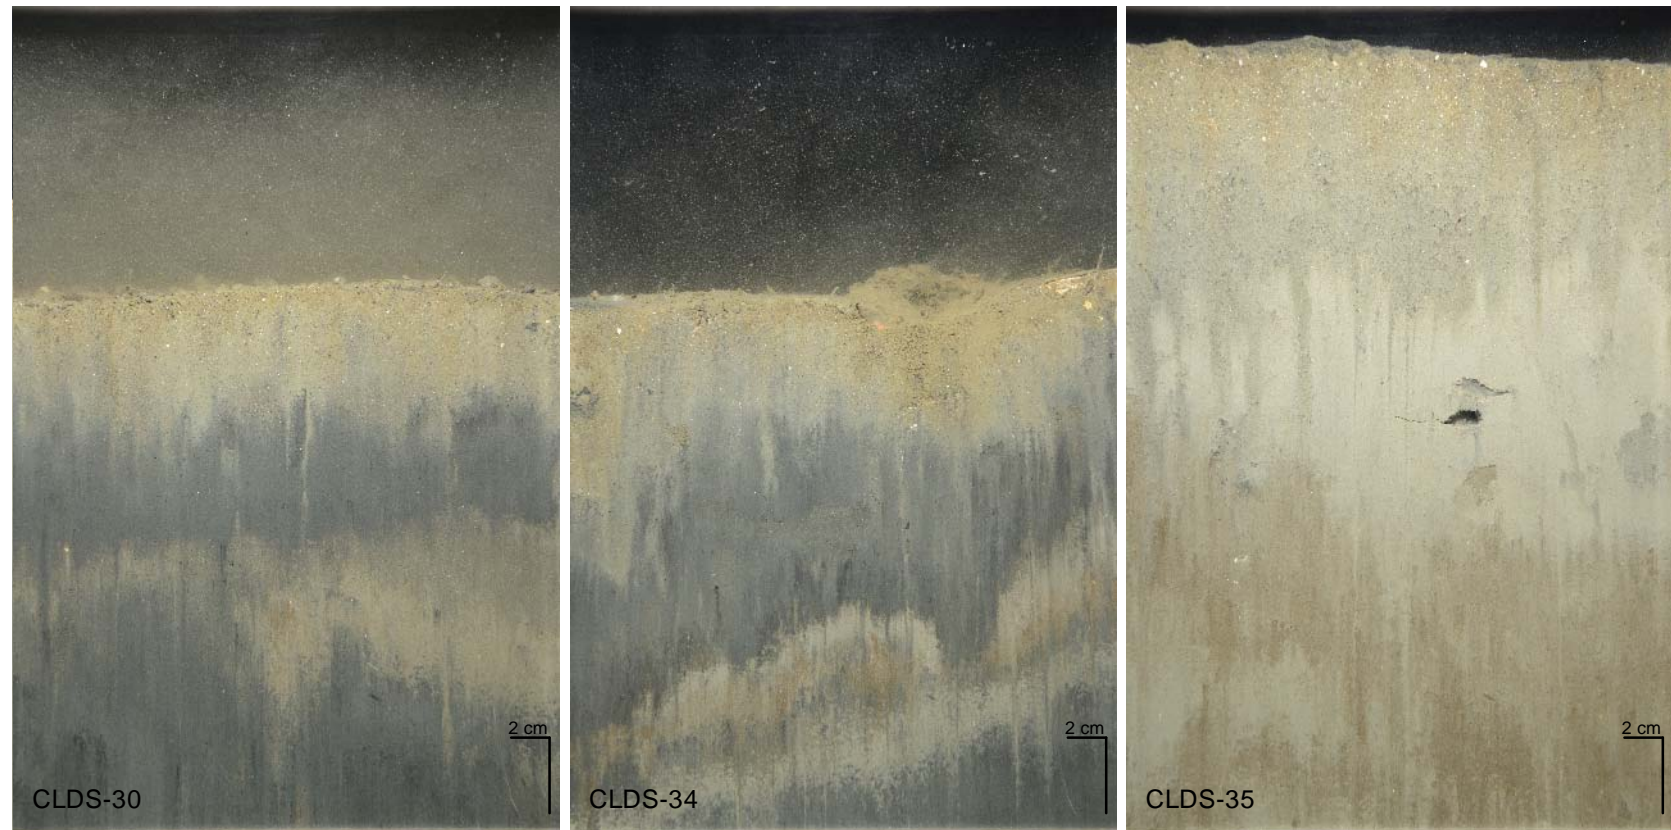
Figure 3-17. Representative profile images from the dredged material placement mound CLIS 09 showing multiple depositional horizons (left and middle image) and very fine sand layer with wood fibers over light colored clayey silt (right image).

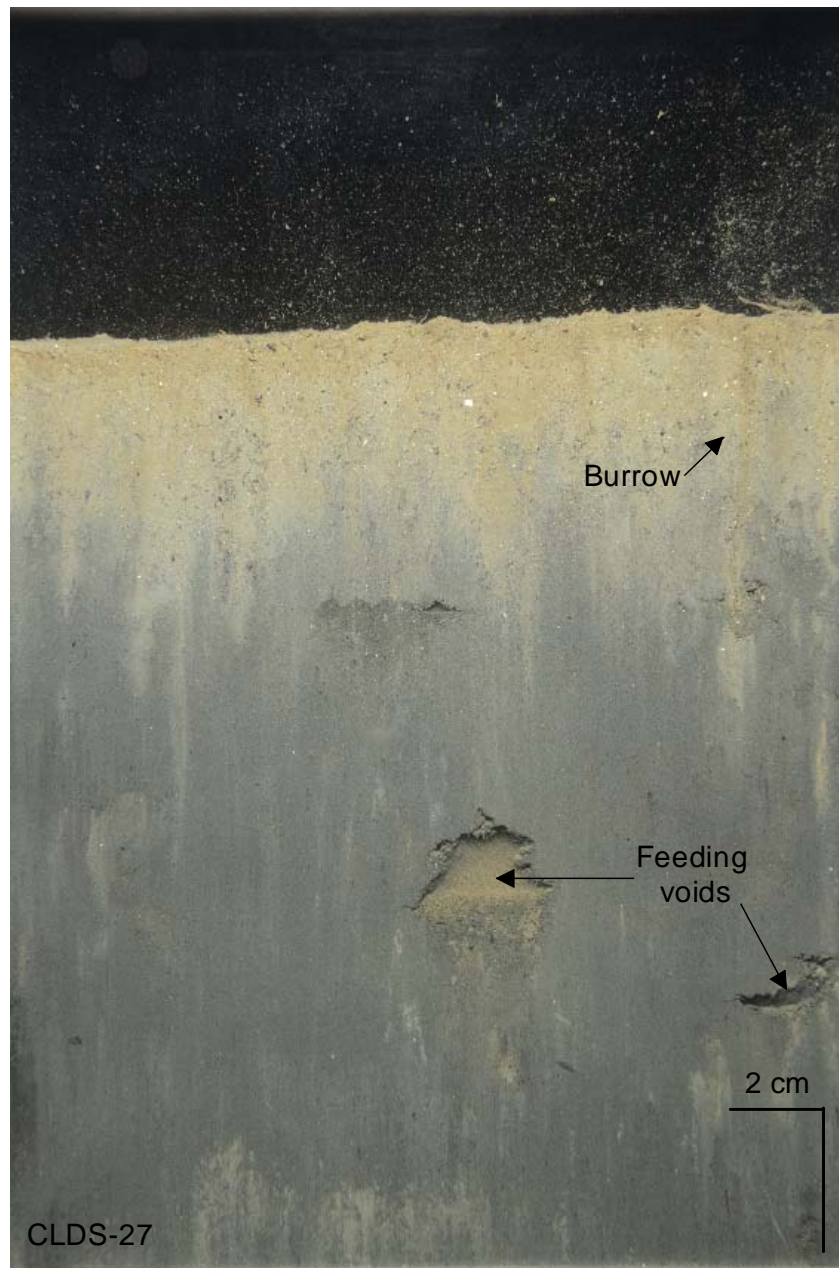
Figure 3-21. Profile image from CLIS 09 Station 27 A showing a large vertical burrow, feeding voids and traces of burrowing throughout the aRPD (Stage 2) that resulted in a Stage 2 on 3 successional designation.

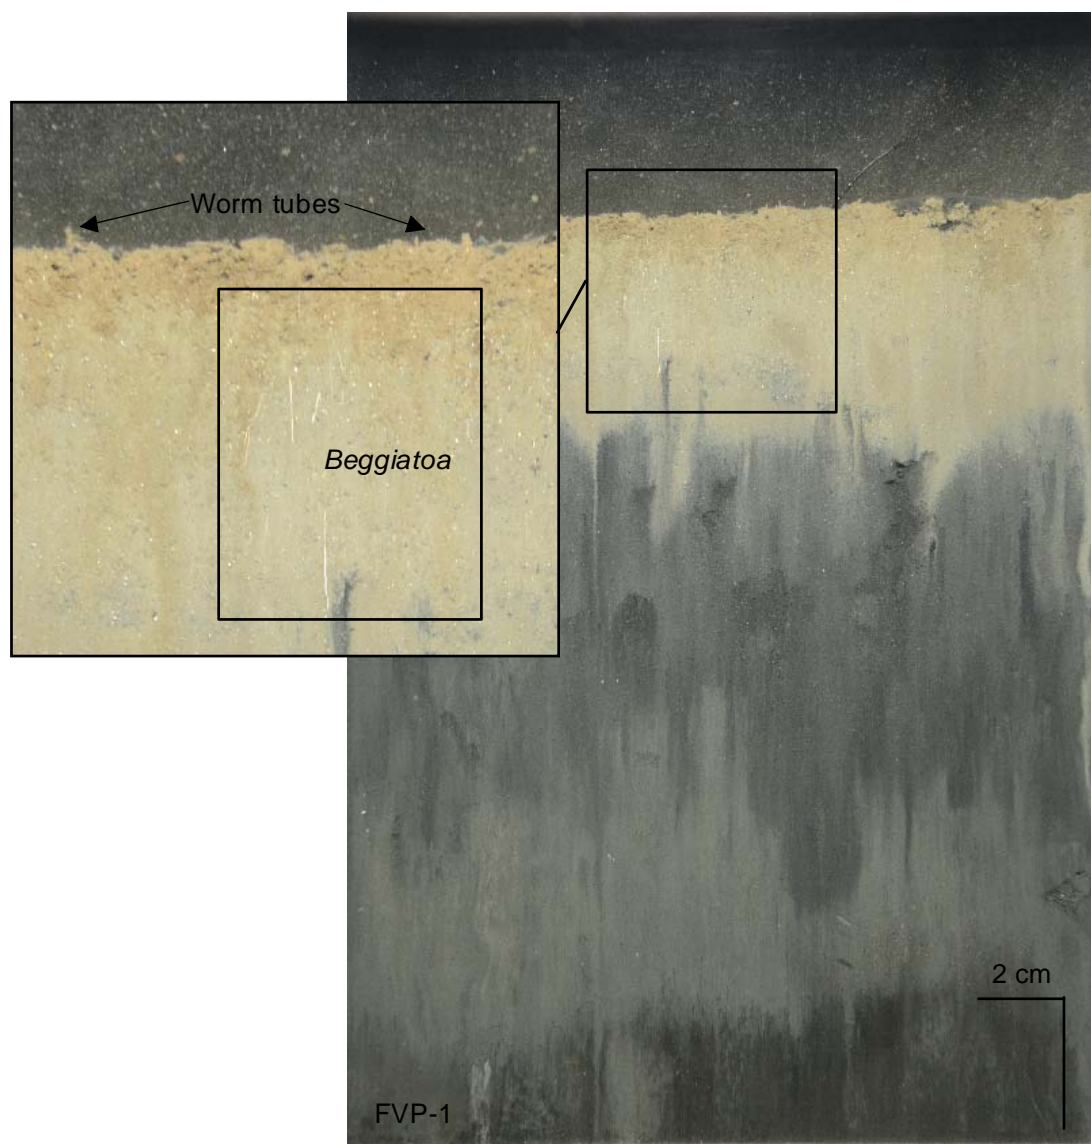
Figure 3-33. Profile image FVP Station 1C showing feeding voids and an assemblage of opportunistic worm tubes at the sediment surface (Stage 1) that resulted in a Stage 1 on 3 successional designation. Inset shows white threads of incipient *Beggiatoa* colonies and Stage 1 worm tubes.
