Monitoring Survey at the Massachusetts Bay Disposal Site September/October 2012

Disposal Area Monitoring System DAMOS

Contribution 195
December 2013

US Army Corps
of Engineers®
New England District

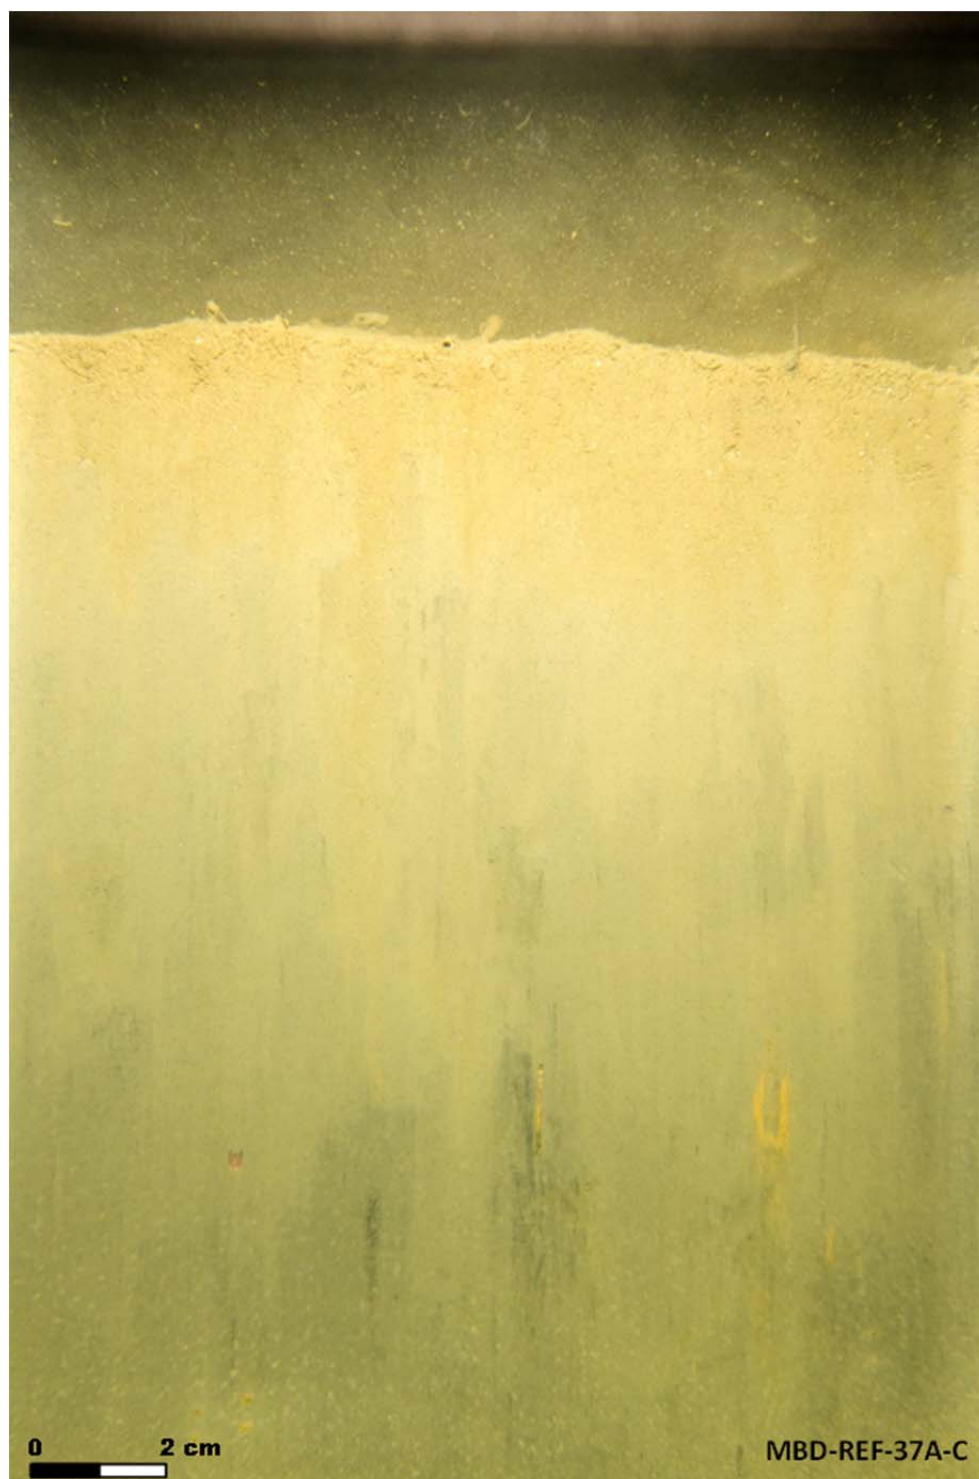
Figure 3-8. Sediment-profile image from MBDS-REF Station 37A showed well-sorted, silt/clay sediments that are typical for locations at the three MBDS reference areas

Physical Sediment Characteristics: As had been found in previous surveys (AECOM 2010), the sediments at all three reference areas were a well-mixed, uniform light brown silt/clay (major mode ≥ 4 phi; Figures 3-7 and 3-8). Similar to reported results from the 2007 survey, there was one smaller region within MBD-REF that had mud-covered rocks present on top of the silt substratum (Figure 3-9). After sampling attempts at this location (Station 37) with no successful sediment-profile image obtained (Figure 3-10), the location was moved a short distance within the reference area where no rocks were present on the surface to prevent camera prism penetration (Station 37A).

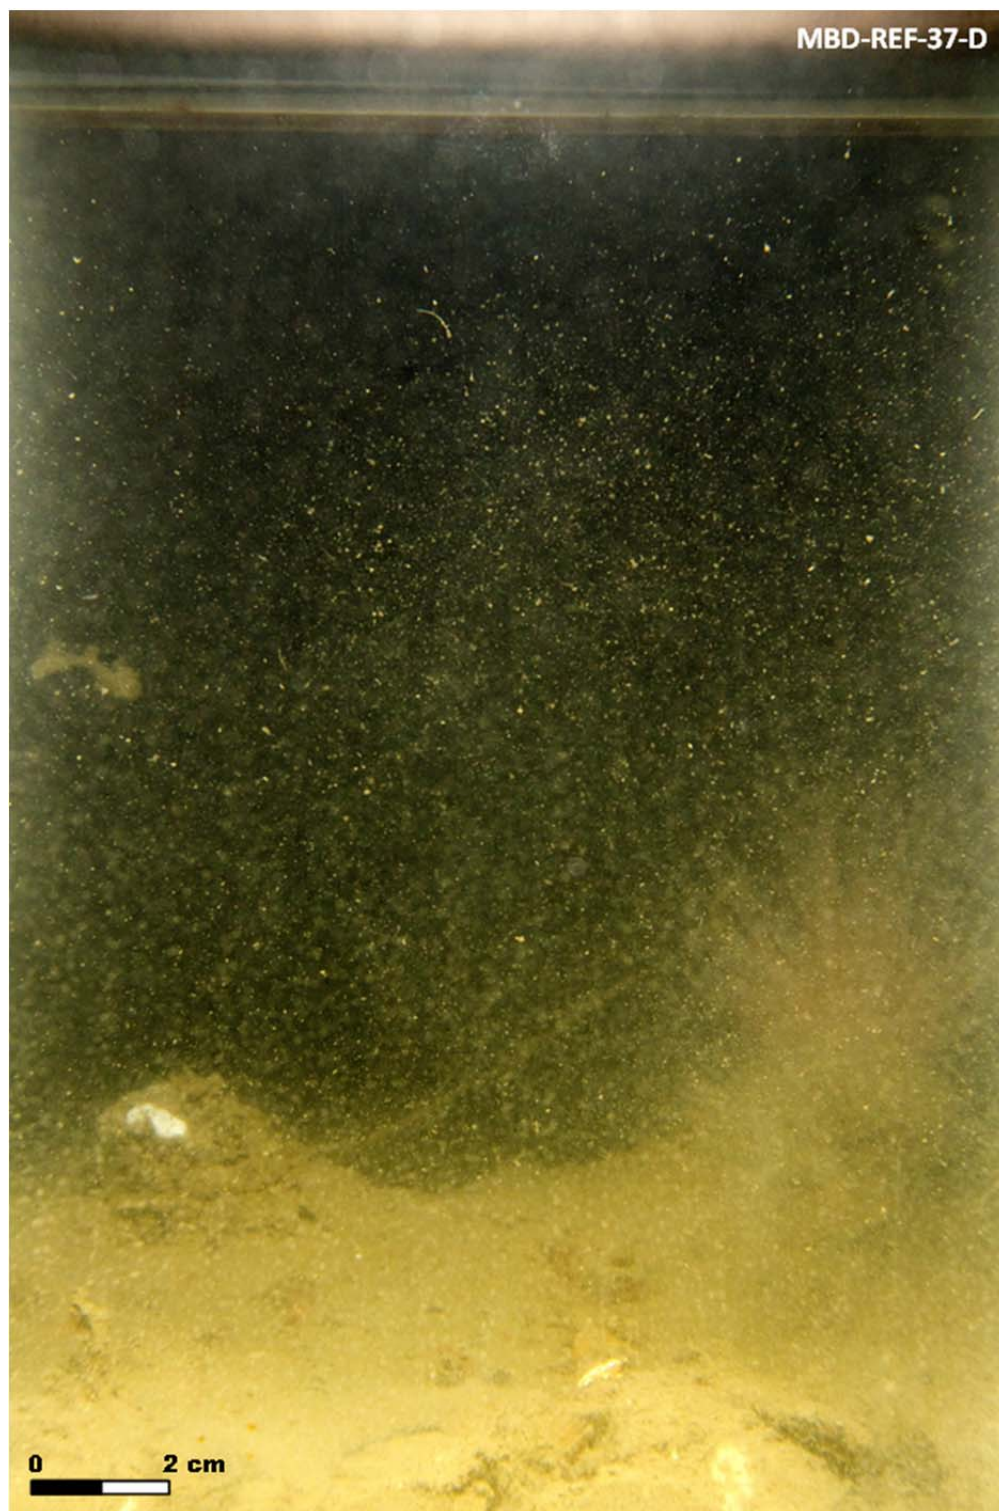
Figure 3-10. Sediment-profile image from MBD-REF Station 37 showed minimal prism penetration because of the rocks on the sediment surface

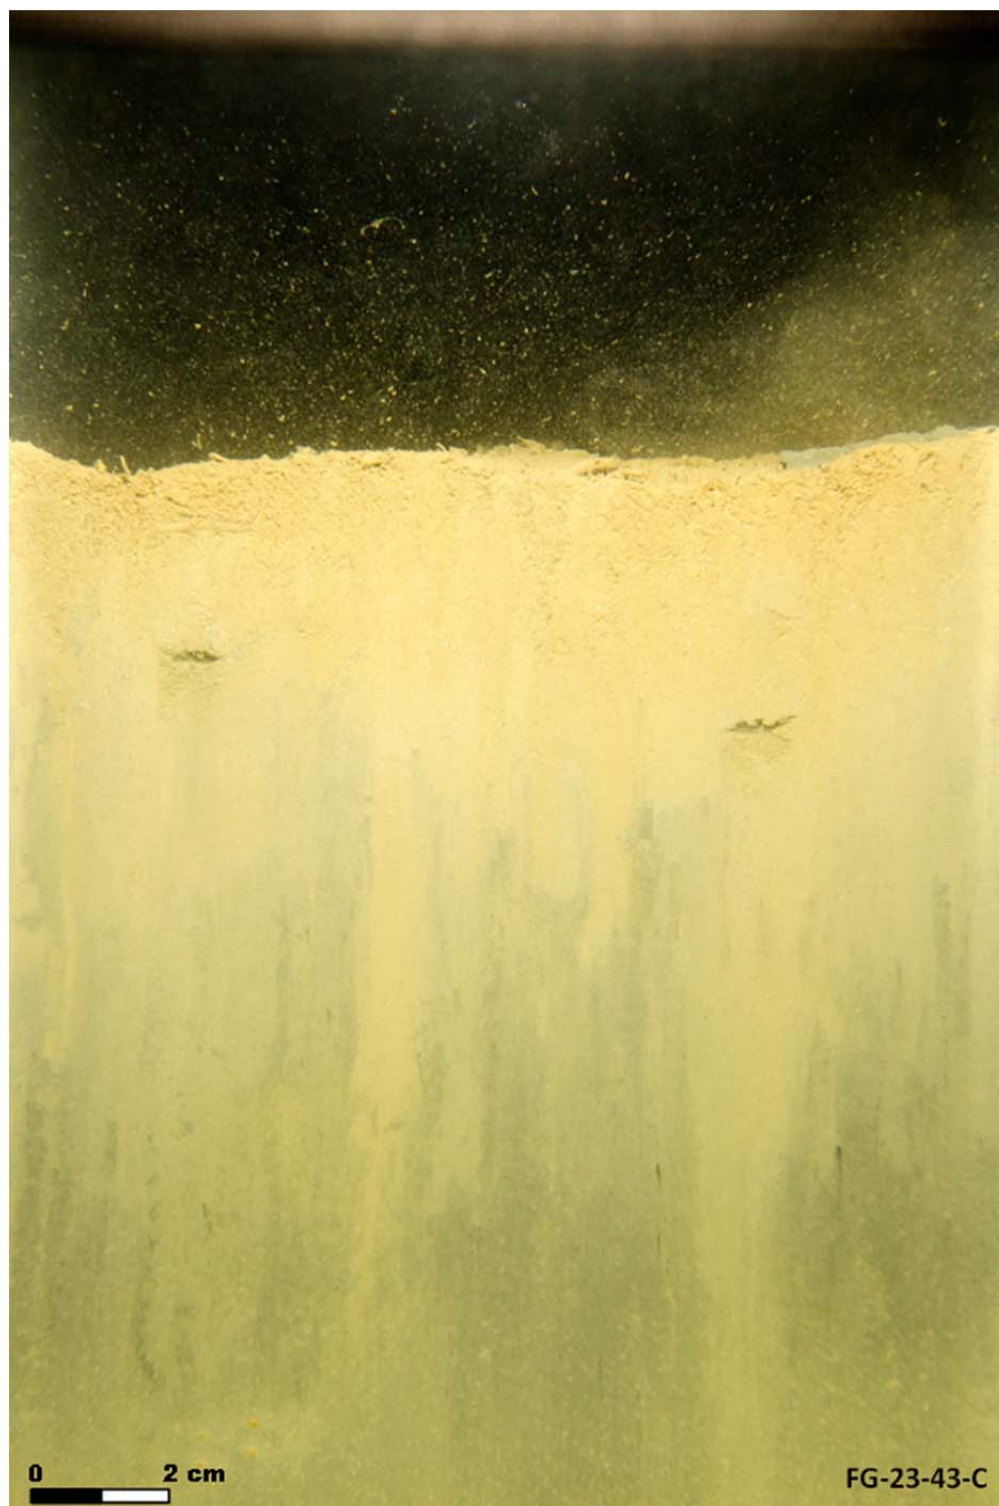
Figure 3-12. Mean station small-scale boundary roughness values (cm) at the MBDS reference areas

Mean small-scale boundary roughness values at the reference stations ranged from 0.9 to 2.1 cm, with an overall mean value of 1.4 cm for the ambient seafloor (Figure 3-12); most of the small-scale topographic relief was due to roughness elements created by faunal activity (Figure 3-13; Appendix C).

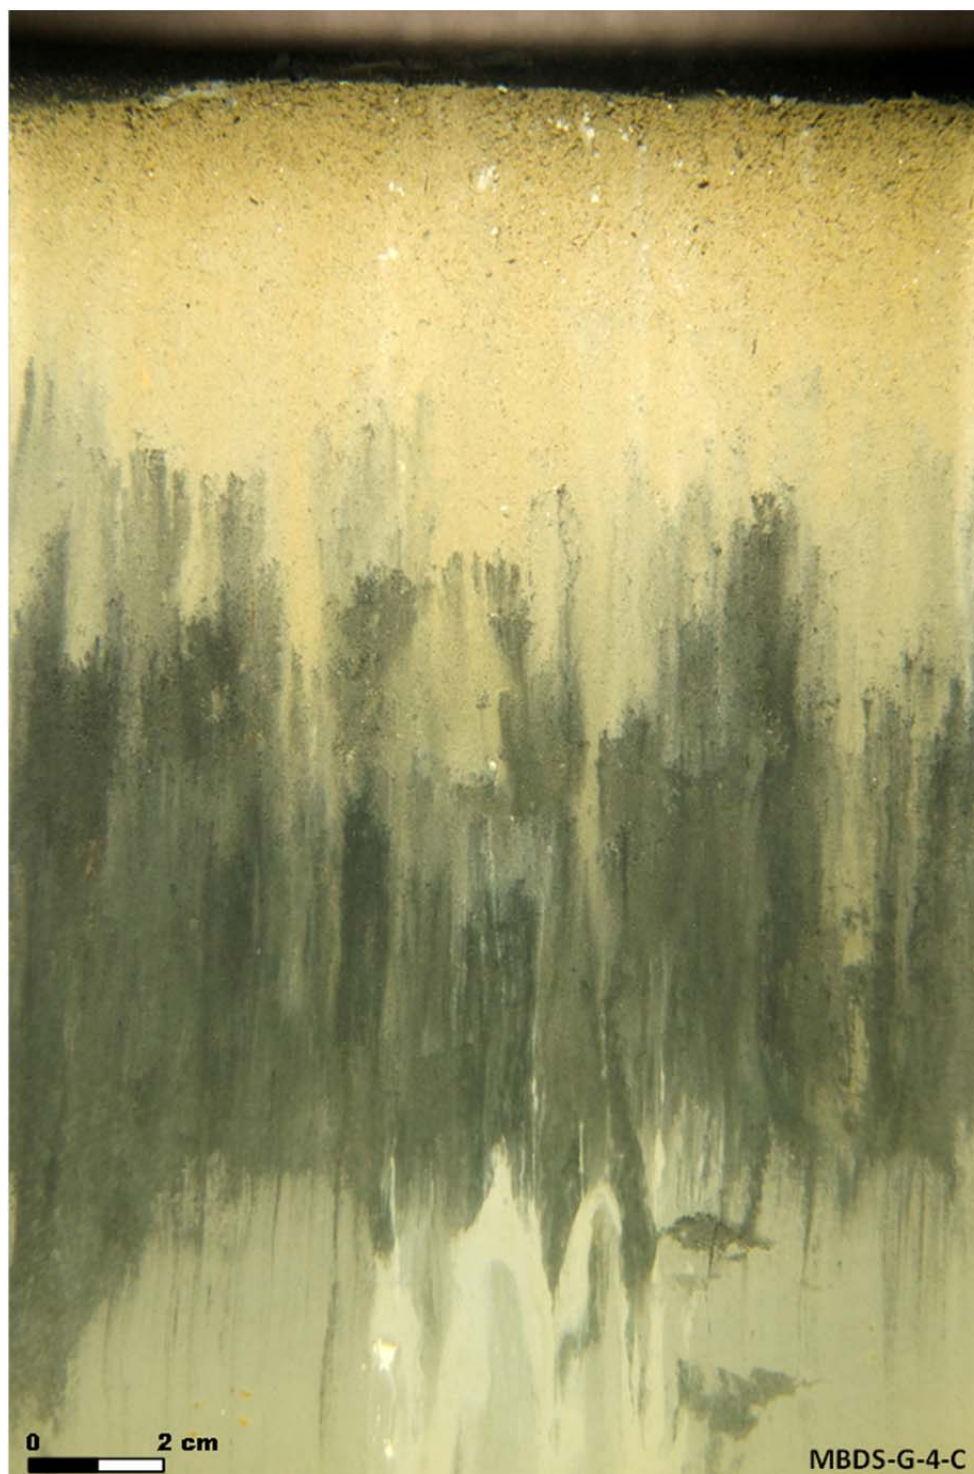
Figure 3-20. Sediment-profile image from MBDS-G Station 4 showed evidence of the old sediment-water interface (lighter colored horizon) at depth, while the more recent deposit had already been colonized and reworked by infauna

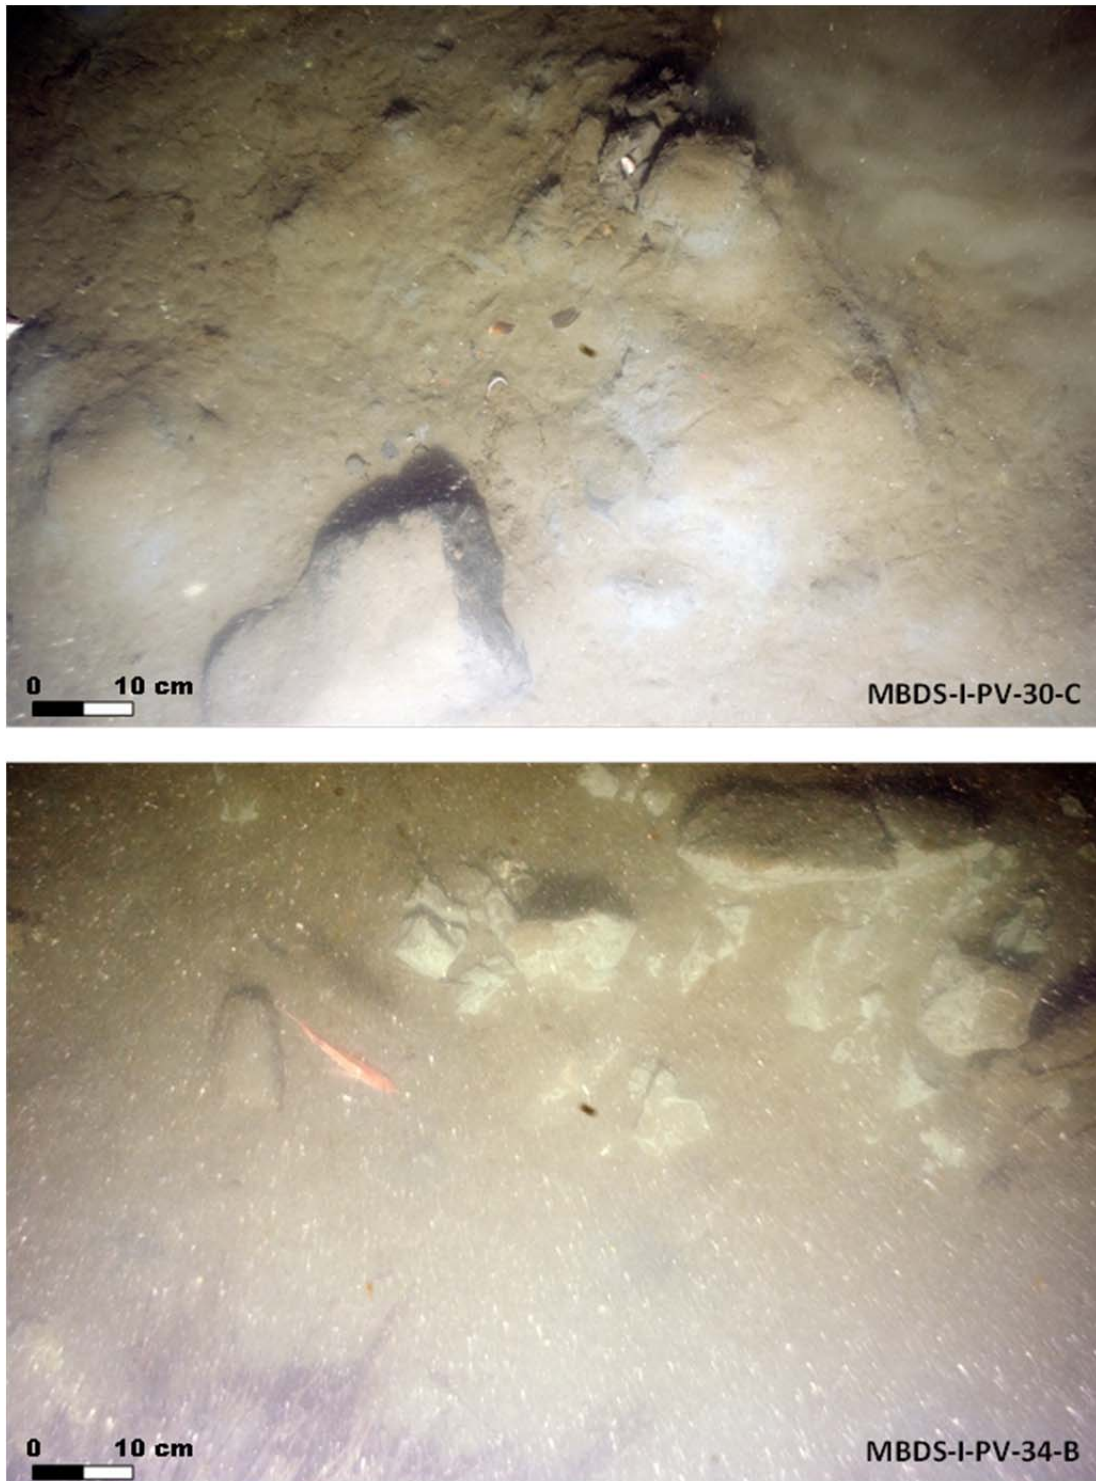
Figure 3-21. Plan-view images from Station 30 (top) and Station 34 (bottom) on MBDS-I mound showed clay clumps that provided some surface relief that will attract fish and larger epifaunal foragers

While sediments at MBDS-H mound were of similar grain size major mode and range as those of MBDS-G mound (Table 3-2), the material disposed at MBDS-I mound had a much higher sand component (Figure 3-18) in the cross-sectional images, even though evidence of some consolidated clay clumps were visible on the sediment surface (Figure 3-21).

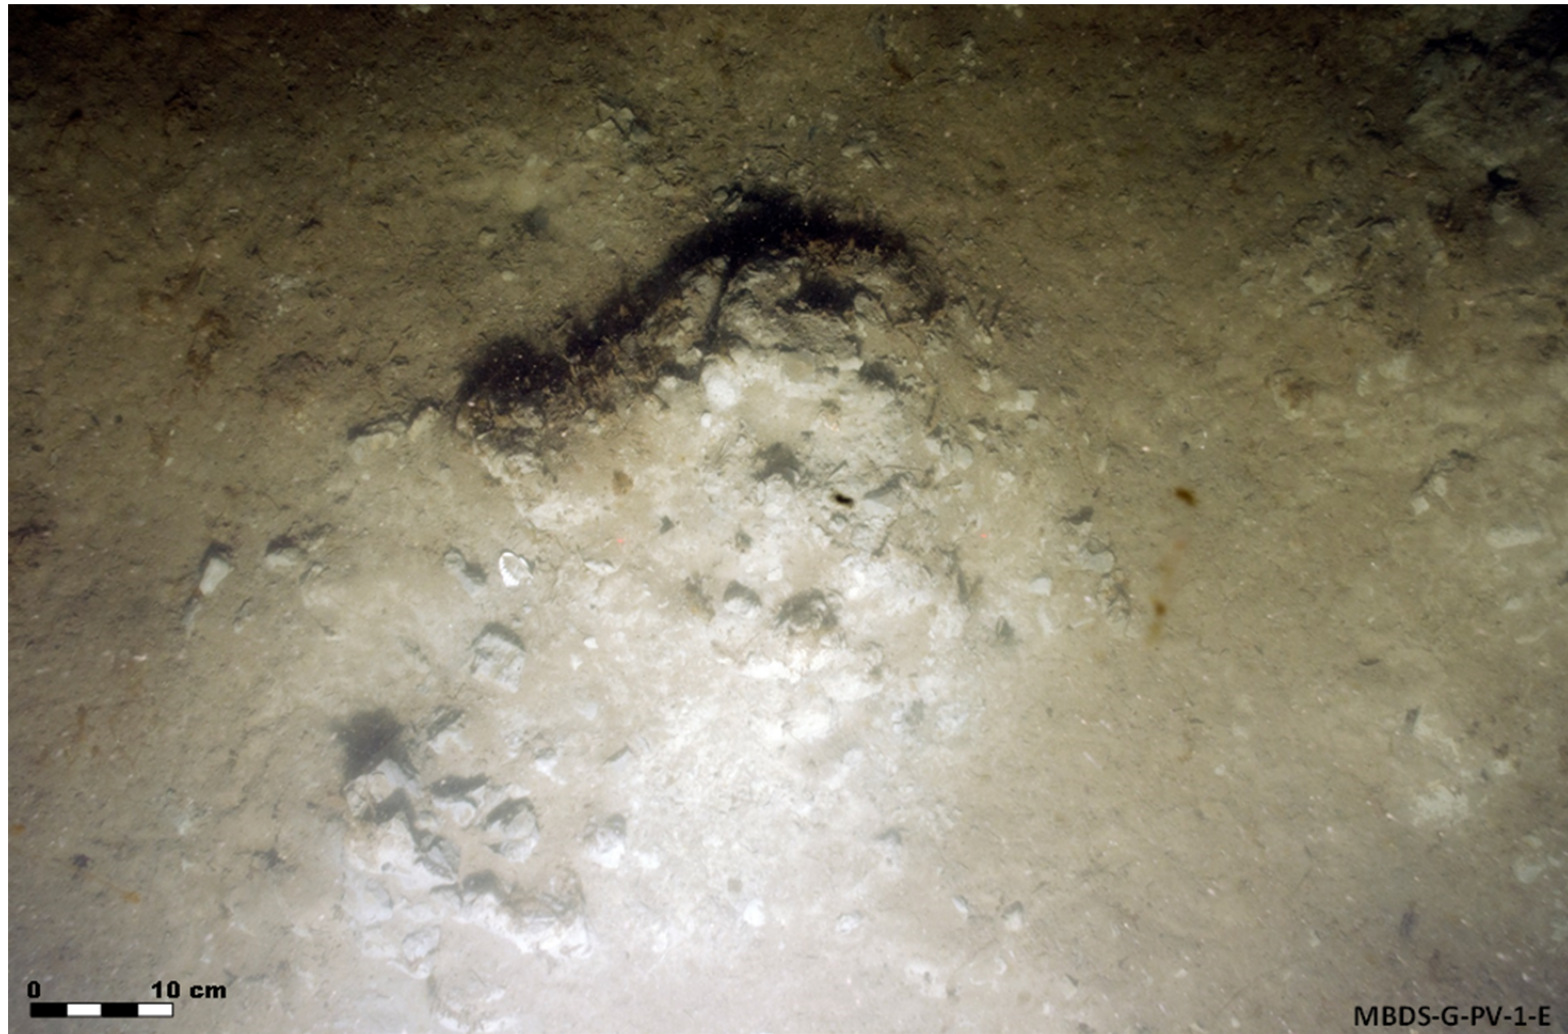
Figure 3-29. Plan-view image from MBDS-G Station 1 showed clay clumps from disposal operations that have been intact long enough to serve as a colonizing surface for suspension-feeding colonial invertebrates

Biological Conditions and Benthic Recolonization: The mean depth of the apparent RPD ranged from 0.8 to 4.7 cm (Table 3-2, Figure 3-26), with an overall mean aRPD depth of 2.5 cm for locations within the MBDS boundary (Table 3-2). Evidence of Stage 3 taxa was found at all locations sampled (Figure 3-27). The thickness of dredged material deposits exceeded the prism penetration depth and was visually obvious (Figure 3-25), but the disposed material had been thoroughly recolonized by mature successional assemblage deposit-feeding taxa (Figure 3-28). Many of the clay clumps found on the surface had been intact long enough to become colonized by epifaunal fouling organisms typically found on rocky surfaces, e.g., hydroids, bryozoans, etc. (Figure 3-29).

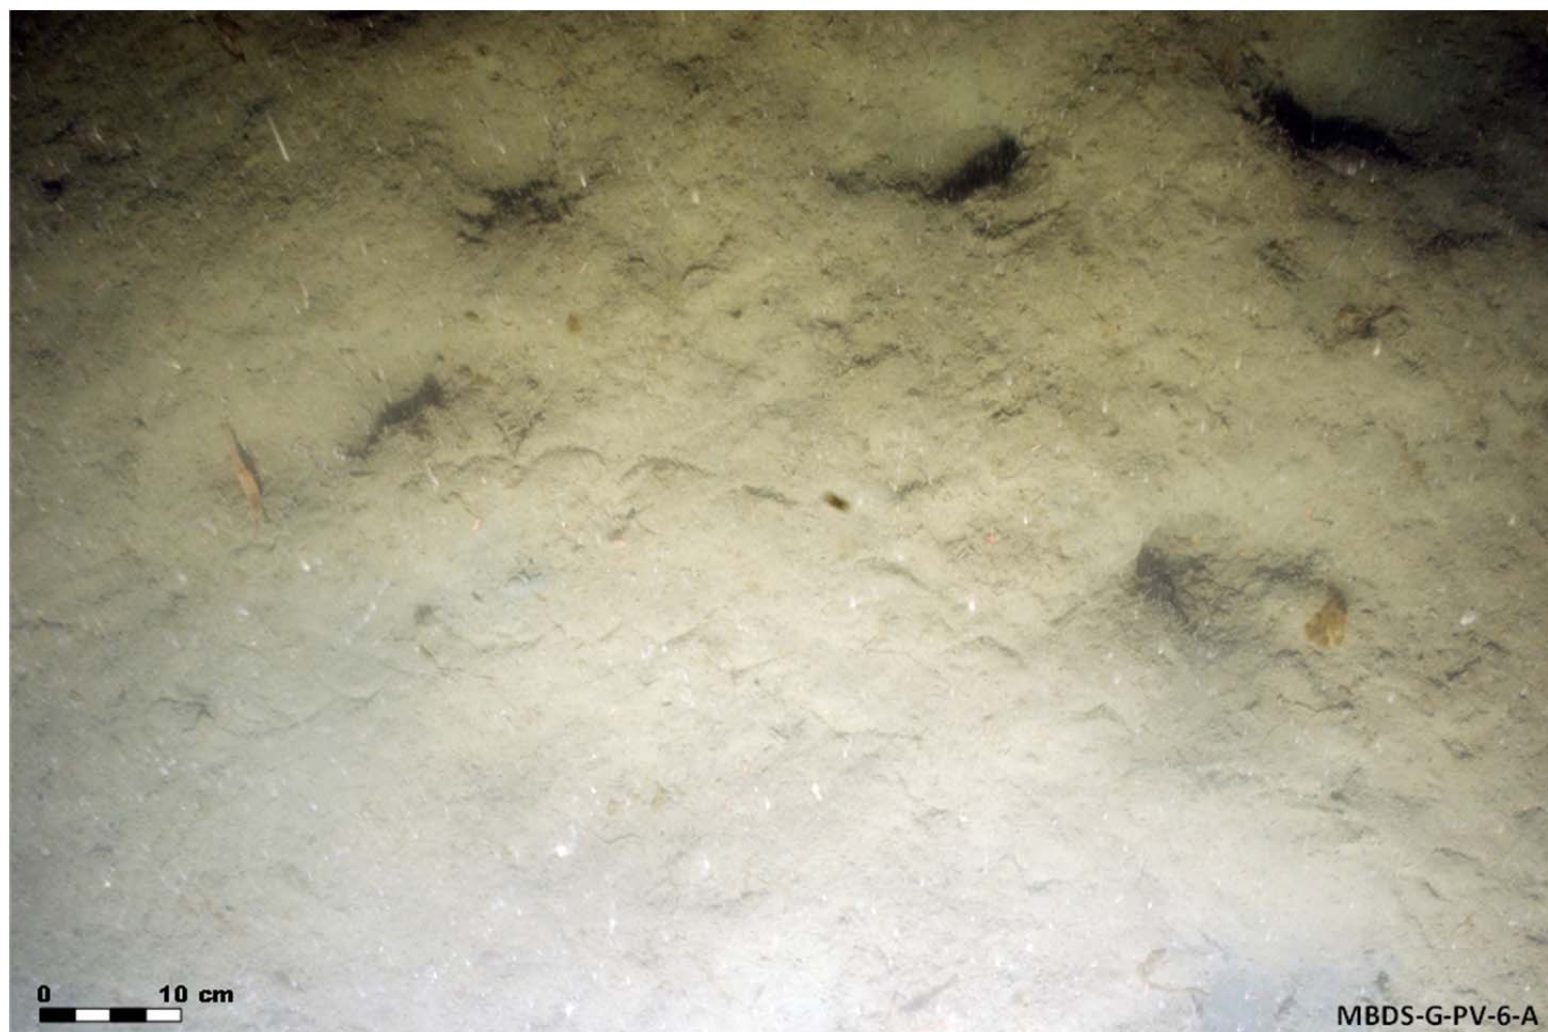
Figure 3-30. Plan-view image from MBDS-G Station 6 showed burrow openings of infaunal deposit feeders as well as shrimp on the sediment surface along with surface tracks from recent crab foraging

The mean depth of subsurface feeding voids ranged from 5.3 to 17.1 cm (Table 3-2); all the sediments surveyed within the disposal site showed evidence of active bioturbation as well as surface foraging activity (Figure 3-30).
