# Disposal Area Monitoring System DAMOS

**MONITORING SURVEYS AT THE  
CENTRAL LONG ISLAND SOUND DISPOSAL SITE  
DECEMBER 2013, JANUARY 2014, & AUGUST 2014**

CONTRIBUTION #197

February 2017

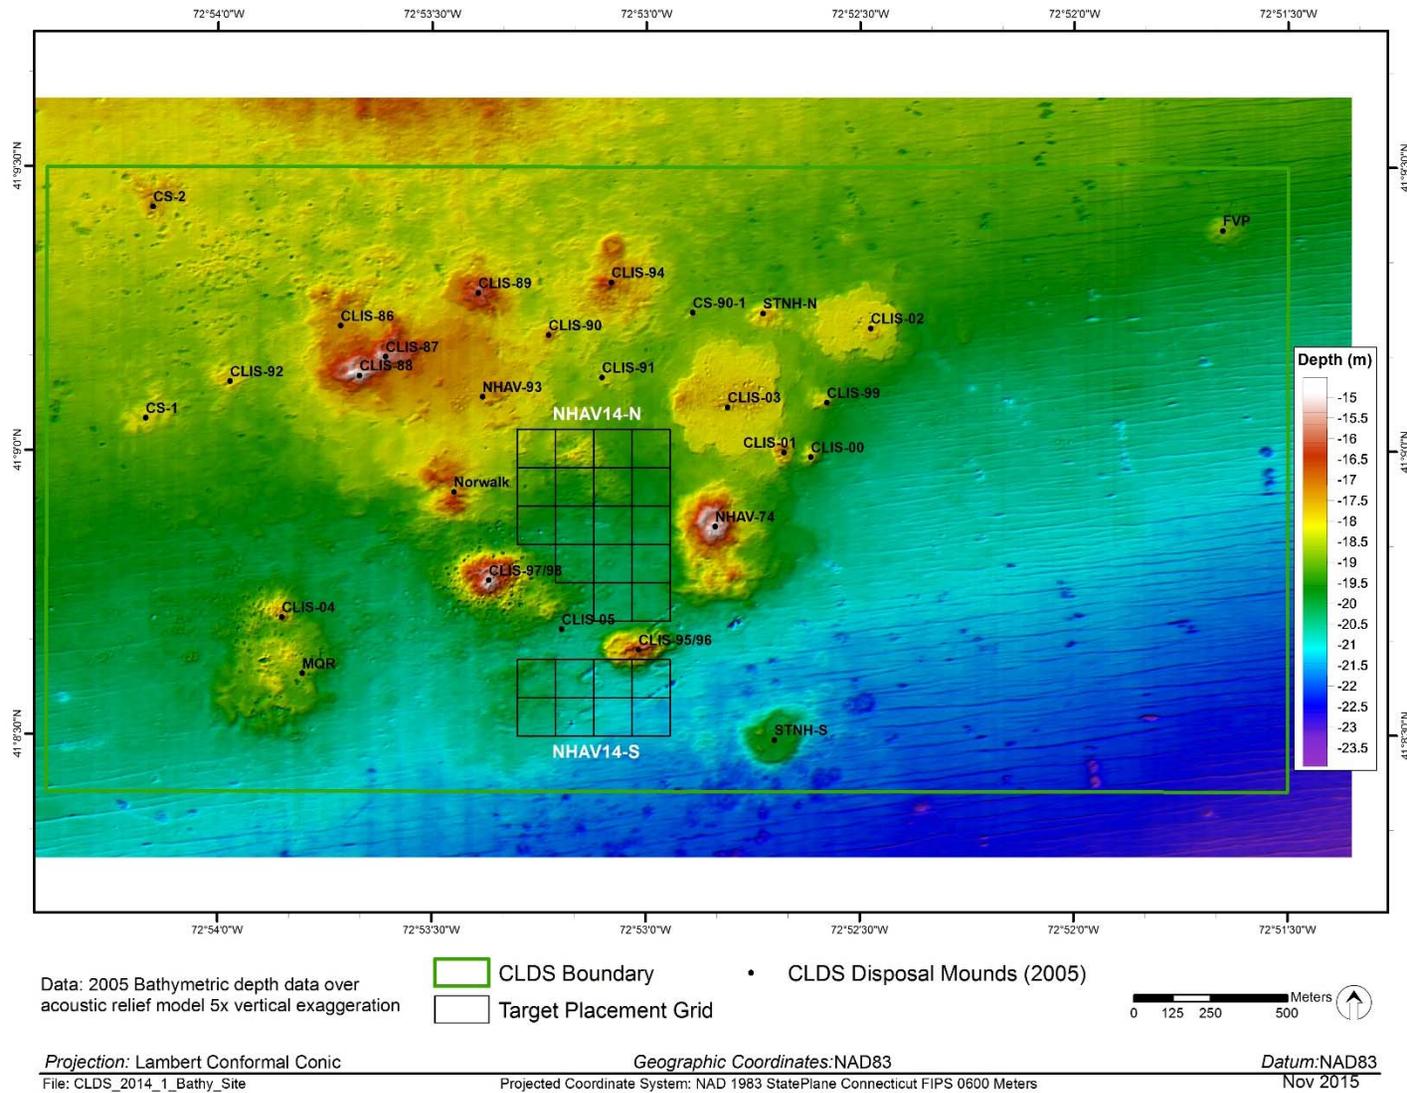
**Figure 1-2.** Bathymetric data with hillshade relief of the full CLDS from July 2005 survey showing named mound locations

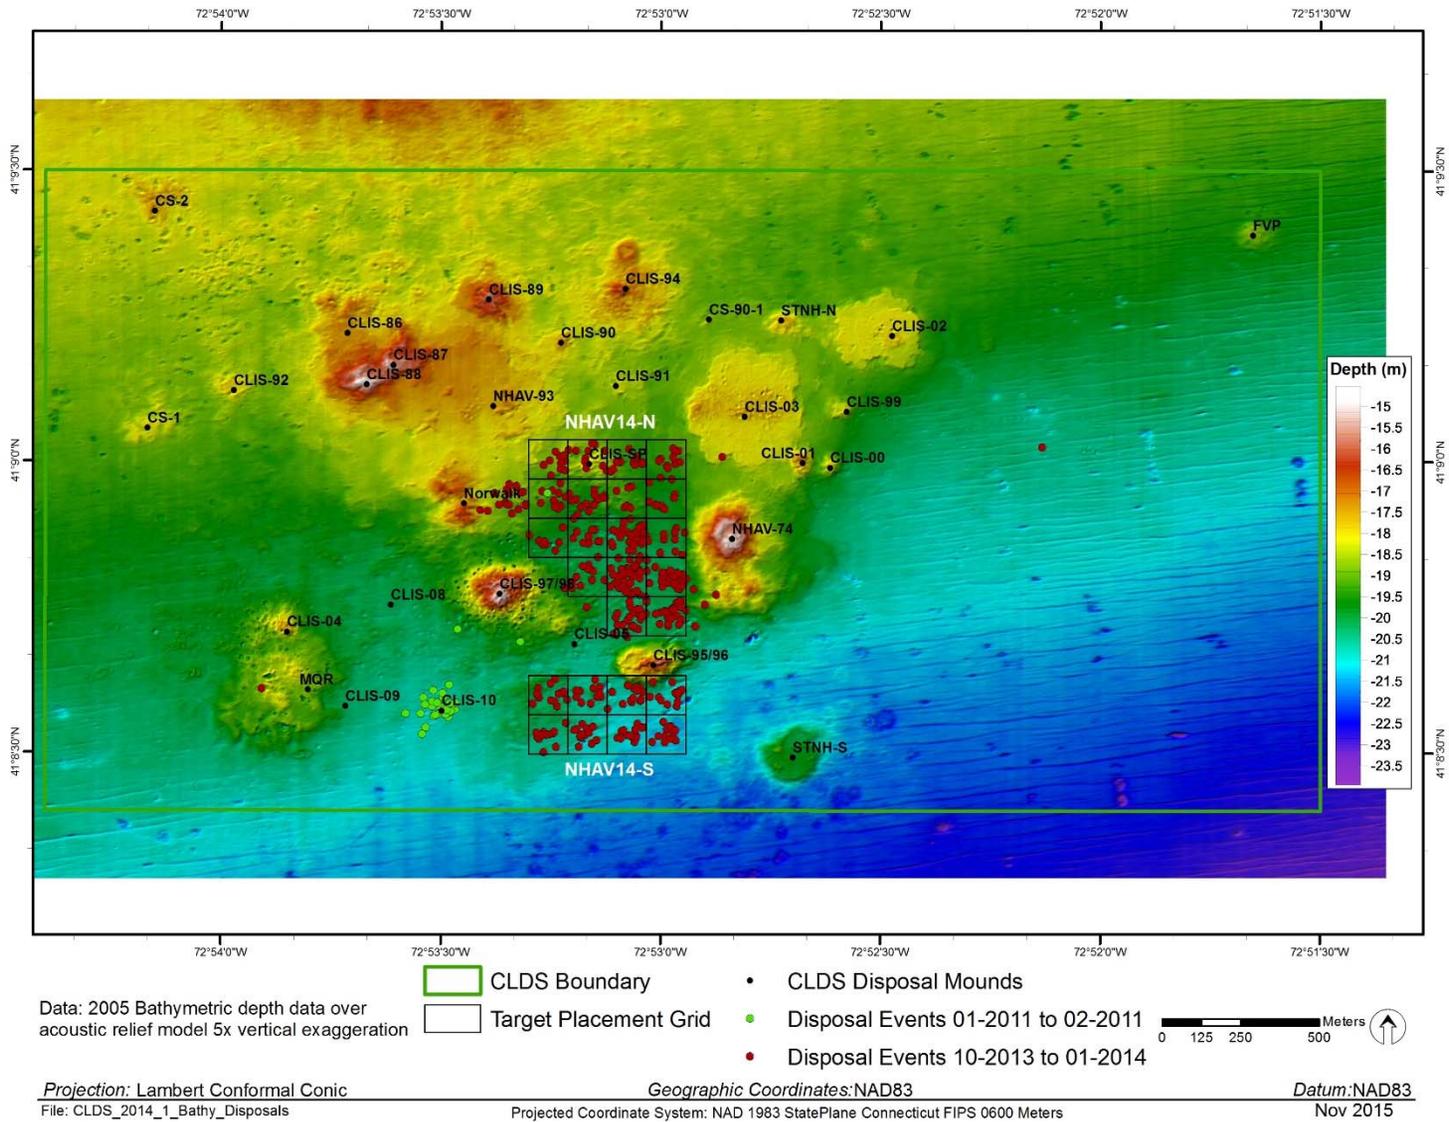
**Figure 1-3.** Location of disposal events at CLDS (Jan 2011 to Jan 2014)

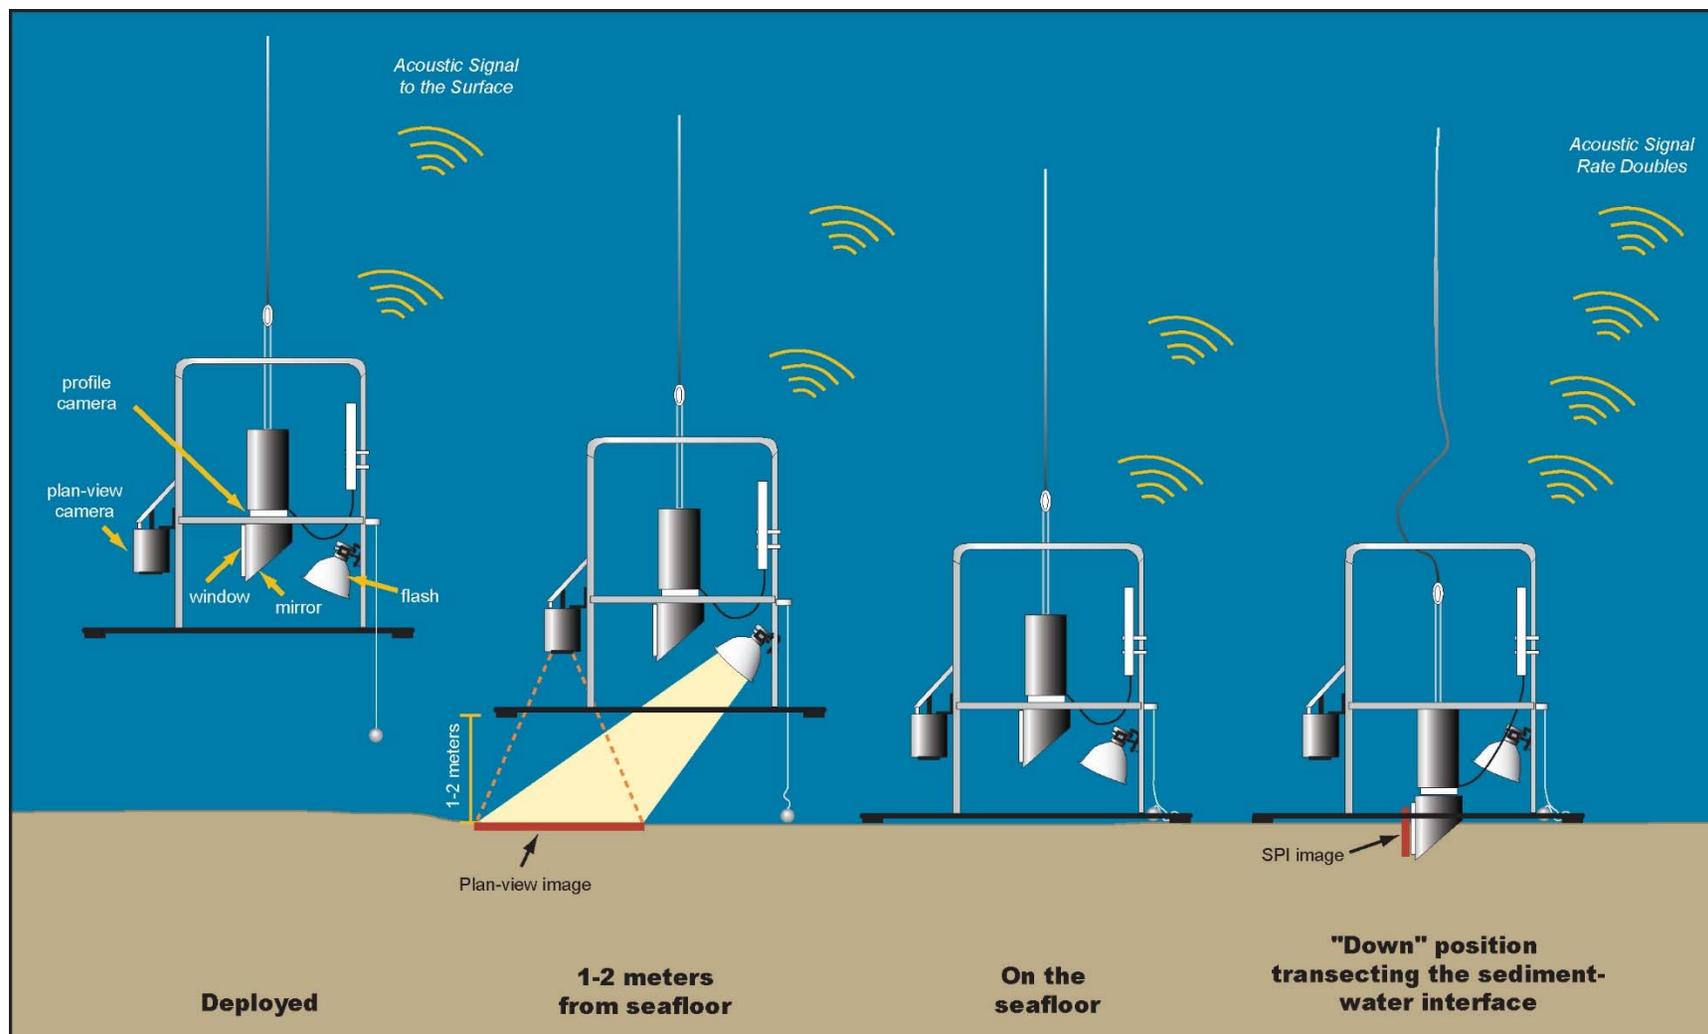
**Figure 2-6.** Schematic diagram of the SPI/PV camera deployment

An Ocean Imaging® Model DSC16000 plan-view underwater camera (PV) system with two Ocean Imaging® Model 400-37 Deep Sea Scaling lasers mounted to the DSC16000 was attached to the sediment-profile camera frame and used to collect plan-view photographs of the seafloor surface; both SPI and PV images were collected during each “drop” of the system. The PV system consisted of a Nikon D-7000 encased in an aluminum housing, a 24 VDC autonomous power pack, a 500 W strobe, and a bounce trigger. A weight was attached to the bounce trigger with a stainless steel cable so that the weight hung below the camera frame; the scaling lasers projected two red dots that are separated by a constant distance (26

The ability of the PV system to collect usable images was dependent on the clarity of the water column. Water conditions at CLDS allowed use of a ½-m trigger wire, resulting in an area of bottom visualization approximately  $0.5 \times 0.3$  m in size.

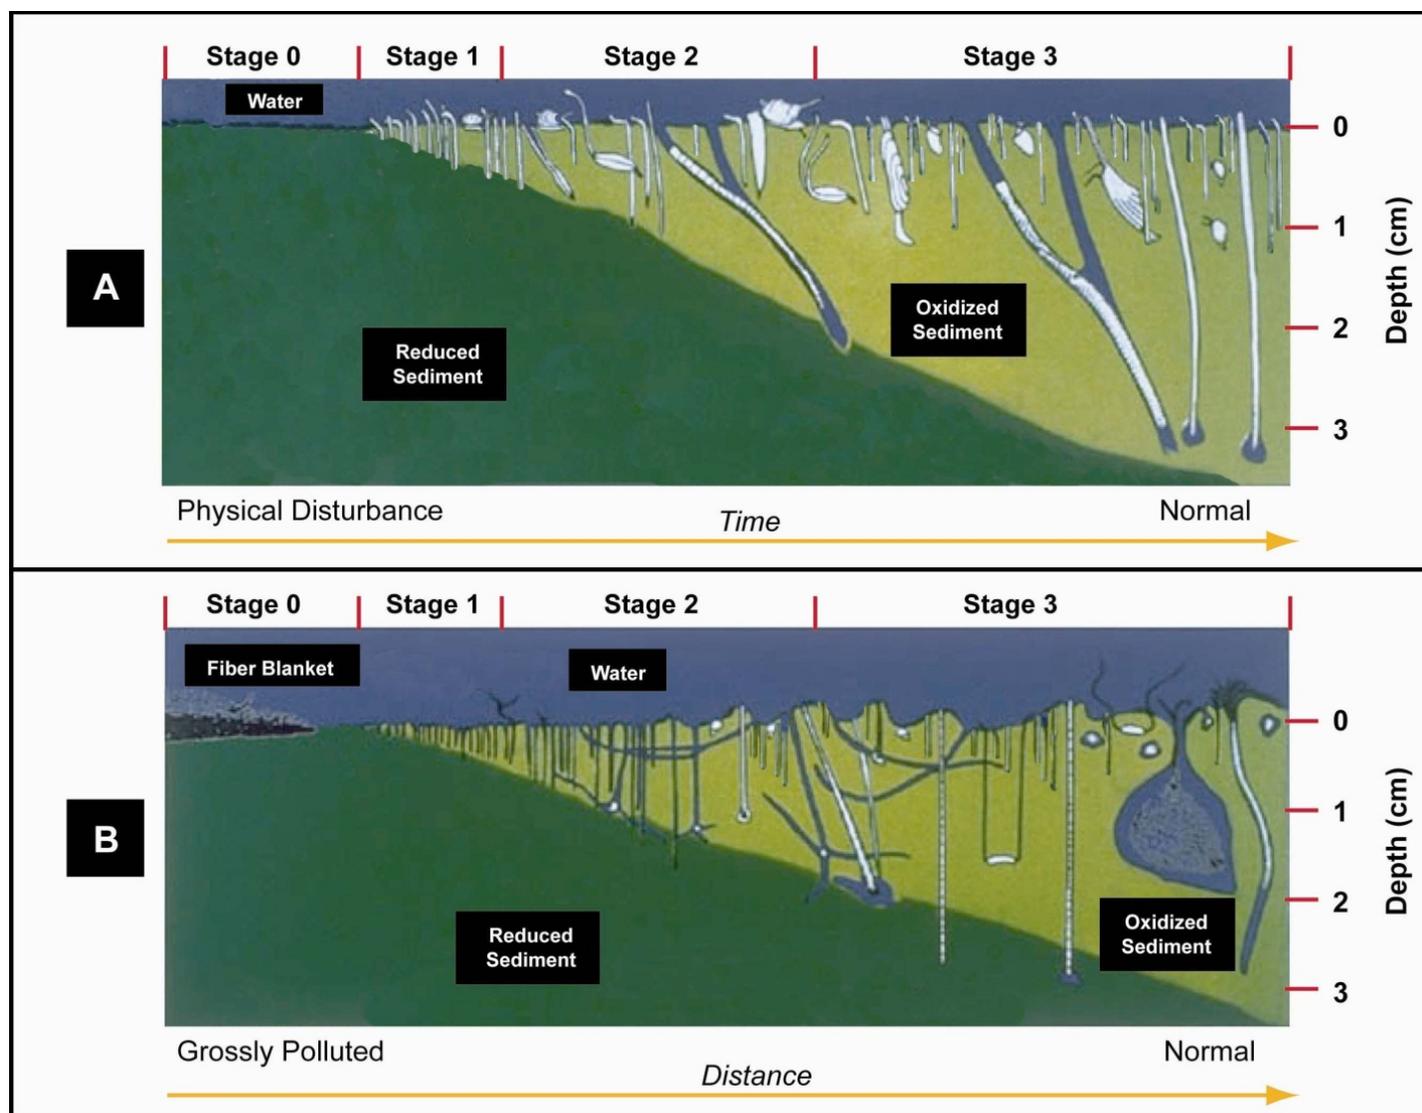
**Figure 2-7.** The stages of infaunal succession as a response of soft-bottom benthic communities to (A) physical disturbance or (B) organic enrichment; from Rhoads and Germano (1982)

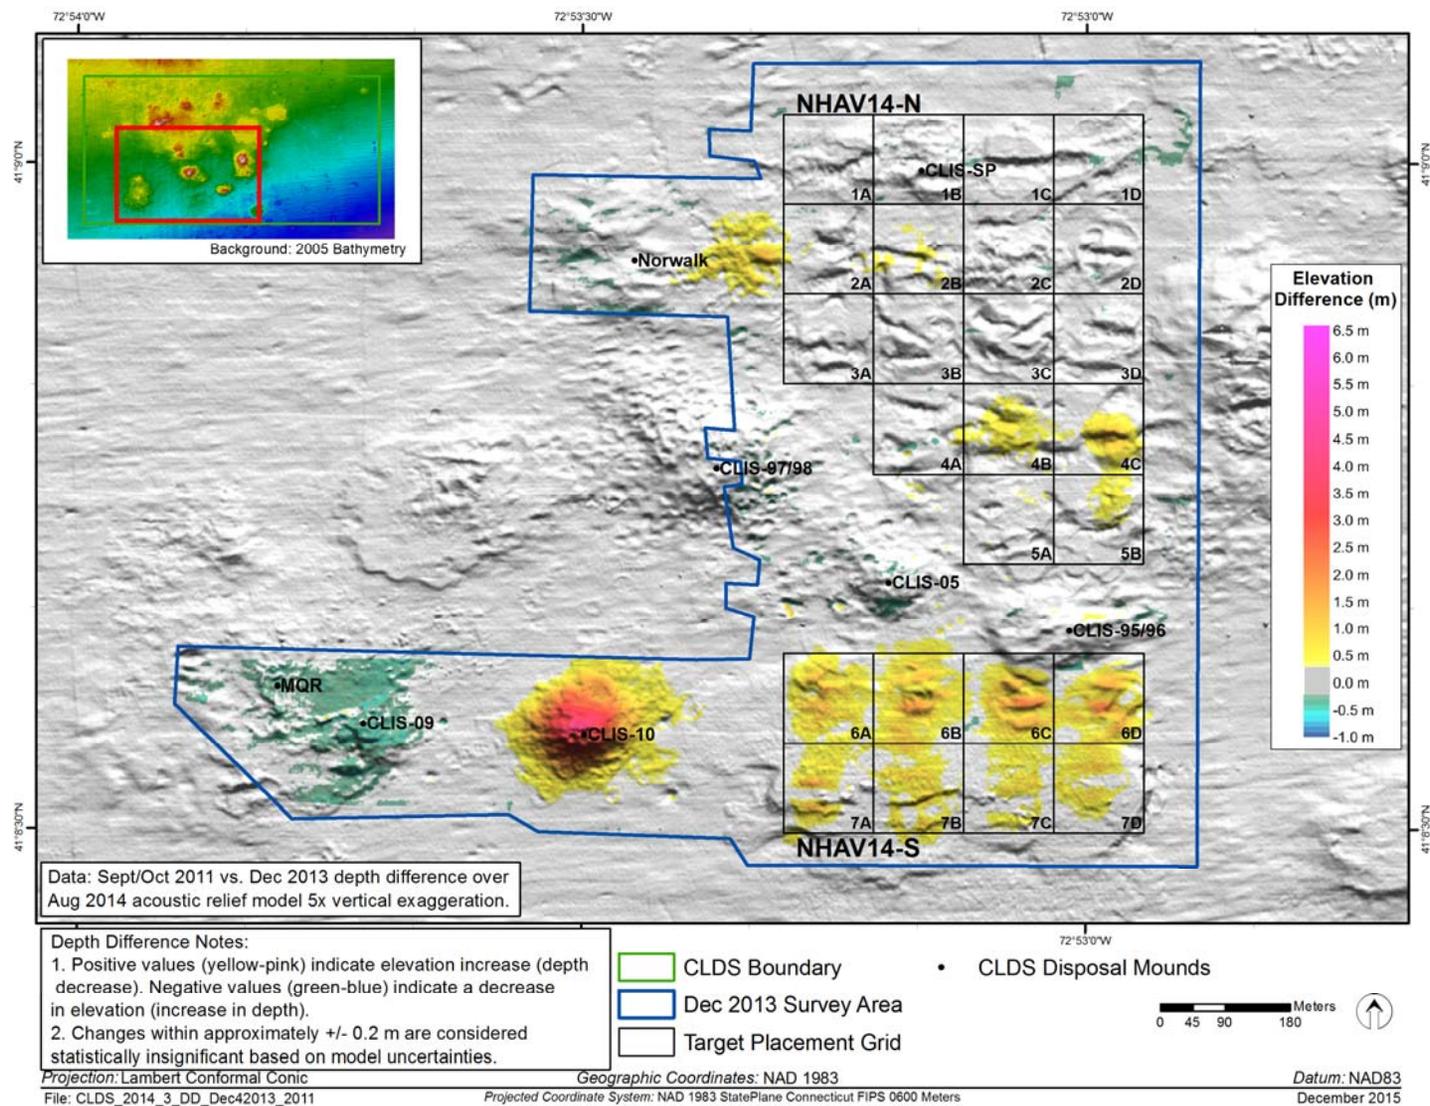
**Figure 3-2.** CLDS depth difference: December 2013 vs. September/October 2011

The December 2013 survey was designed to overlap with the most recent bathymetric survey of that portion of CLDS conducted in 2011 (see Table 1-2). A depth difference analysis between the 2011 bathymetric dataset and the December 2013 dataset highlighted the areas that experienced changes in depth during that two-year span. A substantial accumulation of dredged material was obvious at the CLIS-10 mound and the NHA14-S placement area; smaller deposits of sediment accumulation were noted within the NHA14-N placement area (Figure 3-2). In addition to accumulation areas within the CLIS-10 mound and the two target grids, there was also an area immediately to the west of the NHA14-N grid that received some placement of dredged material (Figure 3-2). Widespread areas of depth increase were documented at the CLIS-09 mound.

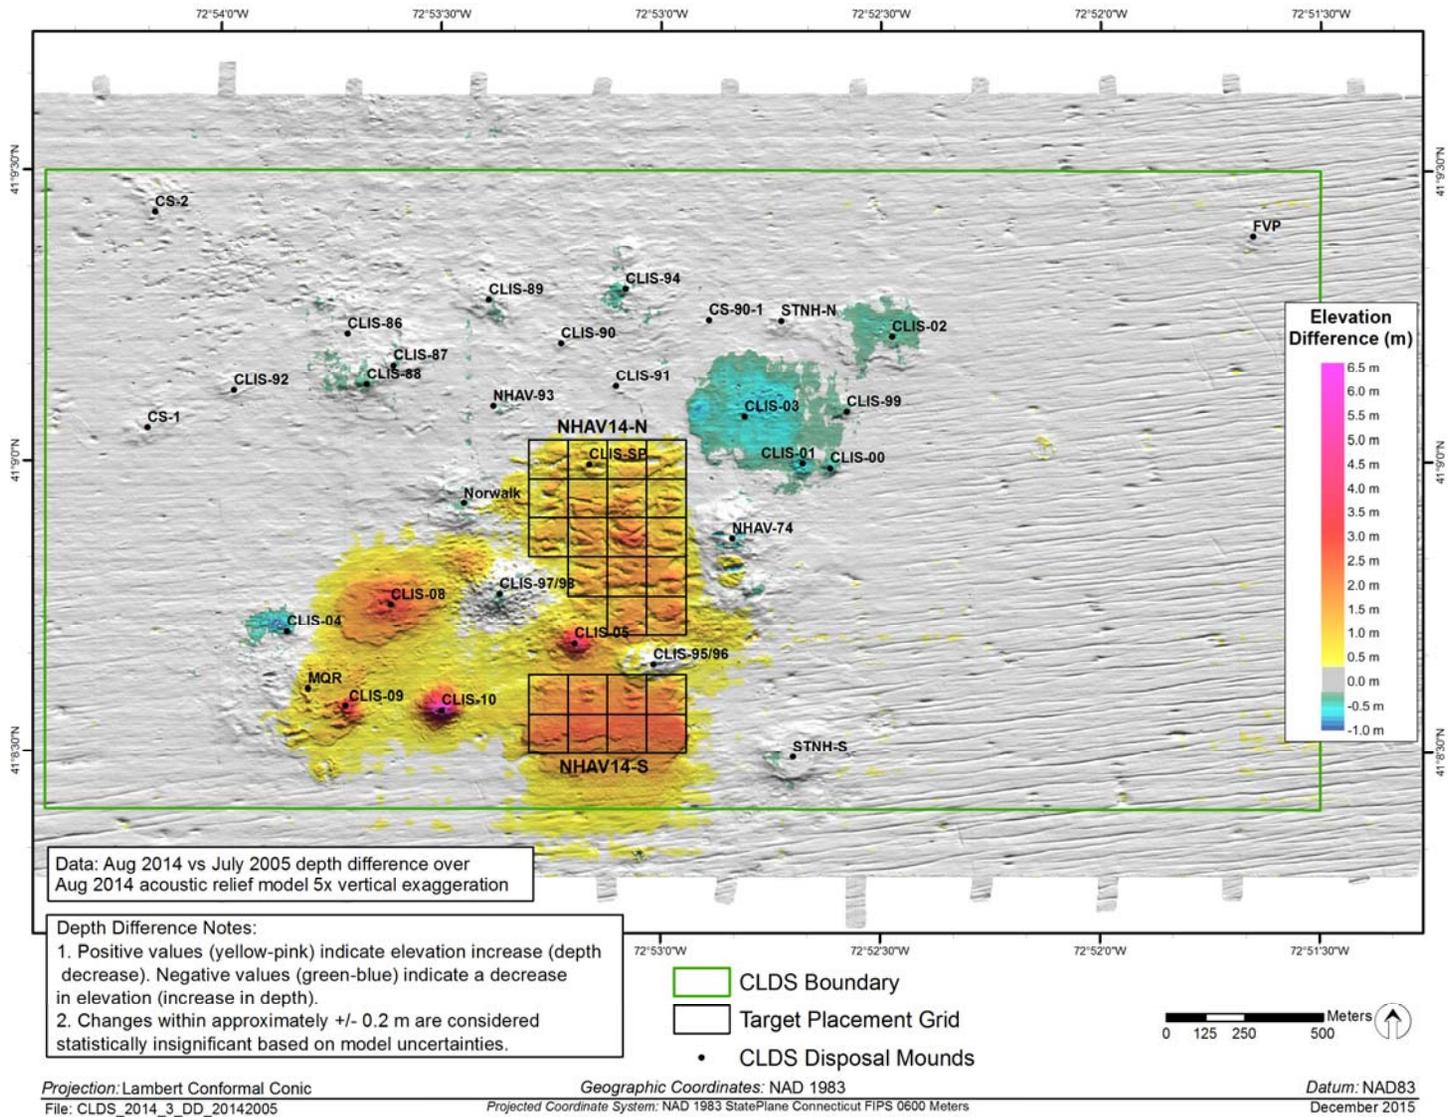
**Figure 3-10.** CLDS depth difference: August 2014 vs. July 2005

The localized areas of both depth increase and decrease in the southern portion of the historical NHAV-74 mound were consistent with what was previously observed in the 2011 survey of CLDS and were described in detail in AECOM (2013). Linear troughs to the north of the previously described feature were apparent in the July 2005/August 2014 depth differencing, suggesting a new surface disturbance on the NHAV-74 mound since the 2011 survey (Figure 3-10).

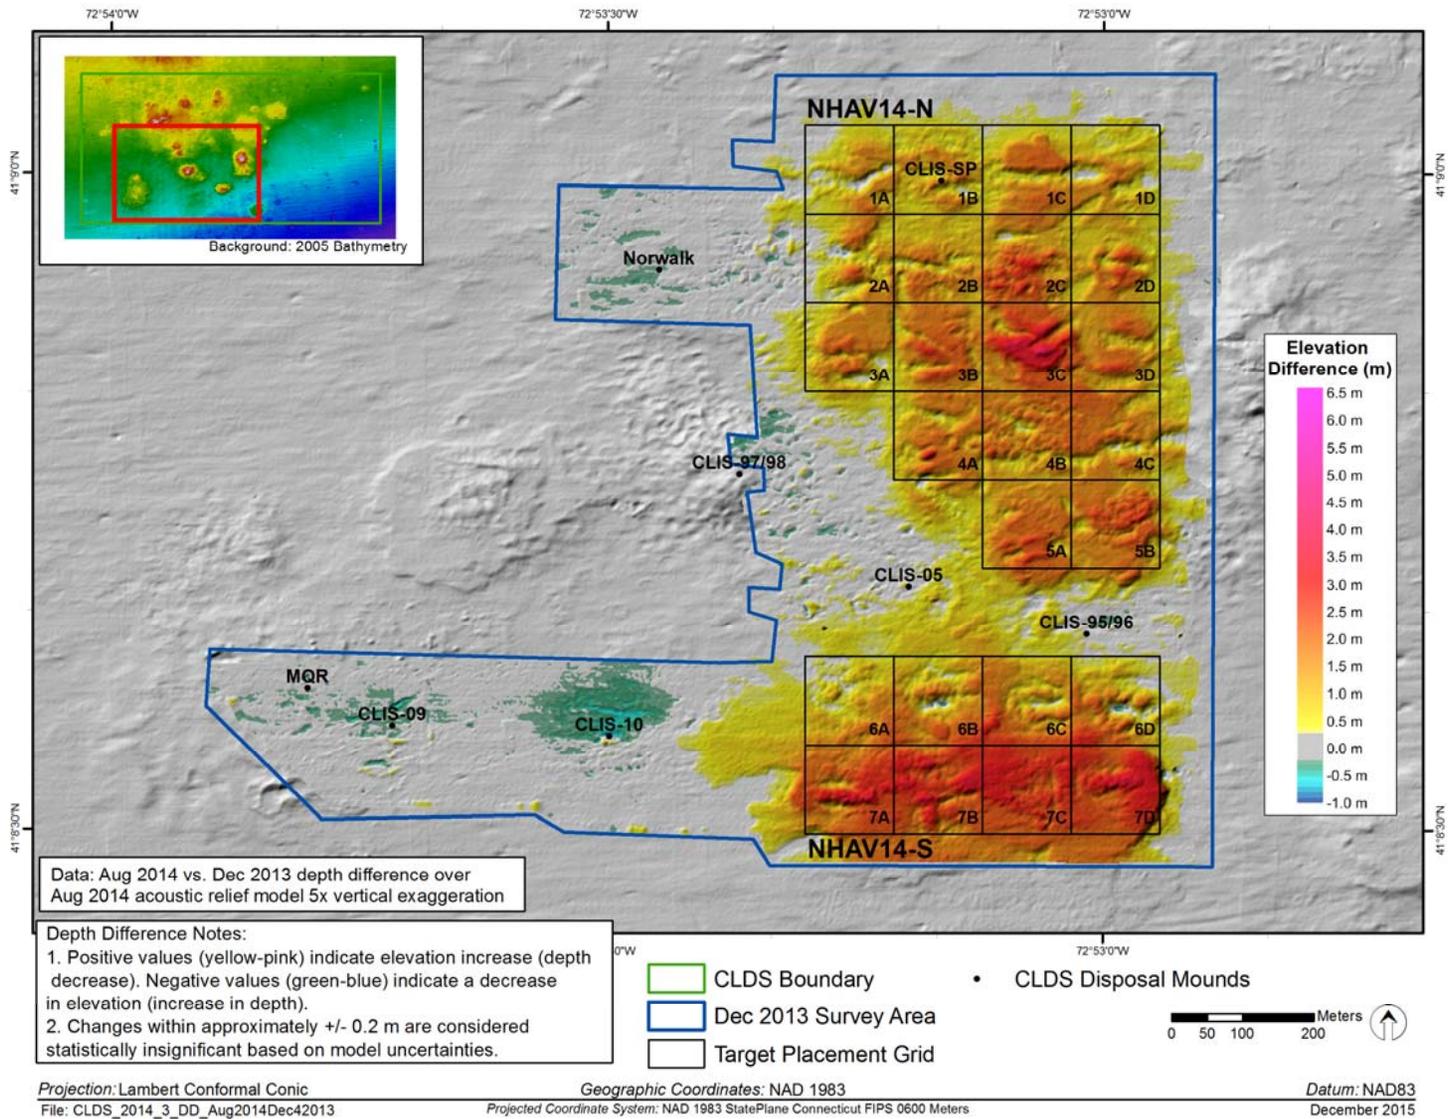
**Figure 3-11.** CLDS depth difference: August 2014 vs. December 2013

private projects (Figure 3-11). Accumulation was widespread throughout both grids and ranged up to 3.0 m. The accumulation areas extended beyond the margins of the target disposal grids and the extent of the December 2013 survey to the south of NHAV14-S. Two areas of depth increase were also noted over the more recently formed disposal mound CLIS-10 and, to a lesser extent, CLIS-09 (Figure 3-11). The depth increase was less than 0.5 m and likely the result of consolidation of the dredged material at both mounds.

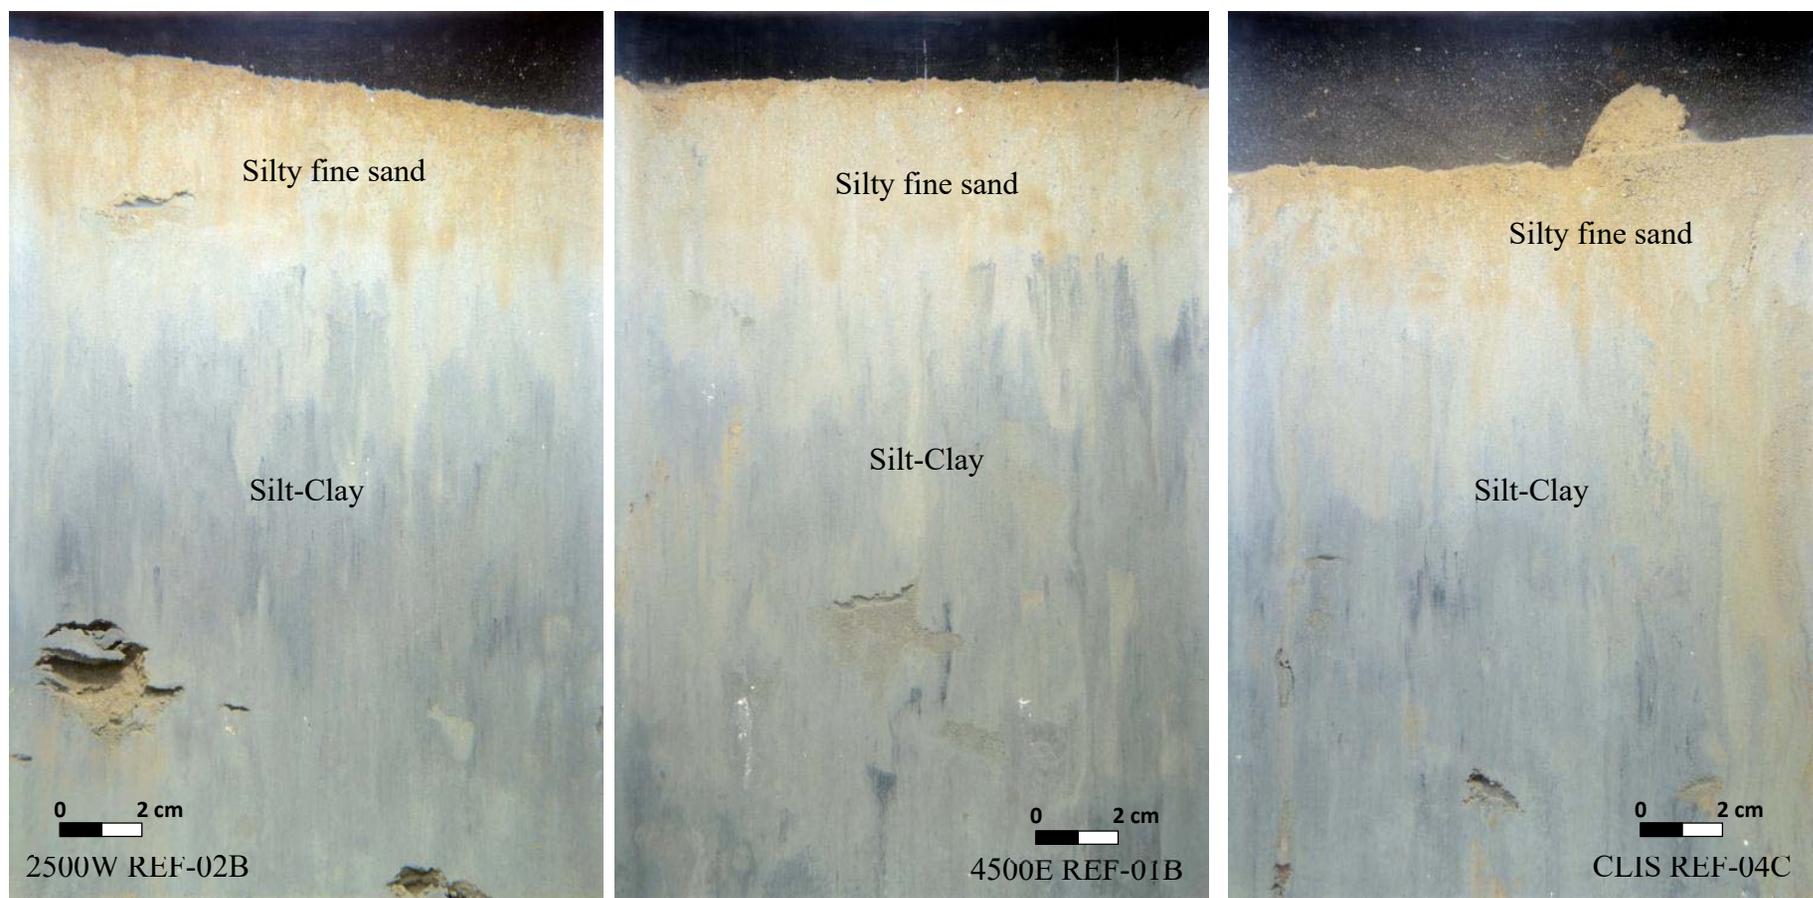
**Figure 3-17.** Representative profile images from the three reference areas displaying a surface layer of silty, very-fine sand overlaying predominantly silt-clay sediment at depth.

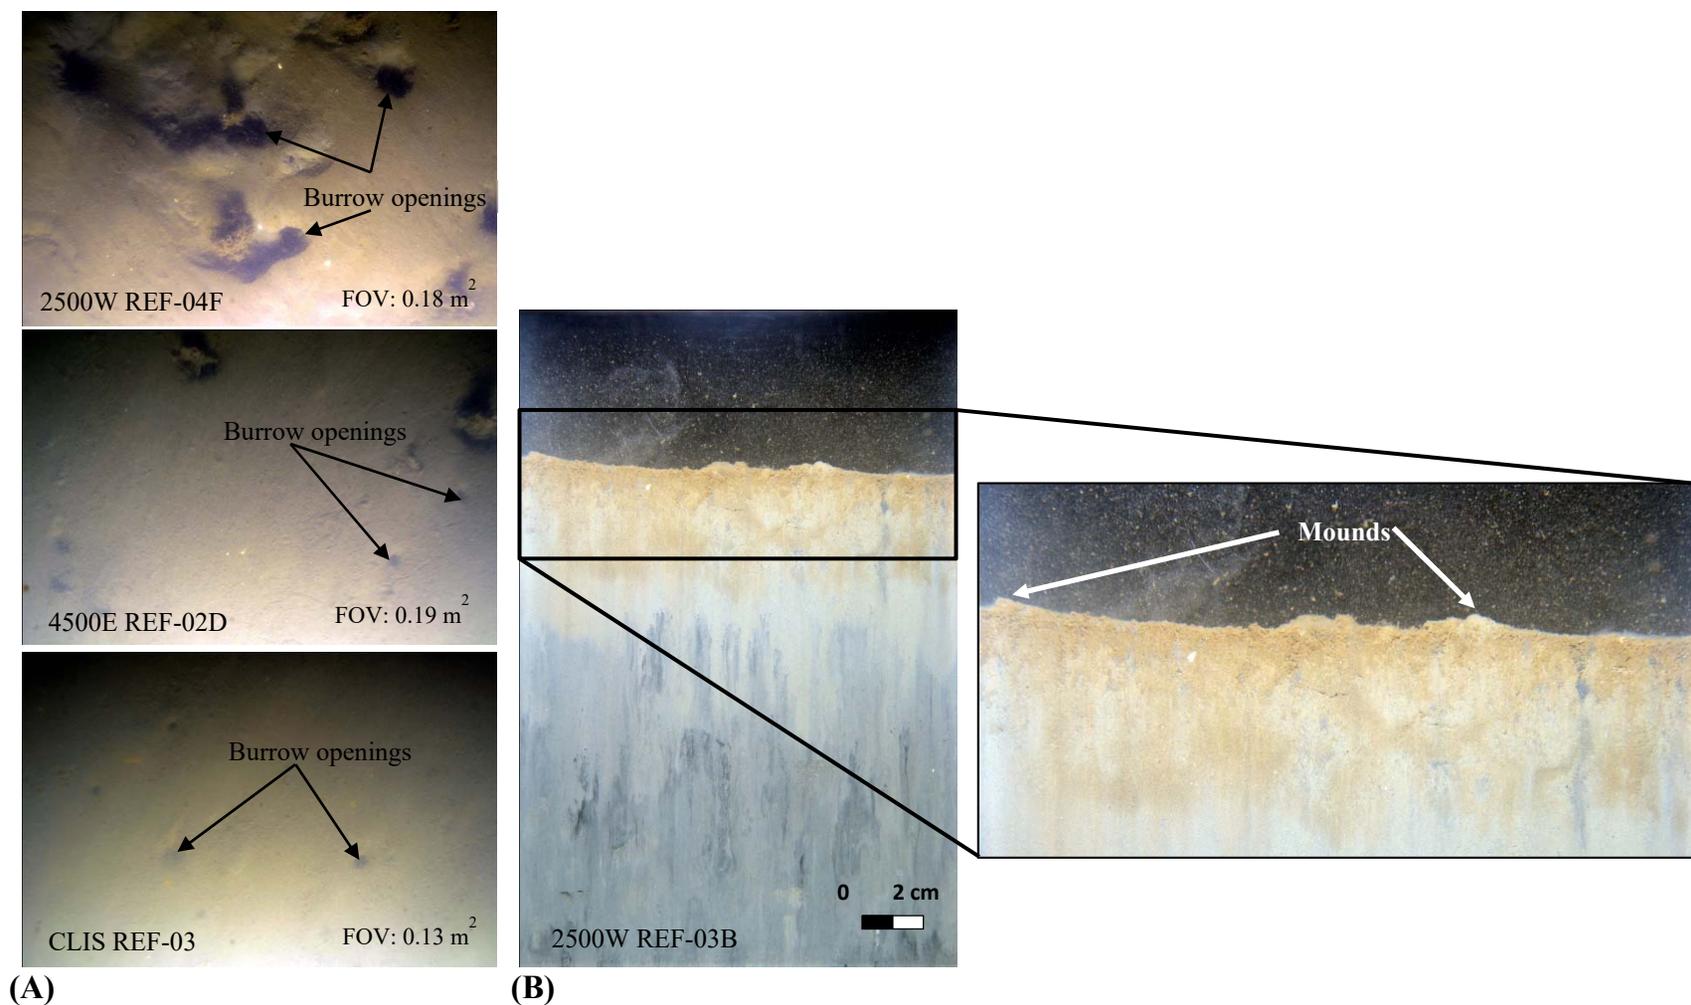
**Figure 3-19.** (A) Representative plan-view images from the three reference areas displaying a surface layer of silty, very-fine sand (FOV = Field of view). (B) Small-scale surface topography (i.e., boundary roughness), displayed at Station 2500W REF-03, due to the presence of biogenic mounds (highlighted in the enlarged portion of the image) created by the burrowing and feeding activity of subsurface organisms.

The means of replicate small-scale boundary roughness ranged from 0.8 to 1.6 cm, with an overall mean of 1.3 cm (Table 3-2). The origin of this small-scale topography was dominated by biological processes among the station replicates (Table 3-2). Physical roughness elements were caused by the presence of clay clumps at some of the stations with fine-grained dredged material and reworking of the recently placed material, while biological roughness elements were due to features such as feeding pits, burrow openings, and fecal mounds.

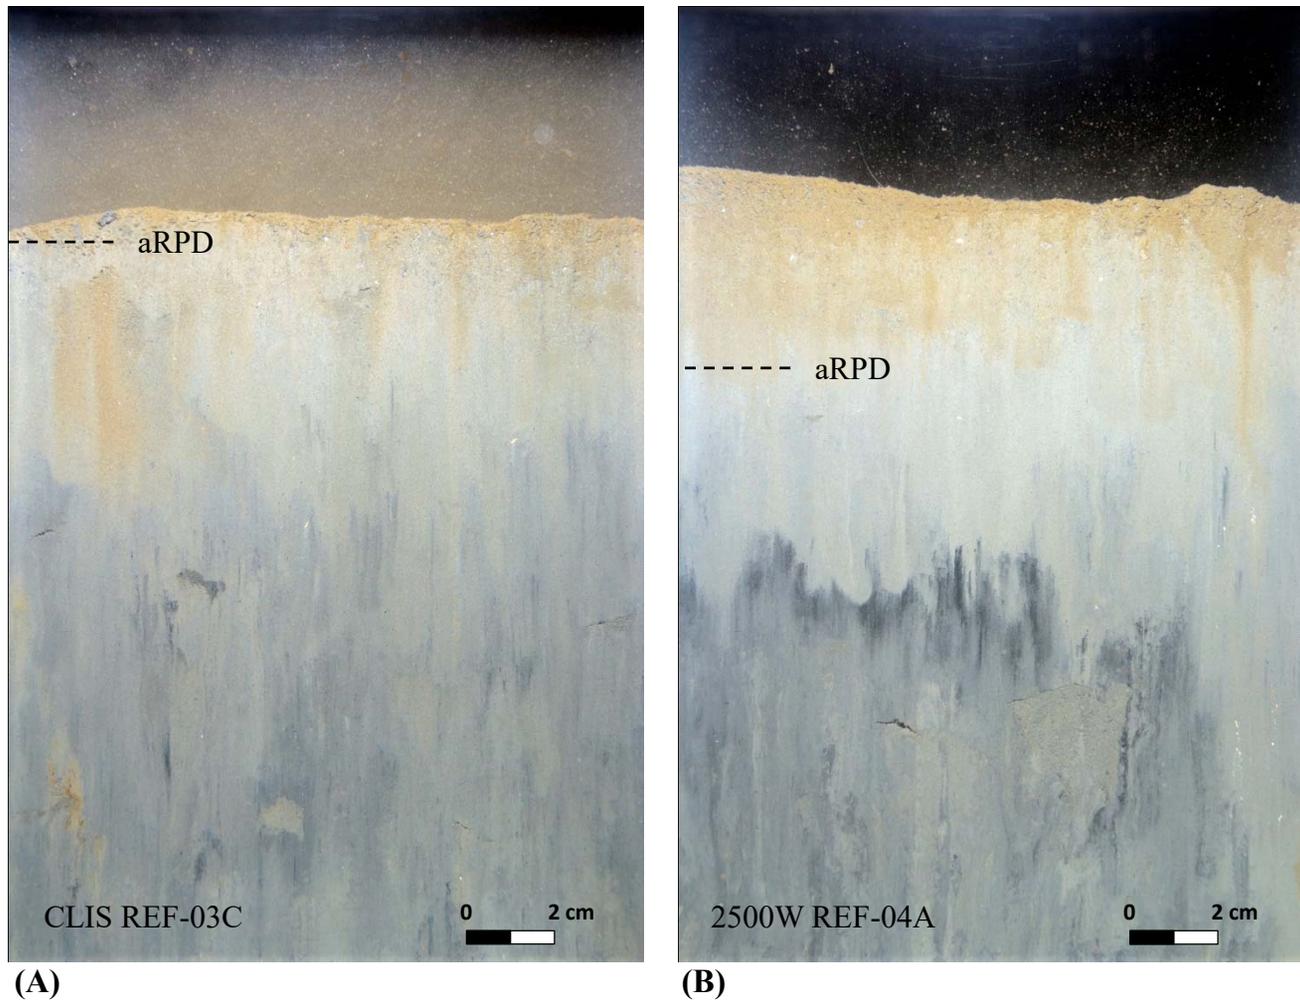
**Figure 3-21.** Profile images representing (A) the minimum and (B) the maximum depth ranges of the aRPD at the reference areas. Dashed horizontal line indicates approximate location of aRPD on each image.

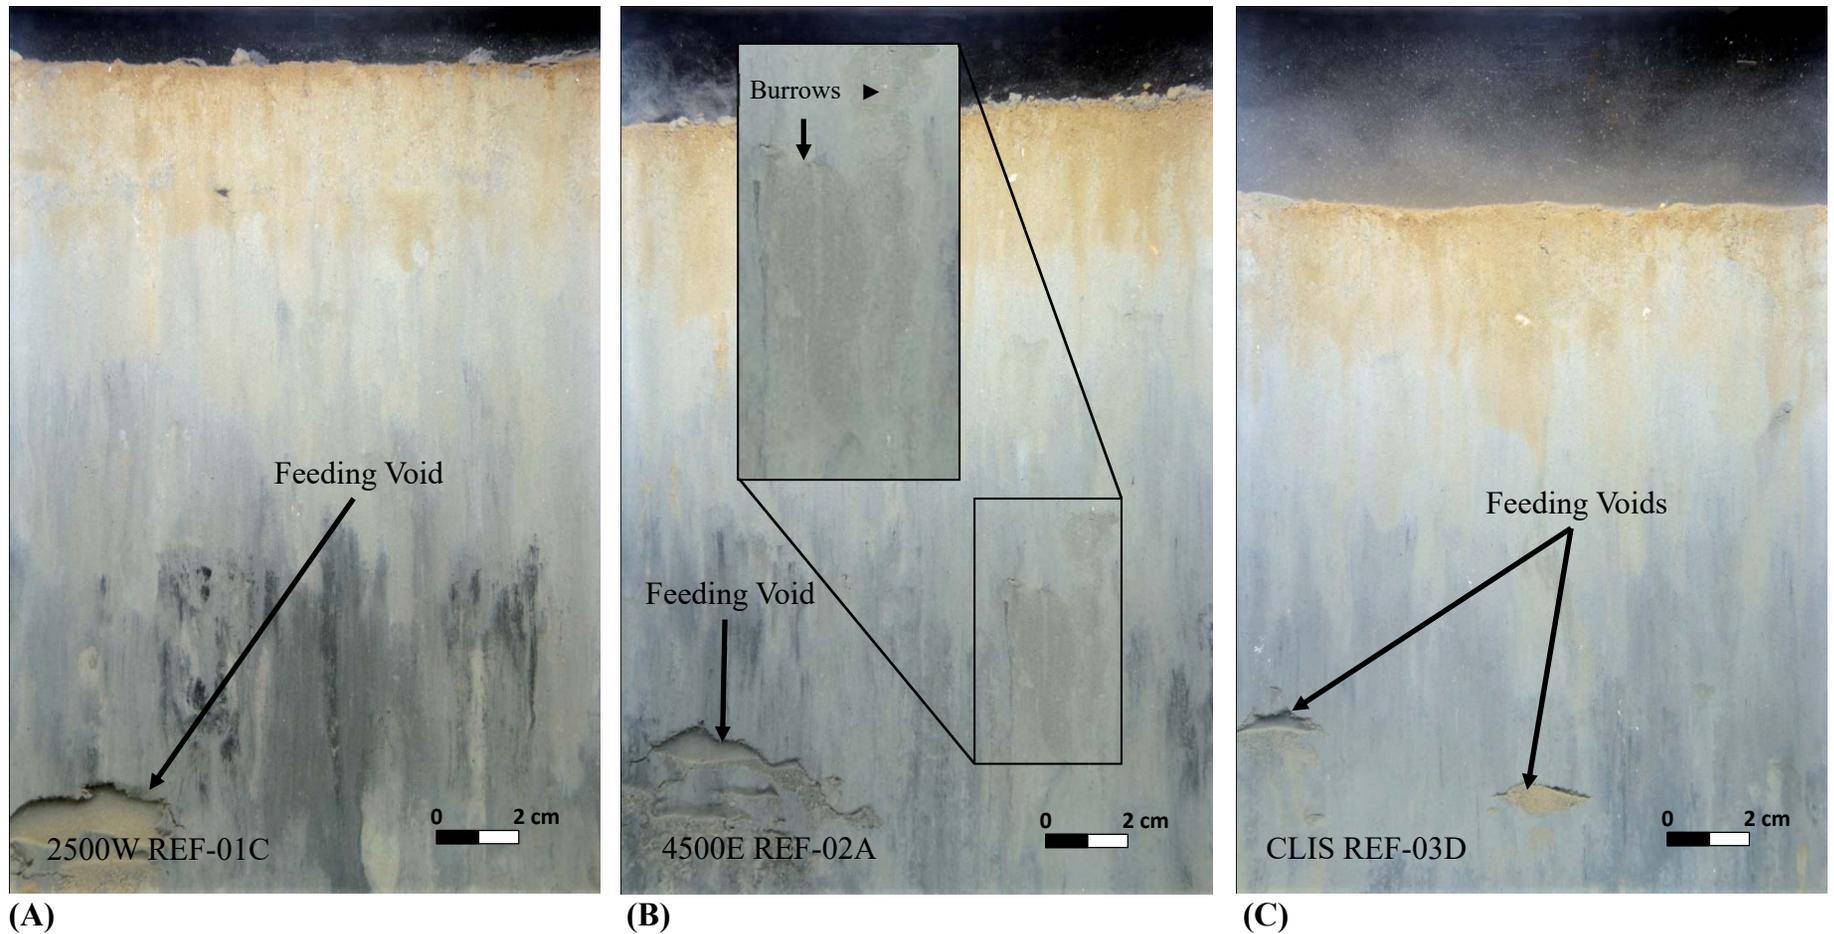
**Figure 3-23.** Representative profile images illustrating extensive Stage 3 activity observed at the reference area stations: (A) large subsurface feeding void at Station 2500W REF-01; (B) large subsurface feeding void and indications of a large burrow in the enlarged portion of the image at Station 4500E REF-02; and (C) medium-large subsurface feeding voids at Station CLIS REF-03.

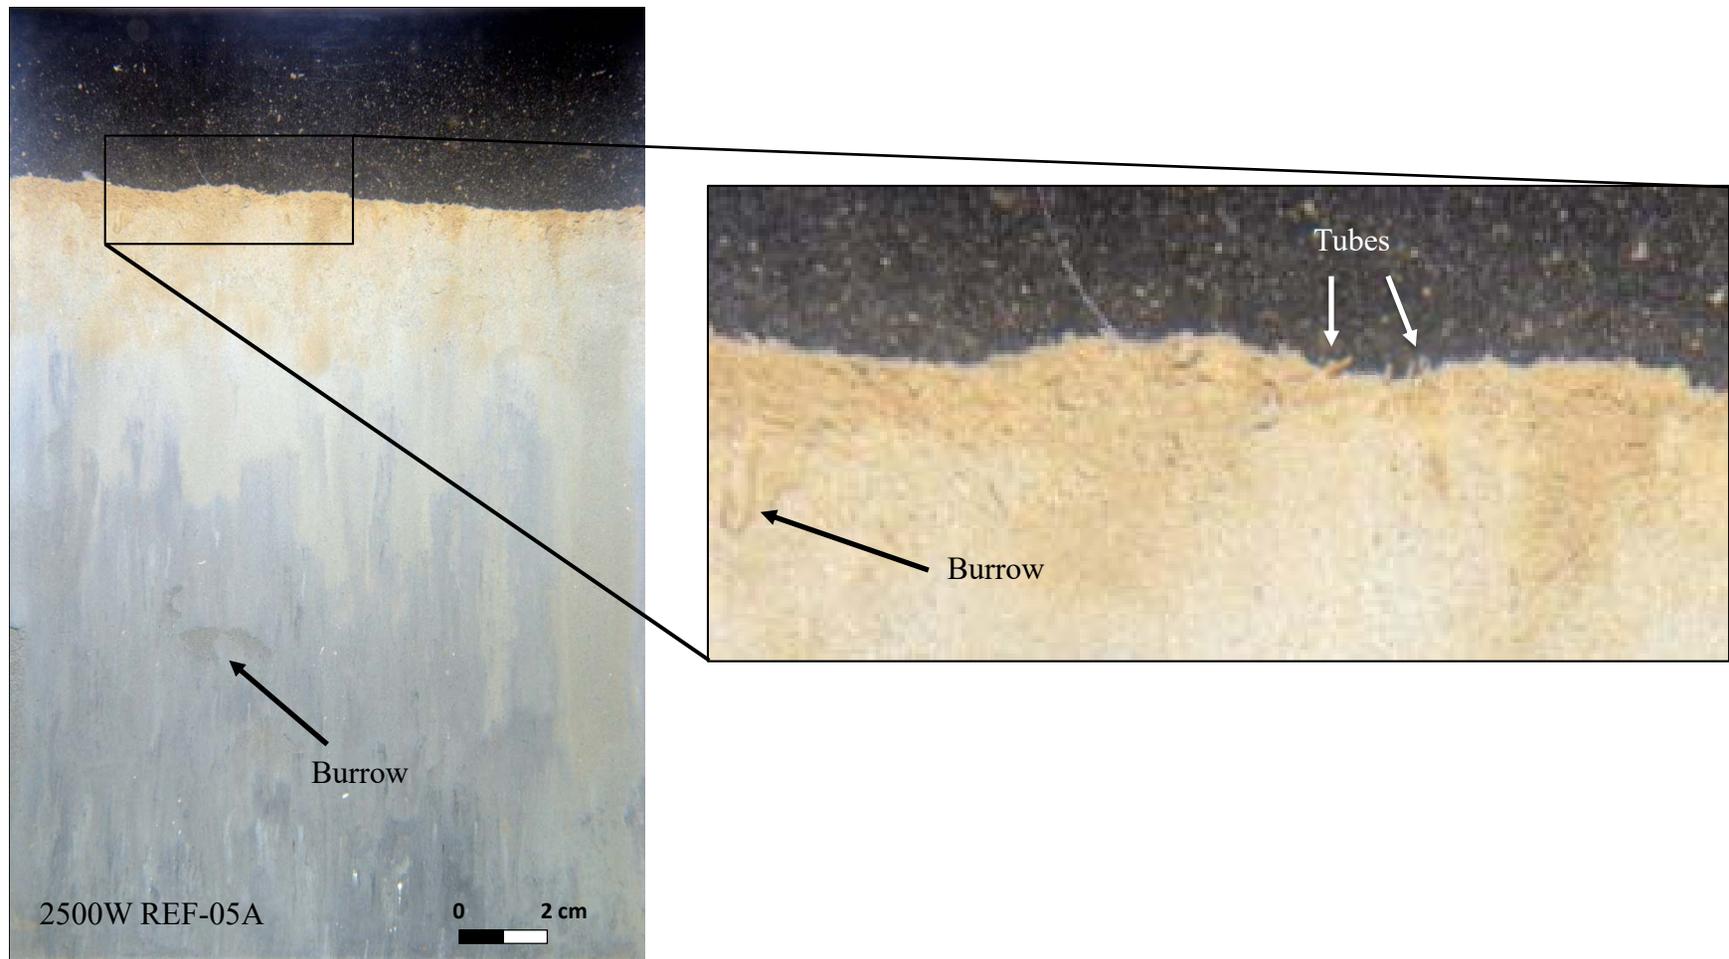
**Figure 3-24.** Representative profile image depicting the presence of Stage 1 activity represented by surface tubes and surface burrows (enlarged image, right), over Stage 3 activity as indicated by the medium-large subsurface burrow in the main image (left).

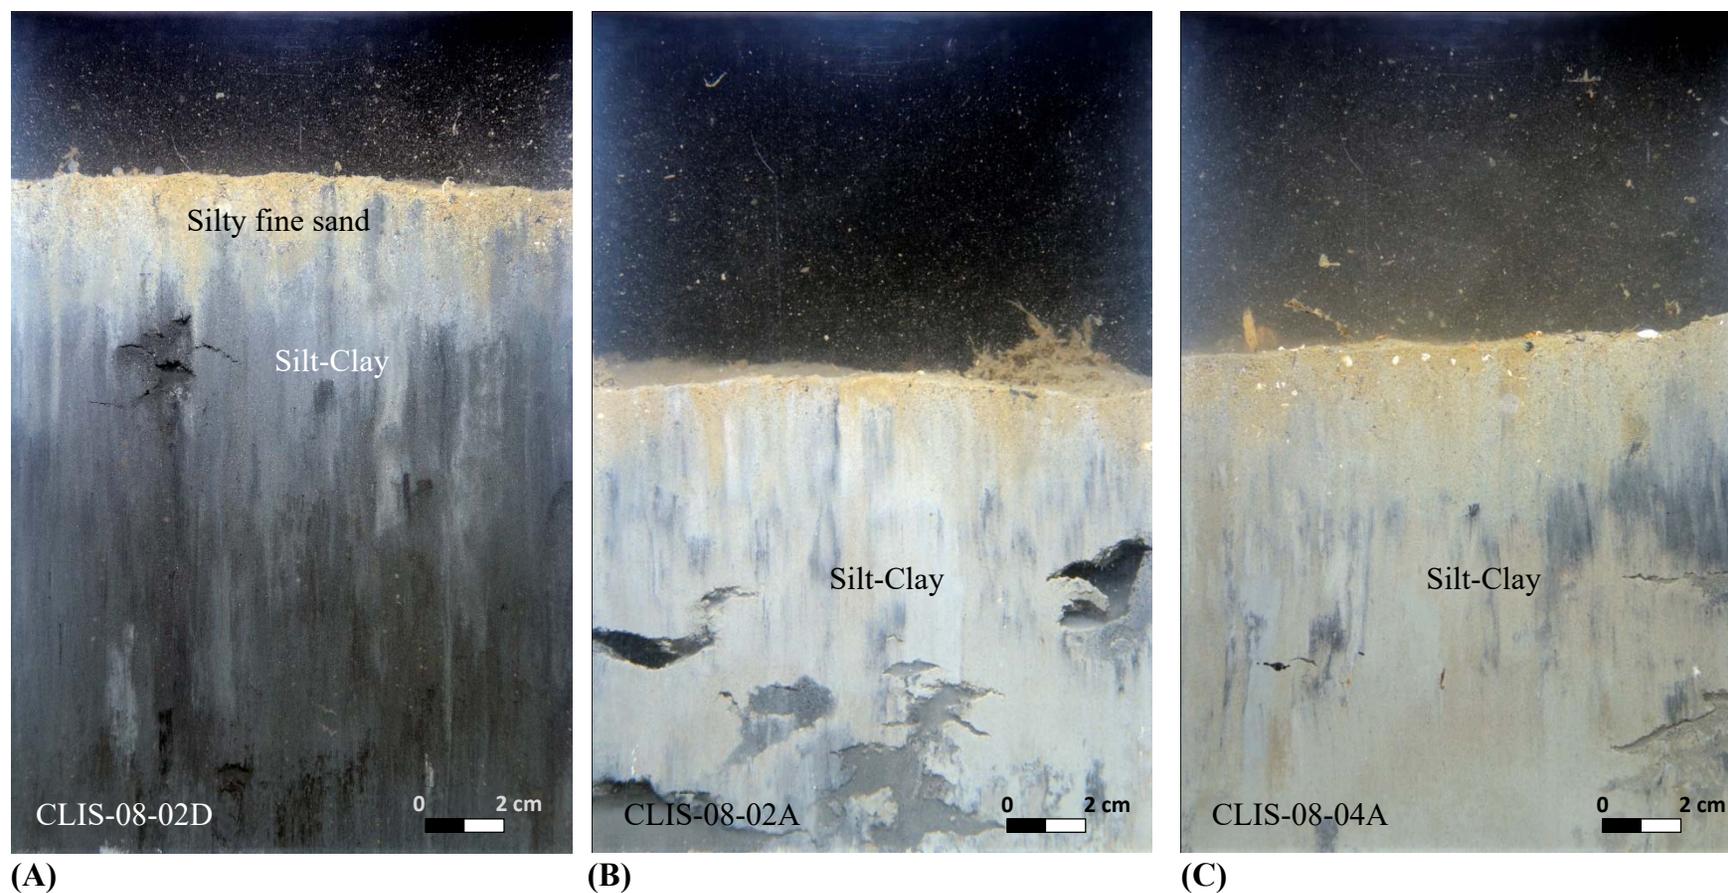
**Figure 3-26.** (A) Profile image from Station CLIS-08-02 displaying a relatively thin surface layer of silty, very fine sand overlaying predominantly silt-clay sediment at depth. Profile images from Stations CLIS-08-02 (B) and CLIS-08-04 (C) displaying the distinctly light-colored silt-clay present at the northern margins of the CLIS-08 mound.
