# Disposal Area Monitoring System DAMOS

**MONITORING SURVEYS AT THE  
CENTRAL LONG ISLAND SOUND DISPOSAL SITE  
DECEMBER 2013, JANUARY 2014, & AUGUST 2014**

CONTRIBUTION #197

February 2017

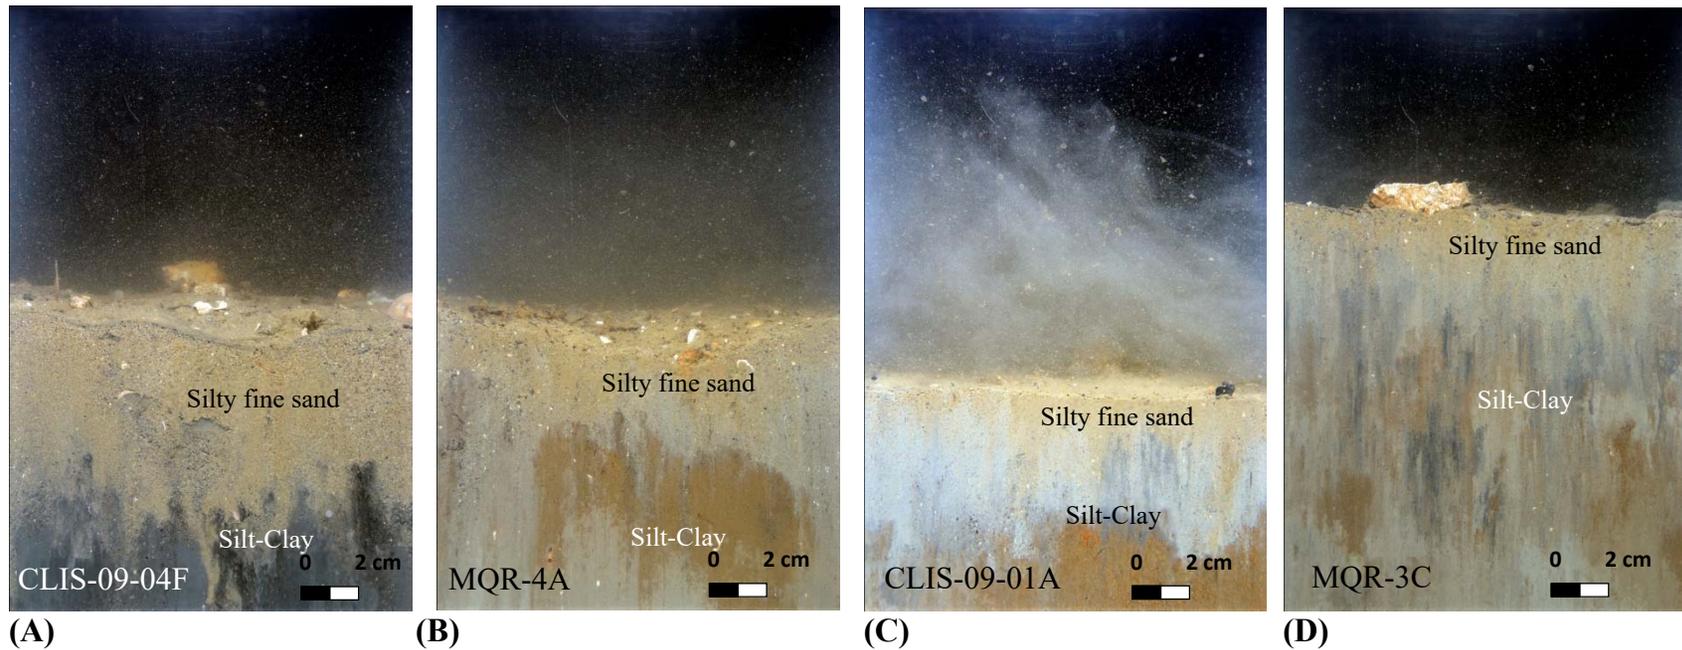
**Figure 3-27.** (A) A representative profile image, from the CLIS-09 mound, displaying a surface layer of silty, very-fine sand overlaying silt-clay sediment at depth. (B) A representative profile image from the MQR mound, displaying a surface layer of silty, very-fine sand overlaying silt-clay sediment at depth. Profile images of mounds CLIS-09 (C) and MQR (D) displaying alternating layers of gray, light brown and rust colored silt-clay.

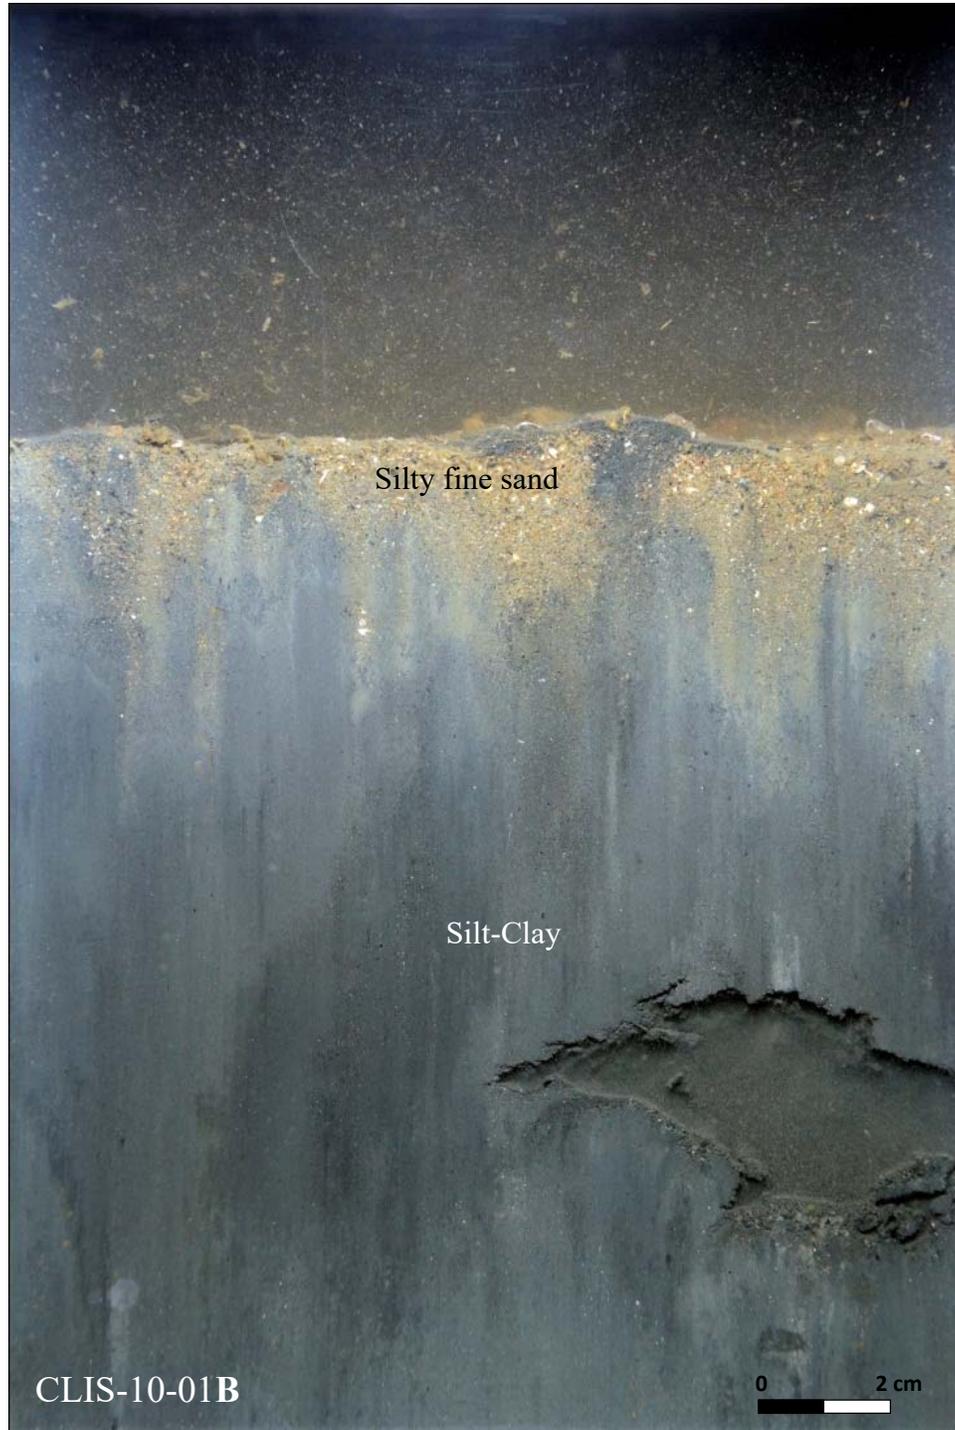
**Figure 3-28.** Profile image at CLIS-10-01 illustrating a thin surface layer of light brown fine sand followed by gray/black silt-clay

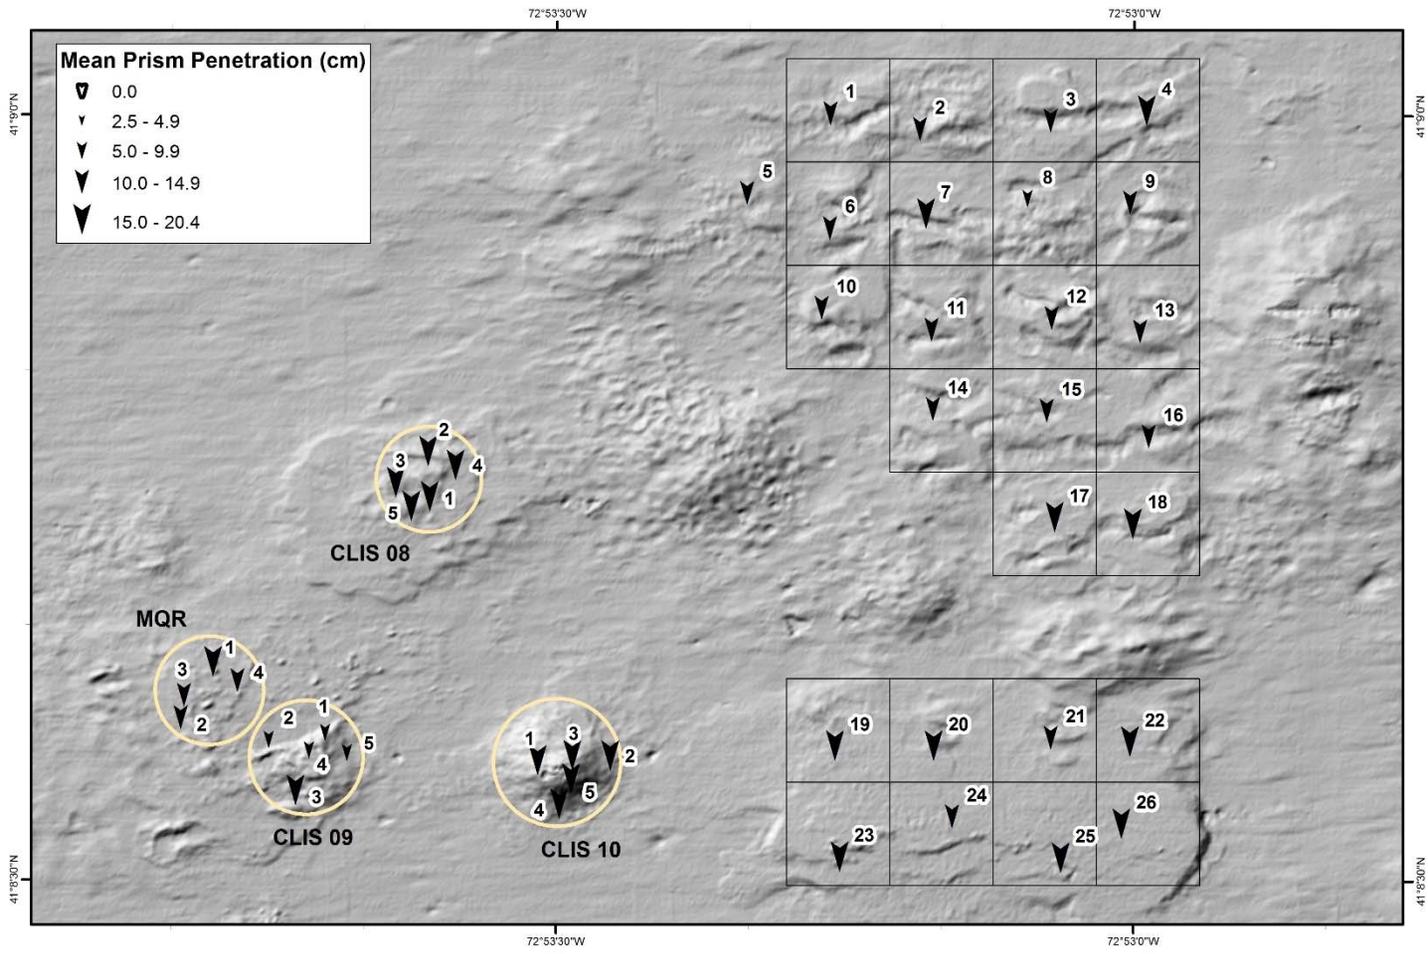
Data: Mean prism penetration over 2014  
acoustic relief model 5x vertical exaggeration

**Figure 3-29.** Mean station camera prism penetration depths (cm) at CLDS

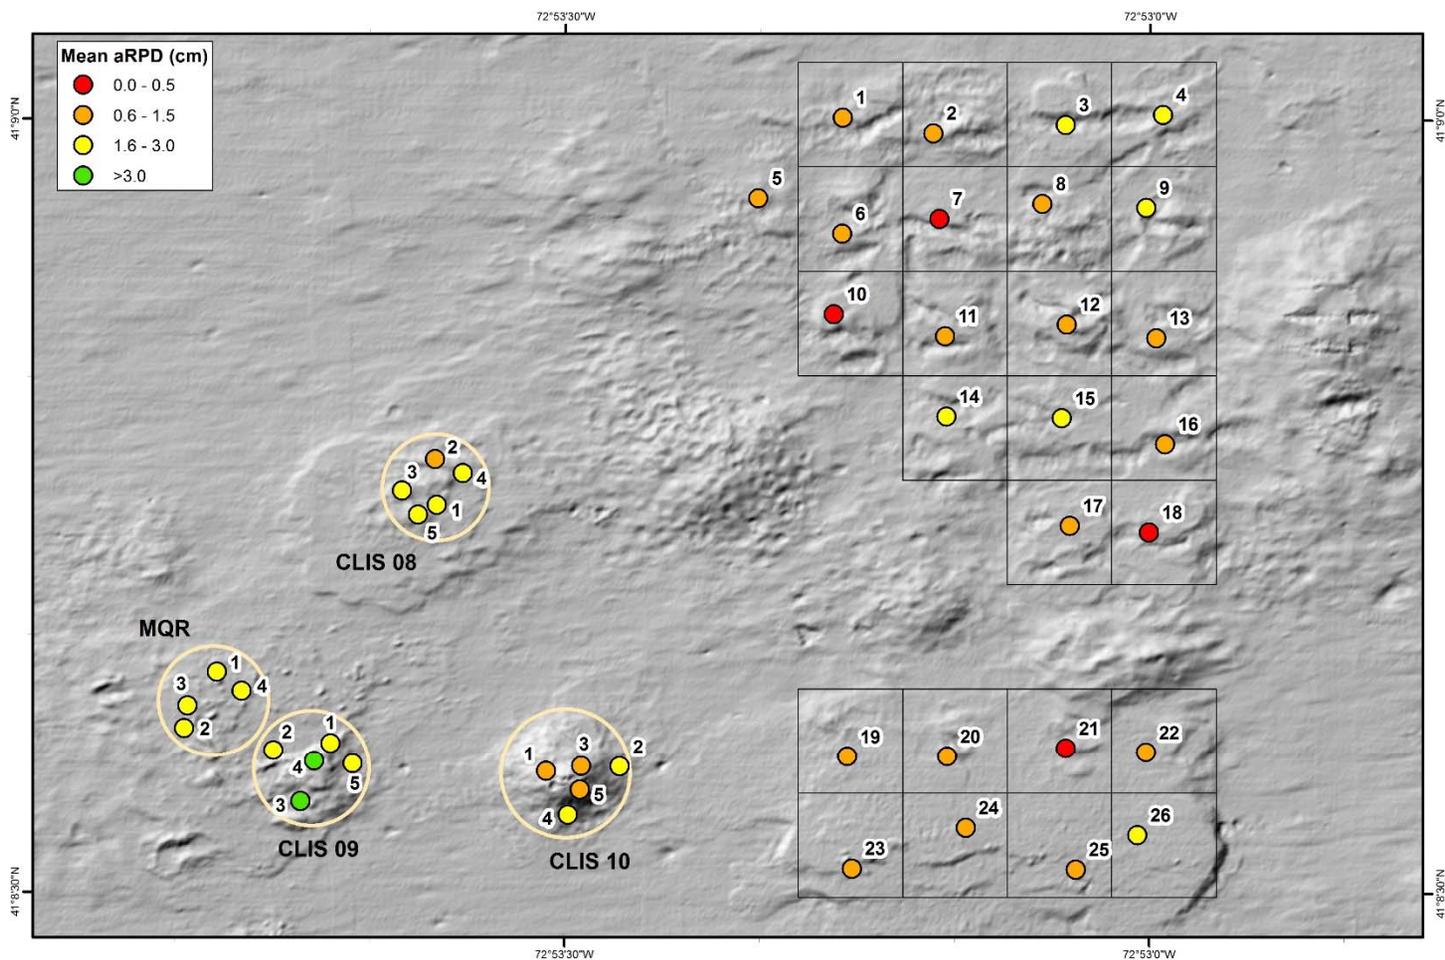
Data: Mean aRPD over 2014  
acoustic relief model 5x vertical exaggeration

**Figure 3-30.** Mean station depth of the apparent RPD (cm) at CLDS

**Biological Conditions at Recent CLDS Placement Areas:** The mean aRPD values at the stations within CLDS ranged from 0.5 to 3.8 cm, with an overall site average of 1.8 cm (Table 3-2, Figure 3-30). Mean aRPD values varied across the site without a particular pattern, but they were generally lower than reference area values (Table 3-3, Figures 3-30 and 3-31).

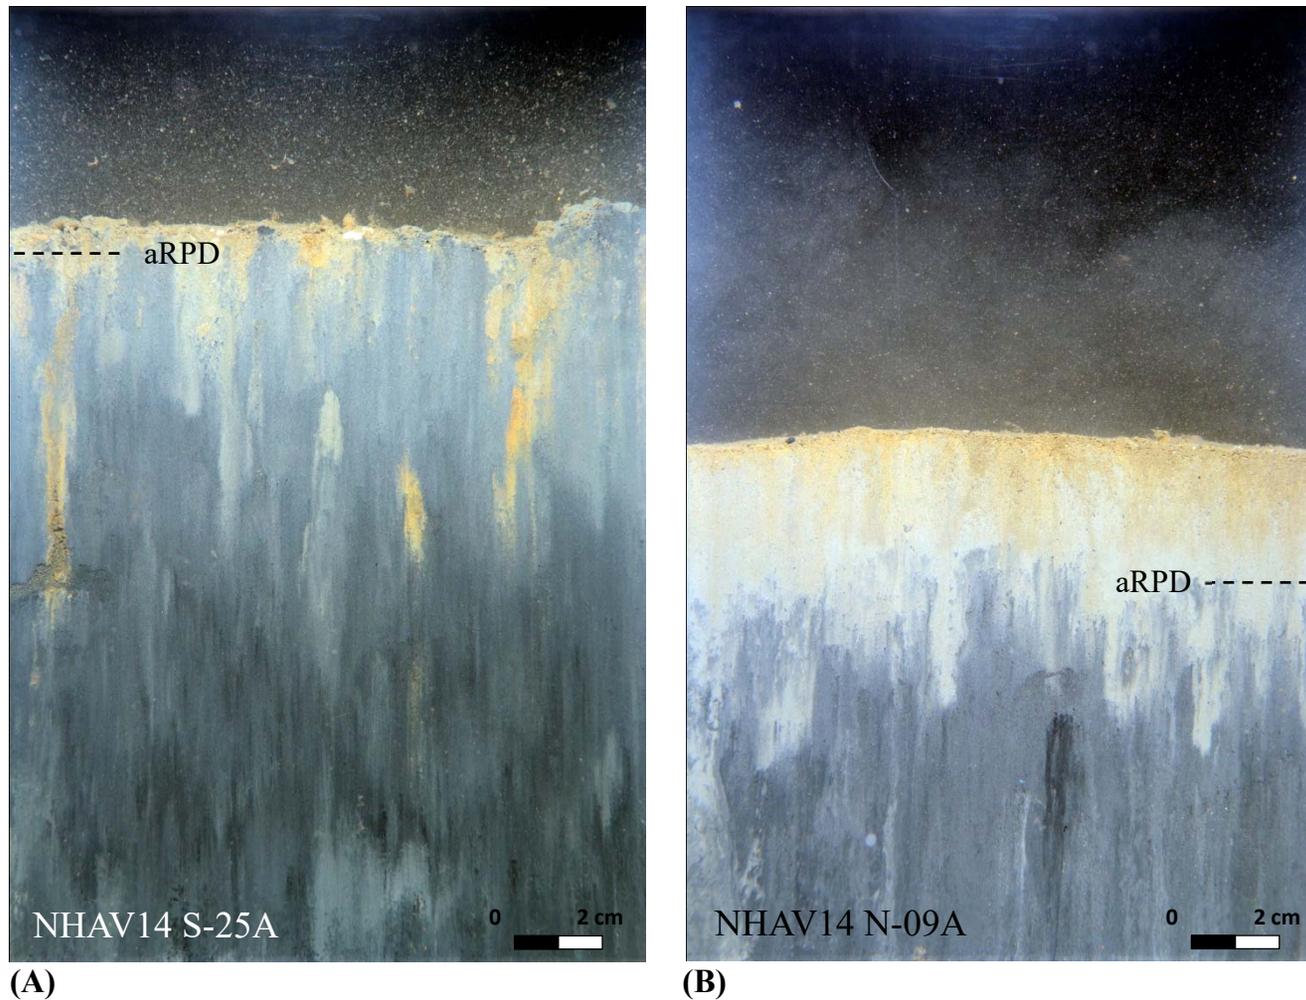
**Figure 3-31.** Profile images representing (A) the minimum and (B) the maximum depth ranges of the aRPD at the CLDS disposal areas. Dashed horizontal line indicates approximate location of the aRPD on each image.

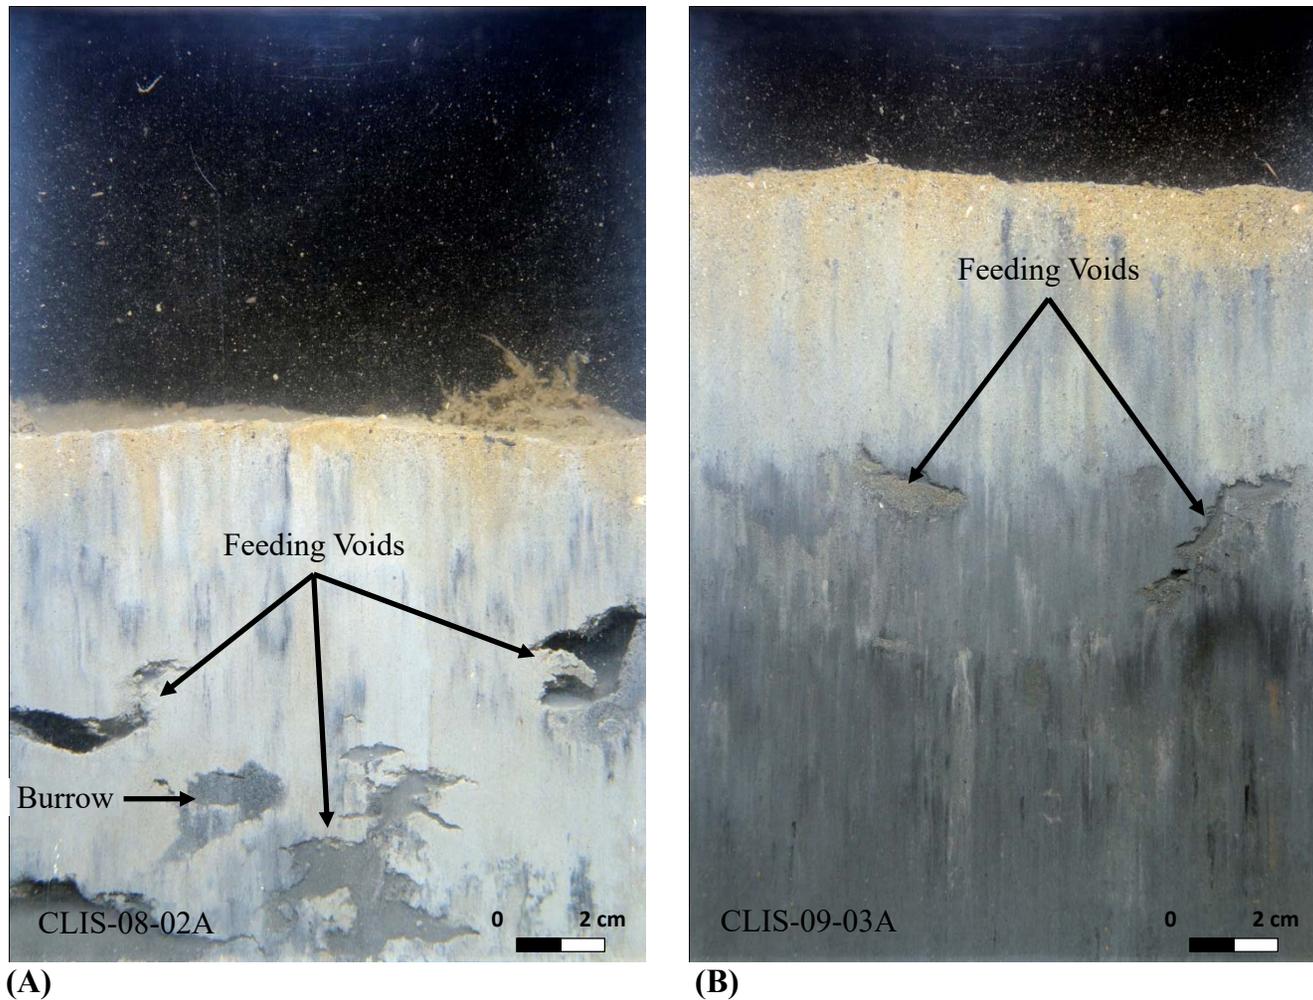
**Figure 3-33.** Representative profile images illustrating extensive Stage 3 activity observed at the disposal area stations: (A) large subsurface feeding voids and indications of a large subsurface burrow at Station CLIS-08-02; (B) large subsurface feeding voids at station CLIS-09-03.

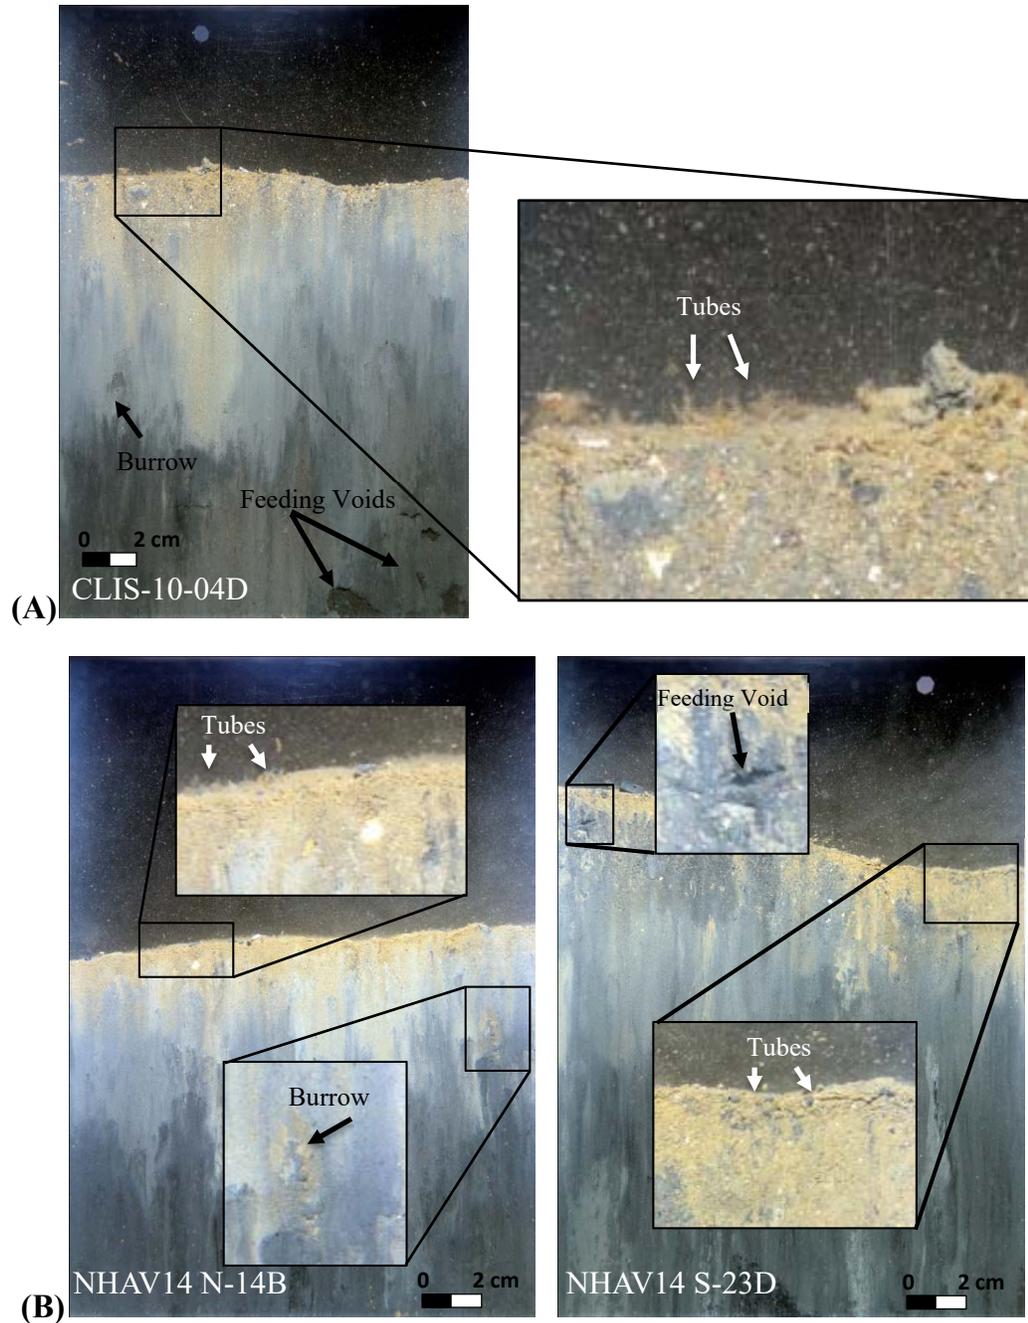
**Figure 3-34.** (A) Profile image from CLIS-10 depicting the presence of Stage 1 activity represented by surface tubes (enlarged image, right), over Stage 3 activity as indicated by the medium-large subsurface burrow and medium-large feeding voids in the main image (left). (B) Profile images depicting intermediate benthic succession at the NHAV14-N and -S mounds: Stage 1 on 2 at Station NHAV14-N-14 represented by surface tubes over burrowing near the sediment-water interface (left), and at station NHAV14-S-23 represented by surface tubes over feeding voids near the sediment-water interface (right).

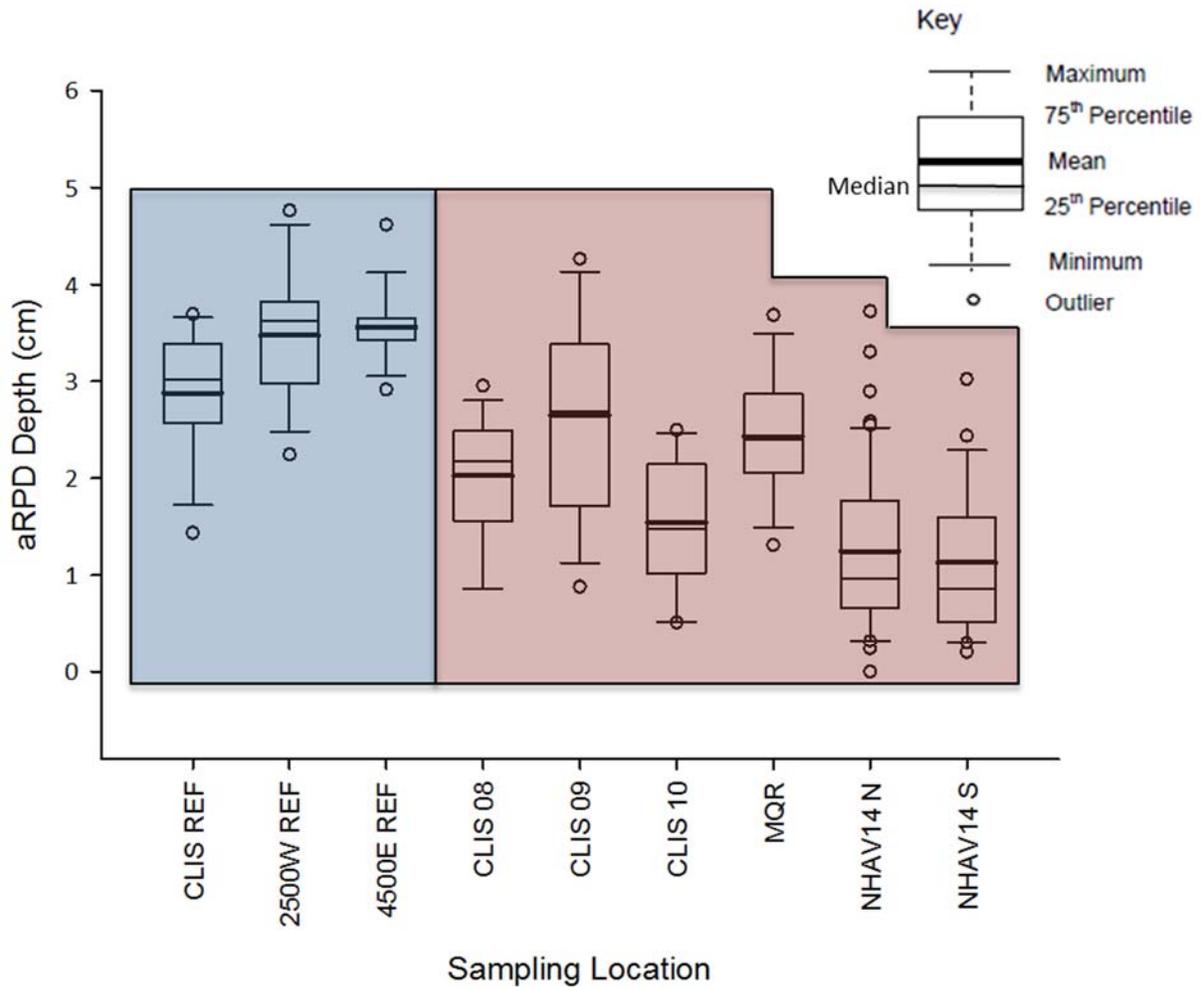
**Figure 3-35.** Distribution of station aRPD values for the reference areas (blue shade) and disposal mounds (red shade). Note the larger mean and median aRPD values for the reference areas compared to the disposal stations.

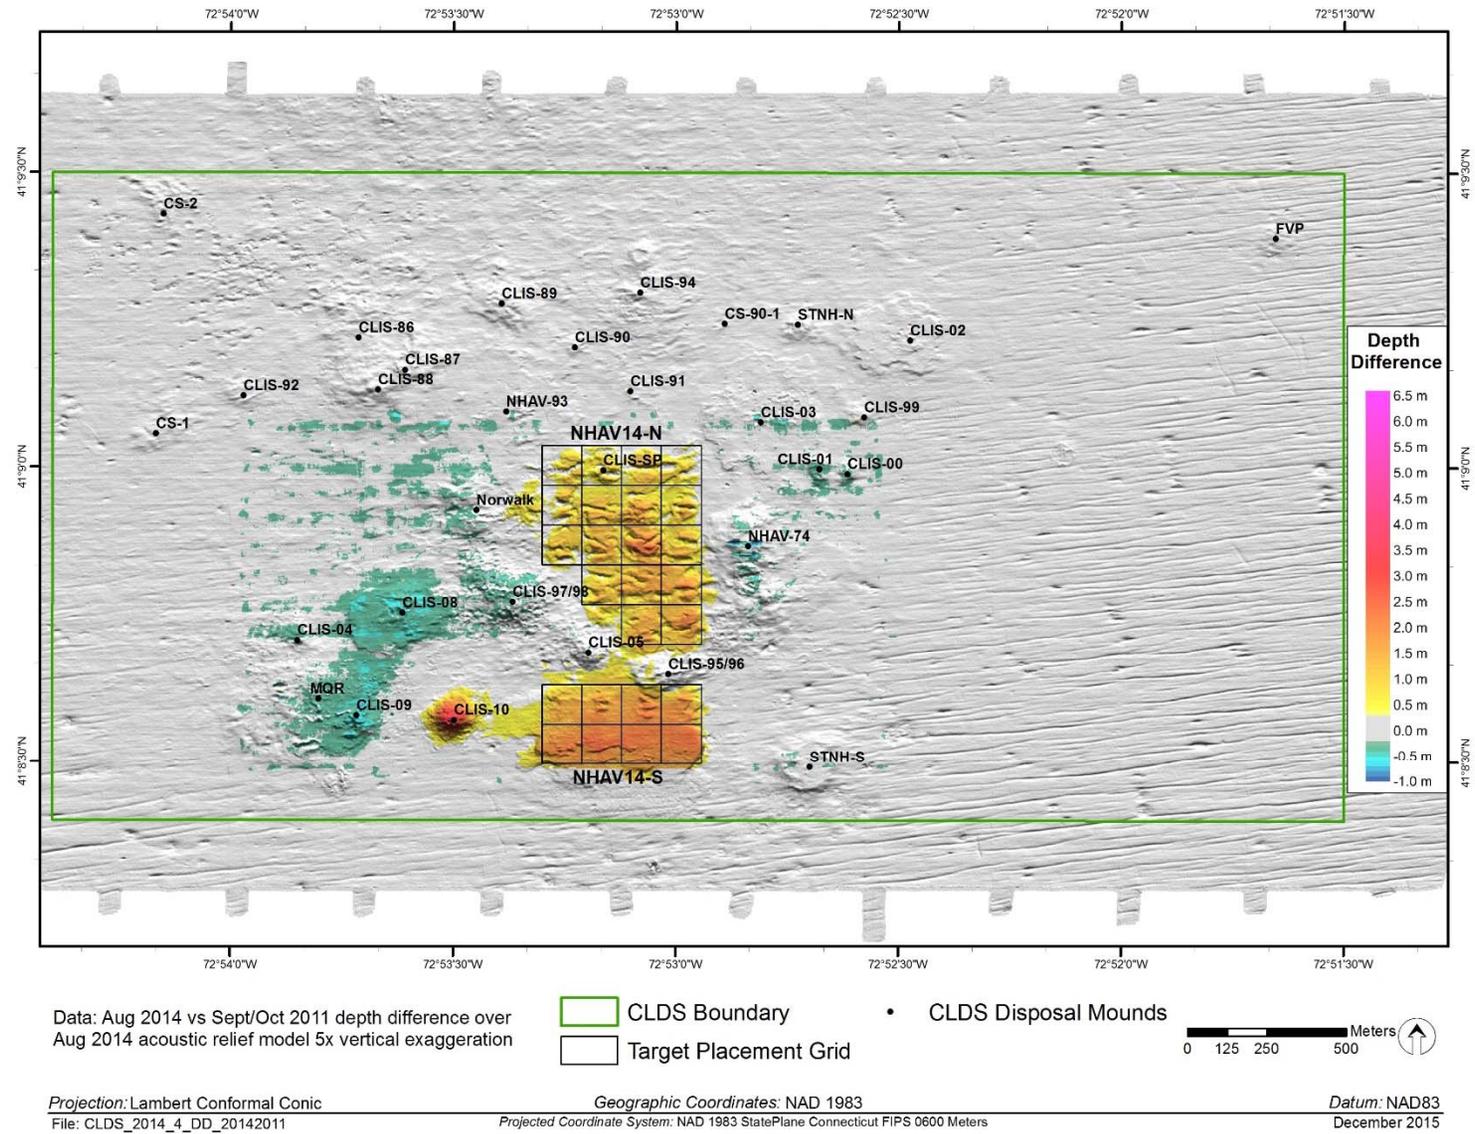
**Figure 4-1.** Depth difference between August 2014 and Sept/Oct 2011

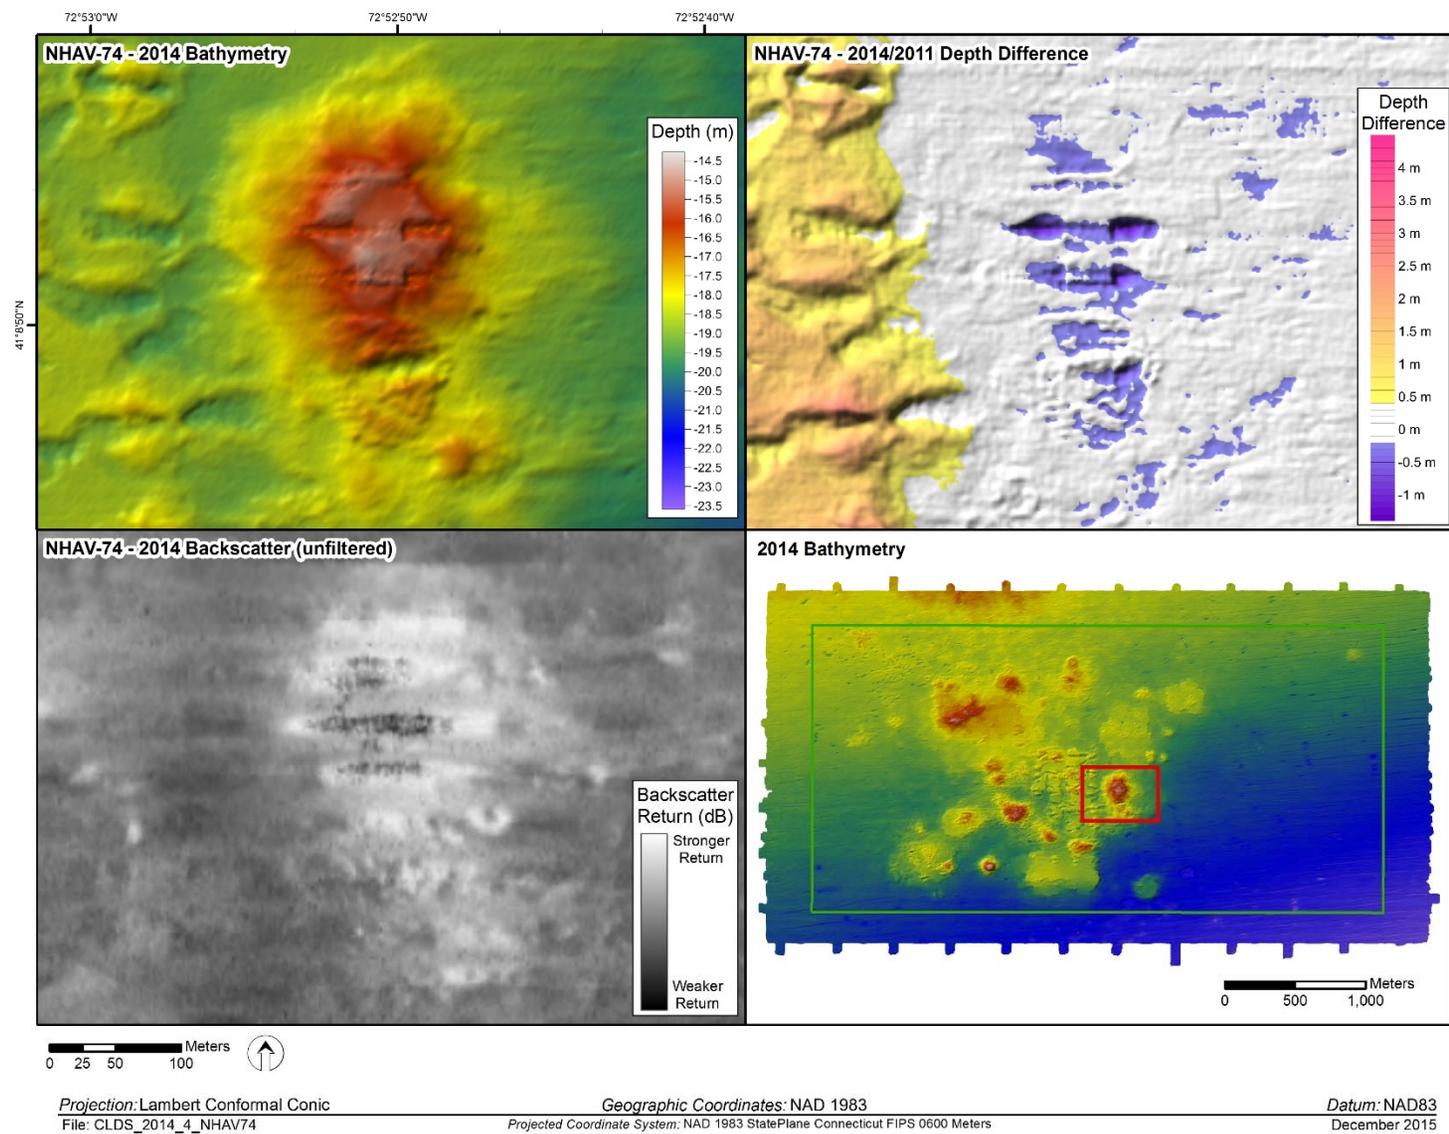
**Figure 4-3.** Close-up of bathymetry, backscatter, and depth difference at NHA V-74 mound

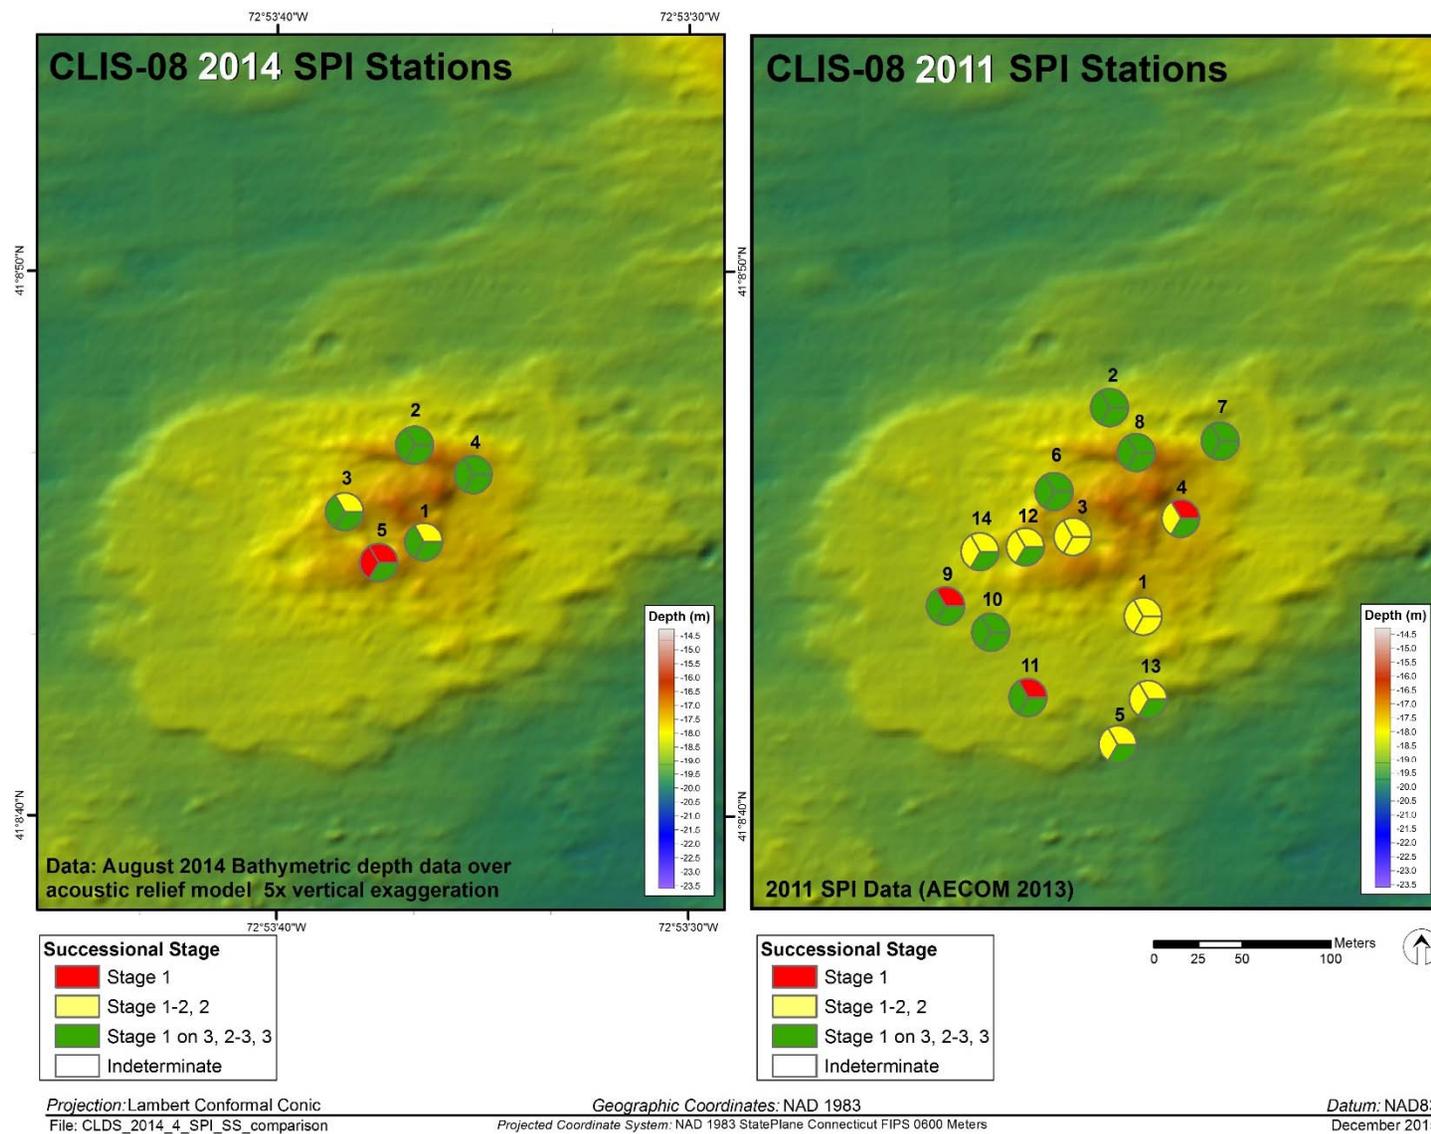
**Figure 4-4.** Close-up of successional stage from 2014 and 2011 at CLIS-08 mound
