Monitoring Cruise at the Massachusetts Bay  
Disposal Site  
November 1988 - January 1989

# **Disposal Area Monitoring System DAMOS**

Contribution 73  
May 1990

**MONITORING CRUISE AT THE  
MASSACHUSETTS BAY DISPOSAL SITE  
NOVEMBER 1988 - JANUARY 1989**

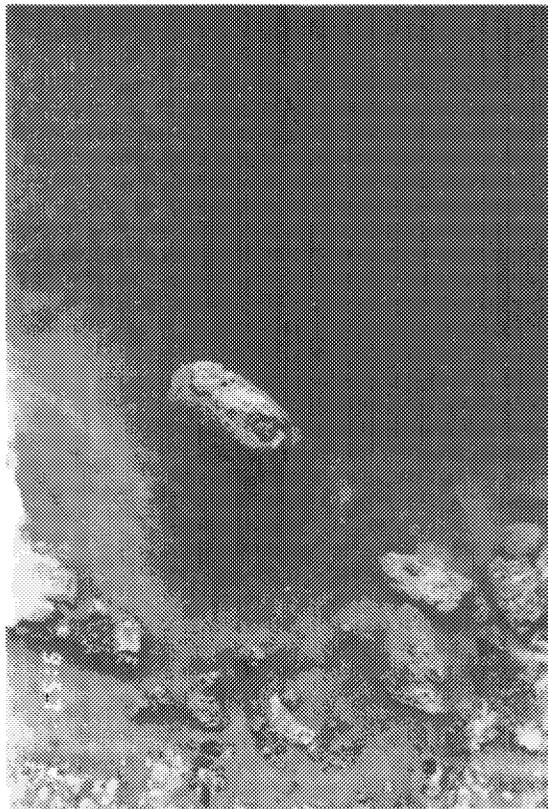
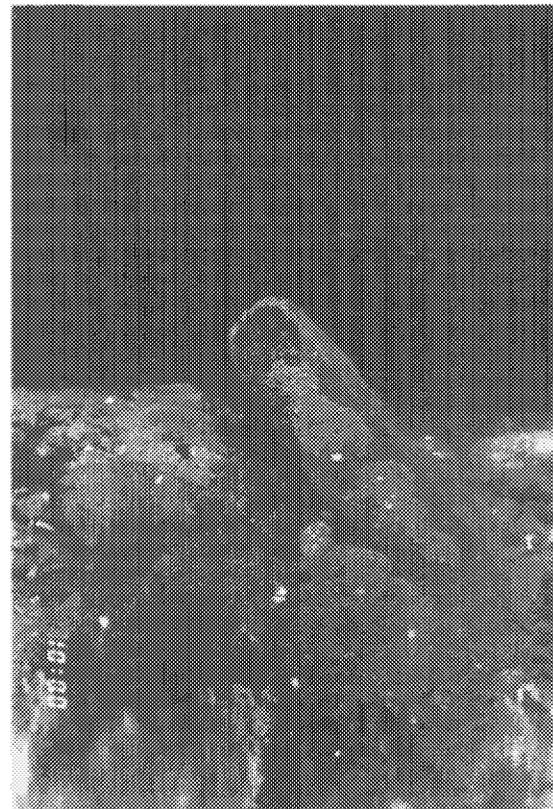
Figure 3-9. REMOTS® photographs from station CTR (A) and 100S (B) showing overconsolidated clay clasts and rubble at the surface and limited camera penetration. Scale = 0.5X.

The apparent "fresh" dredged material consisted of a chaotic mixture of silts, fine sands and sands intermixed with clay (Figure 3-8). The REMOTS® photographs from the stations located closest to the point of disposal (CTR, 100S, 100N, out to 200E, and out to 300W) showed over-consolidated clay clasts and occasional rock rubble at the surface which limited camera penetration (Figure 3-9). At other stations, the dredged material appeared to be less consolidated, exhibiting more stratification and allowing deeper camera penetration (Figure 3-10). At these stations, the mixture of silts, fine silts, and sands was less chaotic with only an occasional buried clay clast, reflecting heterogeneity in the composition of the disposed material. Again, the thickness of the recently-deposited layers often could not be measured accurately because of the lack of a clear marker between the "fresh" dredged material and underlying relict material.
