Monitoring Cruise at the Portland Disposal Site  
January 1989

# Disposal Area Monitoring System DAMOS

Contribution 78  
September 1990

US Army Corps  
of Engineers  
New England Division

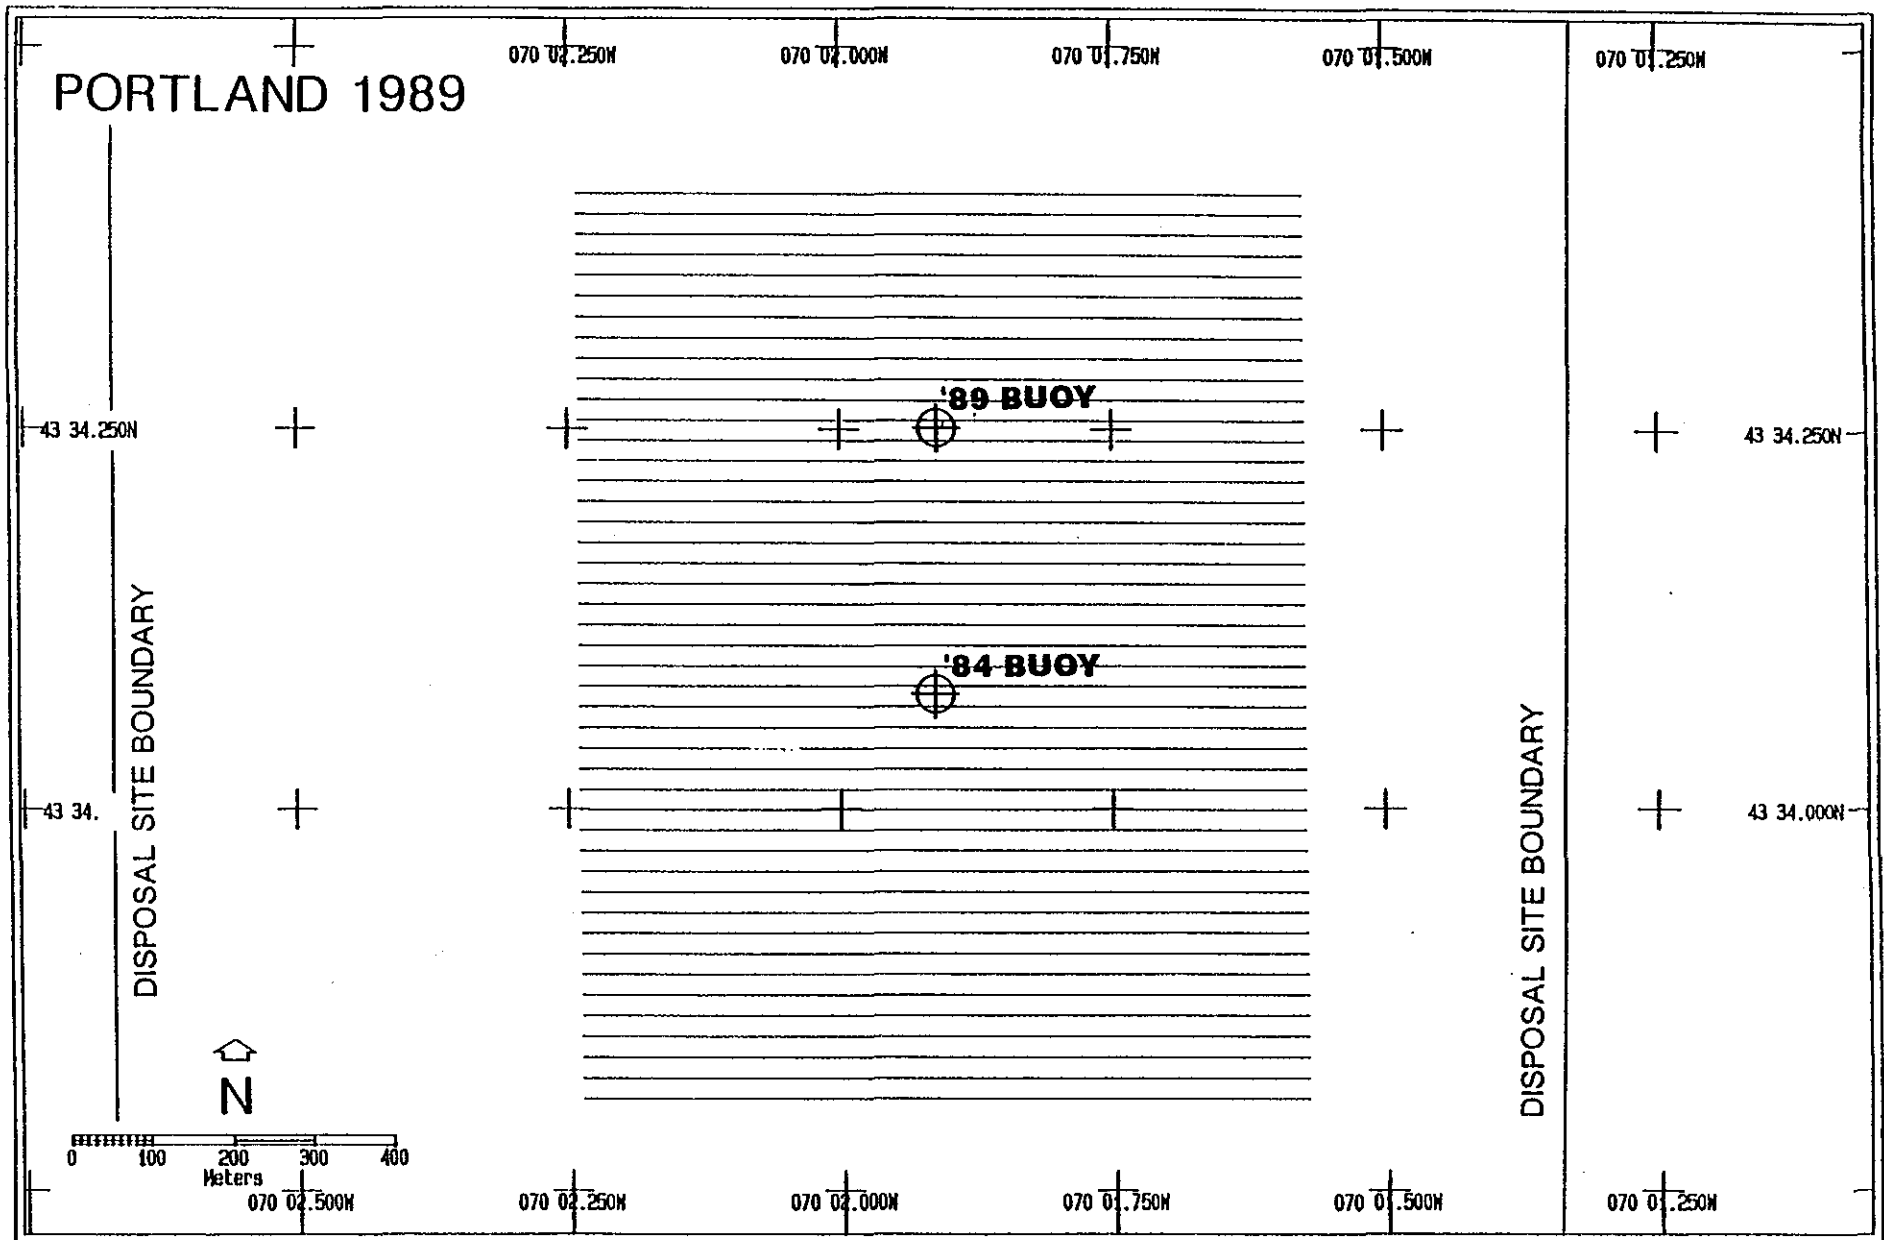
Figure 2-1. Bathymetric survey lanes at Portland, January 1989.

The original survey grid of 900 m x 900 m used in the 1984 survey was enlarged to 900 m x 1100 m to encompass potential dredged material north of the present buoy location (Figure 2-1). Forty-five lanes were surveyed, oriented east and west with 25 m lane spacing, overlaying the 1984 survey track and continuing an additional 200 m north. The survey grid covered the positions of both the 1984 and present buoy locations.

Dredged material disposal began at the Portland site in 1979. Initial disposal occurred at a taut-wire moored buoy located at 43° 34.11' N, 70° 01.91' W. This buoy was the location for specific disposal operations until its removal in 1984. For the last five years, disposal has taken place at a conventionally moored buoy presently located 350 meters north of the taut-wire buoy location (Figure 2-1).

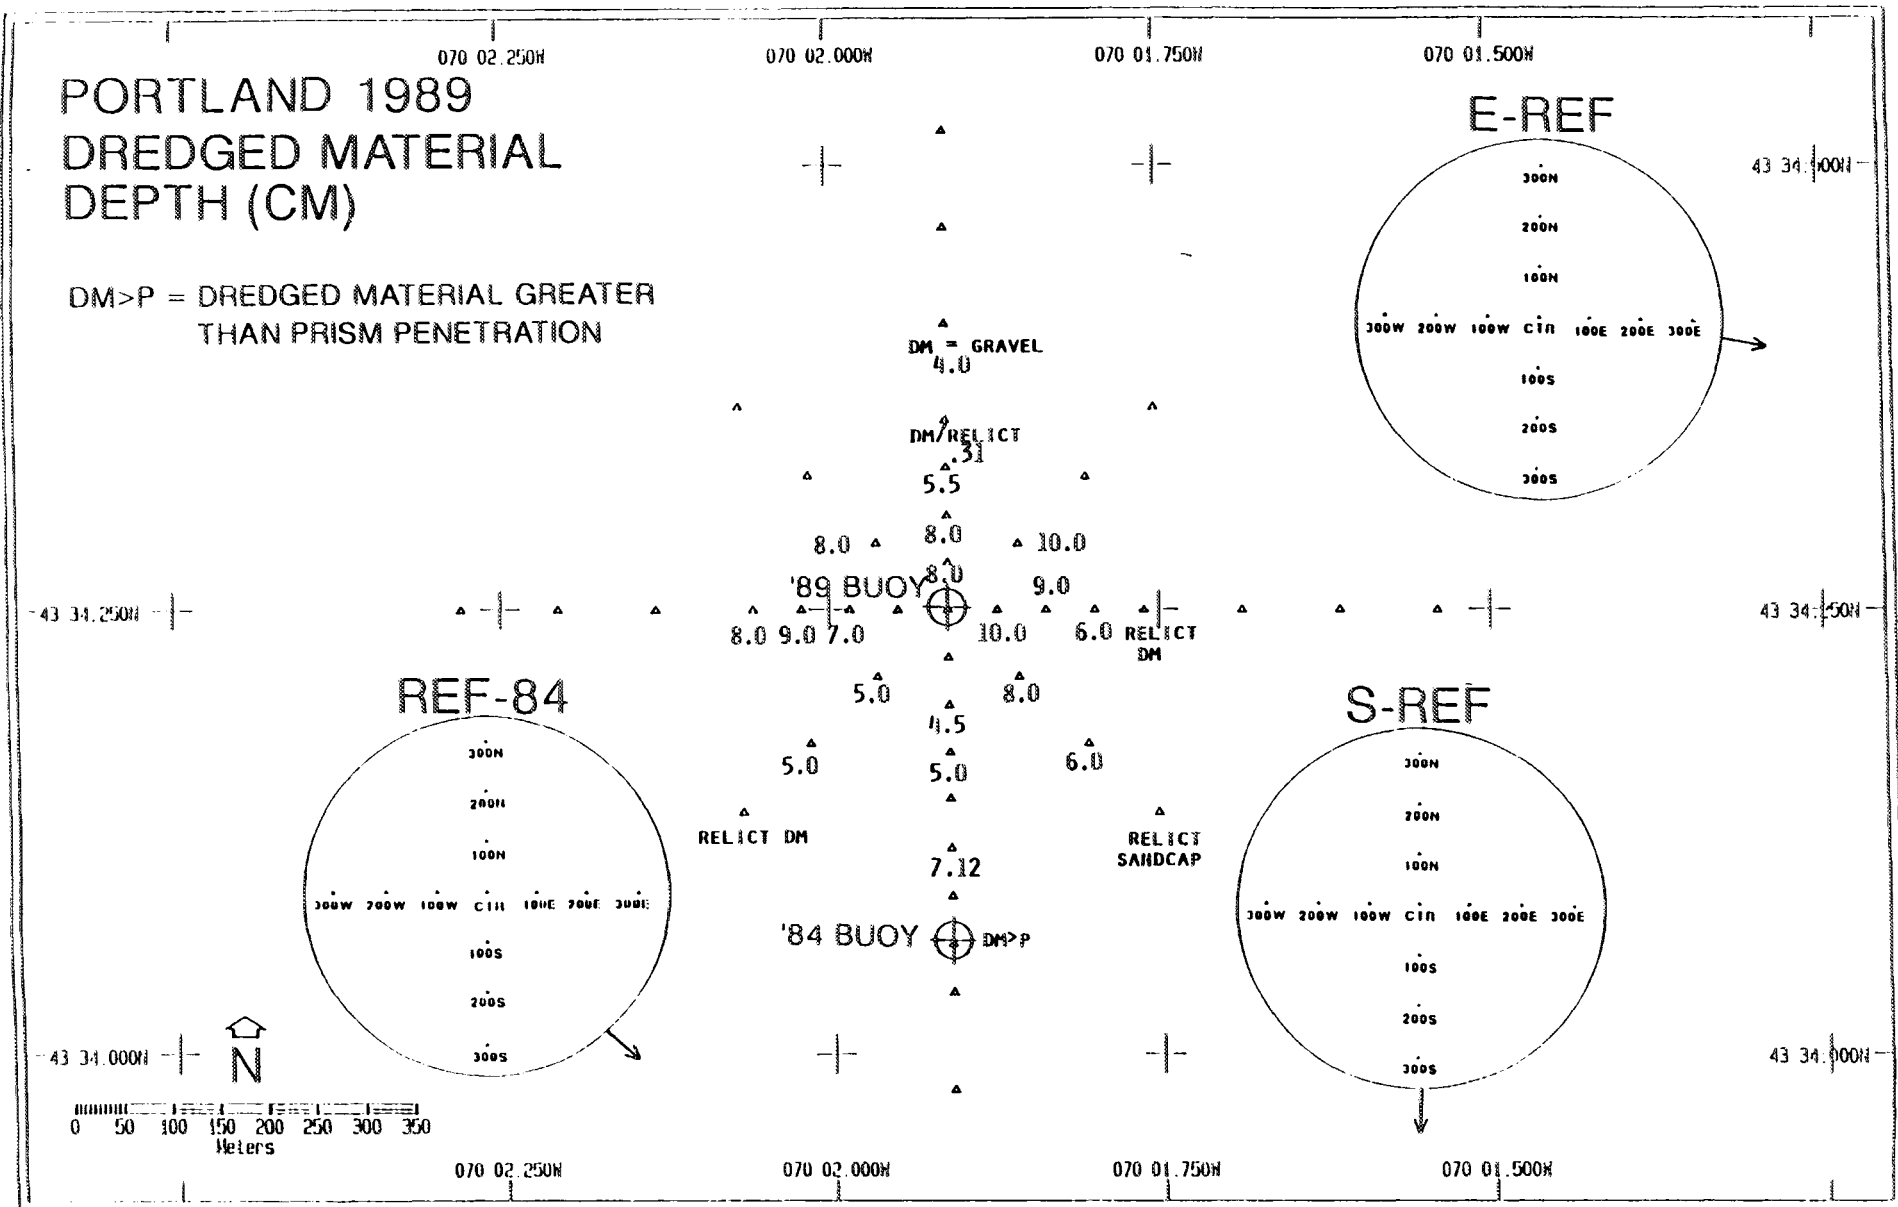
Figure 3-4. Distribution and thickness of dredged material layers at Portland Disposal Site, January 1989.

Recently deposited dredged material covered a circular area centered at the present buoy location and having a diameter of roughly 500 - 600 meters (Figures 3-4 and 3-5). Relict dredged material was evident beyond this area to the east, south, and west (Figure 3-6). Relict dredged material with overlying "fresh" material was visible at several stations scattered throughout the mound. Only a few stations at the outer edges of the REMOTS® sampling grid had no dredged material (Figure 3-7).

The main objectives of the survey were to determine the areal extent of dredged material and assess the benthic recolonization of the disposed material. Dredged material ("relict" and "fresh") was identified at 83% (25/30) of the REMOTS® stations, covering a circular area with a diameter of approximately 700m.

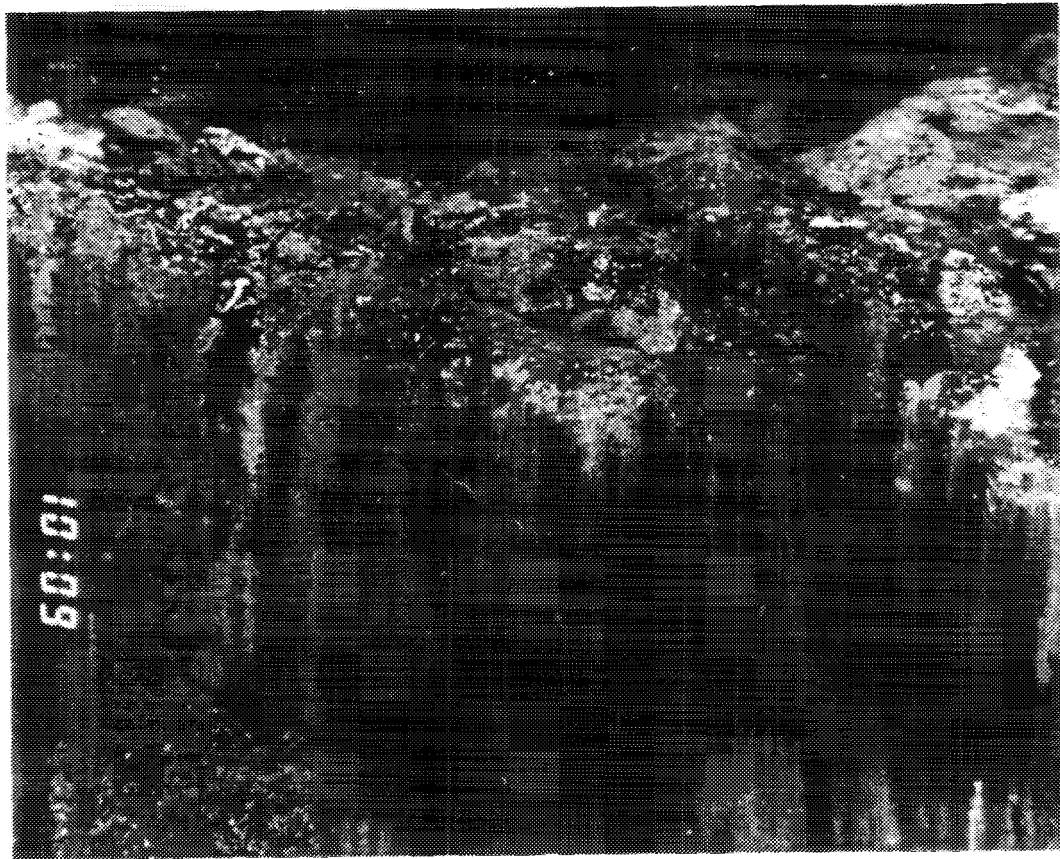
Figure 3-5. Two REMOTS® photos showing recently deposited dredged material at Portland Disposal Site (A = station 100N; B =station 300SE). Note the fine sand deposited on overconsolidated clay.

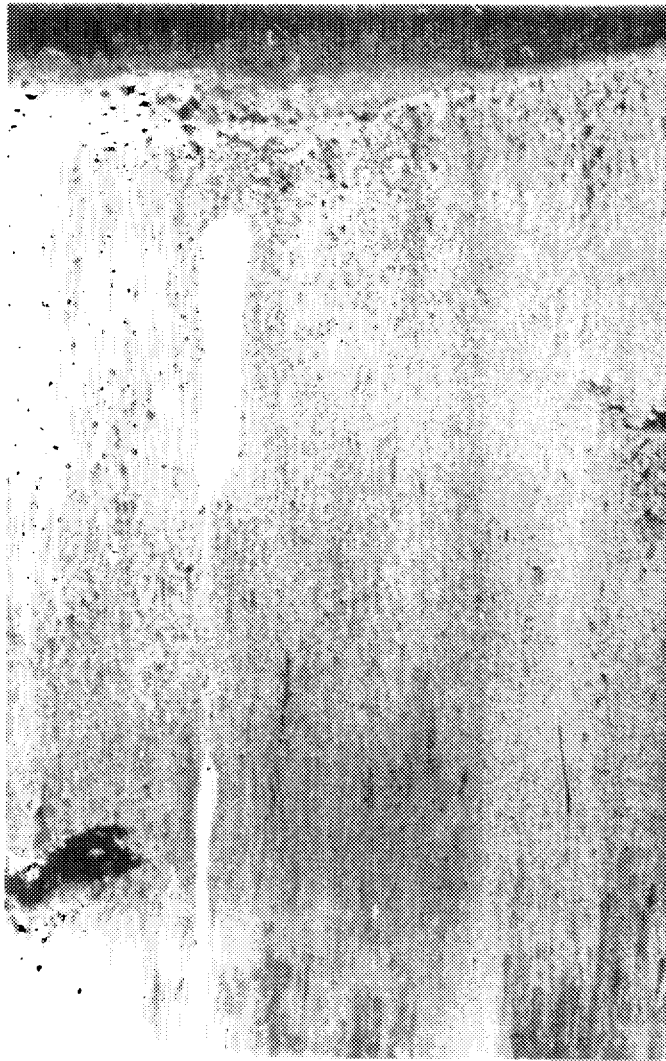
Figure 3-7. Two REMOTS® photos illustrating ambient sediment at Portland Disposal Site. Photo A is from station 300E photo B is from reference station E-REF 100W.

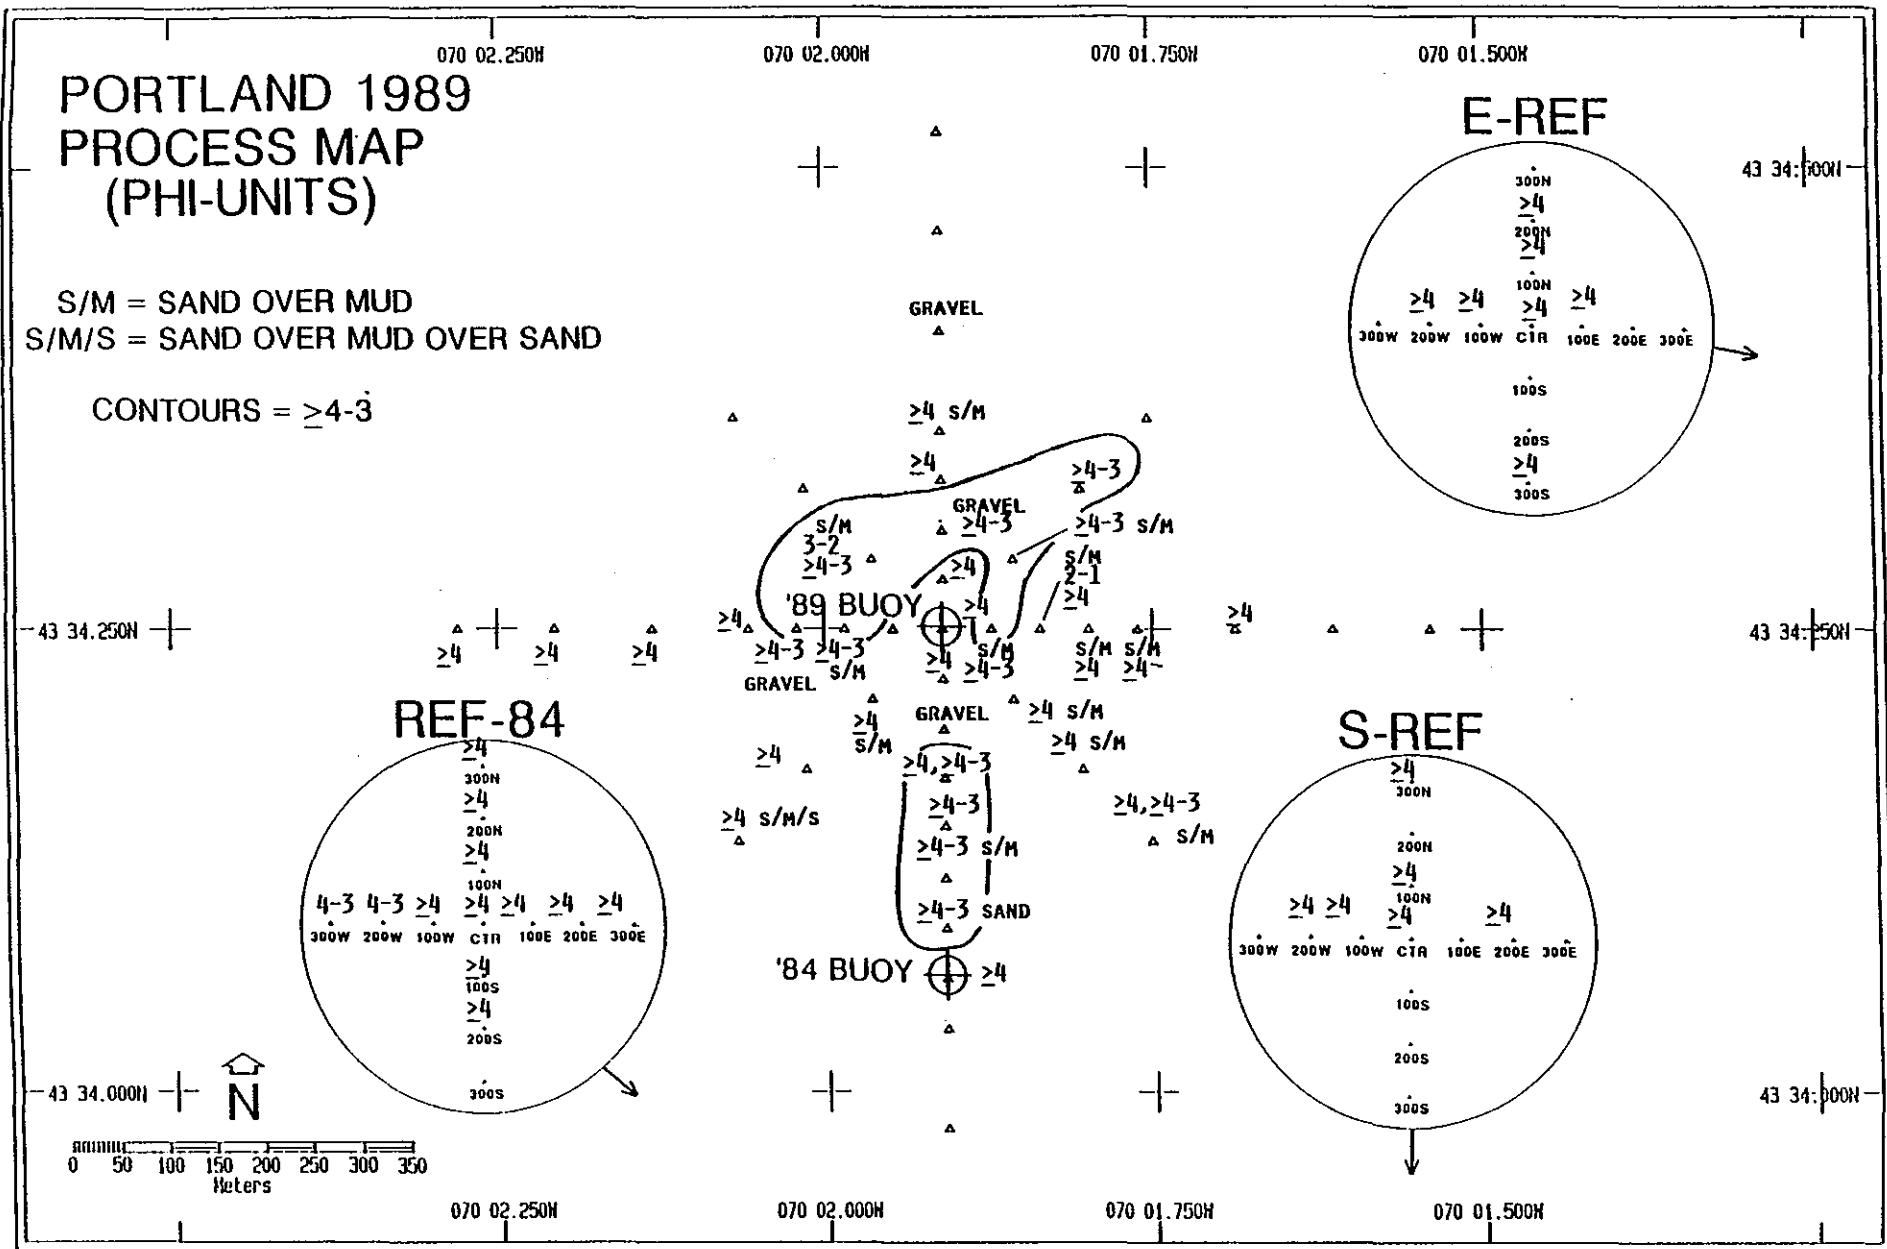
Figure 3-8. Distribution of sediment types at Portland Disposal Site and reference sites, January 1989.

Silt-clay (4 phi) was the most prevalent sediment grain size at the disposal site and at all three reference stations. Stations 150, 200, 250, and 300 south all had very fine sand to silt clay (4 - 3 phi) as the major mode. These stations bracket and extend slightly north of the 1984 disposal buoy area. Similar material was found at the center and north of the present disposal point (Figure 3-8). Sand over mud, and sand/mud/sand stratigraphy existed at many stations scattered across the REMOTS® grid, with gravel visible at four stations (150W, 150N, 300N, and 100S).
