Contribution 209
July 2021

1. AGENCY USE ONLY (LEAVE BLANK)		2. REPORT DATE July 2021		3. REPORT TYPE AND DATES COVERED Contribution, May/June 2020
4. TITLE AND SUBTITLE Monitoring Survey at the Cape Cod Bay Disposal Site May/June 2020			5. FUNDING NUMBERS Contract No. W912WJ-19-D-0010

**MONITORING SURVEY AT THE
CAPE COD BAY DISPOSAL SITE
MAY/JUNE 2020**

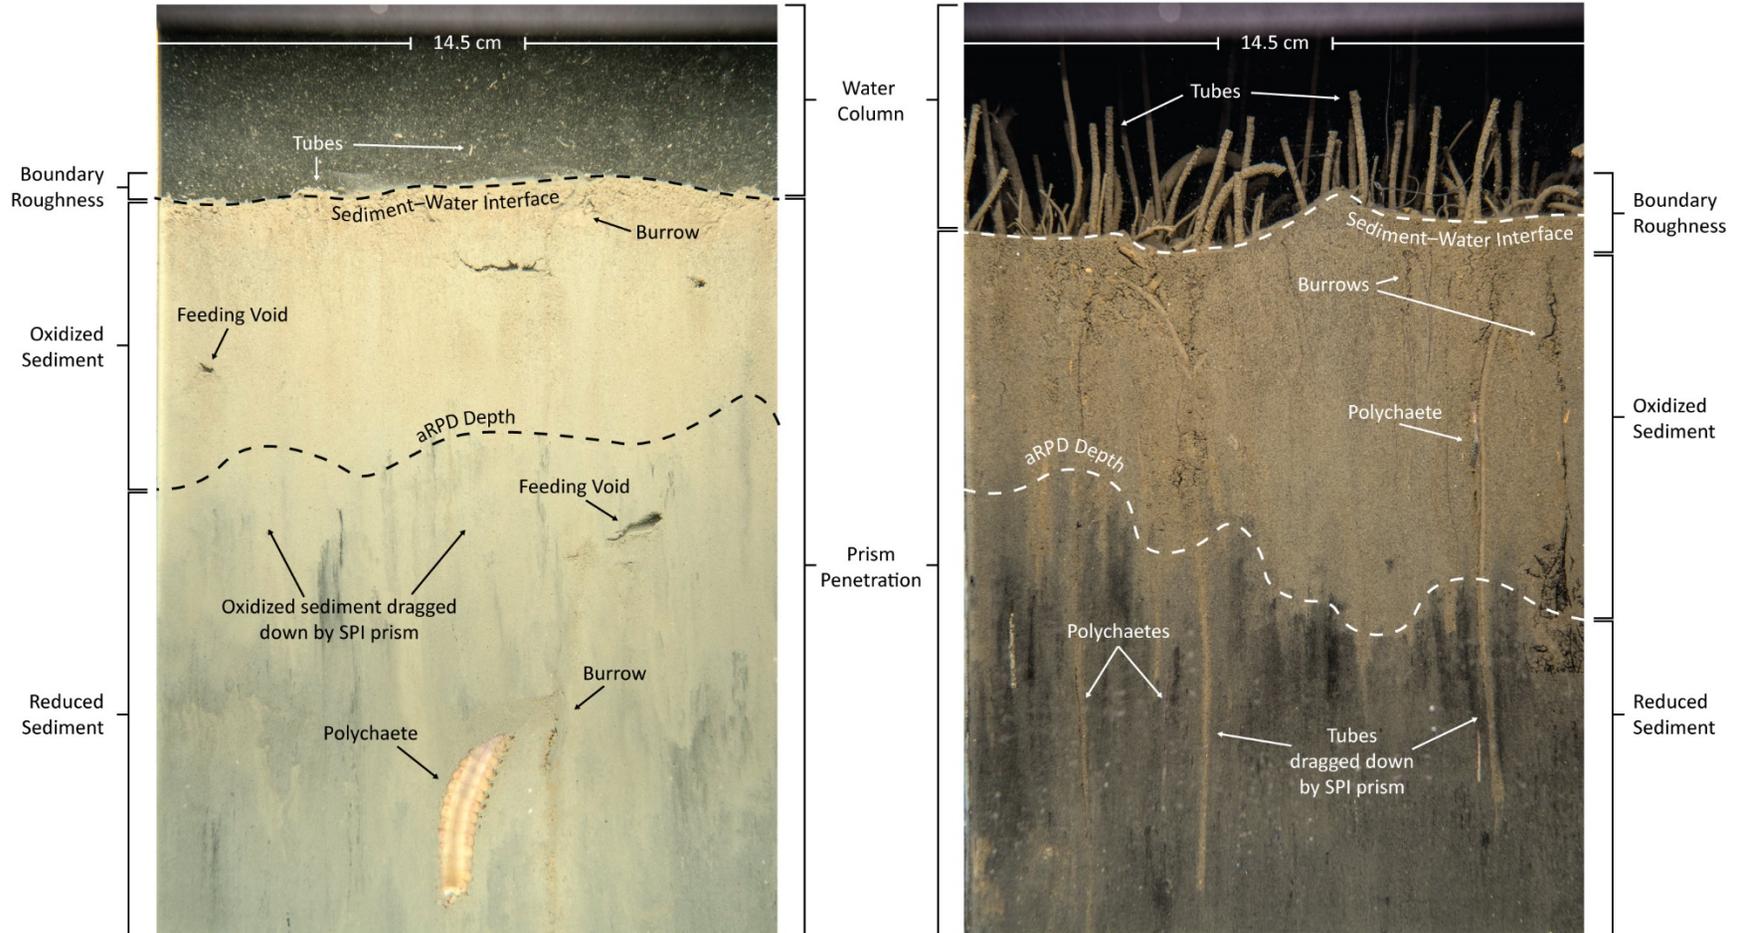
Figure 2-4. SPI images from soft bottom coastal and estuarine environments annotated with many standard variables derived from SPI images. The water column, depth of prism penetration, boundary roughness of the sediment-water interface, and zones of oxidized and reduced sediment are denoted with brackets. The apparent redox potential discontinuity (aRPD), the boundary between oxidized and reduced sediments, is marked with a dashed line. Infauna and related structures (tubes, burrows, feeding voids) are noted with arrows

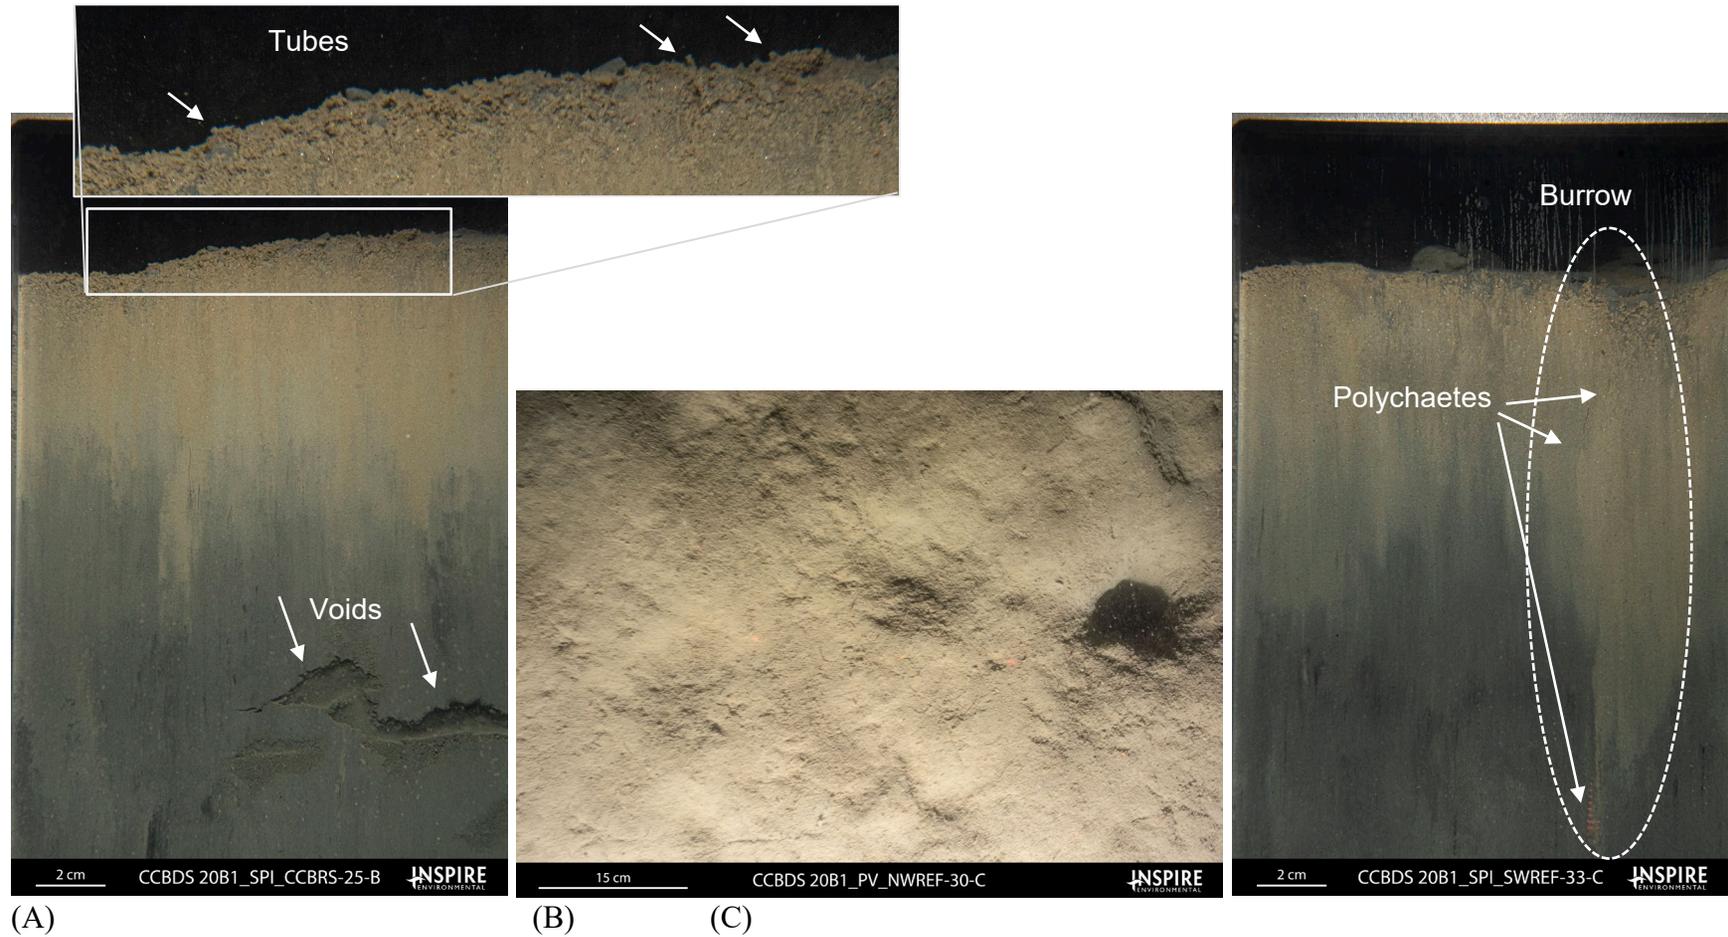
Figure 3-17. Profile and plan view images depicting infaunal successional stages as well as other biological characteristics found at the three CCBDS reference areas at (A) Stage 1 on 3 at Station CCBRS-25 with Stage 1 tubes at the sediment–water interface and large, open feeding voids within the sediment; (B) Stage 2 on 3 at Station NWREF-30 where tubes, burrows, and brittle star burrows were observed across the surface; and (C) Stage 1 on 3 at Station SWREF-33 evidenced by a burrow visible beginning at the sediment water interface and moving to depth with multiple visible polychaetes

Evidence of mature, deposit-feeding infaunal (Stage 3) assemblages was found at all three reference areas, manifested as subsurface feeding voids in SPI replicates, large burrows visible in PV replicates, or presence of deep-burrowing polychaetes in SPI replicates (Table 3-1b; Figures 3-16 and 3-17). Assemblages of Stage 1 on 3 fauna were the predominant successional stage at the reference areas, where deep burrowing polychaetes and/or subsurface feeding voids were frequently observed in combination with small tubes at the sediment water interface (Table 3-1b; Figures 3-16 and 3-17).

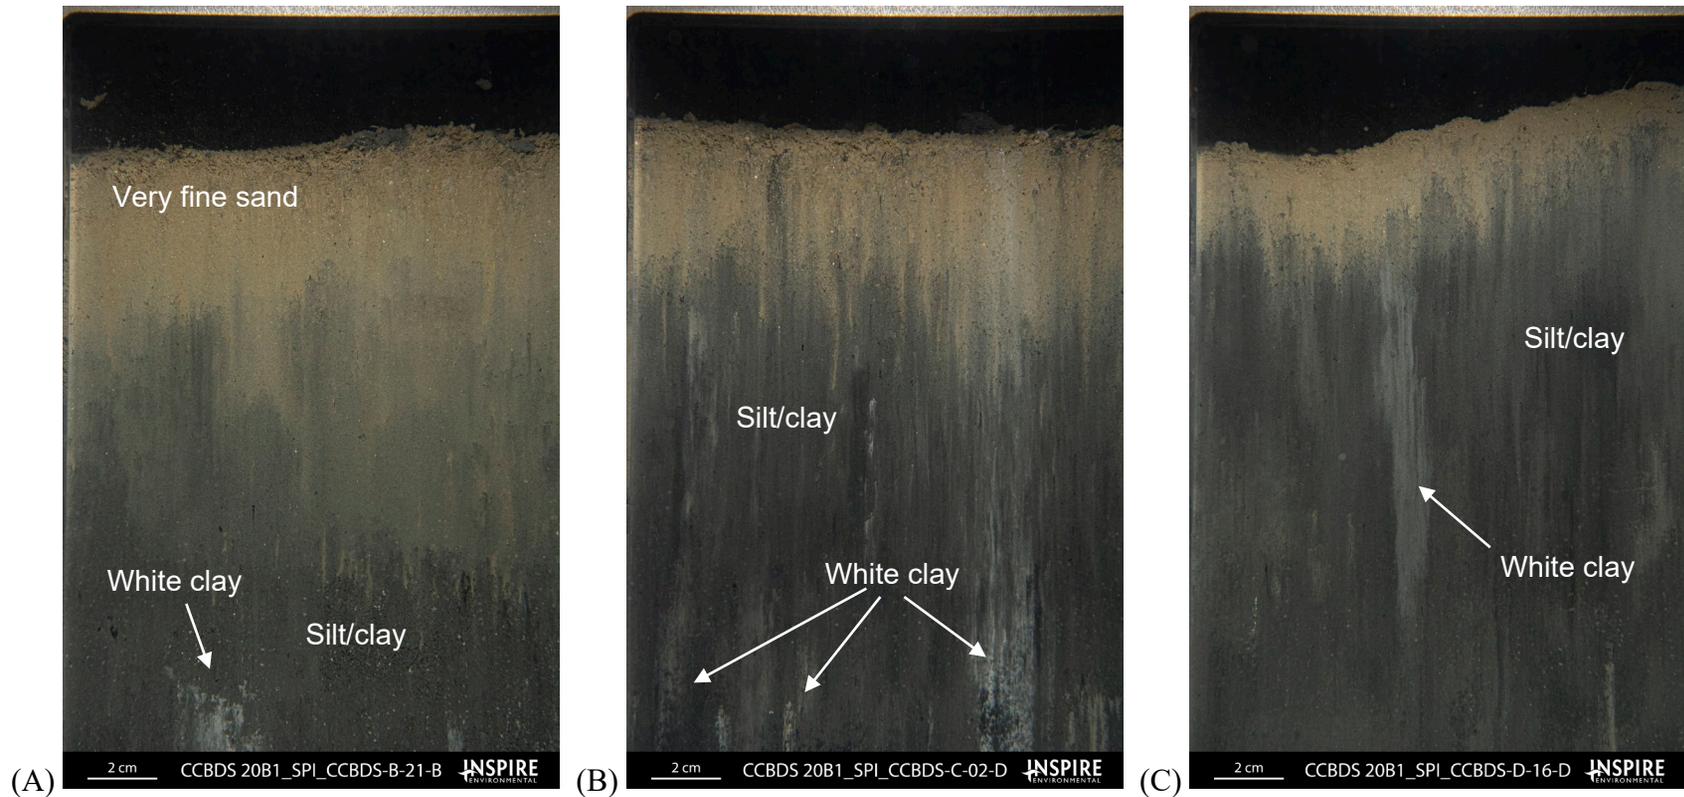
Figure 3-23. Profile images depicting dredged material at CCBDS (A) very fine sand over a buried layer of silt/clay with intermixed white clay at Station 21 at Mound B; (B) slightly reworked silt/clay with white clay intermixed throughout at Station 02 at Mound C; and (C) slightly reworked silt/clay with intermixed white clay at Station 16 at Mound D

Where present at historical Mound B, dredged material was found to be buried beneath a layer of reworked very fine sand (Figures 3-20 and 3-23). At active Mounds C and D, the entire sediment column imaged in the SPI was found to be dredged material, with most stations exhibiting evidence of the sediment being actively reworked by infauna (Figures 3-20 and 3-23).

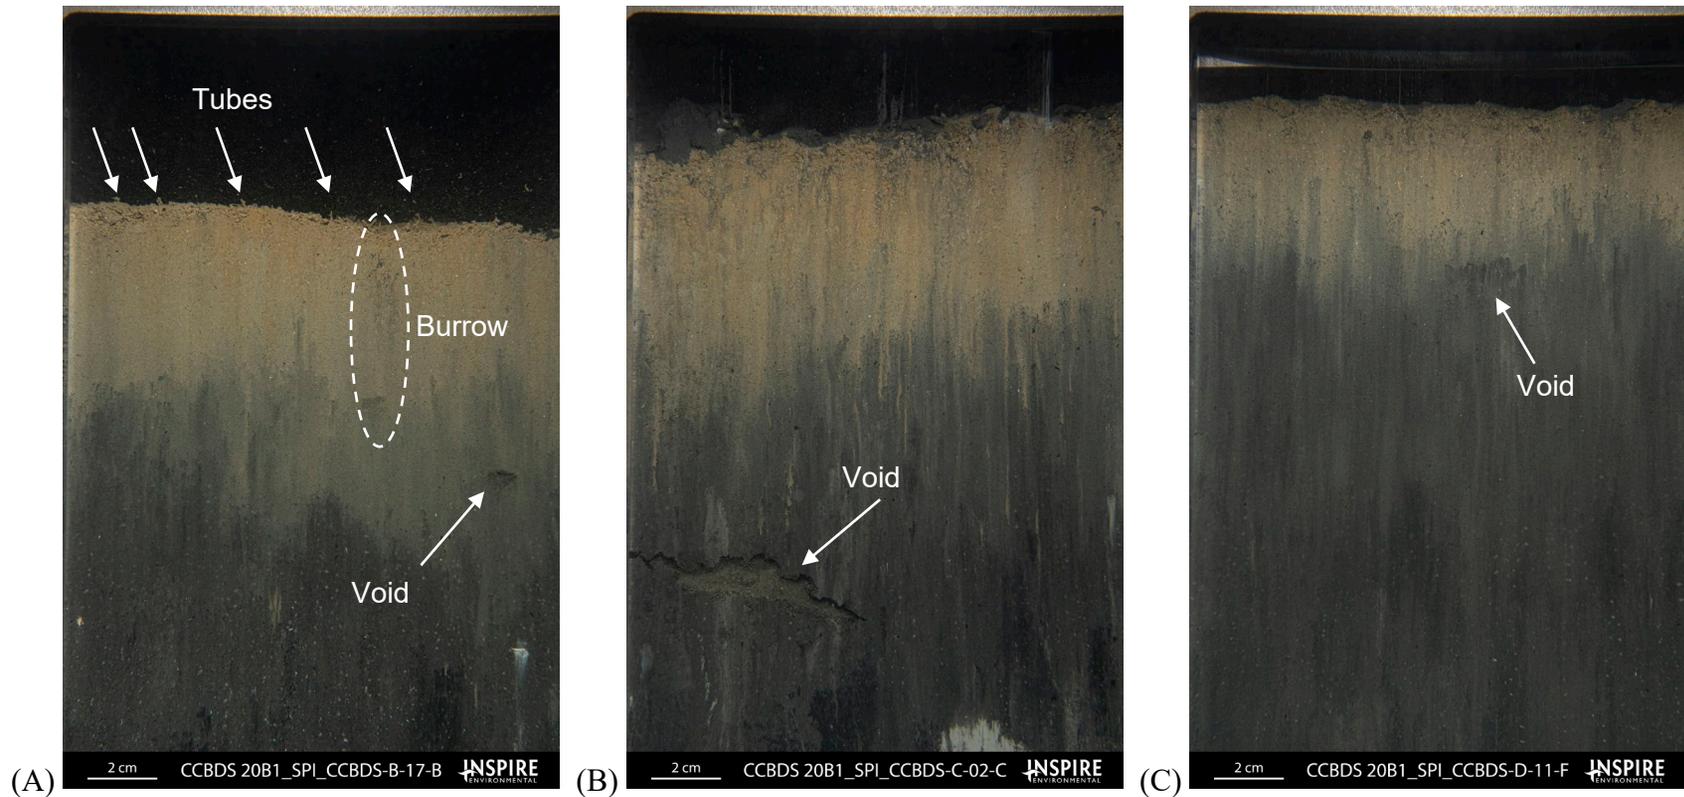
Figure 3-26. Profile images depicting infaunal successional stages as well as other biological characteristics found at the three CCBDS mounds (A) Stage 2 on 3 with tubes and a burrow at the sediment–water interface and feeding voids beneath the aRPD boundary at Mound B Station 17; (B) Stage 1 on 3 with a very large feeding void beneath the aRPD boundary at Mound C Station 02; and (C) Stage 1 on 3 with a shallow, infilled void just beneath the aRPD boundary at Mound D Station 11

At active Mound D, Stage 3 fauna were found in at least one SPI or PV replicate at 2 of the 8 stations, with Stage 2 being the most common successional stage (Table 3-4b; Figure 3-16). Evidence of Stage 2 fauna included polychaete tubes at the sediment–water interface and shallow burrowing in the sediment column (Figure 3-26). When present, subsurface
