Monitoring Survey at the Providence River Confined Aquatic Disposal Cells September/October 2020

Disposal Area Monitoring System – DAMOS

Contribution 211
October 2021

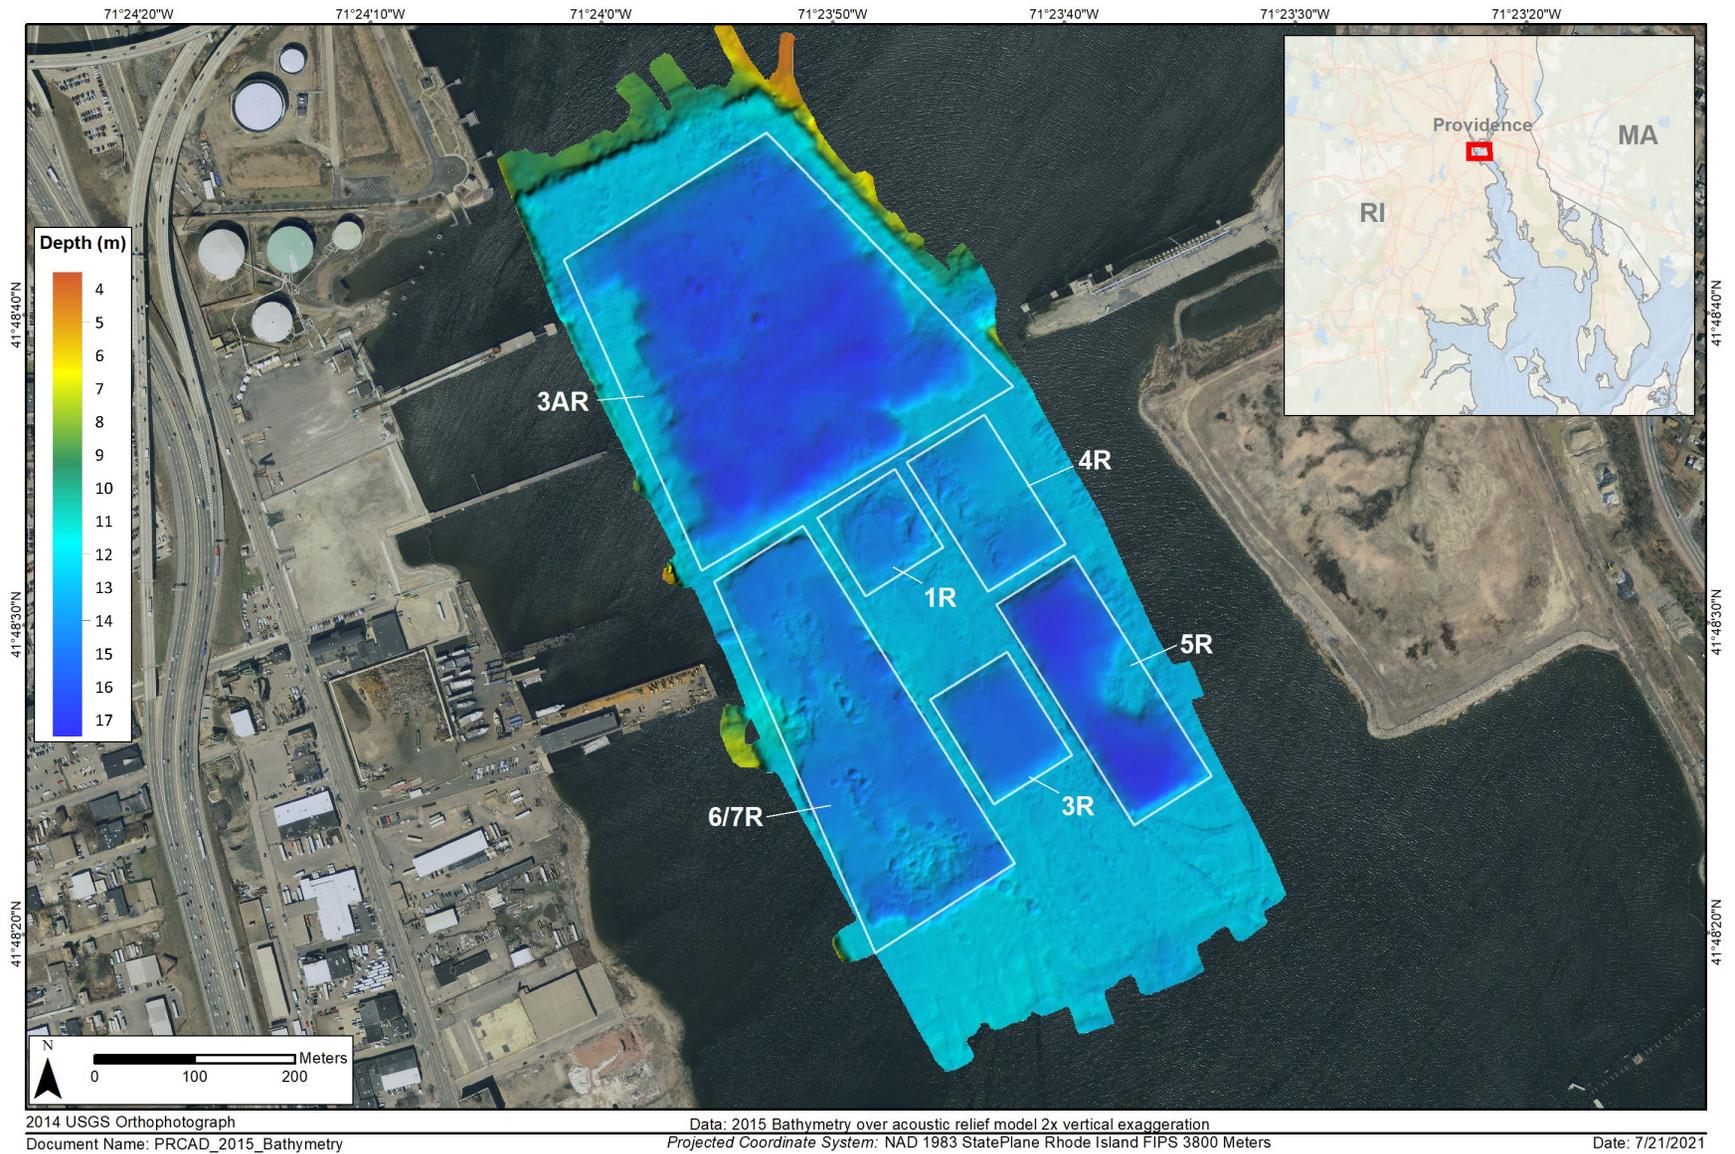
Figure 1-2. Bathymetric depth data over acoustic relief model at PRCAD – October 2015

The 2009 bathymetric survey was conducted at PRCAD as a baseline for longer term study and documented the elevation of each CAD cell below the harbor bottom at that time (USACE 2012). The October 2015 survey was designed to monitor long-term stability and consolidation and found that the PRCAD cells were distinguished from the surrounding channel as topographic depressions, generally 4 to 6 m (13 to 20 ft) below the channel depth of 12.5 m (41 ft). PRCAD Cells 3AR and 5R were the deepest, roughly 6 m (20 ft) below channel depth (Figure 1-2; Carey et al. 2017).

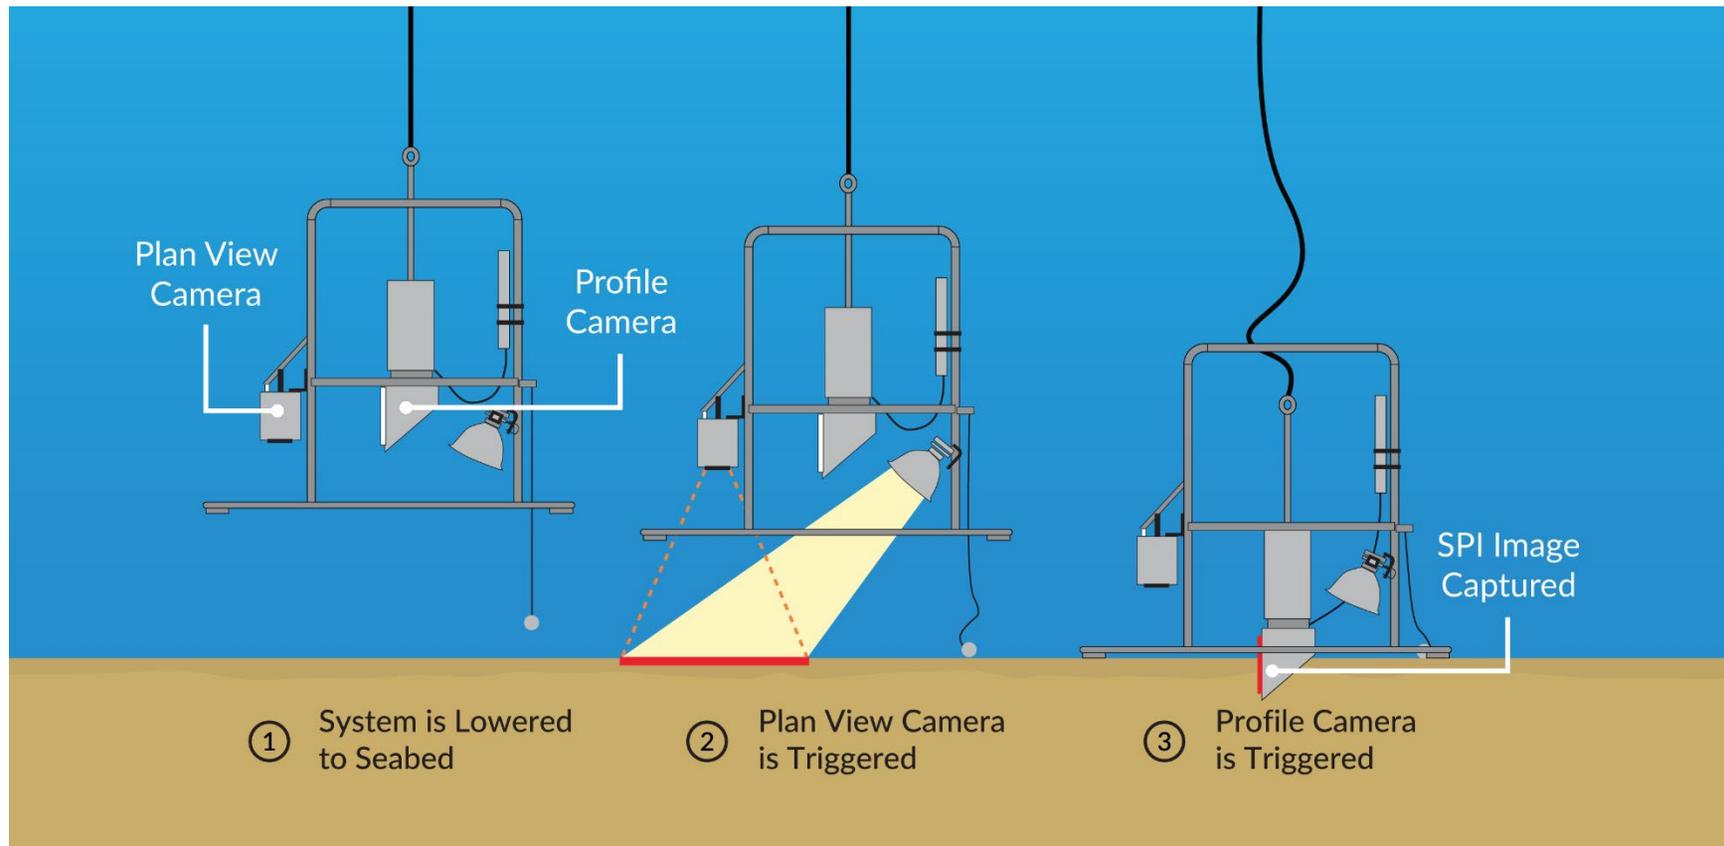
Figure 2-4. Operation of the sediment profile and plan view camera imaging system

An Ocean Imaging® Model DSC24000 plan view underwater camera (PV) system with two Ocean Imaging® Model 400-37 Deep Sea Scaling lasers was attached to the sediment profile camera frame and used to collect plan view images of the seafloor surface. Both SPI and PV images were collected during each “drop” of the system. The PV system consisted of a Nikon D-7200 encased in an aluminum housing, a 24 VDC autonomous power pack, a 500 W strobe, and a bounce trigger. A weight was attached to the bounce trigger with a stainless-steel cable so that the weight hung below the camera frame; the scaling lasers projected two red dots that are separated by a constant distance (26 cm) regardless of the field-of-view of the PV system. The field-of-view can be varied by increasing or decreasing the length of the trigger wire and, thereby, the camera height above the bottom

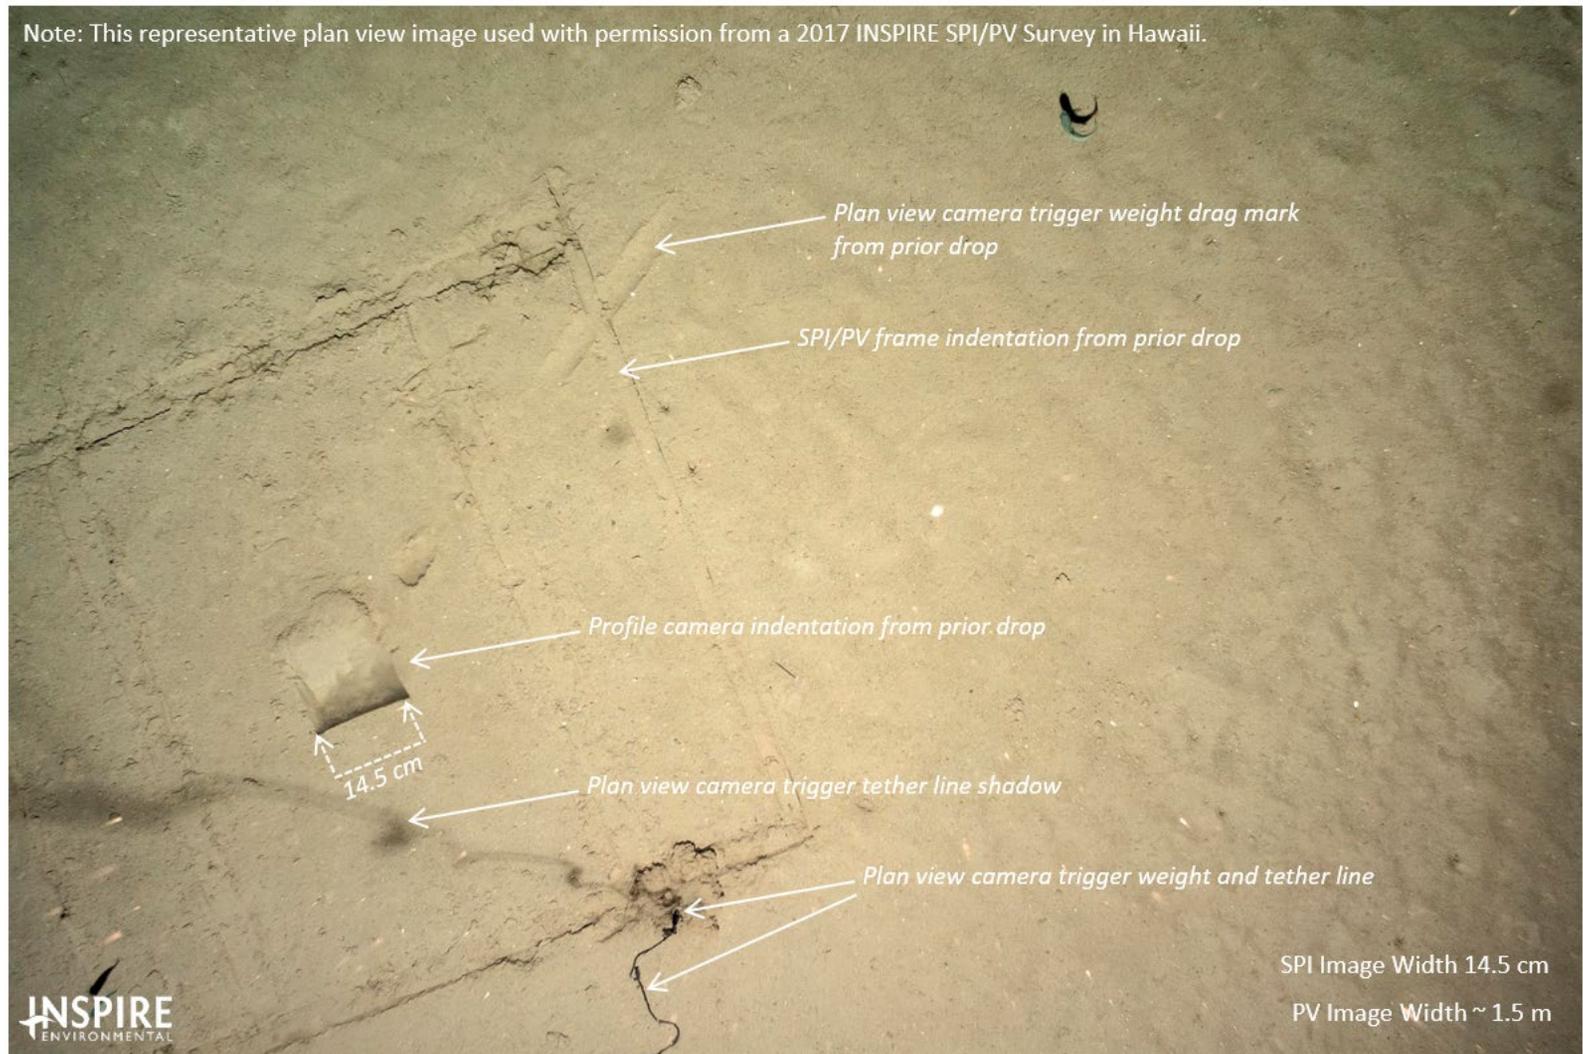
Figure 2-7. This representative plan view image shows the sampling relationship between plan view and sediment profile images. Note: plan view images differ between surveys and stations, and the area covered by each plan view image may vary slightly between images and stations.

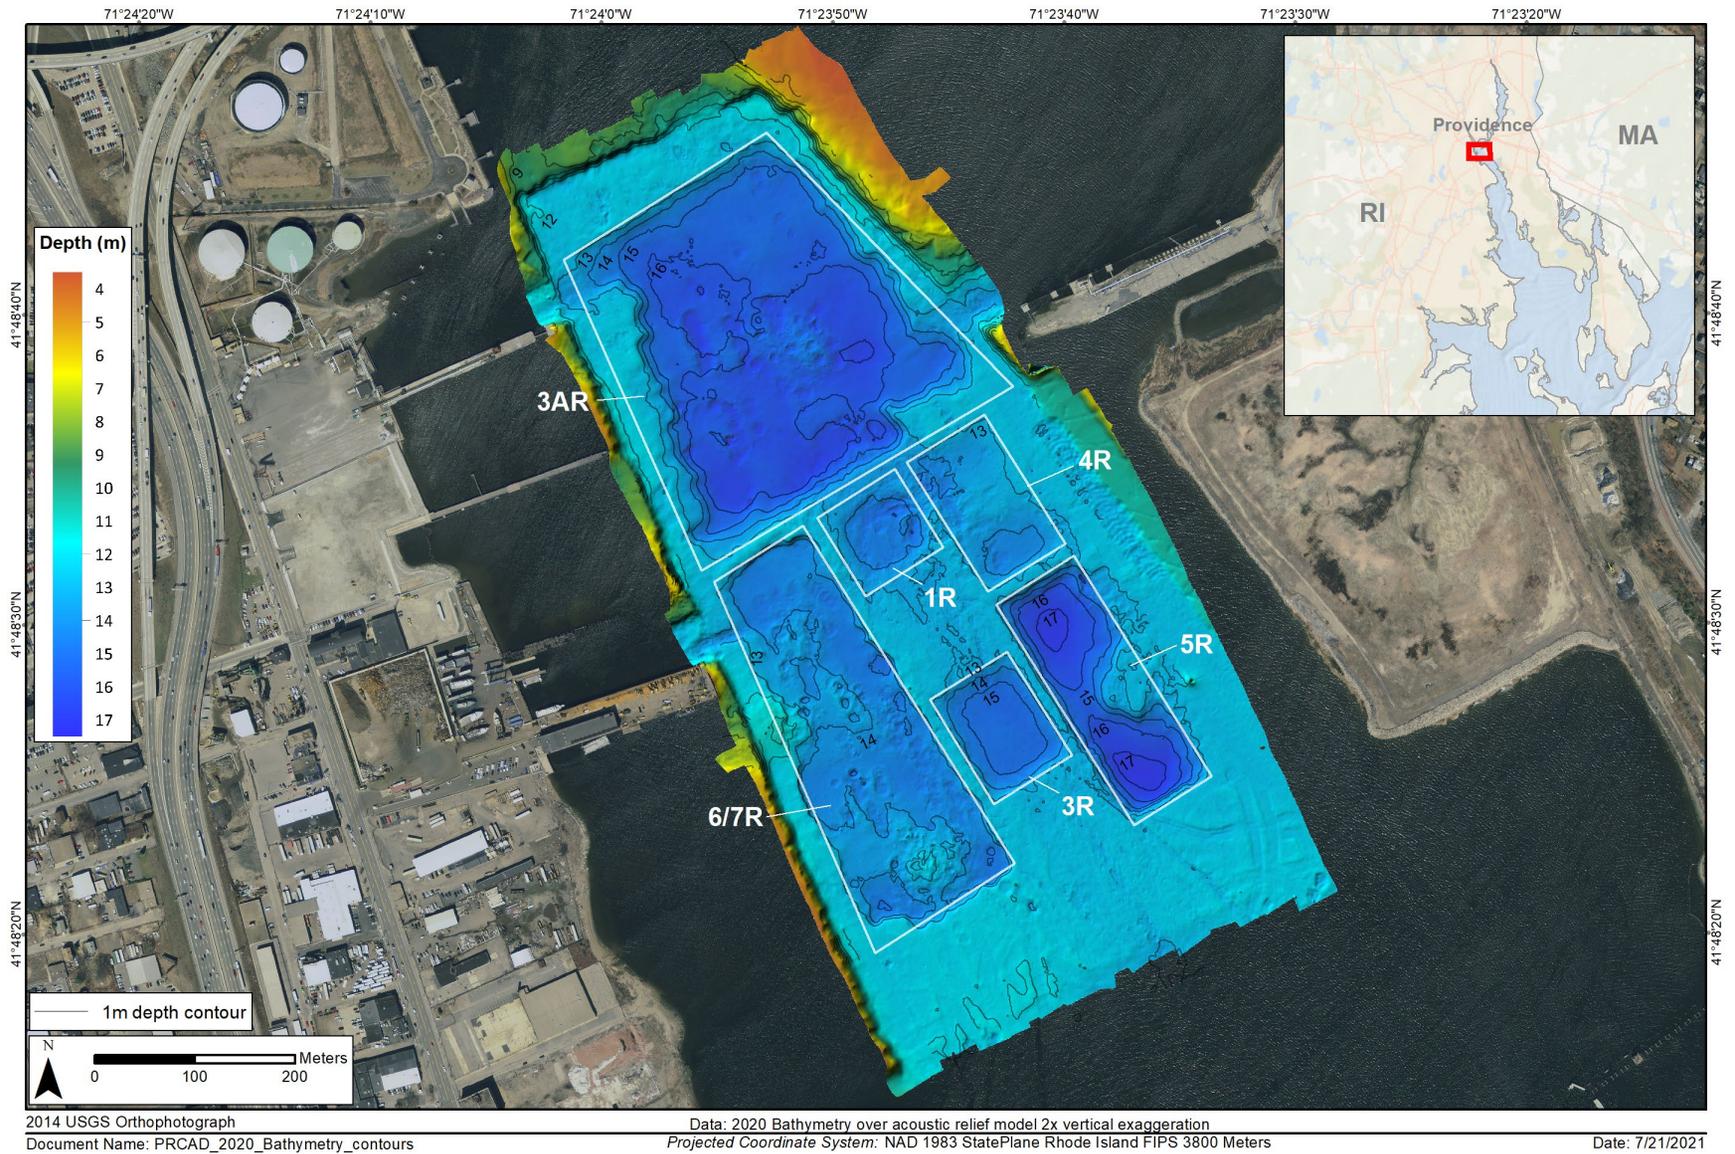
Figure 3-1. Bathymetric contour map of PRCAD – September and October 2020

The multibeam bathymetric data collected in 2020 (Figure 3-1) was also compared with the multibeam bathymetric data collected in 2015 (Figure 1-2). Bathymetric data collected in 2020 were subtracted from 2015 bathymetry to capture any substantial elevation changes that may have occurred over that time period (Figure 3-6). Overall, substantially less elevation increase (i.e., CAD cell filling) was observed during the 2015-2020 period than during the previous period (2009-2015). Elevation increases were observed in the center of Cell 3AR, where a maximum increase of 2.0 m was observed and, to a lesser extent, in Cell 6/7R, where a maximum increase of 1.3 m was observed. Decreased elevation (i.e., deepening) ranging from 0.2 to 1.0 m was observed in and around Cell 1R. This deepening may be due to vessel activity and is discussed further in Section 4.0.

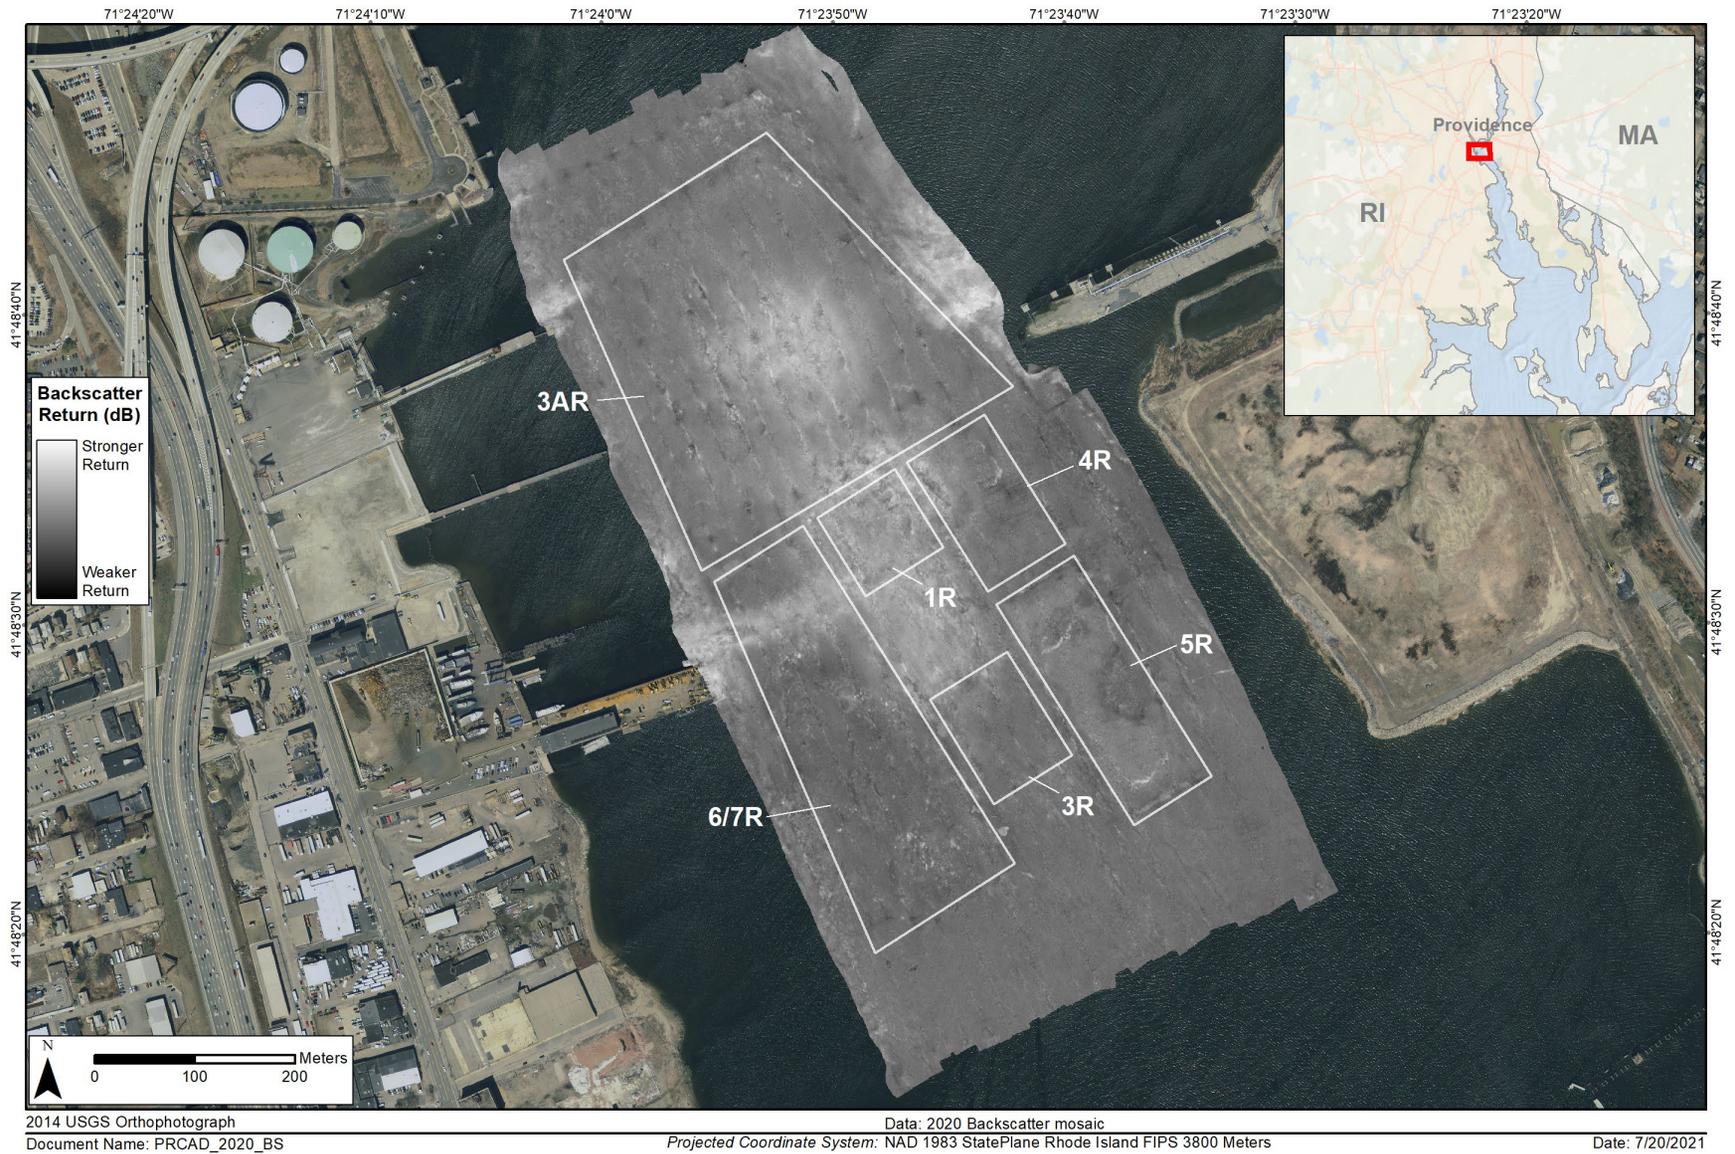
Figure 3-2. Mosaic of unfiltered backscatter data of PRCAD – September and October 2020

stronger returns near the center of the survey area and at the end of piers (Figure 3-2). Filtered backscatter over acoustic hillshaded relief presented an assessment of surficial sediment characteristics independent of slope effects and provided a more readily interpreted map (Figure 3-3).

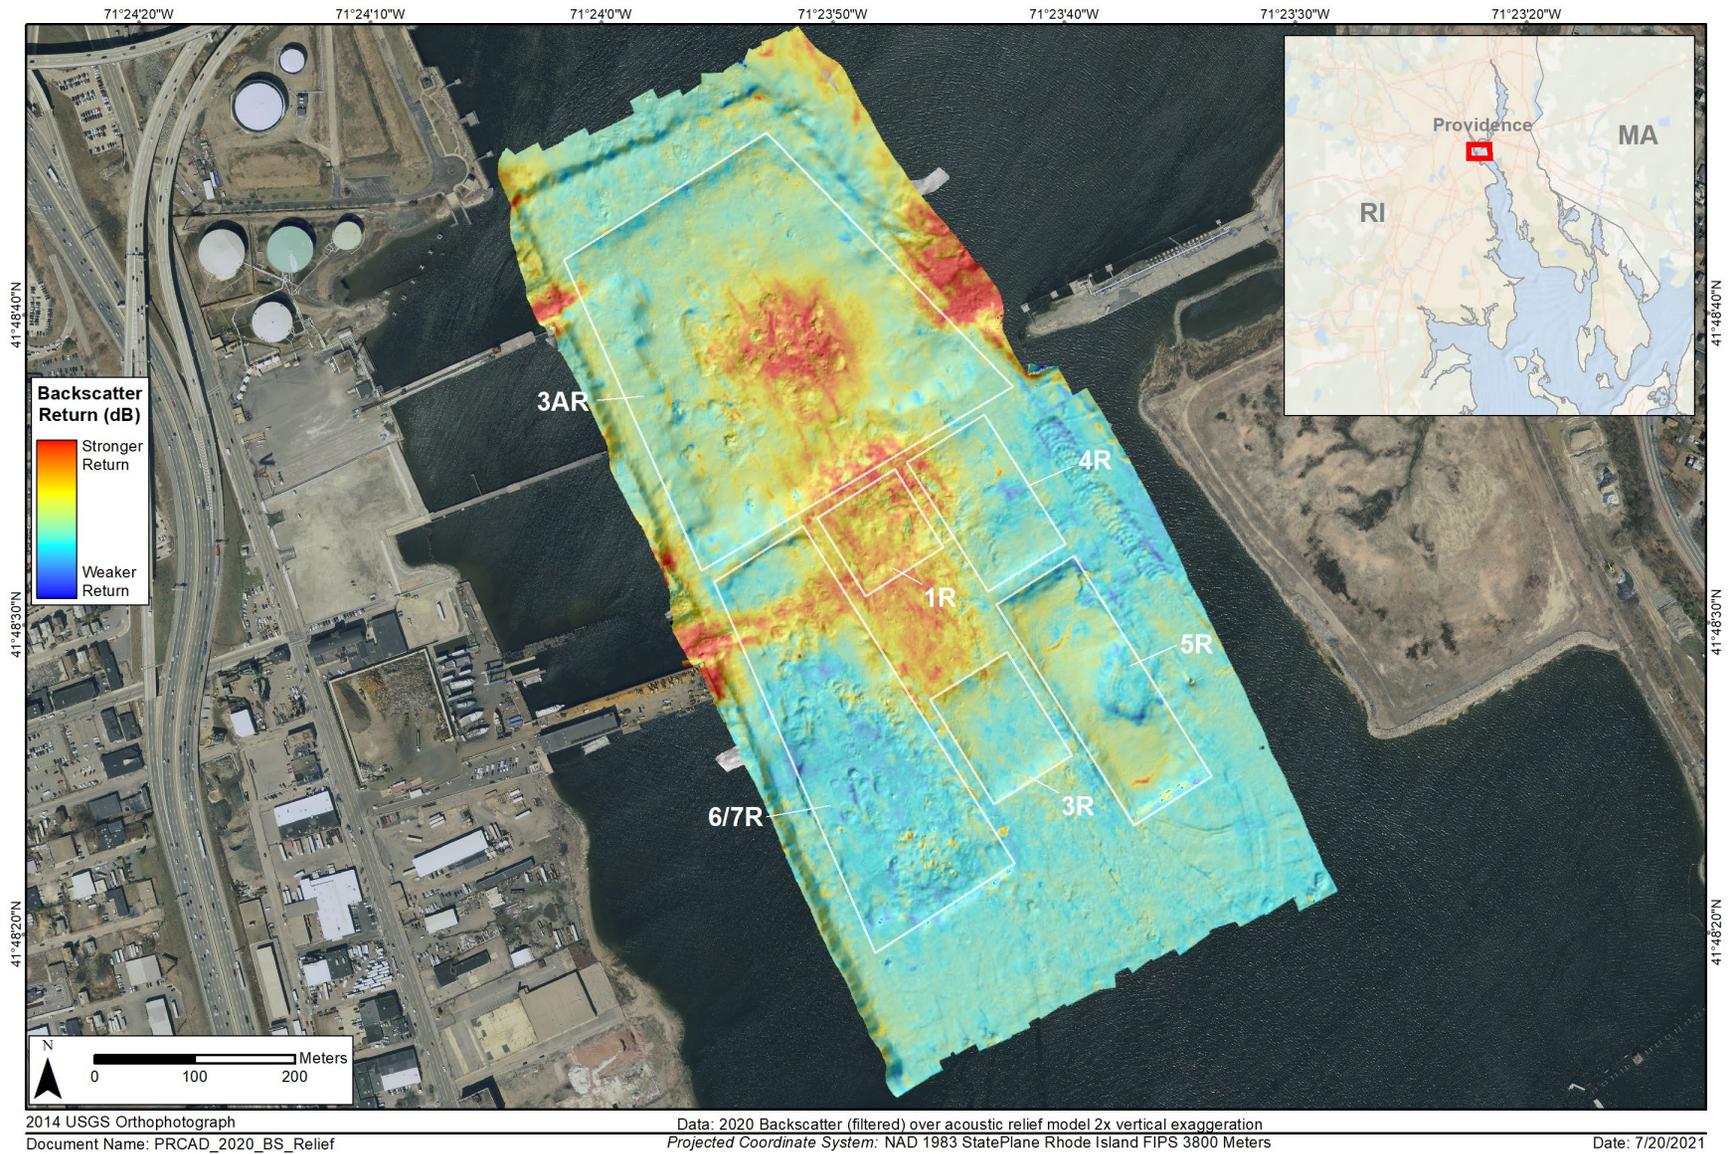
Acoustic backscatter imagery of the PRCAD cells indicated variable patterns of acoustic returns throughout the survey area (Figure 3-3). Strong backscatter returns indicated relatively coarser-grained, rougher, or harder sediment and were observed in CAD Cell 1R, in the center of Cell 3AR, and adjacent to three piers, two along the western side and one on the eastern side of the Providence River. Weaker returns were observed in Cell 6/7R and in portions of other cells. Most of the survey area, including both the topographic depressions of the CAD cells and ambient channel bottom had moderate backscatter returns.

Figure 3-3. Filtered backscatter over acoustic hillshaded relief at PRCAD – September and October 2020

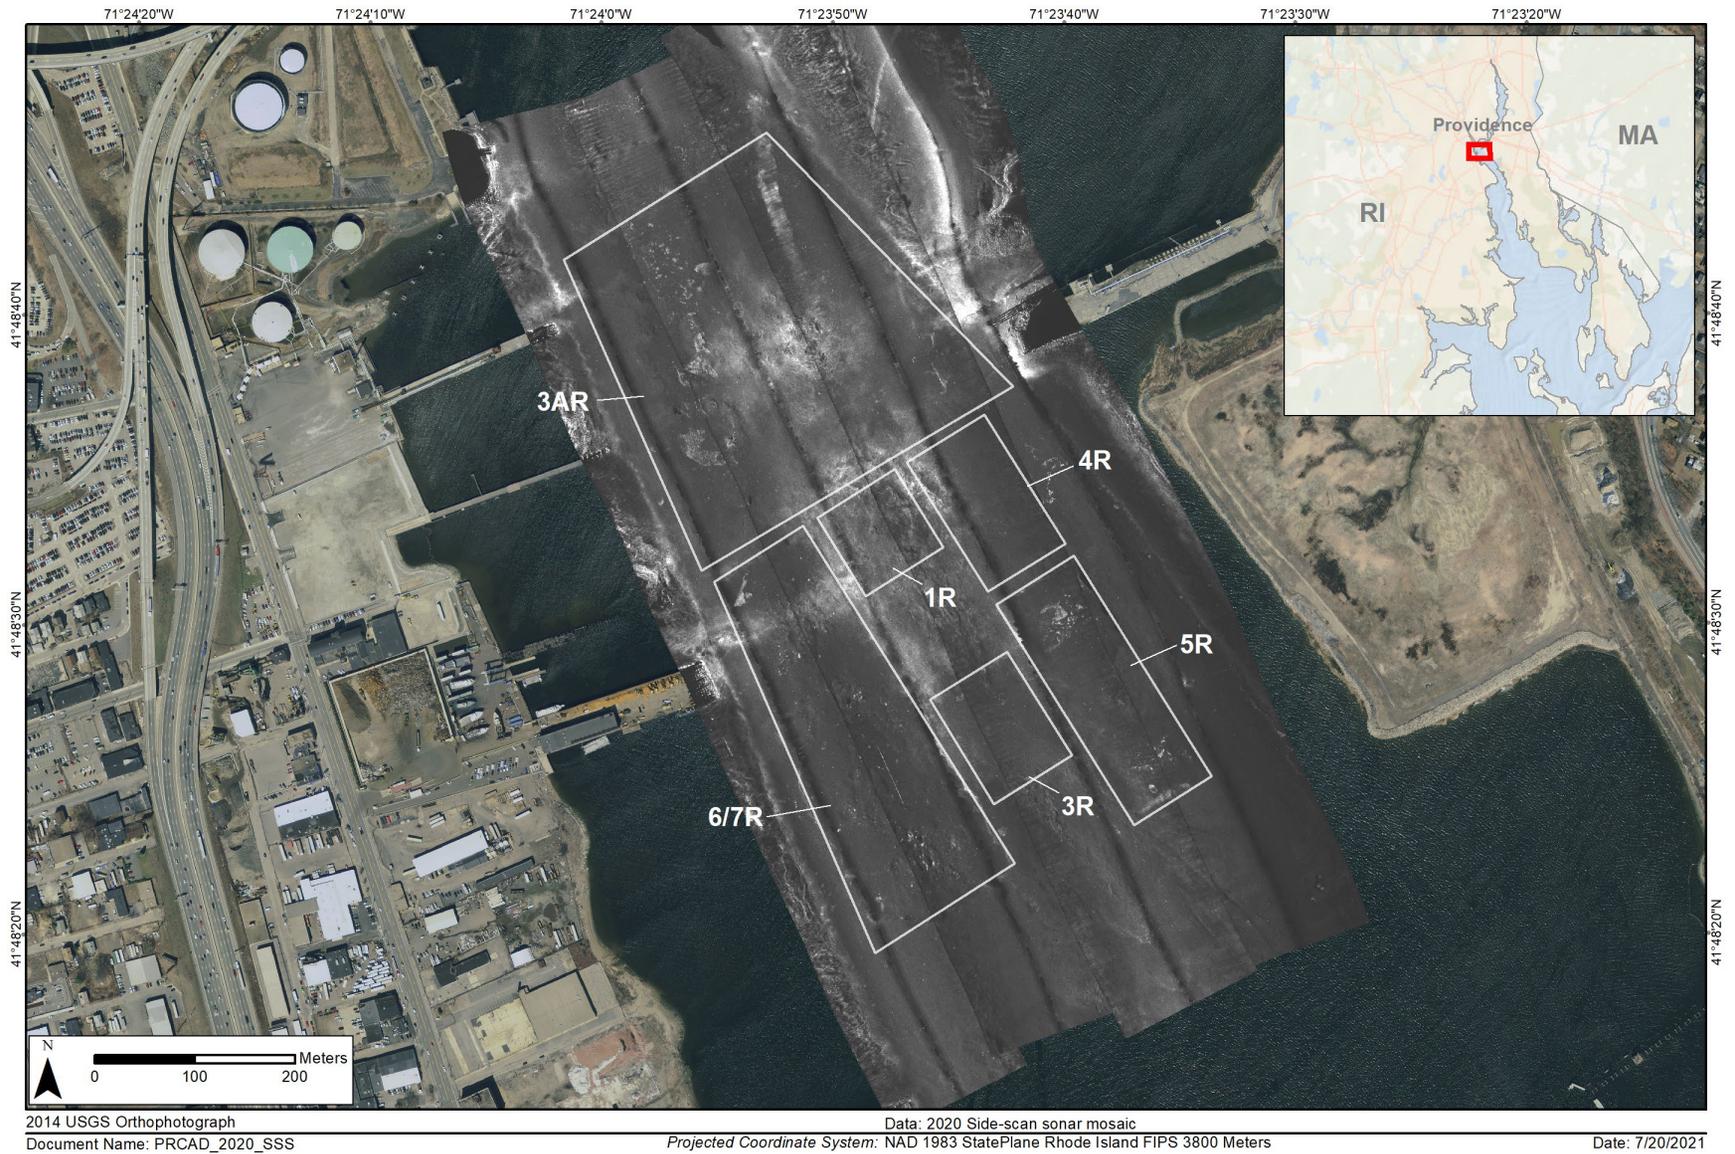
Side-scan sonar results depicted the surface relief and texture of the Providence River channel (Figure 3-4) and confirmed the observations from the backscatter results, but with additional information including identifiable small-scale surficial features on the sediment surface. The side-scan sonar results showed topographical roughness or heterogeneous sediments in Cells 1R and 3AR and adjacent to the three piers. Features of increased topographic relief were observed in these areas as indicated by blips of high side-scan sonar return accompanied by “shadows” created by objects blocking signal return. Rocky substrate and pier pilings were observed along the banks of the channels to the east and west of PRCAD. Coarser-grained, rougher, or harder bottom observed in the backscatter and side-scan sonar returns adjacent to the three piers and in Cell 1R may be due to vessel activity and is discussed further in Section 4.0.

Figure 3-4. Side-scan mosaic of PRCAD – September and October 2020

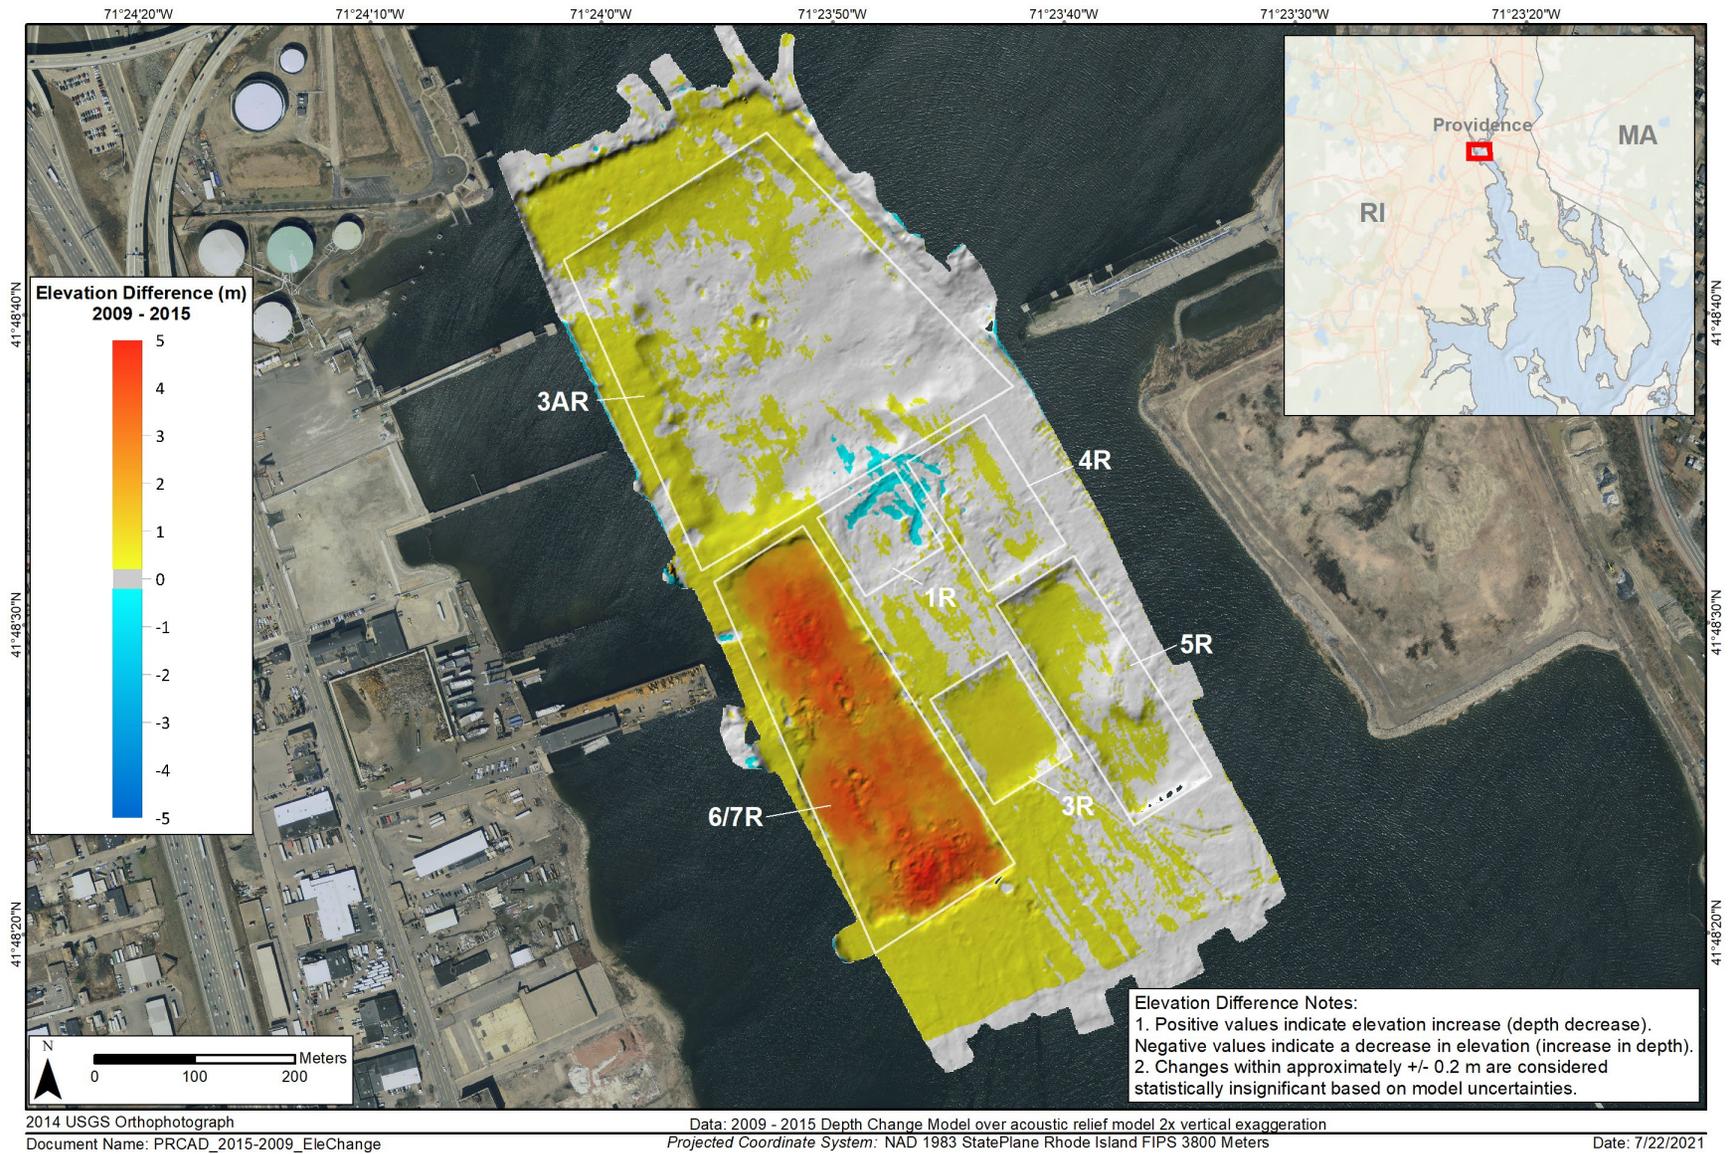
2015 bathymetric data revealed that the majority of positive elevation change (i.e., filling of CAD cells) occurred throughout Cell 6/7R, with accumulation reaching a maximum of 5.1 m increase between 2009 and 2015. Less accumulation (~0.5 m) was observed in Cell 3R, and in parts of Cells 5R and 3AR during this time period. Decreased elevation (i.e., potential deepening of CAD cells likely due to loss of material, as discussed below) was observed in and around CAD Cell 1R (indicated in blue in Figure 3-5).

Figure 3-5. PRCAD elevation difference: 2009 vs. 2015

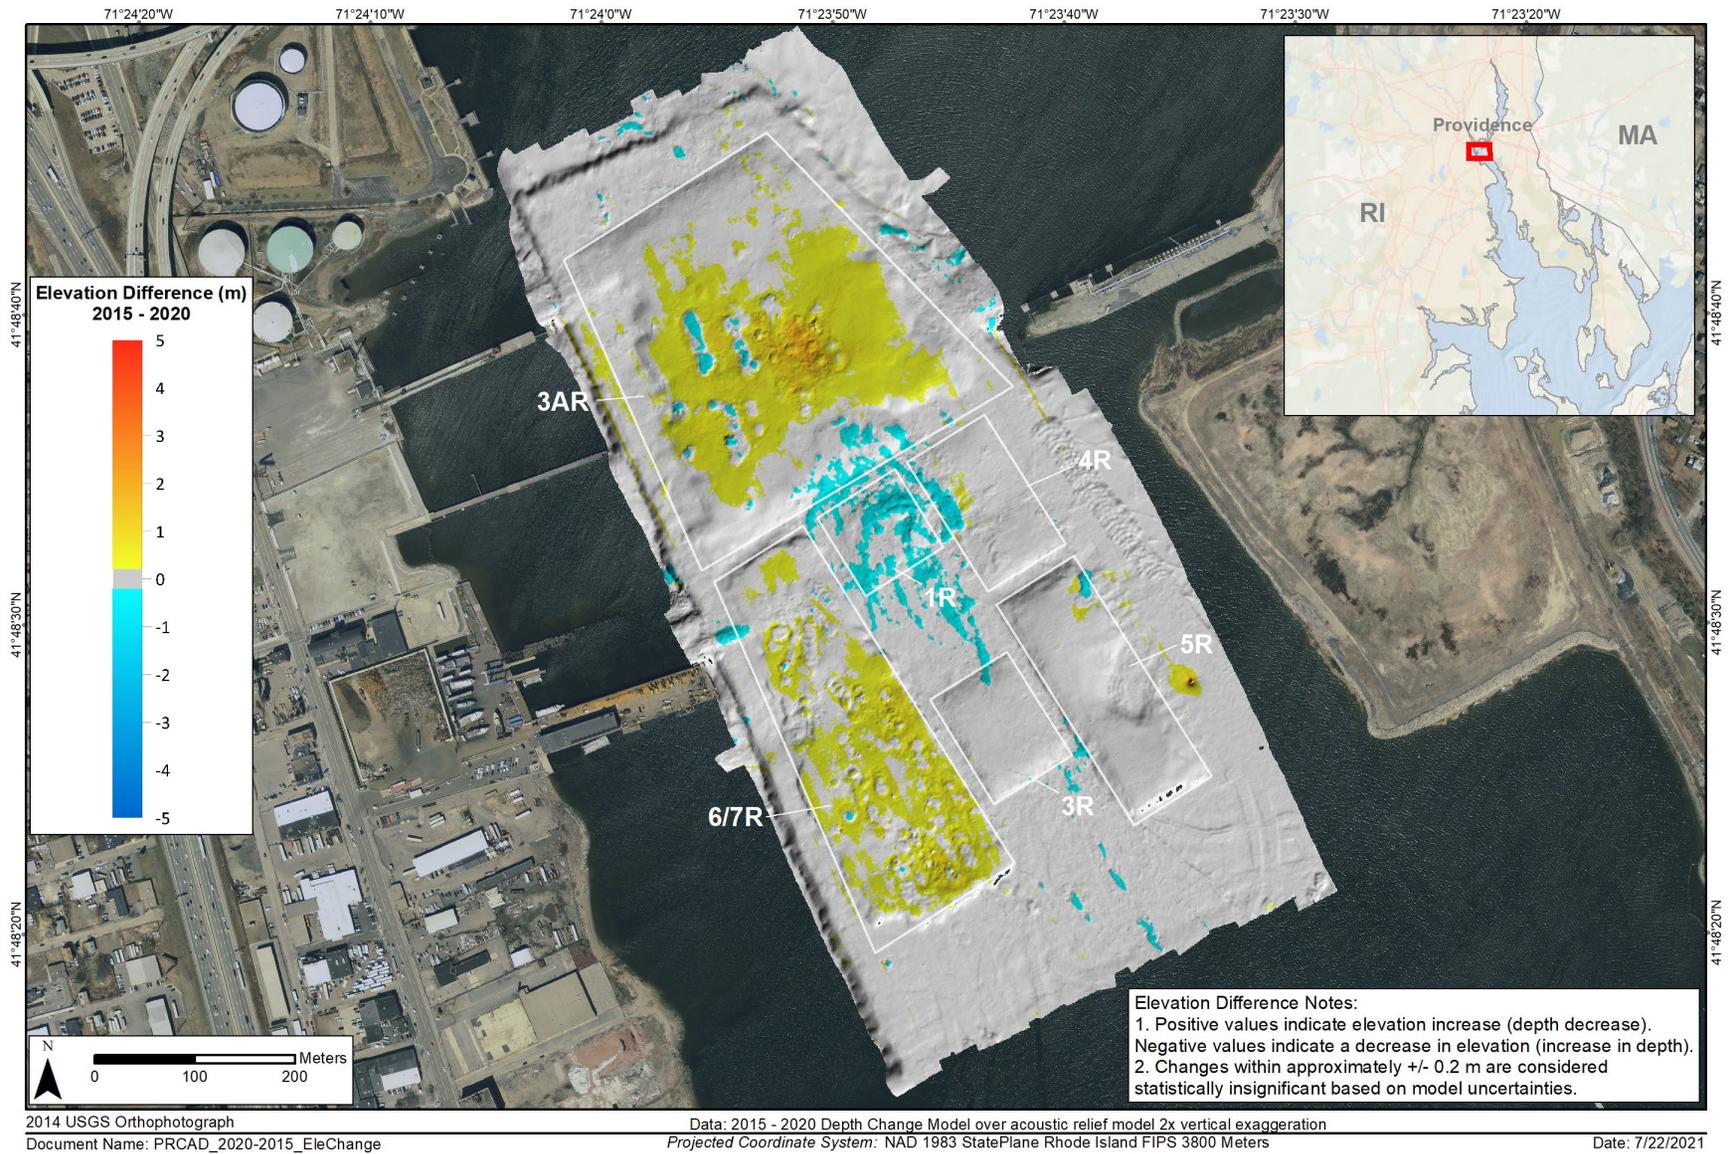
Figure 3-6. PRCAD elevation difference: 2015 vs. 2020

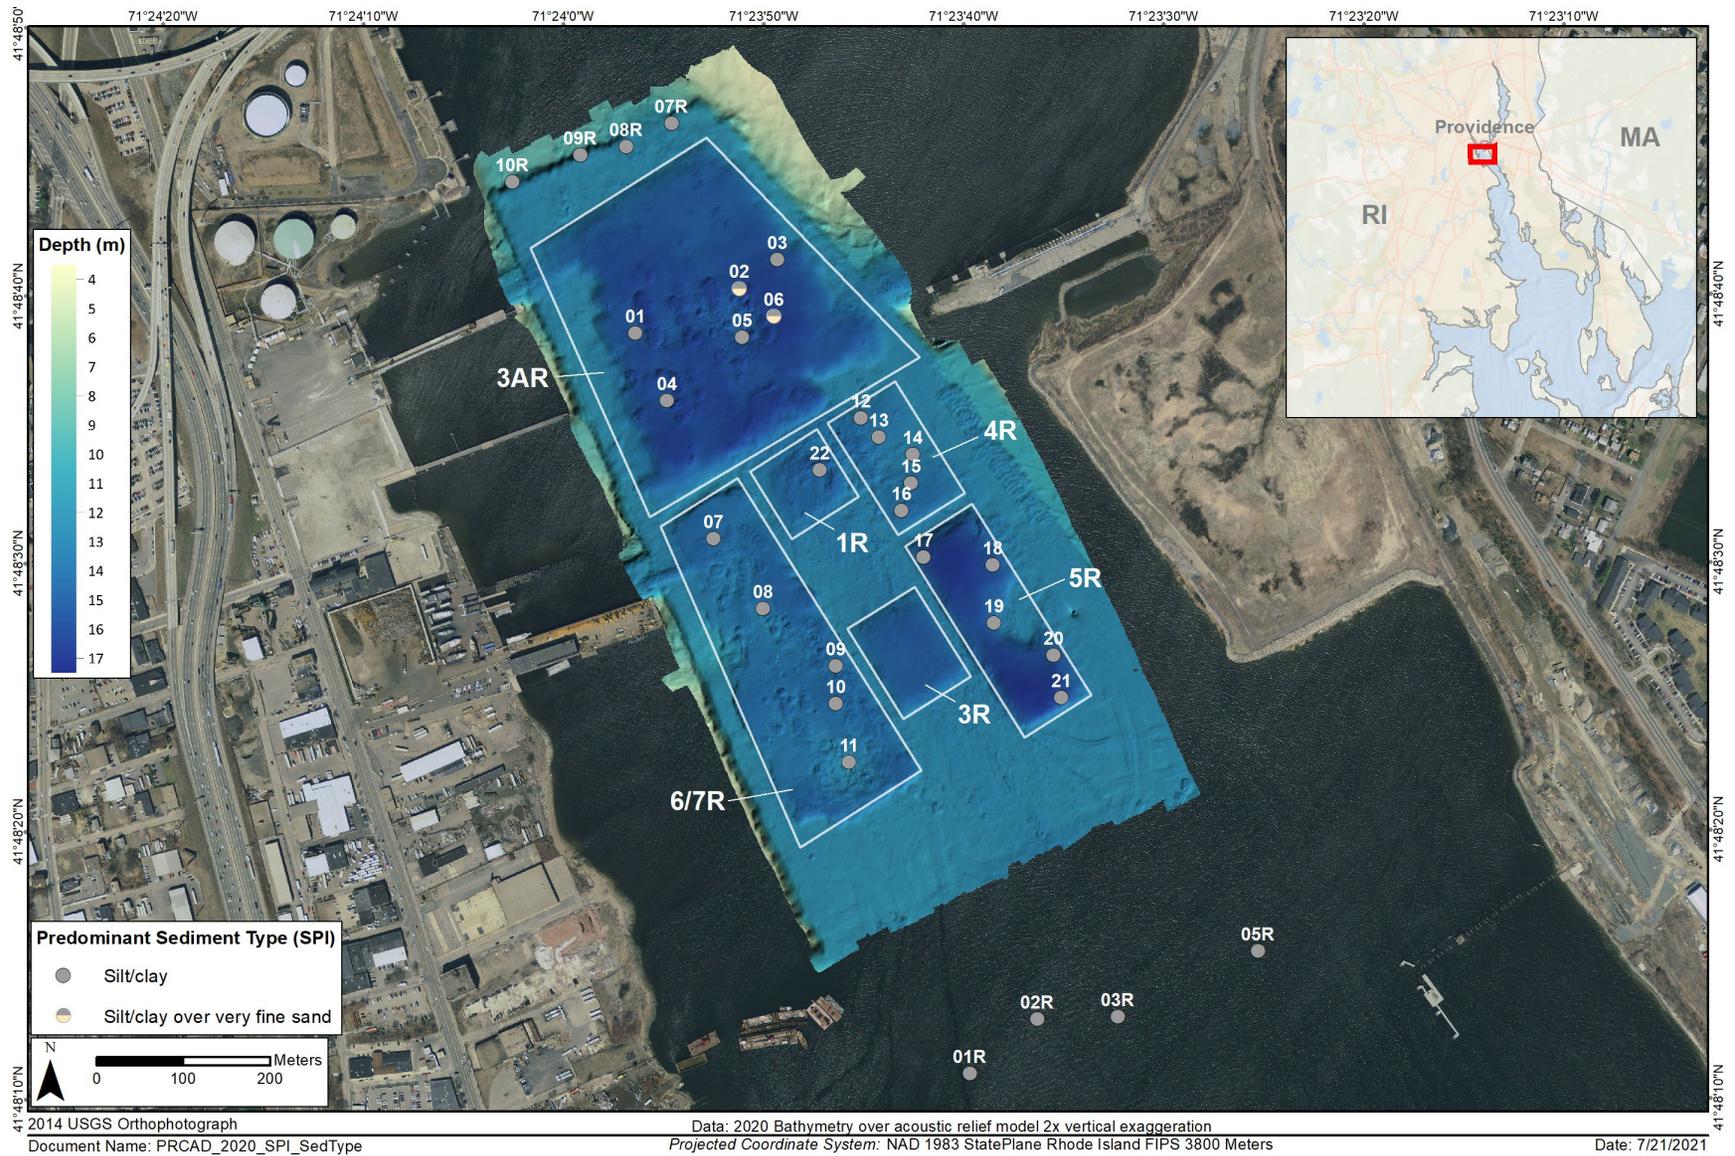
Sediment at all reference stations was predominantly composed of silt/clay (Table 3-1; Figure 3-8) with little variation in physical characteristics observed across reference stations (Figure 3-9). Sediments at both reference areas were very soft with low load-bearing capacity as evident from the generally deep sediment prism penetrations. The weights and stops were consistent during the entire survey (INSPIRE 2020c) and thus, comparisons of prism penetration across stations provided insight into the relative load-bearing capacity of the sediments in the surveyed area. Mean station prism penetration ranged from a minimum of 6.6 cm at Station 03R (REF-South) to a maximum of 19.2 cm at Station 07R (REF-North), but generally was between 13 and 16 cm across the rest of the reference stations (Figure 3-10; Appendix C).

The predominant grain size major mode observed across the majority of PRCAD stations was silt/clay. The only exceptions were two stations within 3AR that consisted of a surficial layer of silt/clay overlying very fine sand (Stations 02 and 06) (Figures 3-8 and 3-18A).

Figure 3-8. Predominant sediment grain size major mode (phi units) at PRCAD and reference areas

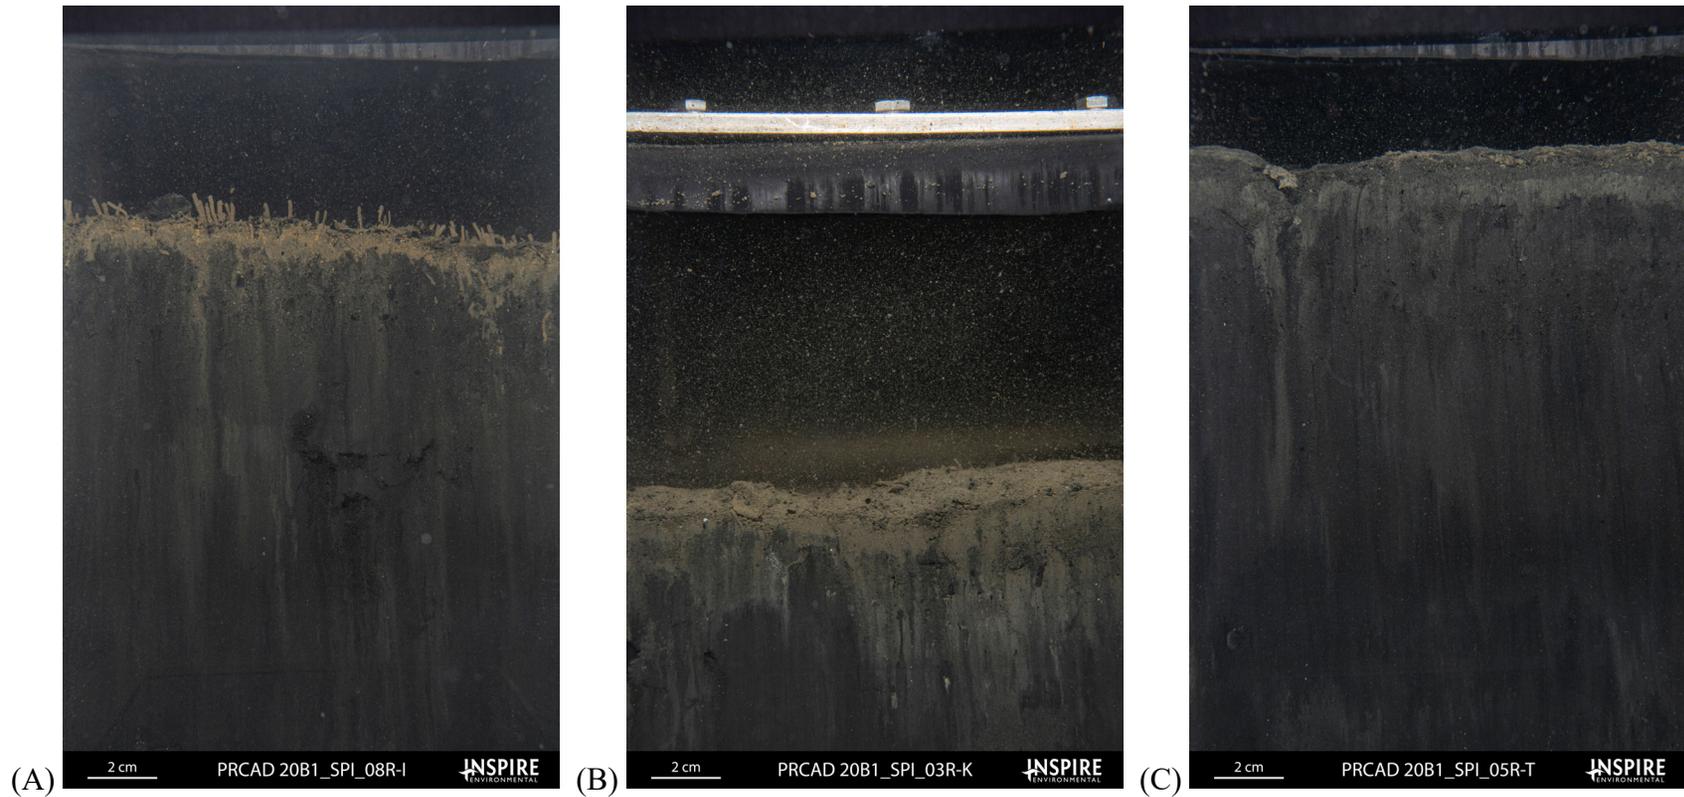
Figure 3-9. Representative sediment profile images at reference areas depicting typical physical characteristics, including predominantly silt/clay soft sediments with deep prism penetration, small biogenically-derived boundary roughness at (A) Station 08R, upstream of PRCAD (REF-North); and Stations (B) 03R and (C) 05R downstream of PRCAD (REF-South)
