Monitoring Survey at the Providence River Confined Aquatic Disposal Cells September/October 2020

Disposal Area Monitoring System – DAMOS

Contribution 211
October 2021

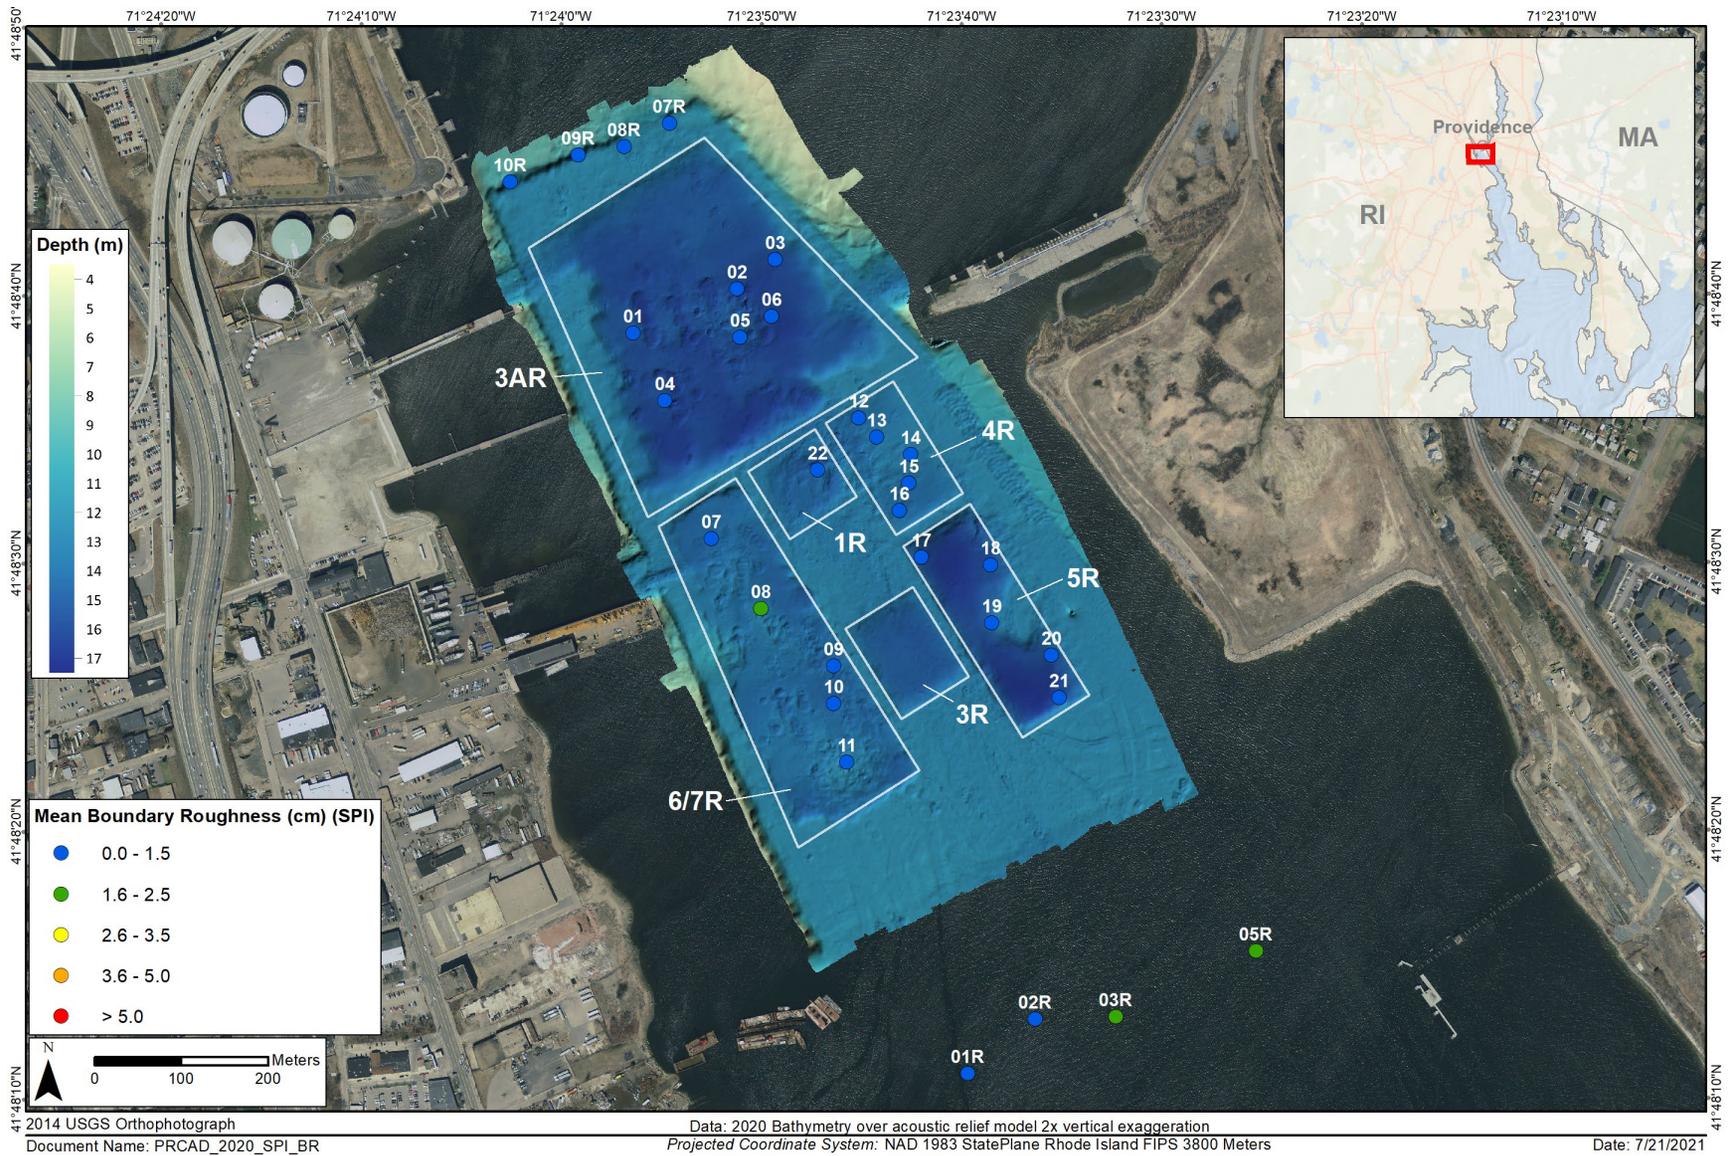
Small-scale boundary roughness measurements were between 0 and 1.5 cm at all stations within PRCAD, with the exception of Station 08 (Cell 6/7R) (Figure 3-11). At Station 08, a large burrow was observed that was transected by the SPI camera prism and resulted in a larger boundary roughness, averaging 2.2 cm at that station (Figures 3-11 and 3-18C; Appendix C). Small-scale boundary roughness was biogenic in origin at all stations within PRCAD (e.g., burrow openings, fecal mounds, and fecal stacks) (Appendices C and D).

Figure 3-11. Mean station small-scale boundary roughness (cm) at PRCAD and reference areas

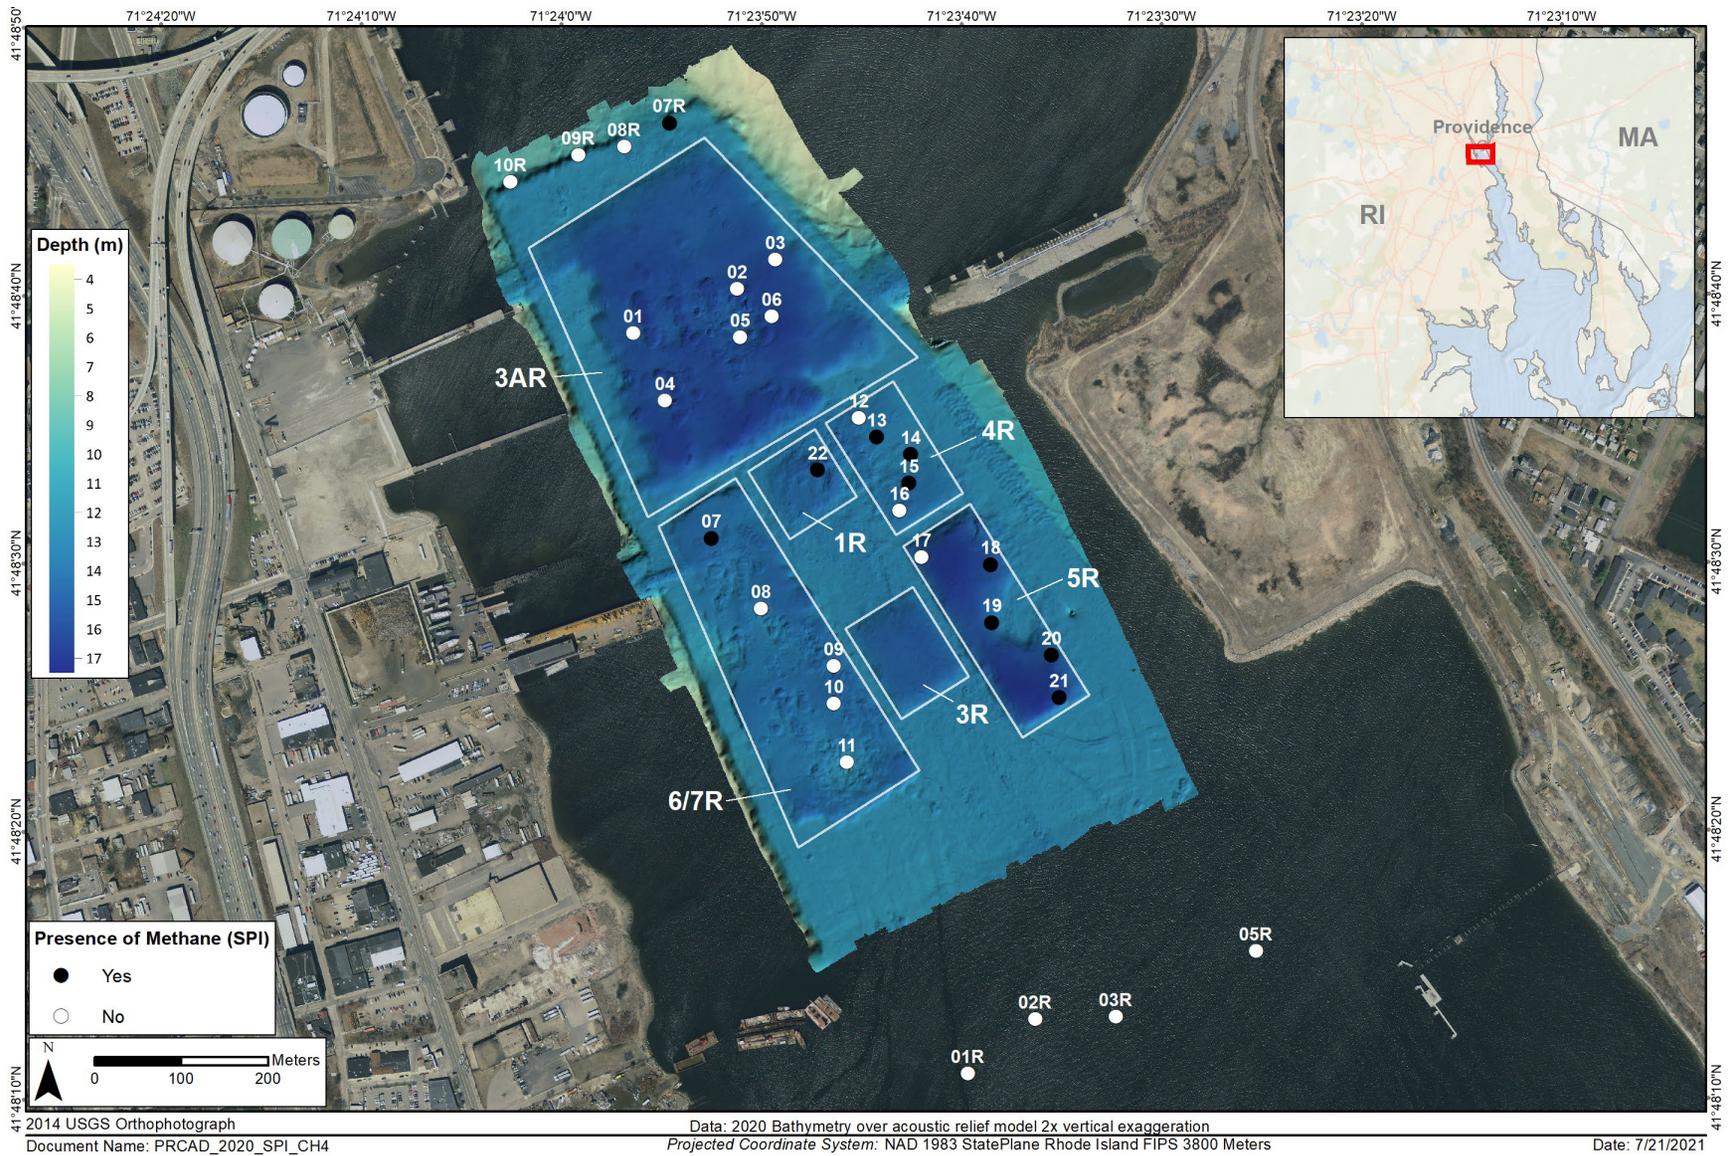
Methane was observed in SPI at one reference station in the REF-North area (Station 07R) (Table 3-2; Figure 3-13). Evidence of low oxygen conditions in the overlying water was observed at Station 07R (REF-North), where a continuous mat of *Beggiatoa* sp. was observed. *Beggiatoa* sp. was observed in the PV images at several other reference stations, but were characterized as trace levels (Stations 08R, 10R, 01R, and 02R) or patches (Station 05R) (Figure 3-14).

Methane was observed in SPI at nine stations at PRCAD, with the most frequent observations occurring in Cell 4R (three out of five stations had methane) and Cell 5R (four out of five stations had methane) (Table 3-2; Figure 3-13). *Beggiatoa* sp. was observed in the PV images collected at the majority of PRCAD stations, including all but three stations (Figure 3-14). The three stations where *Beggiatoa* sp. was not observed were grouped within the vicinity of each other in the central portion of Cell 3AR. *Beggiatoa* sp. was observed as continuous mats across the sediment surface (Stations 16 and 20), discrete patches on the sediment (all stations in Cell 6/7R), or as trace levels on the surface of the sediment (central area of PRCAD, Cell 4R and 1R). *Beggiatoa* sp. was also observed within the sediment column (observed in SPI) as distinctive small white threads at nine PRCAD stations (Appendix C). There were no instances where *Beggiatoa* sp. was observed in SPI but not in the associated PV (Appendices C and D).

Figure 3-13. Presence of methane observed in SPI at PRCAD and reference areas

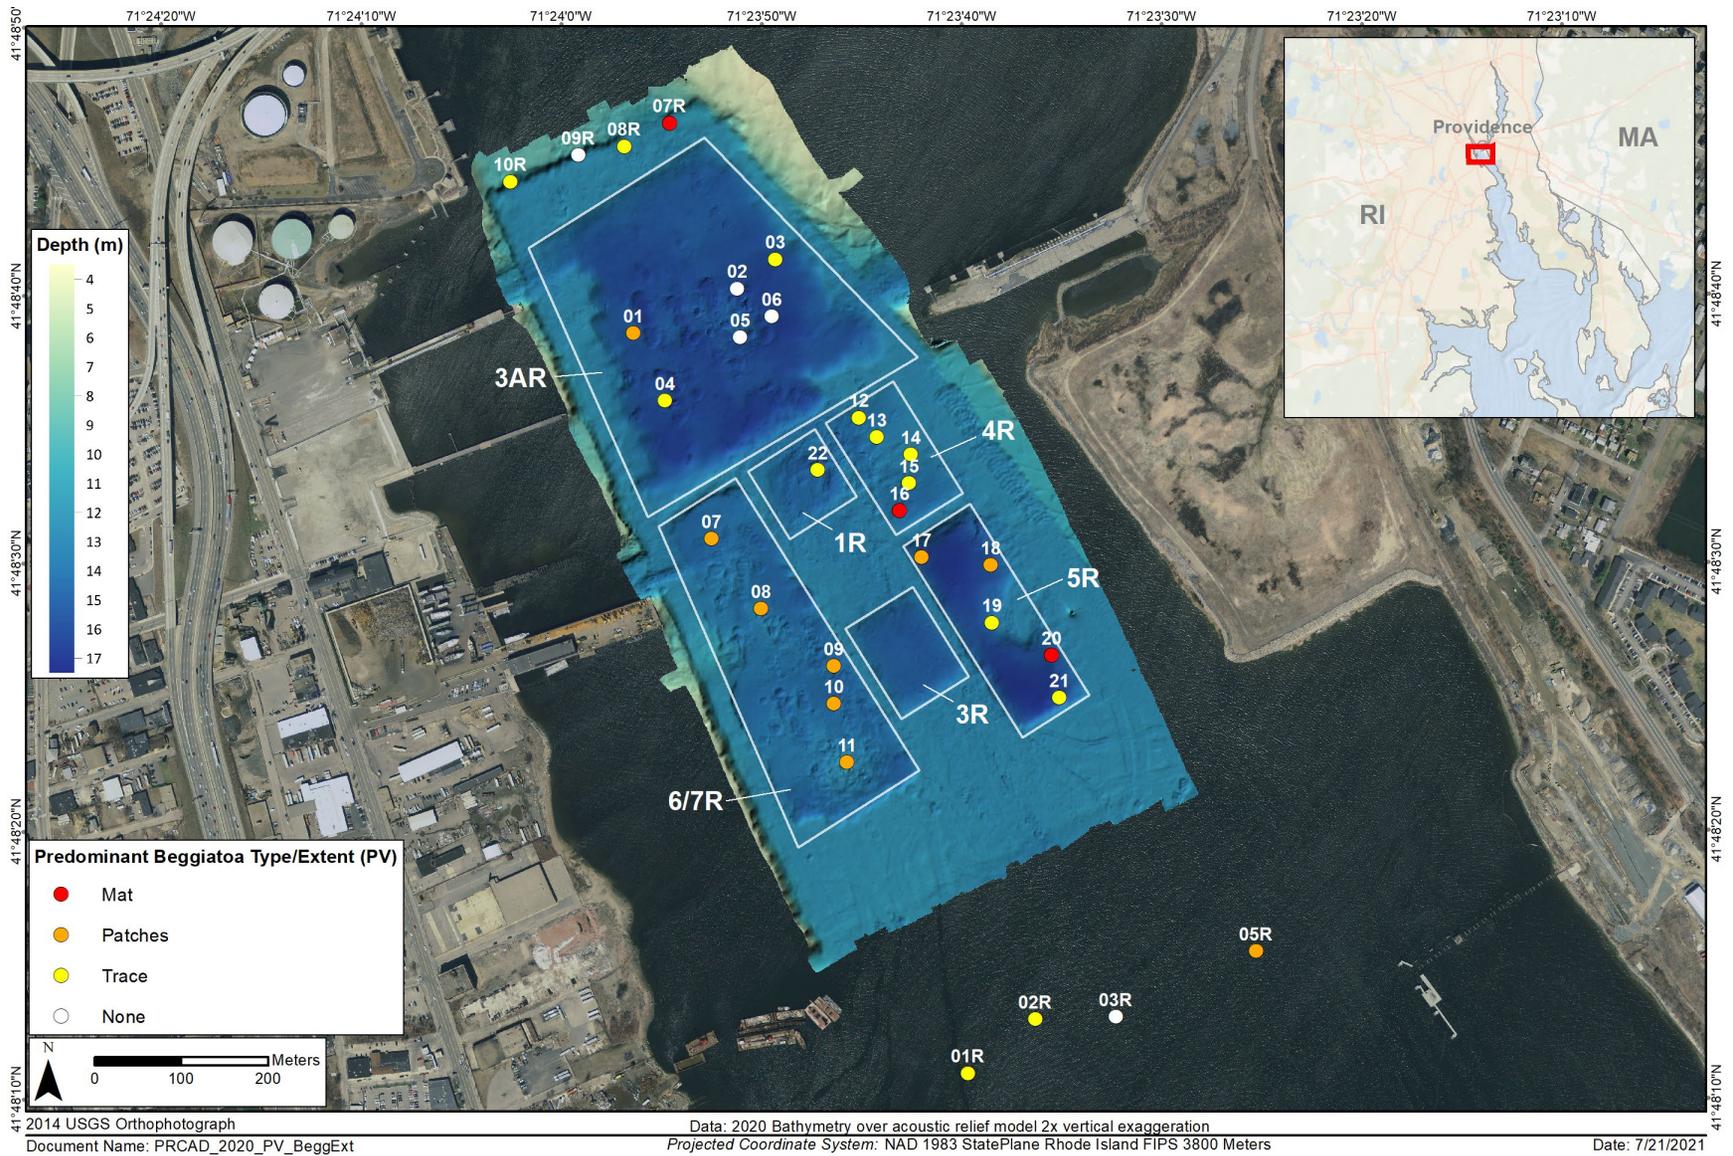
Figure 3-14. Presence and extent of *Beggiaatoa* sp. observed in PV at PRCAD and reference areas

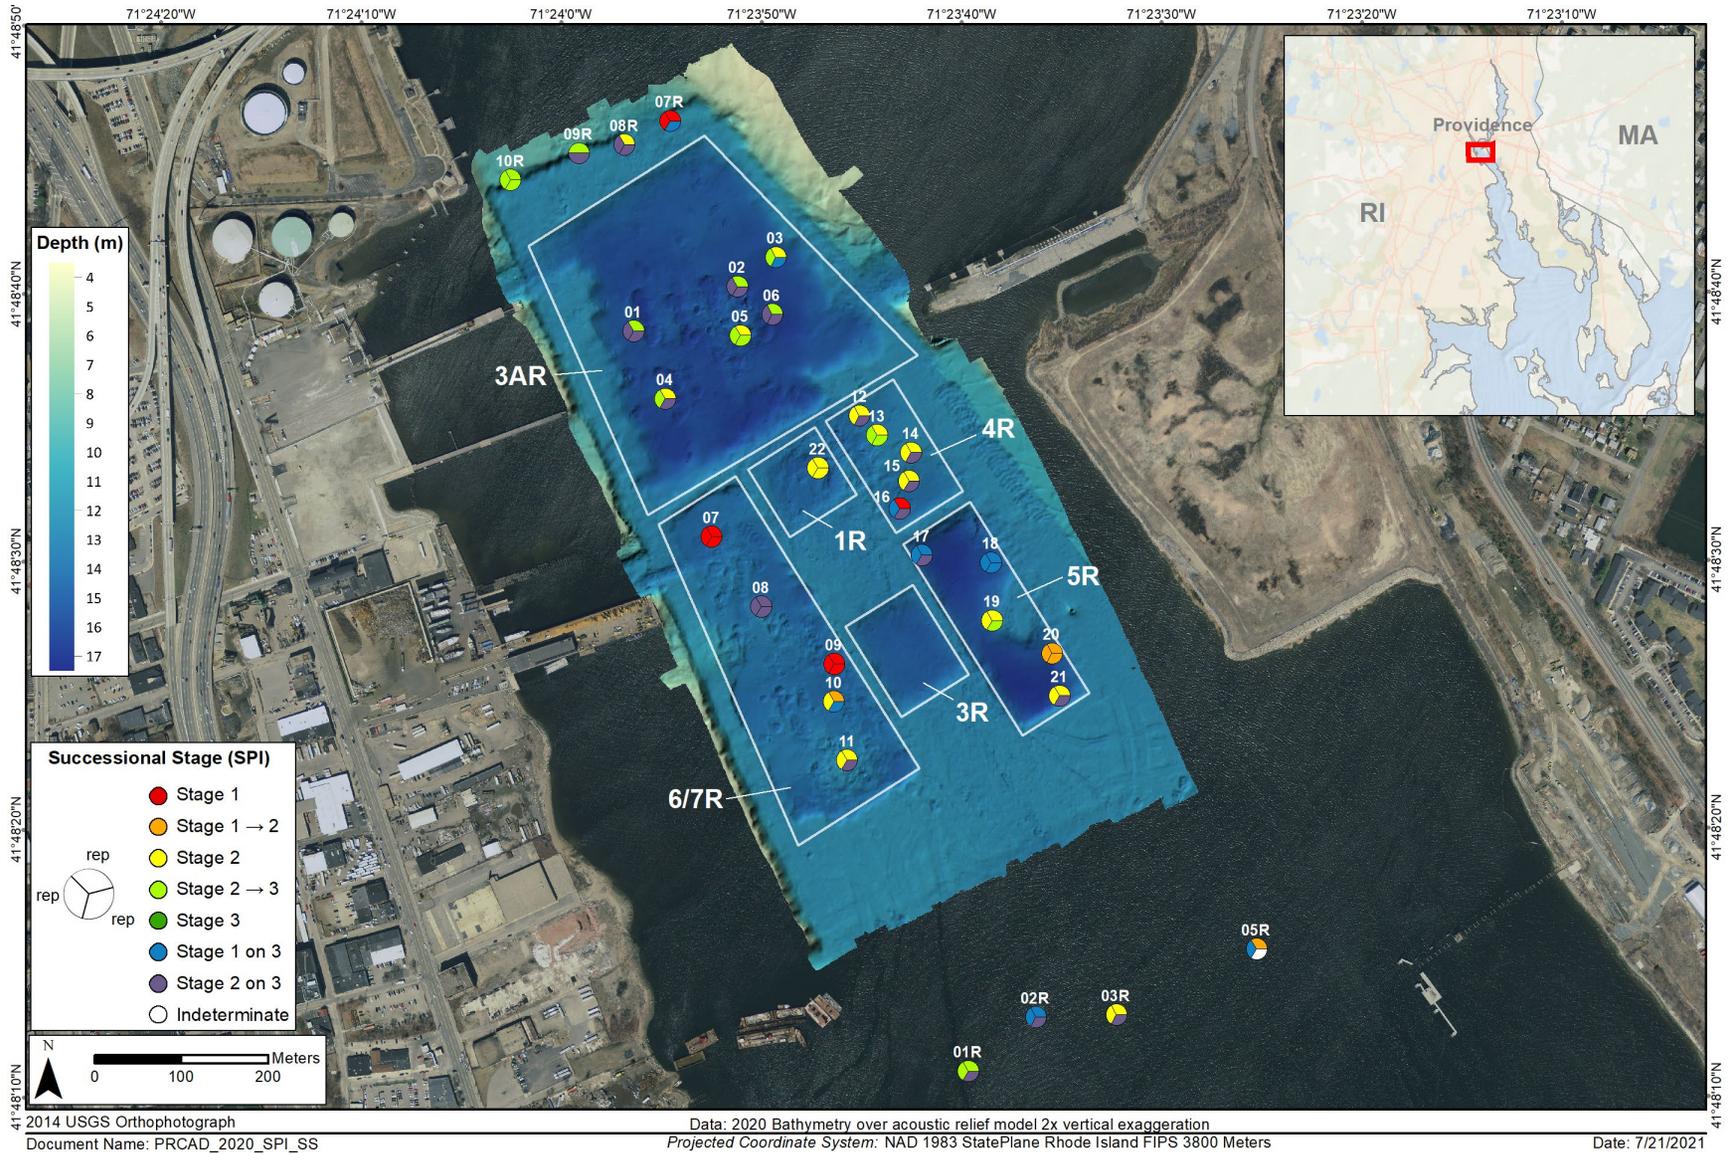
Infaunal successional stage was variable across reference stations (Figure 3-15). Deep subsurface voids, indicating the presence of Stage 3 infauna, were observed in at least one replicate at all but one reference station (no voids were documented at Station 10R) (Figures 3-15, 3-16, and 3-17A). High densities of Stage 2 tubicolous surface fauna were observed at all stations in REF-North, with the exception of Station 07R (Table 3-2; Figure 3-17B). Successional Stage 1 was documented at two replicate images at Station 07R within REF-North, where there was limited evidence of macrofaunal activity, although a subsurface void was observed at one replicate image at this station and was designated at Stage 1->3 (Table 3-2; Appendices C and D). Relatively large, symmetrically circular burrows were frequently observed in PV images at the reference stations (Figure 3-17). Given the characteristics of these burrows, it is possible they were formed by eels. Overall, the biological condition of the reference areas was considered stressed, with high respiration rates and low abundances of Stage 3 infauna.

Infaunal successional stage was variable across the PRCAD stations (Figure 3-15). Generally, infaunal successional stage was more advanced in Cells 3AR and 4R and less advanced in Cells 5R and 6/7R. Infaunal successional Stage 1 on 3 occurred mainly at stations located in 5R and 4R (Stations 16, 17, and 18), where either very small tubes or no tubes were observed at the sediment–water interface concurrent with subsurface voids. These voids were generally small with no oxic layer around them (Figure 3-20A). Infaunal successional Stage 2 on 3 was frequently observed in Cells 3AR and 4R, as denoted by the presence of Stage 2 tubicolous surface fauna at the sediment–water interface and typically small subsurface voids at depth (Figure 3-20B). The presence of large burrows observed in PV images were generally an indication that Stage 3 deep burrowing infauna were present,

Figure 3-15. Infaunal successional stages at PRCAD and reference areas. Results shown provide a value for each of three replicate images at each sampling station.

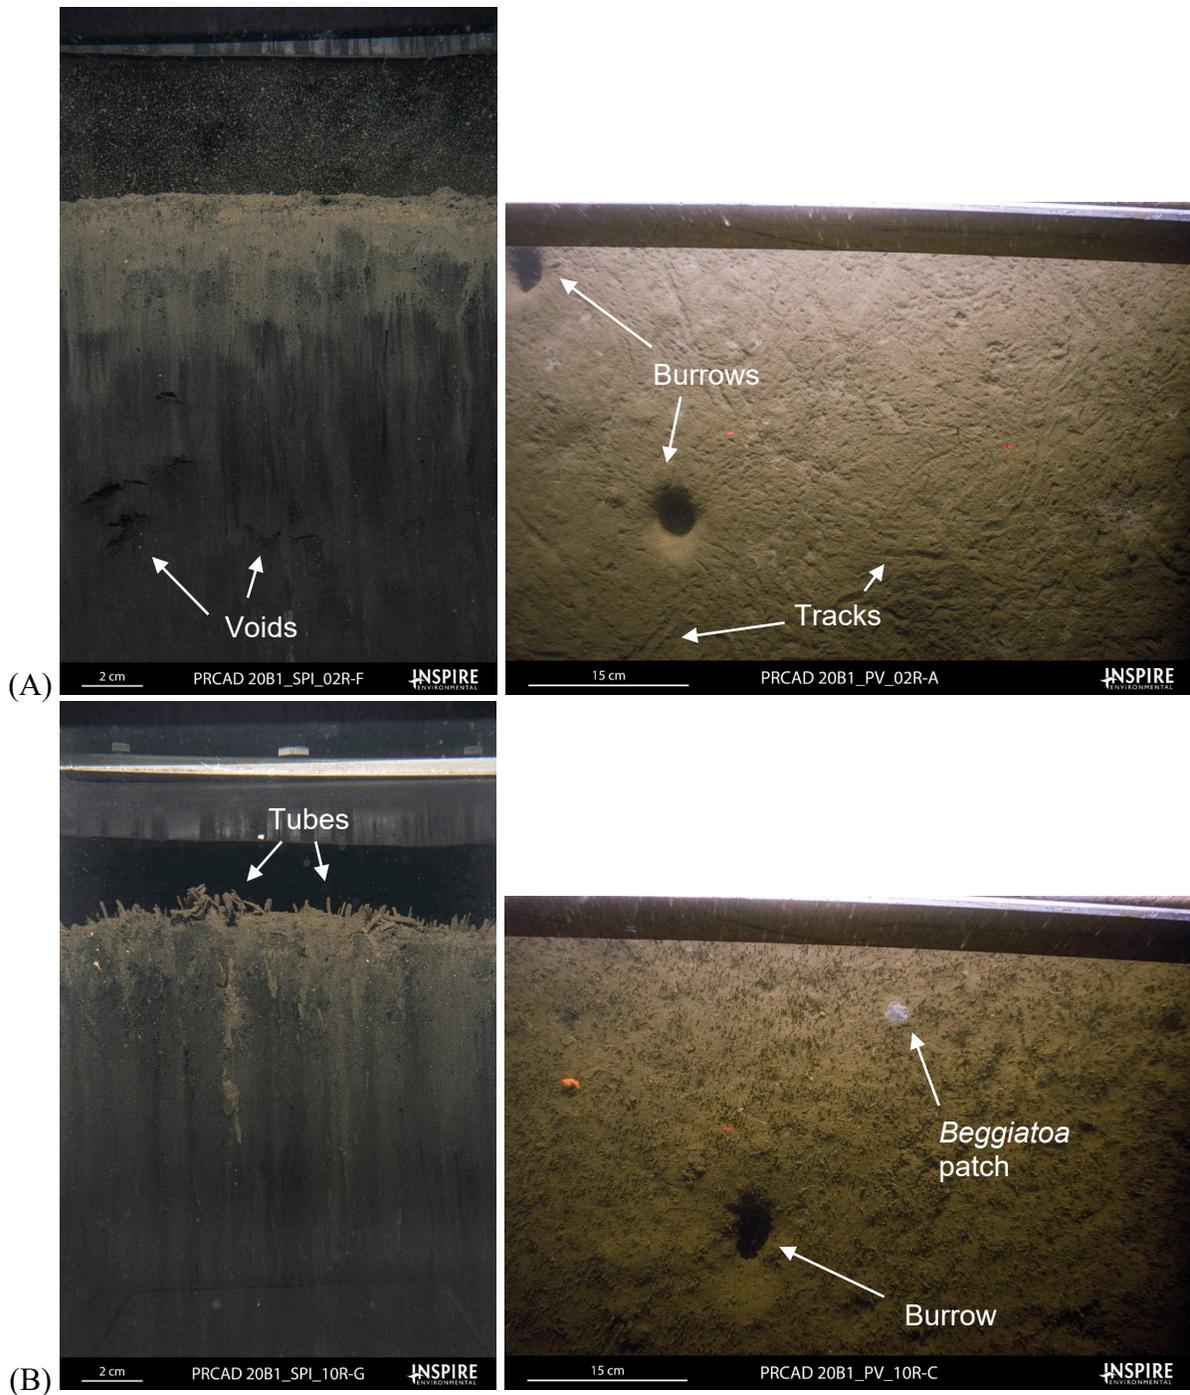
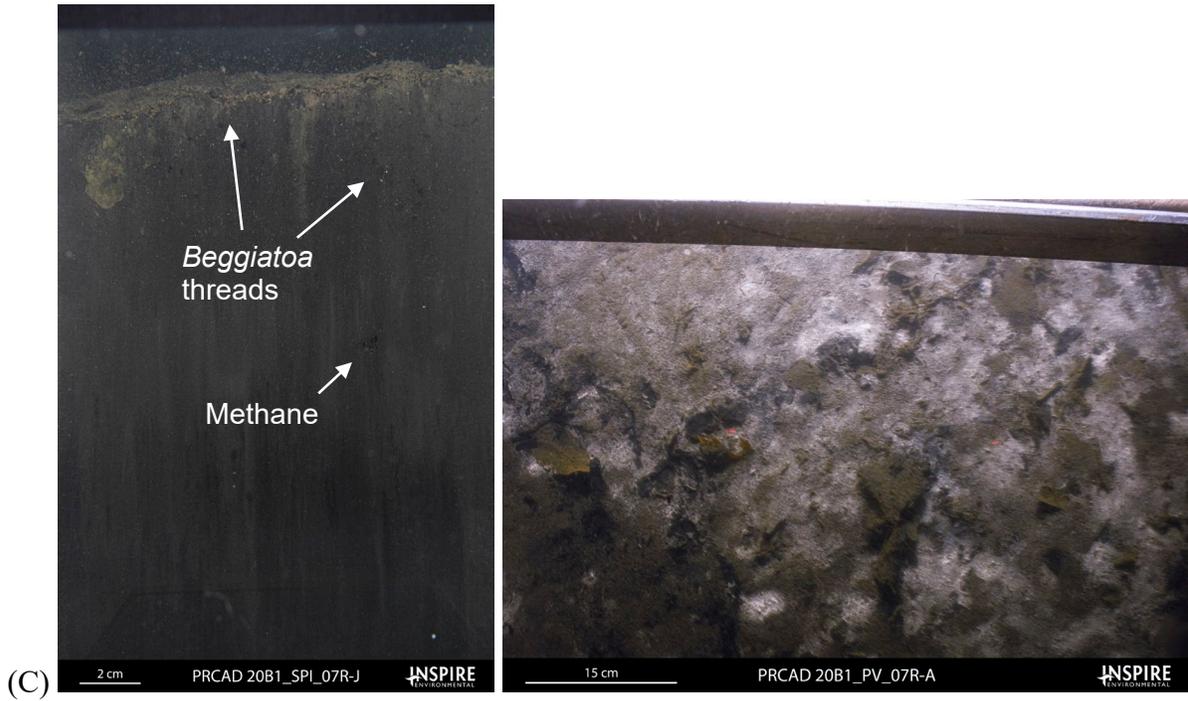
Figure 3-17. Representative sediment profile and plan view images depicting infaunal successional stages at reference stations: (A) Stage 3 at Station 02R downstream of PRCAD, with deep voids, oxygenated burrow features, and large burrows and tracks across the sediment surface; (B) Stage 2->3 at Station 10R upstream of PRCAD with dense tubes on the sediment surface, a large burrow and small patch of *Beggiatoa* sp.; and (C) Stage 1 at Station 07R upstream of PRCAD, with limited infaunal activity, methane in the sediment column, and threads of *Beggiatoa* below the SWI

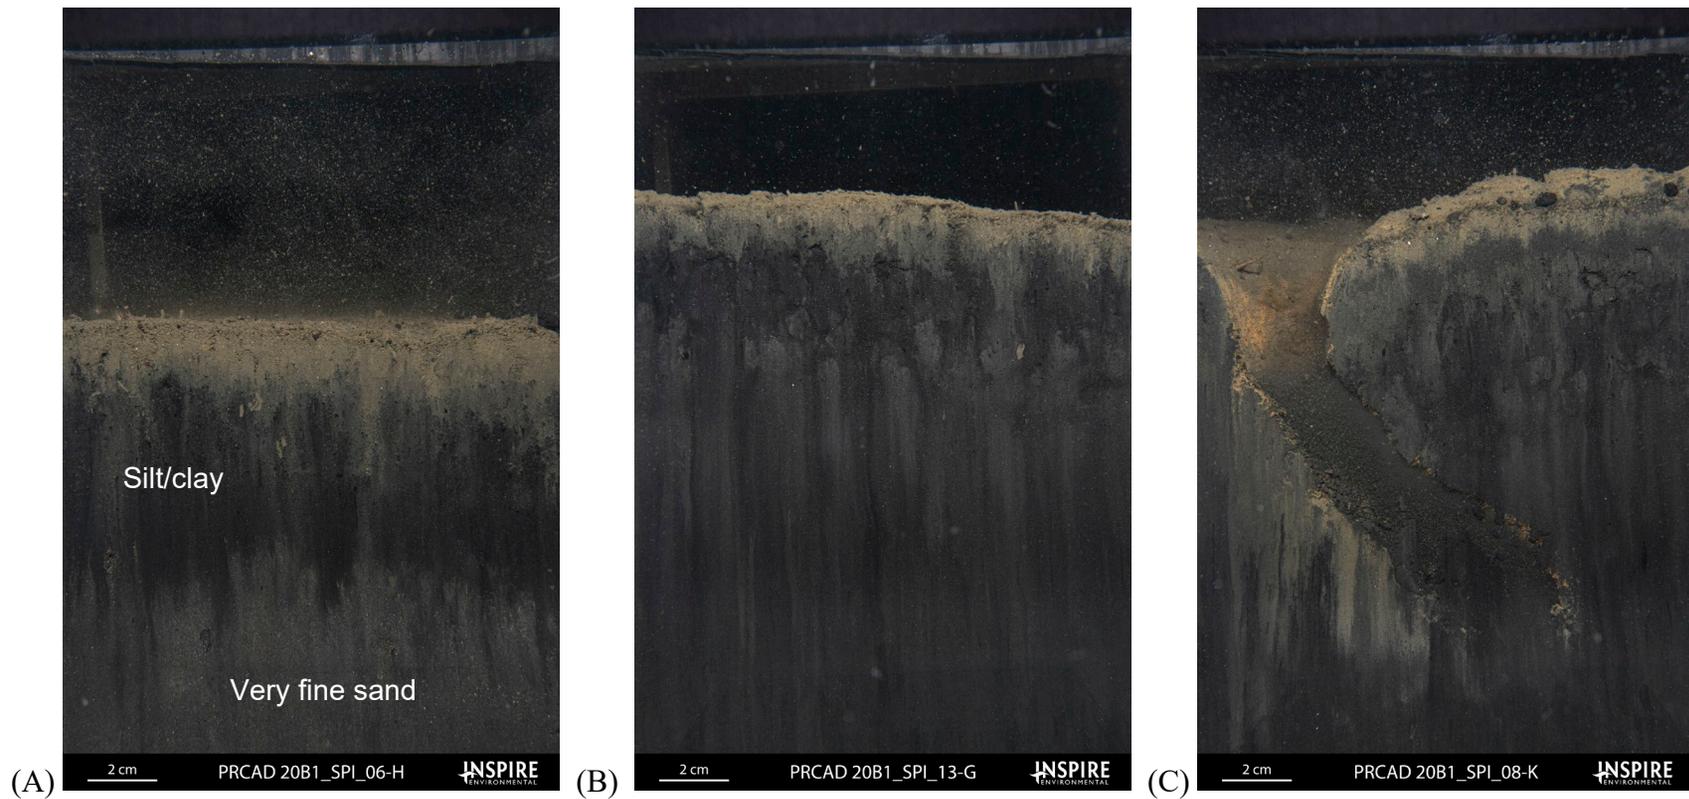
The predominant grain size major mode observed across the majority of PRCAD stations was silt/clay. The only exceptions were two stations within 3AR that consisted of a surficial layer of silt/clay overlying very fine sand (Stations 02 and 06) (Figures 3-8 and 3-18A).

Figure 3-18. Representative sediment profile images depicting physical characteristics at PRCAD stations, including (A) a surficial layer of silt/clay overlying very fine sand at Station 06 (Cell 3AR); (B) deep prism penetration, typical of the soft sediments, at Station 13 (Cell 4R); and (C) relatively high boundary roughness at Station 08 (Cell 6/7R) due to a deep burrow, likely from an eel

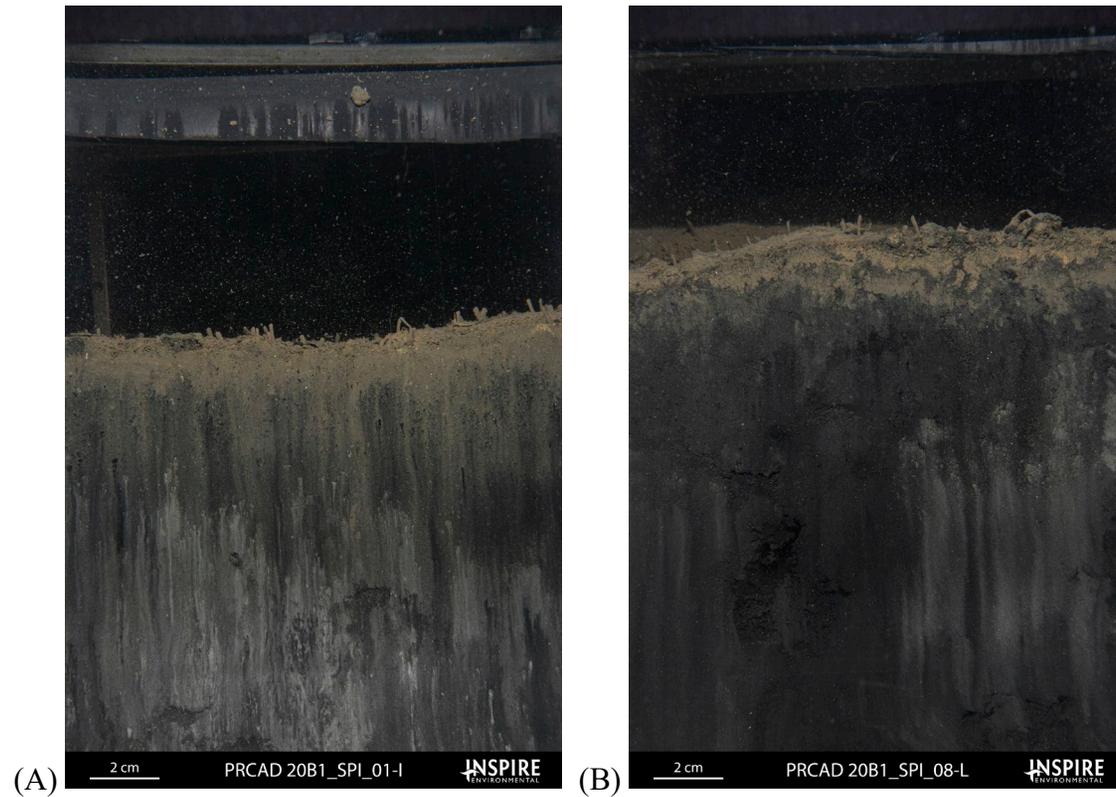
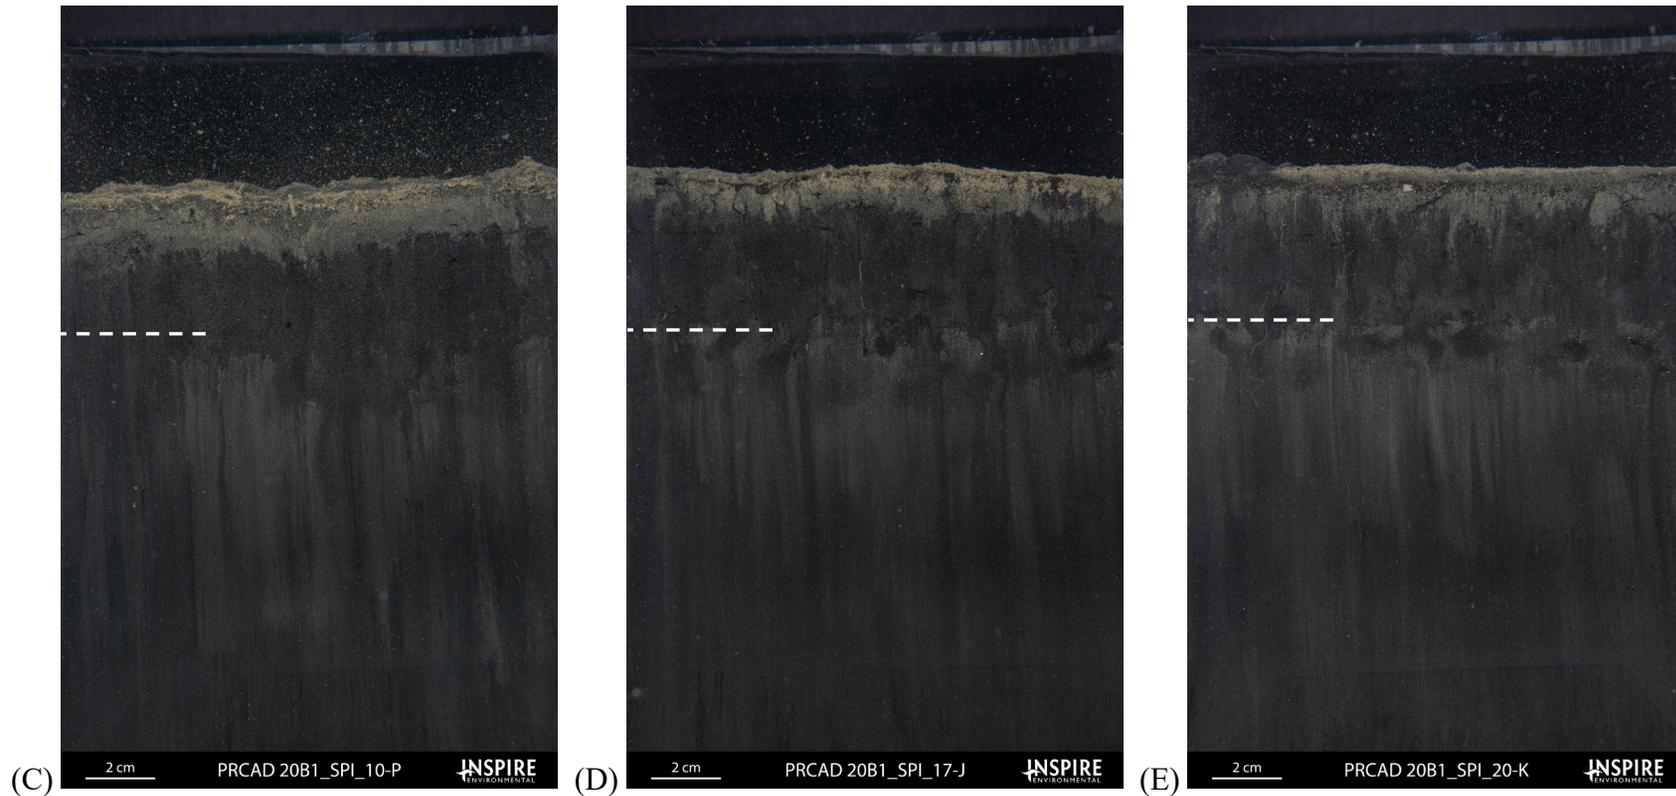
Several physical features observed in SPI across PRCAD stations were indicative of dredged material. Evidence of dredged material observed in SPI included subsurface layers with abrupt horizons indicative of depositional events and patches of mottled white and light gray clay (Figure 3-19). Notably, the lack of distinct dredged material is not an indication that dredged material was not present; dredged material placed at PRCAD was generally similar in sediment composition and physical characteristics as the ambient sediments in this area, therefore a clear distinction between dredged material and native sediments was not expected.

Figure 3-19. Representative sediment profile images depicting features indicative of dredged material presence, including layers and patches of white and light gray clay at (A) Station 01 (Cell 3AR) and (B) Station 08 (Cell 6/7R); and distinct, abrupt subsurface sediment horizons indicating discrete depositional event at (C) Station 10, (D) Station 17, and (E) Station 20

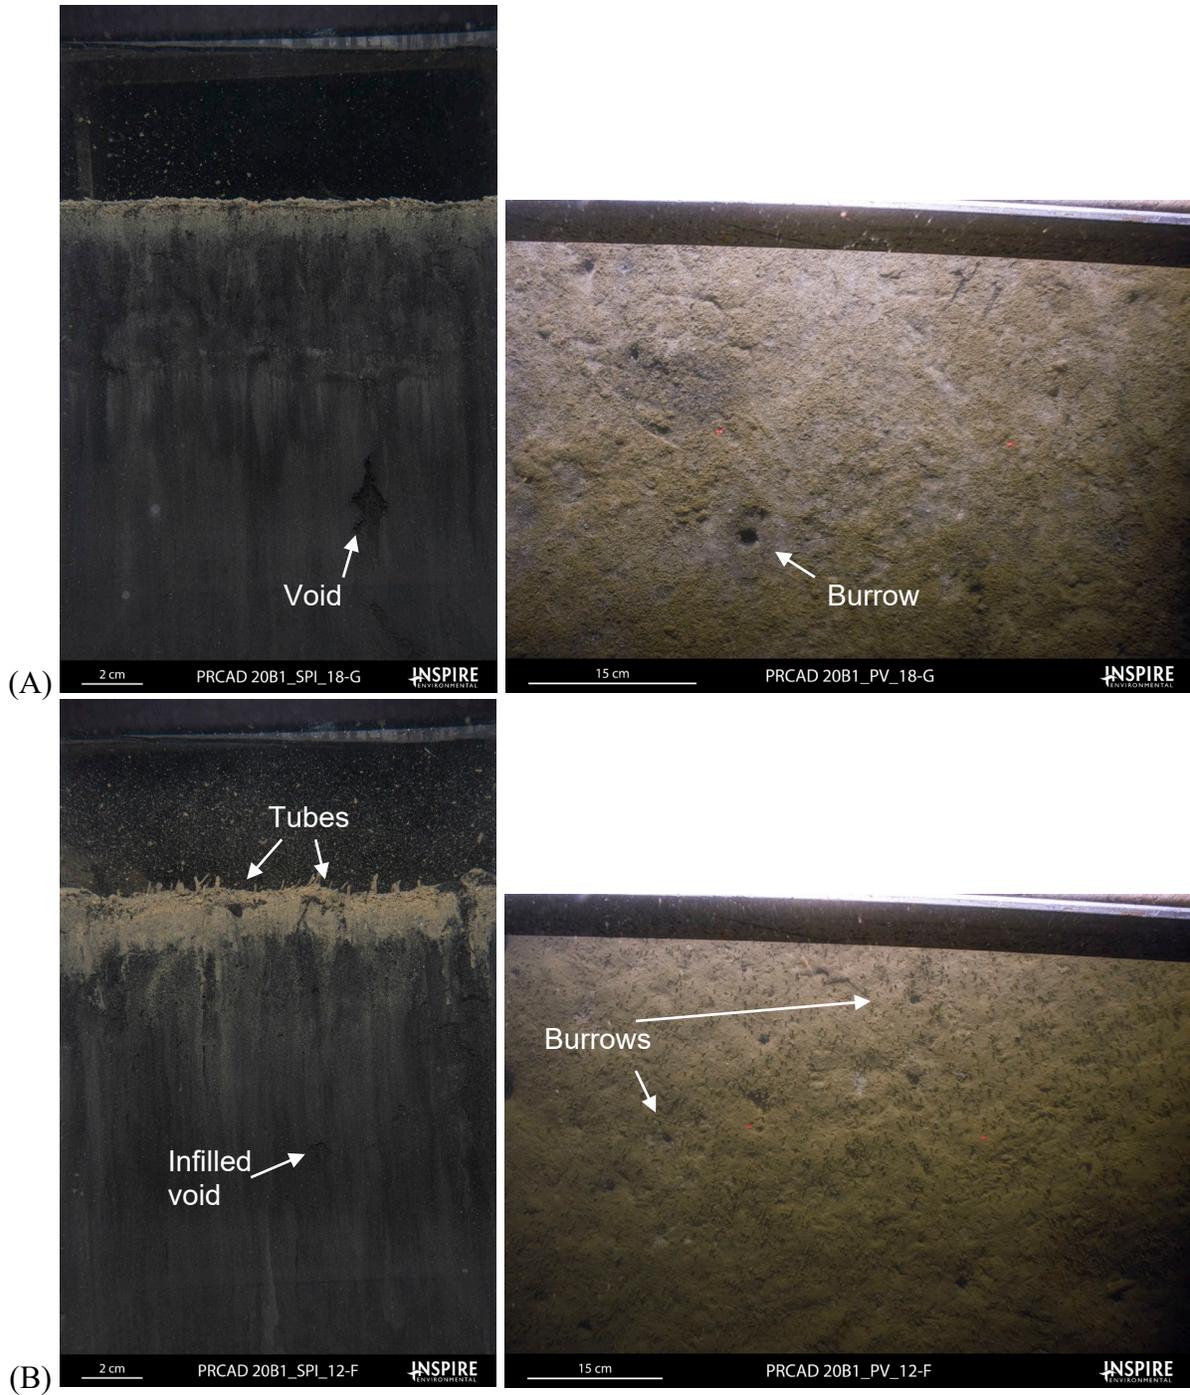
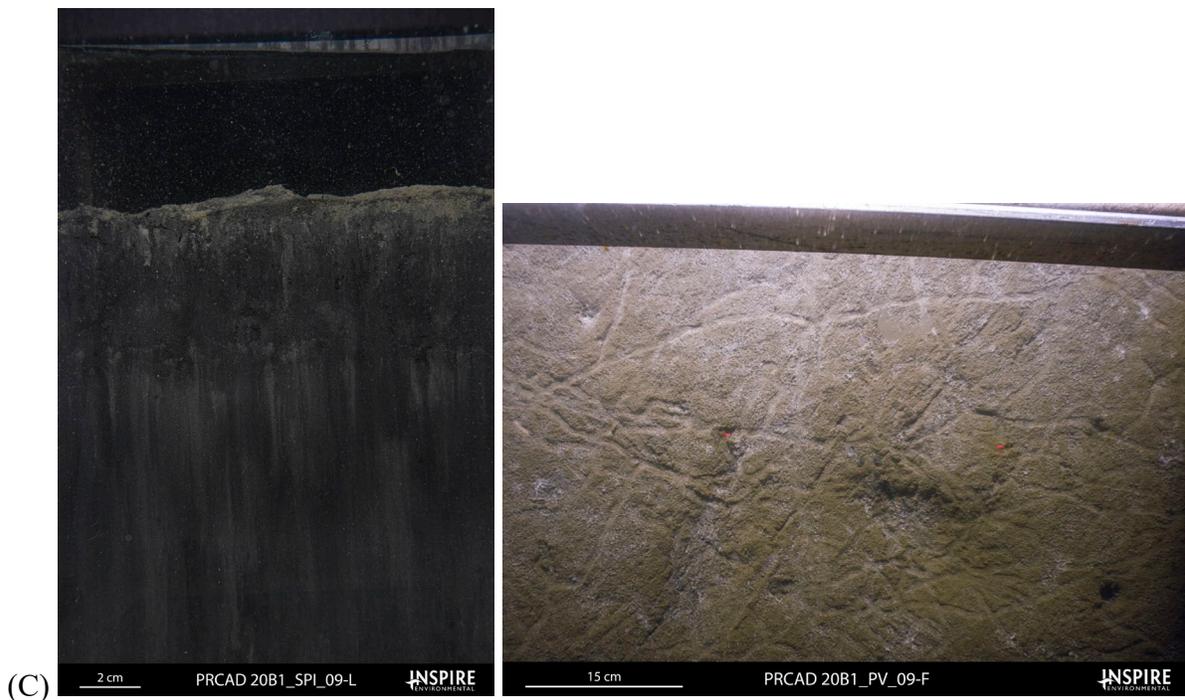
Figure 3-20. Representative sediment profile and plan view images depicting infaunal successional stages at PRCAD stations including: (A) Stage 1 on 3 at Station 18 (Cell 5R) with a large burrow in plan view image with patches of *Beggiatoa* across the sediment surface, shallow burrowing, and a large void at depth in SPI; (B) Stage 2 on 3 at Station 12 (Cell 4R) with numerous Stage 2 tubes at the surface and small burrows in PV, shallow burrowing, and small infilled voids at depth in SPI; and (C) Stage 1 at Station 09 (Cell 6/7R) with numerous epifaunal tracks across the surface in PV, and very shallow aRPD depth and limited biological activity in SPI

R3: At this time, SPI and PV data suggest the biological community is recolonizing at PRCAD, with similar communities present compared with the reference areas. As a result, capping the cells does not appear to be necessary to provide suitable habitat conditions.

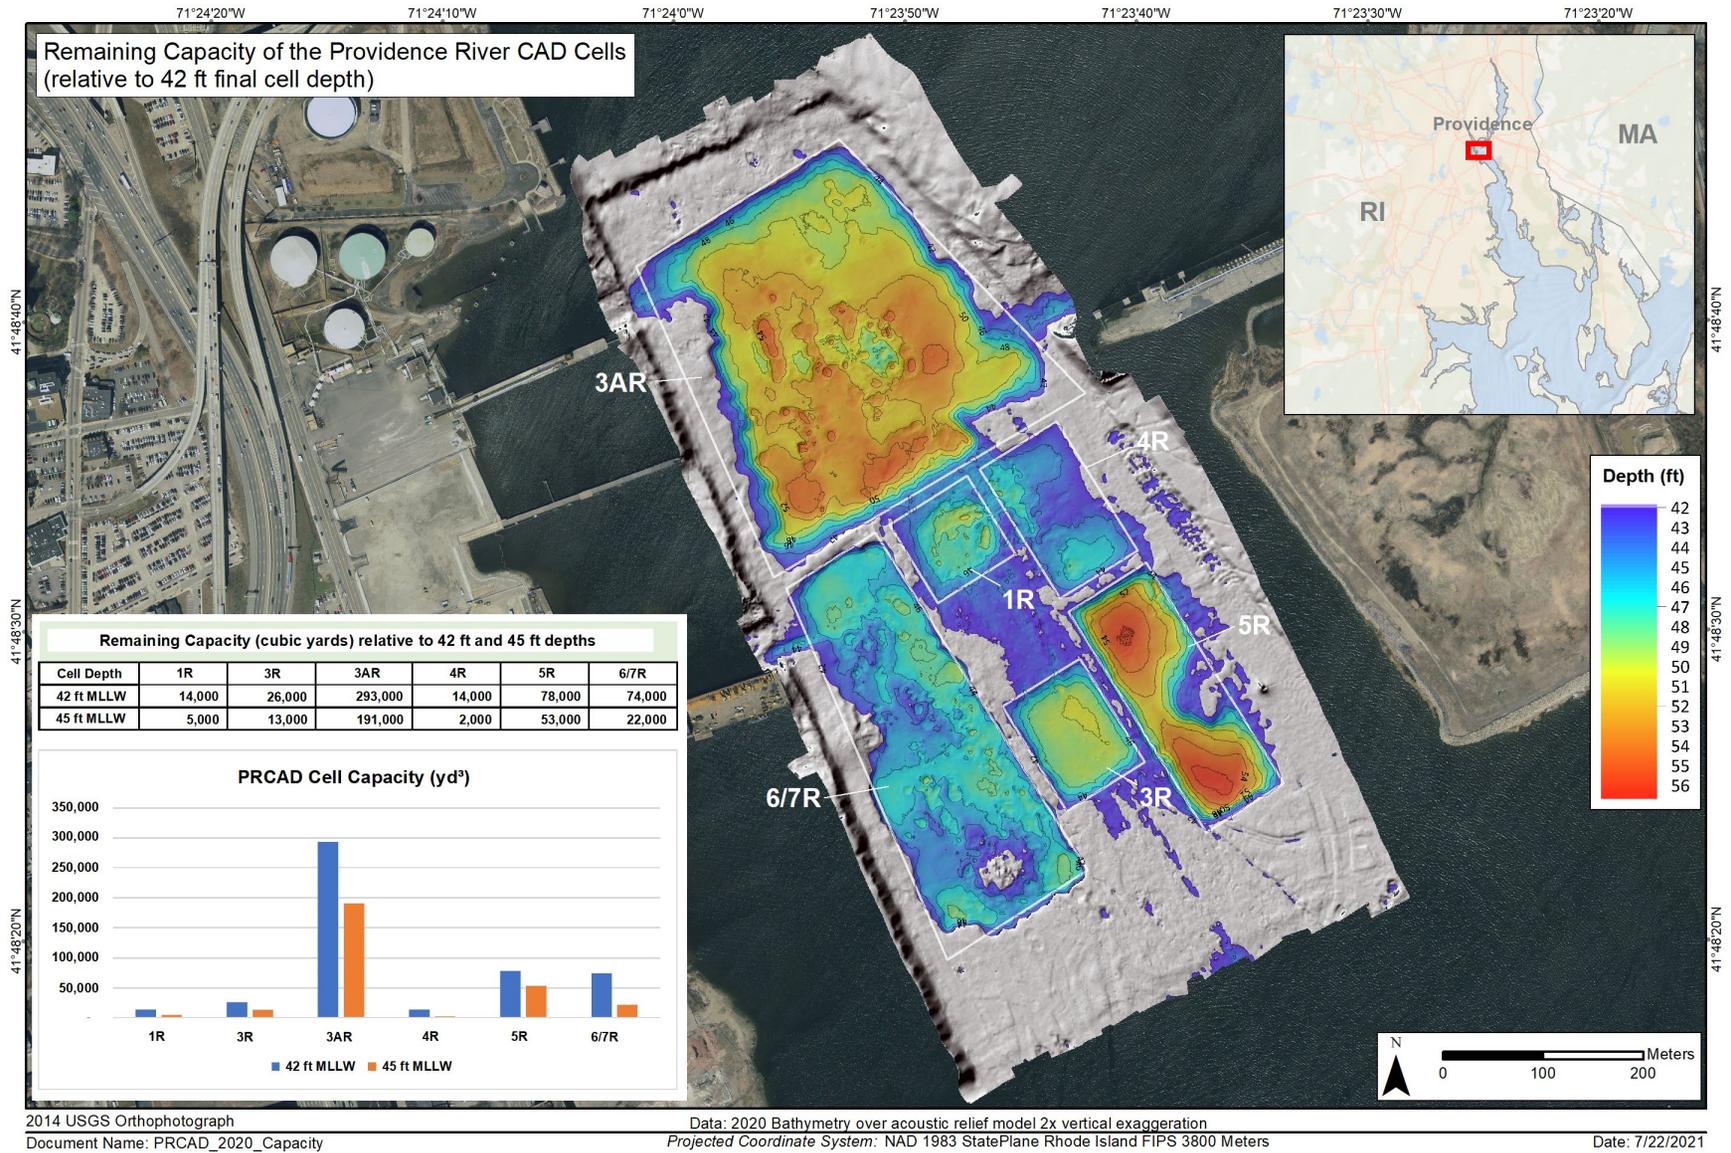
Figure 4-1. Estimated remaining capacity by cell at PRCAD targeting 42 ft depth, visualized using bathymetry over acoustic relief. Inset shows volume remaining in each cell targeting two depth scenarios (42 ft and 45 ft).

Cell 3AR has the greatest remaining capacity with approximately 290,000 yd³ remaining when filled to 42-ft depth and 190,000 yd³ of that volume available for unsuitable material. The deepest areas of Cell 3AR, and therefore where future dredged material placement is recommended, are generally in the southwest corner, as well as in pockets along the southern boundary and eastern portion of the cell. Cell 5R has ~78,000 yd³ of remaining capacity when filled to 42-ft depth with 53,000 yd³ available for unsuitable material. Specifically, discrete areas in the northern and southern portions of Cell 5R, have the greatest capacity and are recommended for future disposal placement. Cell 6/7R has a remaining capacity of ~74,000 yd³ but with existing depths extending just 3 to 4 ft below the target depth of 42 ft only 22,000 yd³ of this capacity is available for unsuitable material. Cell 3R is consistently about 5 ft below the target depth of 42 ft, with a remaining capacity of ~26,000 yd³ and approximately half of this volume available for unsuitable material. Cells 1R and 4R each have less than ~5,000 yd³ of capacity remaining for unsuitable material, so additional dredged material placement in these cells should be limited to suitable material only.

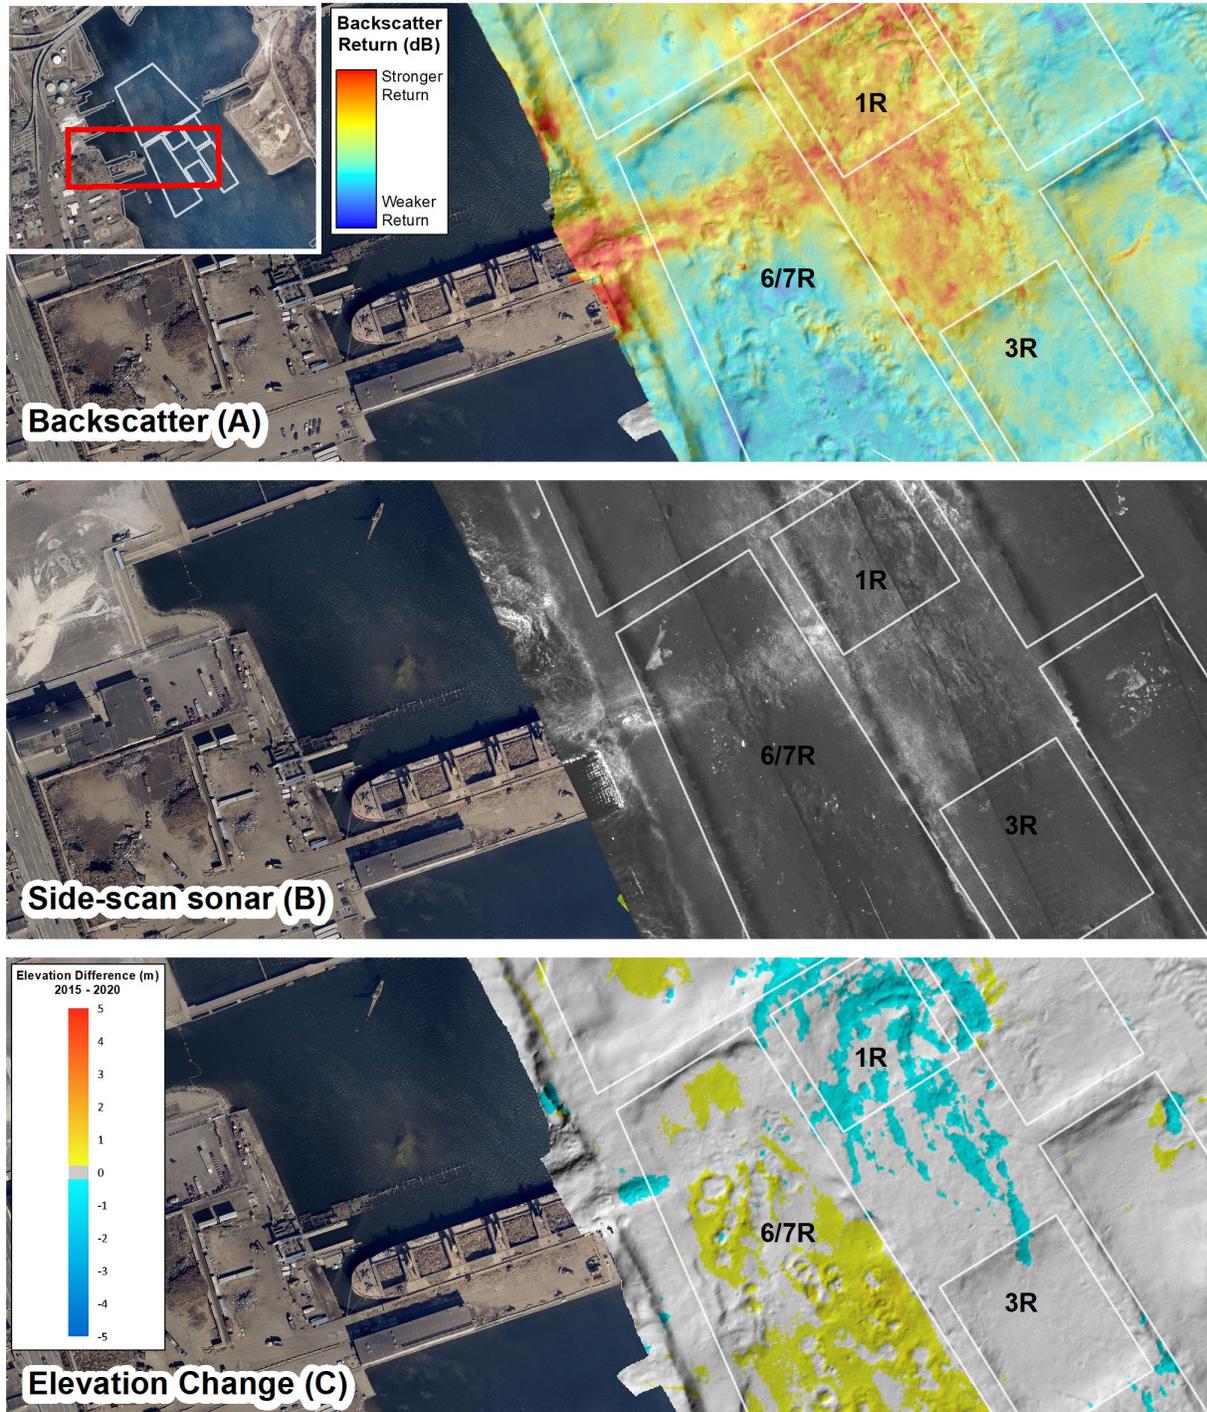
Figure 4-2. Area of potential propellor outwash as seen in (A) backscatter; (B) side-scan sonar; and (C) elevation change model
