Monitoring Survey at the Providence River Confined Aquatic Disposal Cells September/October 2020

Disposal Area Monitoring System – DAMOS

Contribution 211
October 2021

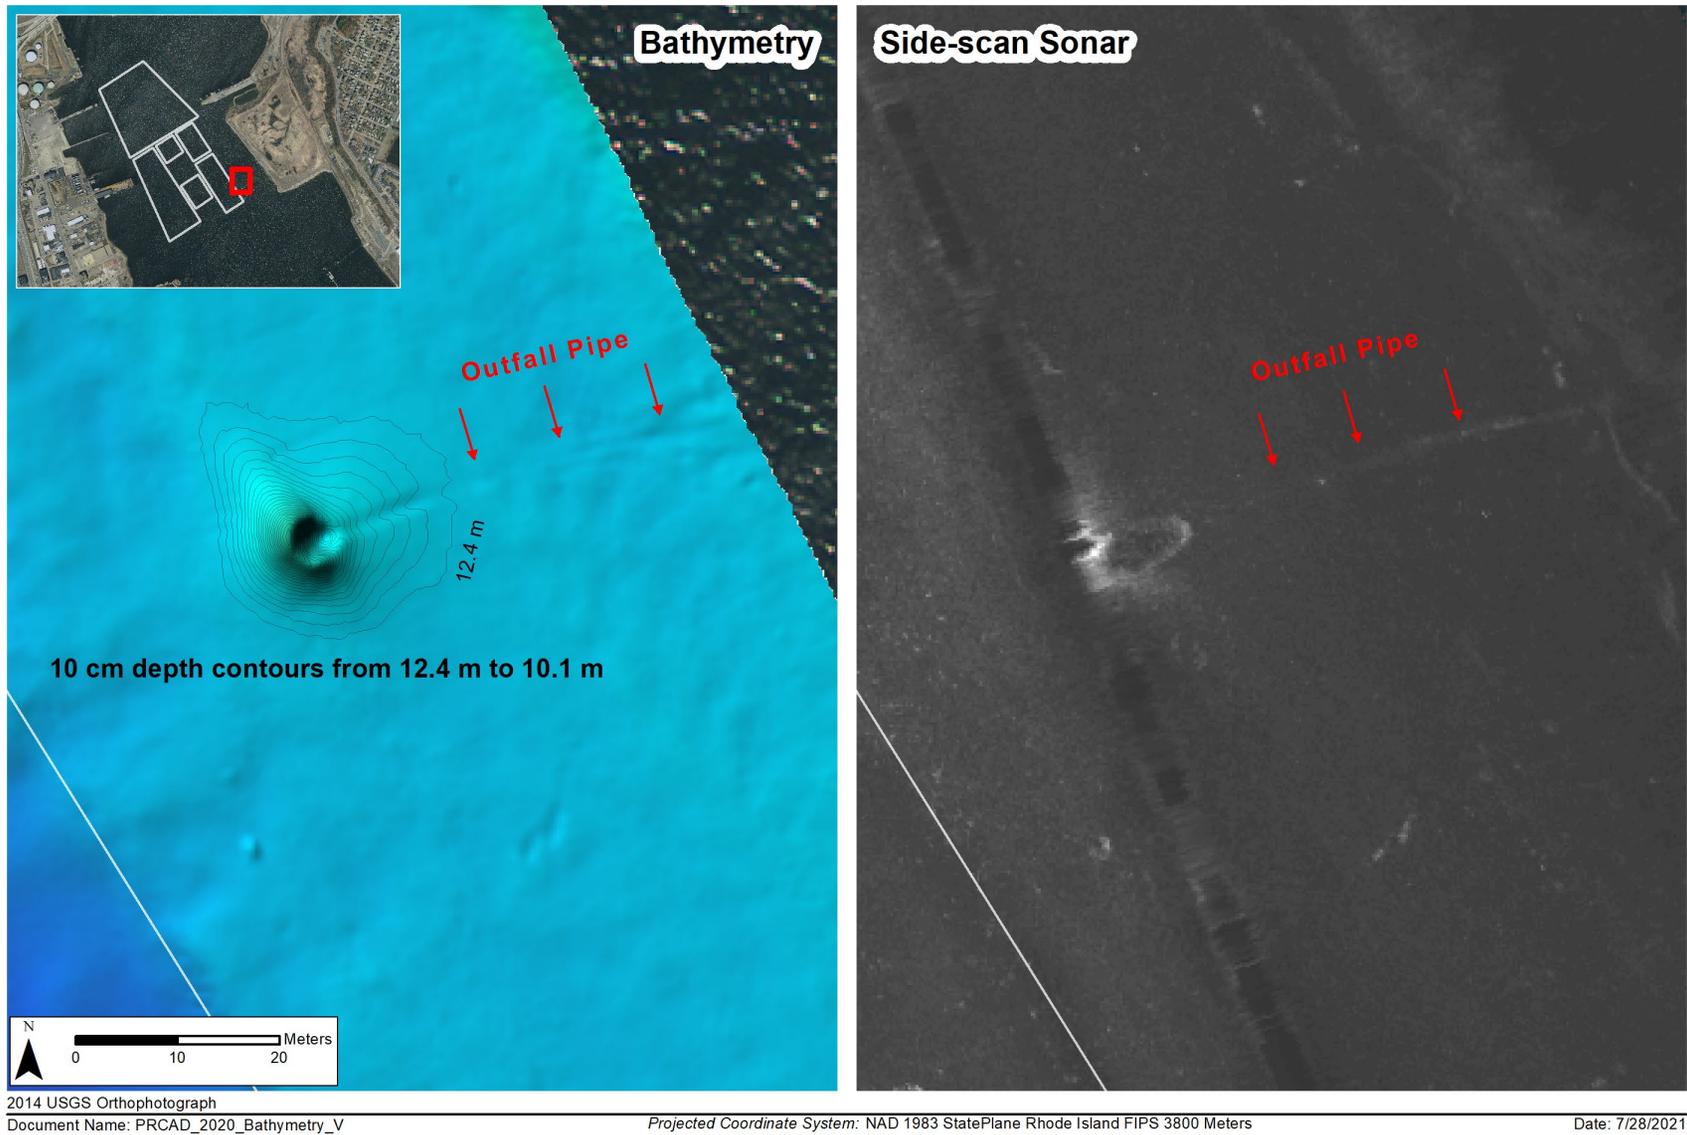
A small volcano-shaped mound was observed in the bathymetry to the east of Cell 5R (Figure 4-3). The steep mound formation rose nearly 2 m above the surrounding channel peaking at 10.1 m depth. A linear feature on the seabed traversing from the east of the mound terminated at the large crater in the middle of the mound. This feature appears to have been created by a dewatering discharge pipe that terminates at the volcano-shaped mound. The dewatering pipe was detected in side-scan sonar returns (Figure 4-3) and originates in a shore-side dredged material dewatering area situated immediately to the east.

Figure 4-3. Dewatering pipe and deposit as seen in bathymetry and side-scan sonar
