Daily Report

Project:	Durham Meadows Pipeline Installation	Date:	October 1, 2019
Location:	South Main Street, Middletown CT	Day of Week:	Tuesday
Project #:	AECOM: 60445033	Report No:	9
Contractor:	Ludlow Construction	Page:	2 of 8

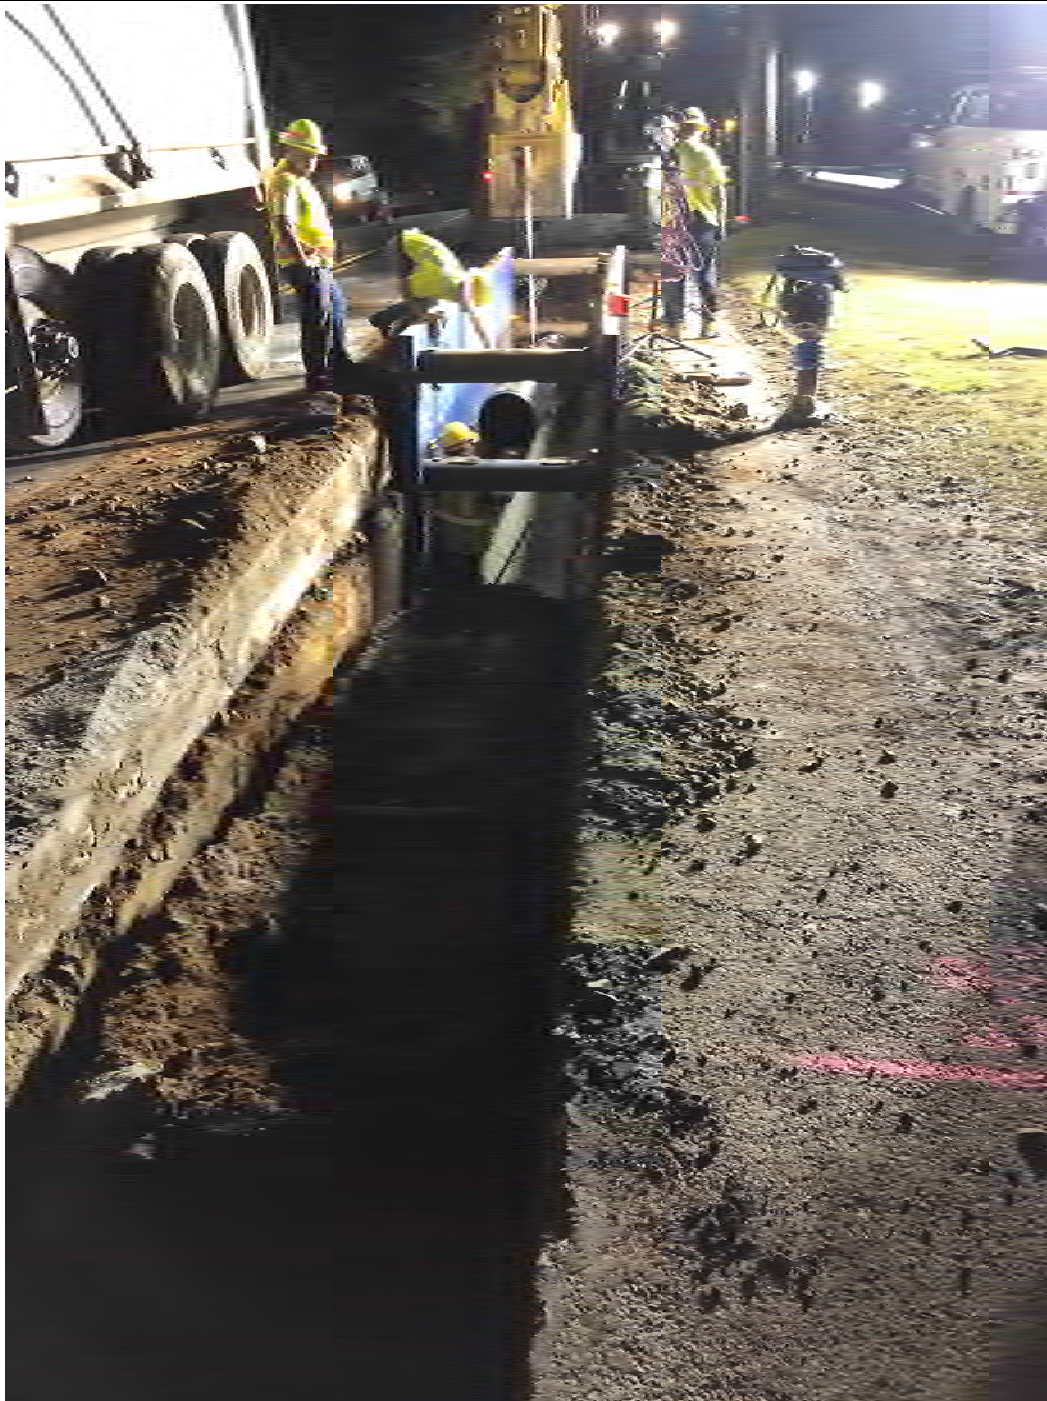
Figure 1 – Lowering second pipe section into trench

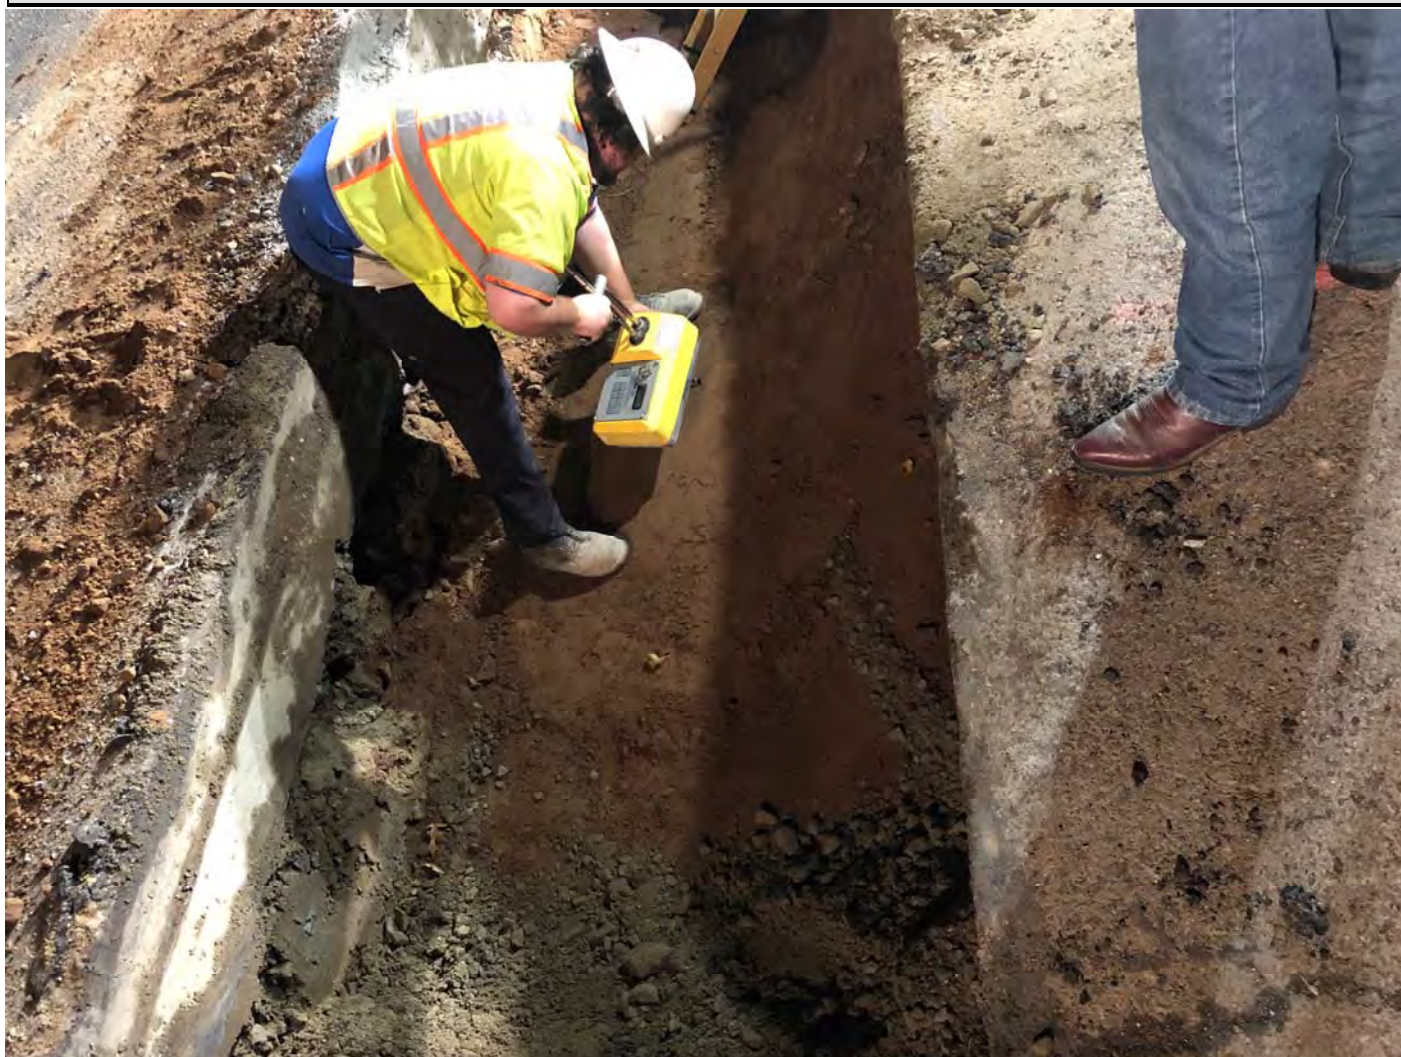
- 2050 – compacting (plate compactor) over 1st, 2nd sections, then compaction testing
 - Failed compaction test, recompacting
 - Passed after 2nd compaction

Figure 2 – Compaction testing above 1st pipe section

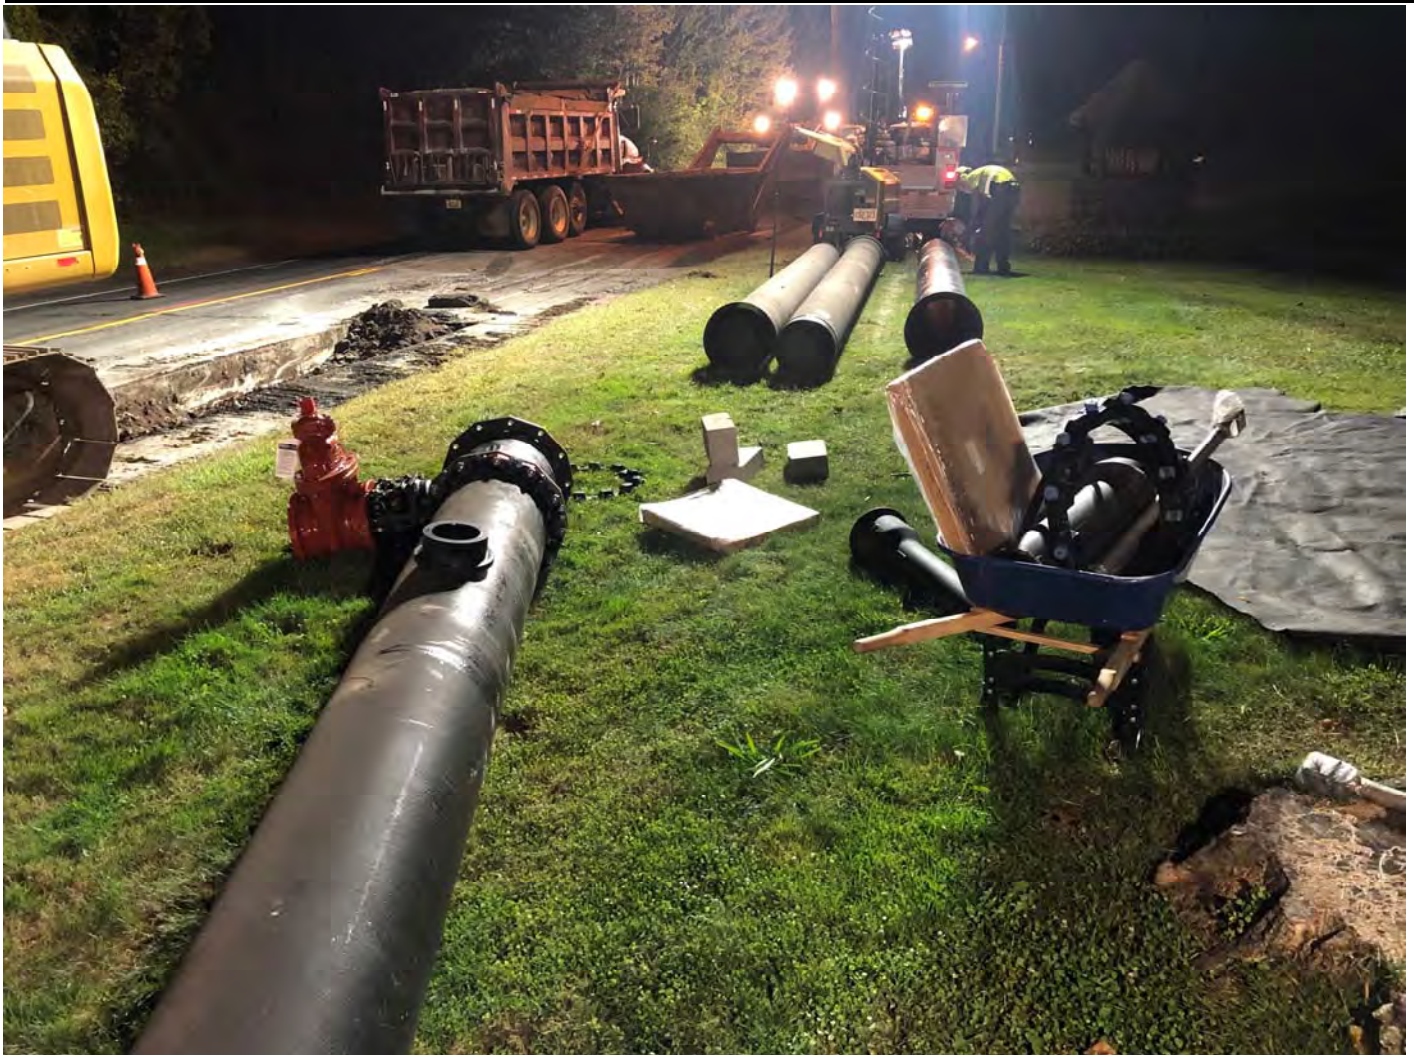
- Trenching for 4th section
- 2150 – 5th section attached, continuing trenching, gate valve section assembled
- 2215 – attaching 6th section with tee section and gate valve located at about Sta. 108+67, then filling overtop

Figure 3 – Assembled Tee and Gate Valve with parts, cutting pipe section in background

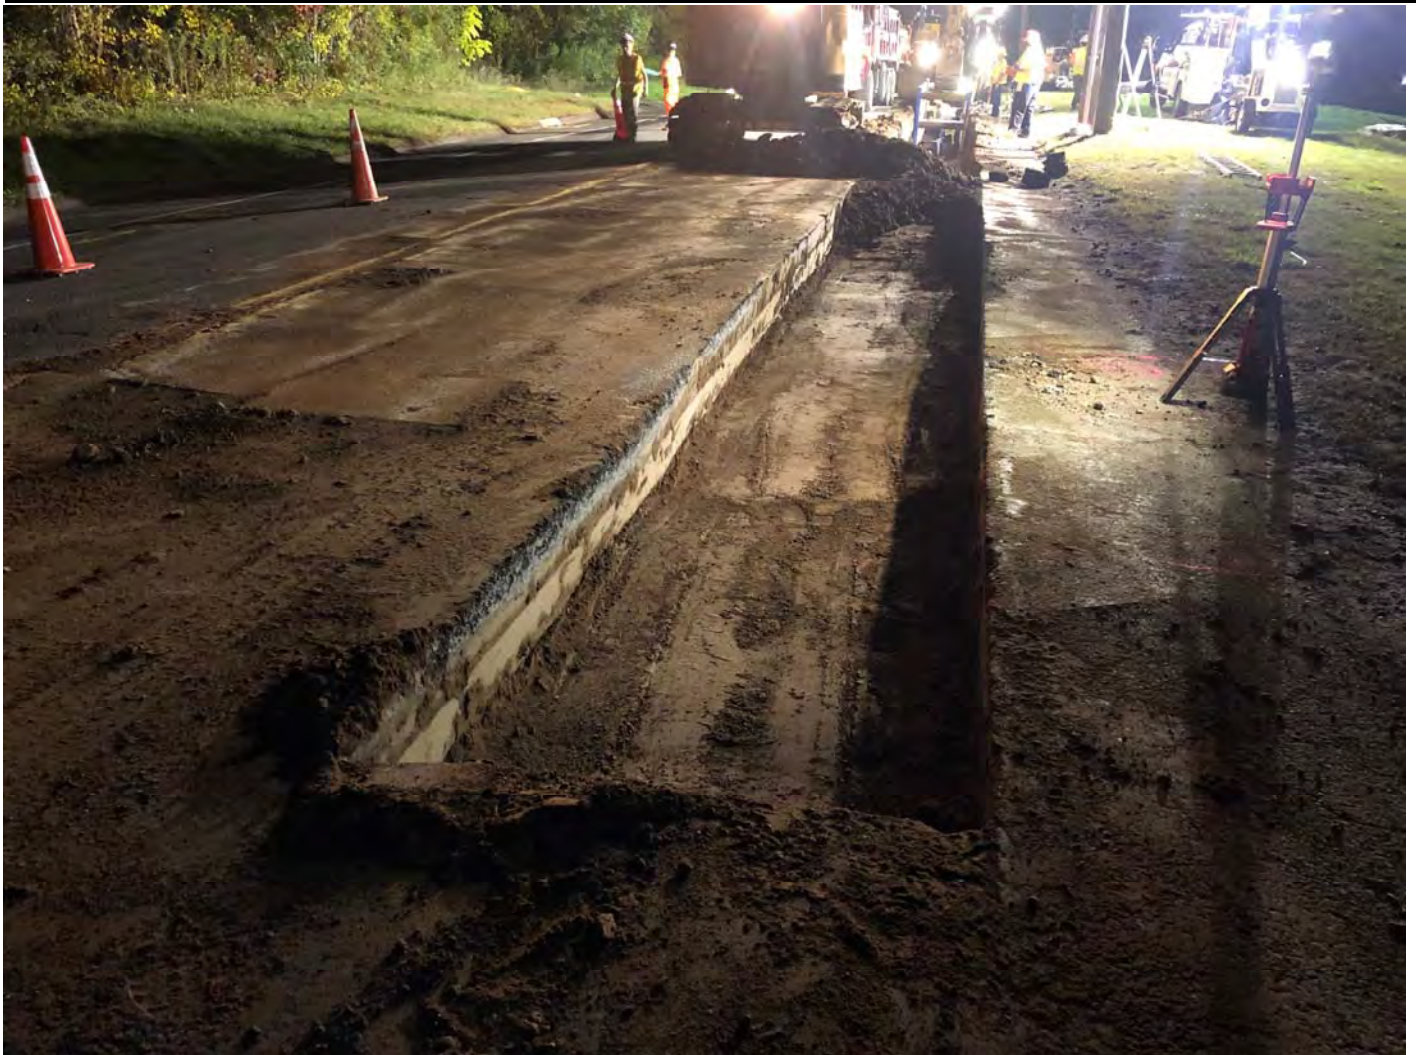
Figure 4 – Compacted top backfill later standing at Station 107+50

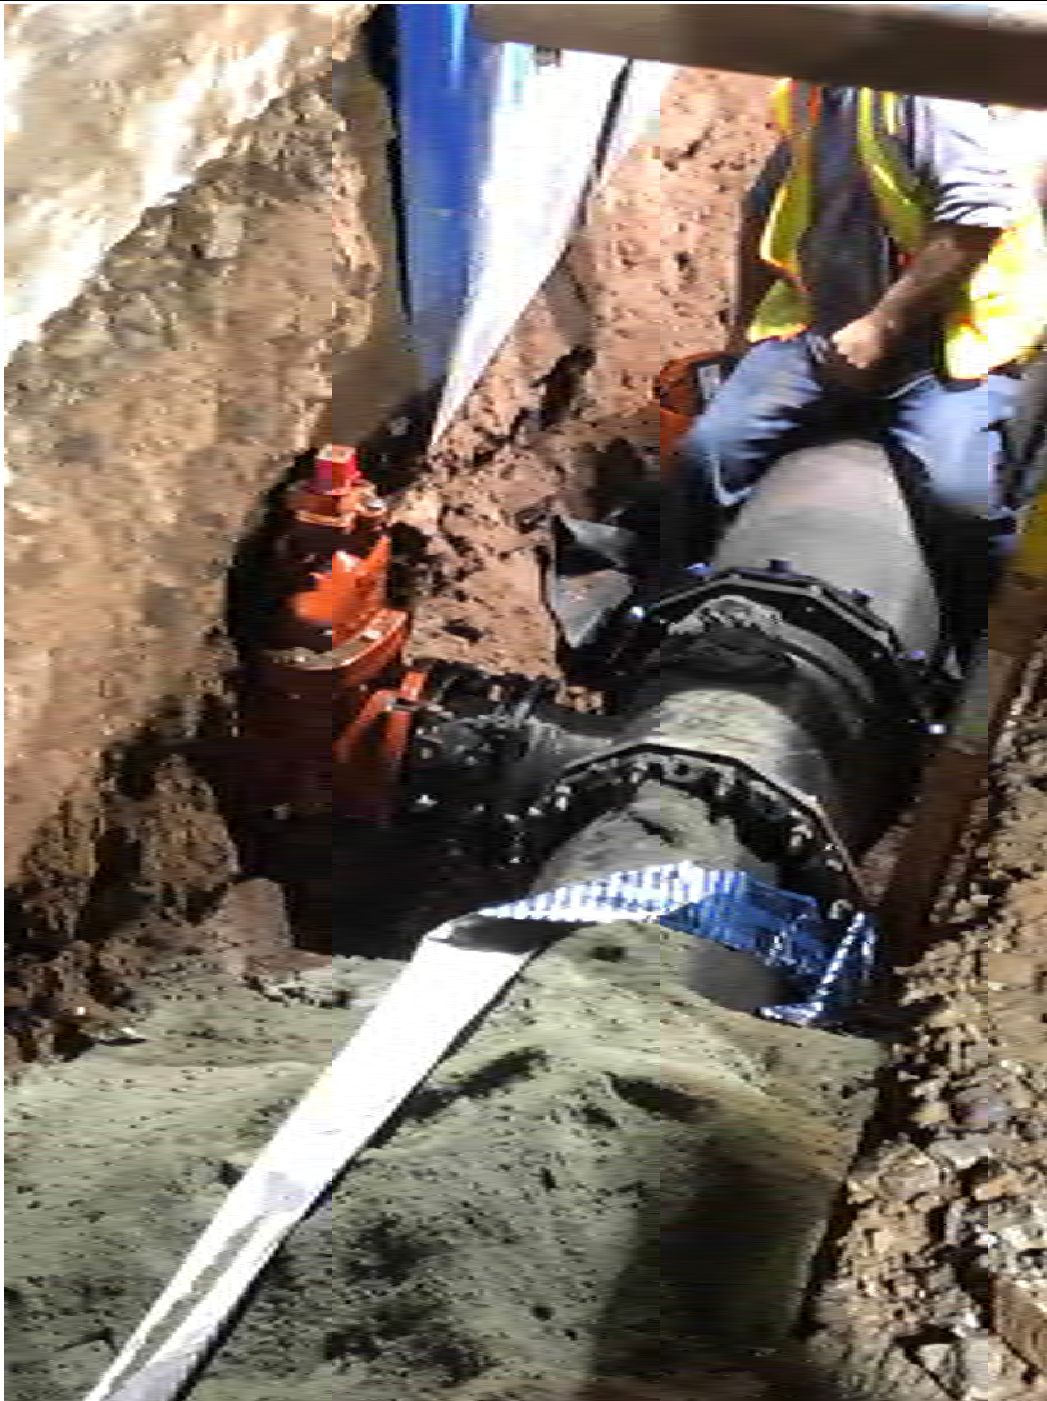
Figure 6 – Attaching 7th pipe section at Tee section with Gate Valve
