Daily Report

Project:	Durham Meadows Pipeline Installation	Date:	October 16, 2019
Location:	Talcott Ridge Drive, Middletown CT	Day of Week:	Wednesday
Project #:	AECOM: 60445033	Report No:	14
Contractor:	Ludlow Construction	Page:	1 of 11

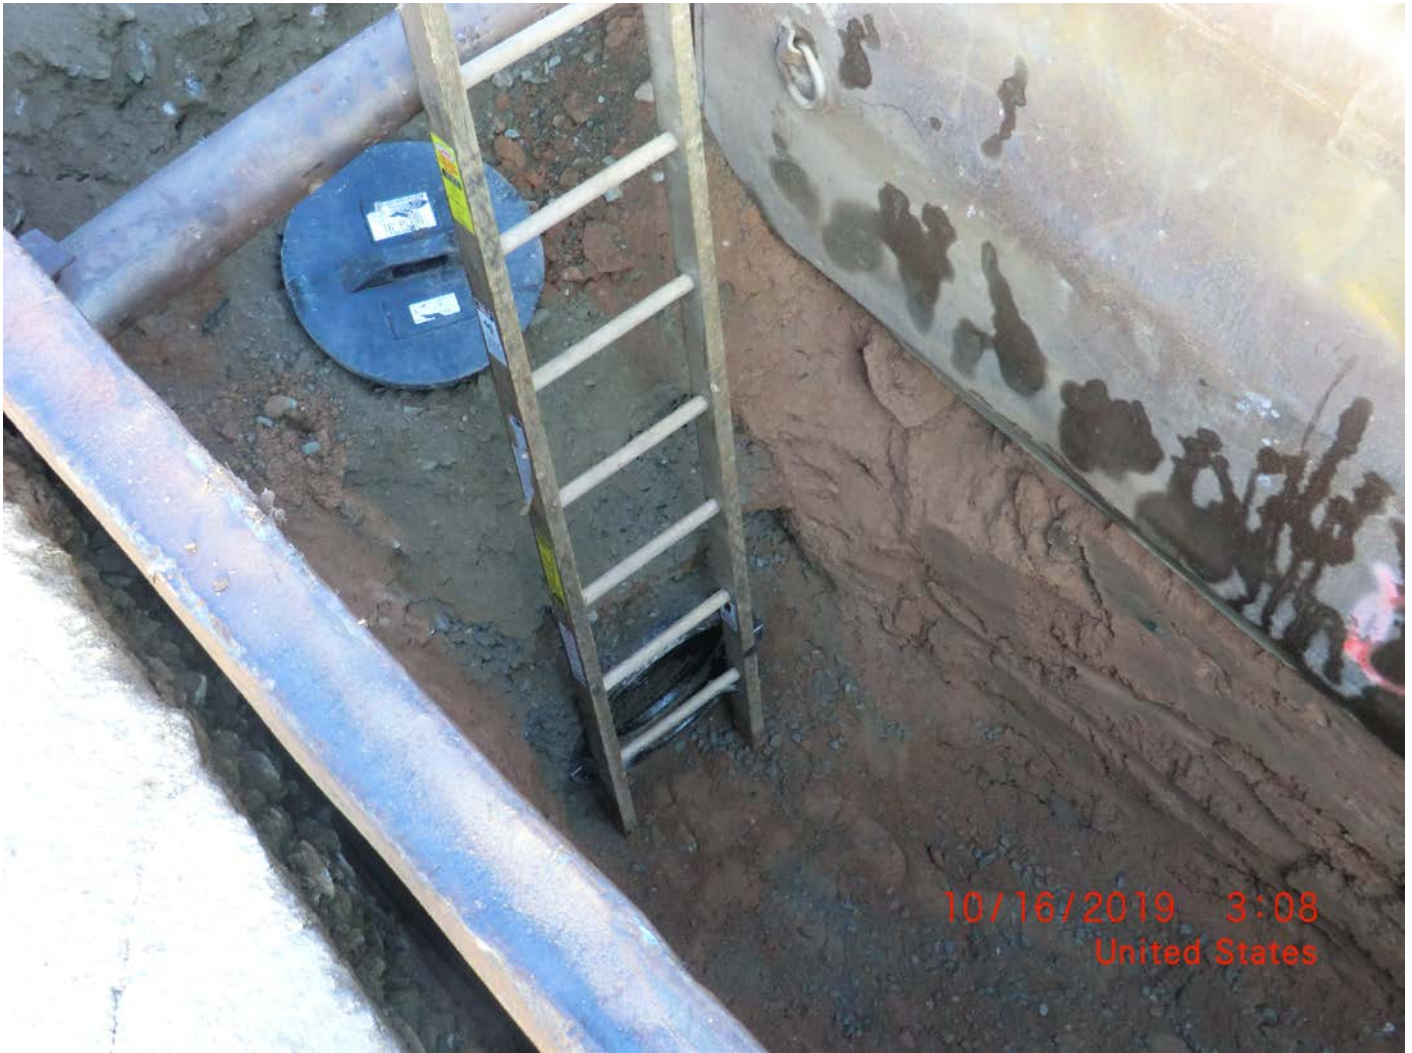
Figure 1 – Station 47+75. Starting point. Disregard time stamp.

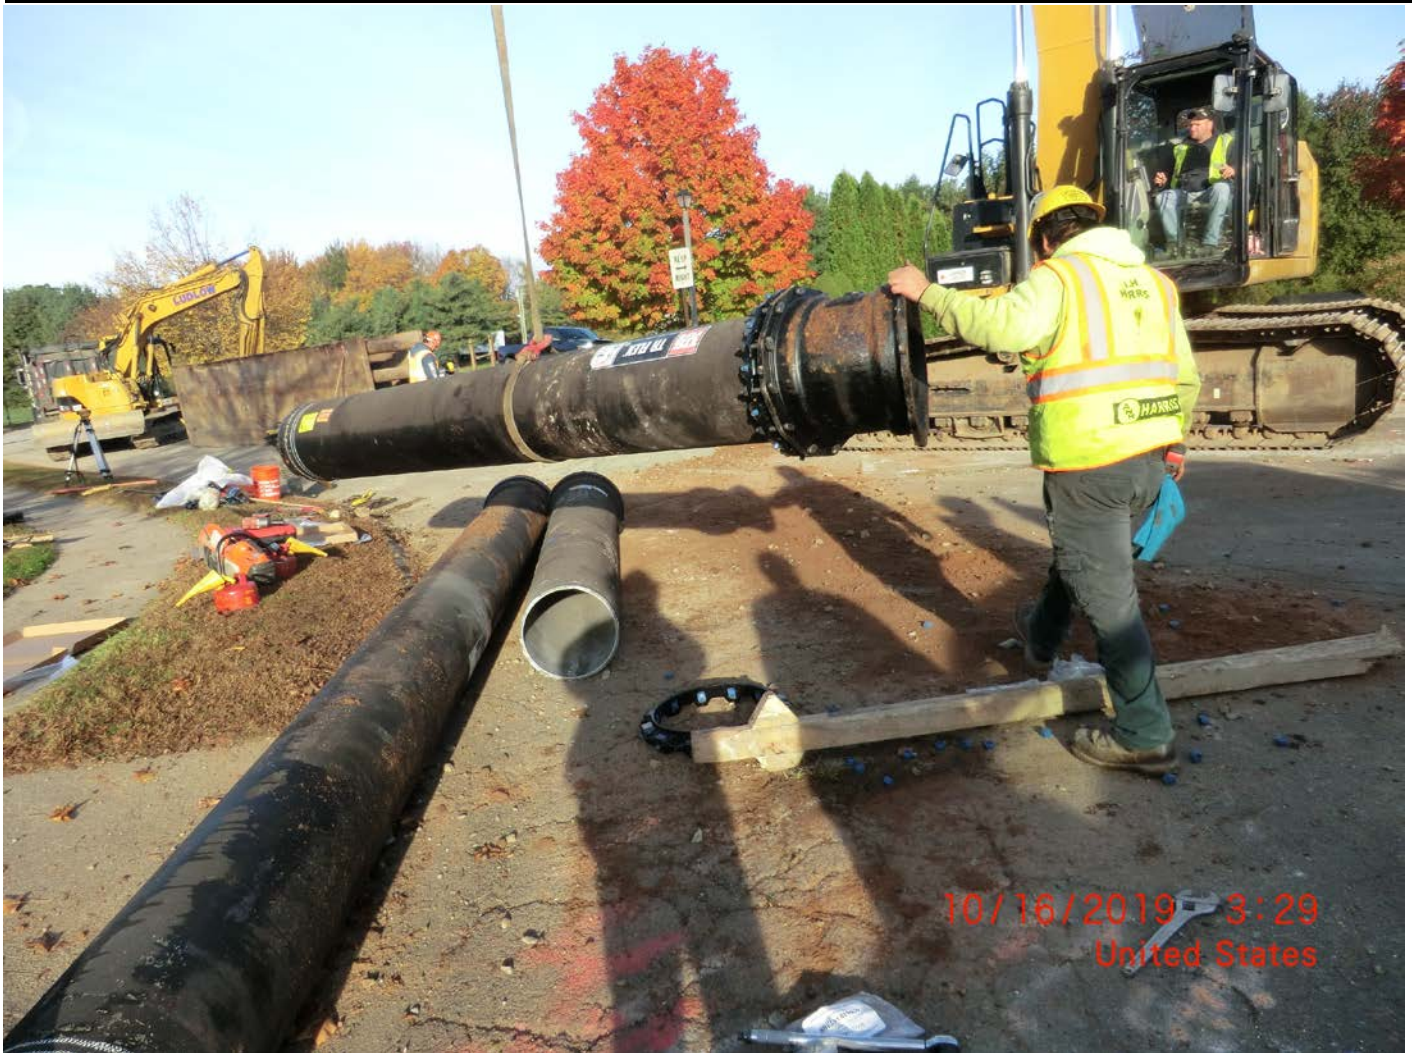
Figure 2 – Facing NW, Picture of 22.5° bend installation. First section of the day. Disregard time stamp.

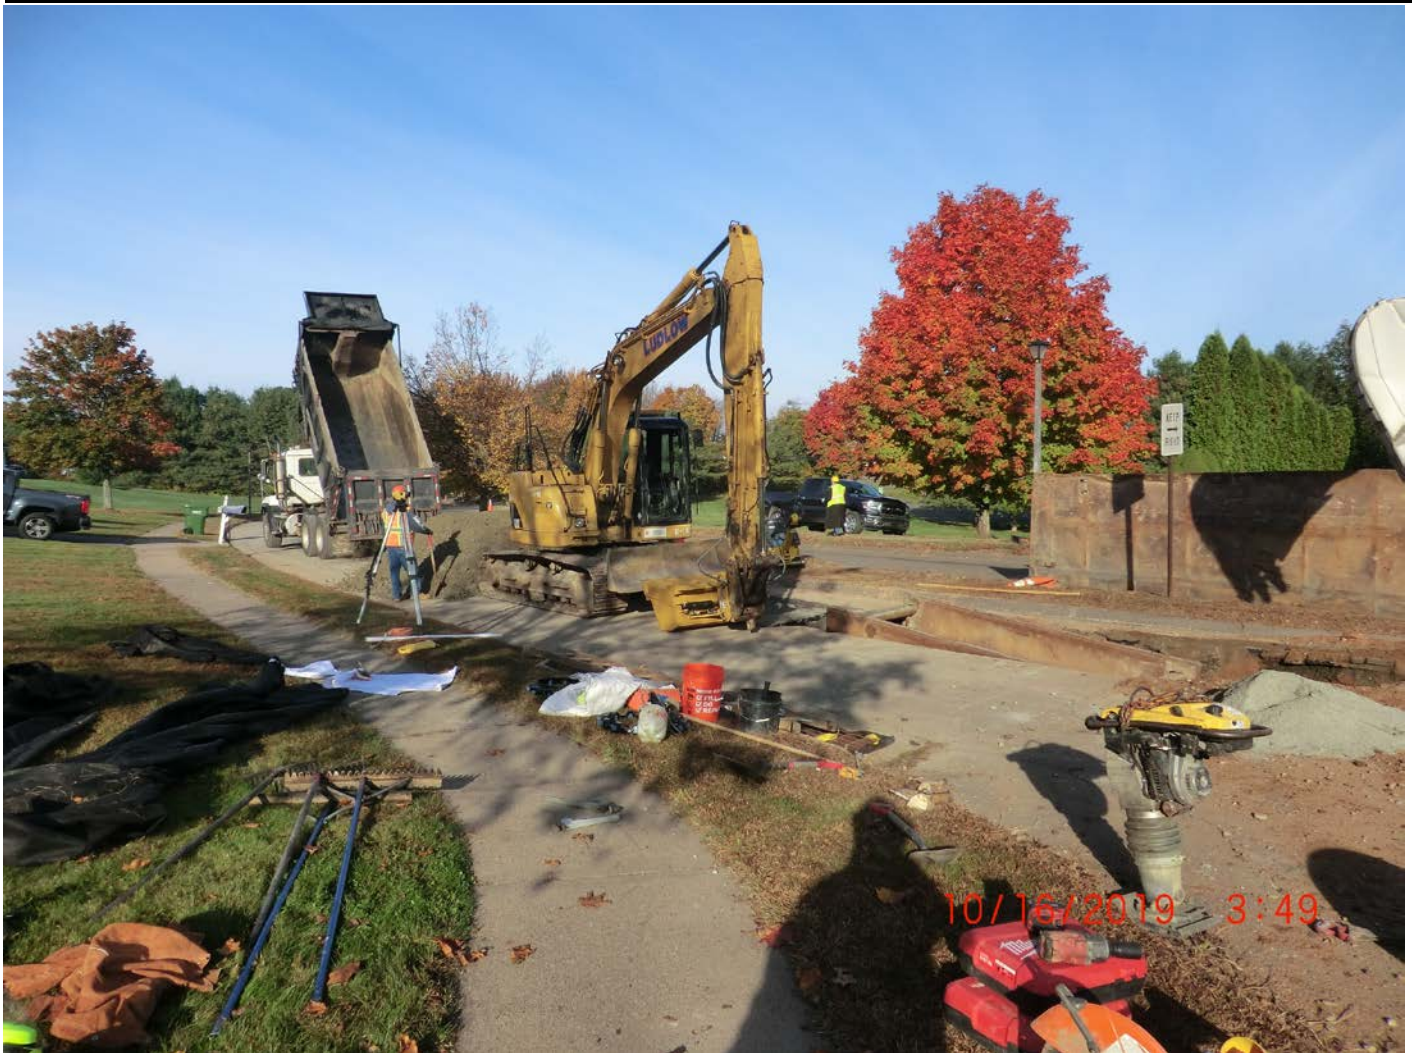
Figure 3 – Picture taken facing west from corner of Watch Hill and Talcott Ridge Drives. Overview of start of day. Disregard time stamp.

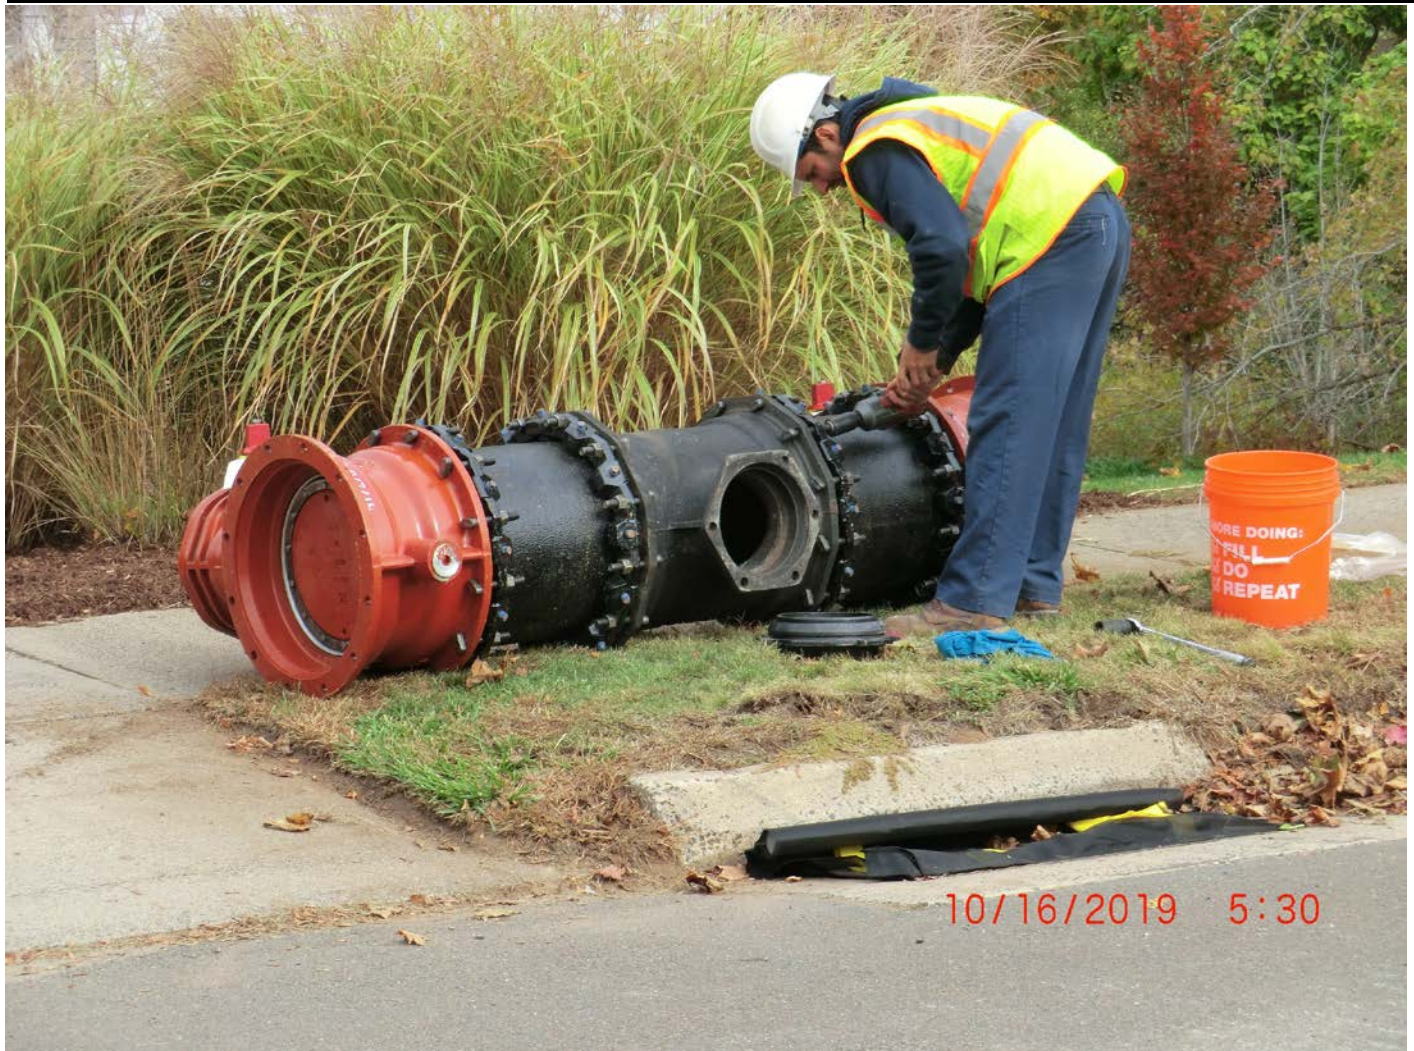
1100 – Conduits located at a depth of 3.5-4 feet. Similar string of 7 lines laid out horizontally. While excavation around the conduit lines continues, a three valve T-section for the 8” replacement line to the Watch Hill Drive Hydrant is being rebuilt after finding that the flange for the 8” T-off was missing a bolt hole. – Note that this assembly will not be installed till tomorrow.

Figure 4 – Disassembling 3-valve T-section. Note the 11-o'clock position on the 8-inch flange (center of shot). There is no bolt hole in the flange. New retainers used in the reconstruction. Disregard time stamp.

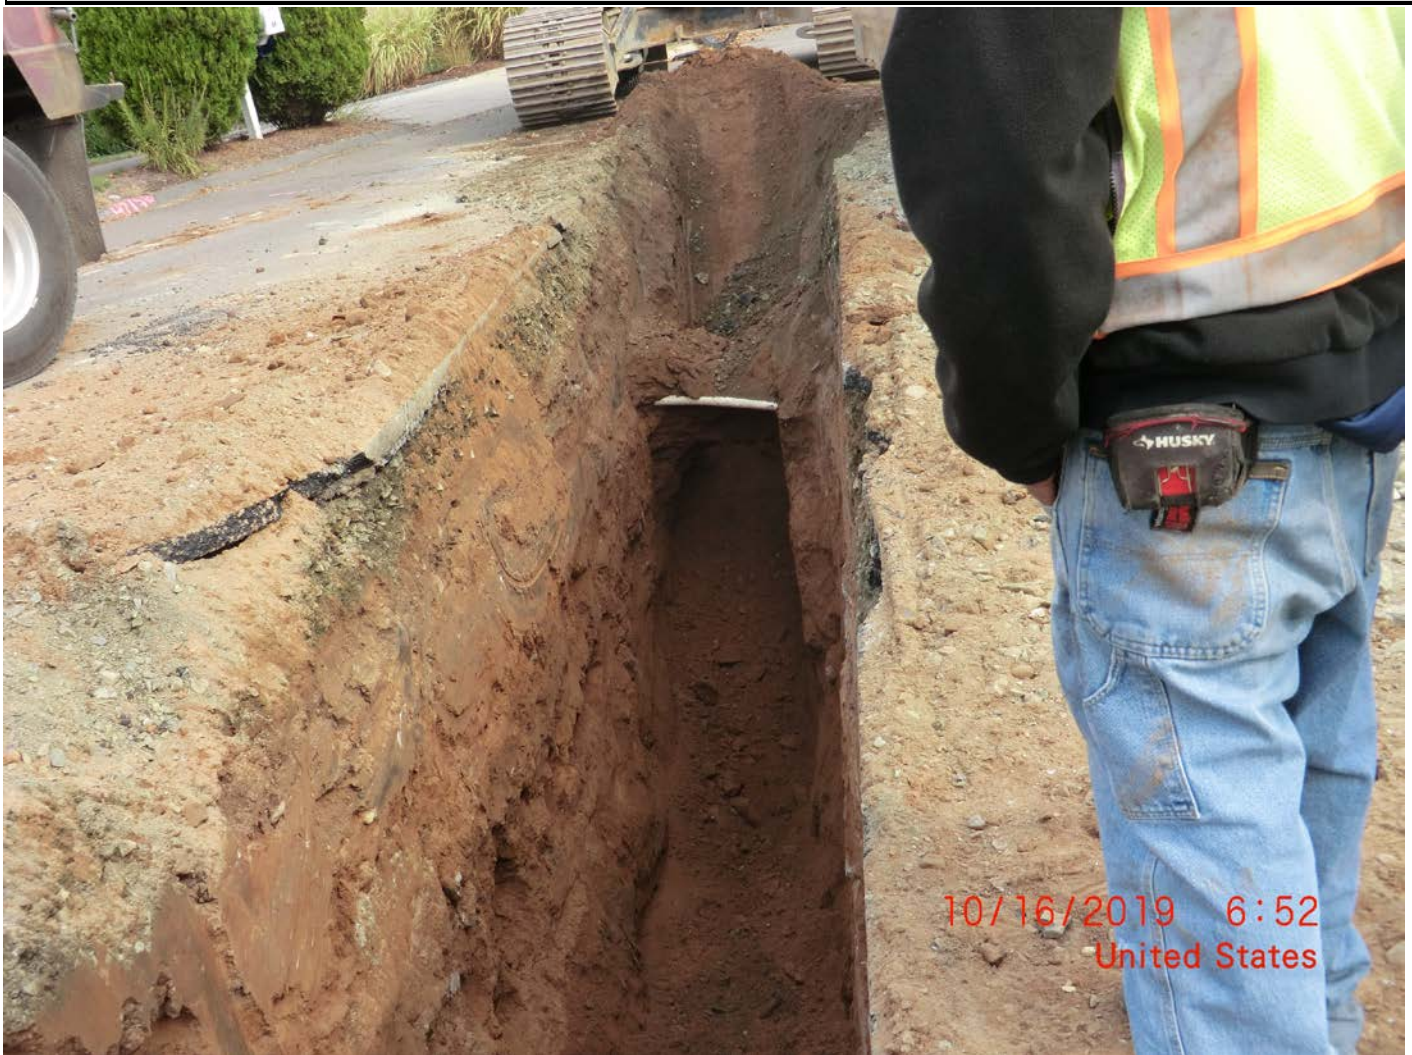
1200 – Still excavating around the conduits. The density/strength of the material around the conduits is very high.

Figure 5 – Facing east into trench. Excavating around electrical/tv conduits. Disregard time stamp.

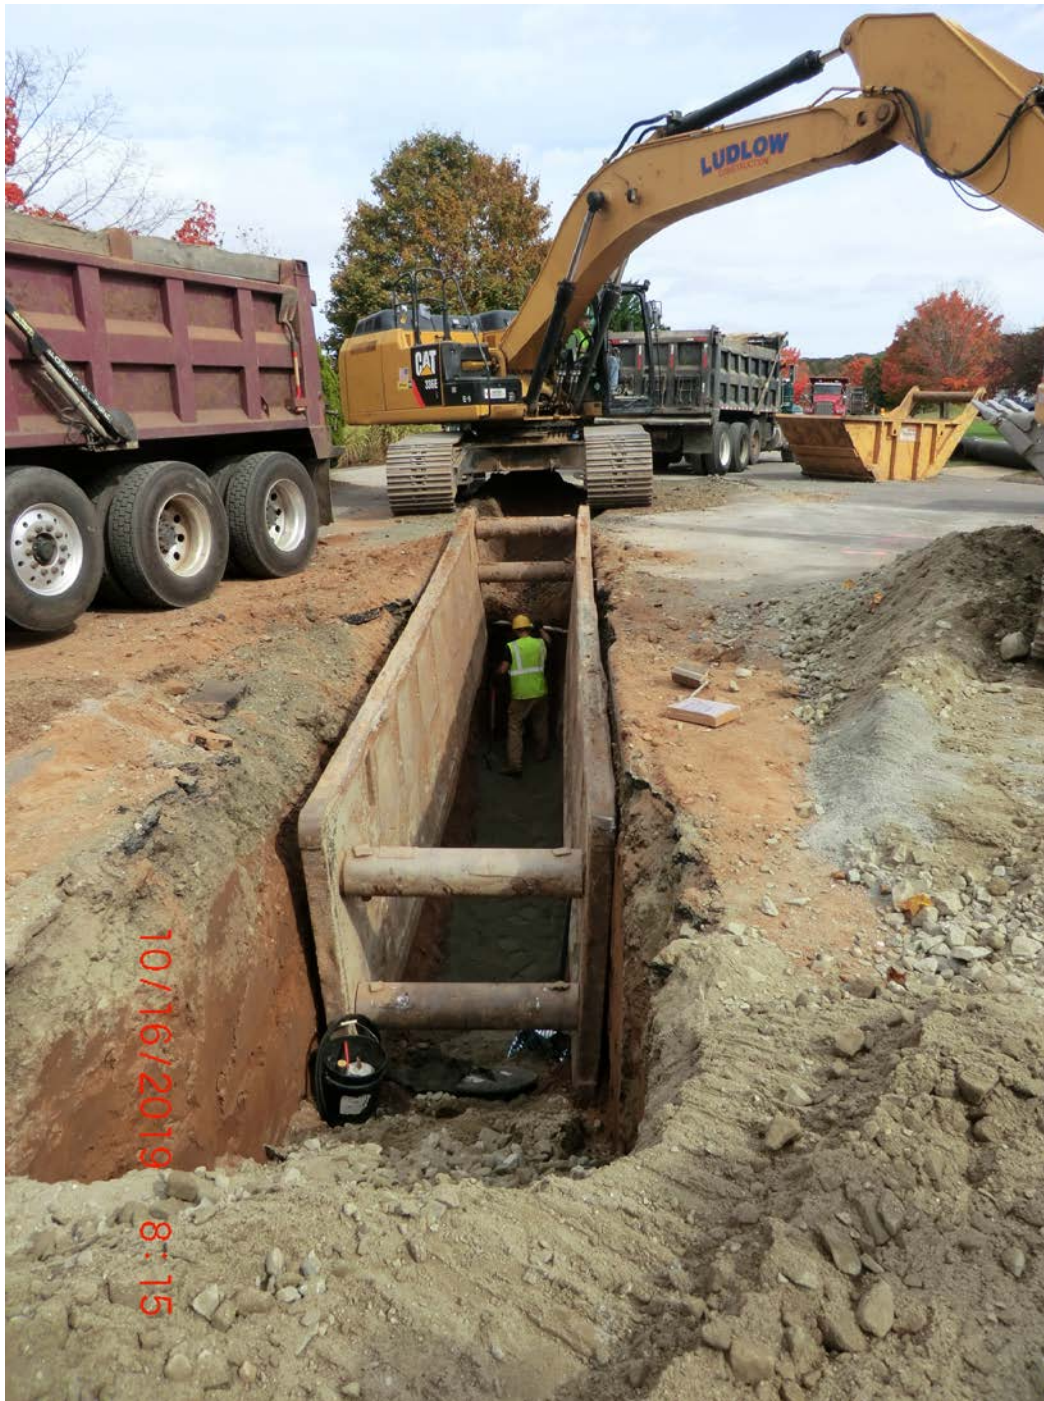
Figure 6 – Facing east, only full 20-foot run of 16” DI installed today. Trench box is 24 feet. Disregard time stamp.

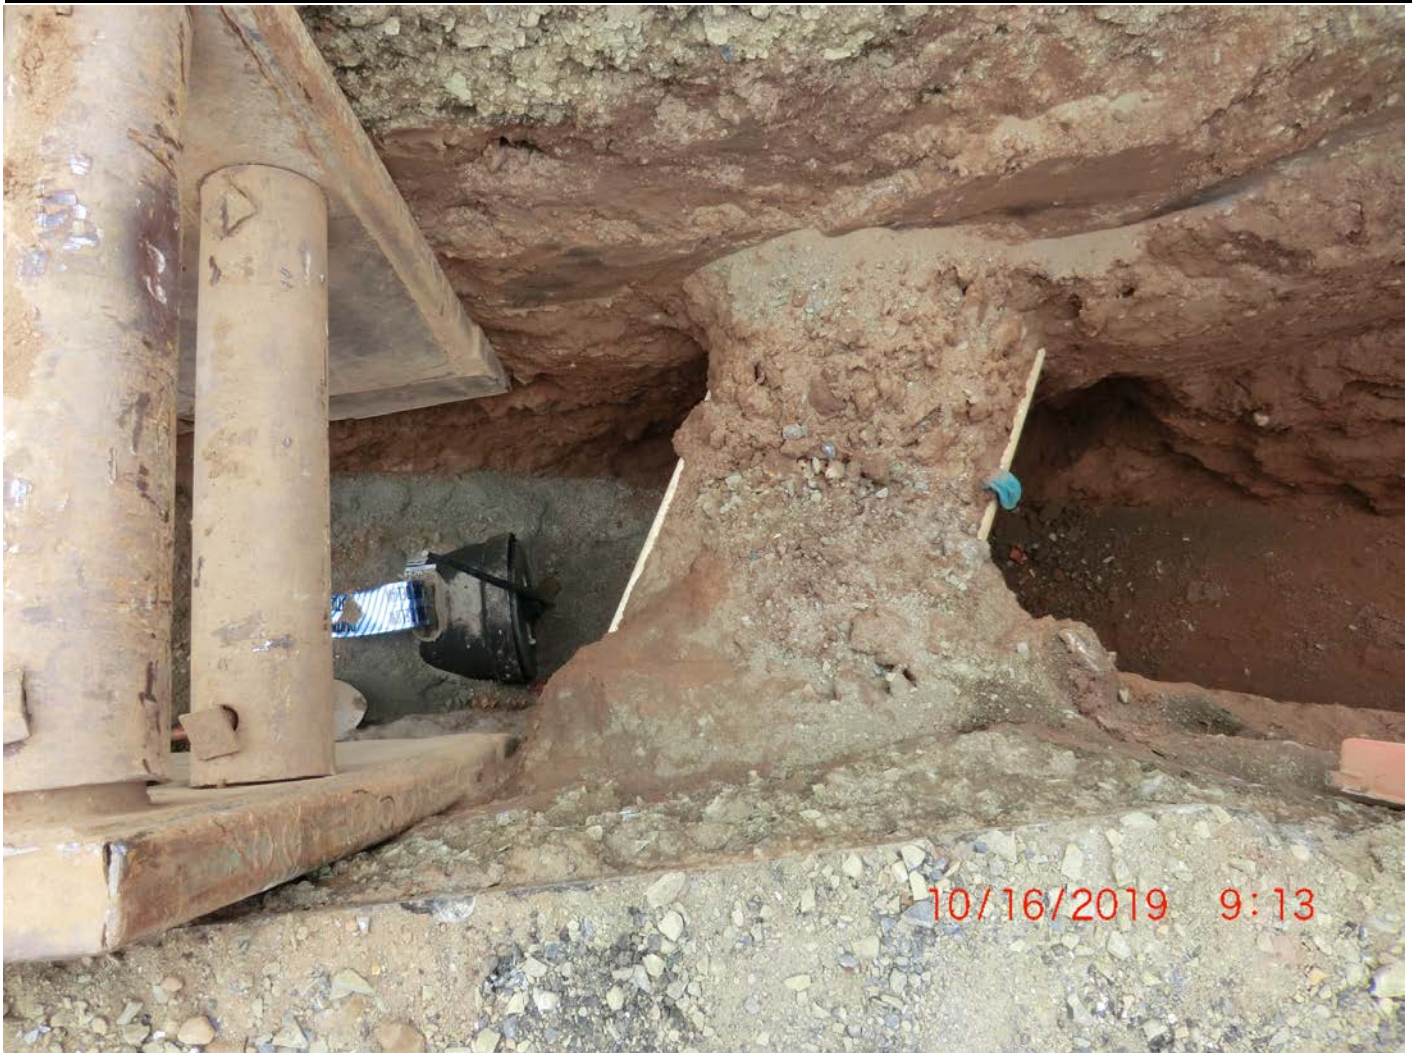
1230 – Setting stone bed for third run of pipe – 20 feet of 16” DI. The bell at the end of the pipe stops just about 2 feet shy of the conduit.

Figure 7 – End of 20-foot section of pipe, approximately 2 feet short of the conduit. Disregard time stamp.

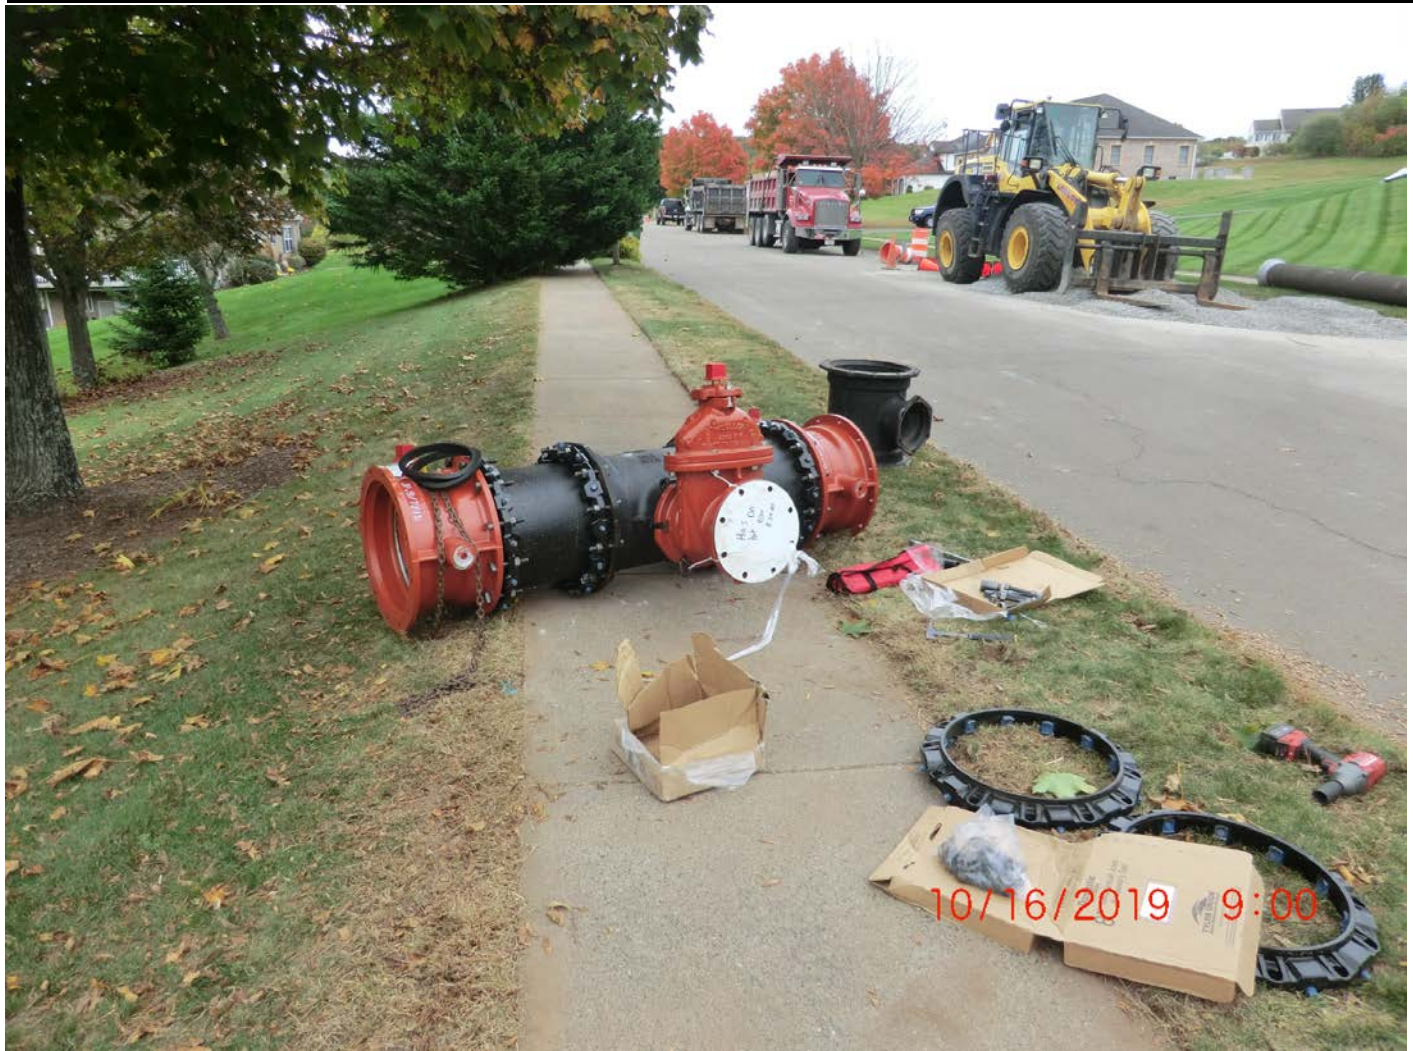
Figure 8 – View of reconstructed assembly shown in Figure 4. This is the Watch Hill Drive 8” Tee-section (to be installed tomorrow on 10/17/19). The left and right are 16” butterfly valves and the center valve is an 8” gate valve. Disregard time stamp.
