#### **Daily Report**

October 17, 2019 **Project:** Date: **Durham Meadows Pipeline Installation** Day of Week: Thursday **Location:** Talcott Ridge Drive, Middletown CT AECOM: 60445033 Report No: 15 Project #: 1 of 10 Page: **Contractor: Ludlow Construction**

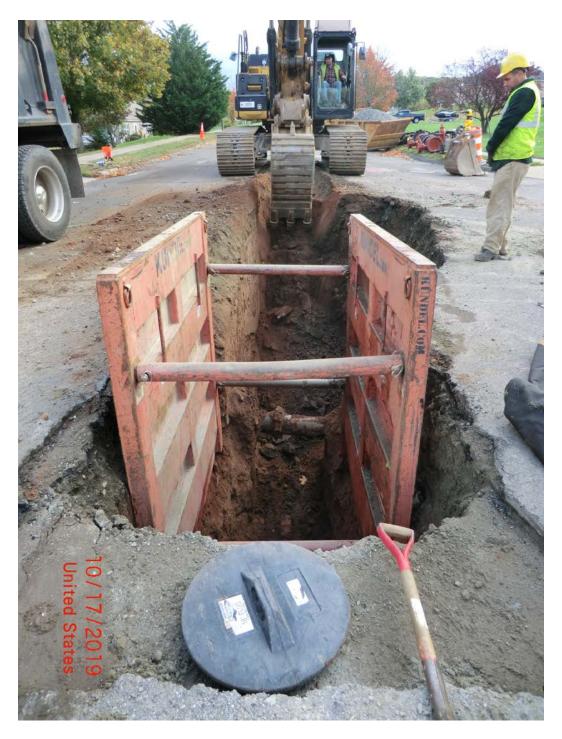
Figure 1 – Start Station 47+27.67. Note existing 8" restrained water line just beyond end of trench box. 16" DI will eventually run 0.5 feet under this line. First section installed – 11 feet to 47+16.67 Picture taken facing east.

0910 – Dig out under existing 8" restrained water line. Line located at approximately 47+19.

0940 – First section of 16" DI pipe installed under existing water line - 11 feet of pipe to 47+16.67. This section crosses under existing 8" restrained water line. There is 0.5 feet of clearance between bottom of existing line and top of 16" DI line installed. Two 16" butterfly, 16x16x8 T and one 8" gate valve assembly coming in next.

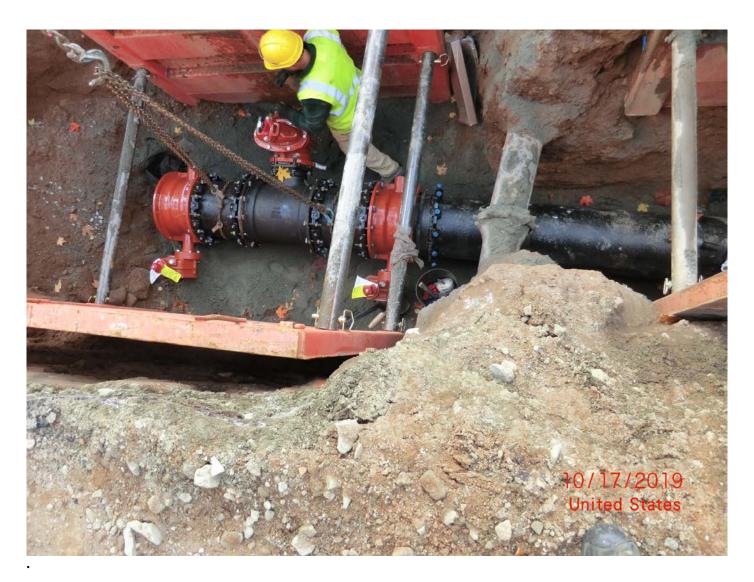
Figure 2 – Facing down into trench from north side. Note 8" existing line to right side crossing over first 11 feet of 16" DI installed. This is followed by the assembly currently being lowered into the trench – two 16" butterfly valves (red) either side of a 16x16x8 Tee-section (centered) with an 8" gate valve (red) 20" off the center line of the T to the south side.

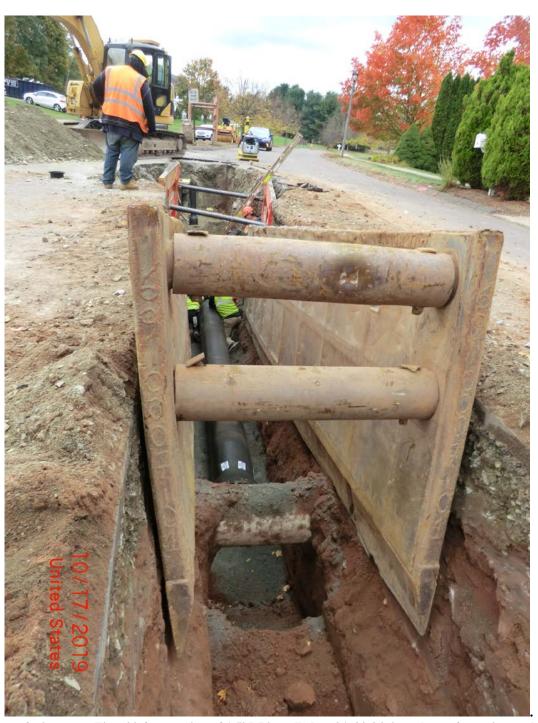
Figure 4 - Picture facing west. First 20-foot section of 16" DI installed to 46+90.34, just short of crossing under 18" catch basin drainage pipe. Next section of pipe will cross approximately 1.5 feet below the drain pipe.

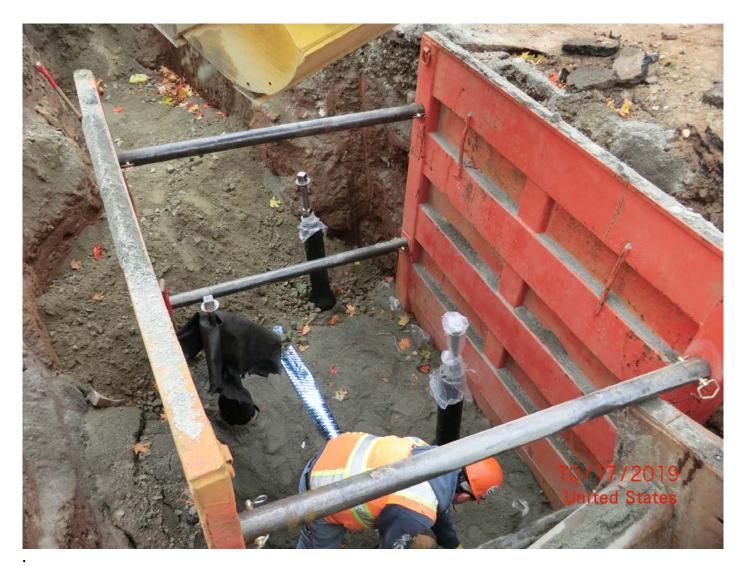
Figure 5 – Facing west into trench. Installing valve extension stems and raising grade. Note shiny water line marker tape.

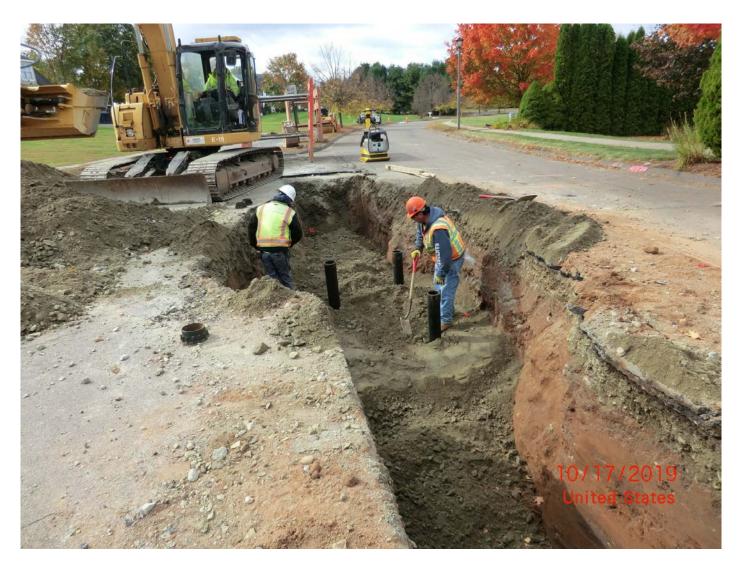
Figure 6 – Facing west, compacting lifts with Jumping Jack around valve box risers.

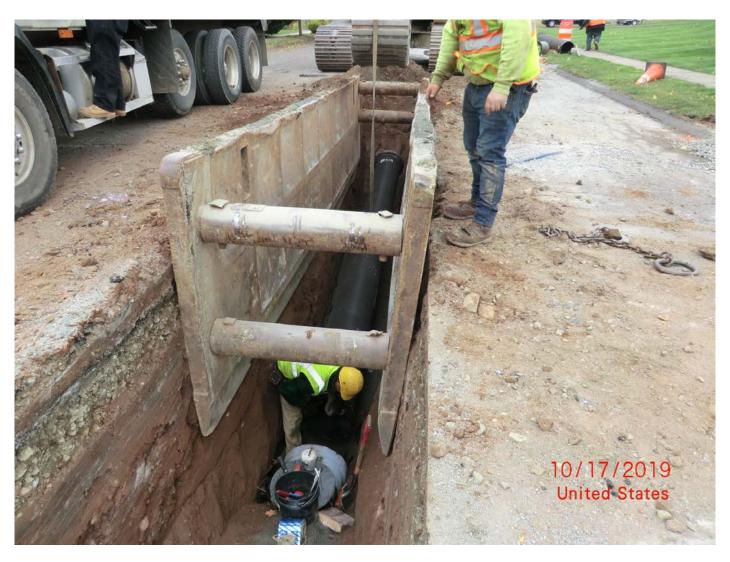
Figure 7 – Facing east, final 20-foot section of pipe installation.
