Daily Report

Project:	Durham Meadows Pipeline Installation	Date:	October 18, 2019
Location:	Talcott Ridge Drive, Middletown CT	Day of Week:	Friday
Project #:	AECOM: 60445033	Report No:	16
Contractor:	Ludlow Construction	Page:	1 of 8

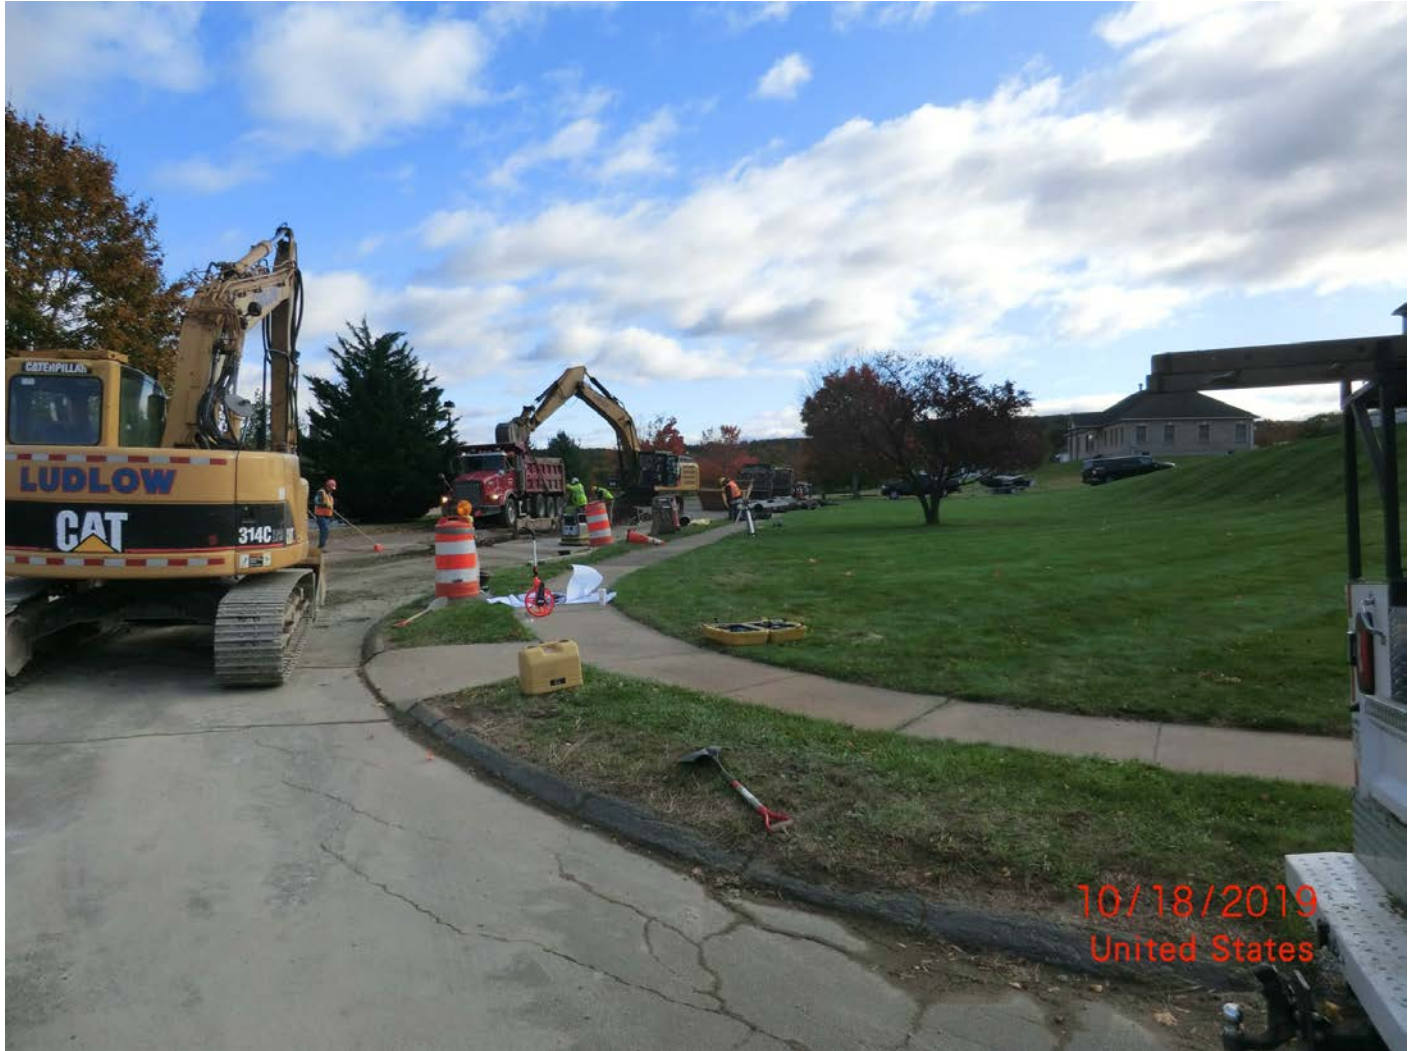
Figure 1 – Facing ENE from corner of Watch Hill and Talcott Drives. Traffic has been routed around Watch Hill Drive to allow work to proceed up Talcott Ridge Drive.

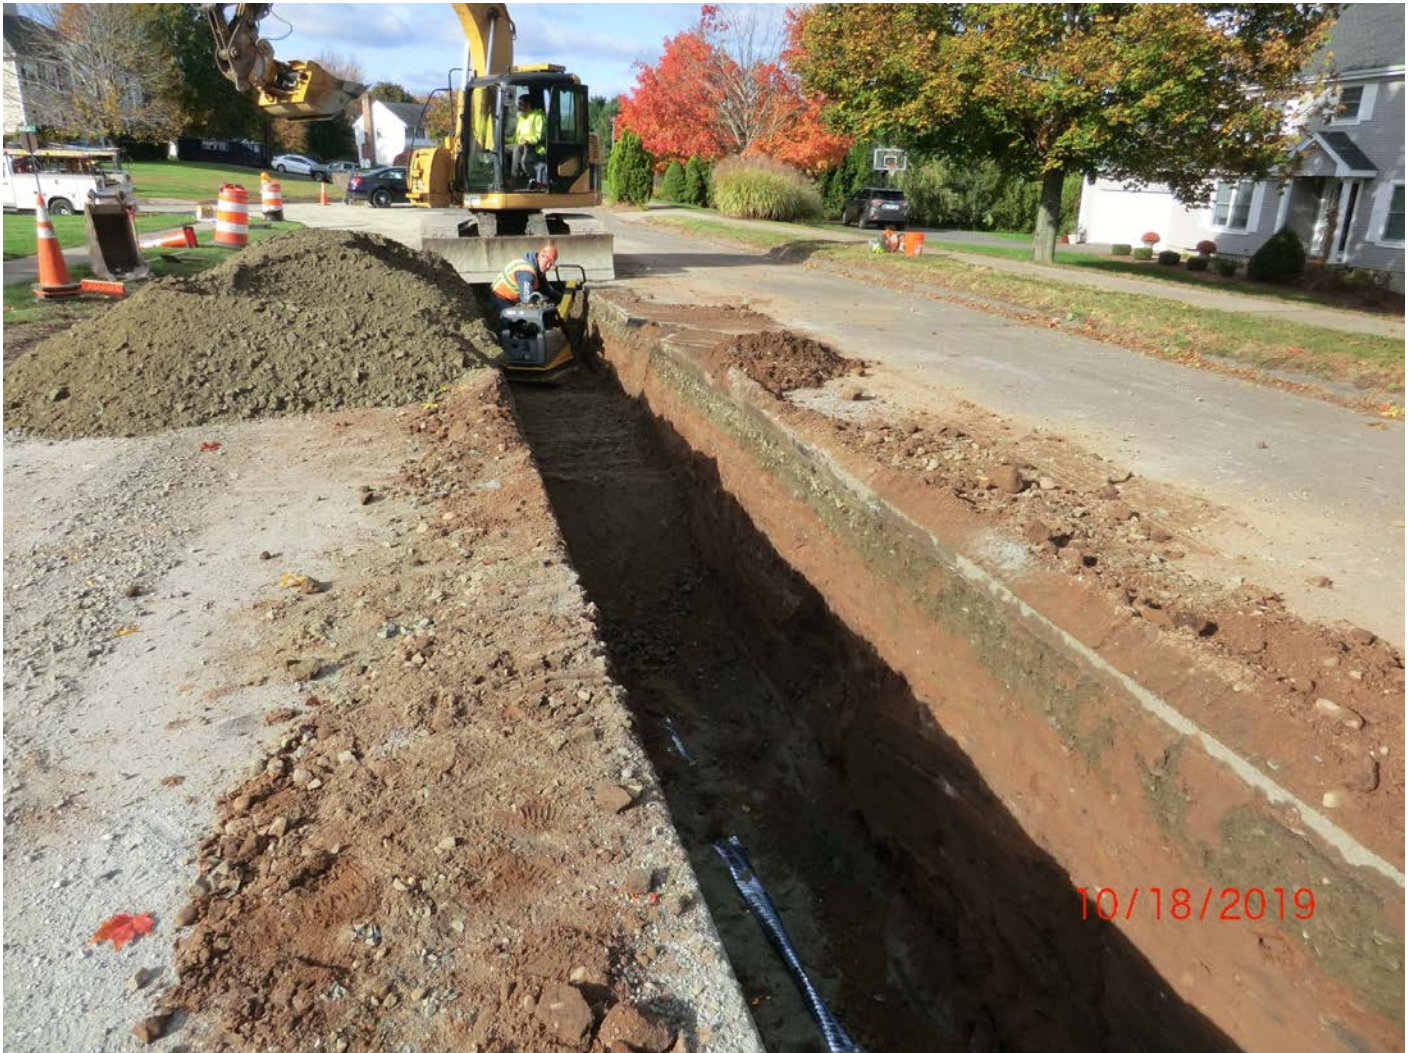
Figure 2 – Facing west, Watch Hill Drive to top left of picture. Compacting lifts along the first two runs of pipe.

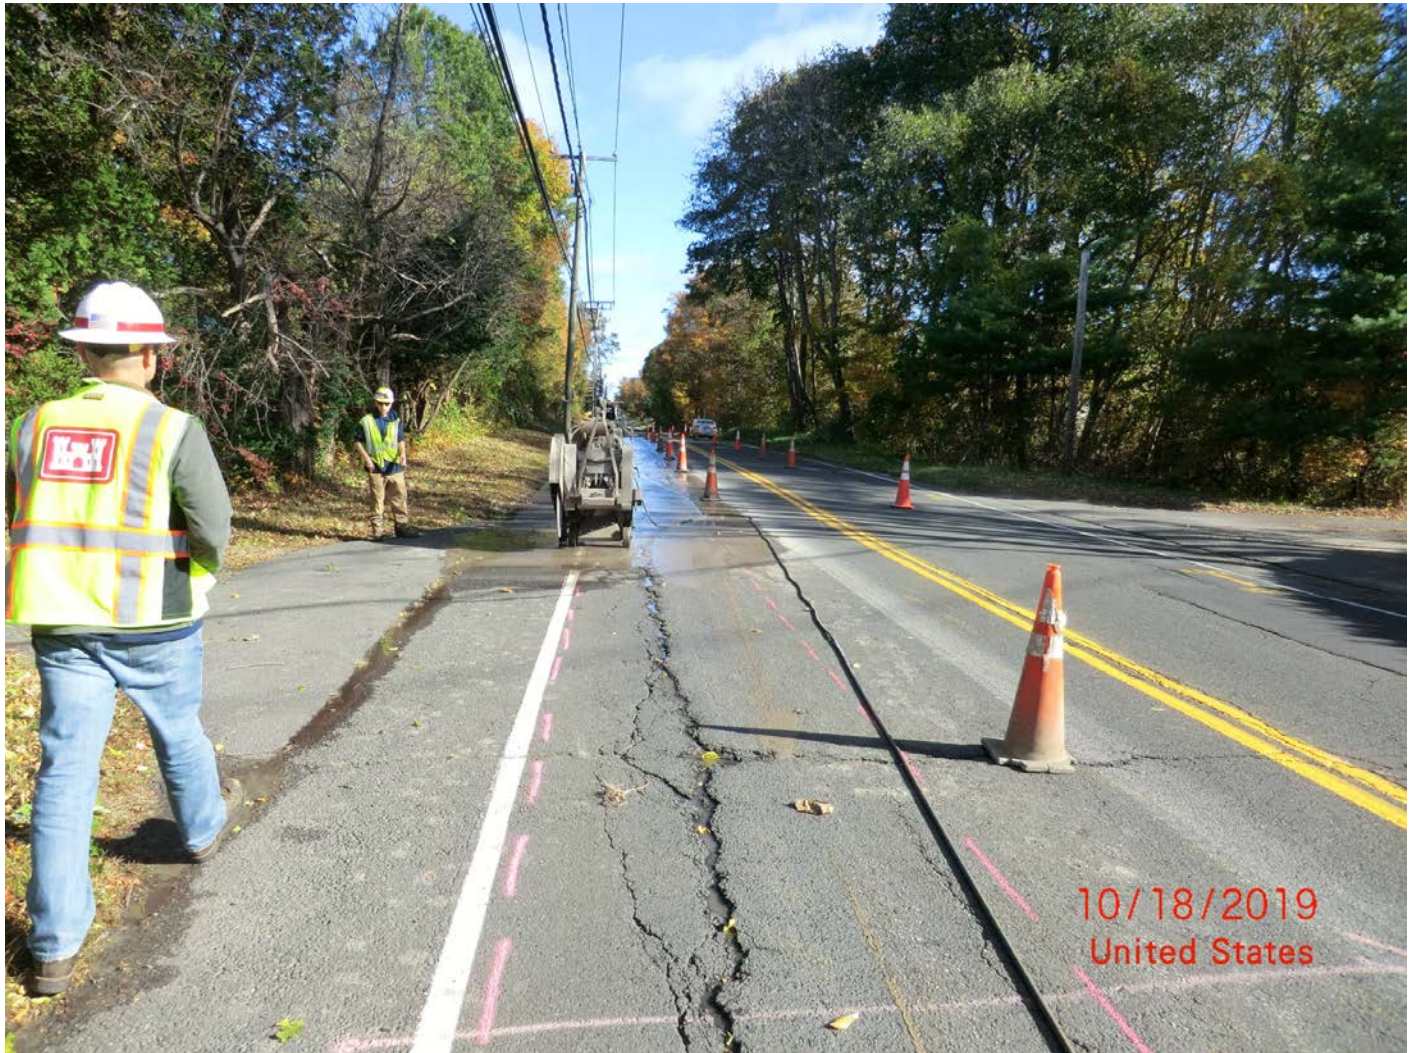
Figure 3 – Picture taken facing north. road cutting on Main Street, Durham.

Main Street Work: Saw cutting continuing on Main Street in Durham. Adds 3 additional workers on Main Street as well as a State Police Detail.

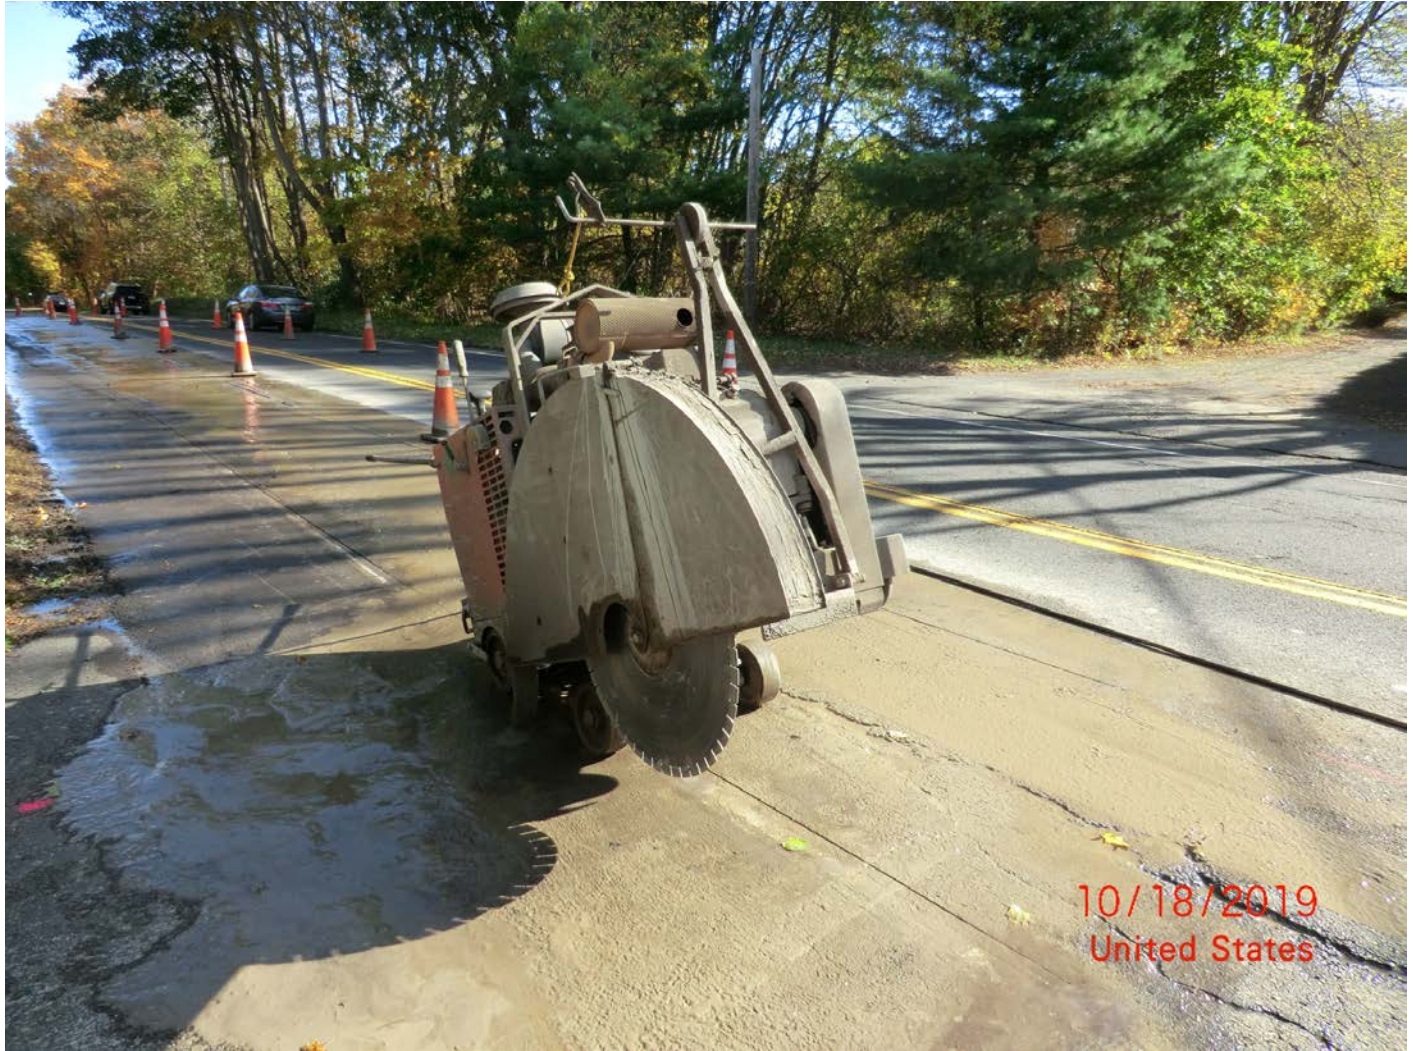
Figure 4 – Picture facing northeast. Road saw, currently waiting for support truck to be repositioned. No culverts along this stretch of road. Operator says they sweep and shovel up cuttings from the operation with a 95%+ efficiency.

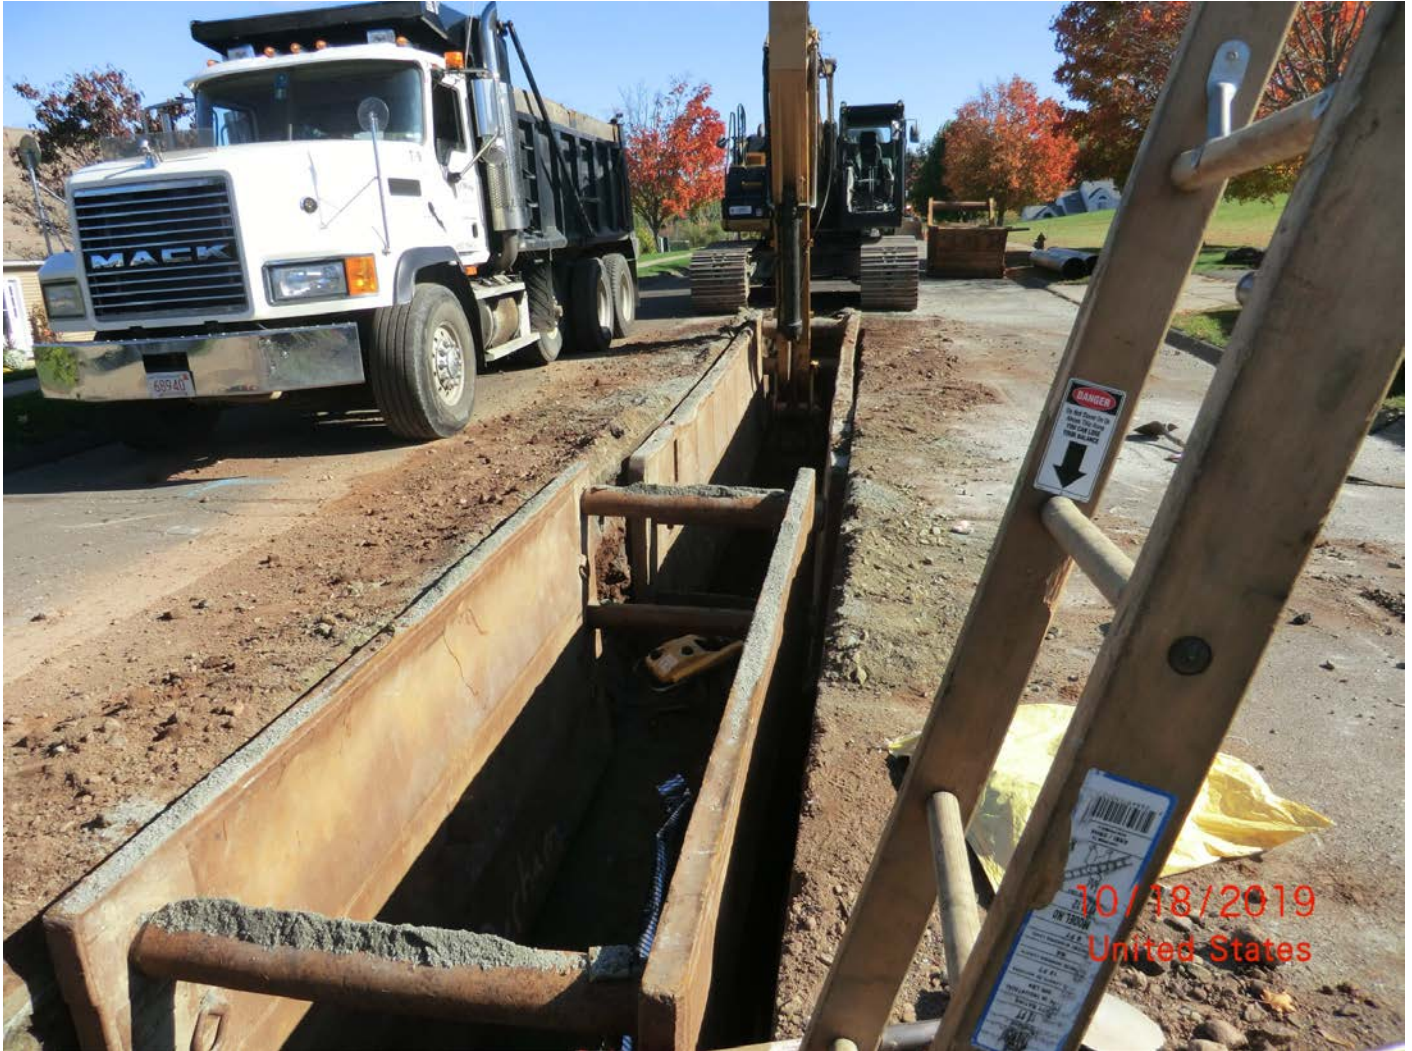
Figure 5 – Facing east with 12 foot and 24 foot trench boxes spanning a water service line. In foreground you can see water line tape over the 6th line of 20-foot pipe, that runs under the water service. The 24-foot trench box is set waiting for installation of 7th pipe.

0955 – Fifth 20-foot line (unrestrained) 16” DI installed to 45+50.34. Currently extending trench for sixth pipe. Hand clearing for a 2” service line, located approximately 15 feet along the 6th pipe installation section (approx. 45+35).

1100 – Back on Talcott Ridge Road, Ludlow on break. 6th 20-foot line (unrestrained) 16” DI installed to 45+30.34.

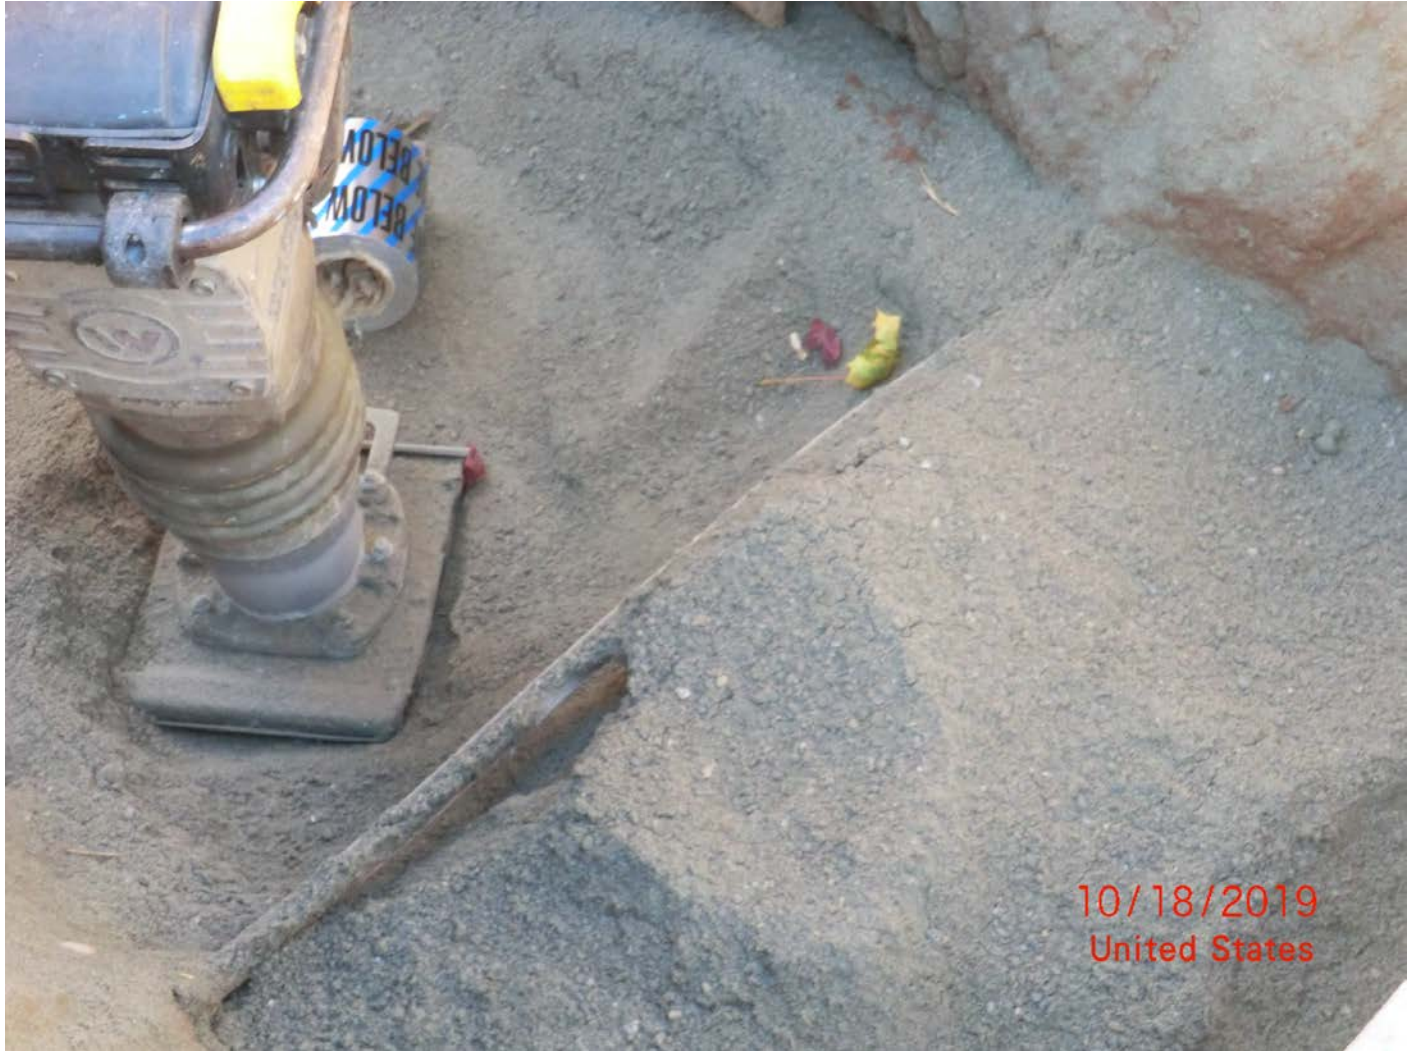
Figure 6 – Looking down into trench, water service line crossing Talcott Ridge Road.. Jumping Jack also pictured to top left of photo.
