## Daily Report

<b>Project:</b>	Durham Meadows Pipeline Installation	<b>Date:</b>	October 24, 2019
<b>Location:</b>	Talcott Ridge Drive, Middletown CT	<b>Day of Week:</b>	Thursday
<b>Project #:</b>	AECOM: 60445033	<b>Report No:</b>	20
<b>Contractor:</b>	Ludlow Construction	<b>Page:</b>	1 of 16

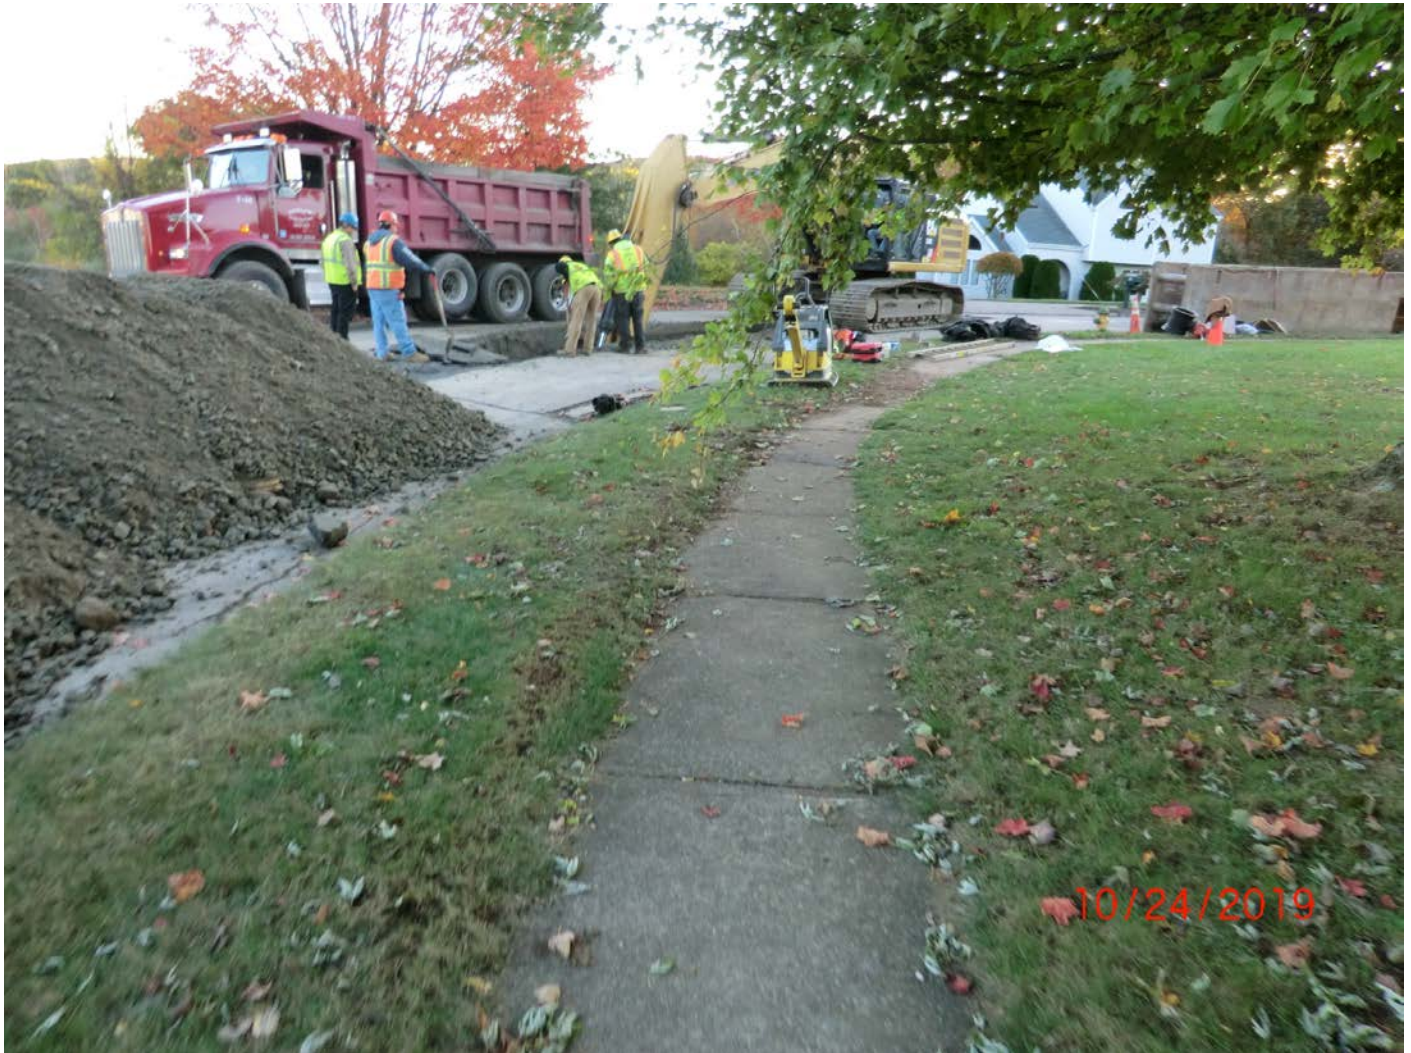
Figure 1 – Facing NE (124 Talcott Ridge seen in upper right of photo). Start of day. Excavating from 22.5-degree bend installed at Sta. 40+71.71 to 18" broken drainage line.

0730 – On site: Talcott Ridge Dr. Excavation on going with large (CAT 336E) excavator. Begin day at Sta. 40+71.71, which is the center of a 22.5<sup>0</sup> bend. With the end of day broken drain pipe issue yesterday, only the tie-offs were noted. The elevations of this bend was recorded as 361.24 feet and the elevation of the blacktop 368.44 feet. Note that this was the second bend installed yesterday.

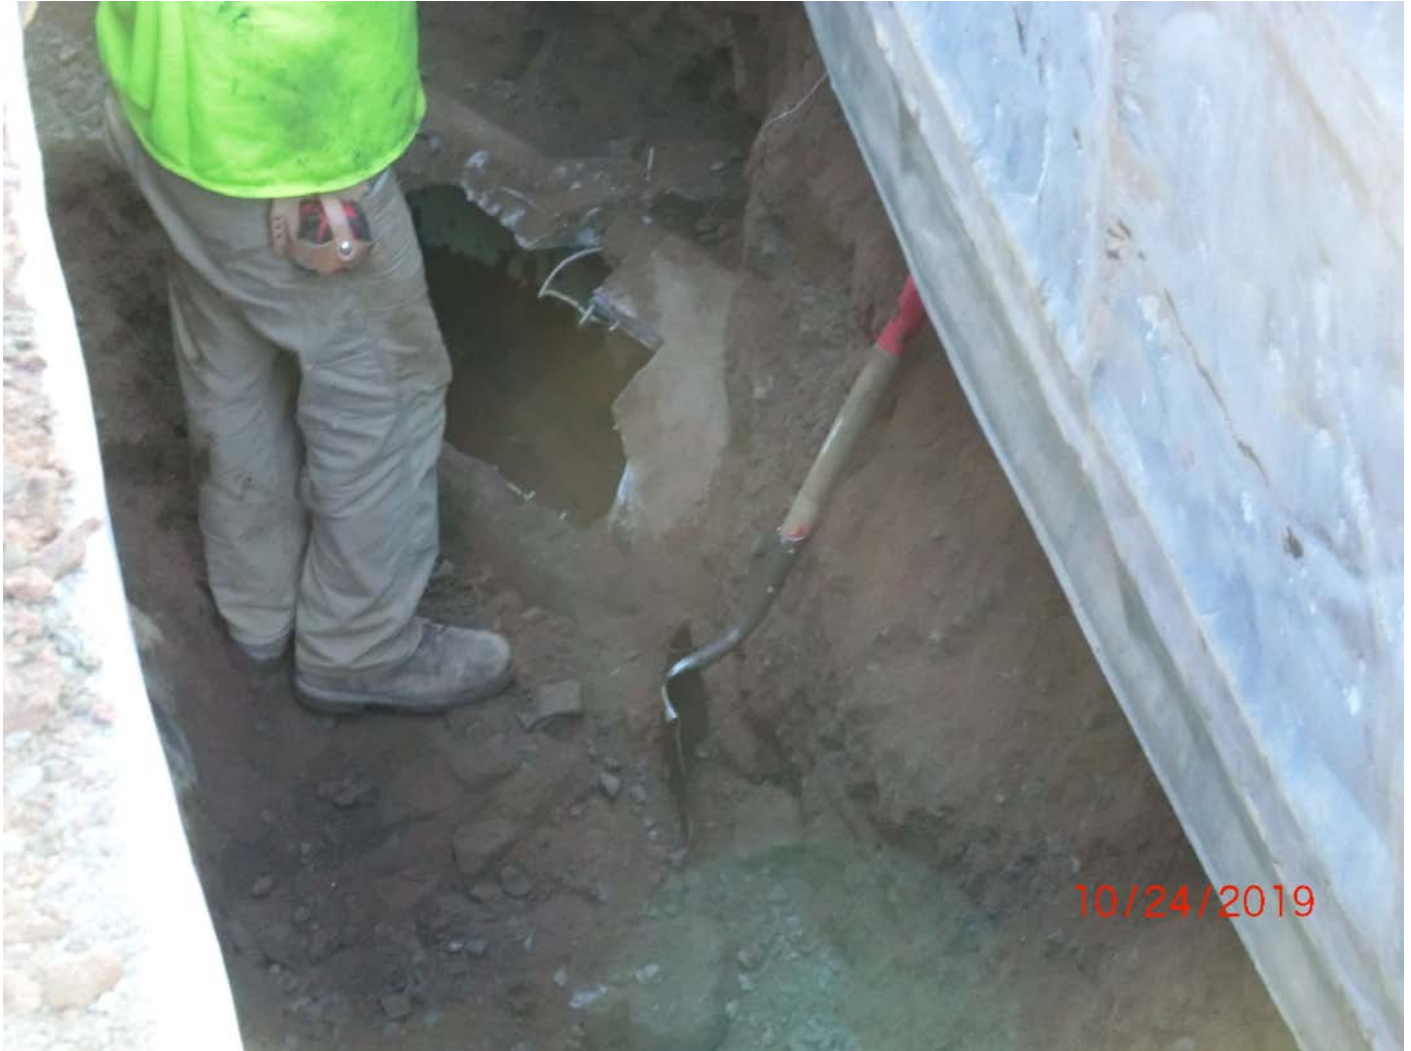
**Figure 2 – Excavated to broken drain line. Cleaning up and exposing line so as to repair the hole.**

0800 – Re-excavated the broken drain pipe from the previous day. Making a larger clearing about the pipe and cleaning it off to allow for it to be fixed.

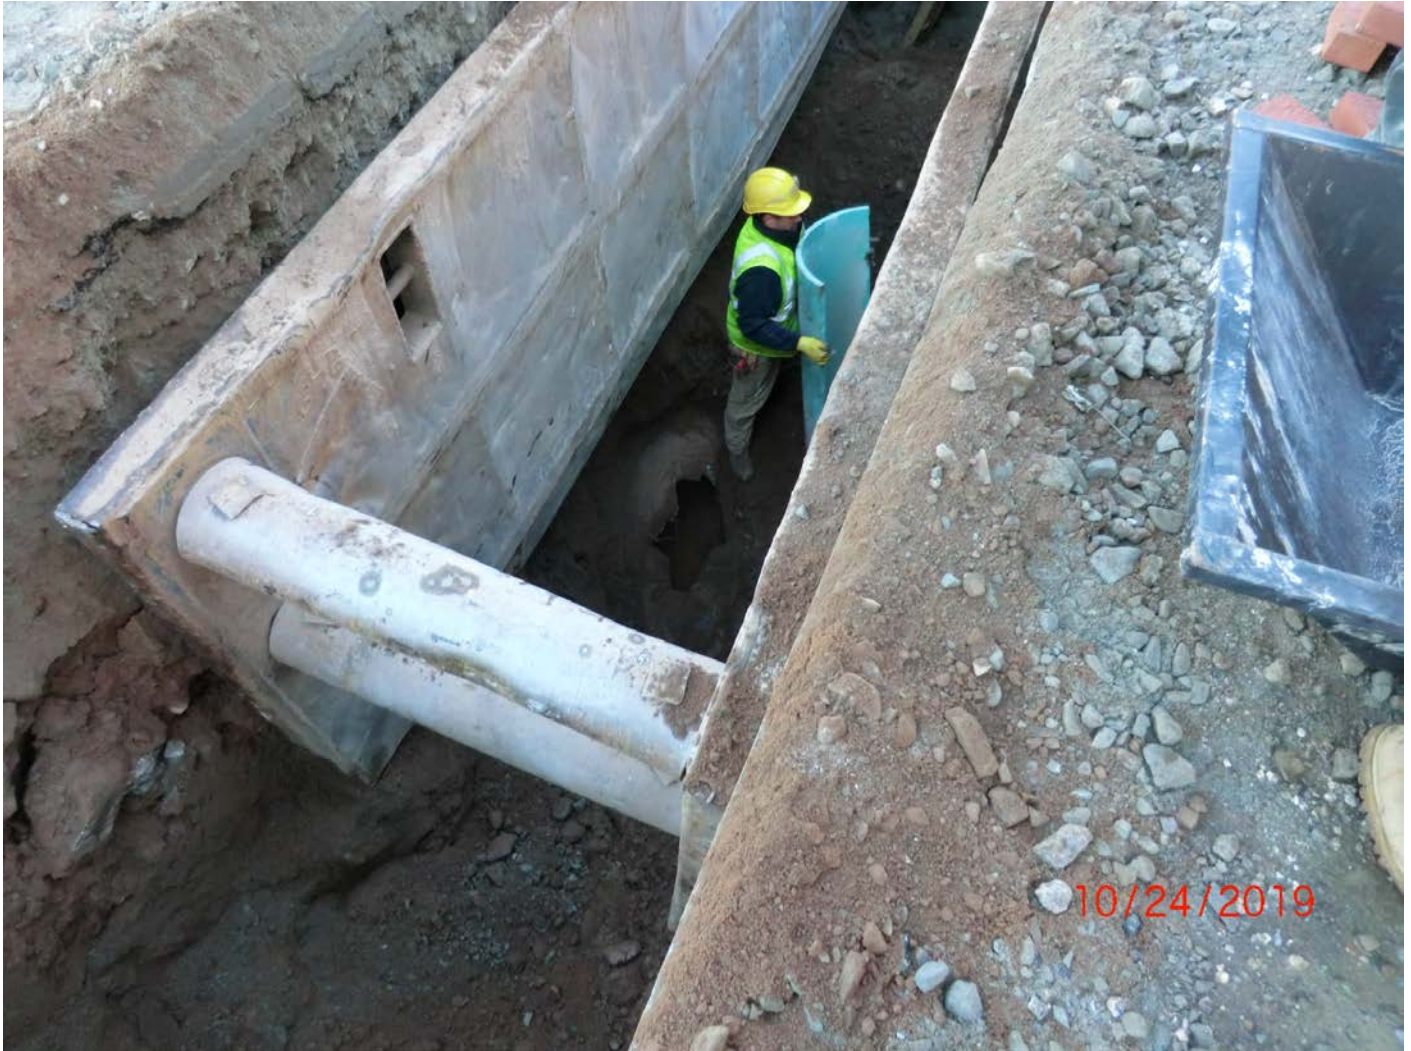
Figure 3 – A partial segment of ADS pipe to be fitted over hole.

0840 – A segment of ADS pipe was cemented into place over the break in the 18" drain pipe that occurred at the end of yesterday. Bricks were used to provide extra support at the ends and on the side. The entire repaired area was then covered with geotextile fabric and 1-foot of gravel laid down over the drain line. The foot of gravel was also the bed for the 16" DI pipe that was installed next.

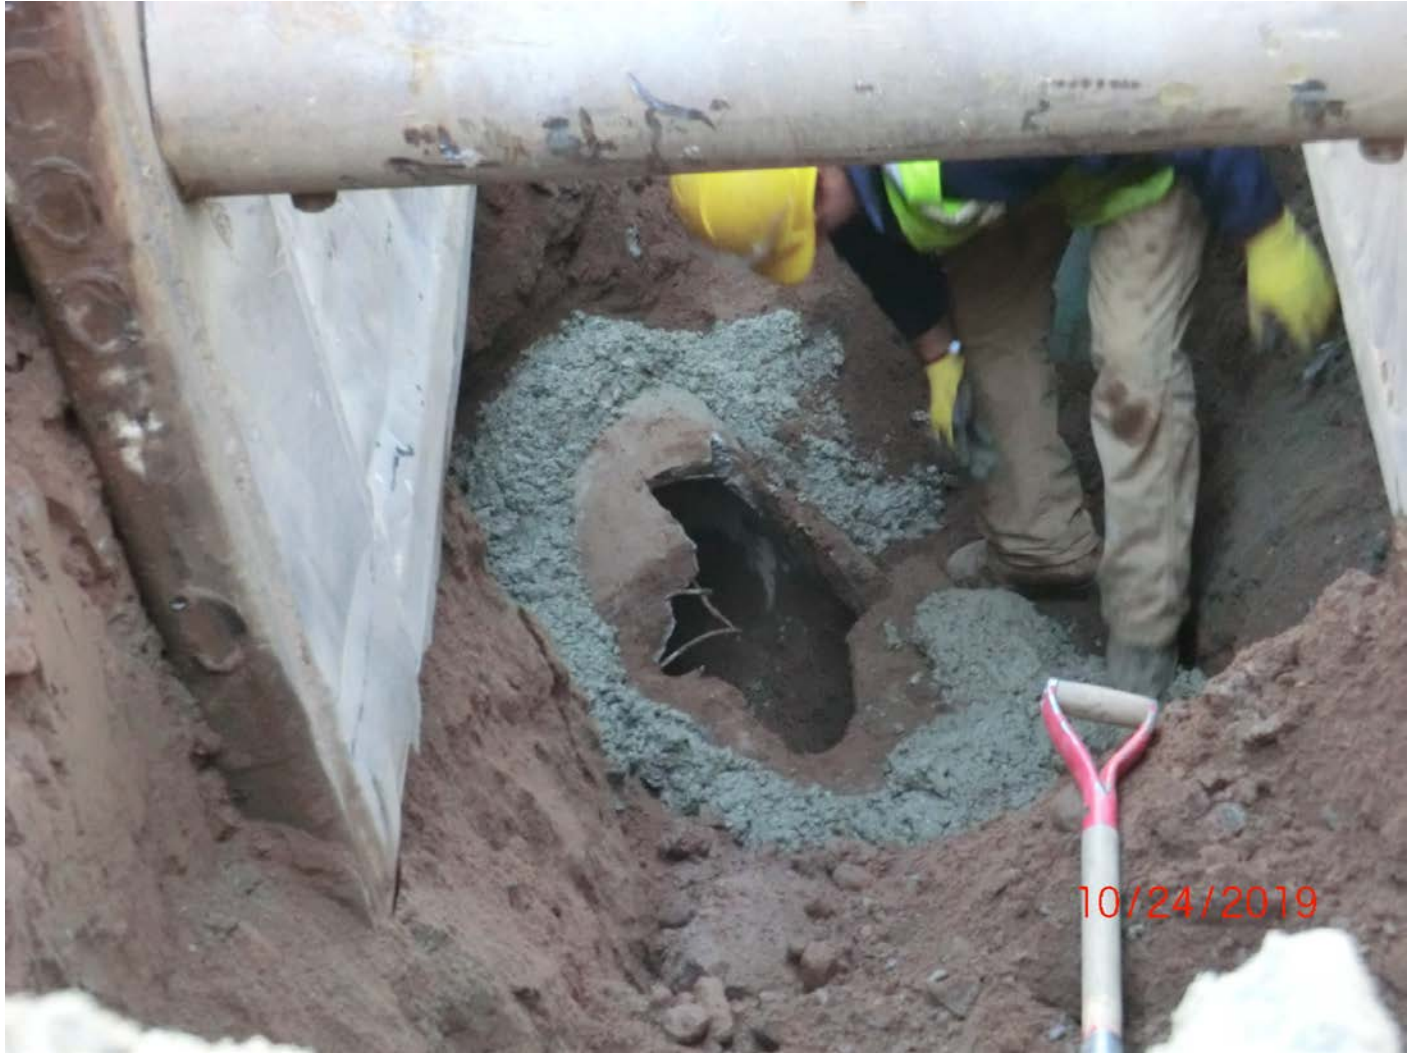
Figure 4 – Cement 'gasket' set completely around hole in drain.

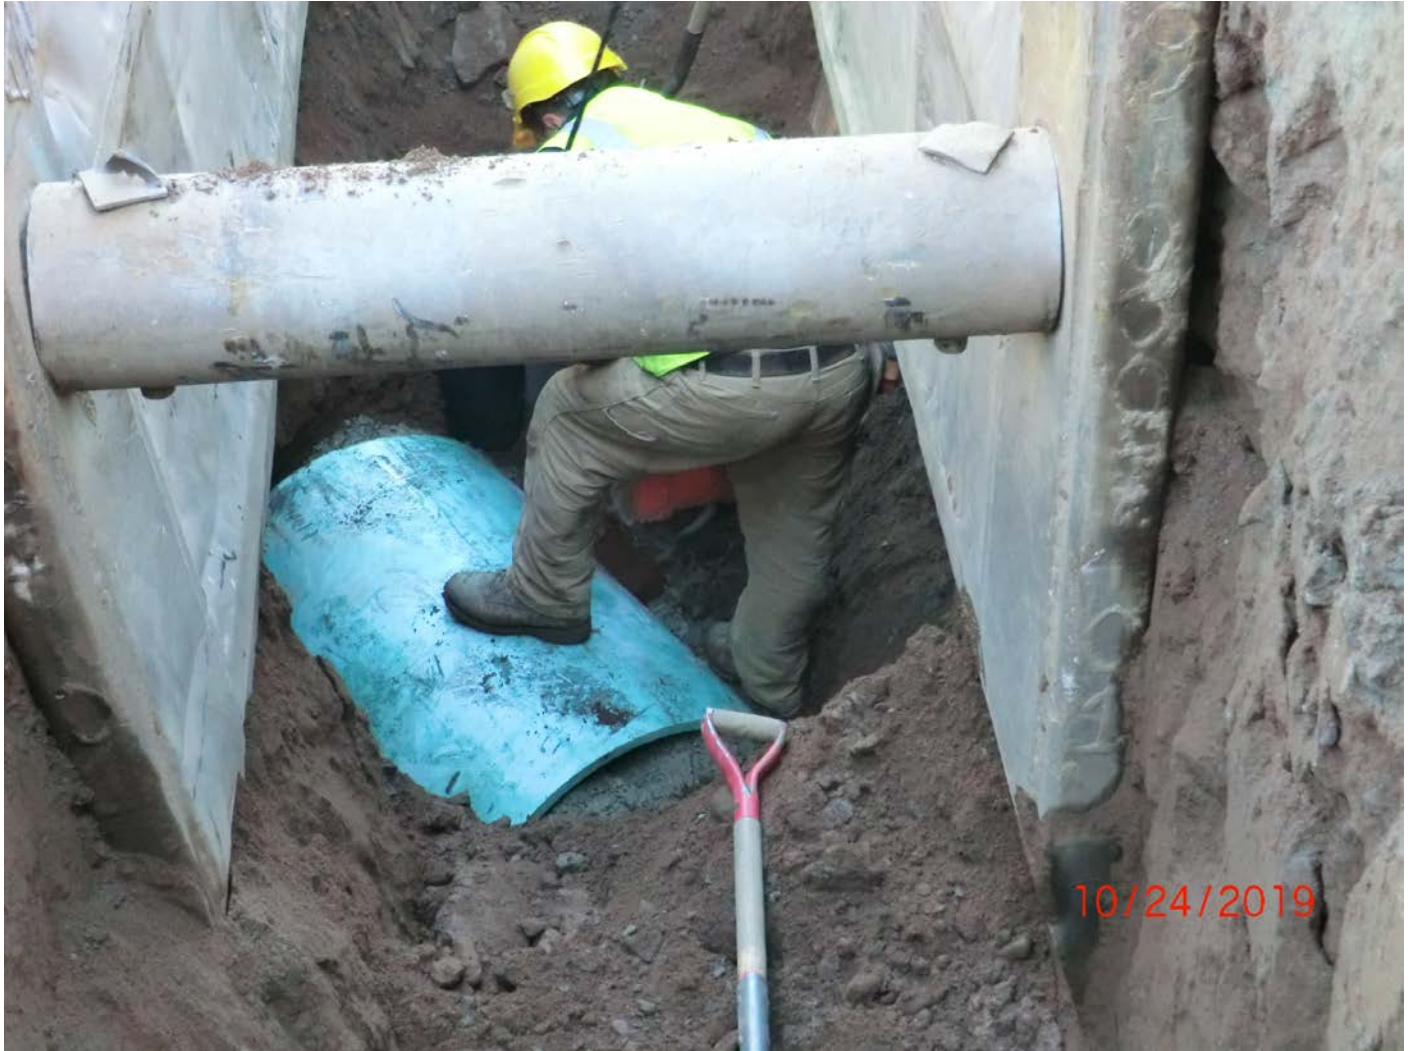
Figure 5 – Segment of ADS pipe set over ‘gasket’ of cement.

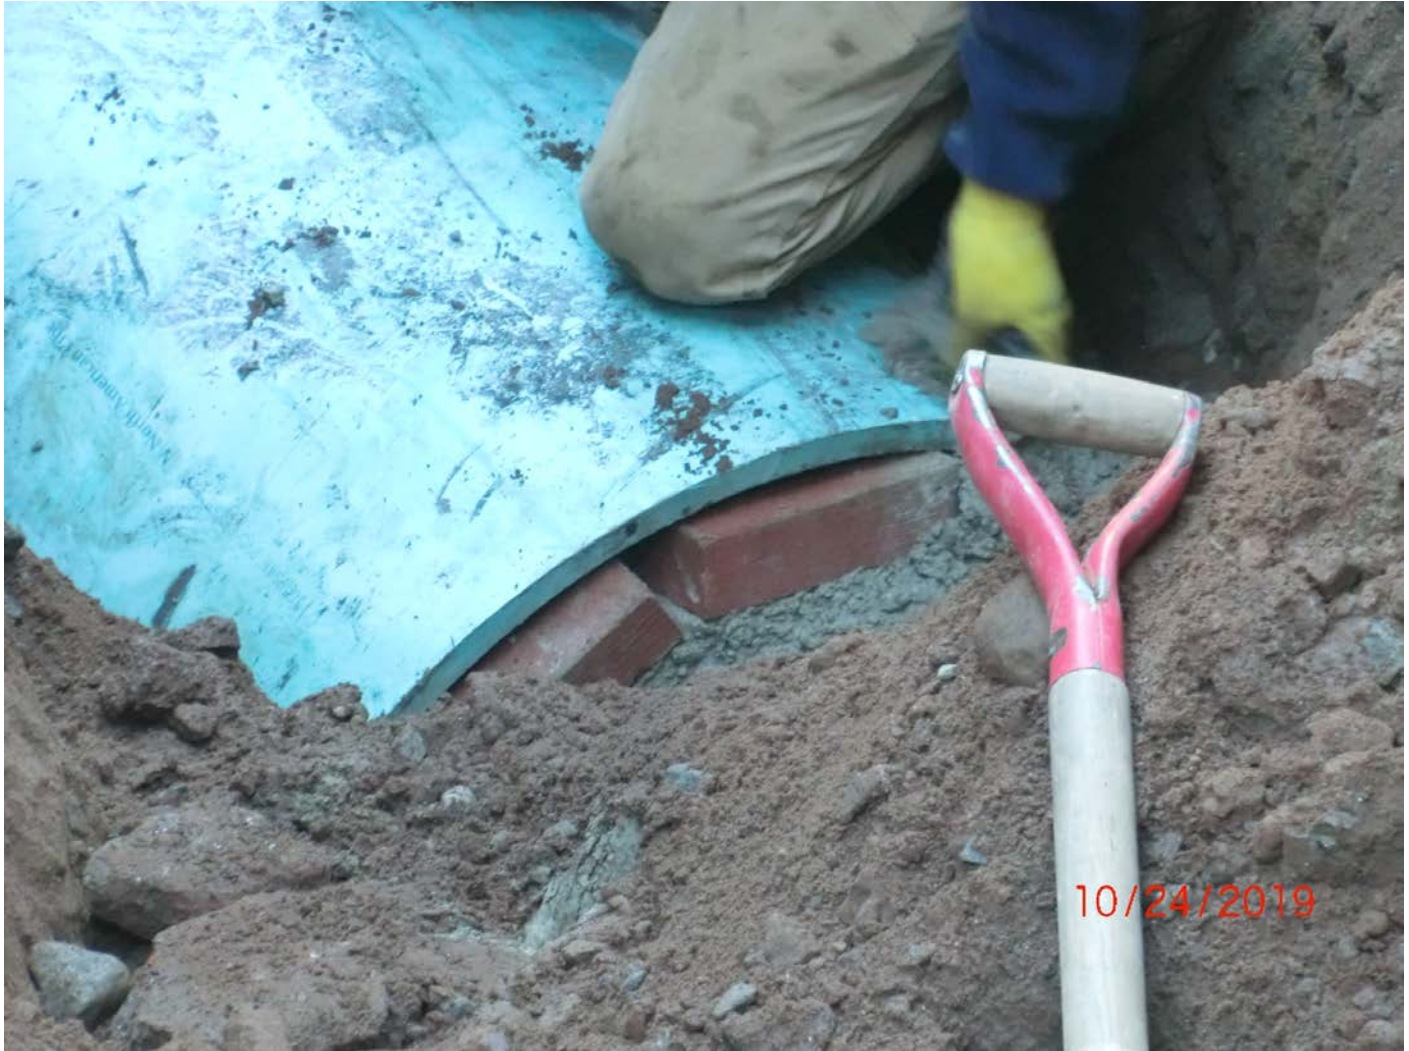
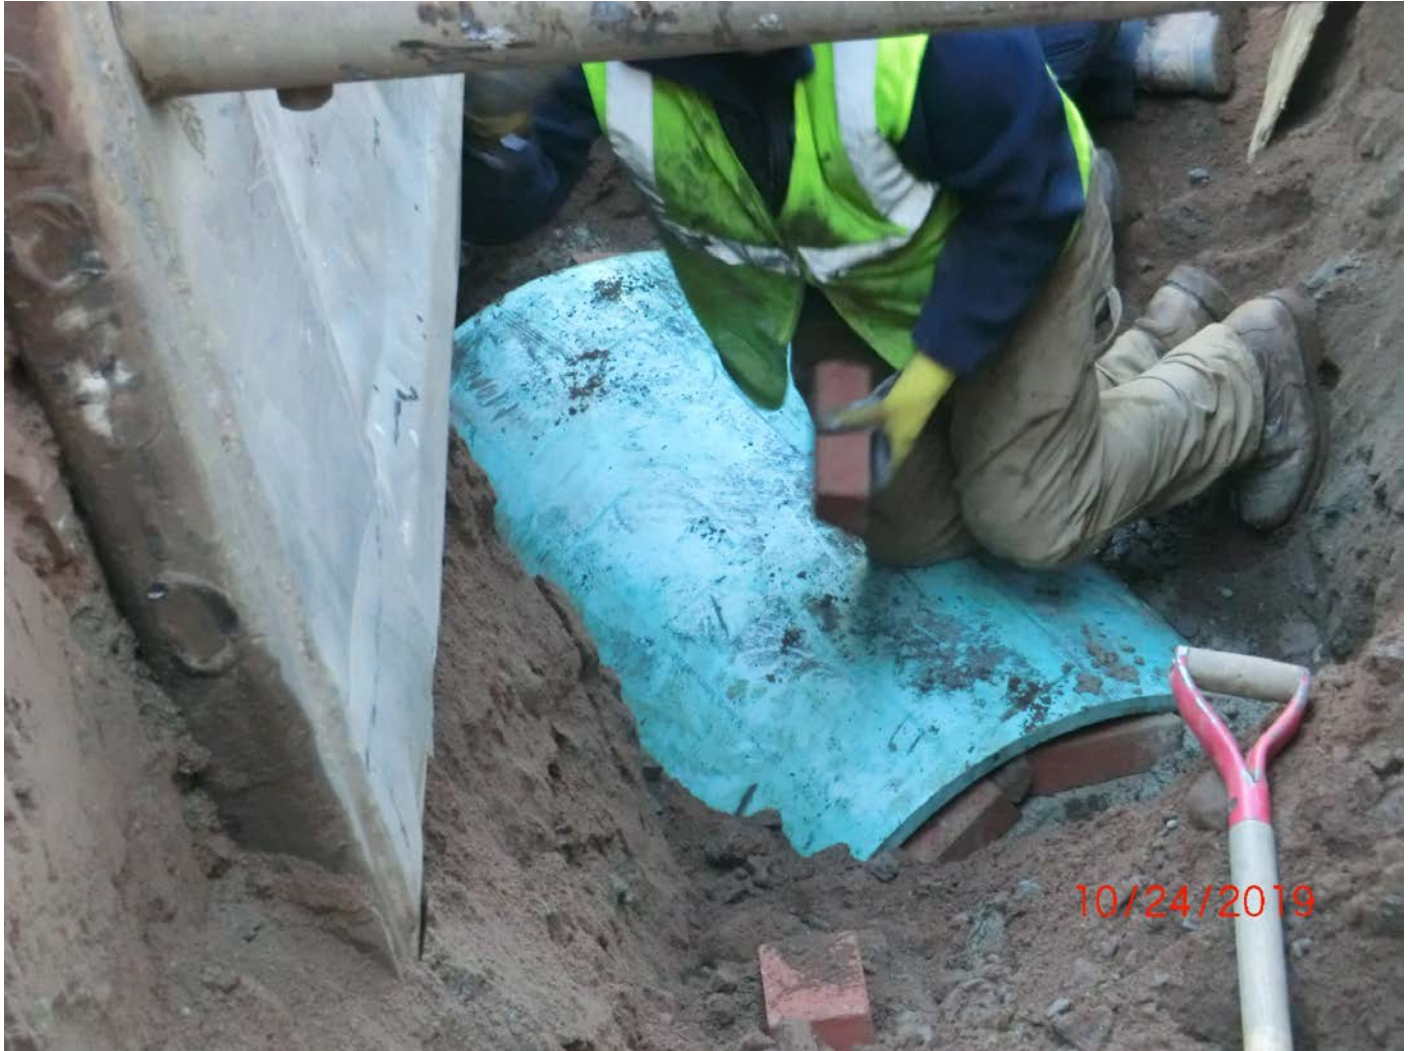
Figure 6 – Ends bricked in for added support and strength.

Figure 7 – Same as previous.

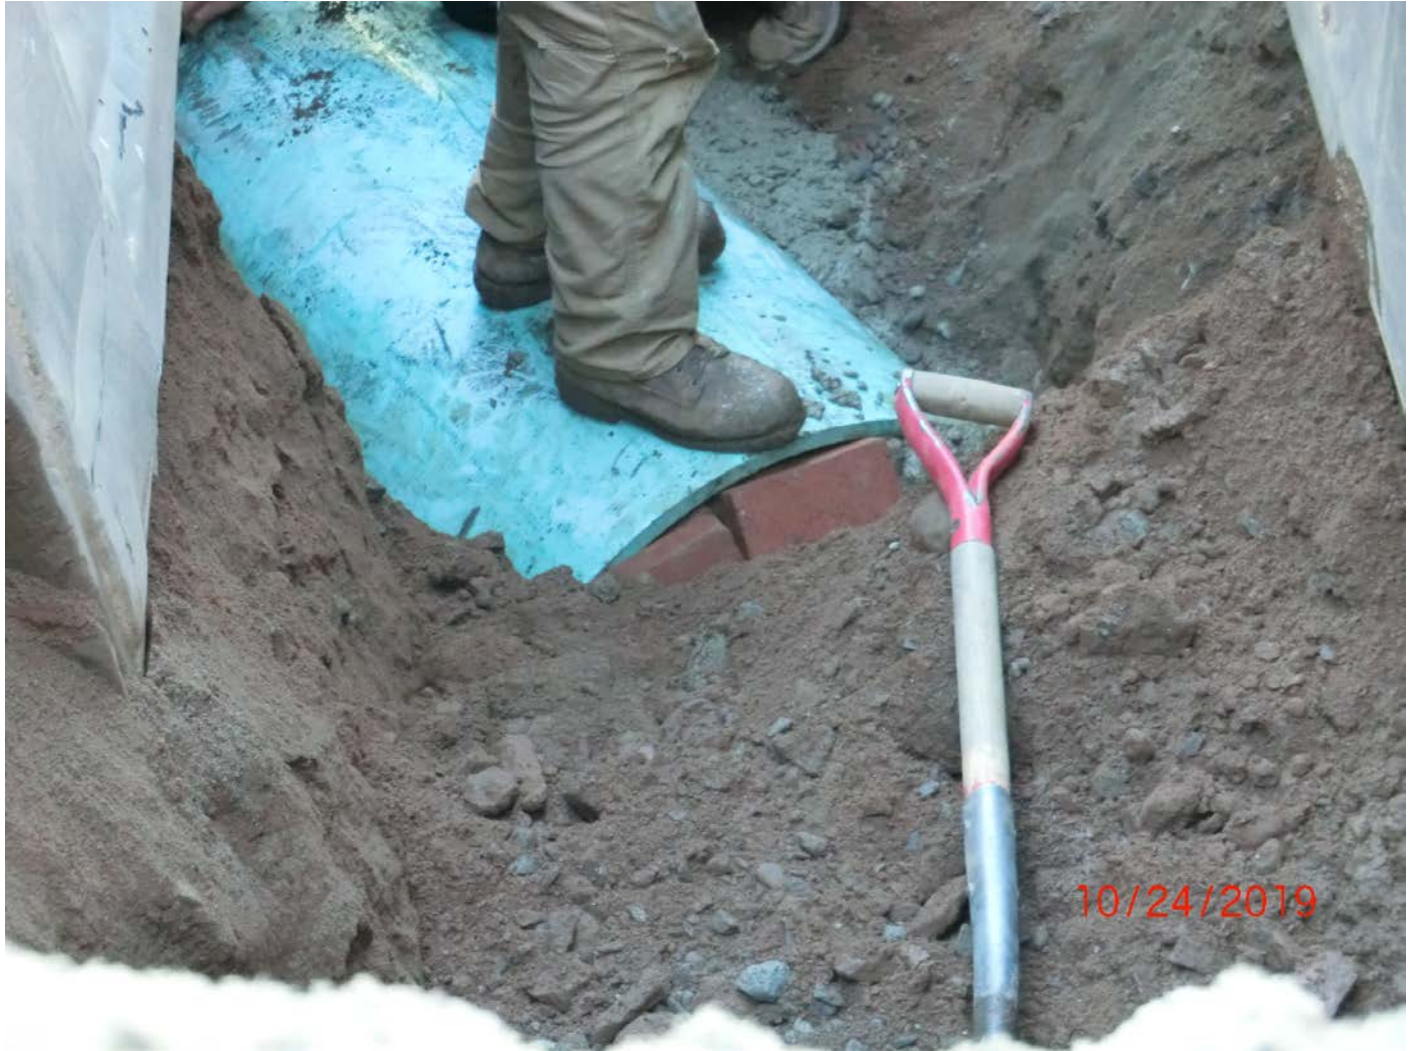
Figure 8 – Final brick face. This was done on both sides of pipe.

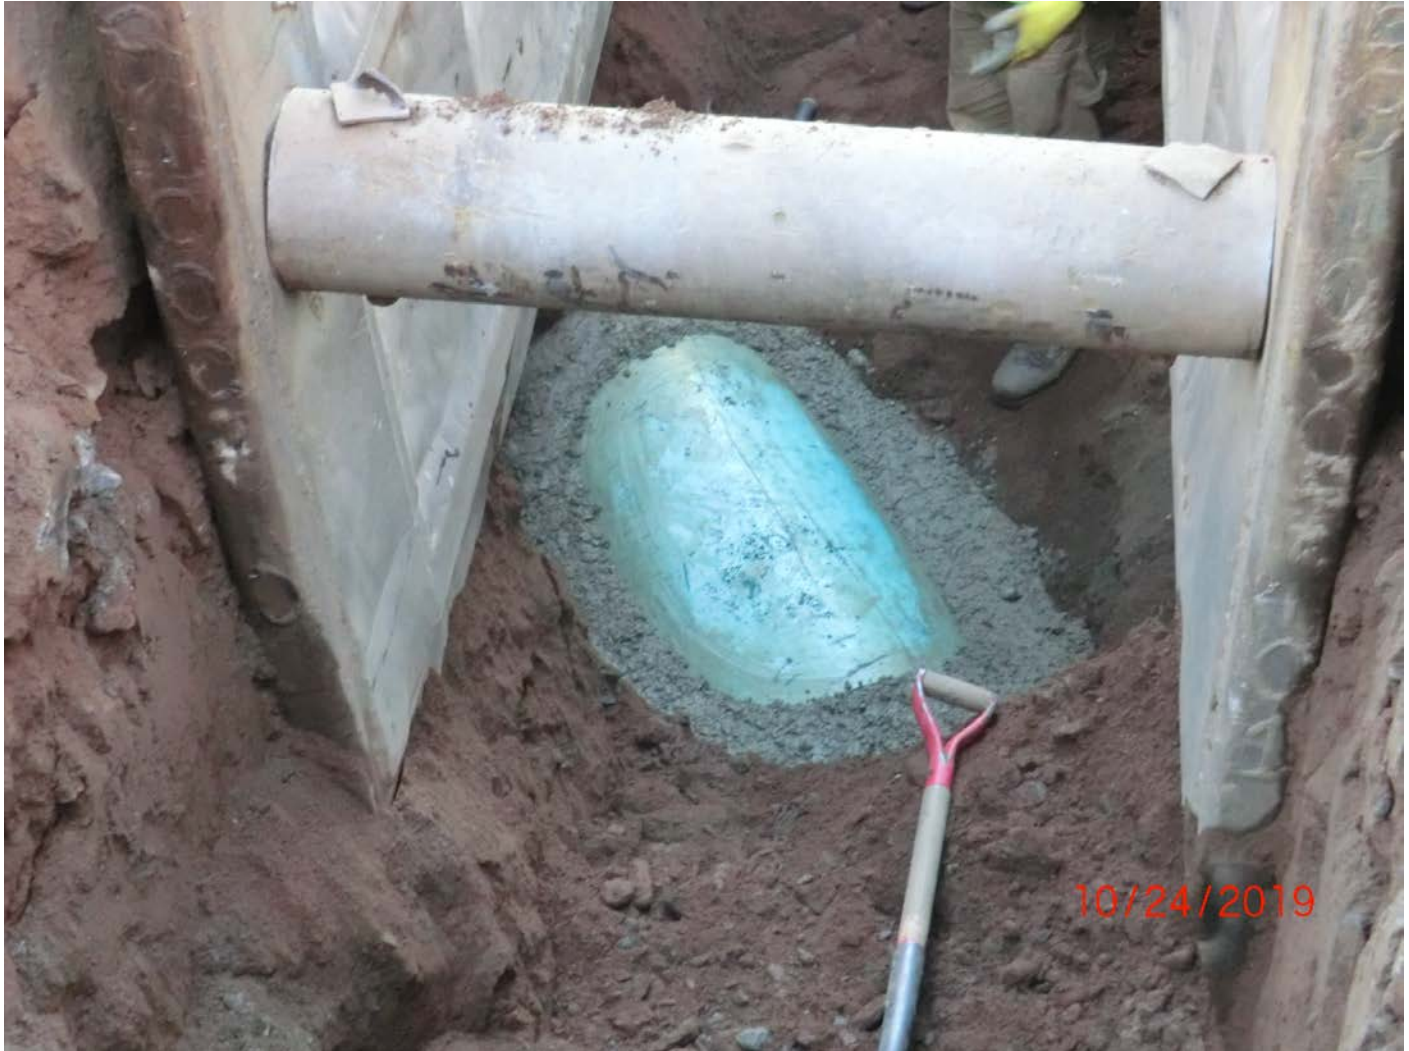
Figure 9 – A second ‘gasket’ of cement set around entire cover. Note that the ends were fill in over the bricks.

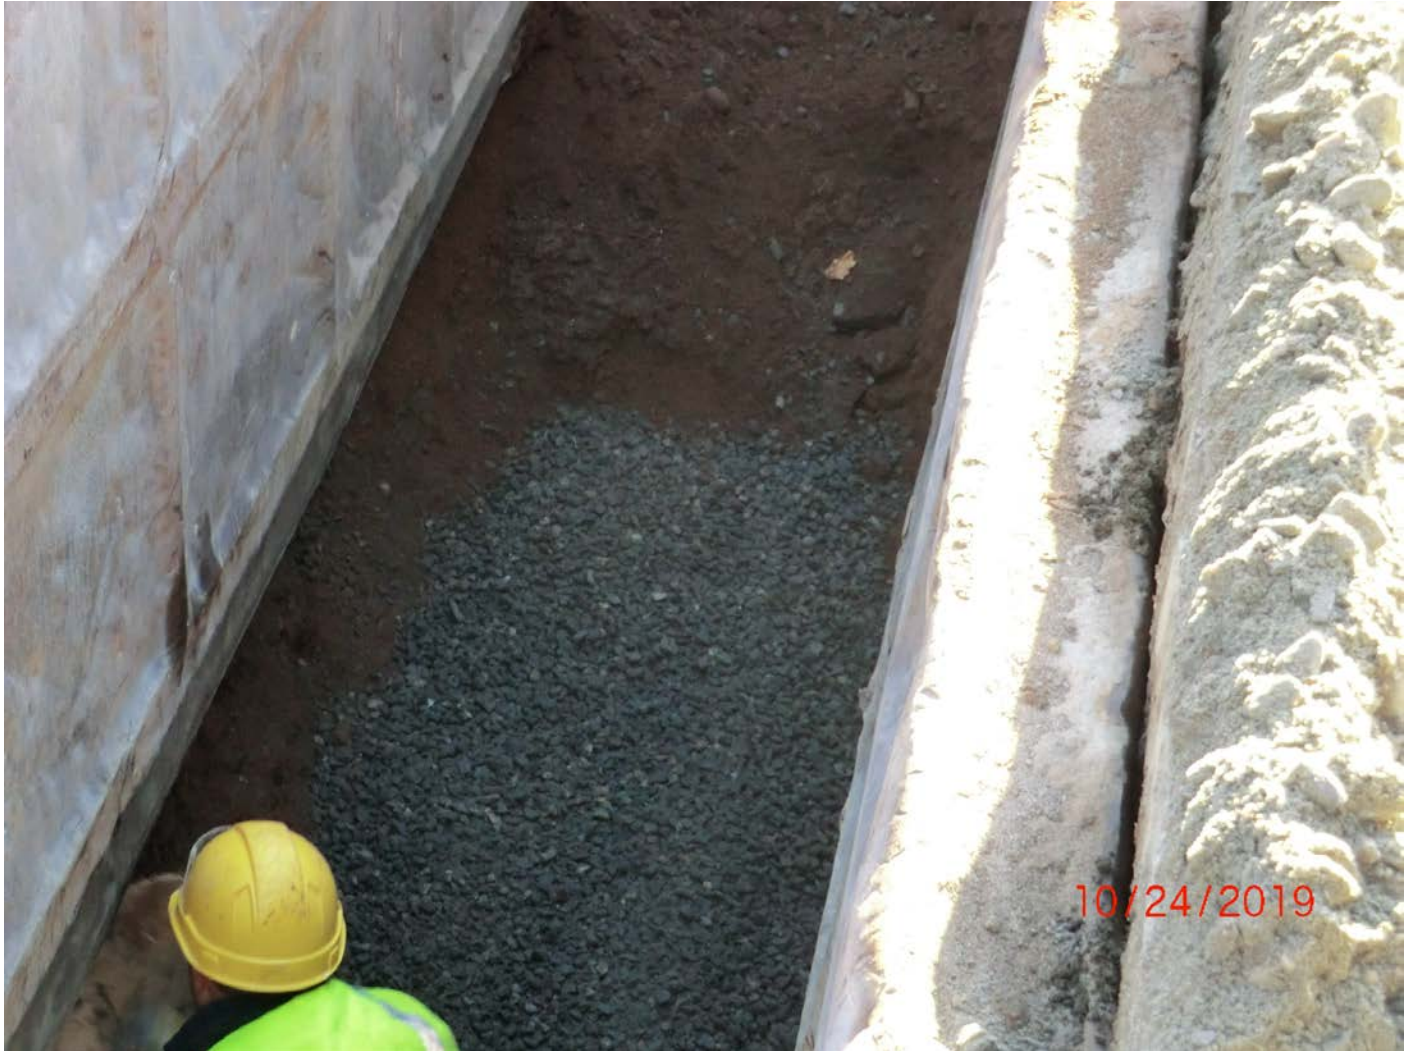
Figure 10 – Not shown, is geotextile fabric placed over the entire patched hole, then covered by 12 inches of gravel to raise the bed to the elevation needed to lay the 16" DI pipe over this section.

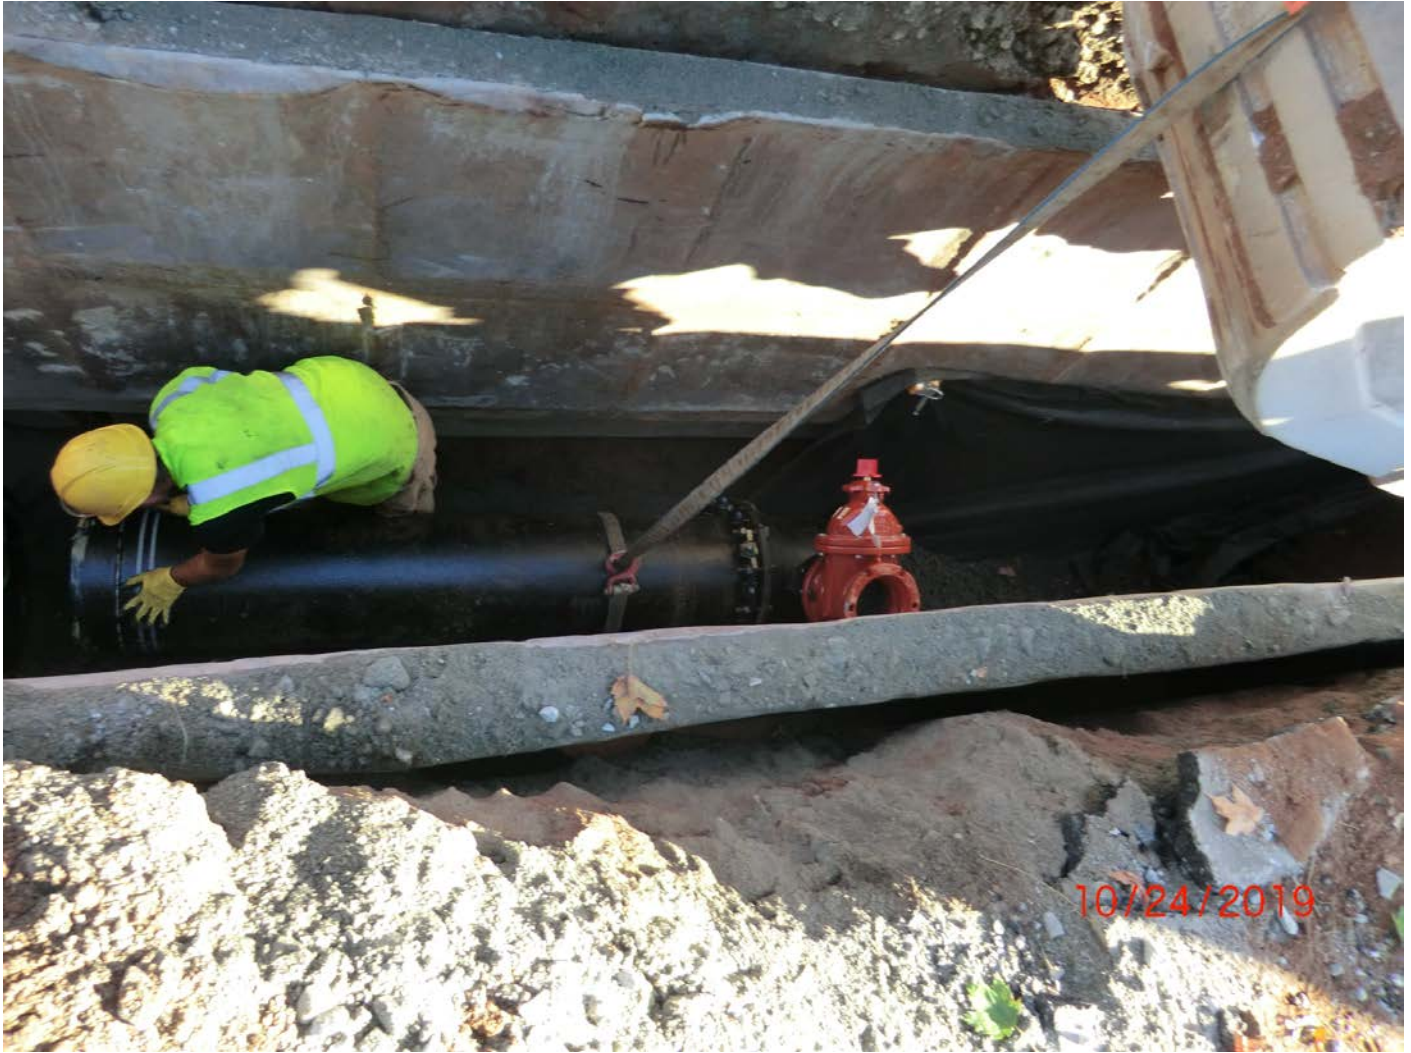
Figure 11 – Installation of Hydrant T section. Note that the T points up at first to fit through the trench box and is then rotated into the proper position once pipe is laid down.

0950 – Installed 7.25 feet of 16” DI plus a 16x6 Hydrant Tee with gate valve. Install to station (center of Tee) 40+44.38 and covered with 1-foot lift of stone dust. Tie offs to the Hydrant Tee and Gate Valve are to the nearest corner of the steel double catch basins, located on the north and south side of Talcott where the road bends to the south. The north tie-off is 38.8 feet to the Tee and 39.5 feet to the valve. The south tie-off is 31.6 feet to the Tee and 31.3 feet to the Valve. The top of Tee is approximately 7.5 feet below grade. Elevations still pending.

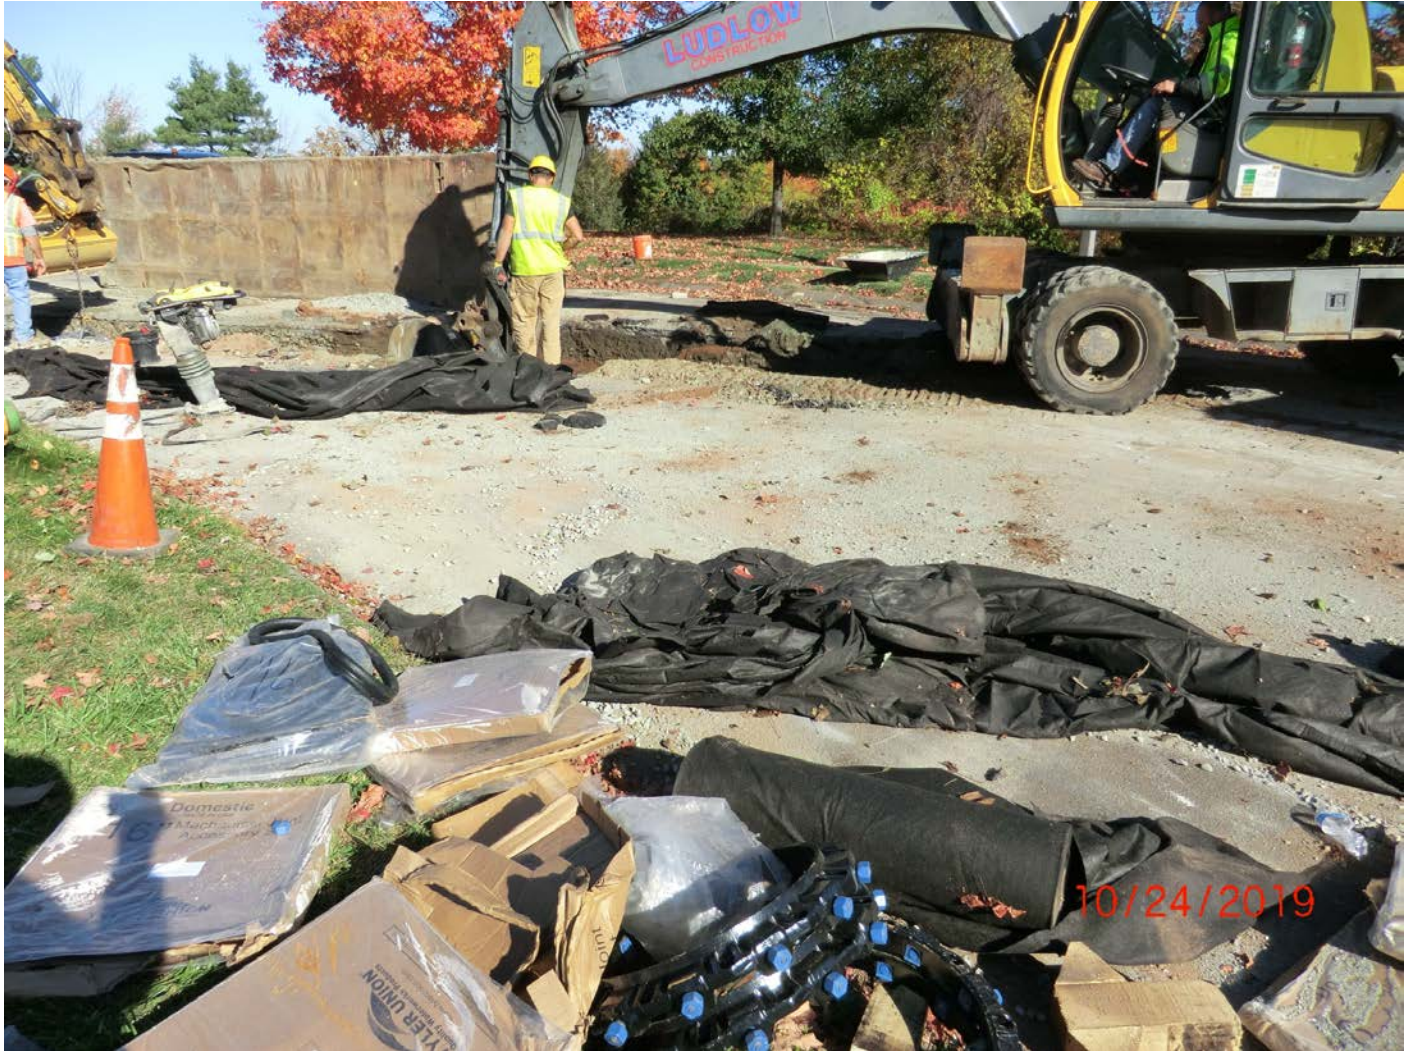
Figure 12 – Excavating a slightly larger hole for the installation of the 12” water line Tee. The existing 12-inch water line will be connected at a later time. Note that the Large Excavator has been switched out for the smaller Rubber Wheeled Excavator. This was done to avoid damaging the driveway of 124 Talcott Ridge, which is located behind the excavator to the right of this picture. Also note that the town ROW and existing valve assembly is located on the other side of this trench to the north side. Picture is taken facing north.

1015 – Install 7 feet of 16” DI plus 0.5 feet from center of Hydrant Tee to Station 40+36.88. At this point the large excavator is swapped out for a Rubber Wheeled Excavator. The rubber wheeled excavator is being employed so as to not destroy the driveway apron at 124 Talcott Ridge Dr. According to Billy (Ludlow), the plan is to shorten the line in that direction and install the 45<sup>0</sup> bend a little earlier in order to stay away from undermining the driveway apron.

1100 – An enlarged excavation for the three-valve 12” water main connection has been excavated. This comes after crossing under the existing fire hydrant line and before crossing under the existing 12” water main. The new assembly lies adjacent to the existing ROW and 12” line and valve assembly. The existing assembly is located to the north side of the new assembly. The crew breaks for lunch before installing the new assembly which consists of 2x16” Butterfly Valves on either end of a 16”x12” T and 12” Gate Valve (center of Tee to 12” Gate Valve is 25”). Hook-up to the existing 12-inch line will occur at a later date. The assembly should add 6.34 feet to the line.
