Daily Report

Project:	Durham Meadows Pipeline Installation	Date:	October 28, 2019
Location:	Talcott Ridge Drive, Middletown CT	Day of Week:	Monday
Project #:	AECOM: 60445033	Report No:	22
Contractor:	Ludlow Construction	Page:	2 of 18

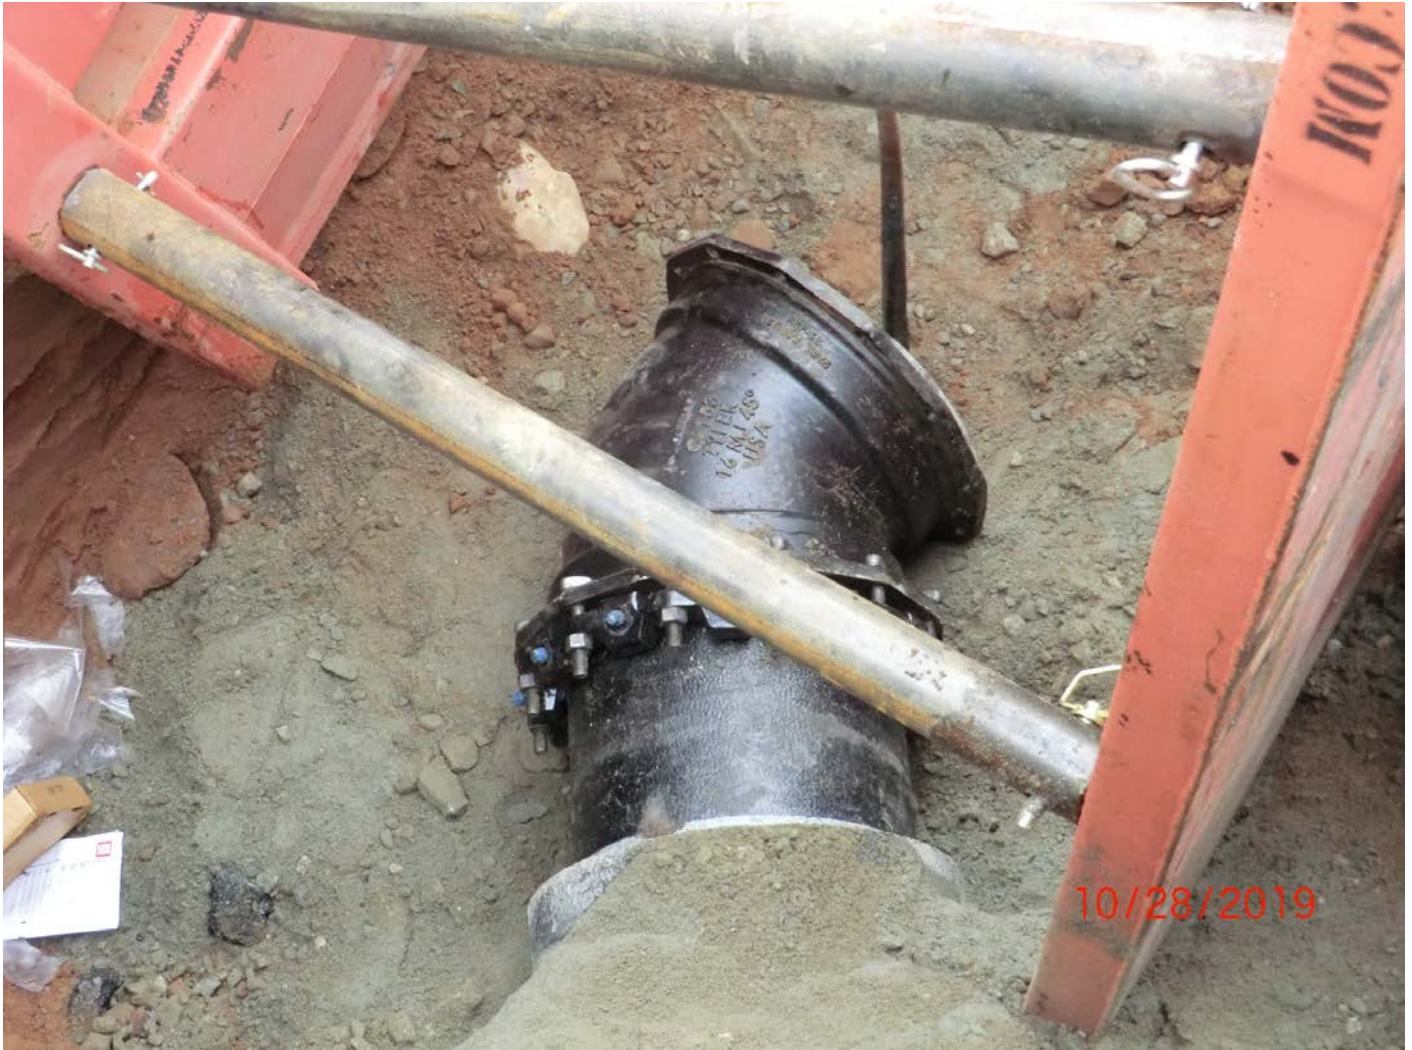
Figure 4 – First pipe of the day. 2-foot nipple with 45-degree bend. This is the last bend, which should return the 16" DIP into the designed (already sawcut) trench.

0900 – Installing the remaining 18 feet of 16” DI pipe left from the nipple cut off. The 45-degree bend added 1 foot for a total of 21 feet from start. New station 39+23.95. All restrained pipe.

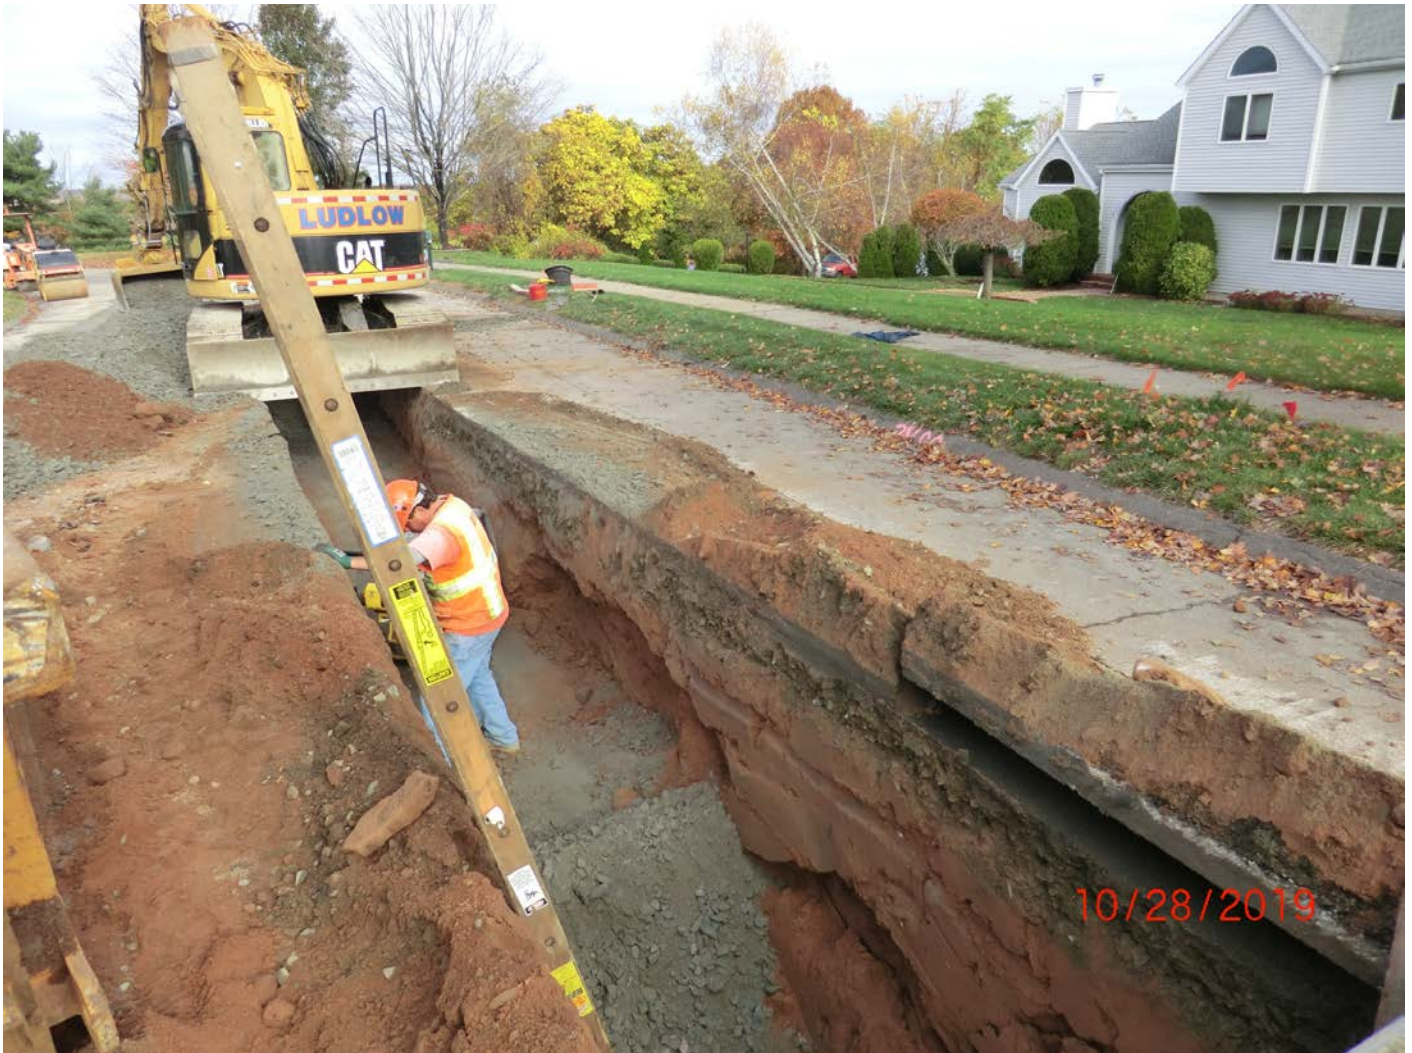
Figure 6 – Facing north. Running compaction and back fill.

1200 – Compaction tests run. The different stations were to access different lift depths.

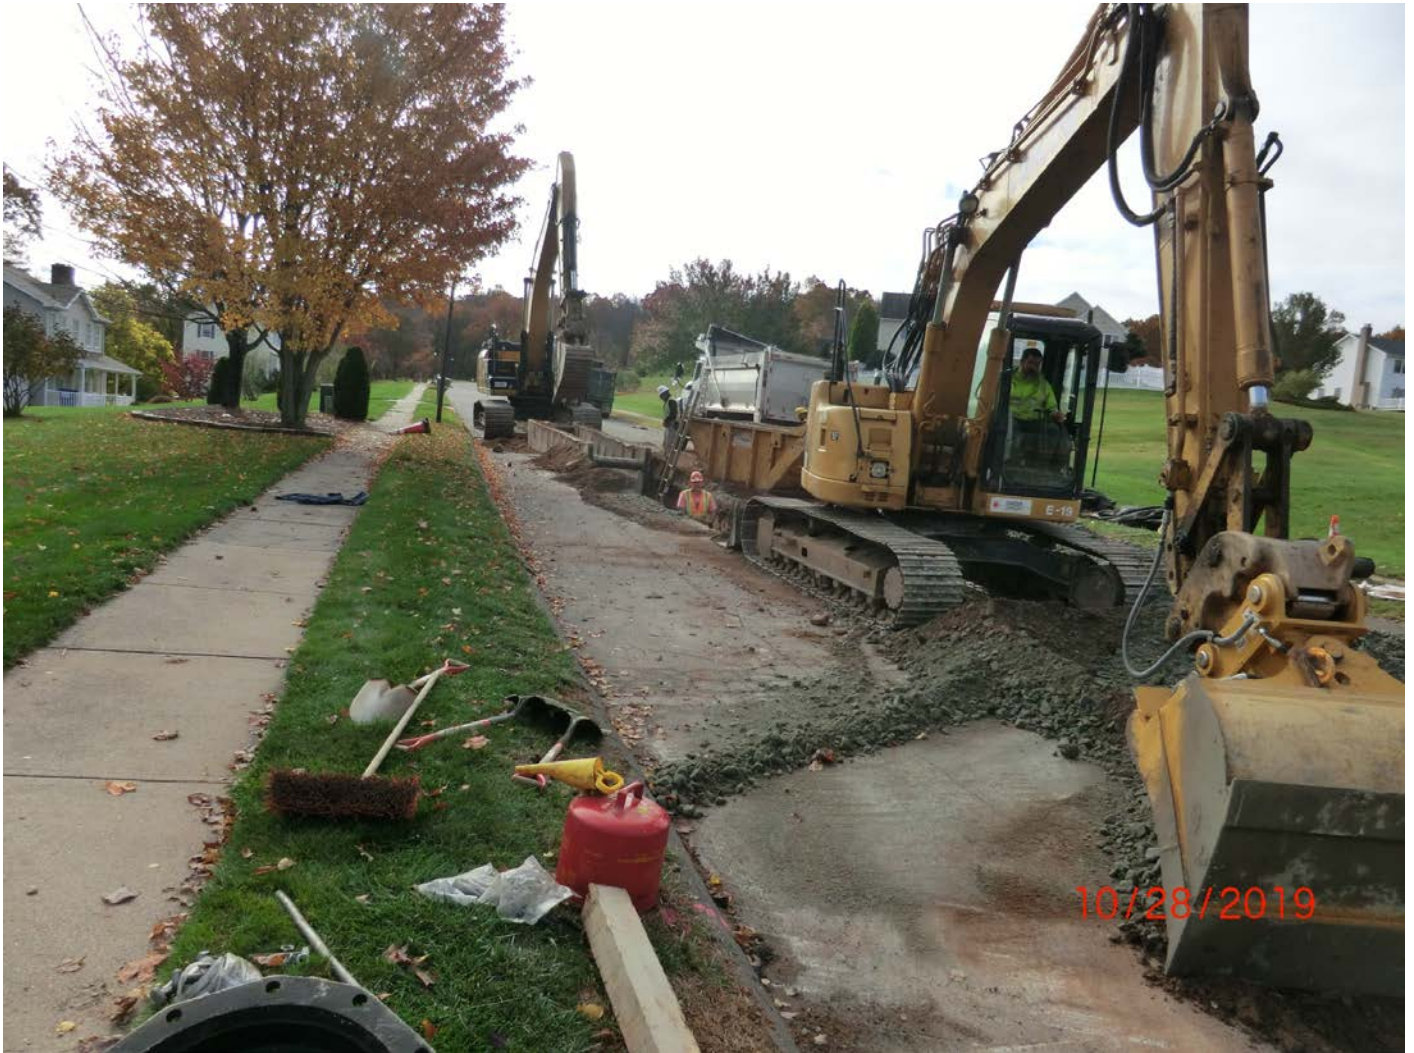
Figure 7 – Facing south, the whole line, trenching and backfilling.

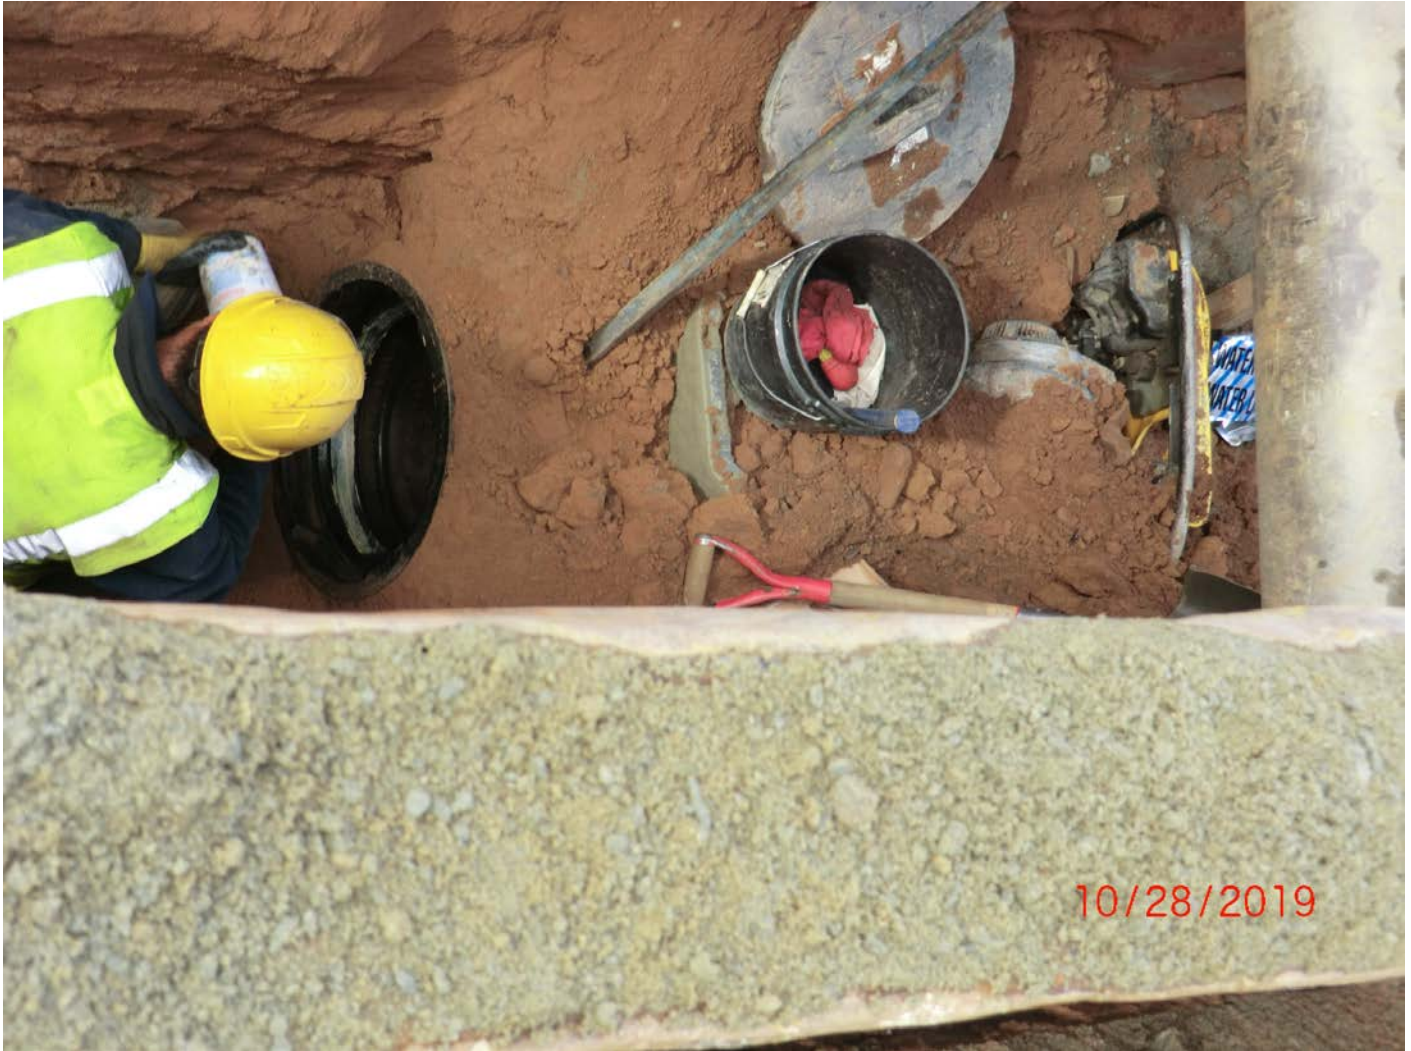
Figure 9 – Same pipe as Figure 8, clean.

1040 – Continuing excavation and back filling. While shifting the trench box a pile of soil accidentally filled the end of the pipe. Andy (Ludlow) did great work in cleaning out all soil from the pipe.

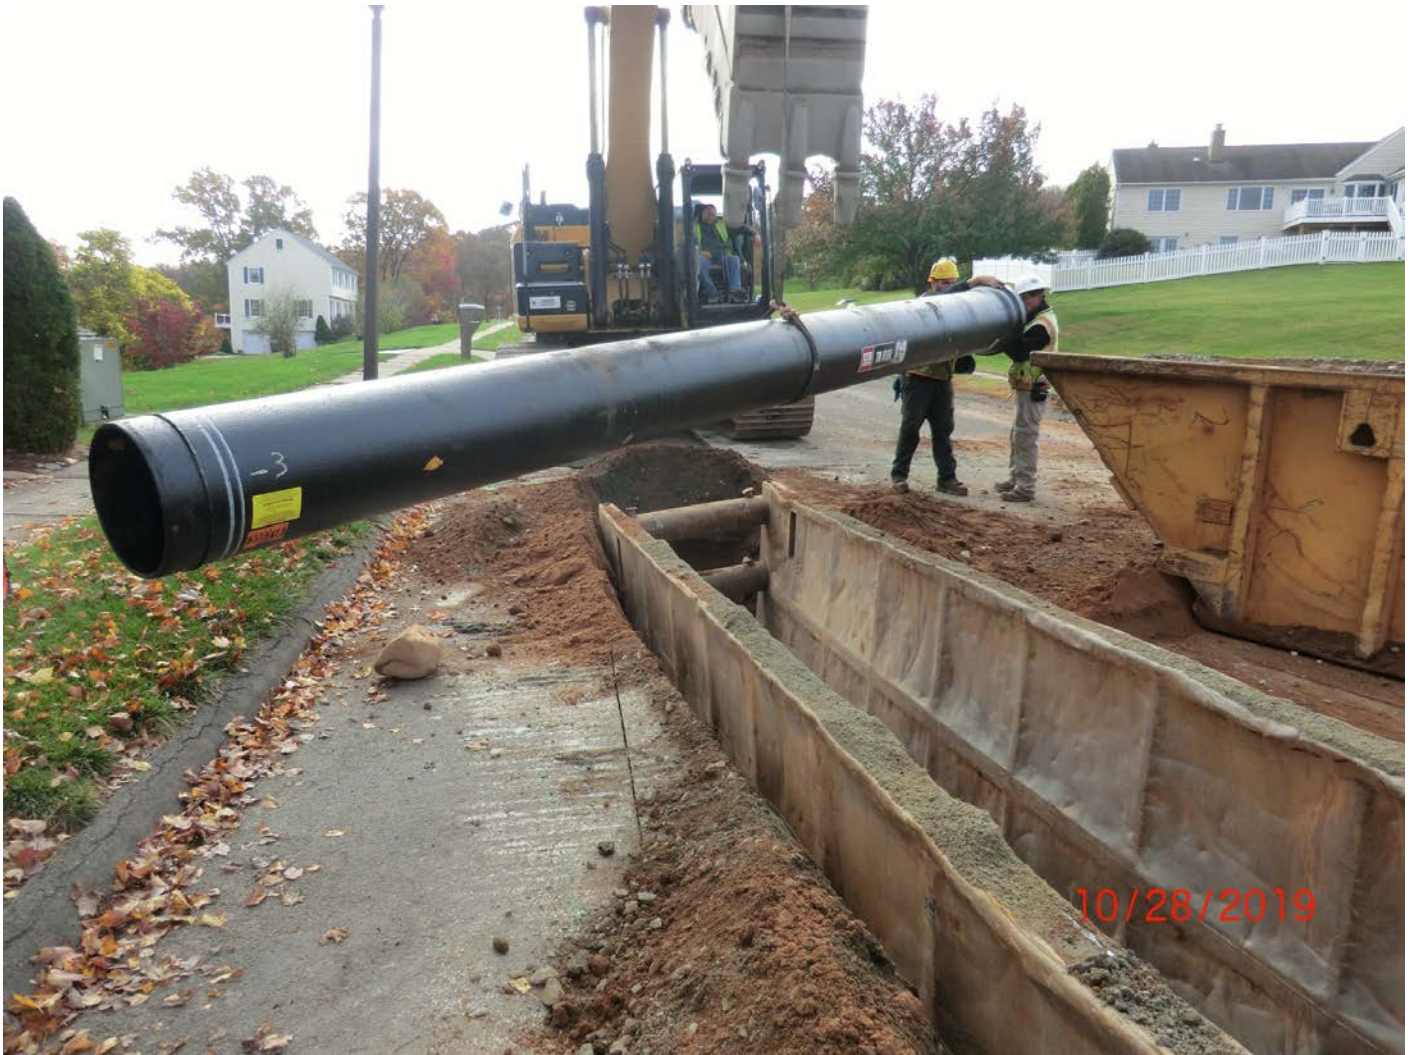
Figure 10 – Restrained pipe installation. 16” DIP

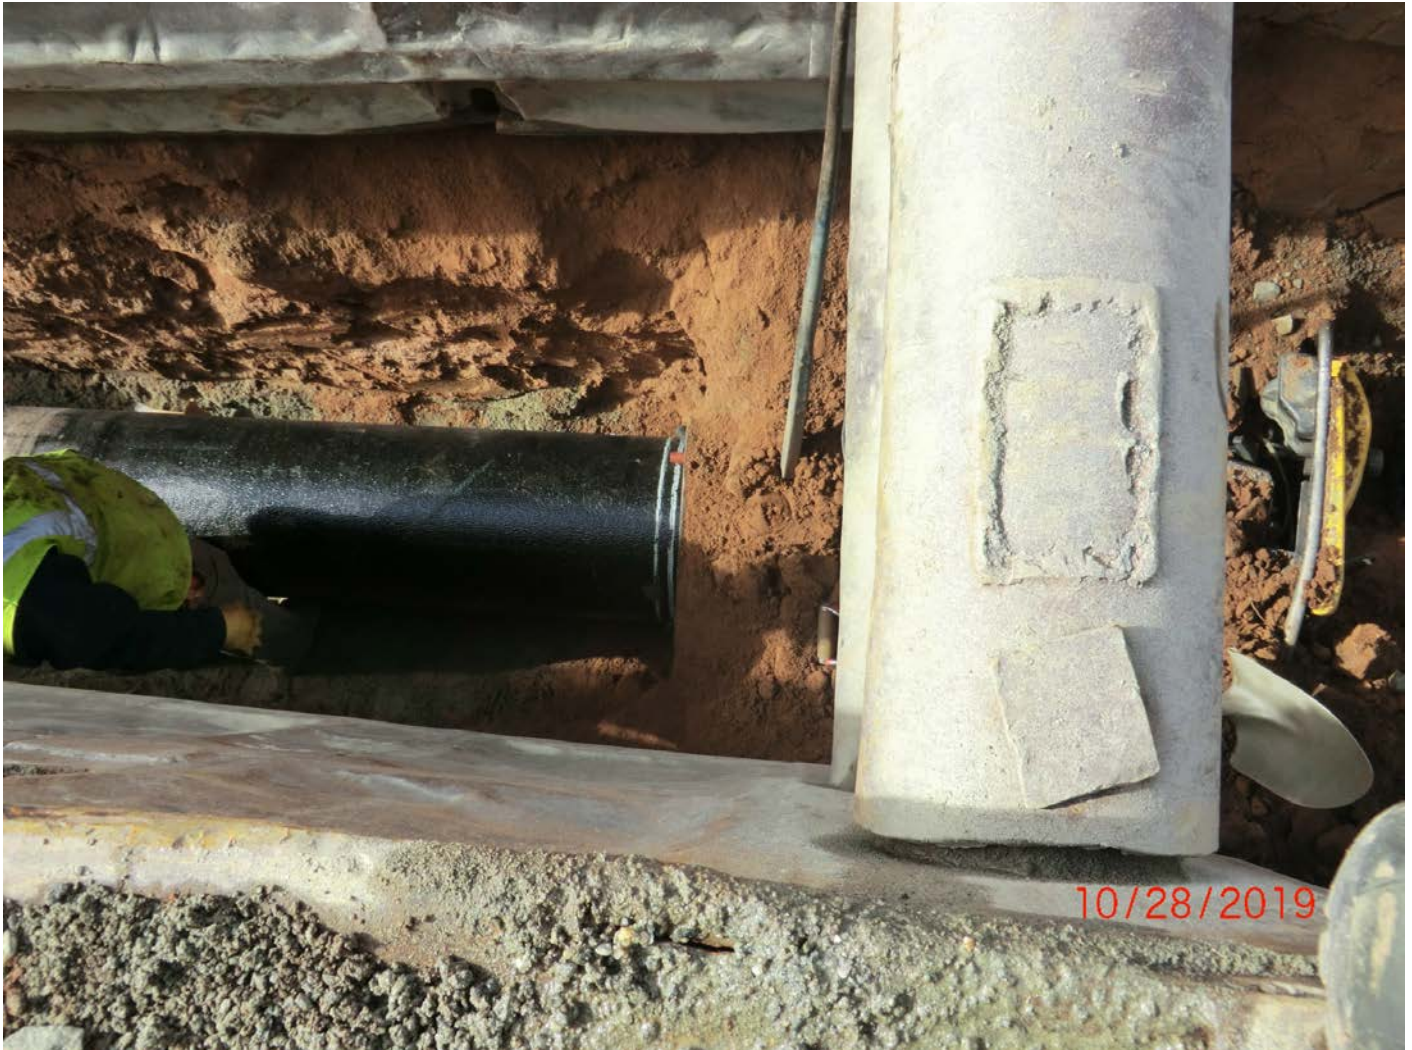
1100 – Install 20 feet of 16” DI restrained pipe to Sta. 38+63.95. This section was deflected slightly to is was somewhat diagonal across the trench. The purpose is to keep the line within the designed trench that has already been sawcut. The pitch and angle made the pipe appear to not be seated, but the connection was checked an confirmed that the locks were in place.

Figure 11 – Restrained 16” DIP, note that locks are set. Set rings appear a little off due to deflection in pipe to keep pipe aligned in existing trench. Station 38+83.95.

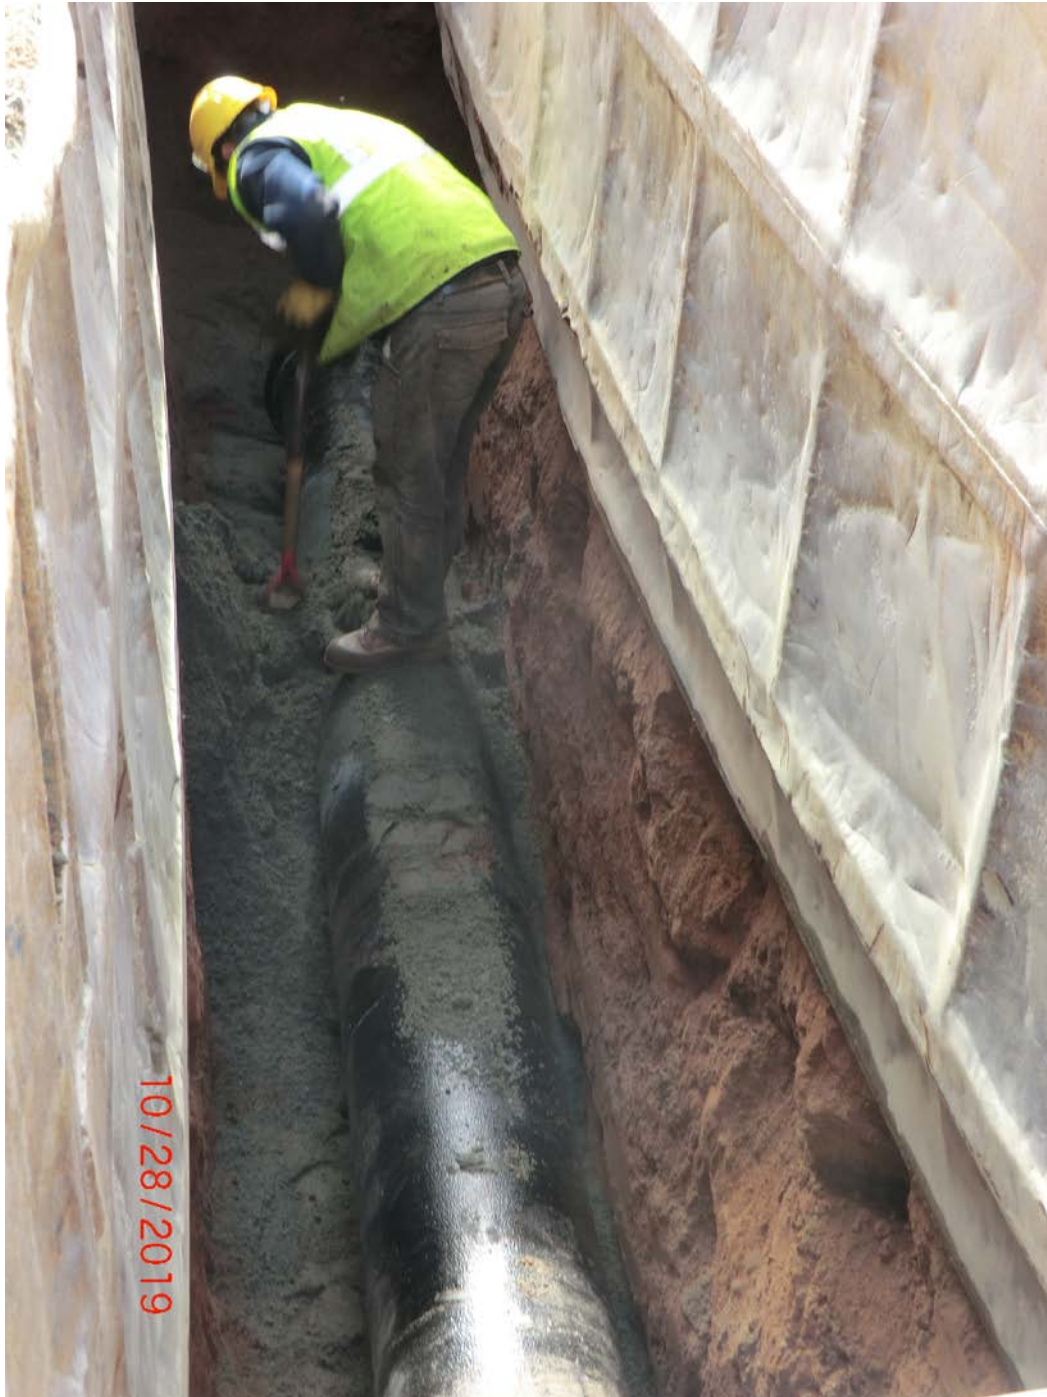
Figure 12 – Deflected alignment. Station at end of pipe is Sta. 38+63.95.

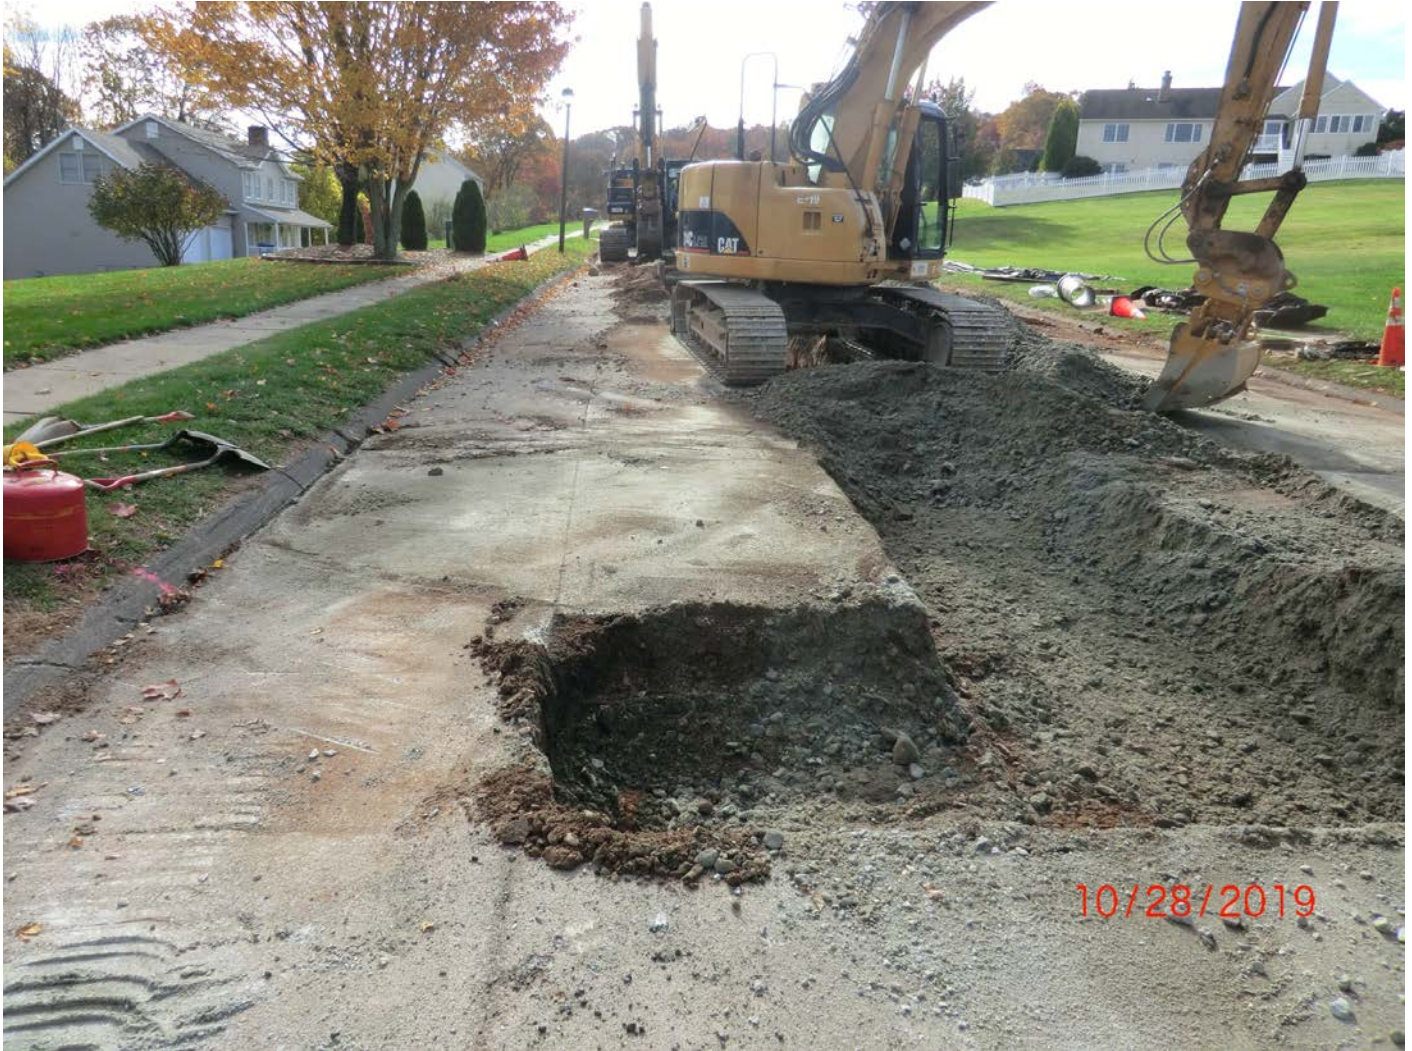
Figure 13 – Trench dug to ascertain location of utilities.

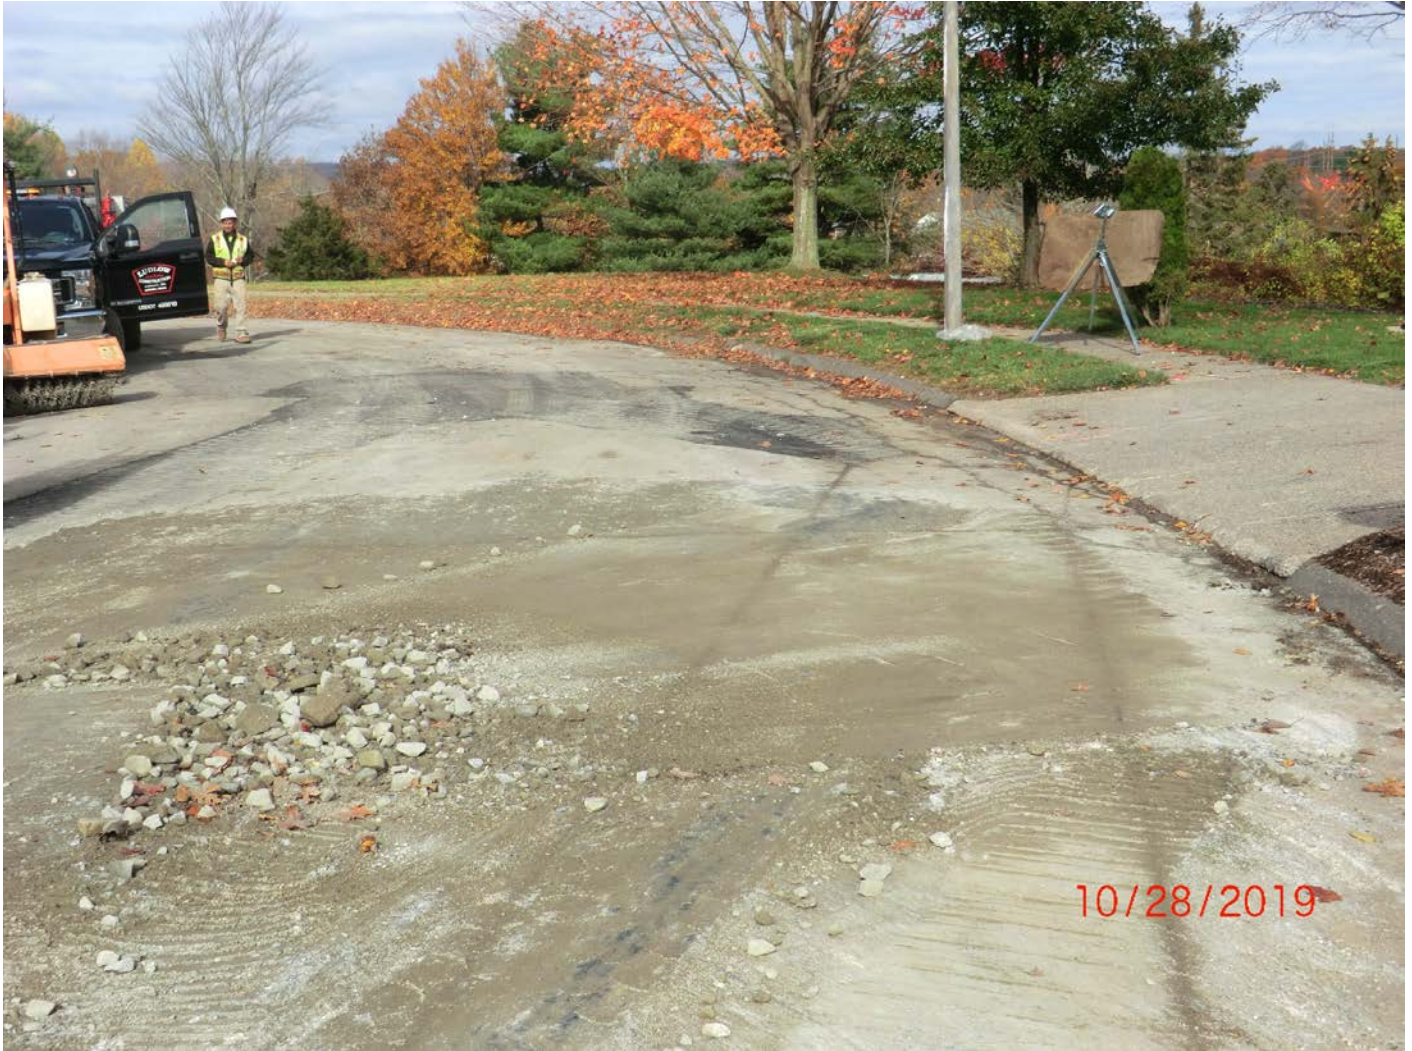
Figure 14 – Facing NW note asphalt patch. The line heading toward the driveway was intended location for 45-degree bend up towards the cul-de-sac. The other patch line to the left of the picture is the actual re-directed path.

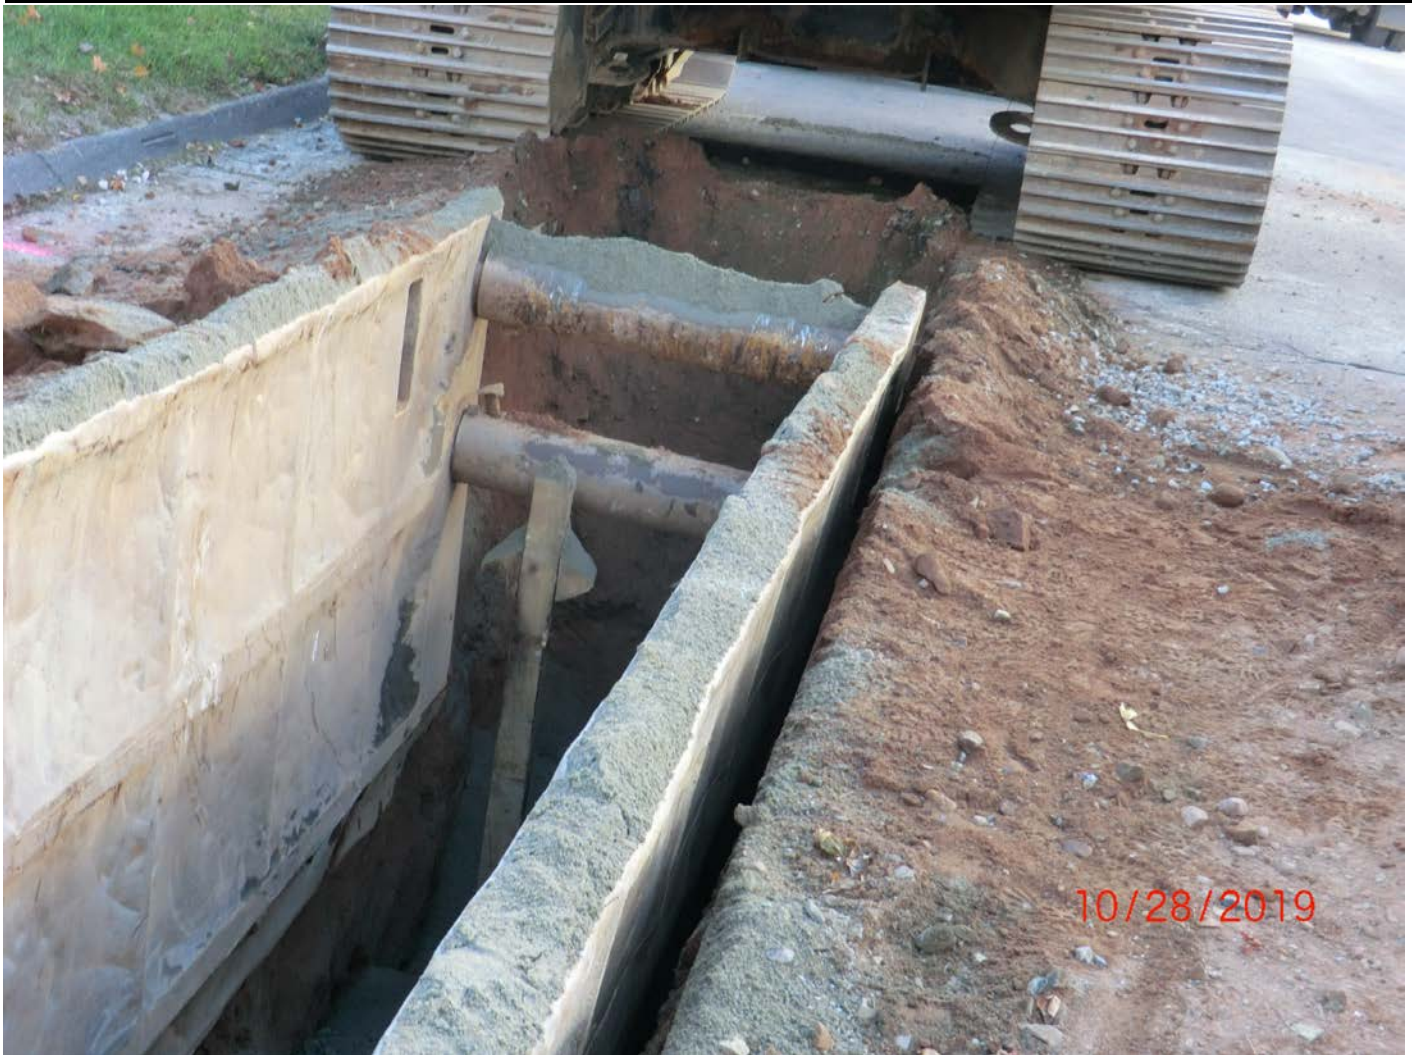
1310 – Install 20 feet of 16” DI unrestrained to Sta.38+23.95. End station for the day.

Figure 15 – The final station of the day, Sta. 38+23.95. Marked by 4x4 stake before burial and hot mix.

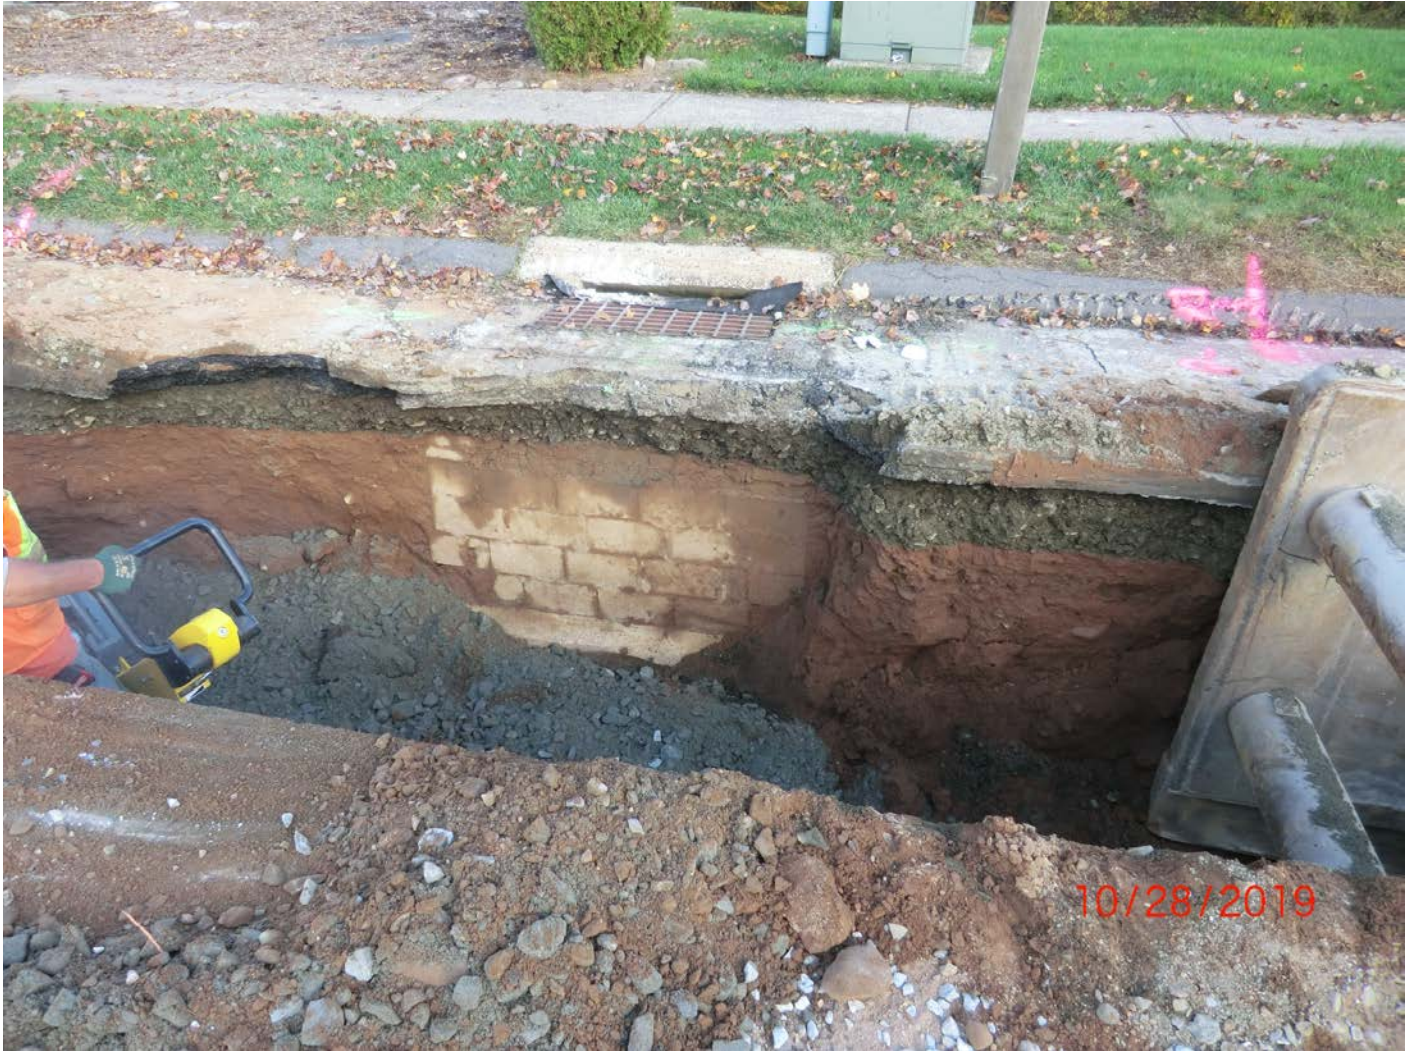
Figure 16 – Facing east, the Catch Basin connected to the drain pipe that was not located where it was listed and which resulted in the re-routing of a section of the water main.
