Daily Report

Project:	Durham Meadows Pipeline Installation	Date:	October 29, 2019
Location:	Talcott Ridge Drive, Middletown CT	Day of Week:	Tuesday
Project #:	AECOM: 60445033	Report No:	23
Contractor:	Ludlow Construction	Page:	1 of 18

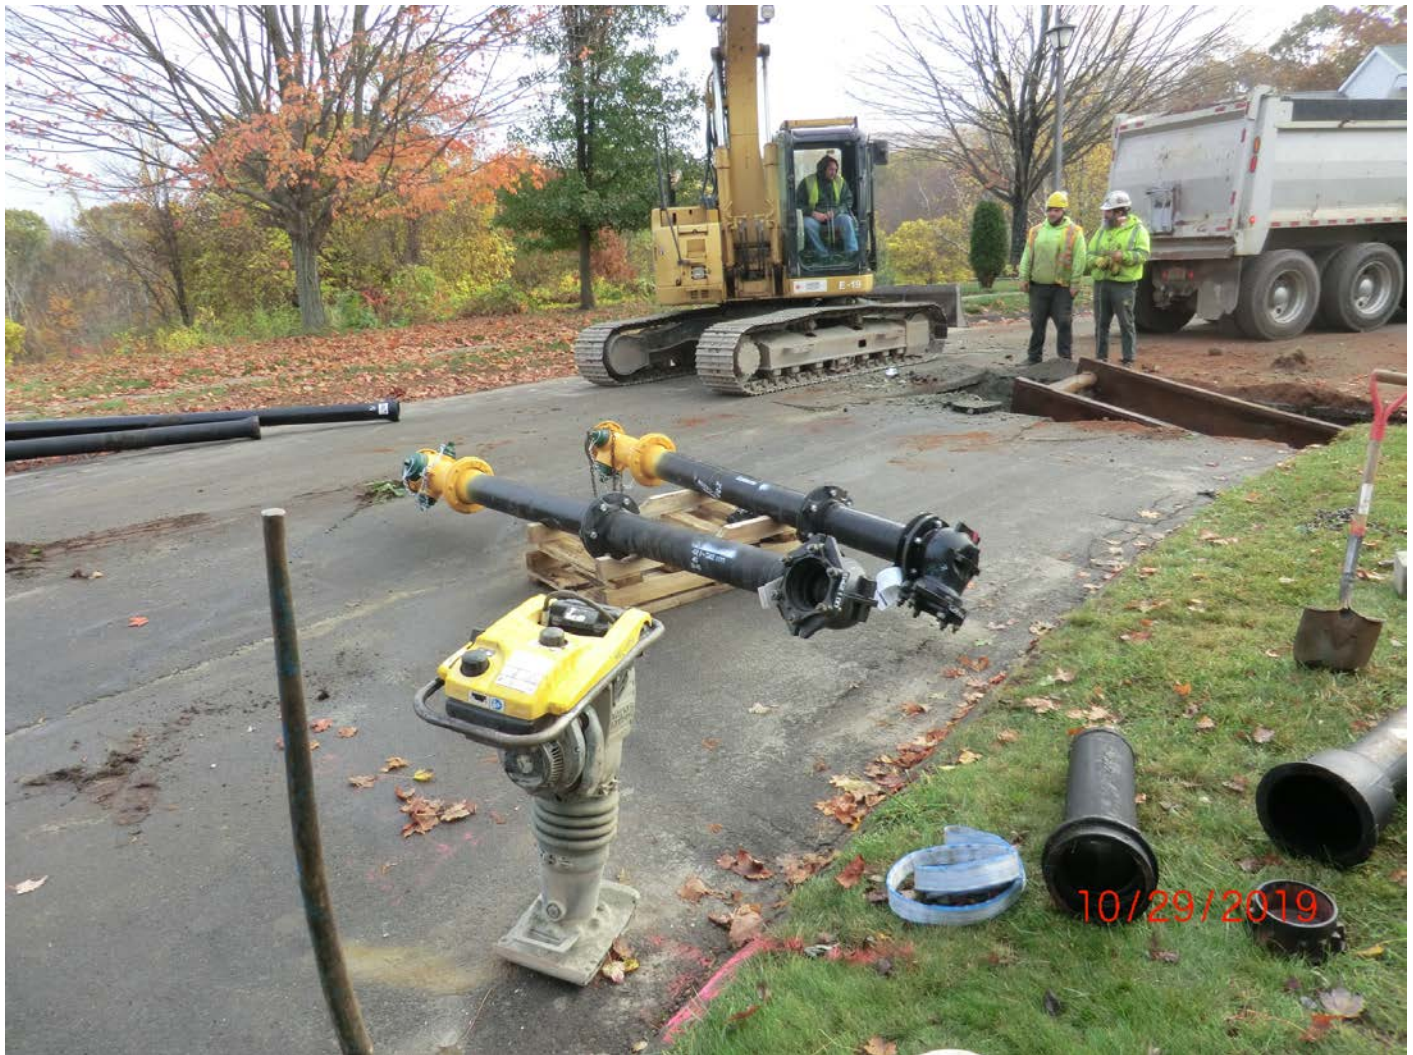
Figure 1 – Hydrant Assemblies. First location on Talcott Ridge. Station Old 40+44.38 / New 40+49.21

0830 – On site: Due to delay in pipe shipments, Ludlow is installing fire hydrants today. First location is 40+44.38 (Adjusted number 40+49.21). Hole for hydrant already dug and being prepped for installation.

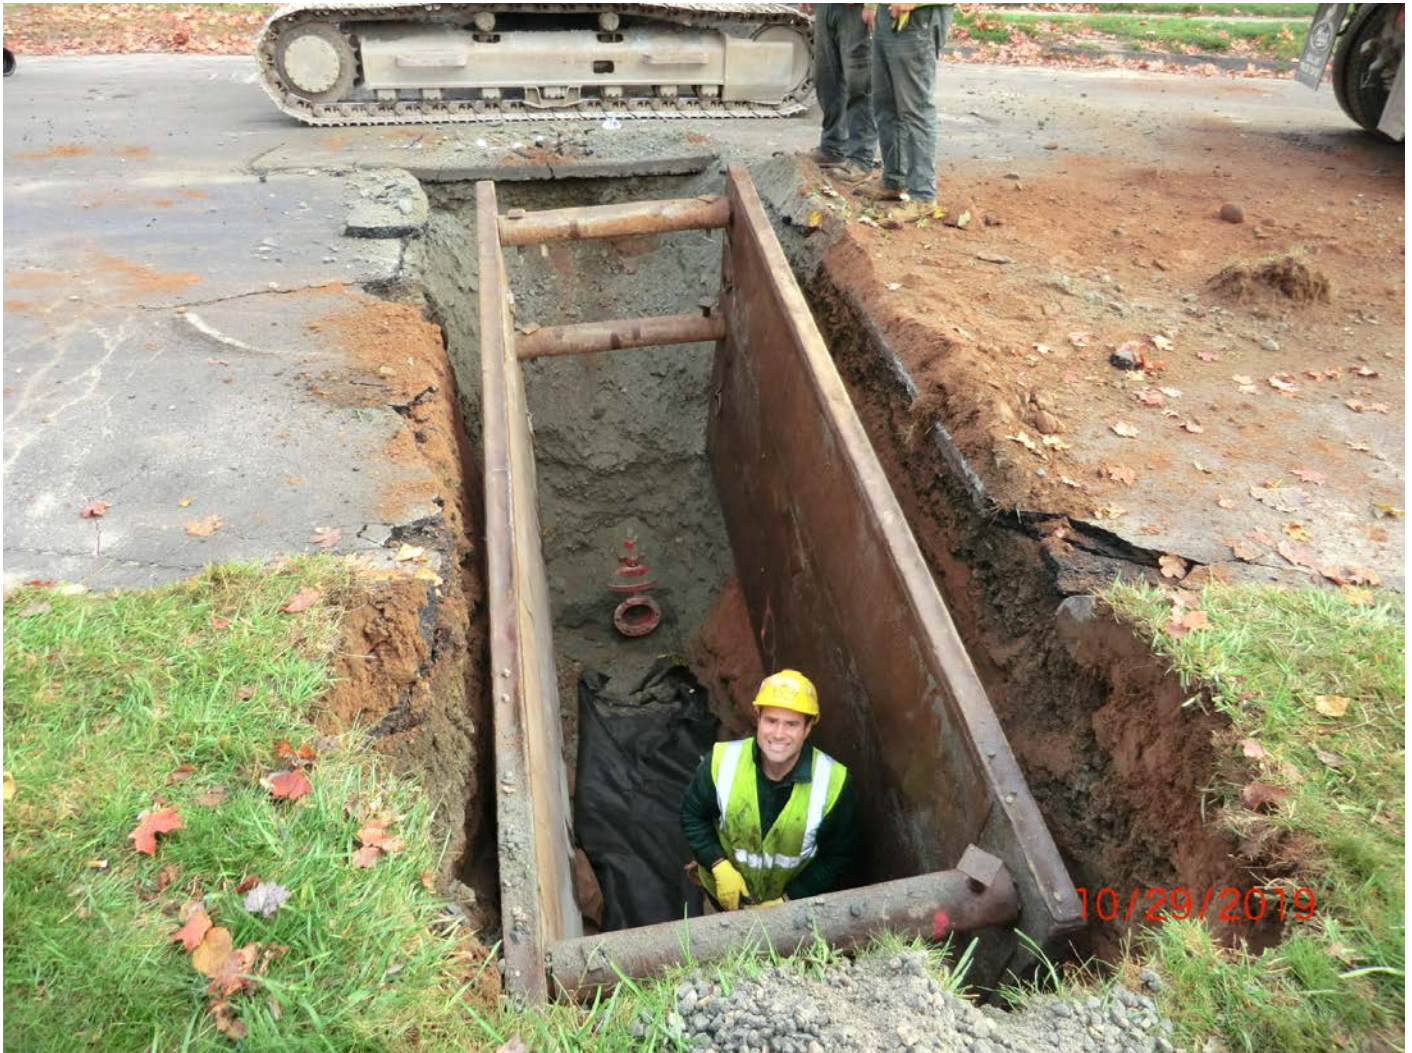
Figure 2 – The man in the box. Preparing base for hydrant line. 6" gate valve (red) seen in center of picture.

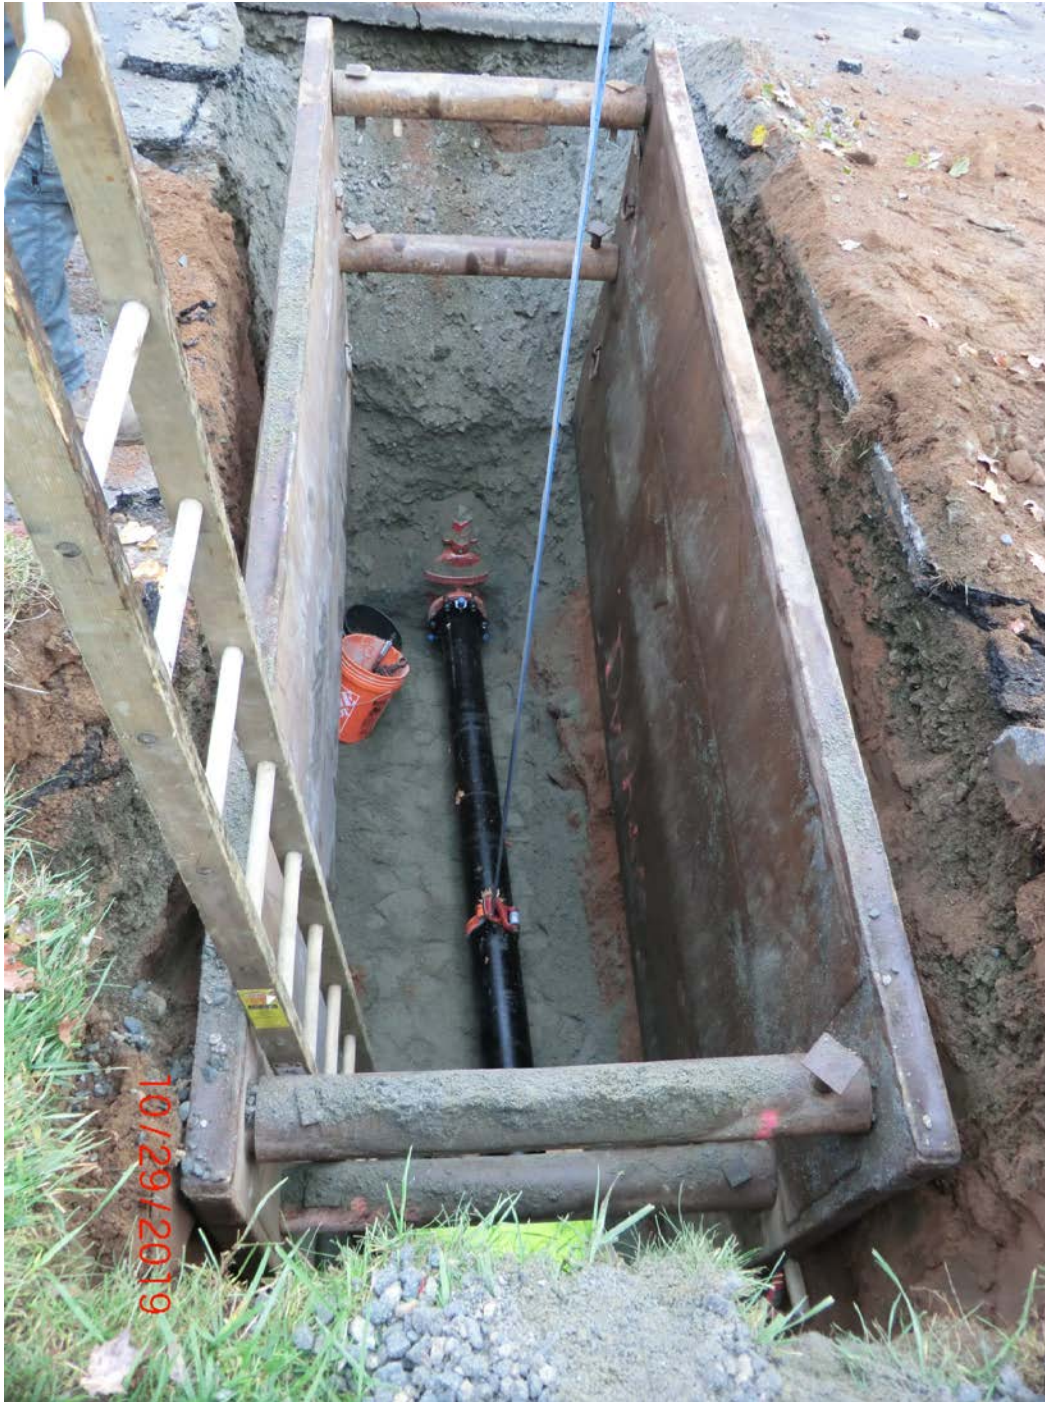
Figure 3 – Setting 6” line with Mega-Lug restraint to gate valve.

0900 – Installing 6” hydrant pipe to Tee. Restrained connections.

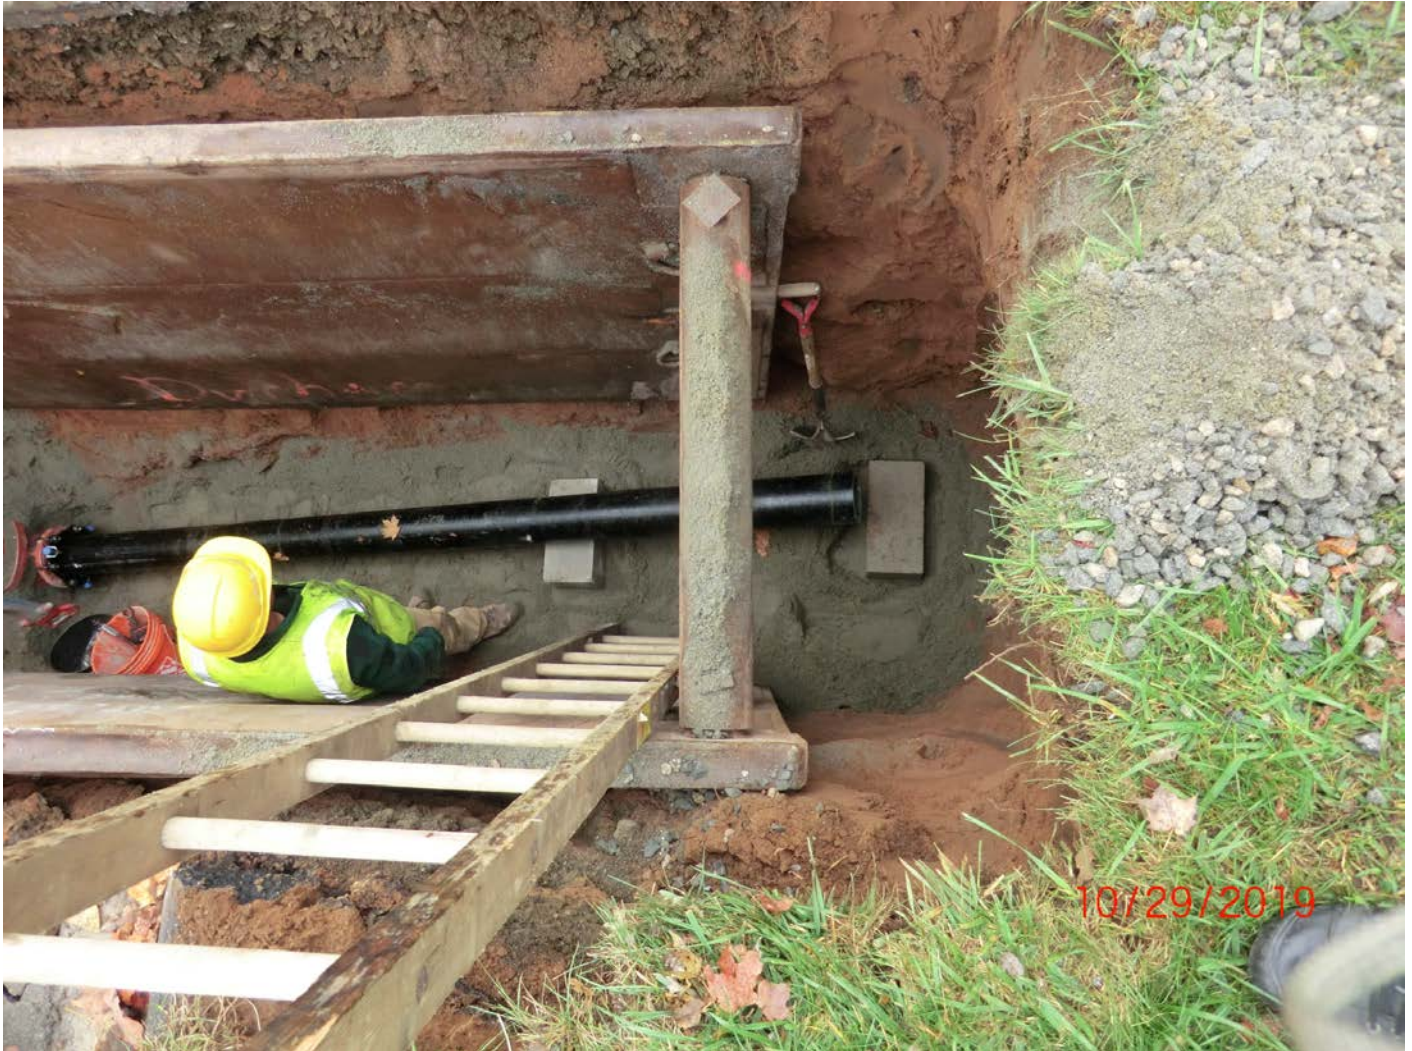
Figure 4 – Awaiting Hydrant Assembly

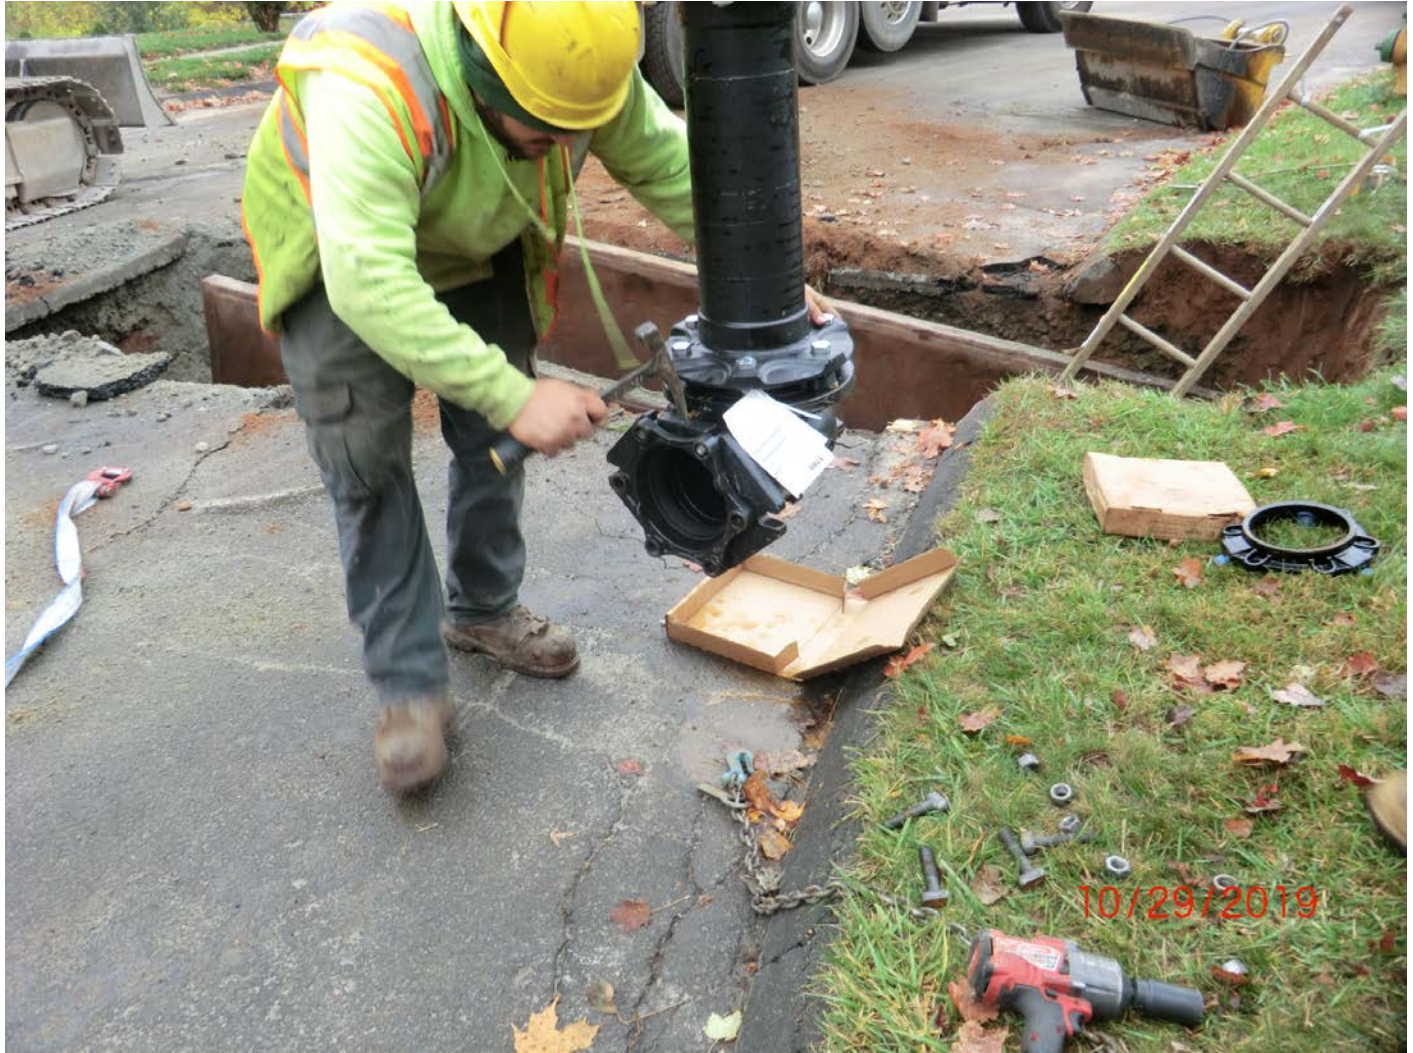
Figure 5 – Removing manufacturer gland. Note bolts already removed, laying on grass.

0910 – Installing hydrant assembly. Note that the assembly came with a non-restrained gland. Ludlow swapped out the manufacturer gland for a Mega-Lug fitting with the check lugs.

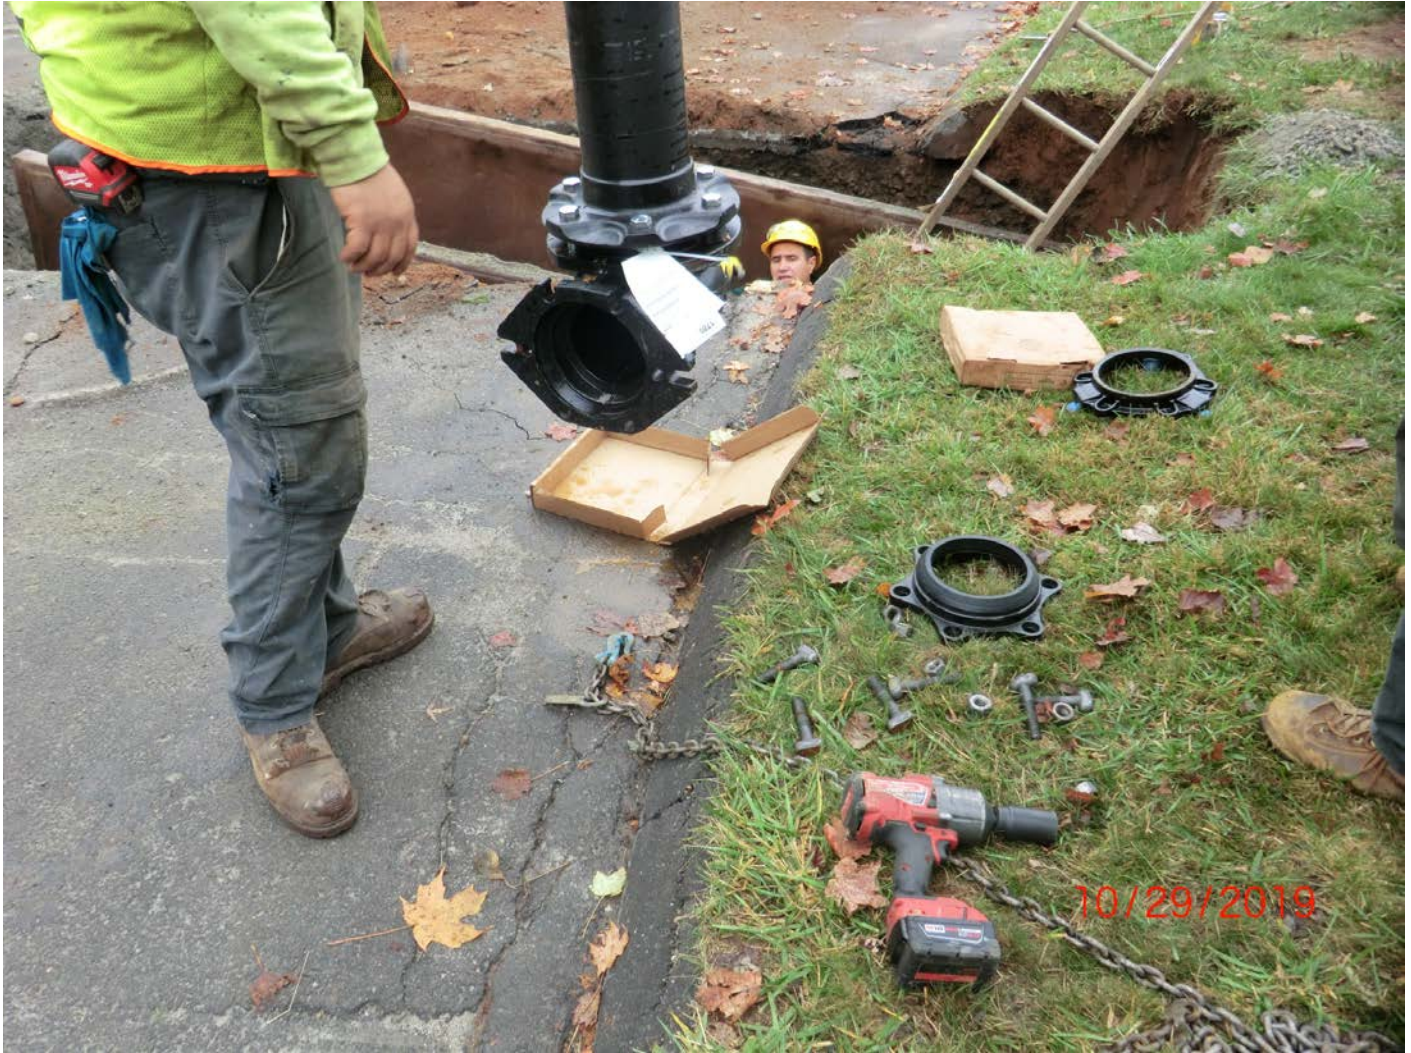
Figure 6 – Hydrant connection with manufacturer gland removed – on grass with bolts. In upper right of picture is the Mega-Lug restraint with check lugs (blue).

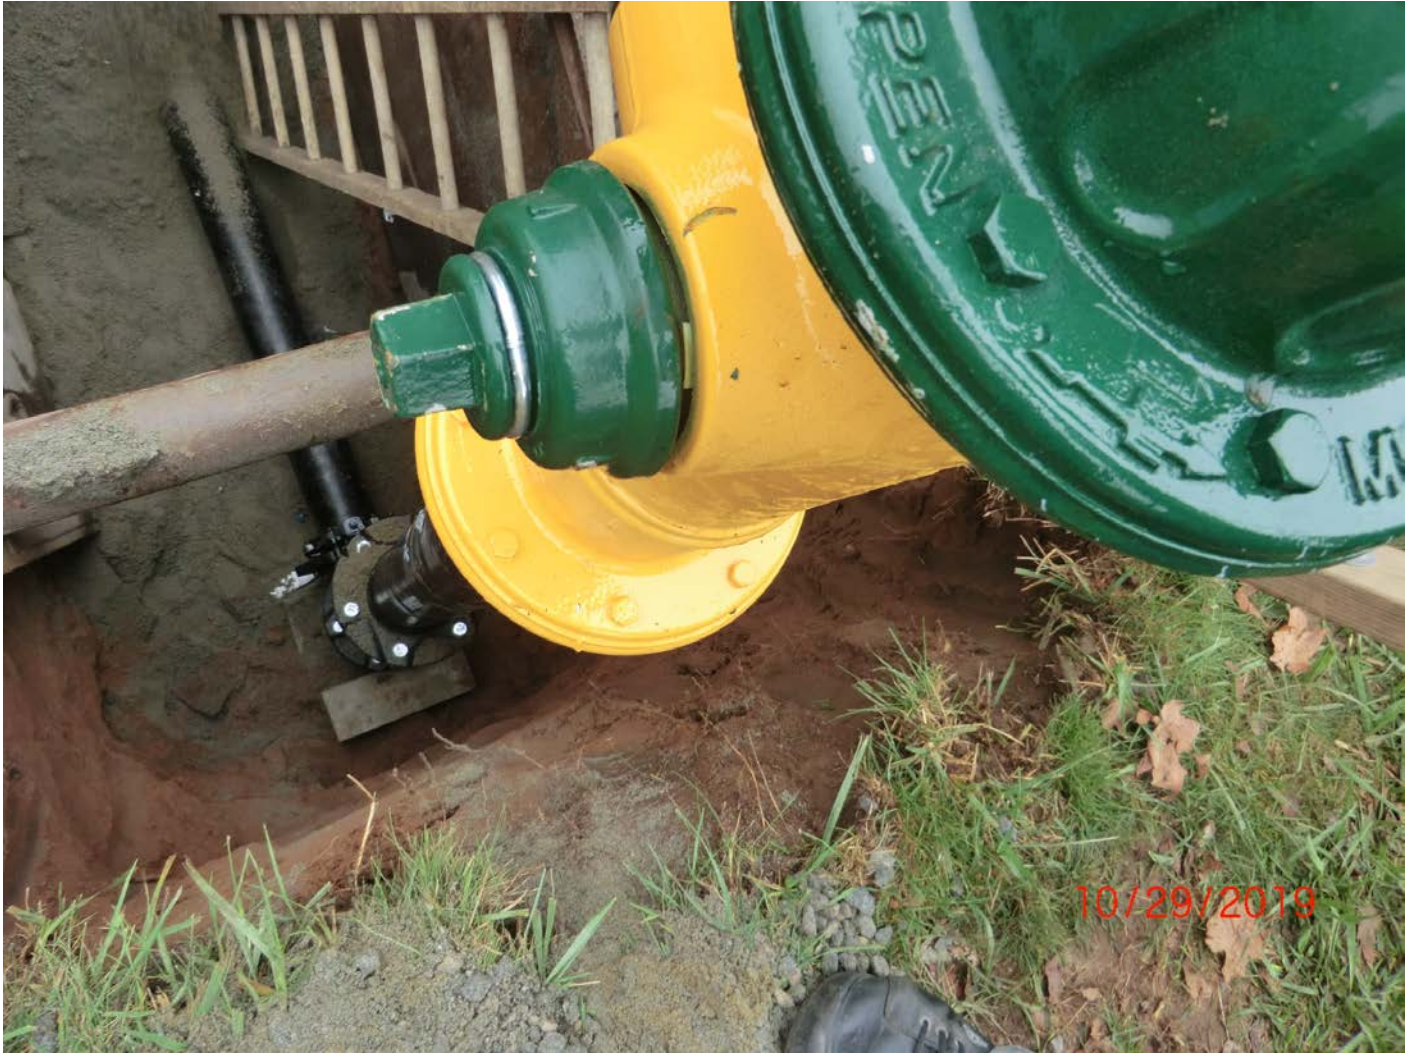
Figure 7 – Completed hydrant assembly connection. Note one 8” thrust block set behind elbow and one 8” block set under the elbow for support (mostly hidden by stone dust, only edge visible).

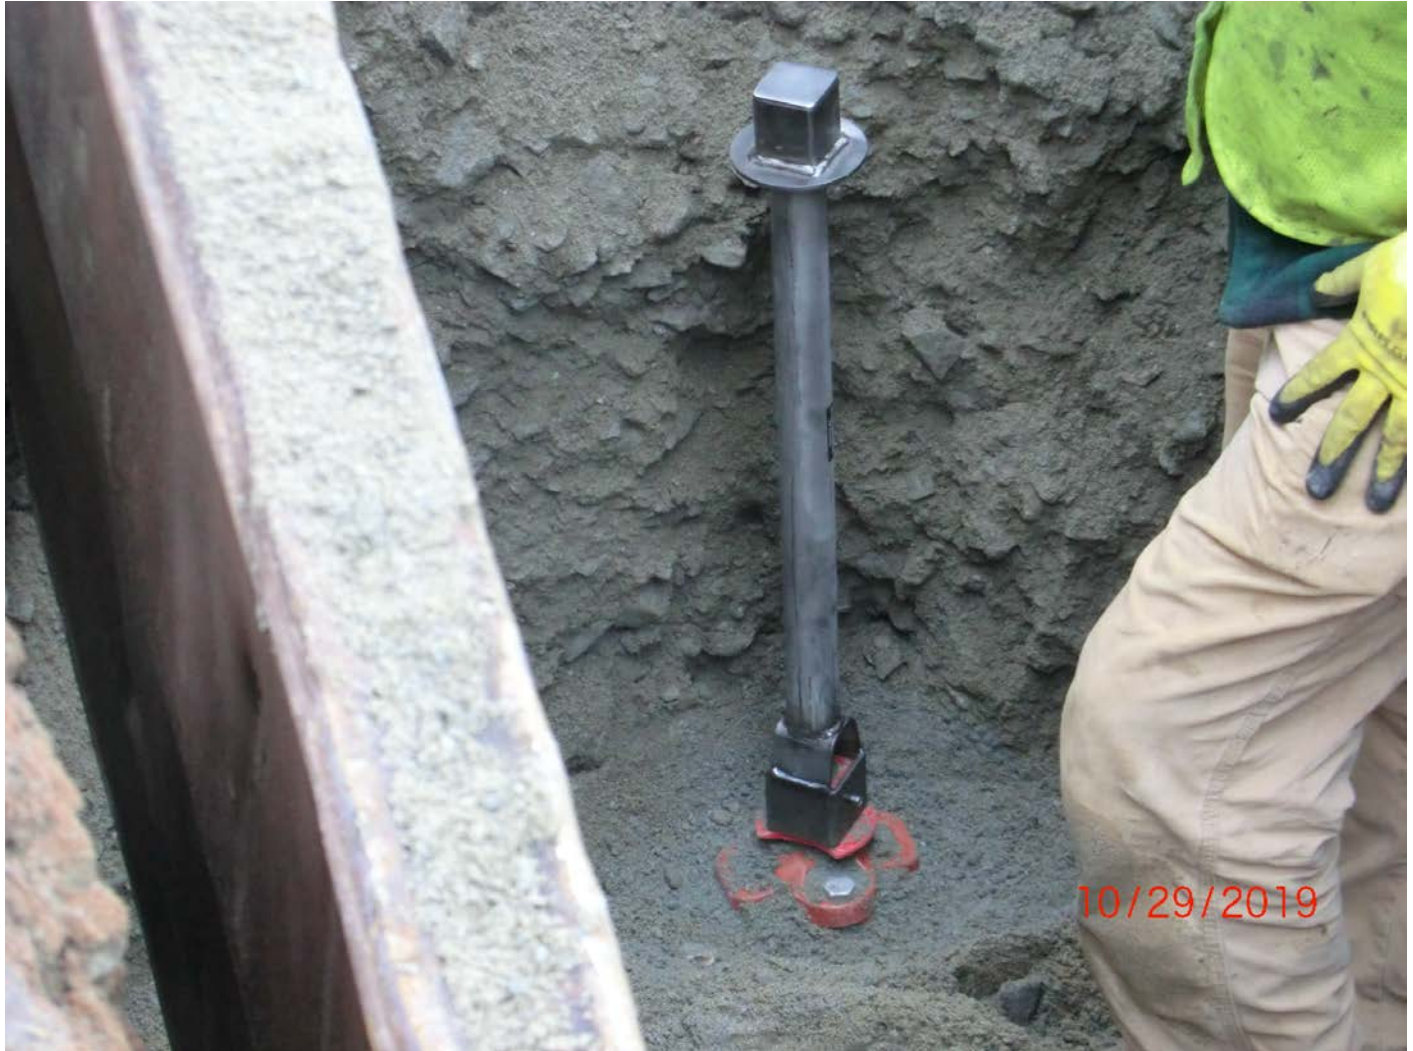
Figure 8 – Street valve connector. Top of gate valve.

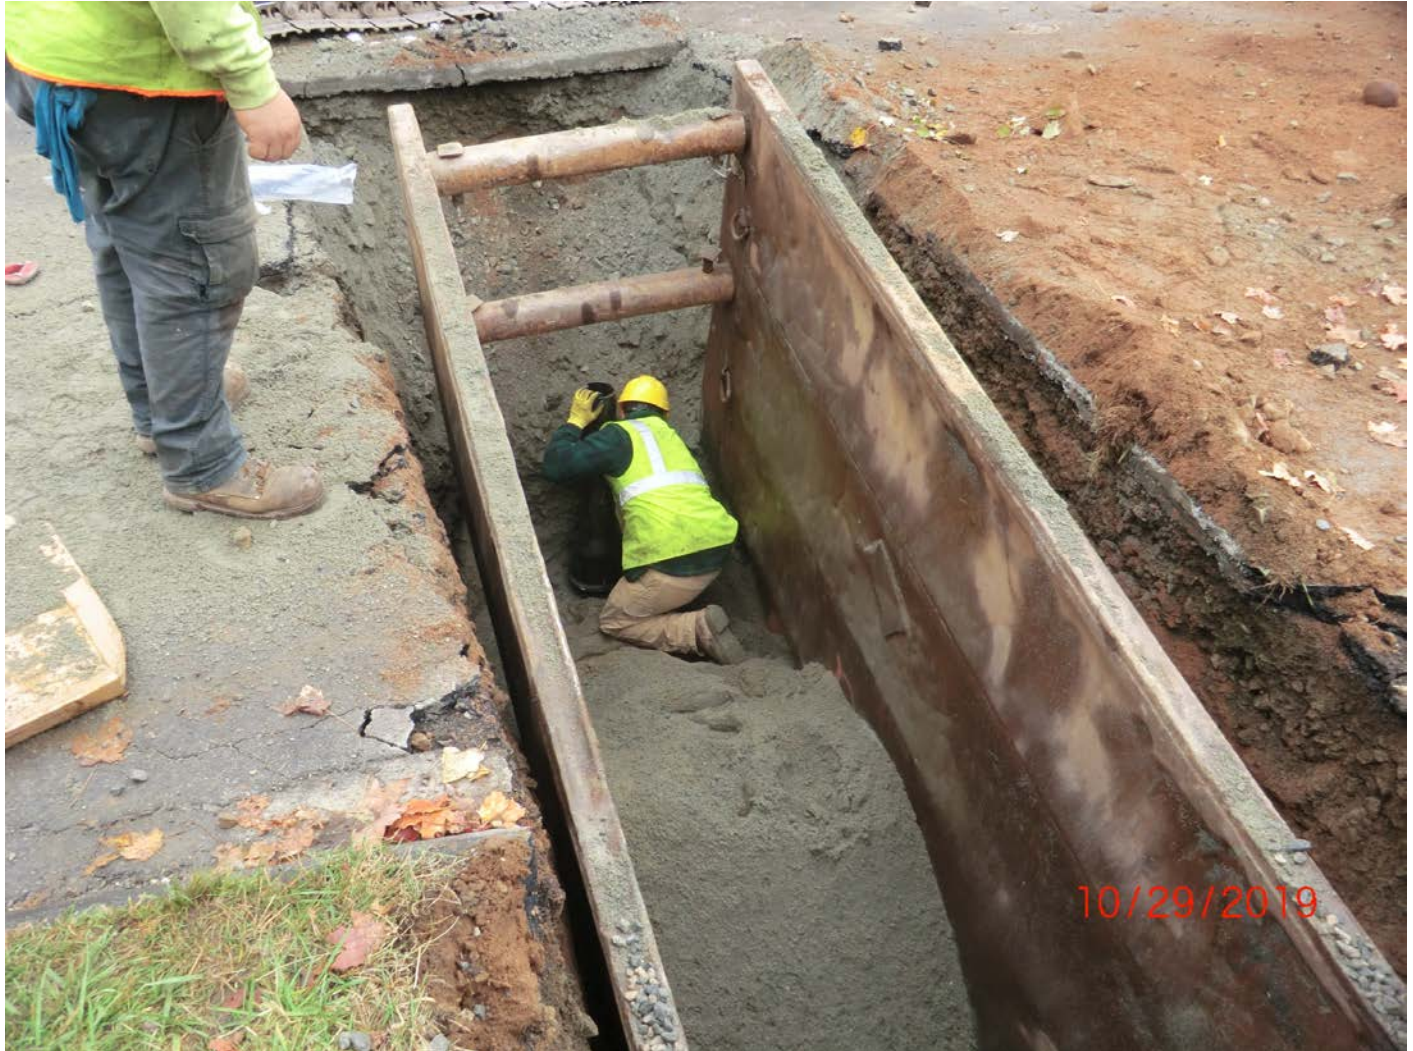
Figure 9 – Valve box placed over street valve connector (pictured in previous figure).

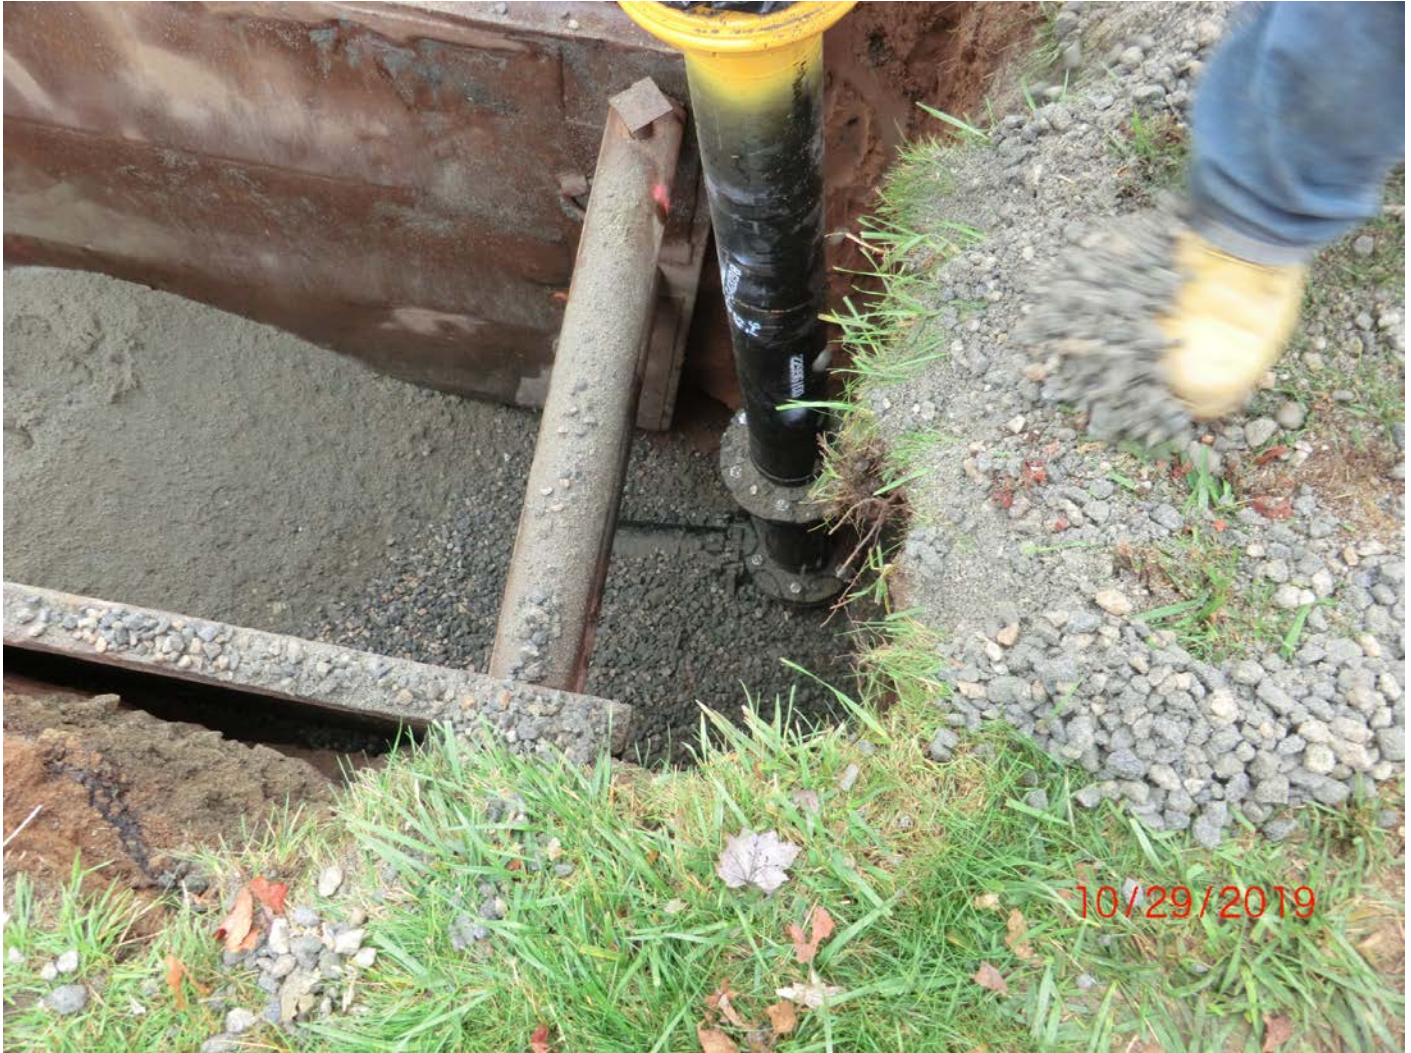
Figure 10 – Crushed stone backfill around base of hydrant and stone dust over pipe. Crushed stone covered by geotextile fabric and entire length covered in stone dust. Compacted and then covered with processed fill compacted in lifts.

1030 – Finished backfilling and compacting first hydrant location. Moved to second location and took break early.

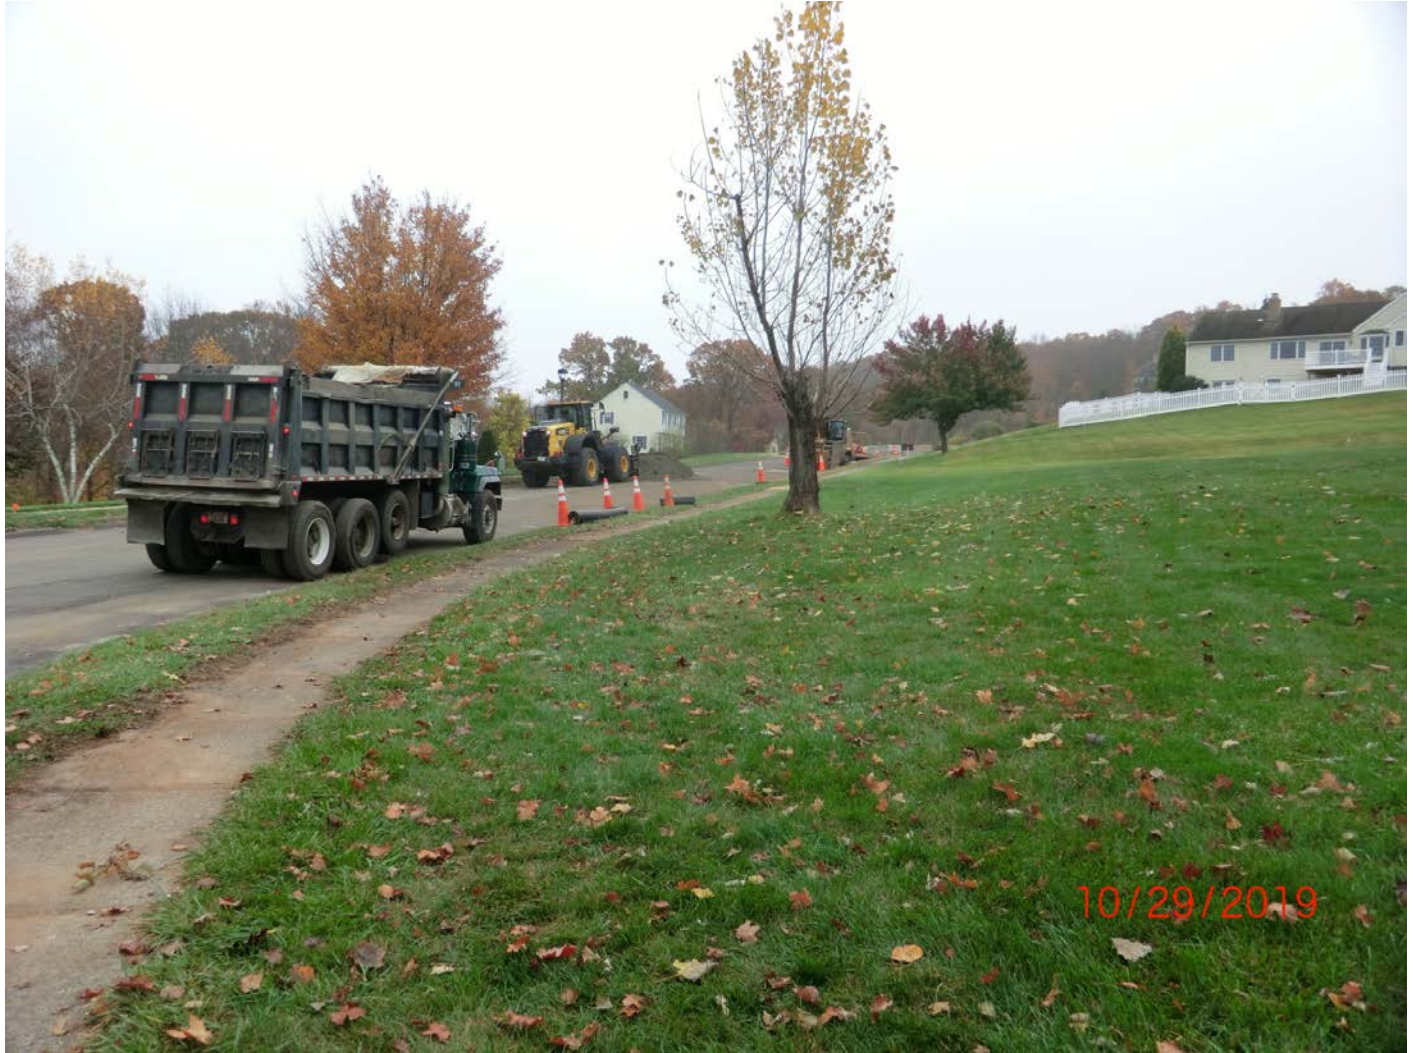
Figure 11 – Mis-communication. Processed fill dropped up the street near yesterdays ending point. Driver unaware that water main pipe was not being installed today. Fill was bucket loaded and delivered to the hydrant installations. Created a wider spread area to clean at the end of the day.

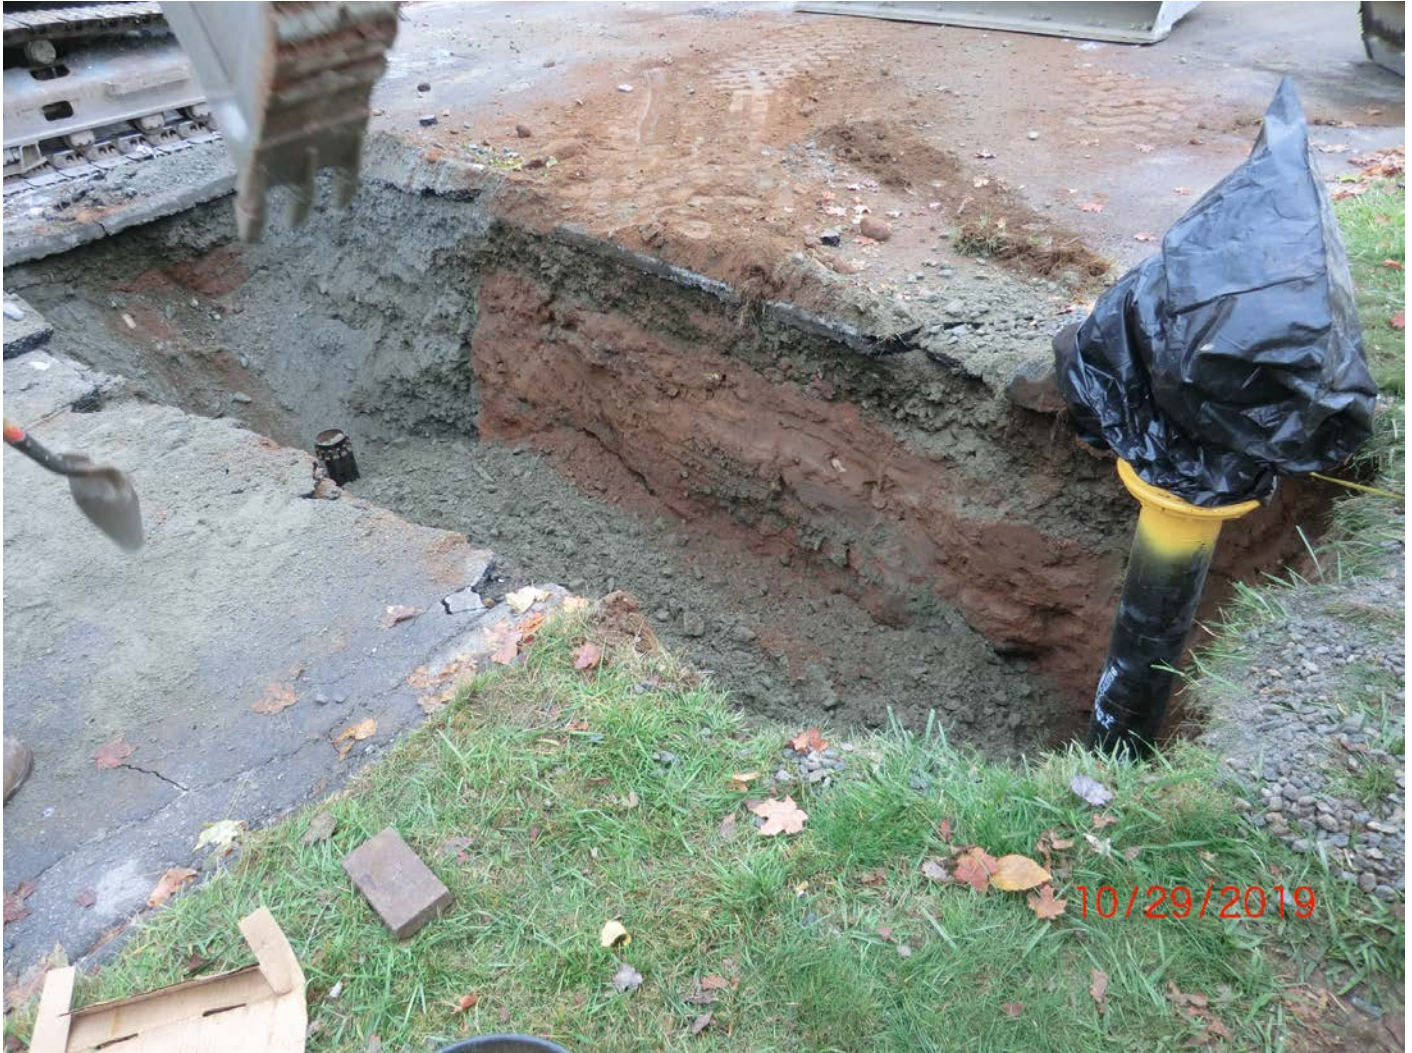
Figure 12 – Backfilling with processed backfill. On right side of picture note bag over hydrant to indicate not in use. Left side of picture is valve extension and riser pipe; note cap on upside down to prevent processed fill from getting into riser.

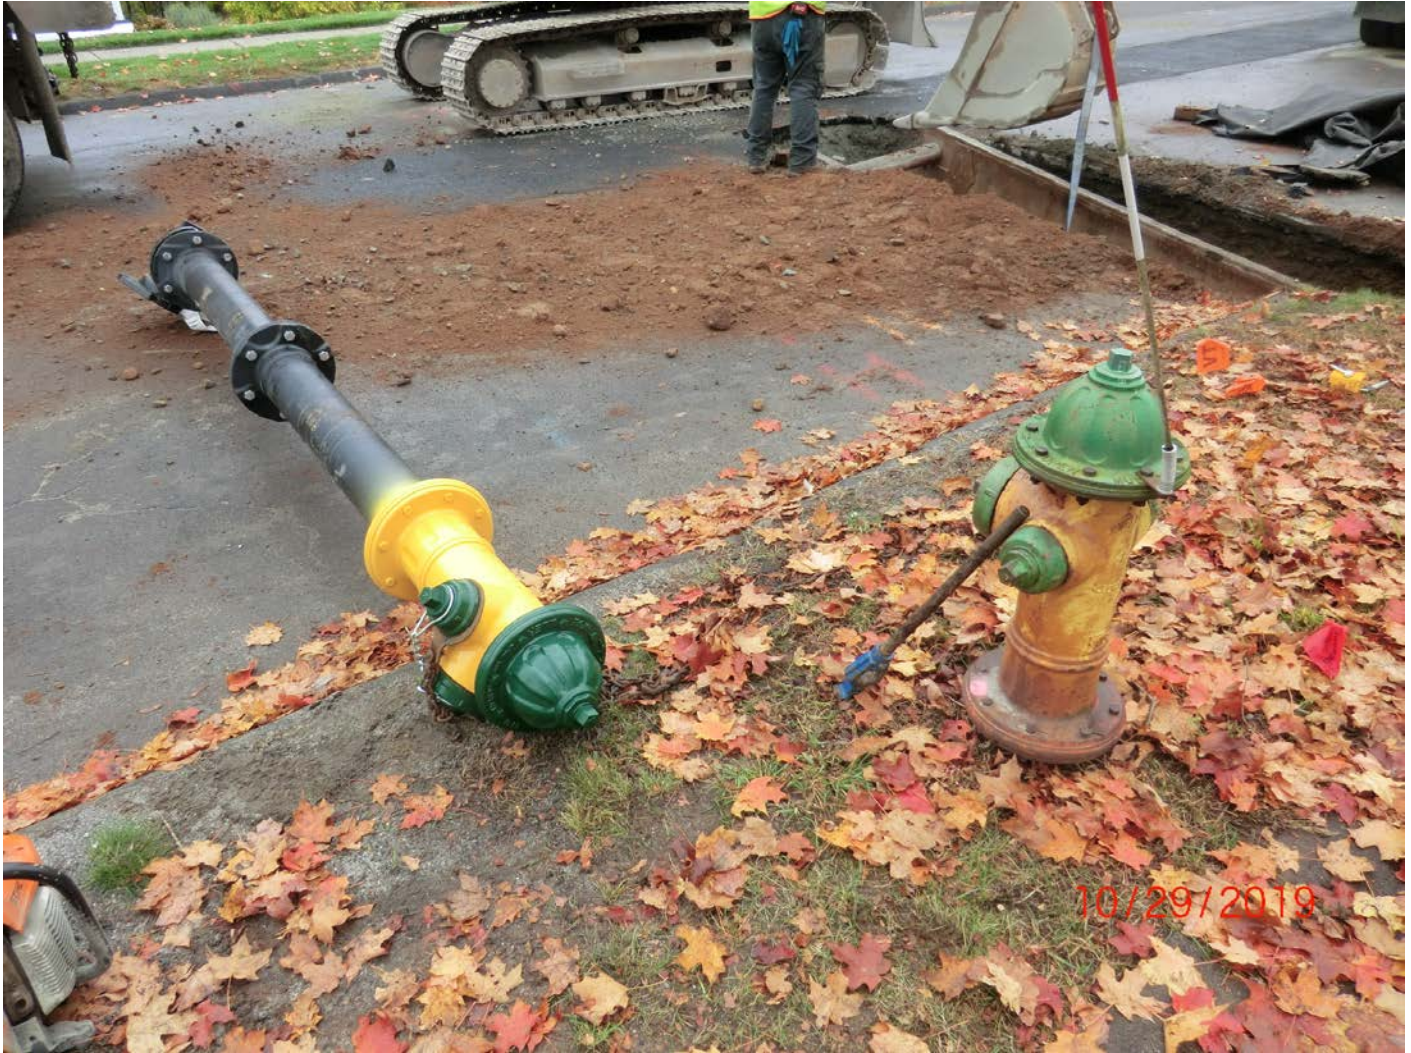
Figure 13 – Existing fire hydrant and new fire hydrant to be installed. Second location at Station Old 41+42.34 / New 41+47.17.

1230 – Installing second fire hydrant at 41+42.34 (Adjusted location 41+47.17). Again, replaced manufacturer gland with Mega-Lug restrained gland.

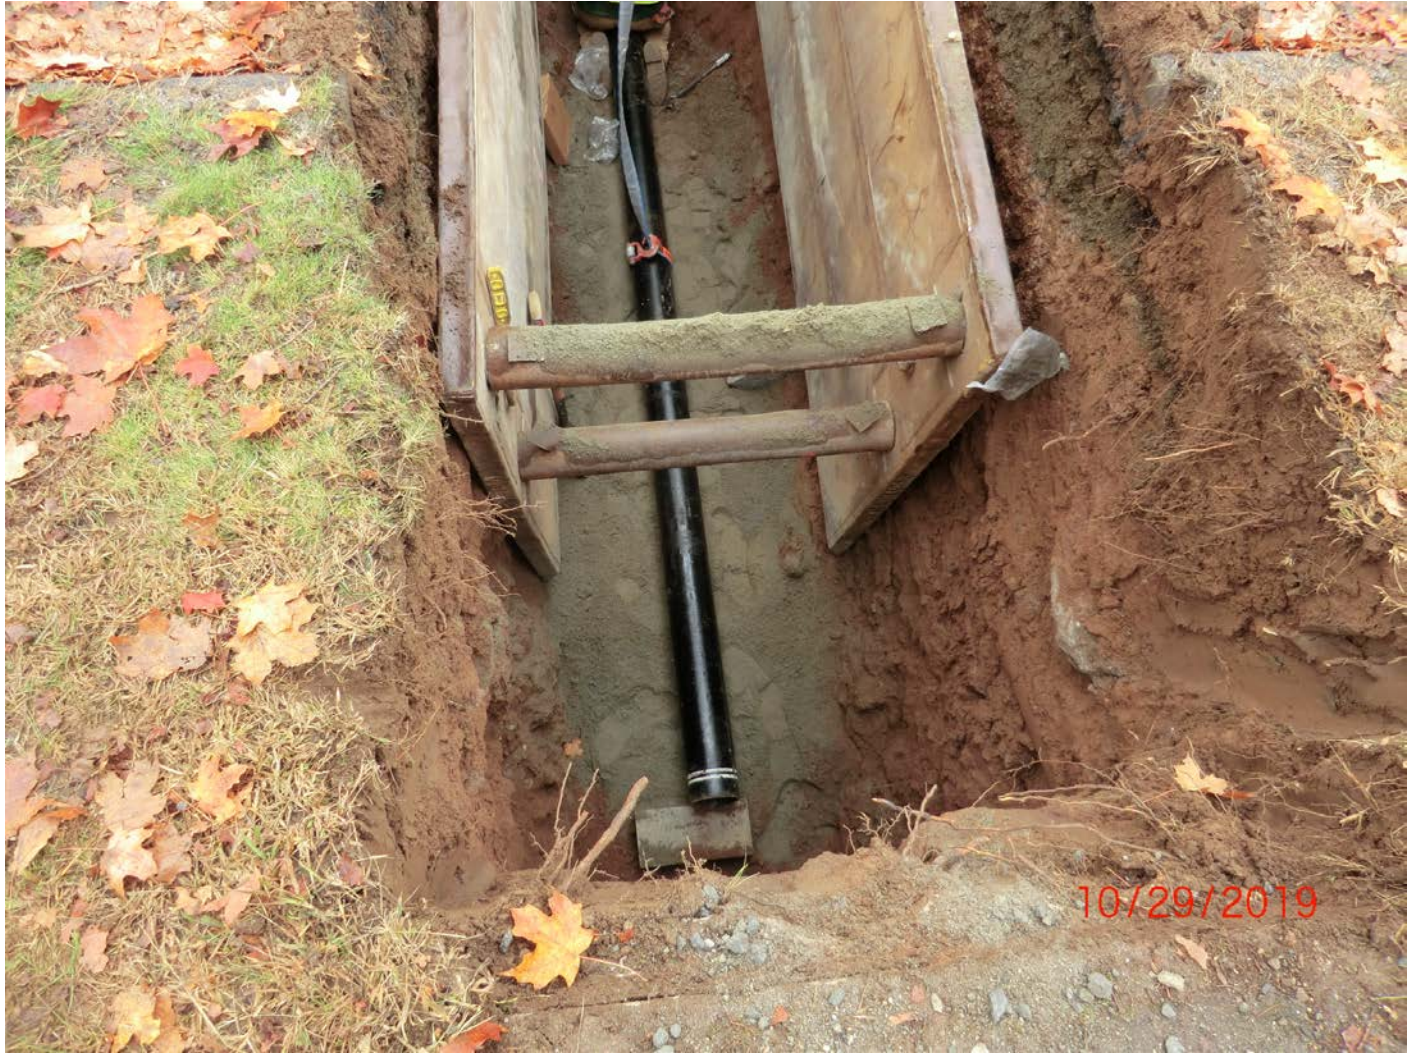
Figure 14 – Awaiting hydrant assembly. Note 8” block for elbow to set on (bottom of picture).

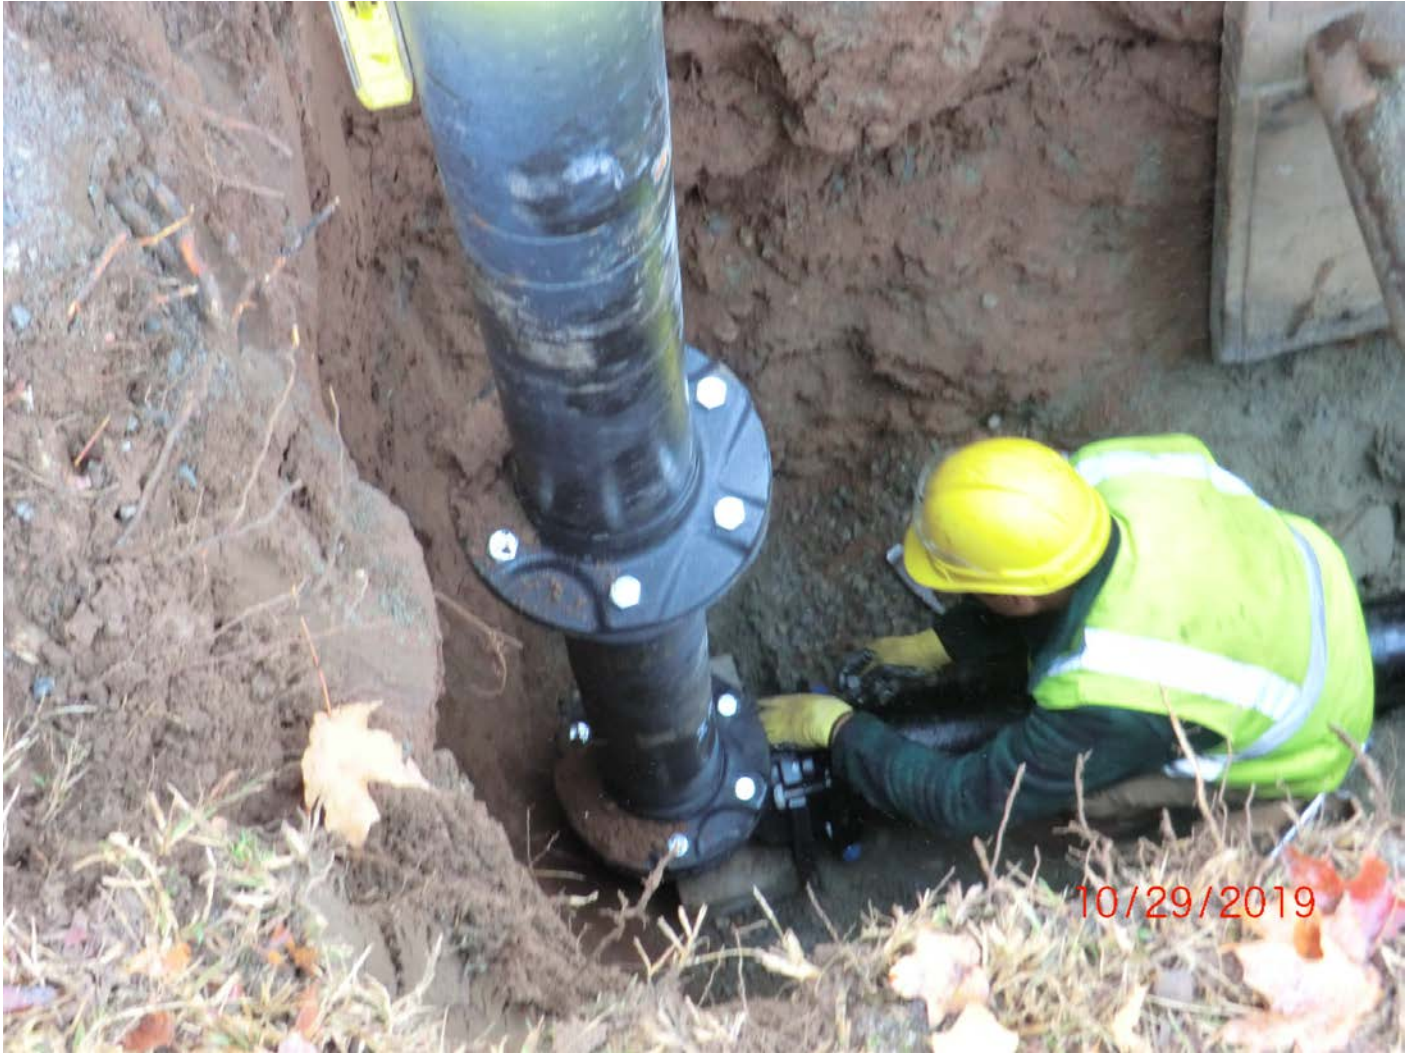
Figure 15 – Attaching hydrant assembly to 6” line with Mega-Lug restraint.
