Daily Report

Project:	Durham Meadows Pipeline Installation	Date:	October 29, 2019
Location:	Talcott Ridge Drive, Middletown CT	Day of Week:	Tuesday
Project #:	AECOM: 60445033	Report No:	23
Contractor:	Ludlow Construction	Page:	1 of 18

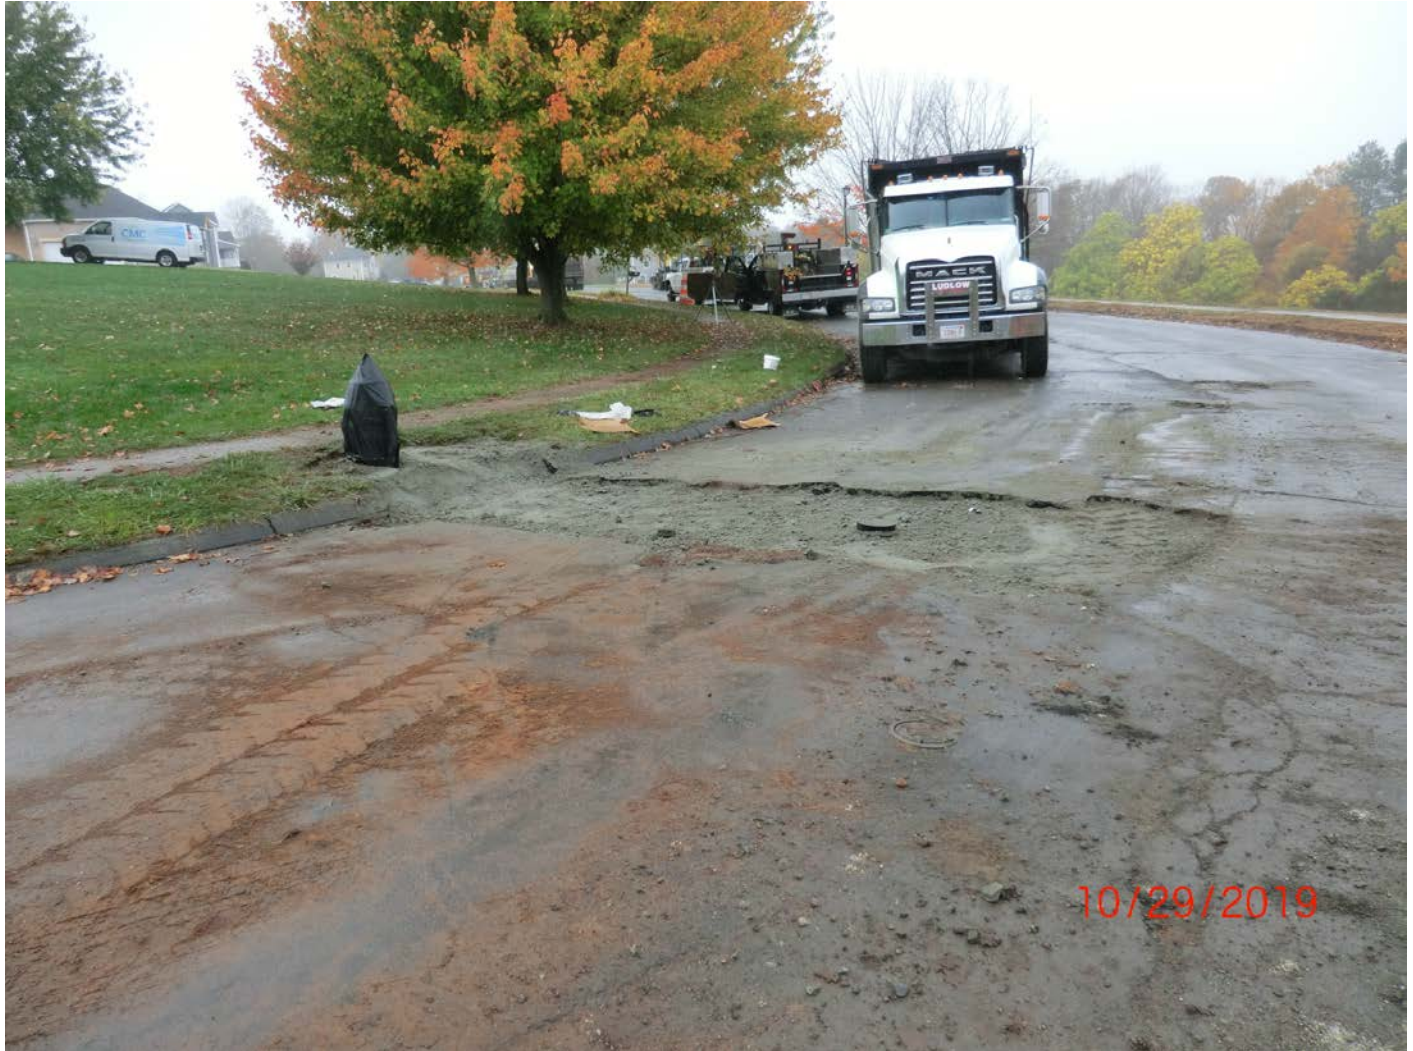
Figure 16 – First hydrant location, awaiting asphalt patch.
