Daily Report

Project:	Durham Meadows Pipeline Installation	Date:	November 08, 2019
Location:	Talcott Ridge Drive, Middletown CT	Day of Week:	Friday
Project #:	AECOM: 60445033	Report No:	27
Contractor:	Ludlow Construction	Page:	1 of 15

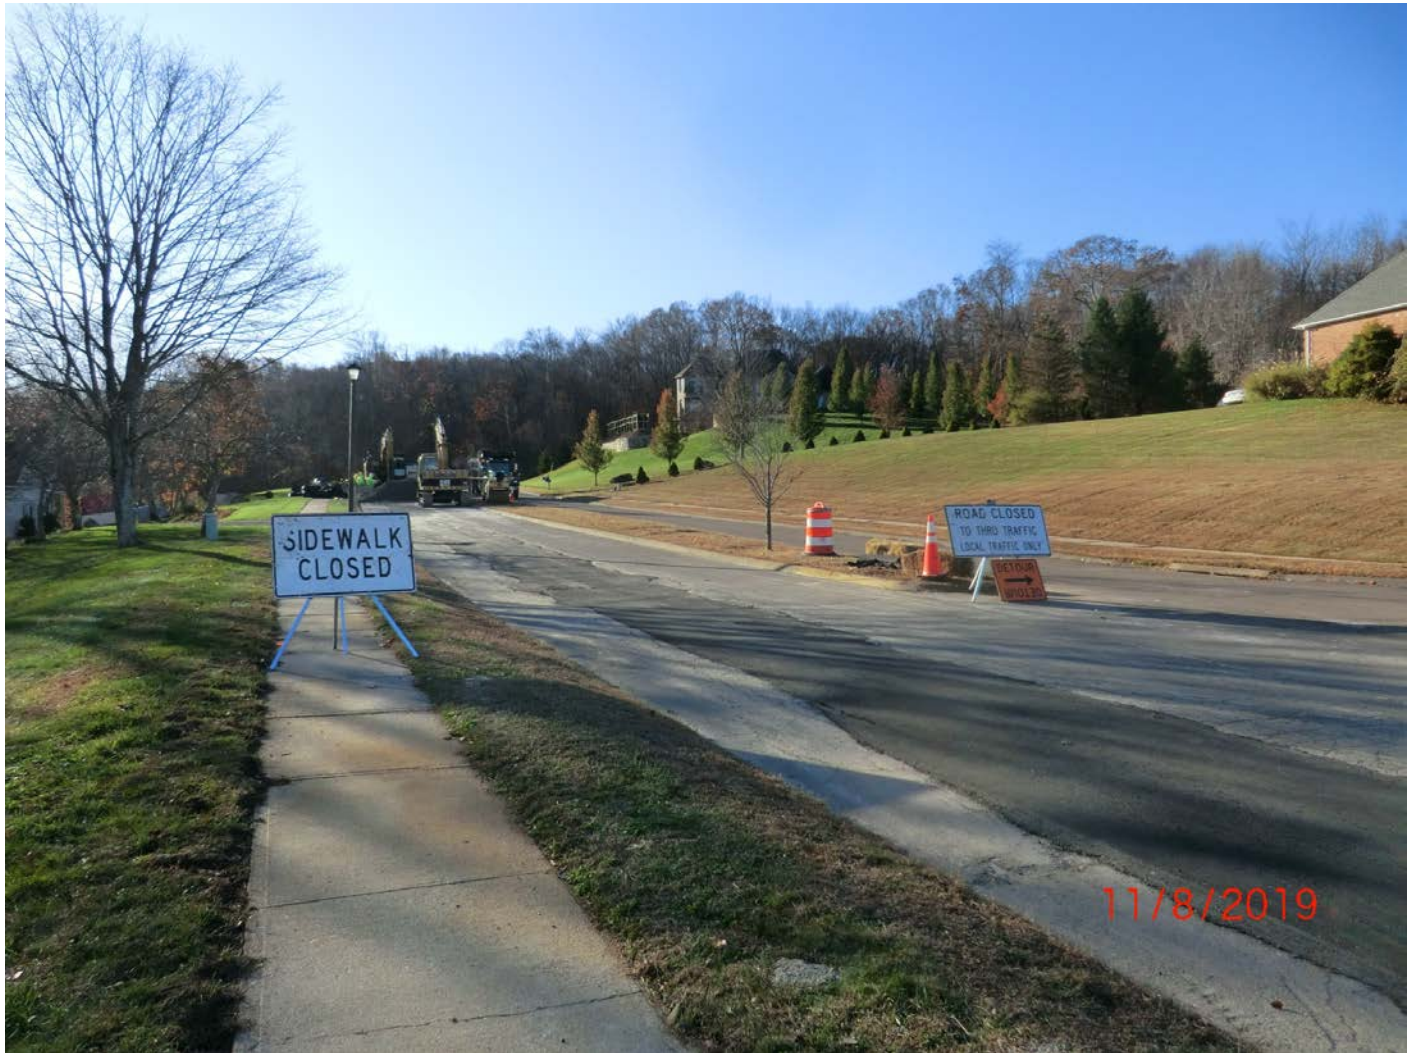
Figure 1 – Facing south, better sign placement.

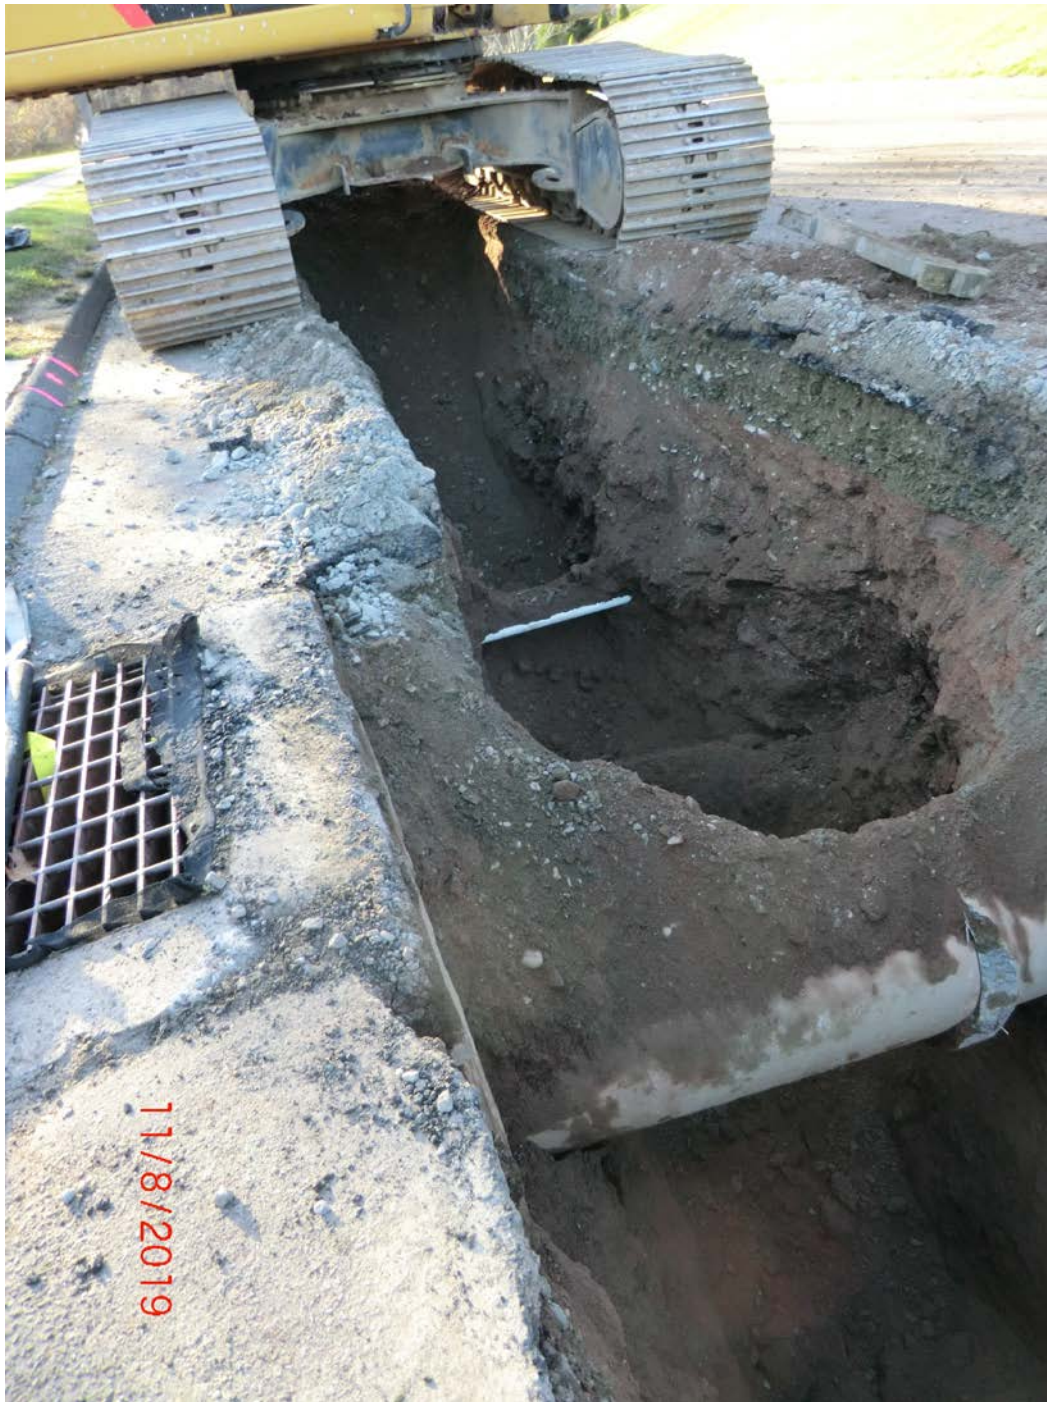
Figure 2 – Facing south and down, the only utilities crossed today. 18” catch basin drain (foreground) and electrical conduit (background).

0800 – On-site. First trench run nearly complete. Crosses under 18” drain pipe and electrical conduit. Located in front of 182 Talcott Ridge Drive.

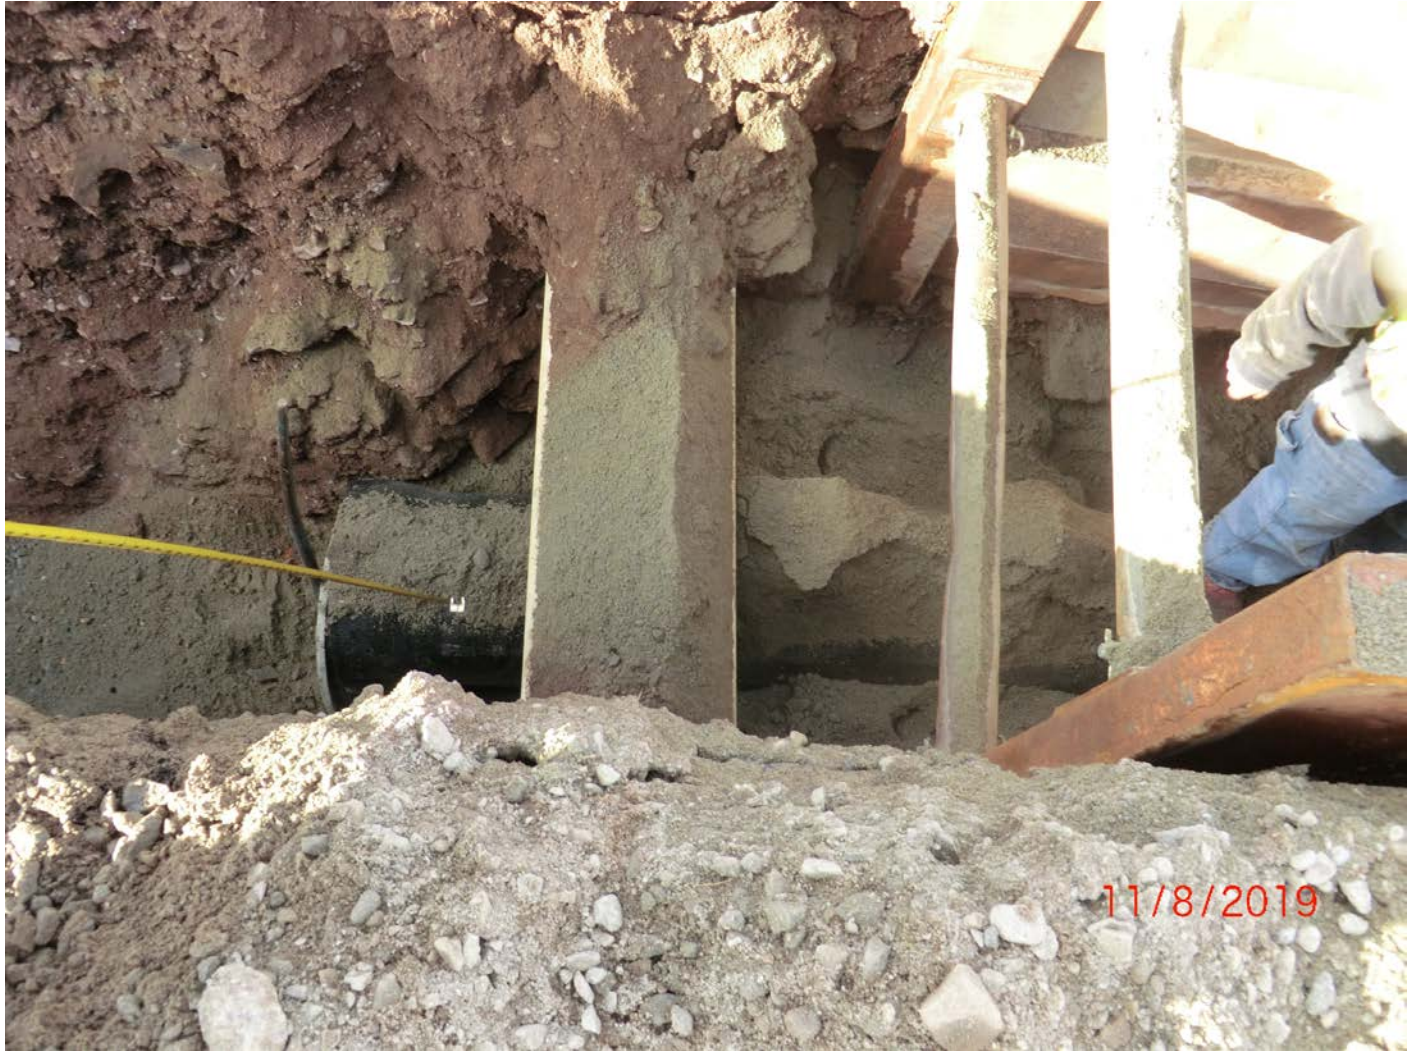
Figure 3 – End of first 20-foot run 16" DI. Depth to top of pipe roughly 6.5-7 feet.

0900 – Setting first stick of unrestrained 16” DI to station 33+04.62.

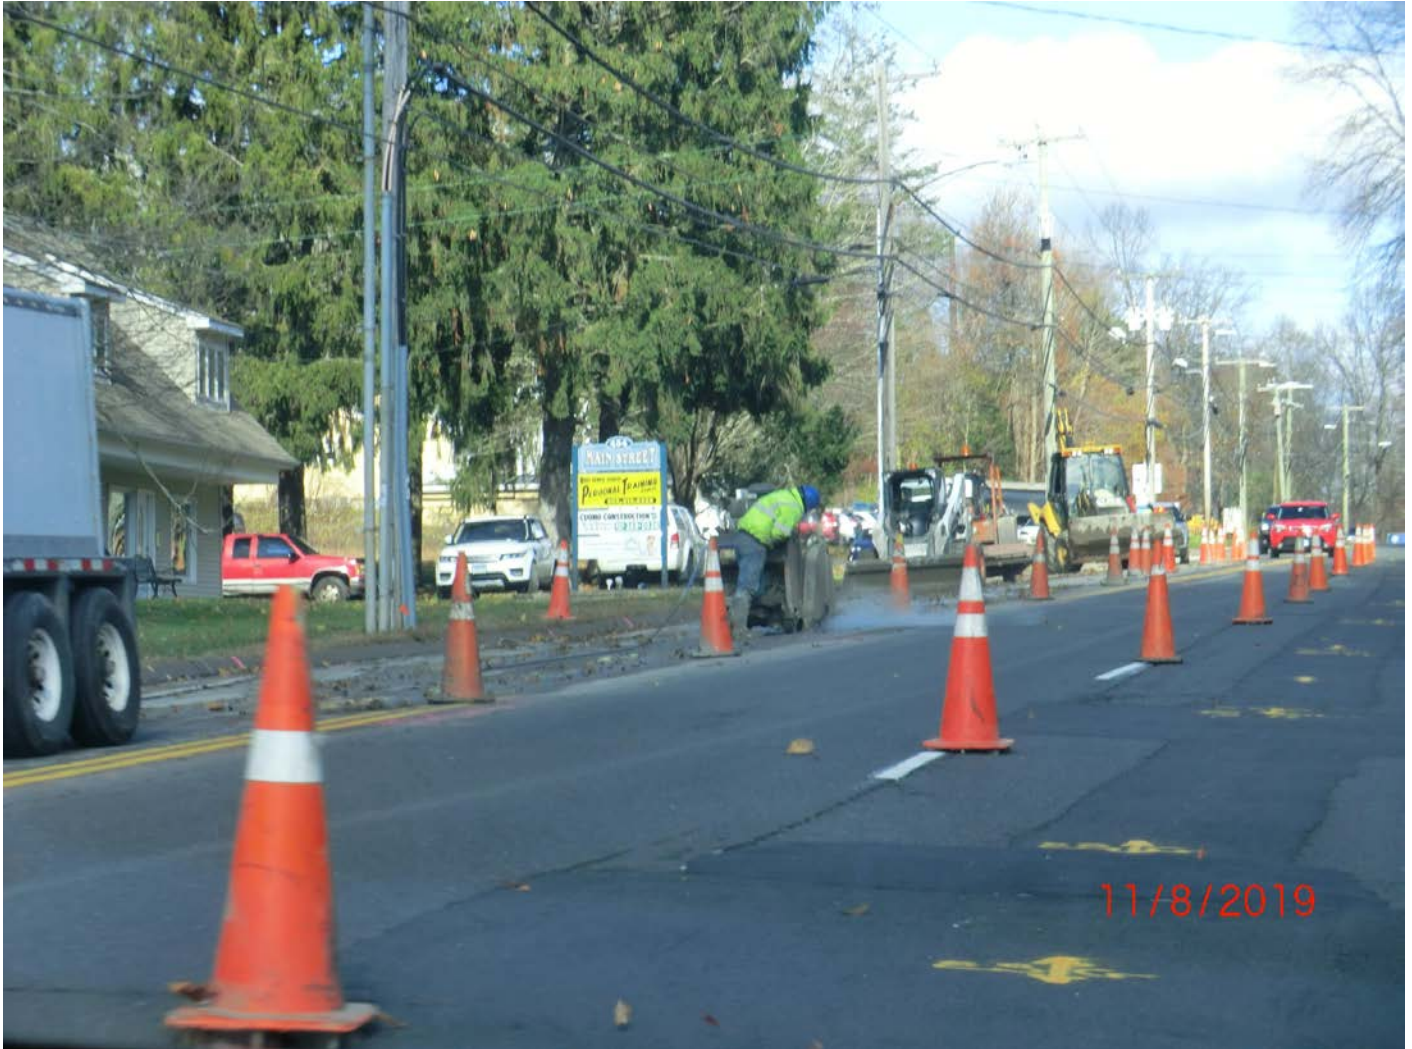
Figure 4 – Facing north, saw cutting Route 17 Main Street in Durham. Lanes fully coned.

1100 – Drove to trailer. Observed winter hot patch coat being placed along Route 17 Main Street in Middletown on the way and road saw cutting in Durham.

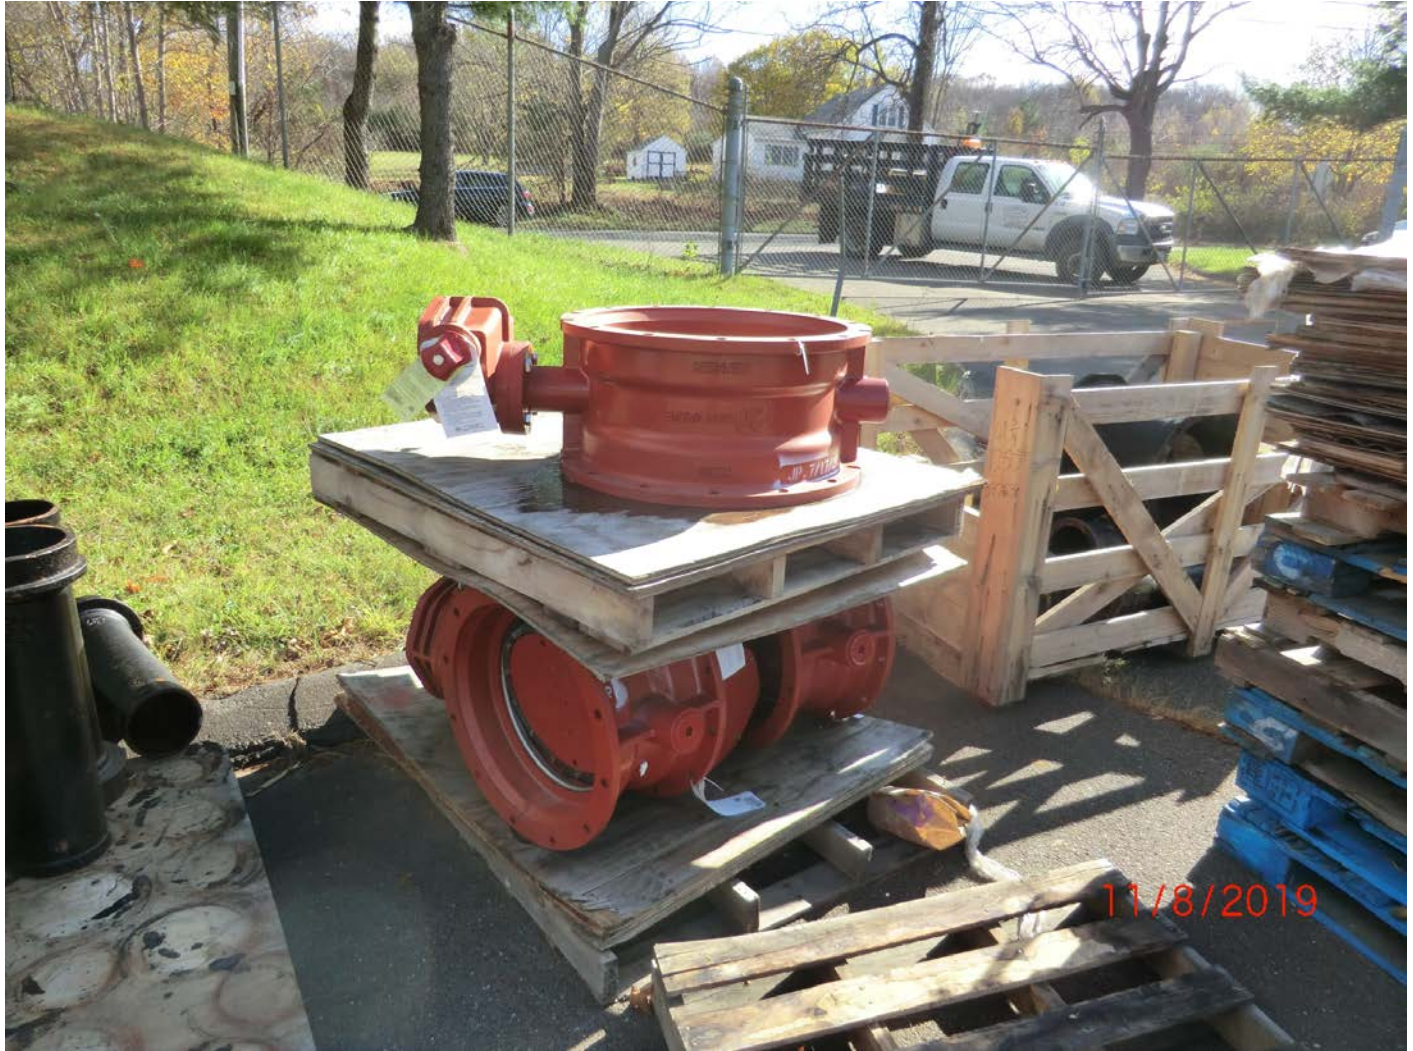
Figure 6 – In CT DOT yard, 20” Butterfly valve on top of couple 16” Butterfly valves. Just some of the piles of hardware stored in the yard.

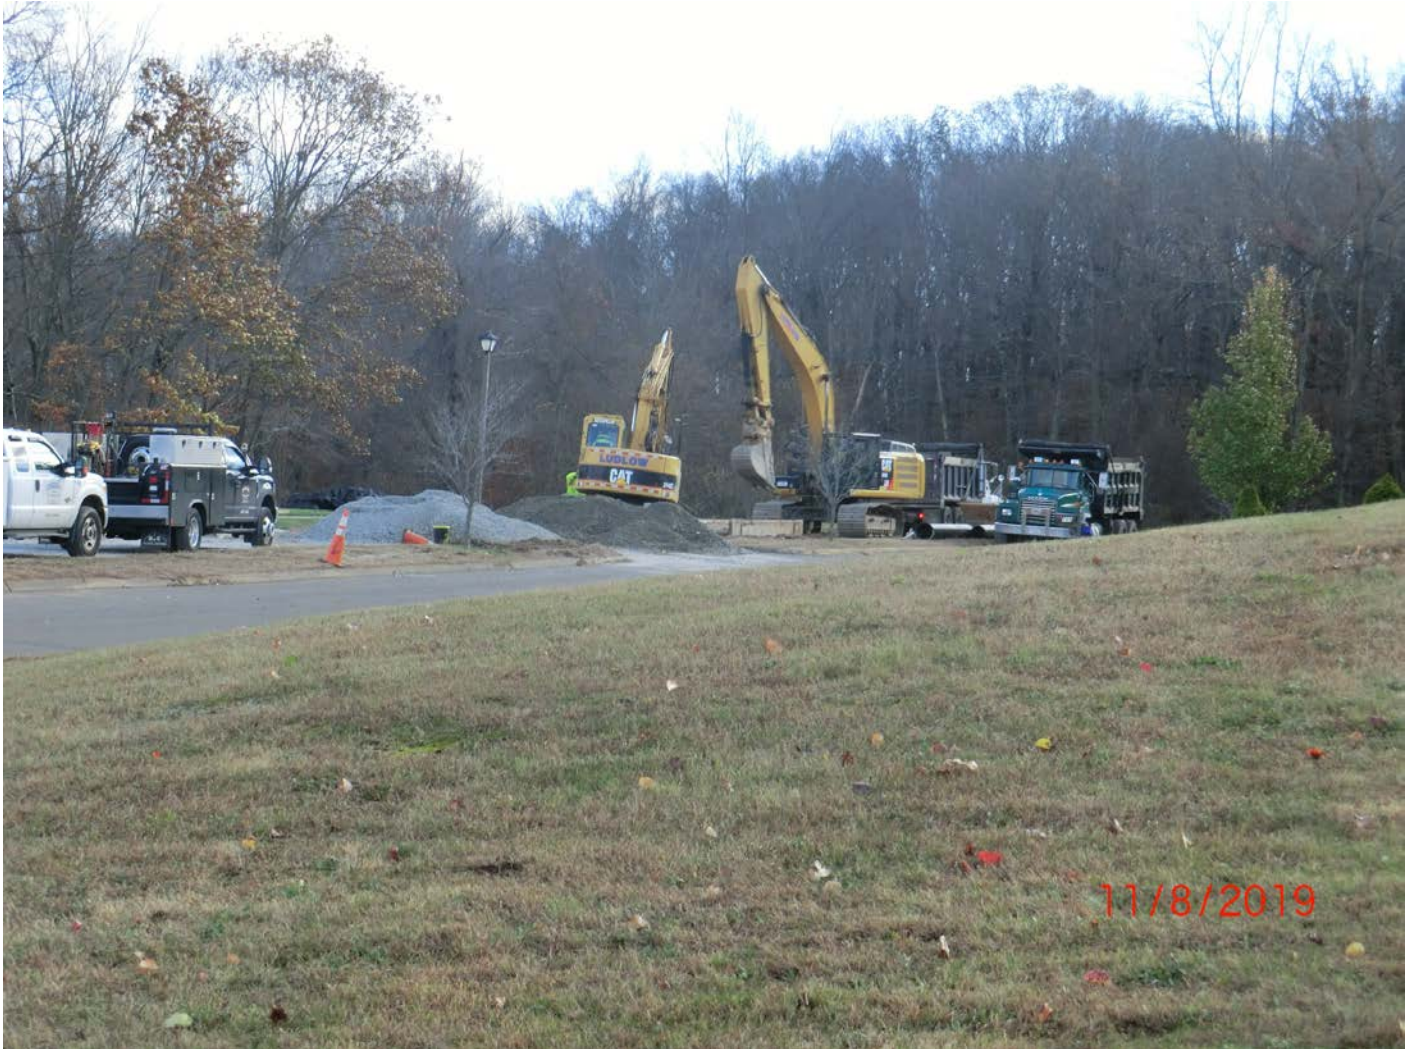
Figure 7 – Facing southeast, shot taken from upper Watch Hill Dr. intersection with Talcott Dr. Just approaching the crest before heading into the cul-de-sac at the end of Talcott. Preparing for final stick of the day.

1300 – Stick 6 – 16” DI Restrained to be last stick of the day. Just prepping trench for last 20 feet. Off site.
