Daily Report

Project:	Durham Meadows Pipeline Installation	Date:	November 14, 2019
Location:	Talcott Ridge Drive, Middletown CT	Day of Week:	Thursday
Project #:	AECOM: 60445033	Report No:	30
Contractor:	Ludlow Construction	Page:	1 of 11

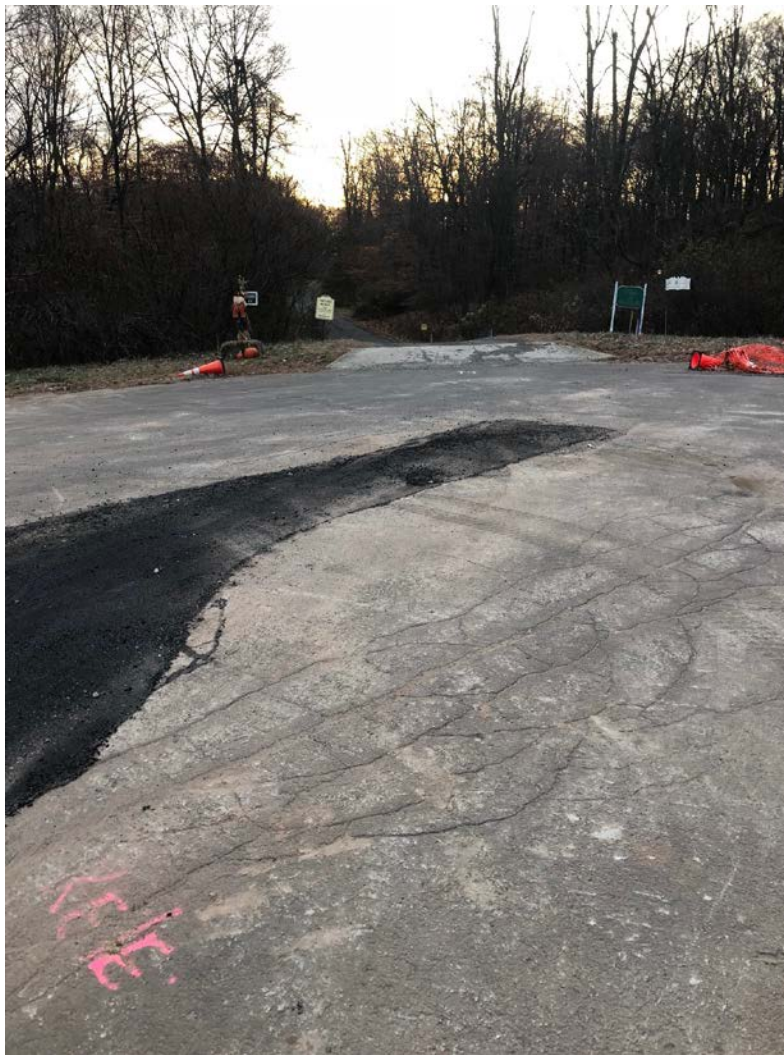
Figure 1 – Patched trench from 11-13-19 at the Talcott Ridge Drive cul-de-sac; view to the southeast.

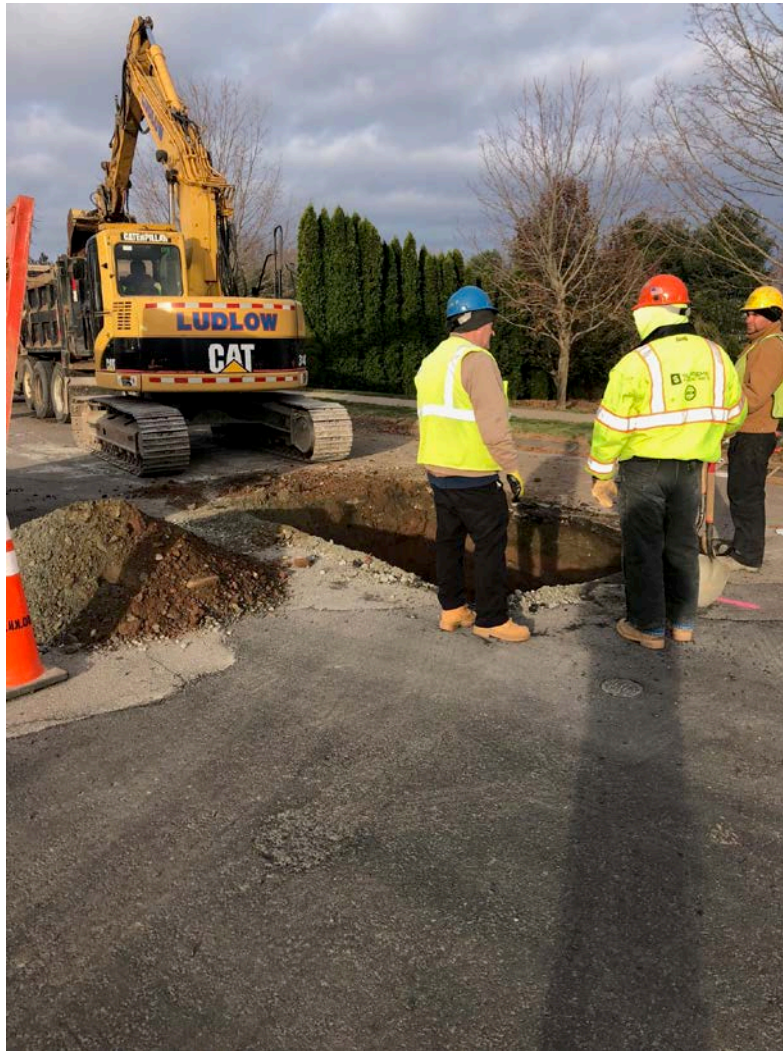
Figure 2 – Excavating existing 8”water line at the intersection of Talcott Ridge Drive and Watch Hill Drive. View to the northwest.

0805 – Ludlow has existing water line daylighted at the intersection of Talcott Ridge Drive and Watch Hill Drive.

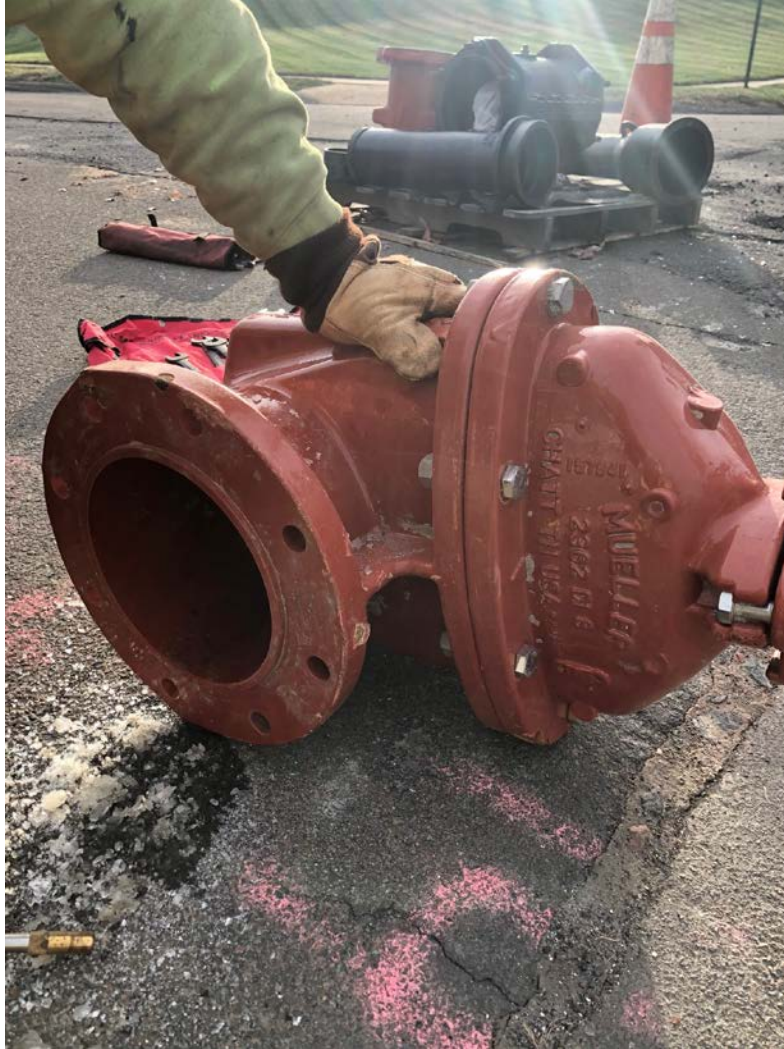
Figure 3 – Tapping gate valve that was connected to the existing water line.

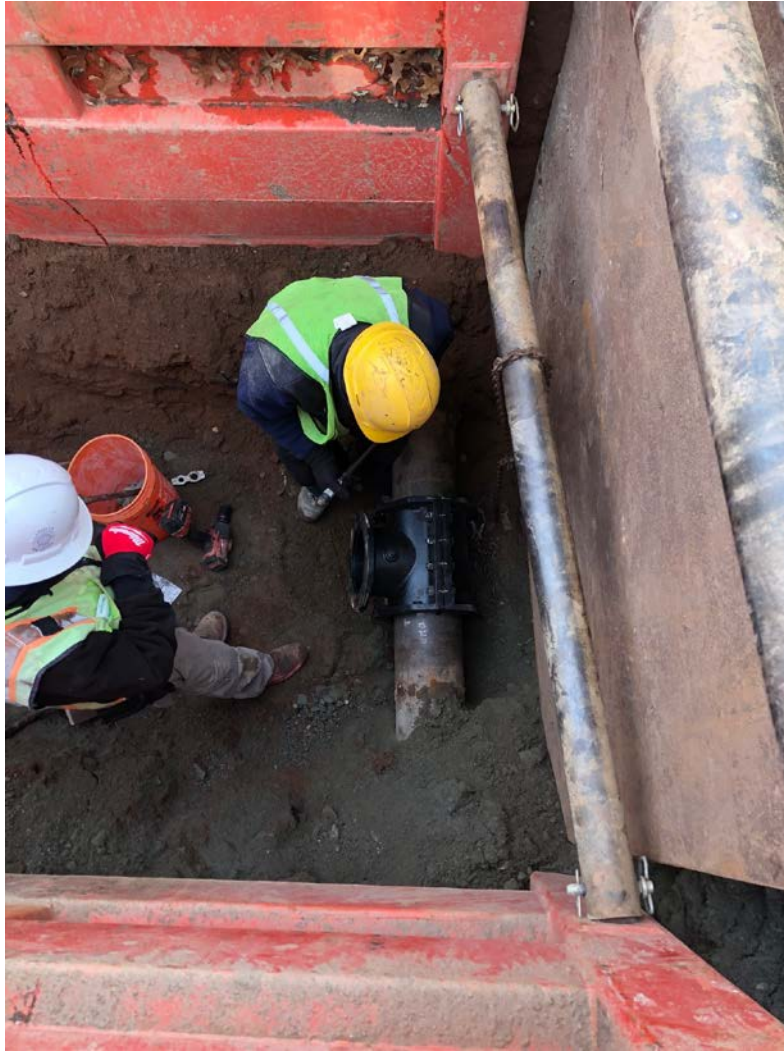
Figure 4 – Tapping sleeve placed onto the existing water line. The tapping valve will connect to this fitting.

0915 – Ludlow begins to place tapping sleeve onto existing water line. The tapping gate valve will be connected to this fitting.

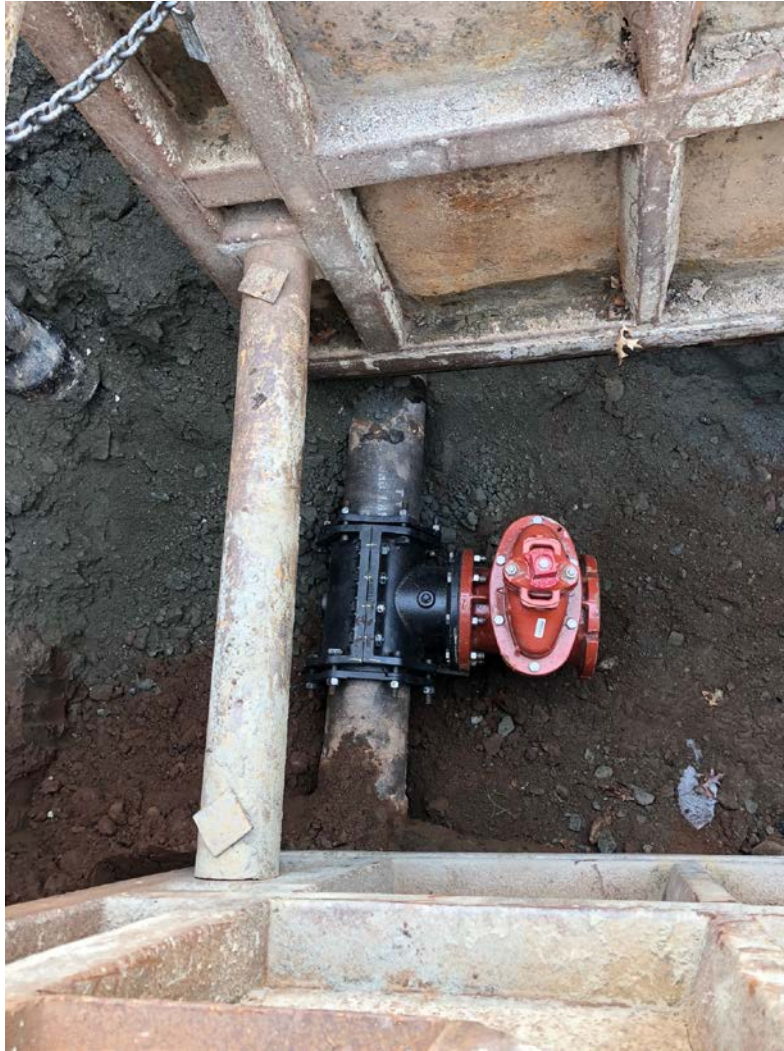
Figure 6 – Newly installed tapping sleeve and valve. Middletown Water Department entered the valve from the right and advanced the tap mechanism to the left to tap into the 8” existing water line.

1140 - Middletown Water Department personnel tapping existing water line. Hole is cut by going through the tapping sleeve that Ludlow just installed. Minimal water released to the excavation during the tapping process.

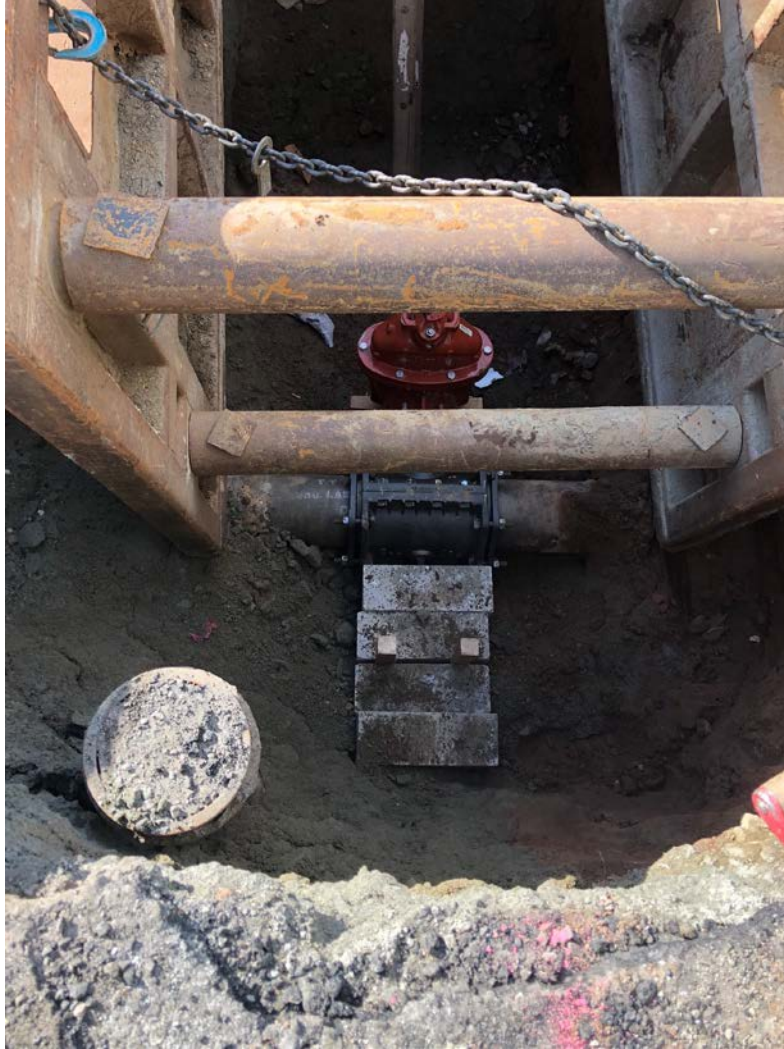
Figure 7 – Water line and tapping sleeve braced and blocked with cement blocks.

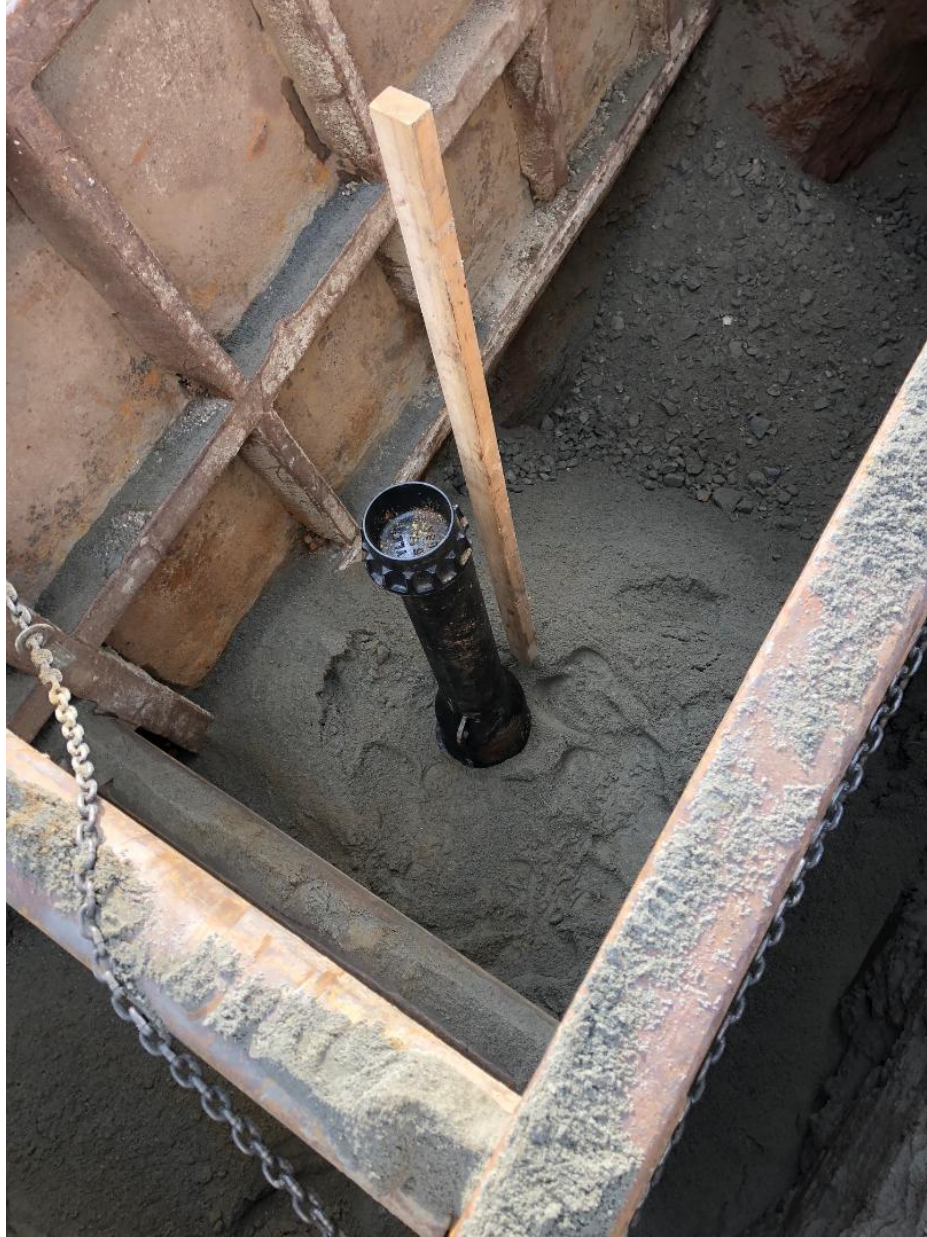
Figure 8 – Valve after installation of riser and gate box, and after sand bedding has been placed over the valve assembly.

1225 – Tapping complete - Middletown Water Department personnel demobing from excavation and work area. Ludlow is installing a riser and gate box that connects to the newly installed valve.

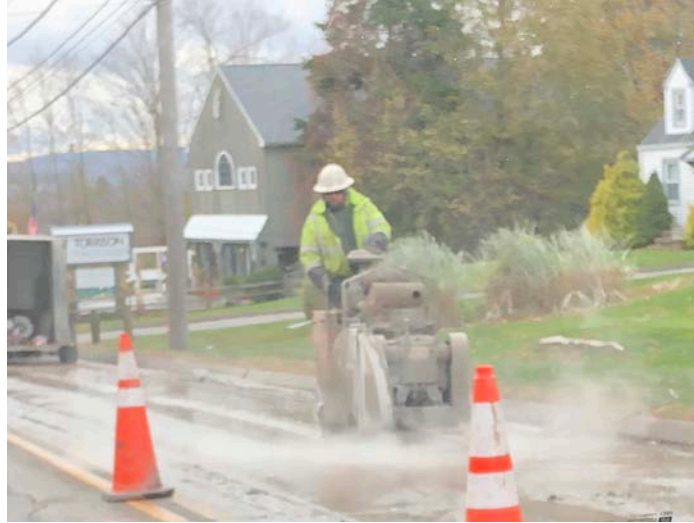
Figure 9 – Saw-cutting asphalt on the southbound lane of Route 17 in Durham.

0955 – A separate crew of Ludlow staff and a subcontractor are saw-cutting trench lines on Route 17, just south of Lino’s on the southbound lane in preparation for the night crew to install pipe.
