Daily Report

Project:	Durham Meadows Pipeline Installation	Date:	November 19, 2019
Location:	Talcott Ridge Drive, Middletown CT	Day of Week:	Tuesday
Project #:	AECOM: 60445033	Report No:	33
Contractor:	Ludlow Construction	Page:	2 of 14

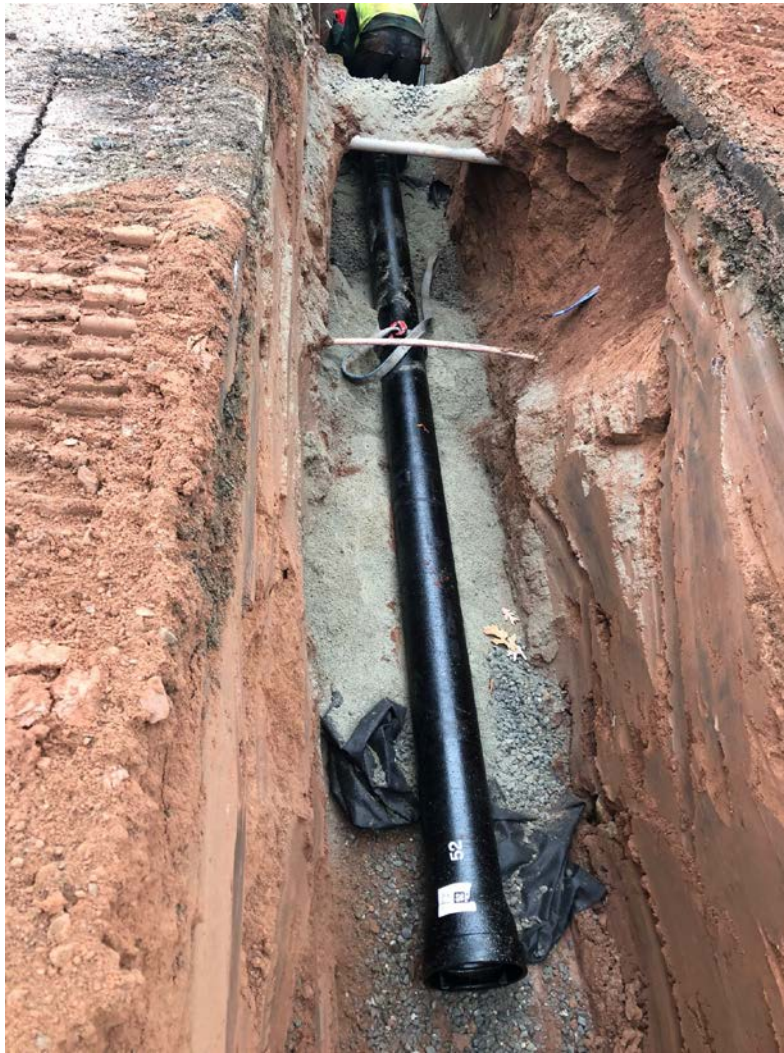
Figure 3 - Second stick of 8" DIP installed by Ludlow beneath a 1" copper water line at 51" BSG and two 4" gray PVC conduits located 39" BSG.

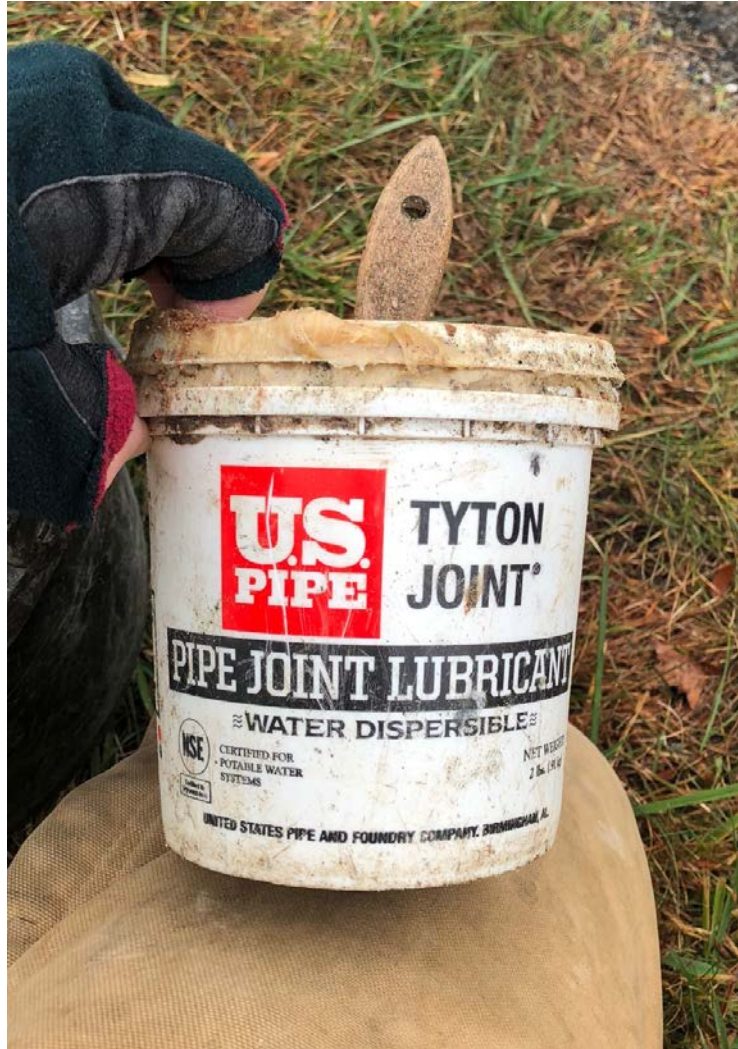
Figure 4 – Pipe lubricant used by Ludlow on the male end of the DIP.

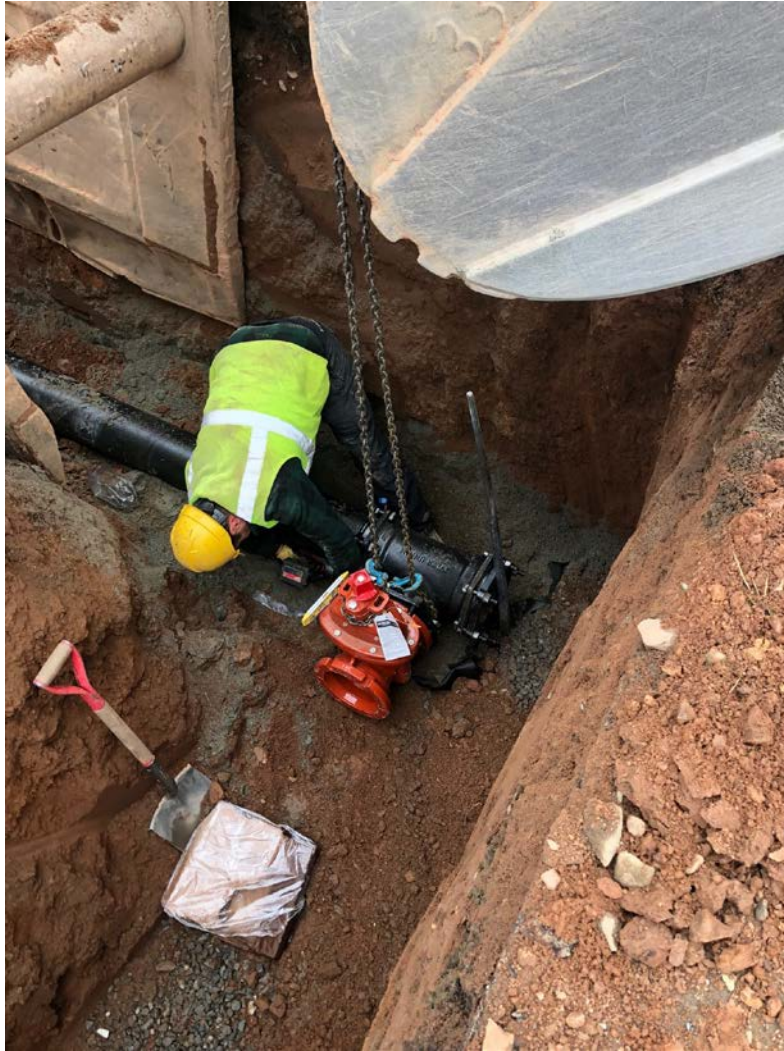
Figure 5 – Installation of 8”x6” tee fitting and valve at approximate Station 604+33.42.

1235 – An 8”x6” tee fitting and a valve are placed on the west end of the 10.5’ section of 8” DIP.

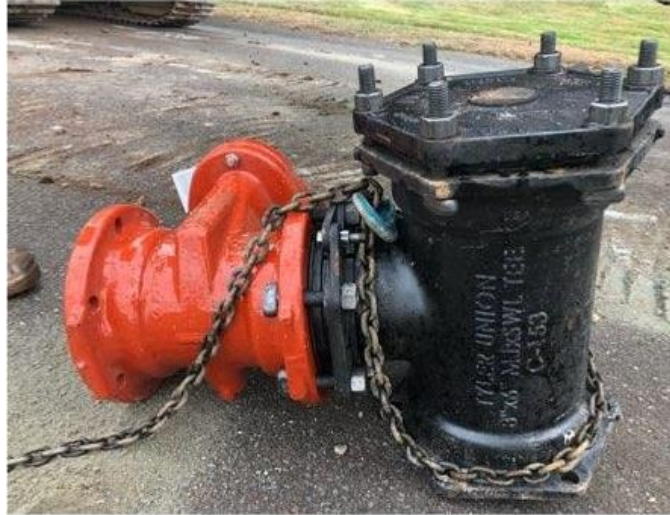
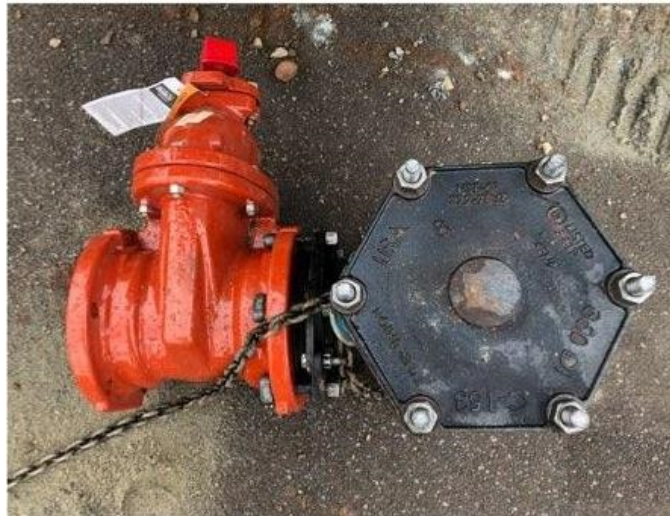
Figure 6 – Close-up of 8”x6” Tee-fitting and valve.

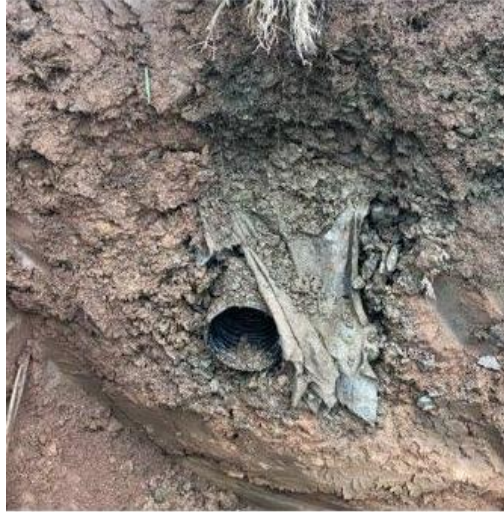
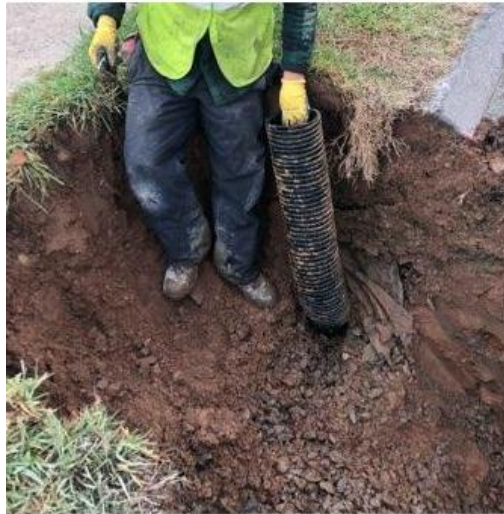
1102 – Excavation turns 90° to the north and stops at curb for the installation of a hydrant. In doing so, a 7” black plastic perforated subdrain pipe and two wires (also running east-west) are severed. The crown of the 7” pipe is located 2.5’ BSG and the wires are located at 40” BSG. These two severed items lie beneath the strip of grass located between the curb and the sidewalk.

1129 – A representative from USIC (CBYD sub) arrives on site. No CBYD markings were observed that would have indicated the presence of the severed wires and subdrain line. According to the USIC rep, a blueprint indicates that the wires service a street light on the south side of Watch Hill Drive (Pole # 8130 in front of 87 Watch Hill Drive).

Figure 7 – 7” black plastic perforated subdrain pipe that was severed by Ludlow.

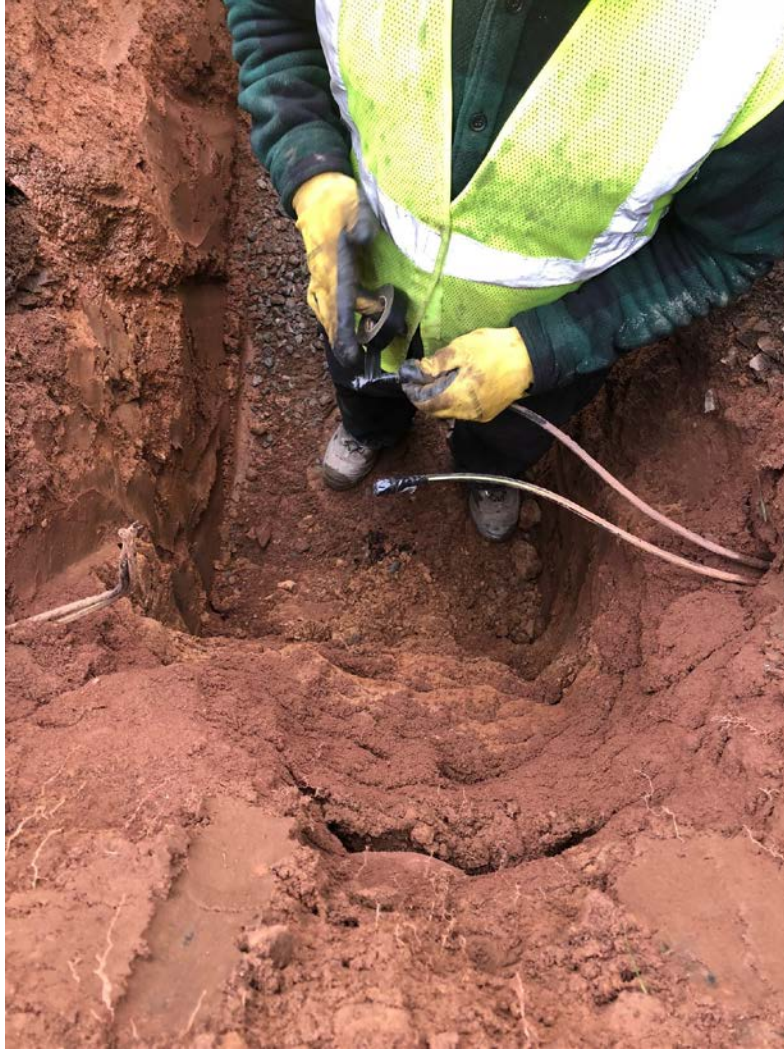
Figure 8 – Ludlow covering ends of severed wires with electrical tape.

1243 – Ludlow secures the ends of the severed wires with black electrical tape.

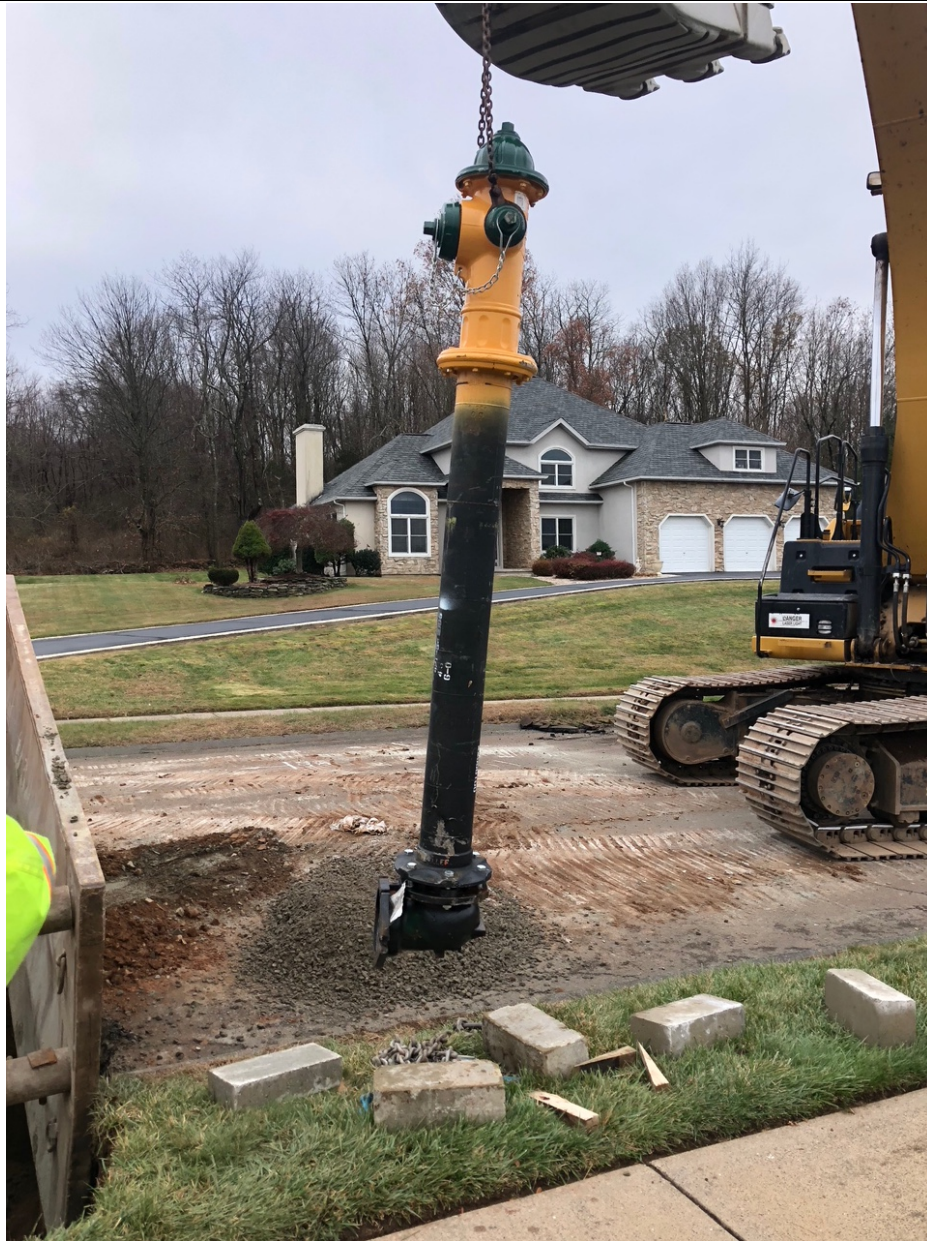
Figure 10- Hydrant assembly about to be installed by Ludlow.

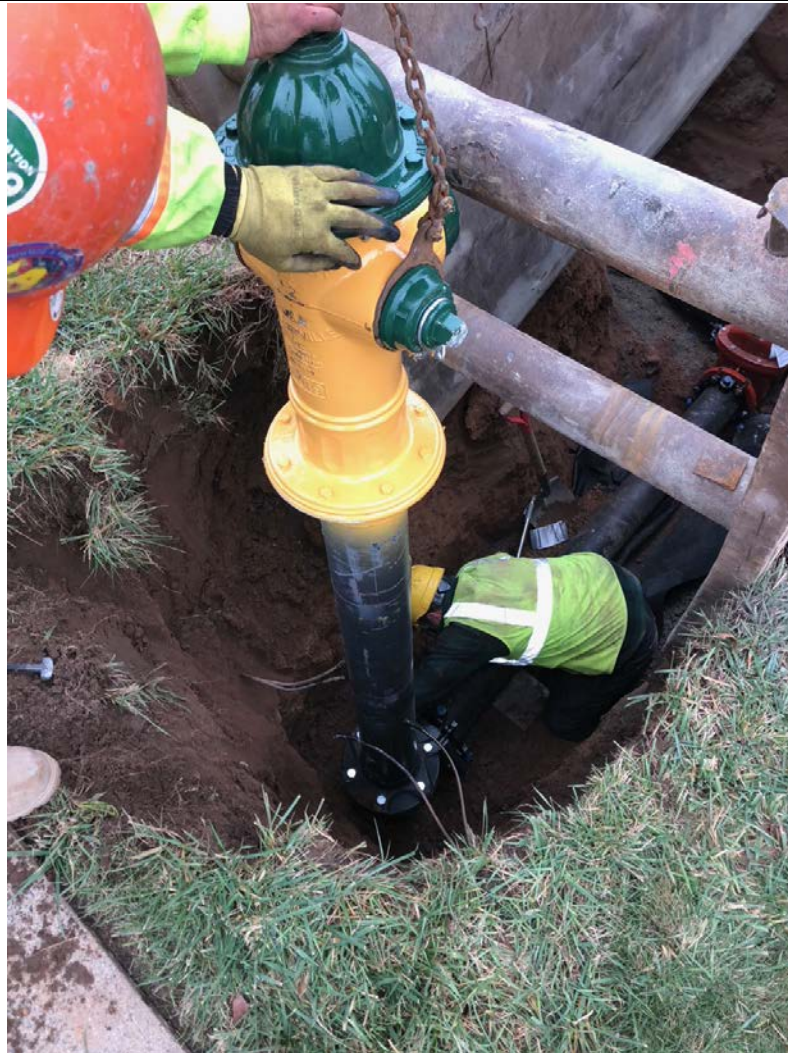
Figure 11– Ludlow installing hydrant assembly.

1335 – Ludlow has installed hydrant assembly and begins to backfill around the piping.

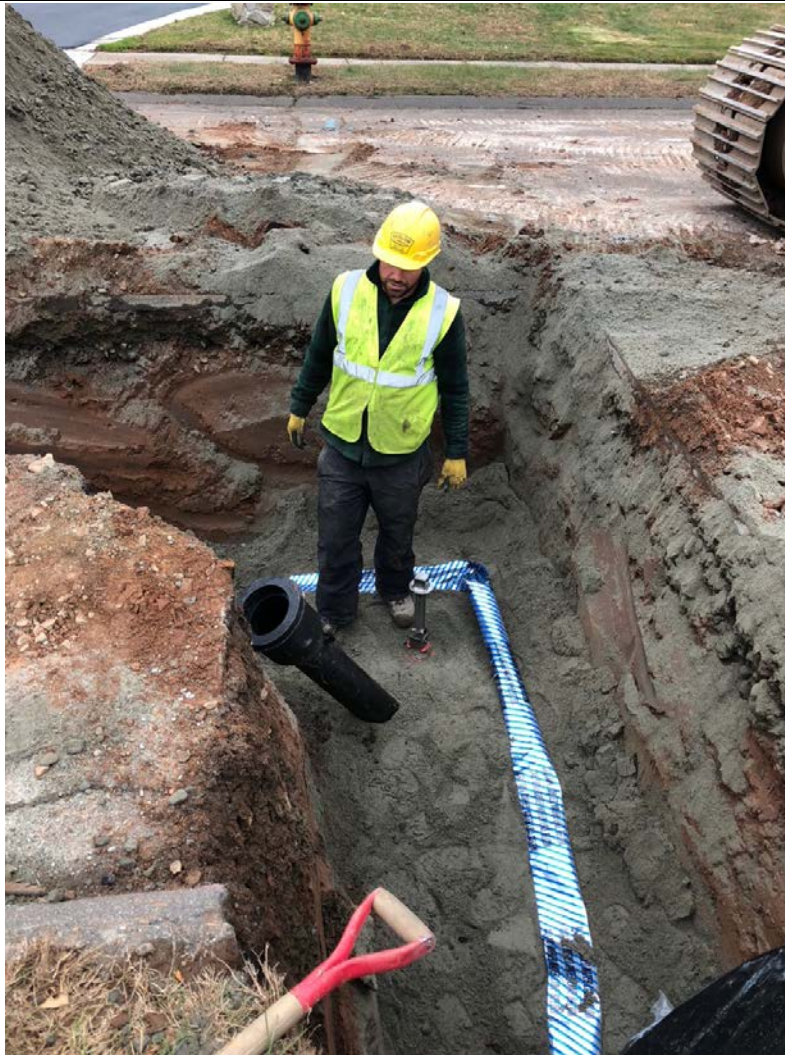
Figure 12– Ludlow installing valve operator extension and gate box onto (now buried) valve.
