Daily Report

Project:	Durham Meadows Pipeline Installation	Date:	November 21, 2019
Location:	Talcott Ridge Drive, Middletown CT	Day of Week:	Thursday
Project #:	AECOM: 60445033	Report No:	35
Contractor:	Ludlow Construction	Page:	1 of 11

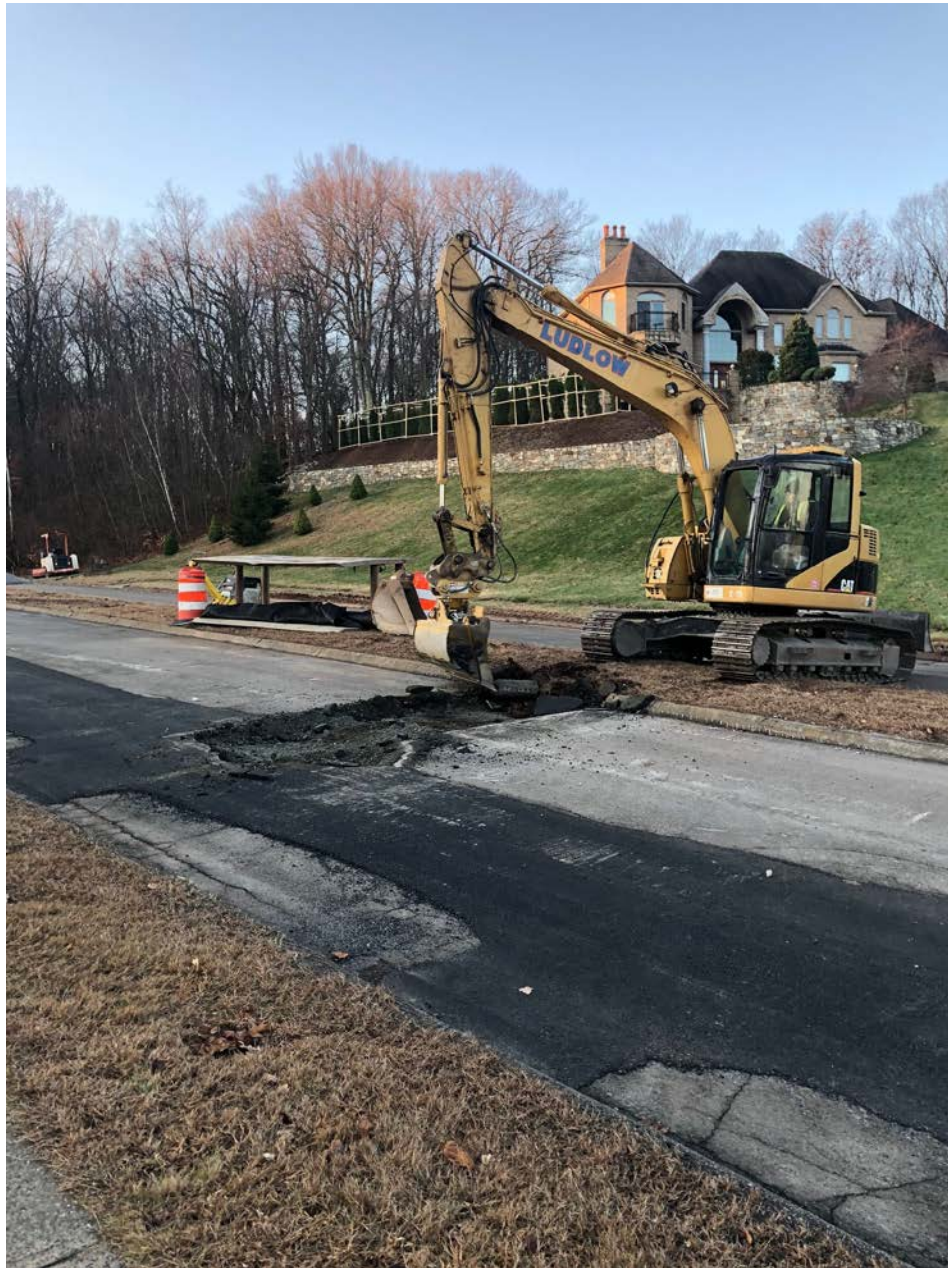
Figure 1 –Ludlow removing asphalt from Station 31+81 that will be trenched for hydrant installation.

0700 –Ludlow mobilizes to Watch Hill Drive at Station 31+81 and begins to peel back asphalt from area that will be excavated to install a hydrant assembly.

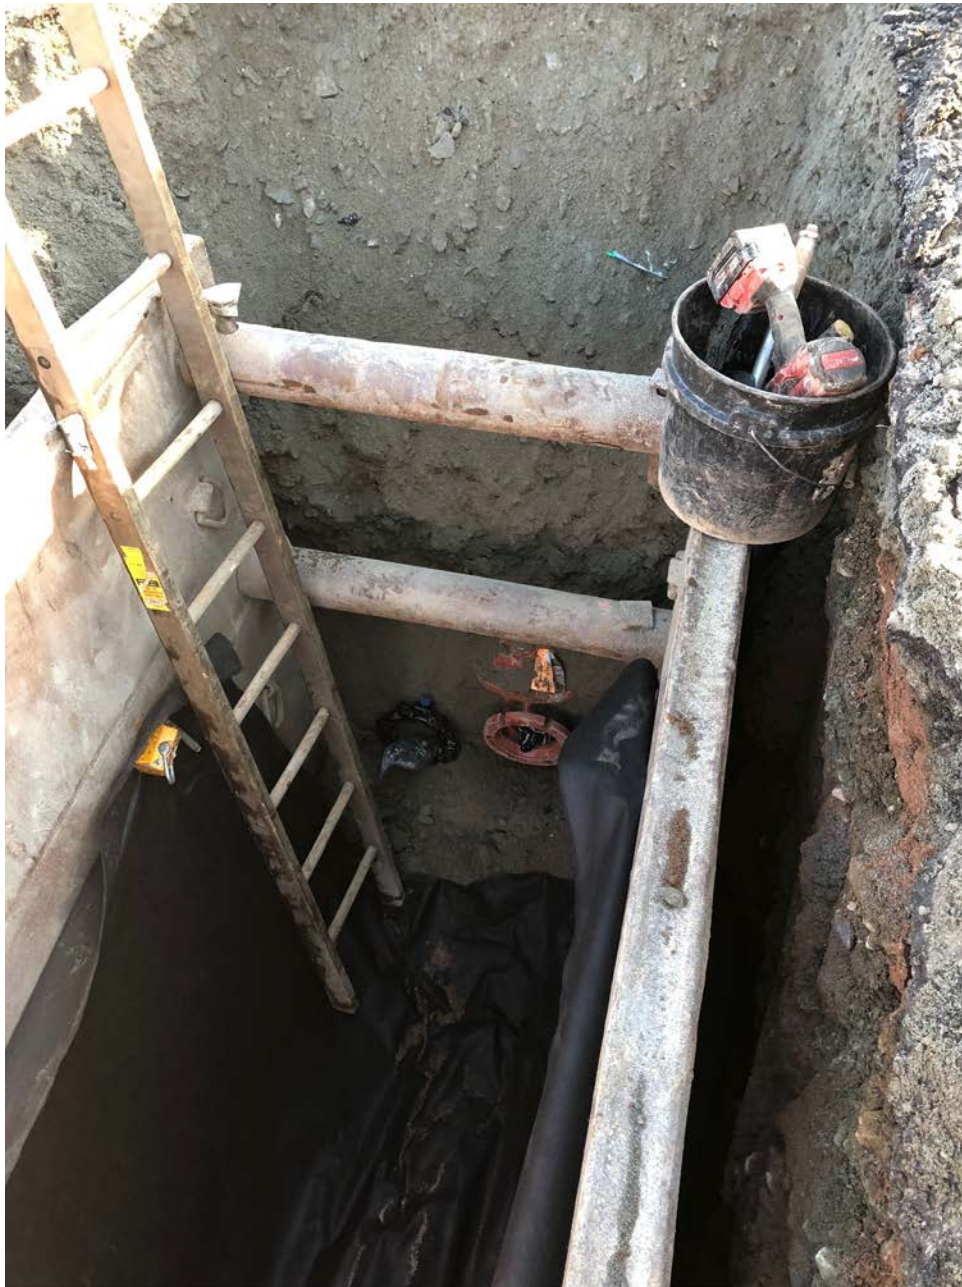
Figure 2 – Valve located on the run of 16” DIP that Ludlow recently placed on the east side of the northbound lane of Talcott Ridge Drive. View to the east.

1010 – Ludlow places first stick of 6” DIP within the trench. This pipe was connected to a valve located on the run of 16” DIP that Ludlow recently placed on the east side of the northbound lane of Talcott Ridge Drive.

1211 – Ludlow connects the hydrant assembly to the 4’8” section of 6” DIP and begins to backfill around the piping. Ludlow also installed a riser and gate box to the valve connected to the 16” DIP on the east side of the northbound lane of Talcott Ridge Drive.

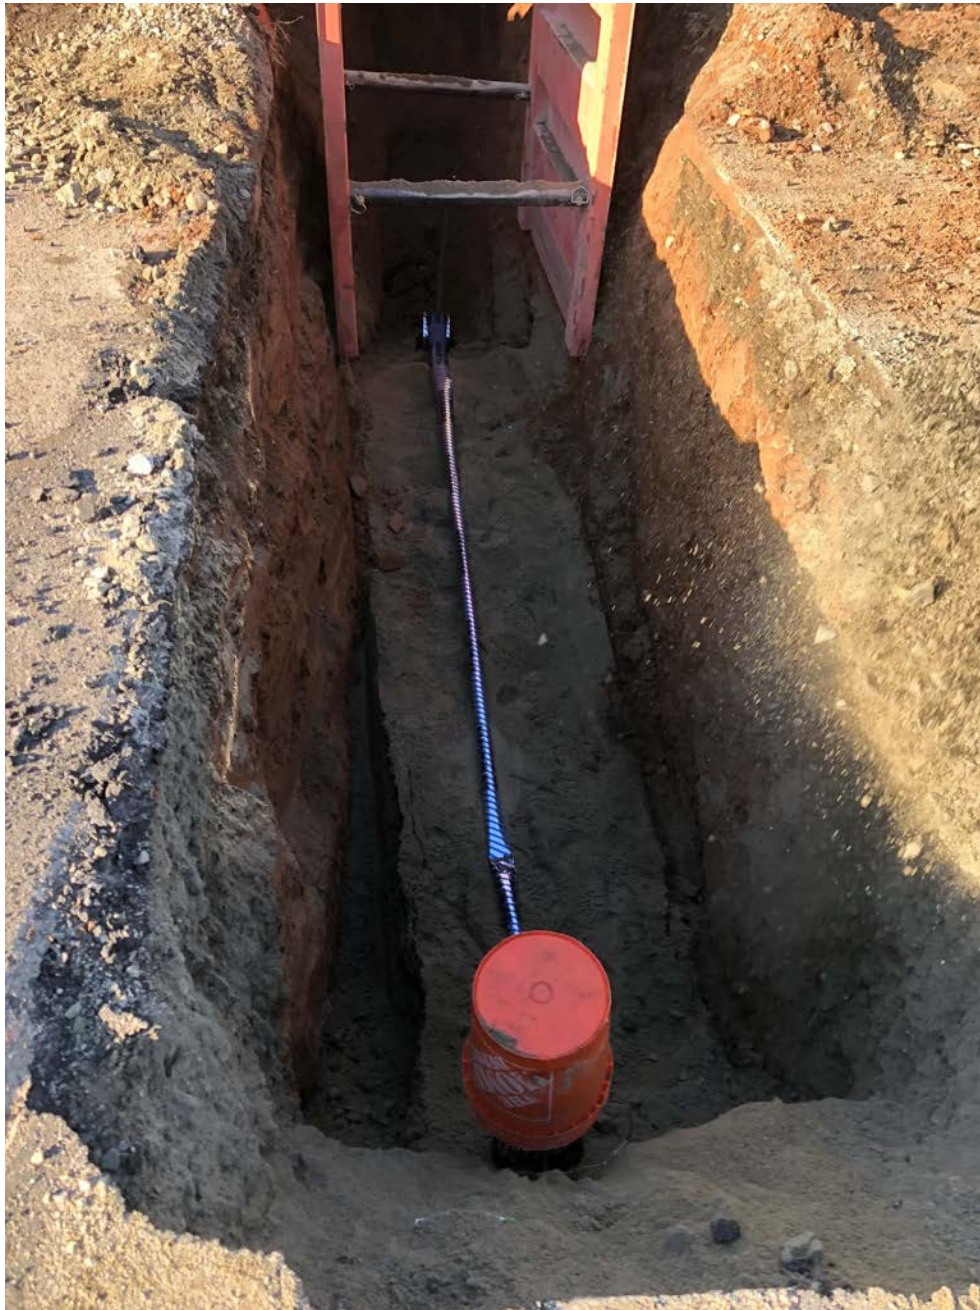
Figure 3 – Sand and caution tape placed over first stick of 6” DIP installed today. Bucket is covering the valve stem and riser that Ludlow placed on the run of 16” DIP that Ludlow recently placed on the east side of the northbound lane of Talcott Ridge Drive. View to the west.

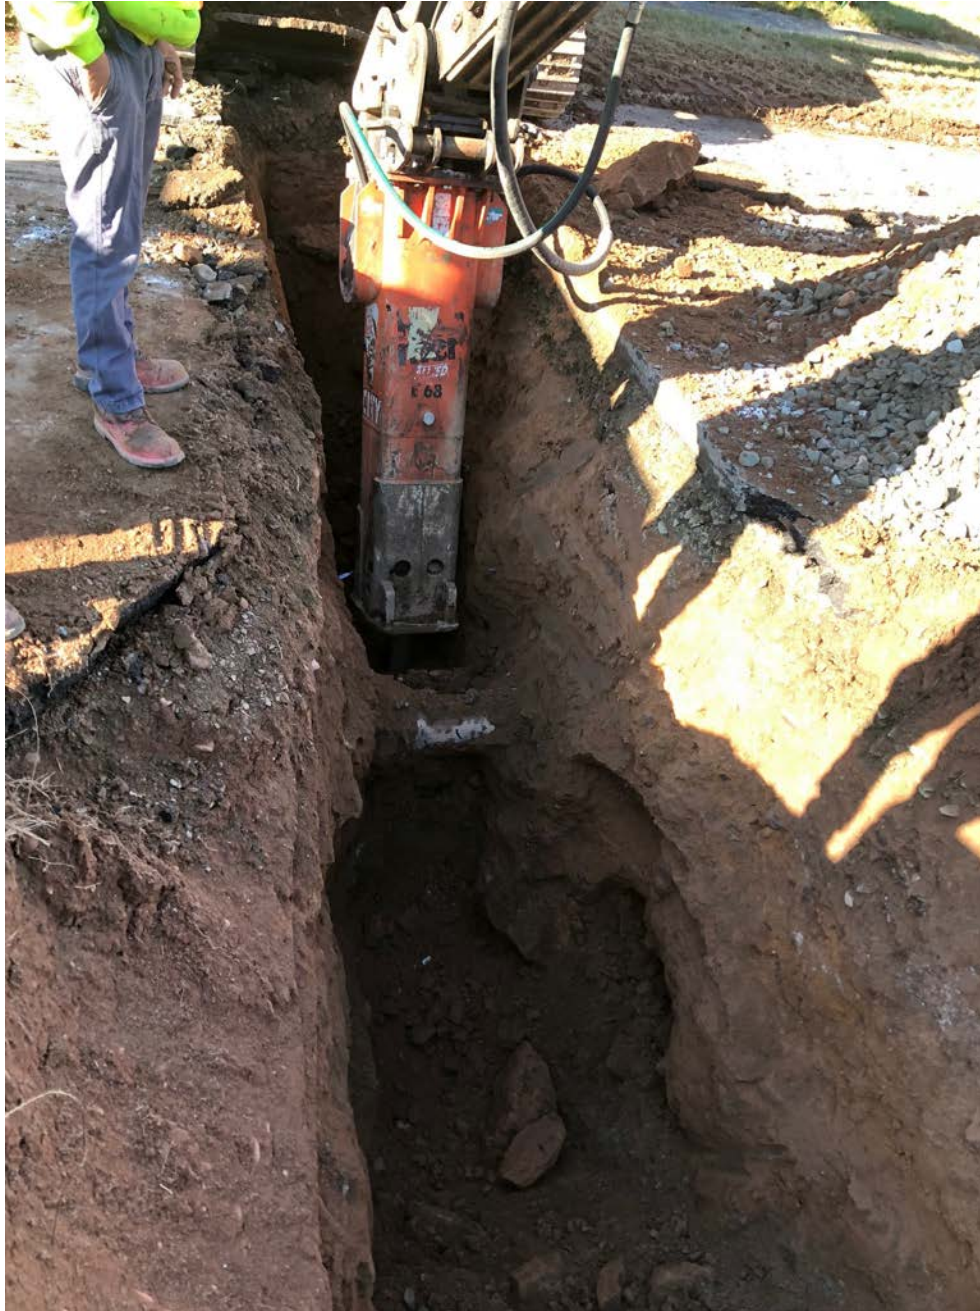
Figure 4 – Ludlow exposes an existing 8” water line that runs beneath the western (southbound) lane of Talcott Ridge Drive. View to the west.

0937 – Ludlow exposed an existing 8" water line that runs beneath the western (southbound) lane of Talcott Ridge Drive.

0945 – Ludlow hammering rock out from beneath the existing 8" water line.

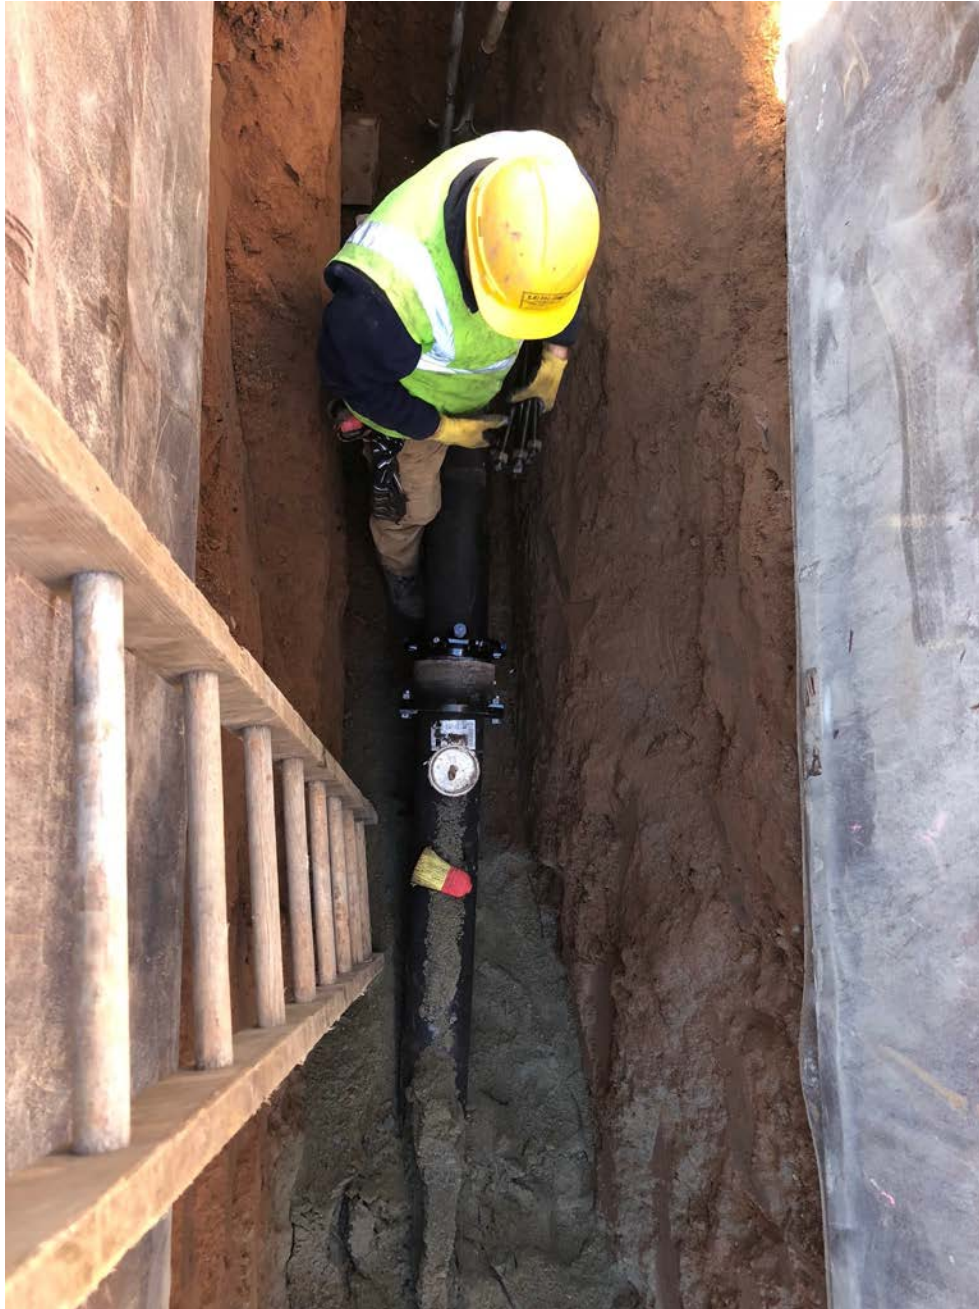
Figure 5 – Ludlow in the process of securing pieces of 6” DIP to each other using a bell clamp/megalug connection.

1049 – Ludlow places a second stick of 6” DIP within the trench (beneath the existing 8” DIP). Connected to the first stick with glands/megalugs.

1140 – Ludlow uses a bell clamp/megalug to connect a 4’8” section of 6” DIP to the second stick of 6” DIP.

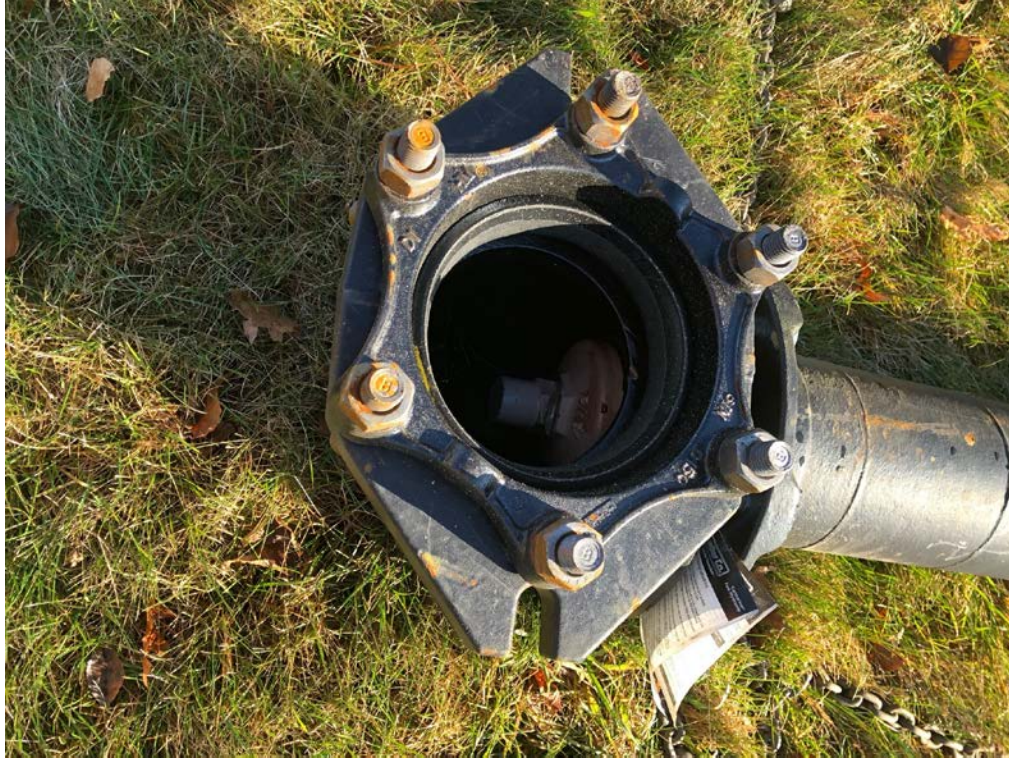
Figure 6 – View inside of the bottom of the fire hydrant assembly.

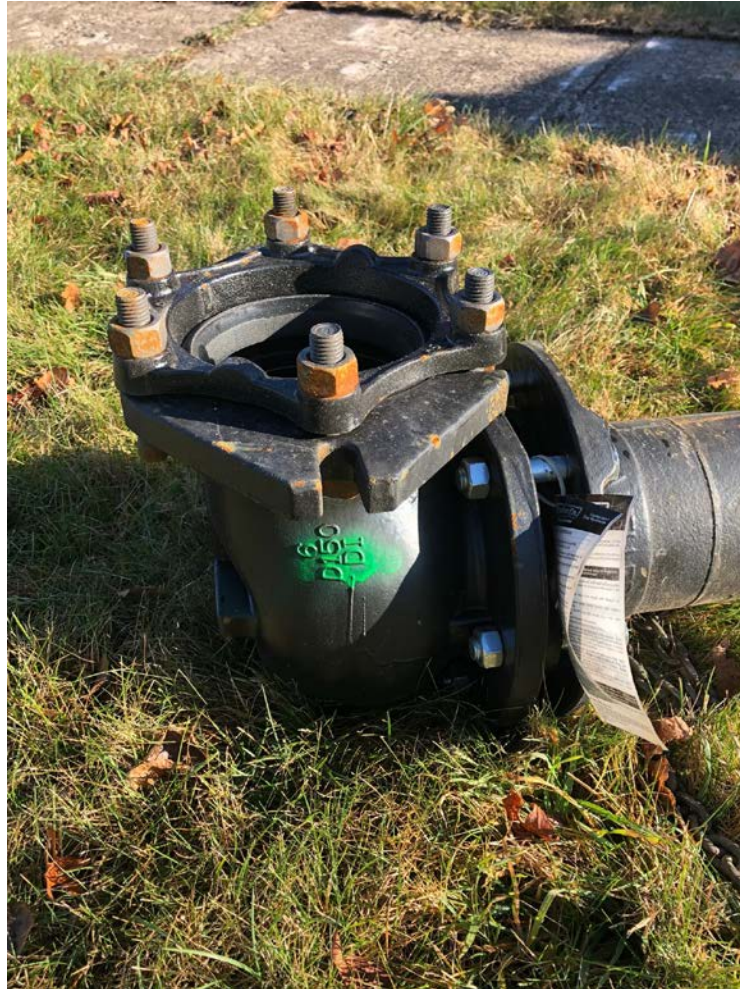
Figure 7 – Another view of the \ bottom of the fire hydrant assembly.

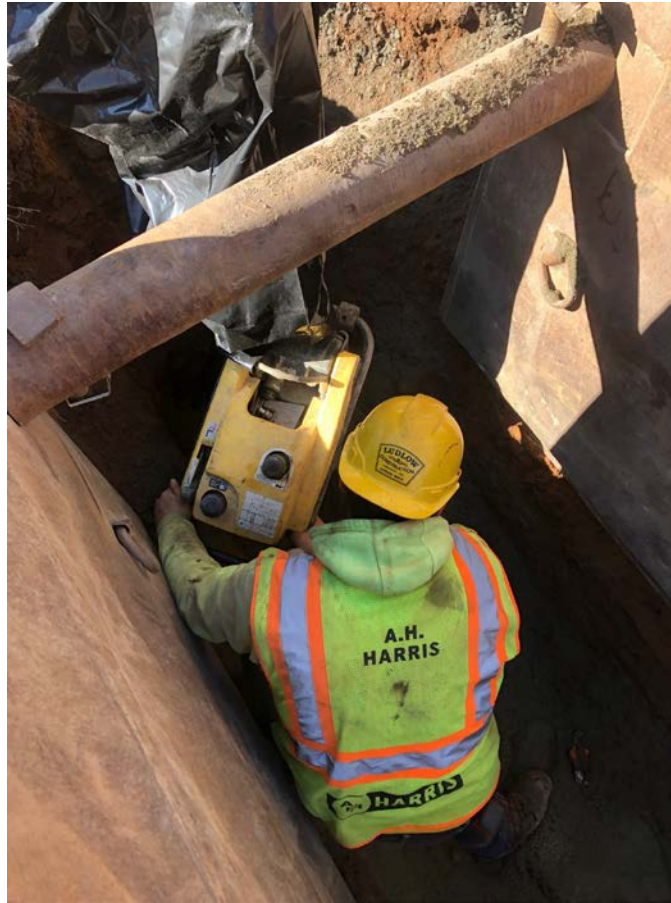
Figure 8 – Ludlow compacting sand around hydrant assembly on west side of trench.

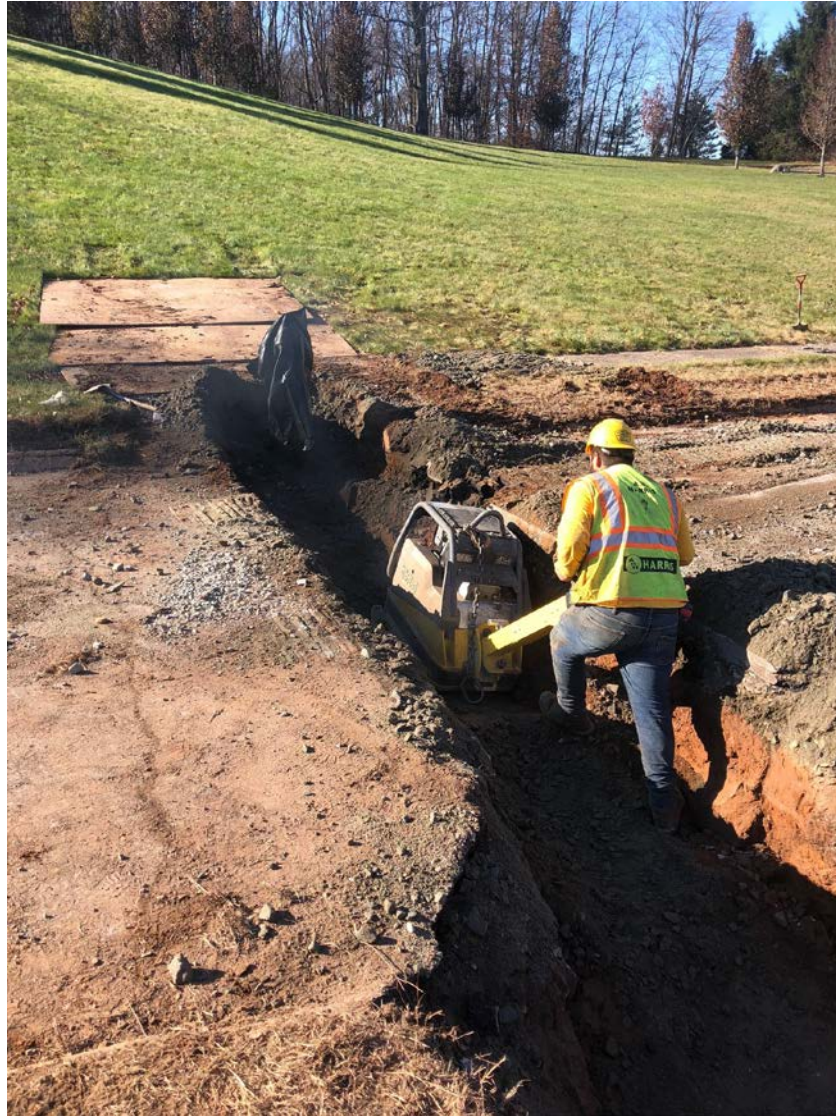
Figure 9 – Ludlow compacting 3” minus gravel backfill.

1305 – Ludlow nearly finished with the placement and compaction of gravel and is awaiting the delivery of asphalt to finish securing the trench
