Daily Report

Project:	Durham Meadows Pipeline Installation	Date:	November 25, 2019
Location:	Talcott Ridge Drive, Middletown CT	Day of Week:	Monday
Project #:	AECOM: 60445033	Report No:	37
Contractor:	Ludlow Construction	Page:	1 of 16

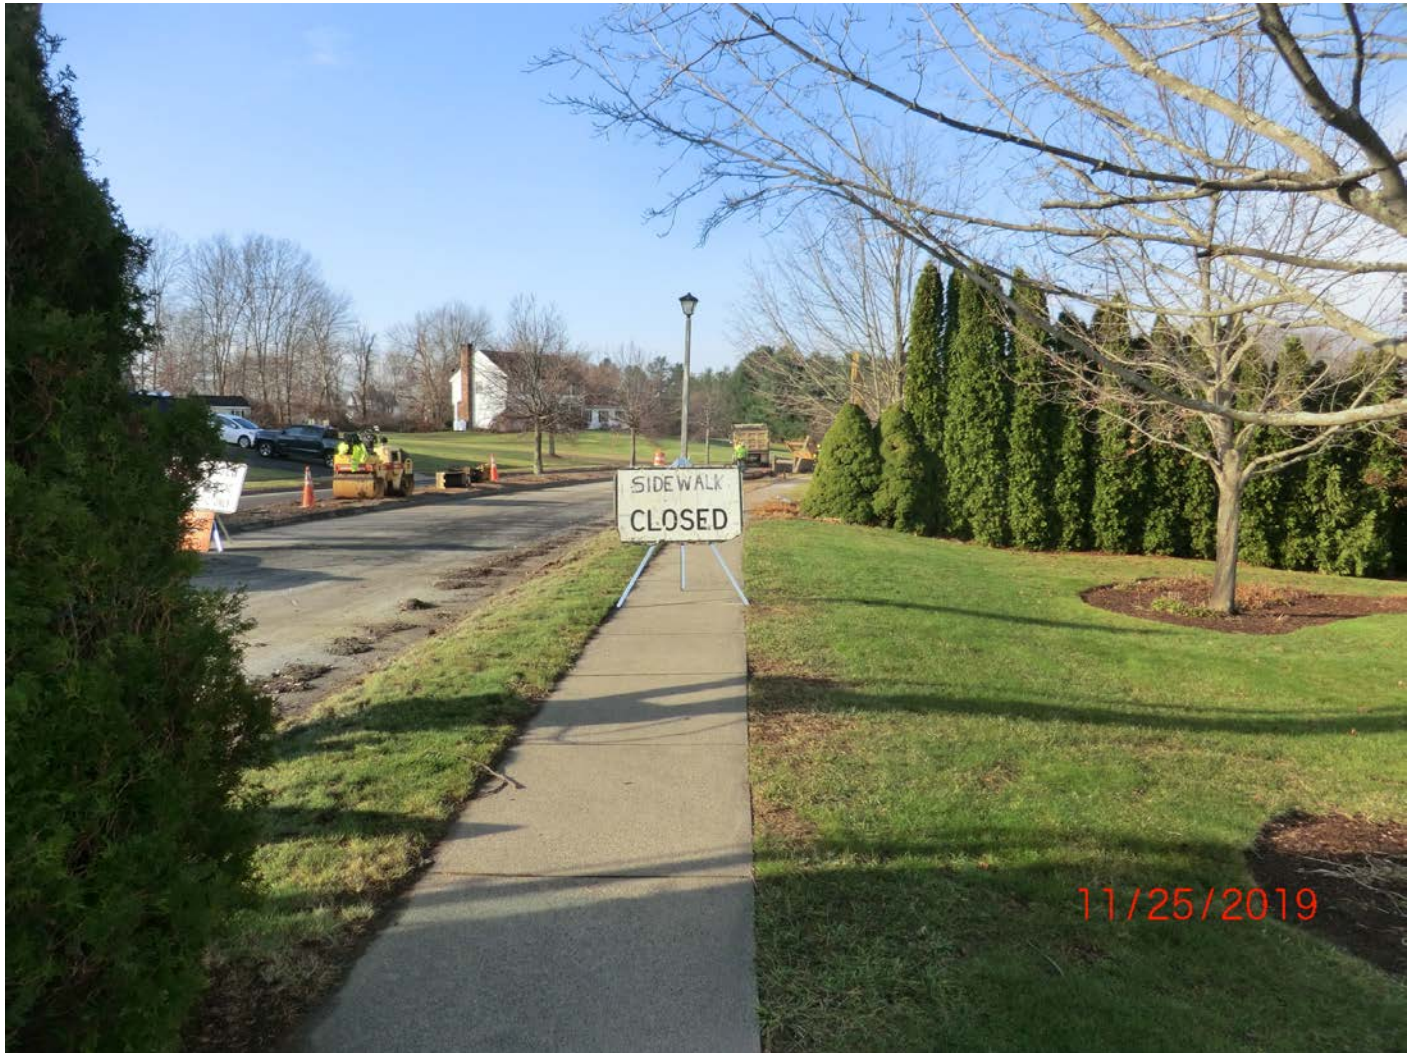
Figure 1 –Facing west from intersection of lower Watch Hill and Talcott Ridge.

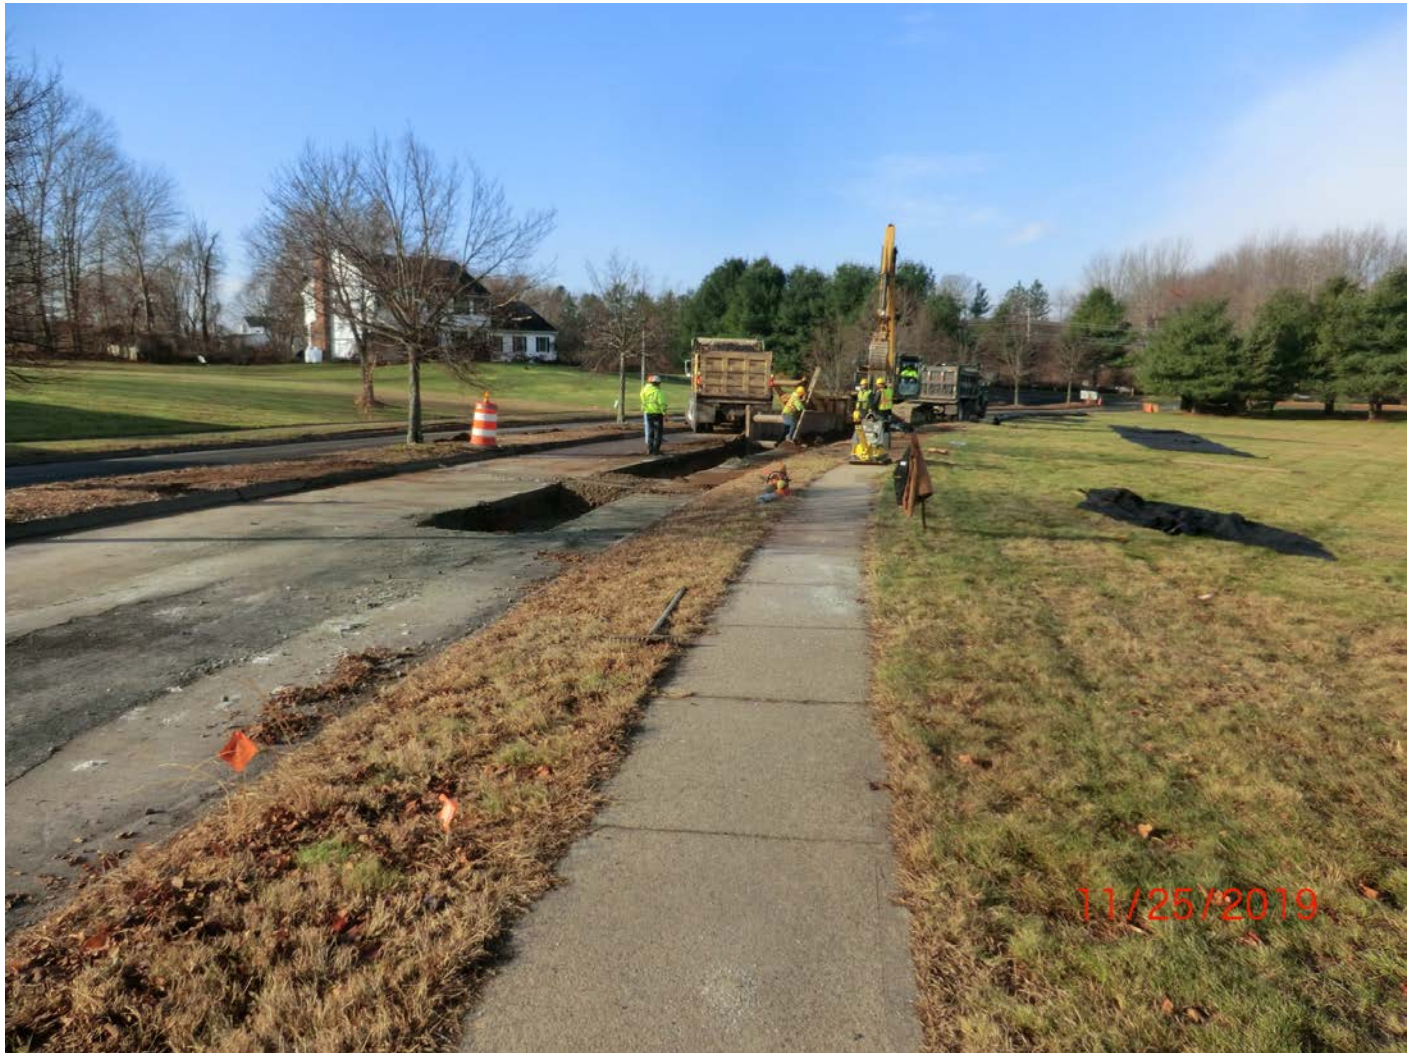
Figure 2 – Facing southwest. Morning progress.

0900 – Inspect Talcott Ridge work. Currently installing restrained 8" DI pipe on the north side of the road between lower Watch Hill Dr. and South Main St. Currently have 60 feet in the ground (755+14 to 754+54).

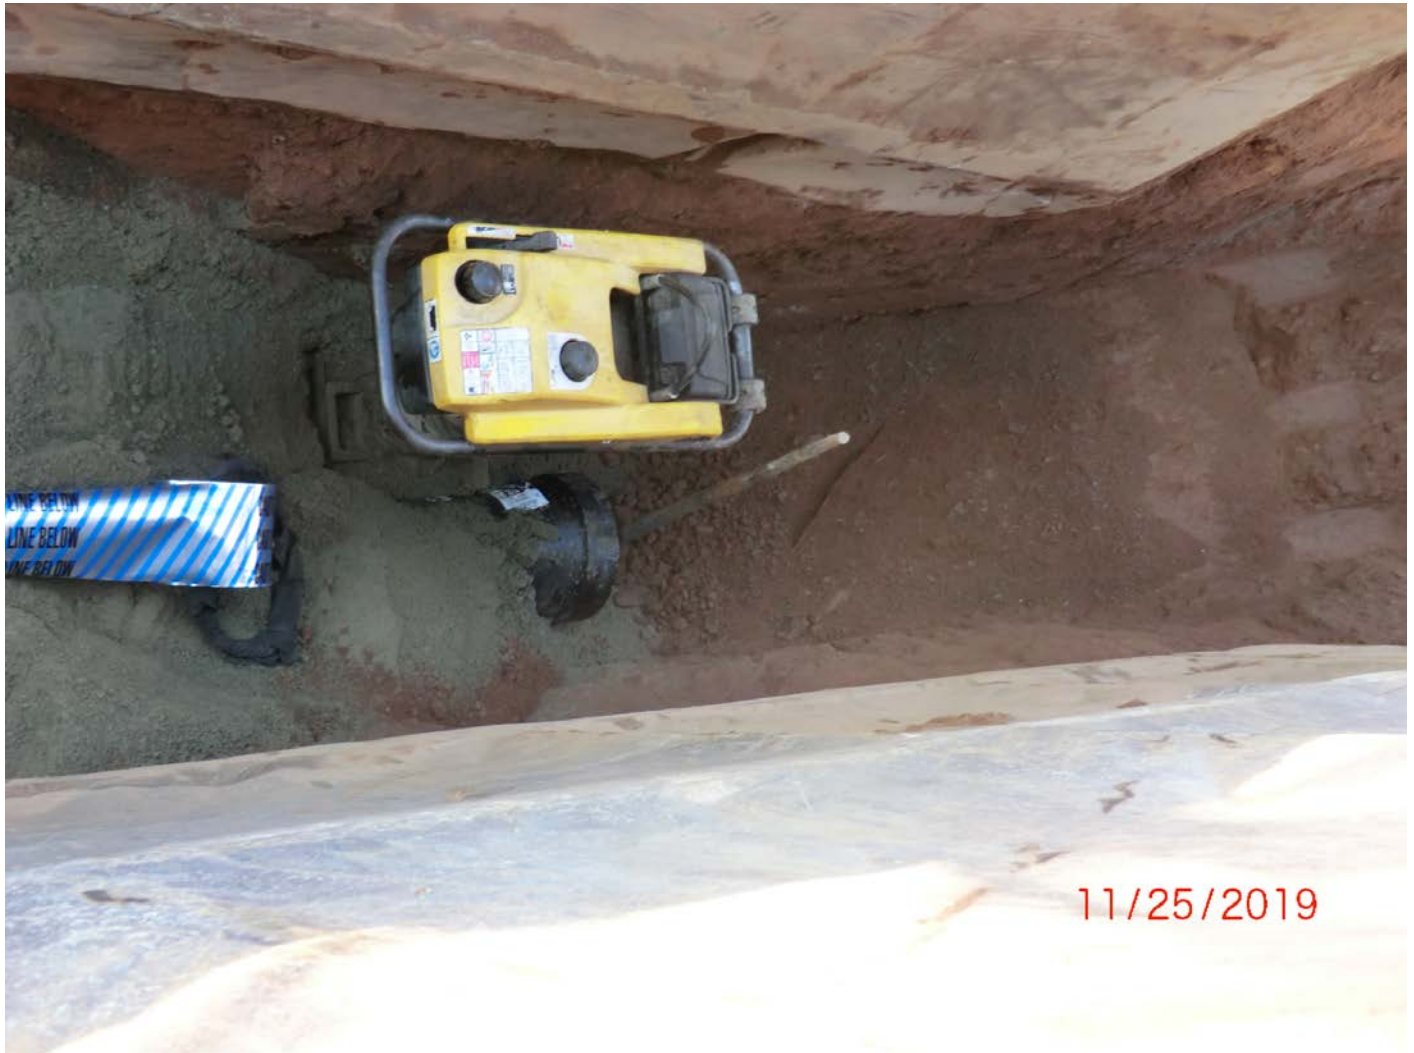
Figure 3 – 8" DIP – restrained bell at Talcott Ridge Drive.

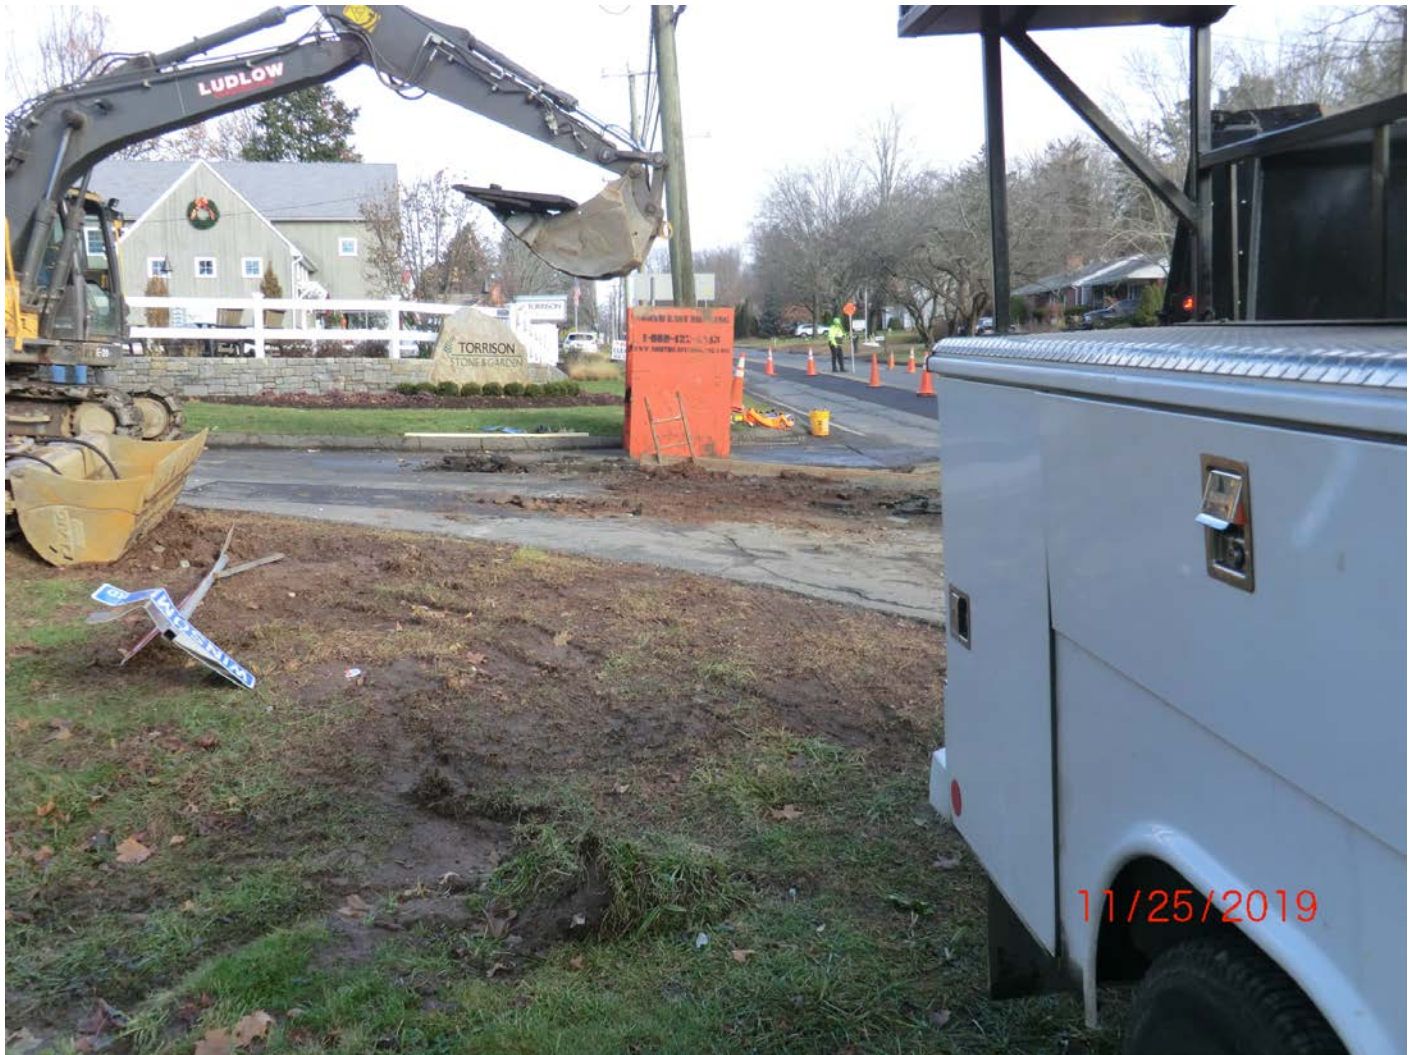
Figure 4 – Facing north on Main Street at Winsome Rd. Trenching off main line to extent 8” hydrant line. Note mangled road and stop sign to left of picture.

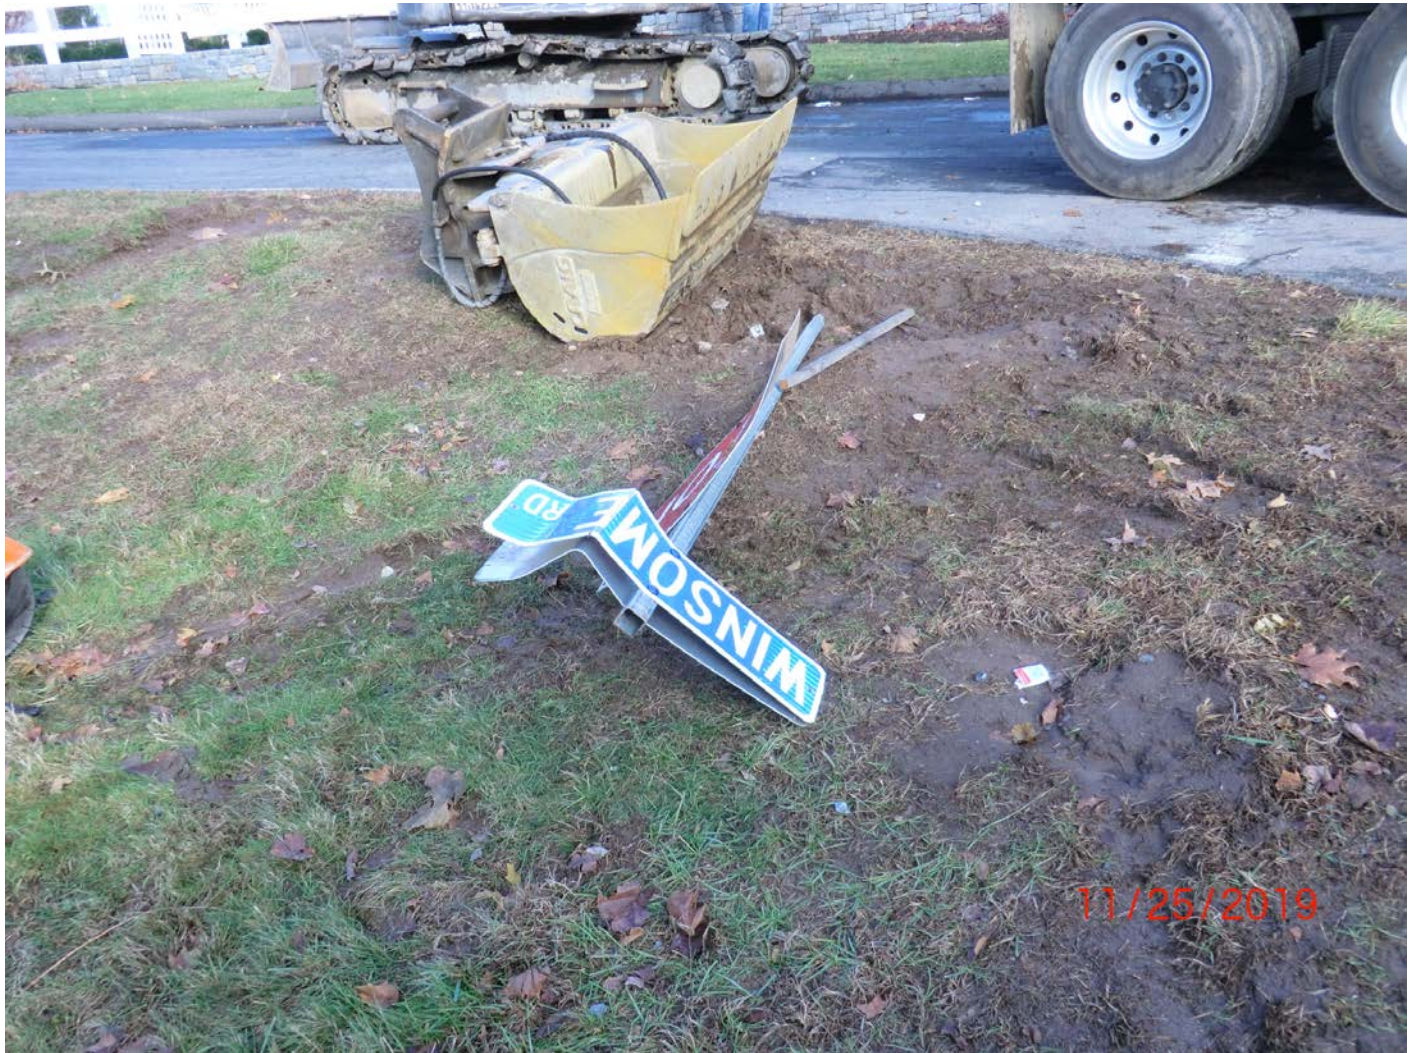
10:50 – Received text from Kurt (USACE) that the Main Street team hit something. Went down to Main Street to investigate. Air-line was ruptured and conduit box broken. {Note earlier that morning a 6” drain line section had been removed during the initial digging and Ludlow was planning on replacing the section with Fernco couplers.}. The air-line belongs to Frontier, who was out at the site to manage the repair. Noted that the street sign/stop sign were also damaged and lying on the ground.

Figure 5 – Damaged Street Sign.

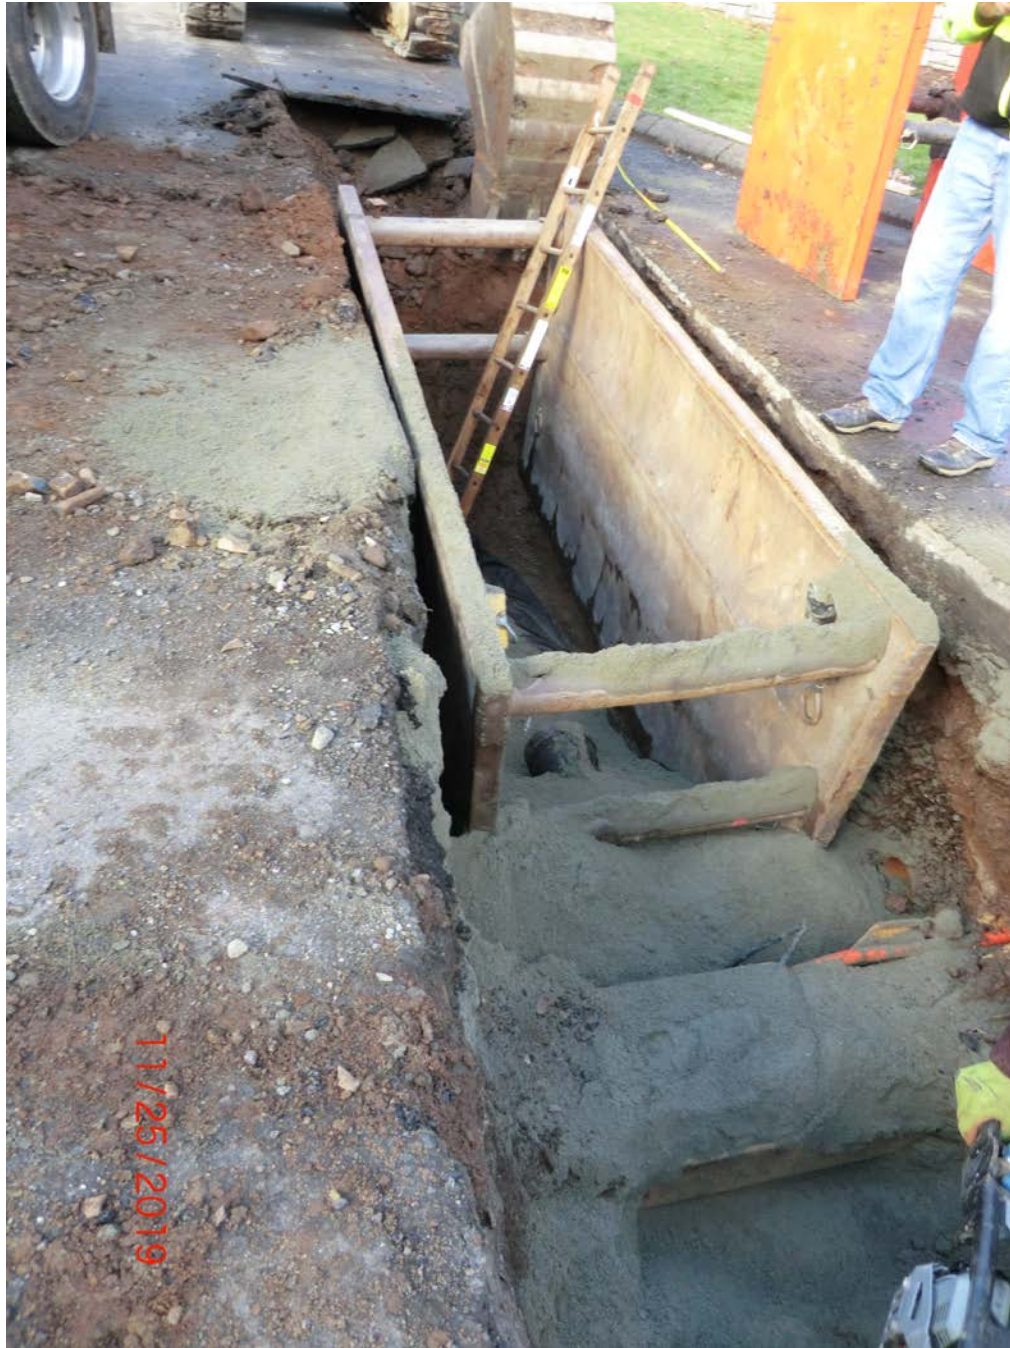
Issues: No issues on Talcott Ridge Drive. On Main Street at the intersection with Winsome St. in Durham a telephone conduit tile casing was broken and an air-line ruptured. This incident required Frontier (owner of the line) to come out in order to repair the air line. The crew also pulled out a section of 6" drain line. The drain line was being repaired using Fernco couplings to re-insert the section removed. [Speaking with Frontier, the air-line is part of the overhead copper line system and is used to maintain several pounds of pressure in the copper lines to avoid condensation and corrosion of the copper line. The air-line system has laterals off the buried line that run up poles to the copper line.]

Figure 6 – View of telephone conduit clay pipe – front right corner of picture. This conduit was later broken and an air-line ruptured. Also note 6” drain pipe on right wall between trench box and conduit. This is to be repaired using Fernco couplings. Upon closer inspection, it appears that the air-line had already been broken at this point – note black tube next to orange conduit line.

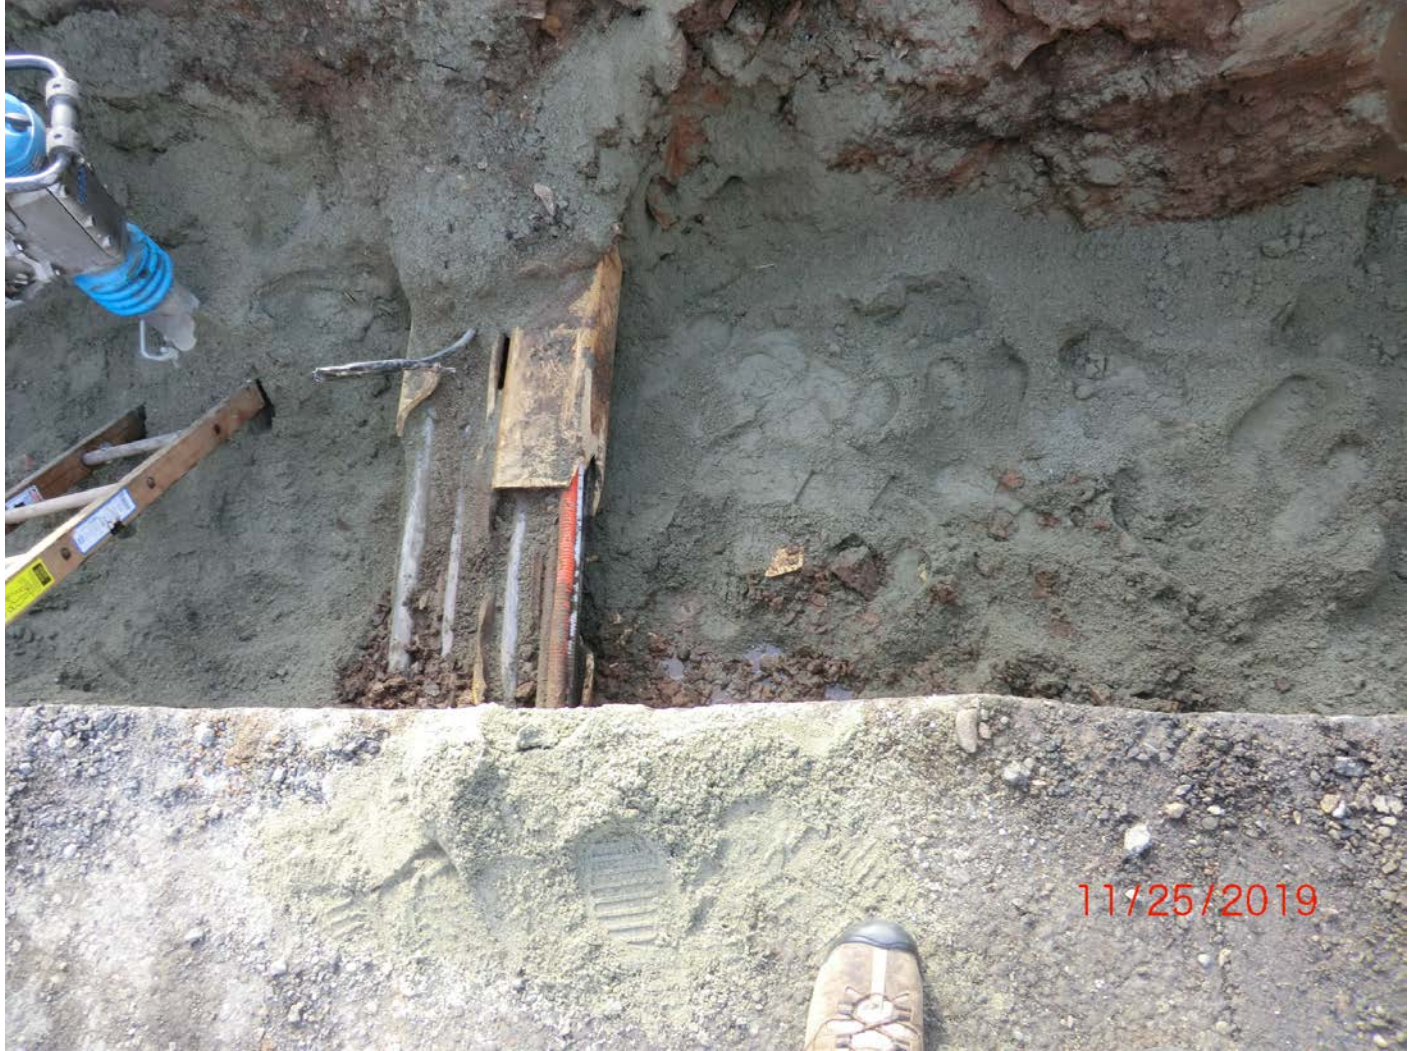
Figure 7 – Another view of the conduit taken later in the morning. Note that the clay conduit has been further broken and the broken air-line is more visible.

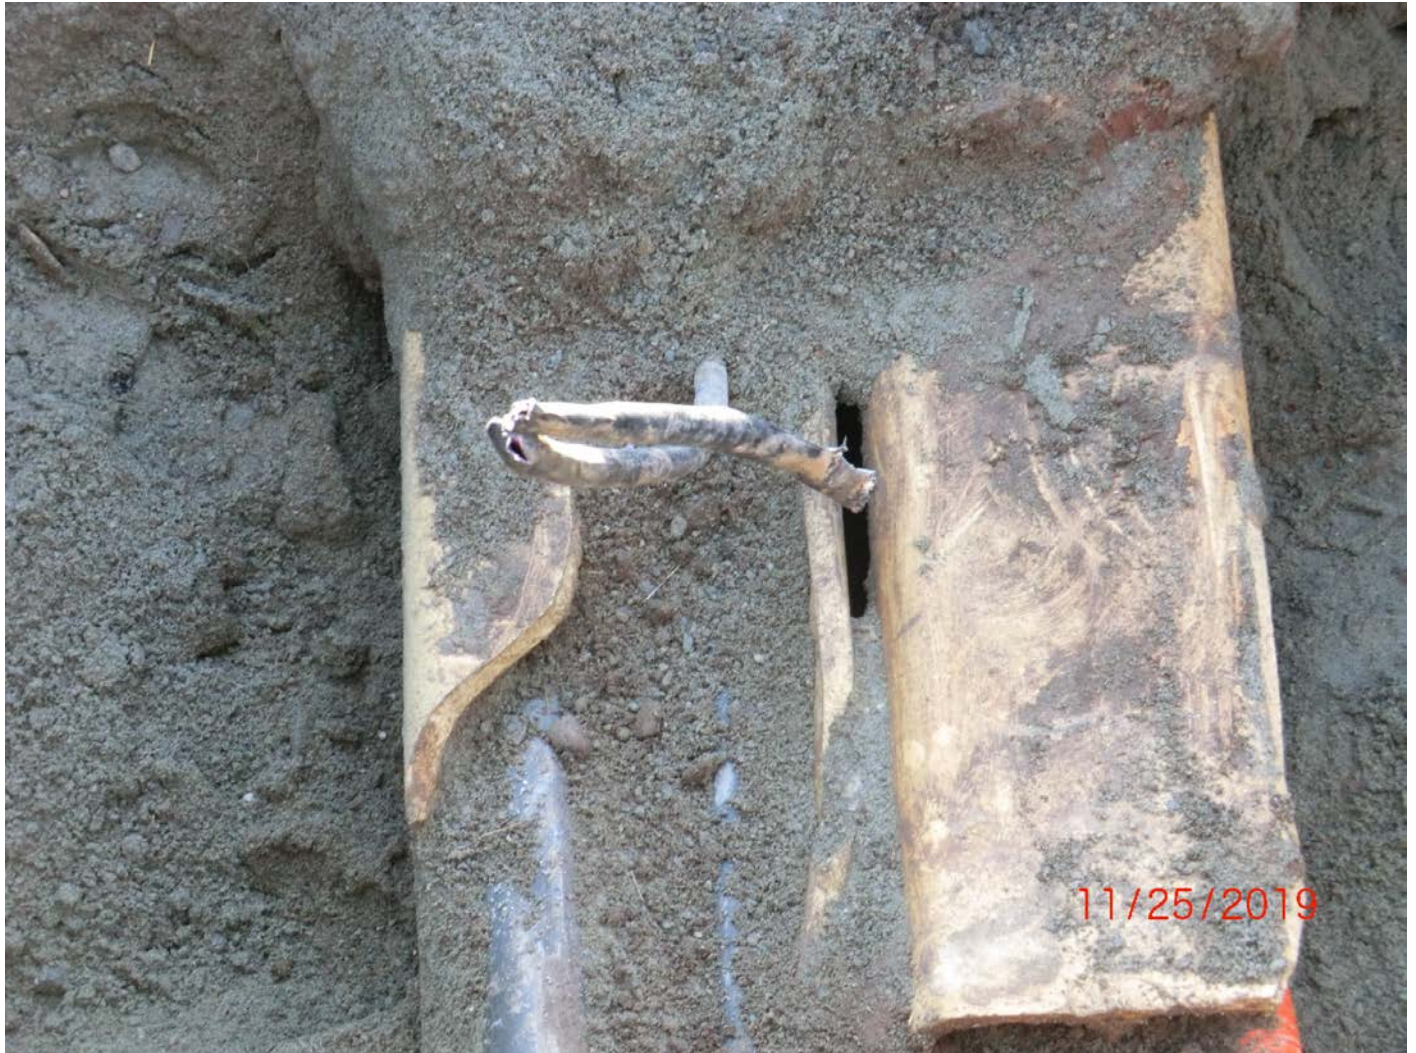
Figure 8 – Broken air-line.

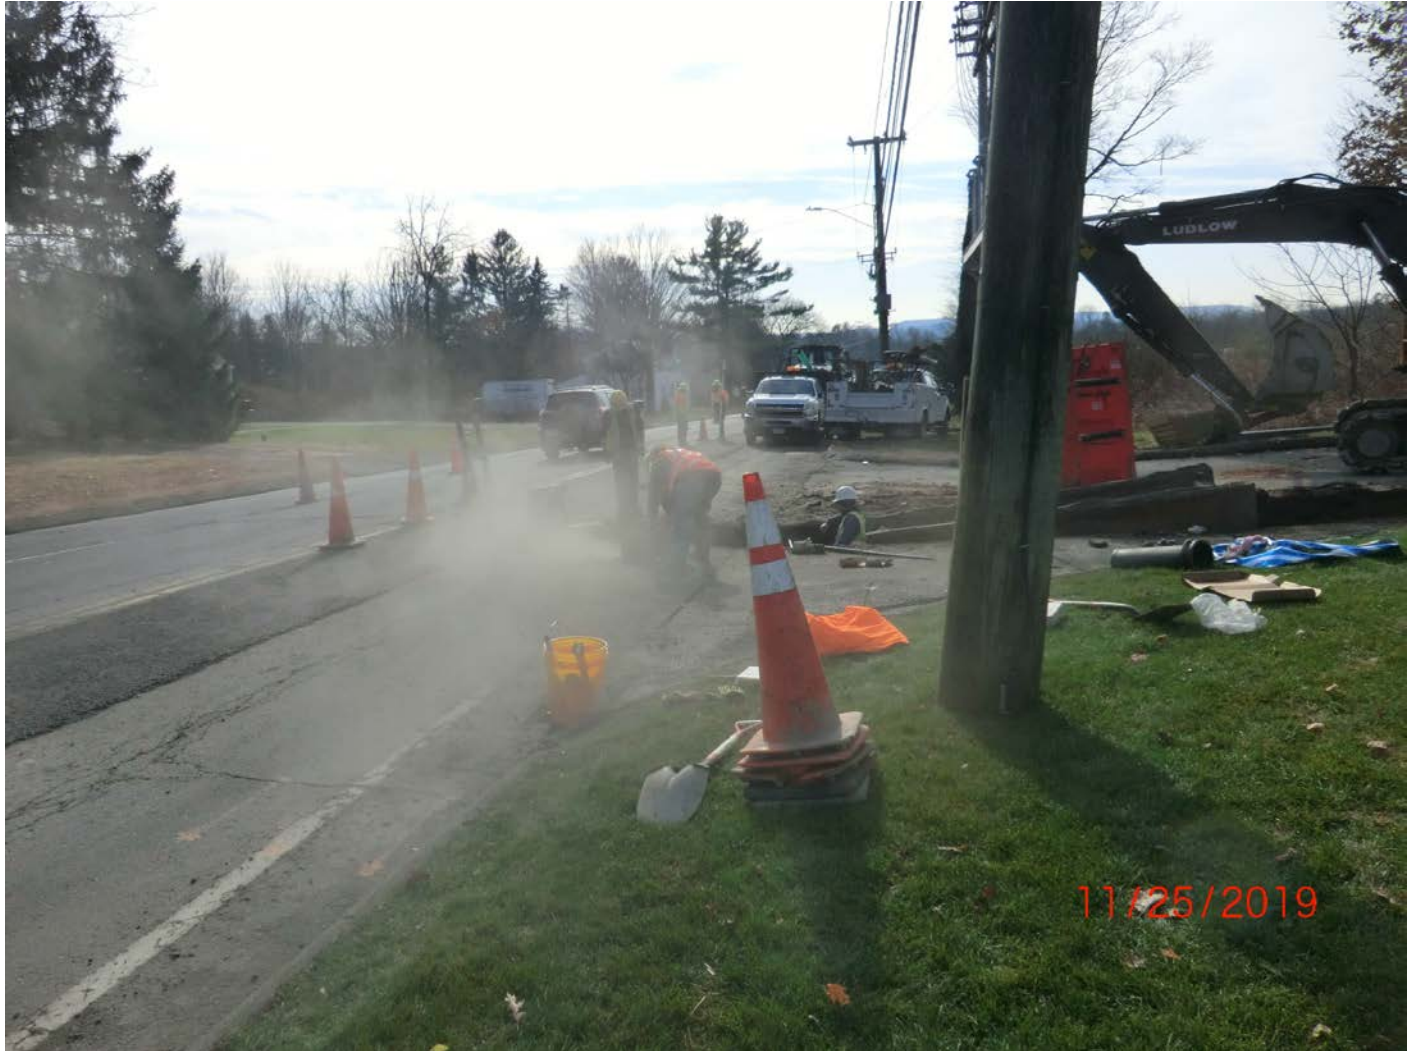
Figure 9 – Facing south on Main St. Cutting a section of road in order to excavate the conduit further to allow for Frontier to access and fix break.

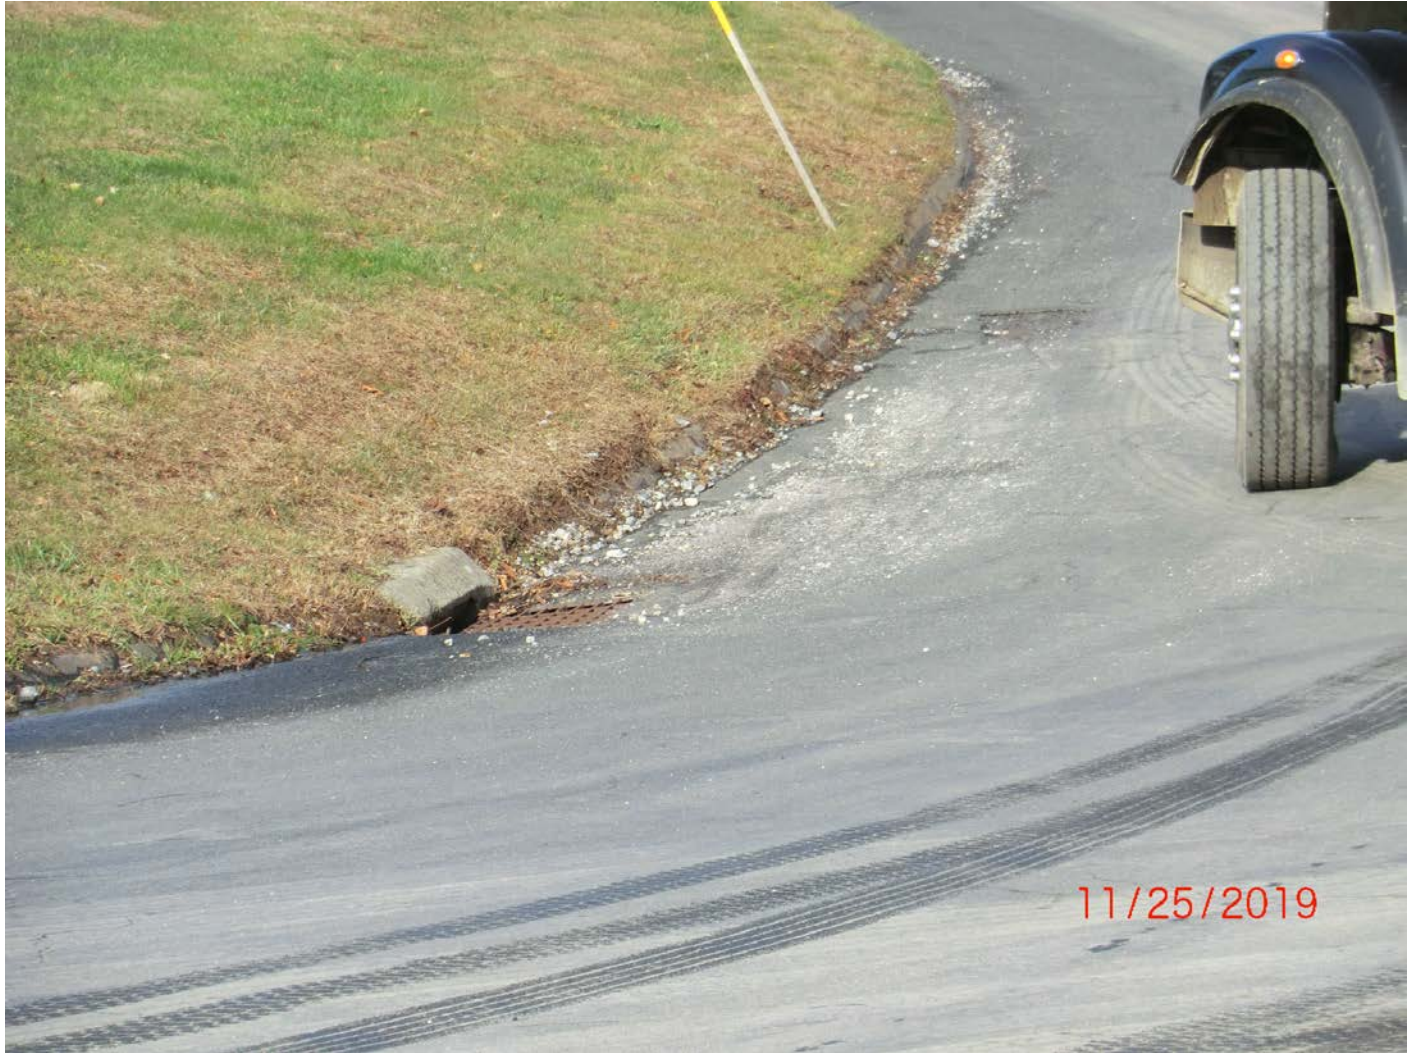
0930 – Took a drive with Kurt (USACE) to inspect the progress on Main Street and to have a look at the haul road and haul site. Gravel was noticed on the road outside the haul site, around work areas (more than would be expected), and along the upper reaches of Talcott Ridge. Kurt made mention of this to Jerry (Ludlow), asked that they address some of the stray gravel during clean up today.

Figure 10 – Gravel collecting on road out side of haul site entrance.

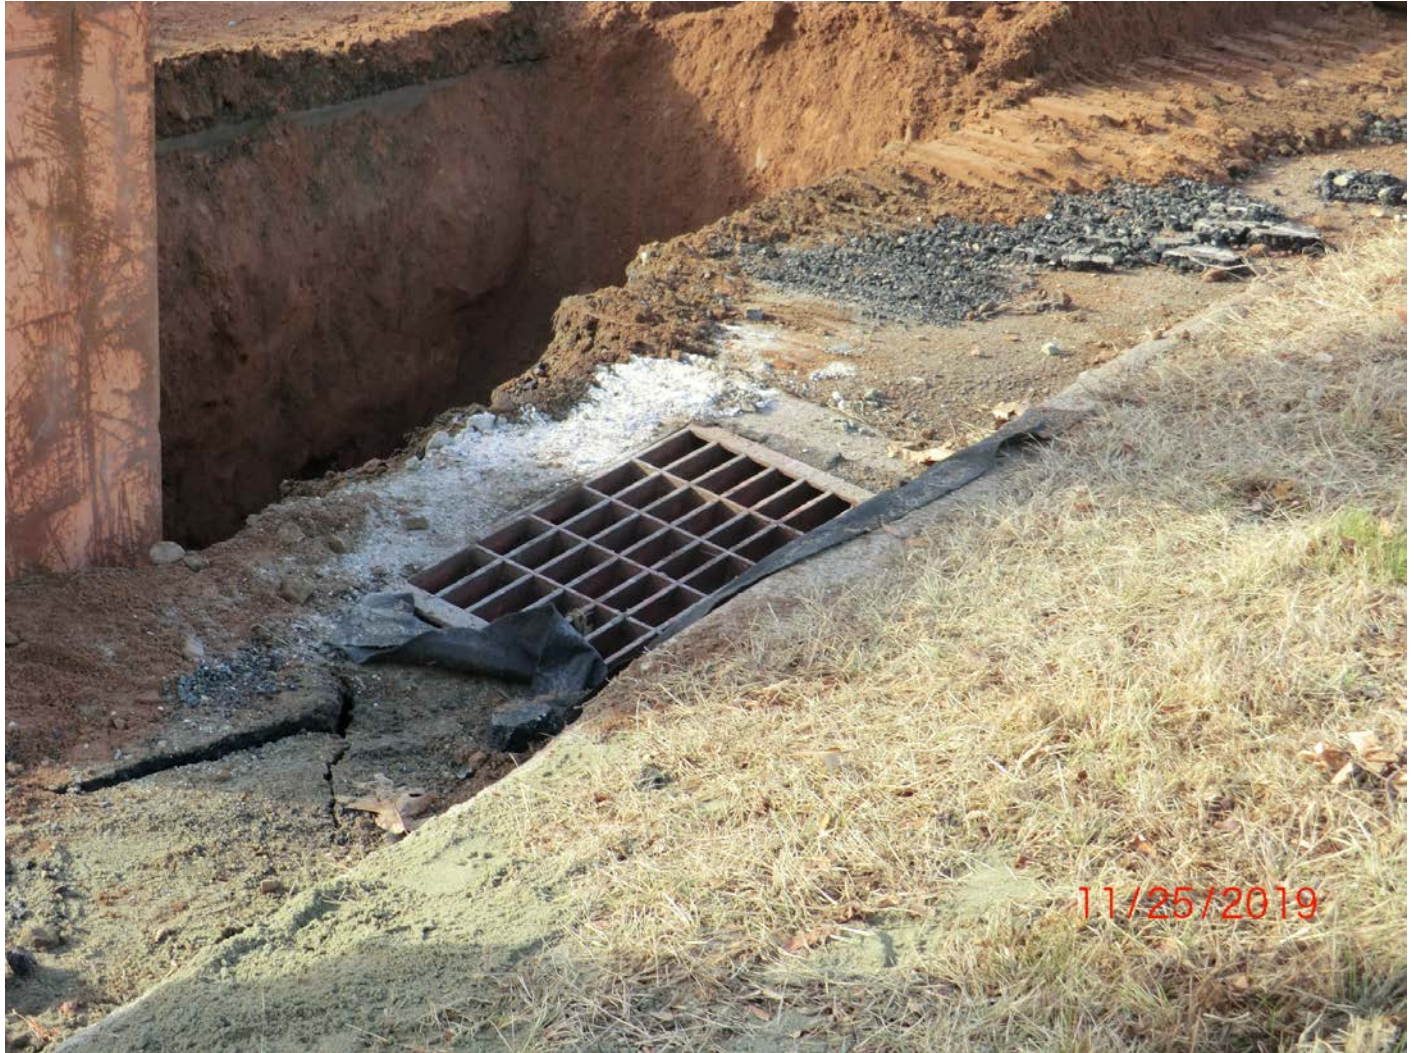
Figure 11 – Close cutting to catch basin on Talcott Ridge. Asphalt around basin broken entirely during removal of trench box. Will need repair during permanent pavement repair.

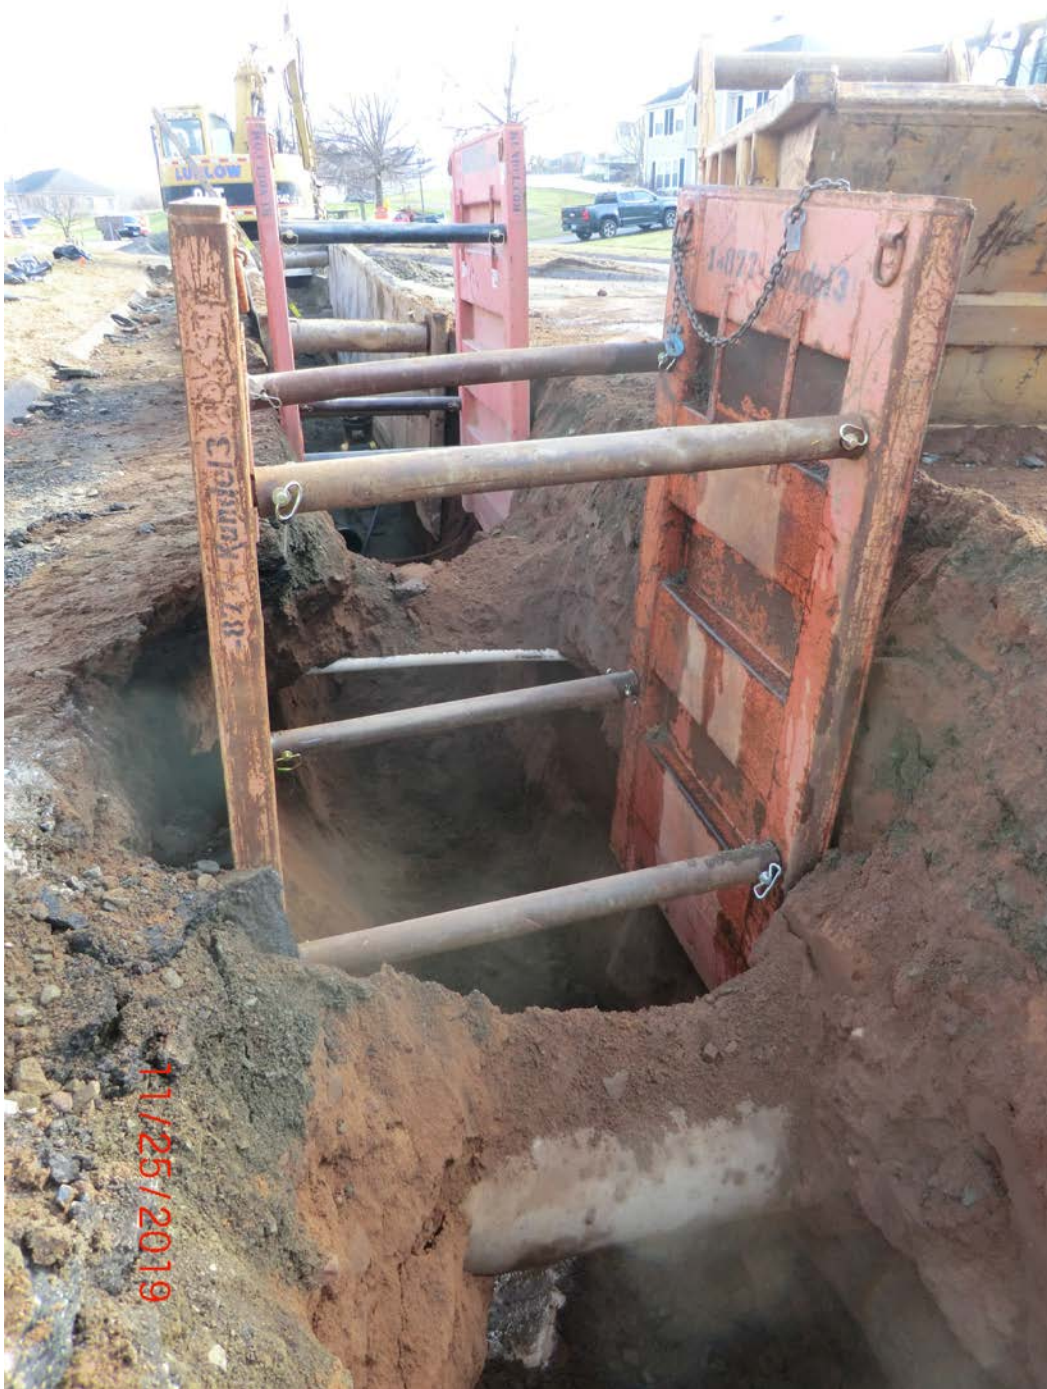
Stations & Pipe Connections: Began at 755+14 and Ended at 753+14. Installed 200 feet of 8" DI pipe with restrained connections. "Straight" shot with slight deflections to follow curve of road. Crossed under one telephone conduit and one drain pipe. Pipe depth 6 feet but dipping to 7 feet to get under piping on Main Street.

Figure 12 – Only utilities crossed on Talcott Ridge today. Electrical conduit in background, drain pipe in foreground. Facing east.
