Daily Report

Project:	Durham Meadows Pipeline Installation	Date:	April 14, 2020
Location:	Packinghouse Hill Road, Water tank, Durham & Middletown, CT	Day of Week:	Tuesday
Project #:	AECOM: 6061487	Report No:	57
Contractor:	Ludlow Construction	Page:	1 of 13

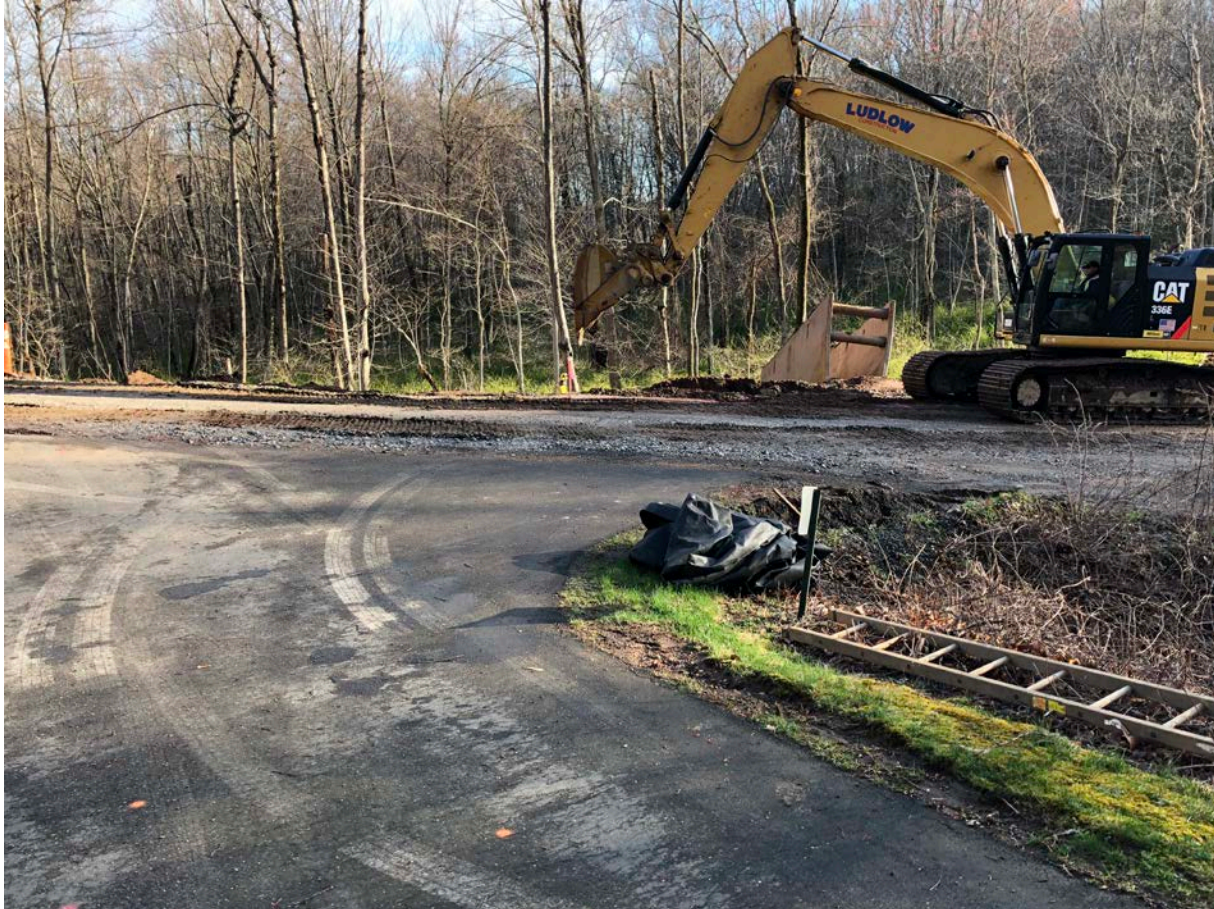
0740: One of the Ludlow crews is daylighting the end of 20" DIP previously placed on the tank access road in order to continue placing 20" DIP. The crew is located across from the Barone's driveway (224 Talcott Ridge Drive) at approximately Station 15+15.

Picture 1: Ludlow begins excavation activities at approximately Station 15+15. View to the northwest.

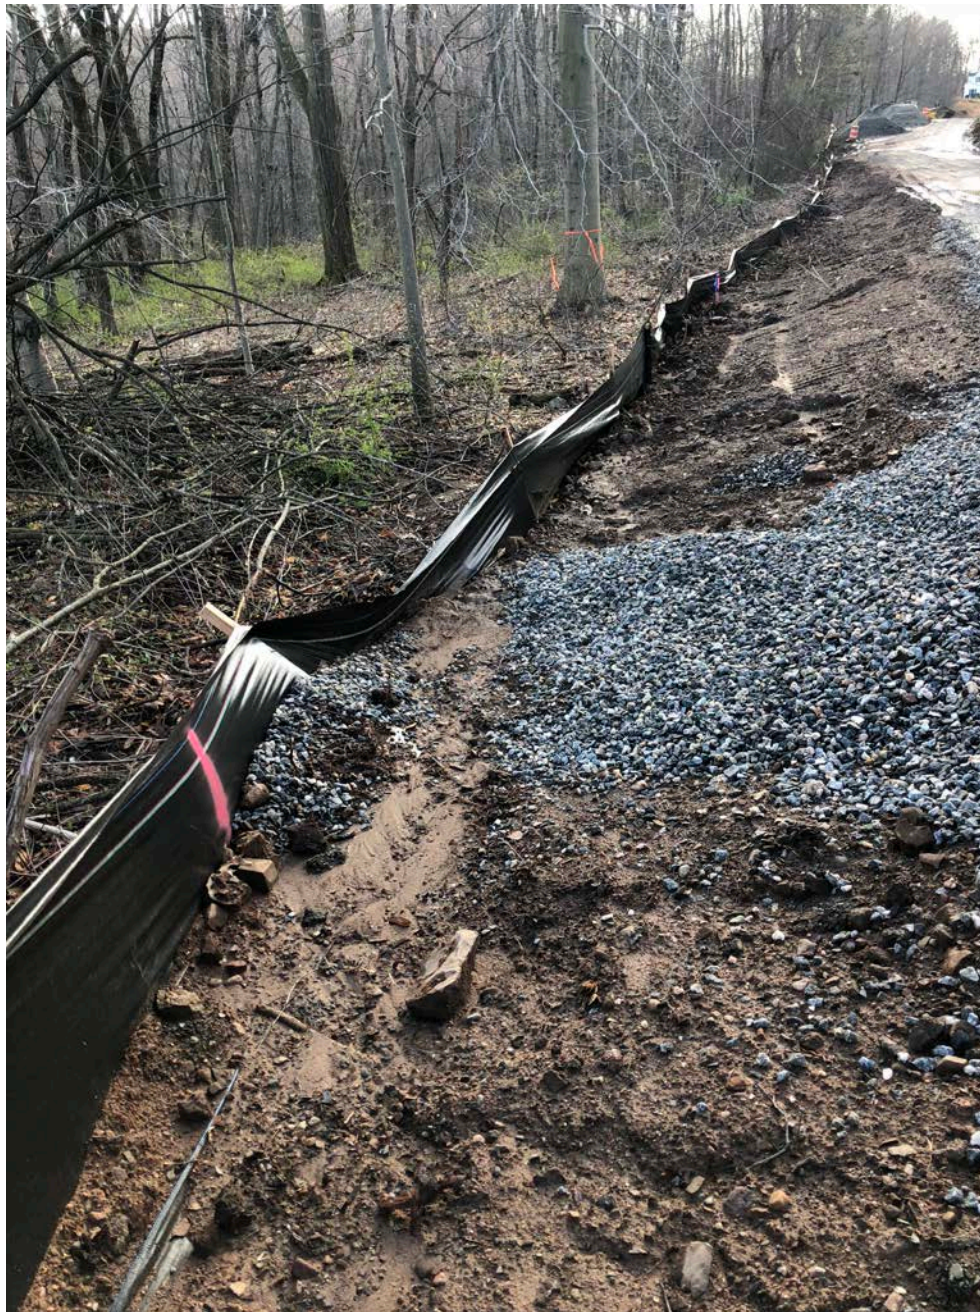
Picture 2: Silt collected on the up-slope side of silt fence that runs along the tank access road. View to the south/southeast.

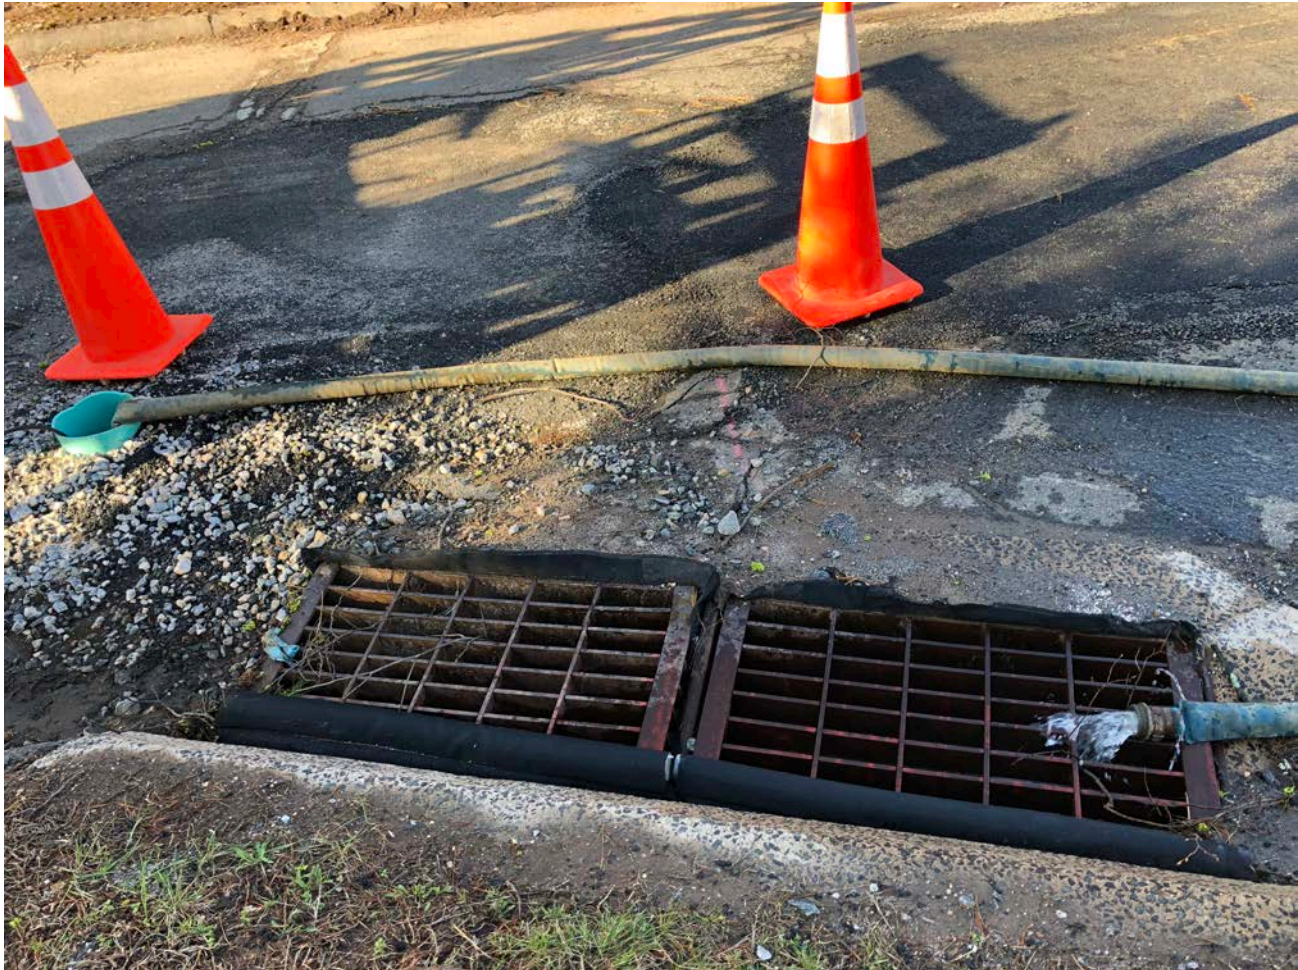
Picture 3: Temporary dewatering well is observed at the northern corner of the intersection of Talcott Ridge Drive and Main Street.

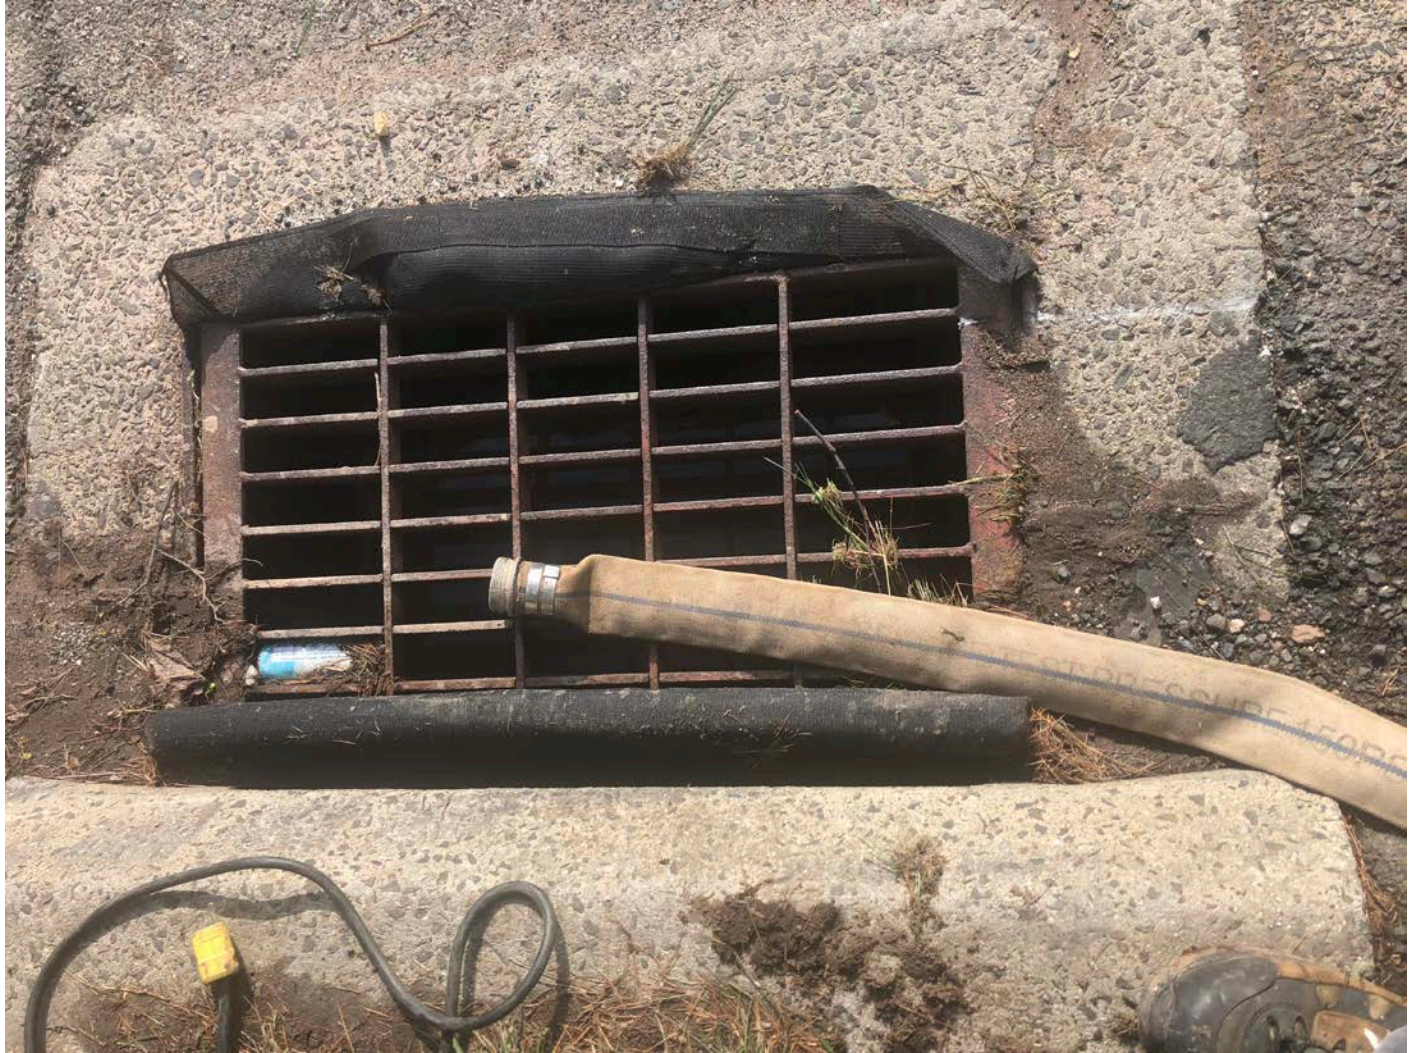
Street. They've daylighted an 8" 90° elbow attached to an 8" line coming west down Talcott Ridge Drive and into Main Street. This elbow appears to be located at Station 751+55. 8" DIP will be placed from Station 751+55 to Station 750+59. A small amount of water is observed at the bottom of the trench approximately 7' below surface grade. A temporary dewatering well is observed at the northern corner of the intersection of Talcott Ridge Drive and Main Street. Ludlow has a pump moving water out of this well and into an adjoining catch basin. All catch basins near the intersection have had silt socks installed in them.

Picture 4: Catch basin with silt sock located south of excavation activities being performed at Station 751+55.

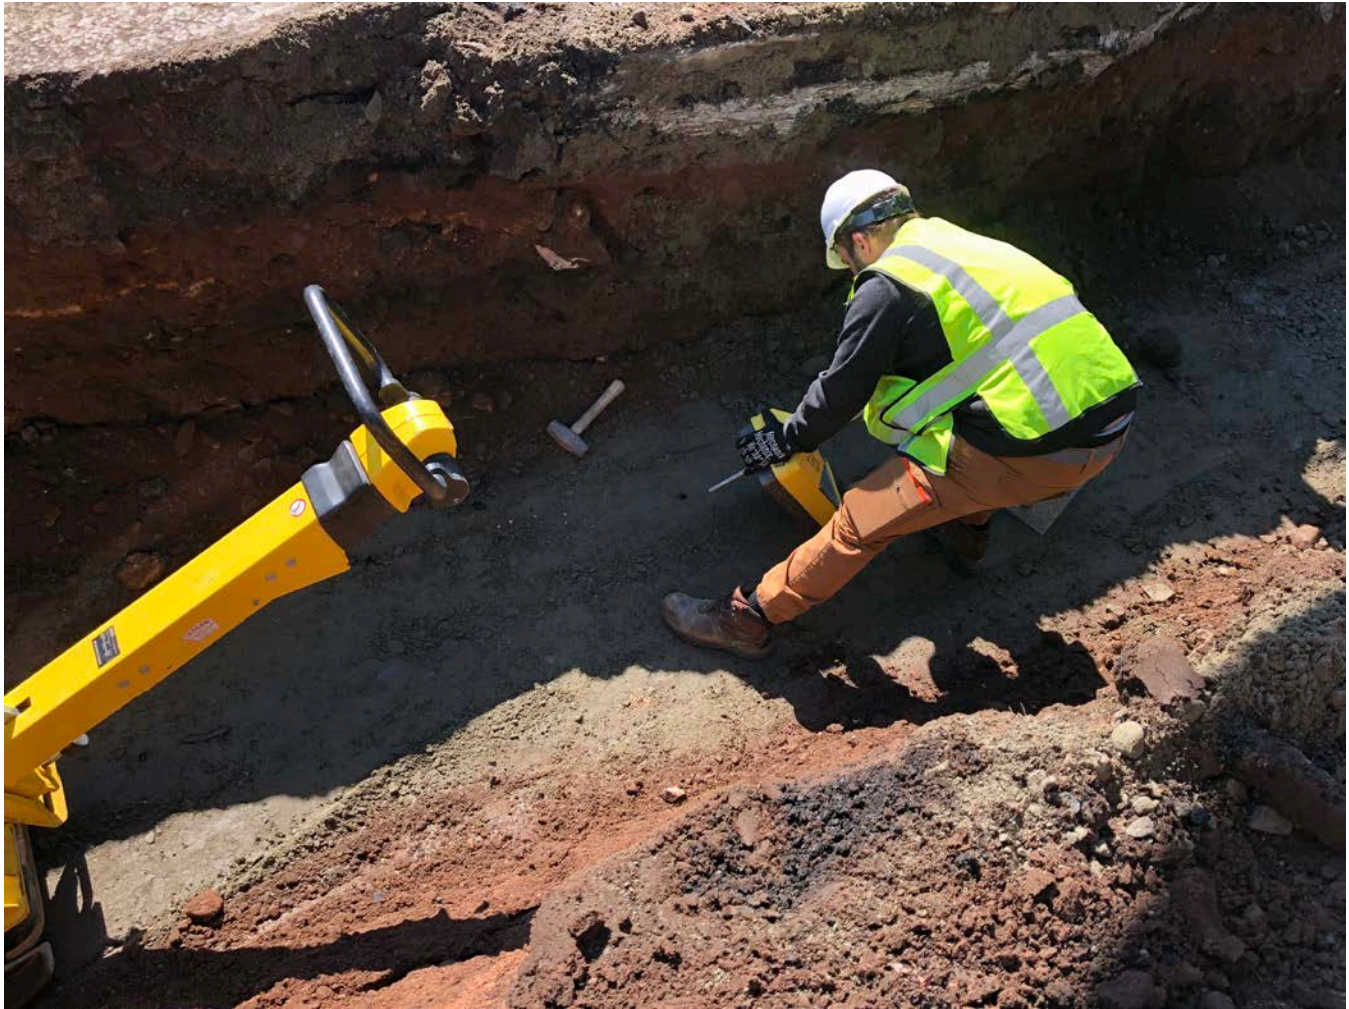
00915: JTC performing compaction tests today. Near Station 751+55, JTC reports a dry density of 95.9%. Compaction test taken off of compacted 3"-minus gravel.

0955: JTC collects second compaction test from the top of 3" minus gravel (second lift) – a result of 95.9% was reported.

Picture 5: Compaction testing being performed at Station 751+55.

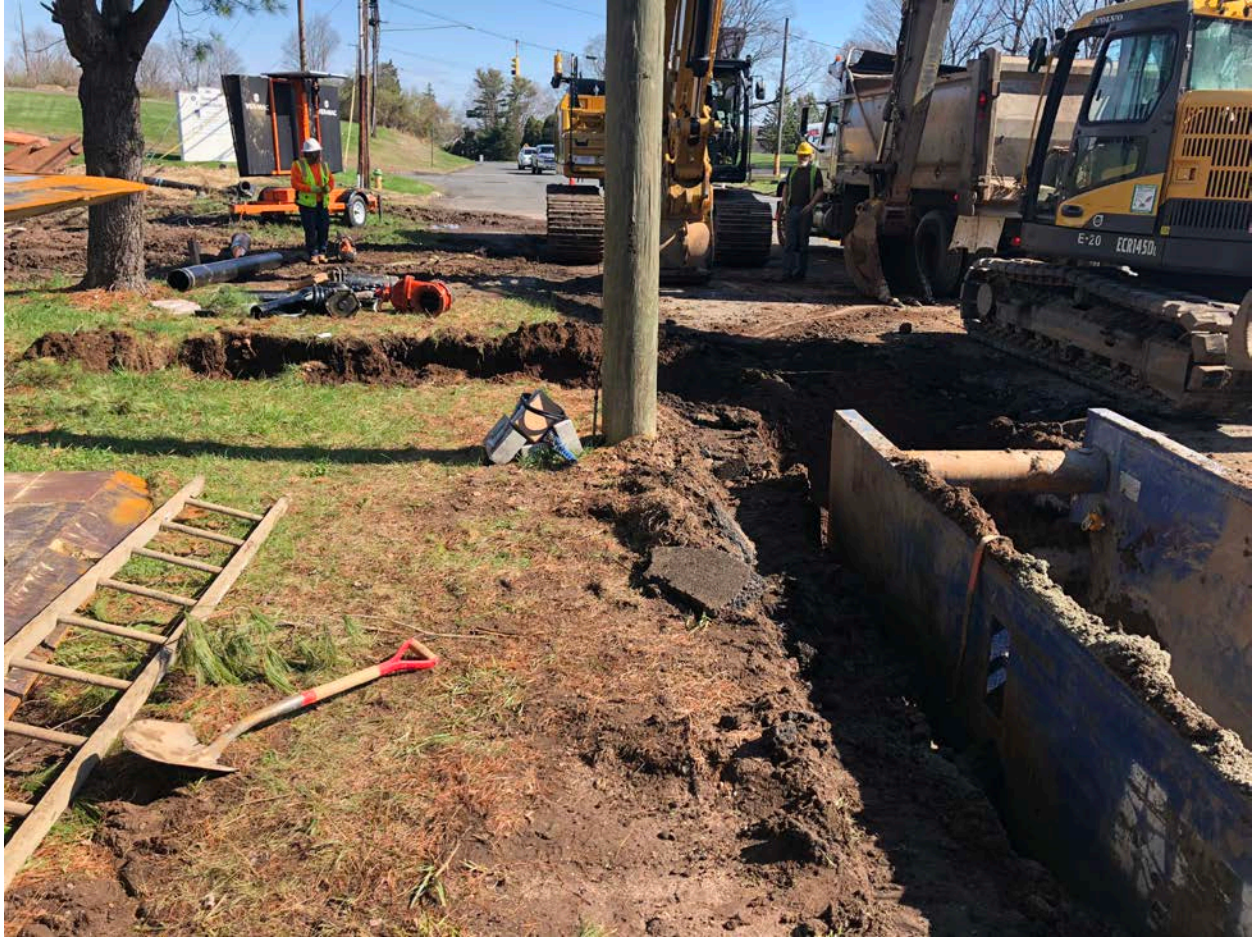
1201: Ludlow has placed a ~10' section of 8" DIP coming off of the Tee/gate valve at Station 750+59, heading west towards the future Booster Pump Station. Note: the Tee (8" x 8" x 8") was stubbed off with an M.J. cap at the northern end of the T fitting.

Picture 6: View of pipe installation activities at Station 750+59.

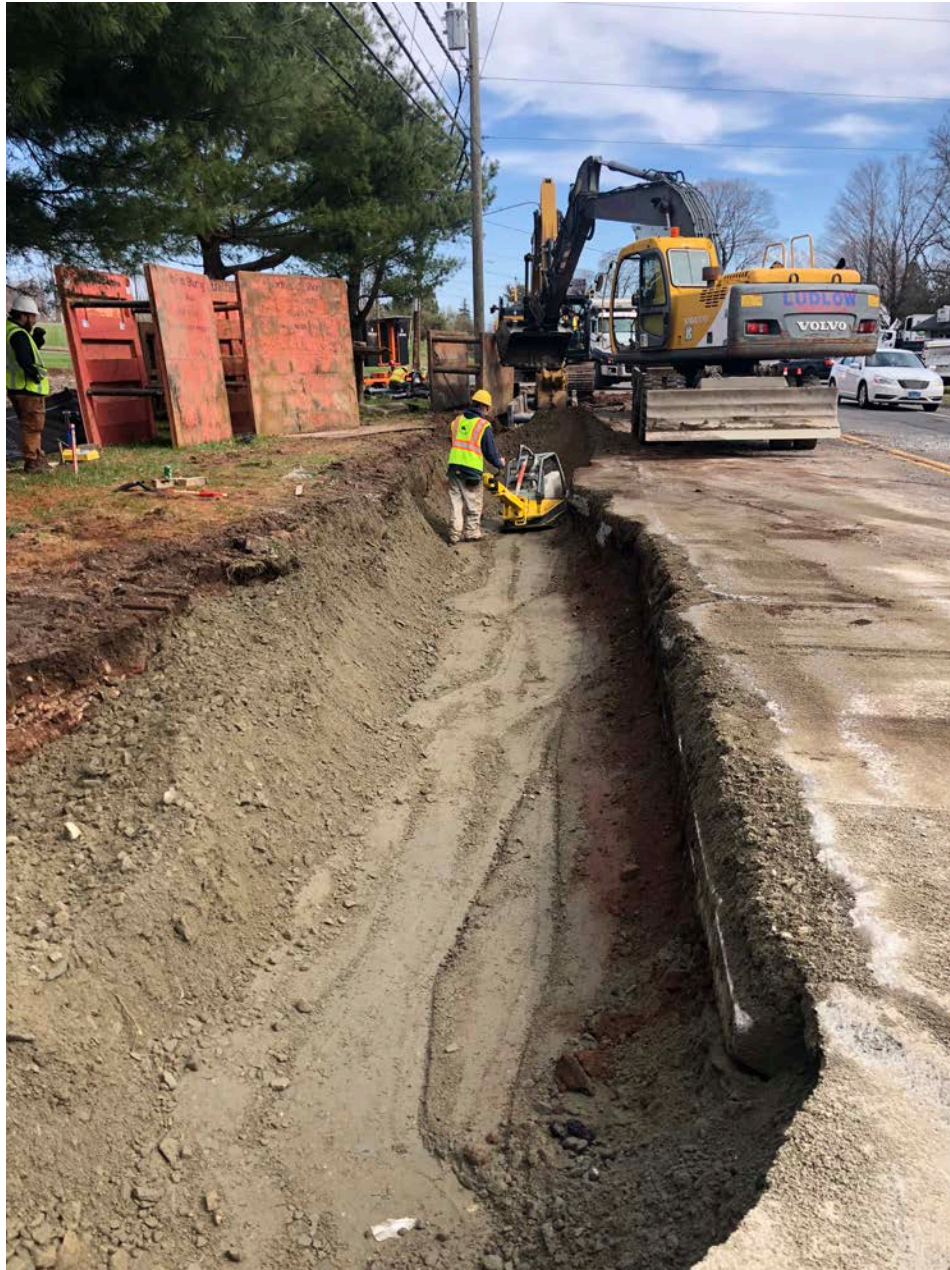
0925: Ludlow currently compacting fill over a second piece of 8" DIP placed under the southbound lane of Main Street.

Picture 7: Ludlow compacting fill between Station 751+55 and Station 750+59. View to the north.

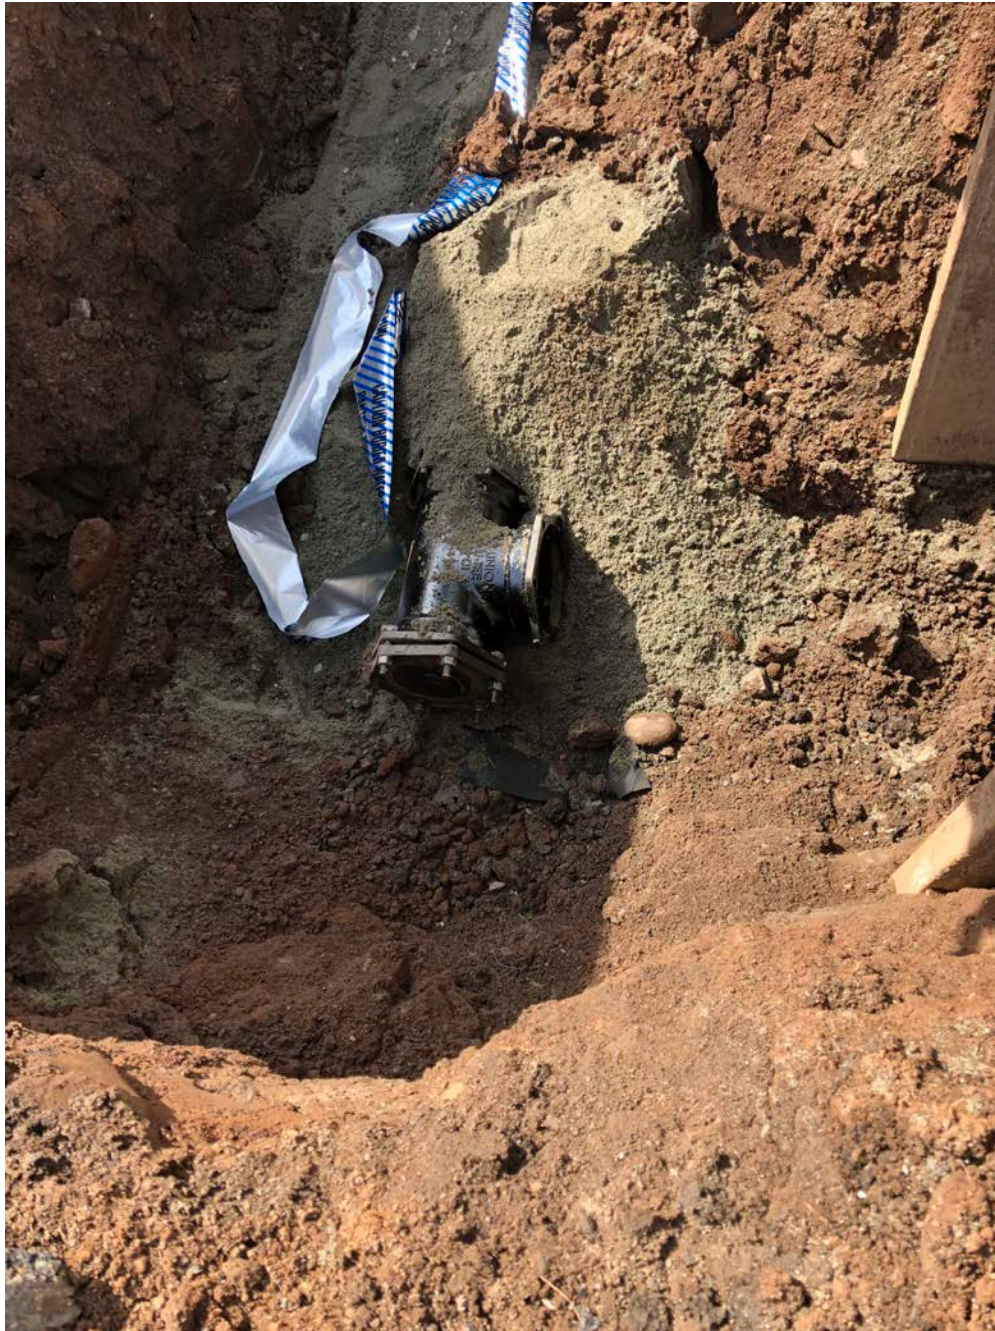
Picture 8: Tee fitting stubbed off with an M.J. cap at 750+59. View to the south.

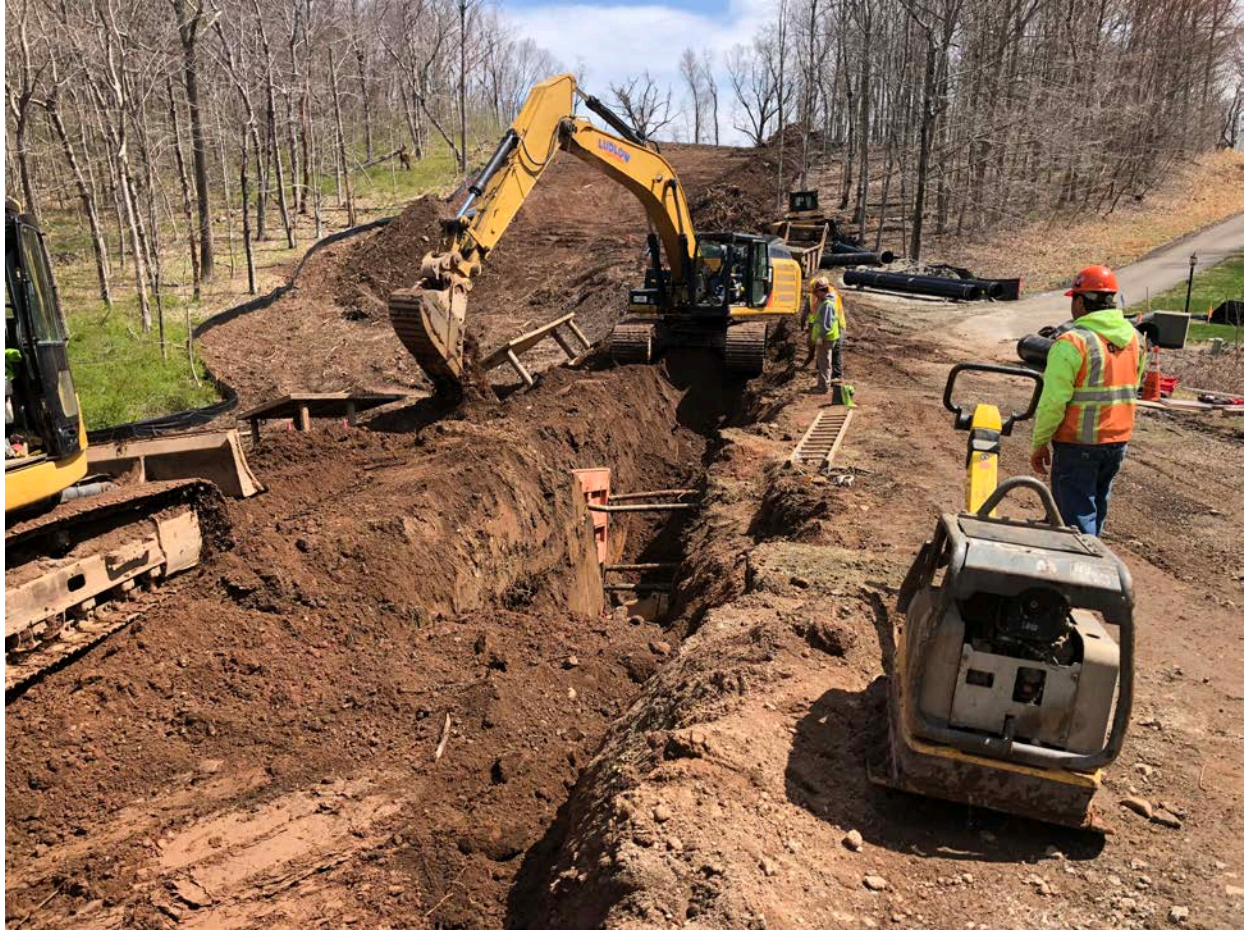
1224: Ludlow continuing to place 20" DIP along the tank access road. Excavation depths were 14'-15' below surface grade in some places. A small amount of water was observed draining into the excavation from previously placed 20" DIP. There wasn't enough water to warrant removal with a pump. A 20" x 6" valve box was placed at Station 14+70 (the bottom of Sheet C3 shows this item was supposed to be placed at 14+69).

Picture 9: Overview of 20" DIP installation on the tank access road. View to the south.

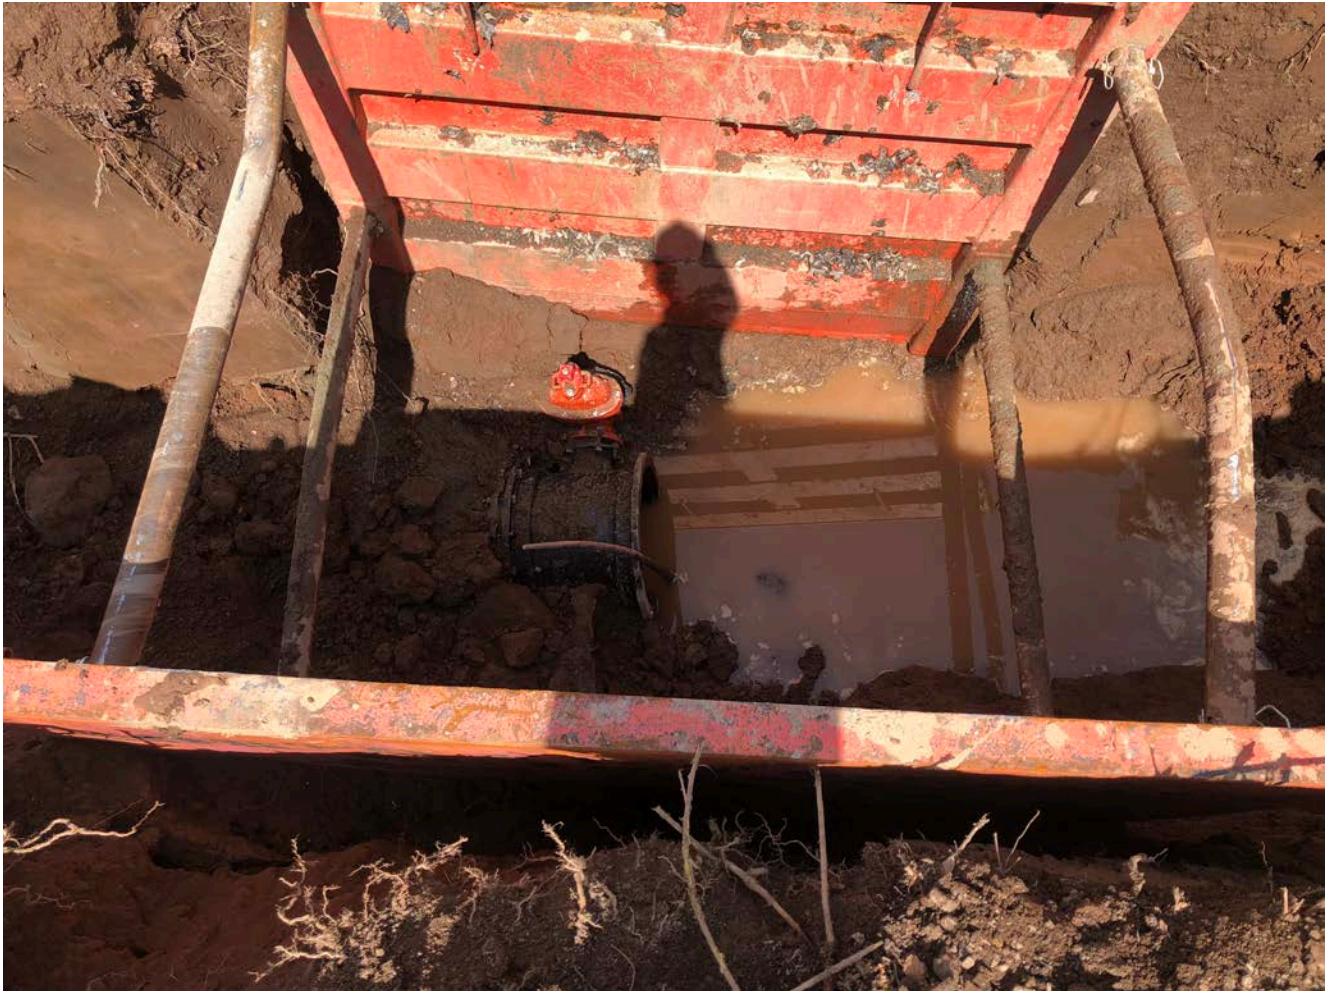
Picture 10: Water observed at bottom of trench today during the installation of 20" DIP.

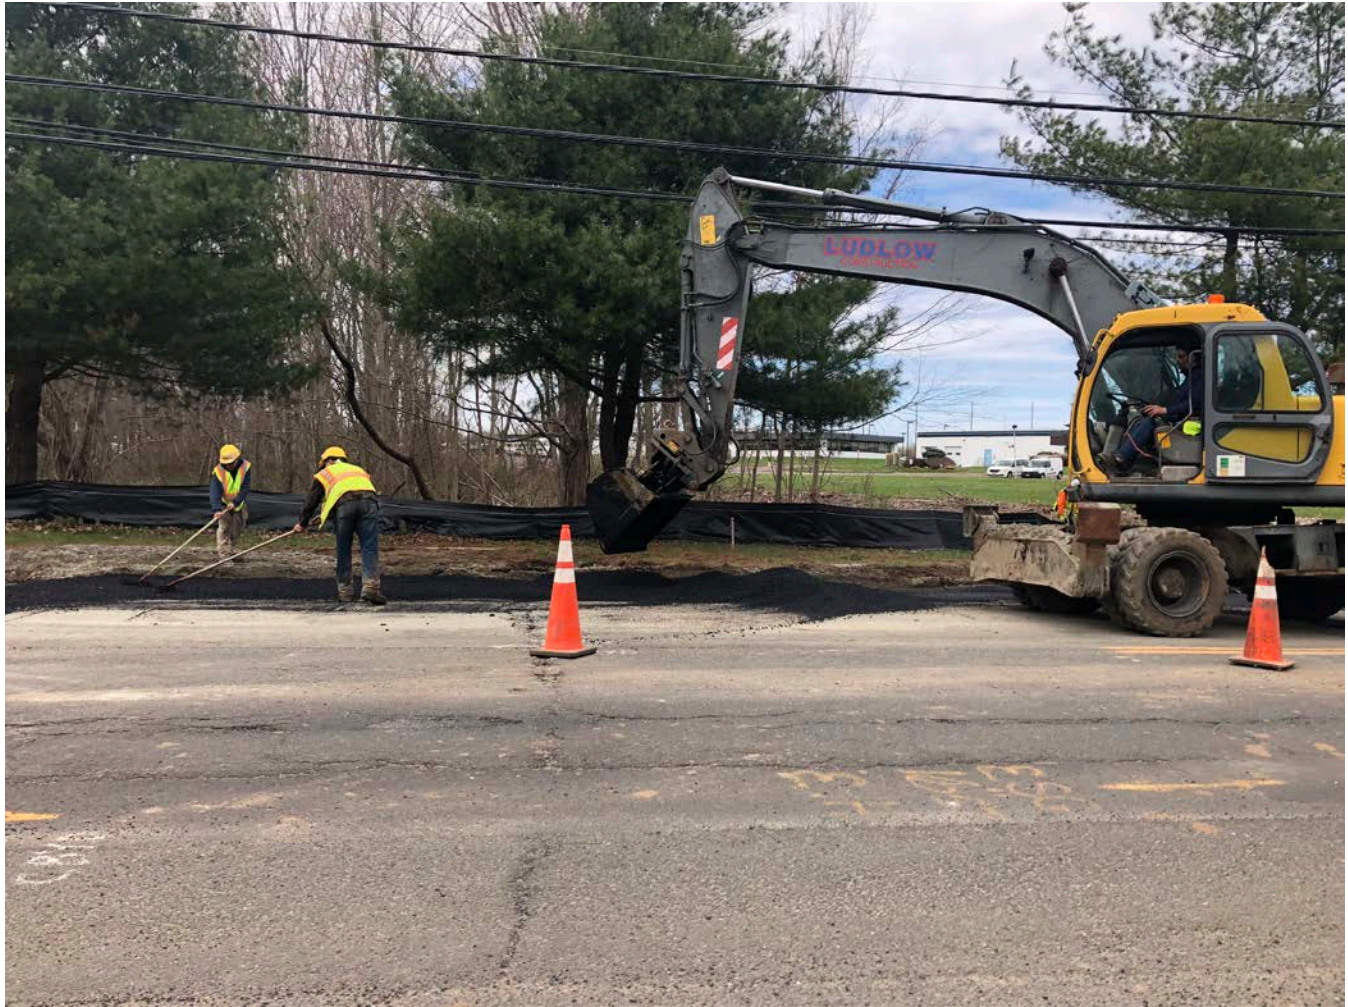
1325: Ludlow continuing to place 20" DIP on the tank access road. The crew on South Main St near Station 750+59 is closing off the trench with hot patch.

Picture 11: Ludlow hot patch between from Station 751+55 to Station 750+59. View to the west.
