Daily Report

Project:	Durham Meadows Pipeline Installation	Date:	April 27, 2020
Location:	Main Street and shared access road, Durham & Middletown, CT	Day of Week:	Monday
Project #:	AECOM: 6061487	Report No:	66
Contractor:	Ludlow Construction	Page:	1 of 13

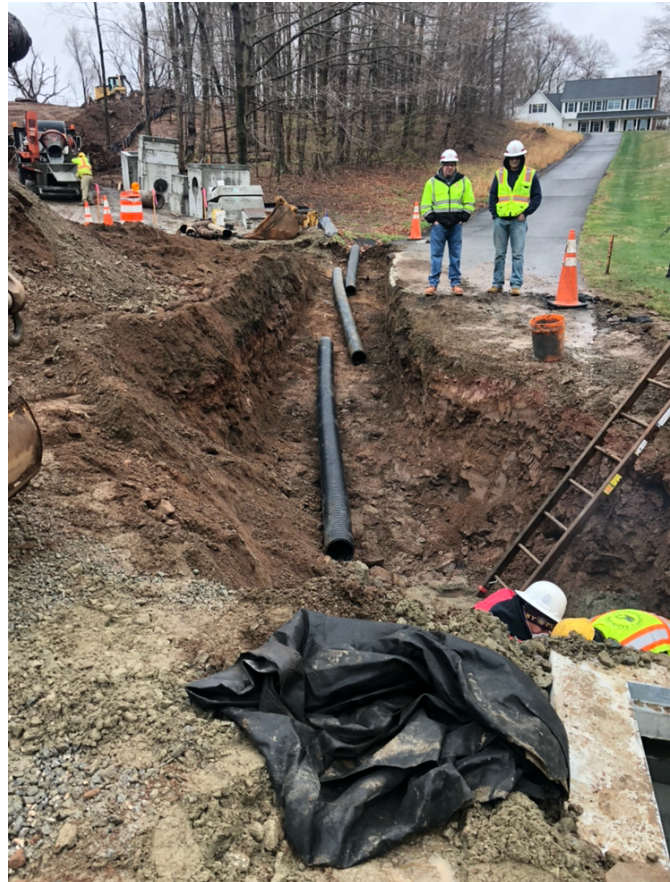
0715: Ludlow preparing to run 8" corrugated black plastic pipe from the east edge of the driveway for 214 Talcott Ridge Drive into the catch basin located at Station 14+40 on the south side of the shared access road. Ludlow indicated that this is a design change.

Picture 1: 8" corrugated black plastic pipe from the east edge of the driveway for 214 Talcott Ridge Drive into the catch basin located at Station 14+40 on the south side of the shared access road. Placement of 8" View to the southeast. Middletown, CT.

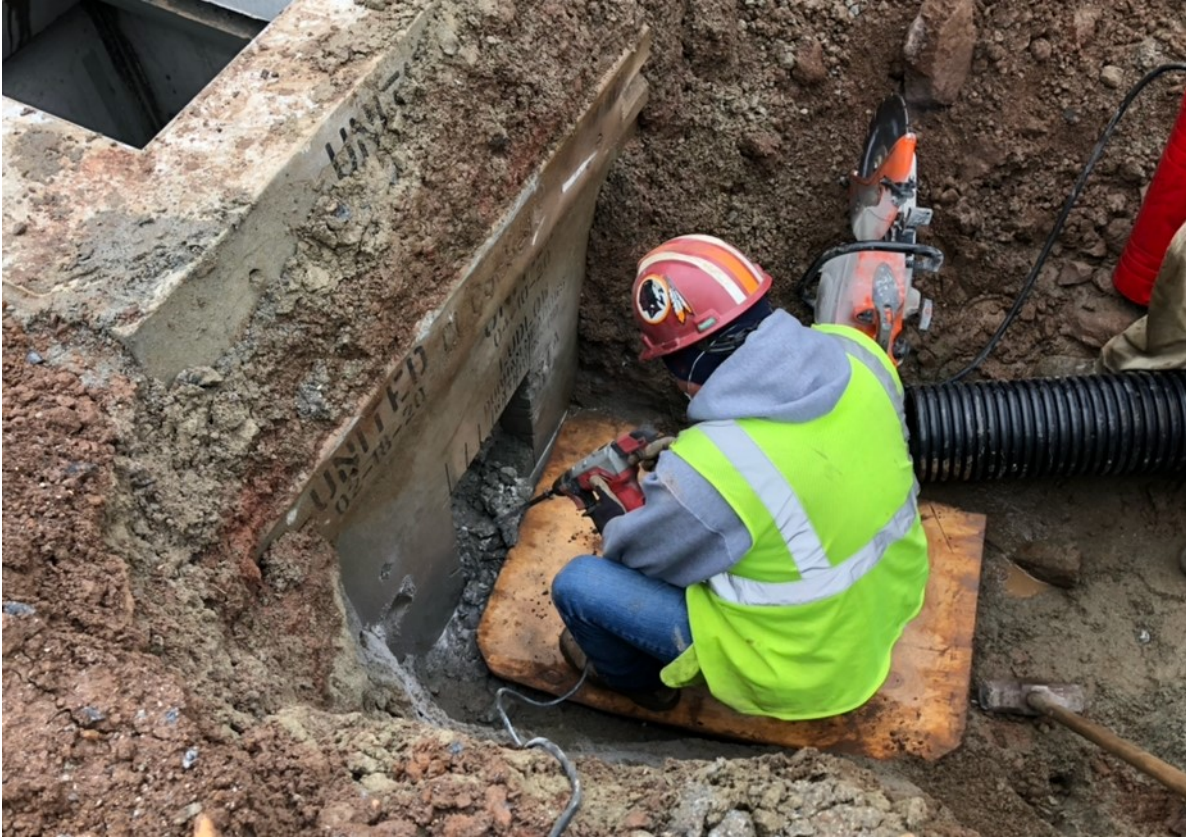
0845: Ludlow has opened a trench from the swale along east side of the driveway at 214 Talcott Ridge Drive into the catch basin located at Station 14+40. They are currently cutting a hole into the side of the catch basin to insert the 8" corrugated black plastic pipe.

Picture 2: Ludlow cutting hole in side of catch basin to receive 8" corrugated black plastic pipe from the east edge of the driveway for 214 Talcott Ridge Drive. Middletown, CT.

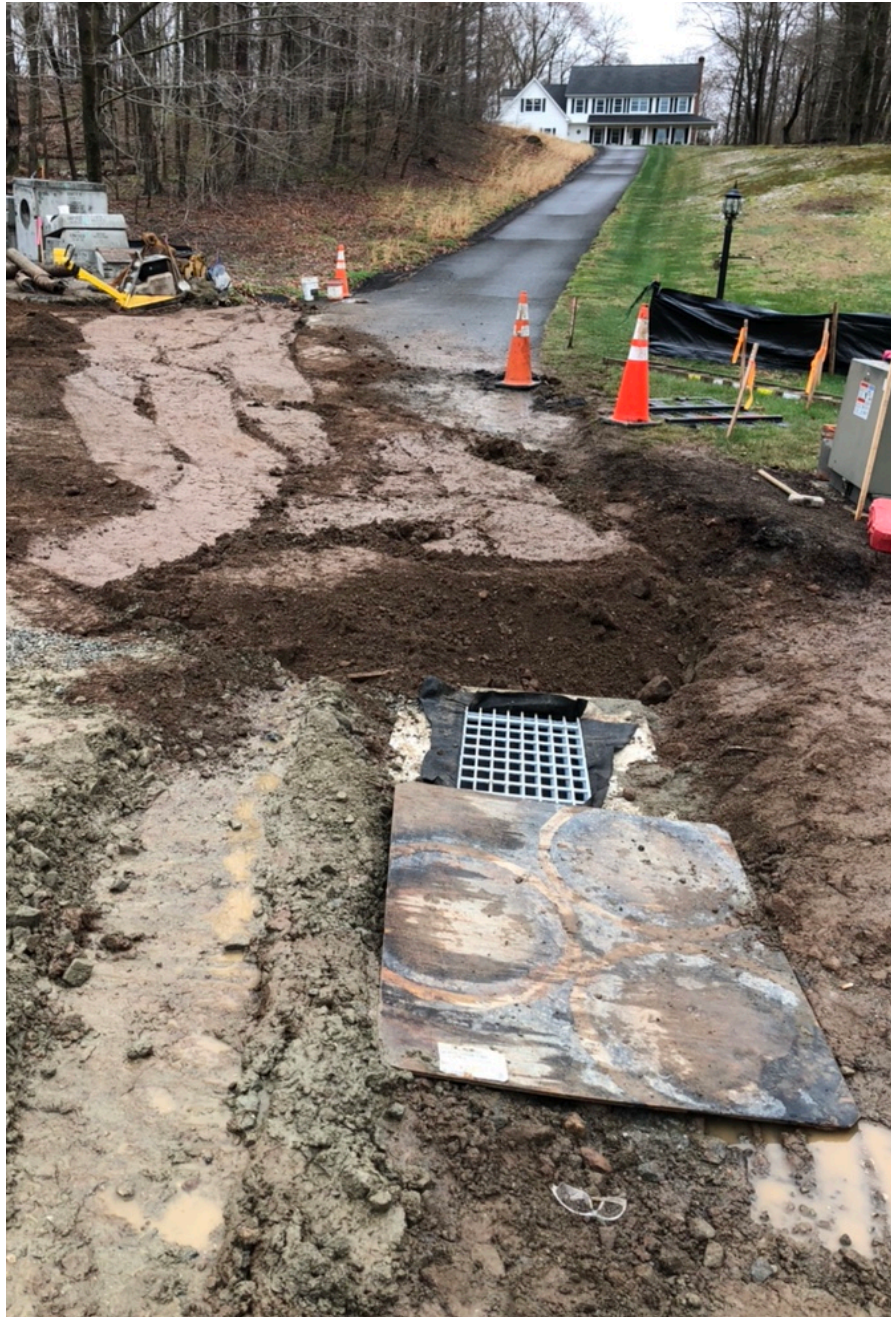
1010: Ludlow has finished the installation of the 8" corrugated black plastic pipe. The pipe was secured in place on the catch basin with bricks and mortar. Ludlow is currently hand digging across the shared access road adjacent to the driveway for 224 Talcott Ridge Drive to locate the power and communication lines that run down the road. Ludlow saw-cut the asphalt apron of the driveway where trenching activities are required to install a 1" curb stop.

Picture 3: Trench closed up after installation of 8" corrugated black plastic pipe from the east edge of the driveway for 214 Talcott Ridge Drive into the catch basin located at Station 14+40. View to the southeast. Middletown, CT.

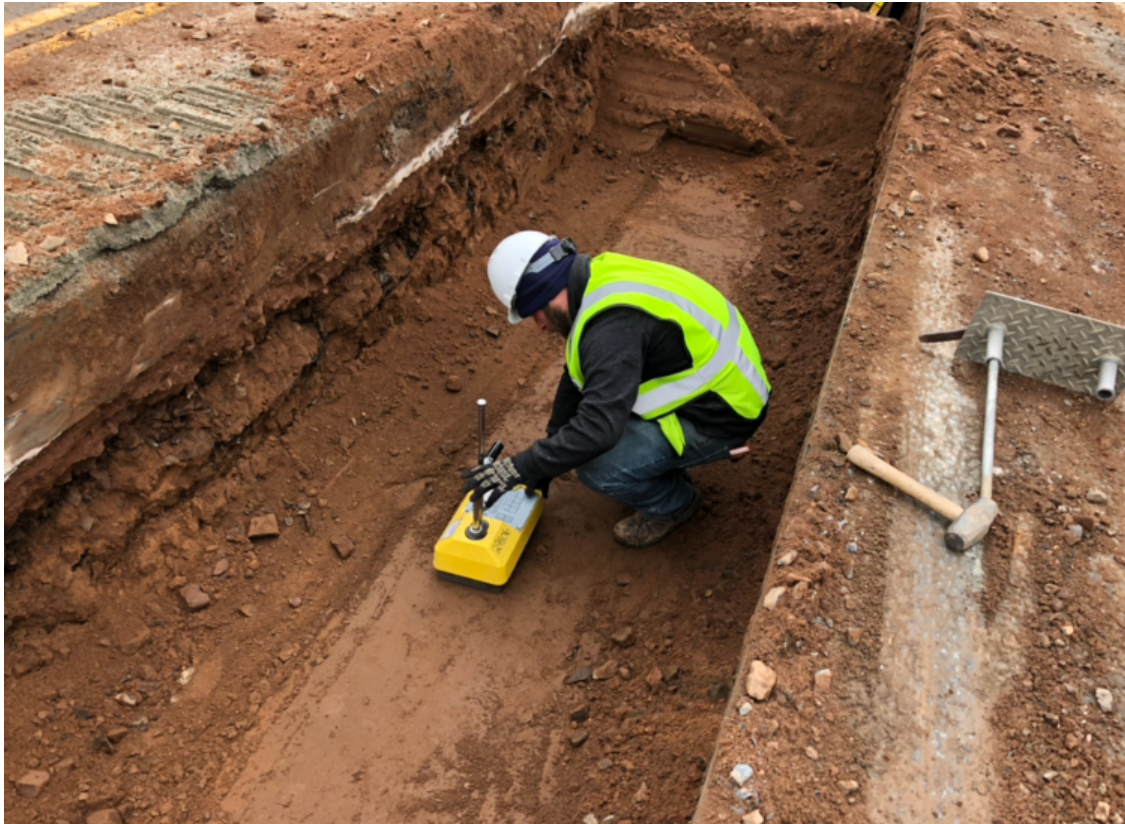
0931: Ludlow has installed a second corporation stop at Station 168+02.5. JTC is present and is performing compaction tests on the first lift of compacted of -3" gravel.

Picture 4: JTC performing soil compaction test at ~Station 168+00. View to the south. Durham, CT.

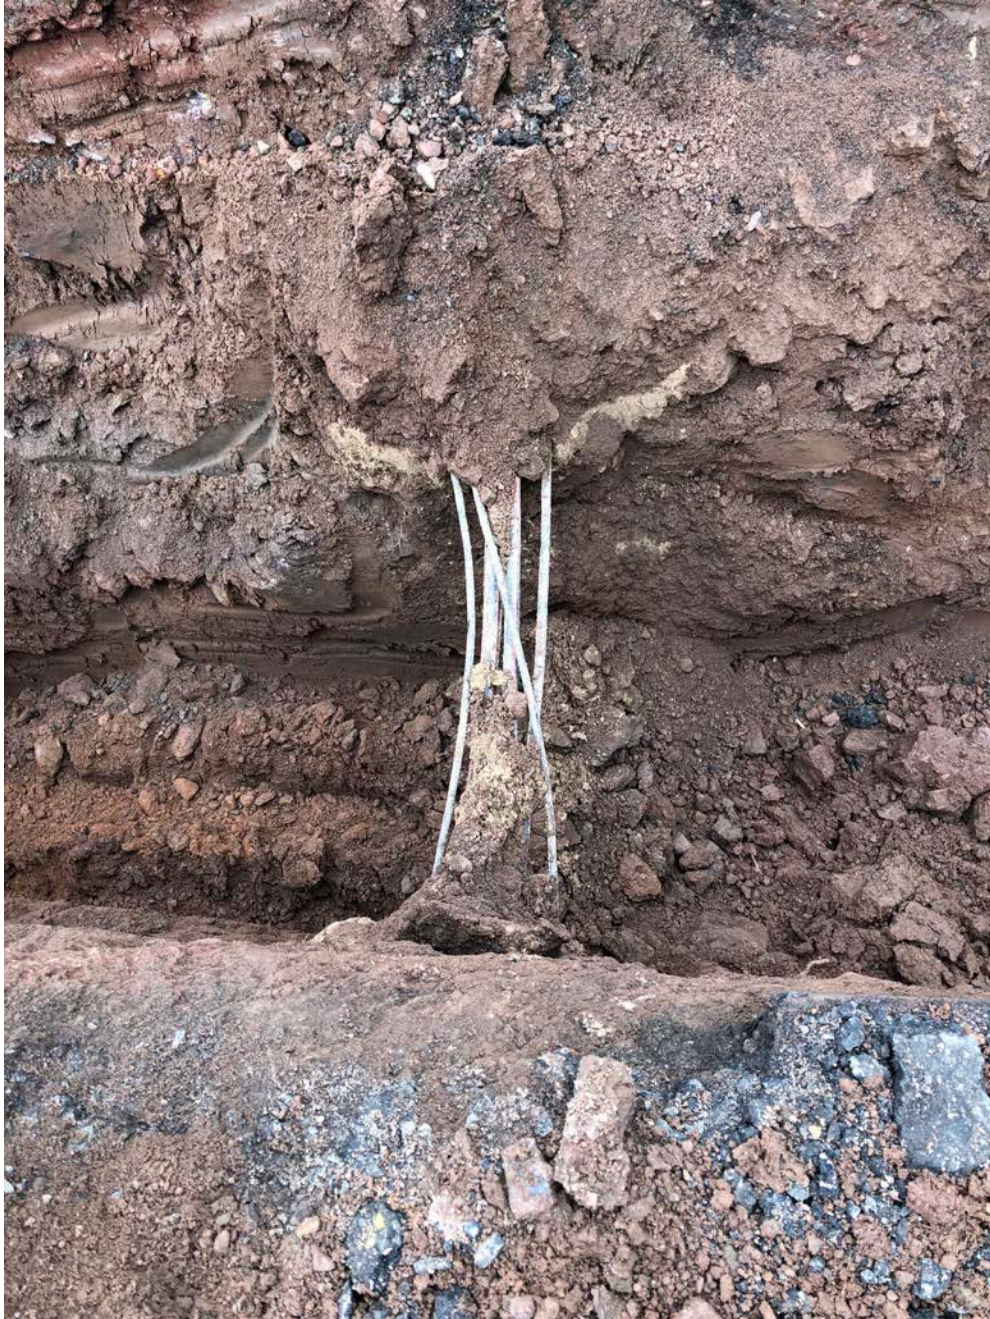
Picture 5: Communication and power lines daylighted by Ludlow adjacent to the driveway for 224 Talcott Ridge Drive. Middletown, CT.

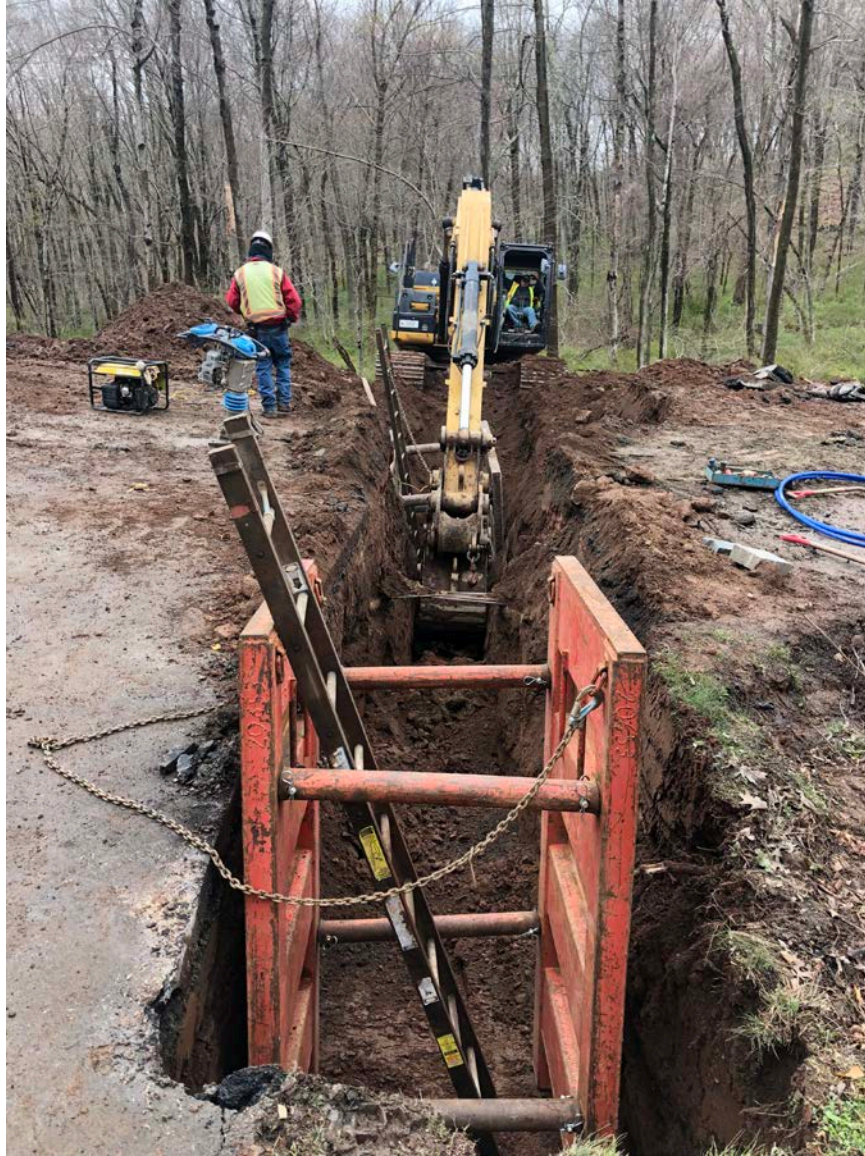
1200: Ludlow continues to work at the intersection of the shared access road and the driveway for 224 Talcott Ridge Drive. The trench has been extended north in order to locate the 20" water line and tap into it to add the 1" curb stop. Ludlow is currently in

Picture 6: Ludlow trenching across the shared access road adjacent to the driveway for 224 Talcott Ridge Drive in order to tap the 20" water line to add a corporation stop. View to the north. Middletown, CT.

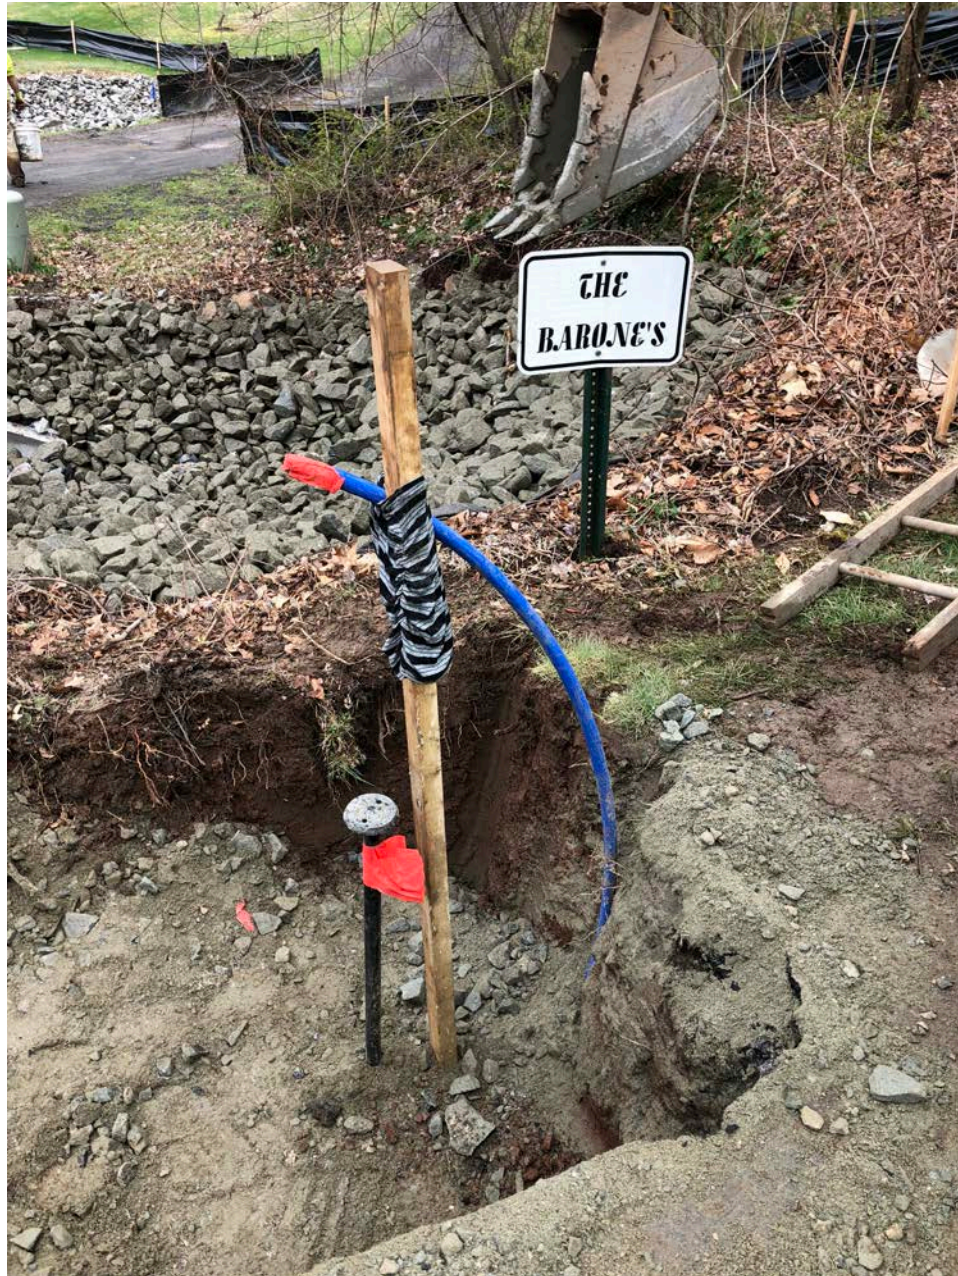
1330: Ludlow has finished installing the 1" curb stop for 224 Talcott Ridge Drive. The curb stop was finished with a valve stem and valve box. Ludlow is currently placing riprap in the plunge pool located between 224 and 216 Talcott Ridge Drive.

Picture 7: Valve stem associated with the curb stop installed for 224 Talcott Ridge Drive. View to the southeast. Middletown, CT.

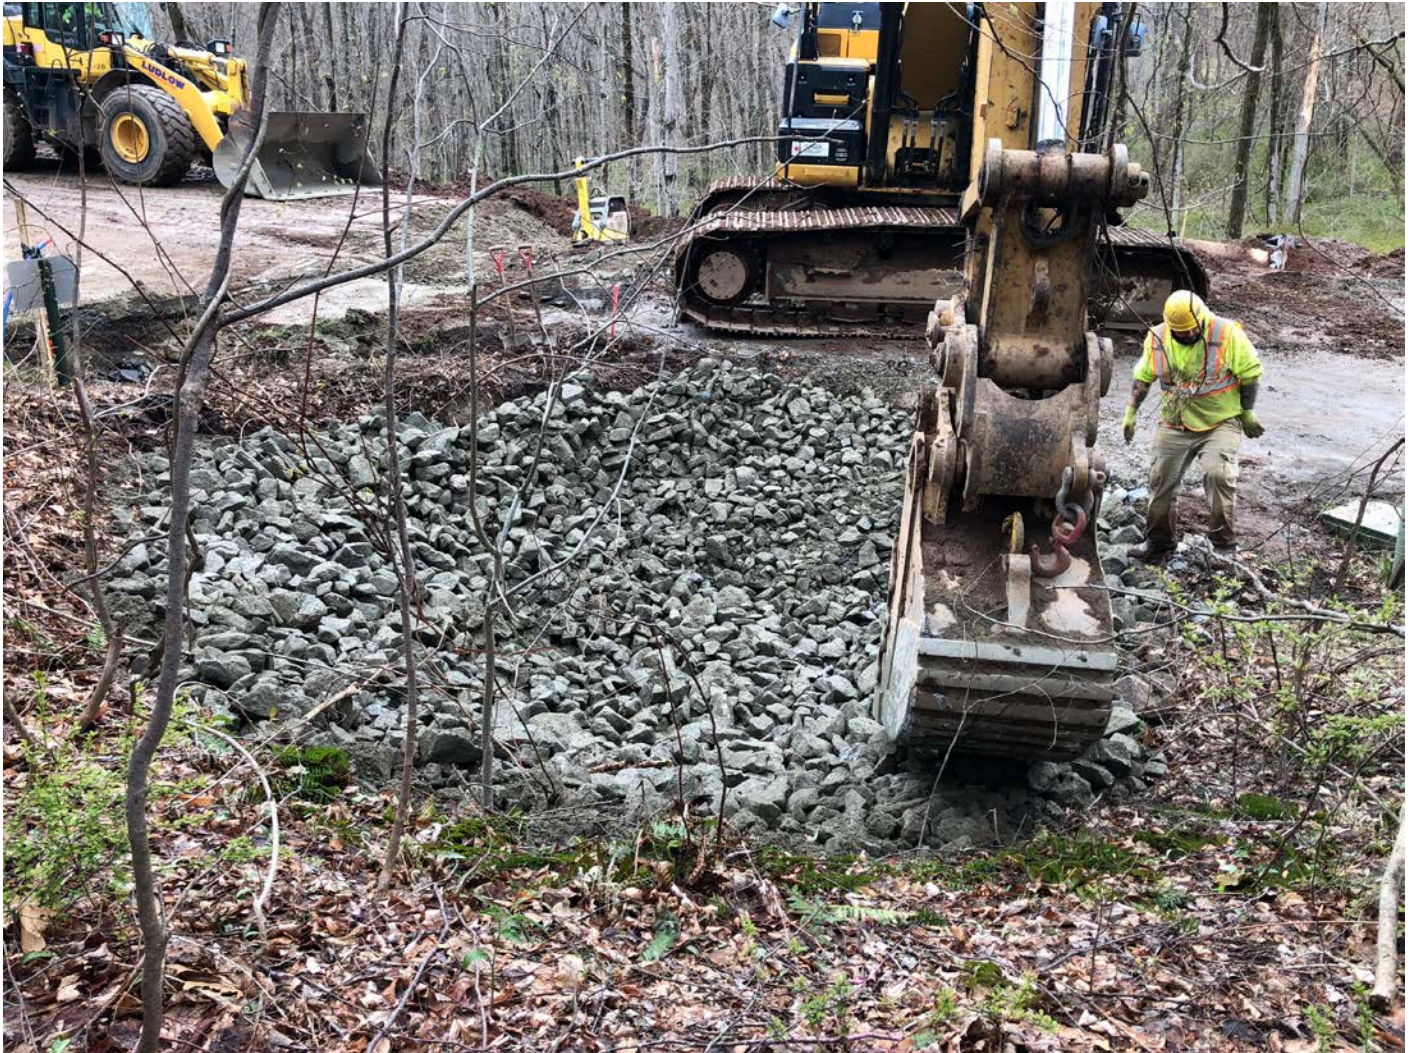
Picture 8: Ludlow placing riprap in the plunge bowl located between the driveways for 224 and 216 Talcott Ridge Drive. View to the north. Middletown, CT.

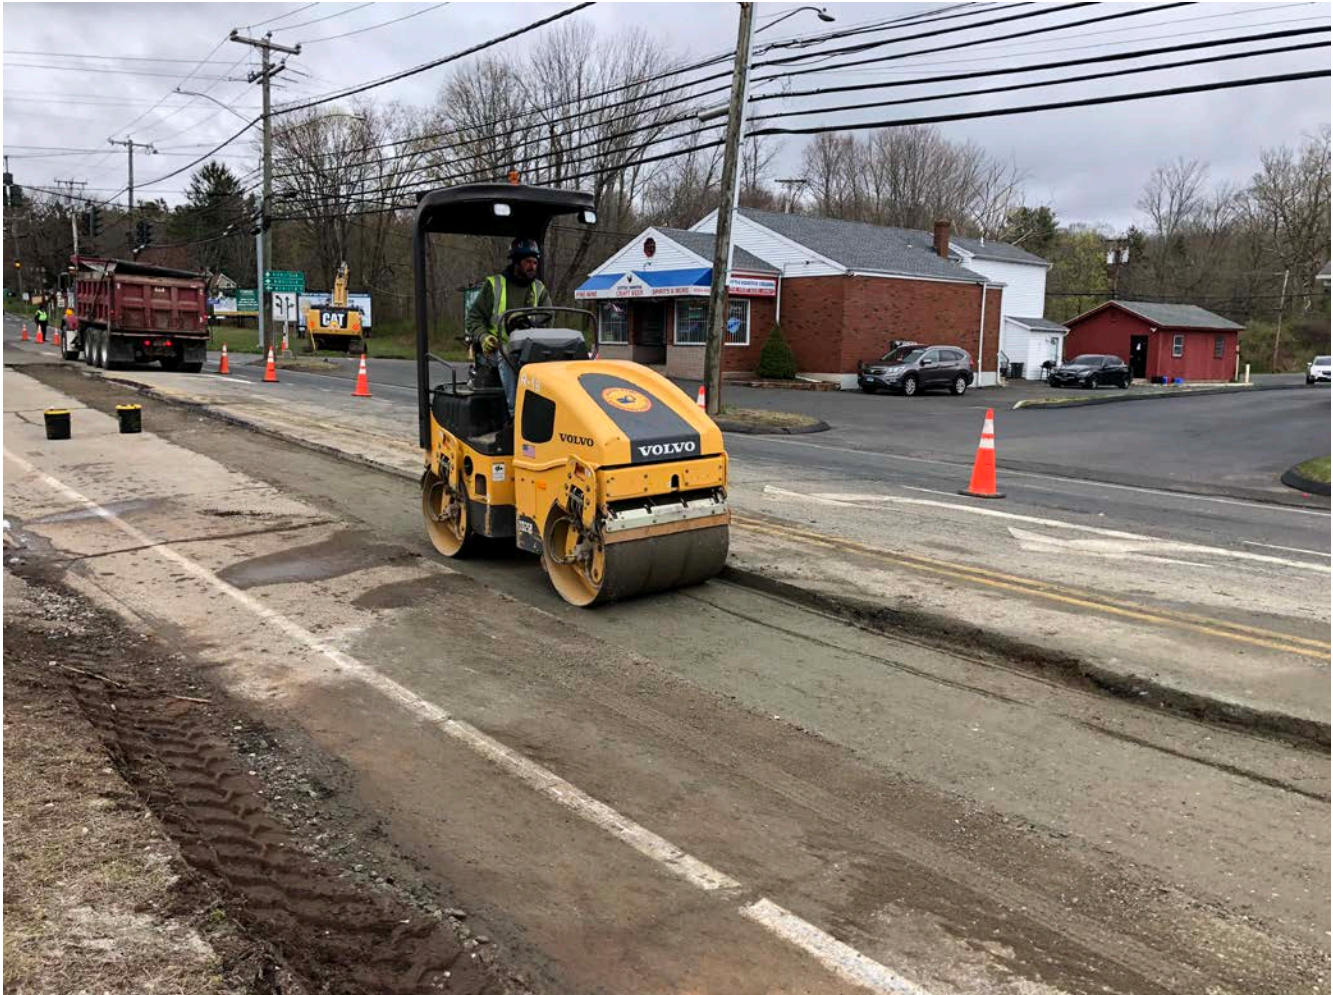
1400: Ludlow has ended the day with 16" DIP placed up to Station 169+40. The hydrant TEE/valve at Station 169+72 was not placed today. The trench has been almost completely backfilled and compacted. A CTDOT representative is on site observing backfilling and compaction activities.

Picture 9: Ludlow compacting backfill at ~Station 168+00. View to the northeast. Durham, CT.
