## Daily Report

<b>Project:</b>	Durham Meadows Pipeline Installation	<b>Date:</b>	May 7, 2020
<b>Location:</b>	Main Street, Durham and shared access road, Middletown, CT	<b>Day of Week:</b>	Thursday
<b>Project #:</b>	AECOM: 6061487	<b>Report No:</b>	73
<b>Contractor:</b>	Ludlow Construction	<b>Page:</b>	1 of 13

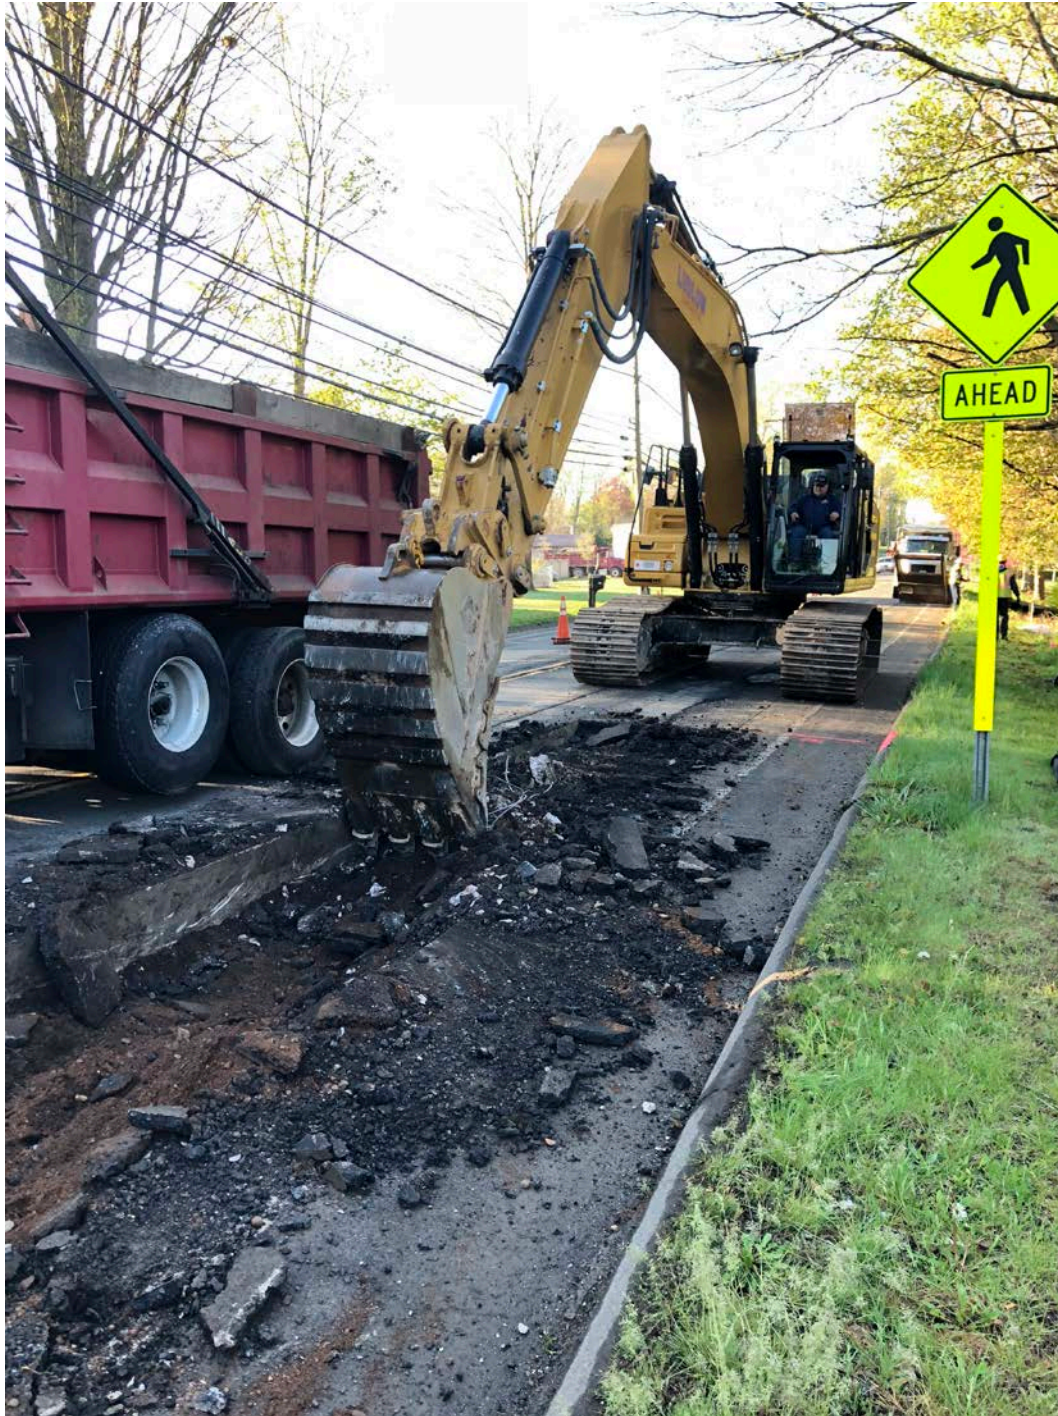
Picture 1: Ludlow excavating on the southbound lane of Main Street at Station 180+52.5. View to the south. Durham, CT.

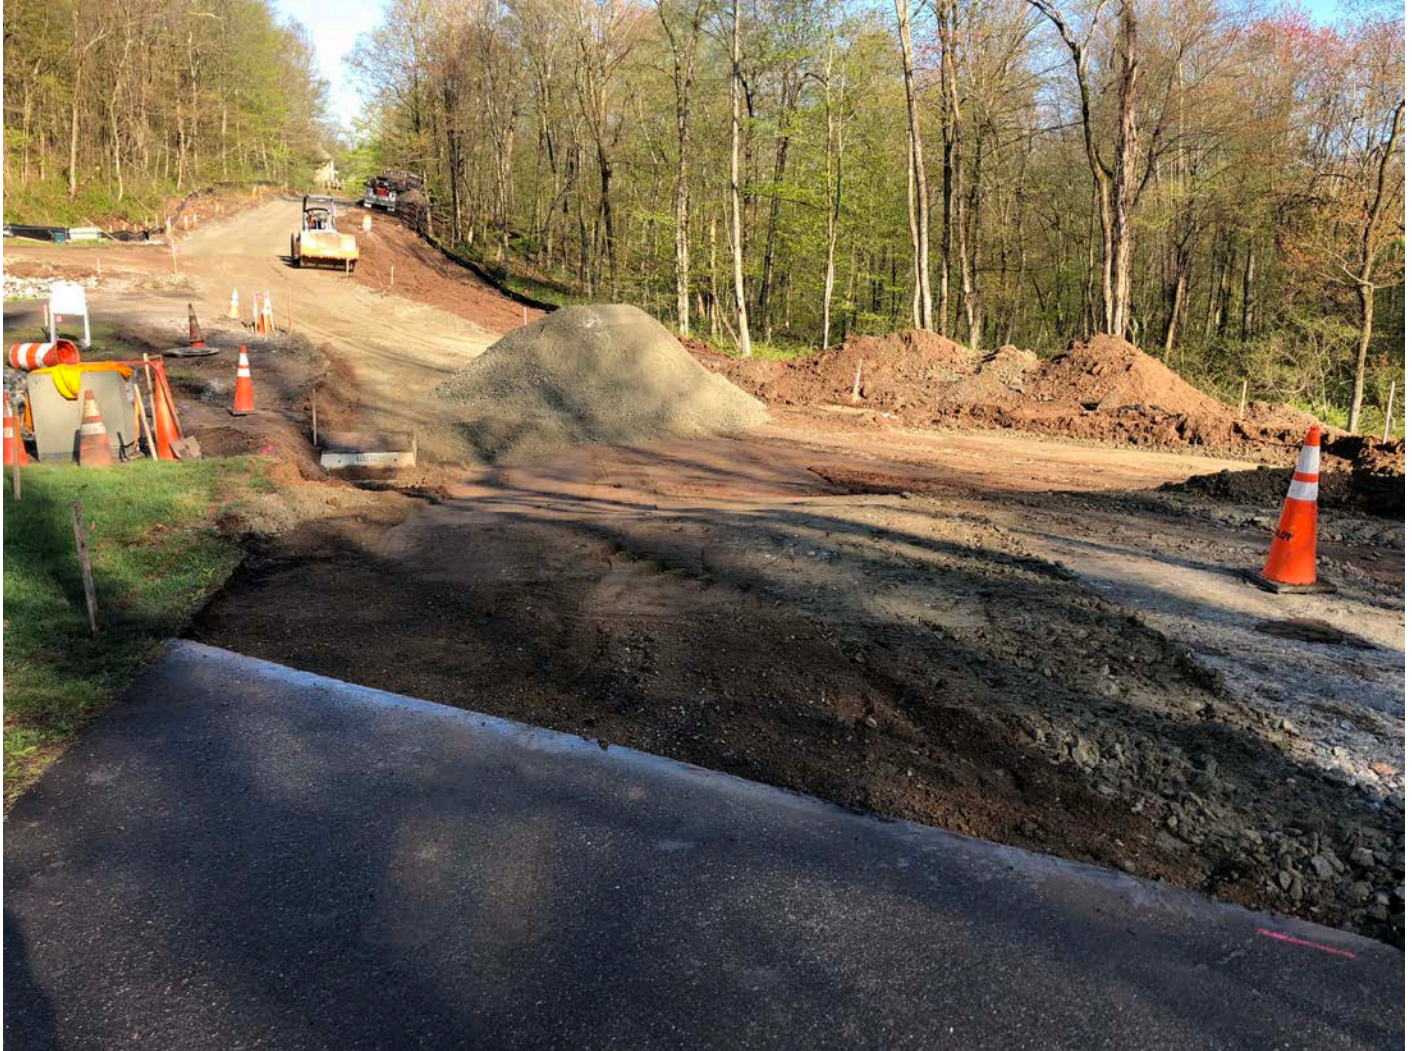
Picture 2: Driveway for 214 Talcott Ridge Drive after end was saw cut to make a clean transition to the shared access road. View to the northwest. Middletown, CT.

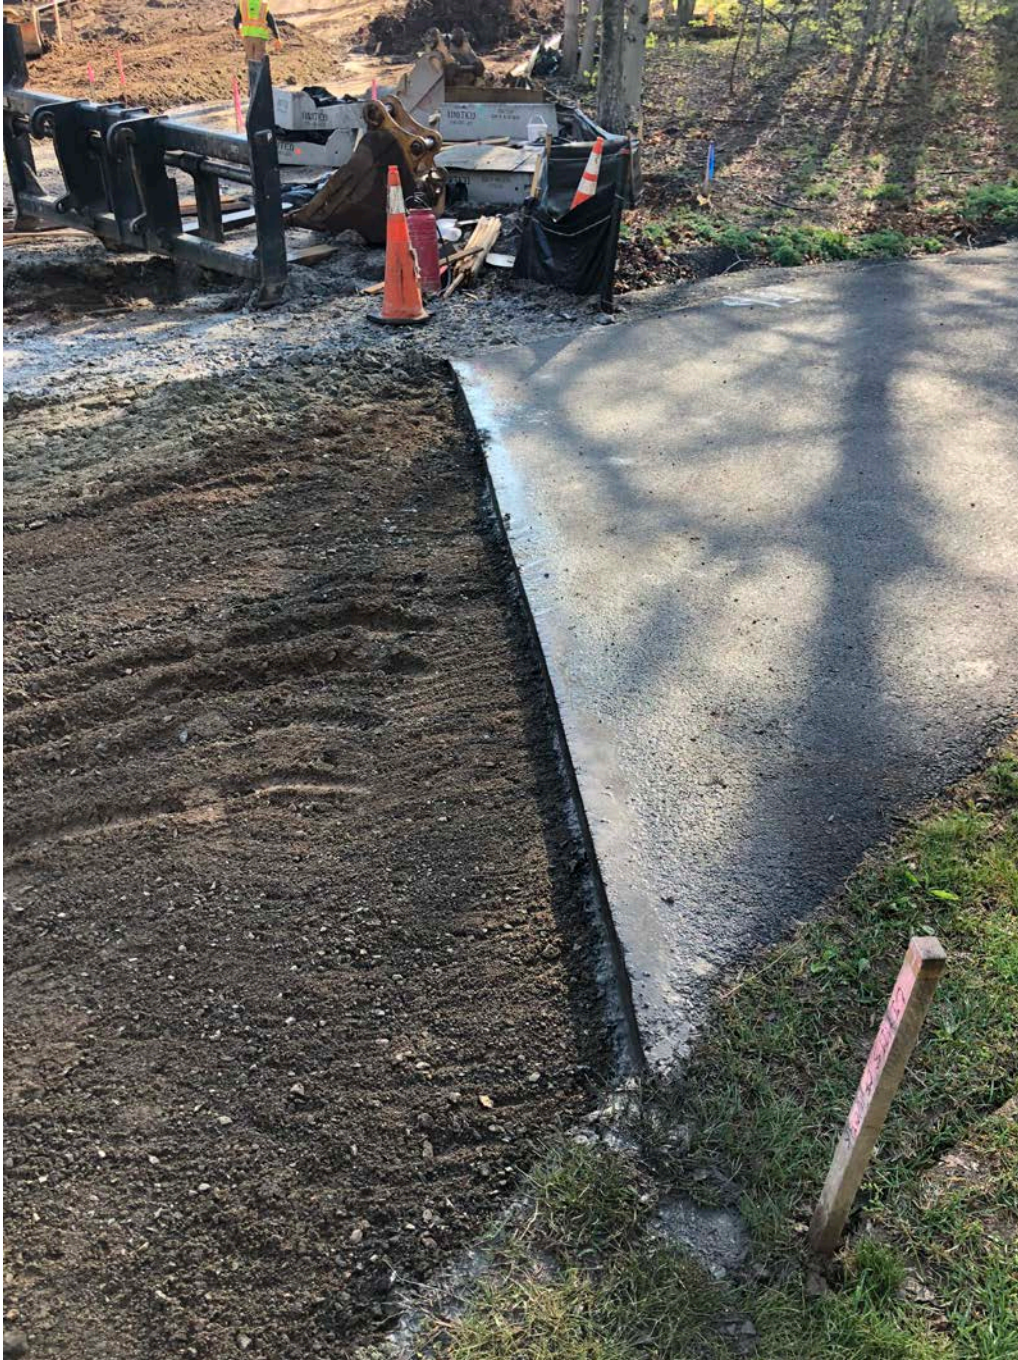
Picture 3: Driveway for 214 Talcott Ridge Drive after end was saw cut to make a clean transition to the shared access road. View to the east. Middletown, CT.

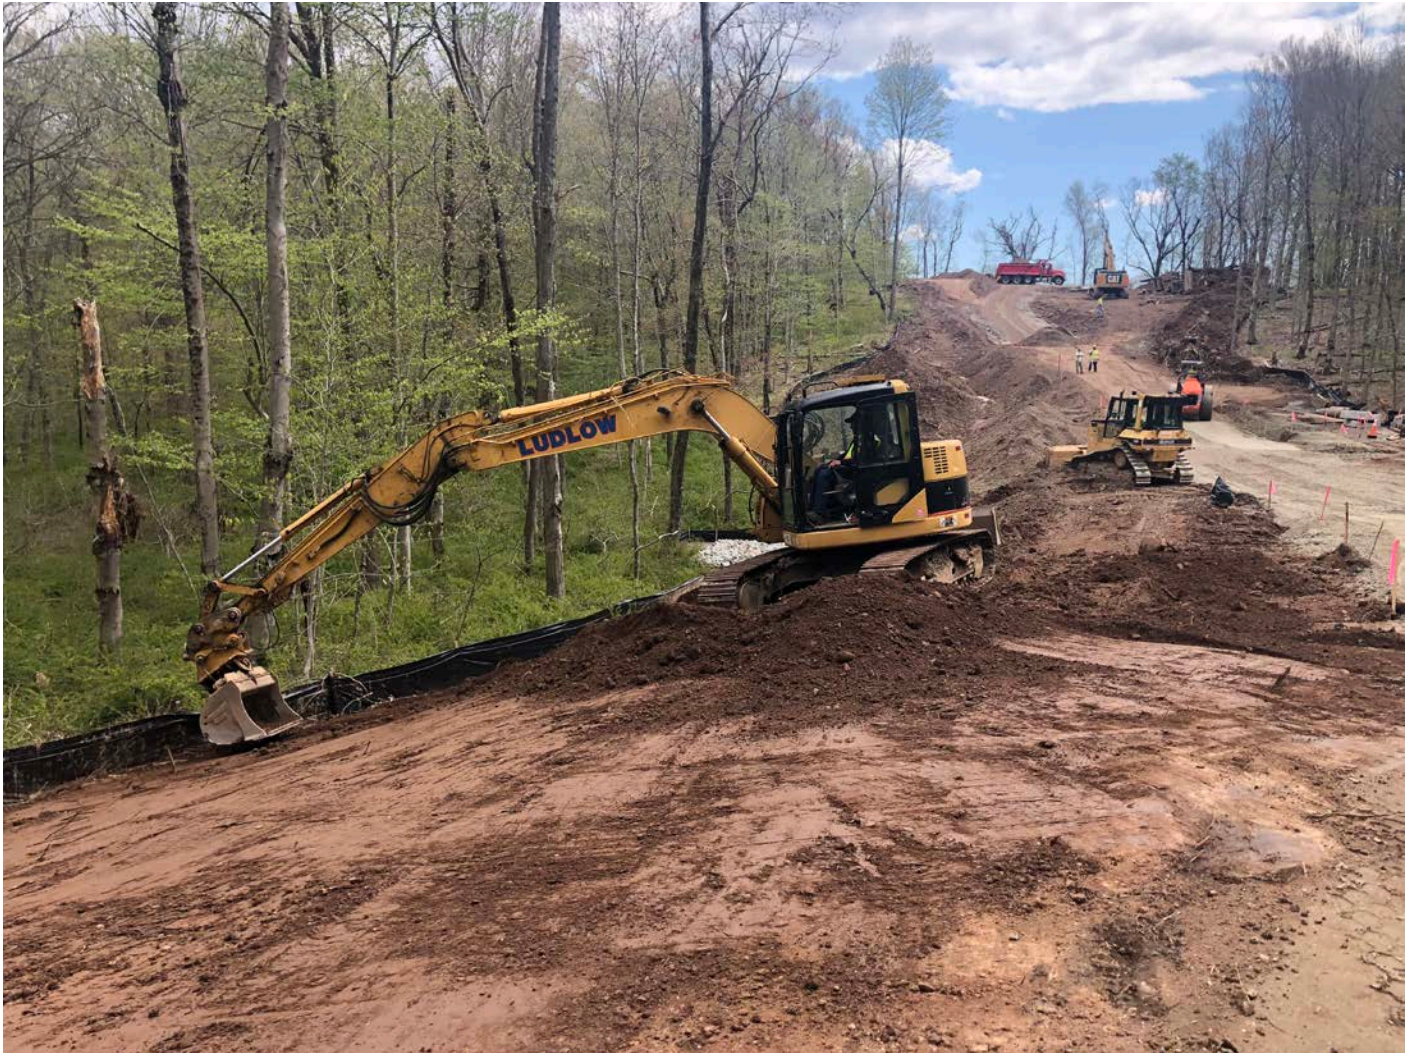
**Picture 4: Ludlow filling and grading along the north side of the shared access road. ~Station 15+50. View to the east. Middletown, CT.**

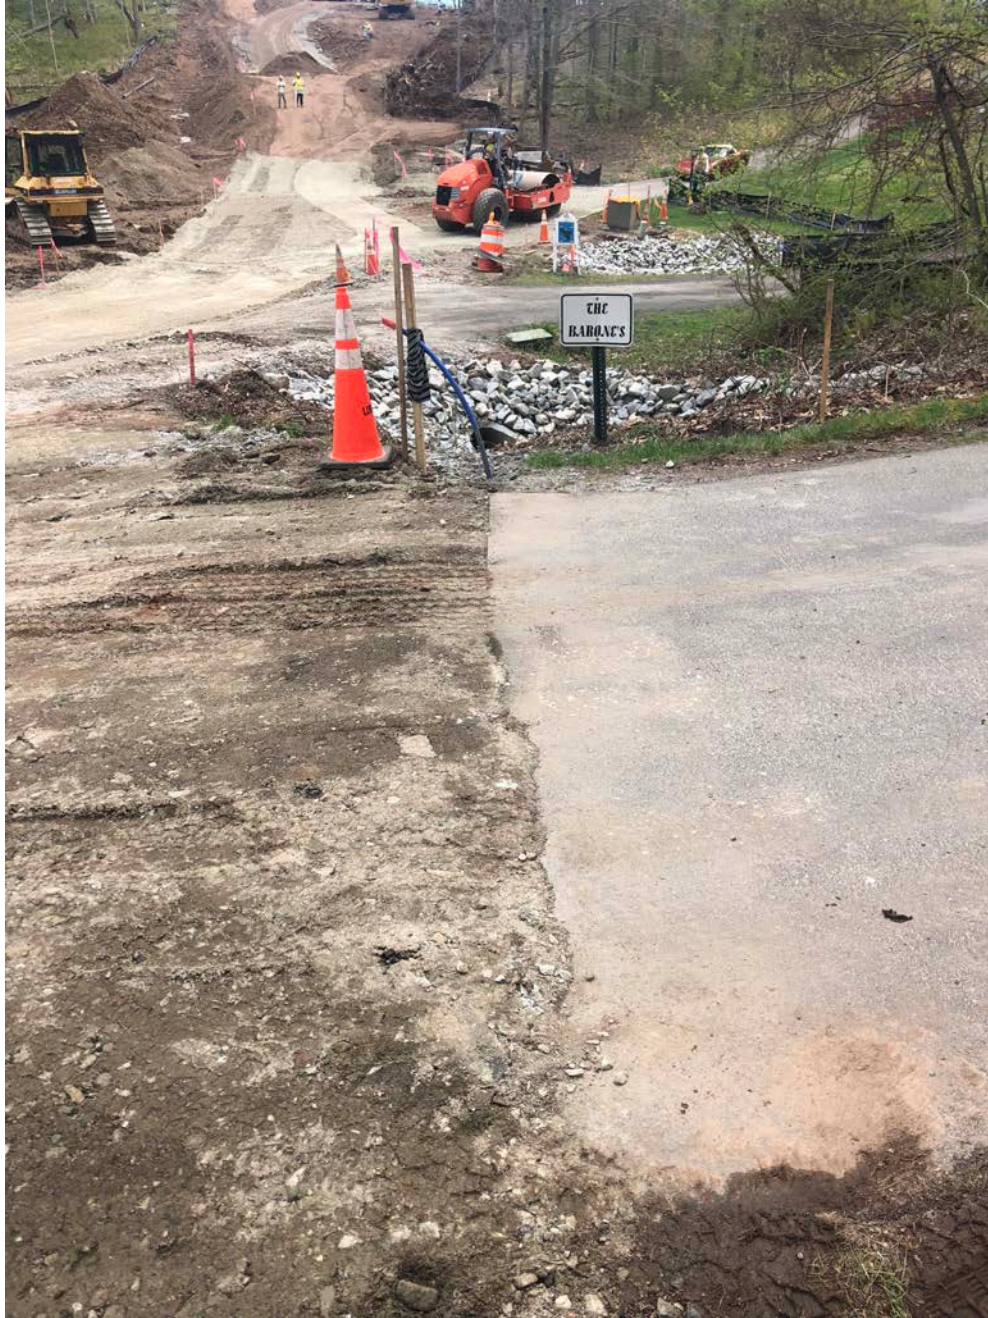
**Picture 5: Driveway for 224 Talcott Ridge Drive after end was saw cut to make a clean transition to the shared access road. View to the east. Middletown, CT.**

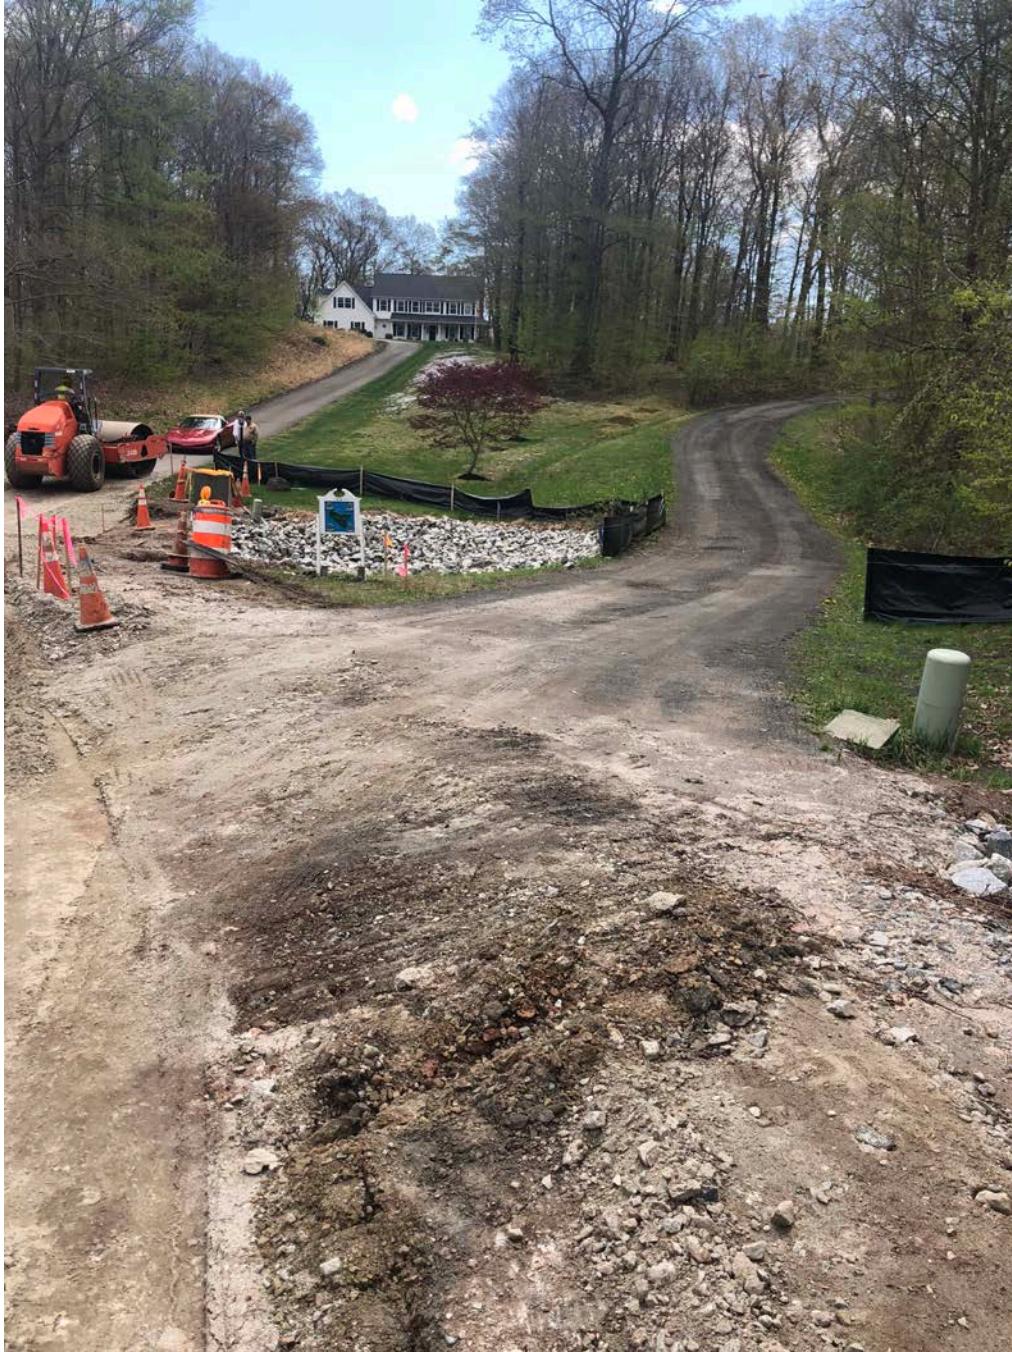
**Picture 6: Driveway for 216 Talcott Ridge Drive as it transitions to the shared access road. View to the east. Middletown, CT.**

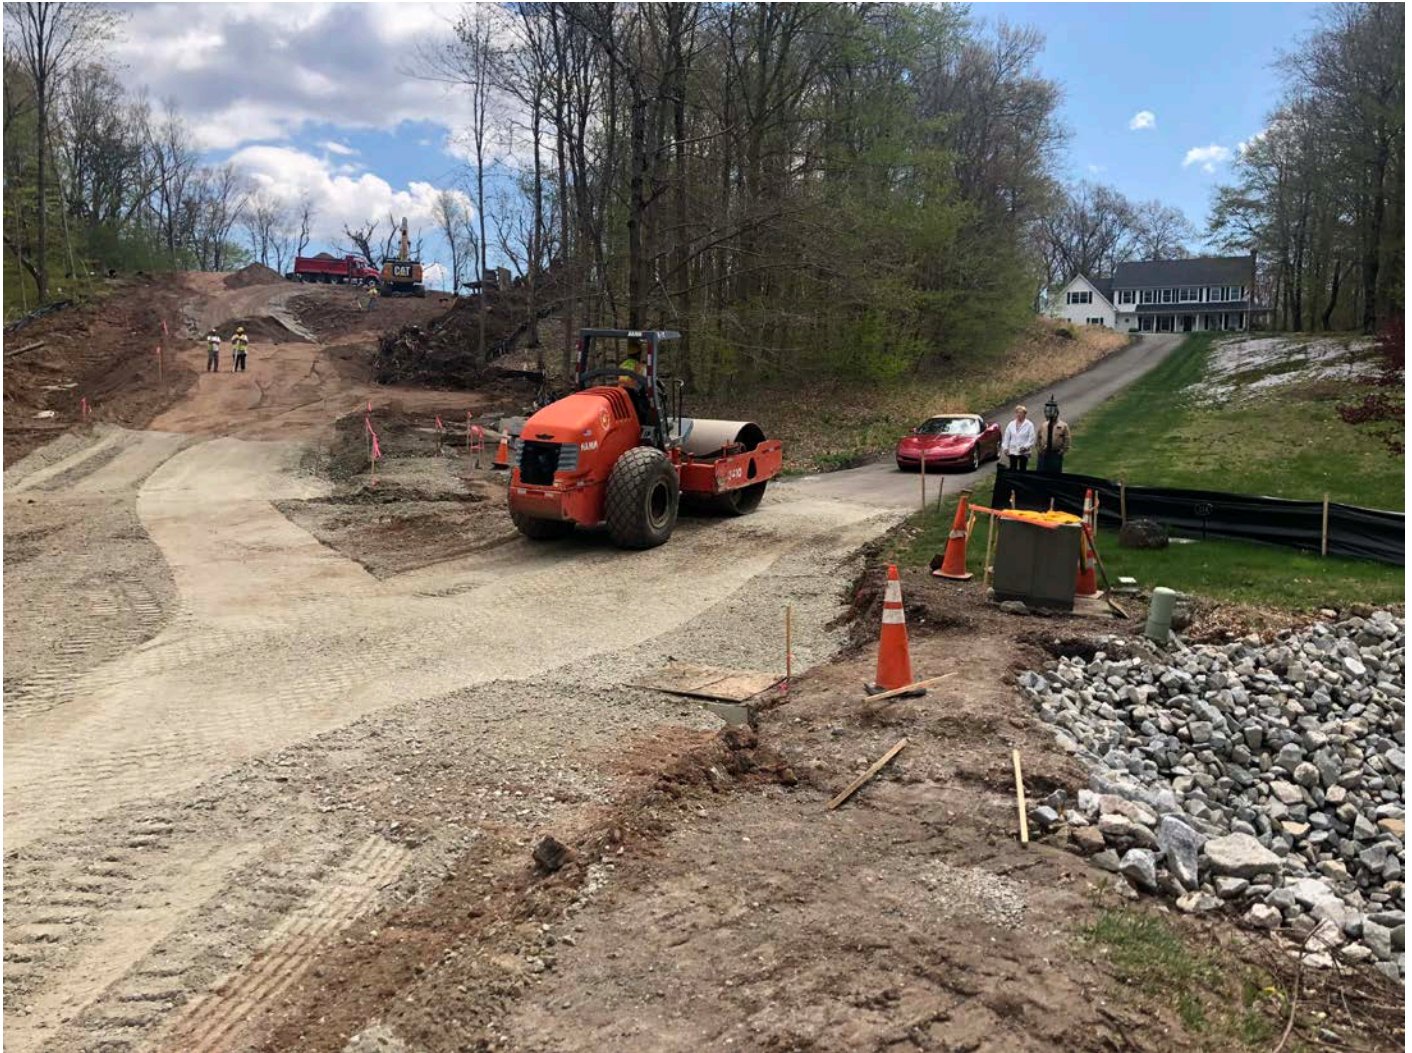
**Picture 7: Ludlow compacting fill adjacent to the driveway for 214 Talcott Ridge Drive. View to the southeast. Middletown, CT.**

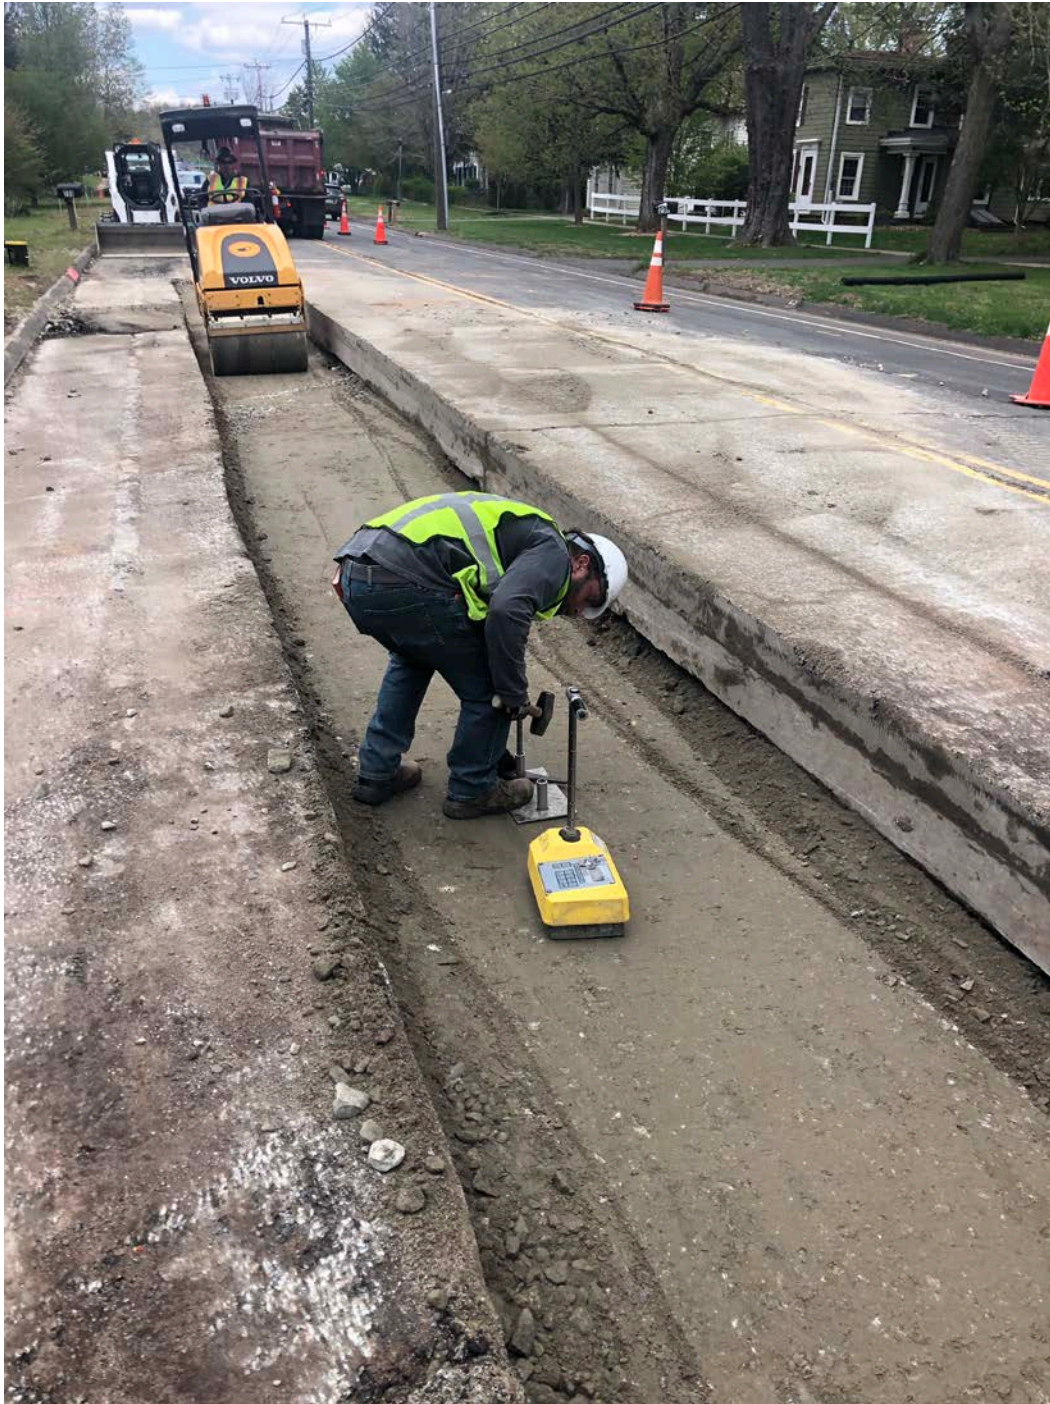
Picture 8: JTC performing compaction testing along the southbound lane of Main Street. View to the northeast. Middletown, CT.

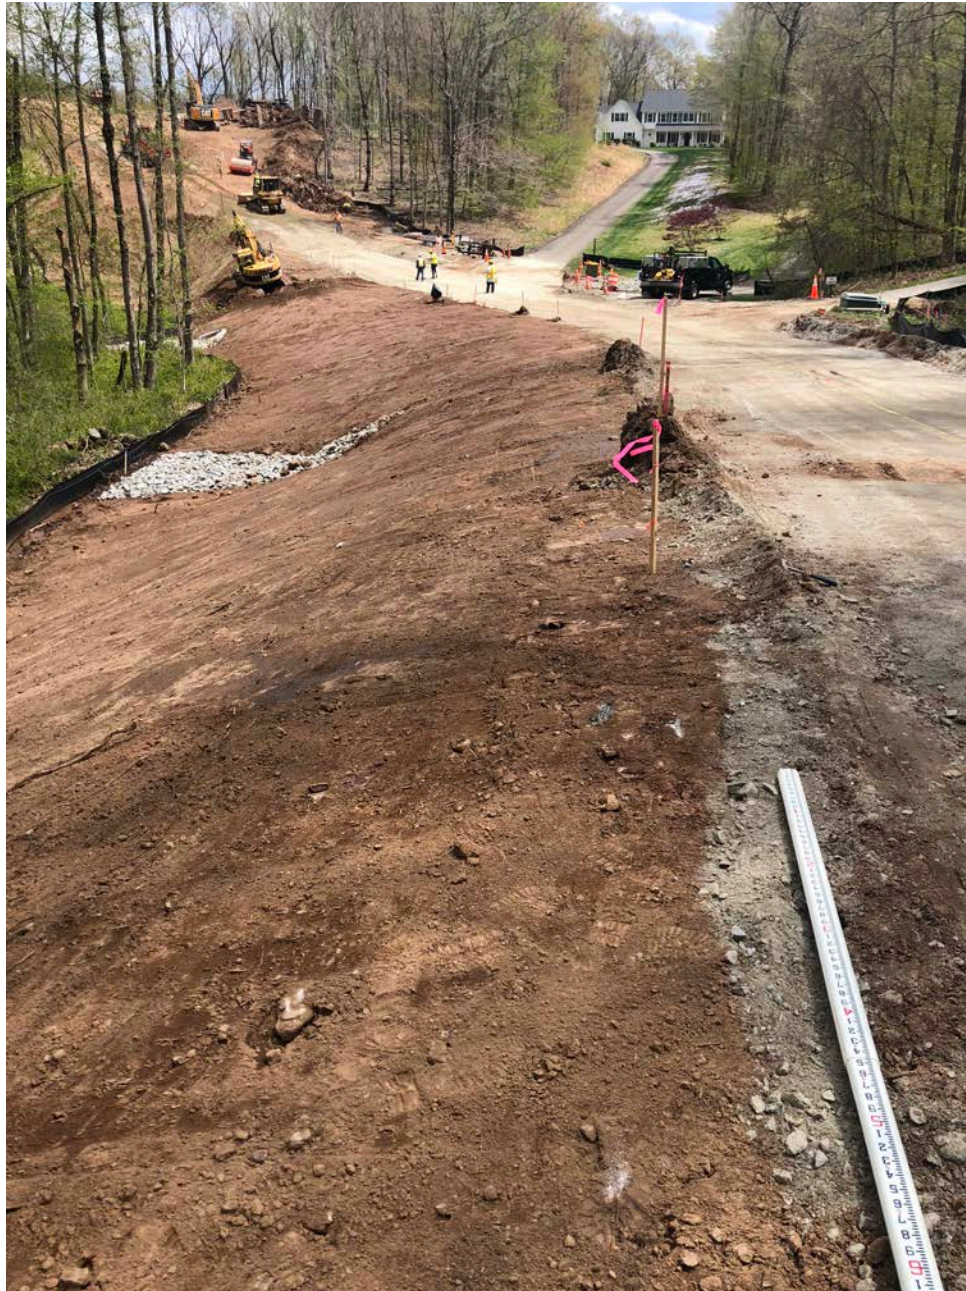
Picture 9: View at the end the day of filling and grading activities along the north side of the shared access road. View to the east. Middletown, CT.
