## Daily Report

<b>Project:</b>	Durham Meadows Pipeline Installation	<b>Date:</b>	June 5, 2020
<b>Location:</b>	Pickett Lane, Durham; Main Street, Durham; and Shared Access Driveway, Middletown;	<b>Day of Week:</b>	Friday
<b>Project #:</b>	AECOM: 6061487	<b>Report No:</b>	92
<b>Contractor:</b>	Ludlow Construction	<b>Page:</b>	1 of 11

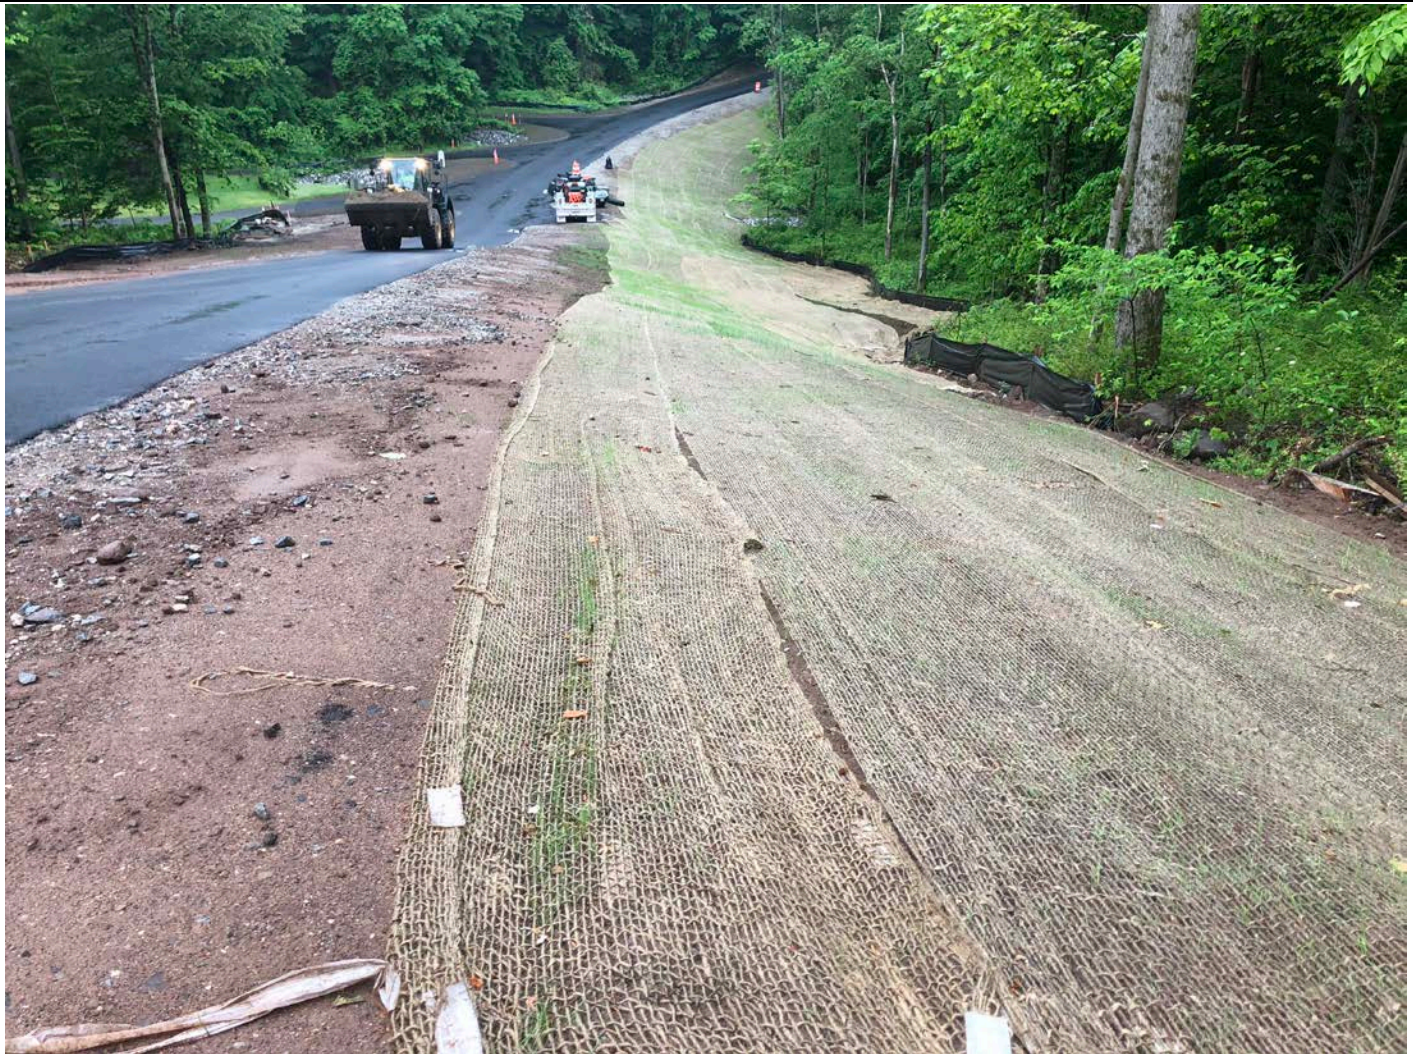
**Picture 1: Updated view of grass seed germination on the north side of the shared access driveway. View to the west, Middletown, CT.**

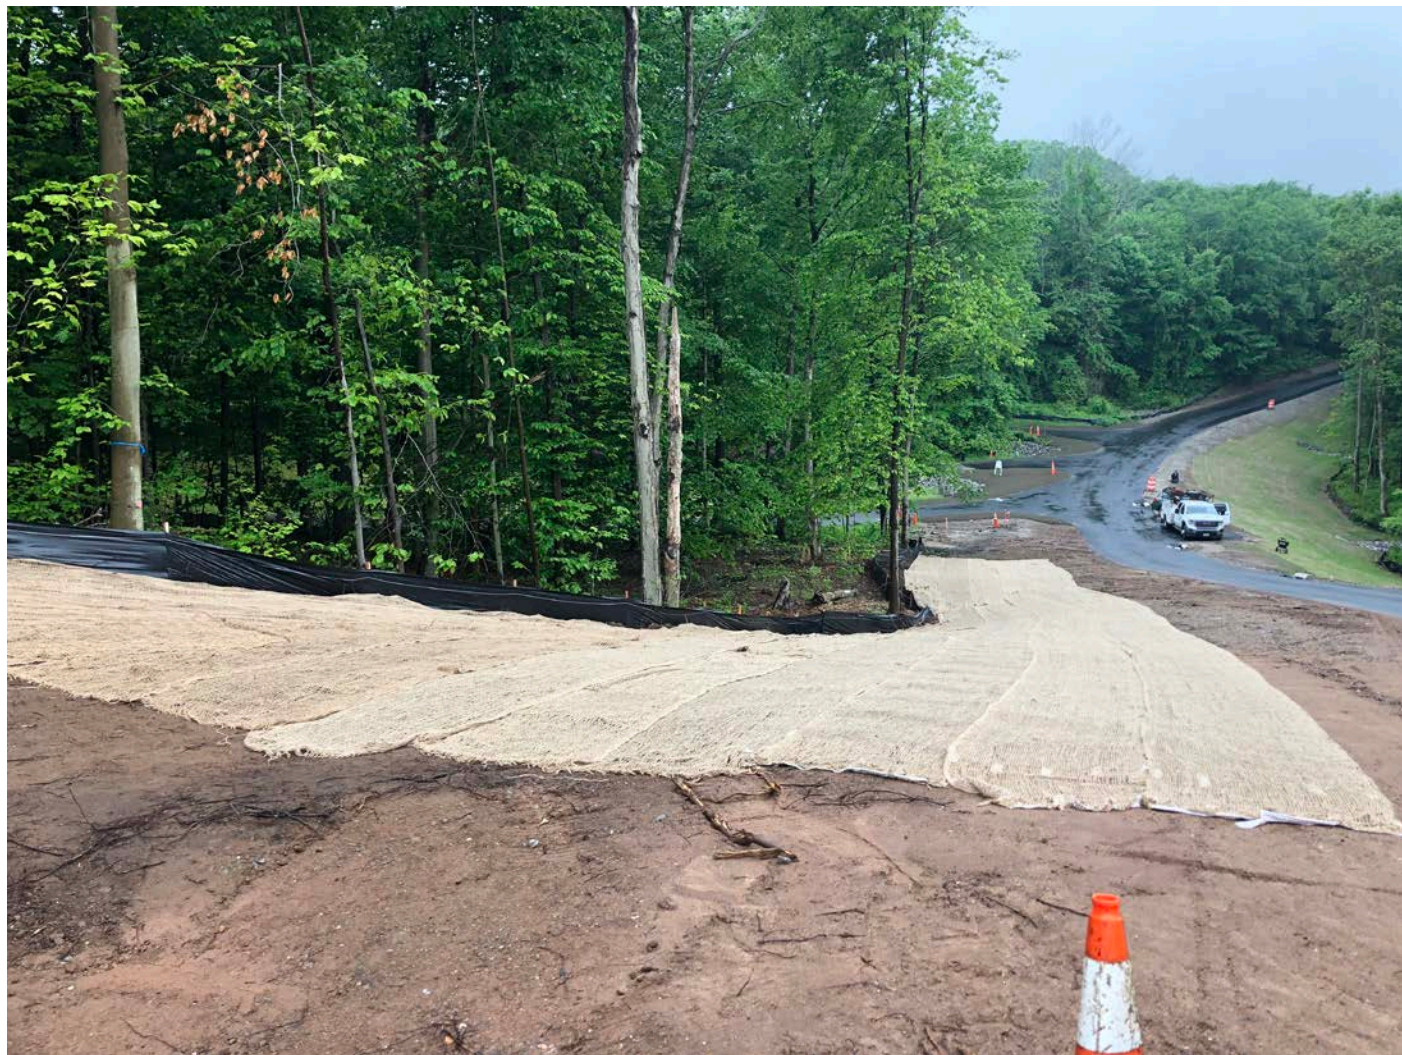
**Picture 2: South side of the shared access driveway after being seeded and having erosion control blankets placed over seed. View to the west. Middletown, CT.**

Ludlow placed fill to the west of the footprint of the water tank today. Ludlow rolled the edge of pavement on the shared access driveway, placed fill adjacent to the driveway, and placed grass seed. In addition, Ludlow placed erosion control blankets on the south side of the shared access driveway from Stations 14+40 to 11+00.

0831: Ludlow is seeding and placing erosion control blankets on the south side of the shared access driveway from Stations 14+40 to 11+00. Ludlow continues to place fill in the depressed area east of the footprint of the water tank.

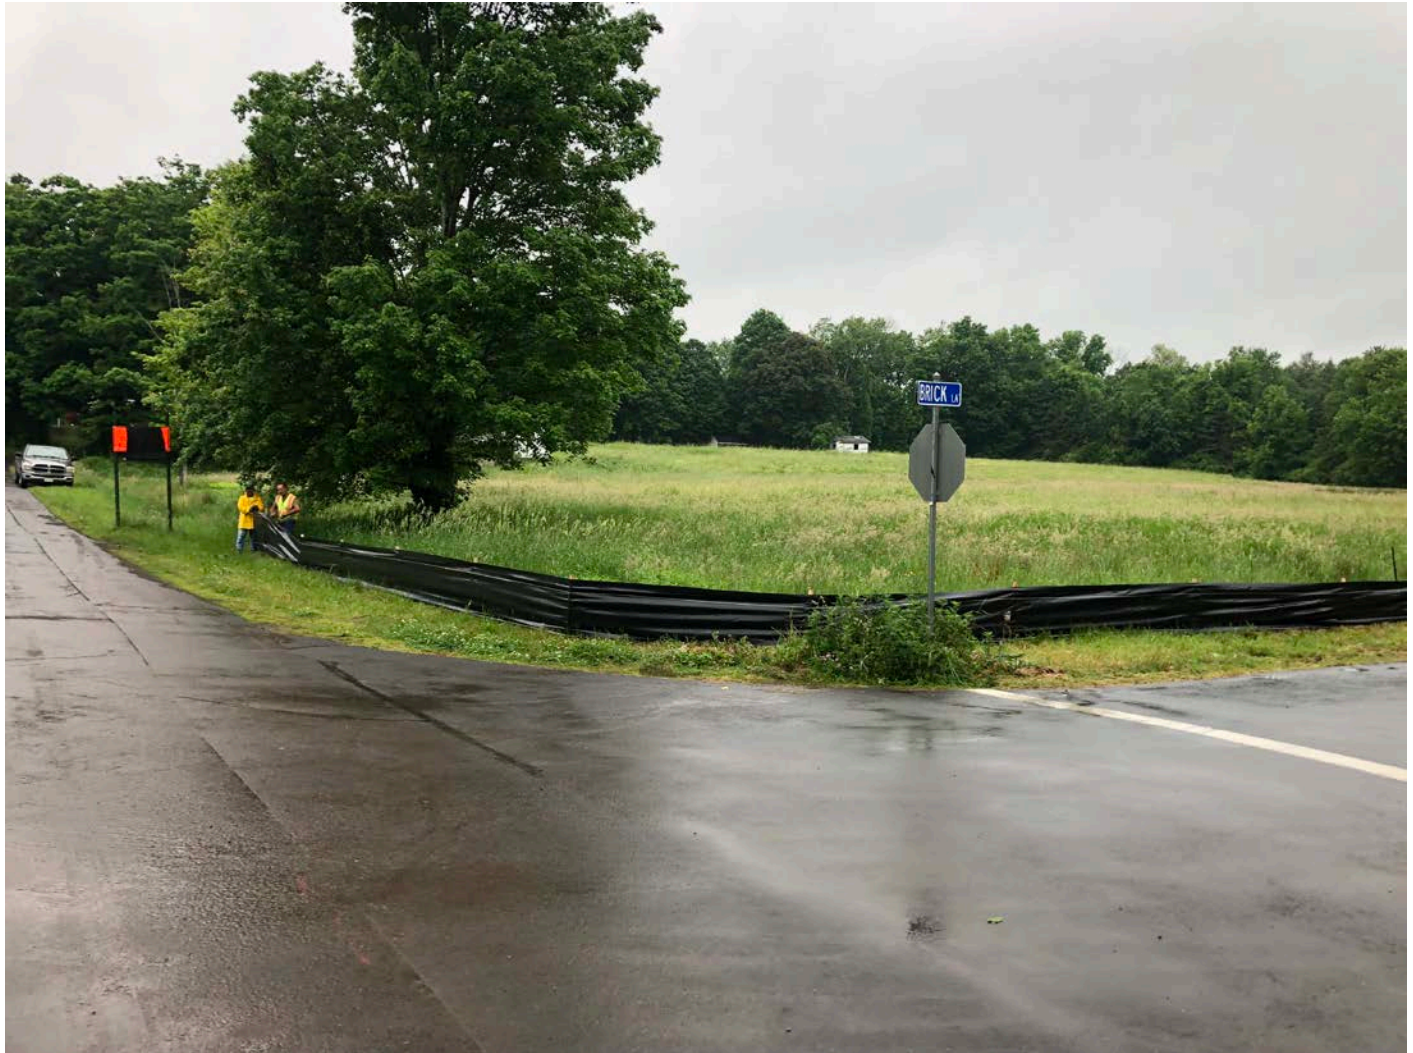
Picture 3: Ludlow at the intersection of Brick Lane and Maiden Lane, placing silt fence. View to the west. Durham, CT.

Ludlow installed silt fence on Maiden Lane from the intersection of Brick Lane and Maiden Lane, west to ~Station 408+00.

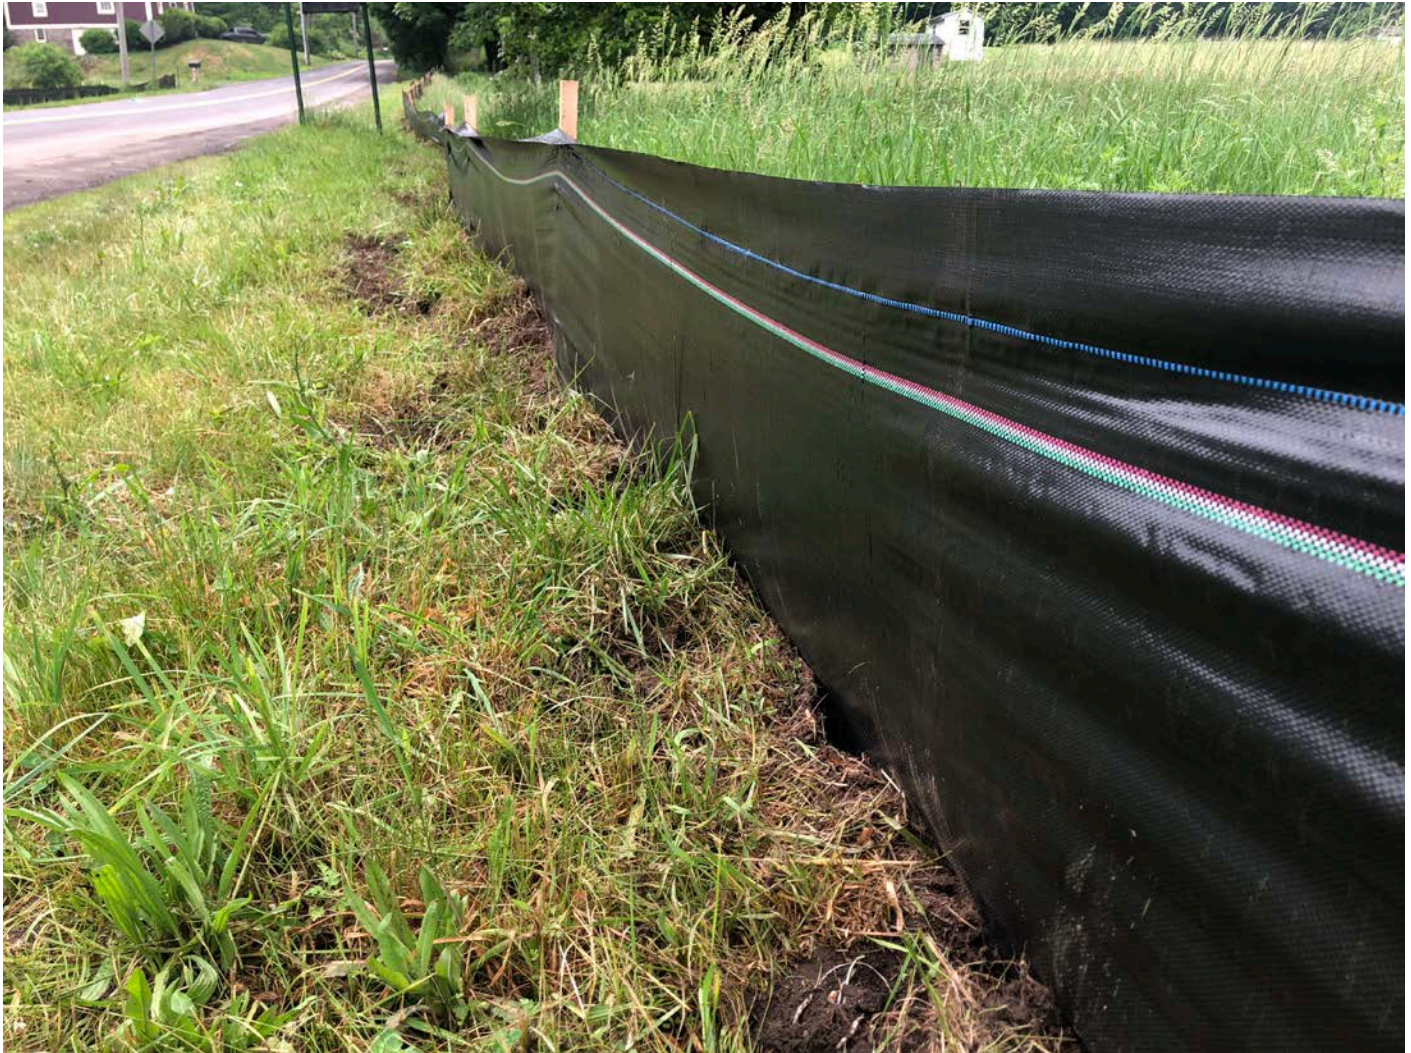
**Picture 4: Bottom of silt fence secured below grade by Ludlow. View to the west. Maiden Lane, Durham, CT.**

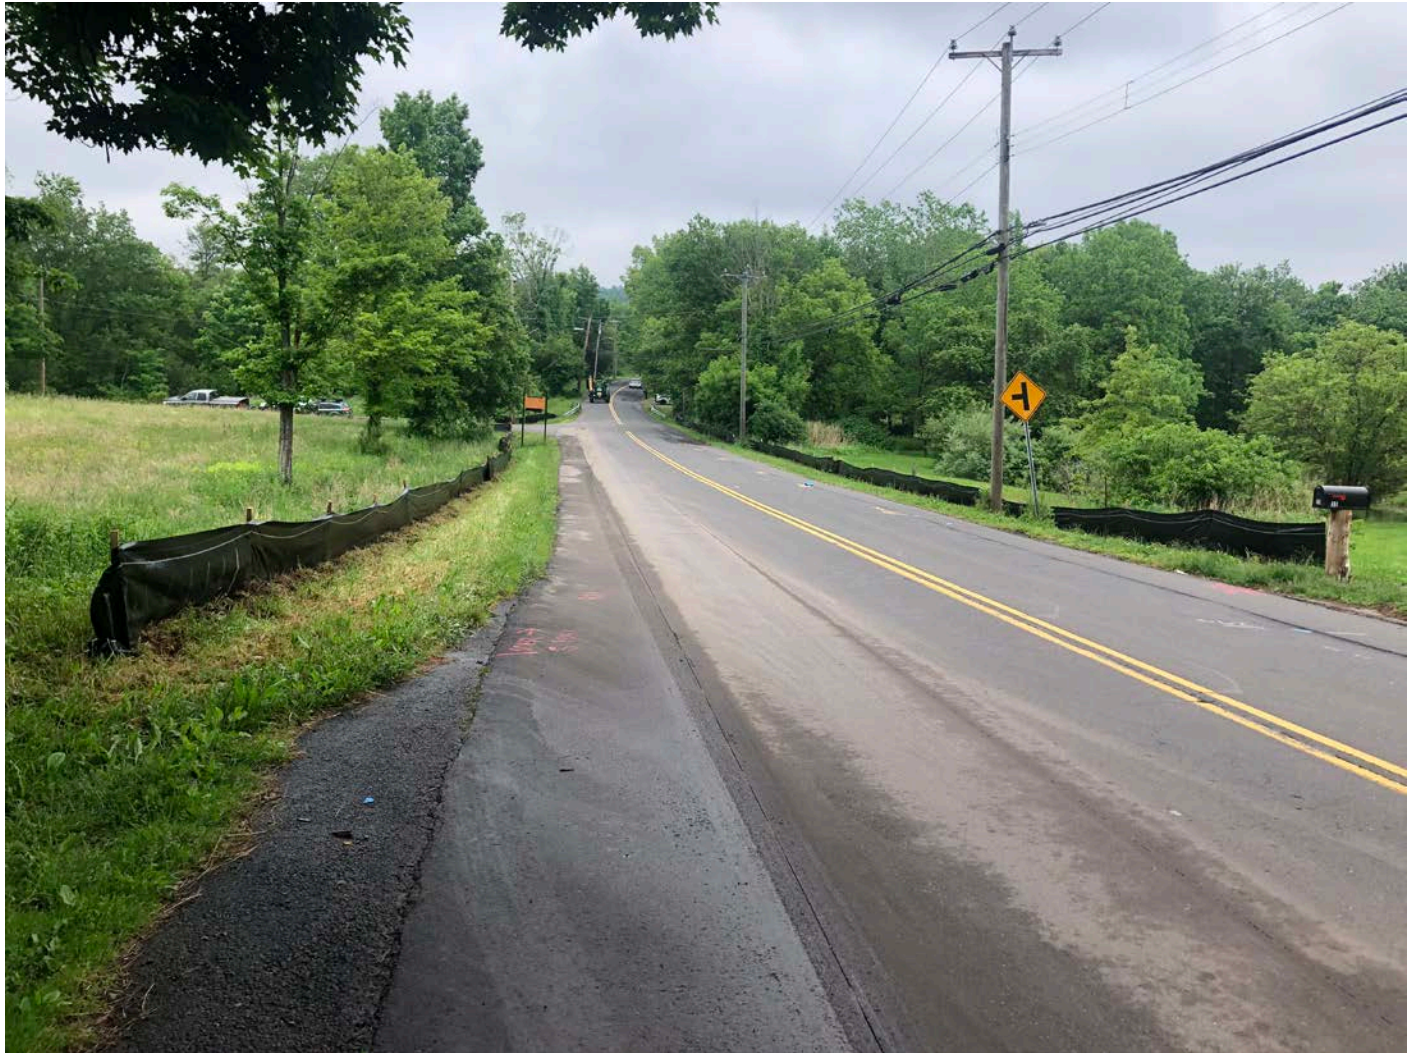
Picture 5: Silt fence placed by Ludlow on Maiden Lane. View to the east. Durham, CT.

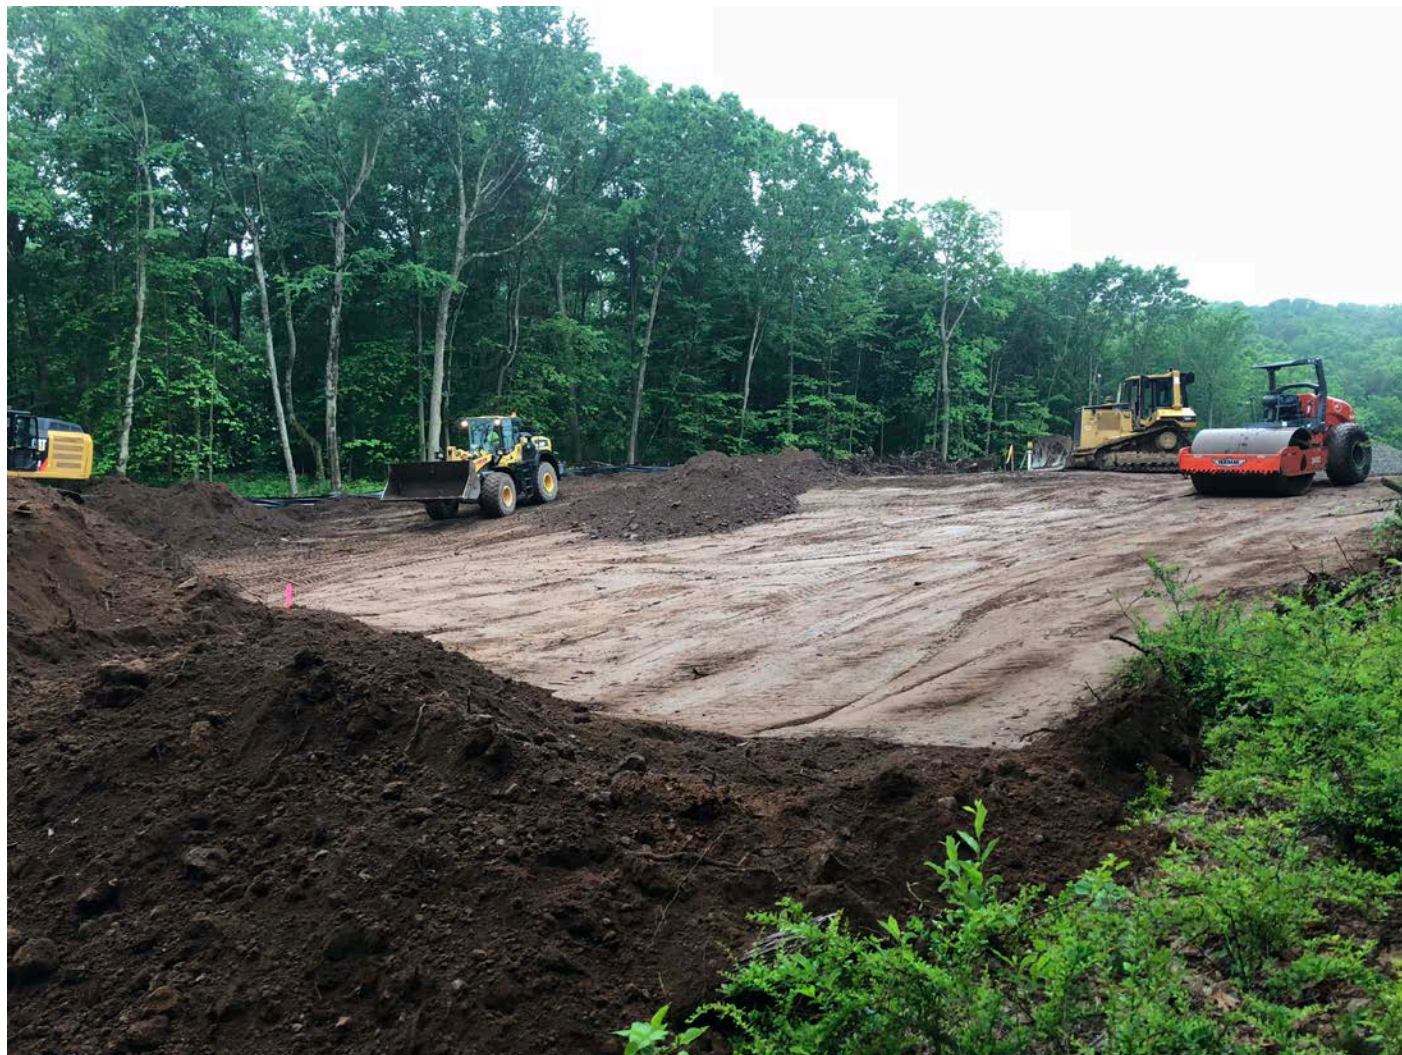
Picture 6: Area to the east of the water tank footprint being filled. View to the southwest. Middletown, CT.

0725: Ongoing work includes rolling the edges of pavement and placing loam and grass seed on the edge of the driveway. Ludlow is also placing fill in a depression to the east of the water tank footprint.

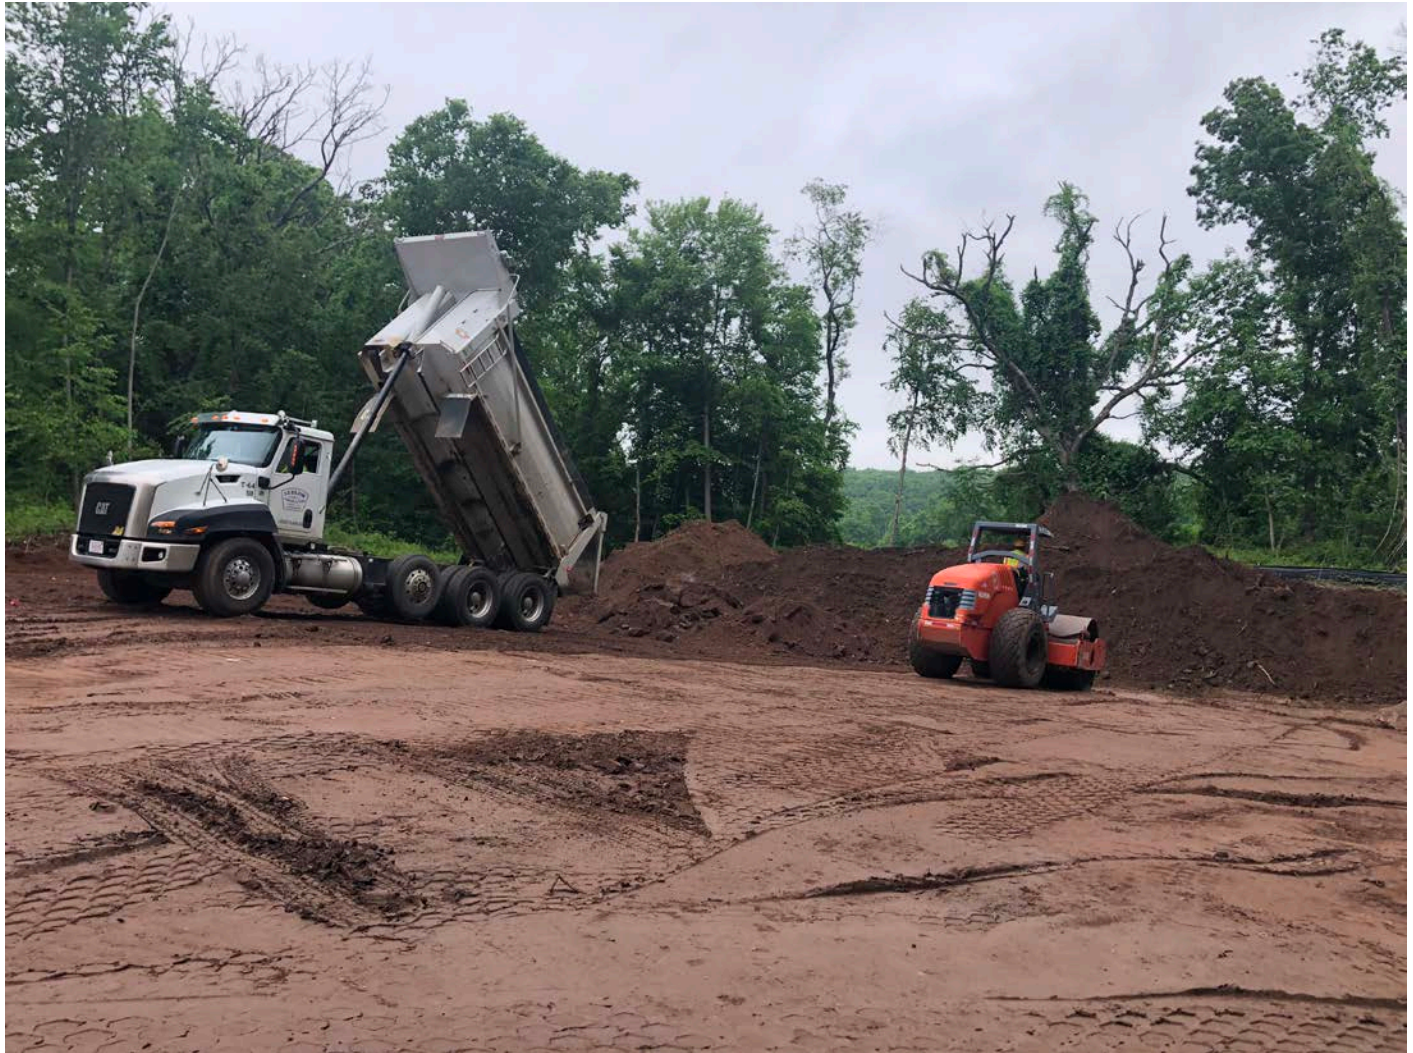
**Picture 7: Ludlow placing fill at the area located east of the water tank footprint. View to the northeast. Middletown, CT.**

1044: Ludlow continues to place and grade fill to the east of the tank pad.

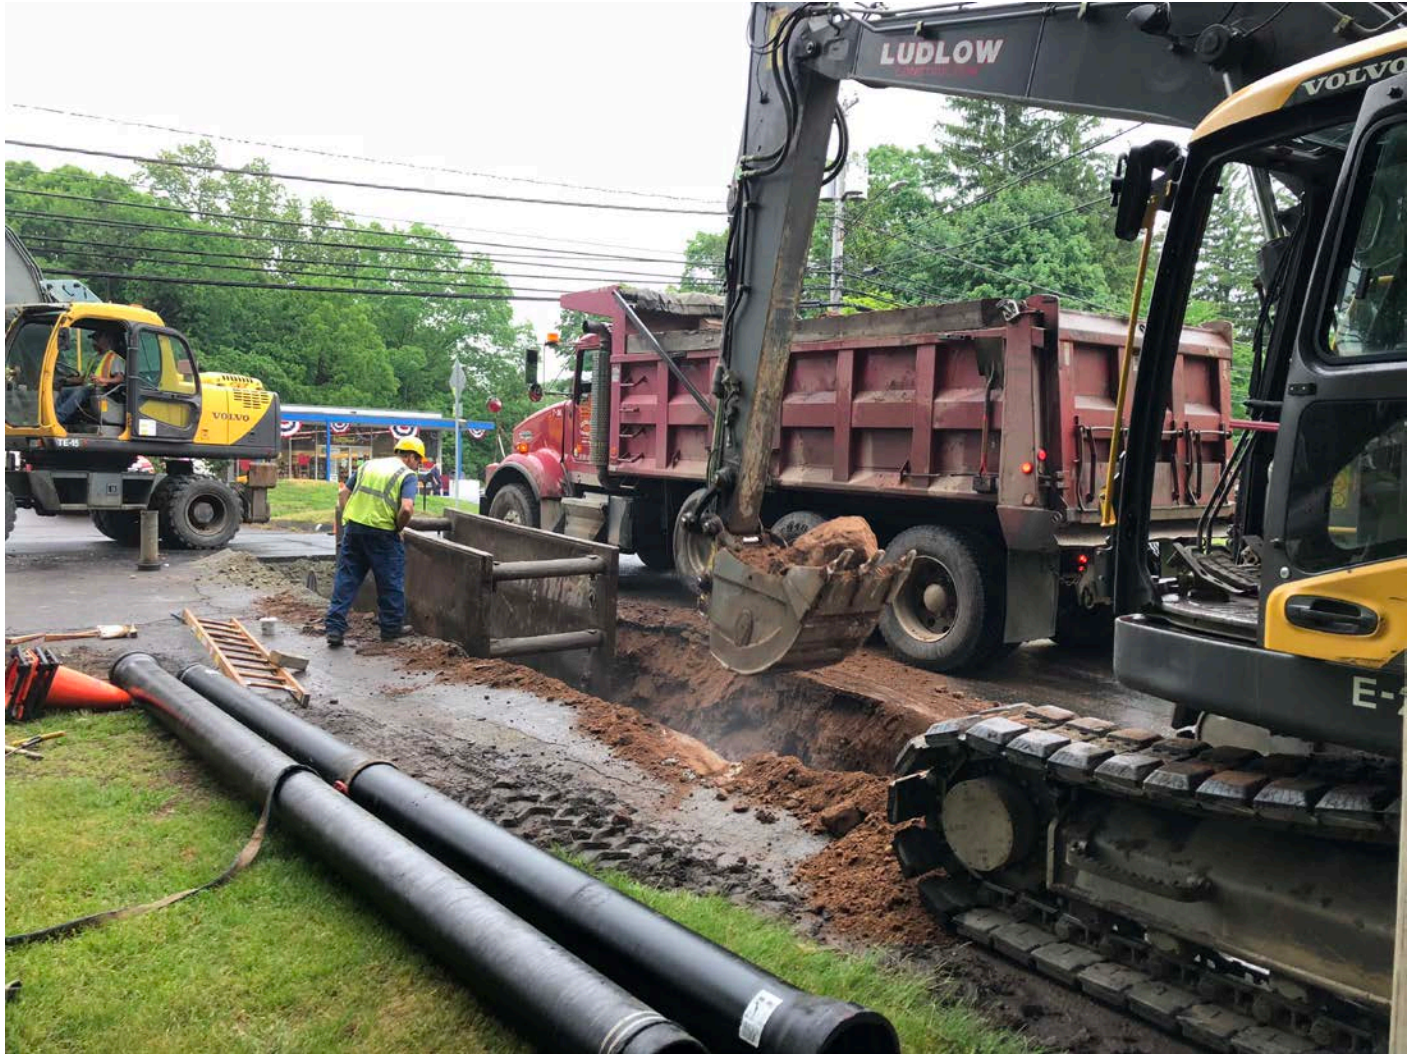
Picture 8: Ludlow placing 8" DIP on Talcott Lane. View to the southeast. Durham, CT.

0915: Ludlow continues to excavate on Talcott Lane at Station 175+27, moving west. Ludlow has 20' of 8" DIP installed so far, coming off a previously-installed valve on the main waterline that runs down Main Street. Ludlow has placed a 1" air bleed valve where the 8" DIP connects to the valve on the main water line.

1008: Approximately 34' of 8" DIP has been installed on Talcott Lane.
